INITIAL ASSESSMENT STUDY
NAVAL STATION
ROOSEVELT ROADS, PUERTO RICO

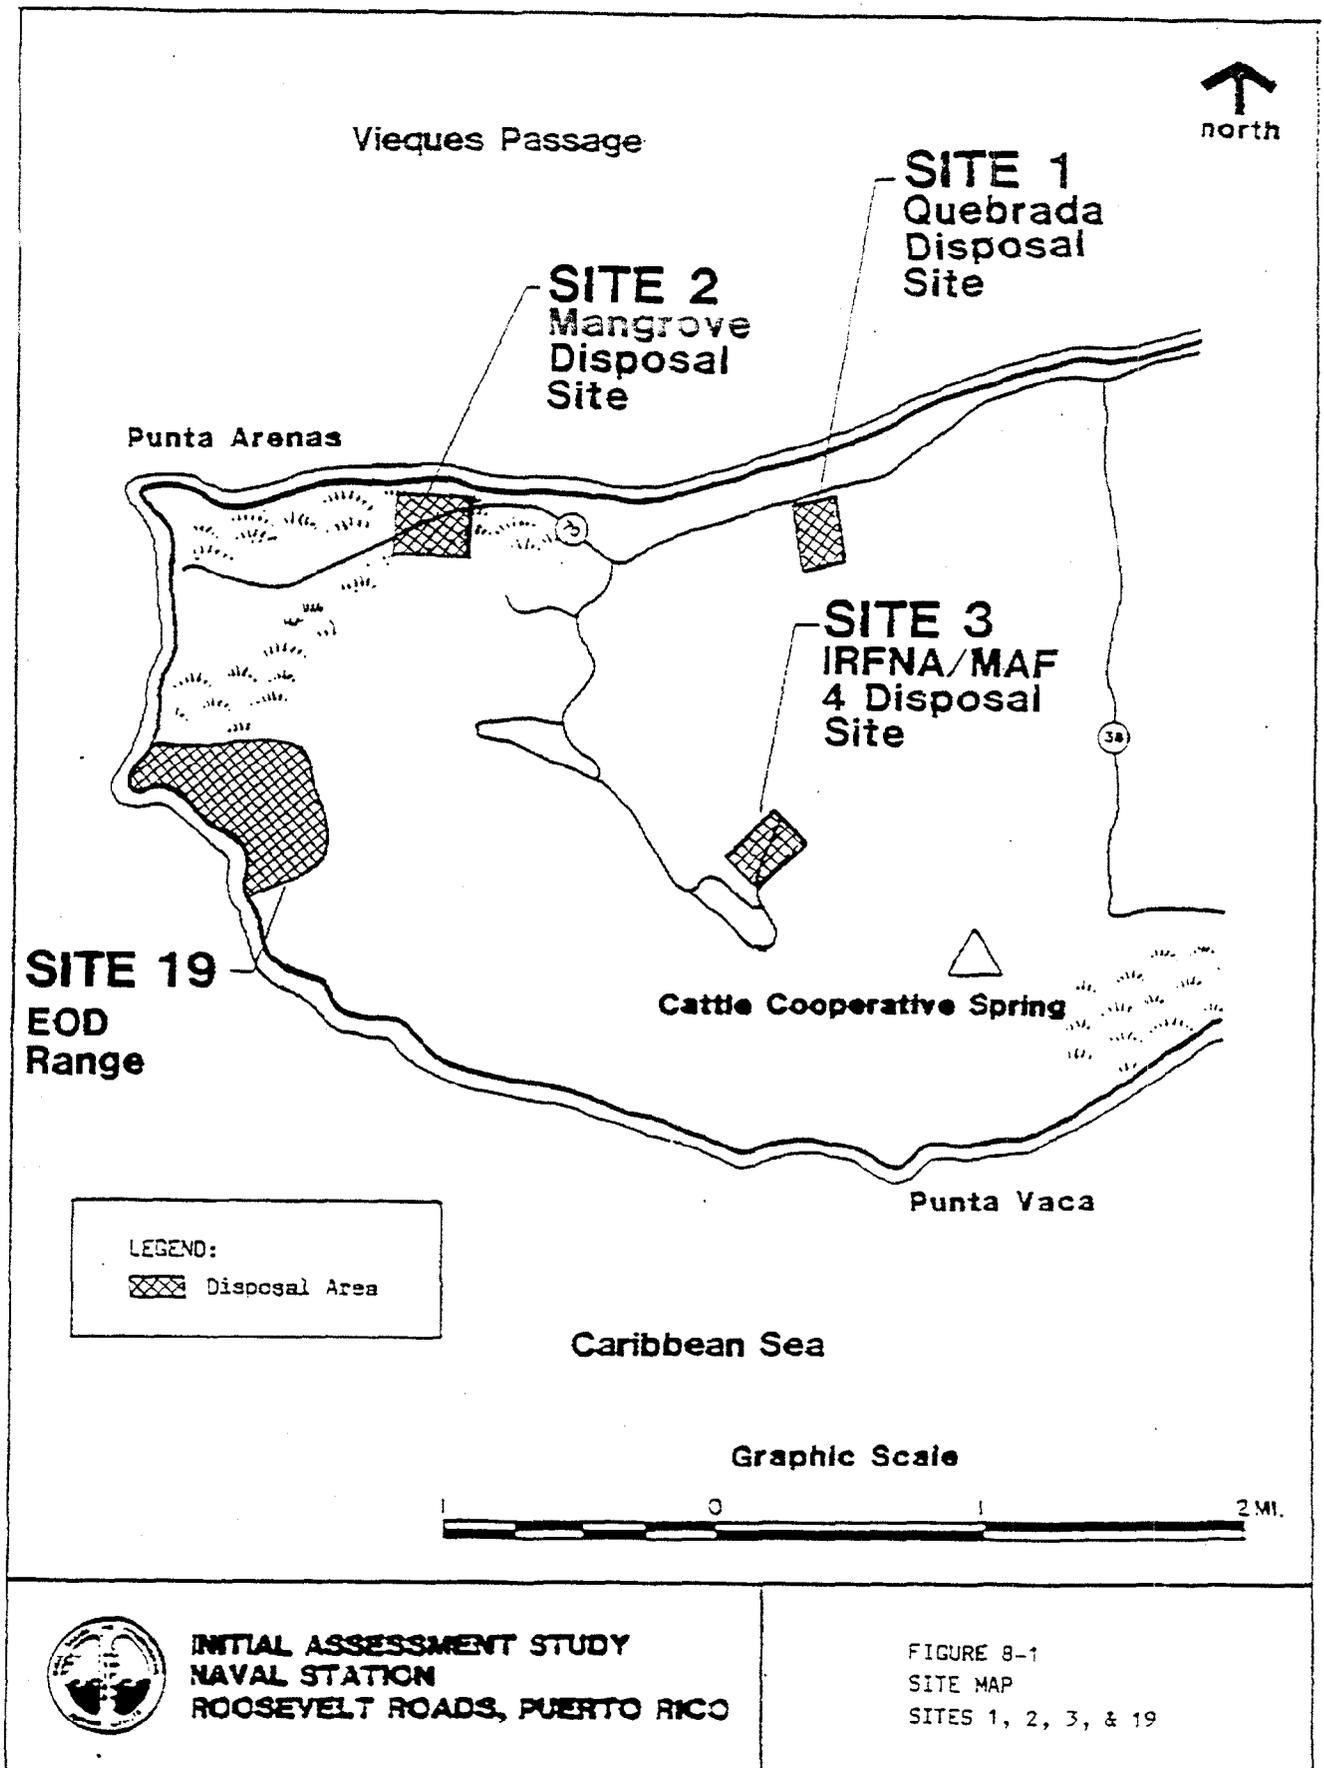
FIGURE 8-1
SITE MAP
SITES 1, 2, 3, & 19

2.1 SITE 1, QUEBRADA DISPOSAL SITE, VIEQUES. This disposal site is located in a quebrada (an intermittent drainage area) south of North Shore Road in the north-central portion of the Naval Ammunition Facility (NAF), Vieques. A dirt road, present along the east side of the quebrada, facilitated easy access to the site. The site was in use from the early 1960s to the late 1970s by both civilian and U.S. Navy personnel (see Figure 8-1).

Site boundaries extend approximately 500 feet along the quebrada in a southerly direction from North Shore Road. The quebrada varies from 20 to 30 feet wide and 10 to 20 feet deep. It is estimated that there are over 1,500 cubic yards (500 feet x 20 feet x 4 feet) of material present at the site, including buried and exposed apparently empty 55-gallon drums, ordnance carriers (2.75-inch rocket launchers), POL, solvent and paint cans, rubble, fluorescent light fixtures, and cars as well as all types of base trash including glass, metal, tires, wood, etc. The material had been tumbled over the side of the quebrada, apparently beginning at the southern end of the quebrada and moving northward along the east side of the quebrada. Attempts had been made to shore up the sides of the quebrada where the material had been deposited. Several steel posts, usually used by combat engineers to string barbed wire or other fencing material, had been driven into the sides of the quebrada apparently to stabilize the mass of disposed material. Some of the material, especially solvent containers, have become detached from the main pile and were lying in the silt and sand at the bottom of the quebrada, where they had apparently been washed to when water was flowing in the quebrada.

Site 1 is recommended for a Confirmation Study.
