IDENTIFICATION
OF
UNCONTAMINATED
PROPERTY
AT THE
NAVAL AMMUNITION
SUPPORT DETACHMENT
VIEQUES ISLAND,
PUERTO RICO

Final Version
23 June 2000

**Identification of Uncontaminated Property
At Naval Ammunition Support Detachment (NASD),
Vieques, Puerto Rico**

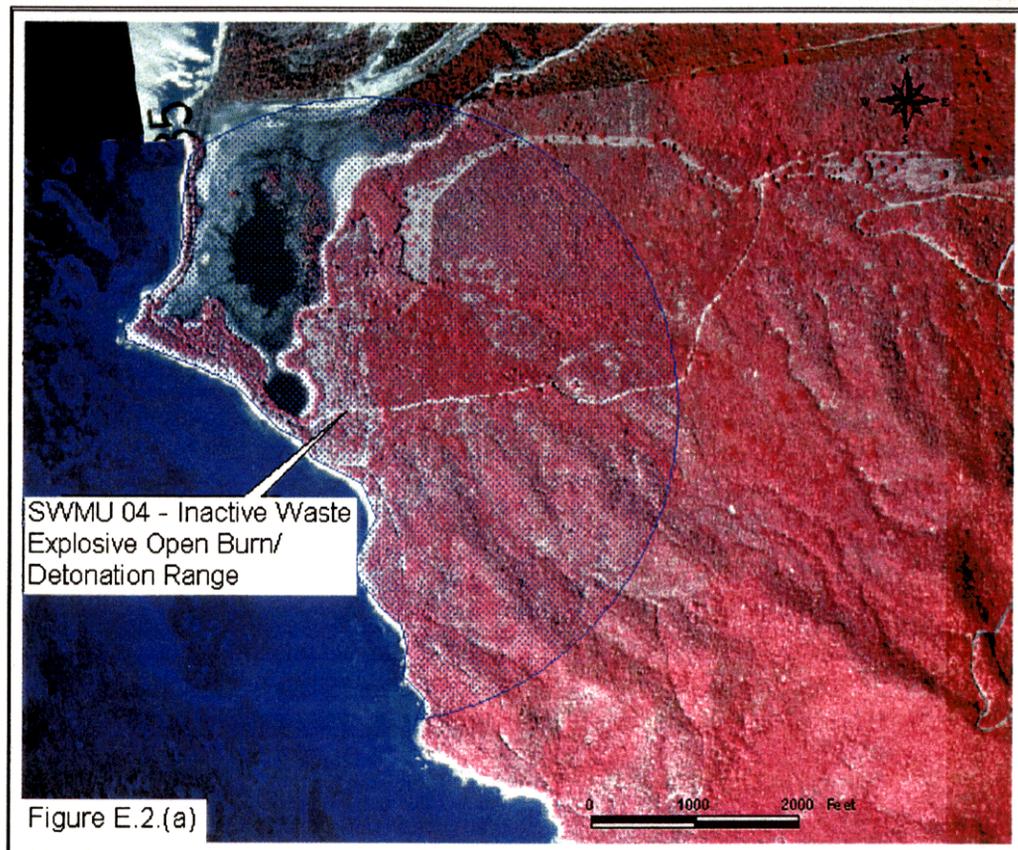
This potentially contaminated area is 439.0 acres as shown in the following figure. The once active area of SWMU 04 was originally believed to be approximately 0.5 miles long and 200 yards wide. However, recent site visits indicate the site may be significantly larger. Transects have been cut through the underbrush and detonated ordnance has been found as much as 2,200 feet from the burn pit area (due to being "exploded" out of the pit). Due to the possibility for ordnance to be found away from the burn pit, a large area was delineated for this potentially contaminated site to provide for a conservative safety buffer. As shown in the figure below, the site boundary was created by placement of an arc 3,000 feet in radius around the site from the north to the south shoreline. No ordnance debris has been found farther than 2,200 feet from the pit area, and it is not anticipated that any would be found at any greater distance.

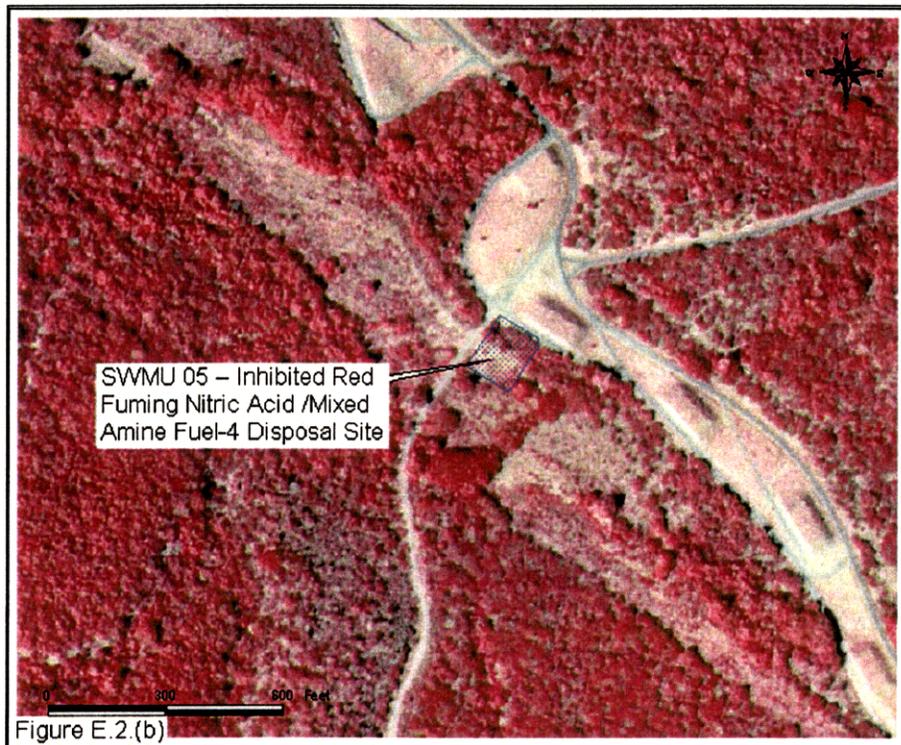
This potentially contaminated area is 0.4 acres in size and includes a buffer of about 50 feet on each side, as shown in the following figure.

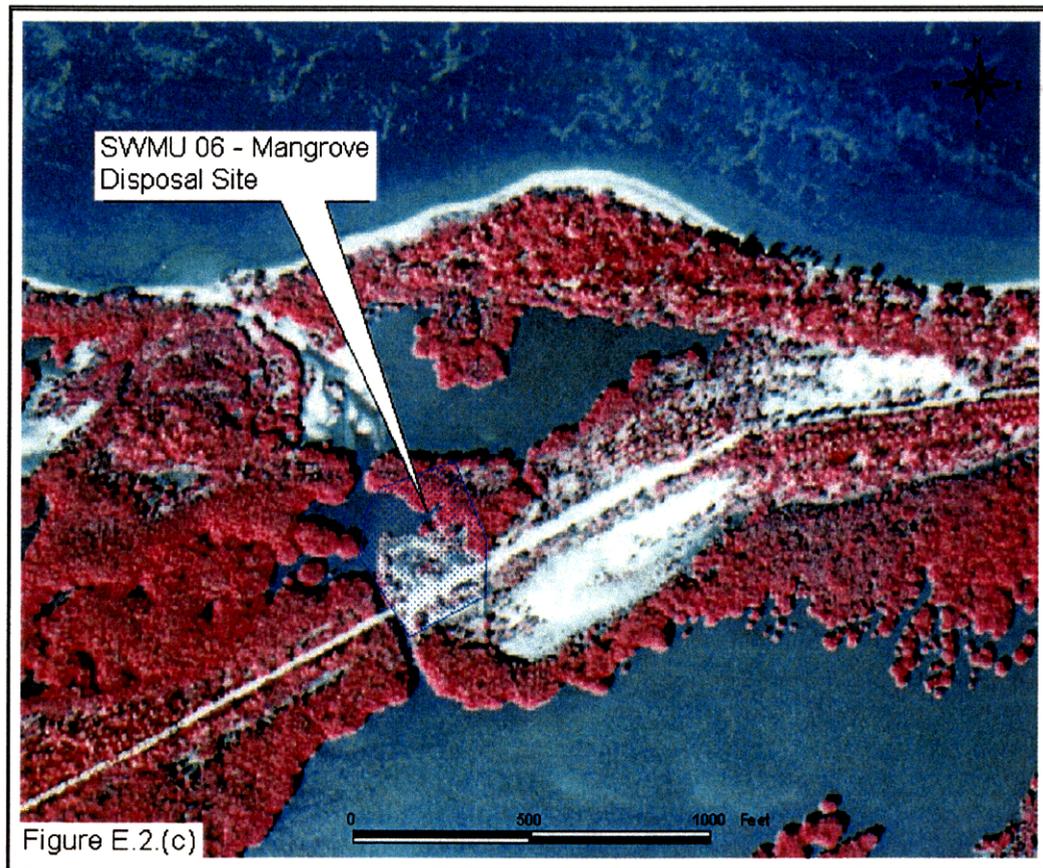
Figure E.2.(c)

In a 1988 investigation, the site was estimated to contain approximately 800 cubic yards of disposal material, including approximately 6,400 pounds of potentially hazardous material. Much of the waste is scrap metal; most is believed to be non-hazardous, solid waste. Soil, surface water, and sediment sampling conducted in 1988 failed to detect elevated levels of contaminants.

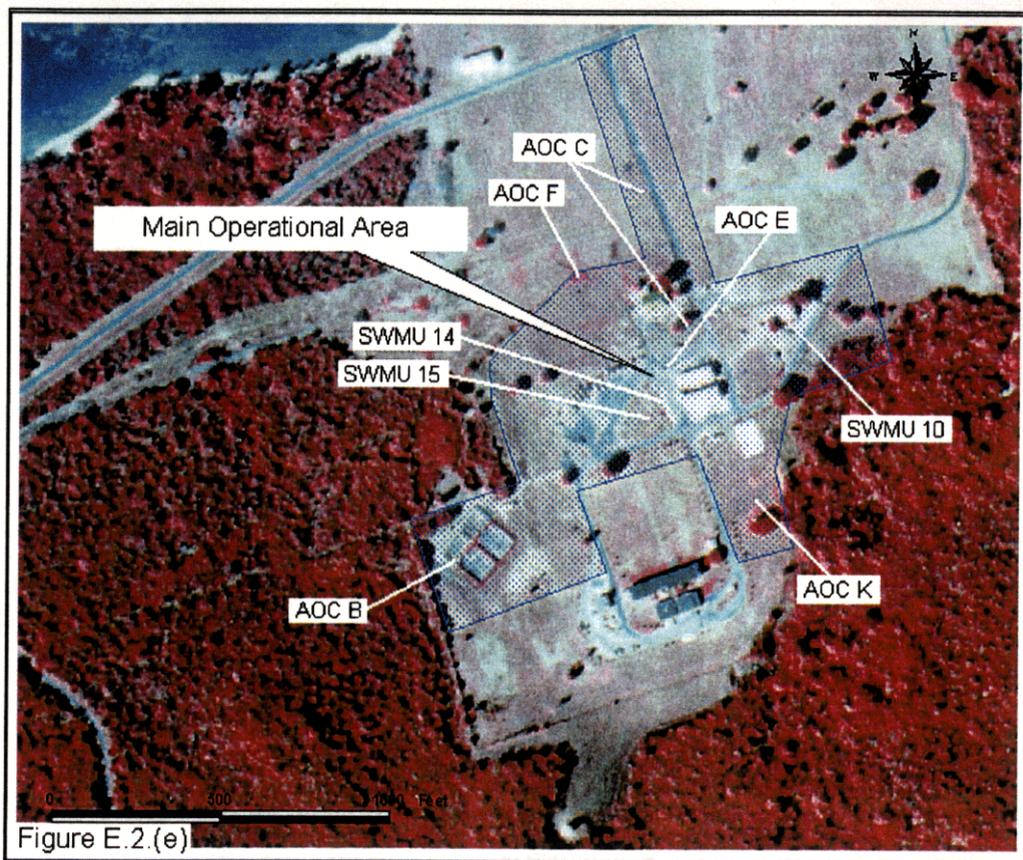
This area is located in the main operational area of NASD. As shown below in Figure E.2(e), it is one of 8 potentially contaminated areas that are delineated as a group due to the close proximity of these areas to each other. A rectangular buffer was of about 200 feet was included to the south and east of this site.

This area is located in the main operational area of NASD. As shown in Figure E.2(e), it is one of 8 potentially contaminated areas that are delineated as a group due to the close proximity of these areas to each other. It is not expected that contaminants from this area will be found outside of the ditch. The potentially contaminated zone for the ditch was created about 180 feet wide to include the ditch and a conservative buffer zone.

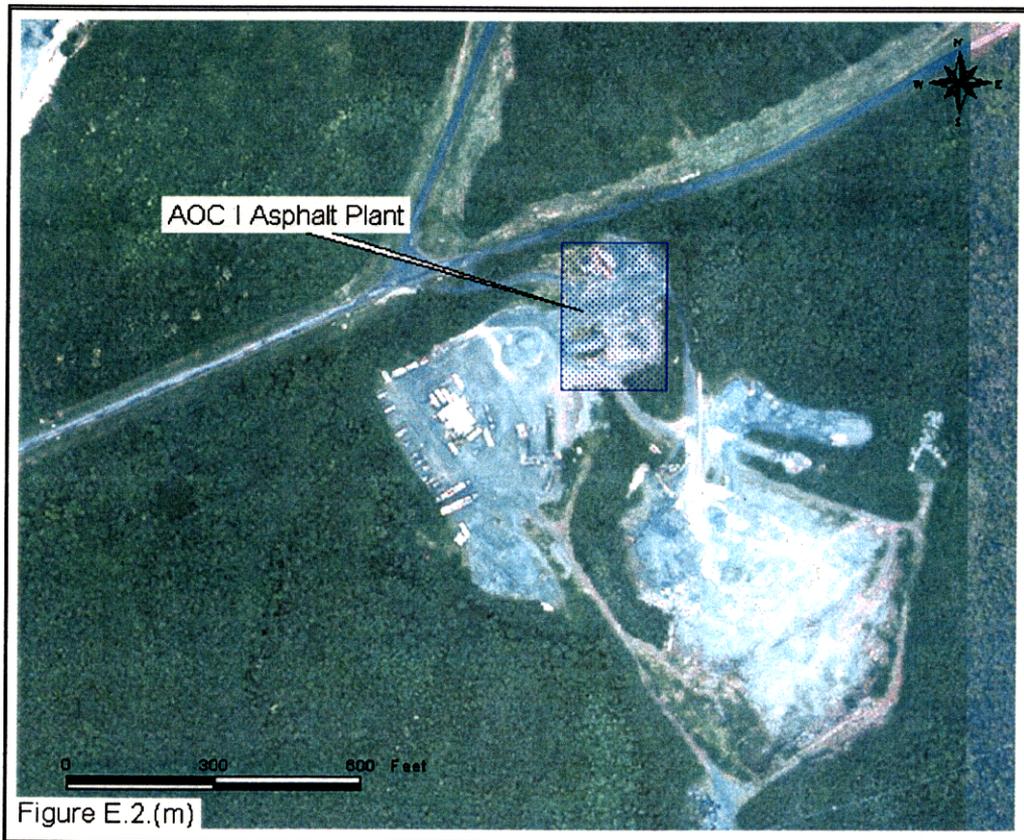
An analysis of recently collected (April 2000) surface soil samples indicate elevated levels for total petroleum hydrocarbons (TPH) in one sample collected from the former storage location of the two diesel ASTs.

(See photographs on page 4 of Enclosure (C)).

(2) Investigative Status

This potentially contaminated area will be investigated and, if necessary, restored under the Navy's IR Program.

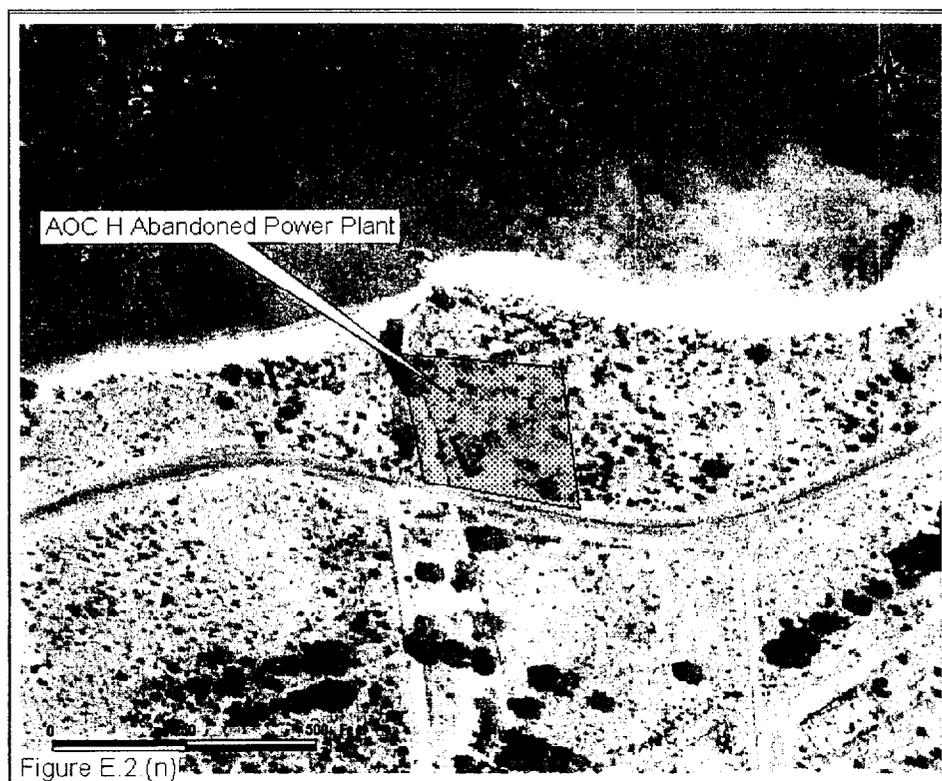
This size of this area is 1.7 acres. Fire Fighter training reportedly was confined to the building. As shown in the figure below, a buffer zone of about 150 feet has been included on the northern, down-gradient side of the area.

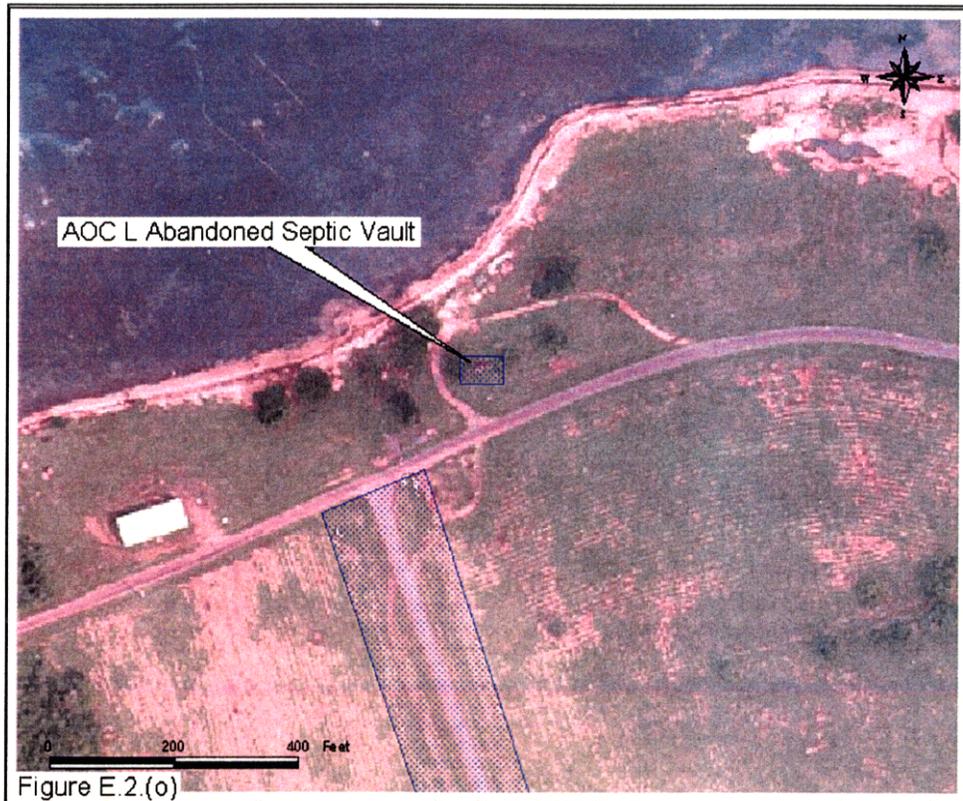
The size of this area is 0.1 acres, as shown in the figure below. As any potential contaminants from this source are likely to be located in or very near the vault, the size of this area was delineated to include the vault and a perimeter buffer zone about 30 feet wide.

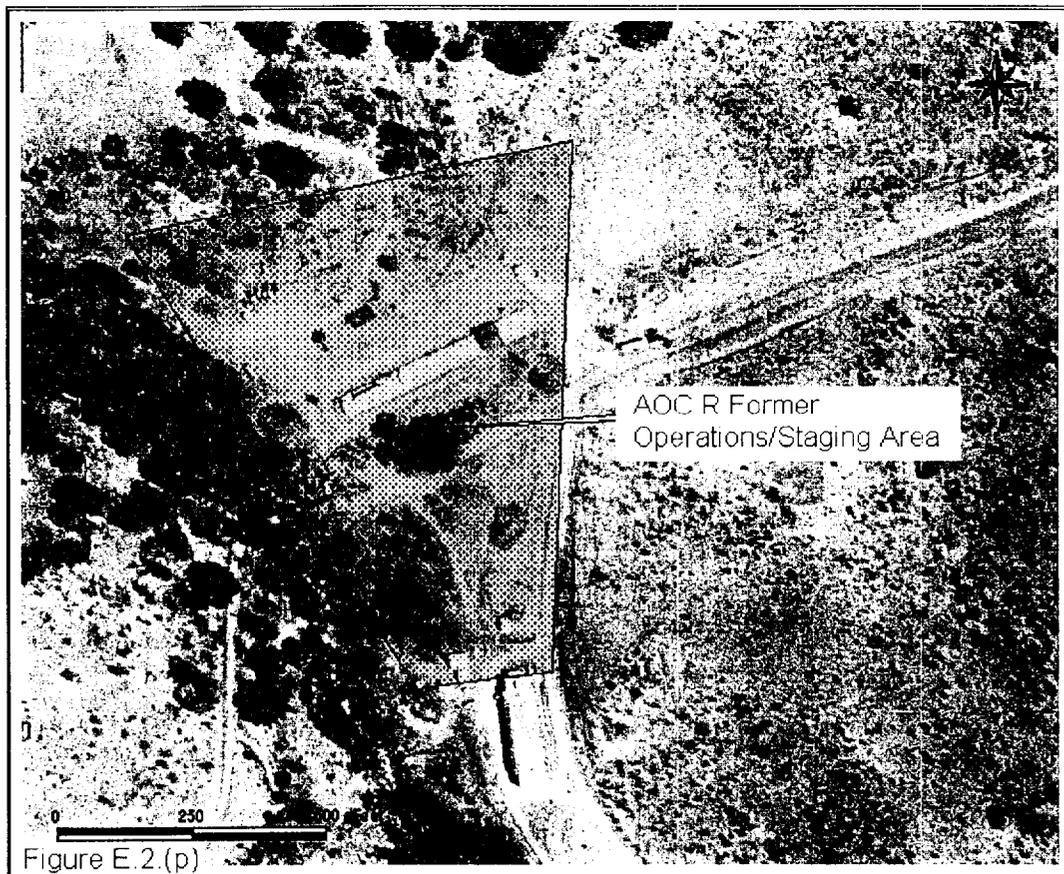
This area is 12.0 acres in size and is shown in the figure below overlaid on an aerial photograph from 1967. The potentially contaminated area was delineated to include the former location of the AST, the concrete pad, the area where vehicle maintenance occurred and a generous buffer zone.

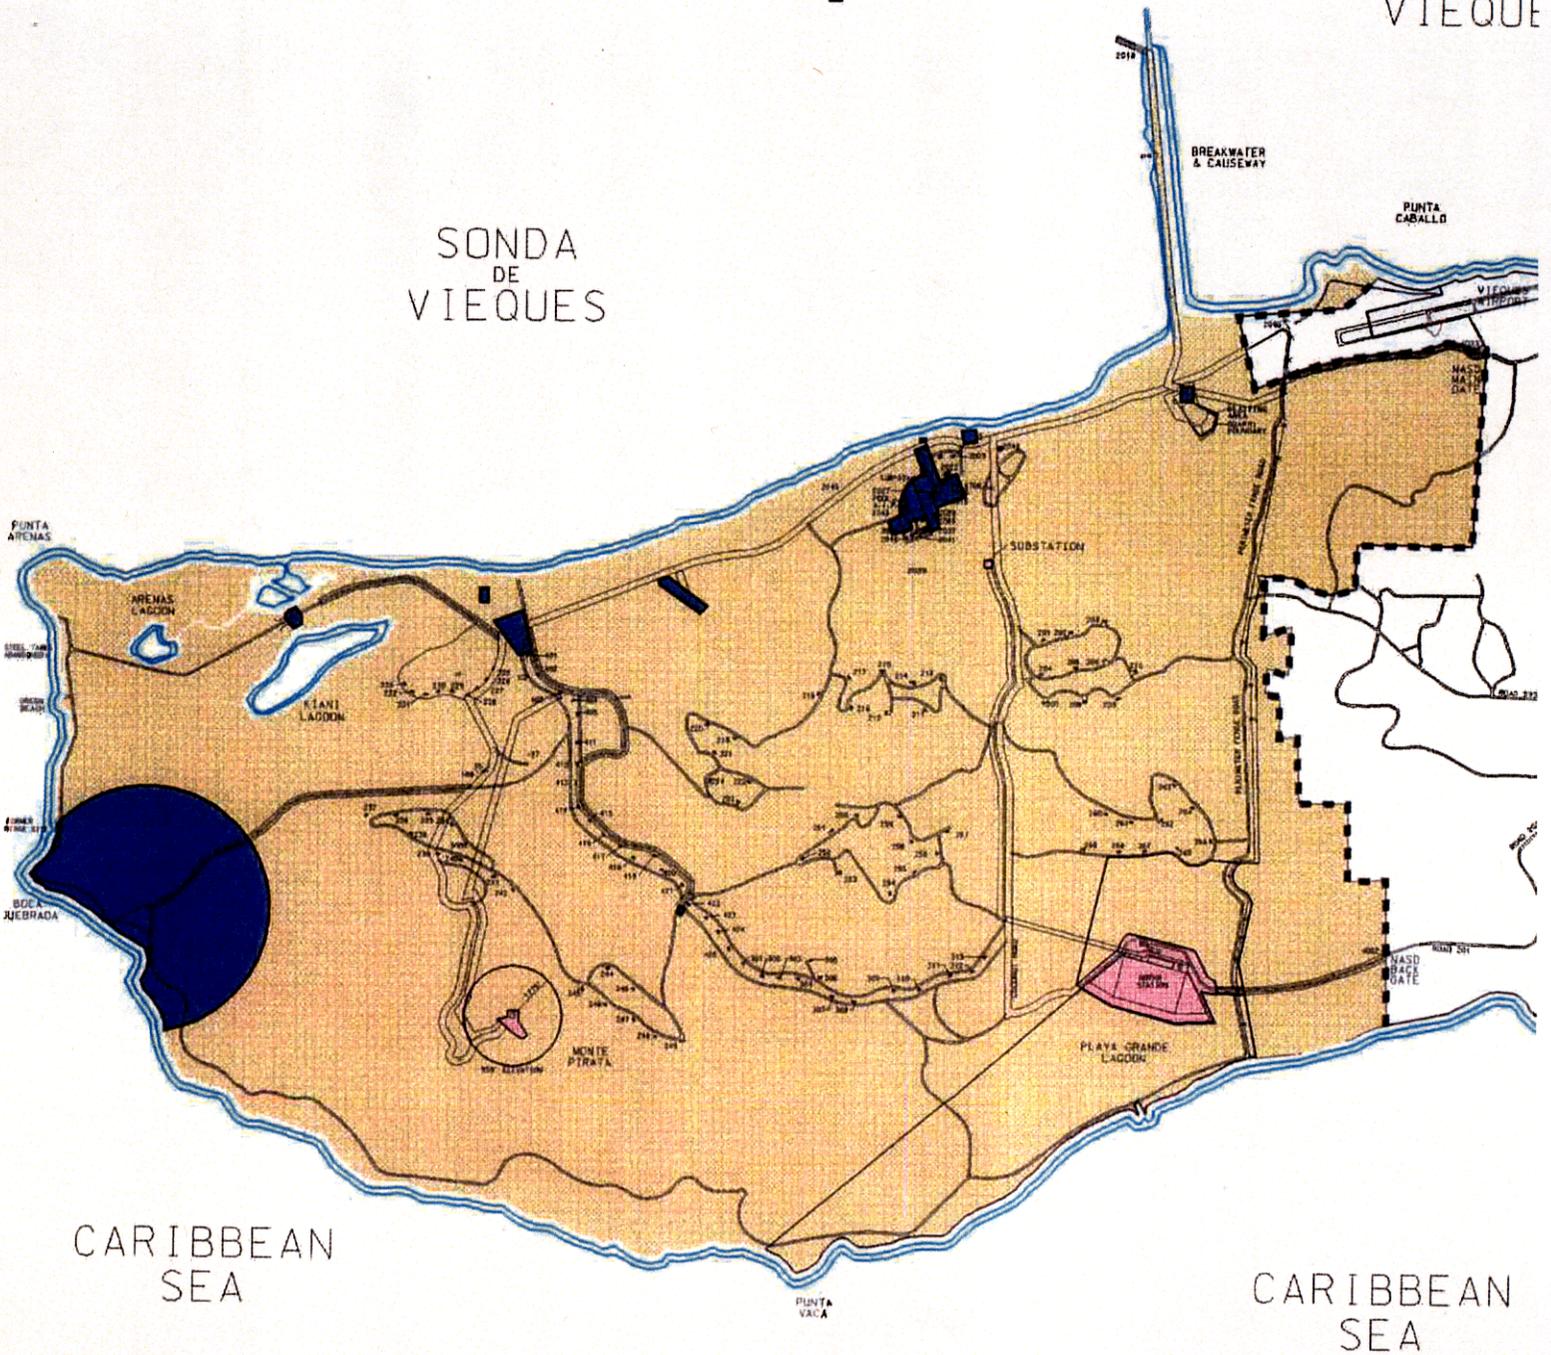
Enclosure (A) is a map which classifies the property in accordance with the results shown on the tables discussed in the above section. Of the approximately 7,879 acres of NASD Vieques property to be transferred, about 7,389 acres have been identified as uncontaminated and 490 acres as potentially contaminated.

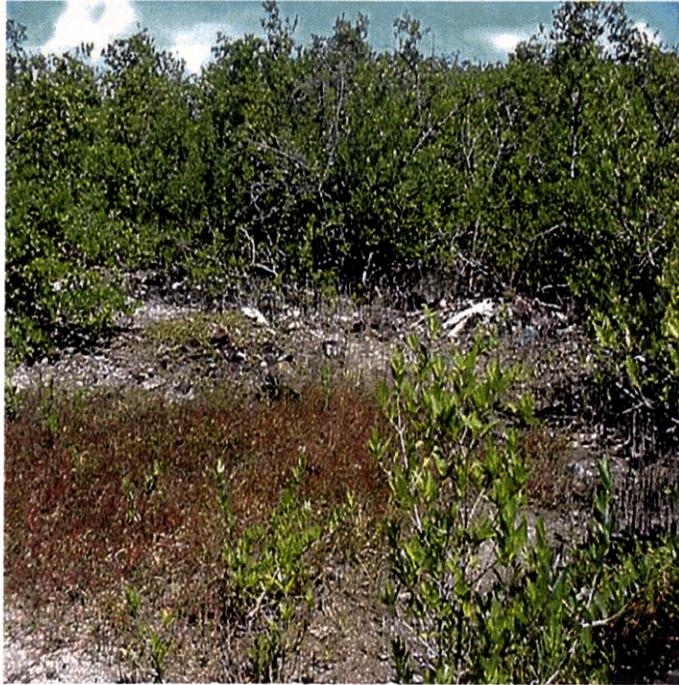
**Mangrove Disposal Site
(Looking South)**

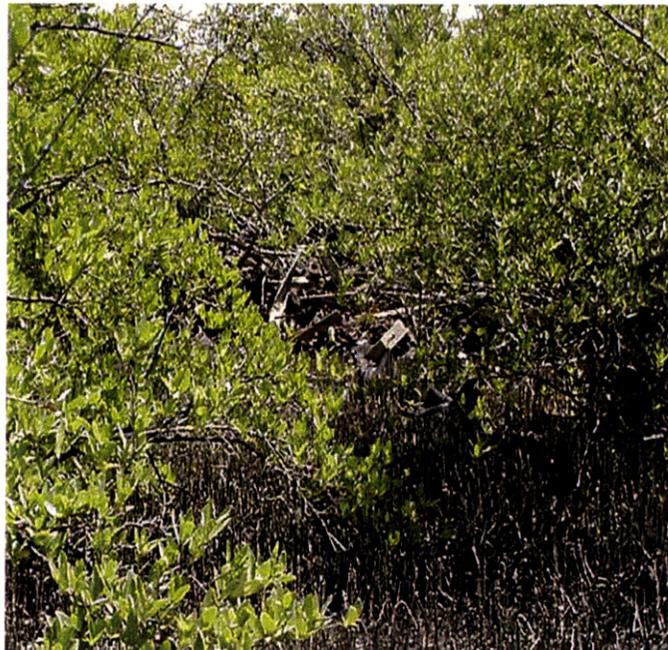
**Mangrove Disposal Site
(Looking NW)**

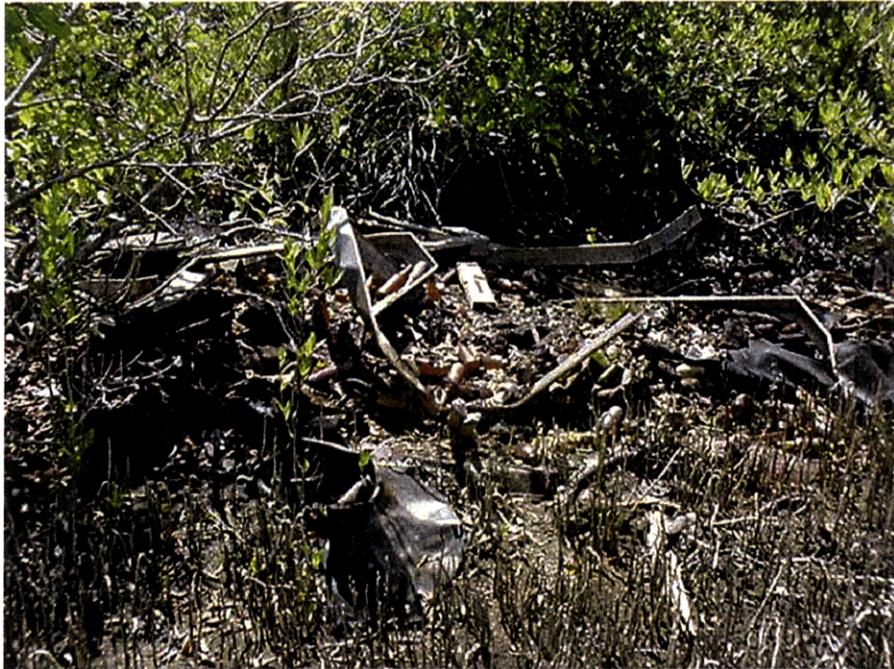
Debris at Mangrove Disposal Site

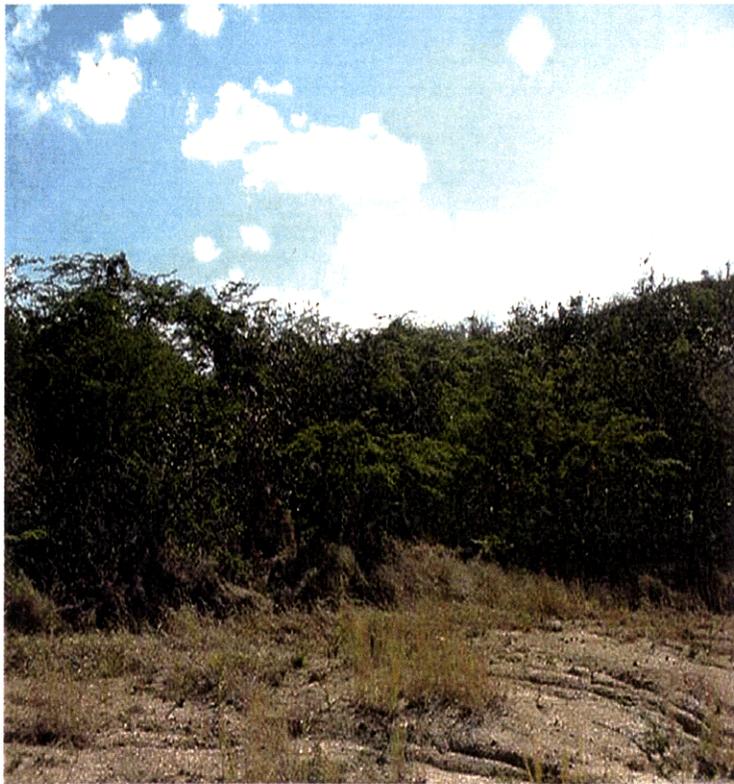
Inactive Open Burning/ Waste Explosive Detonation Range

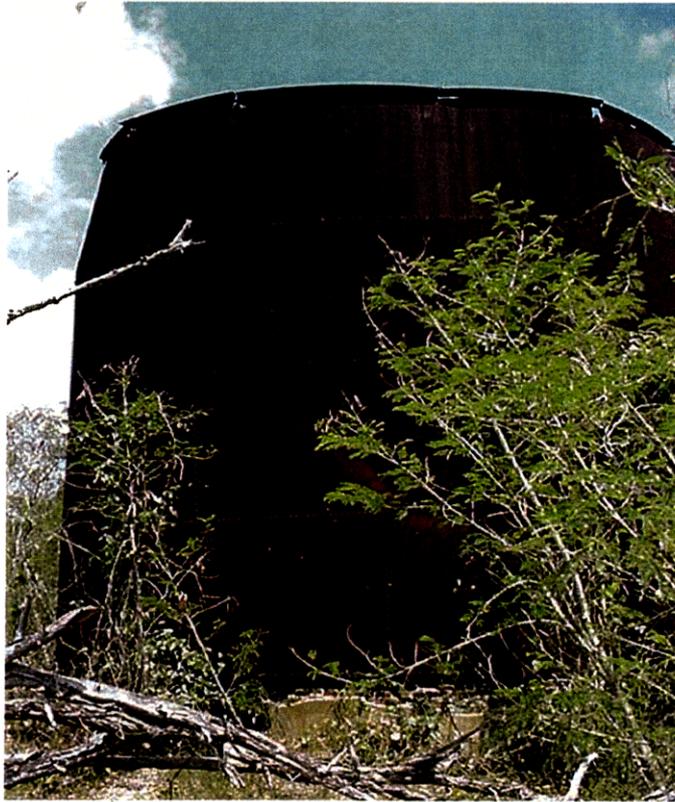
Three large Aboveground Storage Tanks (ASTs), approximately 50,000-60,000 gallons each, are located at Green Beach at the western end of Vieques Island. A black residue was observed emanating from the ASTs; speculated to be residue of molasses from sugar production activities that occurred on Site prior to U.S. Navy operations (1900-1940s). Site interviewees stated that the tanks were used only to store molasses. However, a 1951 drawing obtained from a records search identified the ASTs as containing diesel and gasoline. No piping was observed.

Bulk Storage Tank near Green Beach

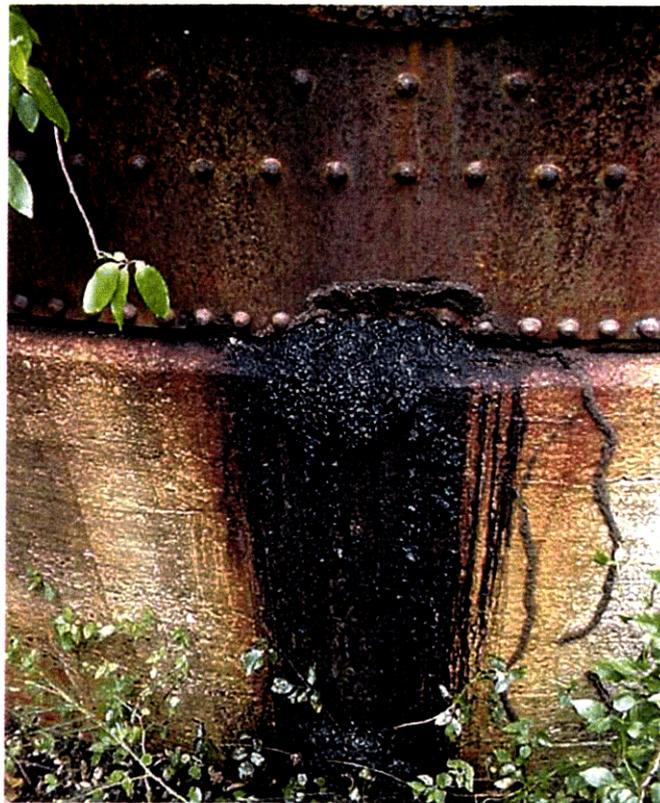
Molasses leaking from Storage Tank

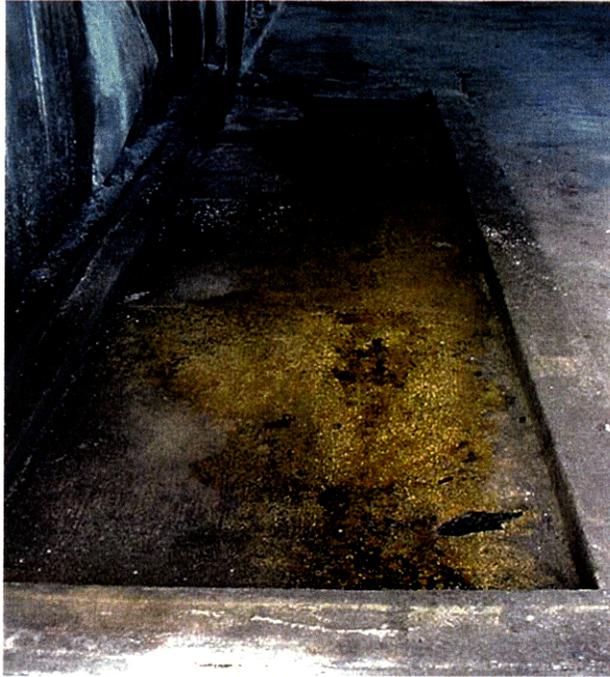
Stained Concrete at Asphalt Plant

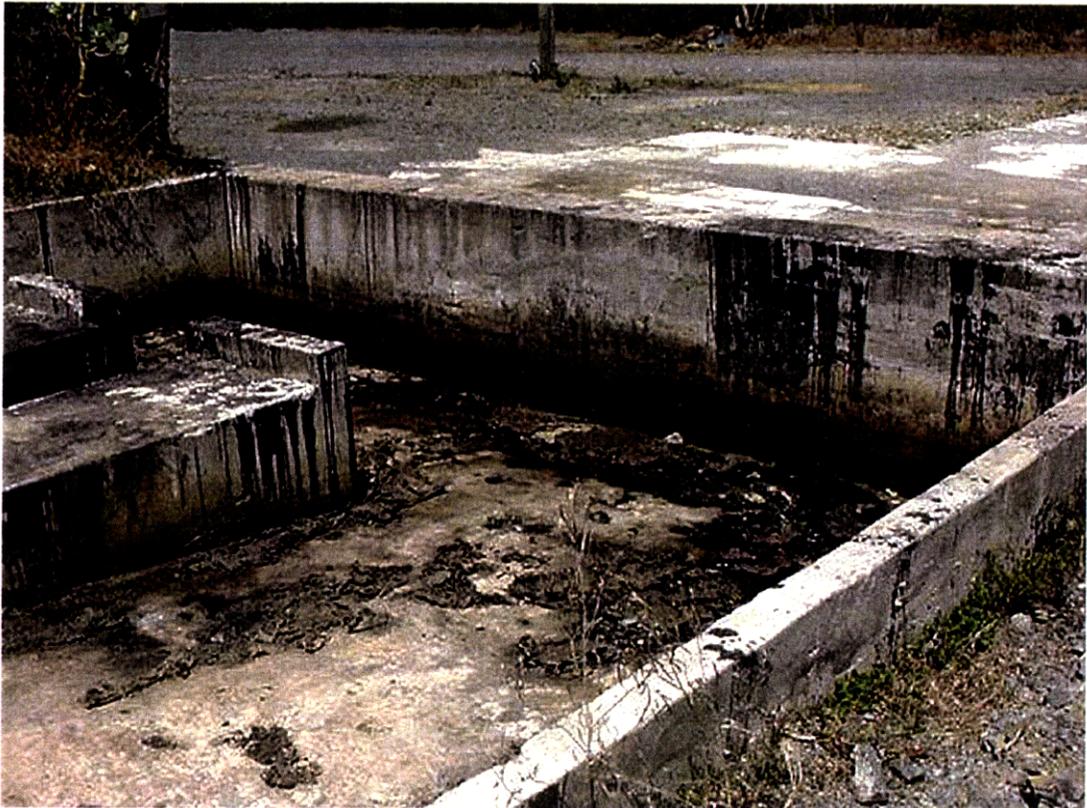
Stained Concrete Pad at Asphalt Plant

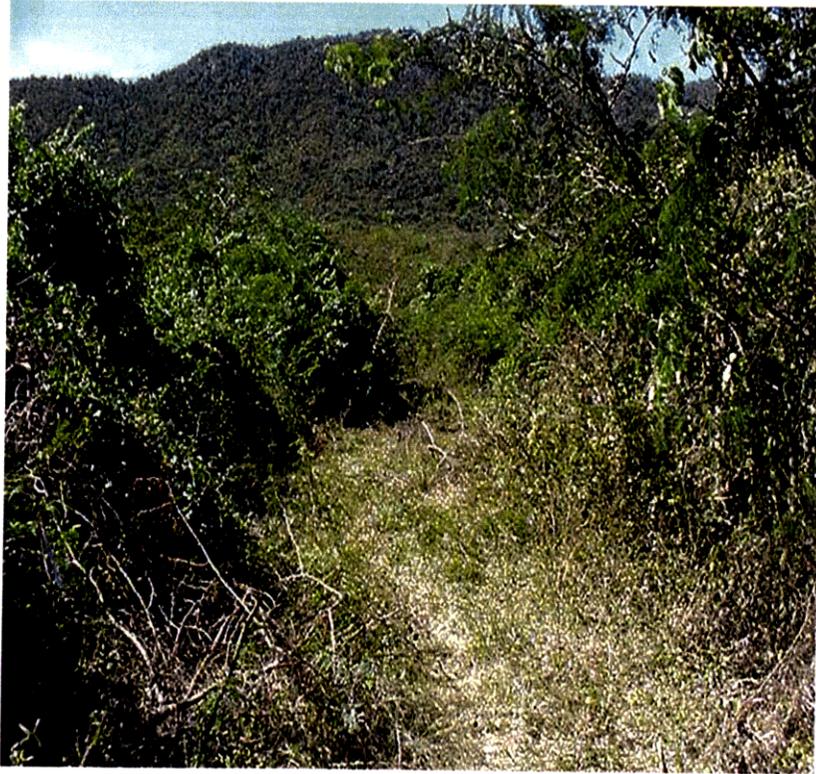
Overgrown Road to IRFNA-MAF 4 Site

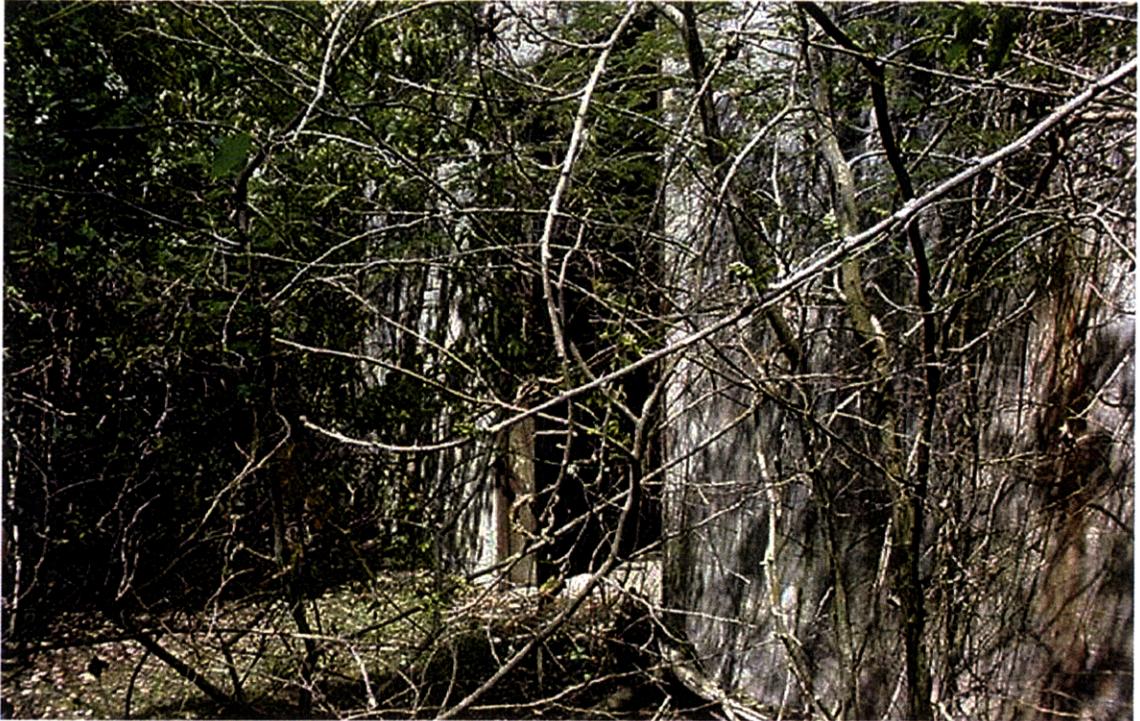
An extensive review and investigation effort was undertaken for these facilities. Gaining access to the inactive magazines proved to be difficult, as many of the magazines, and some of the access roads to them, were completely overgrown. All 102 magazines at NASD were entered, visually inspected for environmental concerns, and photographed. While many magazines had unusual items stored in them (Red Cross supplies, uniforms, electronic equipment, etc.) none showed any indications of a release or threatened release of a CERCLA hazardous substance to the environment. In one magazine, #260, a small amount of a highly viscous, tar-like substance was observed on the floor, but presented no threat of release. Many of the inactive magazines had bats or bees inhabiting them.

Entrance to Inactive Magazine

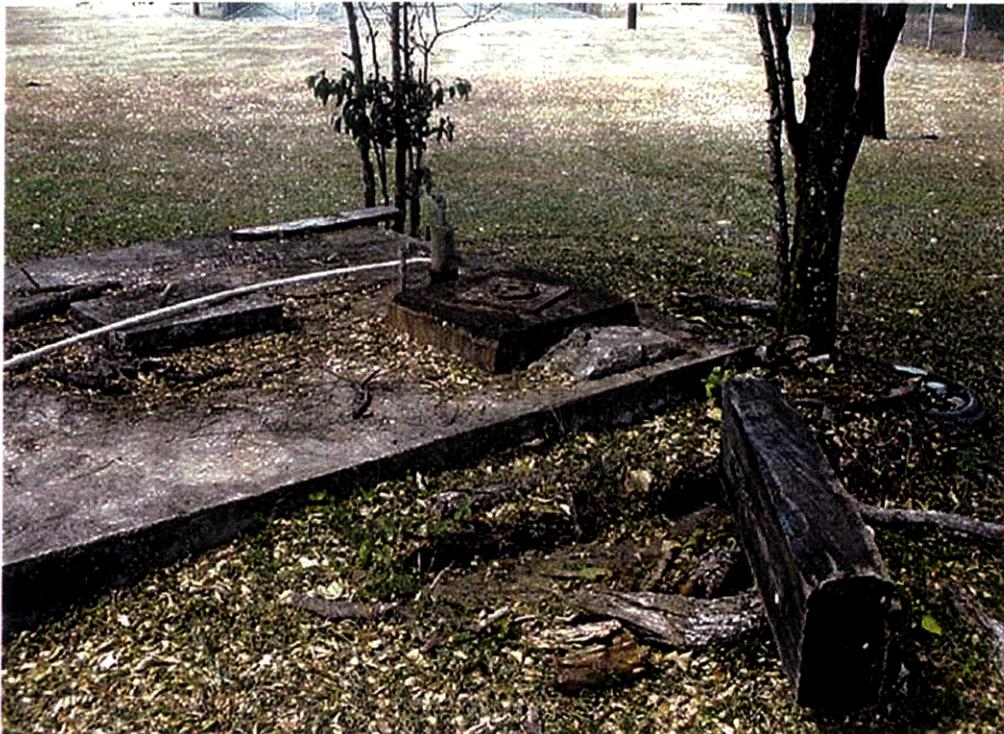
Inactive Potable Well No. 7

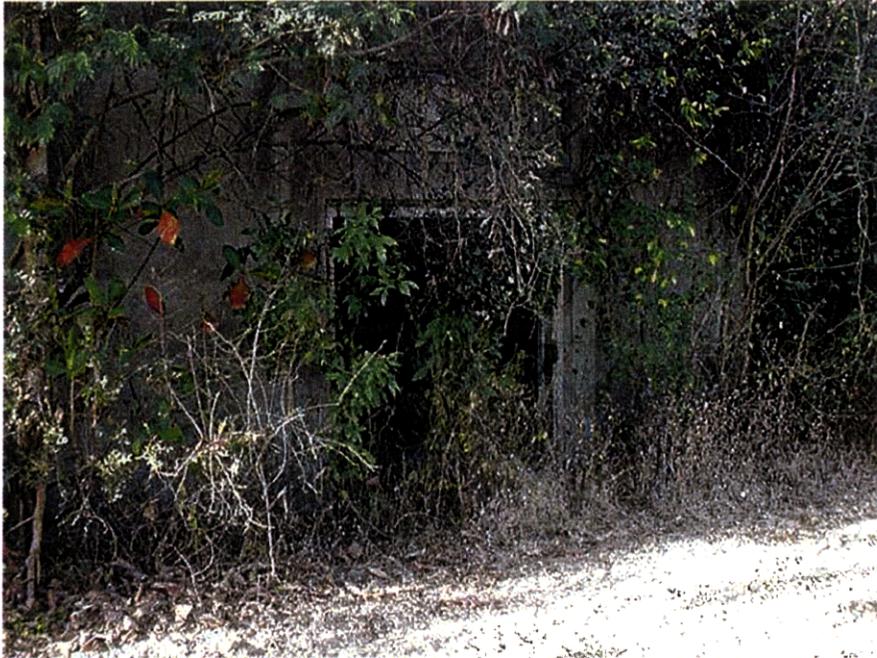
Abandoned Power Plant Building
