**Closure of Fuel Underground Storage  
Tanks No. 1 and No. 2  
Building 2015, Naval Ammunition Support Detachment  
Vieques Island, Puerto Rico**

CTO Task Order 189

Prepared for  
Department of the Navy  
Atlantic Division  
Naval Facilities Engineering Command

March 2001

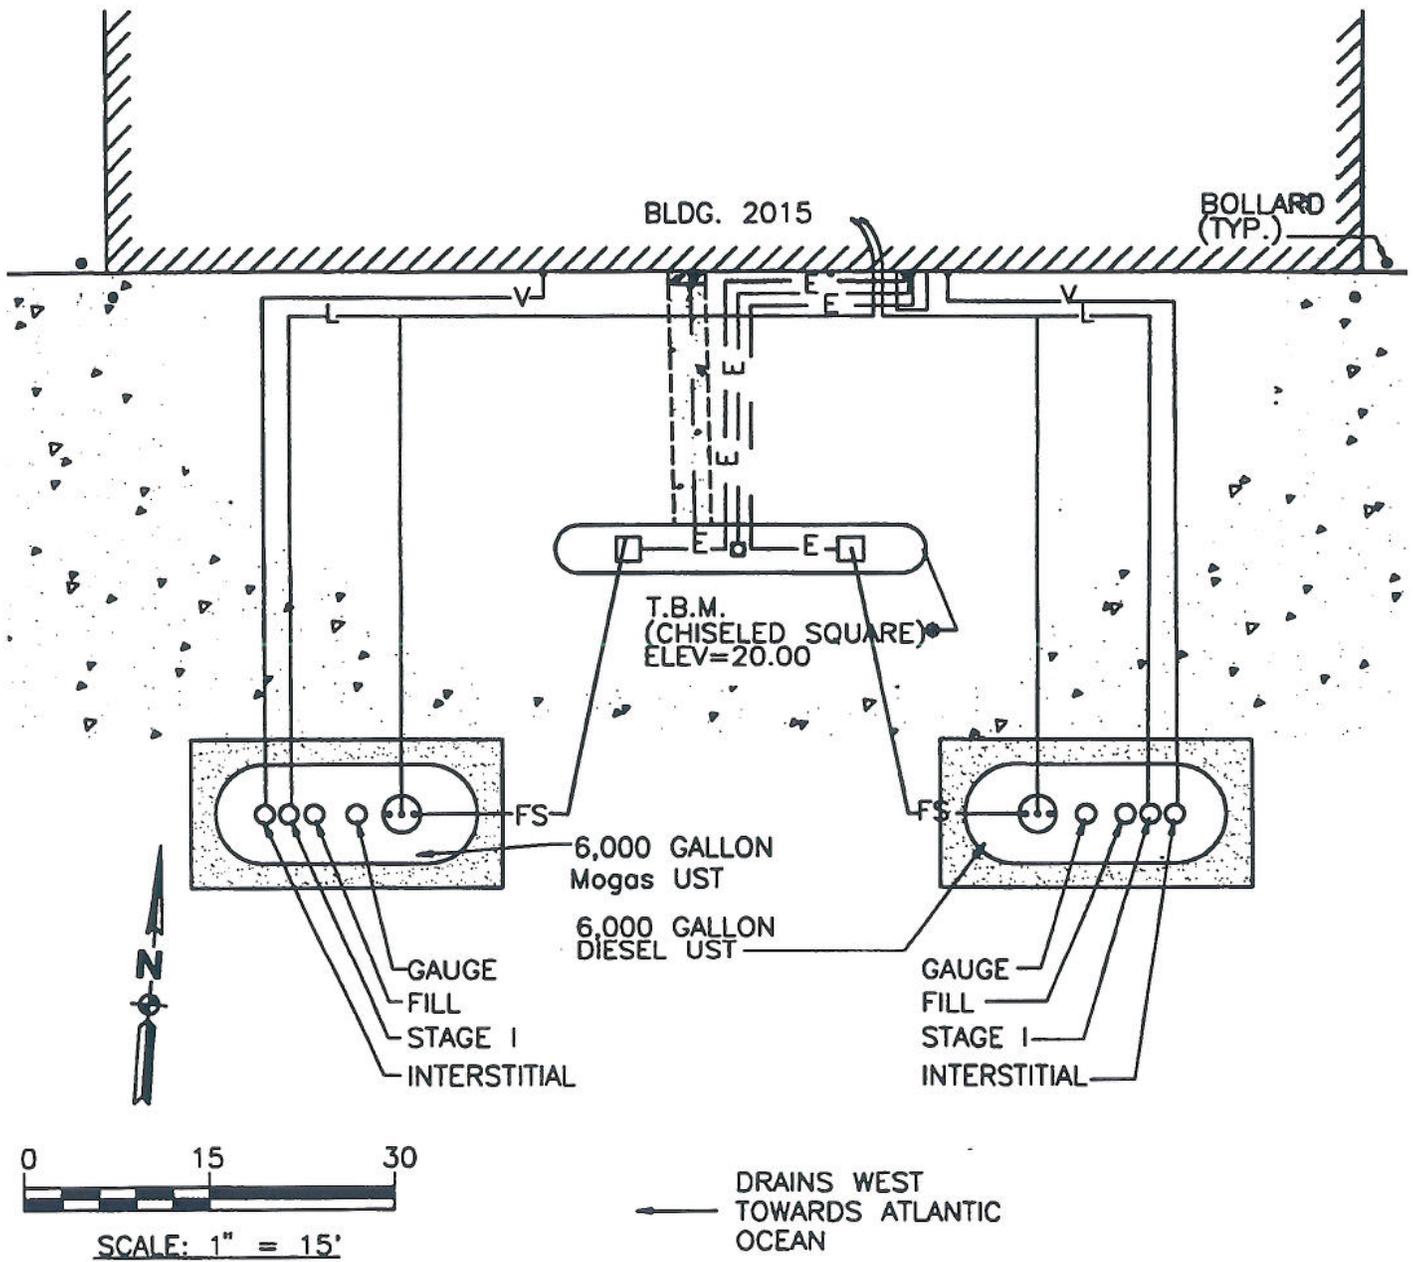
Fuel from the USTs was supplied to the dedicated single product dispenser via two ¾-inch-diameter product supply pipes enclosed in 3-inch-diameter secondary containment piping. The product dispenser was positioned on a concrete island constructed parallel to the USTs. The fill pipe was positioned directly above each UST. Approximately 10 feet of product piping extended underground from the USTs to the dispensers. Additional aboveground components associated with the tanks included an exterior light post on the pump island, leak detection alarms fixed to the exterior of the building, two vent lines also attached to Building 2015, and protective bollards. The locations of these features are shown in Figure 1-3.

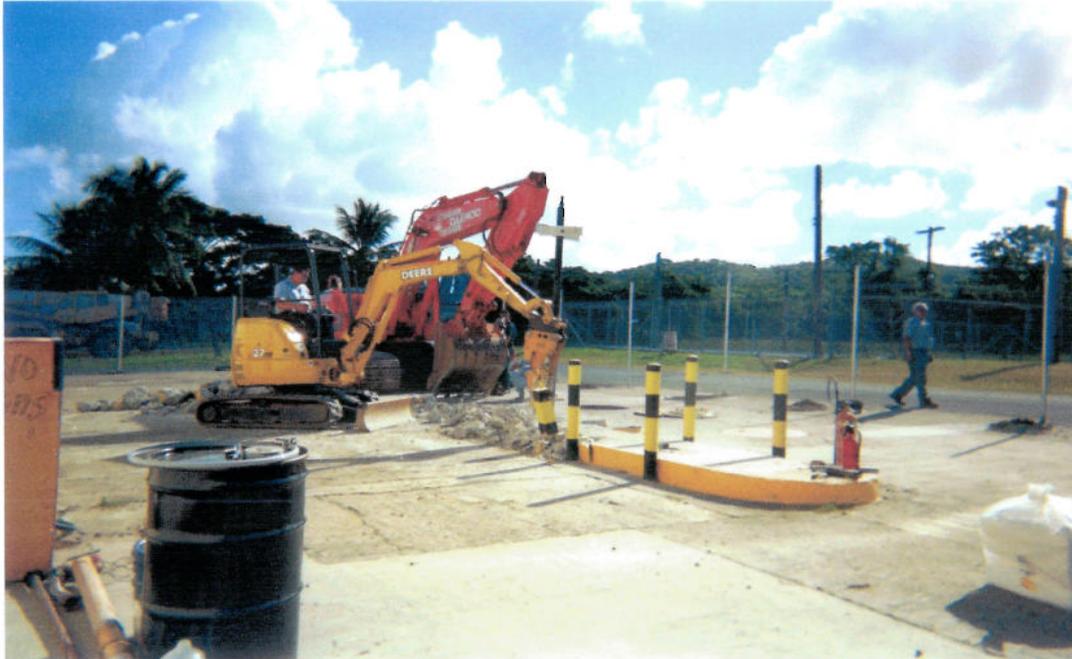
Picture #1: Hydraulic hammer breaking up concrete prior to excavation. View is southeast of Building 2015.

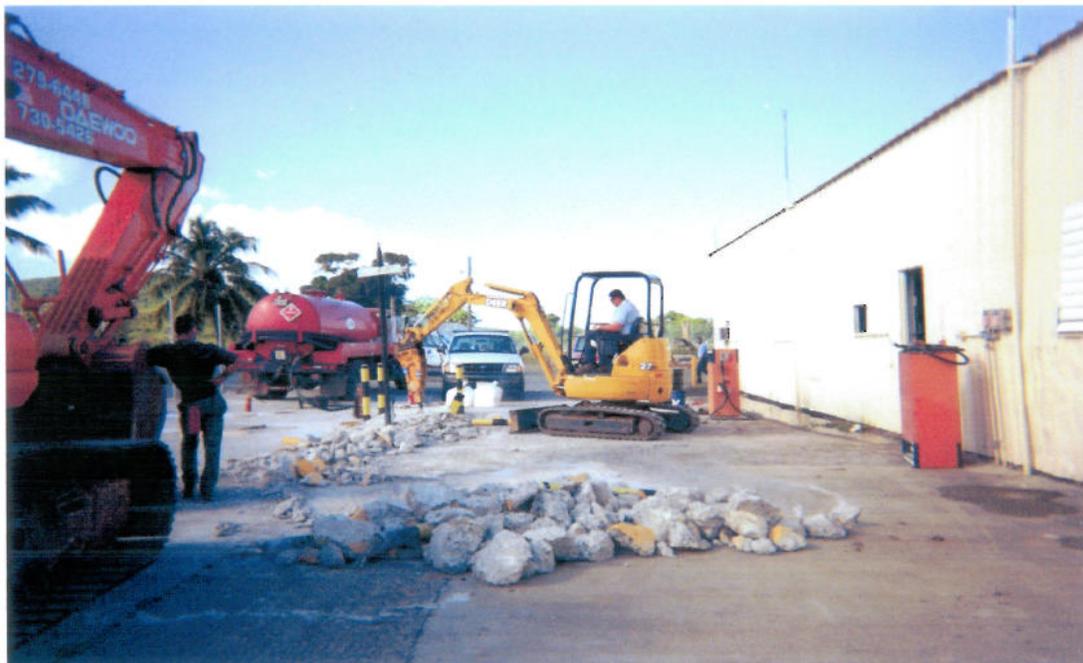
Picture #2: Hydraulic hammer breaking up concrete prior to excavation. View is west of Building 2015.

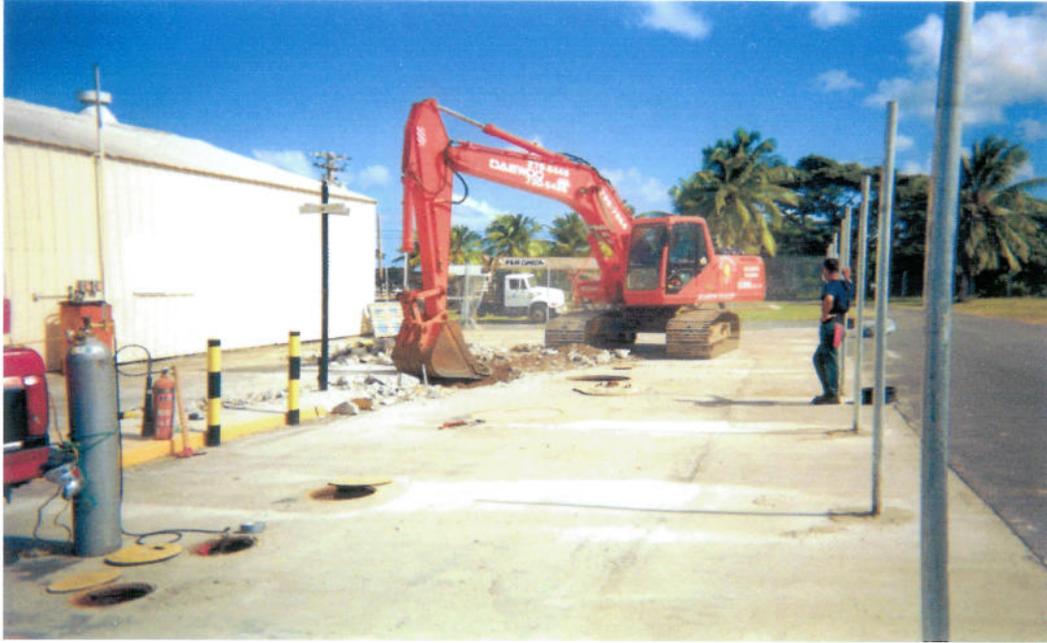
Picture #3: Excavation of Diesel tank. View from southeast side of Building 2015.

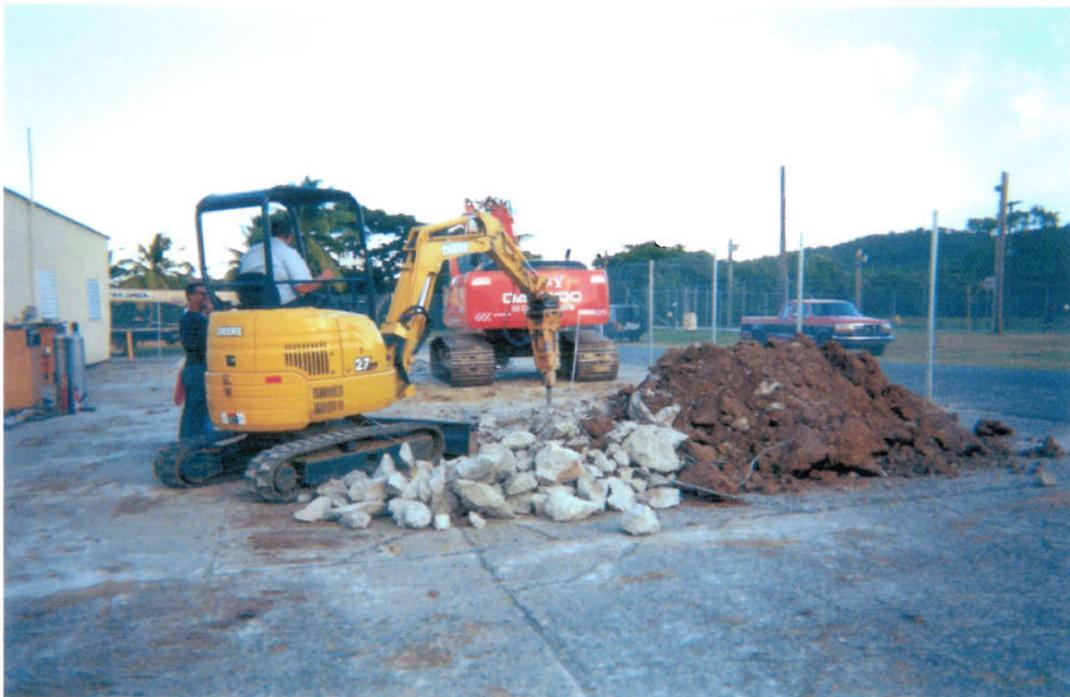
Picture #4: Excavation of Mogas (gasoline) tank. View from west side of Building 2015.

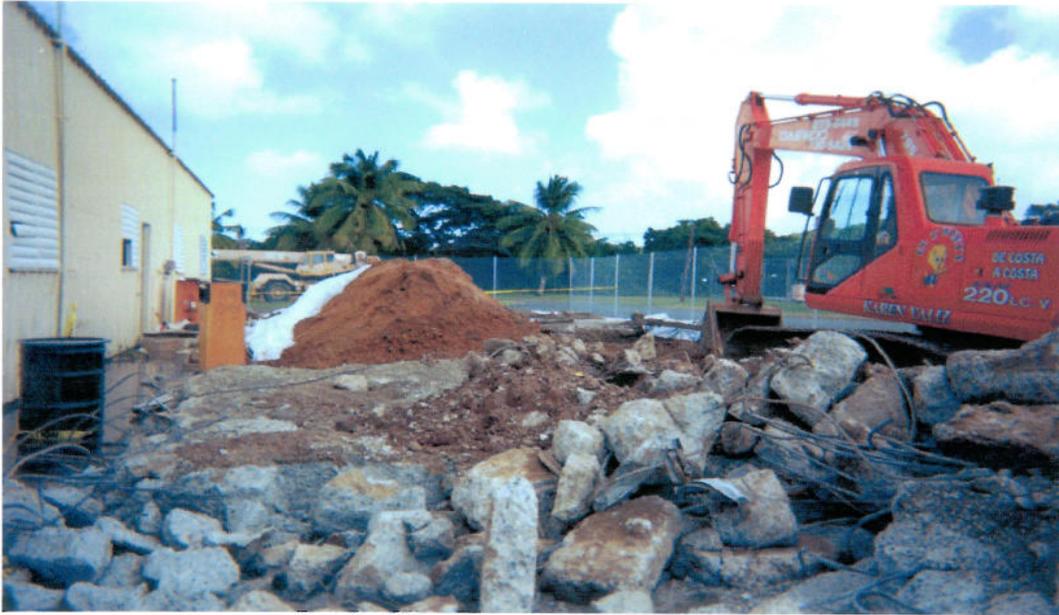
Picture #5: Full excavation of UST site. View from west side of Building 2015.

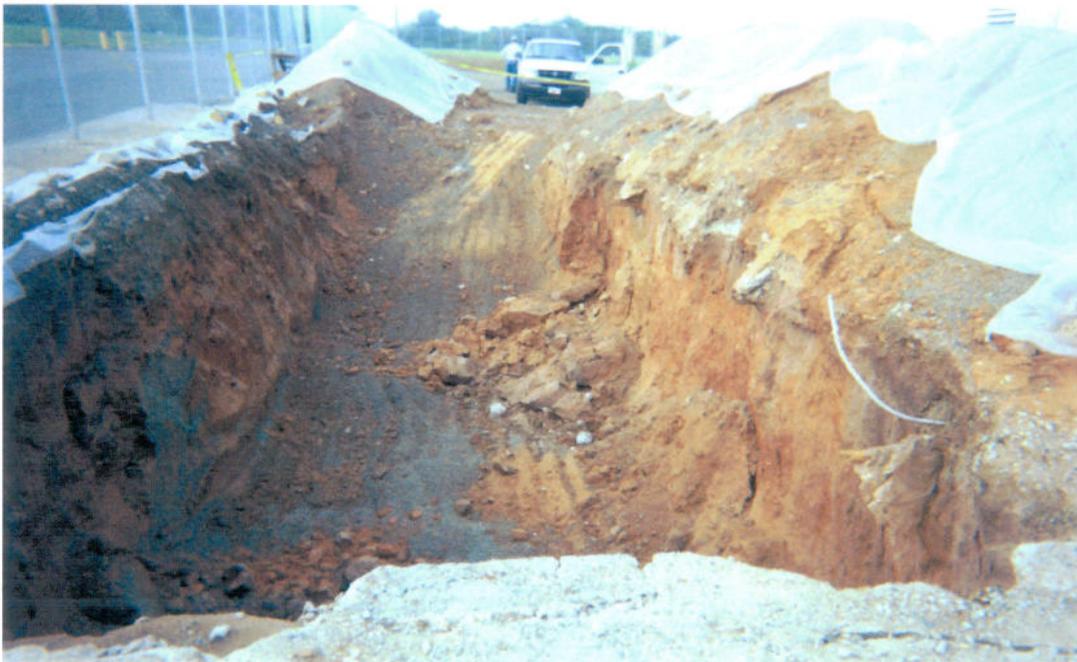
Picture #6: Full excavation of UST site without concrete debris. View from eastside of Building 2015.

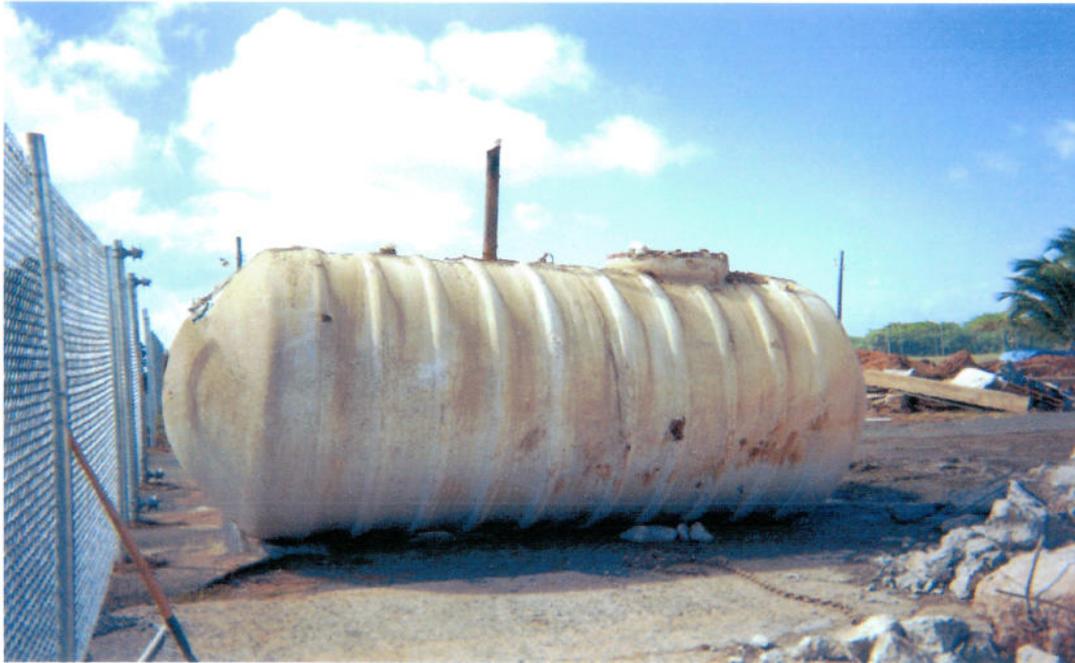
Picture #7: Photo of excavated gasoline tank.

POD RAMMER ON SITE AND THOAS TANK HAD ALREADY  
 BEEN REMOVED. TOOK PICTURES OF THIS EXCAVATED HOLE  
 AND ADDITIONAL SURROUNDING AREA. ALSO TOOK PICTURES  
 OF TANK. DID NOT NOTICE ANY HOLES OR  
 DAMAGED AREAS ON TANK. WORKING ON ROC PROJECT ALSO IN  
 CONJUNCTION W/ OBSERVING TANK PULL.

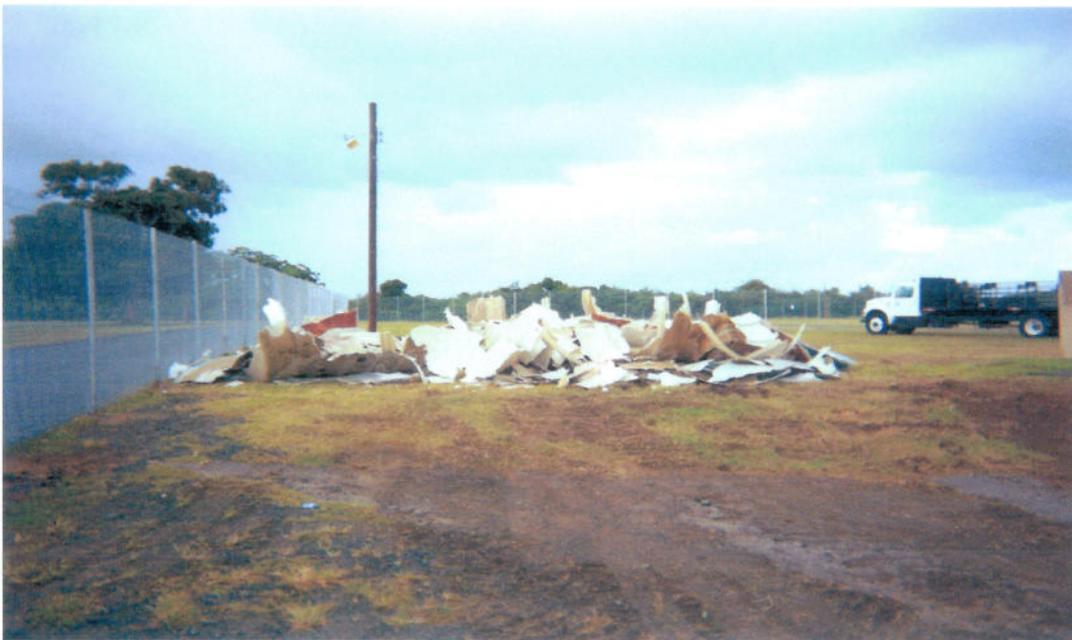
Picture #8: Photo of crushed gasoline tank ready for disposal.

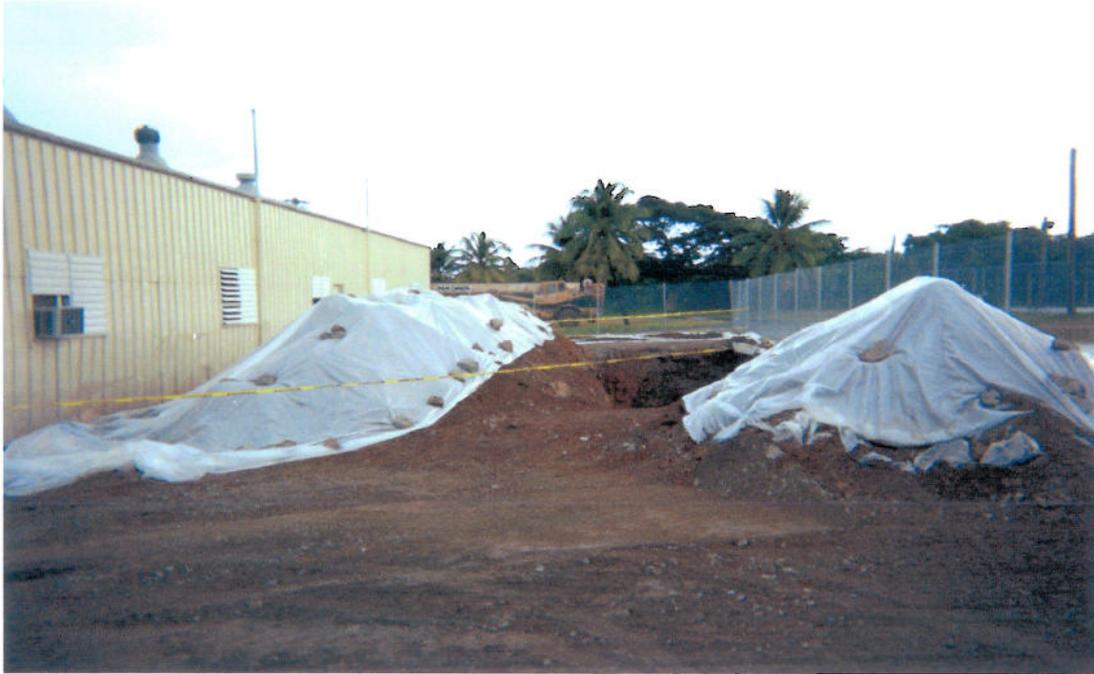
Picture#9: Staged soil prior to backfilling activities. View from westside of Building 2015.

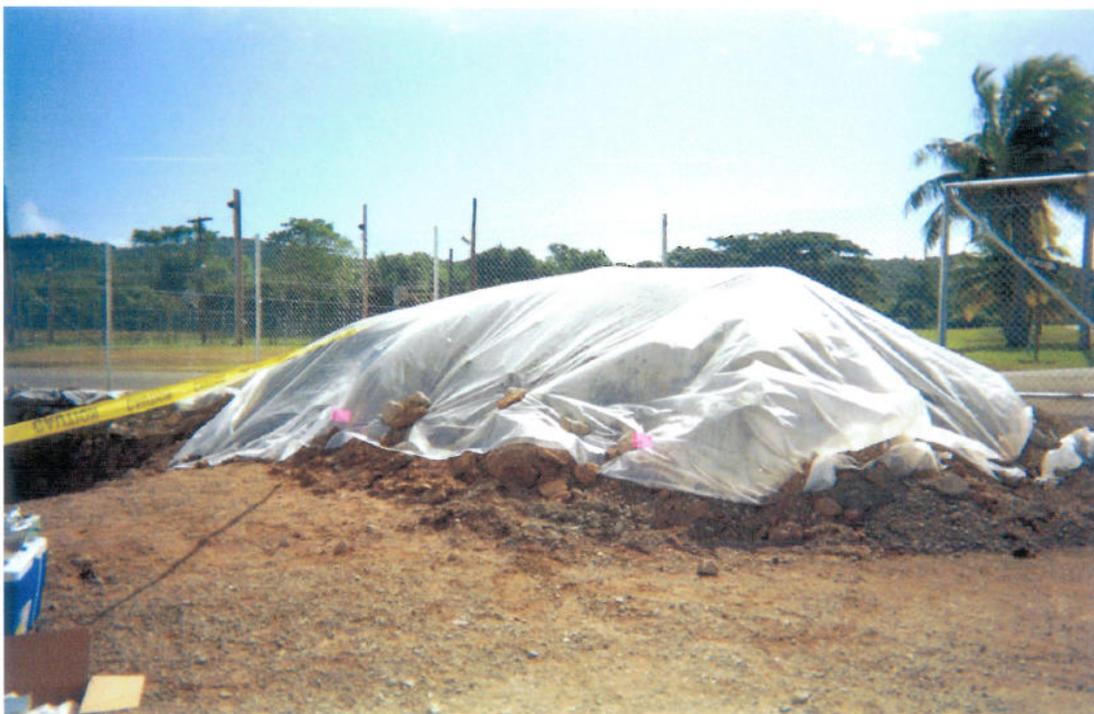
Picture#10: Staged soil (small stockpile) prior to backfilling activities. View from southwest side of Building 2015.

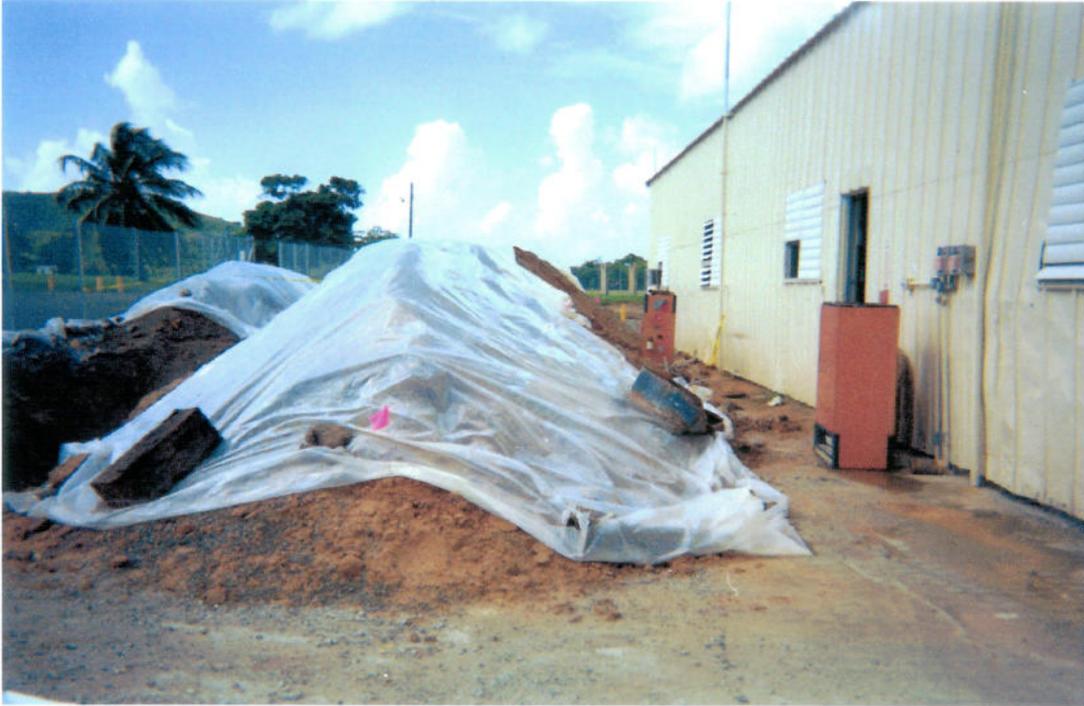
Picture#11: Staged soil (large stockpile) prior to backfilling activities. View from east side of Building 2015.

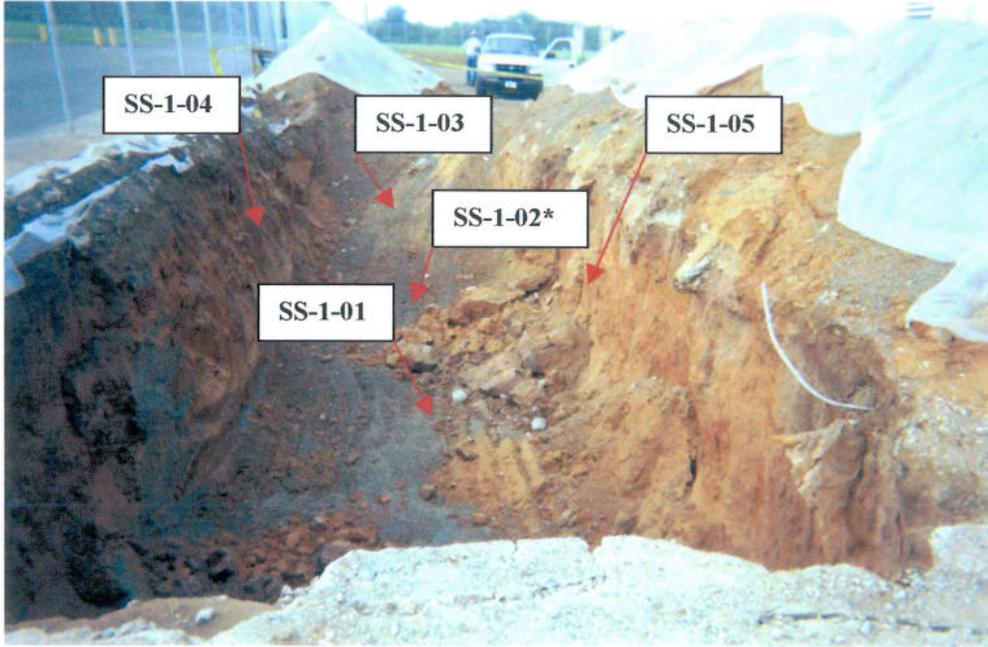
Photo #1: Sample locations for Diesel tank. View is southwest of Building 2015.  
Note: Asterisk denotes locations where field duplicates were taken.

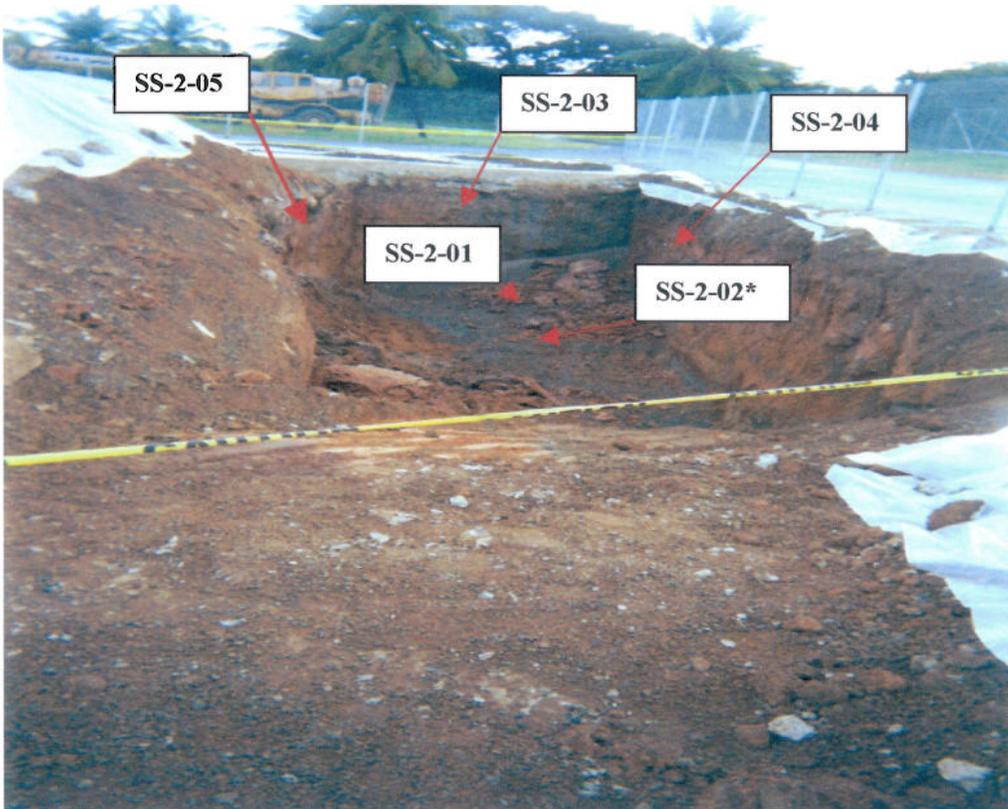
Photo #2: Sample locations for Mogas tank. View is southeast of Building 2015.  
Note: Asterisk denotes locations where field duplicates were taken.

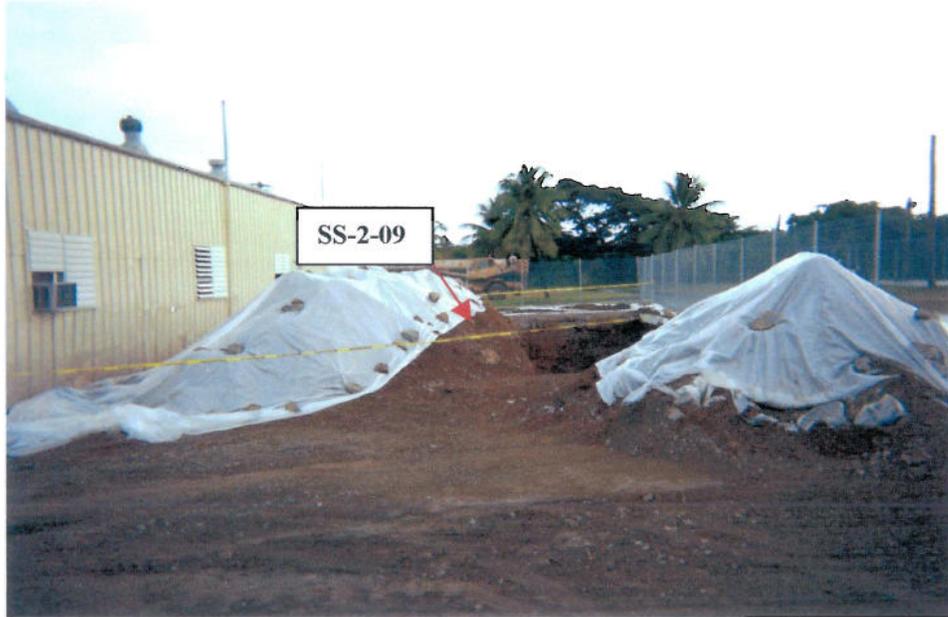
Photo #3: Sample locations taken at the large stockpile. View is southwest of Building 2015.

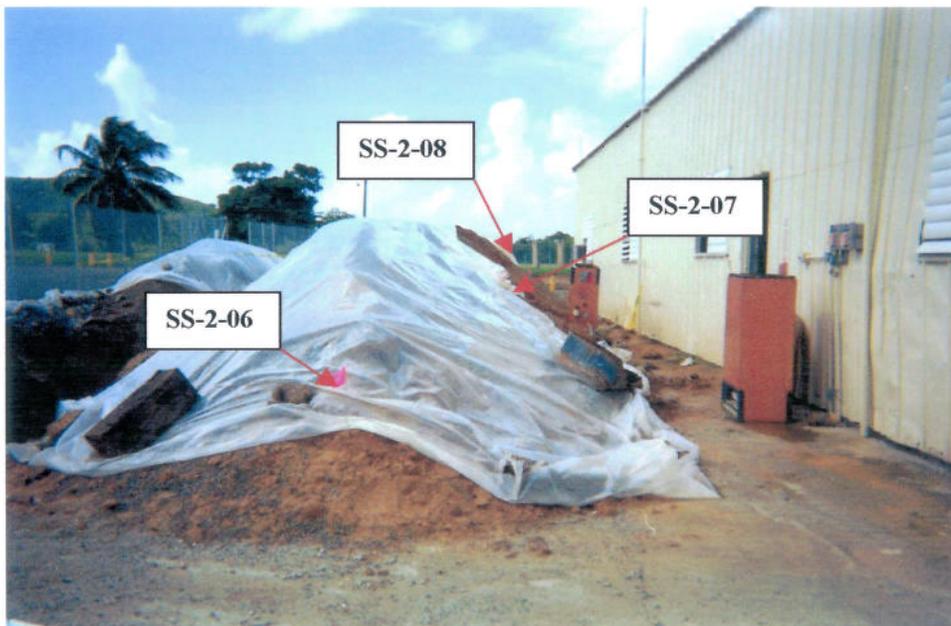
Photo #4: Sample locations taken at the large stockpile. View is southeast of Building 2015.

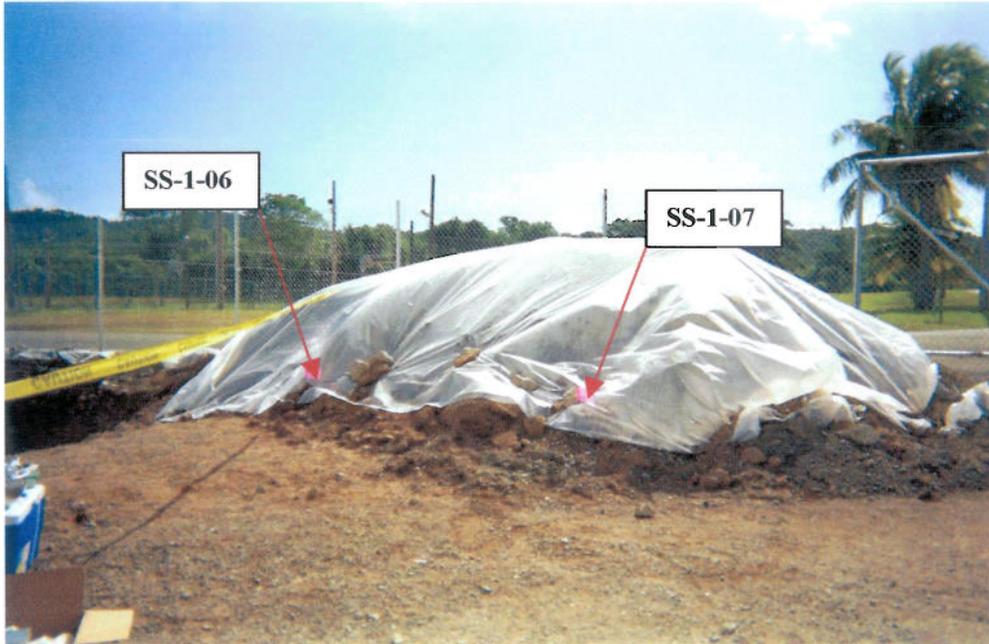
Photo #5: Sample locations taken at the small stockpile. View is southwest of Building 2015.

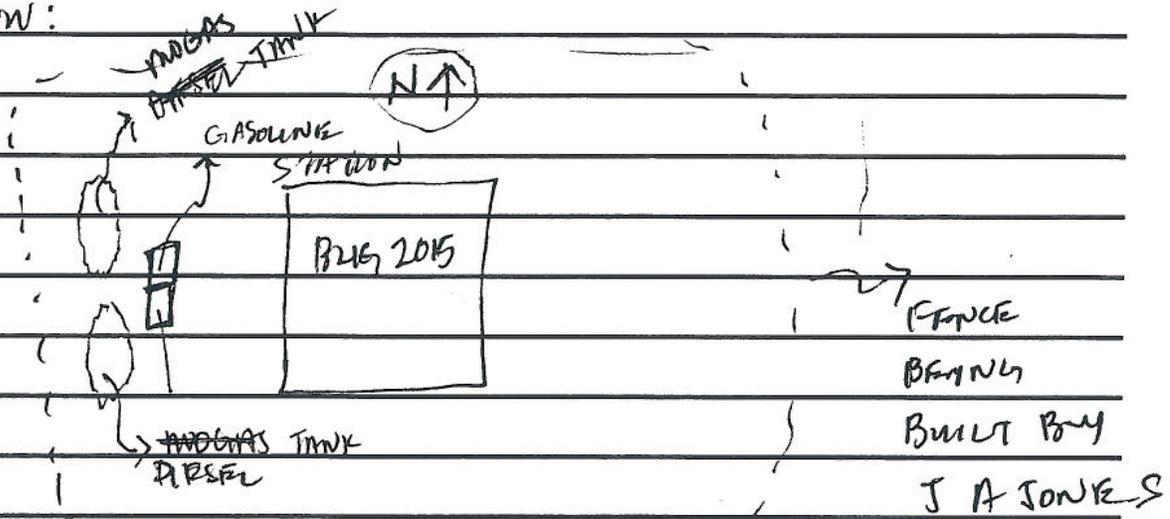
OBS: BEGIN BREAKING UP CONCRETE, SEE DIAGRAM  
BELOW:

PICTURE #27: PICTURE LOOKING FROM N TO SOUTH AT BLDG 2015.
