**Final  
Site Management Plan  
Fiscal Year 2014**

**Atlantic Fleet Weapons Training Area - Vieques  
Vieques, Puerto Rico**

**Contract Task Orders 037**

**November 2013**

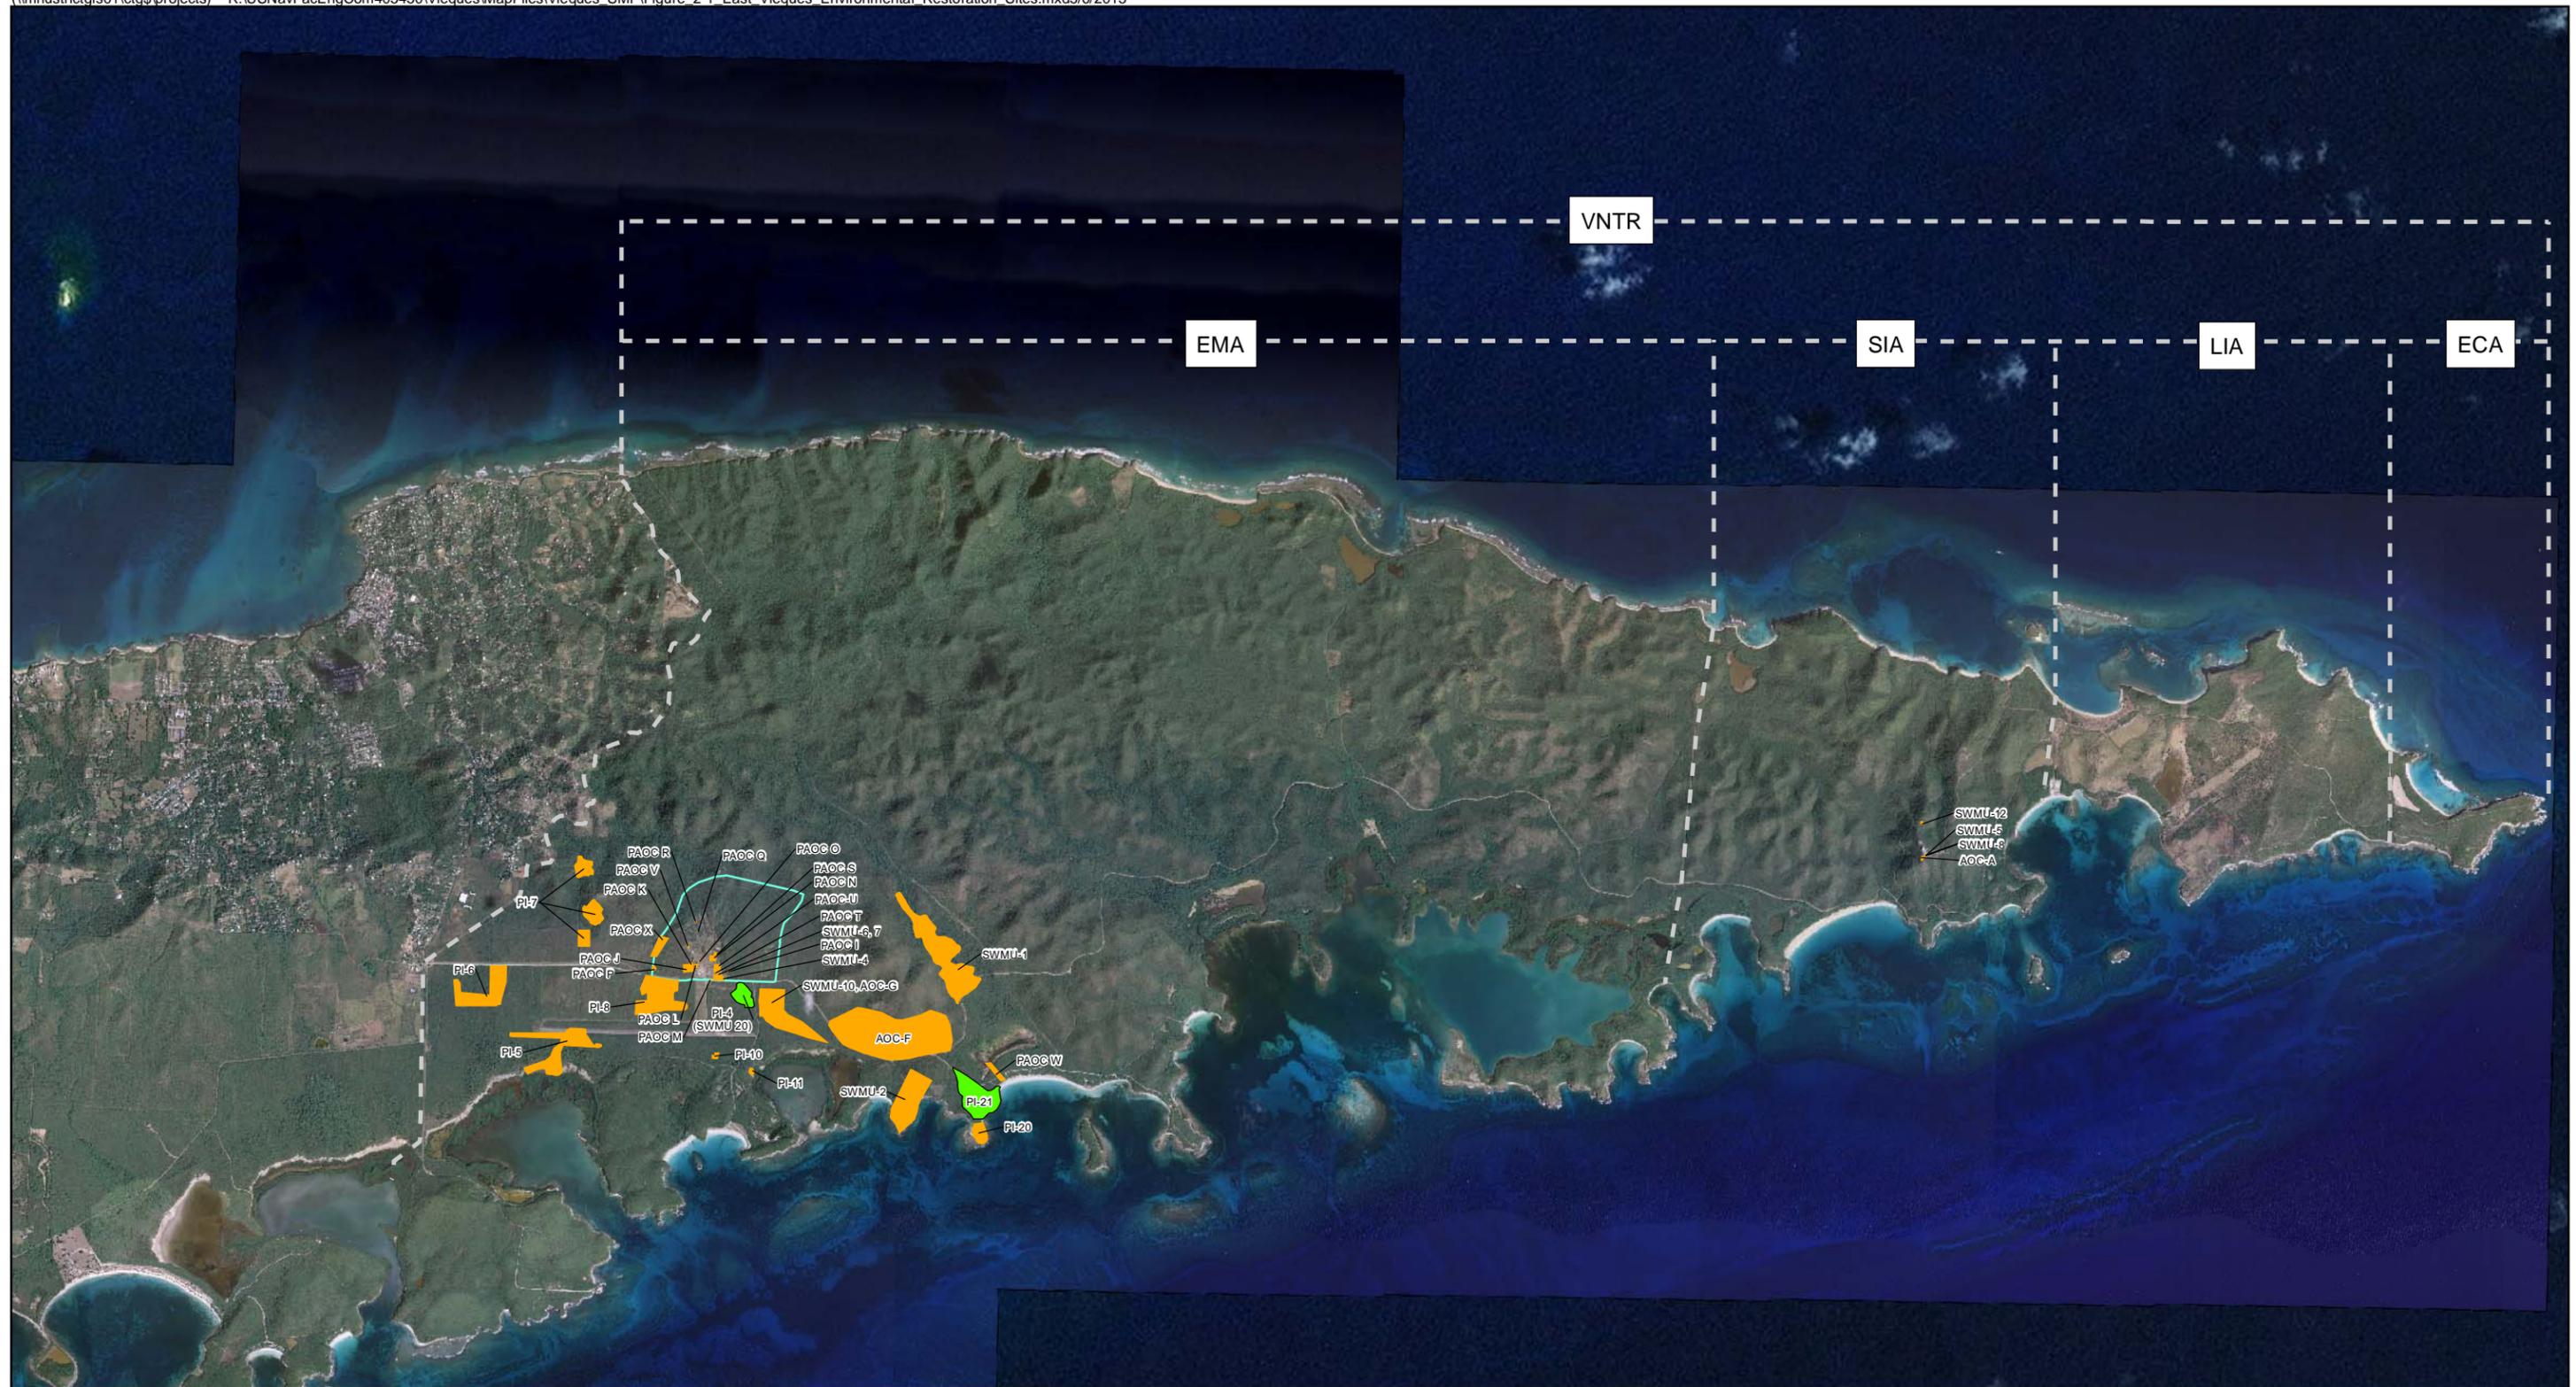
**Figure 2-1**  
**East Vieques Environmental Restoration Sites**  
*Site Management Plan, FY 2014*  
*Vieques, Puerto Rico*

**Legend**  
■ Sites – Decision Document  
■ Sites – Under Investigation  
□ Camp Garcia

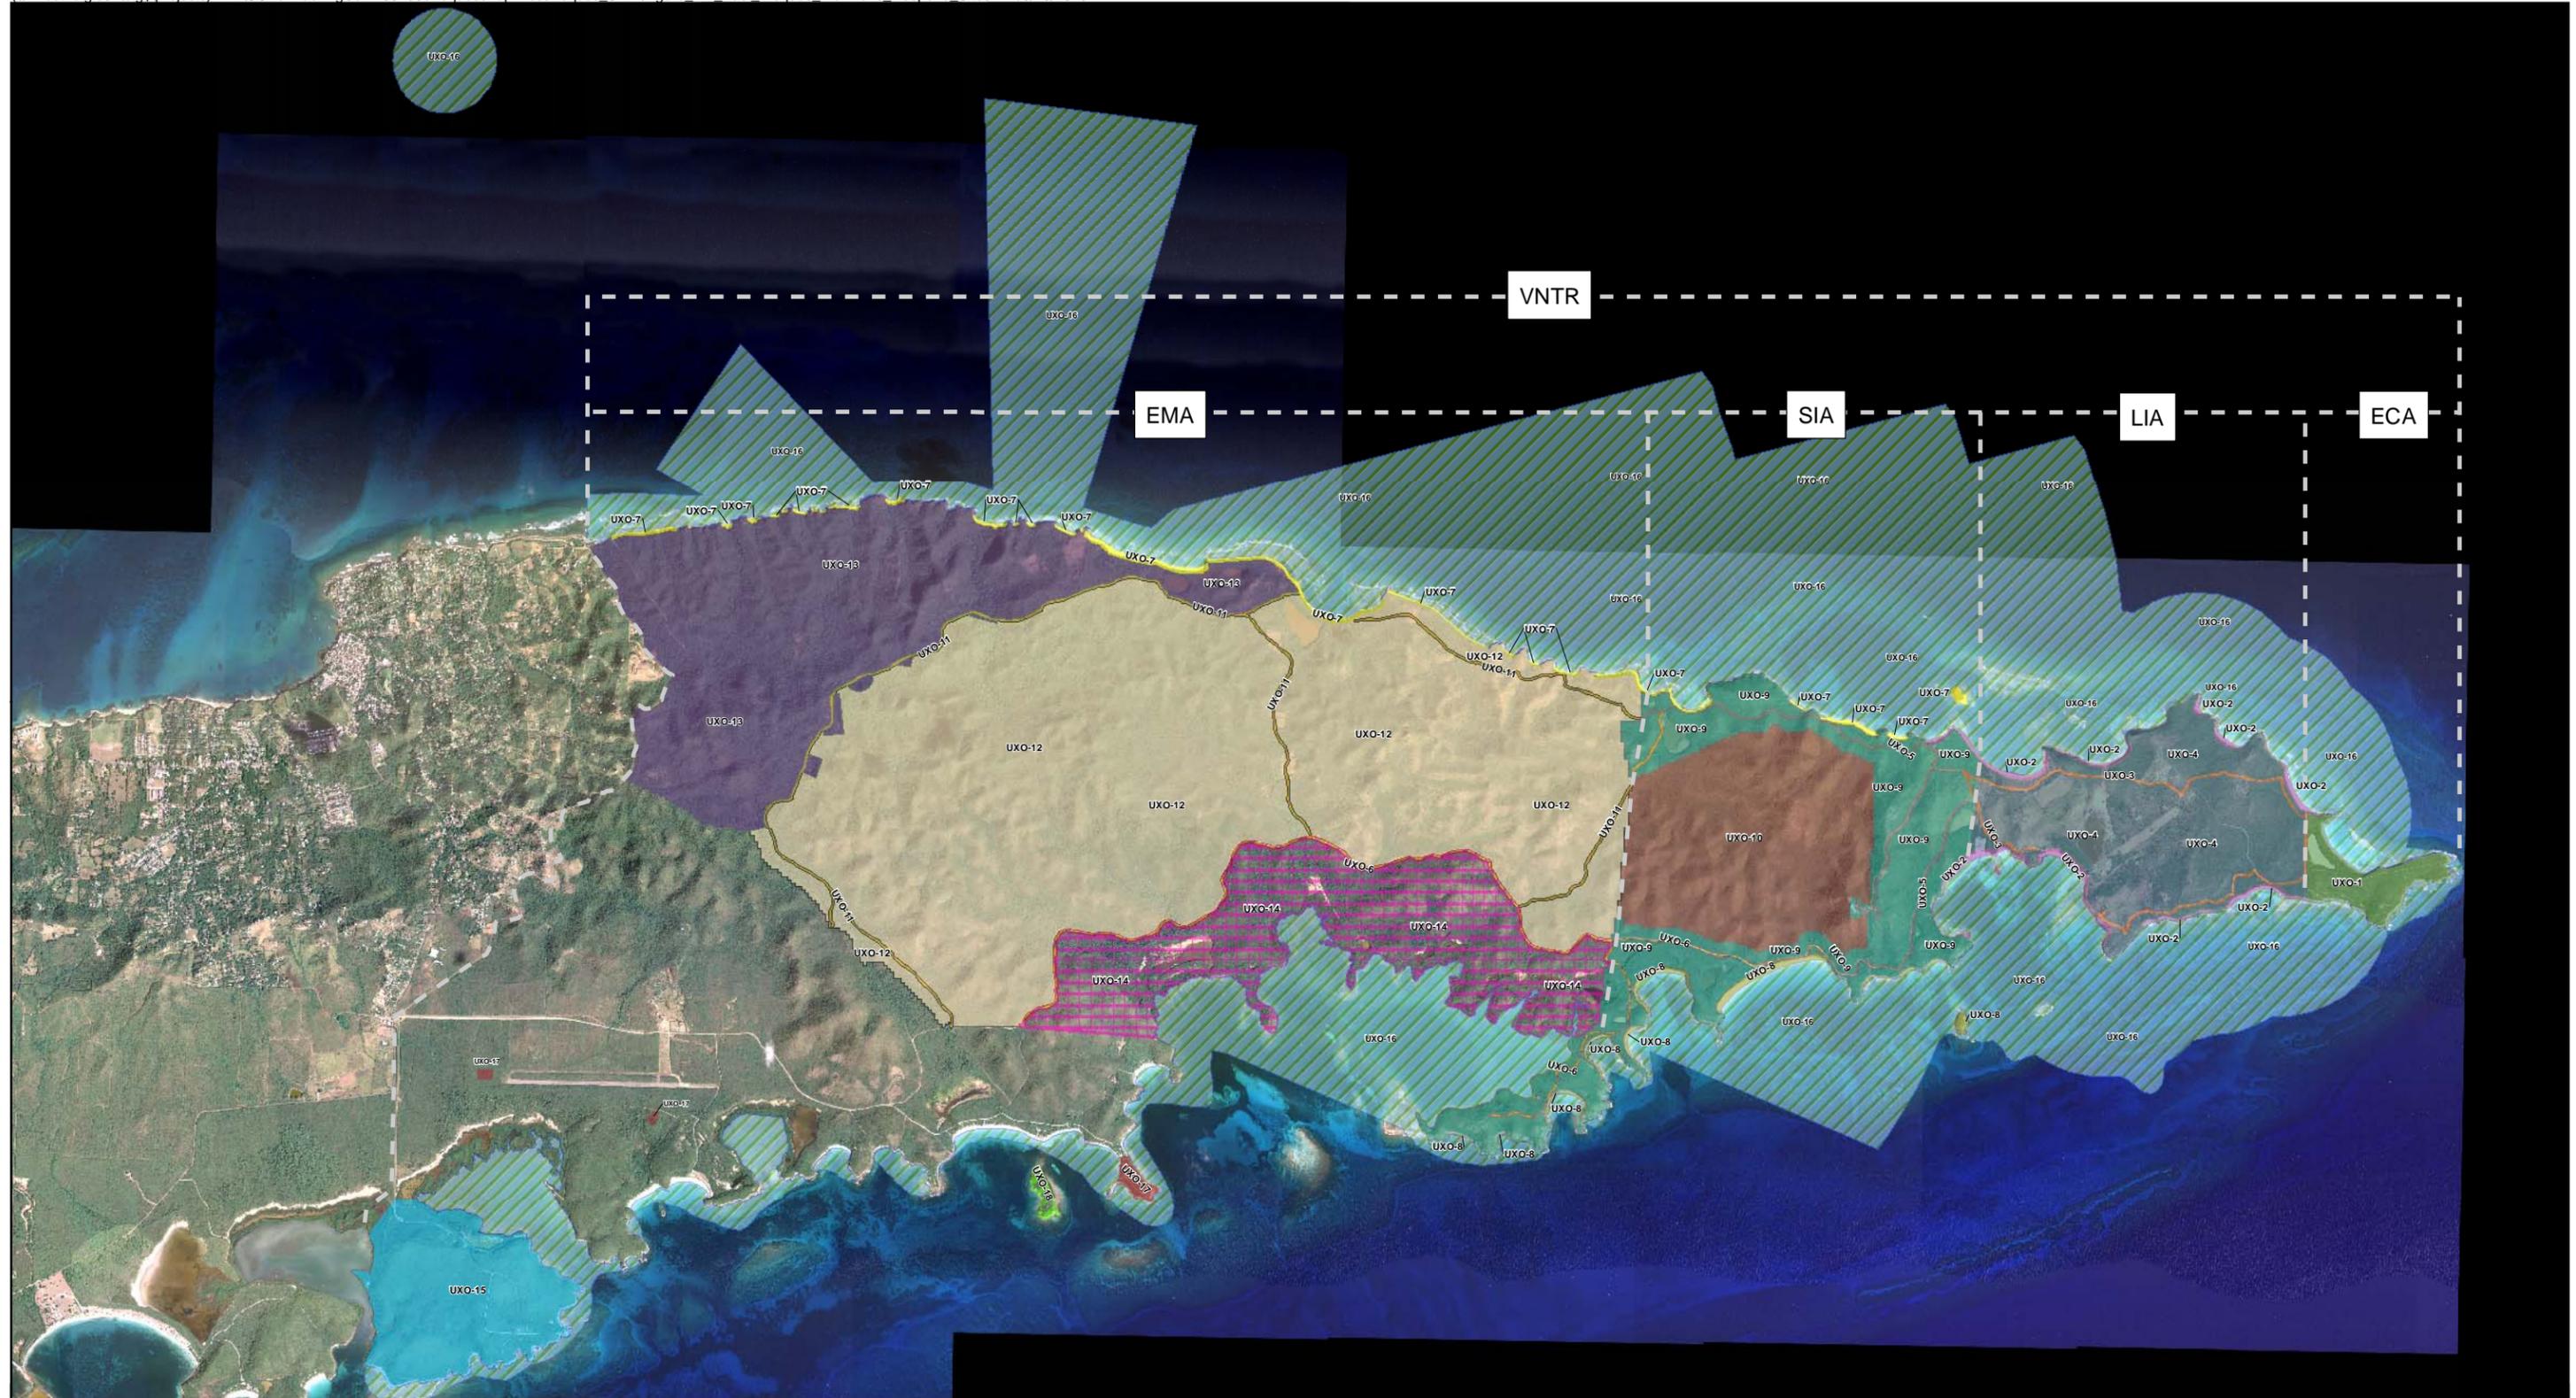
**Figure 2-2**  
**East Vieques Munitions Response Sites**  
 Site Management Plan, FY 2014  
 Vieques, Puerto Rico

- Legend**
- Munitions Response Sites**
- UXO 1 - ECA
  - UXO 2 - LIA Beaches
  - UXO 3 - LIA Roads
  - UXO 4 - LIA Interior
  - UXO 5 - SIA Restricted Roads
  - UXO 6 - EMA/SIA North Beaches
  - UXO 7 - EMA/SIA North Beaches
  - UXO 8 - SIA South Beaches
  - UXO 9 - SIA Exterior
  - UXO 10 - SIA Interior
  - UXO 11 - EMA Public Roads
  - UXO 12 - EMA Interior
  - UXO 13 - EMA West
  - UXO 14 - EMA South
  - UXO 15 - Puerto Ferro
  - UXO 16 - Underwater Areas
  - UXO 17 - Camp Garcia Area (PAOC EE, PAOC FF, and PI 14)
  - UXO 18 - Cayo de la Chiva
