FINAL RESOURCE CONSERVATION AND RECOVERY ACT PARTIAL CLOSURE REPORT
FOR BUILDING 251 DE-ICE/RINSE PUMPHOUSE NAS BRUNSWICK ME
3/1/2010
TETRA TECH NUS

RCRA PARTIAL CLOSURE REPORT
for
BUILDING 251 – DE-ICE/RINSE PUMPHOUSE
NAVAL AIR STATION BRUNSWICK, MAINE
USEPA IDENTIFICATION NUMBER ME8170022018
MARCH 2010

**BUILDING INSPECTION FORM
RCRA PARTIAL CLOSURE PROGRAM
NAS BRUNSWICK
BRUNSWICK, MAINE
CTO WE22**

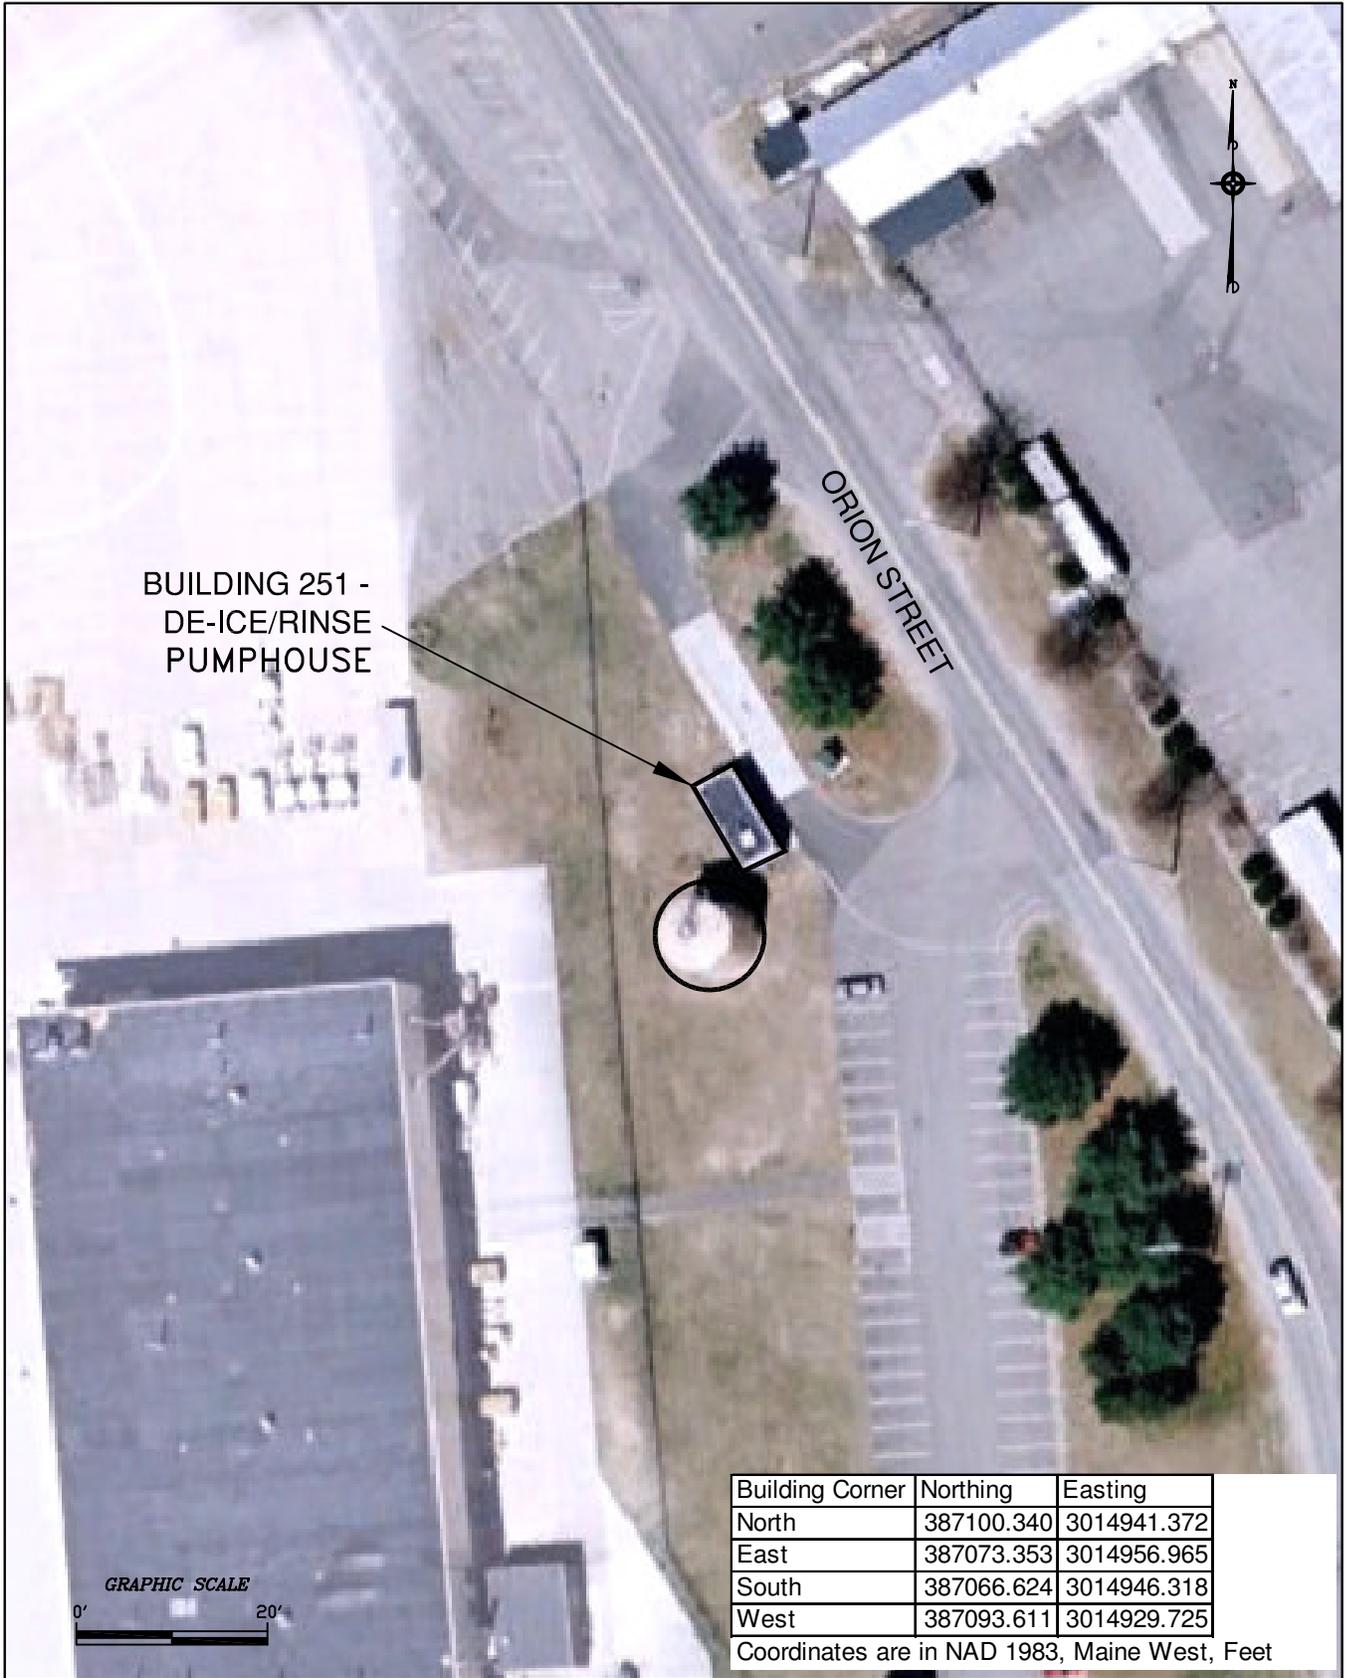
FIGURE NUMBER
FIGURE NO. 2

This investigation of the hazardous waste closure requirement applies to the Building 251 footprint (as shown on Figure 2) only. It does not apply to the land surrounding or the groundwater underlying Building 251.

SITE LOCATION MAP
 BUILDING 251 - DE-ICE/RINSE PUMPHOUSE
 RCRA PARTIAL CLOSURE REPORT
 NAS BRUNSWICK, MAINE

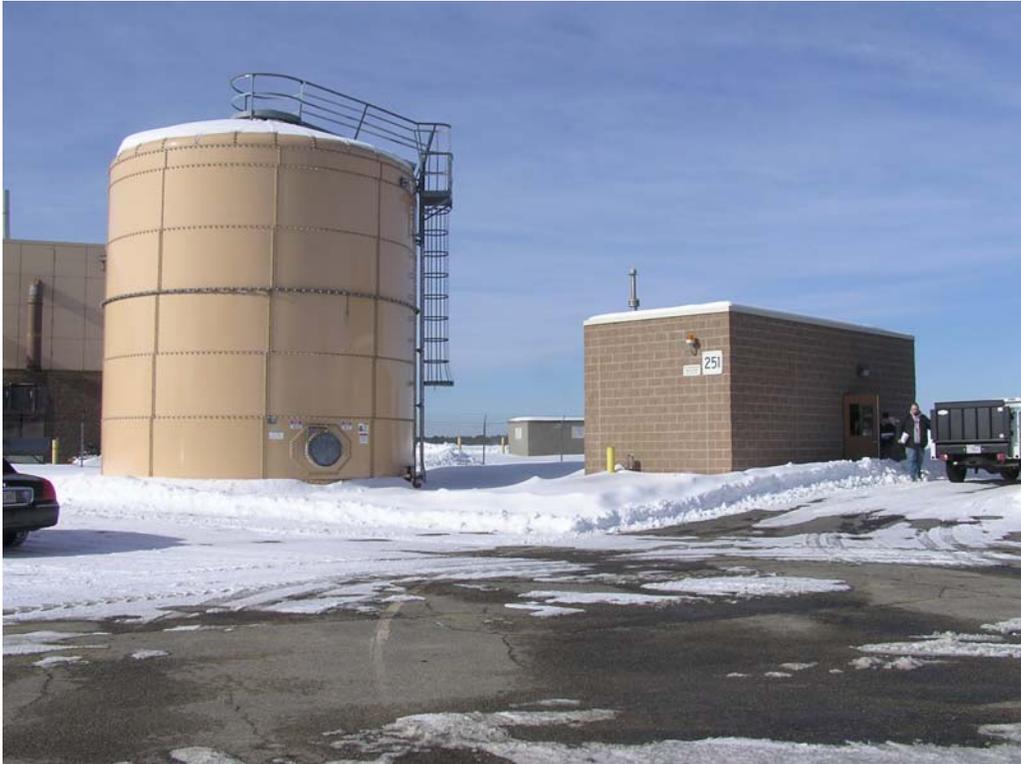
At the time of the site visit, the building and AST exterior appeared in excellent condition. The interior of the tank was not inspected.

No. 1 Building 251 – NAS Brunswick January 22, 2010
Building 251 – Deice/Rinse Pumphouse and associated waste glycol AST.

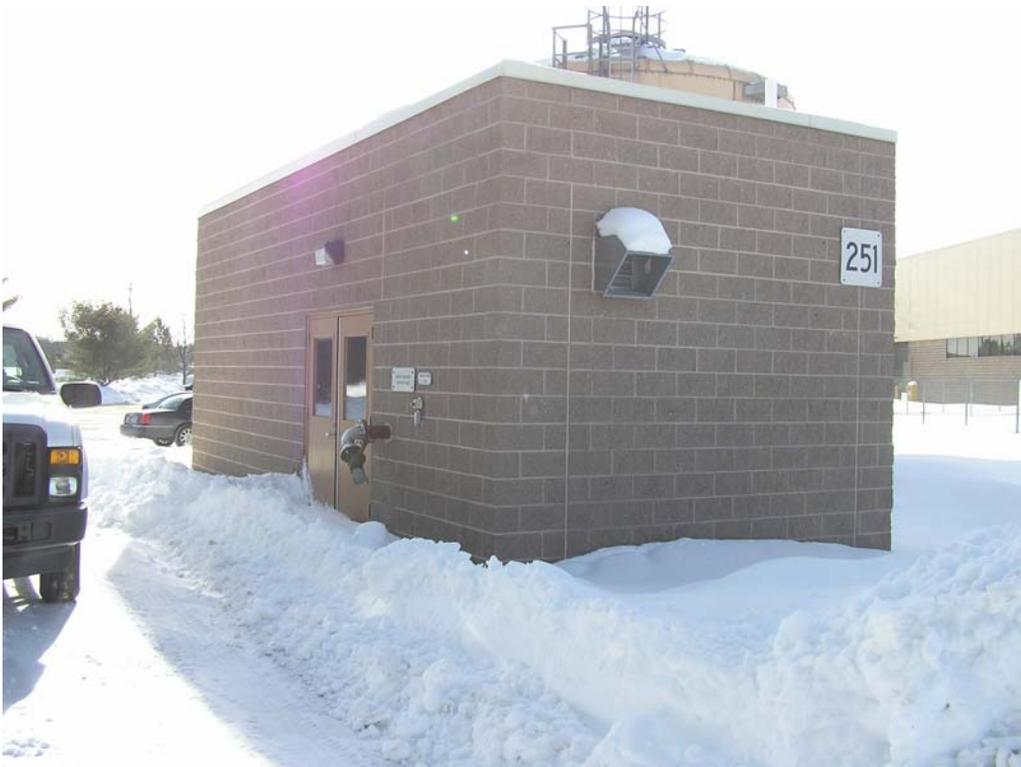
No. 2 Building 251 – NAS Brunswick January 22, 2010
Building 251 – Deince/Rinse Pumphouse with external effluent hookup.
