FINAL RESOURCE CONSERVATION AND RECOVERY ACT PARTIAL CLOSURE REPORT
FOR BUILDINGS 27 AND 30 WITH TRANSMITTAL LETTER NAS BRUNSWICK ME
7/30/2010
NAS BRUNSWICK

RCRA PARTIAL CLOSURE REPORT
for
BUILDINGS 27 AND 30 – FAMILY SERVICES CENTER (FSC) PARCEL
NAVAL AIR STATION BRUNSWICK, MAINE
USEPA IDENTIFICATION NUMBER ME8170022018
JULY 2010

**HWSA INSPECTION REPORT
HAZARDOUS WASTE STORAGE AREAS CLOSURE
NAS BRUNSWICK
BRUNSWICK, MAINE
CTO WE22**

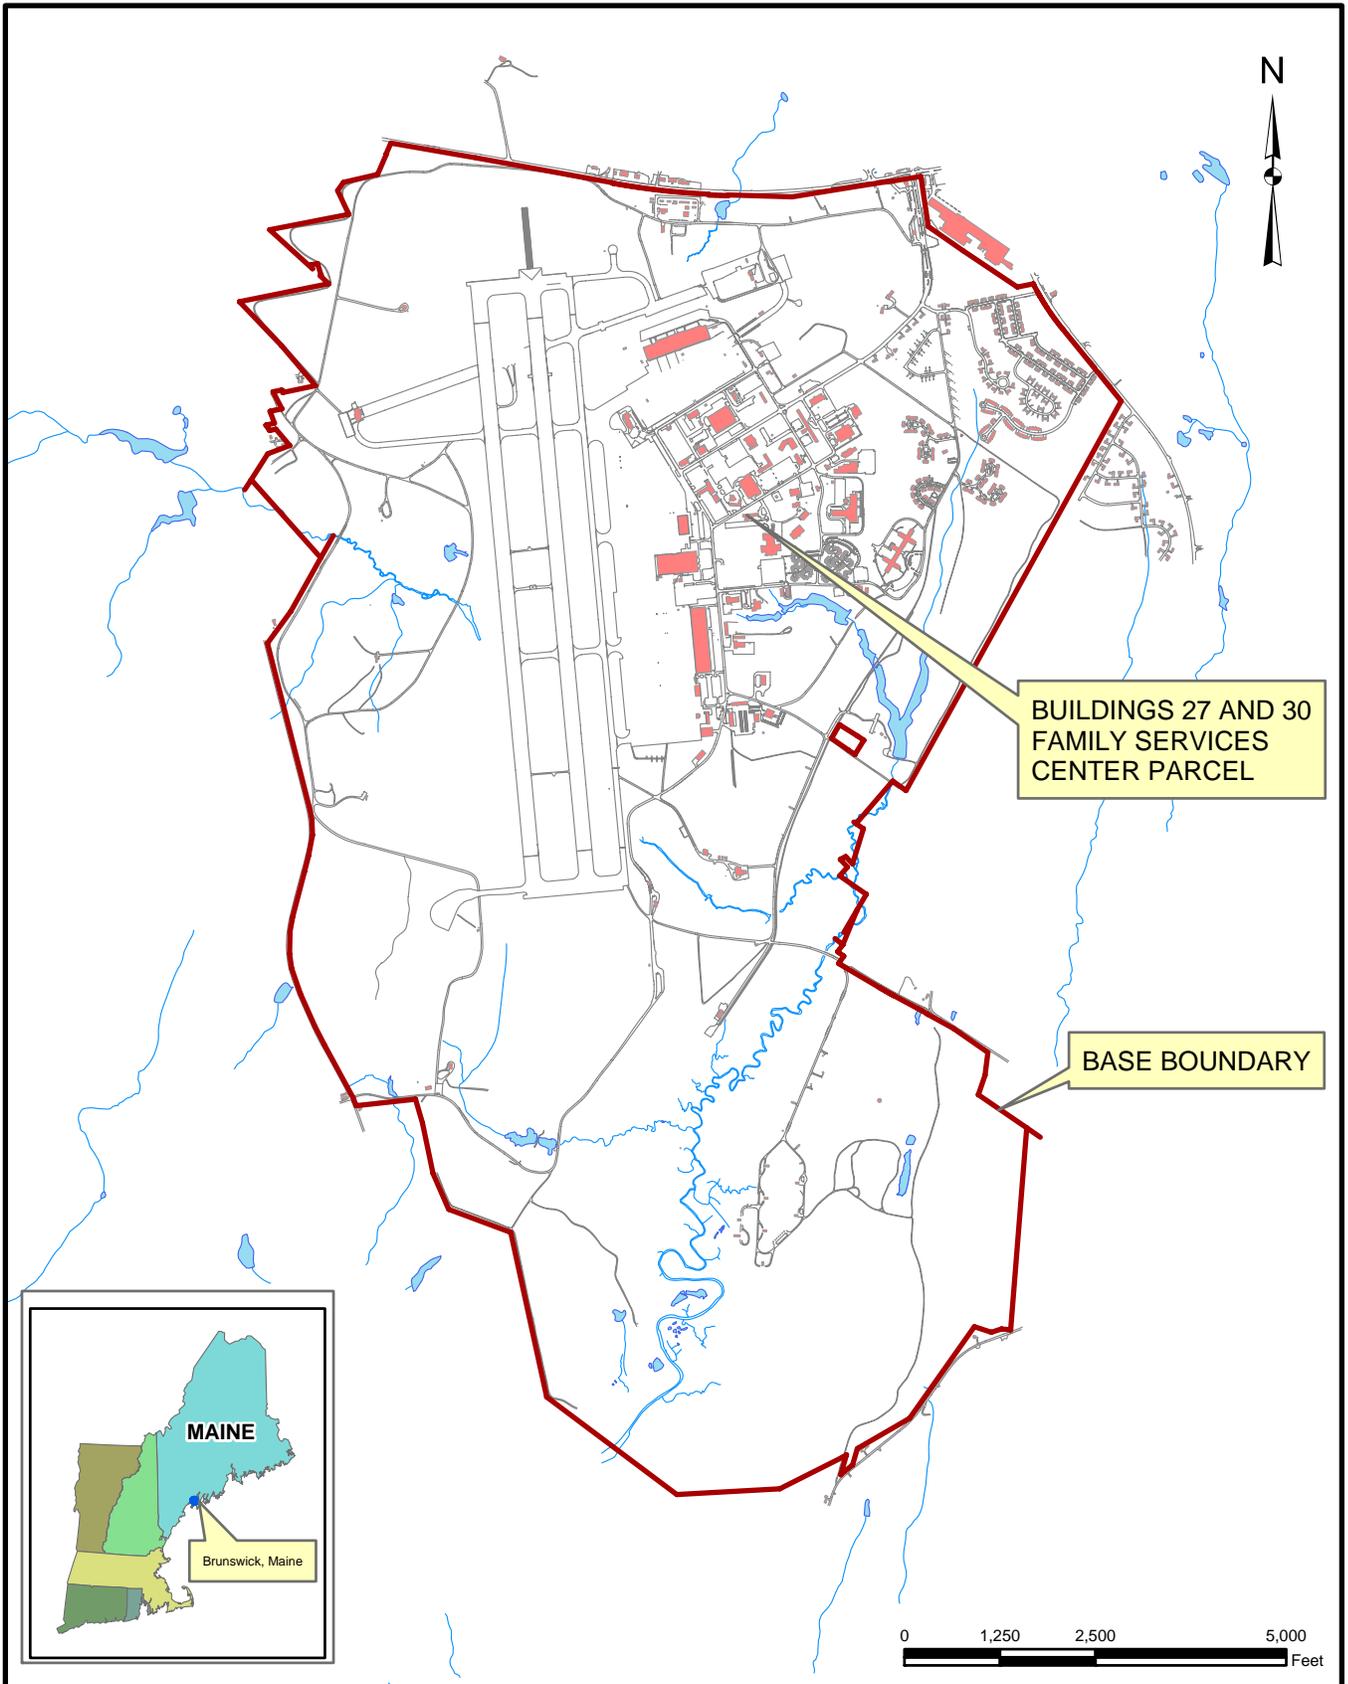
SCALE AS NOTED	
FILE	
I:_NASB_BLDG_27_LOCUS.MXD	
REV	DATE
0	07/28/10
FIGURE NUMBER	
1

SITE LOCATION MAP
BUILDINGS 27 AND 30 - FAMILY SERVICES CENTER PARCEL
RCRA PARTIAL CLOSURE REPORT
NAVAL AIR STATION BRUNSWICK, MAINE

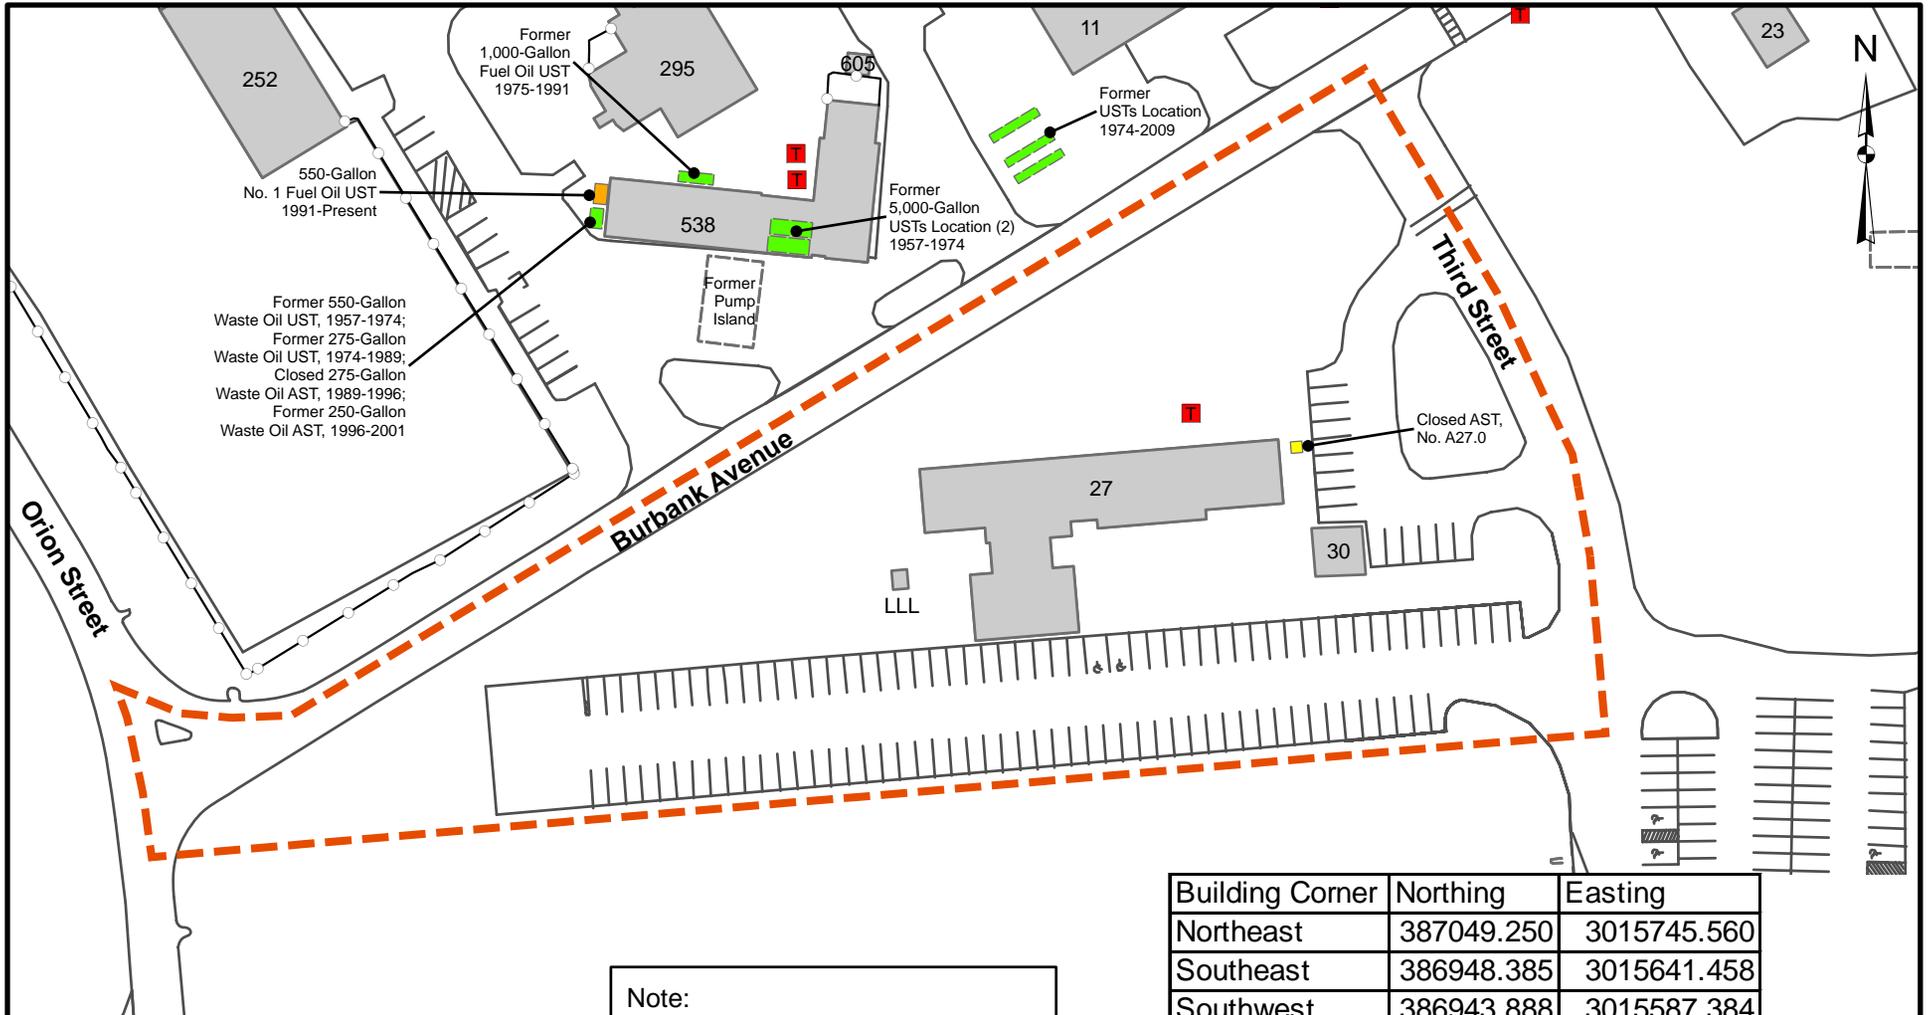
SCALE AS NOTED	
FILE I:\NASB_BLDG_27_SITE_MAP.MXD	
REV 0	DATE 07/28/10
FIGURE NUMBER 2

Former 1,000-Gallon Fuel Oil UST 1975-1991

550-Gallon No. 1 Fuel Oil UST 1991-Present

This investigation of the hazardous waste closure requirement applies to the Buildings 27 and 30 parcel (as shown on Figure 2) only.

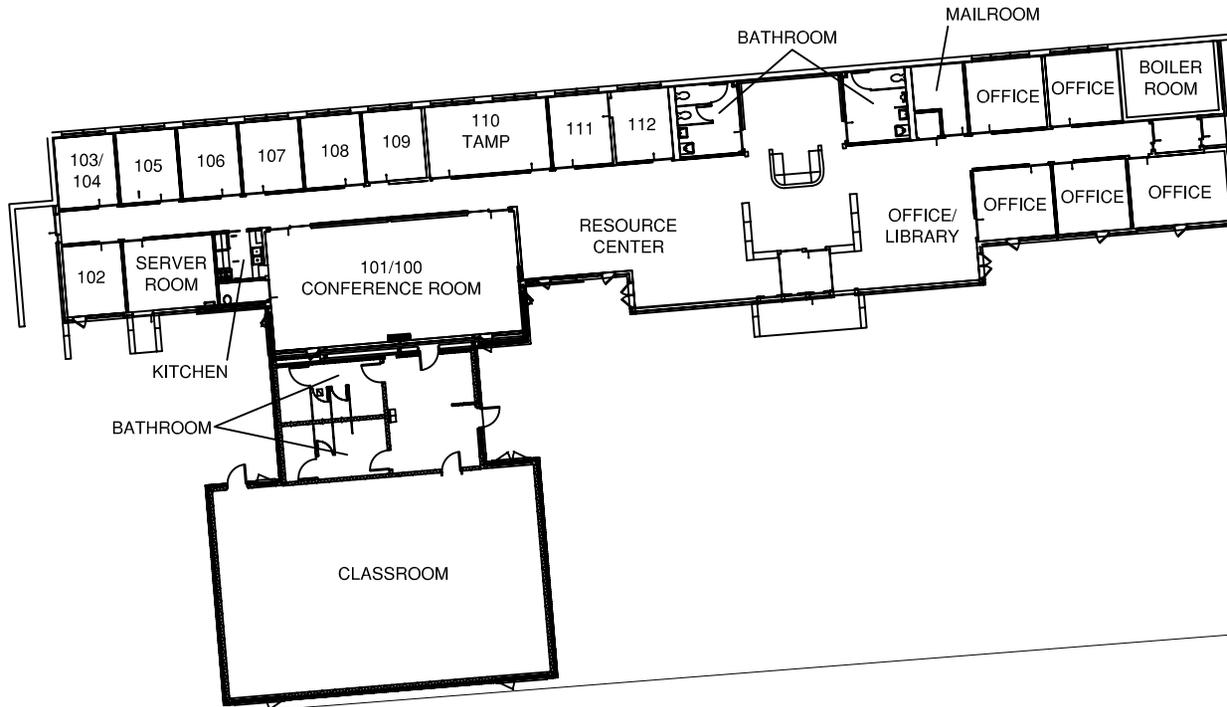
SCALE AS NOTED	
FILE \\.\NASB_BLDG_27_FP.DWG	
REV 0	DATE 07/29/10
FIGURE NUMBER 3

1,000-GALLON (FUEL OIL) AST
PARKING LOT

SMOKING AREA

Building 30 is located immediately east of Building 27, as shown on Figures 2 and 3. The building was constructed in 1995 and consists of a 512-square-foot, one-story structure on a concrete slab foundation. This two-room building served as the FSC storage facility: the easternmost room was used to store household items/materials that were temporarily loaned to military families; the room on the west side of the building was used to store office supplies.

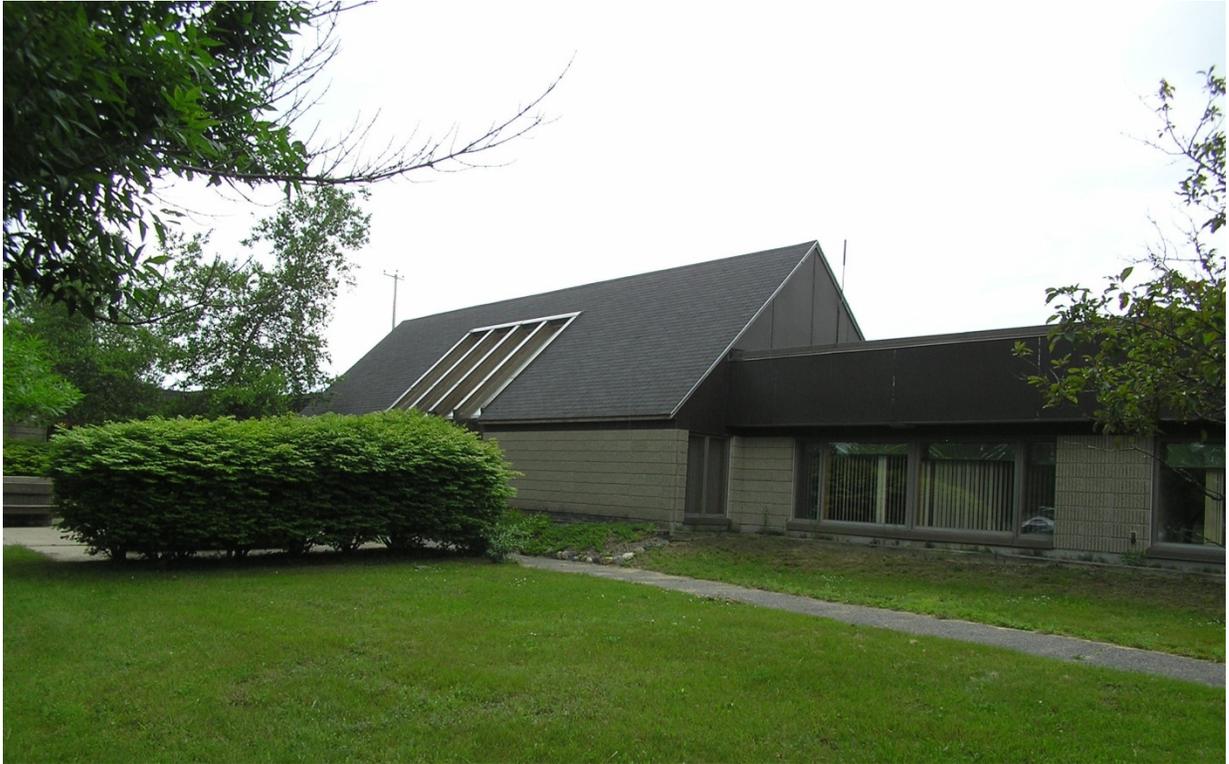
No. 1 Buildings 27 and 30 Parcel – NAS Brunswick
FSC building south elevation – main entrance

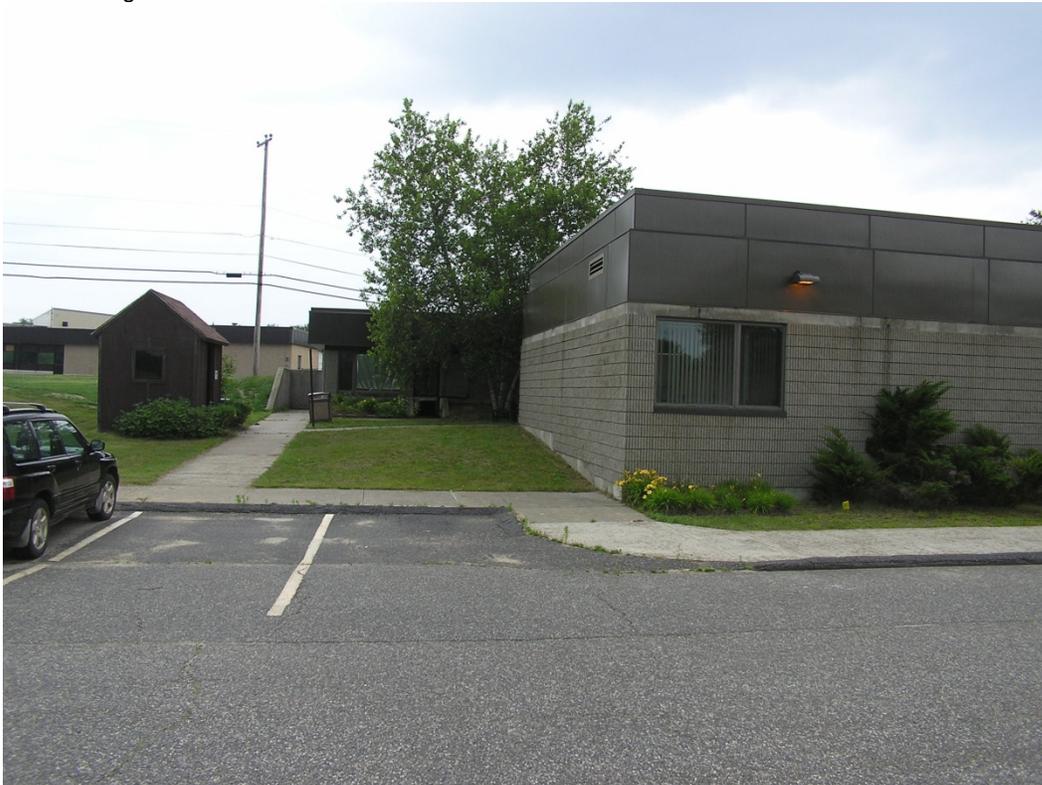
No. 2 Buildings 27 and 30 Parcel – NAS Brunswick
Building 27 southwest elevation; smoking area shelter (Structure LLL) on left

A designated smoking area shed is located immediately west of Building 27. The shed is labeled LLL, and is a 576 SF unheated wooden structure. No hazardous materials were used in its operation and no hazardous waste was generated, according to NAS Brunswick personnel.

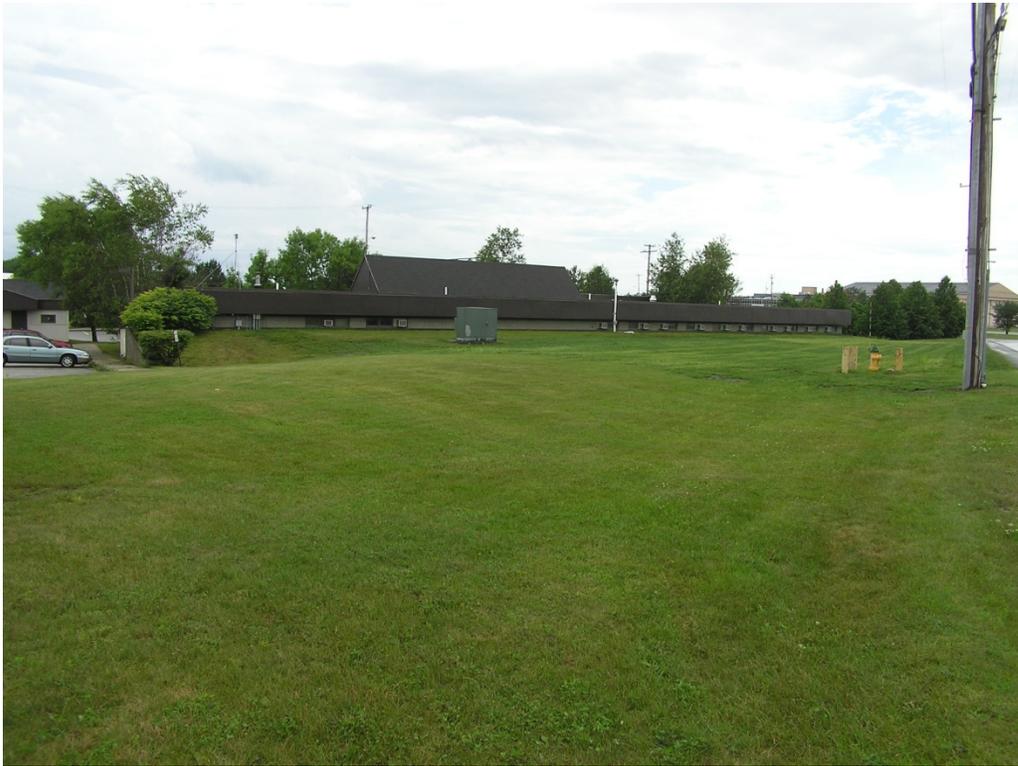
No. 3 Buildings 27 and 30 Parcel – NAS Brunswick
Northeast area of parcel - Building 27 northeast exterior in background

New vegetation was observed on the northern side of Building 27 and Transformer No. 138. Mr. Bruce Smith (Hazardous Waste Manager) noted that a significant excavation of soil, impacted from a historical release at Building 538, occurred at this site in the spring 2010. Additionally, a vent pipe was observed coming out of the ground adjacent to Building 27, which was reported to be a passive soil vapor venting stack by Mr. Smith.

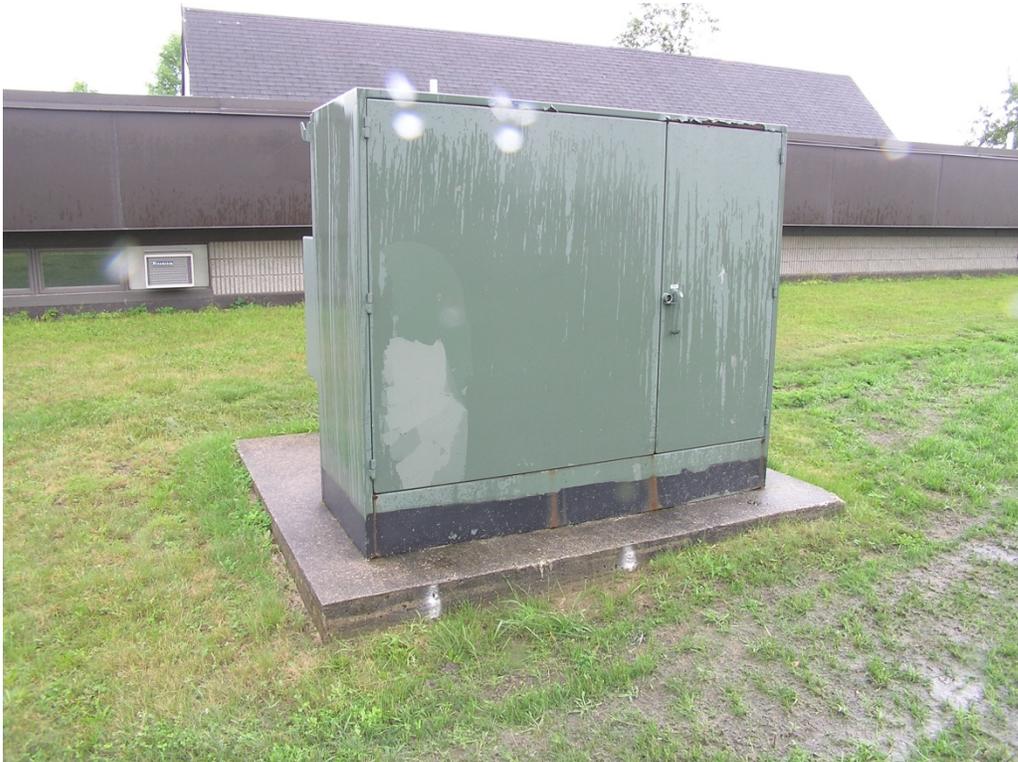
No. 4 Buildings 27 and 30 Parcel – NAS Brunswick
Pad-mounted transformer north of Building 27

- One concrete-pad-mounted transformer was identified on the north side of Building 27. No evidence of a past leak from this transformer was observed. As discussed in Section 3, according to the NAS Brunswick transformer database, the insulating oil in this transformer is mineral oil.

One pad-mounted transformer was observed onsite that was reported to have been manufactured in 1988 manufactured by RTE with S/N 886006358) and containing mineral oil. No signs of a past release (staining, unusual odors, stressed vegetation, etc.) were observed.

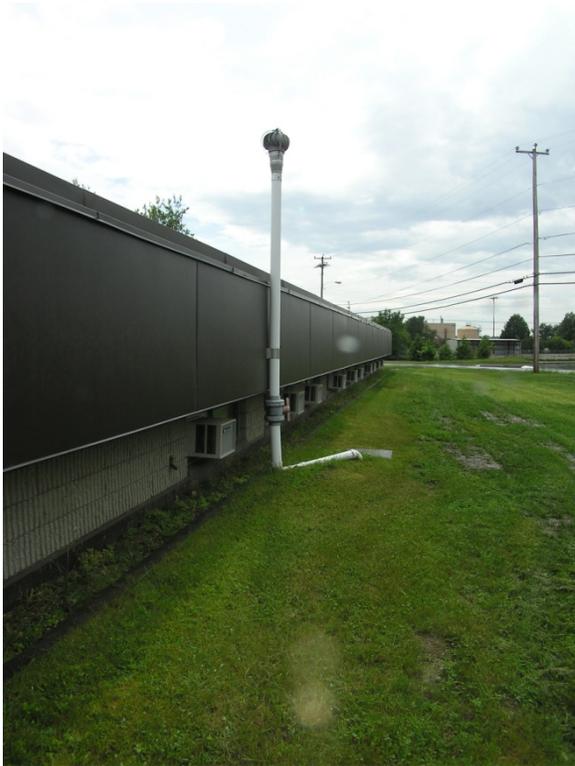
No. 5 Buildings 27 and 30 Parcel – NAS Brunswick

Passive soil vapor extraction vent connected to Building 27's north wall footing drain

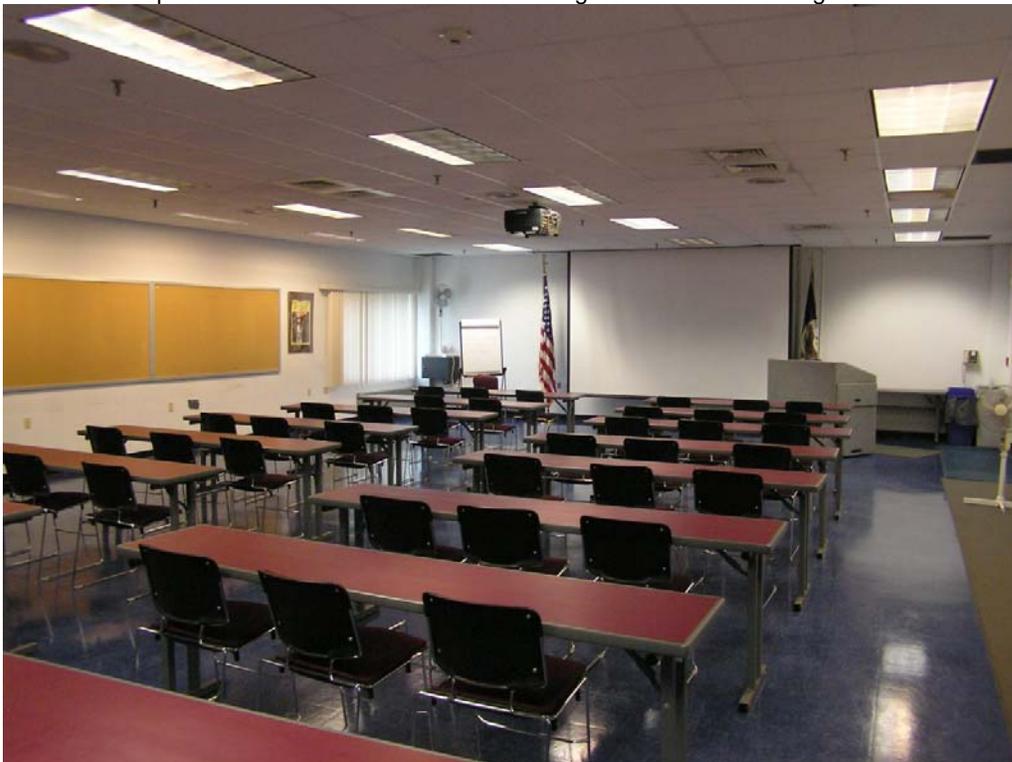
No. 8 Buildings 27 and 30 Parcel – NAS Brunswick

Building 27 FSC classroom

Vinyl tiling was observed in the foyer, immediately outside of the Classroom, and within the Classroom. Based on the construction date of the building (1984) it is not anticipated that the vinyl tiling is potentially asbestos containing material (PACM), although the tile mastic may be PACM. The vinyl tile was observed to be in good condition. The tile mastic was not observed.

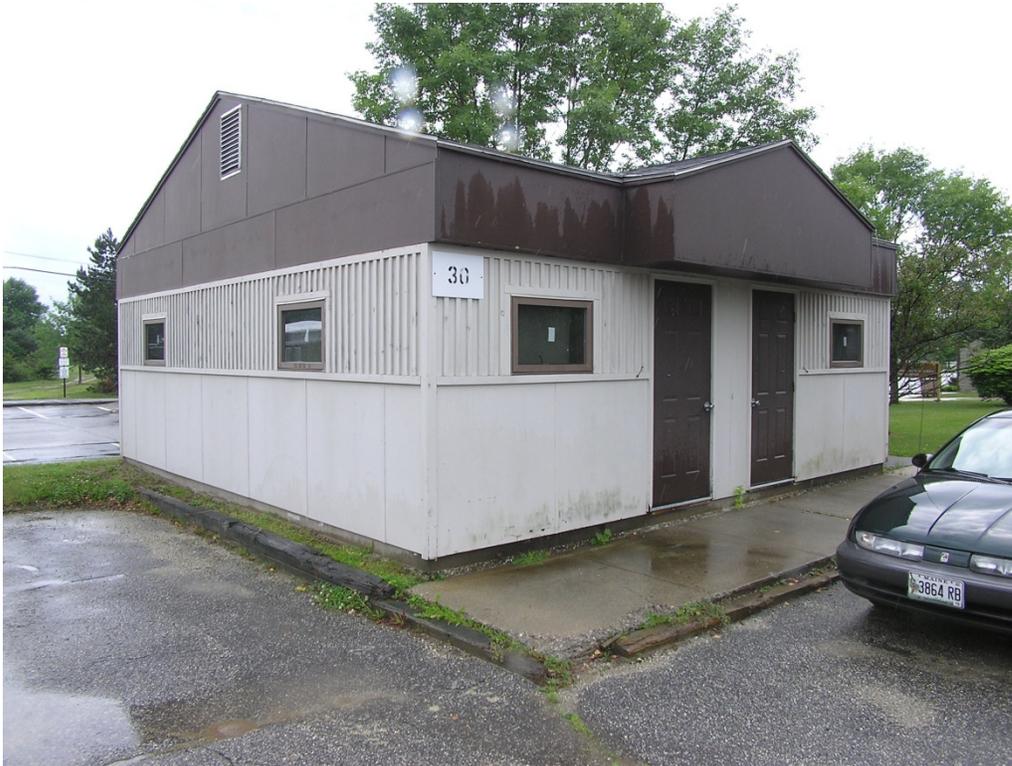
No. 9 Buildings 27 and 30 Parcel – NAS Brunswick
Building 30 FSC Storage building northeast elevation

At the time of inspection, Building 30 was operational and in good condition. The interior consisted of 2 rooms, with separate entrances, for office and household material supply storage.

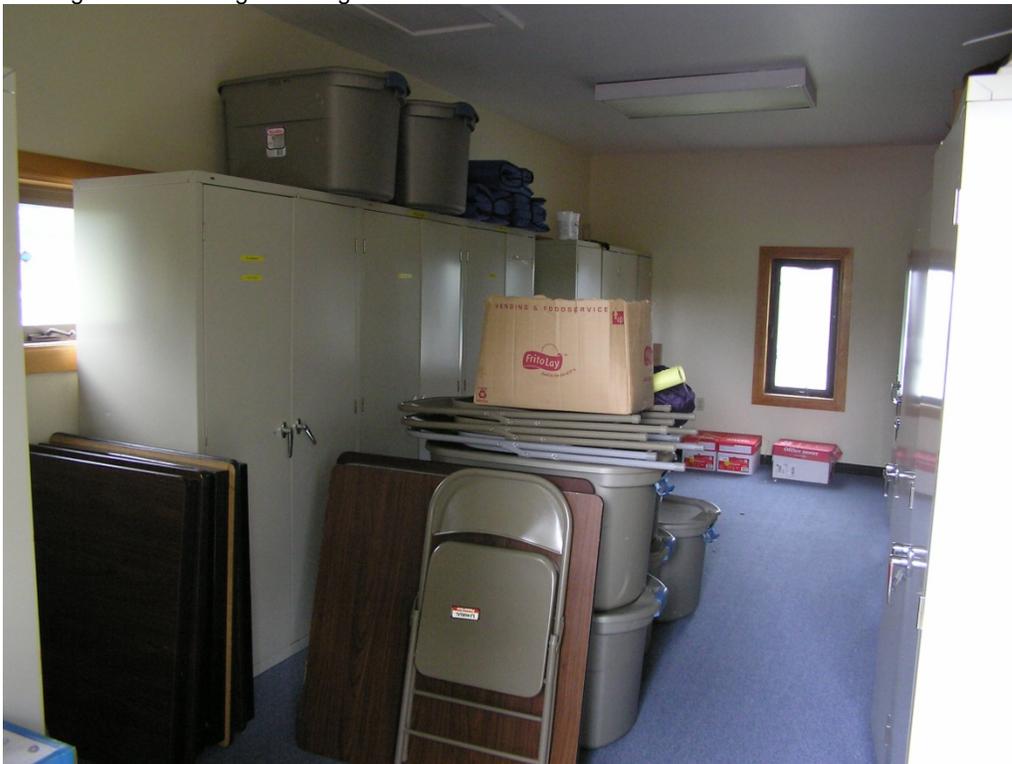
No. 10 Buildings 27 and 30 Parcel – NAS Brunswick
Building 30 FSC Storage building household goods section (eastern half of building)

Building 30 was used only as office supplies and household material storage, and for the temporary accumulation of Universal Waste, according to NAS Brunswick personnel. Household materials and supplies consist of non-hazardous materials loaned to onsite military personnel/families (Cots, kitchen packs, etc.).

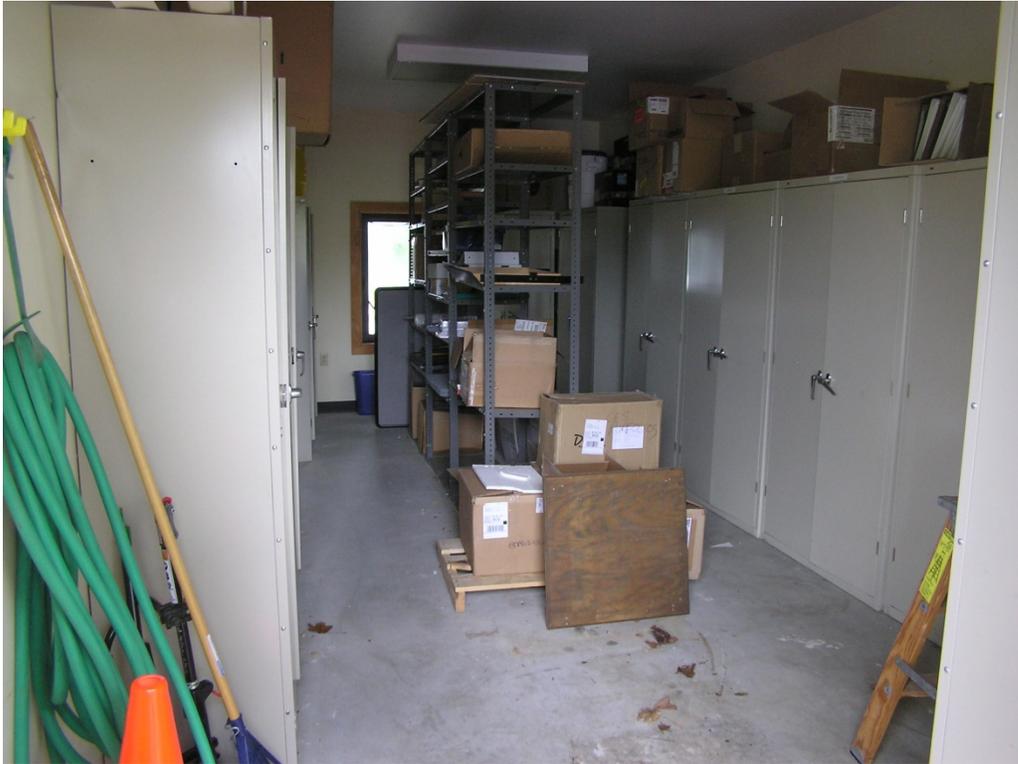
No. 11 Buildings 27 and 30 Parcel – NAS Brunswick
Building 30 FSC Storage building office supplies section (western half of building)

A hazardous materials accumulation area, for the temporary storage of universal wastes (i.e., batteries, used toner cartridges, partially used aerosol cans), is located in the office materials portion of Building 30, within a metal flammable cabinet marked "Hazardous Materials". The universal wastes were developed during activities within Building 27 normal operations. No hazardous waste was generated during Building 27 parcel operations, according to NAS Brunswick personnel.

No record of hazardous waste stored at Building 30 was discovered to date. A temporary Building 27 parcel universal waste accumulation area is located within a metal flammable cabinet, marked "Hazardous Materials", in the office materials portion of Building 30. Mr. Bruce Smith (Hazardous Waste Manager) noted that only Universal Waste (i.e., batteries, used copy machine toner cartridges and spent aerosol cans) were temporarily stored within the Hazardous Materials accumulation area.
