FINAL RESOURCE CONSERVATION AND RECOVERY ACT PARTIAL CLOSURE REPORT  
FOR RED LABEL AREA AND BUILDING 414 WITH TRANSMITTAL LETTER NAS  
BRUNSWICK ME  
8/24/2010  
NAS BRUNSWICK

**RCRA PARTIAL CLOSURE REPORT**  
**for**  
**RED LABEL AREA**  
**BUILDING 414 - RED LABEL LINE SHACK**  
**NAVAL AIR STATION BRUNSWICK, MAINE**  
**USEPA IDENTIFICATION NUMBER ME8170022018**  
**AUGUST 2010**

**BUILDING INSPECTION FORM  
RCRA PARTIAL CLOSURE PROGRAM  
NAS BRUNSWICK  
BRUNSWICK, MAINE  
CTO WE22**

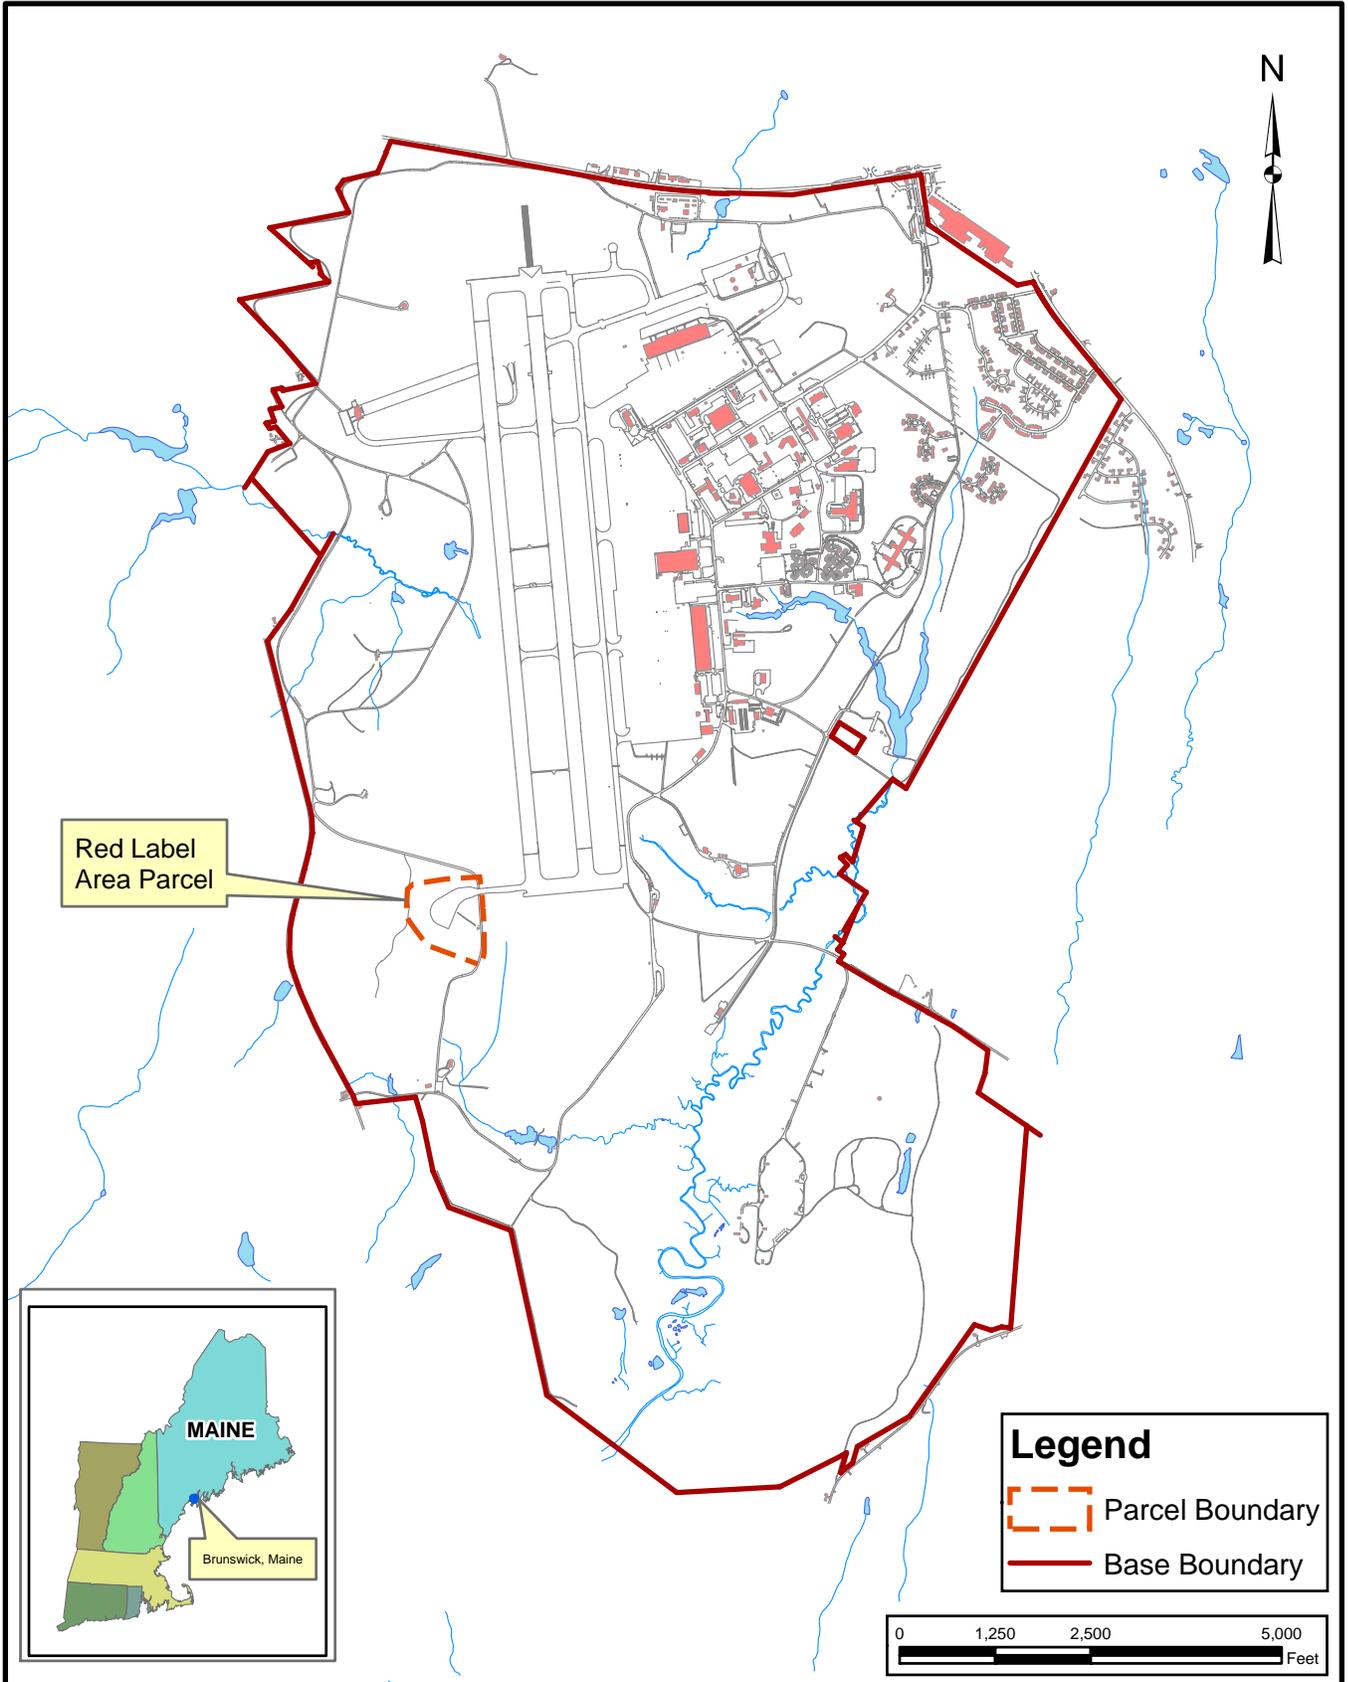
SCALE AS NOTED	
FILE I:\NASB_RCRA_15B_LOCUS.MXD	
REV 0	DATE 08/10/10
FIGURE NUMBER 1

**SITE LOCATION MAP**  
**RED LABEL AREA PARCEL**  
**RCRA PARTIAL CLOSURE REPORT**  
**NAVAL AIR STATION BRUNSWICK, MAINE**

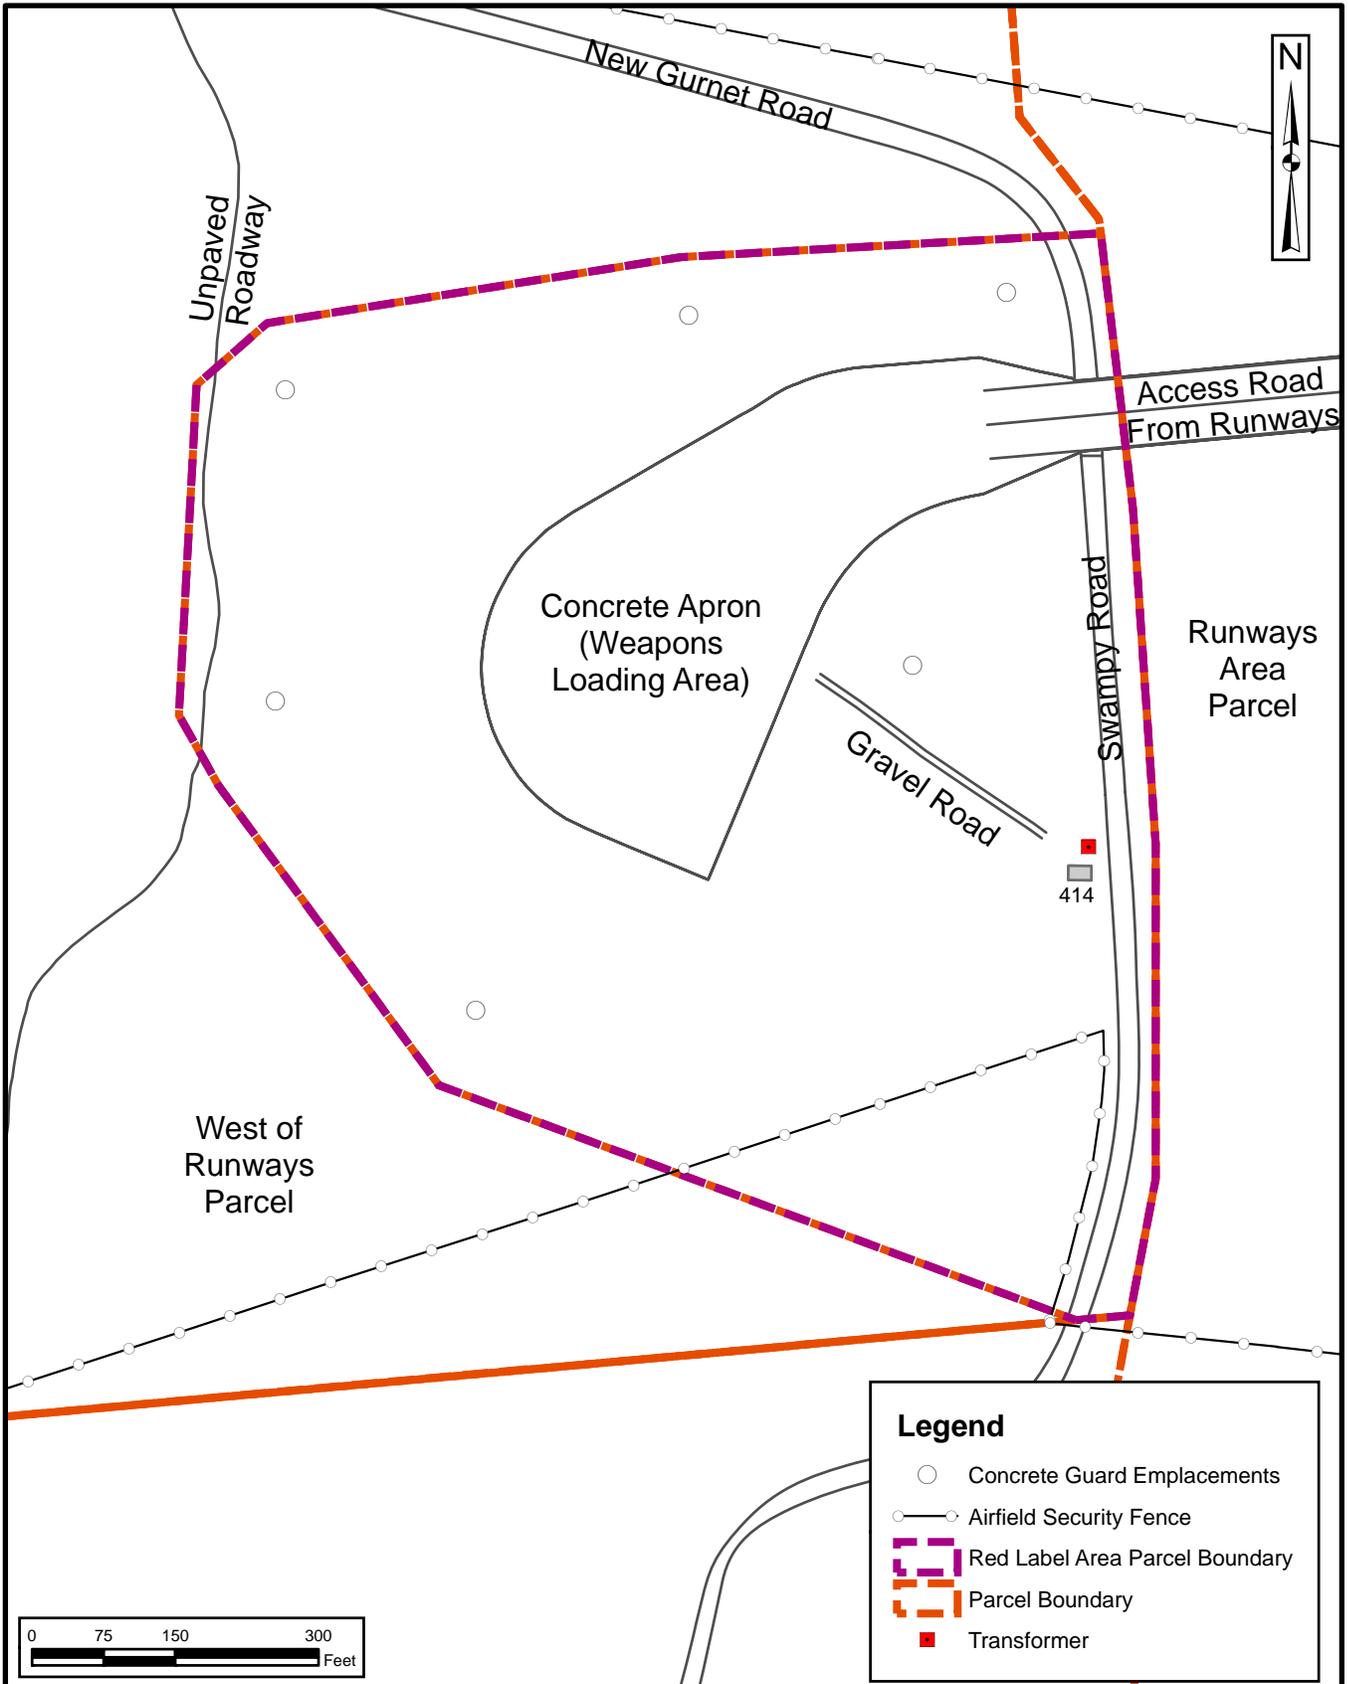
SCALE AS NOTED	
FILE \\NASB_RCRA_15B_SITE_MAP.MXD	
REV 0	DATE 08/10/10
FIGURE NUMBER 2

The Red Label Area, also known as the Combat Aircraft Loading Area (CALA), is located in the southwestern portion of NAS Brunswick (Figure 1). The approximately 21-acre parcel is bordered to the north, west and south by the West of Runway Area and to the east by Swampy Road and the Runways Area (Figure 2).

**SITE PLAN**  
**RED LABEL AREA PARCEL**  
**RCRA PARTIAL CLOSURE REPORT**  
**NAVAL AIR STATION BRUNSWICK, MAINE**

This investigation of the hazardous waste closure requirements applies to the Red Label Area and Building 414 (as shown on Figure 2) only.

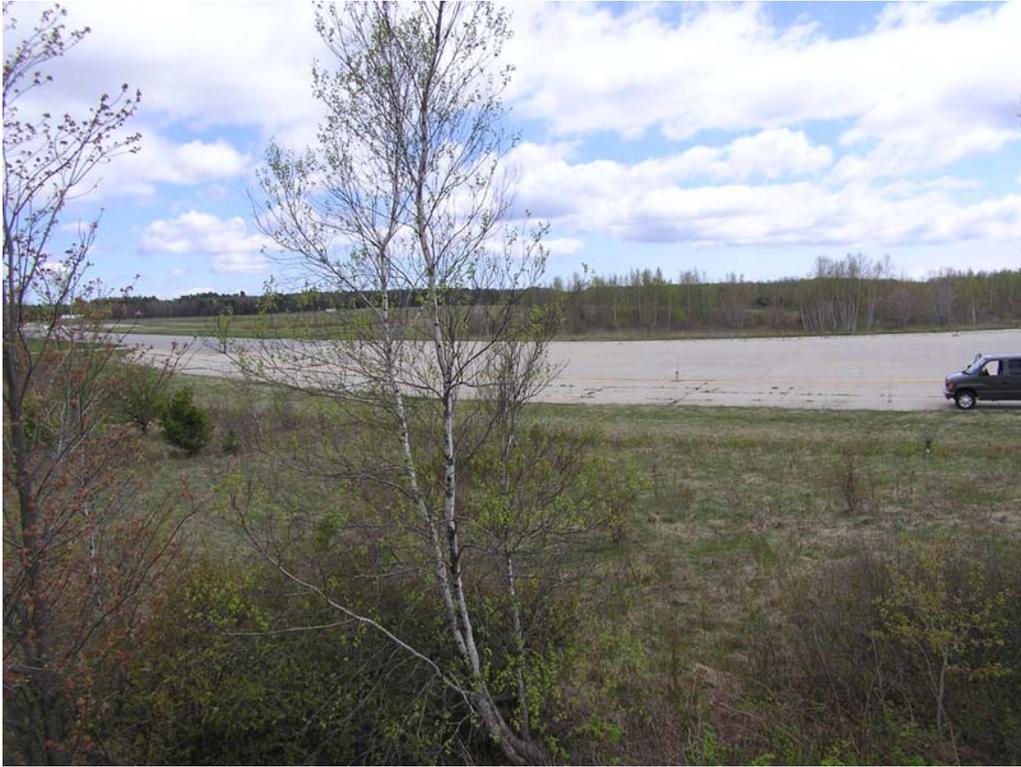
No. 1 Red Label Area Parcel– NAS Brunswick  
Concrete apron (former weapons loading area) from northern hillside

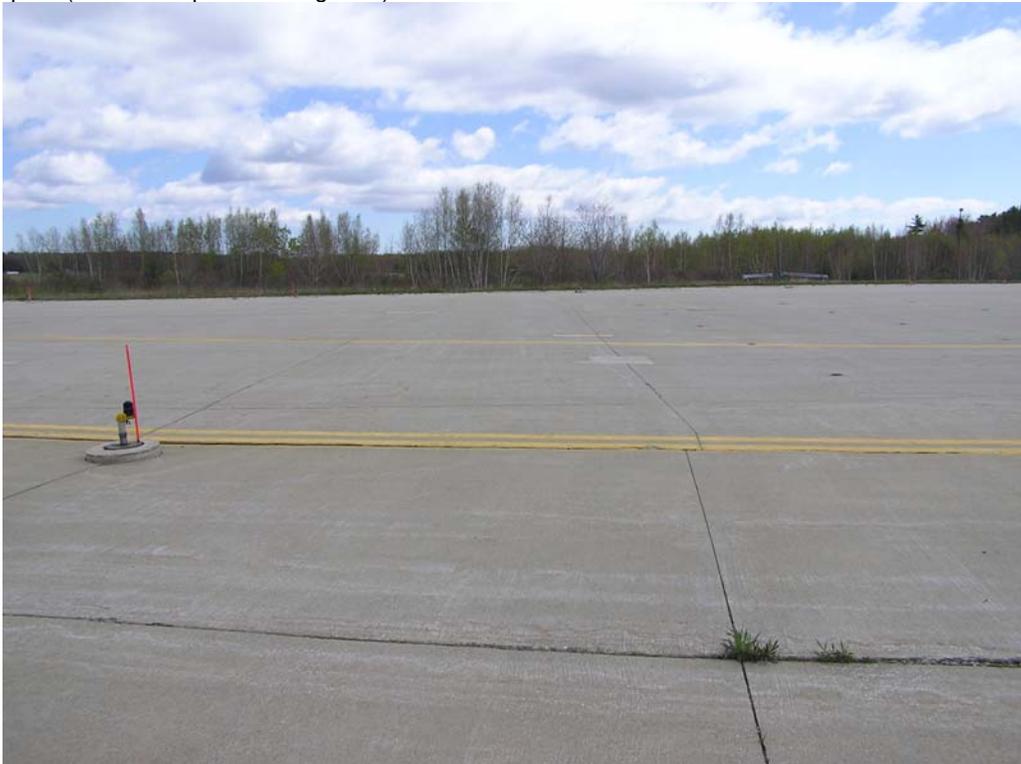
No. 2 Red Label Area Parcel– NAS Brunswick  
Concrete apron (former weapons loading area) from north – ground lighting in the foreground

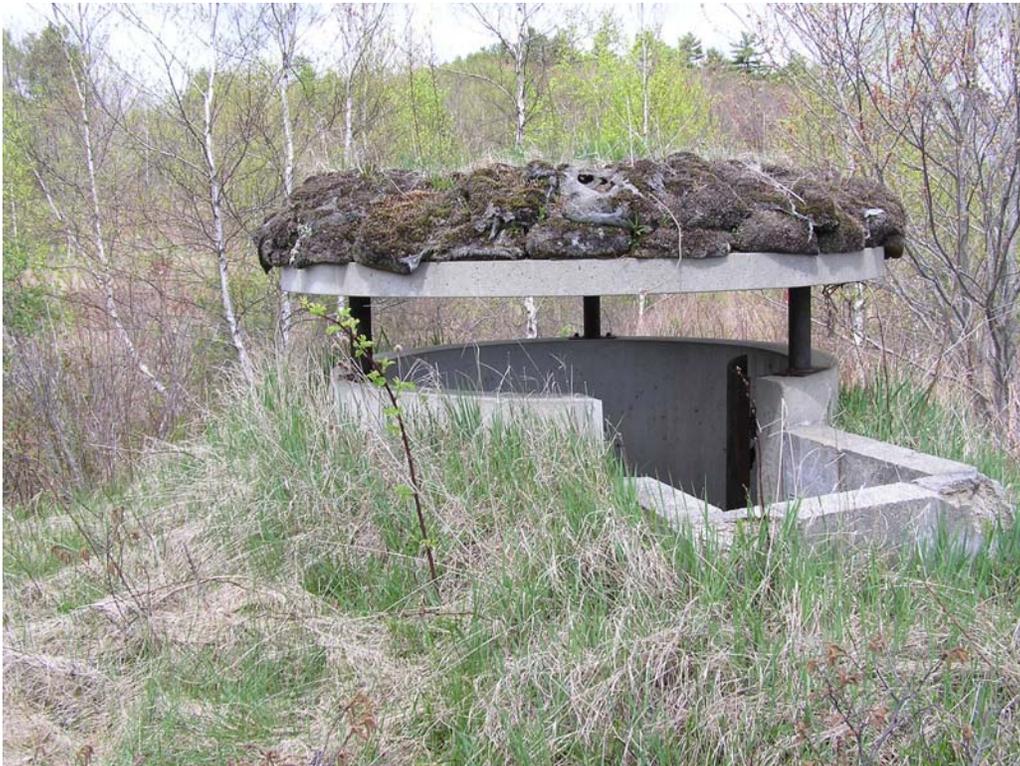
No. 3 Red Label Area Parcel– NAS Brunswick  
Concrete guard emplacement north of former weapons loading area

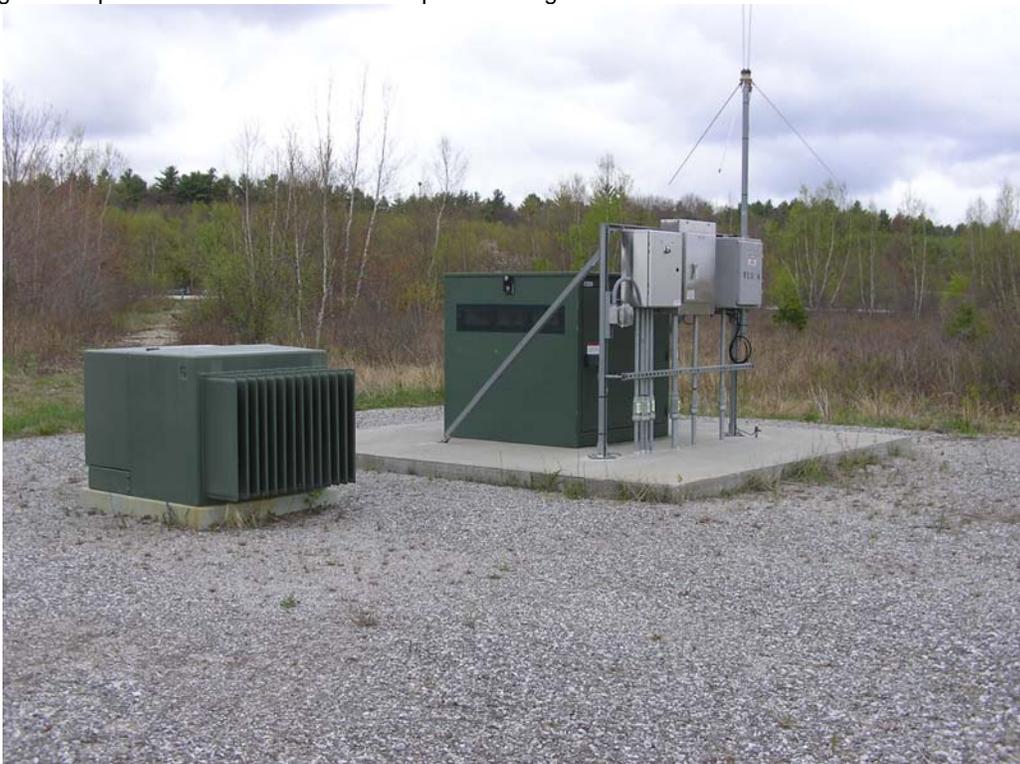
Westinghouse 25 kva pad-mounted Serial No. 82A092074 (Non-PCB <50ppm) - January 1982 at Sharon, PA plant

No. 4 Red Label Area Parcel– NAS Brunswick  
Transformer and electrical supply equipment for Red Label Area lighting (north of Building 414)

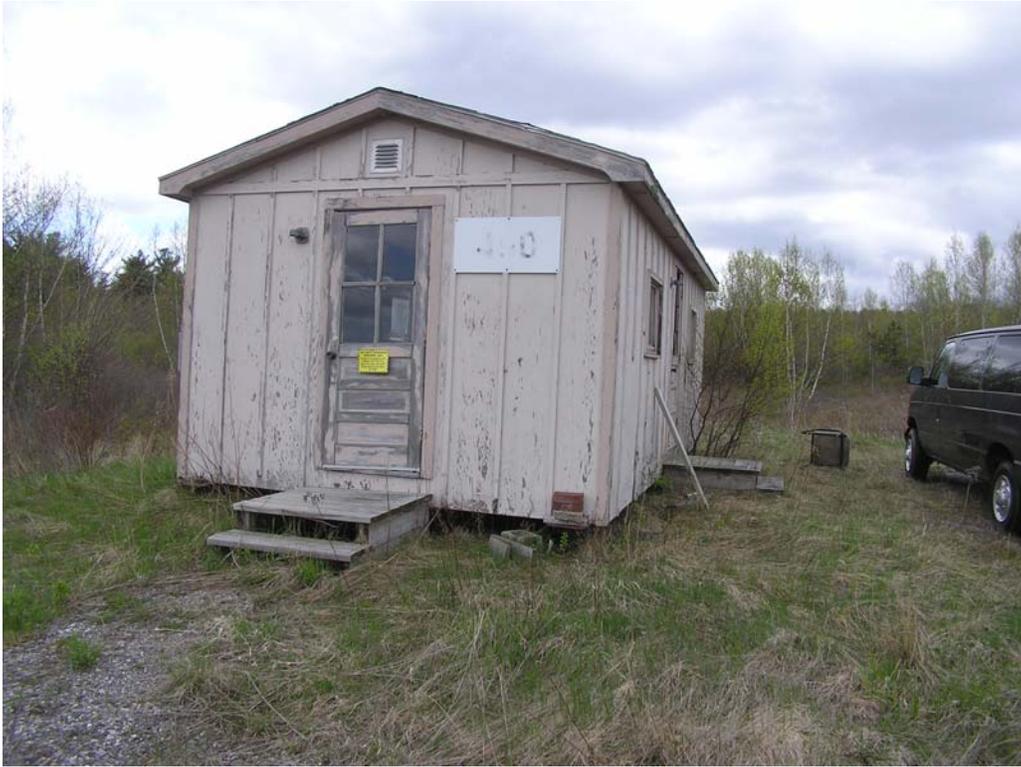
- At the time of the inspection, the Red Label Area was not in use (airfield operations ceased in January 2010) and was in good condition.
- Building 414 was vacant and in poor condition.

No. 5 Red Label Area Parcel– NAS Brunswick  
Building 414 – former Red Label Area line shack

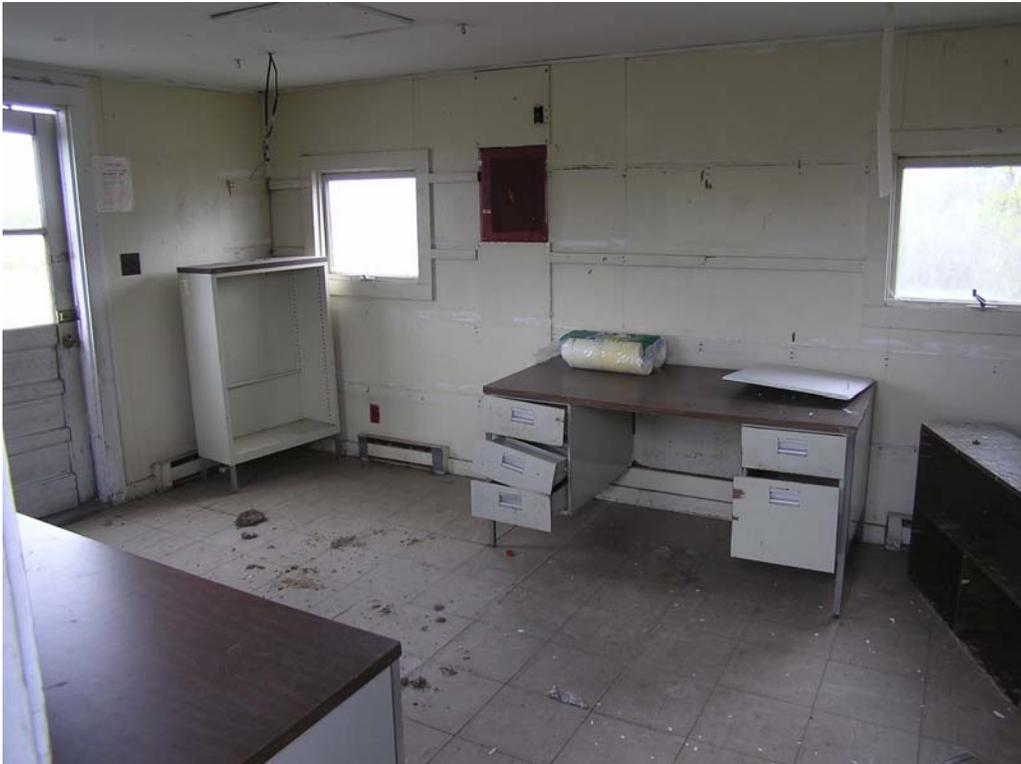
No. 6 Red Label Area Parcel– NAS Brunswick  
Building 414 interior
