FINAL RESOURCE CONSERVATION AND RECOVERY ACT PARTIAL CLOSURE REPORT
FOR BUILDINGS 285, 286, 287 AND 290 WITH TRANSMITTAL LETTER NAS BRUNSWICK
ME
9/27/2010
NAS BRUNSWICK

Subj: Final RCRA Partial Closure Report for Buildings 285, 286, 287, and 290

RCRA PARTIAL CLOSURE REPORT
for
BUILDING 285 – AMMO STORAGE FACILITY
BUILDING 286 – AMMO STORAGE FACILITY
BUILDING 287 – AMMO STORAGE FACILITY
BUILDING 290 – AMMO STORAGE FACILITY
NAVAL AIR STATION BRUNSWICK, MAINE
USEPA IDENTIFICATION NUMBER ME8170022018
SEPTEMBER 2010

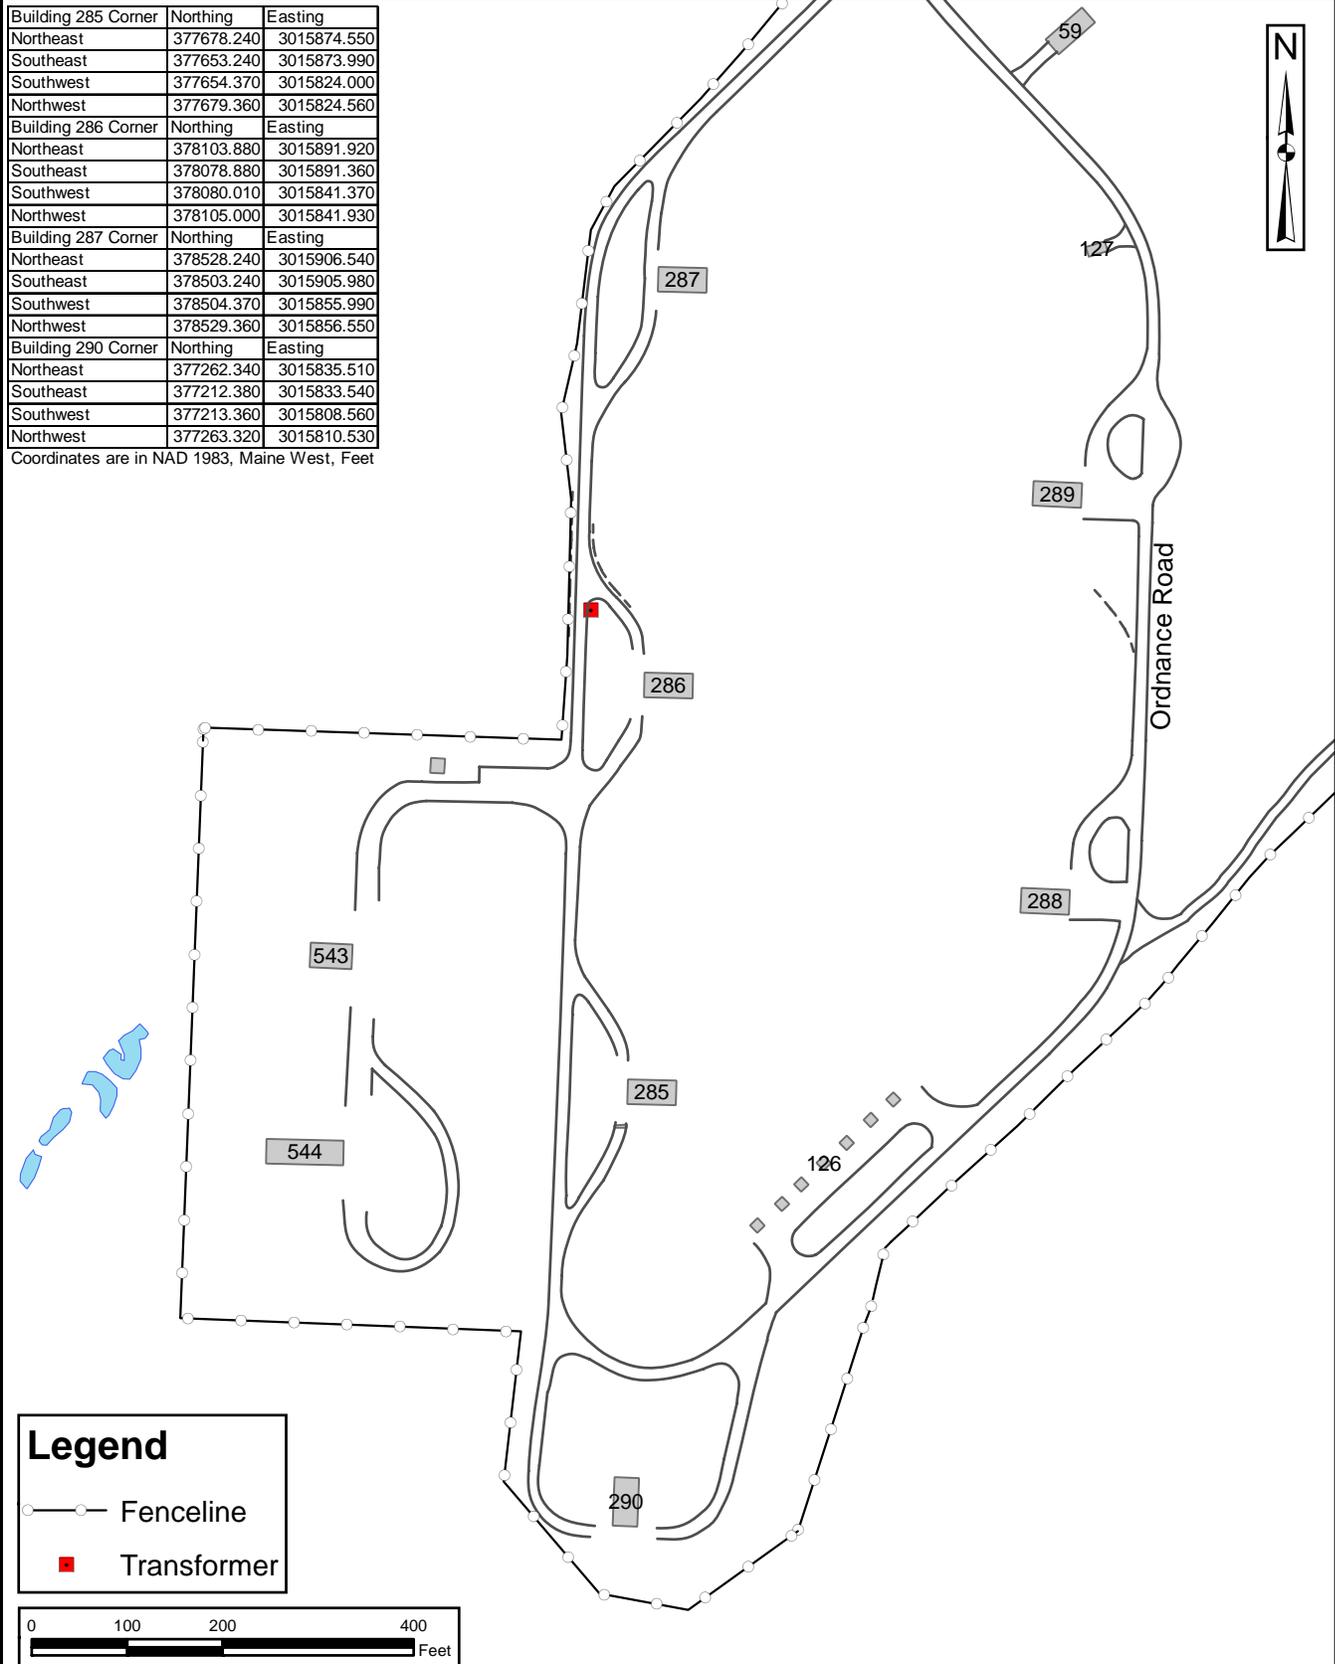
SCALE AS NOTED	
FILE	
<small>\\NASB_BLDG_285,286,287,&290_SITE_MAP.MXD</small>	
REV	DATE
0	09/23/10
FIGURE NUMBER	
2

Building 285 Corner	Northing	Easting
Northeast	377678.240	3015874.550
Southeast	377653.240	3015873.990
Southwest	377654.370	3015824.000
Northwest	377679.360	3015824.560
Building 286 Corner	Northing	Easting
Northeast	378103.880	3015891.920
Southeast	378078.880	3015891.360
Southwest	378080.010	3015841.370
Northwest	378105.000	3015841.930
Building 287 Corner	Northing	Easting
Northeast	378528.240	3015906.540
Southeast	378503.240	3015905.980
Southwest	378504.370	3015855.990
Northwest	378529.360	3015856.550
Building 290 Corner	Northing	Easting
Northeast	377262.340	3015835.510
Southeast	377212.380	3015833.540
Southwest	377213.360	3015808.560
Northwest	377263.320	3015810.530

Coordinates are in NAD 1983, Maine West, Feet

This investigation of the hazardous waste closure requirement applies to the footprints of Buildings 285, 286, 287 and 290 (as shown on Figure 2), only. It does not apply to the land surrounding or the groundwater underlying Buildings 285, 286, 287 or 290.

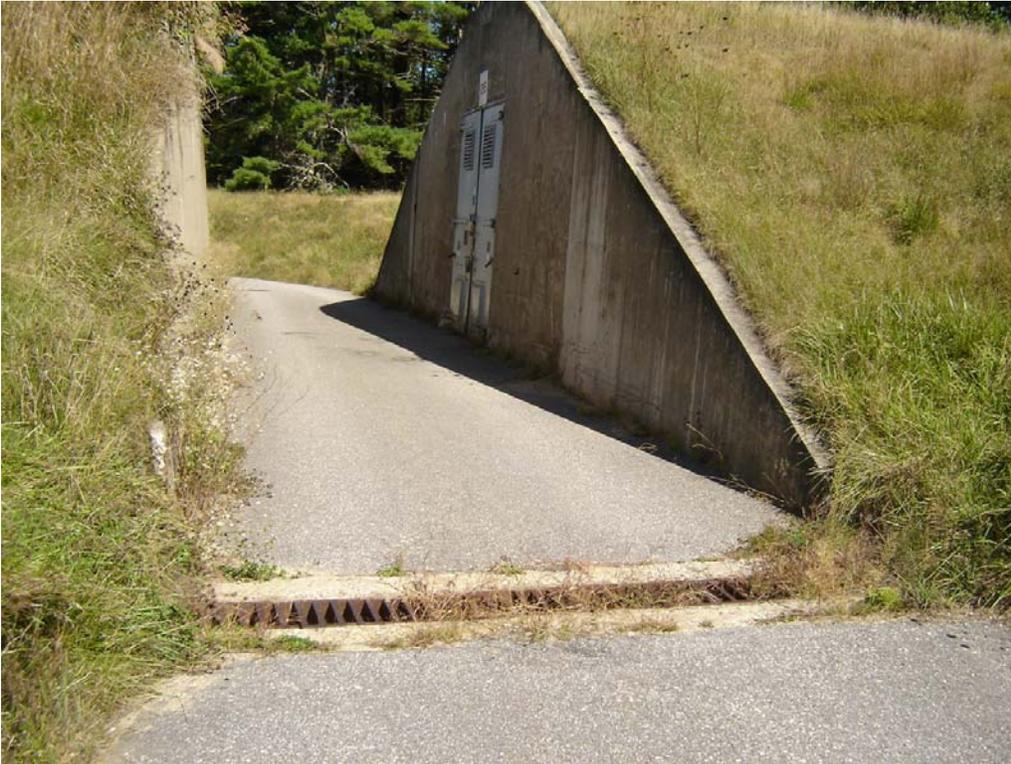
No. 1 Buildings 285, 286, 287 and 290 – NAS Brunswick September 16, 2010
Building 285 – Ammo Storage Facility south elevation

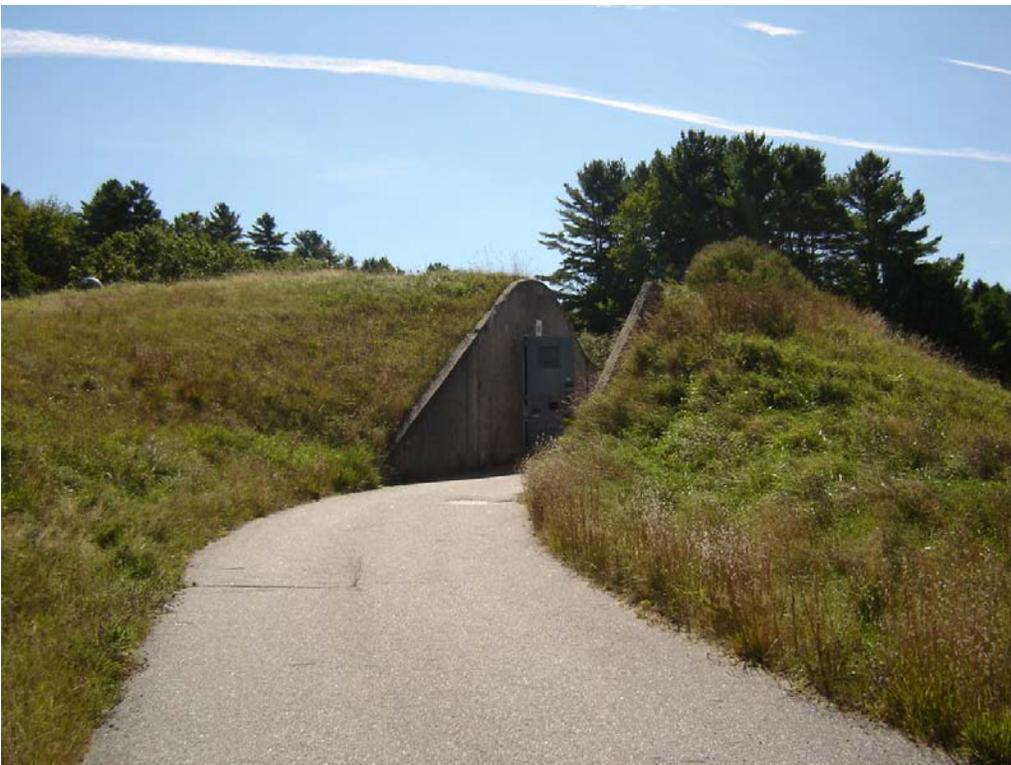
No. 2 Buildings 285, 286, 287 and 290 – NAS Brunswick September 16, 2010
Building 285 – Ammo Storage Facility northwest elevation

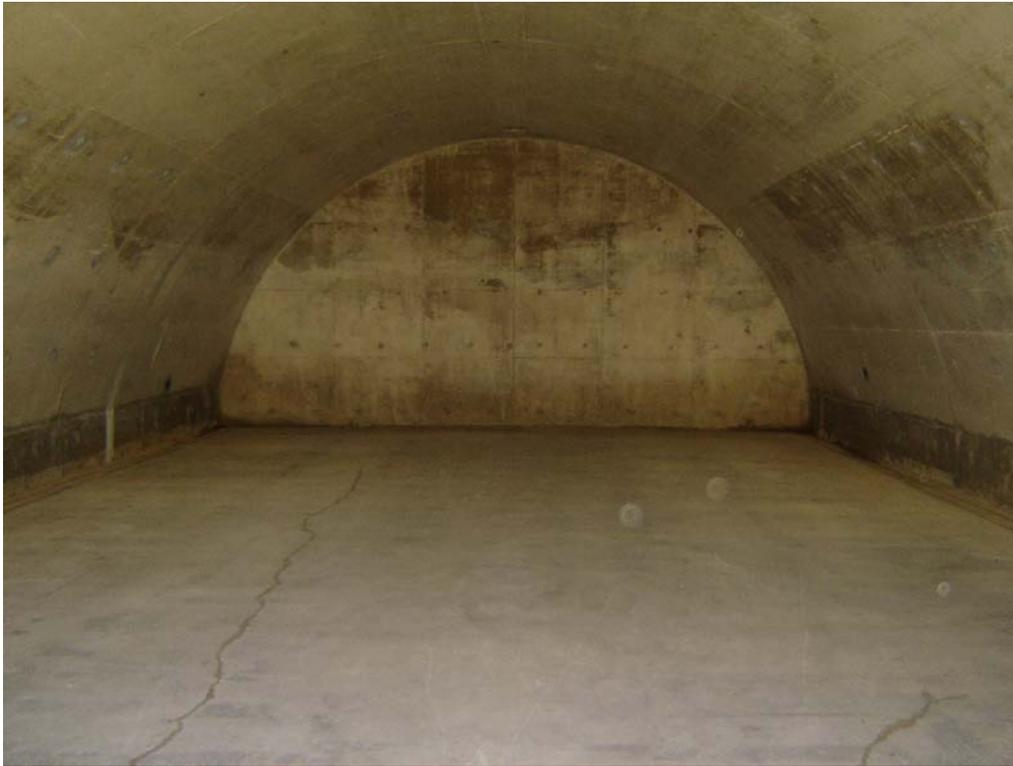
Minor staining that appears to be tire rubber was observed. Joint sealer was observed over the interior of the blast door. No additions, which may conceal signs of a past release, were observed.

No. 3 Buildings 285, 286, 287 and 290 – NAS Brunswick September 16, 2010
Building 285 – Ammo Storage Facility interior

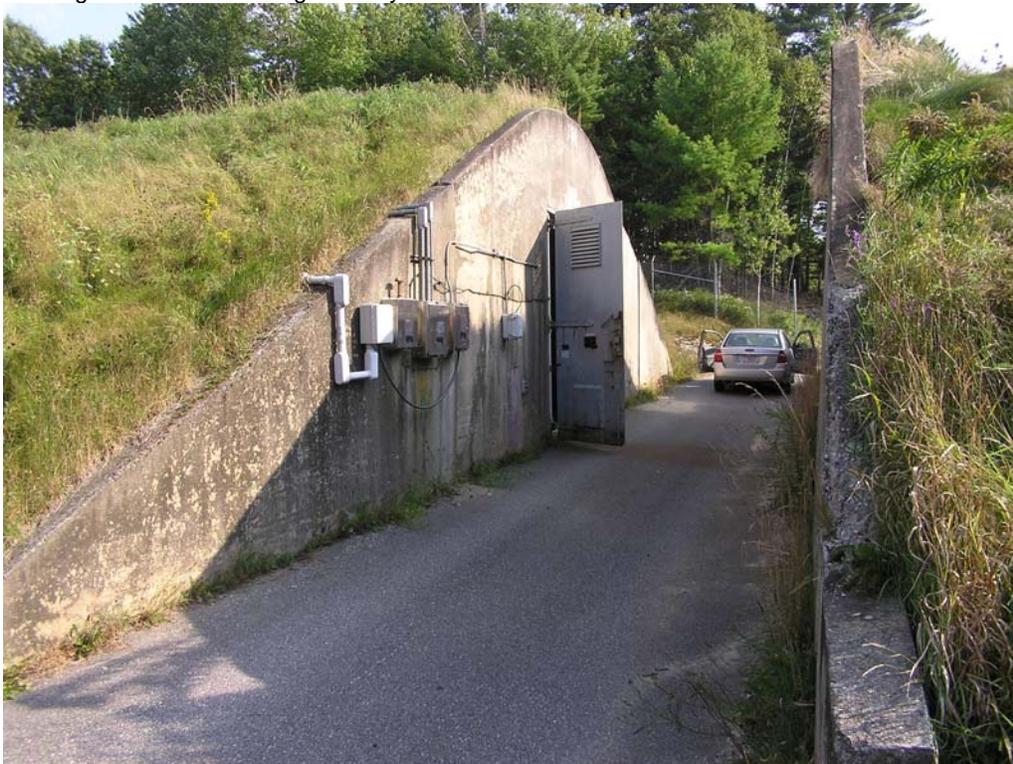
No. 4 Buildings 285, 286, 287 and 290 – NAS Brunswick August 31, 2010
Building 286 – Ammo Storage Facility north elevation.

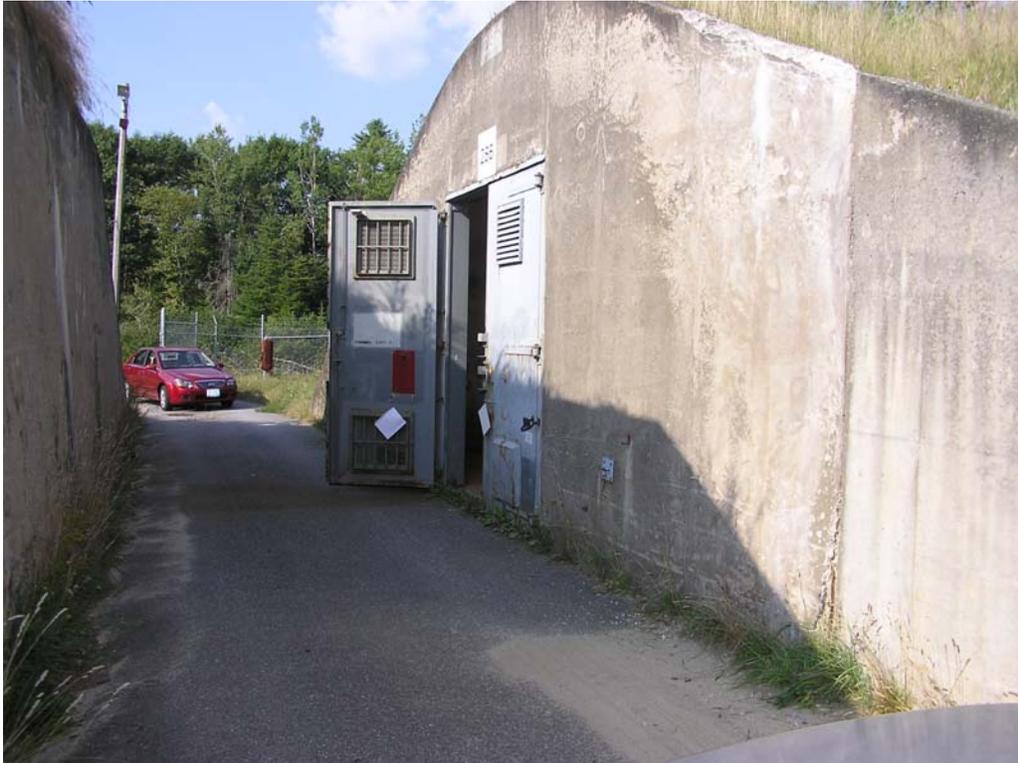
No. 5 Buildings 285, 286, 287 and 290 – NAS Brunswick August 31, 2010
Building 286 – Ammo Storage Facility south elevation.

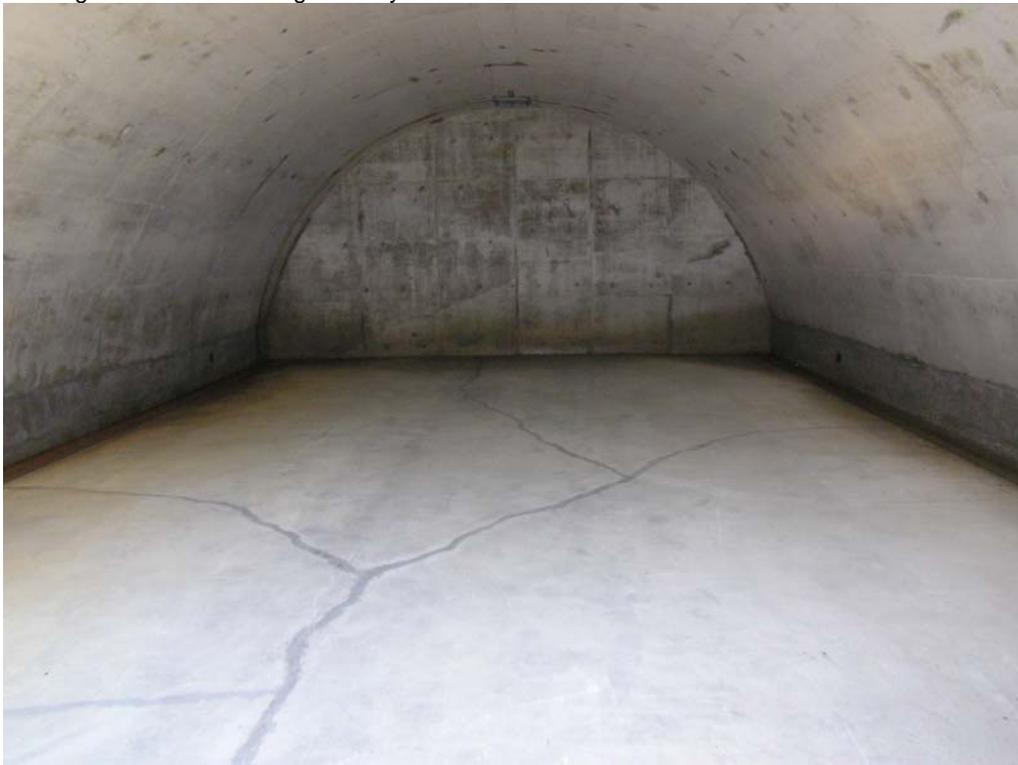
No staining was observed. Joint sealer was observed in cracks on the interior floor. No additions, which may conceal signs of a past release, were observed.

No. 6 Buildings 285, 286, 287 and 290 – NAS Brunswick August 31, 2010
Building 286 – Ammo Storage Facility interior.

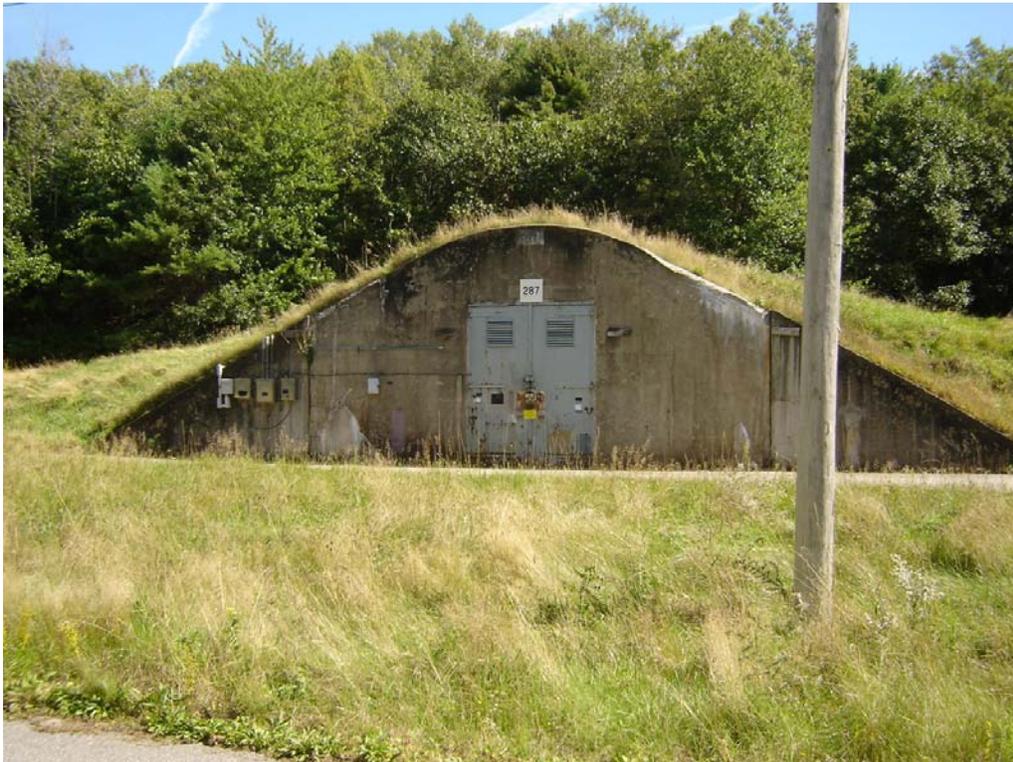
No. 7 Buildings 285, 286, 287 and 290 – NAS Brunswick September 16, 2010
Building 287 – Ammo Storage Facility west elevation.

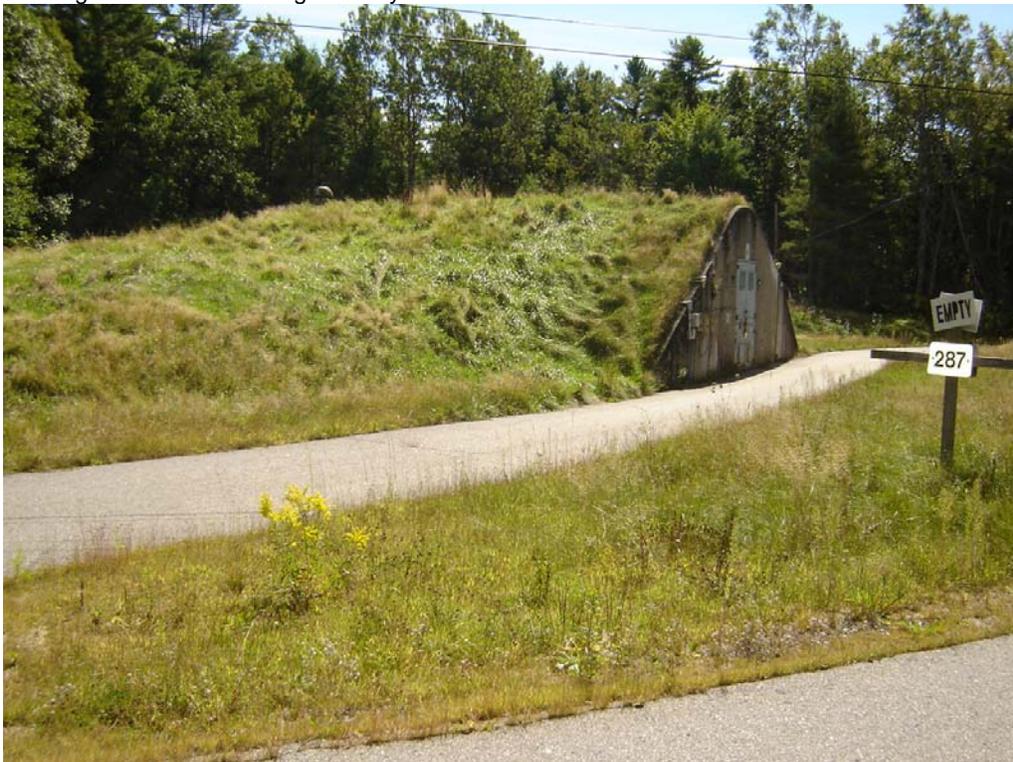
No. 8 Buildings 285, 286, 287 and 290 – NAS Brunswick September 16, 2010
Building 287 – Ammo Storage Facility north elevation.

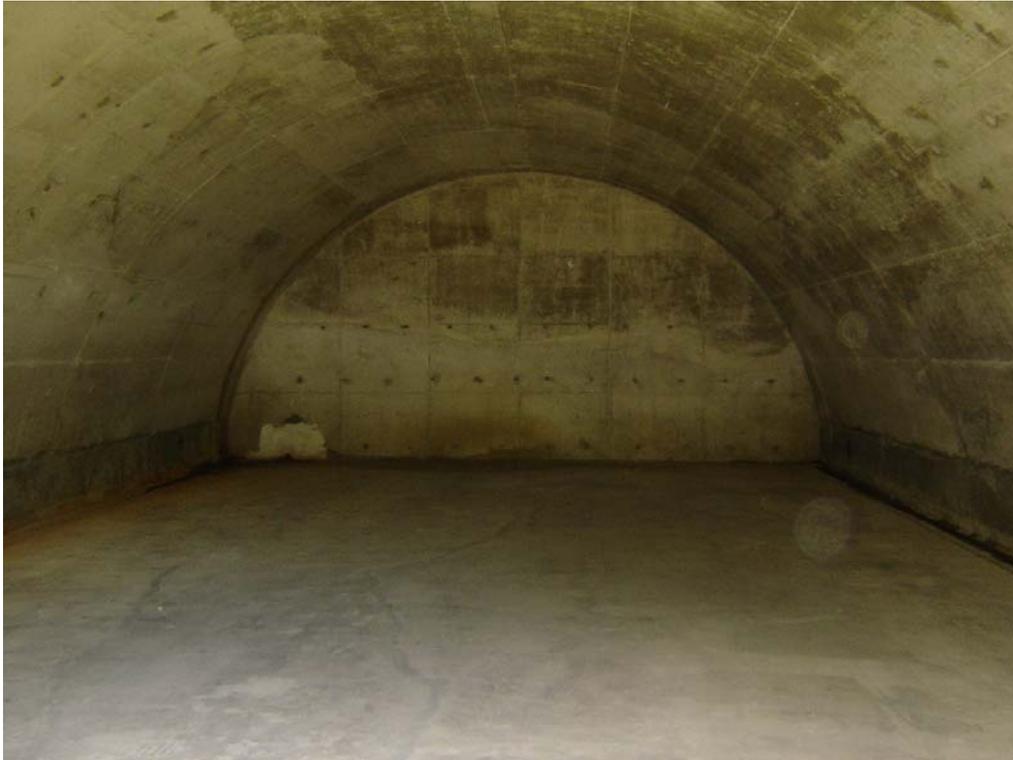
Minor staining that appears to be tire rubber was observed. Joint sealer was observed in cracks on the interior floor and water damage in the southwest interior corner was observed with concrete patch. No additions, which may conceal signs of a past release, were observed.

No. 9 Buildings 285, 286, 287 and 290 – NAS Brunswick September 16, 2010
Building 287 – Ammo Storage Facility interior.

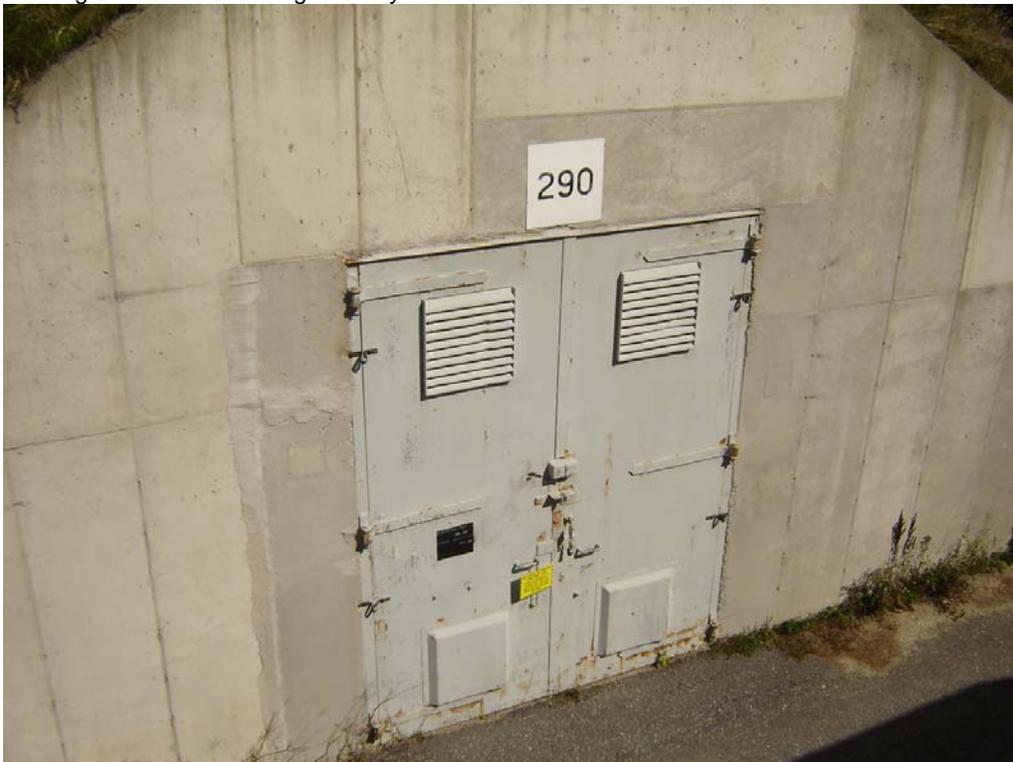
No. 10 Buildings 285, 286, 287 and 290 – NAS Brunswick September 16, 2010
Building 290 – Ammo Storage Facility south elevation.

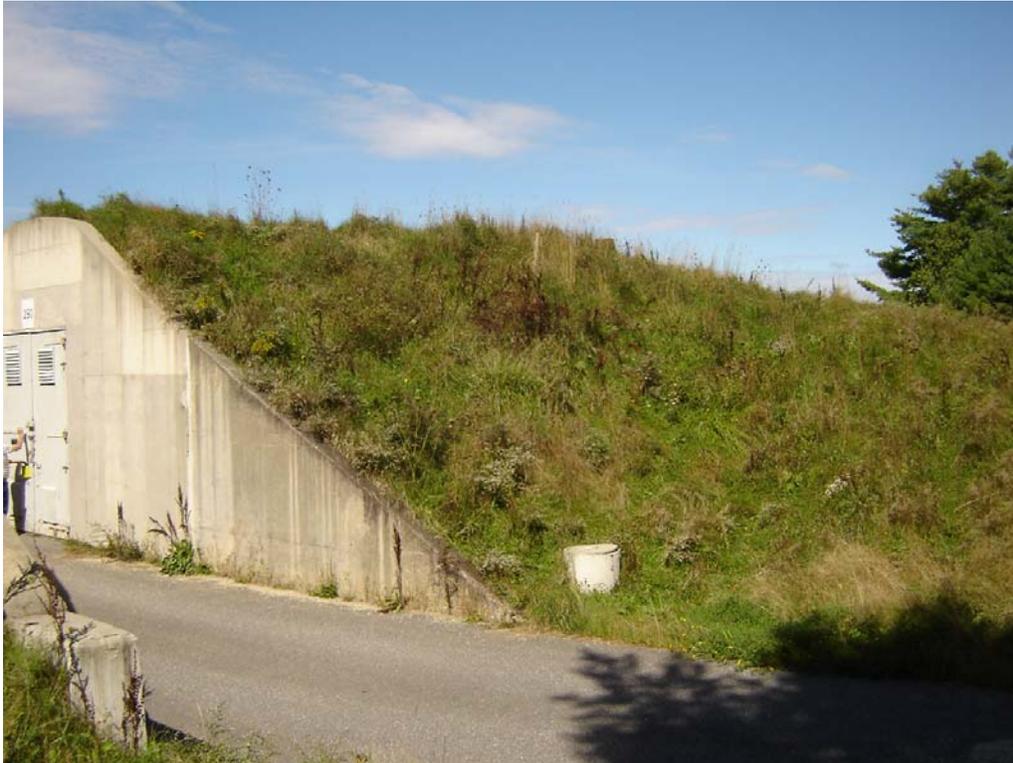
No. 11 Buildings 285, 286, 287 and 290 – NAS Brunswick September 16, 2010
Building 290 – Ammo Storage Facility southeast elevation.

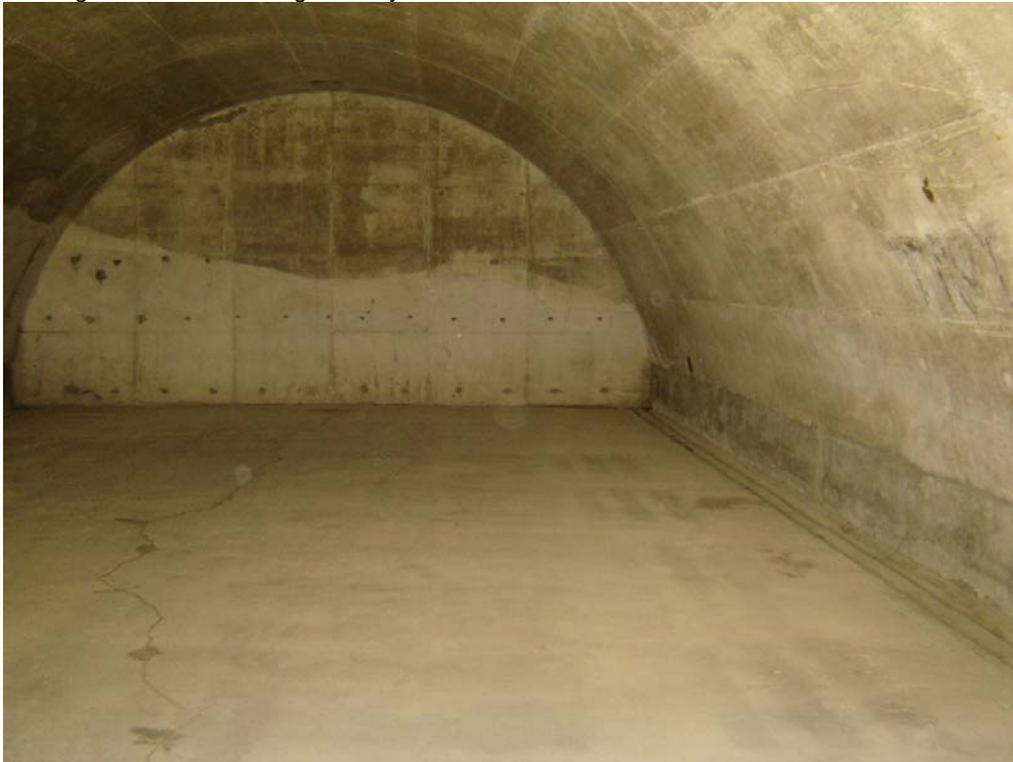
Minor staining that appears to be tire rubber was observed. Joint sealer was observed in cracks on the interior floor. A concrete patch approximately 3 feet by 25 feet was observed on the floor near the exterior door (a date of 2002 was in the concrete). No additions, which may conceal signs of a past release, were observed.

No. 12 Buildings 285, 286, 287 and 290 – NAS Brunswick September 16, 2010
Building 290 – Ammo Storage Facility interior.
