FINAL RESOURCE CONSERVATION AND RECOVERY ACT PARTIAL CLOSURE REPORT
FOR BUILDINGS 59, 62, 127 AND 128 WITH TRANSMITTAL LETTER NAS BRUNSWICK ME
9/27/2010
NAS BRUNSWICK

Subj: Final RCRA Partial Closure Report for Buildings 59,62, 127, and 128

RCRA PARTIAL CLOSURE REPORT
For
BUILDING 59 – HIGH EXPLOSIVE (HE) MAGAZINE
BUILDING 62 – AMMO STORAGE FACILITY
BUILDING 127 – NATIONAL GUARD MAGAZINE
BUILDING 128 – NATIONAL GUARD MAGAZINE
NAVAL AIR STATION BRUNSWICK, MAINE
USEPA IDENTIFICATION NUMBER ME8170022018
SEPTEMBER 2010

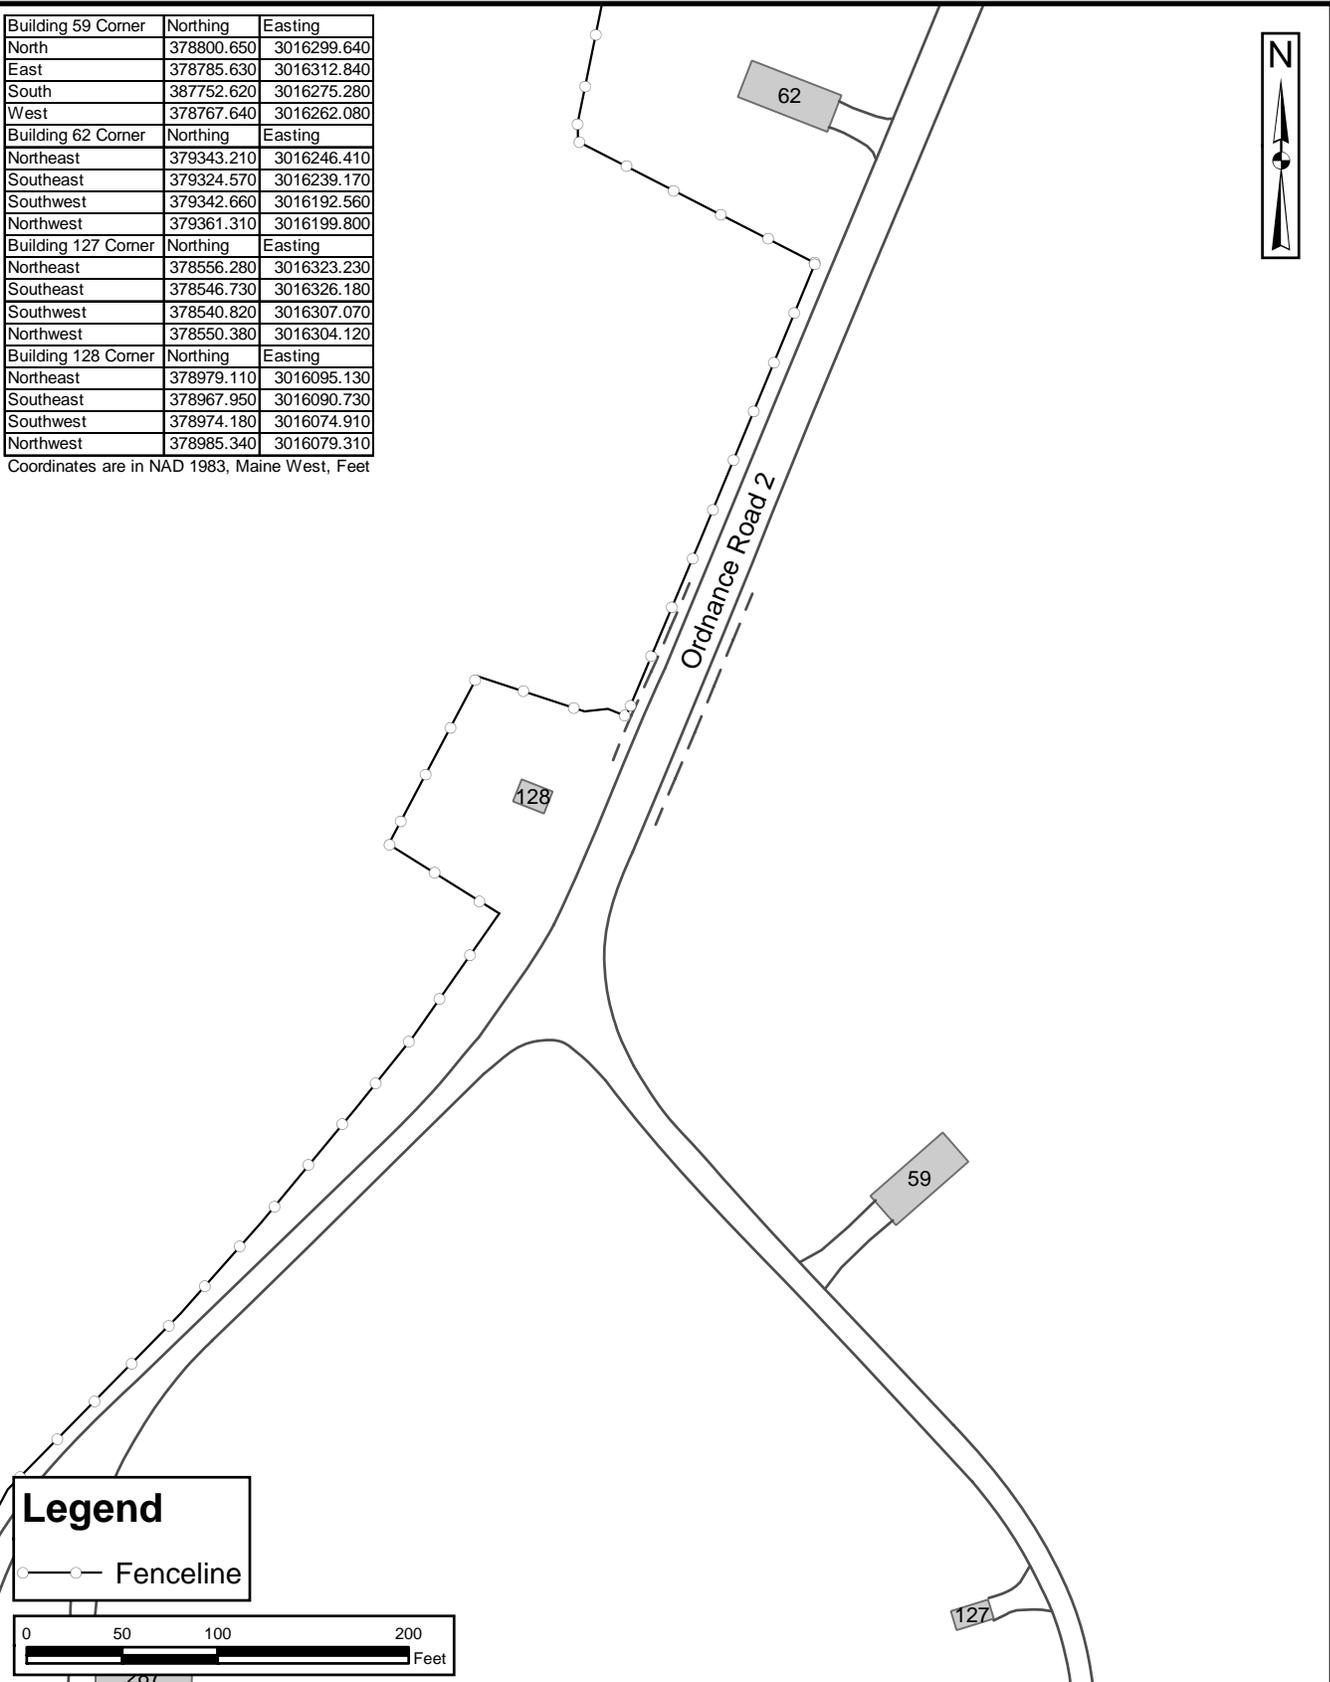
SCALE AS NOTED	
FILE L:\NASB_BLDG_59,62,127&128_SITE_MAP.MXD	
REV 0	DATE 09/23/10
FIGURE NUMBER 2

Building 59 Corner	Northing	Easting
North	378800.650	3016299.640
East	378785.630	3016312.840
South	387752.620	3016275.280
West	378767.640	3016262.080
Building 62 Corner	Northing	Easting
Northeast	379343.210	3016246.410
Southeast	379324.570	3016239.170
Southwest	379342.660	3016192.560
Northwest	379361.310	3016199.800
Building 127 Corner	Northing	Easting
Northeast	378556.280	3016323.230
Southeast	378546.730	3016326.180
Southwest	378540.820	3016307.070
Northwest	378550.380	3016304.120
Building 128 Corner	Northing	Easting
Northeast	378979.110	3016095.130
Southeast	378967.950	3016090.730
Southwest	378974.180	3016074.910
Northwest	378985.340	3016079.310

SITE PLAN
 BUILDING 59, 62, 127, AND 128 - WEAPONS BUILDINGS
 RCRA PARTIAL CLOSURE REPORT
 NAVAL AIR STATION BRUNSWICK, MAINE

This investigation of the hazardous waste closure requirement applies to the footprints of Buildings 59, 62, 127 and 128 (as shown on Figure 2), only. It does not apply to the land surrounding or the groundwater underlying Buildings 59, 62, 127 or 128.

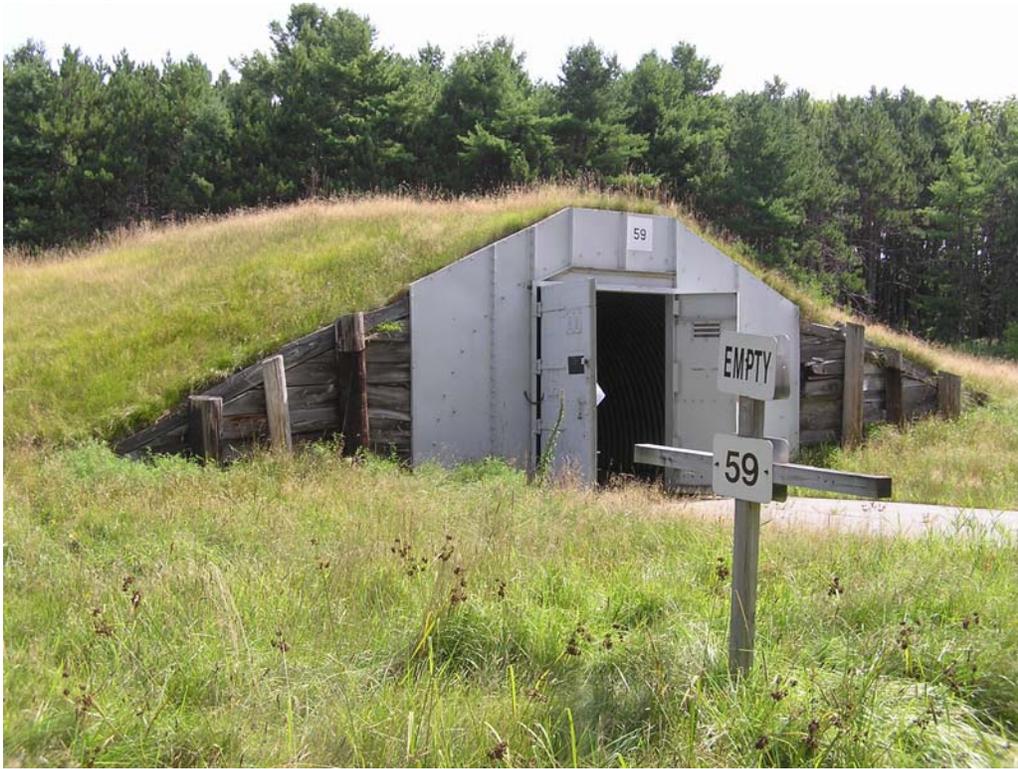
No. 1 Buildings 59, 62, 127 and 128 – NAS Brunswick August 12, 2010
Building 59 – High Explosive Magazine west elevation

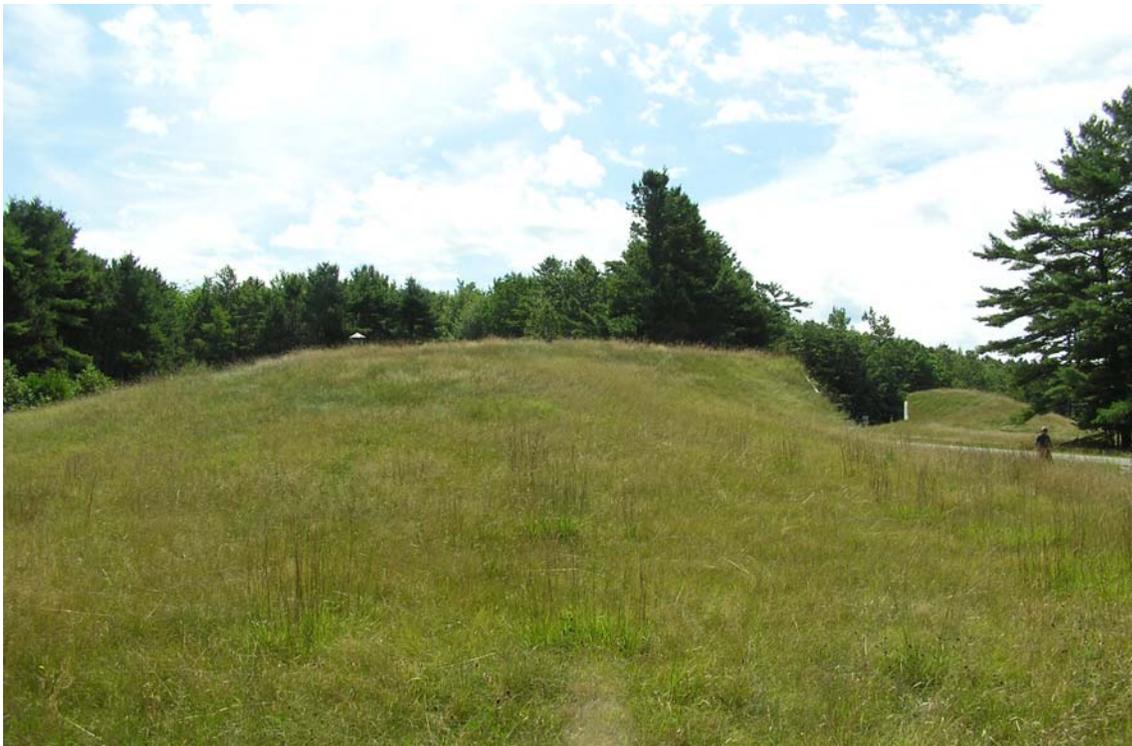
No. 2 Buildings 59, 62, 127 and 128 – NAS Brunswick August 12, 2010
Building 59 – High Explosive Magazine northwest elevation; Building 127 shown in background

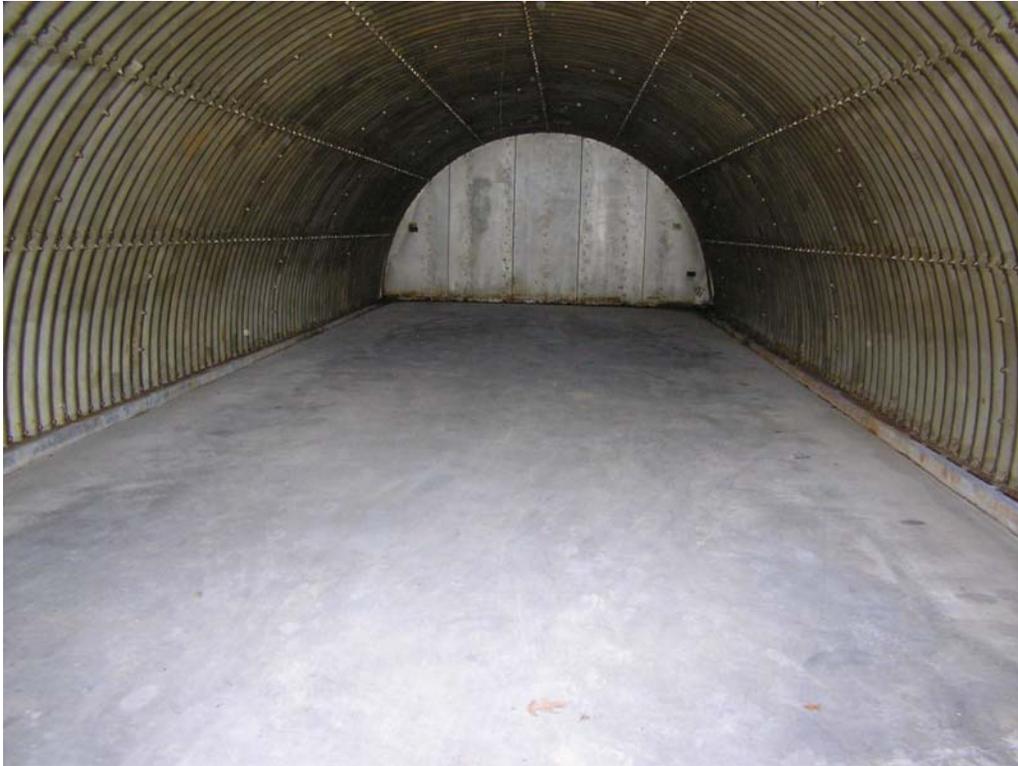
At the time of the site visit, the building appeared in fair condition. The building was empty.
 No evidence of current or past hazardous waste generation activities was observed.
 No evidence of hazardous waste residues was observed.
 No evidence of staining or additions, which may conceal signs of a past release, were observed.
 No hazardous waste storage areas or hazardous waste accumulation areas were observed.

No. 3 Buildings 59, 62, 127 and 128 – NAS Brunswick August 12, 2010
Building 59 – High Explosive Magazine interior

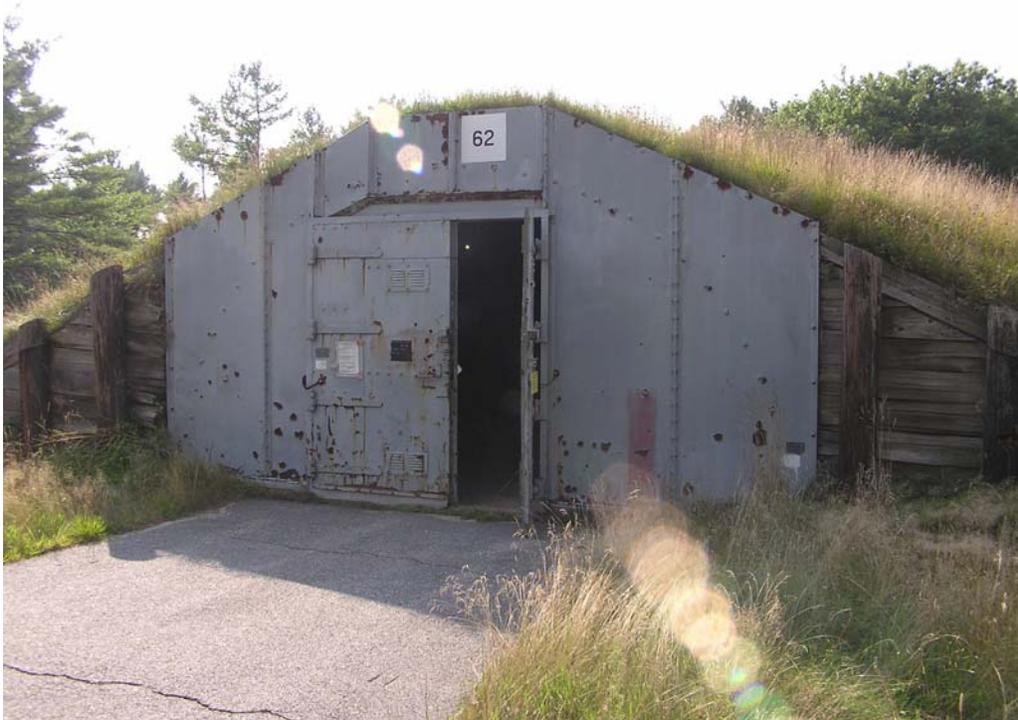
No. 4 Buildings 59, 62, 127 and 128 – NAS Brunswick August 31, 2010
Exterior of Building 62 – Ammo Storage Facility

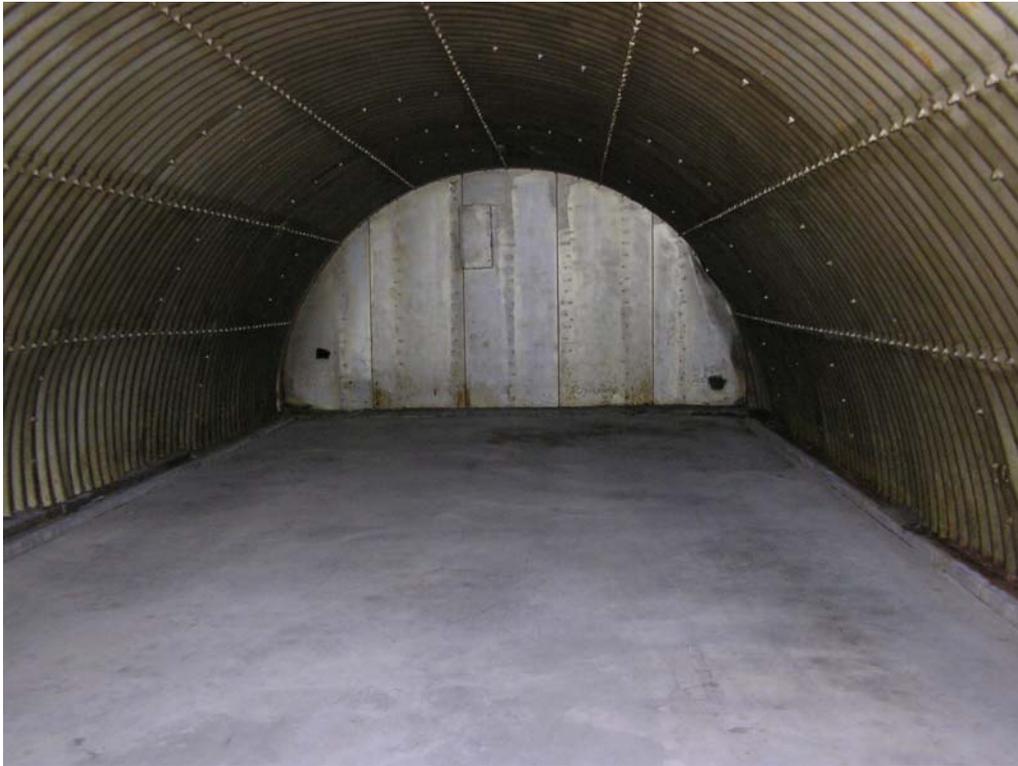
At the time of the site visit, the building appeared in fair condition. The building was empty.
 No evidence of current or past hazardous waste generation activities was observed.
 No evidence of hazardous waste residues was observed.
 No evidence of staining or additions, which may conceal signs of a past release, were observed.
 No hazardous waste storage areas or hazardous waste accumulation areas were observed.

No. 5 Buildings 59, 62, 127 and 128 – NAS Brunswick August 31, 2010
Building 62 – Ammo Storage Facility interior

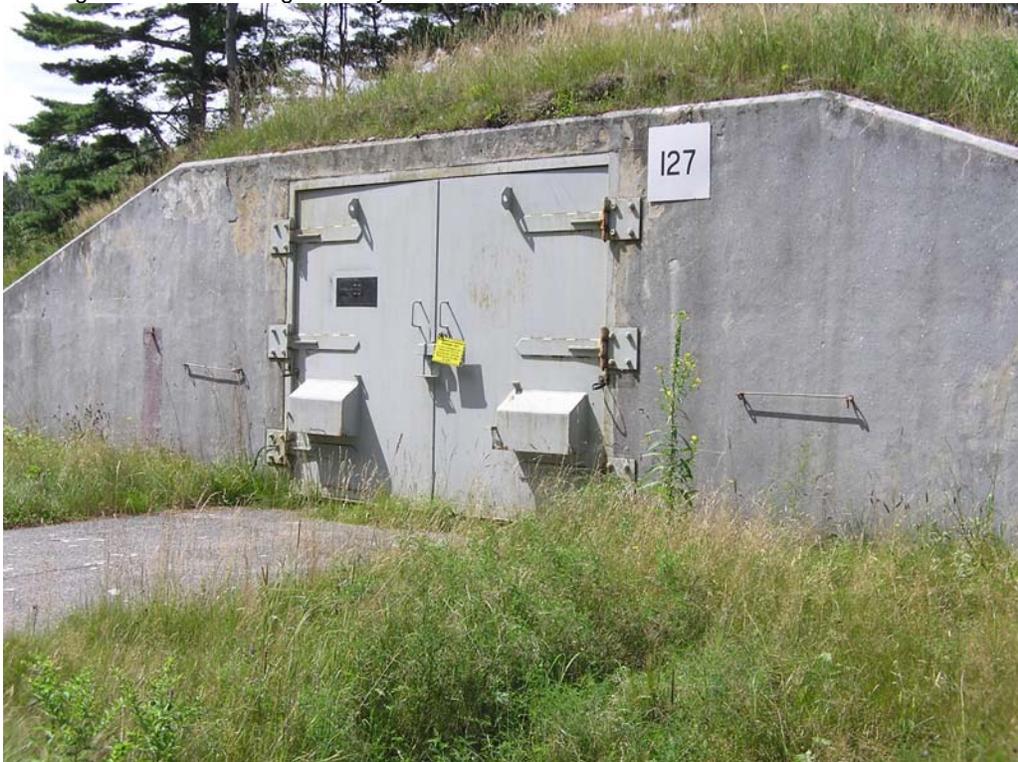
No. 6 Buildings 59, 62, 127 and 128 – NAS Brunswick August 12, 2010
Building 127 – Maine National Guard Magazine northeast elevation

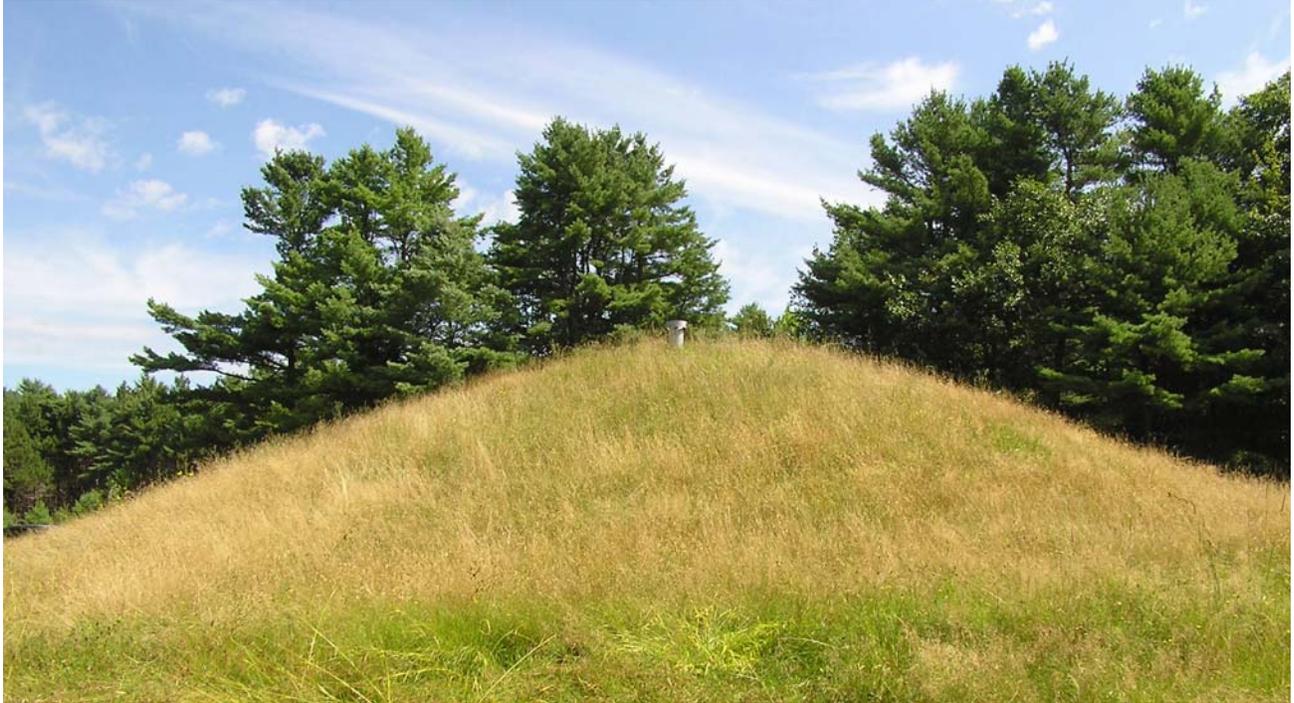
No. 7 Buildings 59, 62, 127 and 128 – NAS Brunswick August 12, 2010
Building 127 – Maine National Guard Magazine west elevation

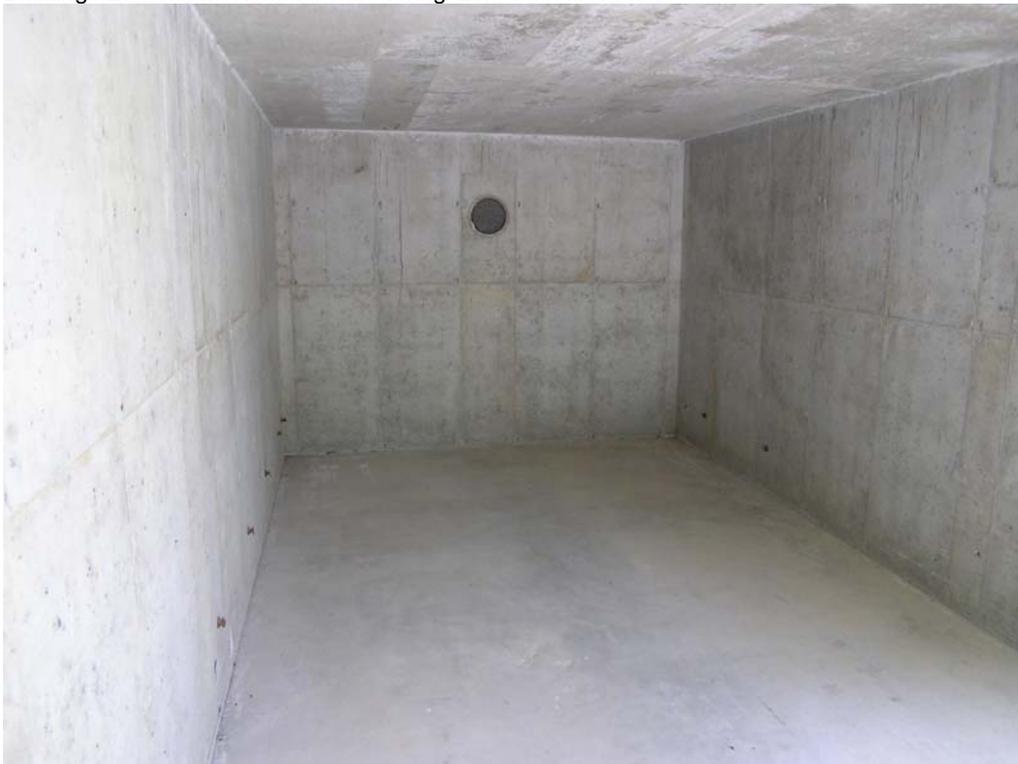
At the time of the site visit, the building appeared in good condition. The building was empty.
 No evidence of current or past hazardous waste generation activities was observed.
 No evidence of hazardous waste residues was observed.
 No evidence of staining or additions, which may conceal signs of a past release, were observed.
 No hazardous waste storage areas or hazardous waste accumulation areas were observed.

No. 8 Buildings 59, 62, 127 and 128 – NAS Brunswick August 12, 2010
Building 127 – Maine National Guard Magazine interior

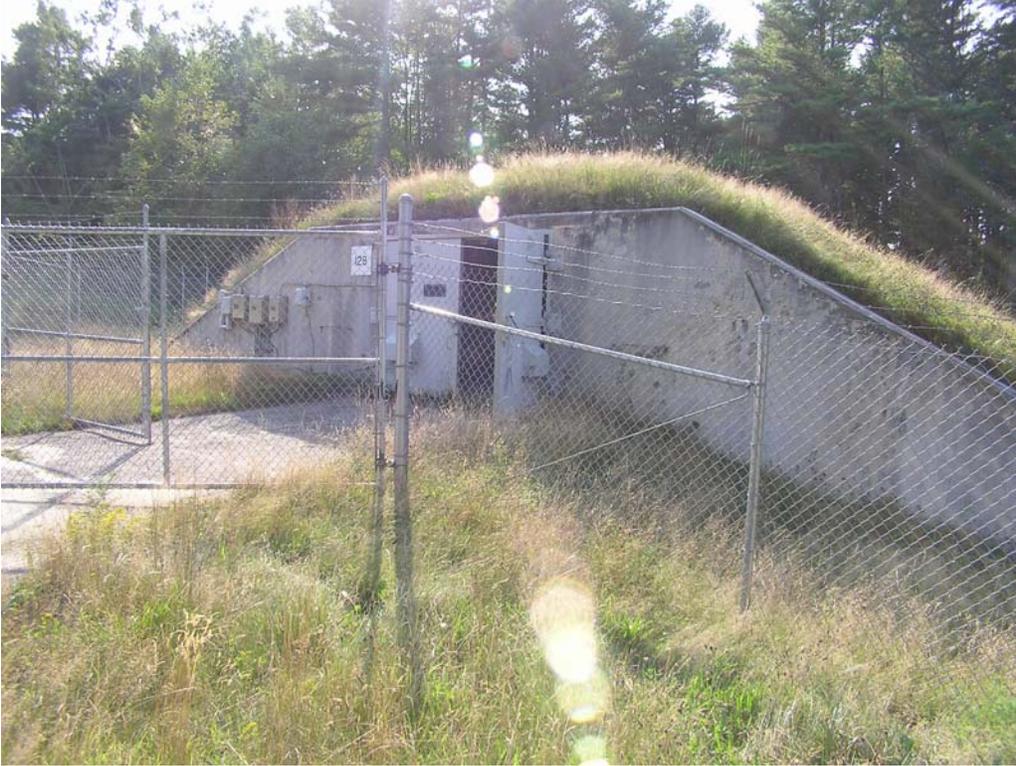
No. 1 Buildings 59, 62, 127 and 128 – NAS Brunswick August 31, 2010
Building 128 – Maine National Guard Magazine west elevation

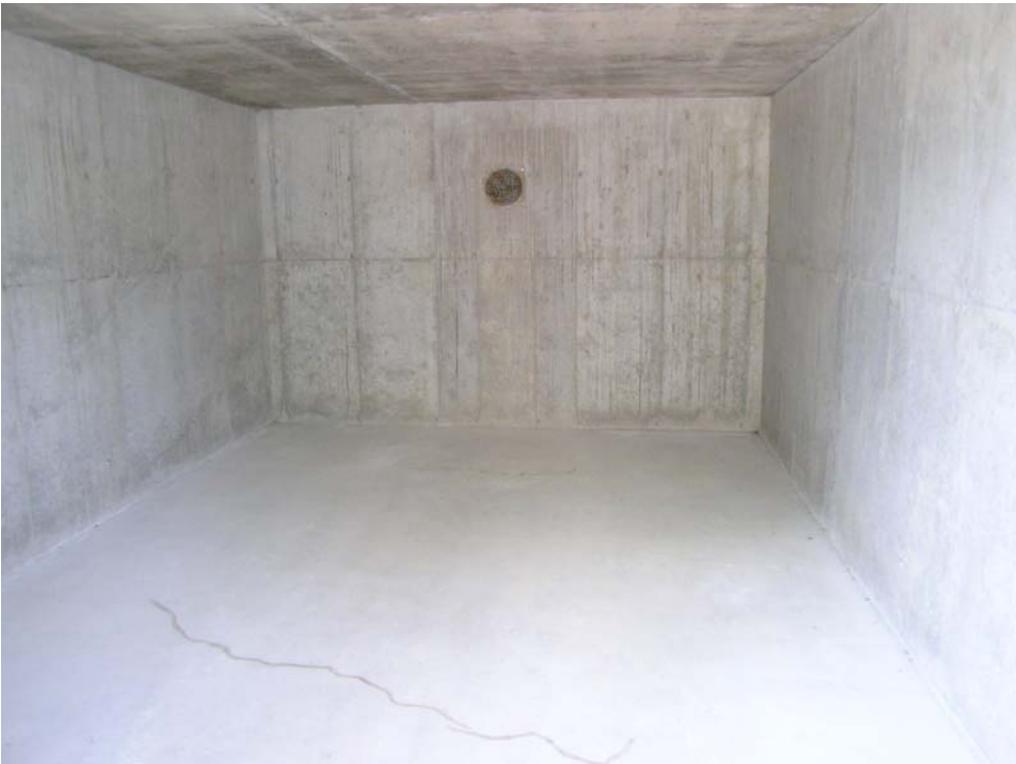
At the time of the site visit, the building appeared in good condition. The building was empty.
 No evidence of current or past hazardous waste generation activities was observed.
 No evidence of hazardous waste residues was observed.
 No evidence of staining or additions, which may conceal signs of a past release, were observed.
 No hazardous waste storage areas or hazardous waste accumulation areas were observed.

No. 2 Buildings 59, 62, 127 and 128 – NAS Brunswick August 31, 2010
Building 128 – Maine National Guard Magazine interior
