FINAL RESOURCE CONSERVATION AND RECOVERY ACT PARTIAL CLOSURE REPORT
FOR BUILDINGS 201 AND 420 WITH TRANSMITTAL LETTER NAS BRUNSWICK ME
9/28/2010
NAS BRUNSWICK

RCRA PARTIAL CLOSURE REPORT
for
BUILDING 201 – GALLEY PARCEL
BUILDING 420 – STORAGE SHED
NAVAL AIR STATION BRUNSWICK, MAINE
USEPA IDENTIFICATION NUMBER ME8170022018
SEPTEMBER 2010

**BUILDING INSPECTION FORM
RCRA PARTIAL CLOSURE PROGRAM
NAS BRUNSWICK
BRUNSWICK, MAINE
CTO WE22**

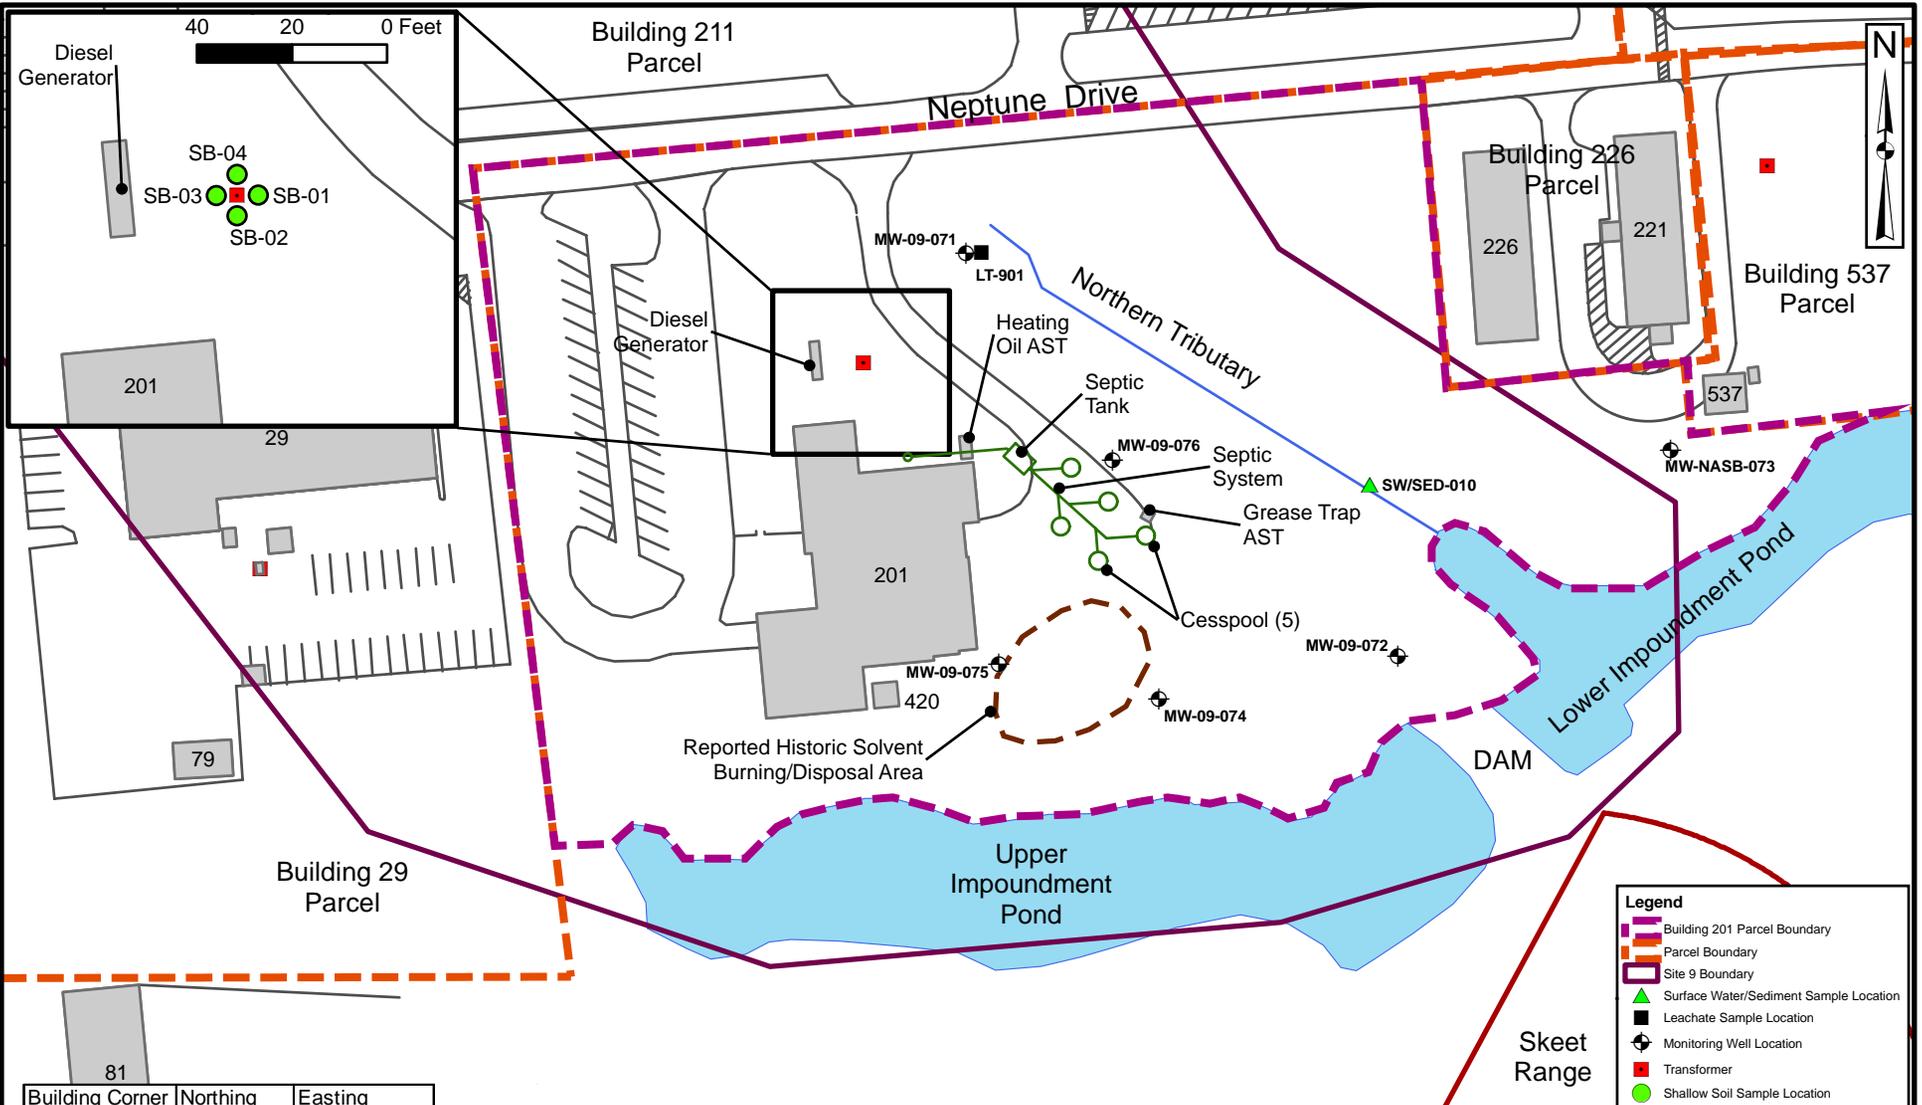
SITE PLAN
BUILDING 201 - GALLEY PARCEL
RCRA PARTIAL CLOSURE REPORT
NAVAL AIR STATION BRUNSWICK, MAINE

The locations of the existing ASTs are included on Figure 2. No oil-water separators are listed for Building 201.

- One pad-mounted transformer was observed to the north of Building 201 (Figure 2). No evidence of a past leak from this transformer was observed.

Because Building 201 was constructed prior to 1979 and PCB-containing transformers were identified in the NAS Brunswick Transformer Database, the transformer pad located north of Building 201 could potentially be an area of PCB soil contamination, if there had been an historical transformer leak. (A review of historical aerial photographs did not identify a potential former location of the listed PCB-containing transformers that differed from the existing transformer pad.) To assess potential PCB soil contamination, on May 6, 2010, surface soil samples were collected from four locations surrounding the transformer pad, using a hand auger. A total of eight composite soil samples (plus one field duplicate) were collected for PCB analysis: the soil samples were collected from 0 to 6 inches and 6 to 24 inches below ground surface (bgs) at locations adjacent to each of the four sides of the existing transformer pad (Figure 2).

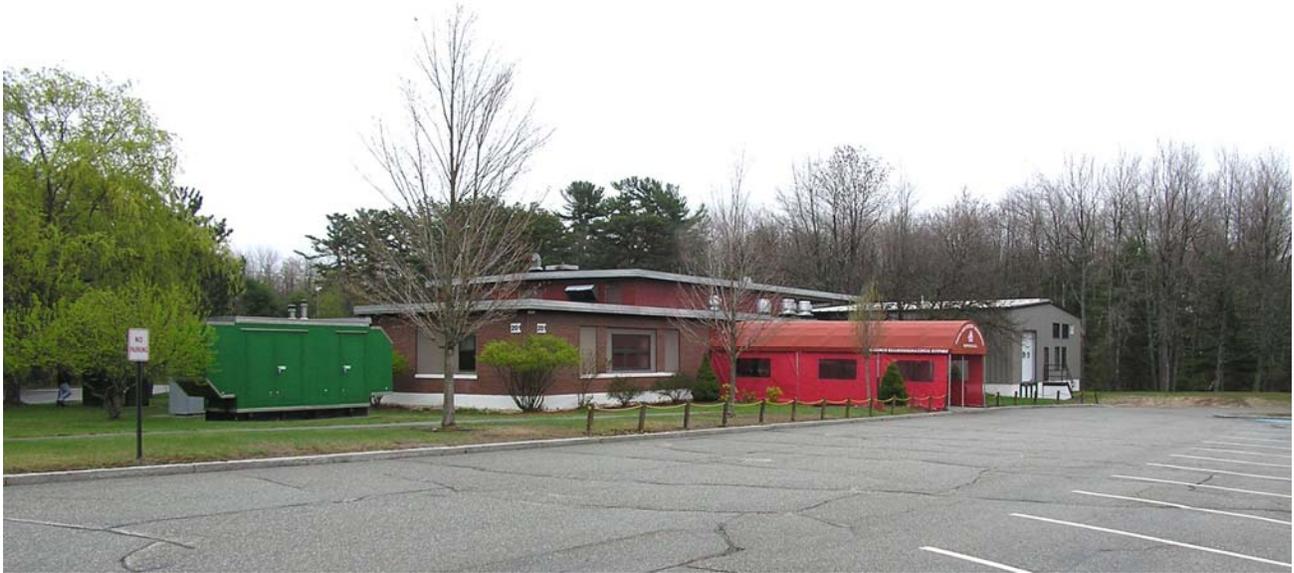
No. 1 Building 201 Parcel – NAS Brunswick April 27, 2010
Galley (Neptune Hall) northwest elevation; main entrance canopy at center, emergency diesel generator at left and walk-in freezer addition (grey structure) at right background

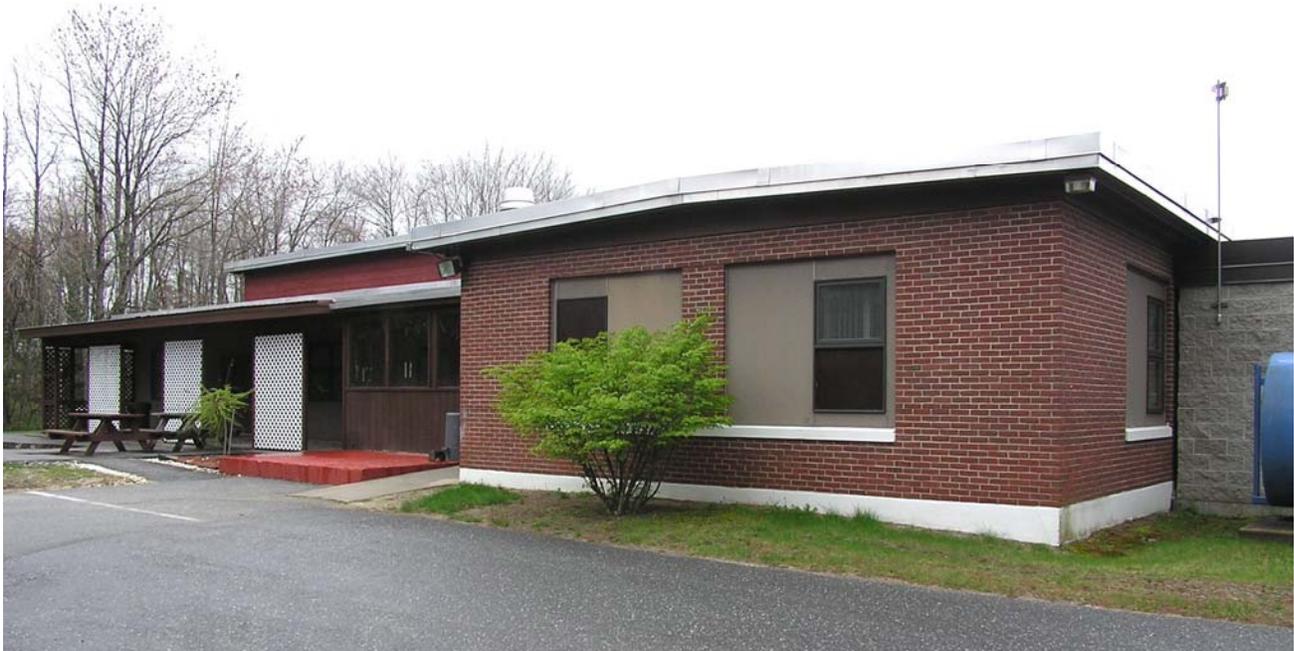
No. 2 Building 201 Parcel – NAS Brunswick April 27, 2010
Galley (Neptune Hall) northeast elevation; heating oil AST, located on the northeastern side of the building, partly visible on extreme right of frame

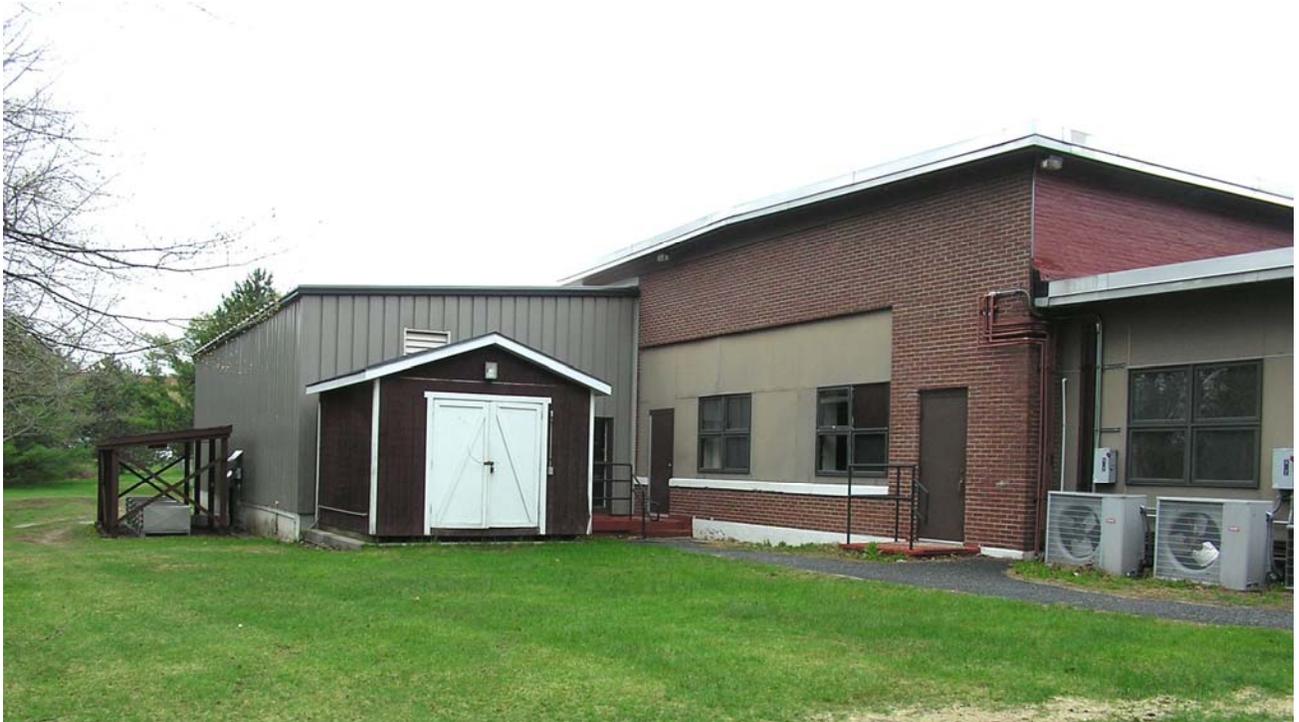
No. 3 Building 201 Parcel – NAS Brunswick April 27, 2010
Building 201 (Galley) southeast elevation; Building 420 (storage) left center of frame in front of the walk-in freezer addition (grey structure)

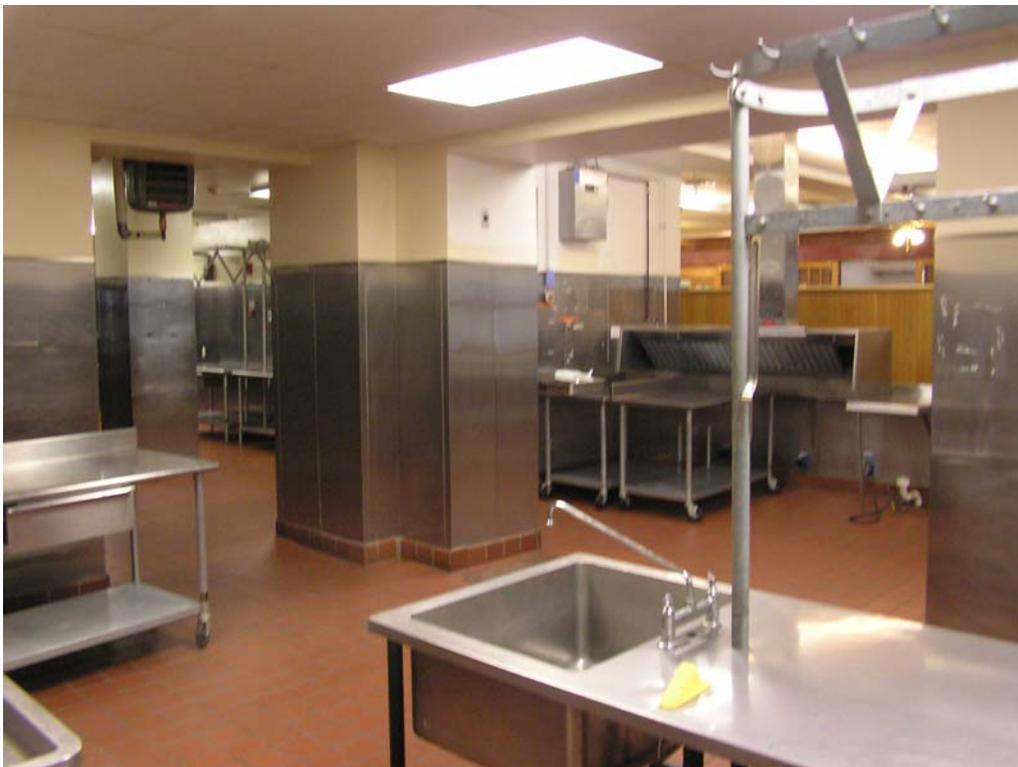
No. 4 Building 201 Parcel – NAS Brunswick April 27, 2010
Galley kitchen area

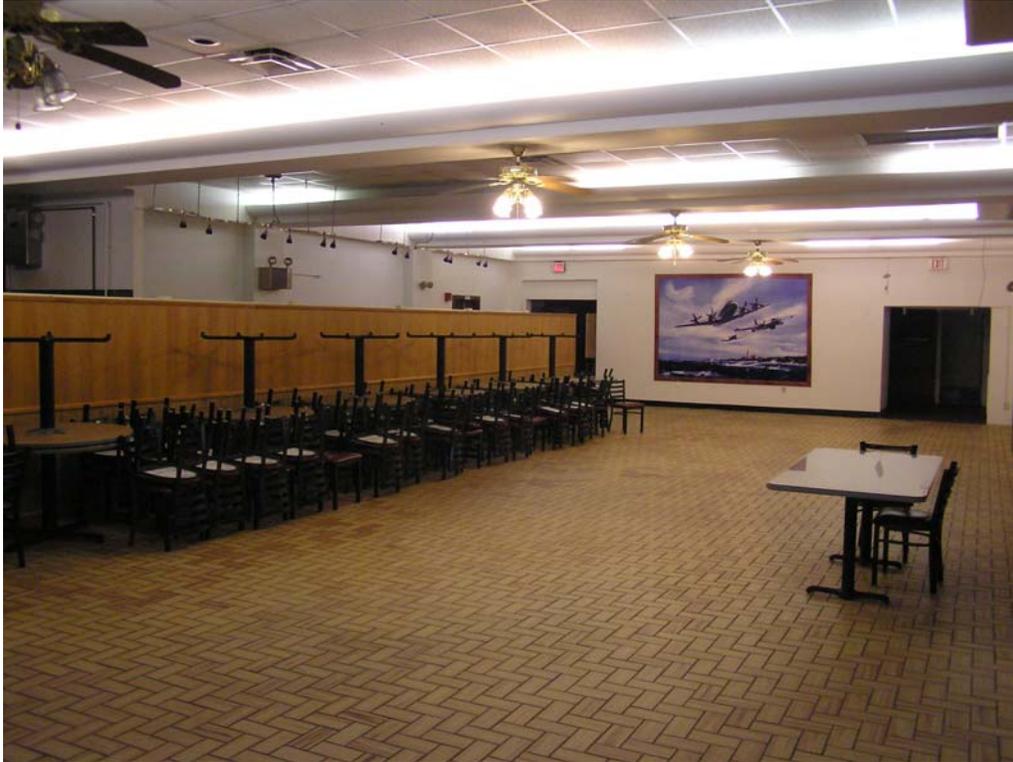
No. 4 Building 201 Parcel – NAS Brunswick
Galley mess hall

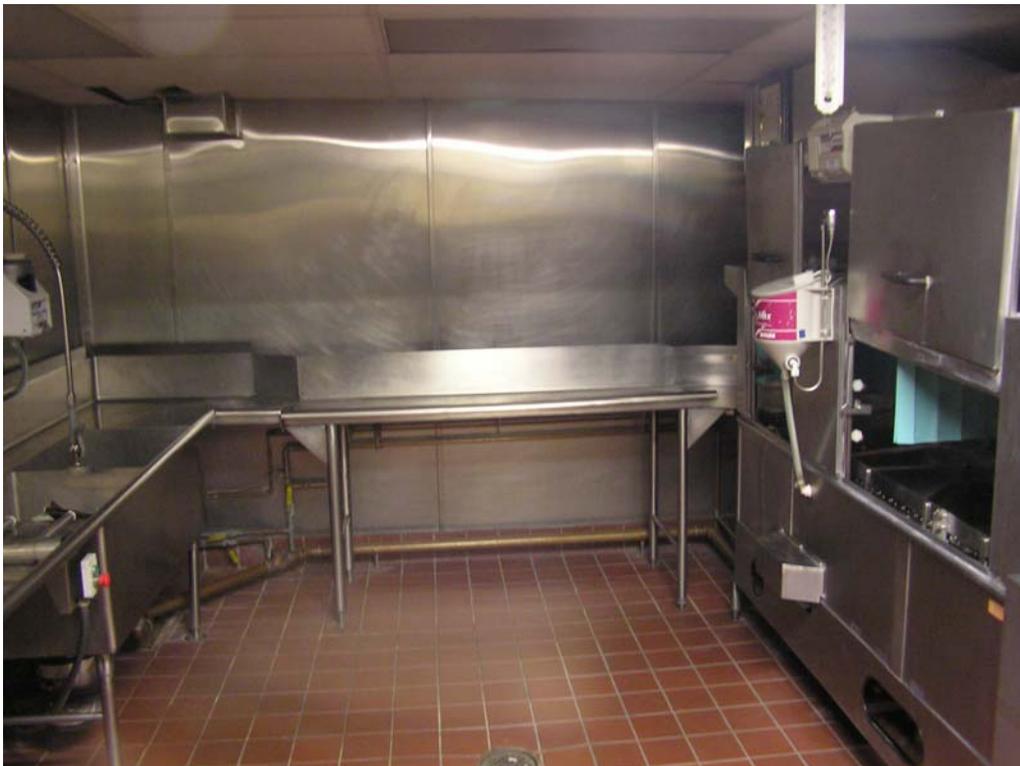
No. 7 Building 201 Parcel – NAS Brunswick
Galley scullery

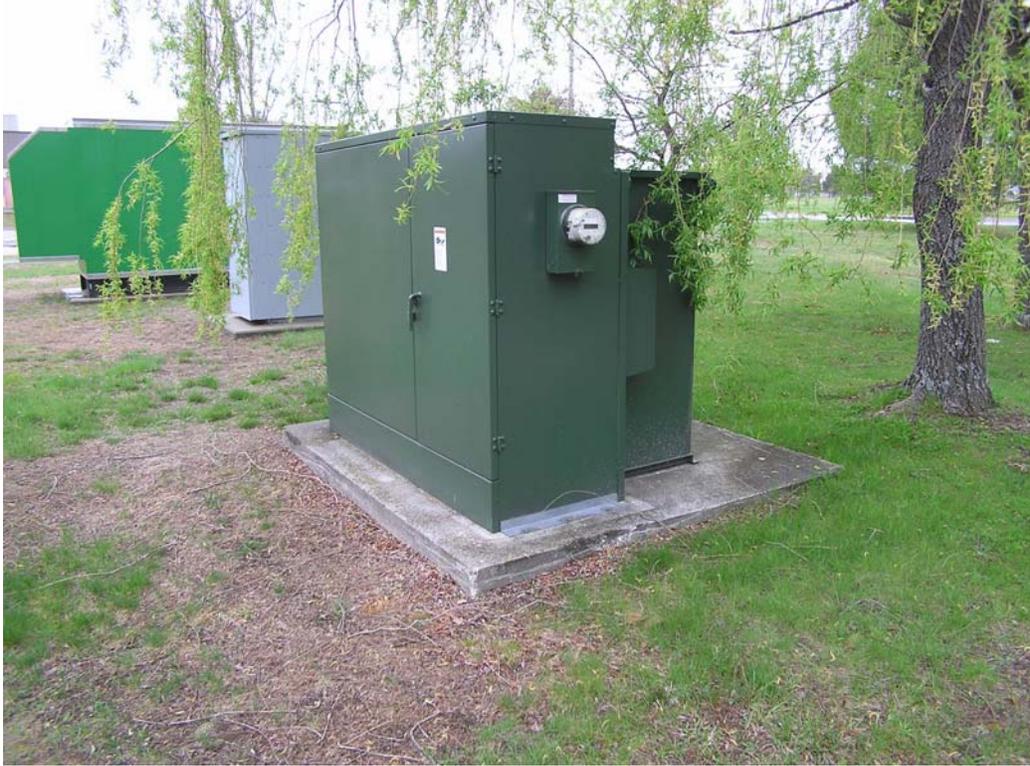
One non-PCB containing transformer (serial number 1603401593) was observed.

No. 7 Building 201 Parcel – NAS Brunswick April 27, 2010
Electrical transformer located north of Building 201, switch box and generator in background.

Due to the age of the building, soil sampling around the pad is recommended in order to confirm that the soil is free of PCBs from potential former transformers.

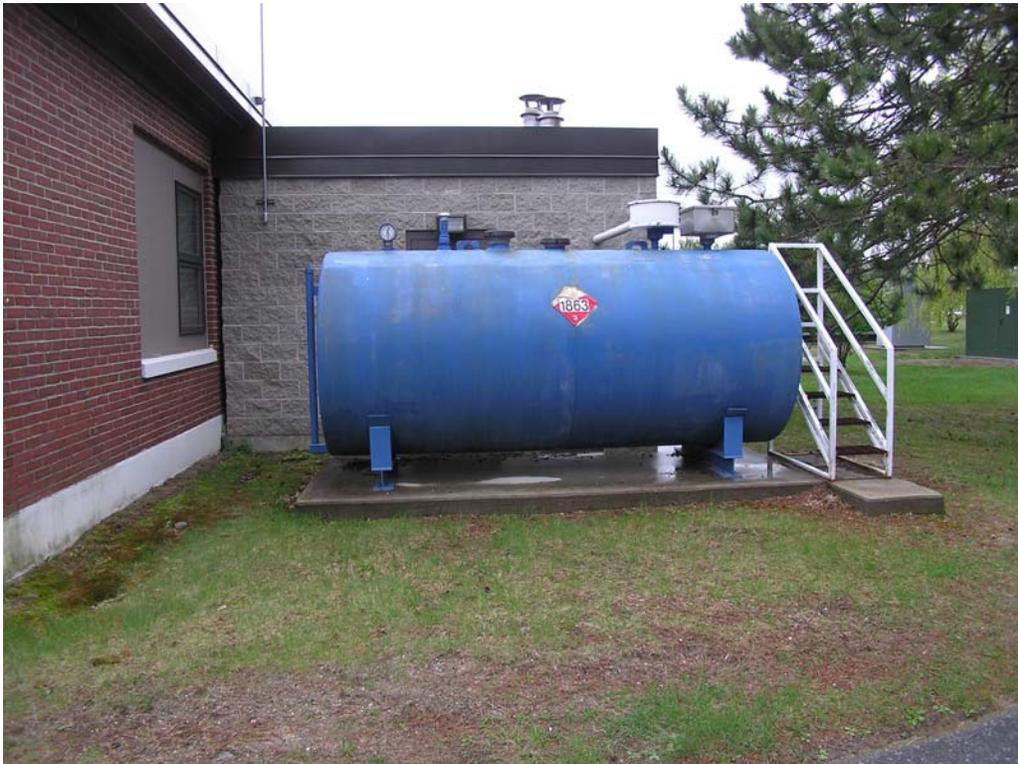
No. 8 Building 201 Parcel – NAS Brunswick April 27, 2010
Building 201 fuel oil AST located on the northeastern corner of the building

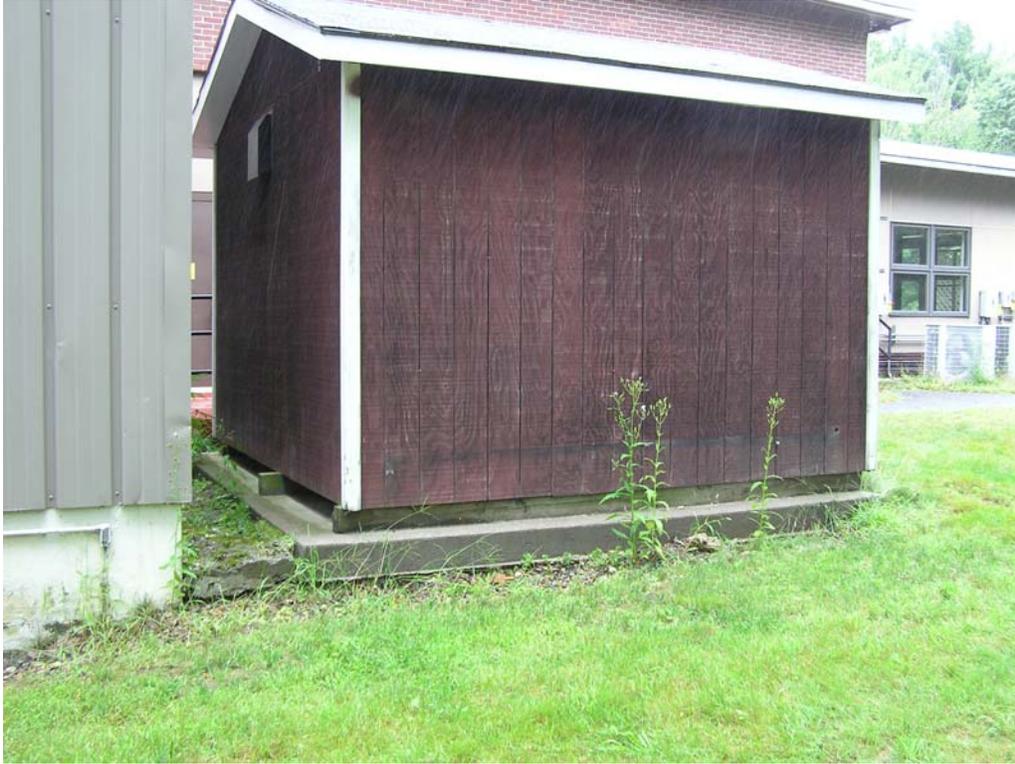
No. 9 Building 201 Parcel – NAS Brunswick
Building 420 (storage) southwest elevation

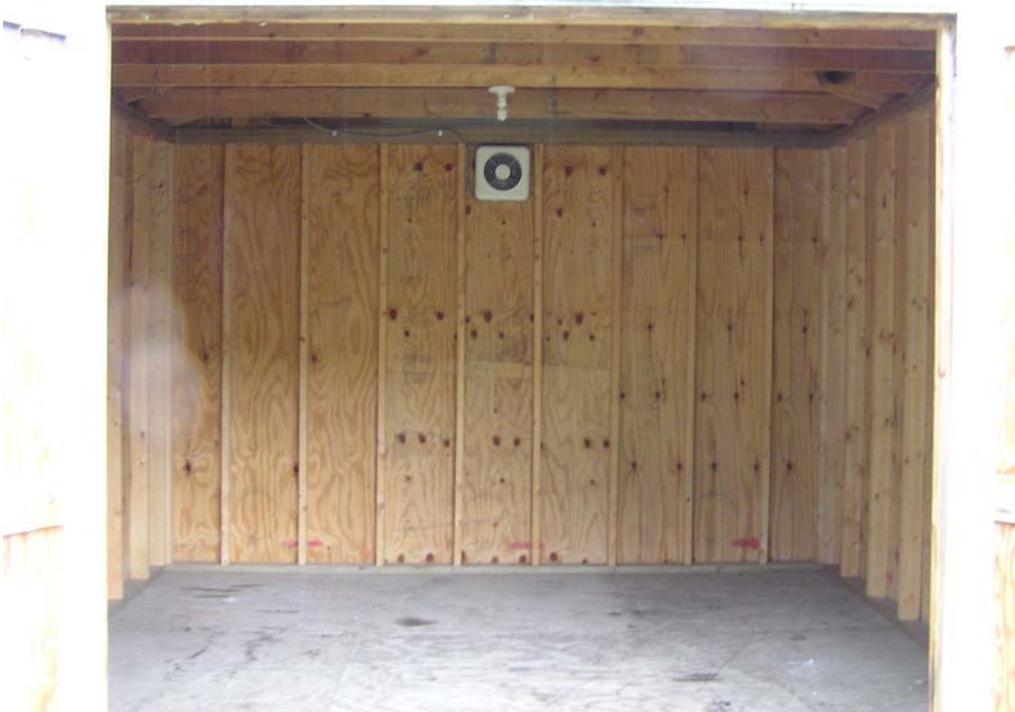
No. 10 Building 201 Parcel – NAS Brunswick
Building 420 (storage) interior
