FINAL RESOURCE CONSERVATION AND RECOVERY ACT PARTIAL CLOSURE REPORT
FOR BUILDING 277 WITH TRANSMITTAL LETTER NAS BRUNSWICK ME
10/19/2010
NAS BRUNSWICK

RCRA PARTIAL CLOSURE REPORT
for
BUILDING 277 – PUBLIC WORKS SEWAGE PUMP HOUSE
NAVAL AIR STATION BRUNSWICK, MAINE
USEPA IDENTIFICATION NUMBER ME8170022018
OCTOBER 2010

**HWSA INSPECTION REPORT
HAZARDOUS WASTE STORAGE AREAS CLOSURE
NAS BRUNSWICK
BRUNSWICK, MAINE
CTO WE22**

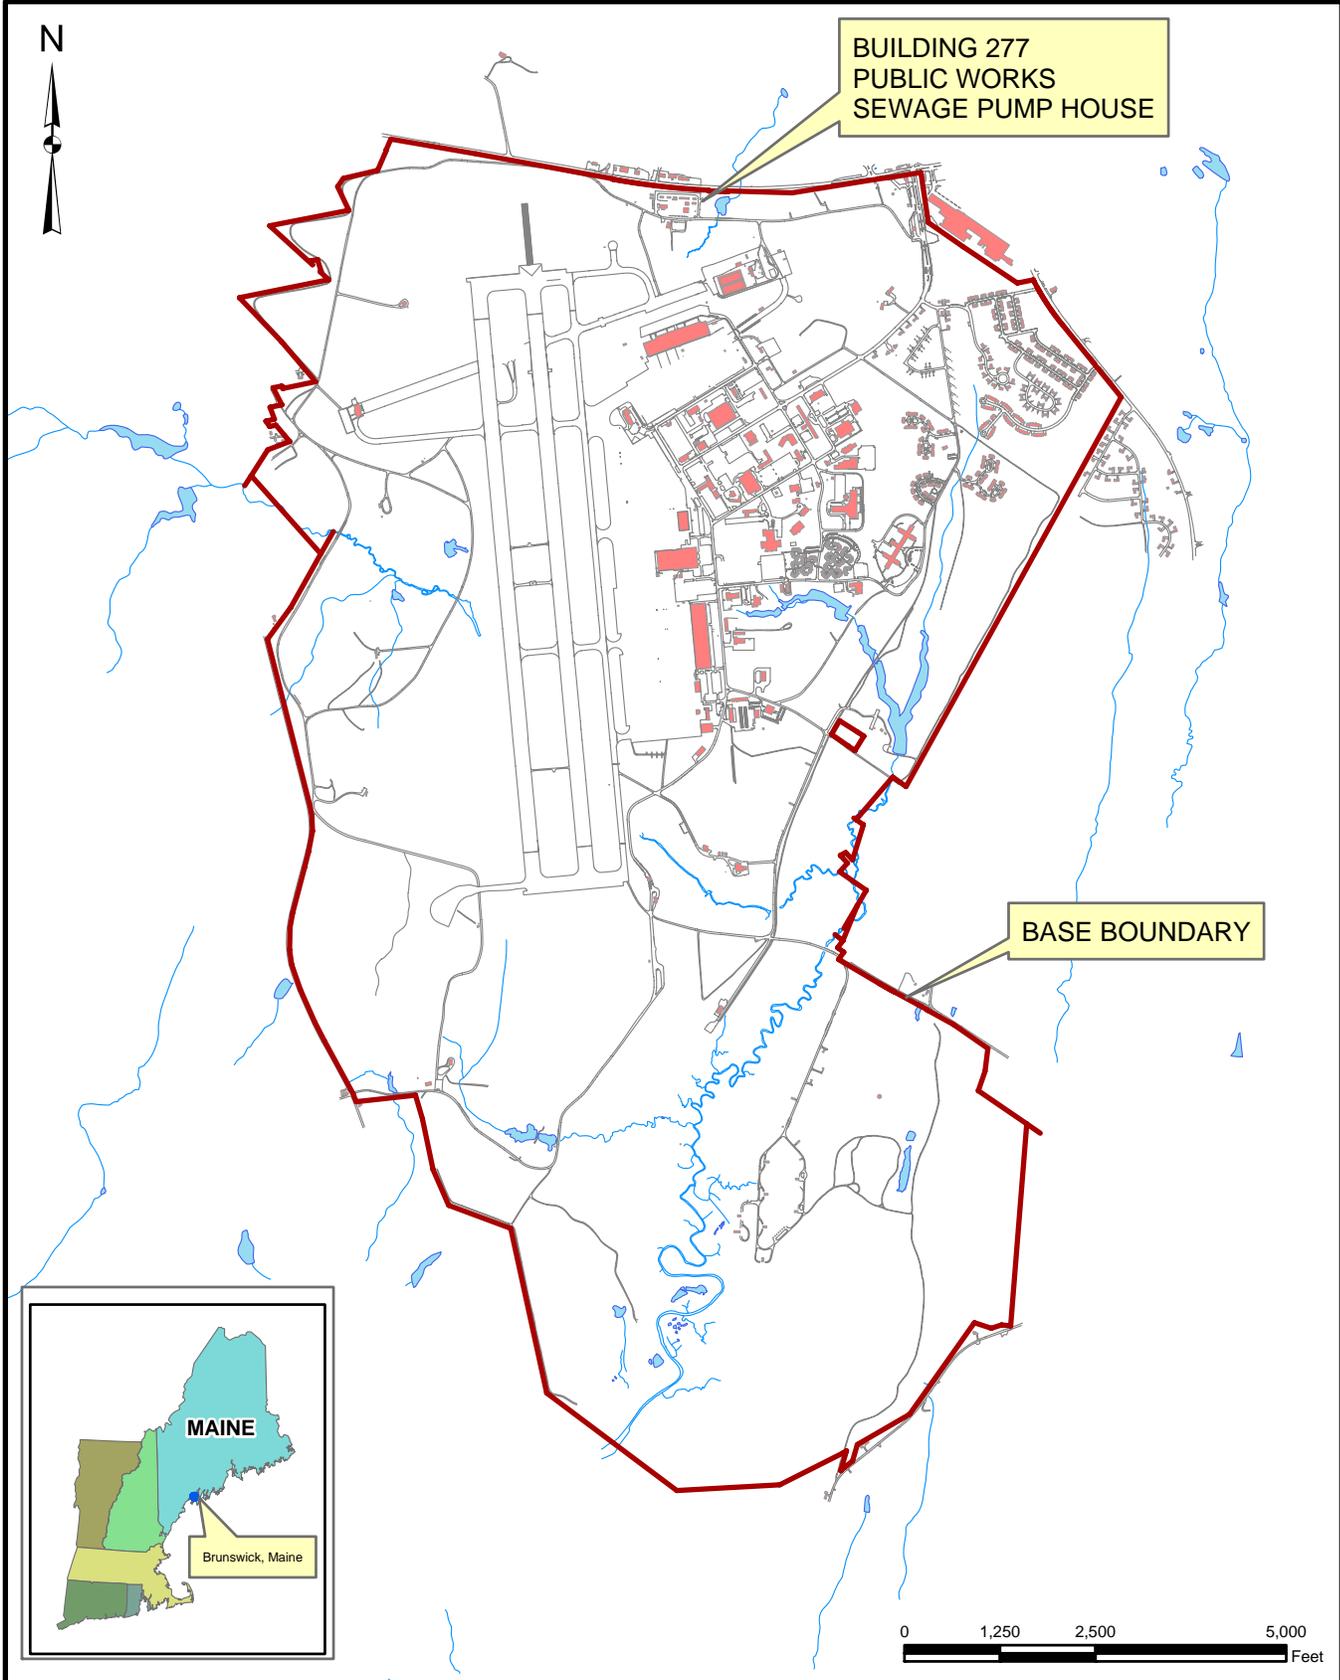
SCALE AS NOTED	
FILE I:\WASB_BLDG_277_LOCUS.MXD	
REV 0	DATE 10/15/10
FIGURE NUMBER 1

SITE LOCATION MAP
BUILDING 277 - PUBLIC WORKS SEWAGE PUMP HOUSE
RCRA PARTIAL CLOSURE REPORT
NAVAL AIR STATION BRUNSWICK, MAINE

Building 277 is located in the northern area of NAS Brunswick (Figure 1), along the inner base security fence on the north side of Perimeter Road, east of the former Naval Mobile Construction Battalion (NMCB) 27 Compound, also known as the SeaBee Compound (Figure 2). It is surrounded by grass-covered NAS Brunswick grounds sloping east and northeast toward an unnamed surface water body, and the outer security fence and Route 24, respectively. Building 277 is located along the western border of Site 8, Perimeter Road Disposal Site, a disposal site for construction and demolition debris, from 1964 to 1974.

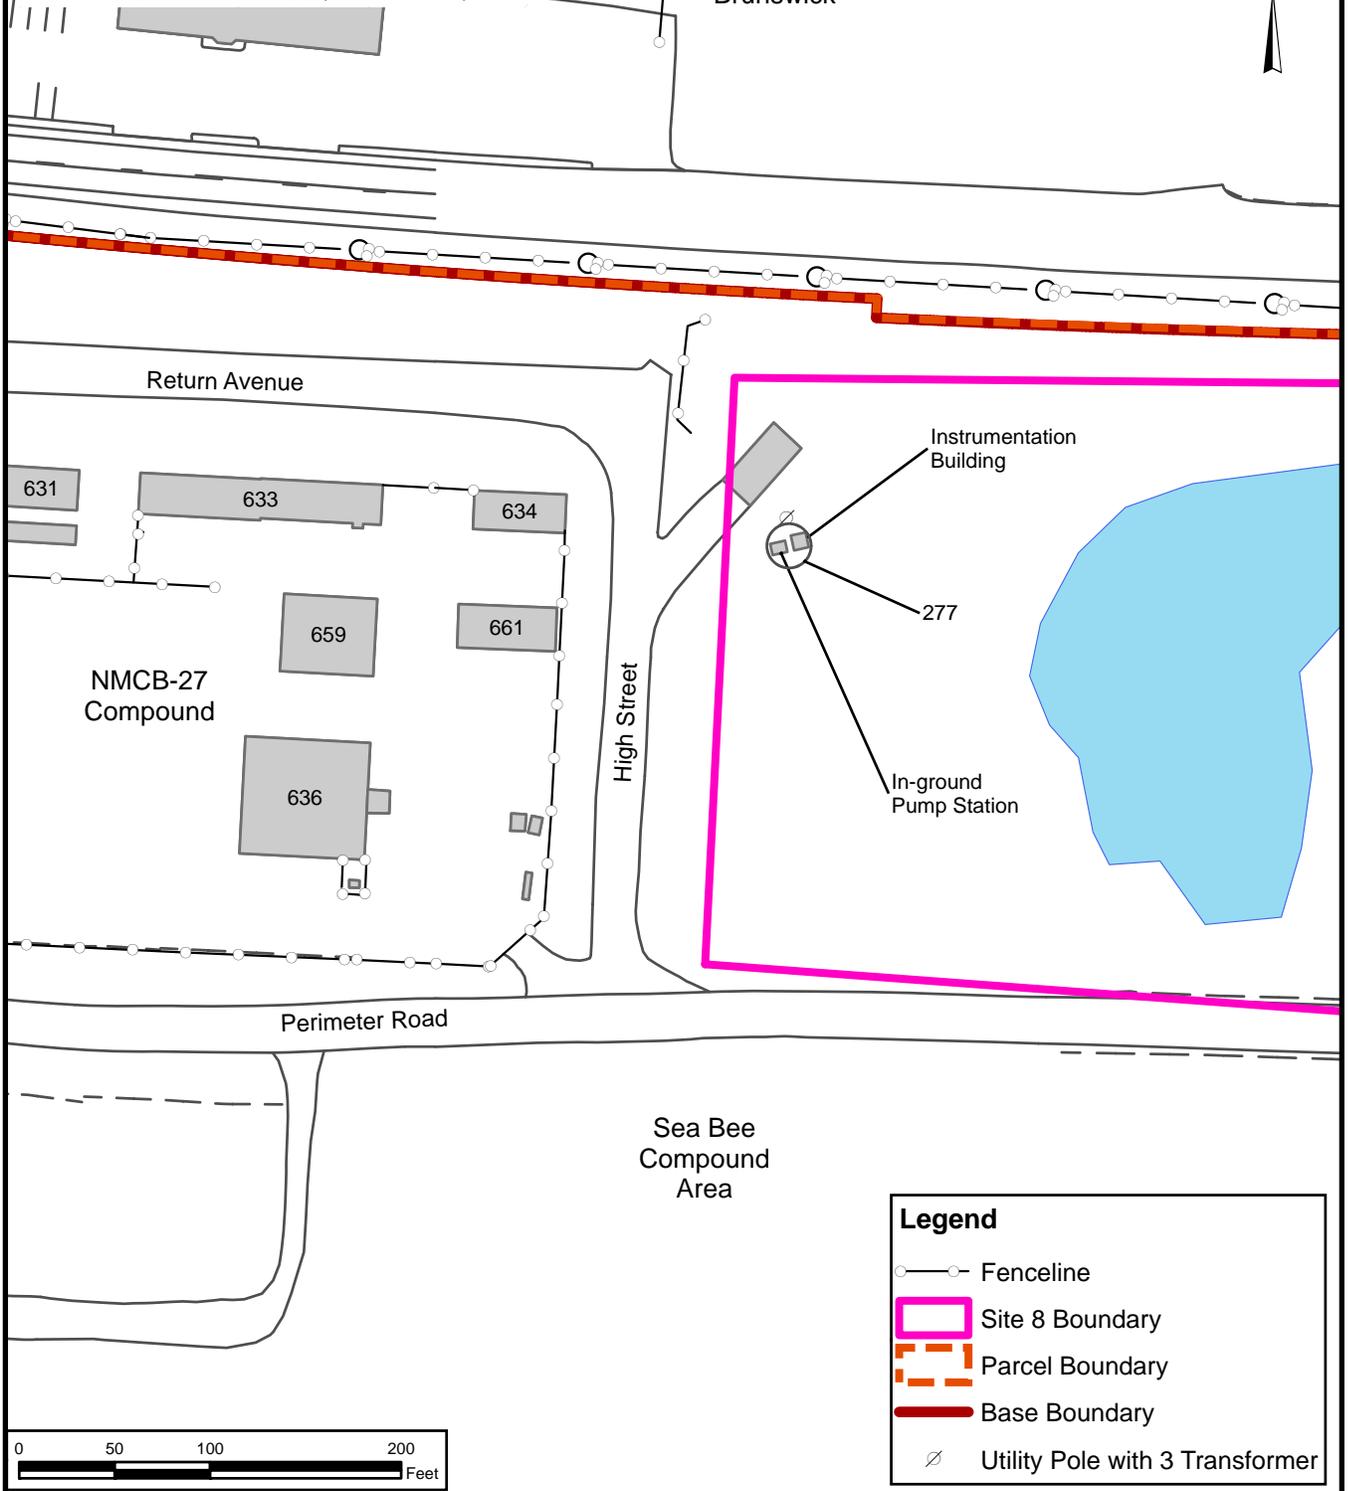
SCALE AS NOTED	
FILE \\NASB_BLDG_277_MAP.MXD	
REV 0	DATE 10/15/10
FIGURE NUMBER 2

Building 277 Corner	Northing	Easting
Northeast	391099.338	3015080.574
Southeast	391091.524	3015082.285
Southwest	391089.813	3015074.470
Northwest	391097.628	3015072.759

SITE PLAN
BUILDING 277 - PUBLIC WORKS SEWAGE PUMP HOUSE
RCRA PARTIAL CLOSURE REPORT
NAVAL AIR STATION BRUNSWICK, MAINE

This investigation of the hazardous waste closure requirement applies to the building footprint of Building 277 (building footprint as shown on Figure 2). It does not apply to the land surrounding or the groundwater underlying Building 277.

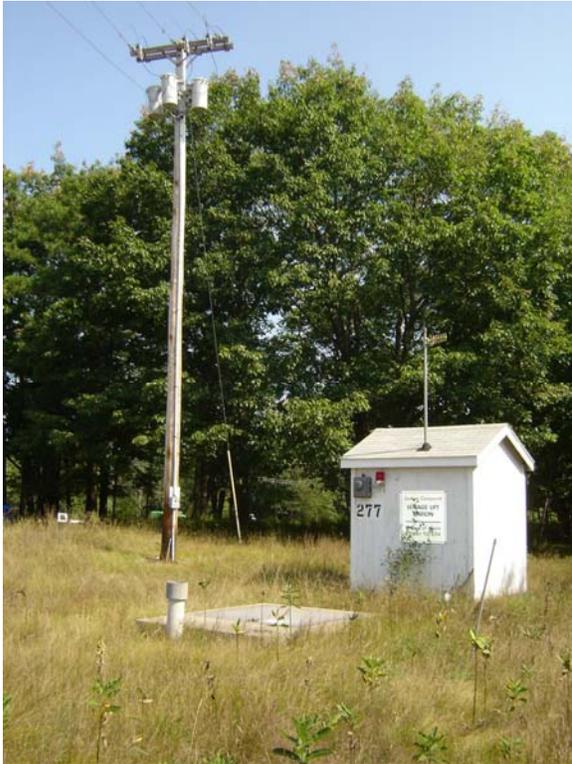
No. 1 Building 277 – NAS Brunswick September 2, 2010
Building 277 southwest elevation; utility pole with three transformers in background

- No peeling or flaking paint was observed on the building exterior or interior.
- Three transformers that could be a potential source of PCB contamination were observed on a utility pole approximately 10 feet north of the pump station. Surface soil immediately west of the utility pole base was discolored by dark staining.

Three utility pole-mounted 15 KVA transformers were observed immediately north of Building 277 that were reported to have been manufactured in 1990 by ABB, with S/N's 90A341747, 90A34148 and 90A34149, and containing non-polychlorinated biphenyls (PCBs) oil.

A surficial soil sample (Sample ID NASB-B277-SB01) was collected on September 2, 2010 from 0-6 inches below grade and submitted for PCB analysis via EPA Method 8081. The sample was collected on the west side of the utility pole, at its base, and within an area of soil staining. The soil staining may also be associated with pole preservation materials, i.e. creosote. No other signs of a past release (unusual odors, stressed vegetation, etc.) were observed.

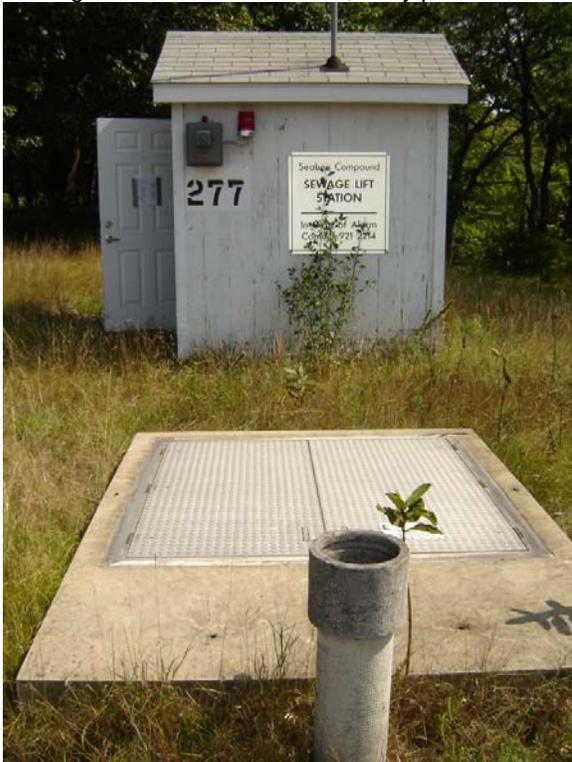
No. 2 Building 277 – NAS Brunswick September 2, 2010
Building 277 west elevation; pump station vault in foreground and instrumentation building in background

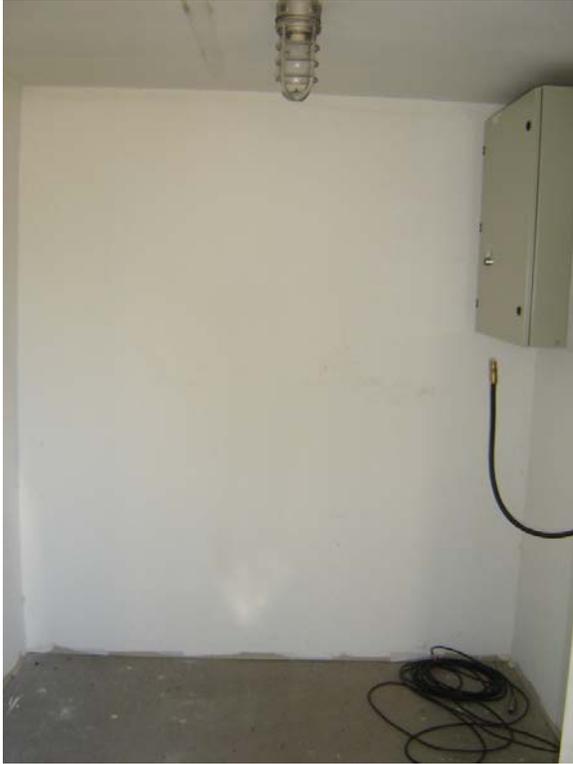
No. 3 Building 277 – NAS Brunswick
Building 277 interior

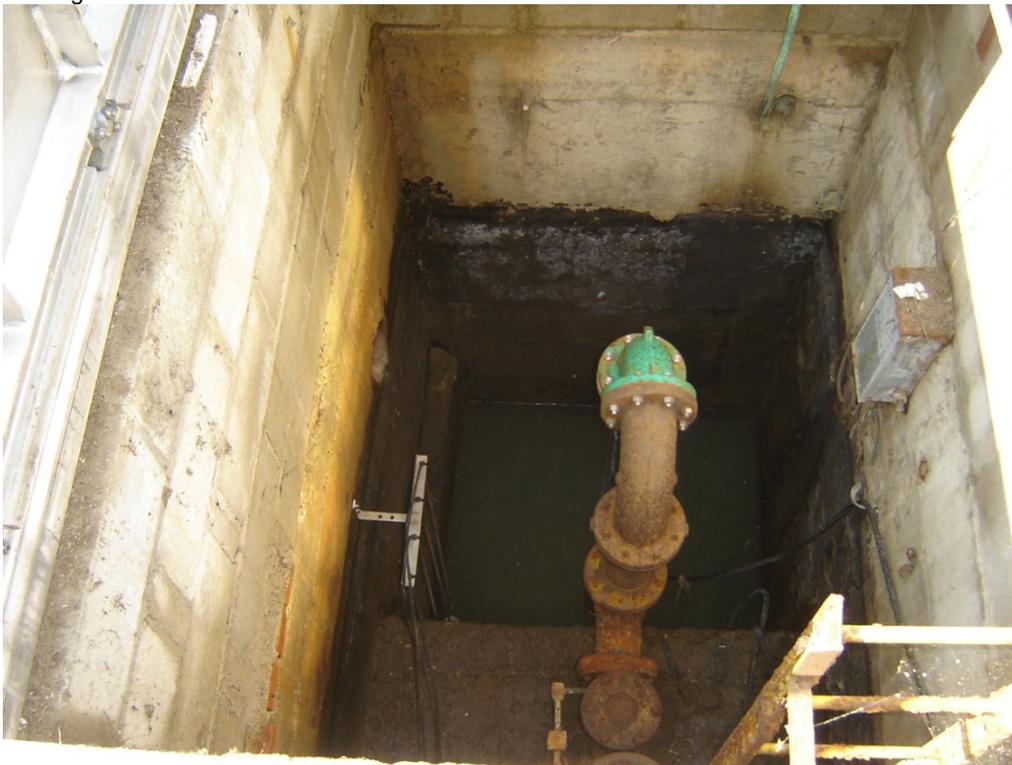
No. 4 Building 277 – NAS Brunswick
Building 277 pump station wet well interior

- The in-ground pump station access doors were opened to observe the wet well; no solvent or petroleum odors were noted.
- No evidence of current or past hazardous waste generation was observed.
