FINAL RESOURCE CONSERVATION AND RECOVERY ACT PARTIAL CLOSURE REPORT  
FOR BUILDINGS 650 AND 651 WITH TRANSMITTAL LETTER NAS BRUNSWICK ME  
10/19/2010  
NAS BRUNSWICK

**RCRA PARTIAL CLOSURE REPORT**  
**for**  
**BUILDING 650 – JP-8 TANK I**  
**BUILDING 651 – JP-8 TANK II**  
**NAVAL AIR STATION BRUNSWICK, MAINE**  
**USEPA IDENTIFICATION NUMBER ME8170022018**  
**OCTOBER 2010**

**HWSA INSPECTION FORM  
HAZARDOUS WASTE STORAGE AREAS CLOSURE  
NAS BRUNSWICK  
BRUNSWICK, MAINE  
CTO WE22**

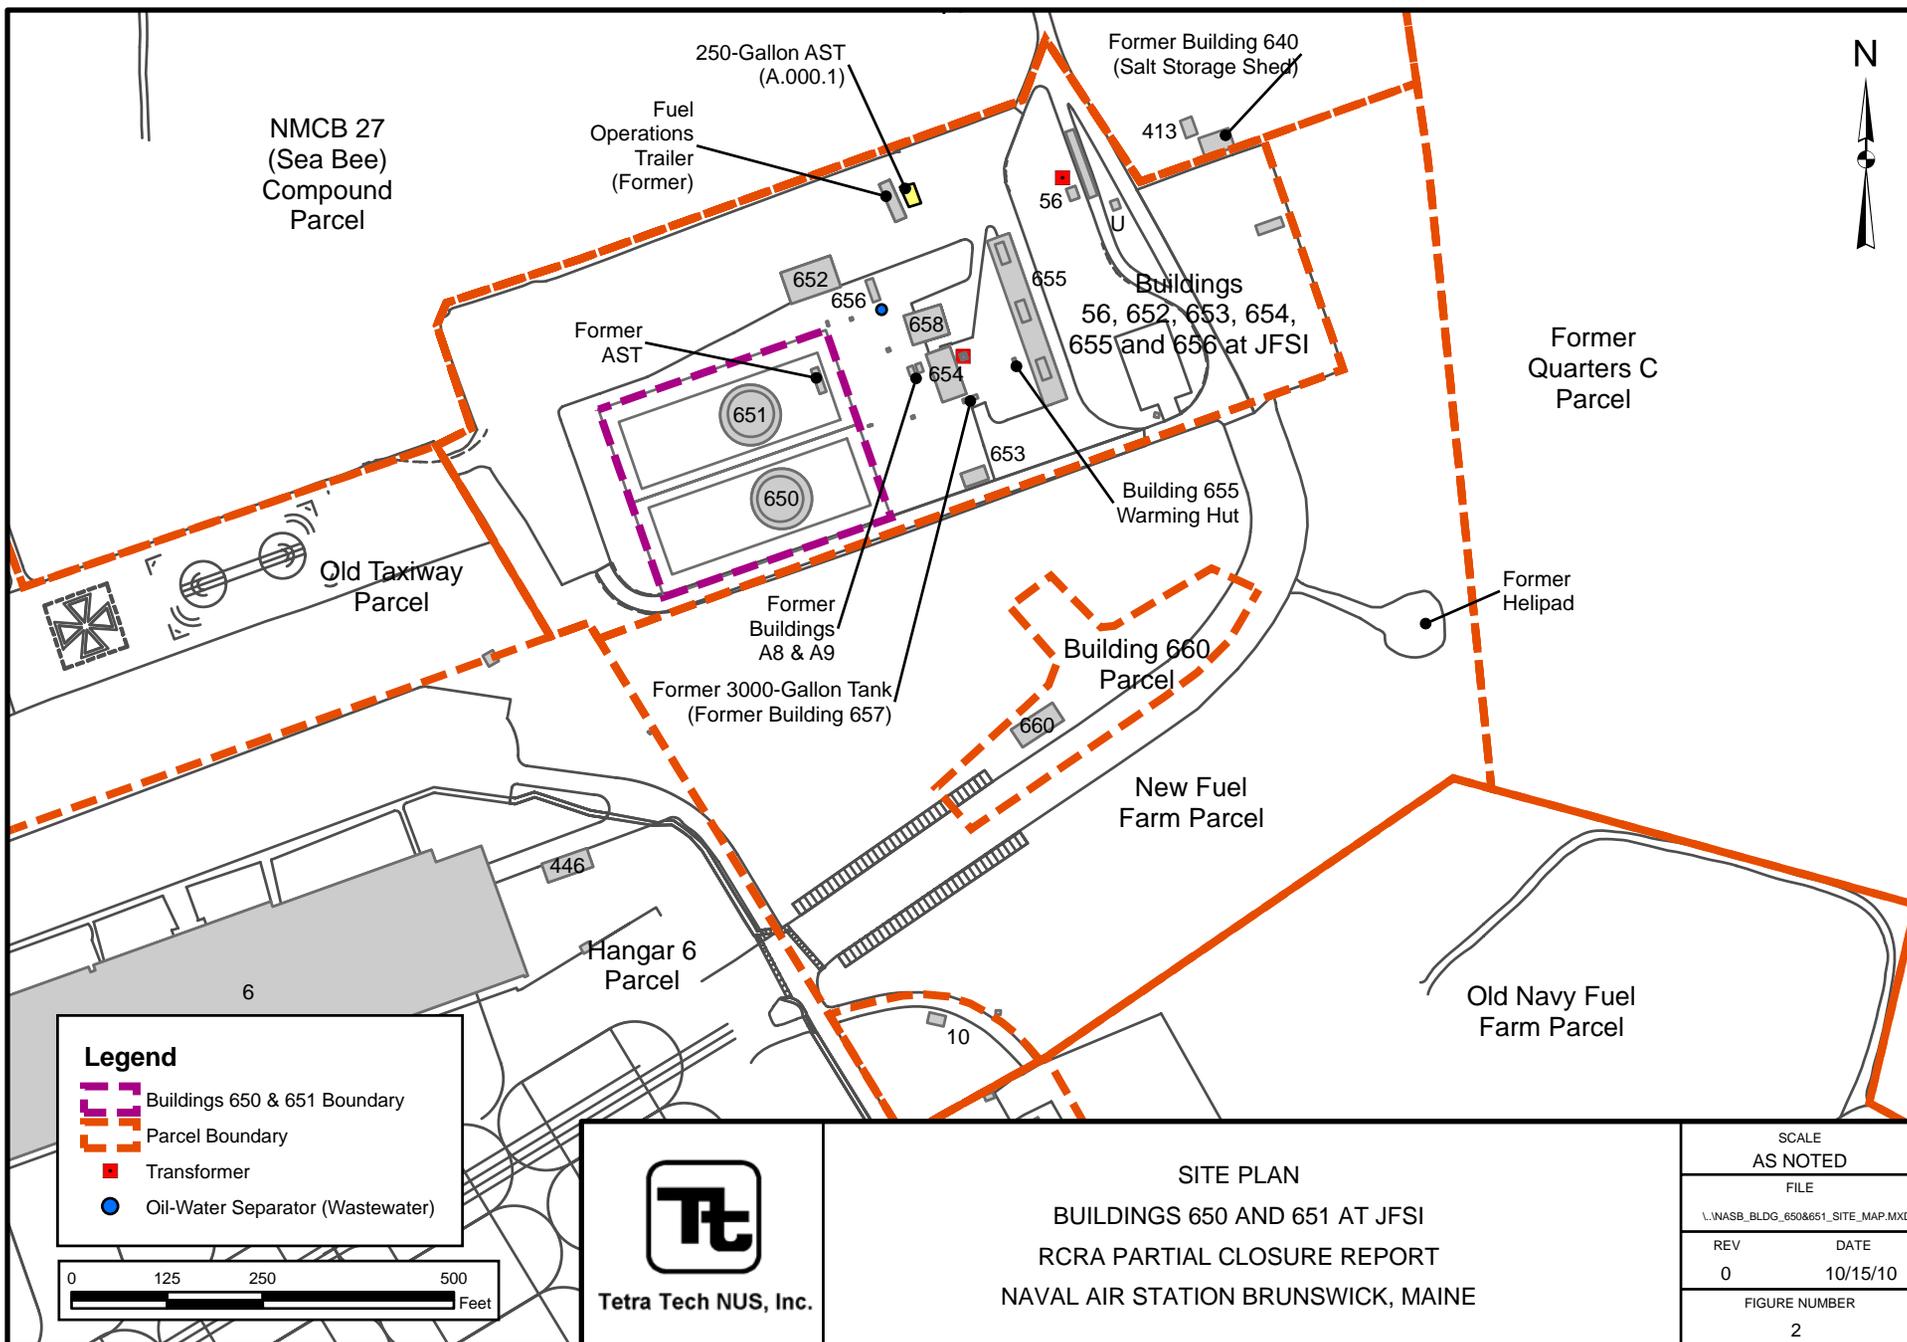
| FIGURE NUMBER | |

This investigation of the hazardous waste closure requirement applies only to the footprints (as shown on Figure 2) of Buildings 650 and 651. It does not apply to the land surrounding or the groundwater underlying Buildings 650 or 651.

**SITE PLAN**  
**BUILDINGS 650 AND 651 AT JFSI**  
**RCRA PARTIAL CLOSURE REPORT**  
**NAVAL AIR STATION BRUNSWICK, MAINE**

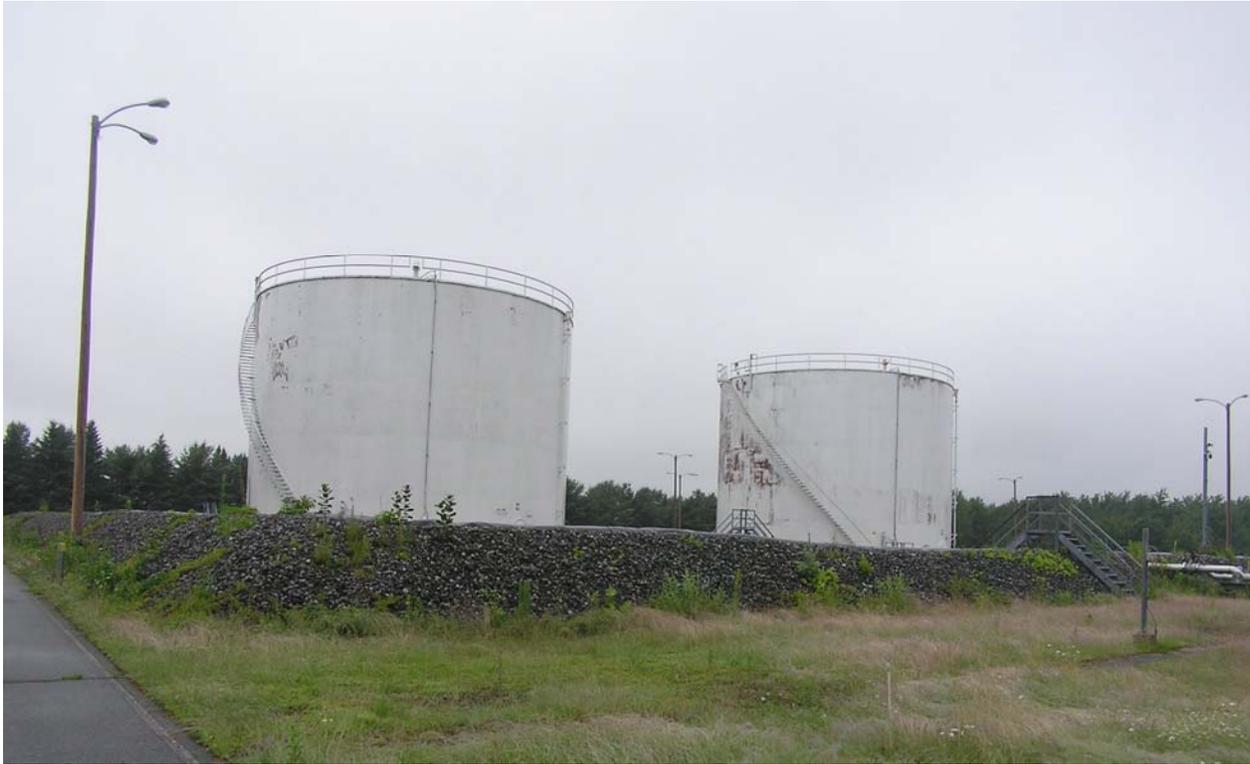
No. 1 Buildings 650 and 651 – NAS Brunswick June 23, 2010  
Building 650 – JP-8 Tank I and Building 651 – JP-8 Tank II east elevation; showing secondary containment berm

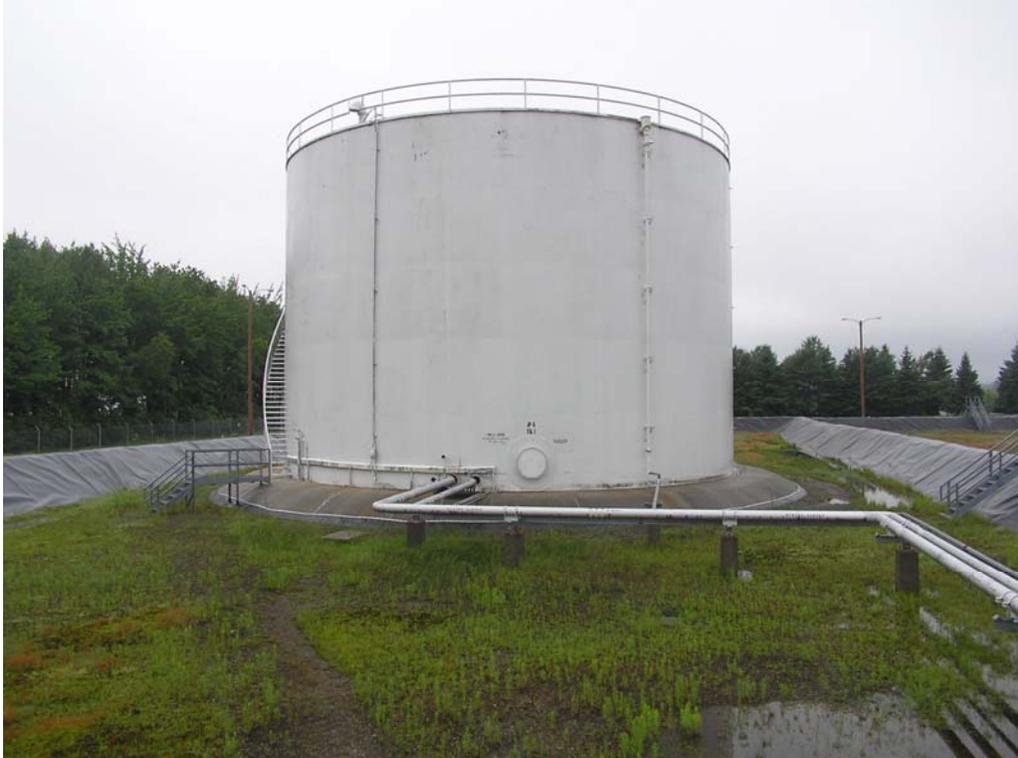
No. 2 Buildings 650 and 651 – NAS Brunswick June 23, 2010  
Building 650 – JP-8 Tank I east elevation

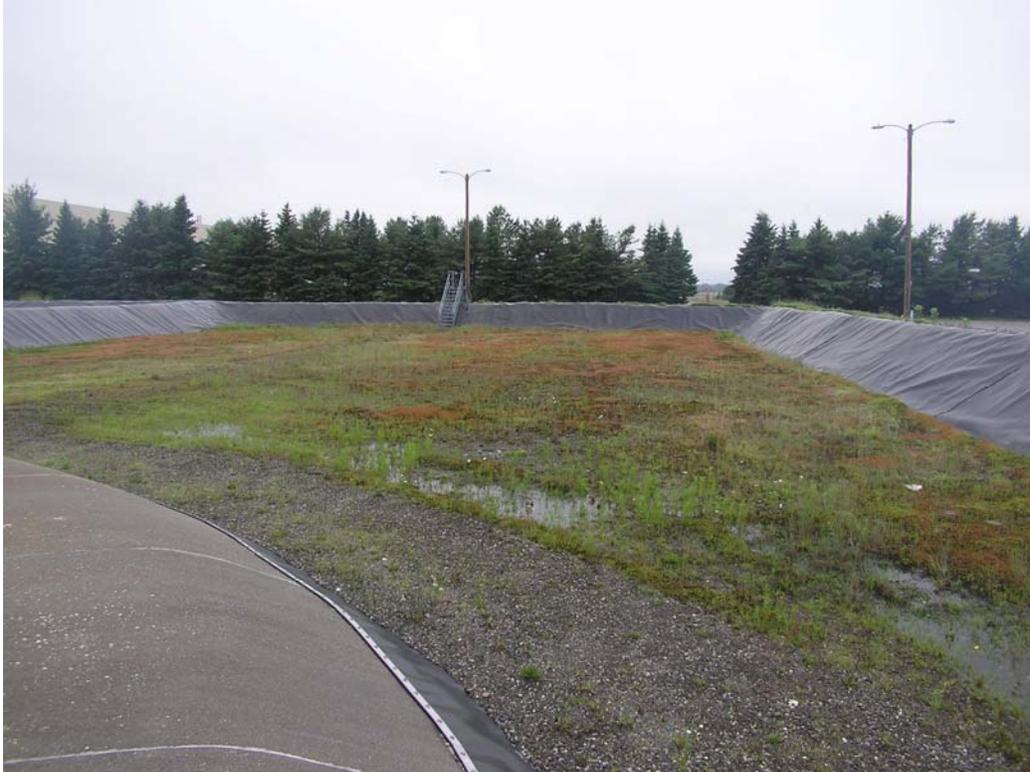
June 23, 2010

No. 3 Buildings 650 and 651 – NAS Brunswick  
Building 651 – JP-8 Tank I looking west at secondary containment area

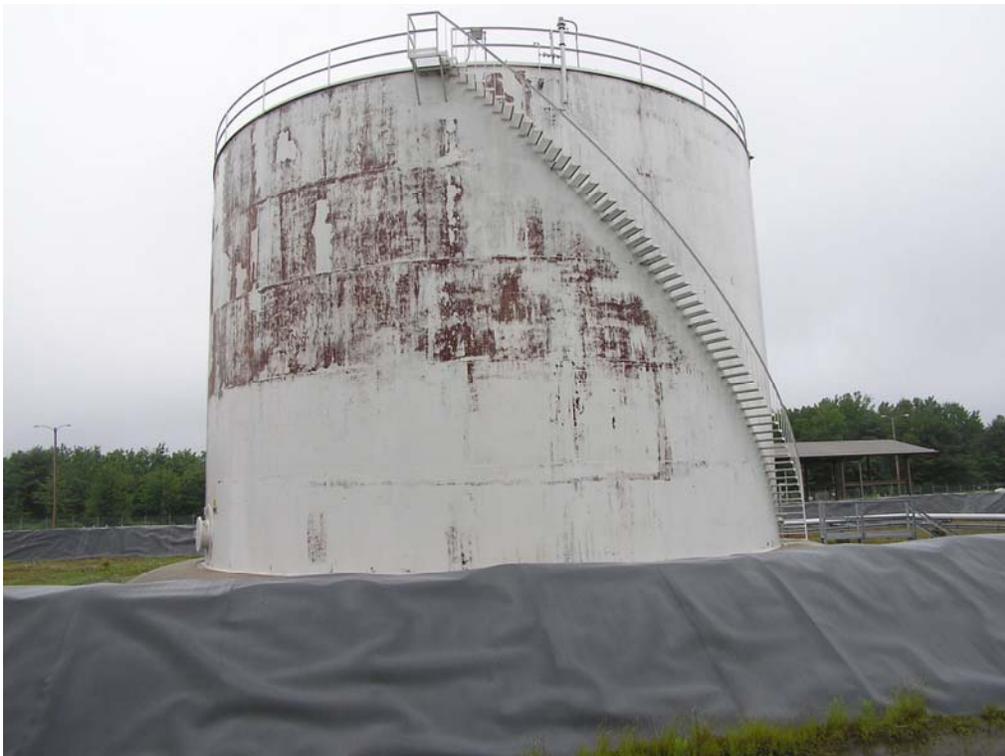
June 23, 2010

- At the time of inspection, Buildings 650 and 651 were closed and in good condition. Labeling observed on each of the ASTs indicated that the tanks were closed as of April 28, 2010 (Building 650) and December 10, 2008 (Building 651).
- Two catch basins were observed within the secondary containment for each tank. According to site plans, the catch basins drain to Building 656 (fuel farm oil/water separator).
- No evidence of current or past hazardous waste generation activities was observed.
- No signs of a past release (staining, unusual odors, stressed vegetation, etc.) were observed.
- No modifications to the structure, which may conceal signs of a past release, were observed.
- A concrete pad is visible within the secondary containment, east of Building 651, in the approximate area of the former AST (A656.0).
- Deteriorated coating (paint) was observed on the exterior of both tanks.

- No record of hazardous waste stored at Building 650 or 651 was found.
- At the time of inspection, Buildings 650 and 651 were closed and in good condition. Placards were observed on each of the ASTs indicating that the tanks were closed as of April 28, 2010 (Building 650) and December 10, 2008 (Building 651).
- Two catch basins were observed within the secondary containment for each tank. According to site plans, the catch basins drain to Building 656 (fuel farm oil/water separator).
- No evidence of current or past hazardous waste generation activities was observed.
- No signs of a past release (staining, unusual odors, stressed vegetation, etc.) were observed.
- No modifications to the structure, which may conceal signs of a past release, were observed.
- Peeling paint was observed on the exterior of both tanks.

No. 4 Buildings 650 and 651 – NAS Brunswick  
Building 651 – JP-8 Tank II south elevation showing deteriorated coating on upper tank exterior; secondary containment berm in foreground and Off-Load Rack (Building 652) visible in background

If paint peels, flakes, or is otherwise removed, the paint-chip waste material may be a hazardous waste, subject to RCRA requirements. Paint wastes exhibiting the "toxicity characteristic" as measured using the Toxicity Characteristic Leaching Procedure (TCLP) must be handled and disposed of in conformance with hazardous waste laws and regulations. Therefore, sampling of the loose paint observed during the site visit was conducted on July 7, 2010 and September 17, 2010 (Building 650, only).

Samples of the loose exterior peeling paint or coating material observed on Tanks I and Tank II were collected in July and September 2010. The samples were analyzed for total RCRA 8 metals (July 2010, only) and TCLP Metals (September 2010, only). The paint-chip samples were analyzed by Tetra Tech's subcontracted analytical laboratory, Analytics Environmental Laboratory (Analytics), of Portsmouth, New Hampshire. The resulting analytical data underwent limited data validation consisting of field duplicate evaluation, blank contamination evaluation, and completeness evaluation.

As presented in Table 1, TCLP metals concentrations in the sample collected from Building 650 in September 2010 do not exceed TCLP criteria. The total metals concentrations in the Building 650 and 651 paint-chip samples do not exceed 20 times the TCLP limit with the exception of lead (Building 650 sample). Based on the records research findings, site visit observations, and sampling results, it was determined that neither further investigation nor sampling of Building 650 or 651 is required to complete the MEDEP hazardous waste closure requirements.

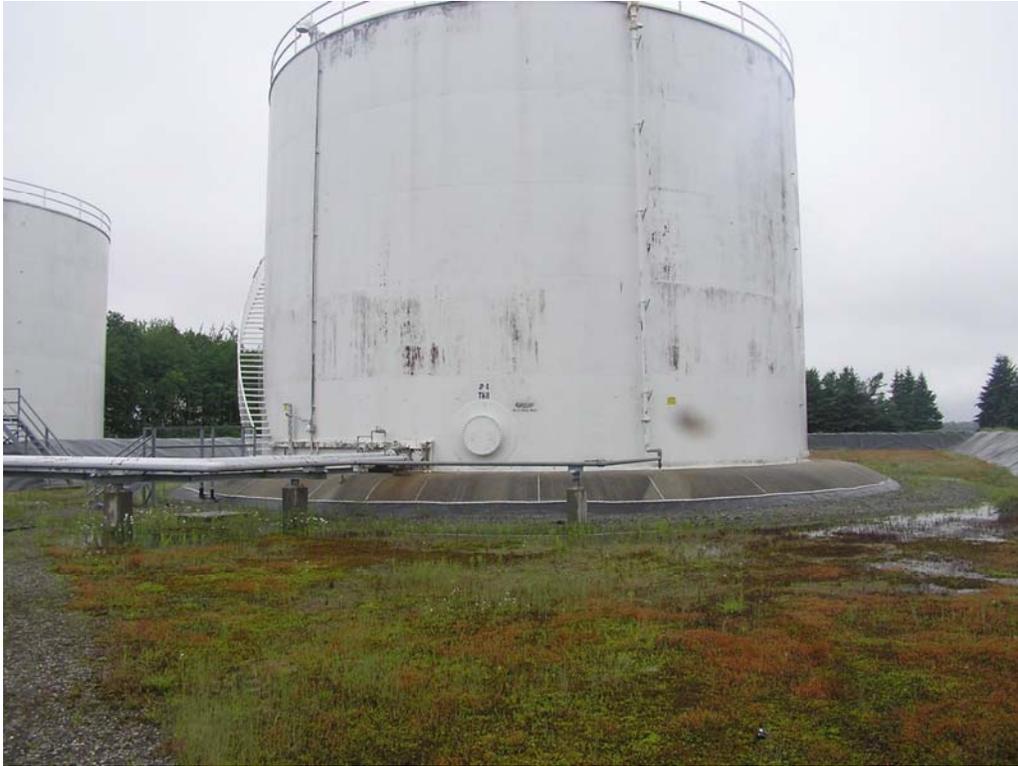
No. 5 Buildings 650 and 651 – NAS Brunswick June 23, 2010  
Building 651 – JP-8 Tank II northeast elevation; Tank I in the right background

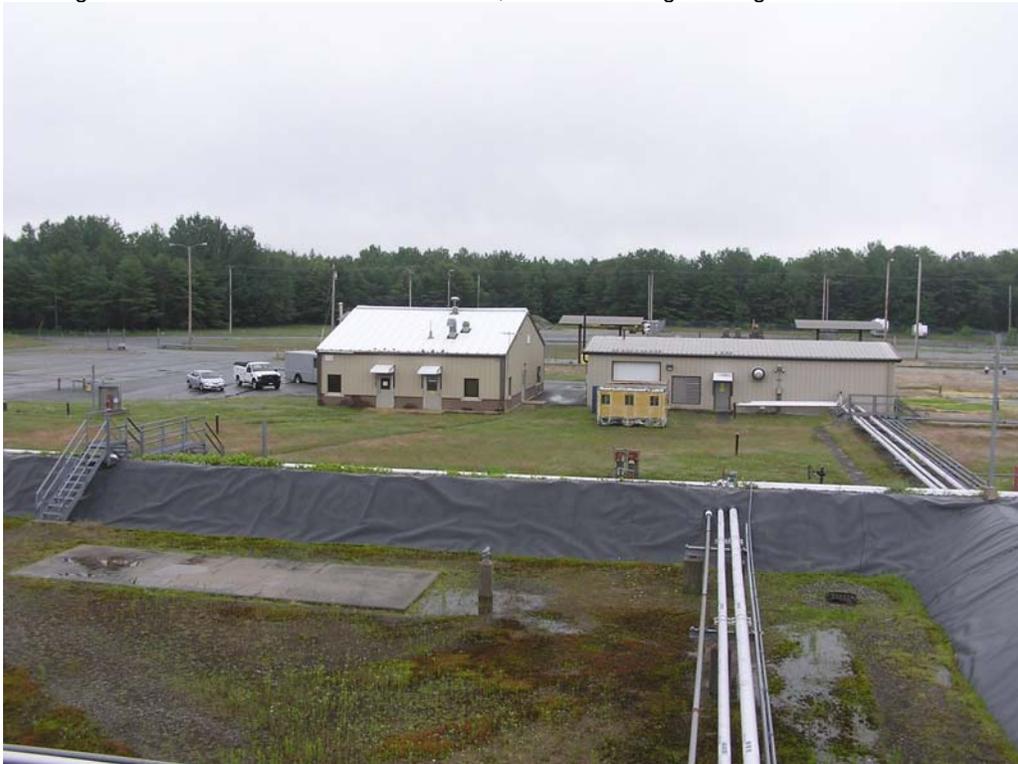
One 25,950-gallon, single-walled steel, contaminated-fuel AST referred to as Tank 3, and identified as A656.0 in the NAS Brunswick AST Inventory was previously located east of Building 651 within the secondary containment. According to the AST inventory records, the AST (A656.0) was installed in 1992 and removed in August 1994.

No. 6 Buildings 650 and 651 – NAS Brunswick June 23, 2010  
Building 651 – JP-8 Tank II eastern secondary containment area with former contaminated fuel AST (Tank 3) pad visible inside secondary containment berm; POL Testing Facility (Building 658) and JP-8 Pump House (Building 654) left to right in background
