FINAL RESOURCE CONSERVATION AND RECOVERY ACT PARTIAL CLOSURE REPORT
FOR BUILDING 111 WITH TRANSMITTAL LETTER NAS BRUNSWICK ME
11/5/2010
NAS BRUNSWICK

RCRA PARTIAL CLOSURE REPORT
for
BUILDING 111 – PUBLIC WORKS SEWAGE PUMP HOUSE
NAVAL AIR STATION BRUNSWICK, MAINE
USEPA IDENTIFICATION NUMBER ME8170022018
OCTOBER 2010

**HWSA INSPECTION REPORT
HAZARDOUS WASTE STORAGE AREAS CLOSURE
NAS BRUNSWICK
BRUNSWICK, MAINE
CTO WE22**

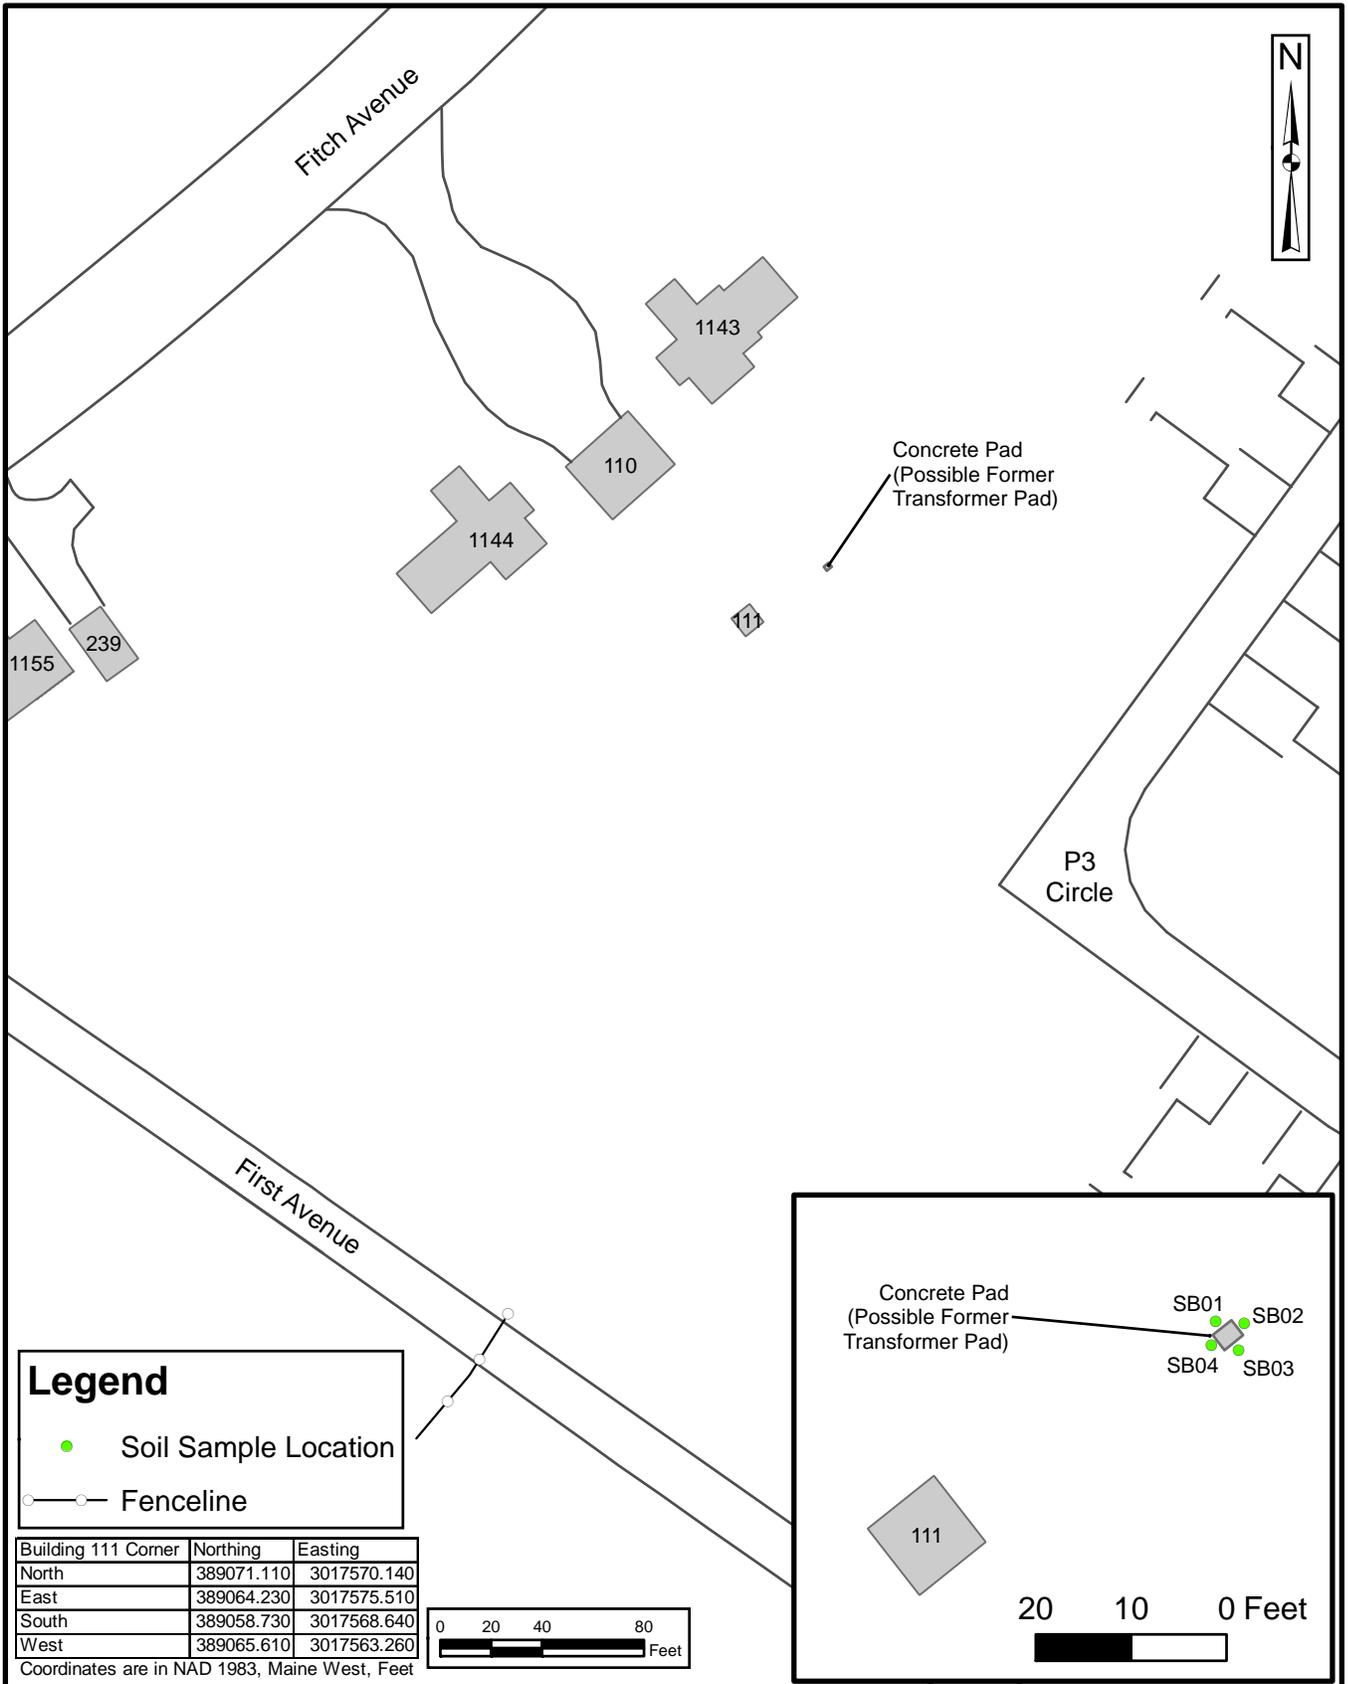
SCALE AS NOTED	
FILE L:\NASB_BLDG_111_SITE_MAP.MXD	
REV 0	DATE 10/21/10
FIGURE NUMBER 2

This investigation of the hazardous waste closure requirement applies to the building footprint of Building 111 (building footprint as shown on Figure 2). It does not apply to the land surrounding or the groundwater underlying Building 111.

SITE PLAN
BUILDING 111 - PUBLIC WORKS SEWAGE PUMP HOUSE
RCRA PARTIAL CLOSURE REPORT
NAVAL AIR STATION BRUNSWICK, MAINE

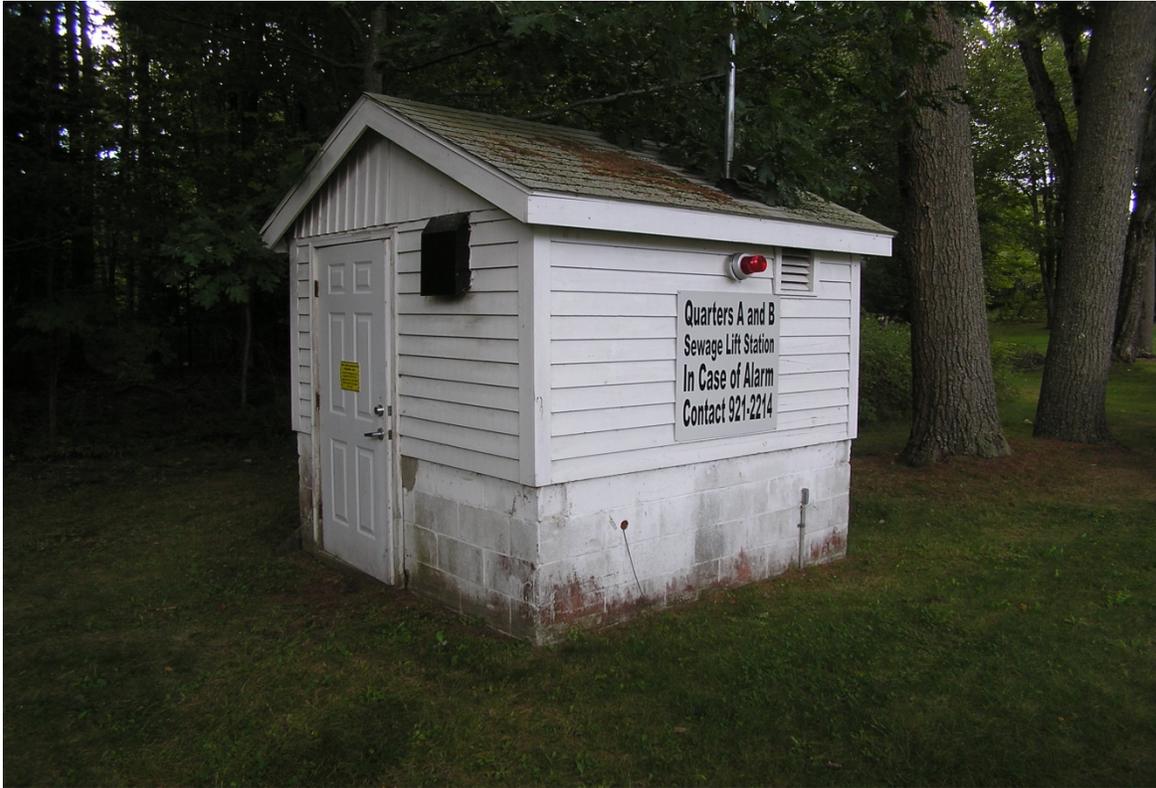
No. 1 Building 111 – NAS Brunswick
Building 111 northeast elevation; entrance on east side

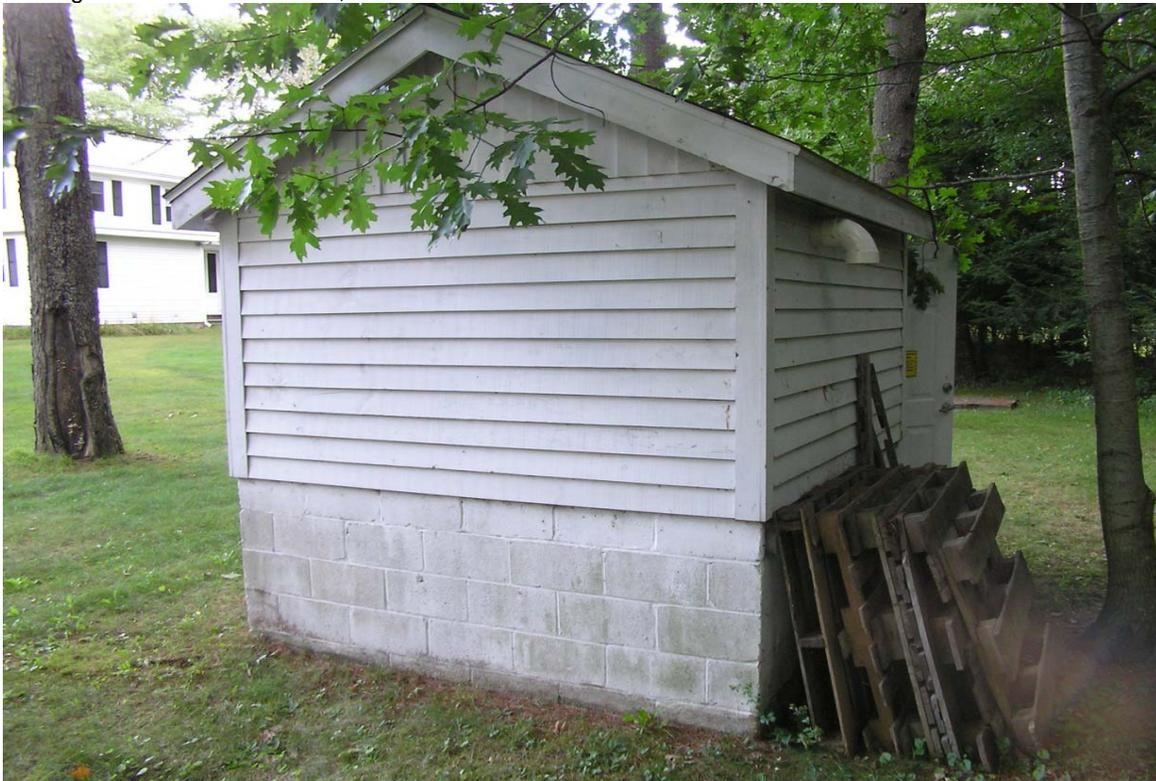
No. 2 Building 111 – NAS Brunswick
Building 111 southwest elevation; in-ground pump station PVC vent pipe exiting from south side

- At the time of the site visits, Building 111 was unoccupied, in good condition, and was operational.
- The pump station wet well access cover was not opened to observe the wet well; however, no solvent or petroleum odors were noted as being emitted from the wet well passive vent pipe.

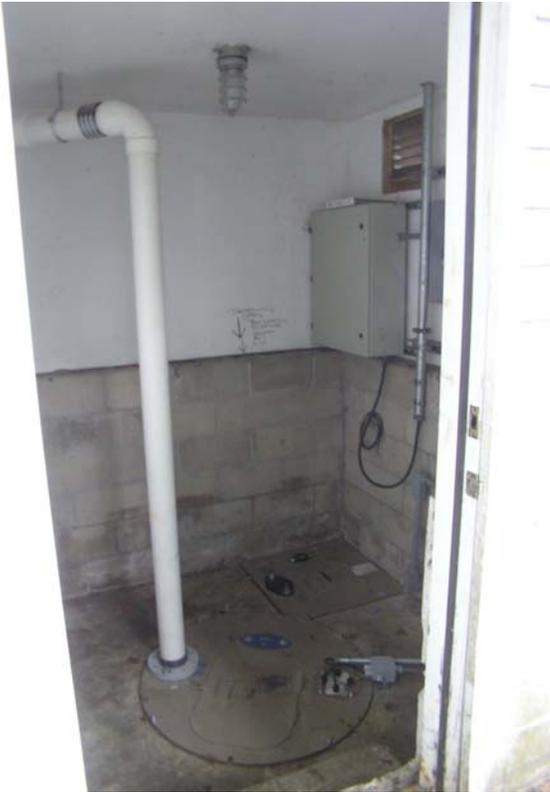
No. 3 Buildings 111 – NAS Brunswick
 Building 111 interior; access to in-ground pump station in floor and PVC vent pipe

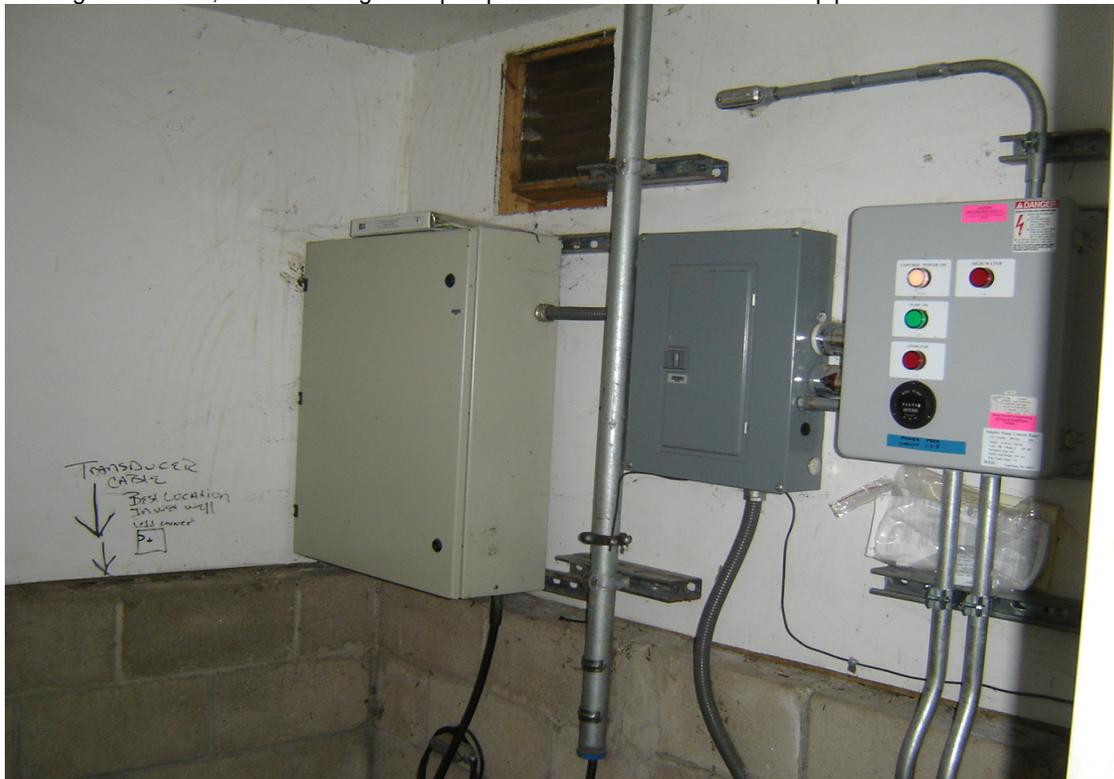
No. 4 Buildings 111 – NAS Brunswick
 Building 111 interior; electric, alarm panels, and system on/off panels mounted on north wall

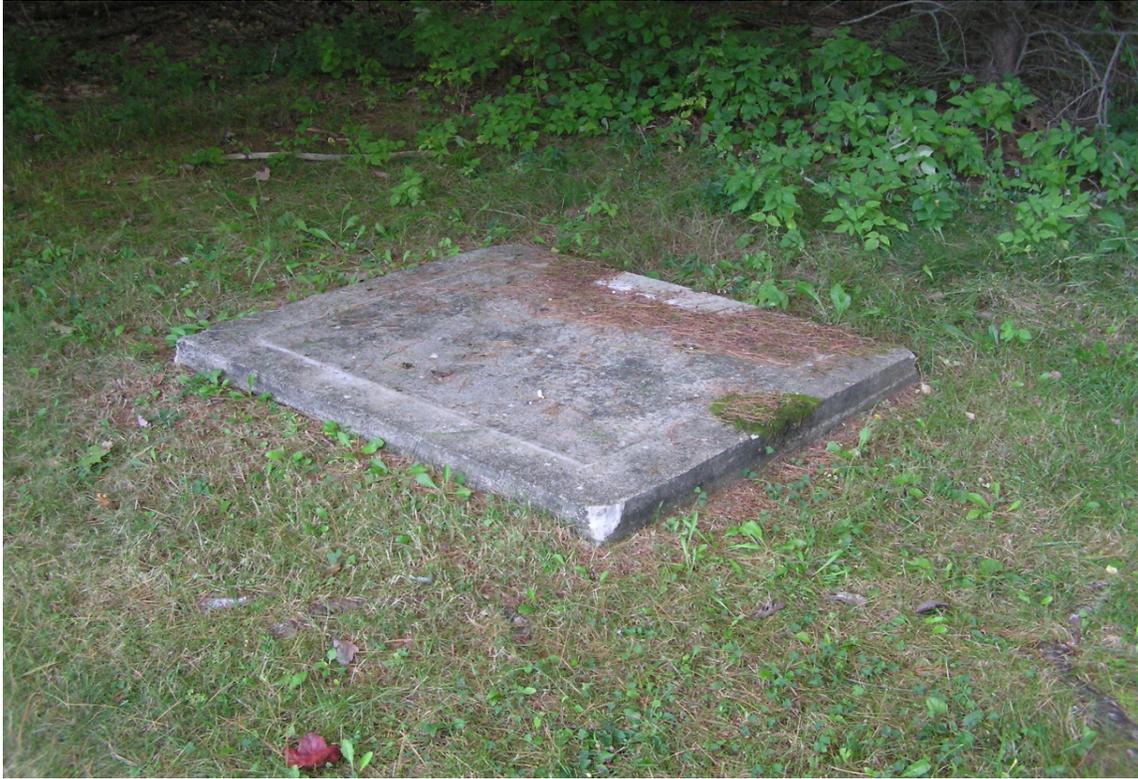
- A small, unused concrete pad was observed approximately 30 feet east of Building 111. Although the concrete pad was discolored, no surface soil staining was observed in the vicinity.

The unused concrete pad near Building 111 may have been a mounting platform for a transformer. Due to the 1943 construction date of the pump station, it is possible that a previously pad-mounted transformer contained PCB oil. To evaluate the concrete pad area for an historical PCB release, soil samples were collected from each side of the concrete pad (Figure 3) on September 16, 2010. The samples were collected using hand-auger methods, and were from locations immediately adjacent to the sides of concrete pad. Samples were collected from 0 to 6 and 6 to 24 inches below ground surface (bgs) at each location.

No transformer that could be a potential source of polychlorinated biphenyls (PCBs) contamination in the event of a leak was observed. Additionally, there are no transformers reported as associated with Building 111 on the NAS Brunswick transformer List; however, a concrete pad of unknown origin was observed located 30 feet (approximately) east of Building 111.

No. 5 Buildings 111 – NAS Brunswick
Possible former transformer pad, approximately 30 feet east of Building 111

The soil samples were submitted for PCB analysis by Tetra Tech's subcontracted analytical laboratory (Analytics Environmental Laboratory, Portsmouth, New Hampshire). The resulting analytical data underwent limited data validation, blank contamination evaluation, and completeness evaluation. As presented in Table 1, PCB was not detected in the soil samples collected adjacent to the concrete pad near Building 111.
