FINAL RESOURCE CONSERVATION AND RECOVERY ACT PARTIAL CLOSURE REPORT
FOR BUILDINGS 36 AND 46 WITH TRANSMITTAL LETTER NAS BRUNSWICK ME
11/8/2010
NAS BRUNSWICK

Subj: Final RCRA Partial Closure Report for Buildings 36 and 46

RCRA PARTIAL CLOSURE REPORT
for
DYERS GATE SECURITY BUILDINGS AREA
BUILDING 36 – DYERS GATE SENTRY HOUSE
BUILDING 46 – DYERS GATE SECURITY INSPECTION OFFICE
NAVAL AIR STATION BRUNSWICK, MAINE
USEPA IDENTIFICATION NUMBER ME8170022018
NOVEMBER 2010

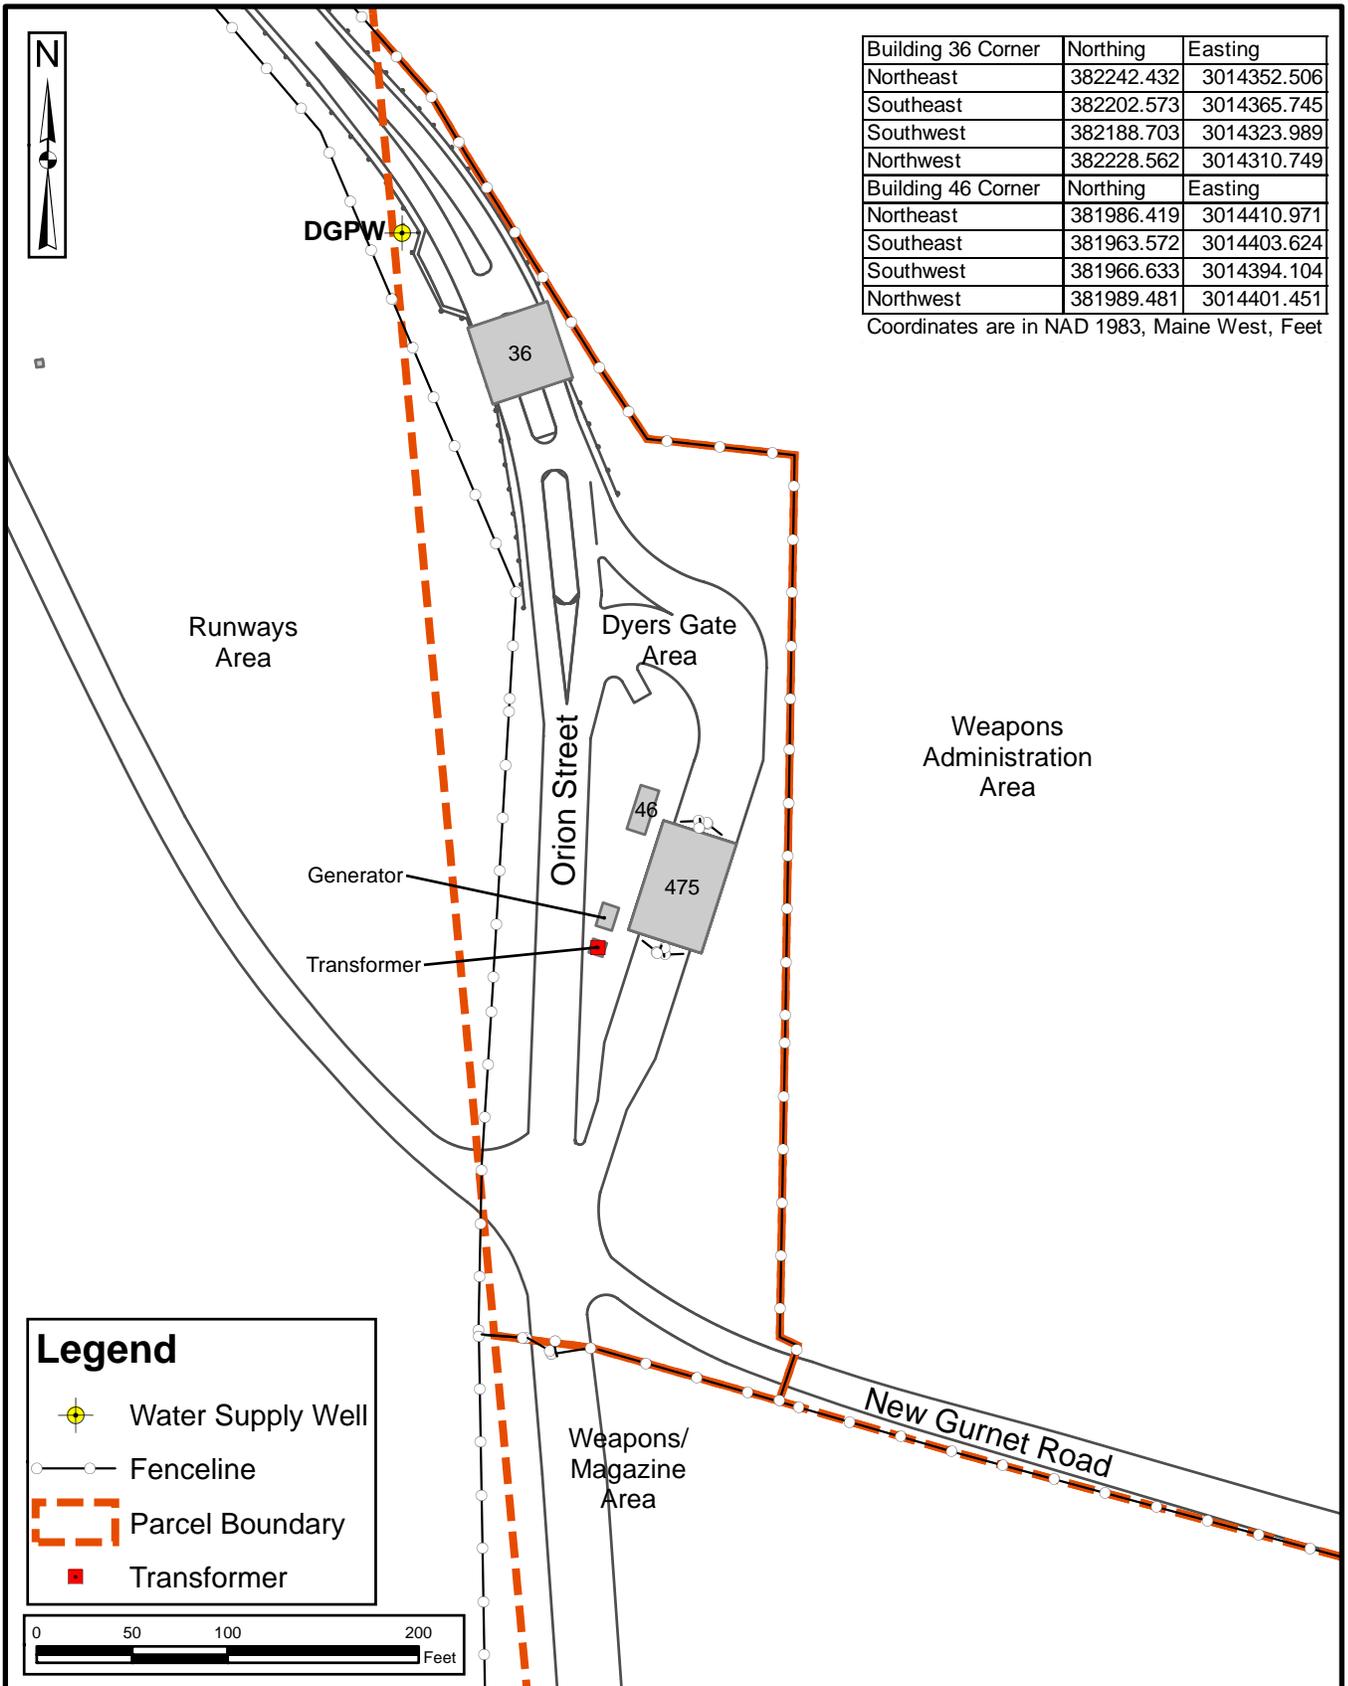
SCALE AS NOTED	
FILE L:\NASB_BLDG_36&46_SITE_MAP.MXD	
REV 0	DATE 11/05/10
FIGURE NUMBER FIGURE NO. 2

Building 36 is located on Orion Street in the northern portion of the area and north of Buildings 475 and 46 (Figure 2). Building 36 was constructed in 2004 and consists of a 200-square-foot, single-story, steel-framed structure on a concrete slab foundation. A steel awning covers the roadway and building structure. The building interior consists of a sentry area, restroom facility, and electrical/storage area. The building has an electrical heating system.

Building 46 is located in the central portion of the area, north of Building 475 (Figure 2). The building was constructed in 2004 and consists of a 300-square-foot, single-story, steel-framed structure on a concrete slab foundation. The building interior consists of a sentry area, restroom facility, and electrical/storage area. Building 46 has an electrical heating system.

SITE PLAN
 BUILDING 36 - DYERS GATE SENTRY HOUSE
 BUILDING 46 - SECURITY INSPECTION OFFICE
 RCRA PARTIAL CLOSURE REPORT
 NAVAL AIR STATION BRUNSWICK, MAINE

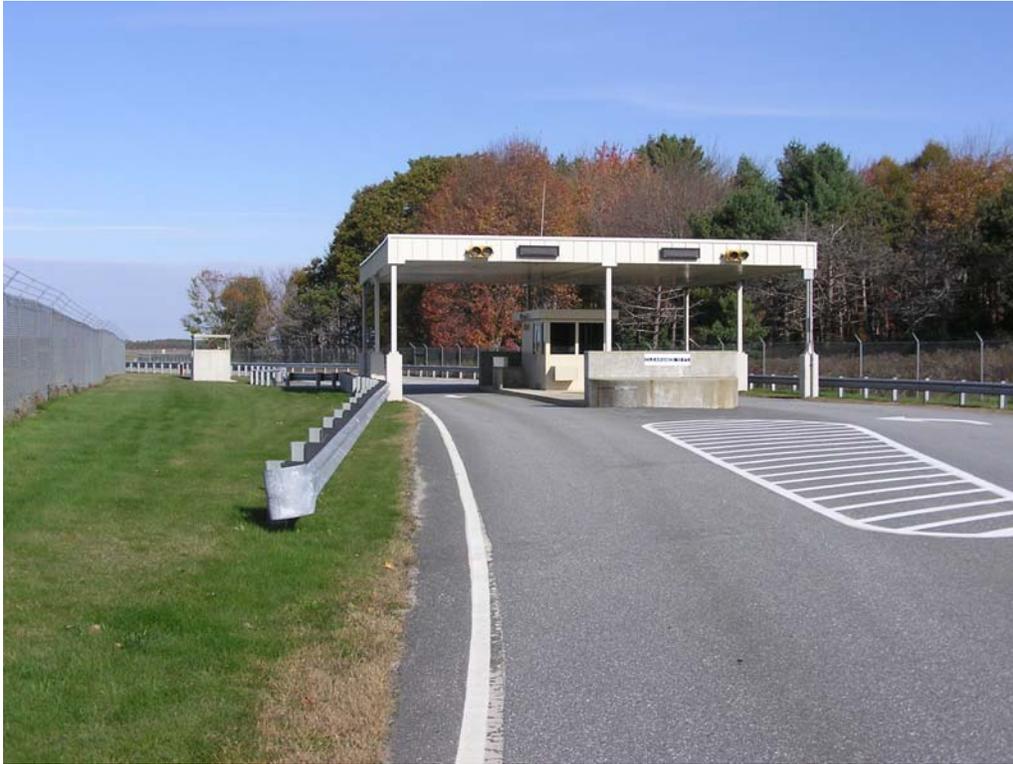
- At the time of inspection, Building 36 was vacant and in excellent condition.
- No evidence of current or past hazardous waste generation activities was observed.
- No signs of a past release (staining, unusual odors, stressed vegetation, etc.) were observed.
- No modifications to the structure, which may conceal signs of a past release, were observed.
- No peeling or flaking paint was observed on the exterior or interior steel door of the building.

No. 1 Buildings 36 and 46 – NAS Brunswick
Building 36 – Dyers Gate Sentry Building south elevation

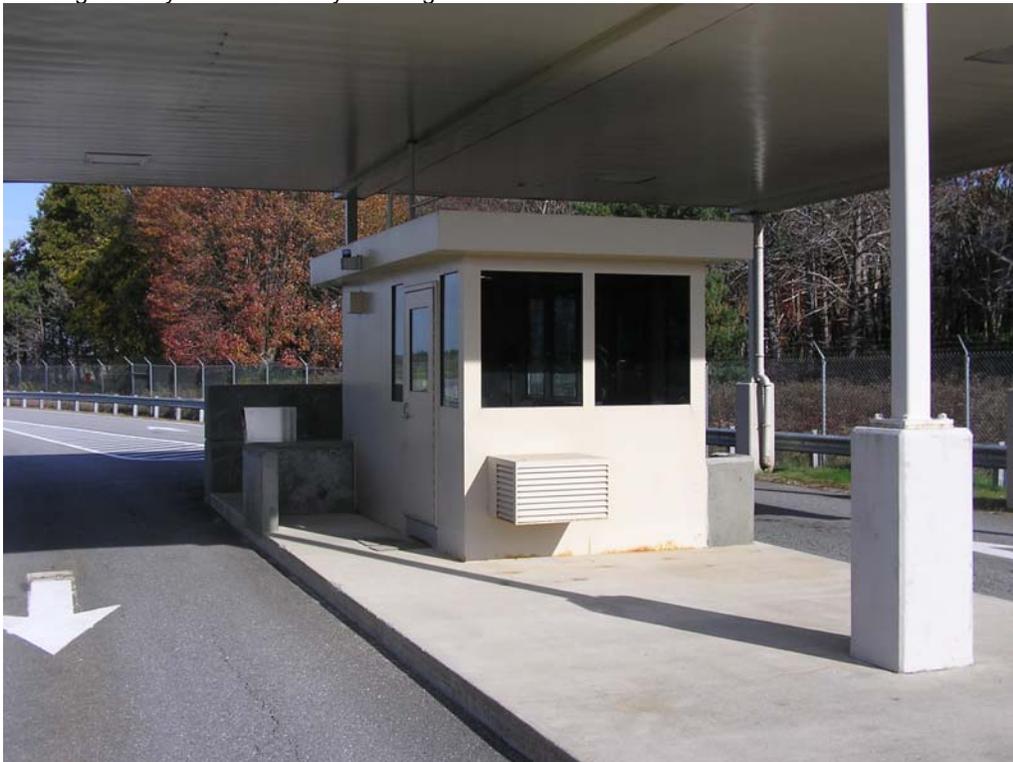
No. 2 Buildings 36 and 46 – NAS Brunswick
Building 36 - Dyers Gate Sentry Building south elevation

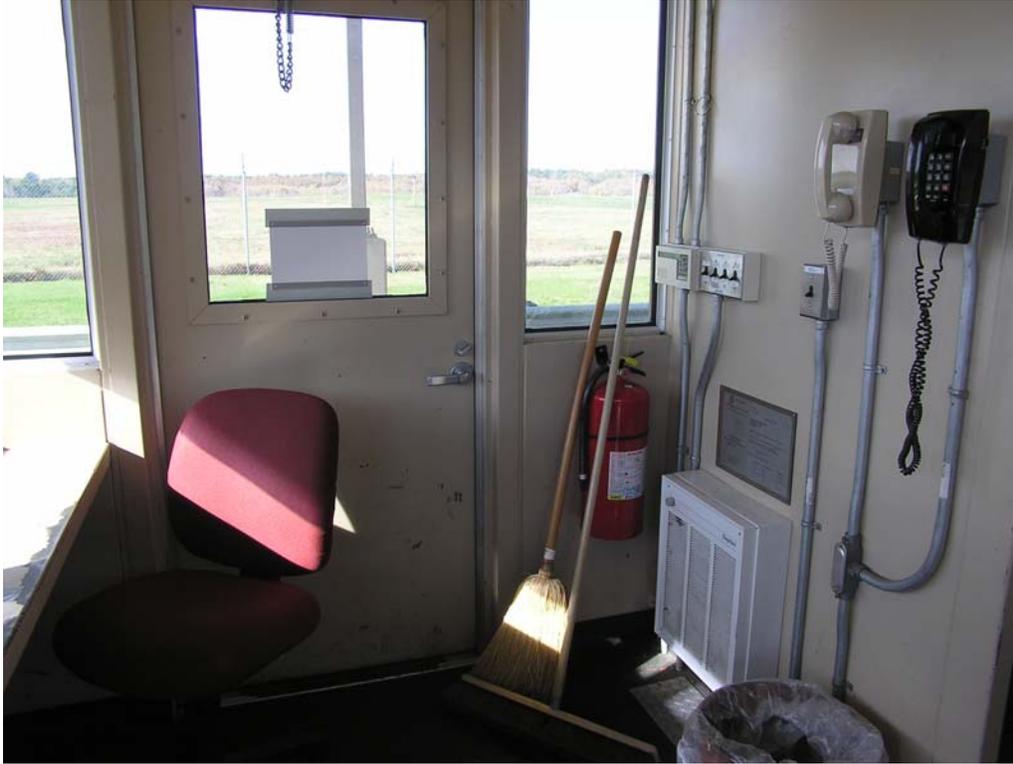
No. 3 Buildings 36 and 46 – NAS Brunswick
Building 36 - Dyers Gate Sentry Building interior

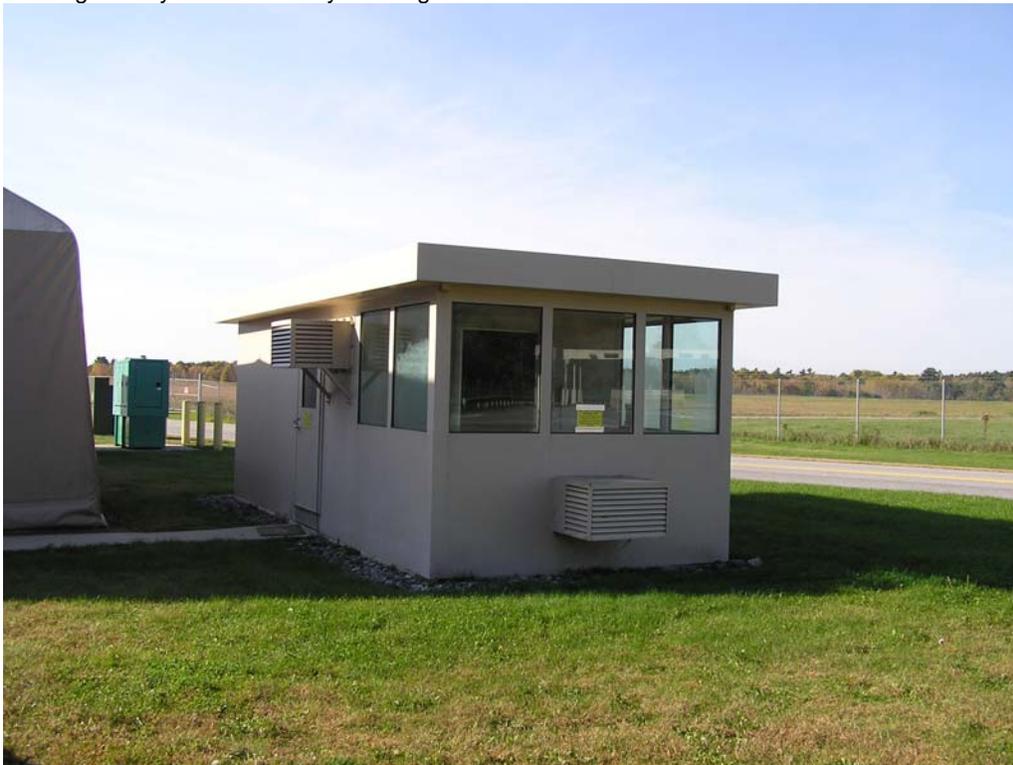
- At the time of inspection, Building 46 was vacant and in excellent condition.
- No evidence of current or past hazardous waste generation activities was observed.
- No signs of a past release (staining, unusual odors, stressed vegetation, etc.) were observed.
- No modifications to the structure, which may conceal signs of a past release, were observed.
- No peeling or flaking paint was observed on the exterior or interior steel door of the building.

No. 4 Buildings 36 and 46 – NAS Brunswick
Building 46 - Dyers Gate Security Inspection Office north elevation; Building 475 at left of frame and emergency generator and transformer in background

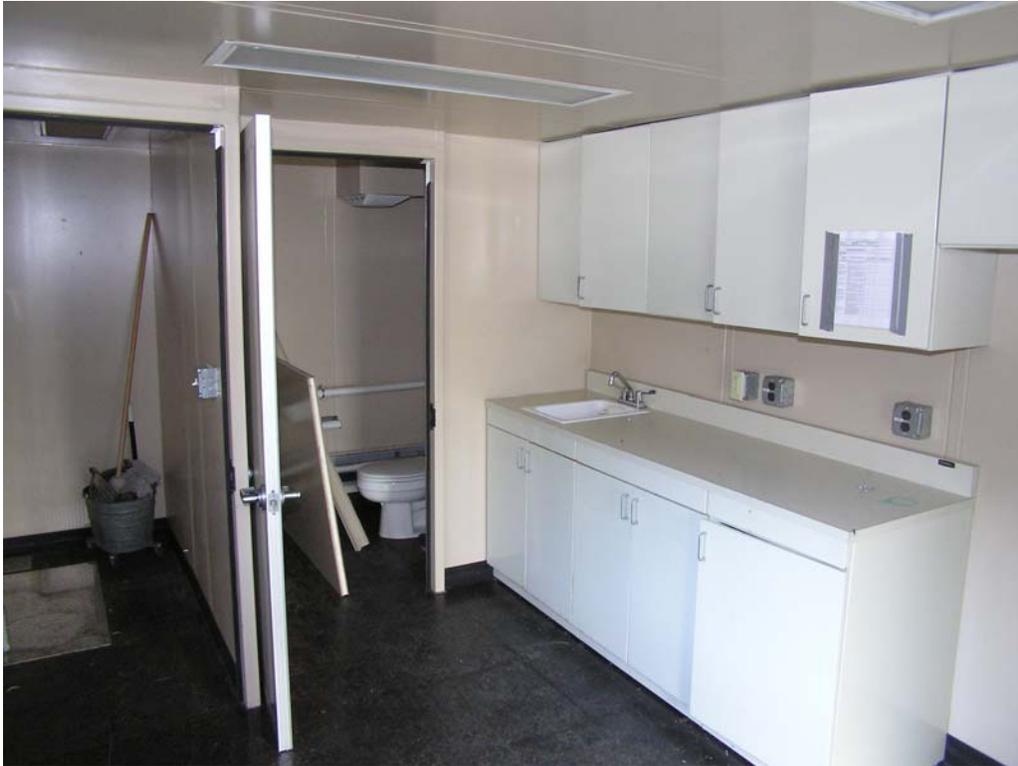
No. 5 Buildings 36 and 46 – NAS Brunswick
Building 46 - Dyers Gate Security Inspection Office interior

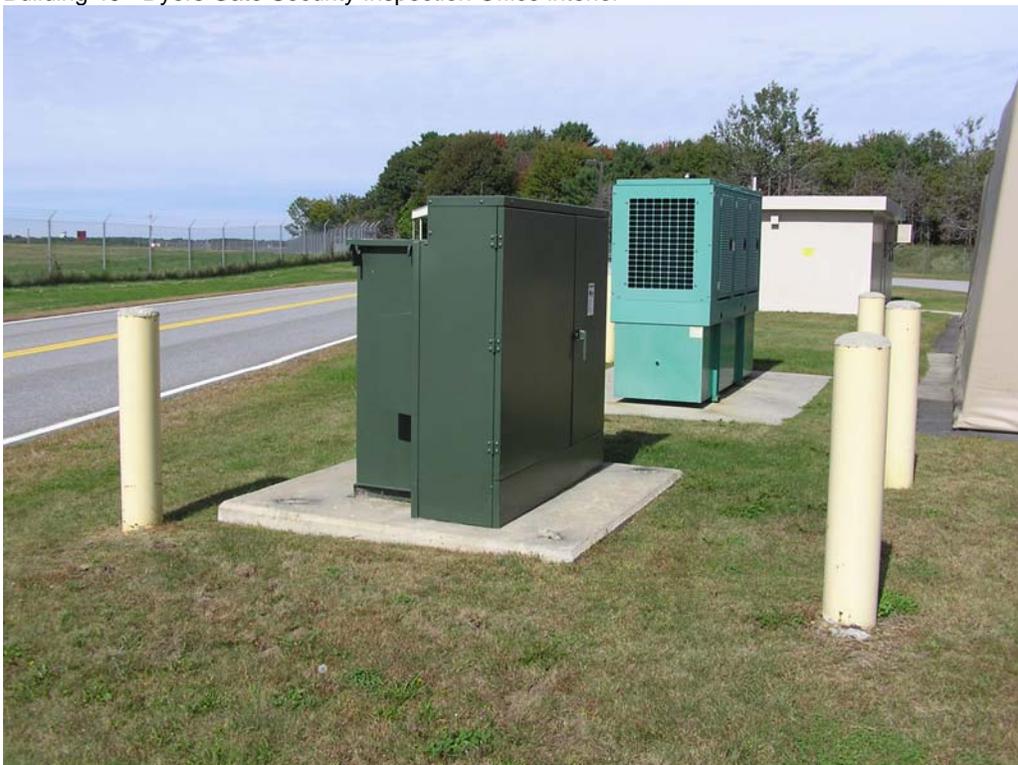
The NAS Brunswick Aboveground Storage Tank (AST) and Underground Storage Tank (UST) inventory records for Building 36 indicate that one AST has been associated with the building (Environmental Department, 2009). A pad-mounted emergency generator is located west of Building 475 (to the south), as discussed below. The generator contains a 100-gallon double-walled steel AST (A36.0) containing diesel fuel for the generator. It was installed in 2004 and is inactive.

The NAS Brunswick Transformer Database lists no transformers associated with Building 46. One pad-mounted transformer is located south of Building 46, southwest of Building 475. No additional information was available on the transformer. As of July 1, 1979, the United States Environmental Protection Agency (EPA) prohibited all manufacturing of new PCB-containing electrical equipment (transformers and capacitors). Since the buildings and structures present within the Dyers Gate Security Buildings Area were built in 2004, it is unlikely that the transformer is PCB-containing.

No. 6 Buildings 36 and 46 – NAS Brunswick
Transformer and emergency generator south of Building 46 - Dyers Gate Security Inspection Office; Building 475 at right of frame
