FINAL RESOURCE CONSERVATION AND RECOVERY ACT PARTIAL CLOSURE REPORT
FOR BUILDING 37 WITH TRANSMITTAL LETTER NAS BRUNSWICK ME
12/1/2010
NAS BRUNSWICK

Subj: Final RCRA Partial Closure Report for Building 37

RCRA PARTIAL CLOSURE REPORT
for
BUILDING 37 – MIDCOAST REGIONAL REDEVELOPMENT AUTHORITY (MRRA) OFFICE
PARCEL
NAVAL AIR STATION BRUNSWICK, MAINE
USEPA IDENTIFICATION NUMBER ME8170022018
NOVEMBER 2010

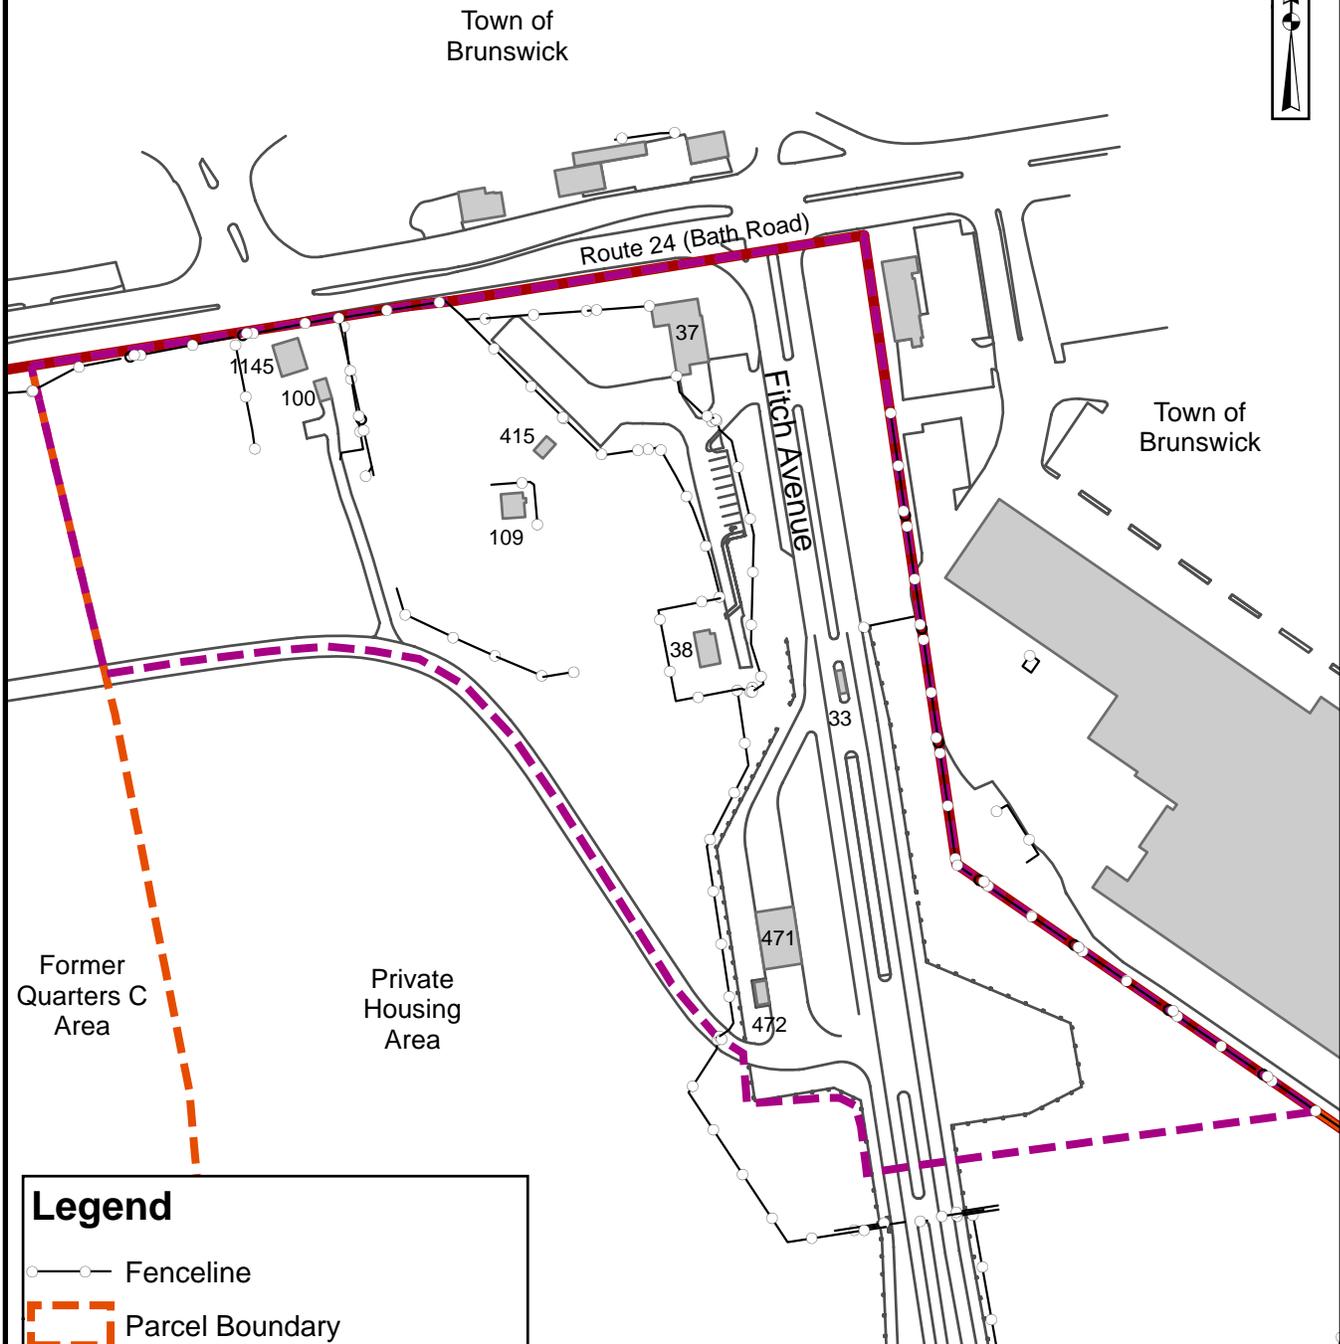
SCALE AS NOTED	
FILE I:\NASB_BLDG_37_SITE_MAP.MXD	
REV 0	DATE 11/16/10
FIGURE NUMBER FIGURE NO. 2

Building 37 Corner	Northing	Easting
Northeast	391388.700	3017719.720
Southeast	391322.820	3017731.600
Southwest	391307.950	3017698.220
Northwest	391381.070	3017670.850

SITE MAP
 BUILDING 37 - MMRA OFFICE PARCEL
 RCRA PARTIAL CLOSURE REPORT
 NAVAL AIR STATION BRUNSWICK, MAINE

Building 37 itself is located at the intersection of Fitch Avenue and Route 24, in the northeastern portion of the parcel (Figure 2). It was constructed in 1943 and consists of a 2,320-square-foot, single-story, wood-framed structure on a concrete masonry unit (CMU) block foundation. The building floor plan is presented as Figure 3. Building 37 has a forced hot water heating system. Photographs of the building are provided as an attachment to this report.

This investigation of the hazardous waste closure requirement applies to the Building 37 parcel (as shown on Figure 2) only.

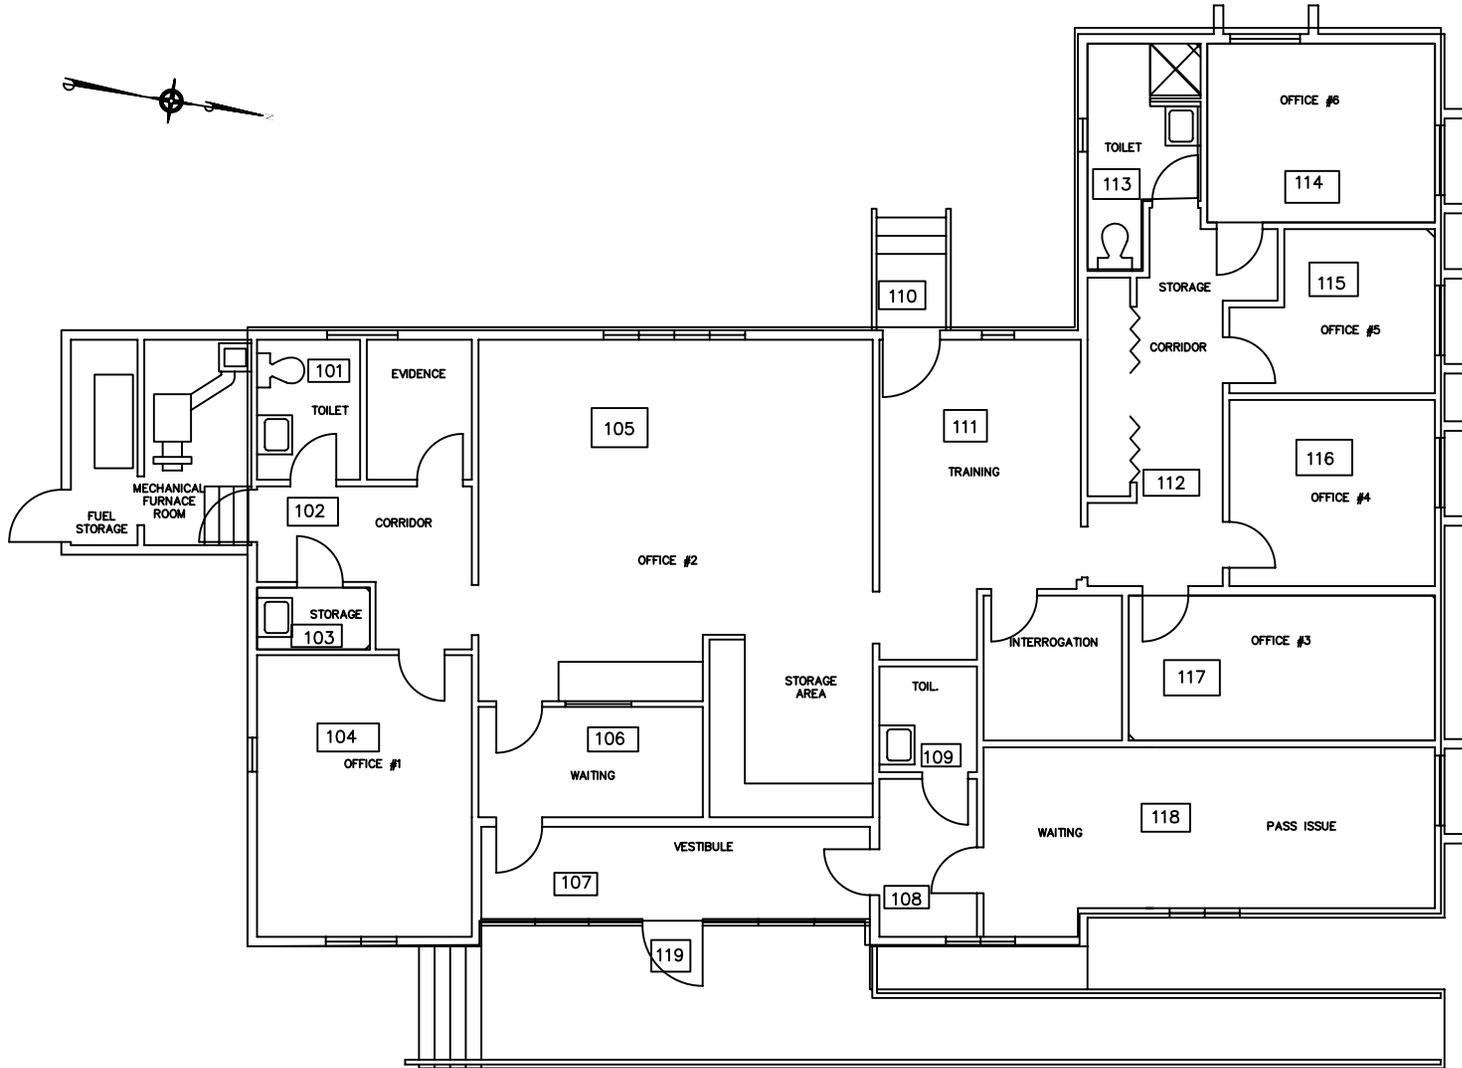
SCALE AS NOTED	
FILE \\.\NASB_BLDG_37_FP.DWG	
REV 0	DATE 11/16/10
FIGURE NUMBER 3

FLOOR PLAN
 BUILDING 37 - MRRA OFFICE PARCEL
 RCRA PARTIAL CLOSURE REPORT
 NAVAL AIR STATION BRUNSWICK, MAINE

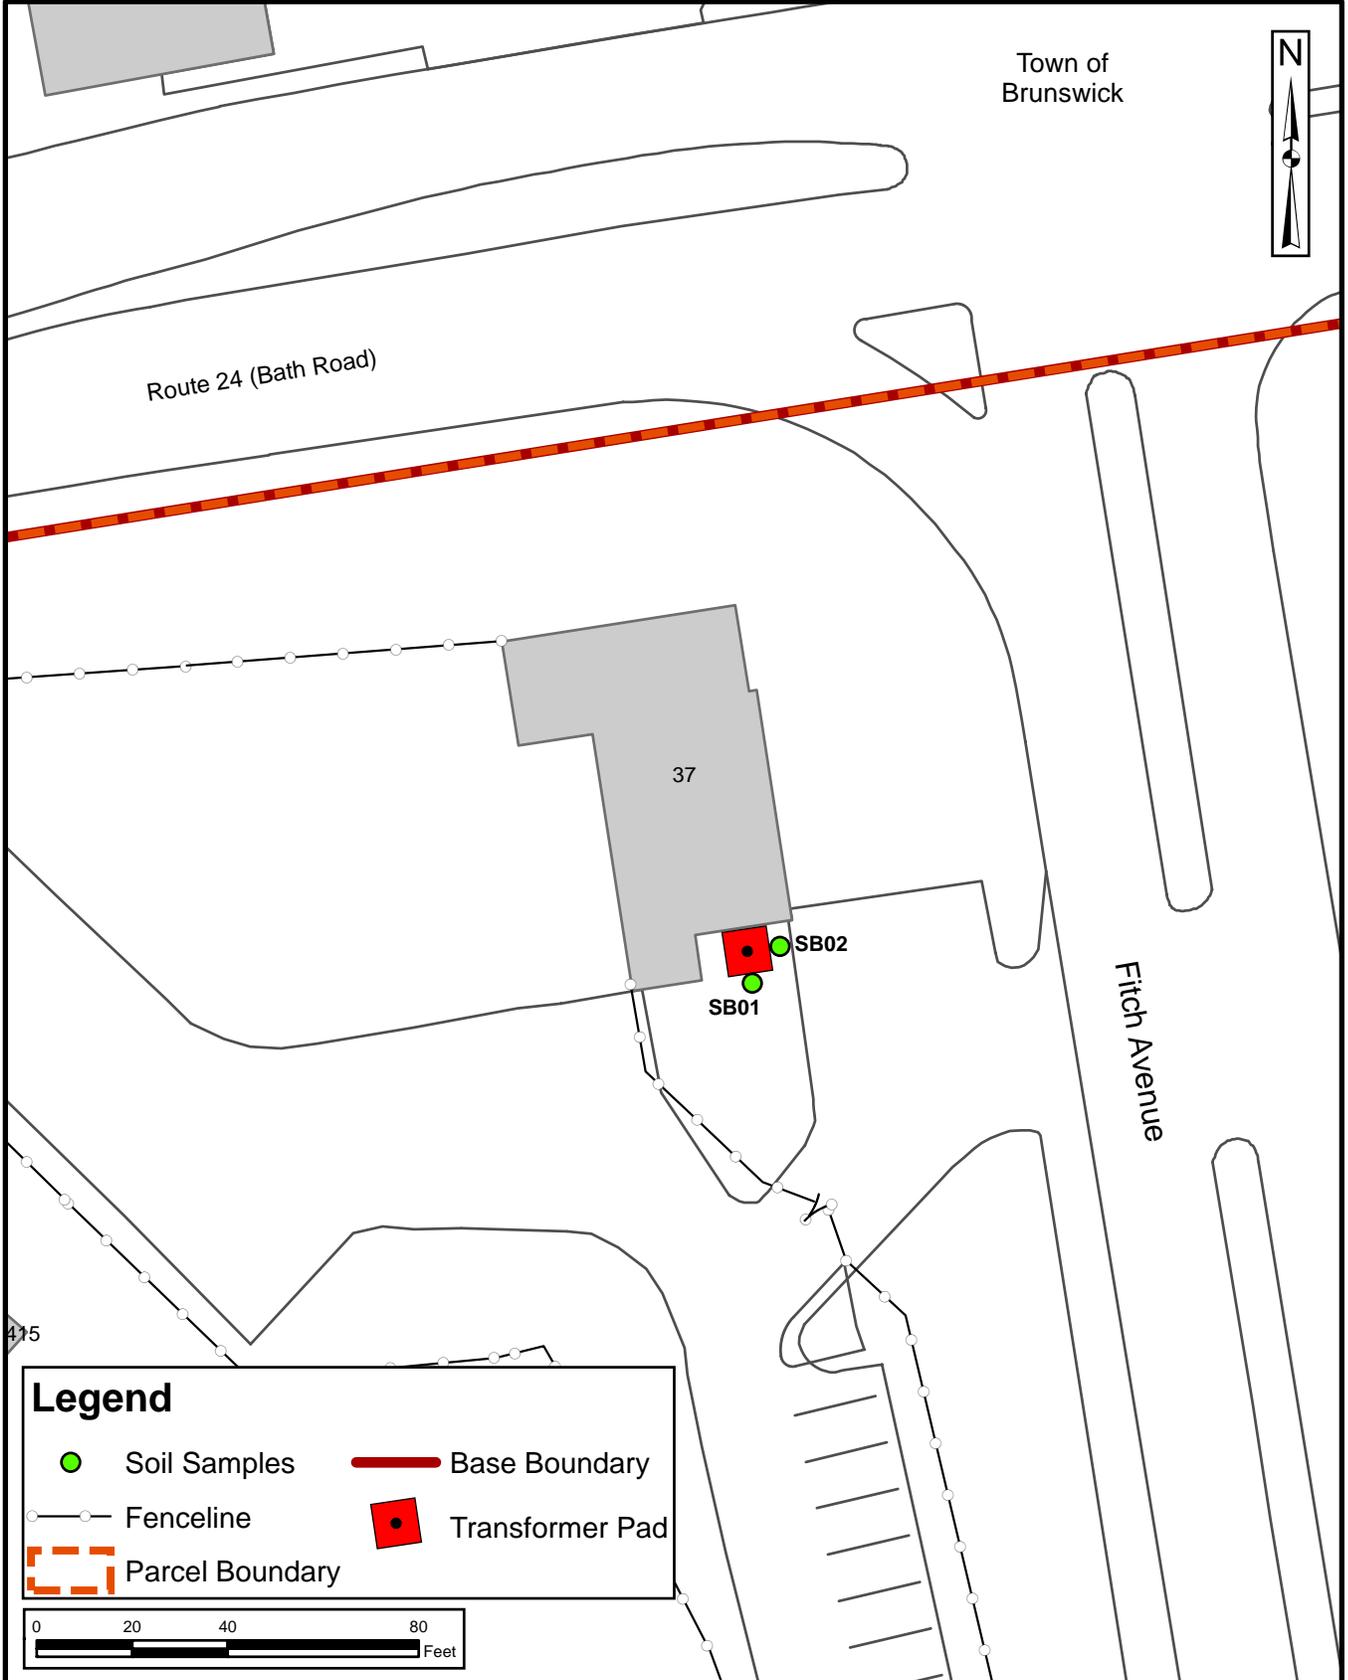
SCALE AS NOTED	
FILE L:\NASB_BLDG_37_SAMP_LOC.MXD	
REV 0	DATE 11/16/10
FIGURE NUMBER FIGURE NO. 4

SAMPLE LOCATION MAP
 BUILDING 37 - MRRA OFFICE PARCEL
 RCRA PARTIAL CLOSURE REPORT
 NAVAL AIR STATION BRUNSWICK, MAINE

Because Building 37 was constructed prior to 1979, the transformer pad, located south of the building, could potentially be an area of PCB soil contamination, if there had been an historical transformer leak. On October 14, 2010, Tetra Tech collected surface soil samples from two locations surrounding the transformer pad. A hand auger was used to collect two samples from 0 to 6 inches below ground surface (bgs) and two samples from 6 to 24 inches bgs. No soil was present on the northern and western sides of the concrete pad, where it is adjacent to the building. Sample locations are presented on Figure 4.

data underwent limited data validation, consisting of an evaluation of field duplicate(s), blank contamination, and completeness. As presented in the attached Table 1, PCB levels are compared to the MEDEP RCRA standard for total PCBs in soil, 1 part per million (ppm). PCBs were not detected in any of the soil samples collected at Building 37. The EPA Regional Screening Levels [RSLs] for Residential Soil are included in Table 1 for informational purposes (EPA, 2009).

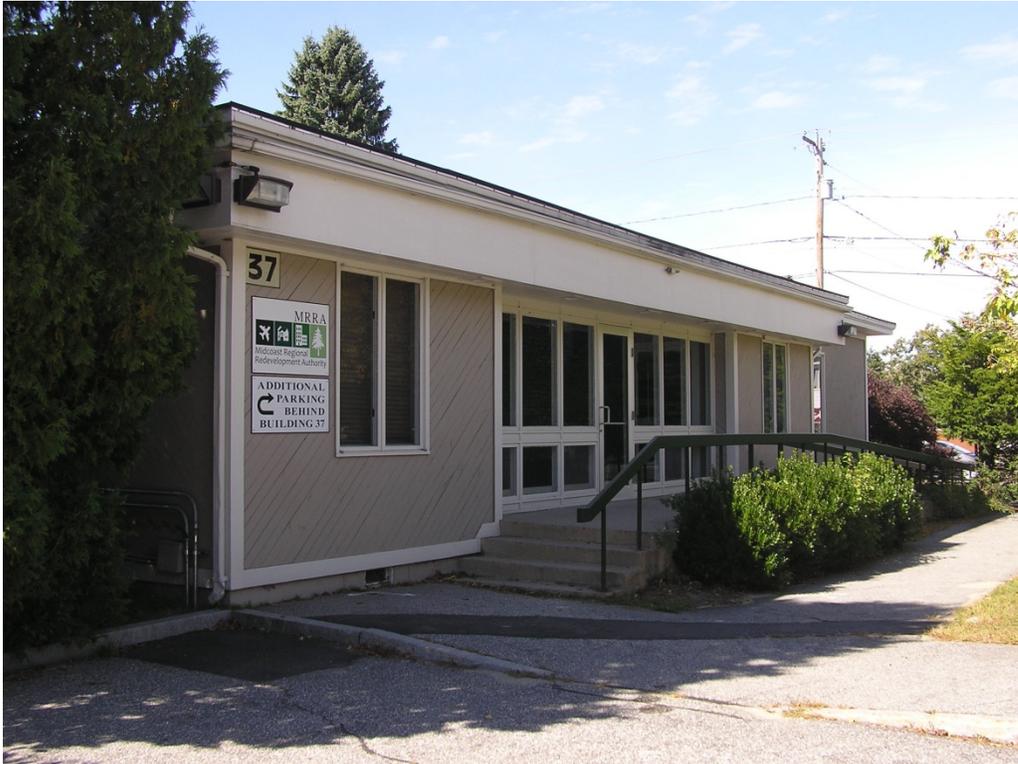
No. 1 Building 37 – NAS Brunswick
MRRA Office northwest elevation

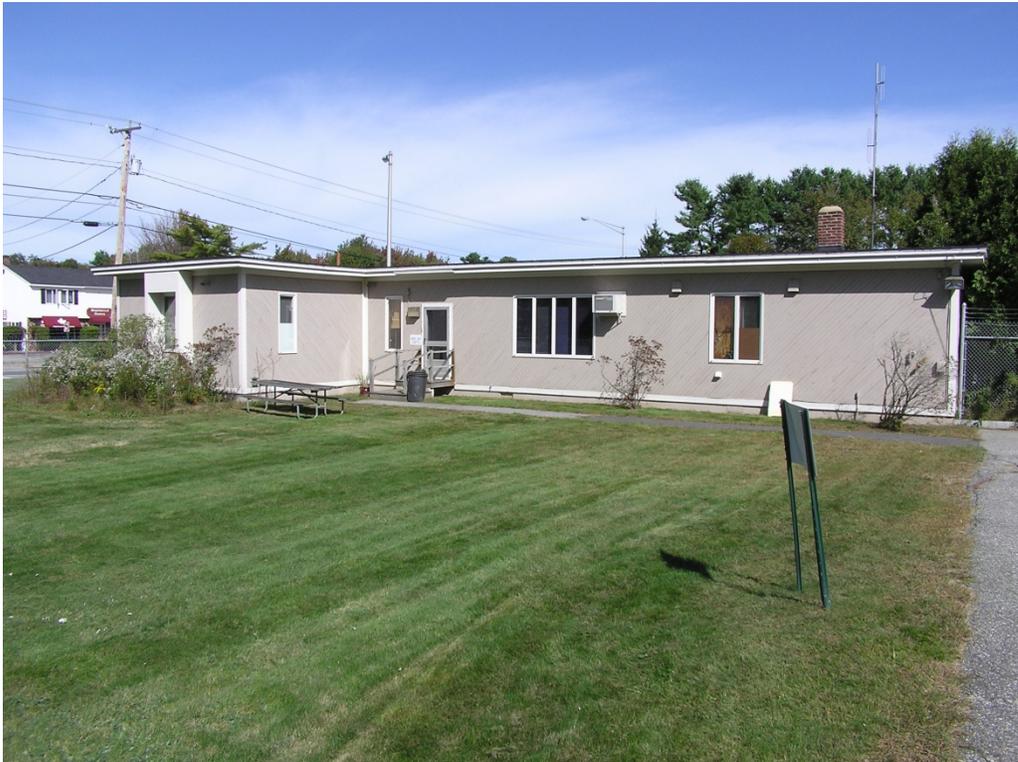
No. 1 Building 37 – NAS Brunswick
MRRA Office west elevation

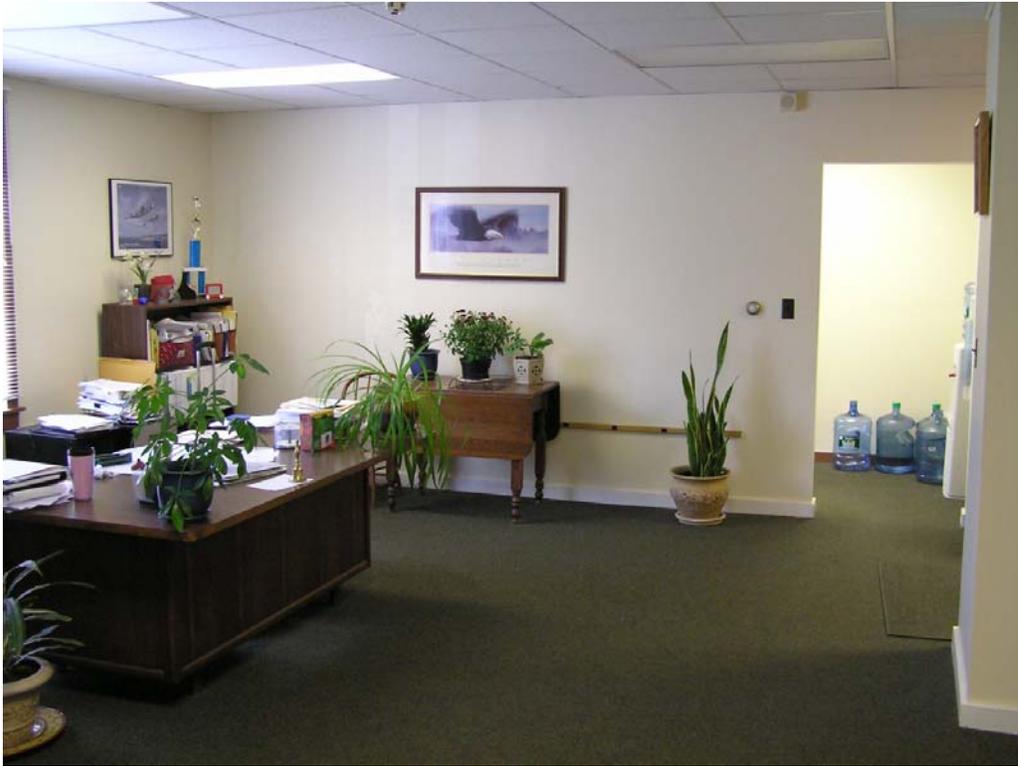
No. 3 Building 37 – NAS Brunswick
MRRA Office interior (Room 105)

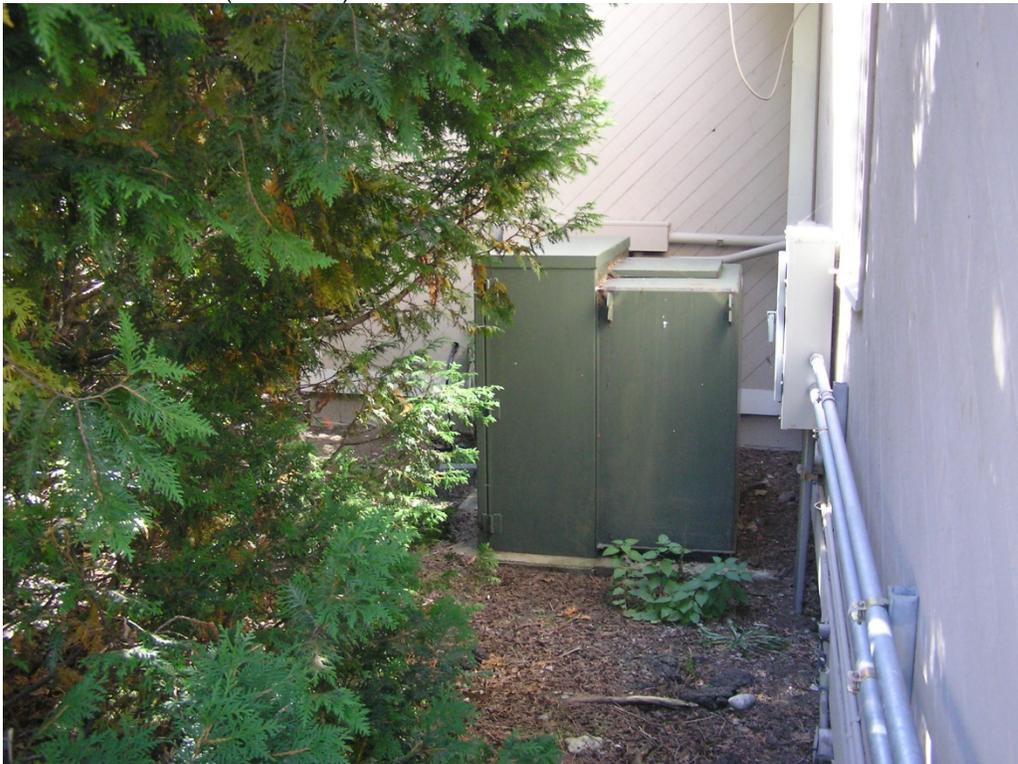
One transformer that could be a potential source of polychlorinated biphenyls (PCBs) contamination in the event of a leak was observed on the southeastern corner of the building.

112.5 kVa pad-mounted Westinghouse transformer (serial no. 81JJ540178) (contains mineral oil)

No. 4 Building 37 – NAS Brunswick
MRRA Office transformer pad
