FINAL RESOURCE CONSERVATION AND RECOVERY ACT PARTIAL CLOSURE REPORT
FOR BUILDING 77 WITH TRANSMITTAL LETTER NAS BRUNSWICK ME
12/10/2010
NAS BRUNSWICK

Subj: Final RCRA Partial Closure Report for Building 77

RCRA PARTIAL CLOSURE REPORT
for
BUILDING 77 – WEAPONS BUILD-UP FACILITY
NAVAL AIR STATION BRUNSWICK, MAINE
USEPA IDENTIFICATION NUMBER ME8170022018
DECEMBER 2010

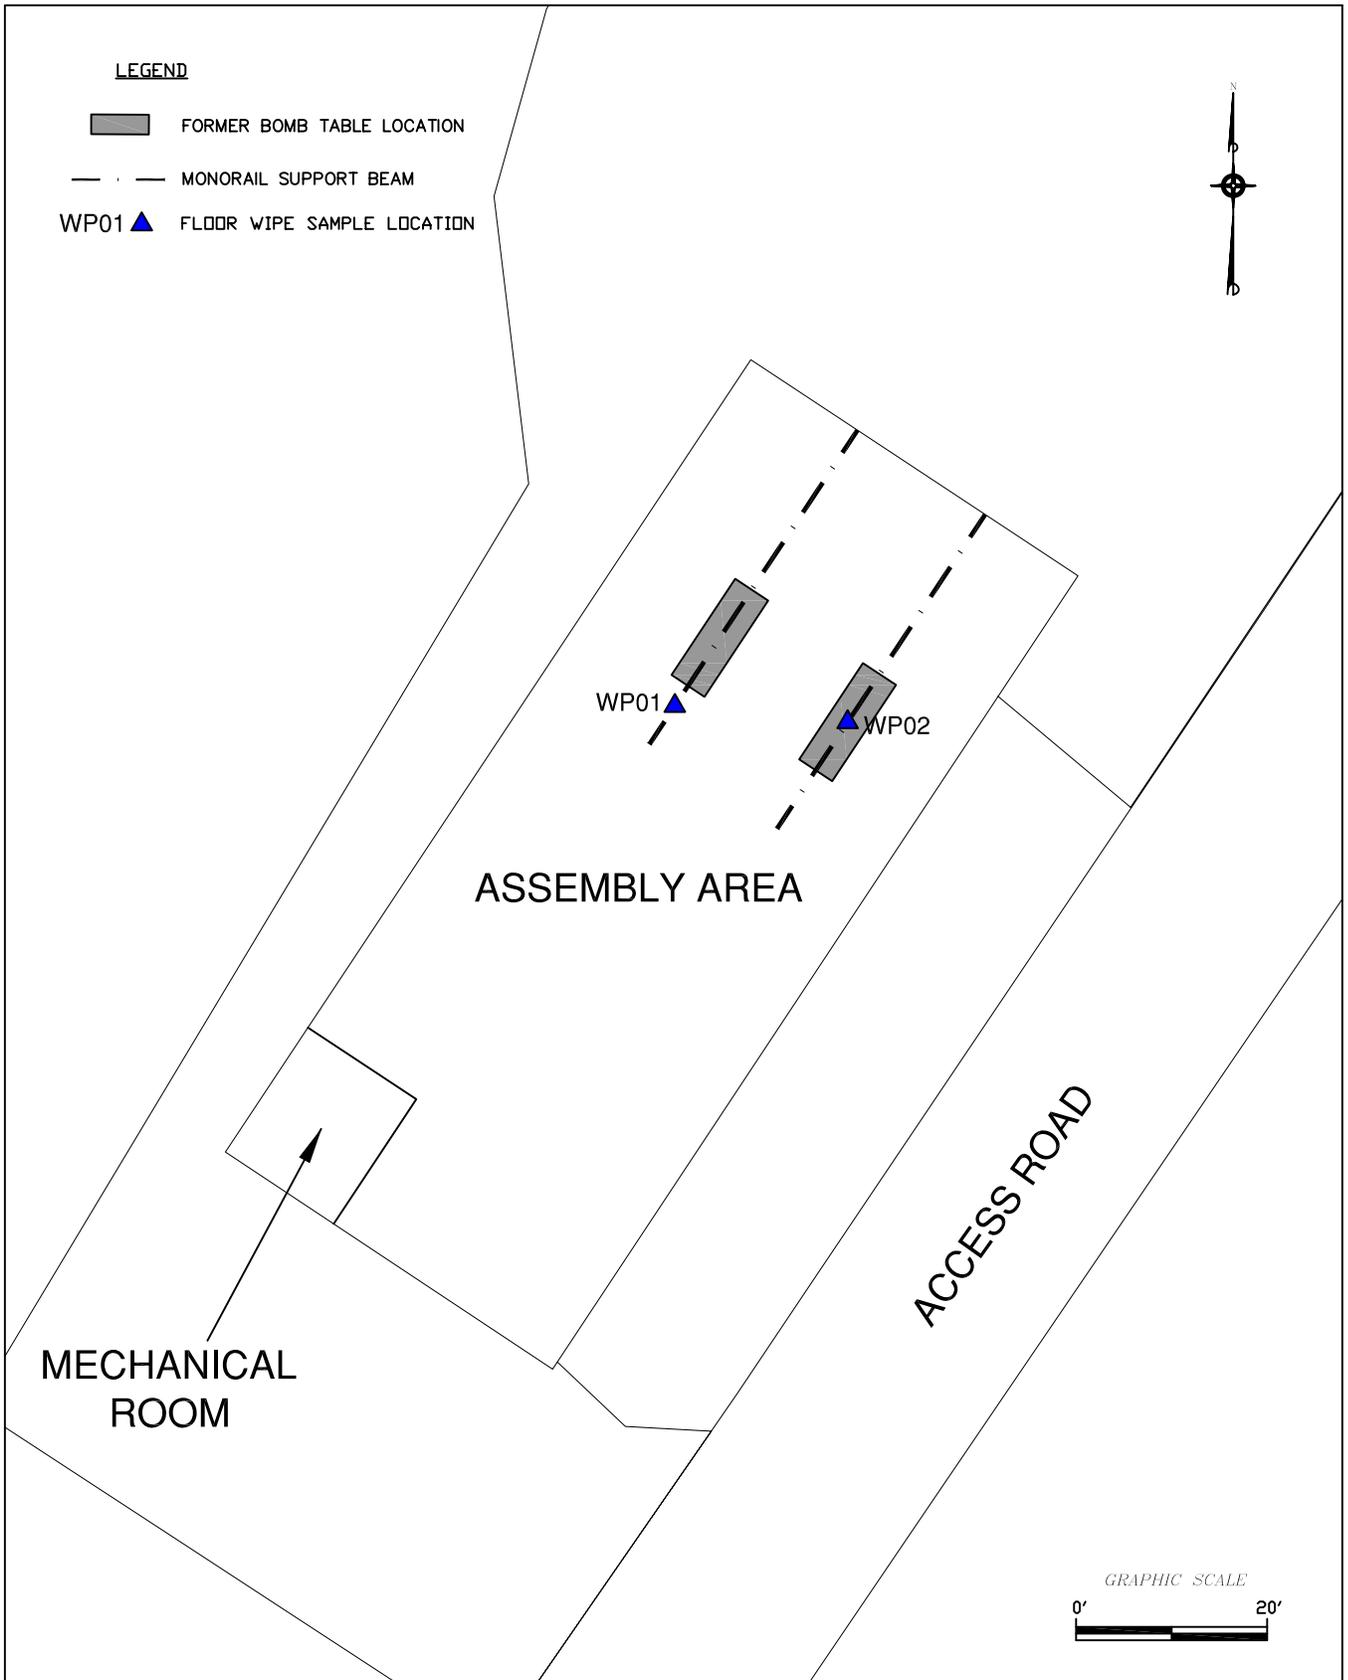
SCALE AS NOTED	
FILE \\.\NASB_BLDG_77_PRE.DWG	
REV 0	DATE 12/09/10
FIGURE NUMBER 3

On June 17, 2010, floor-wipe samples were collected from two locations in Building 77, as shown on Figure 3. The wipe samples were submitted for RCRA metals and semi-volatile organic compounds (SVOCs) analysis by Tetra Tech's subcontracted analytical laboratory, Analytics Environmental Laboratory (Analytics), of Portsmouth, New Hampshire. The resulting analytical data underwent limited data validation consisting of laboratory blank contamination evaluation and completeness evaluation.

PRE-CLEANING SAMPLING LOCATIONS
 BUILDING 77 - WEAPONS BUILD-UP FACILITY
 RCRA PARTIAL CLOSURE REPORT
 NAVAL AIR STATION BRUNSWICK, MAINE

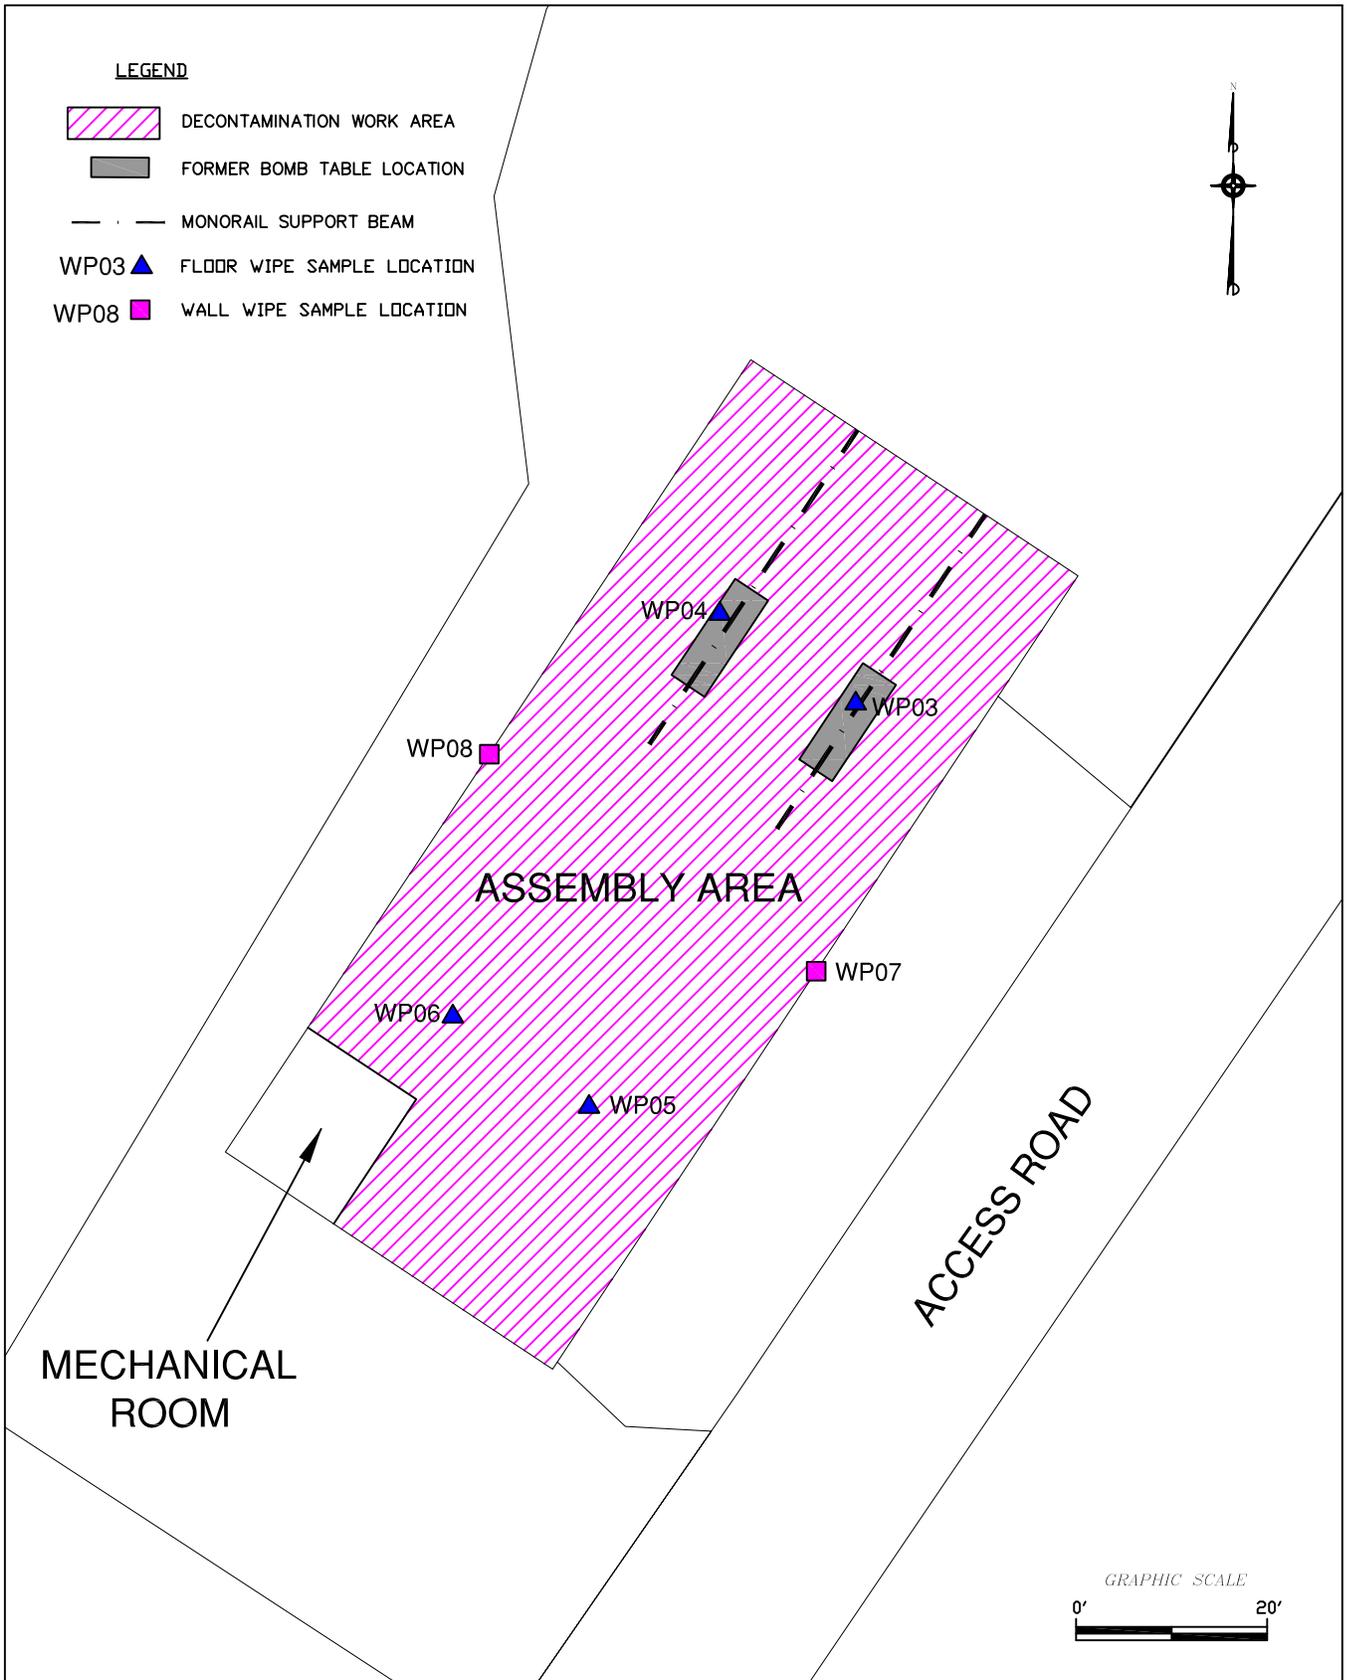
SCALE AS NOTED	
FILE \\.\NASB_BLDG_77_POST1.DWG	
REV 0	DATE 12/09/10
FIGURE NUMBER 4

Post-cleaning, confirmatory floor- and wall-wipe samples were collected from the cleaned floor area of Building 77 on September 30, 2010 (Figure 4). Samples were submitted to Analytics for lead analysis. The resulting analytical data underwent limited data validation consisting of field duplicate evaluation, blank contamination evaluation, reporting limit evaluation, and completeness evaluation. As seen in Table 2, which presents the September 30, 2010 wipe sample results, lead levels in the post-cleaning confirmatory floor-wipe samples were above the associated MEDEP floor criterion.

POST-CLEANING SAMPLES - EVENT 1
 BUILDING 77 - WEAPONS BUILD-UP FACILITY
 RCRA PARTIAL CLOSURE REPORT
 NAVAL AIR STATION BRUNSWICK, MAINE

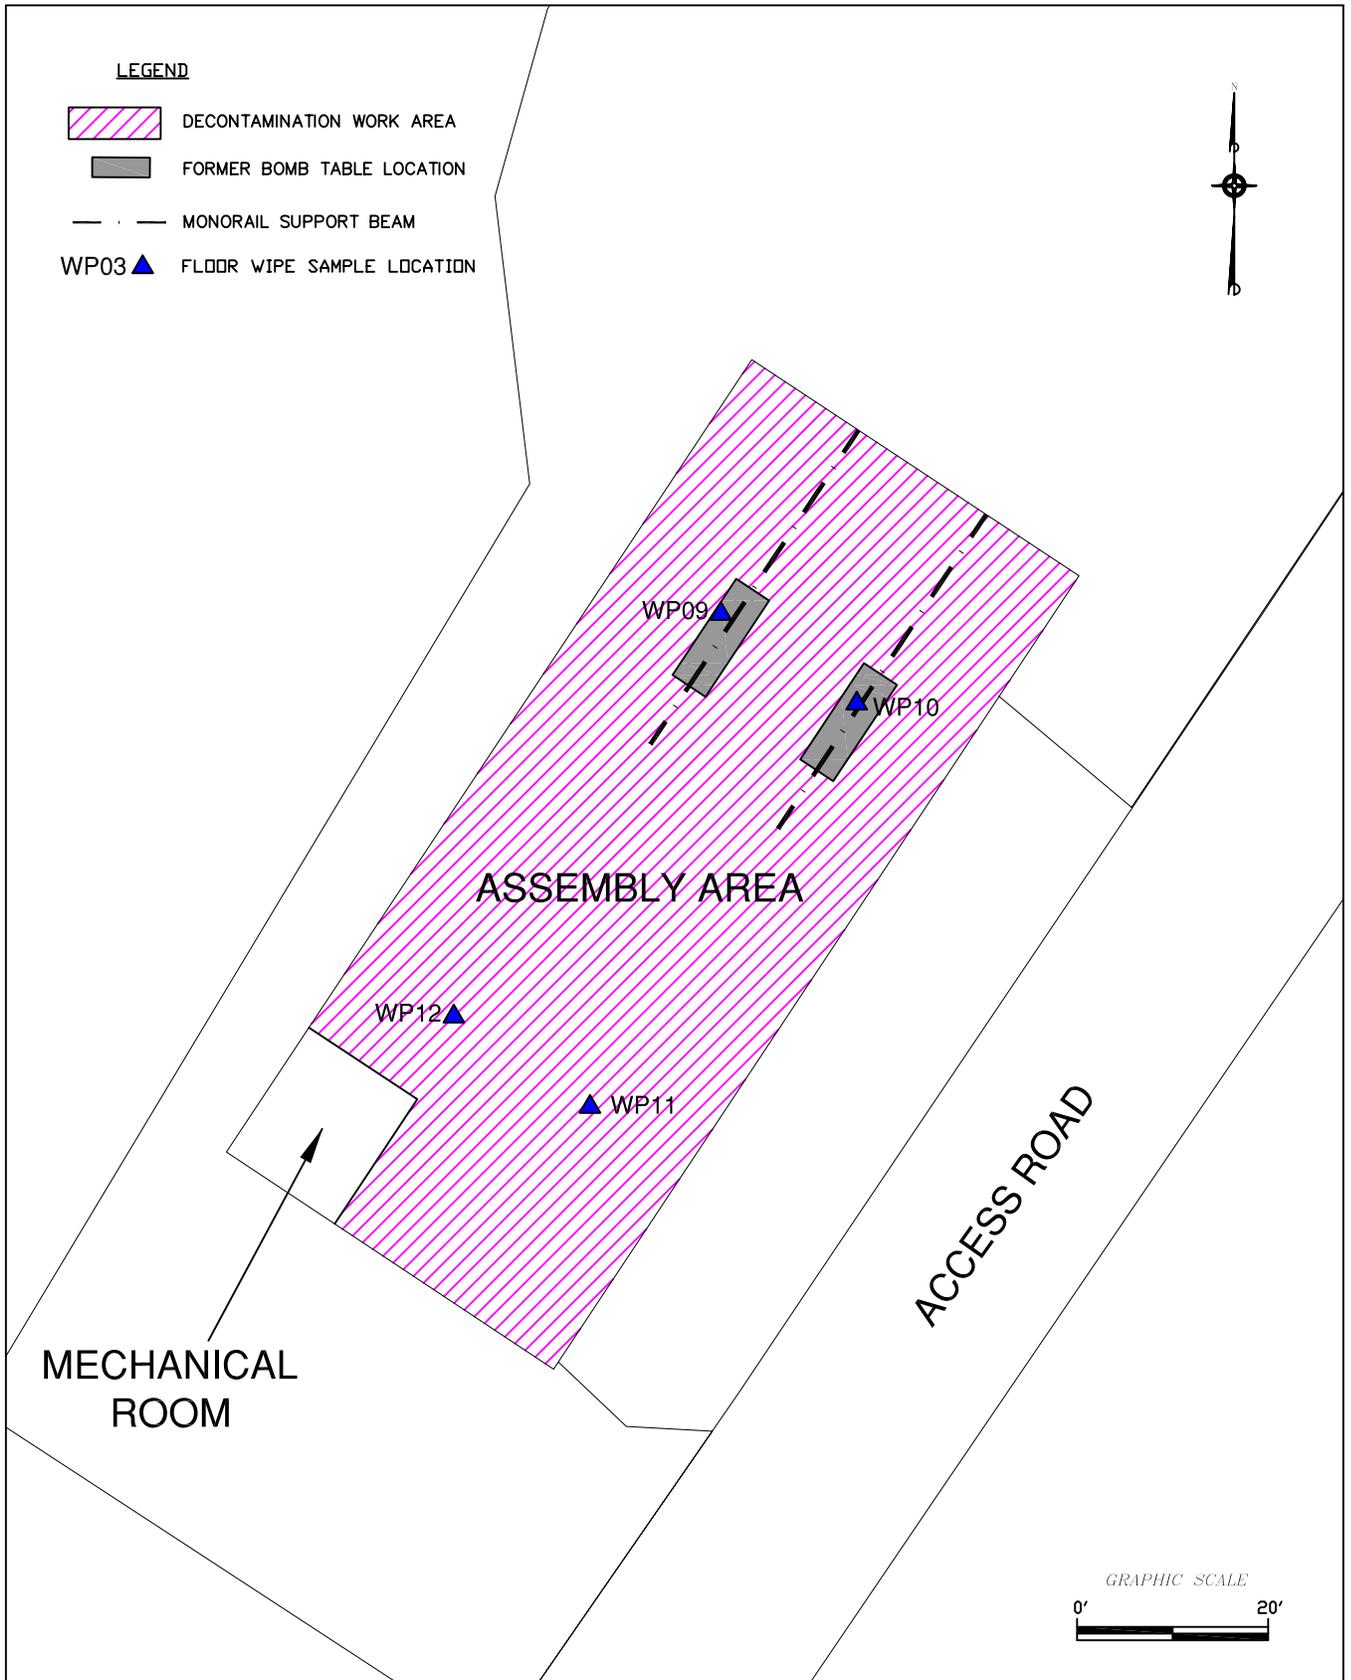
SCALE AS NOTED	
FILE \\.\NASB_BLDG_77_POST2.DWG	
REV 0	DATE 12/09/10
FIGURE NUMBER 5

A second decontamination event (Event 2) was conducted at Building 77 on October 21 and 22, 2010, based on lead criterion exceedances in post-cleaning wipe samples, as discussed above. Floors and walls were cleaned again, using the procedures described above. After the work areas were allowed to dry, post-cleaning confirmatory wipe samples (Event 2) were collected on October 25, 2010. Four floor-wipe samples were collected for lead analysis by Analytics (Figure 5). The resulting analytical data underwent limited data validation consisting of blank contamination evaluation, reporting limit evaluation, and data completeness evaluation. The October 25, 2010 wipe sample results are included in Table 3. The confirmatory wipe sample results following the Event 2 decontamination indicated that lead was not detected at levels exceeding the associated MEDEP criterion (40 µg/ft²). Based upon these results, additional closure action is not warranted at Building 77.

POST-CLEANING SAMPLES - EVENT 2
 BUILDING 77 - WEAPONS BUILD-UP FACILITY
 RCRA PARTIAL CLOSURE REPORT
 NAVAL AIR STATION BRUNSWICK, MAINE

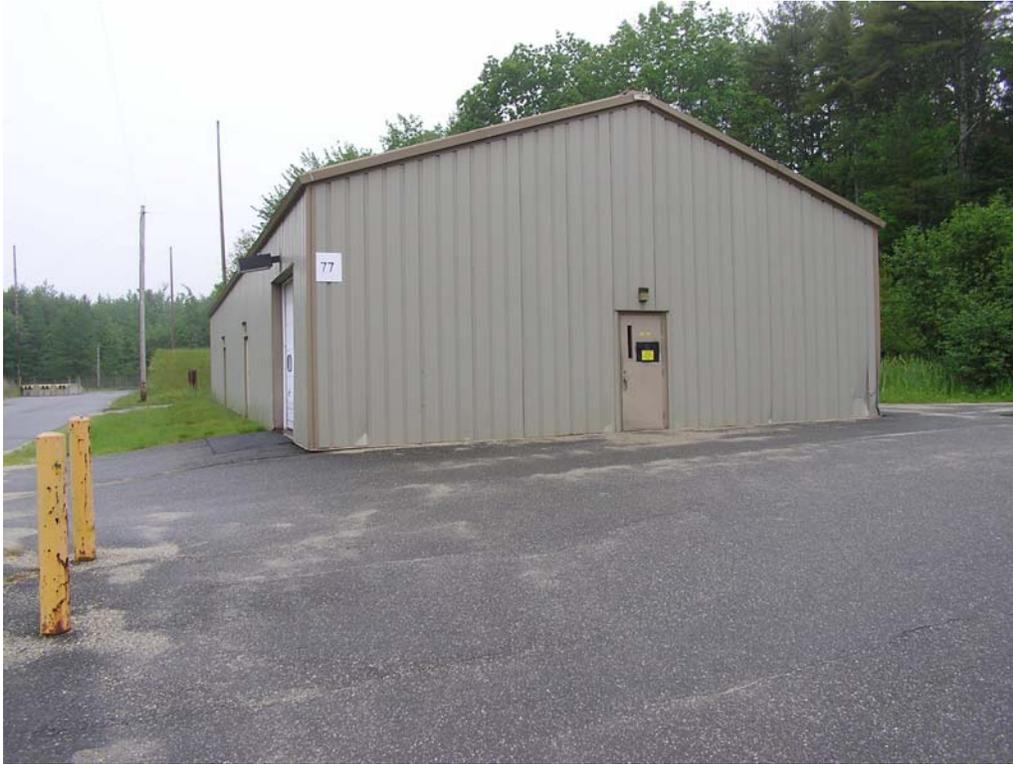
No. 1 Building 77 Weapons Build-Up Facility – NAS Brunswick June 3, 2010
Weapons Build-Up Facility north elevation; Building 145 – Loading Platform visible the left background

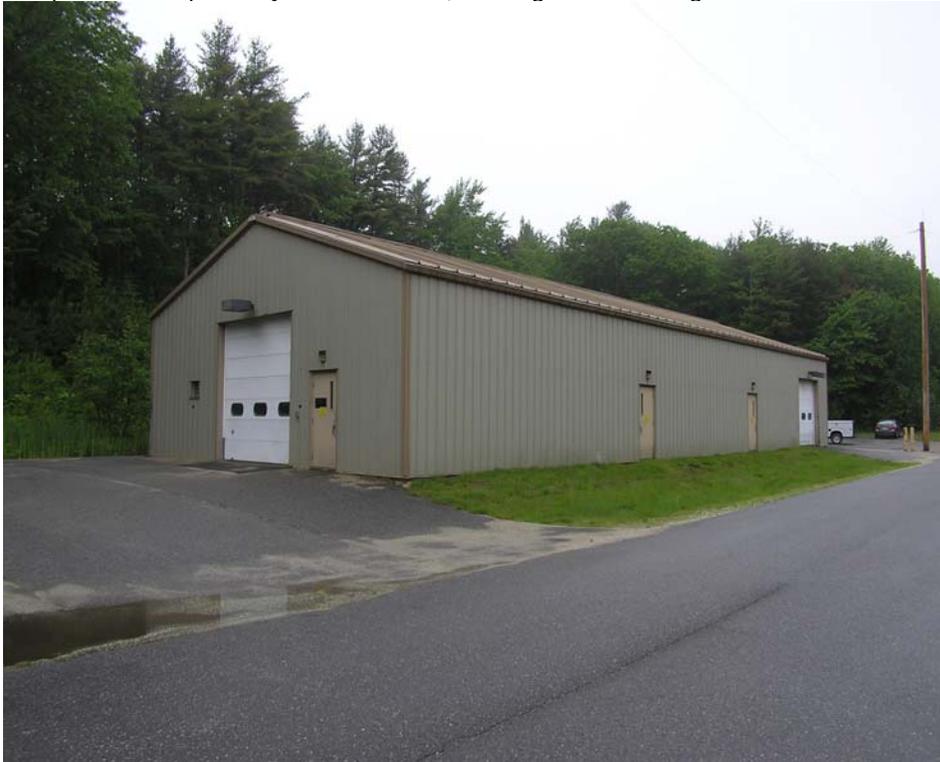
- One pole-mounted transformer was observed northeast of Building 77, at the edge of the access road.
- At the time of the initial site visit, a tank was observed in a subsurface concrete vault to the north of the building. According to NAS personnel, the tank had been drained and was scheduled to be removed in July 2010. (NAS Brunswick personnel later reported that the tank was removed on August 30, 2010 and is currently stored in the northwest corner of Building 77.) No evidence of a past release from this tank was observed.

No. 2 Building 77 Weapons Build-Up Facility – NAS Brunswick June 3, 2010
Weapons Build-Up Facility southeast elevation with pole-mounted transformer to the right background

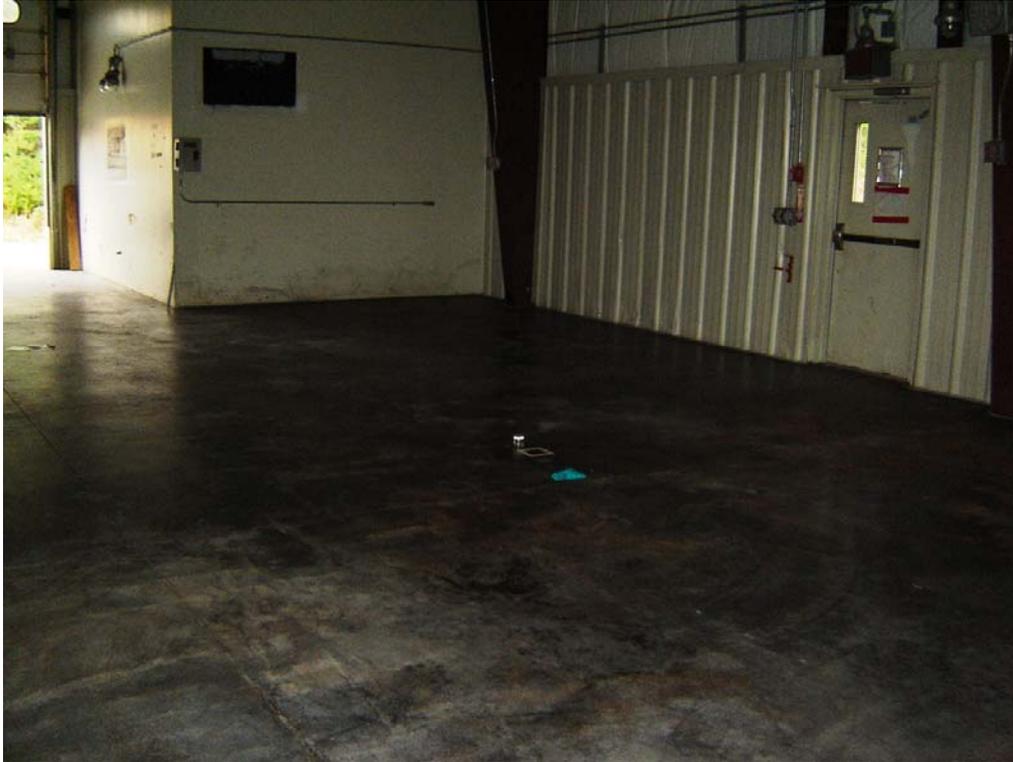
No. 3 Building 77 Weapons Build-Up Facility – NAS Brunswick October 25, 2010
Weapons Build-Up Facility southwest interior area; wipe sample (WP-12) location shown in foreground.

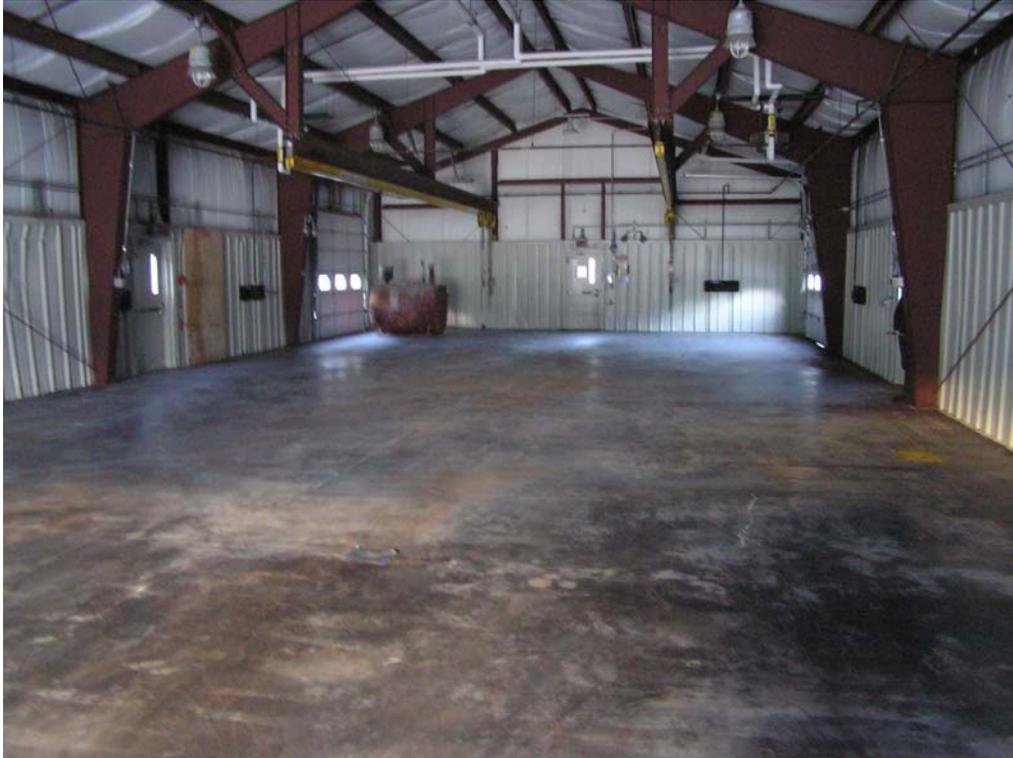
- During a December 2, 2010 follow-up site visit, the closed, No. 2 fuel oil storage tank (removed from the vault) was being stored in the northwest area of the building.

No. 4 Building 77 Weapons Build-Up Facility – NAS Brunswick December 2, 2010
Weapons Build-Up Facility interior viewed from south (post-cleaning); closed storage tank in the northwest corner

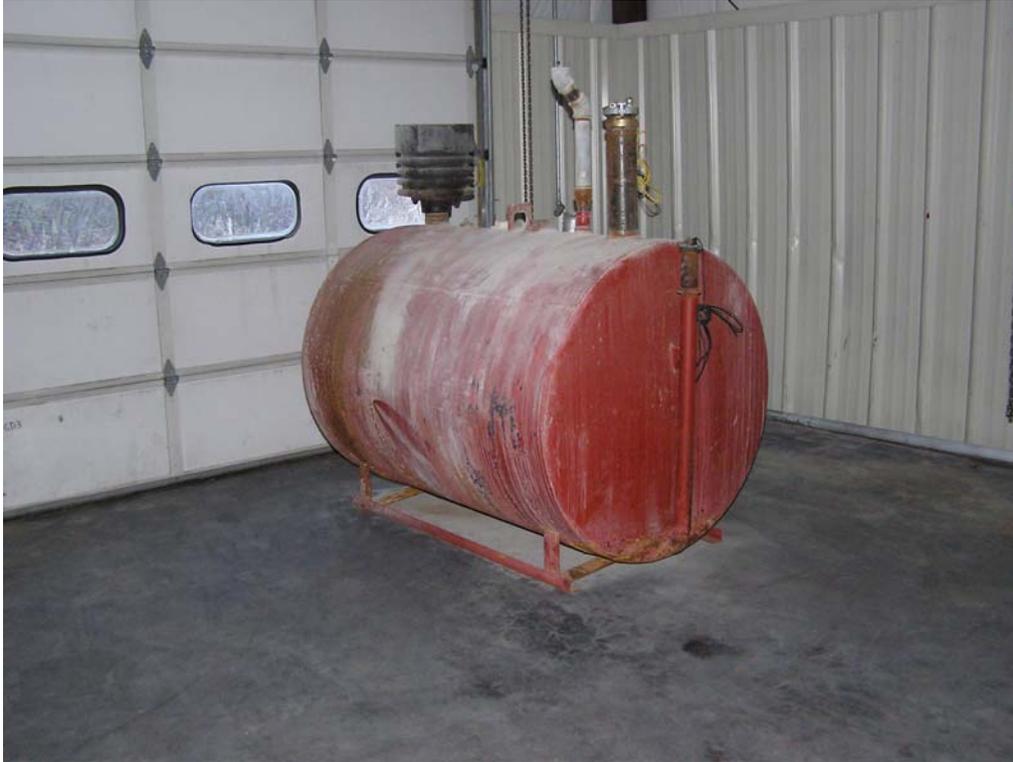
No. 5 Building 77 Weapons Build-Up Facility – NAS Brunswick December 2, 2010
Weapons Build-Up Facility interior northwest corner closed storage tank (in temporary storage after removal from vault)

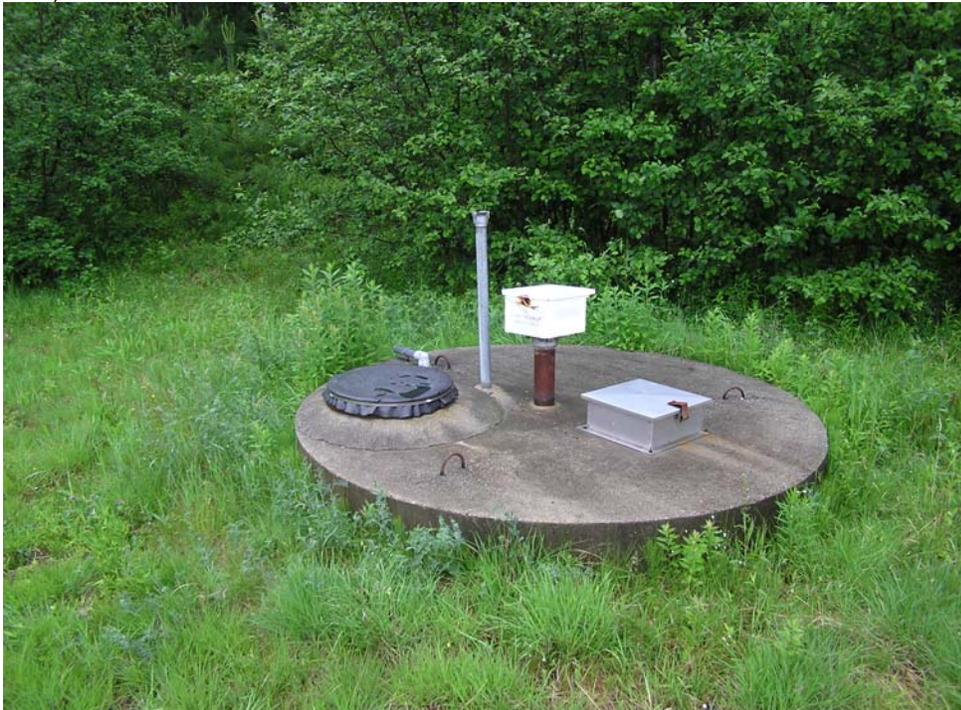
According to the NASB underground storage tank (UST) database, one 600 gallon #2 fuel oil UST (registration #10045-492) was installed September 1992, removed in July 1997. The UST was replaced with a 500 gallon double-walled, vaulted #1 fuel oil above ground storage tank (AST) (registration #10045-500) with underground piping left in place. The AST is located north of Building 77 and scheduled to be removed in July 2010. There are no additional USTs, ASTs or oil-water separators (OWS) registered to Building 77.

No. 6 Building 77 Weapons Build-Up Facility – NAS Brunswick June 3, 2010
Vaulted heating oil storage tank system north of Building 77 (prior to tank removal)
