FINAL RESOURCE CONSERVATION AND RECOVERY ACT PARTIAL CLOSURE REPORT  
FOR BUILDING 43 WITH TRANSMITTAL LETTER NAS BRUNSWICK ME  
12/17/2010  
NAS BRUNSWICK

Subj: Final RCRA Partial Closure Report for Building 43

**RCRA PARTIAL CLOSURE REPORT**  
for  
**BUILDING 43 – TELEPHONE EXCHANGE PARCEL**  
**NAVAL AIR STATION BRUNSWICK, MAINE**  
**USEPA IDENTIFICATION NUMBER ME8170022018**  
**DECEMBER 2010**

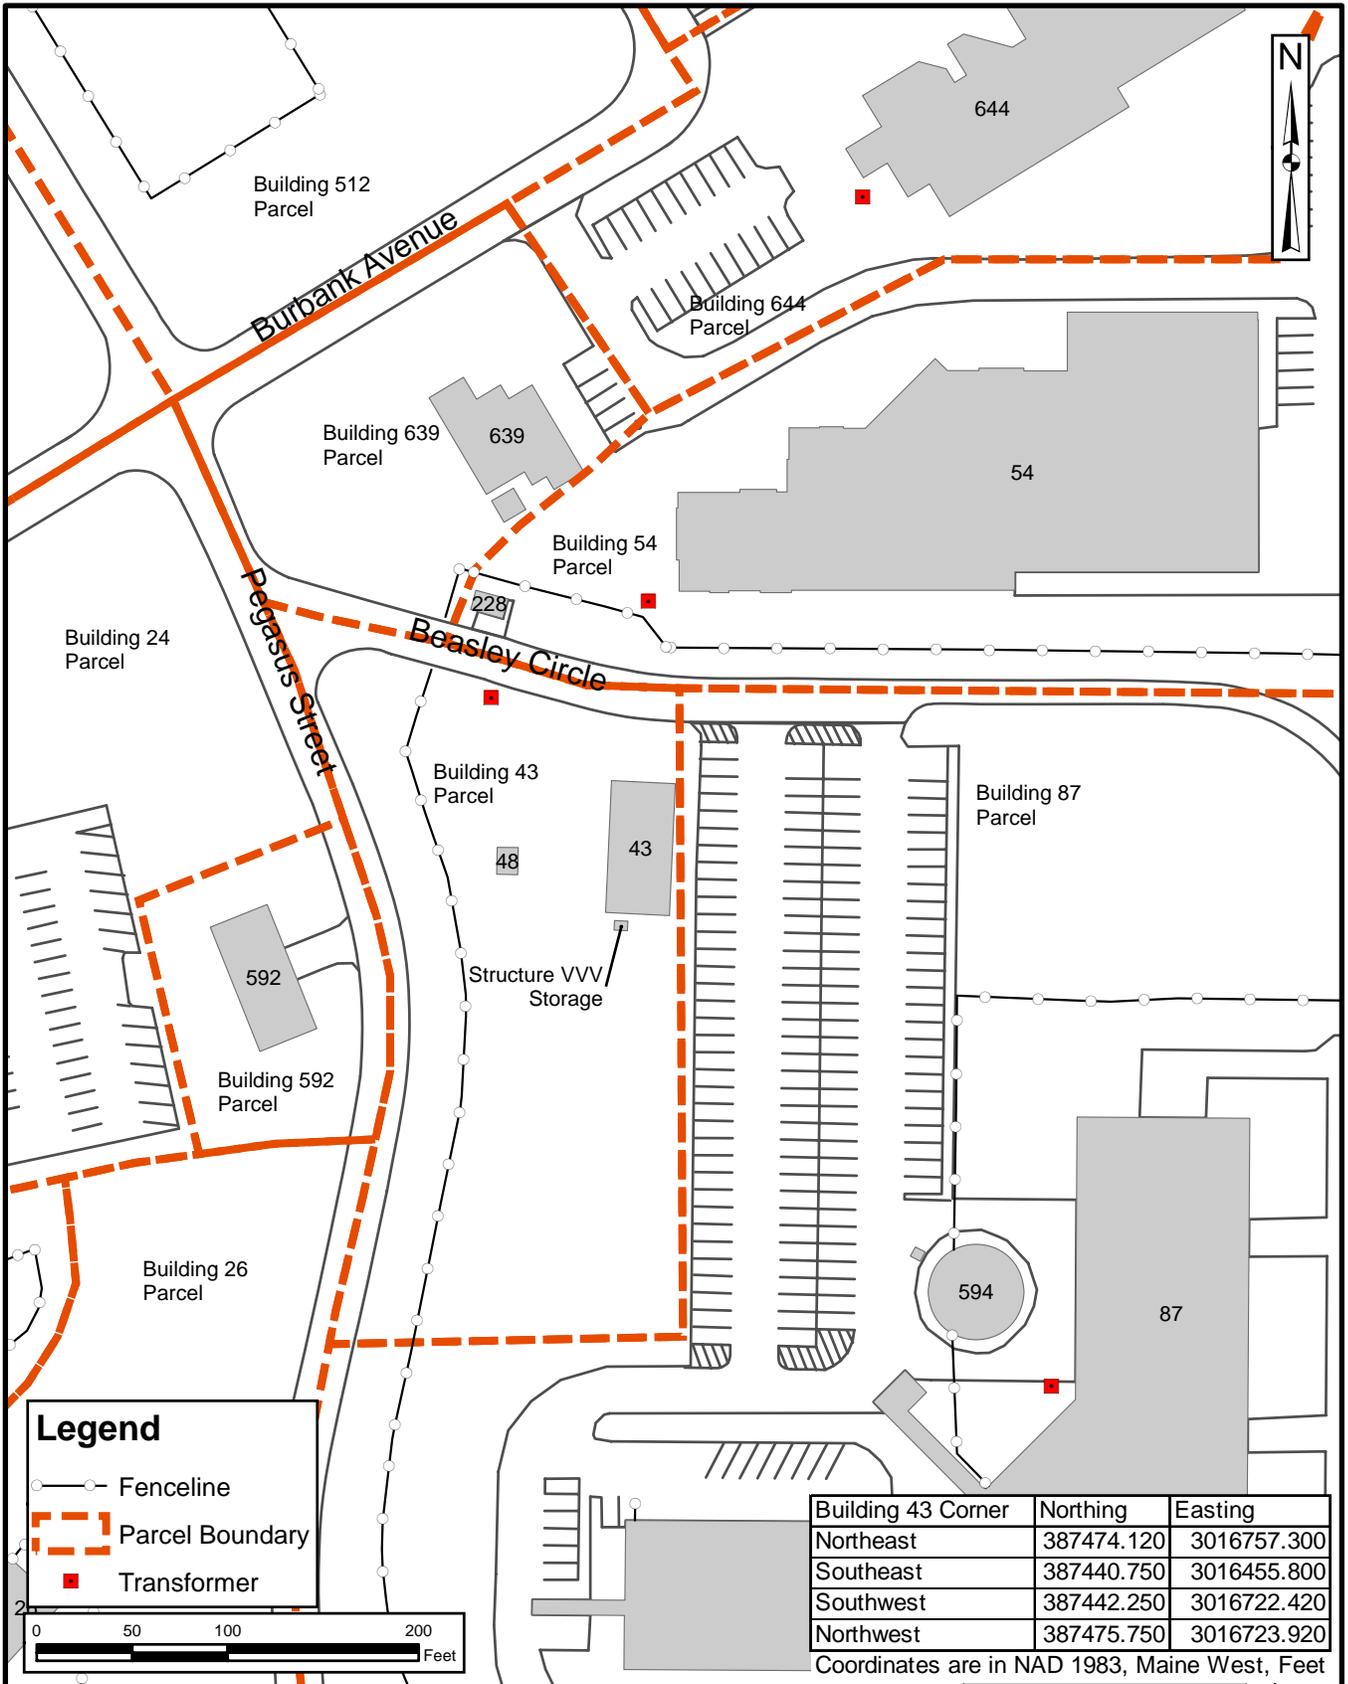
SCALE AS NOTED	
FILE \\NASB_BLDG_43_SITE_MAP.MXD	
REV 0	DATE 12/10/10
FIGURE NUMBER FIGURE NO. 2

Building 43 itself is located near the northeastern corner of the parcel (Figure 2). It was constructed in 1988 and consists of a 1,156-square-foot, single-story, concrete structure with stucco finish, on a concrete slab foundation. Building 43 has an electric baseboard heating system. Photographs of the building are provided as an attachment to this report.

**SITE PLAN**  
**BUILDING 43 - TELEPHONE EXCHANGE PARCEL**  
**RCRA PARTIAL CLOSURE REPORT**  
**NAVAL AIR STATION BRUNSWICK, MAINE**

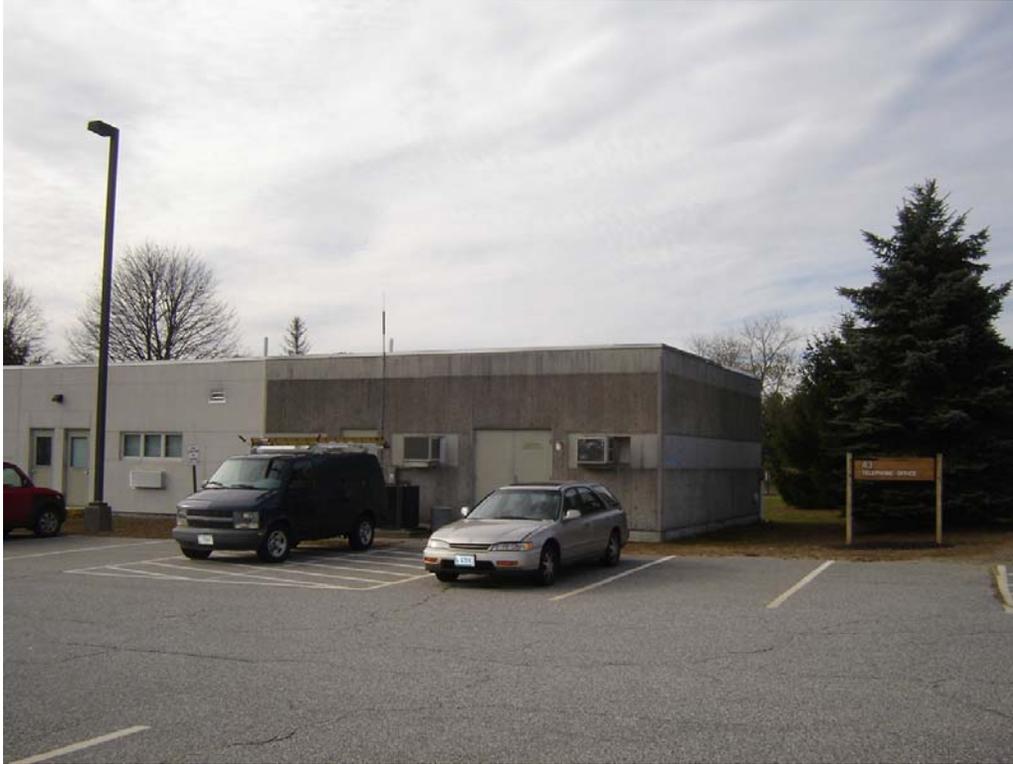
No. 1 Building 43 – Telephone Exchange Parcel, NAS Brunswick November 11, 2010  
Telephone Exchange west elevation.

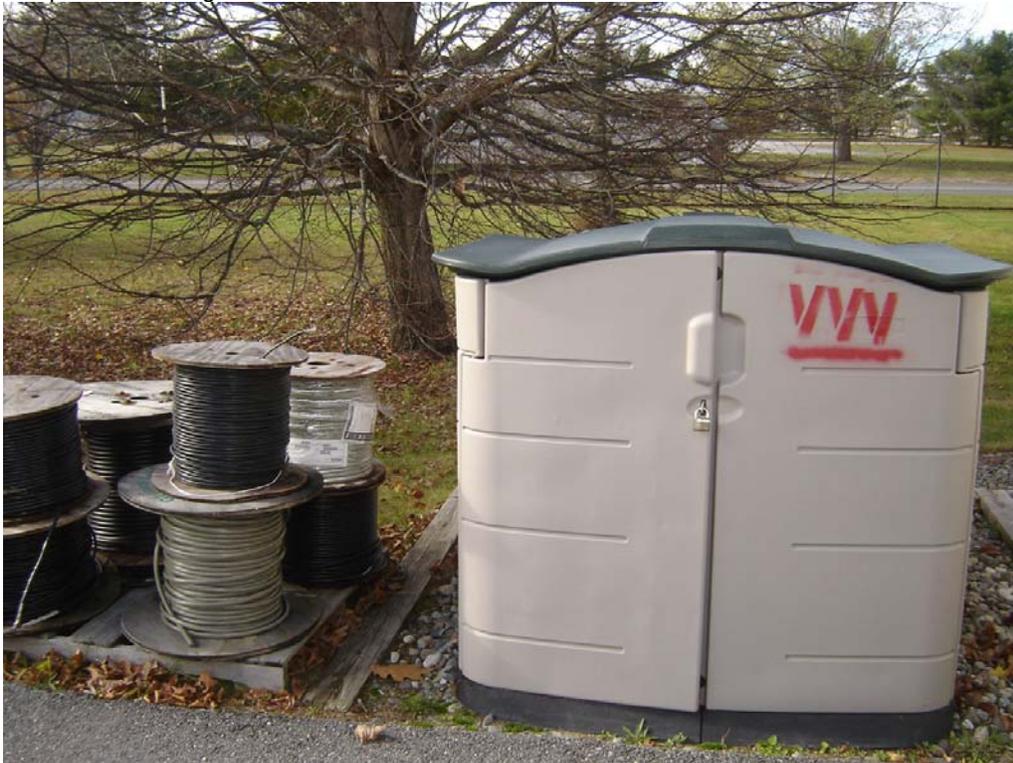
Structure VVV is located at the southeastern corner of Building 43 and is used as a tool shed and for snow-blower storage. The shed is plastic and measures 4 feet by 6 feet by 4 feet.

No. 2 Building 43 – Telephone Exchange Parcel, NAS Brunswick November 11, 2010  
Structure VVV – Tool shed and snow blower storage

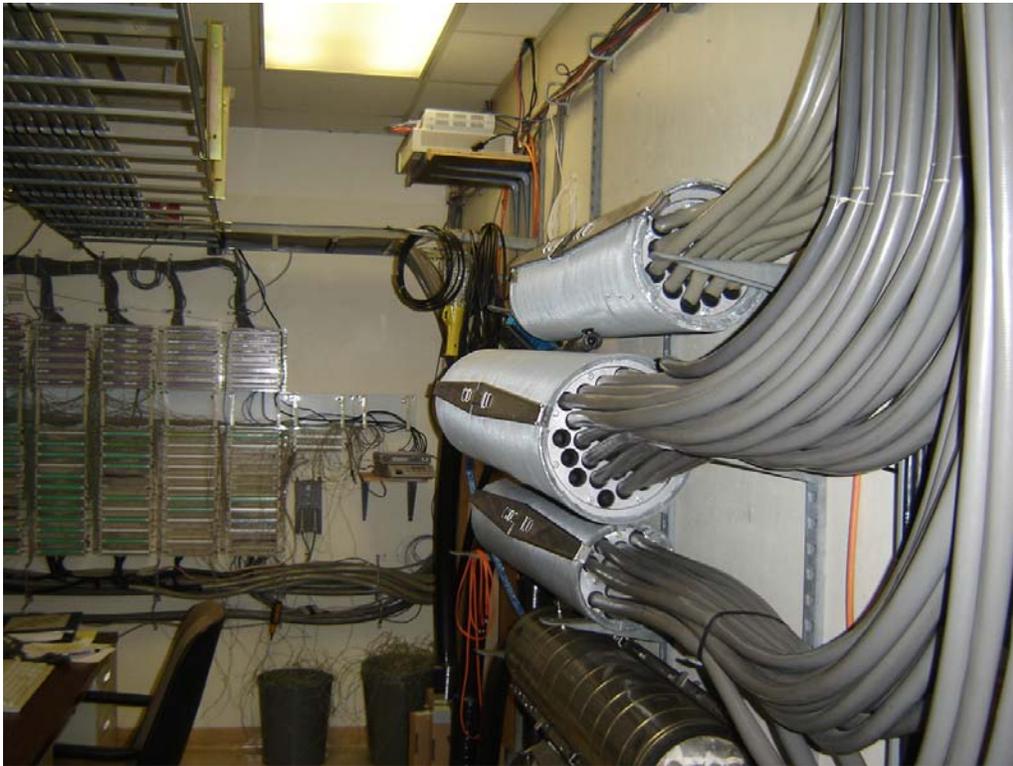
No. 3 Building 43 – Telephone Exchange Parcel, NAS Brunswick November 11, 2010  
Telephone cable bundles in the Telephone Exchange equipment/switch room

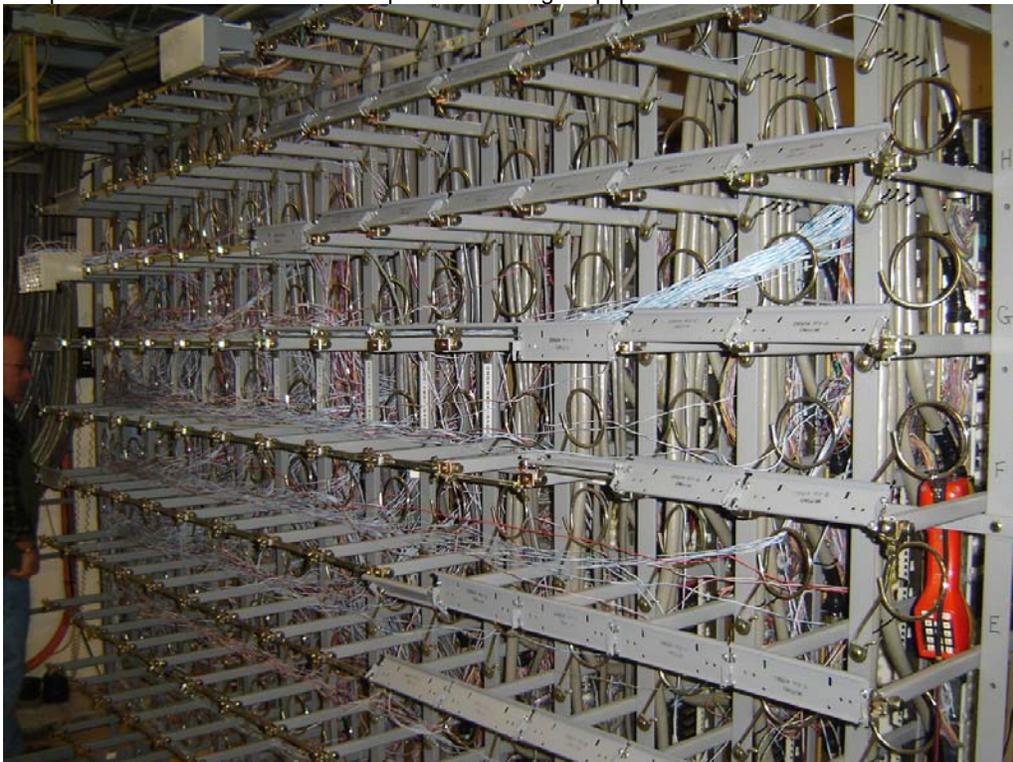
No. 4 Building 43 – Telephone Exchange Parcel, NAS Brunswick November 11, 2010  
Telephone equipment in the Telephone Exchange equipment/switch room
