FINAL RESOURCE CONSERVATION AND RECOVERY ACT PARTIAL CLOSURE REPORT  
FOR BUILDING 658 WITH TRANSMITTAL LETTER NAS BRUNSWICK ME  
12/17/2010  
NAS BRUNSWICK

**RCRA PARTIAL CLOSURE REPORT**  
**for**  
**BUILDING 658 – FUEL FARM POL TESTING FACILITY**  
**NAVAL AIR STATION BRUNSWICK, MAINE**  
**USEPA IDENTIFICATION NUMBER ME8170022018**  
**DECEMBER 2010**

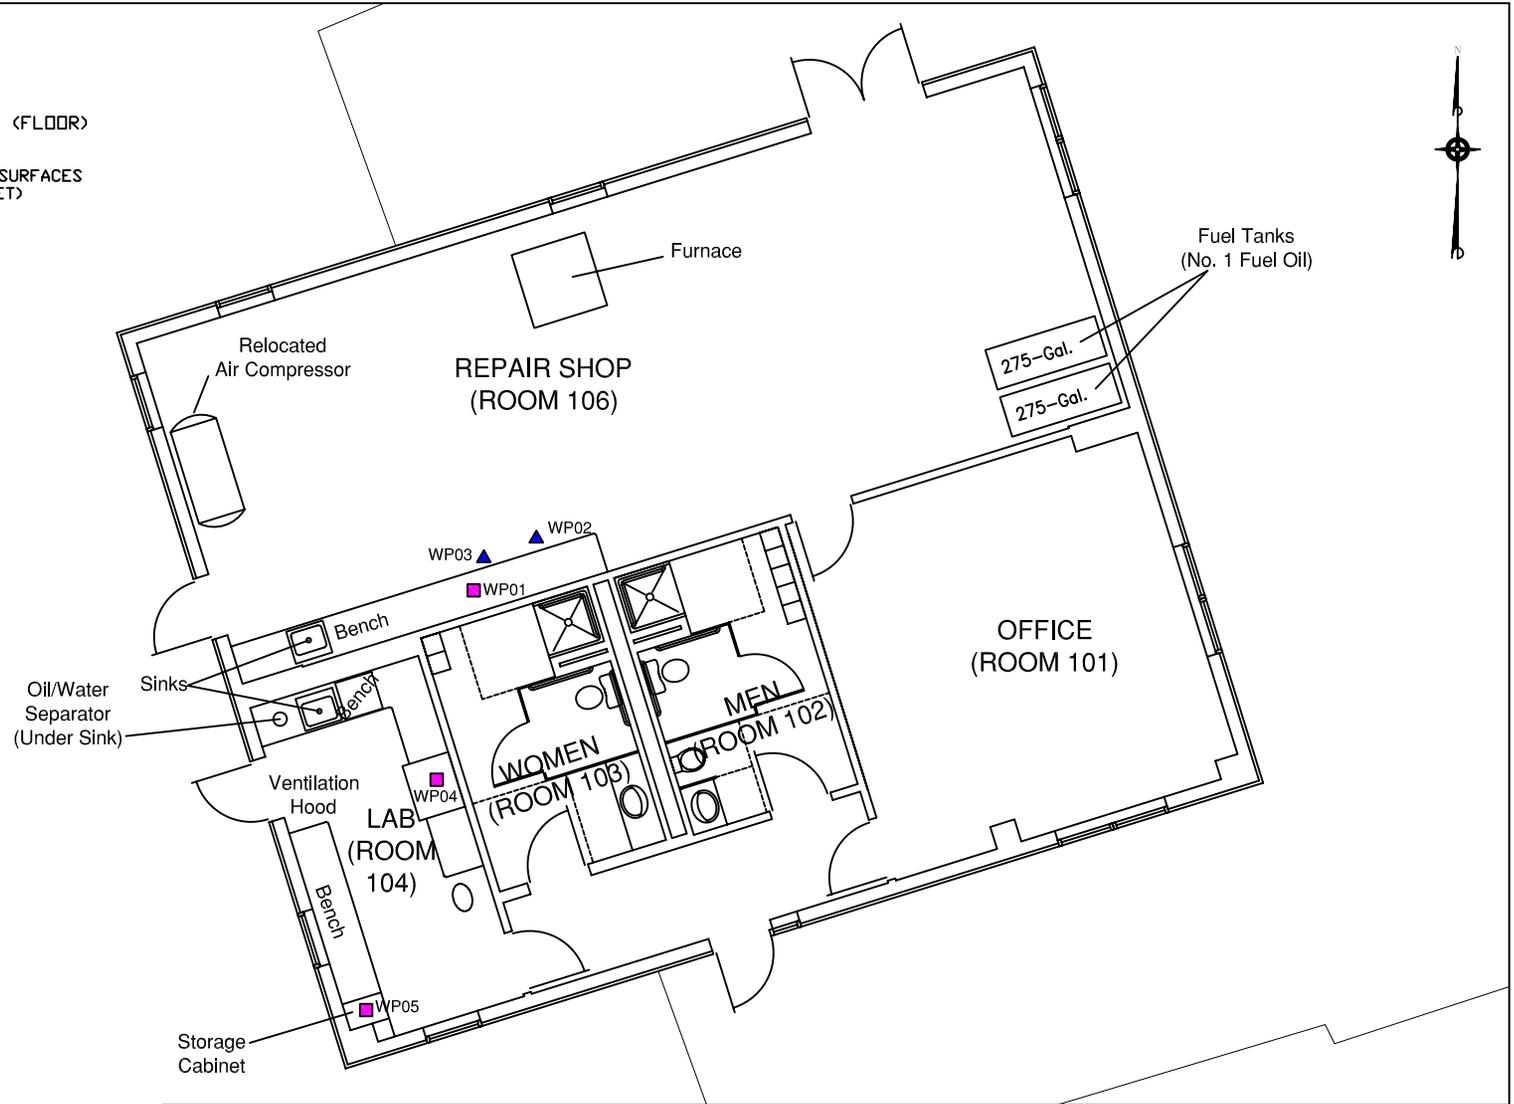
PRE-CLEANING SAMPLE LOCATIONS  
 BUILDING 658 - FUEL FARM POL TESTING FACILITY  
 RCRA PARTIAL CLOSURE REPORT  
 NAVAL AIR STATION BRUNSWICK, MAINE

On July 7, 2010, wipe samples were collected from five locations (WP01 through WP05) in Building 658, as shown on Figure 3. The samples were submitted for RCRA metals and semi-

As shown in Table 1, in each of the two repair shop (Room 106) floor-wipe samples, lead was detected at levels exceeding the MEDEP criterion for floors ( $40 \mu\text{g}/\text{ft}^2$ ). In addition, the lead level in the workbench wipe sample exceeded the MEDEP criterion for flat surfaces up to a height of 8 feet ( $250 \mu\text{g}/\text{ft}^2$ ). All levels of other detected metals in these samples were below the screening values.

Based on these analytical results, cleaning of Room 106 was required to remove lead-contaminated residue exceeding the associated MEDEP criterion for dust on floors (discussed in Section 6).

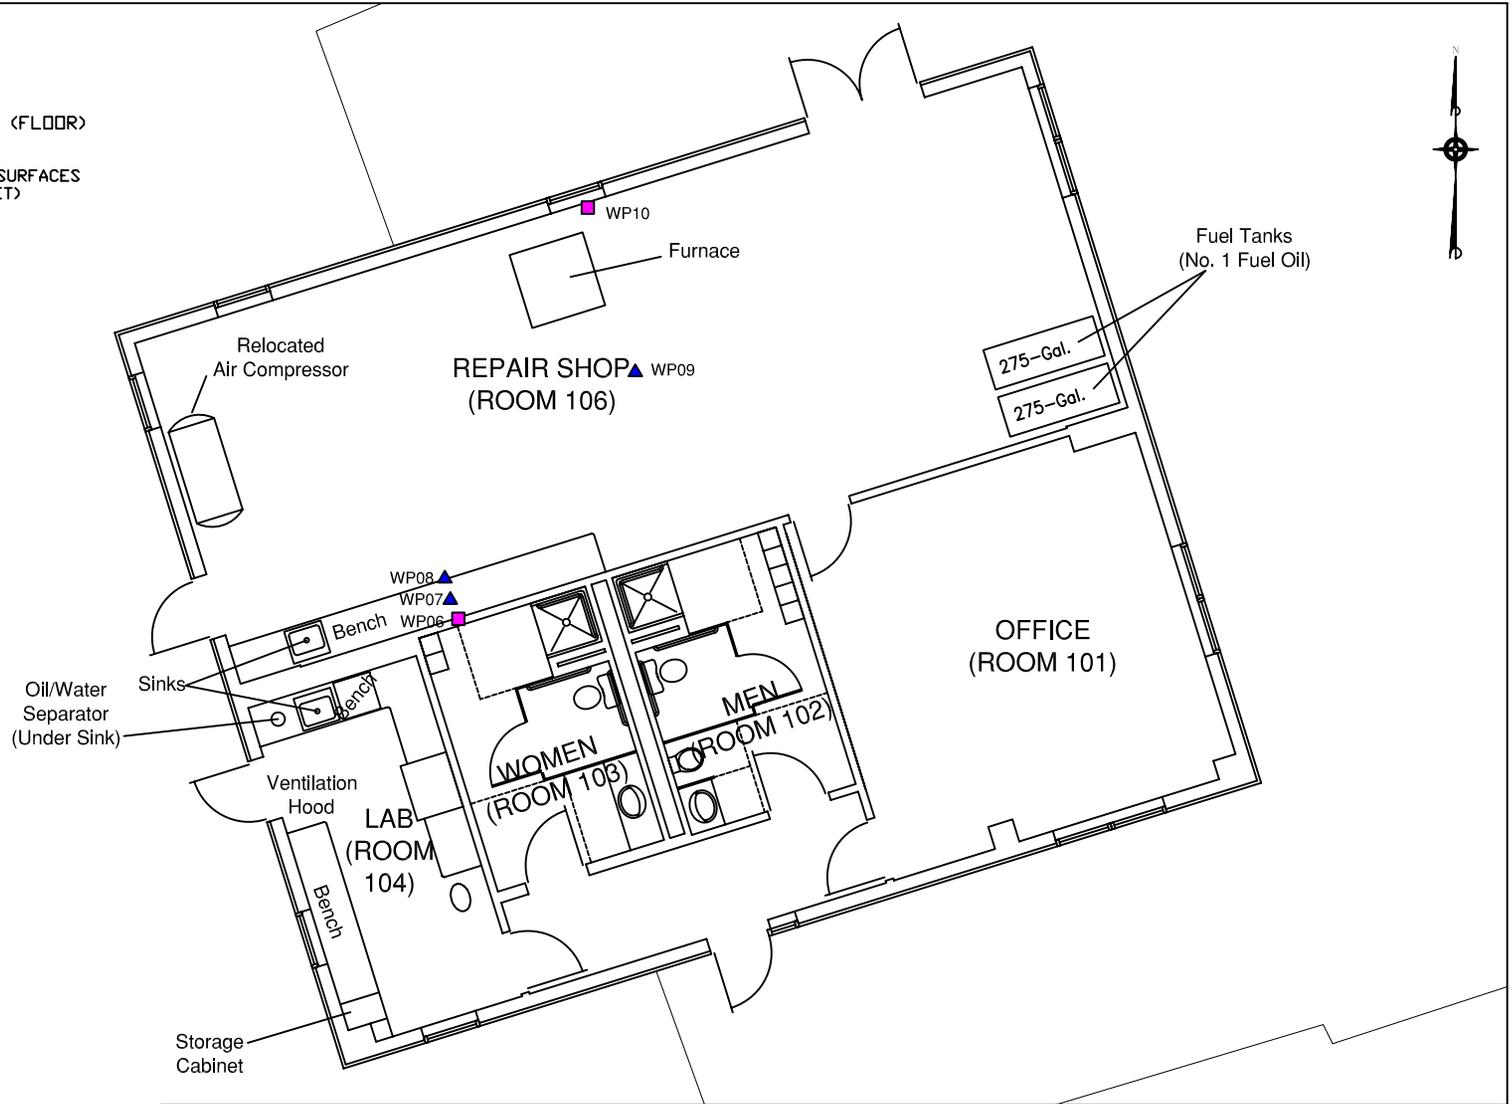
POST-CLEANING SAMPLE LOCATIONS  
 BUILDING 658 - FUEL FARM POL TESTING FACILITY  
 RCRA PARTIAL CLOSURE REPORT  
 NAVAL AIR STATION BRUNSWICK, MAINE

On October 28, 2010, five post-cleaning, confirmatory floor- and wall-wipe samples (WP6 through WP10) were collected from the cleaned rooms in Building 658, as shown on Figure 4. The wipe samples were submitted to Analytics for RCRA metals analysis. The resulting analytical data underwent limited data validation consisting of blank contamination evaluation and completeness evaluation. The confirmatory wipe sample results from the October 28, 2010 samples are included in Table 2. These post-cleaning results indicate that lead was not detected at levels exceeding the associated MEDEP criteria (40 µg/ft<sup>2</sup> for floors and 250 µg/ft<sup>2</sup> for walls and flat surfaces up to 8 feet high).

Tetra Tech's cleaning subcontractor (Global Remediation Services [Global]) performed floor- and wall-cleaning activities at Building 658, based on criteria exceedances in previous wipe samples, as discussed in Section 4. On October 27, 2010, cleaning activities were conducted in the repair shop (Room 106) and the laboratory (Room 104). The floors were manually swept and then vacuumed with a high-efficiency particulate air (HEPA) vacuum. After sweeping and vacuuming, floors and walls were sprayed with a 2-percent, lead-specific detergent solution, scrubbed, and pressure-washed, using a 5,000-pounds-per-square-inch (psi) steam cleaner. All cleaning wastewater was containerized using a wet-vacuum, placed in two 55-gallon drums, and transferred to the NAS Brunswick hazardous waste department for disposal. Upon completion, the Tetra Tech field representative performed a visual inspection of the cleaned areas.

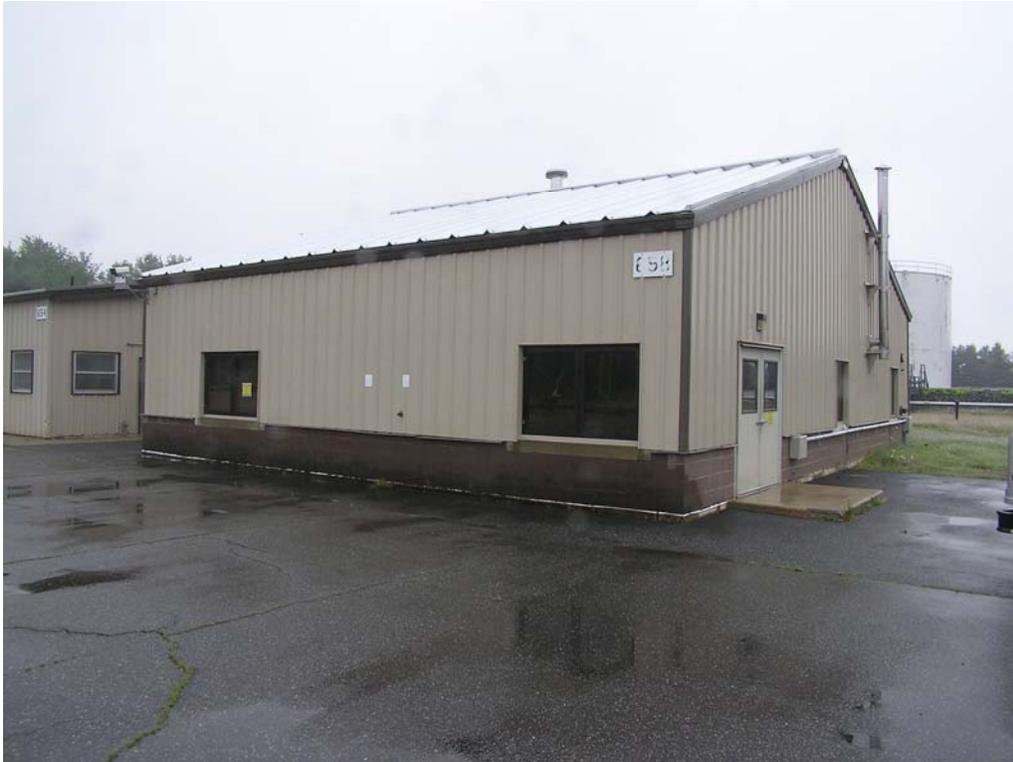
No. 1 Building 658 – Fuel Farm POL Testing Facility, NAS Brunswick June 23, 2010  
Fuel Farm POL Testing Facility northeast elevation; Building 651 visible behind Building 658

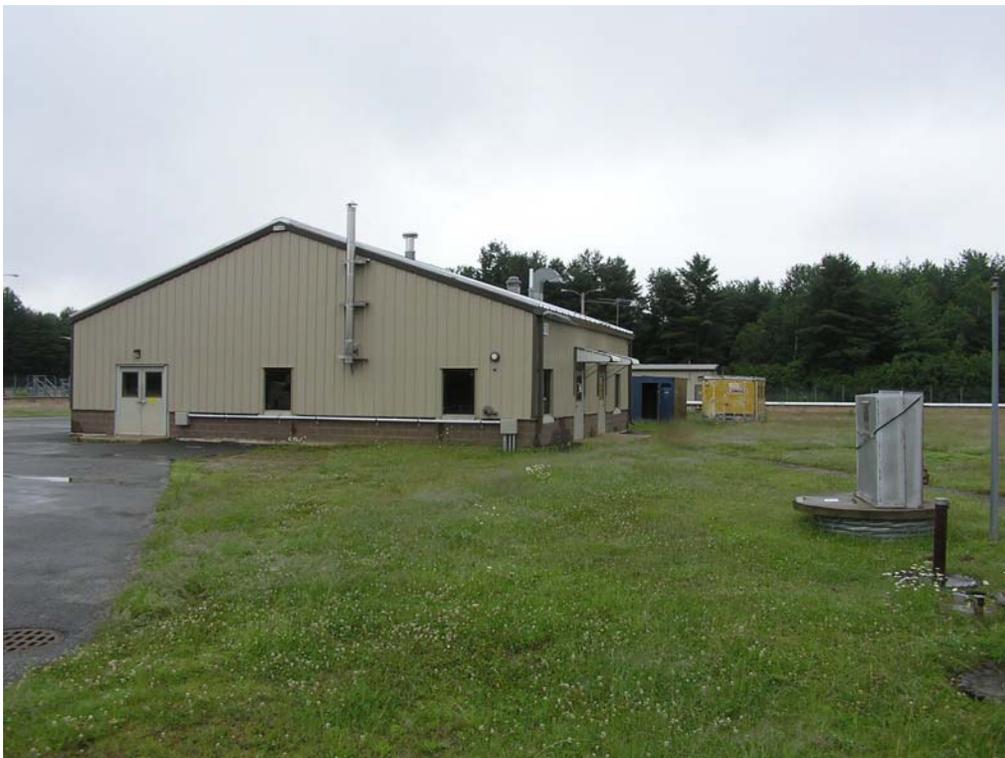
No. 2 Building 658 – Fuel Farm POL Testing Facility, NAS Brunswick June 23, 2010  
Fuel Farm POL Testing Facility north elevation; Building 656 (Oil Water Separator) in right foreground

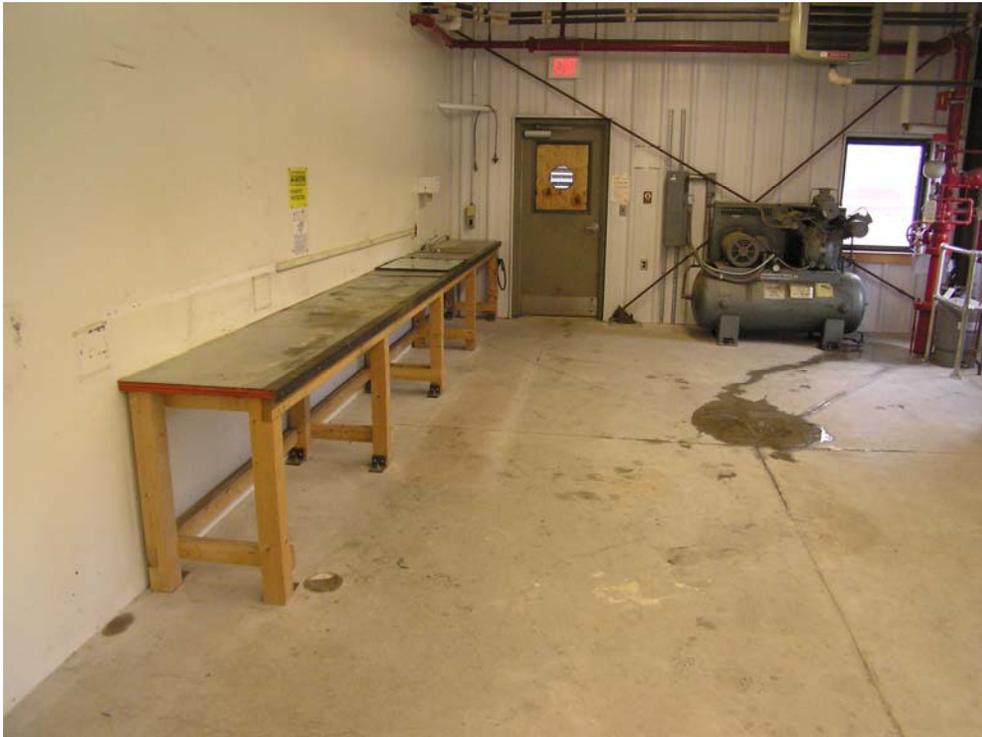
- No floor drains were observed in Building 658.
- According to NAS personnel, lawn mower engines and other equipment were repaired in the repair shop (Room 106). A work bench, likely used for metal grinding (based on an eye protection warning sign and an abrasive wheel equipment grinder checklist posted on the wall above the bench), was observed in the repair shop (Room 106).

No. 3 Building 658 – Fuel Farm POL Testing Facility, NAS Brunswick June 23, 2010  
Fuel Farm POL Testing Facility repair shop (Room 106) interior; workbench where wipe samples WP-01 through WP-03, WP-06 through WP-08 were collected

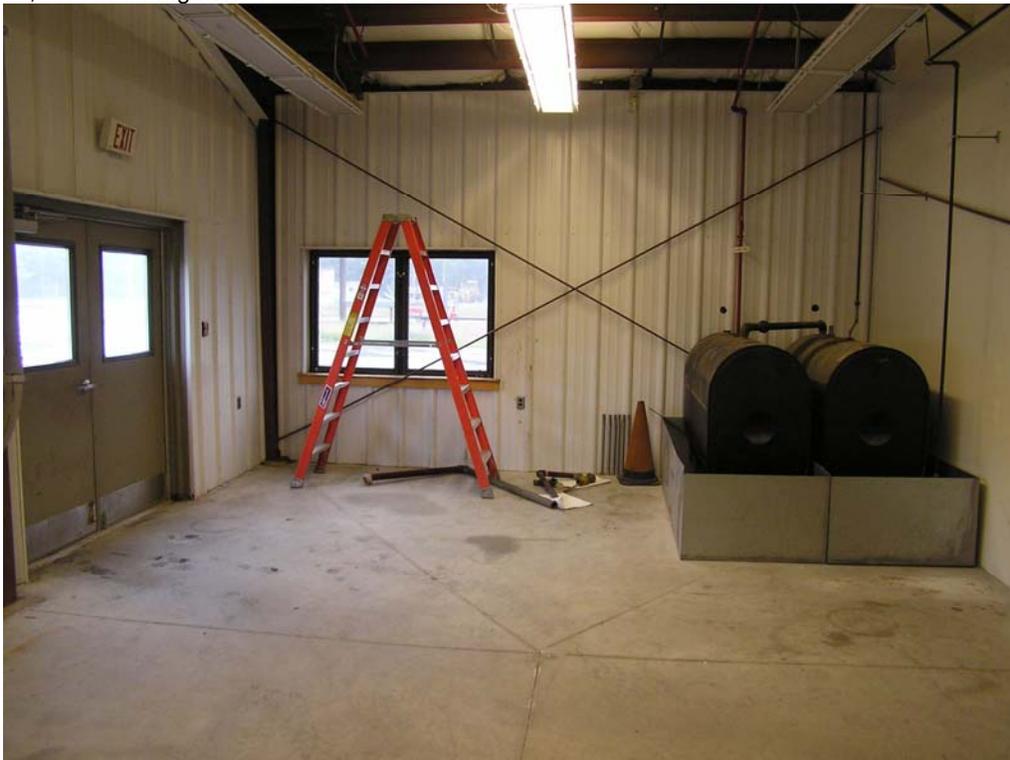
- Two fuel-oil ASTs (A658.0 and A658.1), an air compressor, and an oil furnace were observed in the repair shop (Room 106). No evidence of a past release from the ASTs was observed.

No. 4 Building 658 – Fuel Farm POL Testing Facility, NAS Brunswick June 23, 2010  
Fuel Farm POL Testing Facility repair shop (Room 106) showing two No. 1 fuel oil ASTs

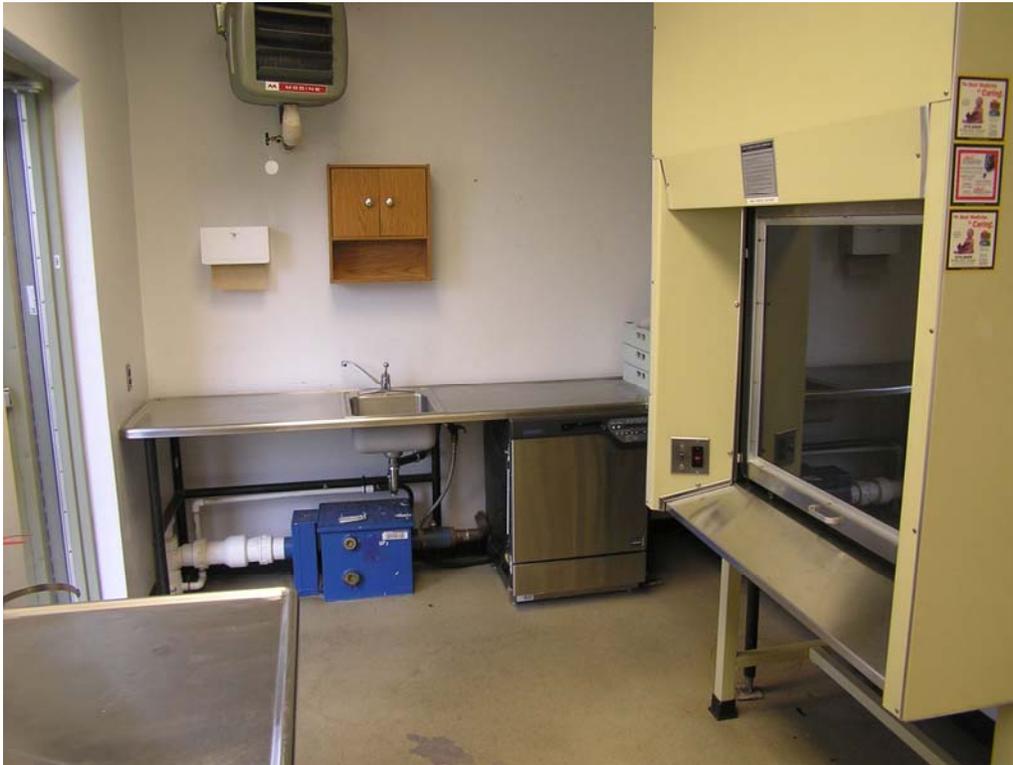
- Piping relating to the fire protection system and water supply is located in the northwest corner of the repair shop.
- According to NAS personnel, the laboratory was used to test fuel oil. A ventilation hood and a waste storage cabinet were observed in the laboratory (Room 104). An oil/water separator was also observed underneath the sink in the laboratory. (According to NAS Brunswick Environmental personnel the oil/water separator was removed, cleaned, and sent to metal recycling in December 2010.)

No. 5 Building 658 – Fuel Farm POL Testing Facility, NAS Brunswick June 23, 2010  
Fuel Farm POL Testing Facility laboratory (Room 104) interior; fume hood and sink with oil/water separator

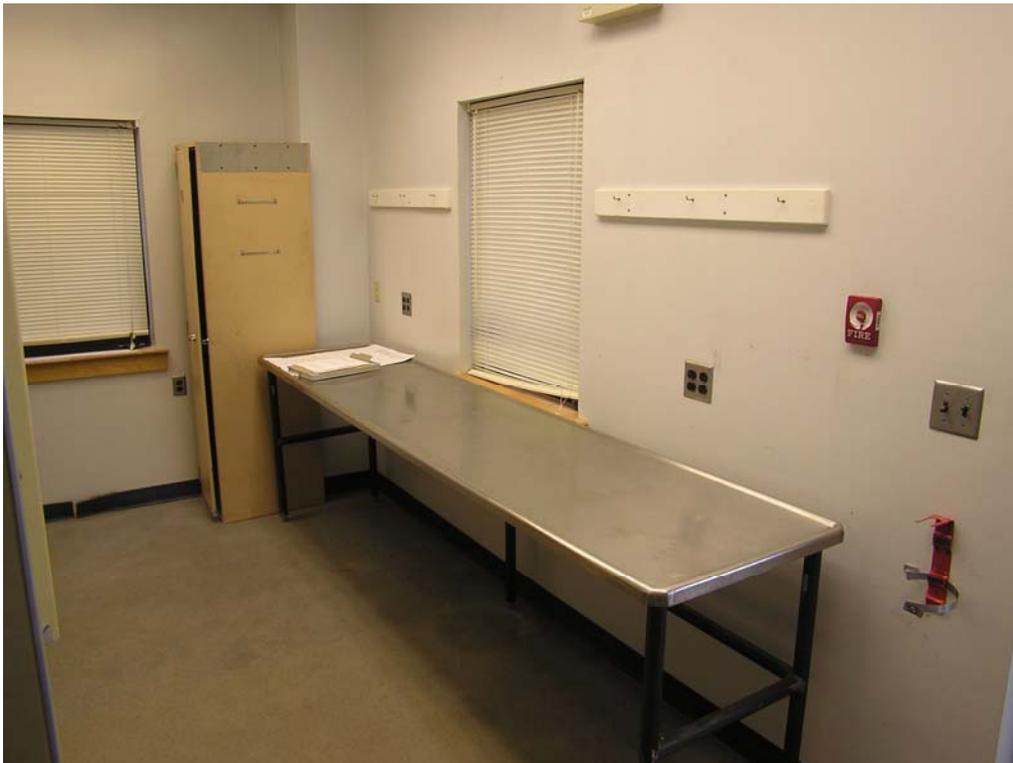
No. 6 Building 658 – Fuel Farm POL Testing Facility, NAS Brunswick June 23, 2010  
Fuel Farm POL Testing Facility interior; laboratory (room 104) bench and storage cabinet
