FINAL RESOURCE CONSERVATION AND RECOVERY ACT PARTIAL CLOSURE REPORT
FOR BUILDINGS 450 AND 451 WITH TRANSMITTAL LETTER NAS BRUNSWICK ME
1/6/2011
NAS BRUNSWICK

Subj: Final RCRA Partial Closure Report for Buildings 450 and 451

RCRA PARTIAL CLOSURE REPORT
for
BUILDING 450 – FIRE DEPARTMENT ALERT RESPONSE OFFICE
BUILDING 451 – FIRE DEPARTMENT TRAINING OFFICE
NAVAL AIR STATION BRUNSWICK, MAINE
USEPA IDENTIFICATION NUMBER ME8170022018
DECEMBER 2010

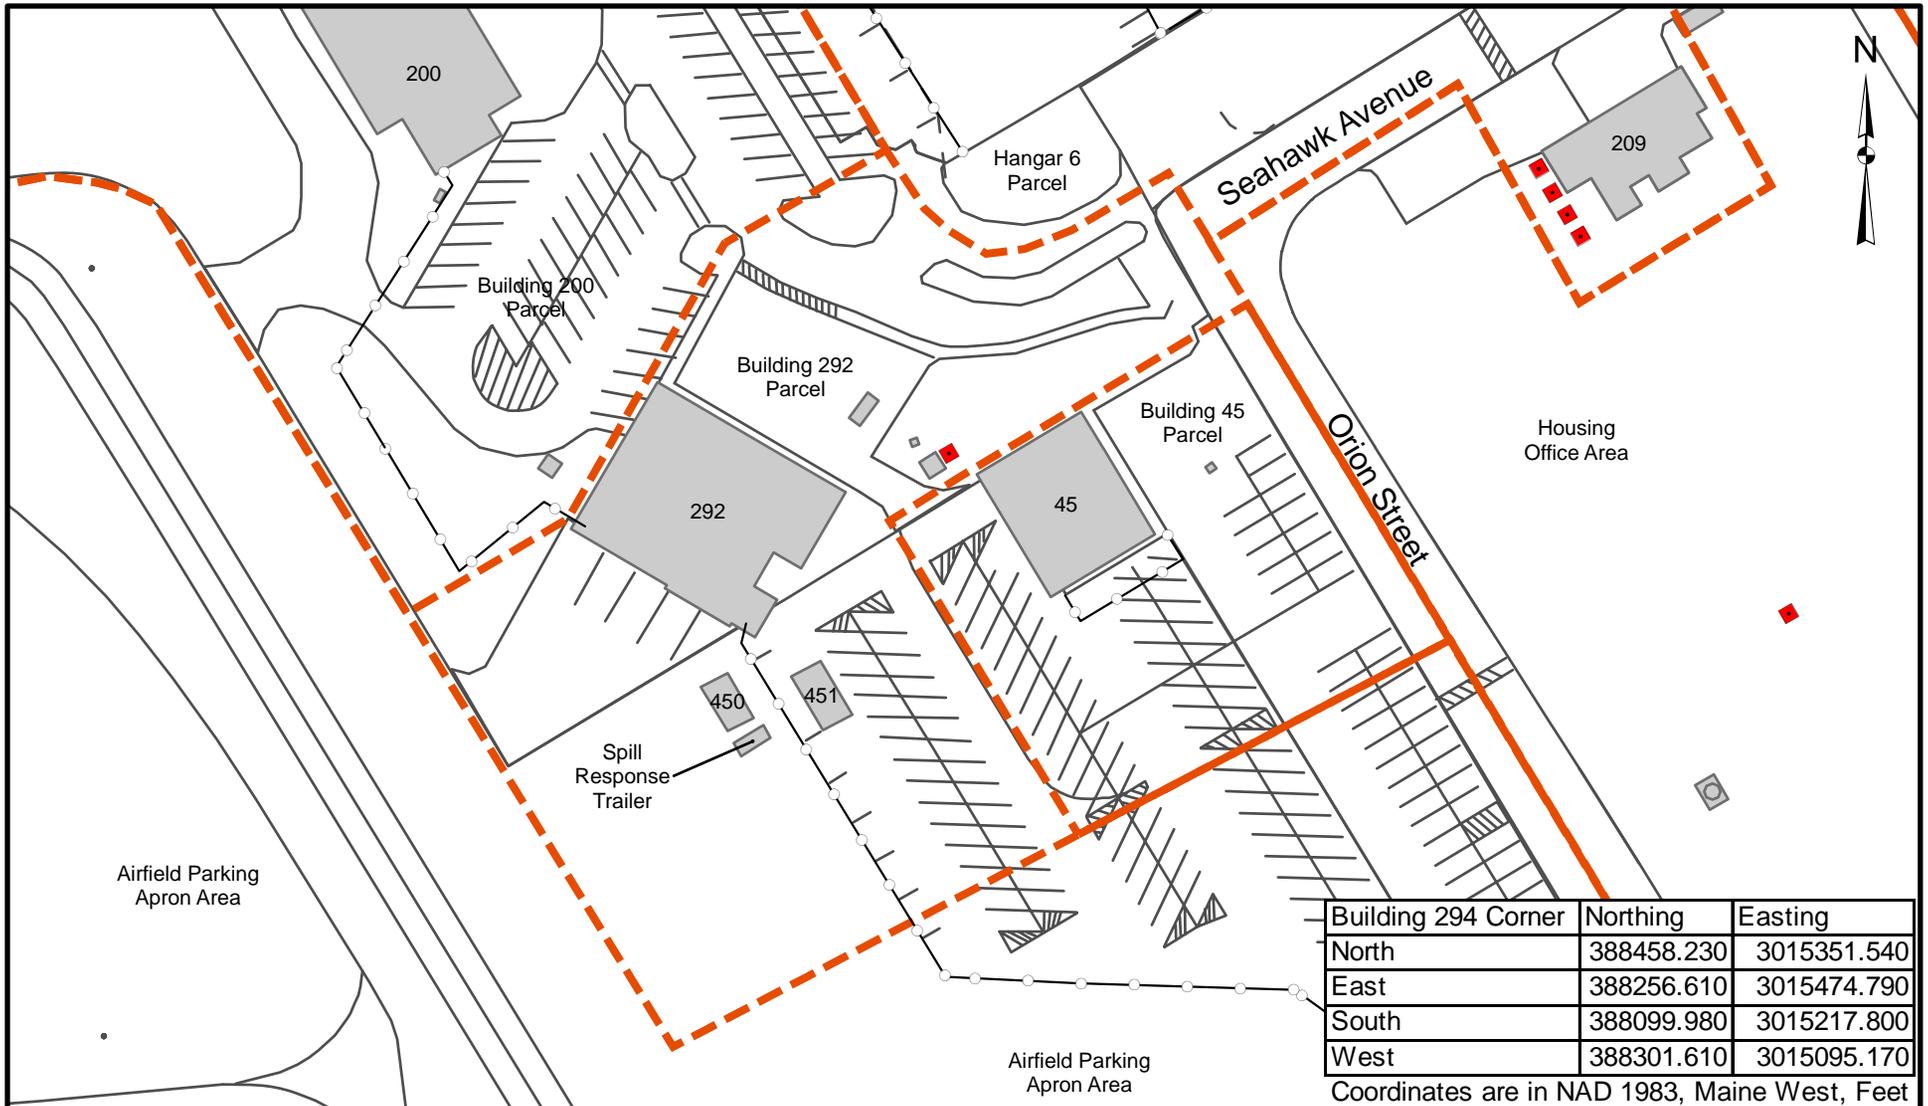
SCALE AS NOTED	
FILE I:\NASB_BLDG_450&451_SITE_MAP.MXD	
REV 0	DATE 12/30/10
FIGURE NUMBER FIGURE NO. 2

SITE PLAN
BUILDING 450 - FIRE DEPARTMENT ALERT RESPONSE OFFICE
BUILDING 451 - FIRE DEPARTMENT TRAINING OFFICE
RCRA PARTIAL CLOSURE REPORT
NAVAL AIR STATION BRUNSWICK, MAINE

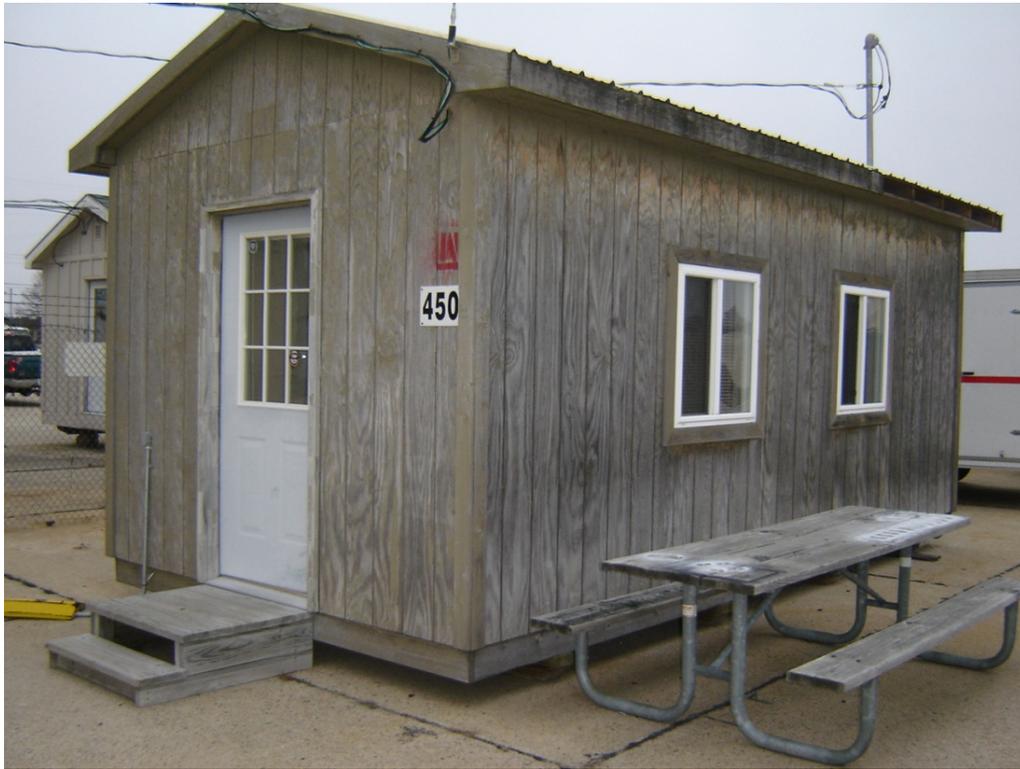
No. 1 Buildings 450 and 451, NAS Brunswick December 20, 2010
Alert Response Office northwest elevation; Training Office in left background and spill response trailer in right background

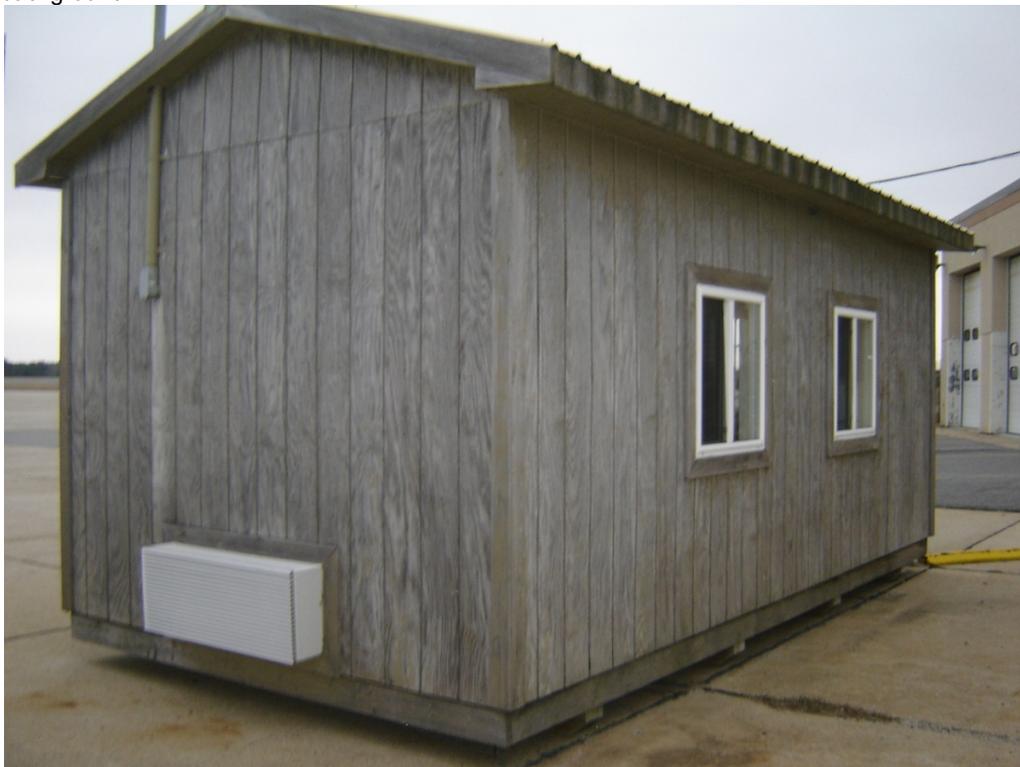
No. 2 Buildings 450 and 451, NAS Brunswick December 20, 2010
Alert Response Office southeast elevation

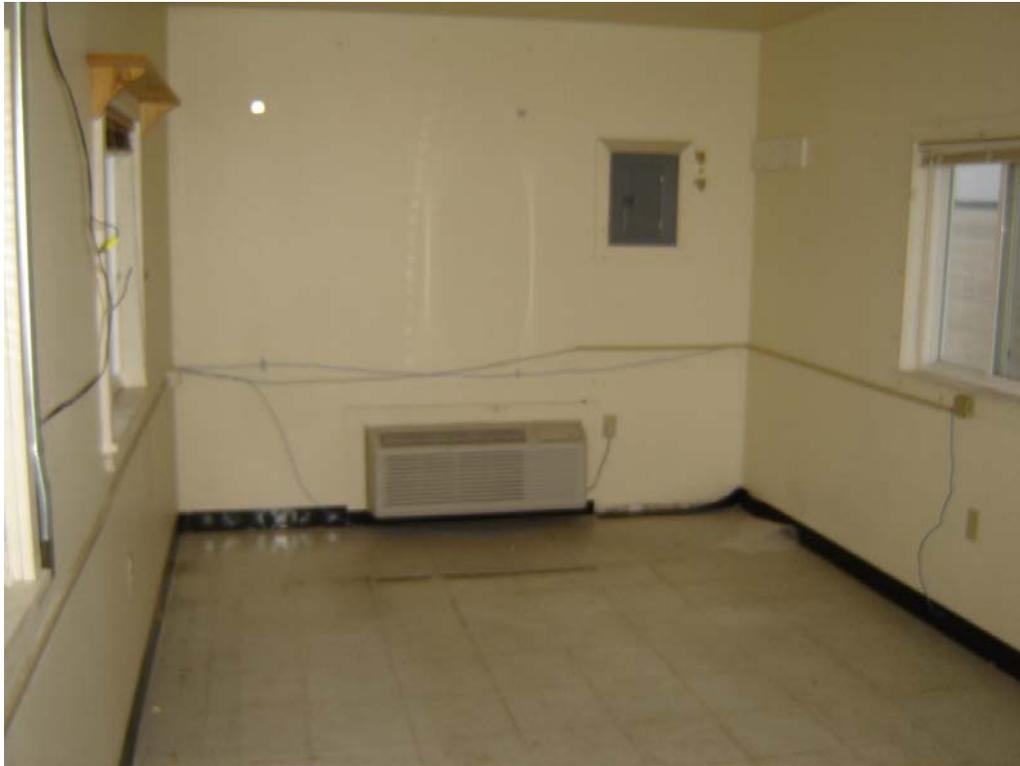
- Some floor tiles, 12-inch by 12-inch, on the floor of Building 450 were observed to be in fair to poor condition and were loose. The tiles and adhesive mastic are suspected to be asbestos-containing materials (ACM), based on the estimated building construction date (approximately 1980).

No. 3 Buildings 450 and 451, NAS Brunswick December 20, 2010
Alert Response Office interior (looking south)

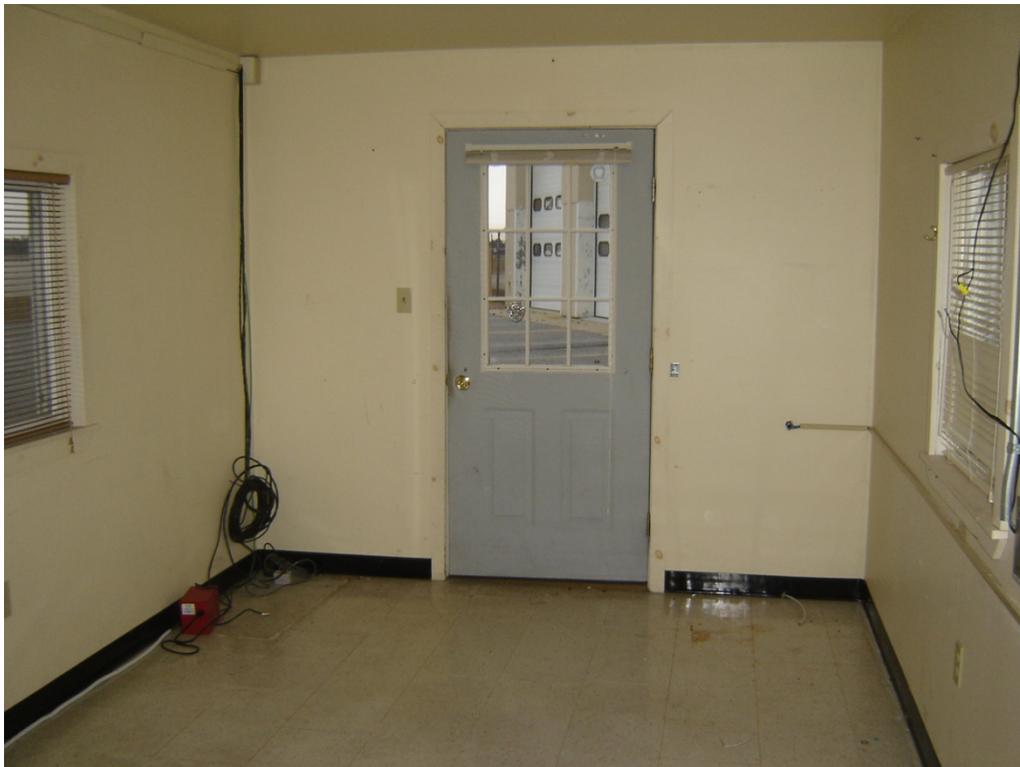
No. 4 Buildings 450 and 451, NAS Brunswick December 20, 2010
Alert Response Office interior (looking north)

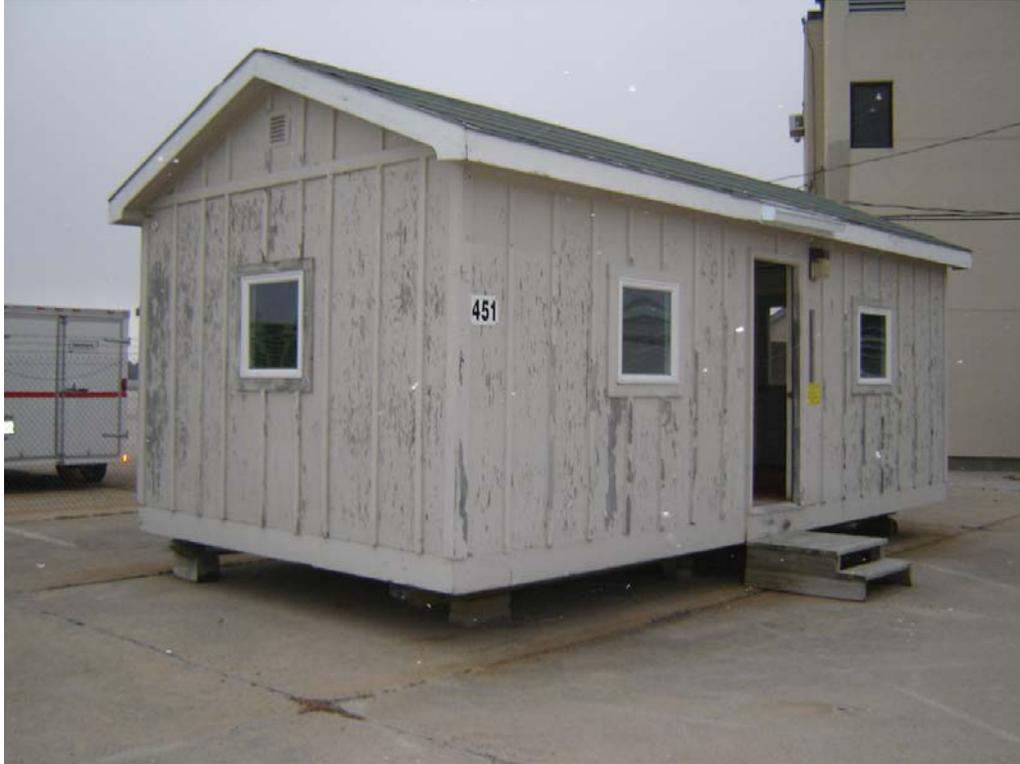
- Peeling paint was observed on the building's exterior.

No. 5 Buildings 450 and 451, NAS Brunswick December 20, 2010
Training Office southeast elevation (spill response trailer in background to the west)

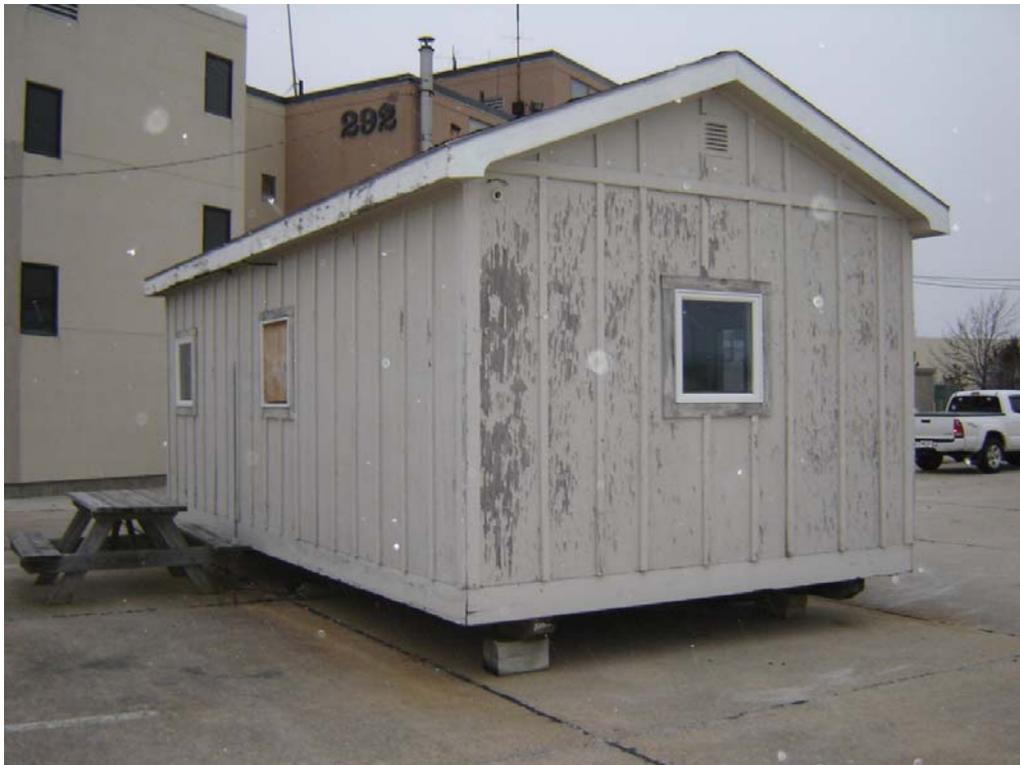
No. 6 Buildings 450 and 451, NAS Brunswick December 20, 2010
Training Office southwest elevation (looking northeast, towards Building 292)

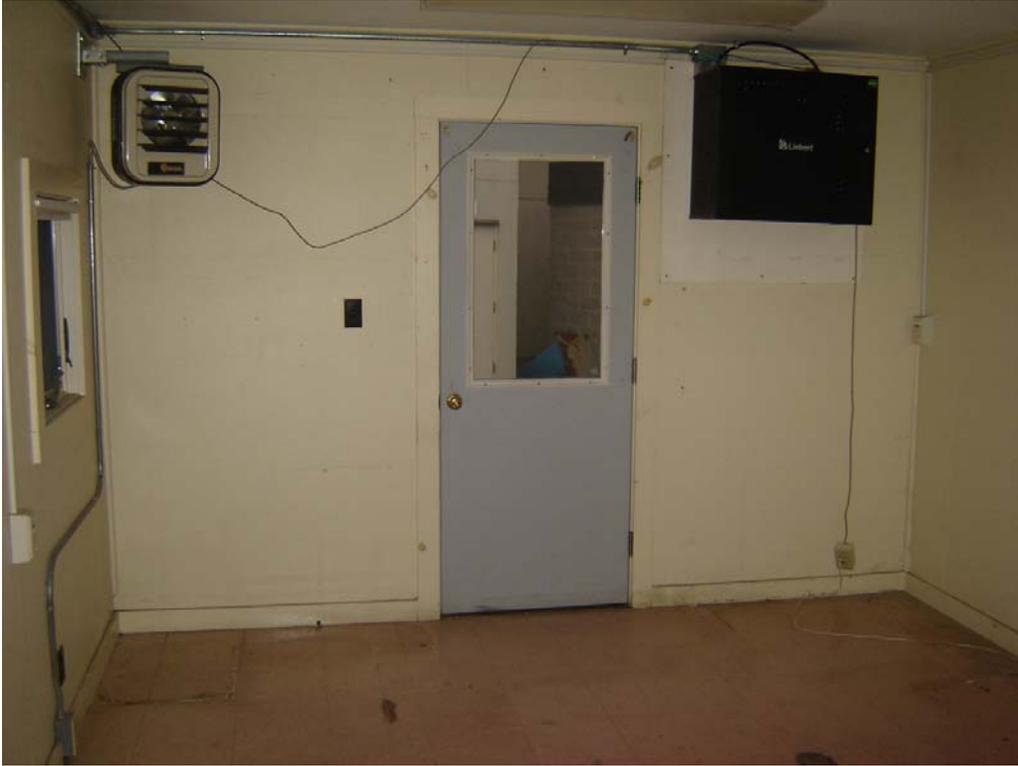
No.7 Buildings 450 and 451, NAS Brunswick December 20, 2010
Training Office interior

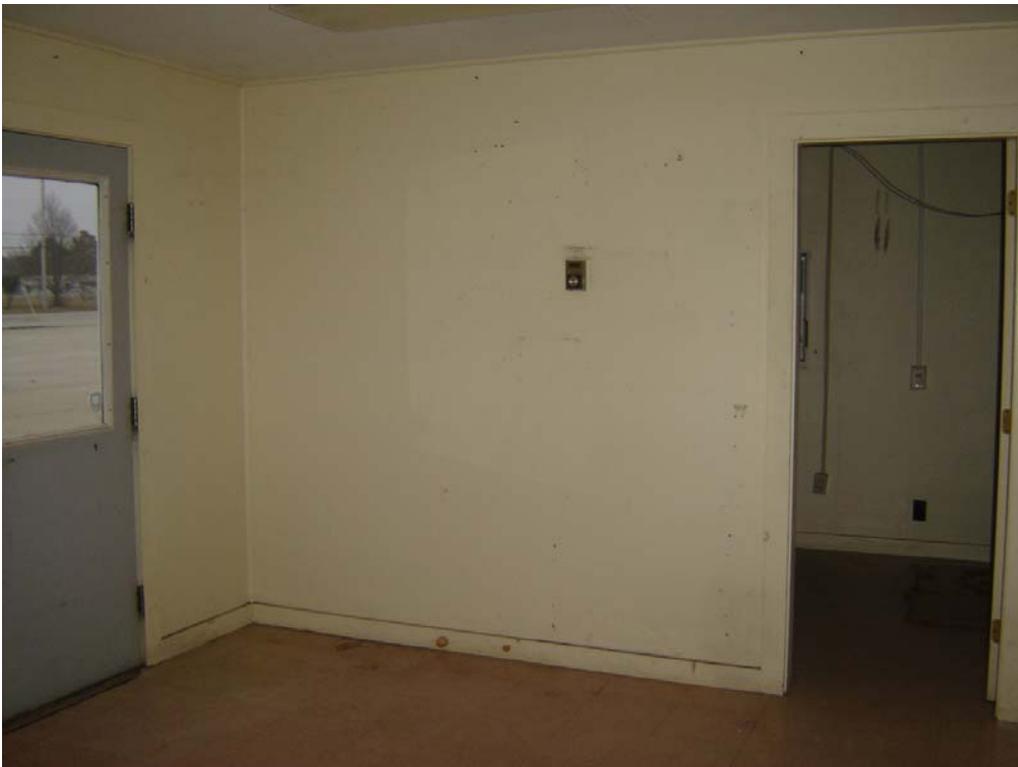
No. 8 Buildings 450 and 451, NAS Brunswick December 20, 2010
Training Office interior; east entrance/exit door and entrance to second room on south side
