FINAL RESOURCE CONSERVATION AND RECOVERY ACT PARTIAL CLOSURE REPORT
FOR BUILDING 480 WITH TRANSMITTAL LETTER NAS BRUNSWICK ME
1/6/2011
NAS BRUNSWICK

RCRA PARTIAL CLOSURE REPORT
for
BUILDING 480 – WEAPONS AREA SENTRY HOUSE
NAVAL AIR STATION BRUNSWICK, MAINE
USEPA IDENTIFICATION NUMBER ME8170022018
DECEMBER 2010

**HWSA INSPECTION FORM
HAZARDOUS WASTE STORAGE AREAS CLOSURE
NAS BRUNSWICK
BRUNSWICK, MAINE
CTO WE22**

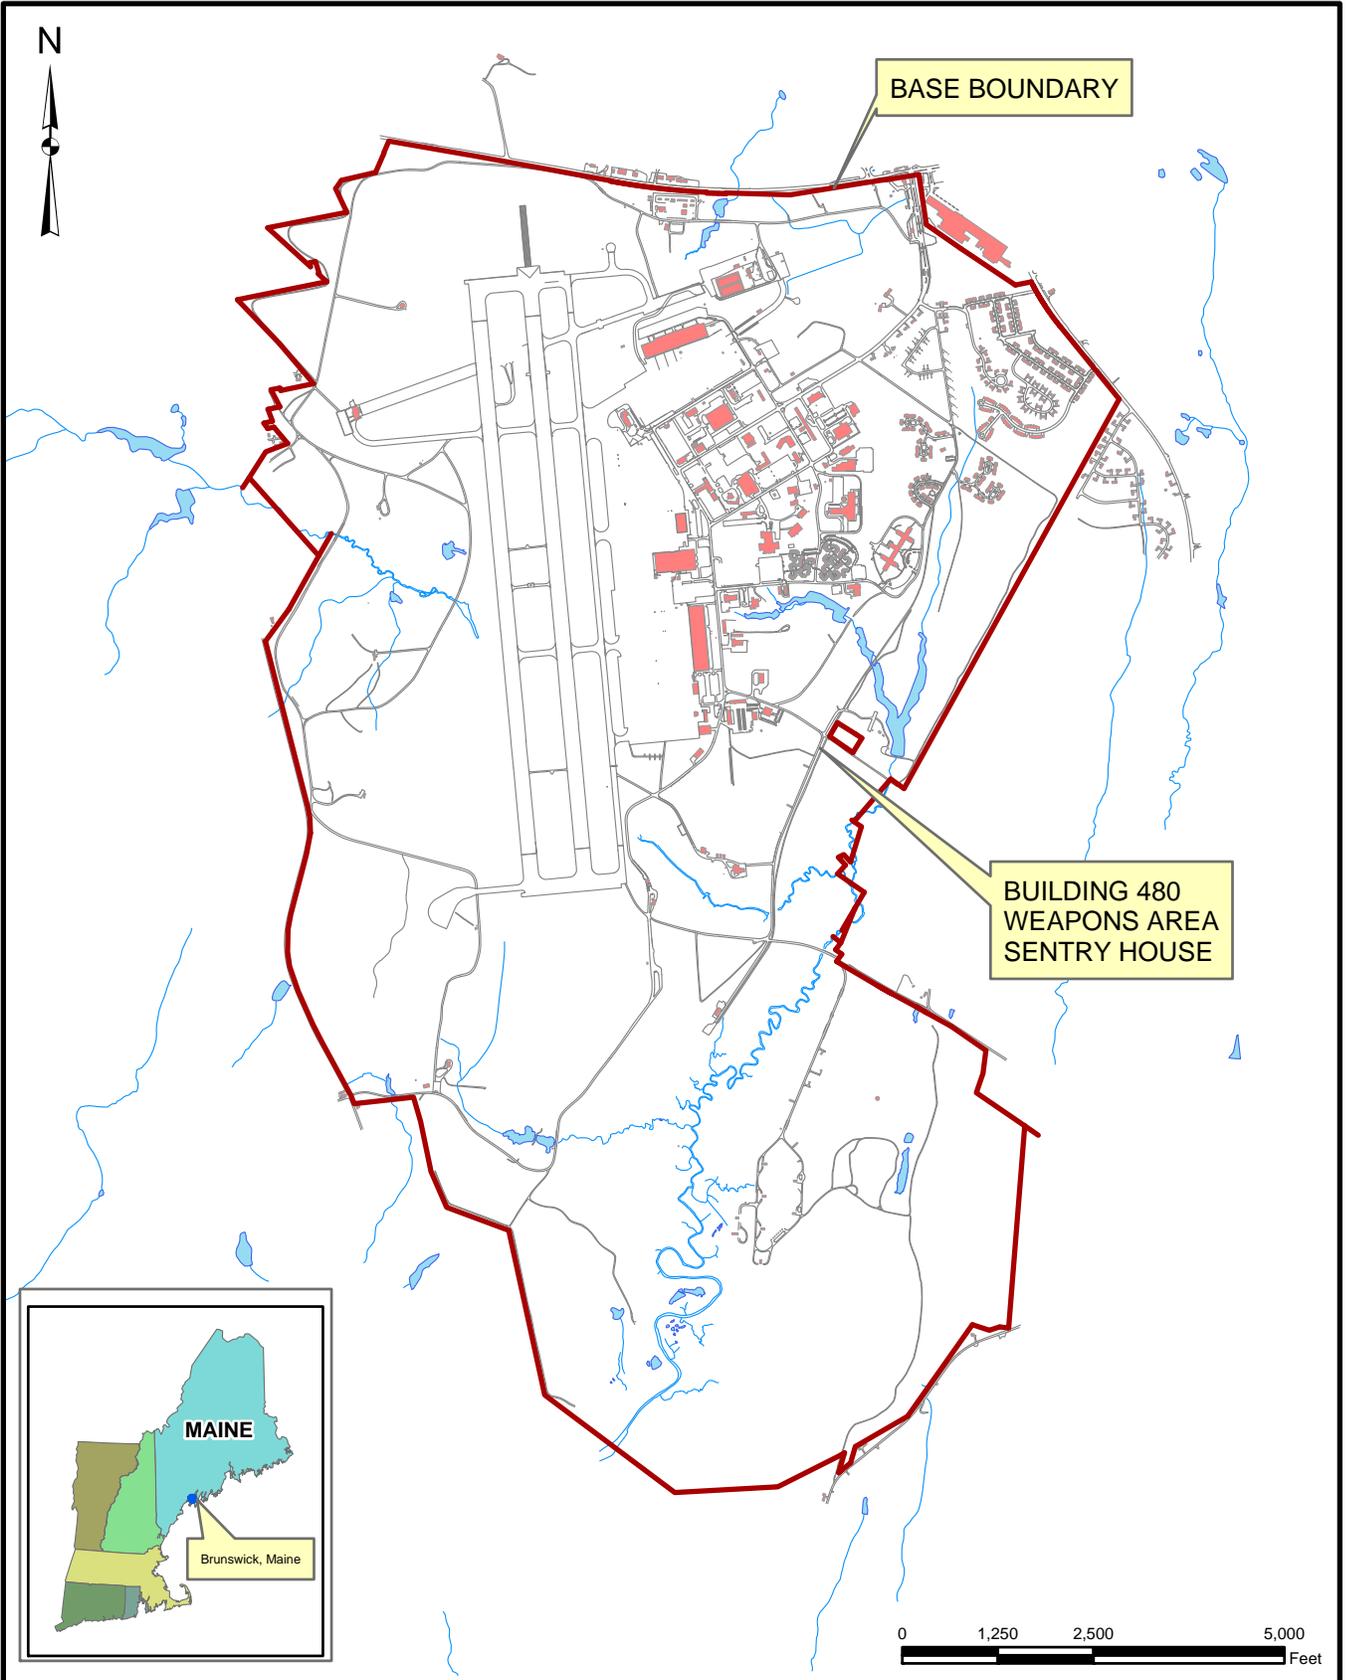
SCALE AS NOTED	
FILE I:\WASB_BLDG_480_LOCUS.MXD	
REV 0	DATE 12/30/10
FIGURE NUMBER 1

SITE LOCATION MAP
BUILDINGS 480 - WEAPONS AREA SENTRY HOUSE
RCRA PARTIAL CLOSURE REPORT
NAVAL AIR STATION BRUNSWICK, MAINE

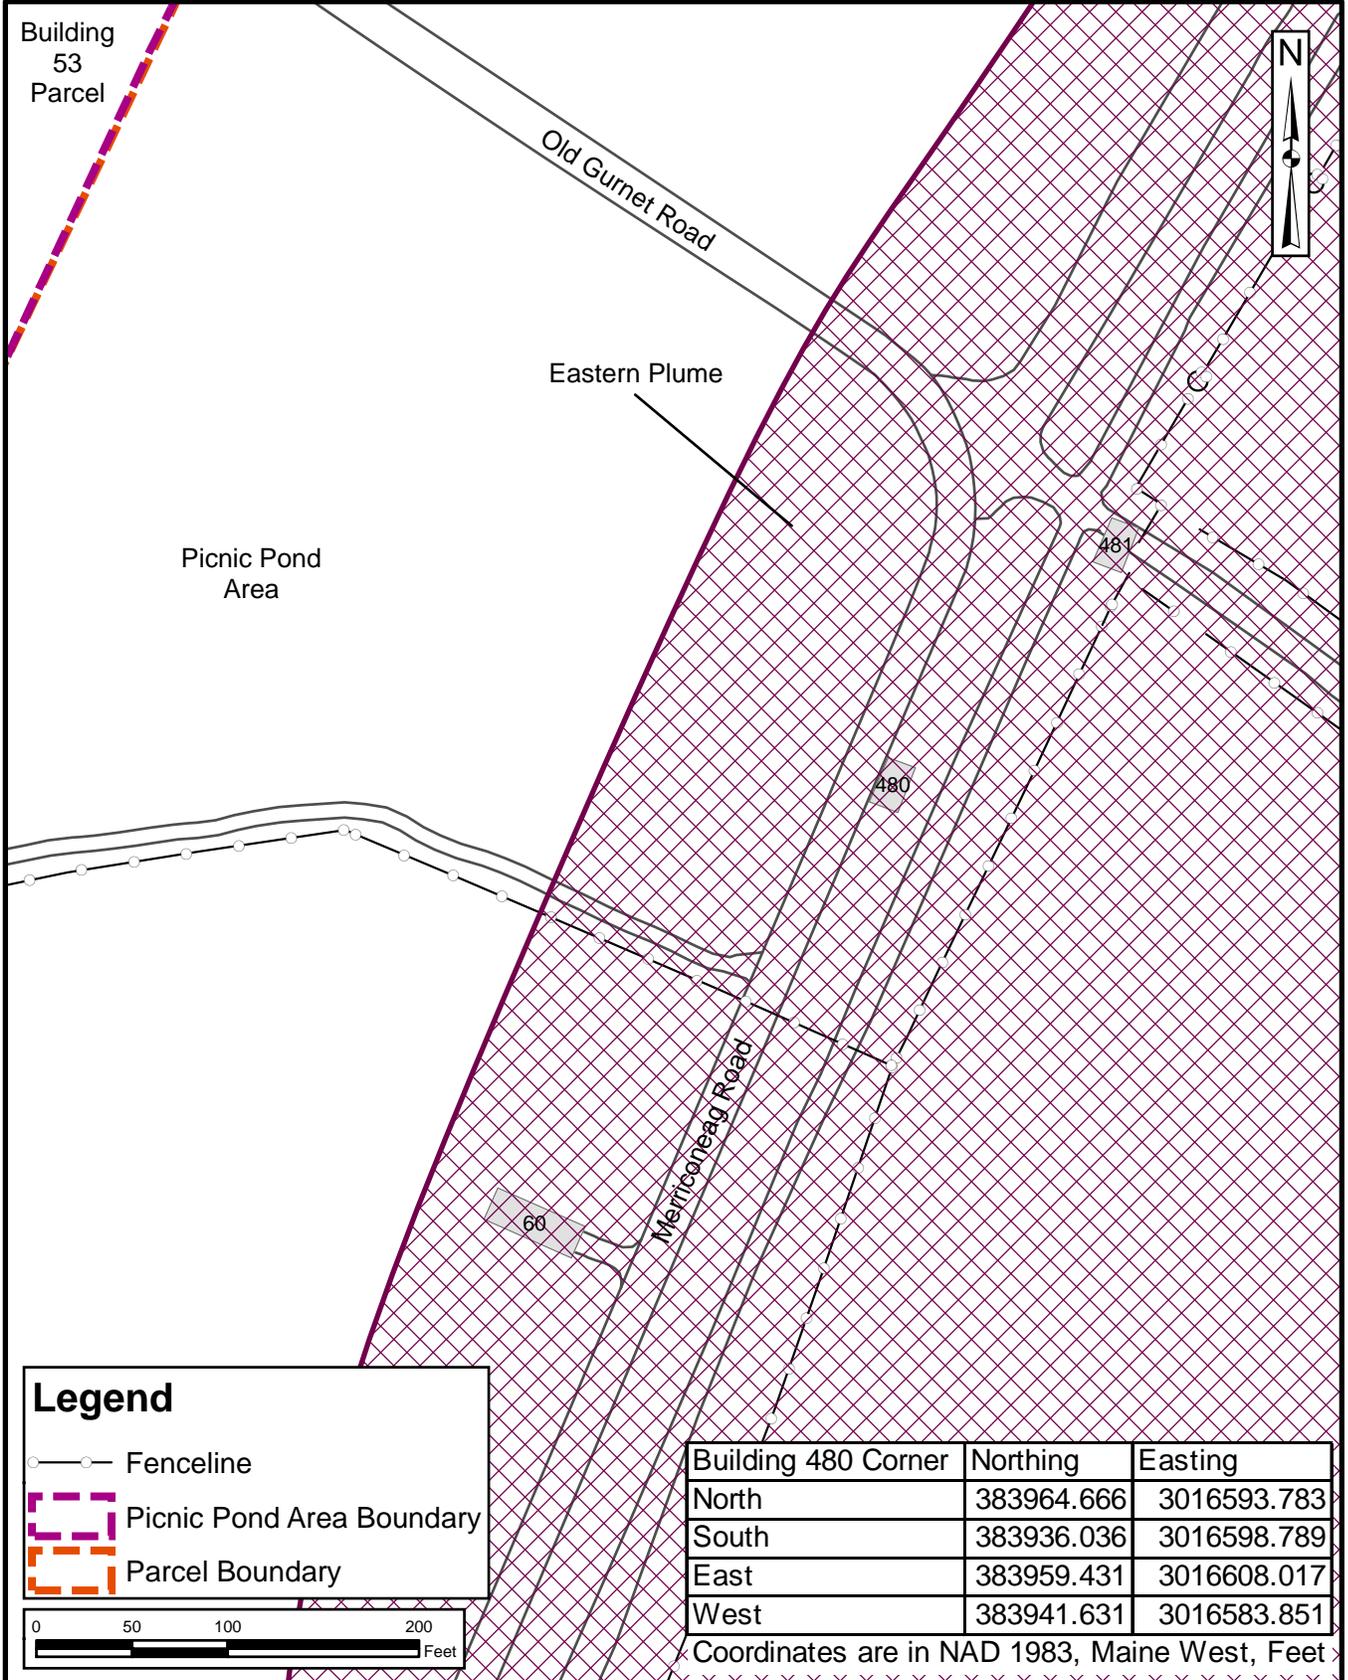
SCALE AS NOTED	
FILE L:\NASB_BLDG_480_SITE_MAP.MXD	
REV 0	DATE 12/30/10
FIGURE NUMBER FIGURE NO. 2

SITE LOCATION MAP
BUILDING 480 - WEAPONS AREA SENTRY HOUSE
RCRA PARTIAL CLOSURE REPORT
NAVAL AIR STATION BRUNSWICK, MAINE

The investigation conducted under this report applies only to the building footprint of Building 480 (as shown on Figure 2). The Picnic Pond Area RCRA Partial Closure Report addresses the land surrounding and the groundwater underlying Building 480.

This investigation of the hazardous waste closure requirement applies to the footprint of Building 480 (as shown on Figure 2), only. It does not apply to the land surrounding or the groundwater underlying Building 480.

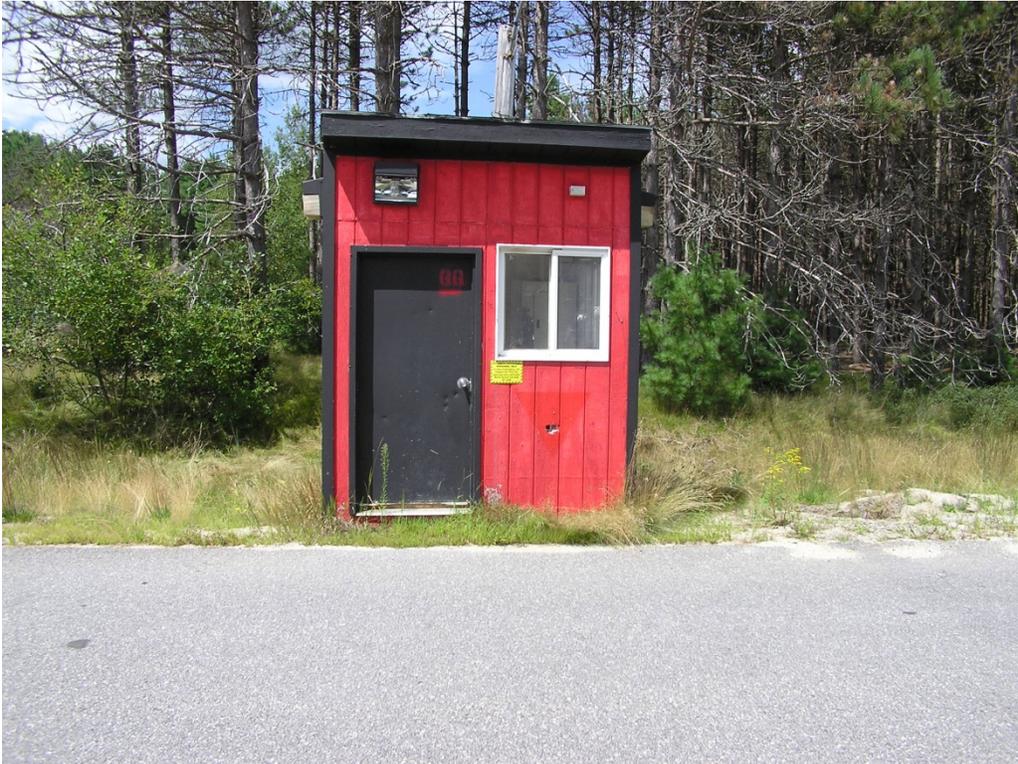
No. 1 Building 480 – Weapons Area Sentry House, NAS Brunswick August 12, 2010
Weapons Area Sentry House eastern elevation

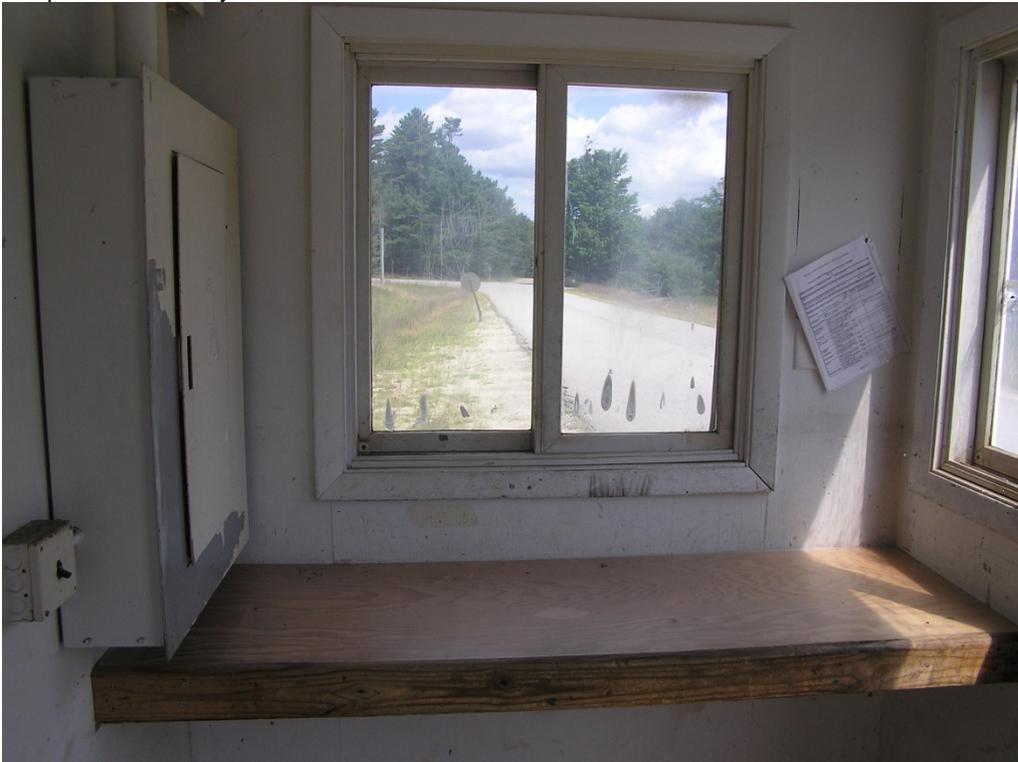
No. 2 Building 480 – Weapons Area Sentry House, NAS Brunswick August 12, 2010
Weapons Area Sentry House interior with electrical panel at left of frame
