FINAL RESOURCE CONSERVATION AND RECOVERY ACT PARTIAL CLOSURE REPORT  
FOR BUILDING 51 WITH TRANSMITTAL LETTER NAS BRUNSWICK ME  
1/21/2011  
NAS BRUNSWICK

**RCRA PARTIAL CLOSURE REPORT**  
**for**  
**BUILDING 51 – NCIS/FIRE PREVENTION PARCEL**  
**NAVAL AIR STATION BRUNSWICK, MAINE**  
**USEPA IDENTIFICATION NUMBER ME8170022018**  
**JANUARY 2011**

**HWSA INSPECTION FORM  
HAZARDOUS WASTE STORAGE AREAS CLOSURE  
NAS BRUNSWICK  
BRUNSWICK, MAINE  
CTO WE22**

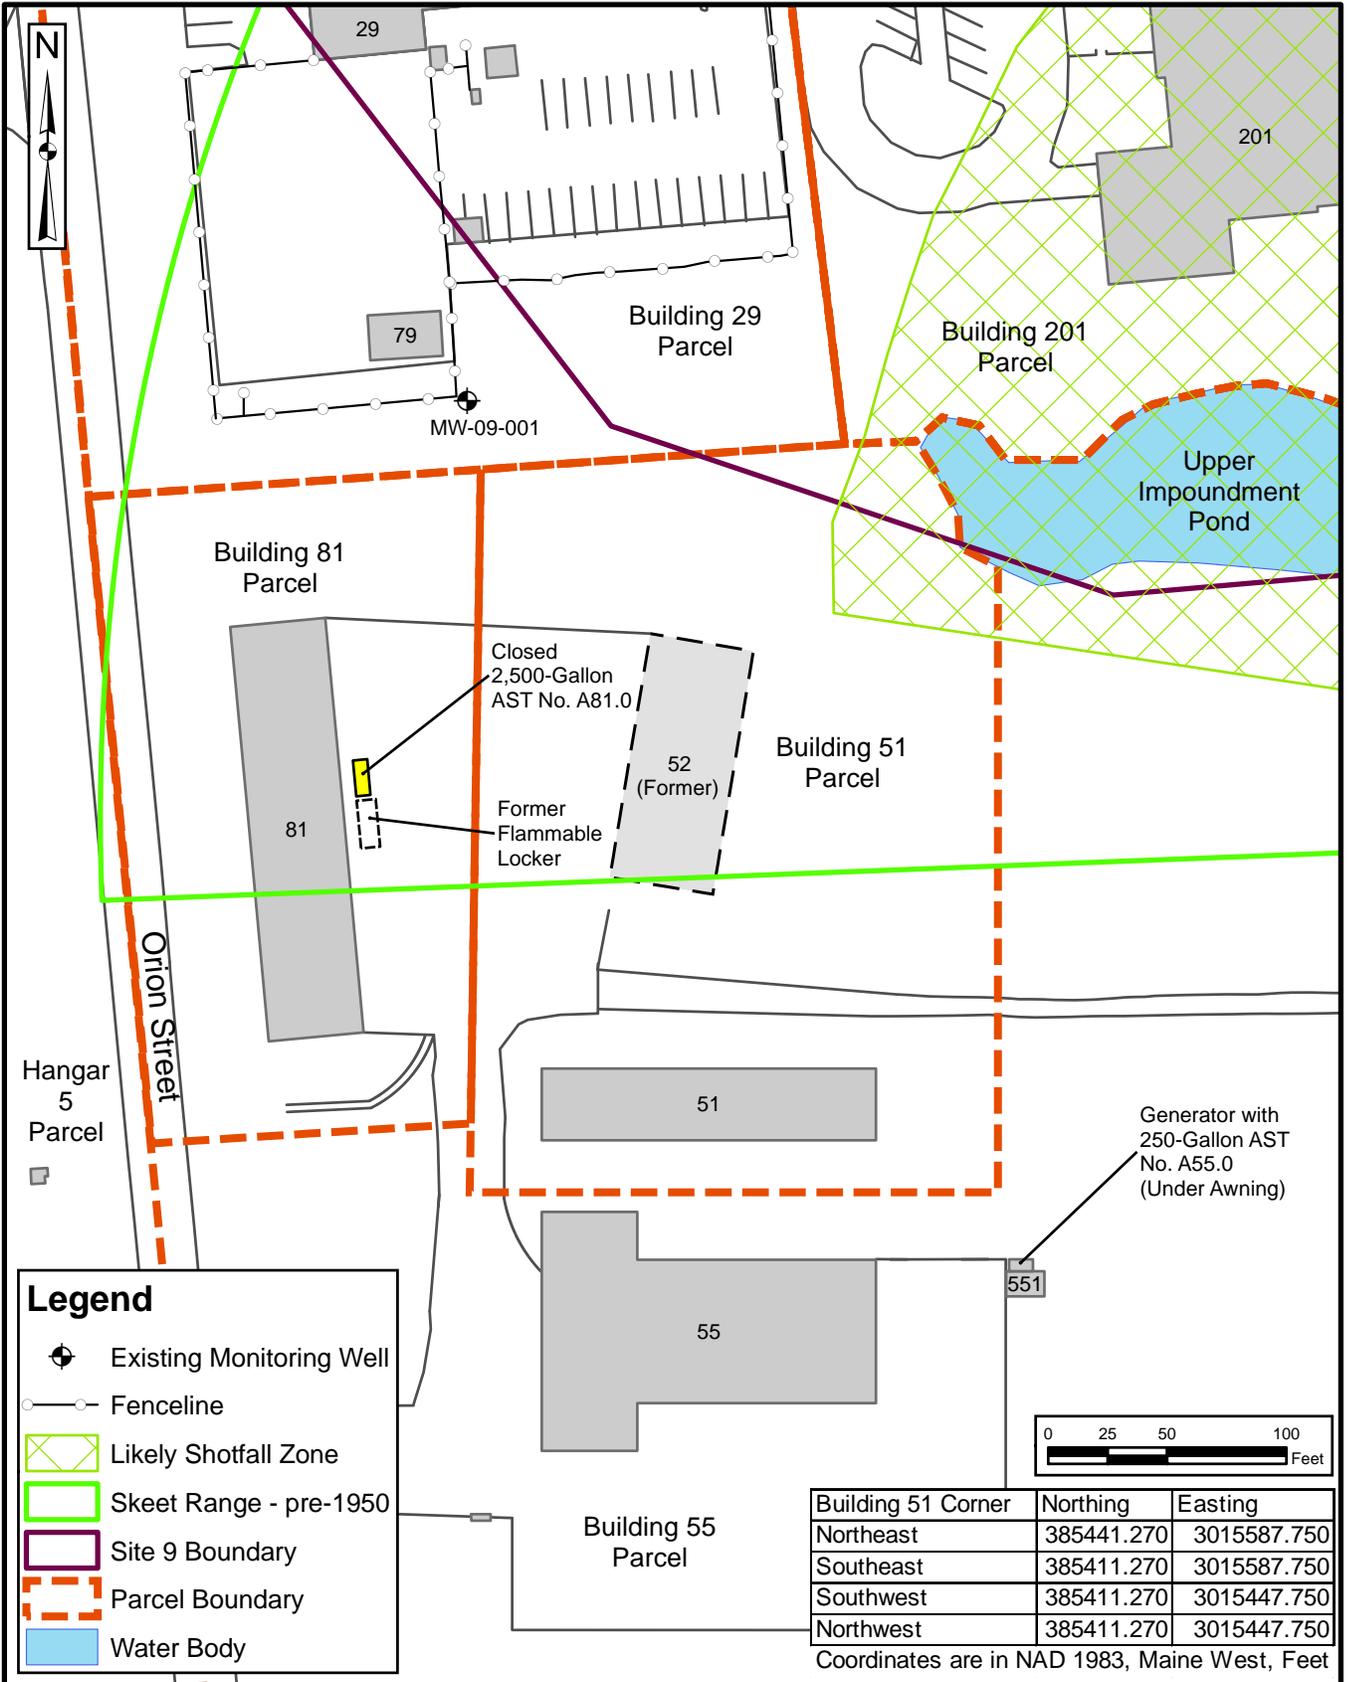
A portion of the northeastern area of the parcel lies within the boundaries of Installation Restoration Program (IRP) Site 9, the Neptune Drive Disposal Site (Figure 2). Also, the southern boundary of the Skeet Range Military Munitions Response Program (MMRP) Site crosses through the central portion of the parcel. Additional information on Site 9 and the Skeet Range as they relate to the Building 51 parcel is provided below, in Section 3.

As indicated on Figure 2, the northeast portion of the Building 51 parcel is located within the "likely shotfall zone" of the former NAS Brunswick Skeet Range, located east of the parcel and south of the Lower Impoundment Pond. The range is currently being investigated under the MMRP. The Skeet Range investigation results have not been published as of the date of this closure report. Any potential adverse impacts to the parcel resulting from past skeet range activities will be addressed by the MMRP.

As noted in Section 2, a small portion of the southwestern boundary of IRP Site 9 falls within the northeastern portion of the Building 51 parcel (Figure 2). From the Site 9 landfill/source area, located to the north/northeast of the parcel, groundwater flow is generally in a south-southeast direction. Therefore, migration of contaminated groundwater from the IRP Site 9 source area would not be expected to impact the Building 51 parcel, which is located southwest of Site 9.

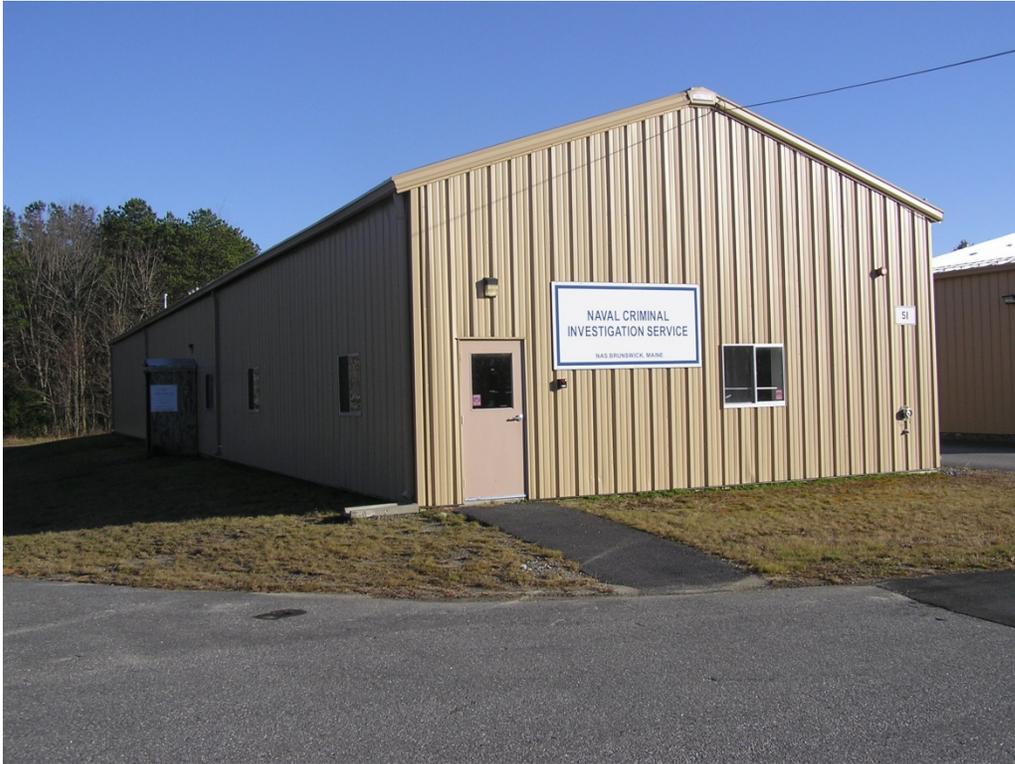
No. 1 Building 51 – NCIS/Fire Prevention, NAS Brunswick December 2, 2010  
NCIS/Fire Prevention Building western elevation; Building 55 to right of frame

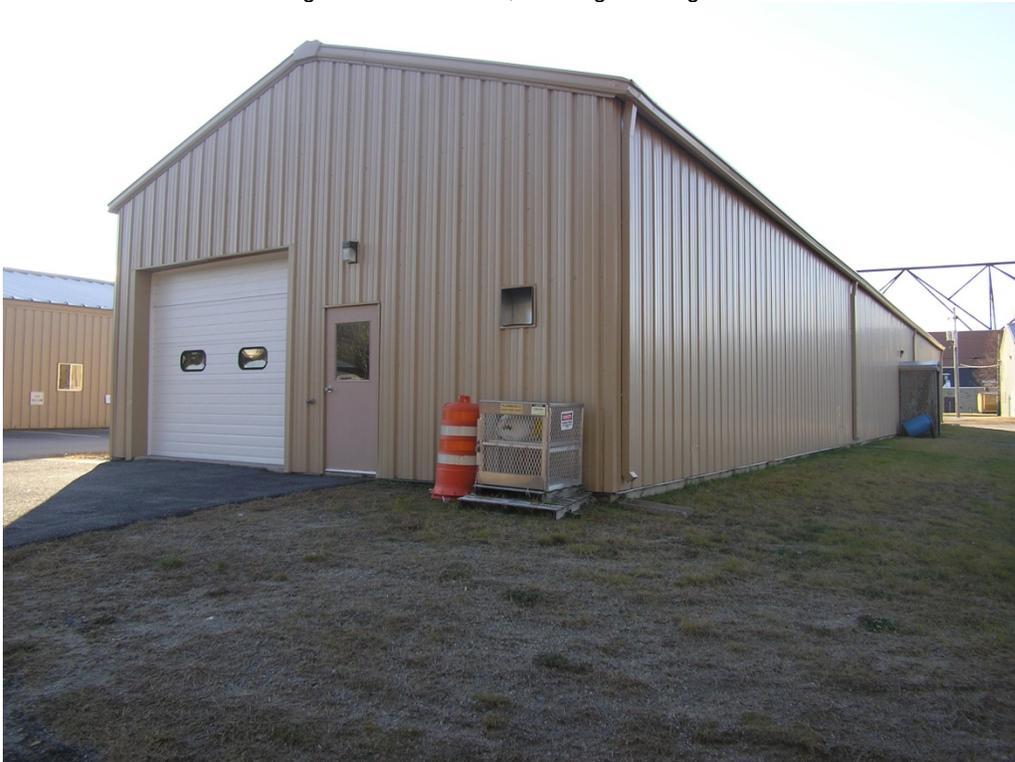
No. 2 Building 51 – NCIS/Fire Prevention, NAS Brunswick December 2, 2010  
NCIS/Fire Prevention Building eastern elevation

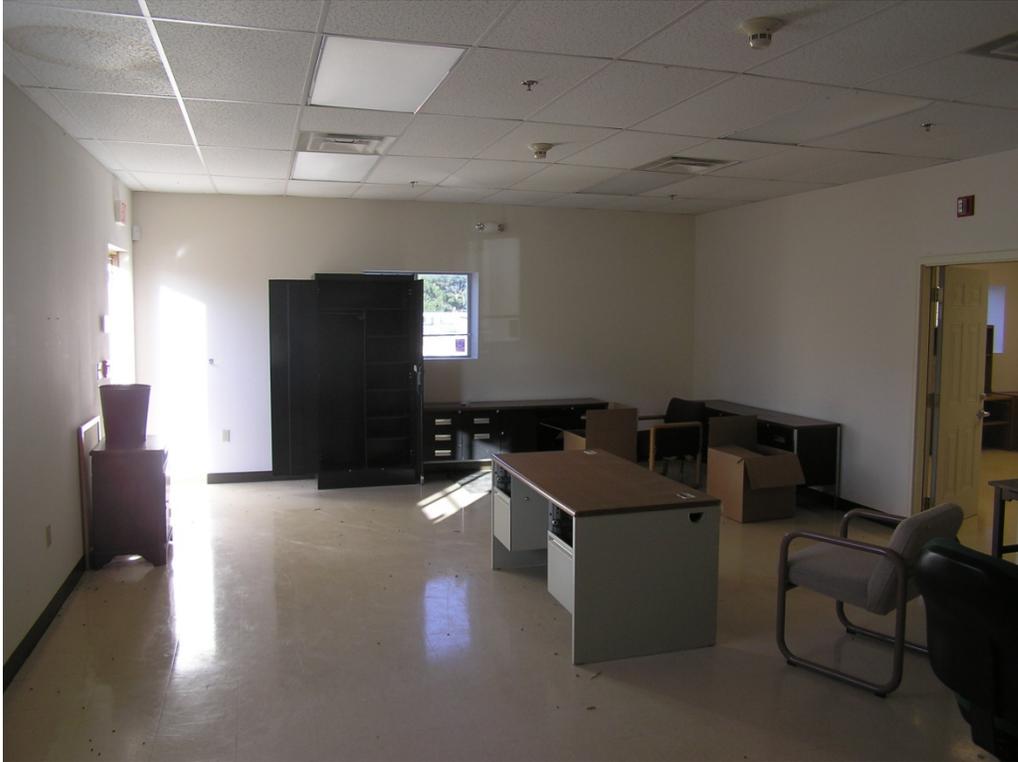
No. 3 Building 51 – NCIS/Fire Prevention, NAS Brunswick December 2, 2010  
NCIS/Fire Prevention Building interior; NCIS office in western portion of building

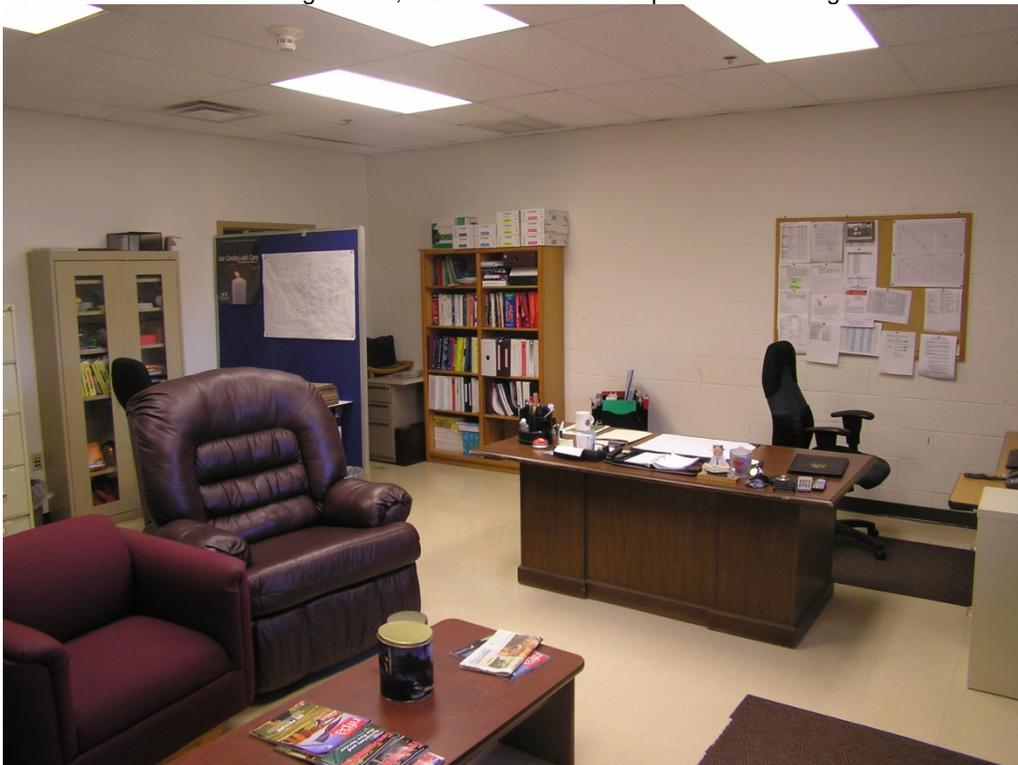
No. 4 Building 51 – NCIS/Fire Prevention, NAS Brunswick December 2, 2010  
NCIS/Fire Prevention Building interior; Fire Prevention office in eastern portion of building

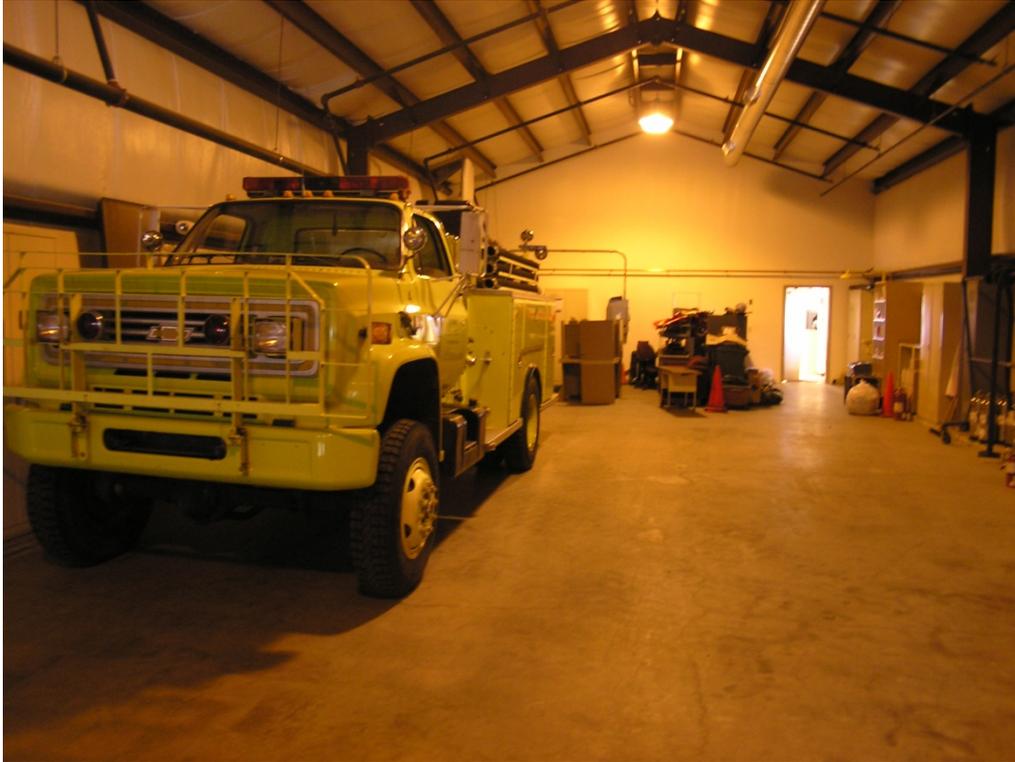
- At the time of inspection, Building 51 was in good condition; the NCIS portion of the building was vacant and contained office furniture; the Fire Prevention portion of the building was occupied and contained office furniture, fire equipment, 27 5-gallon containers of aqueous film-forming foam (AFFF), and a fire engine.

No. 5 Building 51 – NCIS/Fire Prevention, NAS Brunswick December 2, 2010  
NCIS/Fire Prevention Building interior; Fire Prevention garage used for equipment and fire engine in eastern portion of building

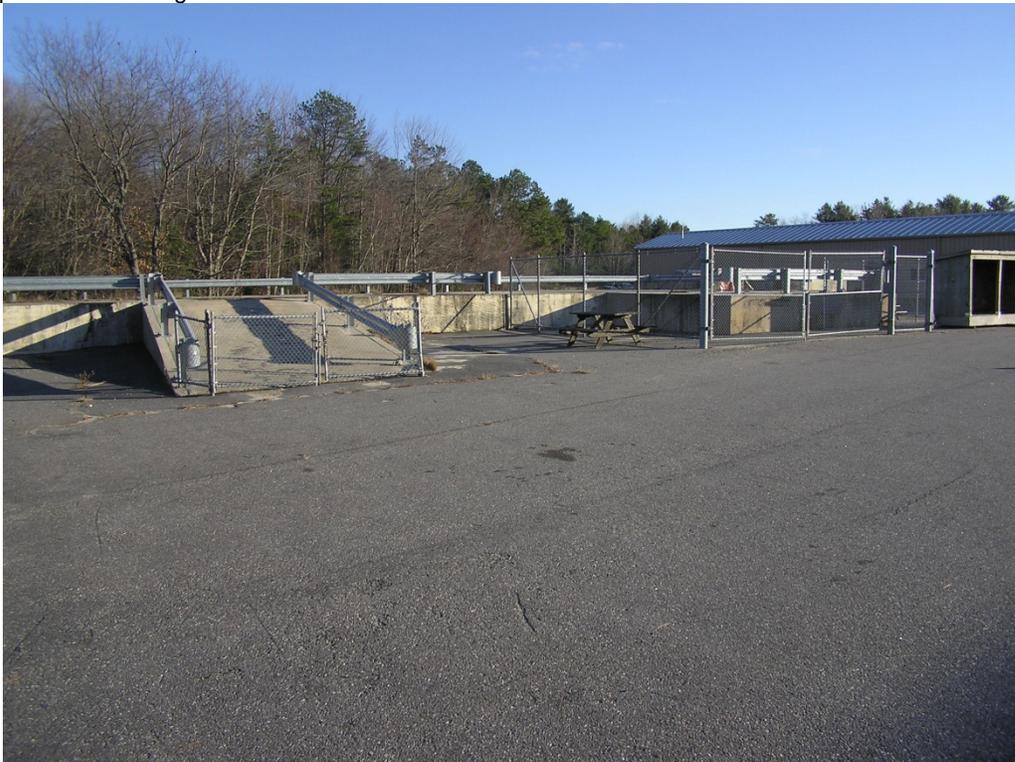
The foundation of a former building, Building 52 (Inert Storehouse), demolished prior to 2008, is located north of Building 51 in the northern portion of the parcel. That building's concrete, loading-ramp foundation remains, surrounded by chain-link fencing. Steel guardrails have been installed along the foundation's perimeter. Since the demolition of Building 52, this structure has been used for the bulk loading of dumpsters.

Former Building 52, demolished prior to 2008, served as an inert storehouse for its entire service timeframe. Based on its use as an inert storehouse, it is unlikely that any activities within the building would have generated hazardous waste. The existing, concrete loading-platform, remaining after demolition of Building 52, was used only for bulk loading and unloading of empty dumpsters. Therefore, the location of the former building was not targeted for further investigation.

No. 6 Building 51 – NCIS/Fire Prevention, NAS Brunswick December 2, 2010  
Former Building 52 (Inert Storehouse) foundation north of Building 51
