FINAL RESOURCE CONSERVATION AND RECOVERY ACT PARTIAL CLOSURE REPORT  
FOR WEST BASE AREA LAND AREA 15A WITH TRANSMITTAL LETTER NAS BRUNSWICK  
ME  
2/11/2011  
NAS BRUNSWICK

Subj: Final RCRA Partial Closure Report for West Base Area (Land Area 15A)

**RCRA PARTIAL CLOSURE REPORT**  
**for**  
**WEST BASE AREA**  
**NAVAL AIR STATION BRUNSWICK, MAINE**  
**USEPA IDENTIFICATION NUMBER ME8170022018**  
**FEBRUARY 2011**

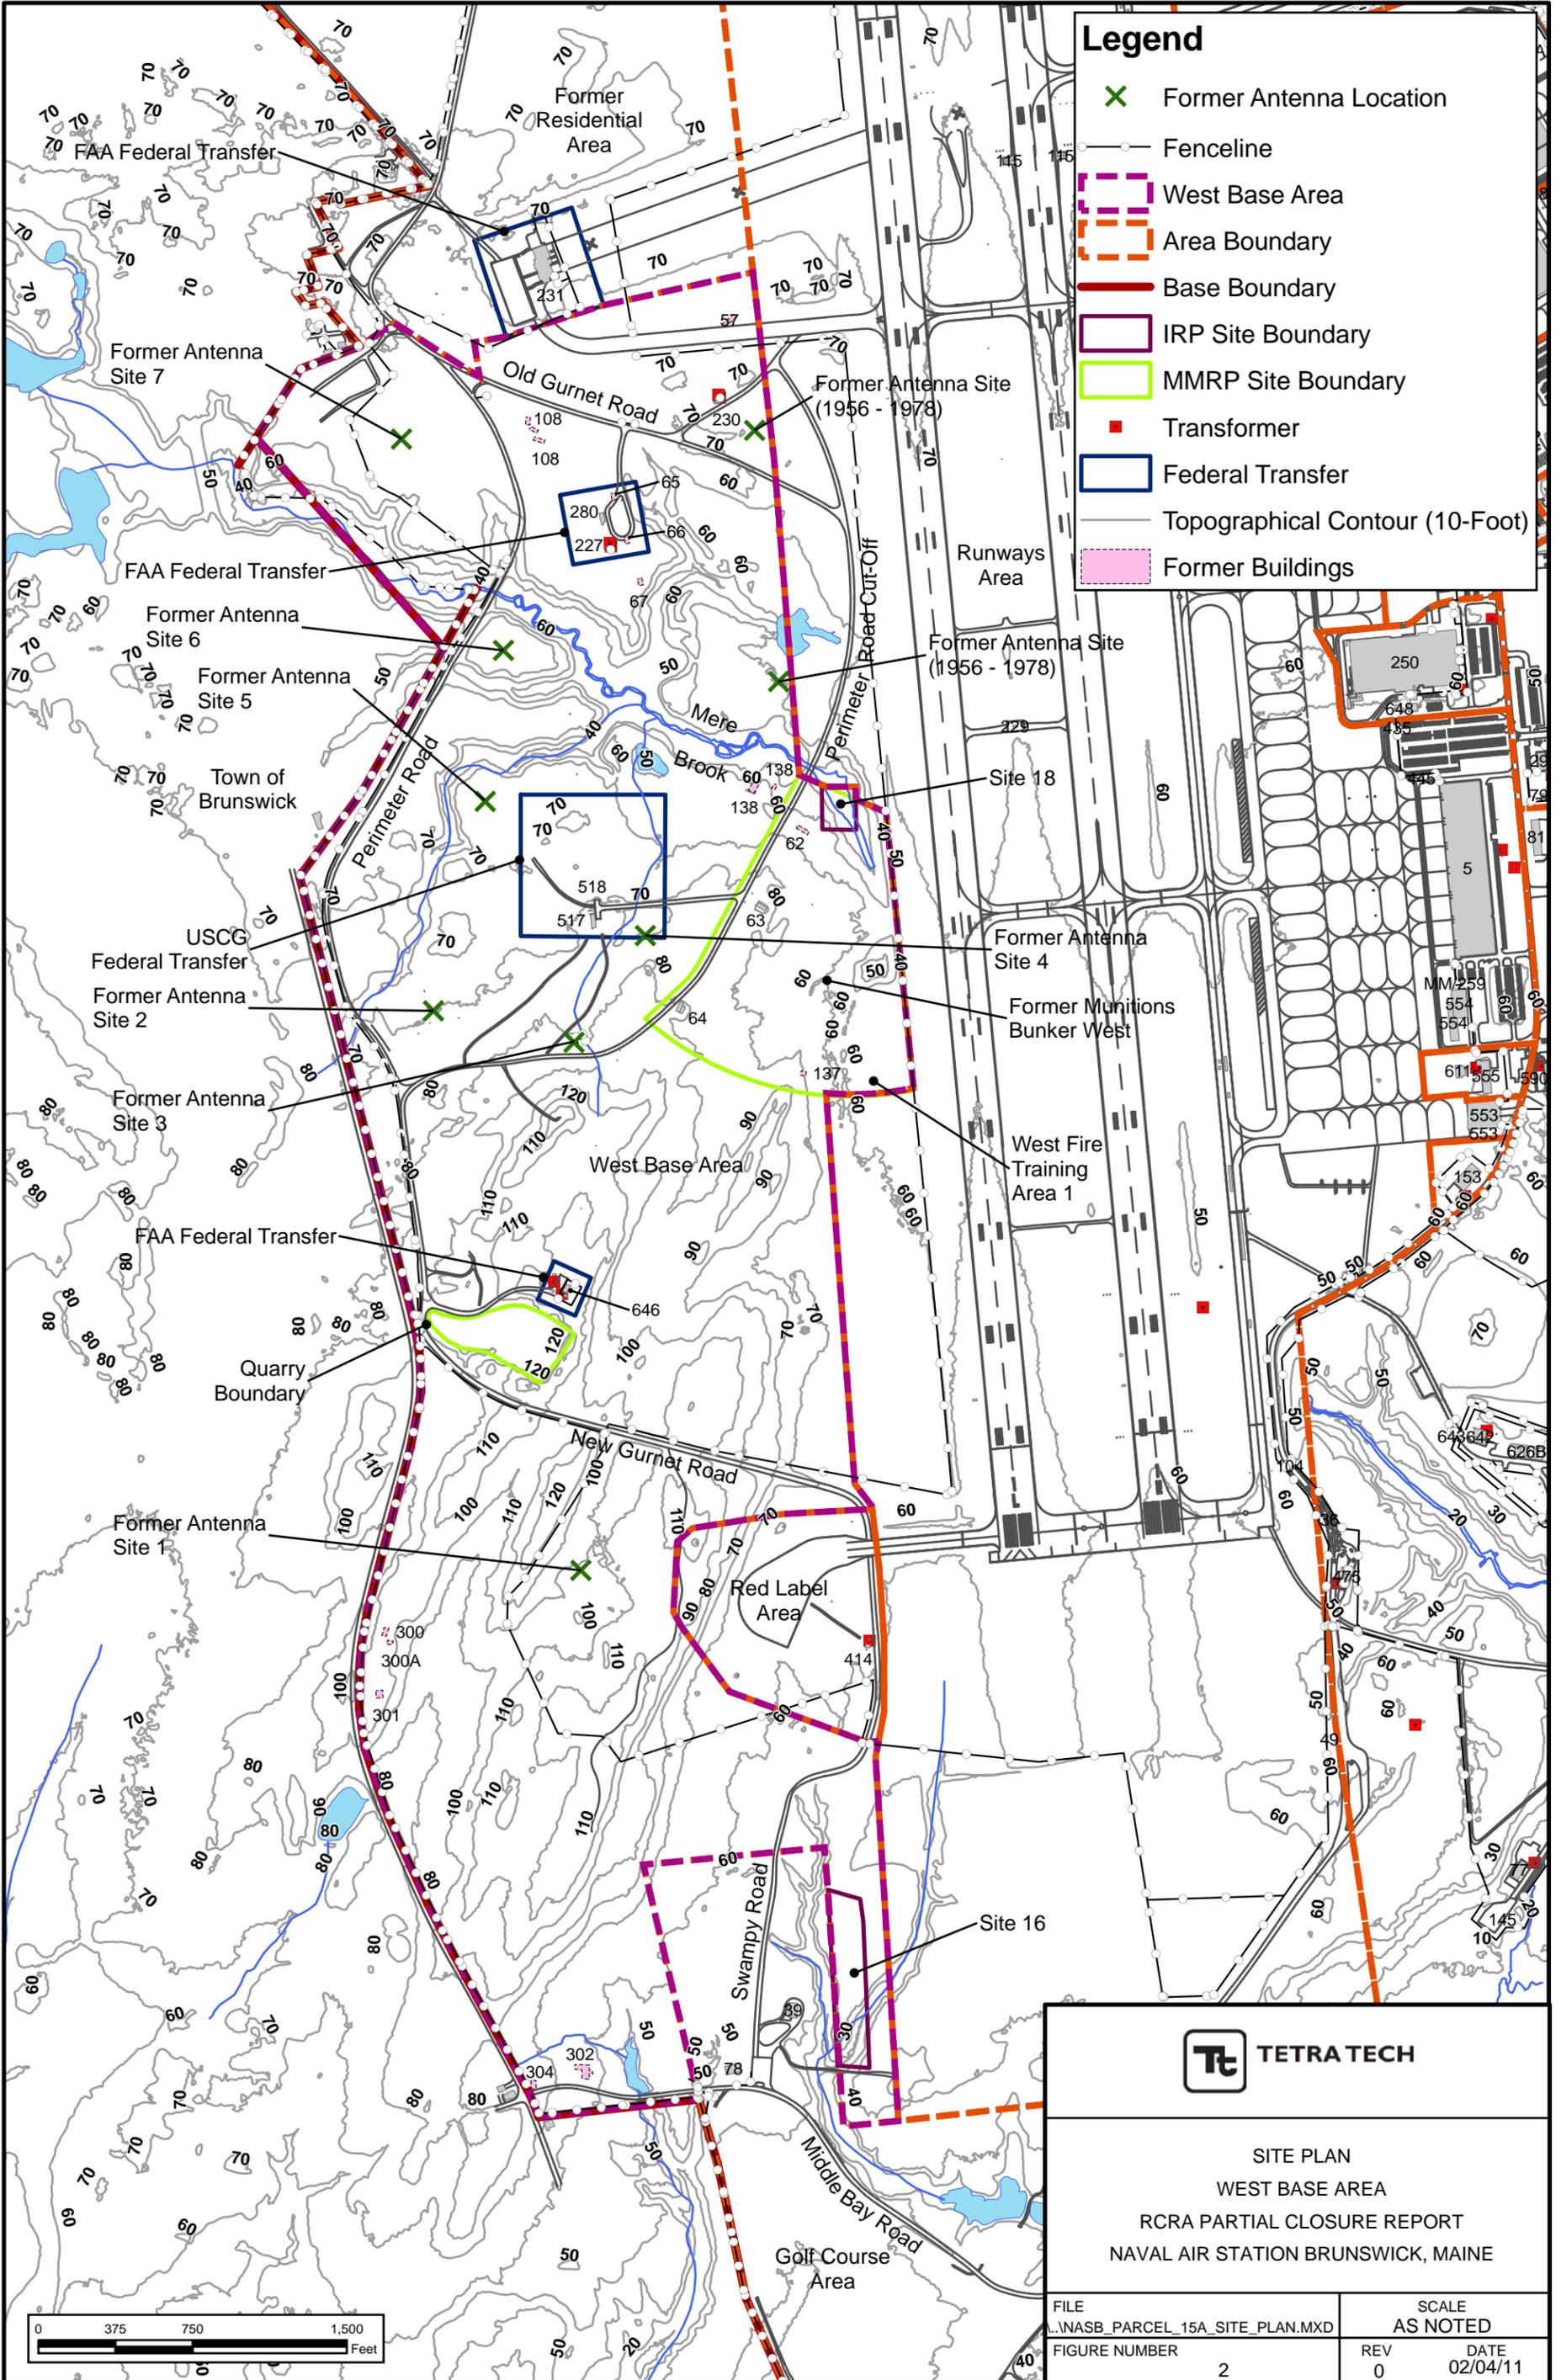
FILE ...NASB_PARCEL_15A_SITE_PLAN.MXD	SCALE AS NOTED
FIGURE NUMBER 2	REV 0
	DATE 02/04/11

The West Base Area is located in the west-central area of NAS Brunswick, bordering the western boundary of the base (Figure 1). As shown in Figure 2, the approximately 399-acre West Base Area is bordered as follows:

As indicated in Figures 2 and 3, three areas physically located within the West Base Area have

This investigation of the hazardous waste closure requirements applies to the West Base Area (as shown on Figure 2) only, with exclusion as noted in Section 2.

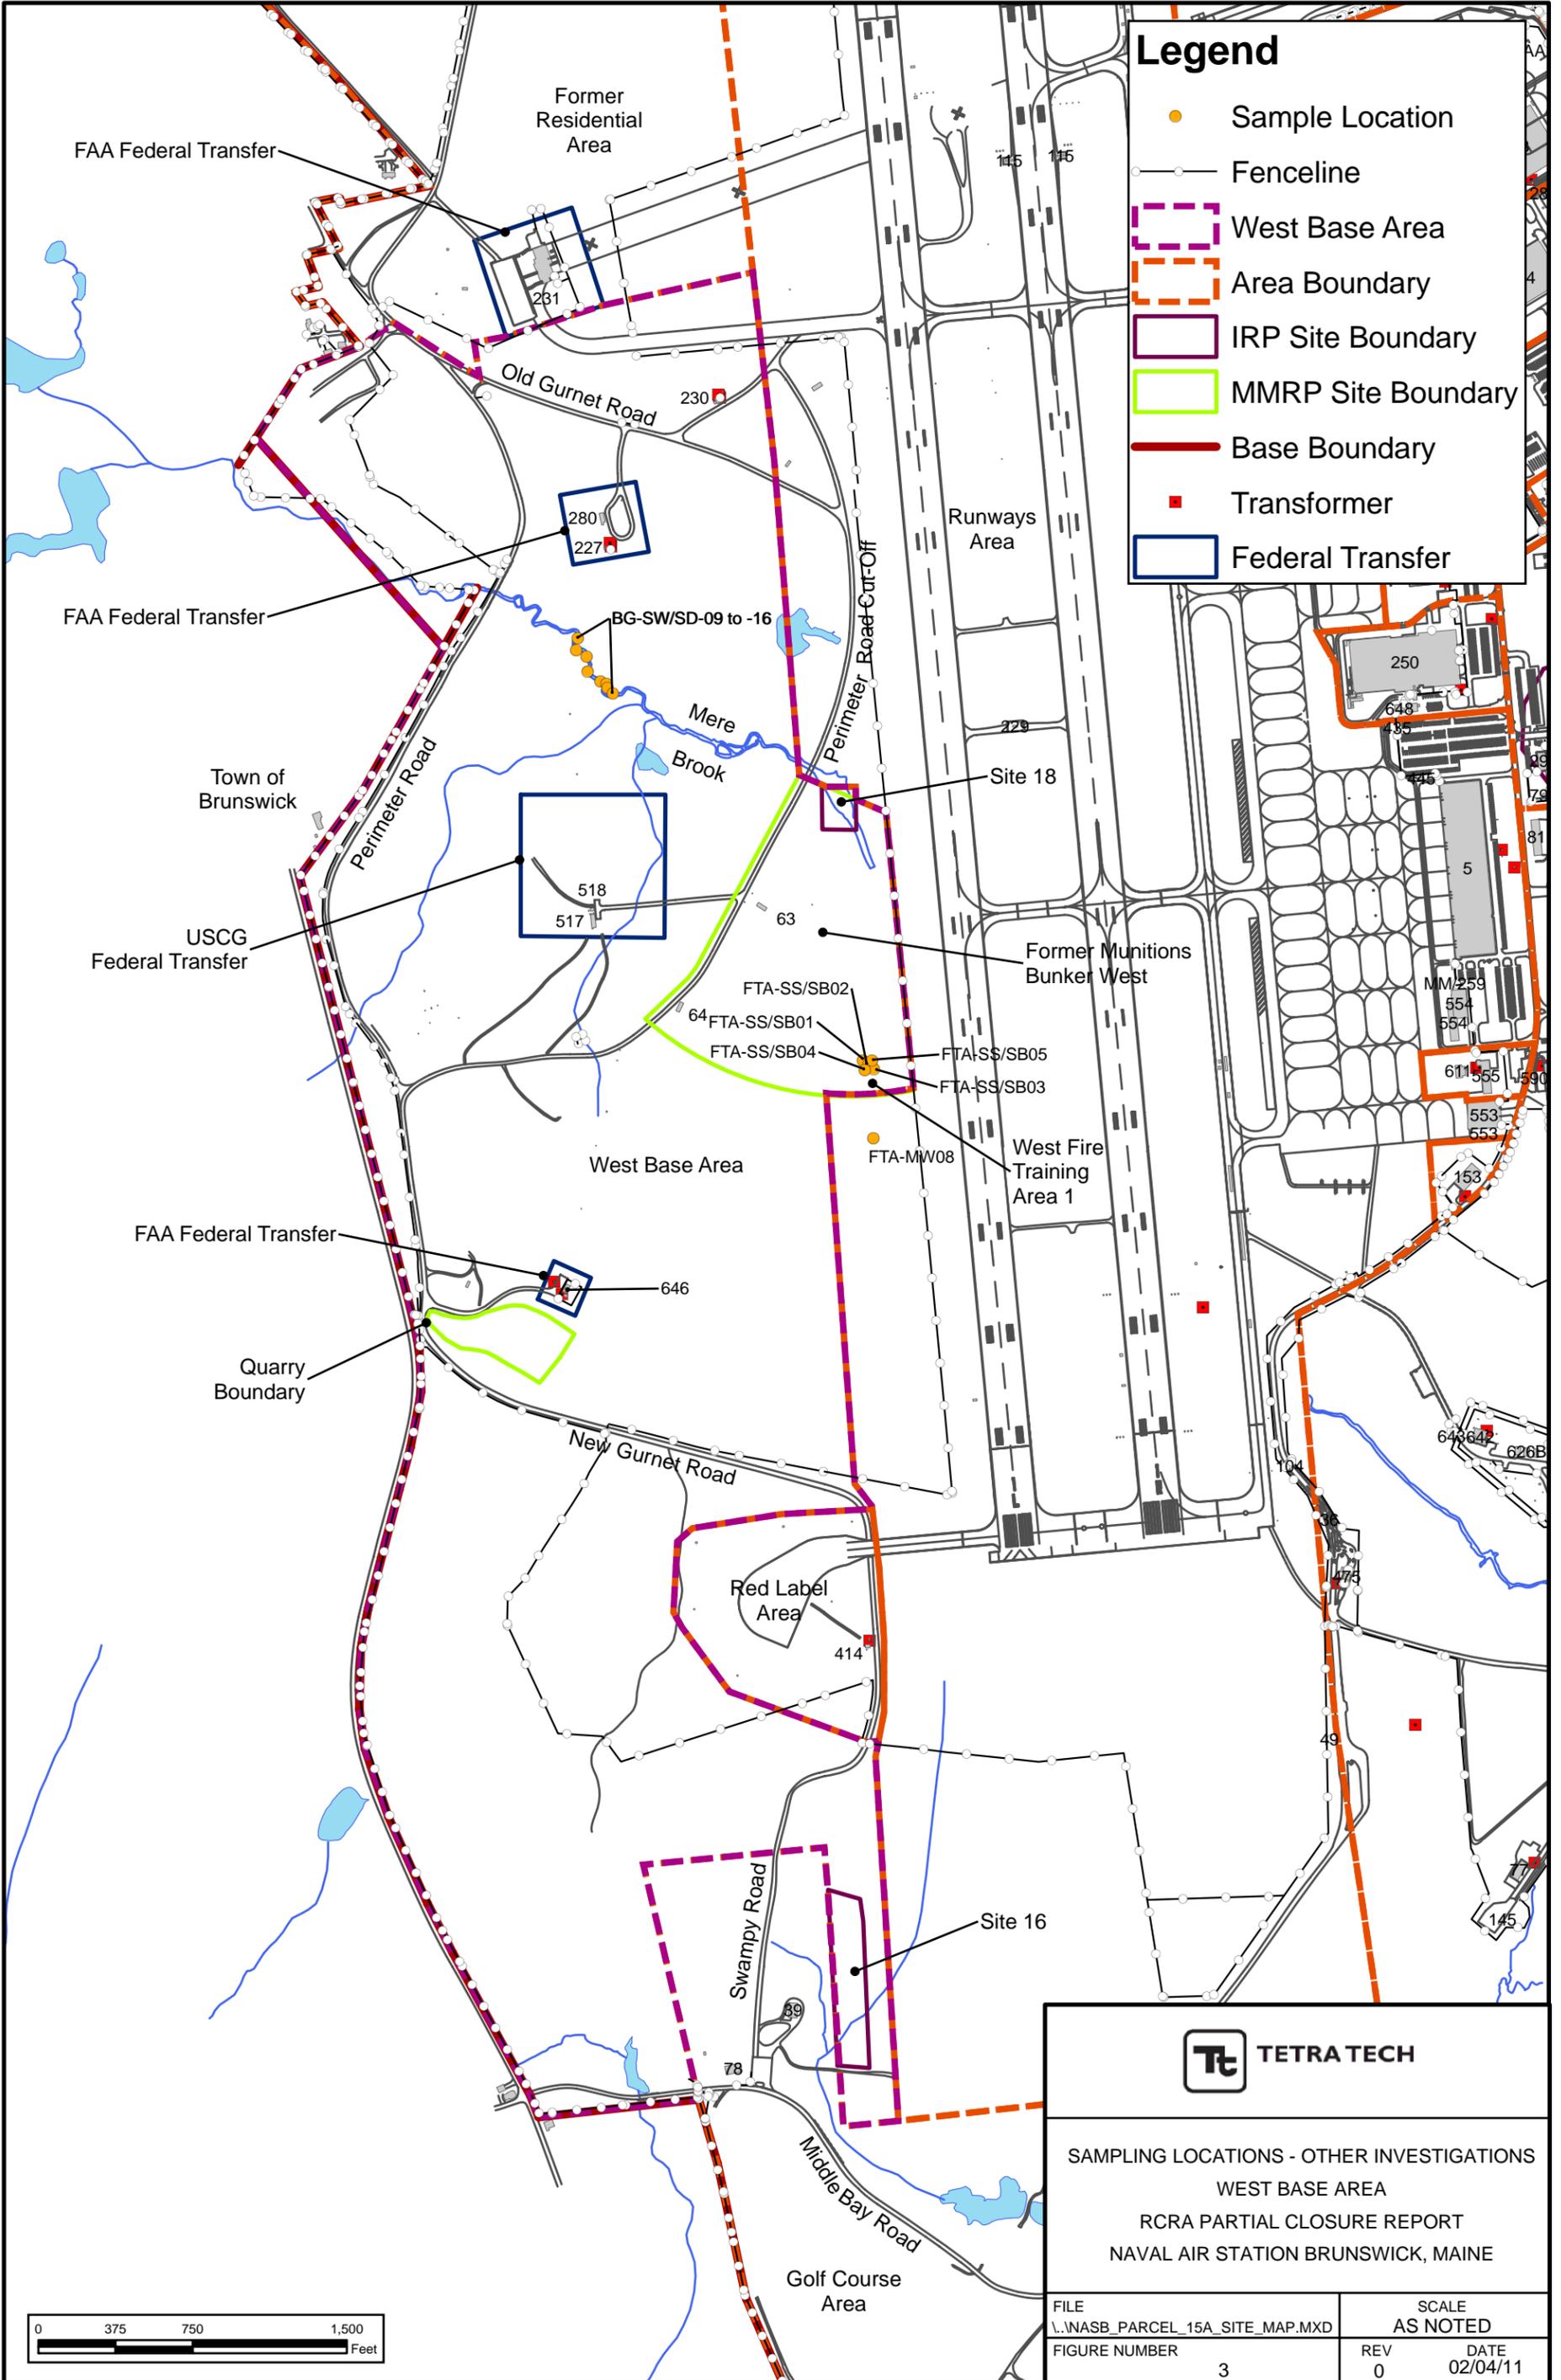
FILE	I:\NASB_PARCEL_15A_SITE_MAP.MXD		SCALE	AS NOTED
FIGURE NUMBER	3	REV	0	DATE
				02/04/11

As part of the AOPI investigation, five surficial soil samples and five subsurface soil samples (including two duplicate samples) were collected from five boring locations in October 2010 (a revision from the field work described in the Work Plan for the AOPI Screening Investigation) (Tetra Tech, 2010). These soil sample locations are shown on Figure 3 and are summarized below.

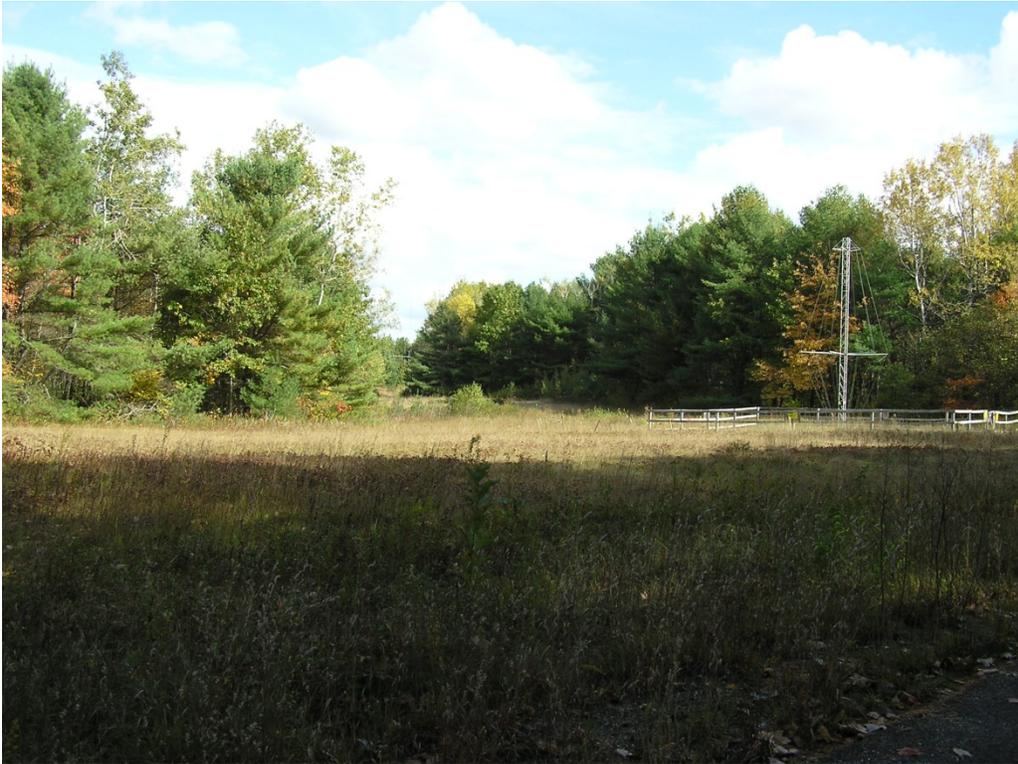
No. 1 West Base Area, NAS Brunswick October 14, 2010  
Antenna Site 3 (prior to antenna removal) from southwest

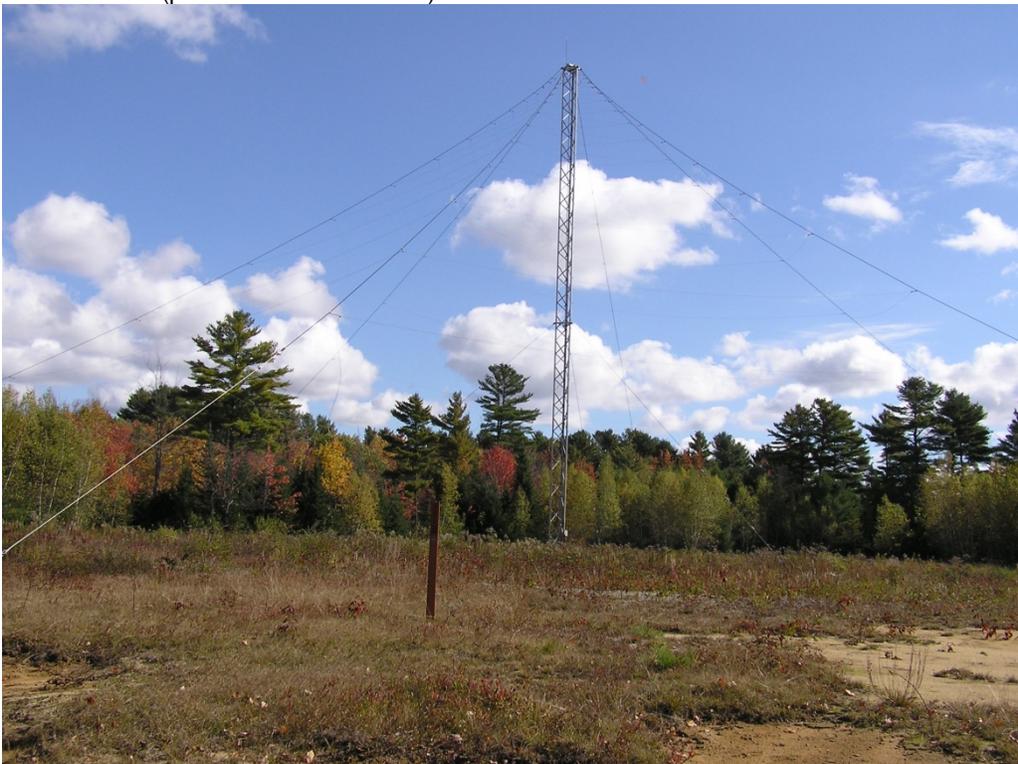
No. 1 West Base Area, NAS Brunswick October 14, 2010  
Antenna Site 6 (prior to antenna removal) from west

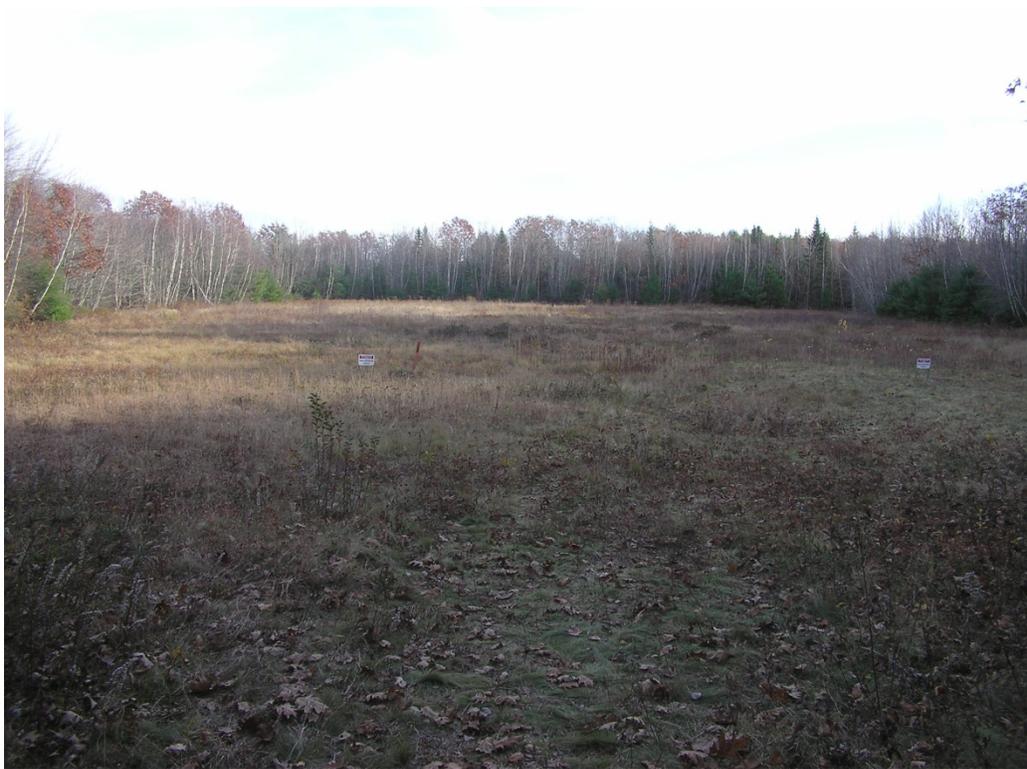
Seven former antenna sites observed, with no paint chips observed on ground, and with the antennas removed from their base, or cut to approximately 18-inches above grade. No evidence of current or other past hazardous waste disposal, or hazardous waste generation was observed. No evidence of hazardous waste residues was observed. No signs of a past release (staining, unusual odors, etc.) were observed. No hazardous waste storage areas were evident.

No. 3 West Base Area, NAS Brunswick November 3, 2010  
Antenna Site 1 (after antenna removal) from west

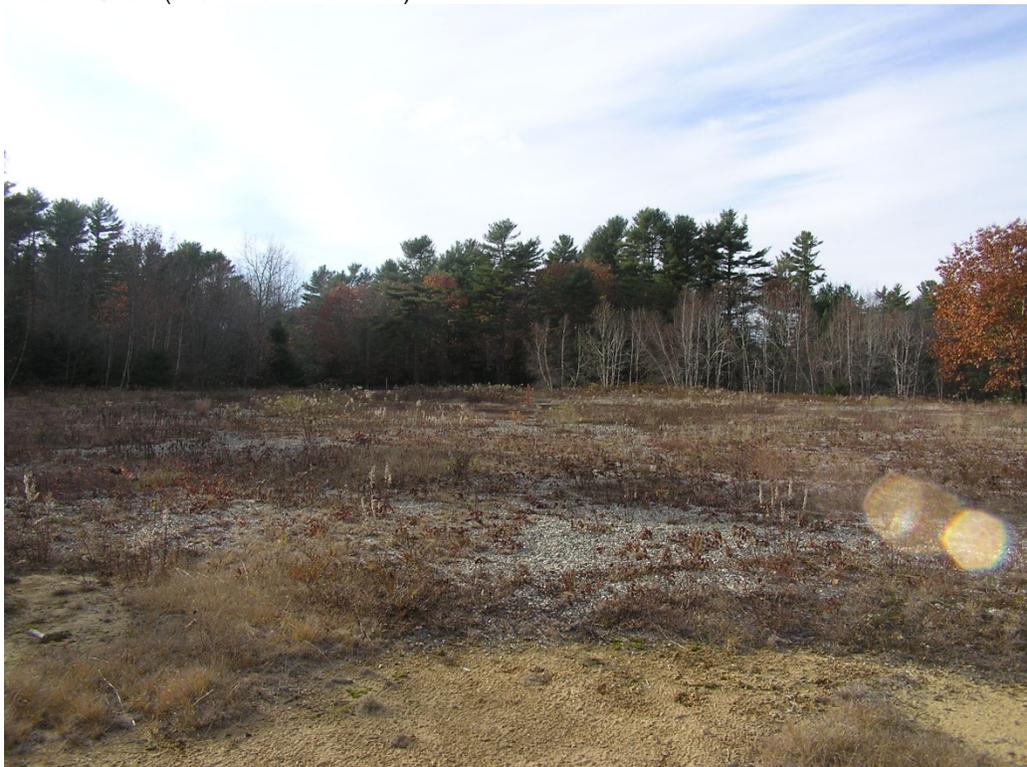
No. 4 West Base Area, NAS Brunswick November 3, 2010  
Antenna Site 6 (after antenna removal) from west

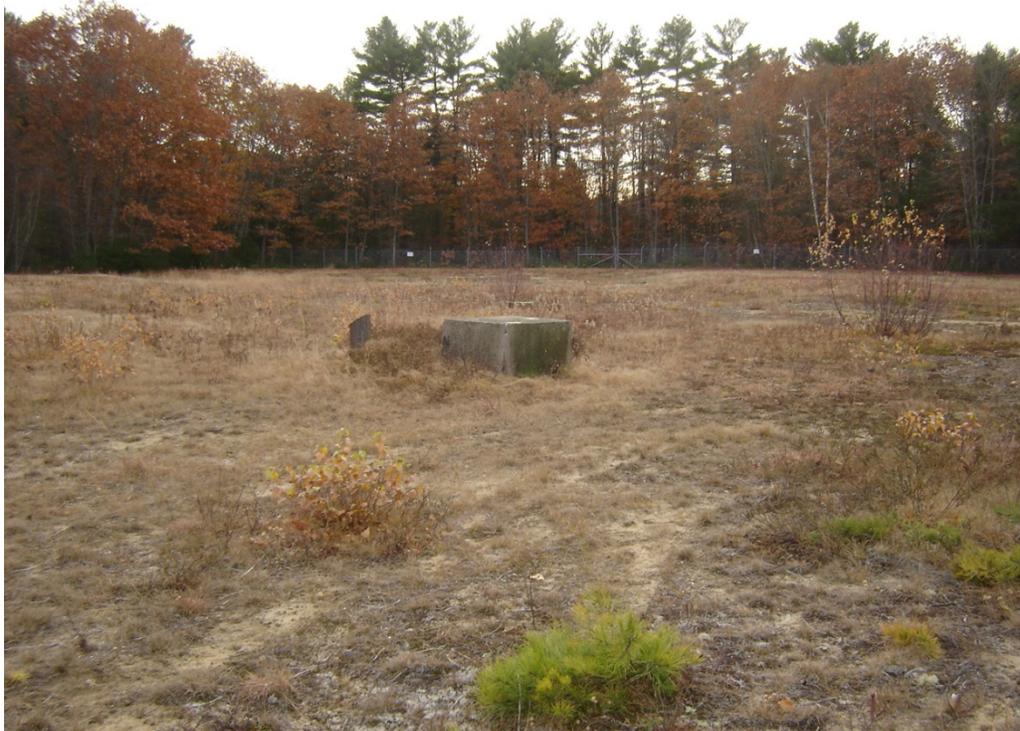
No. 5 West Base Area, NAS Brunswick November 3, 2010  
Antenna Site 7 (after antenna removal) from east

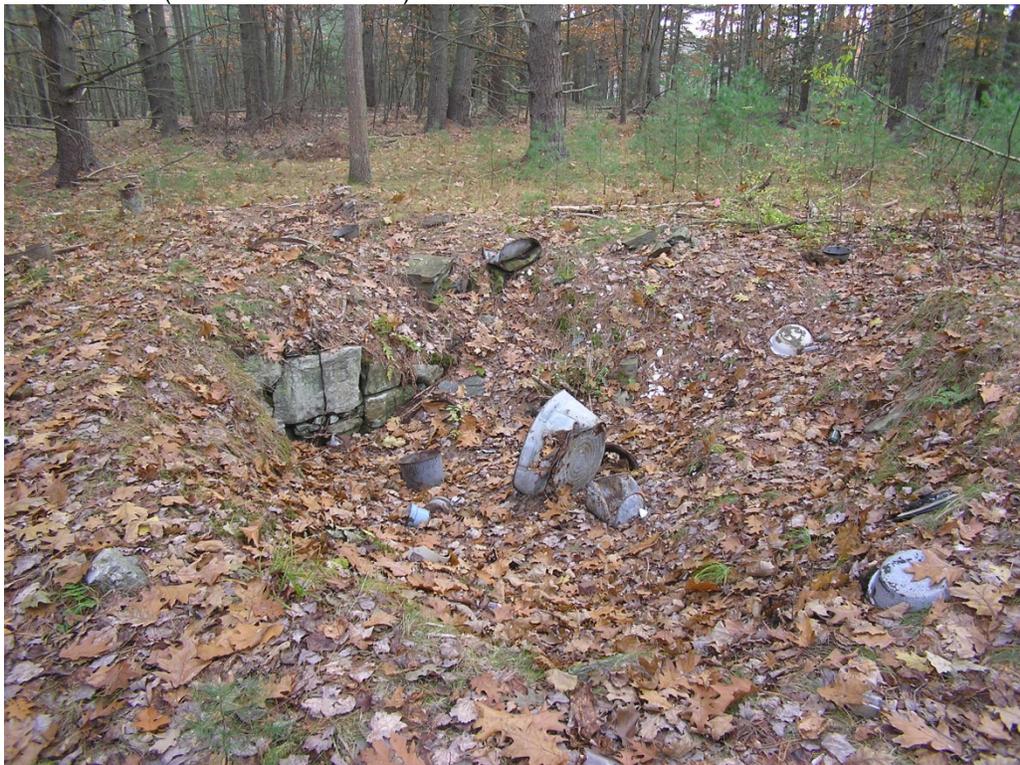
- One historical cellar foundation in the northwest portion of the area was observed. Discarded household items were observed in and around the cellar hole. These items were observed scattered along the ground surface, including corroded metal pots and pans, corroded metal cans, old glass bottles and jars, and broken porcelain items. A barrel labeled "trash" was observed nearby.

The nature and frequency of discarded household items appears to be an insignificant remnant of the former historic residential use of the area, before it was acquired by the federal government to establish NAS Brunswick.

At the time of inspection, the West Base Area was vacant and the grounds appeared to be in reasonably good condition. One historic cellar (late 19<sup>th</sup>-early 20<sup>th</sup> century) with household waste (artifacts) and some metal debris were observed in the woods, south of the Former Residential Area.

No. 6 West Base Area, NAS Brunswick November 3, 2010  
Possible historic site cellar hole, located south of Perimeter Road and Old Gurnet Road intersection
