# Preliminary Assessment/Site Investigation

## Volume I of II Text and Figures

Marine Corps Base Camp Lejeune  
Jacksonville, North Carolina

**Department of the Navy**  
Naval Facilities Engineering Command  
Mid-Atlantic Division  
Norfolk, Virginia

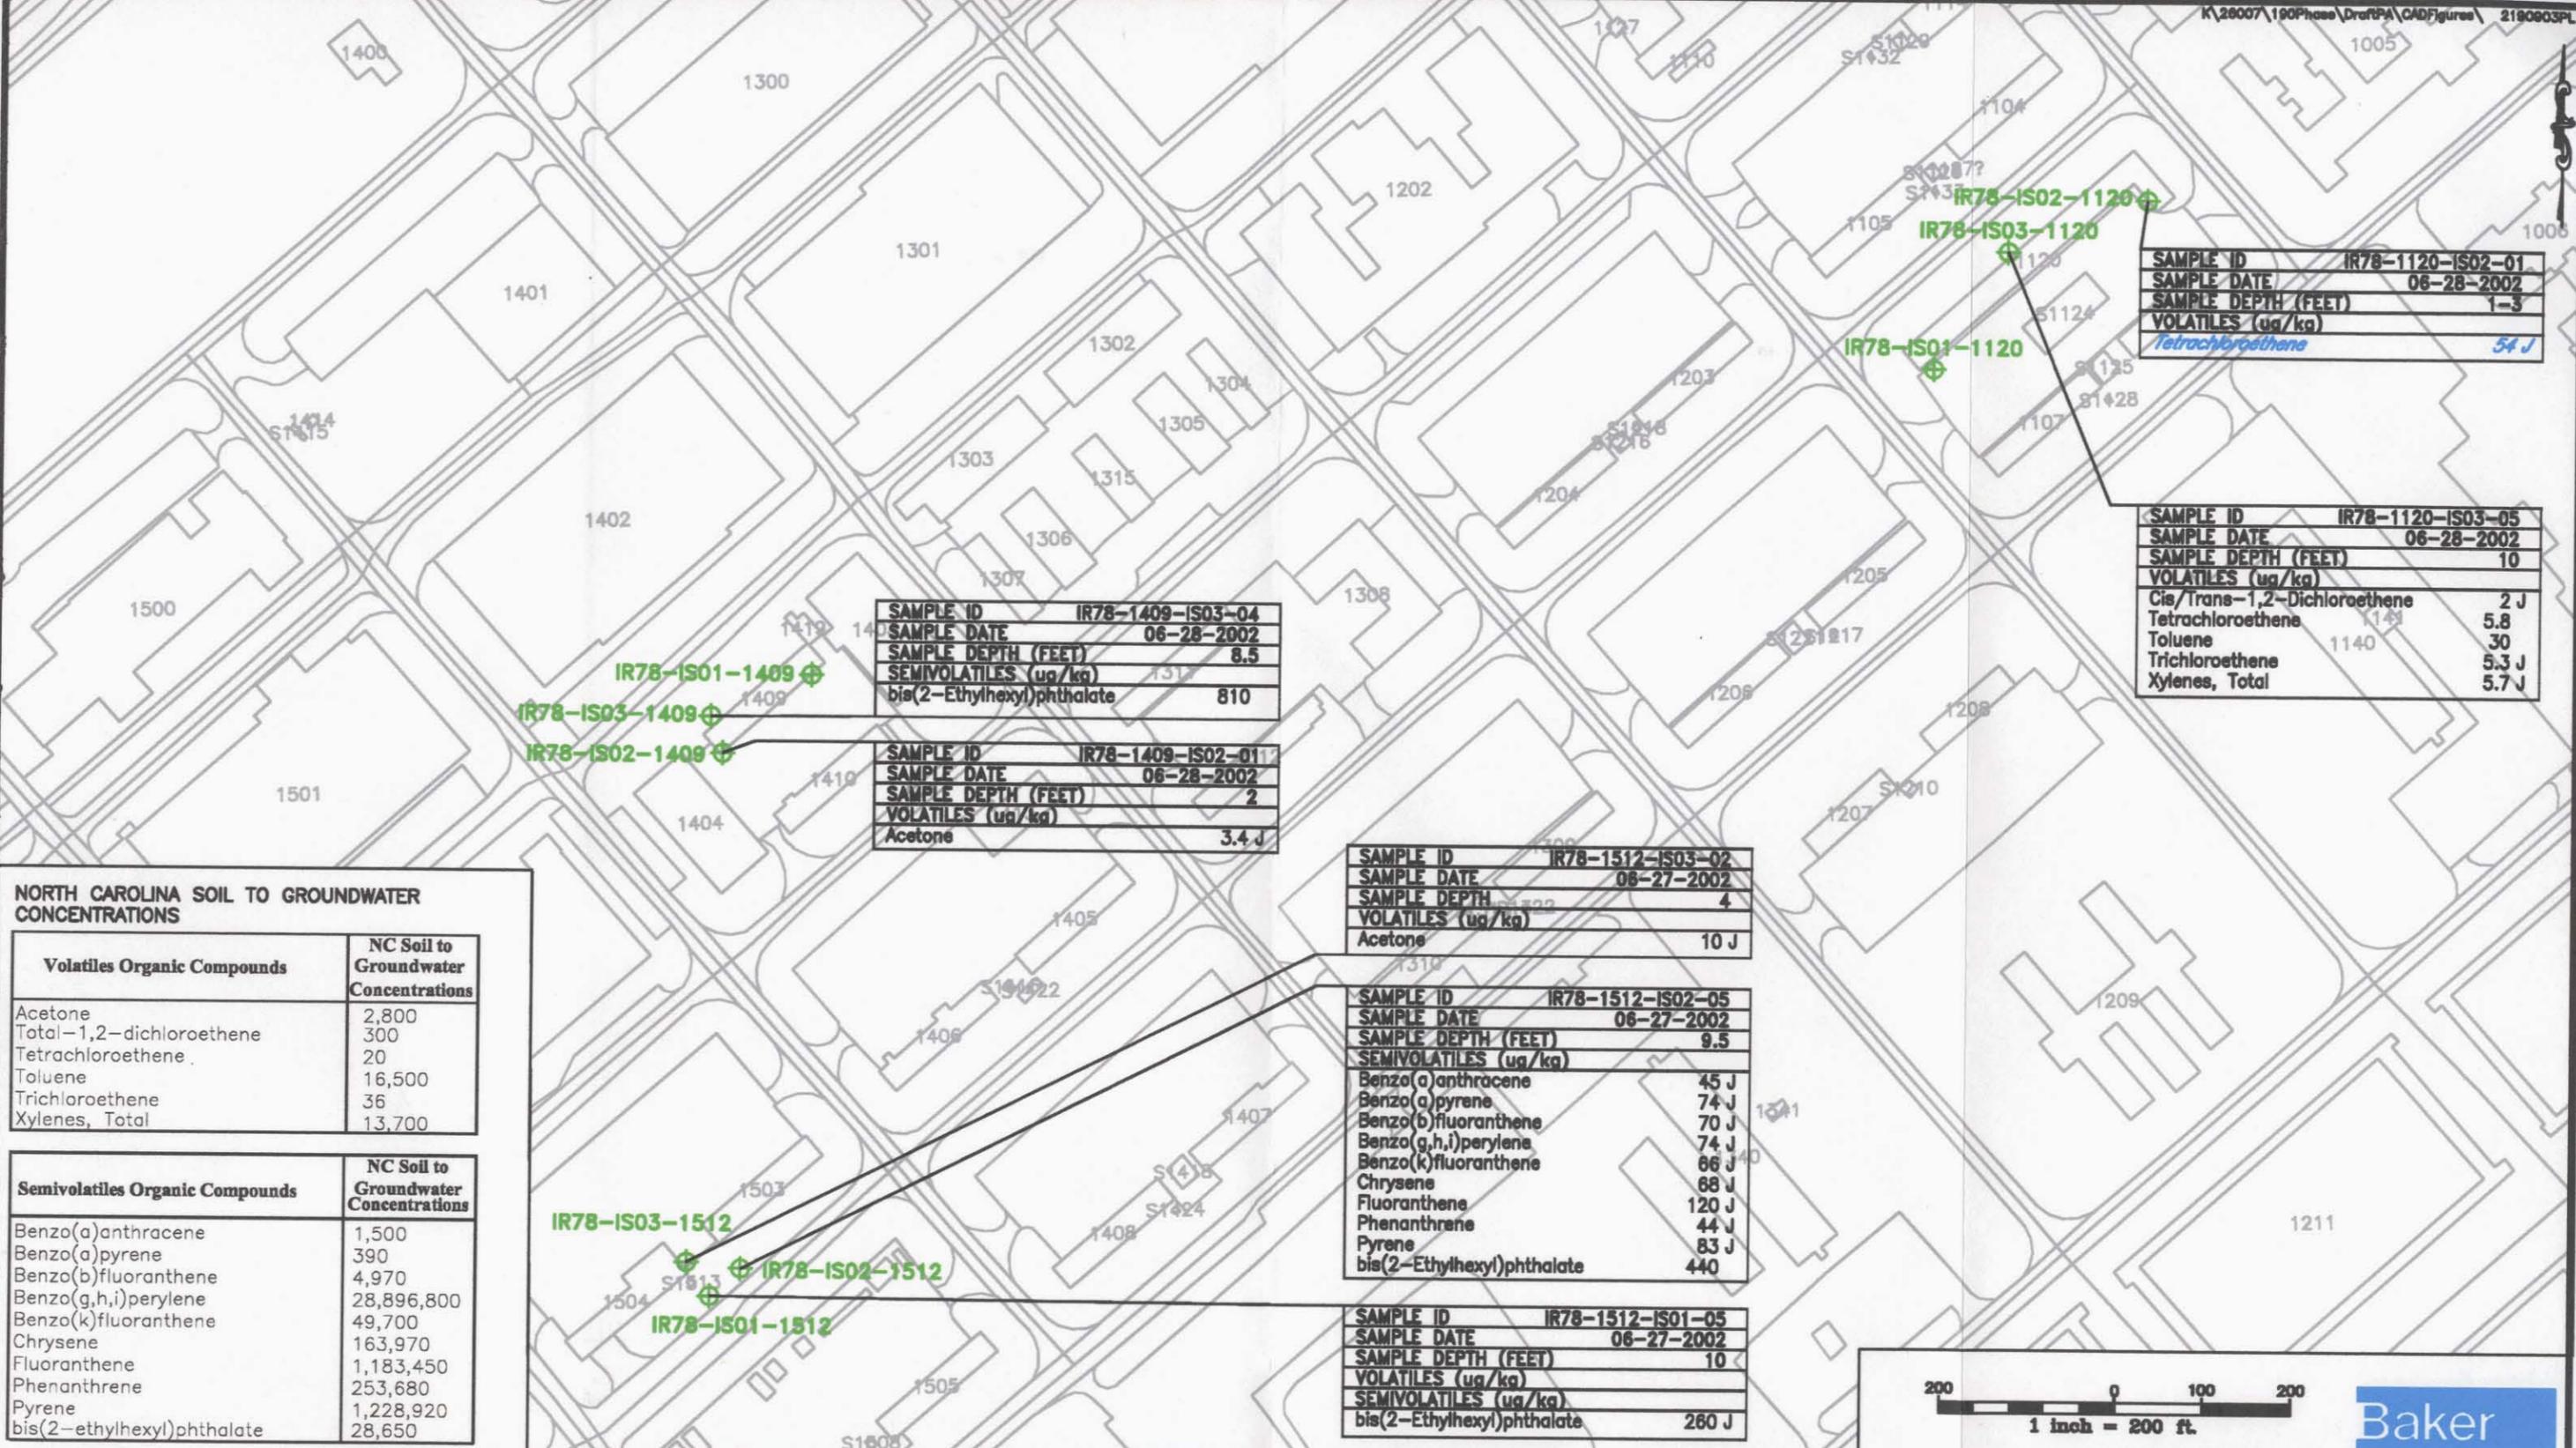
SAMPLE ID	IR78-1120-IS02-01
SAMPLE DATE	06-28-2002
SAMPLE DEPTH (FEET)	1-3
VOLATILES (ug/kg)	
Tetrachloroethene	54 J

SAMPLE ID	IR78-1120-IS03-05
SAMPLE DATE	06-28-2002
SAMPLE DEPTH (FEET)	10
VOLATILES (ug/kg)	
Cis/Trans-1,2-Dichloroethene	2 J
Tetrachloroethene	5.8
Toluene	30
Trichloroethene	5.3 J
Xylenes, Total	5.7 J
