FIELD INVESTIGATION PHOTOGRAPH ALBUM

**OPERABLE UNIT NO. 6
(SITES 36, 43, 44, 54 AND 86)**

**MARINE CORPS AIR STATION, NEW RIVER
JACKSONVILLE, NORTH CAROLINA**

AUGUST 17, 1995

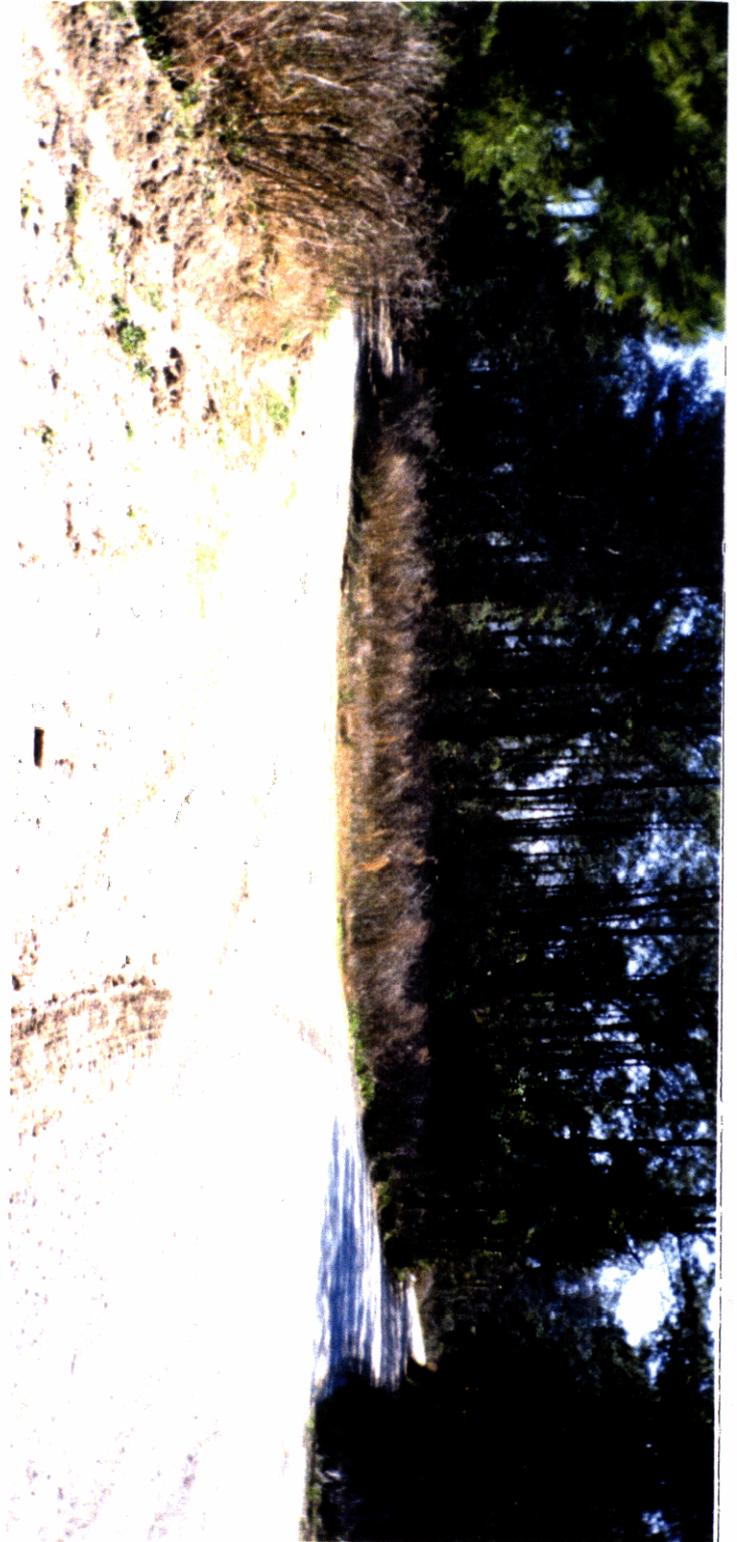
OU6.Site36.1995.02

The Former Disposal Area, pictured in the foreground, is bordered by a gravel access road to the north and south. The New River is located approximately 200 feet to the east of the Former Disposal Area, beyond the trees pictured here.

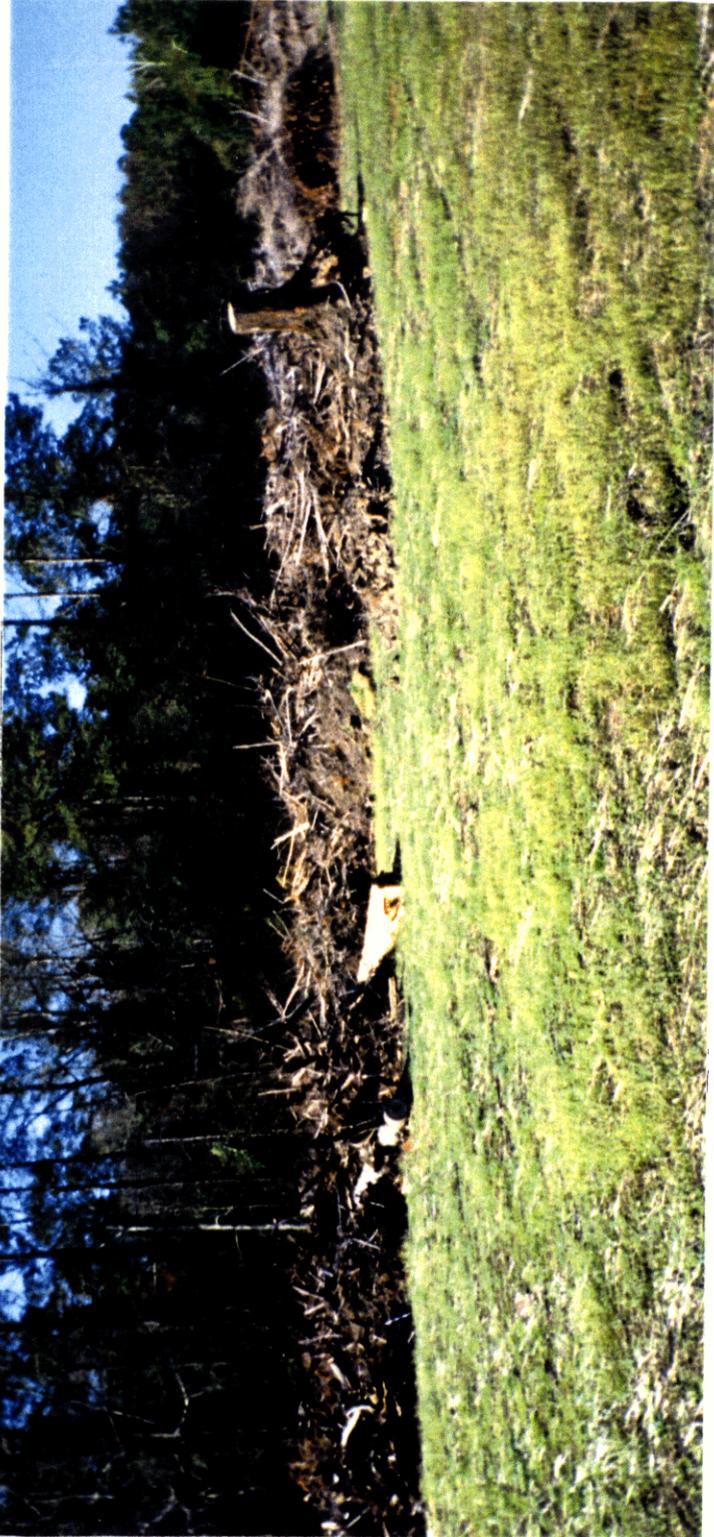
OU6.Site36.1995.03

This photograph was taken facing southwest at an open field area, adjacent to the Former Disposal Area. The wood debris, pictured here, was shredded and spread over the entire field prior to the commencement of RI field activities.

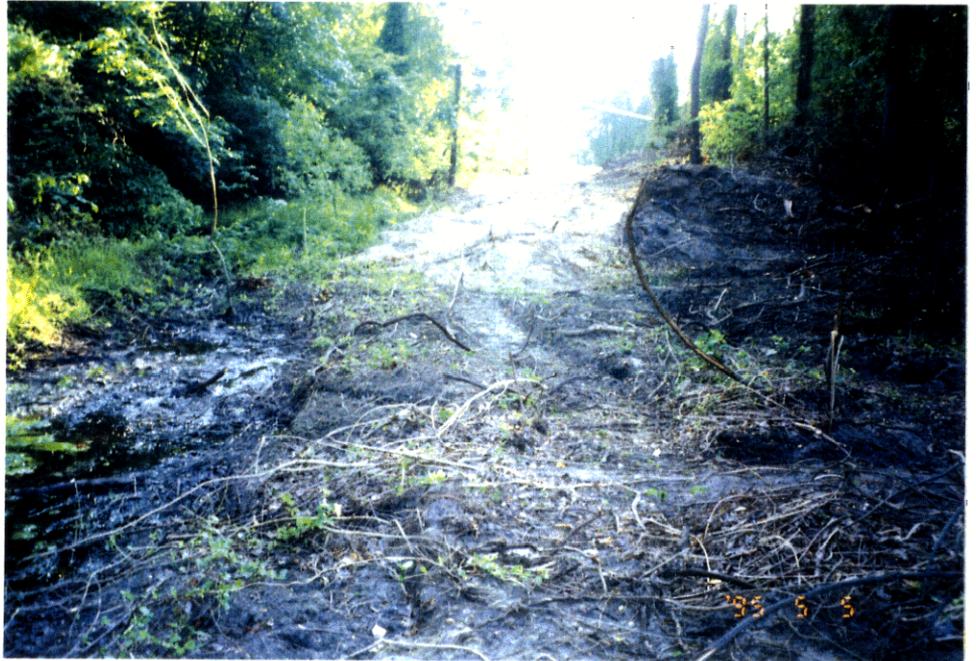
OU6.Site36.1995.04

This photograph depicts a utility corridor that was cleared during the RI. The proposed sewage transmission line would have traversed the southern portion of the study area. The right-of-way was eventually moved further south to avoid Site 36.

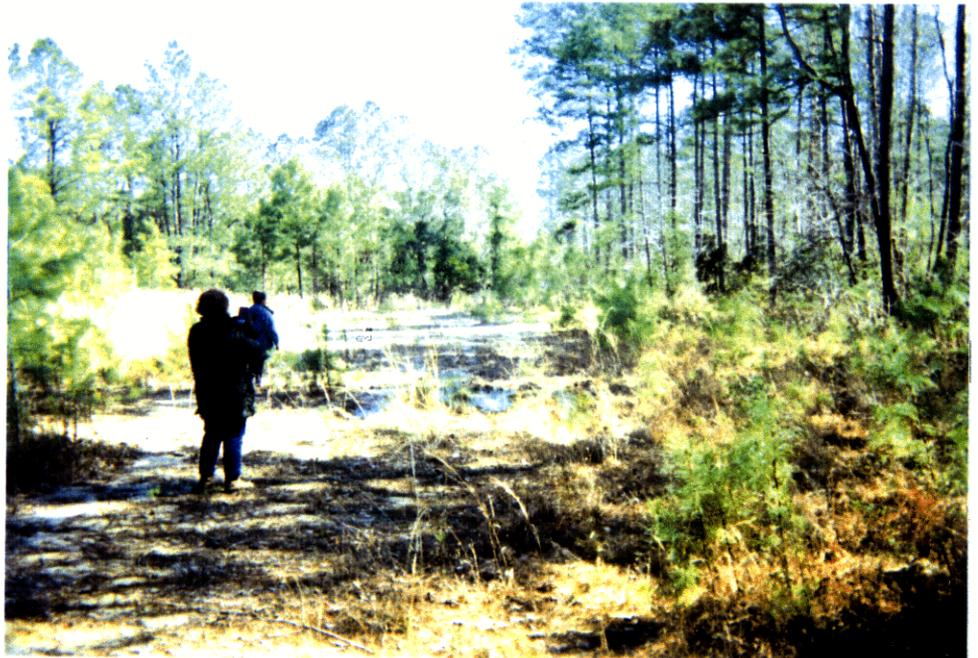
OU6.Site36.1995.05

The clearing, pictured here, constitutes the southwest portion of Site 36. This area was first identified during the RI site scoping visit.

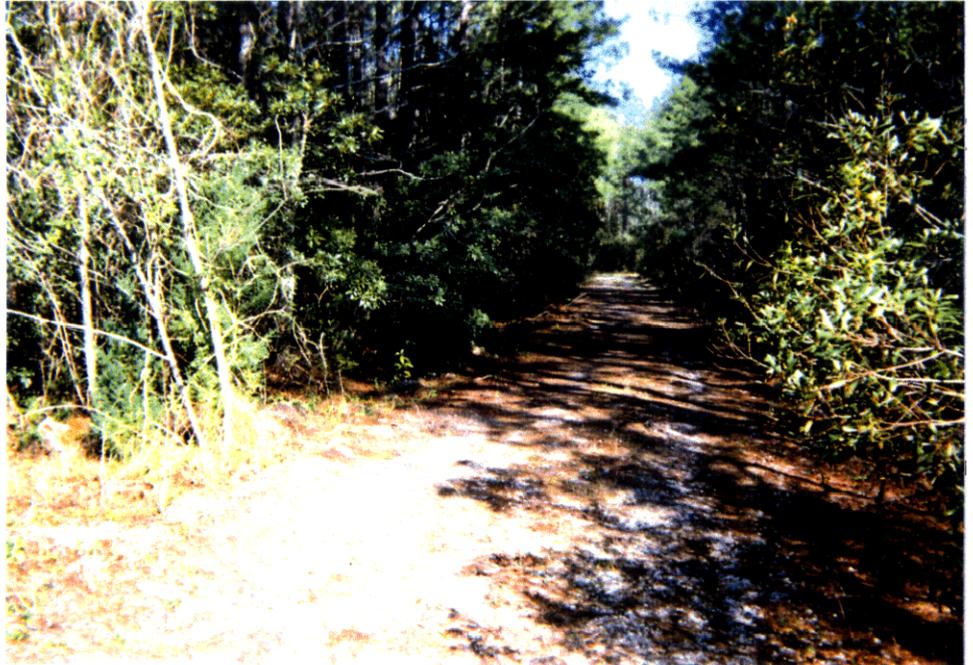
OU6.Site43.1995.06

This photograph was taken facing east from Agan Street toward the central portion of Site 43. The gravel road pictured here provides access to the main portion of the study area; unimproved paths extend outward from this road.

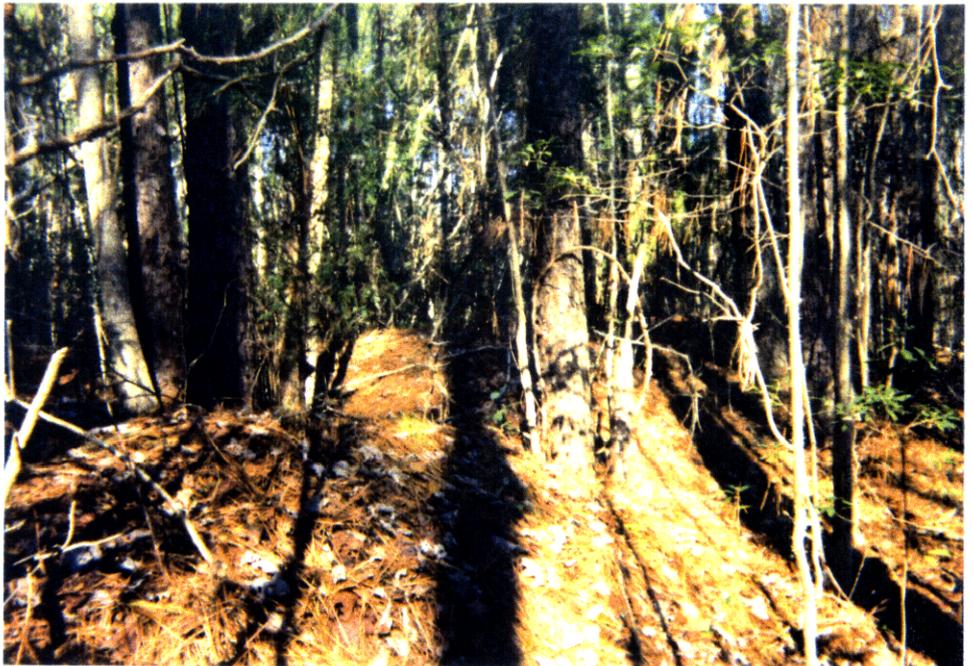
OU6.Site43.1995.07

Several earthen mounds, like the one pictured here, are located within the southeastern portion of Site 43.

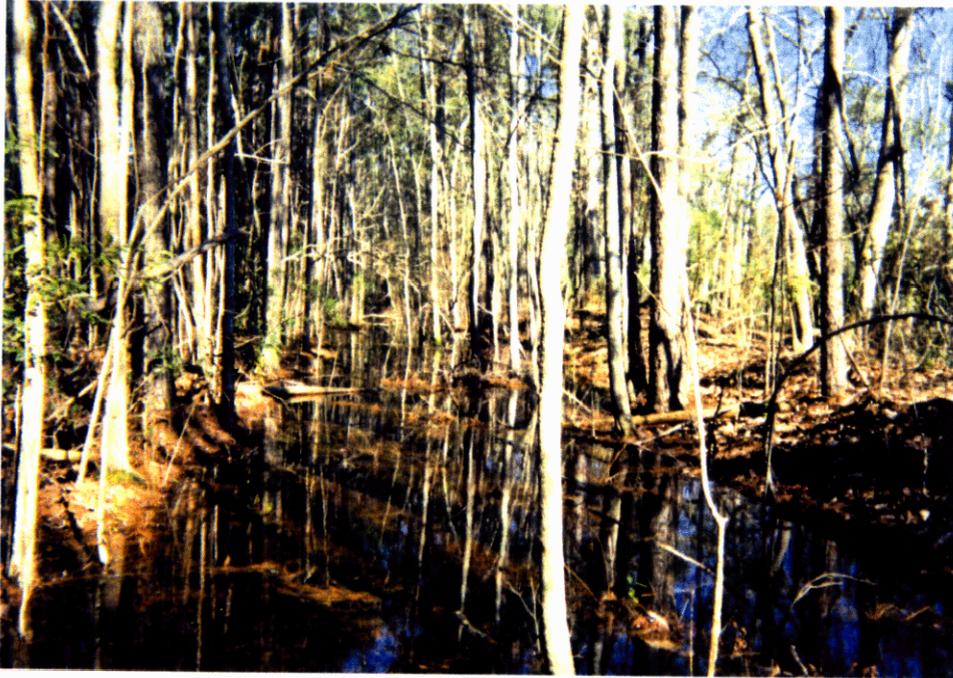
OU6.Site43.1995.08

The standing water, pictured here, is part of what appears to be a man-made drainage that serves the southern portion of Site 43. Much of the study area is subject to flooding during precipitation events.

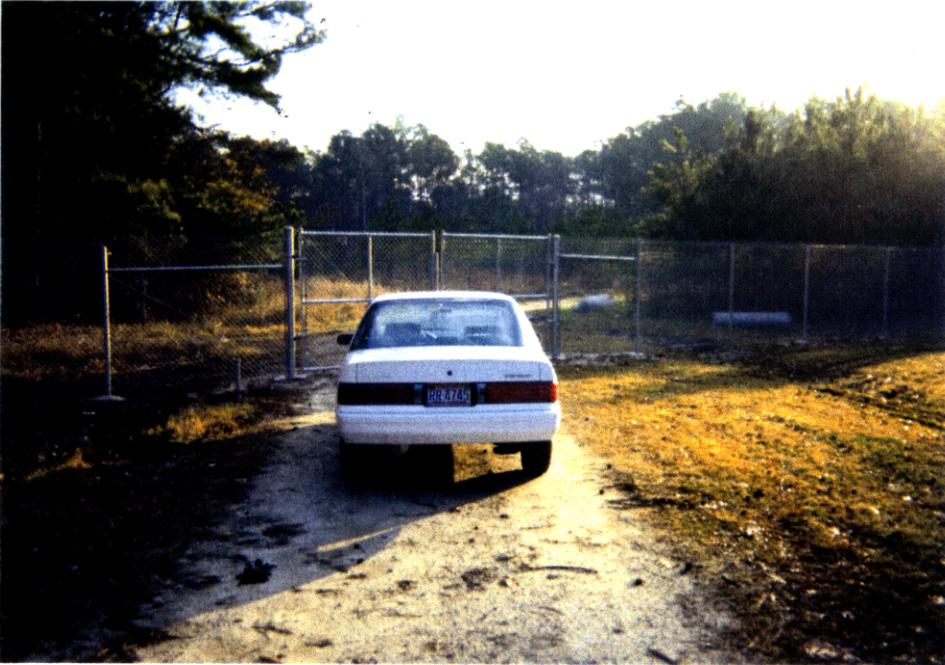
OU6.Site44.1995.09

This picture was taken at the entrance gate of Site 44. Base housing units, located at the end of Baxter Street and along Jones Street, line this portion of the study area.

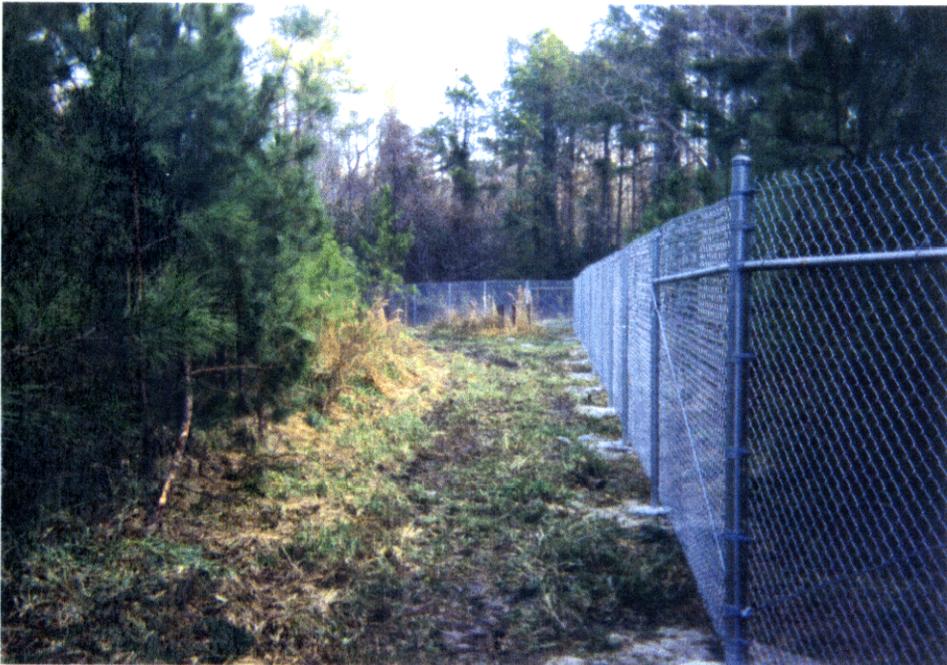
OU6.Site44.1995.10

This photograph was taken facing northeast along the 6-foot chain link fence that surrounds a majority of Site 44.

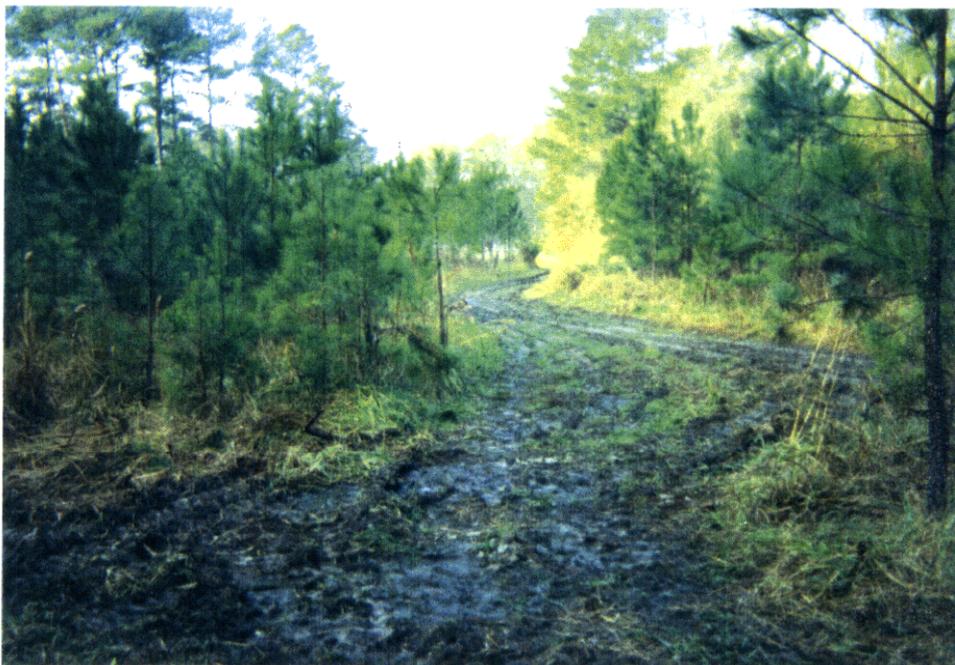
OU6.Site44.1995.11

Site 44 is comprised of a gently sloping field. Small pine trees, weeds and tall grass cover the majority of the suspected disposal area.

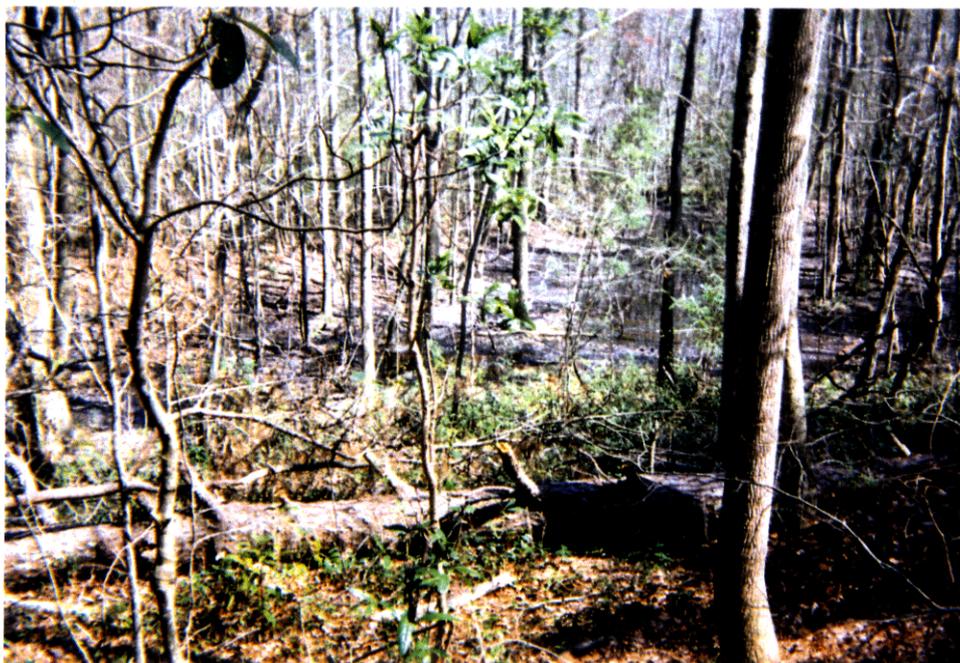
OU6.Site44.1995.12

This photograph depicts the eastern portion of the study area, not within the fenced portion of Site 44. This area is prone to flooding during heavy precipitation episodes.

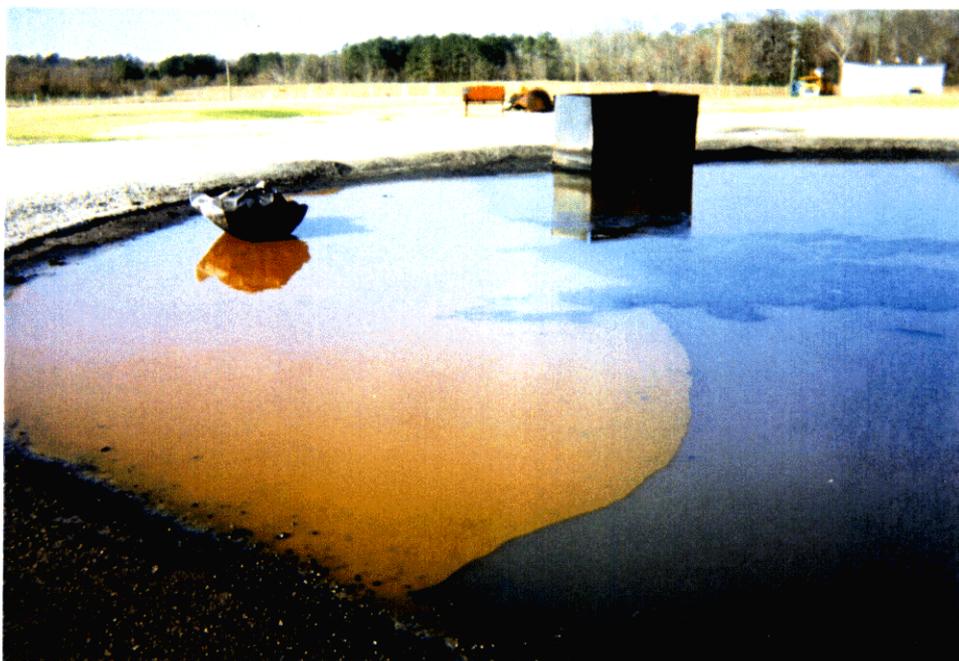
OU6.Site54.1995.14

The visible sheen, pictured here, is typical of the product layer that remains after fire training exercises have been conducted. Prior to its removal, excess product is temporarily retained in either the lined burn pit or the oil and water separator.

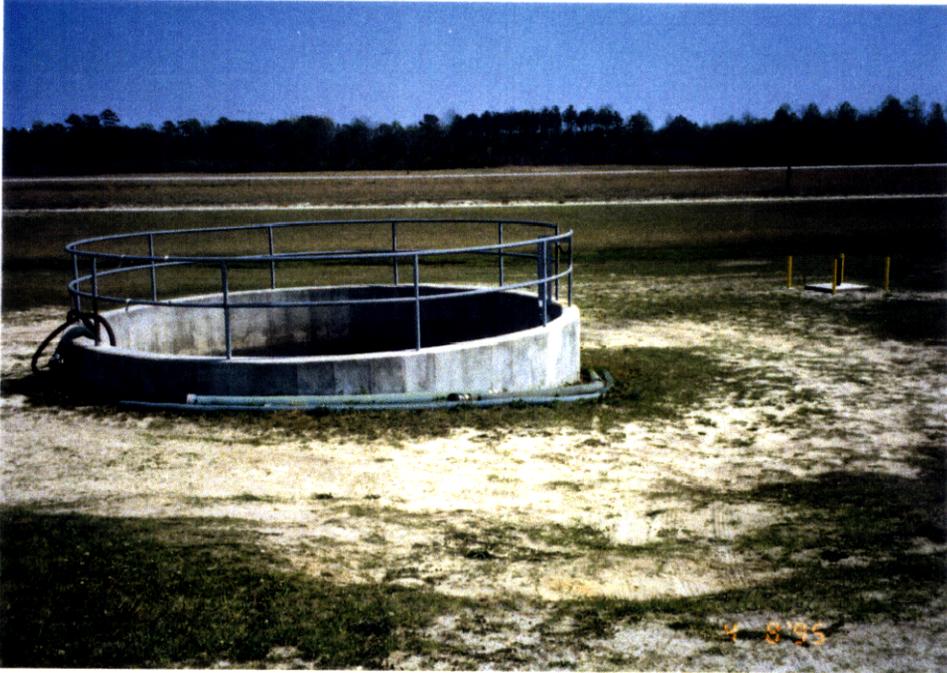
OU6.Site54.1995.15

The oil and water separator, pictured here, receives excess fluid from the burn pit. The separator is routinely maintained by base personnel.

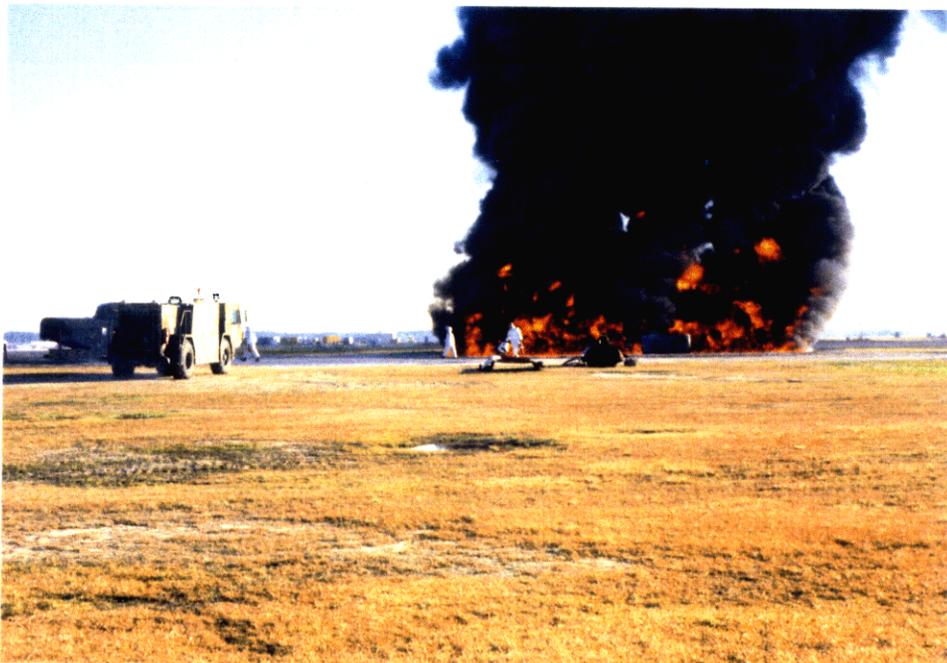
OU6.Site54.1995.17

This photograph depicts fire training activities at the Site 54 burn pit. JP-type fuels are ignited and then extinguished with high pressure water trucks.

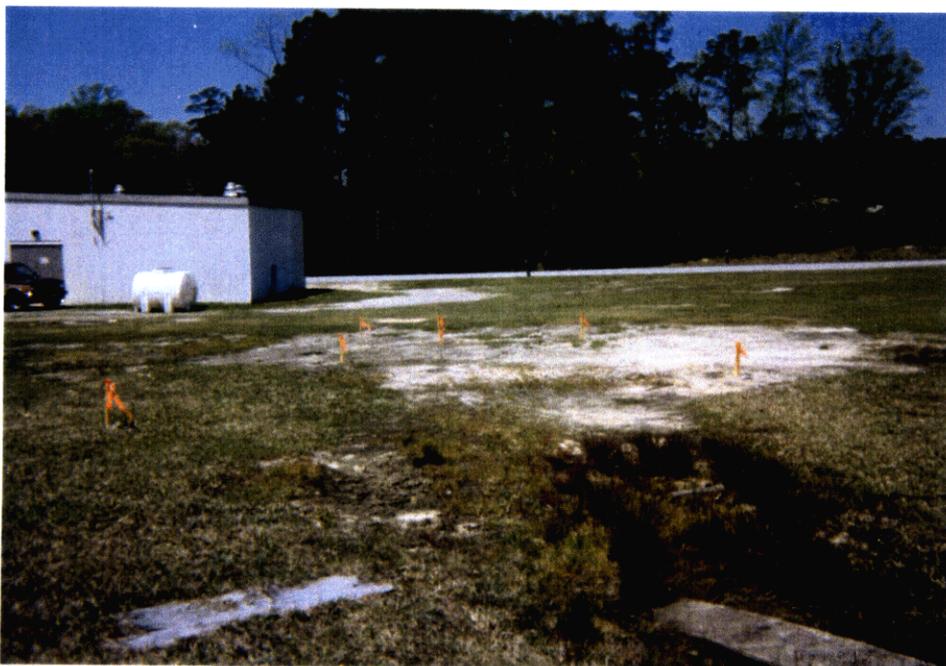
**OU6.Site54.1995.18**

A lack of vegetative cover at this location was noted during the RI scoping site visit and may suggest the presence of soil contamination. The area is located approximately 150 feet southwest of the burn pit.

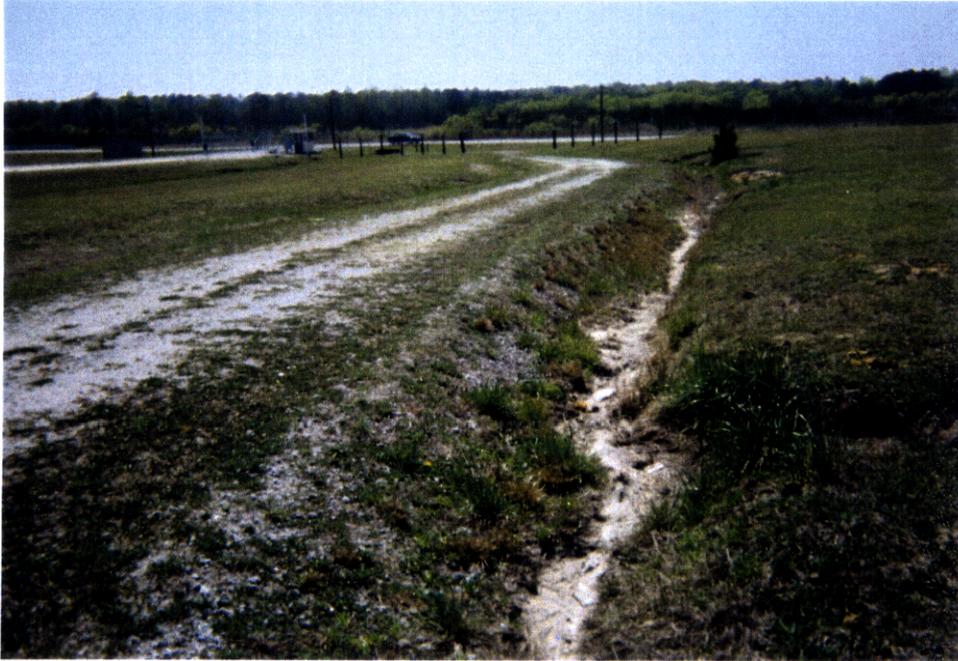
OU6.Site54.1995.19

The drainage ditch, pictured here, flows southwest from the burn pit area toward Perimeter Road. During periods of high precipitation this ditch fills with runoff water from the study area.

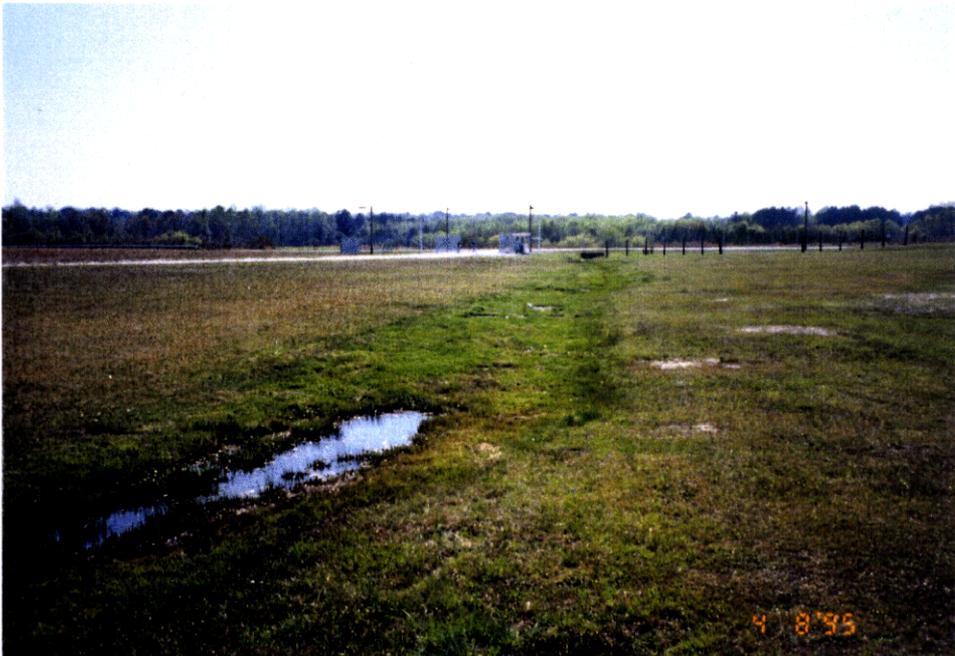
OU6.Site54.1995.20

The low area or drainage, pictured here, lies immediately to the east of the study area beyond the oil and water separator. This area remained saturated during the field investigation.

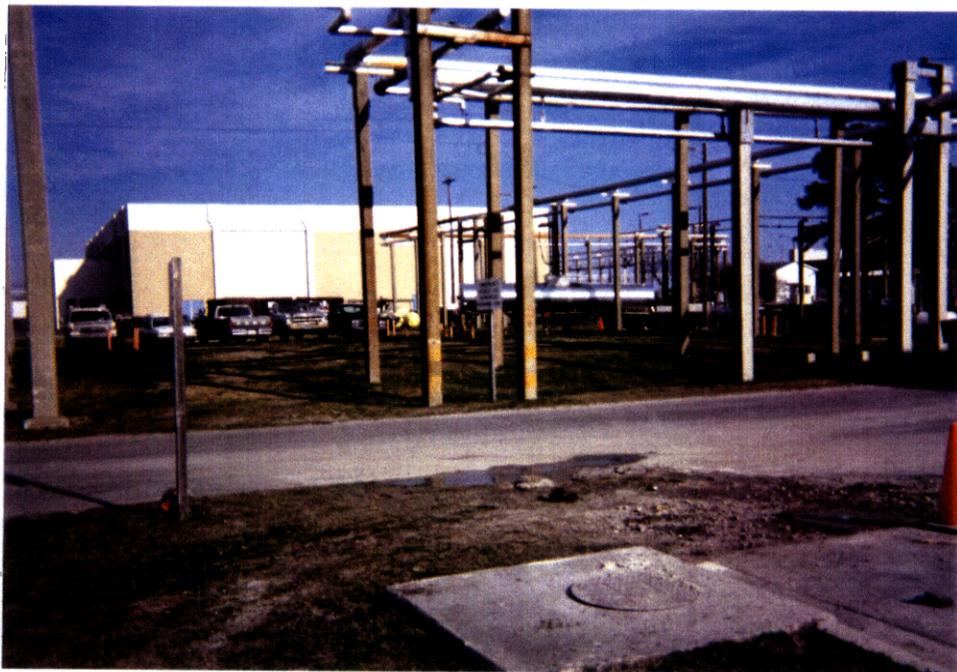
OU6.Site86.1995.21

This photograph was taken facing southeast from Campbell Street toward Site 86. As the photograph depicts, overhead steam utility lines are located within the study area boundary.

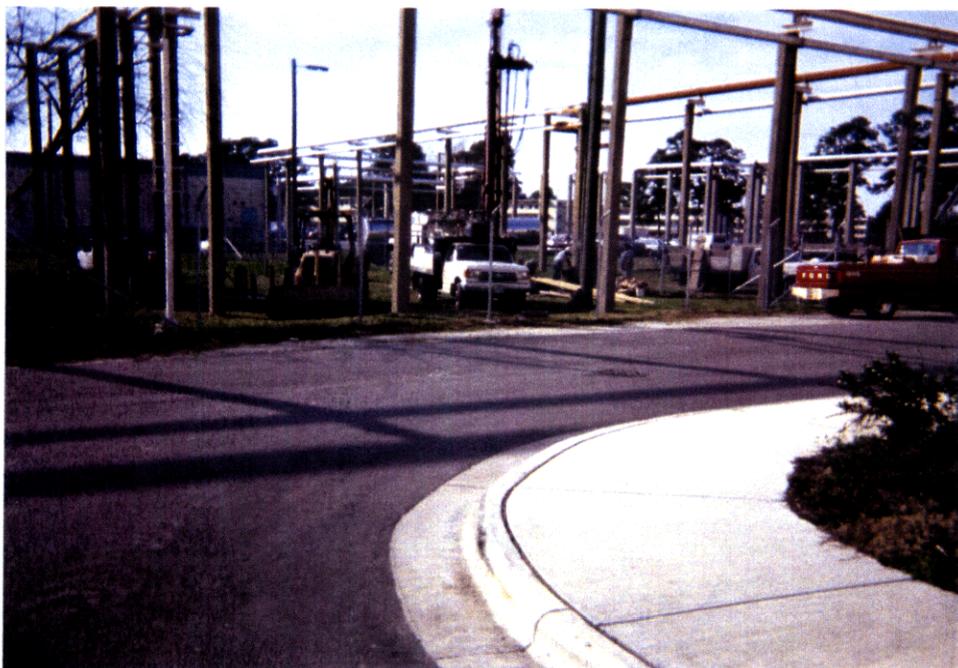
OU6.Site86.1995.22

This photograph was taken facing northwest from Foster Street toward the study area. A construction contractor used the eastern portion of Site 86 as an equipment staging area during the RI.

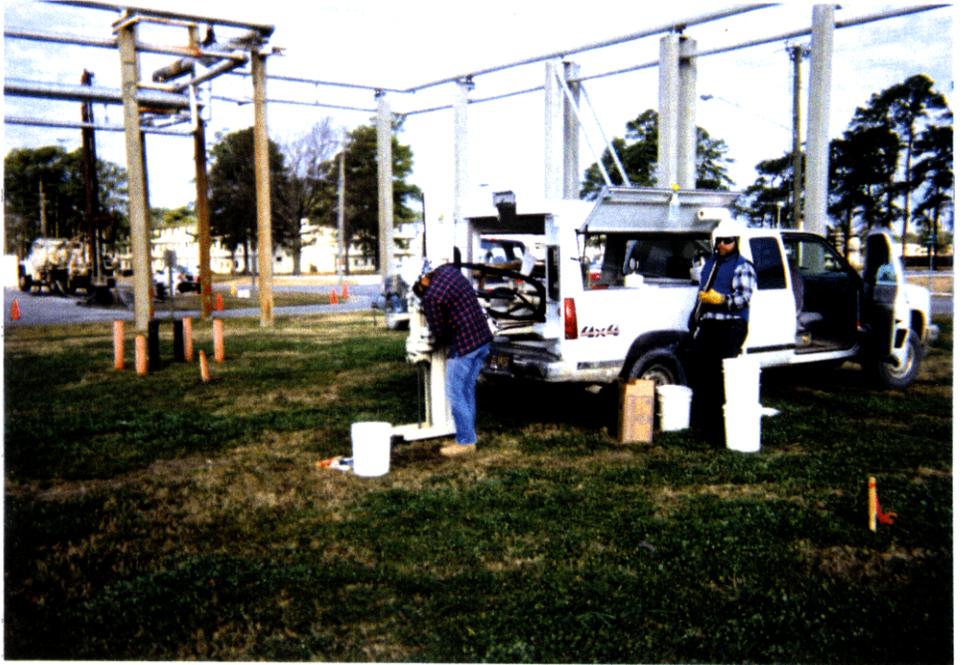
OU6.SL.1995.23

This photograph depicts GeoProbe soil sampling operations at Site 86. This direct push sampling technique generated only a very small amount of waste soils during the RI.

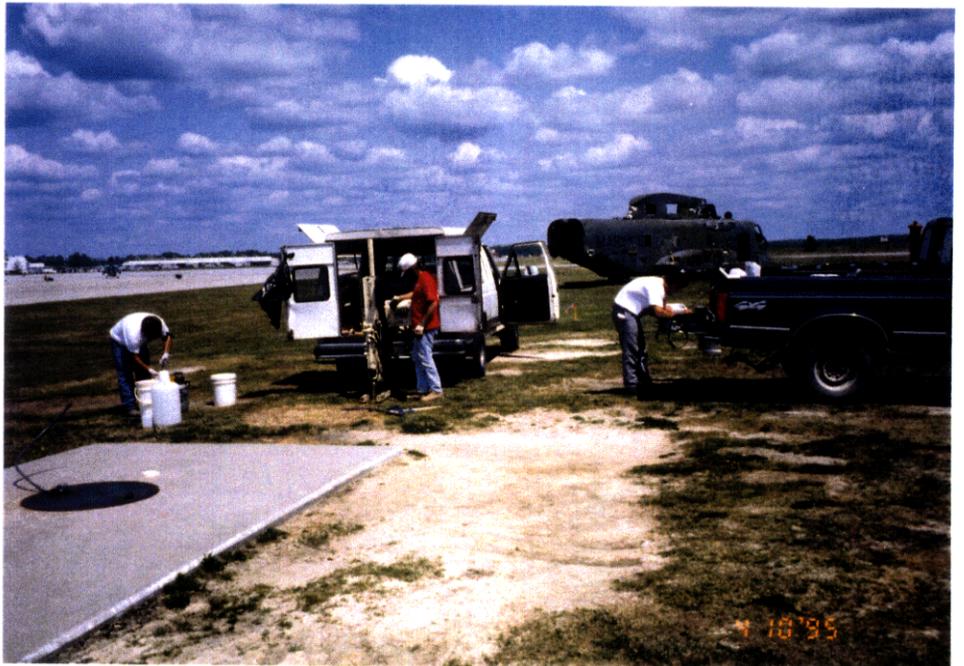
OU6.SL.1995.24

As this photograph depicts, all operations relating to the soil investigation (i.e., sample acquisition, field analysis, and decontamination) were mobilized between boring locations.

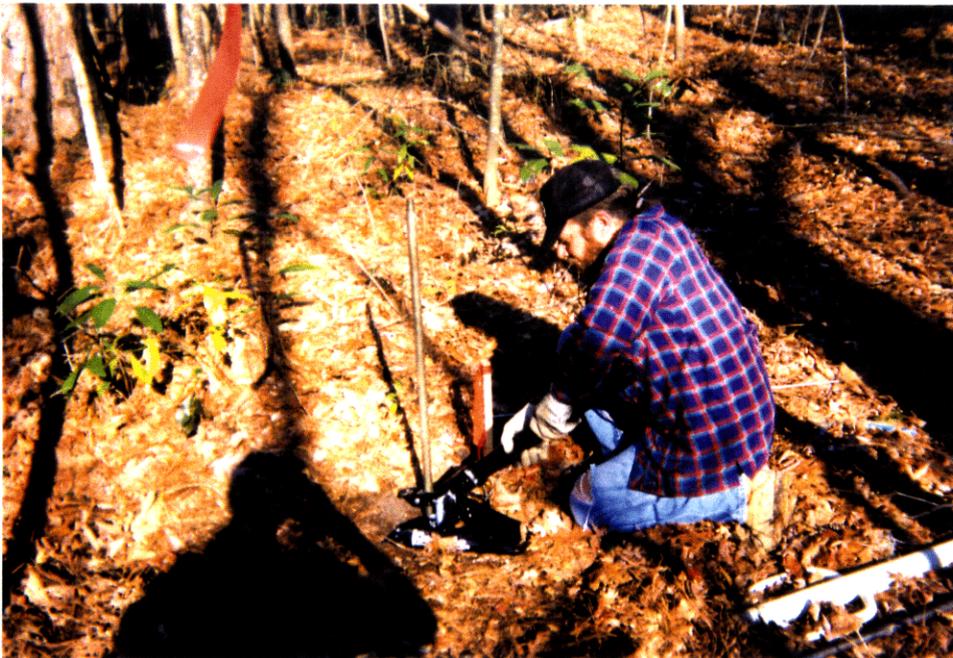
OU6.SL.1995.25

Soil sample cores, like the one depicted here, were extruded from disposable acetate sleeves as part of the direct push sampling technique. Each core was visually described and then selectively retained for laboratory analysis.

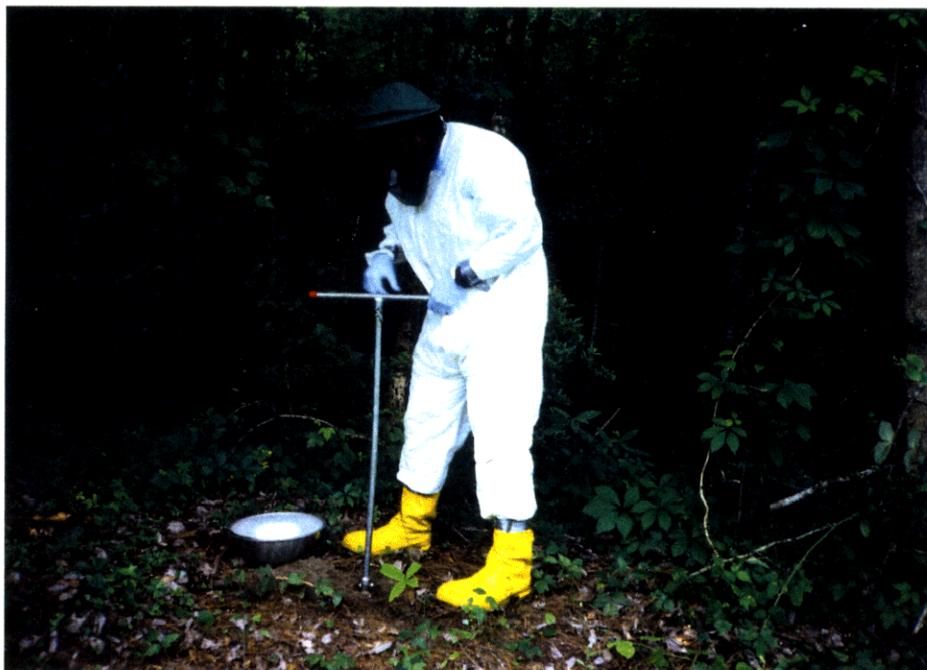
OU6.SL.1995.27

Soil samples were gathered at known drum or container locations using a hand auger, as depicted here.

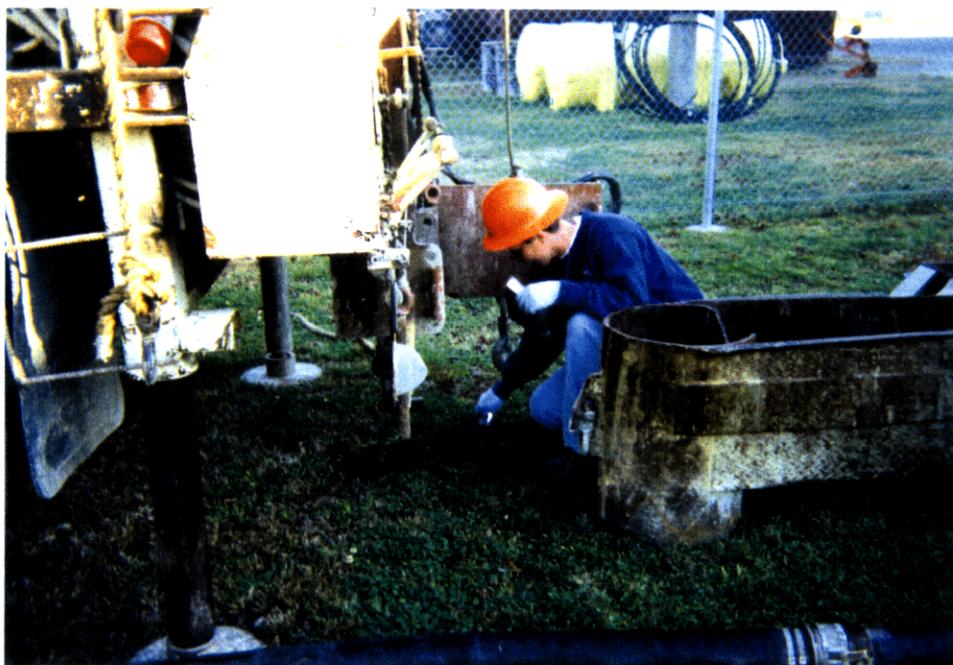
OU6.SL.1995.28

Surface soil samples were collected using a stainless steel sampling trowel, as depicted here.

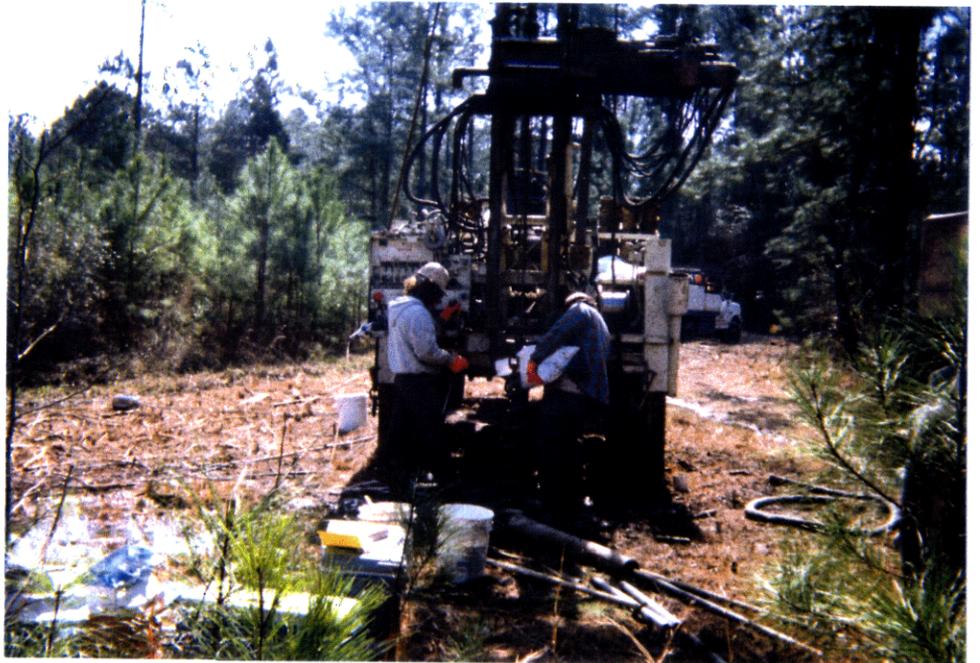
OU6.GW.1995.29

Well installation was completed using the truck mounted drill rig, as pictured here. The personnel are adding sand pack material to the annulus of the borehole around the well screen.

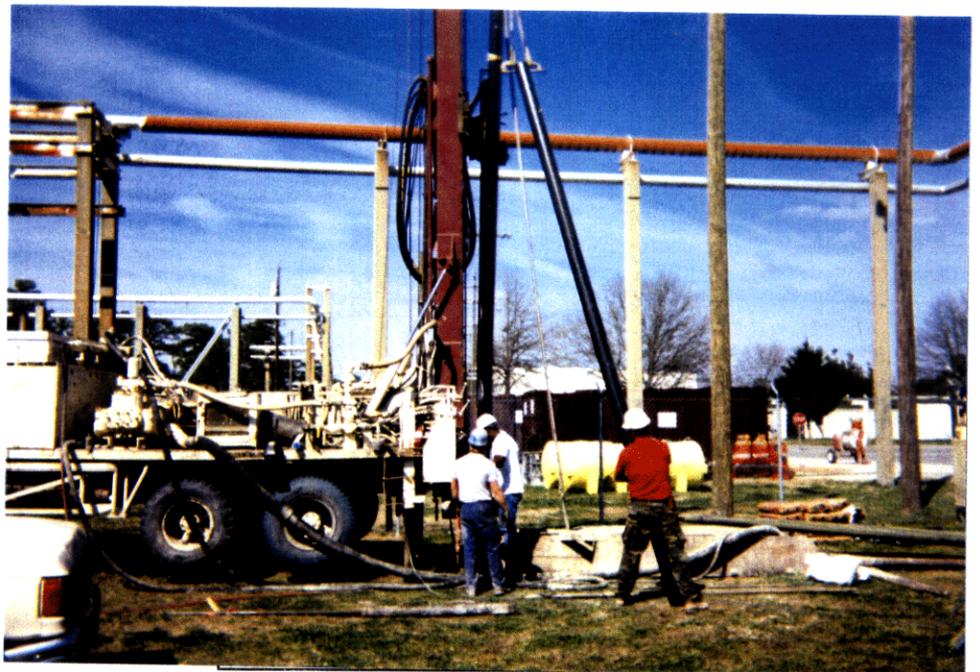
OU6.GW.1995.30

Steel casing, pictured here, is being installed as part of type-III well installation operations. The sections of casing were welded together and placed into the semi-confining layer.

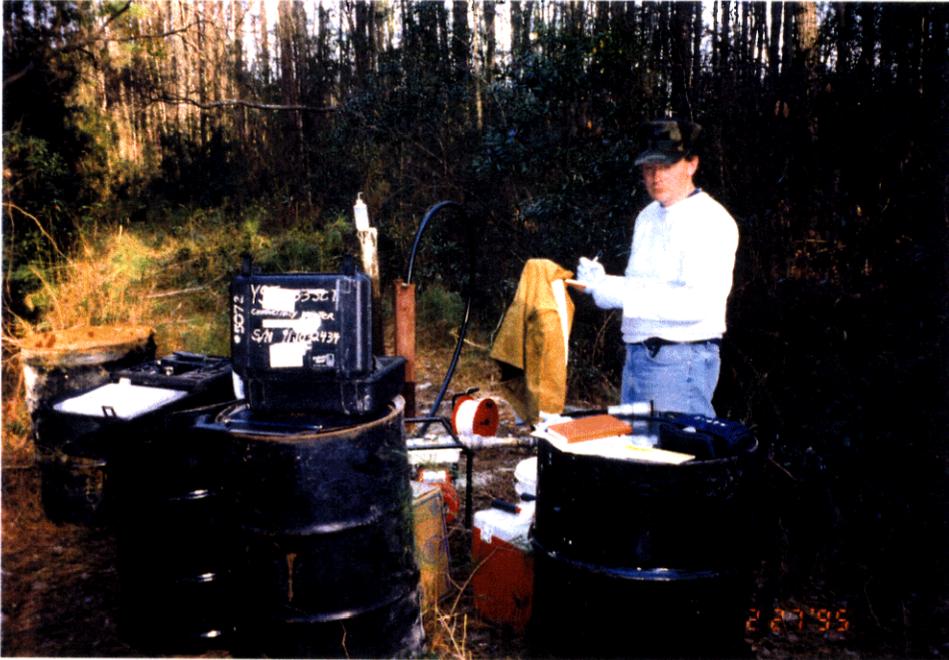
OU6.GW.1995.31

Shallow well development was completed using a centrifugal pump. Groundwater parameters such as pH, conductivity, and turbidity were recorded during the well development process.

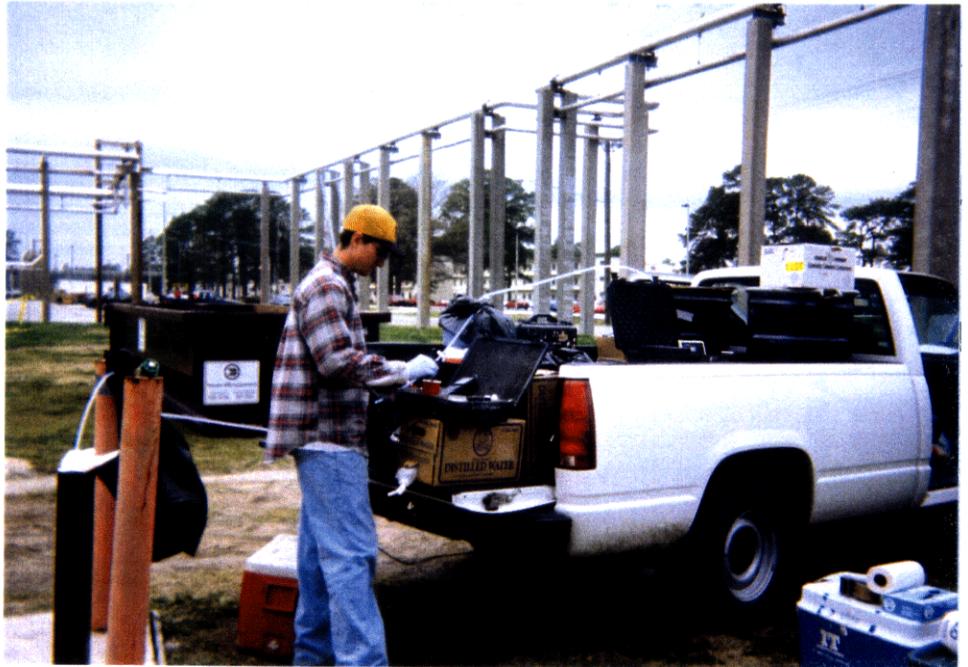
OU6.GW.1995.33

A low flow purge method was employed to sample all of the existing and newly installed monitoring wells at each of the five RI sites. Indicators of aquifer stabilization such as pH, conductivity, and turbidity were recorded during the purge process.

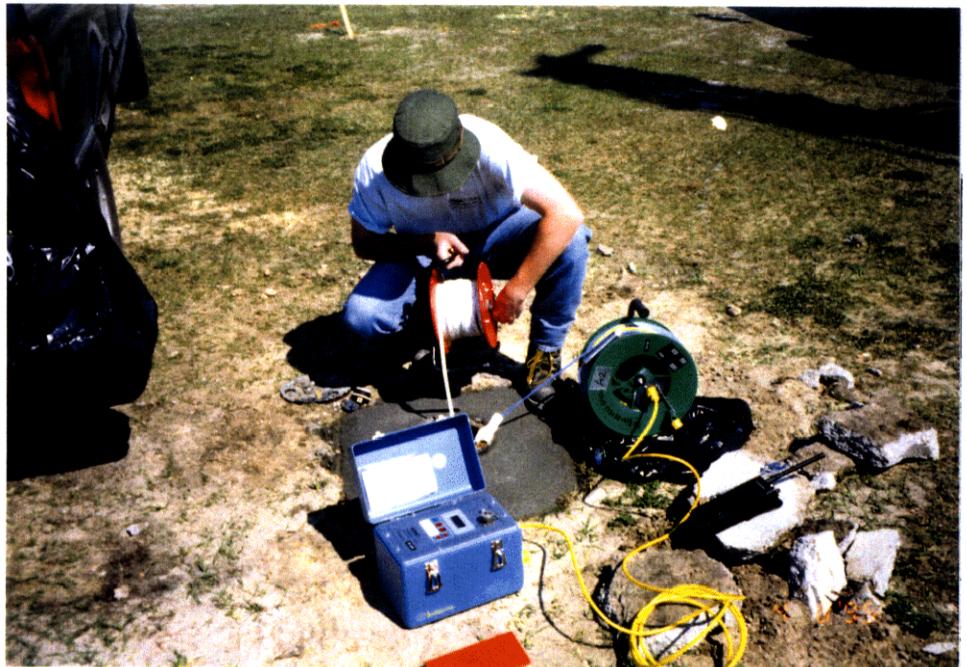
OU6.GW.1995.34

Additional aquifer data were recorded as part of the groundwater investigation. This photograph depicts operations associated with a falling-head slug test.

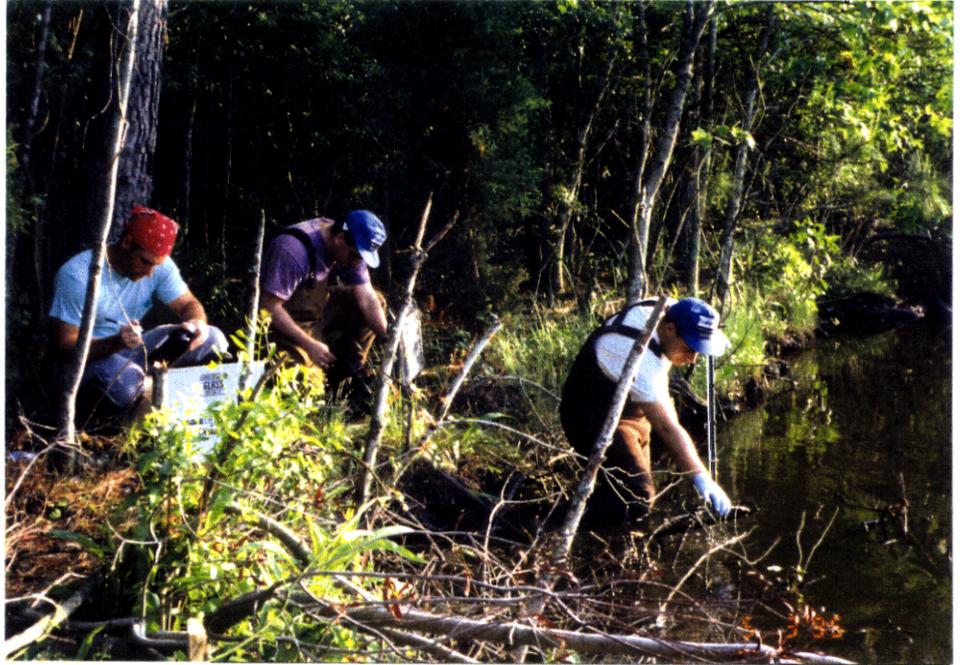
OU6.SW.1995.35

The personnel here are collecting surface water samples for laboratory analysis. In addition to laboratory tests, measurements of specific conductance, pH, and dissolved oxygen were recorded during the surface water investigation.

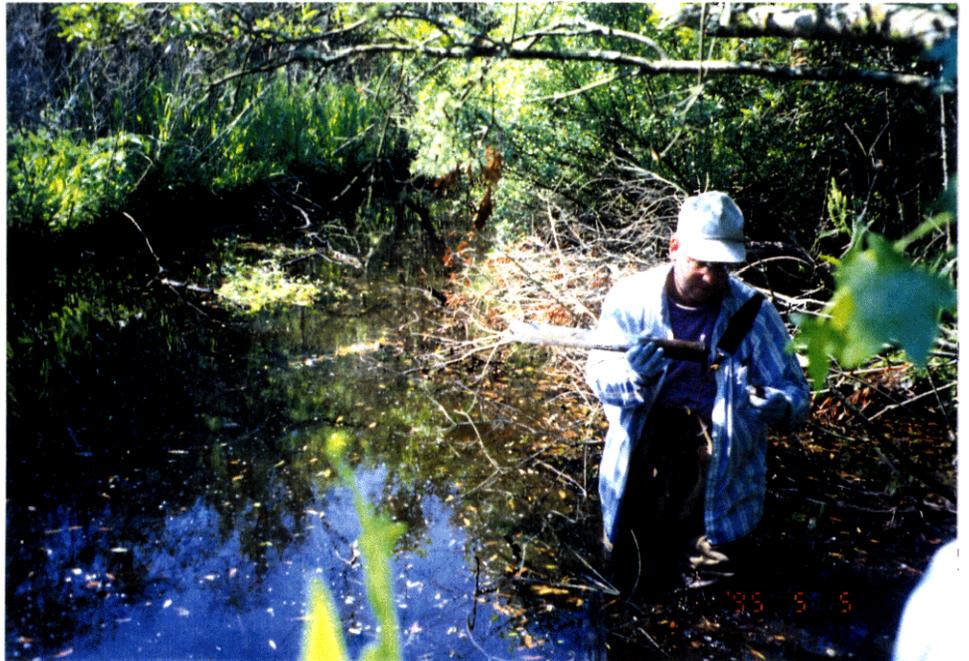
OU6.SD.1995.36

Sediment samples were collected with dedicated acetate sleeves, as pictured. The sediment sample was extruded from the sleeves into sample jars.

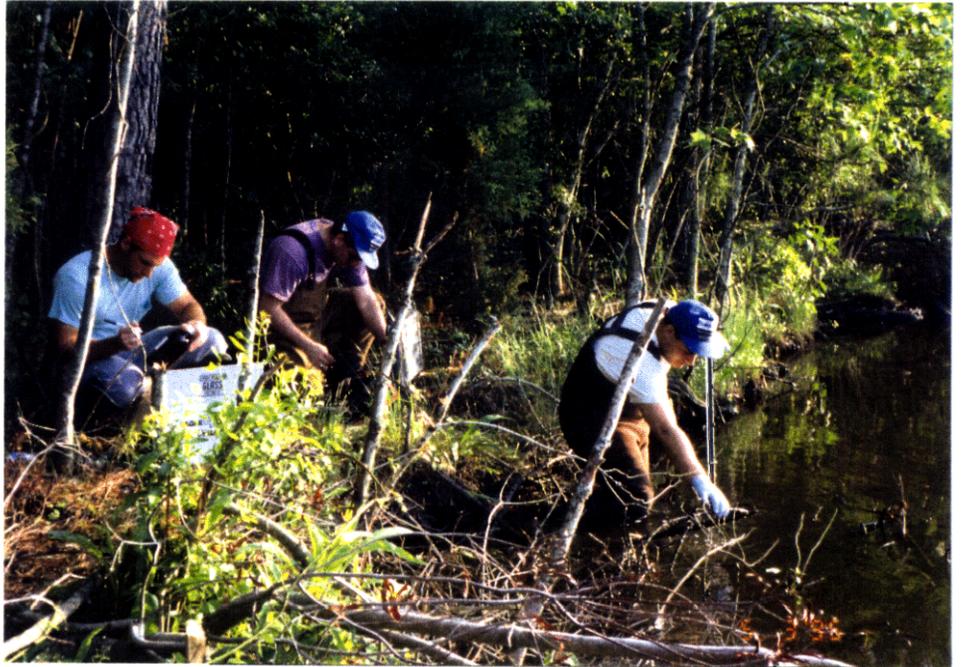
OU6.SD.1995.36

Sediment samples were collected with dedicated acetate sleeves, as pictured. The sediment sample was extruded from the sleeves into sample jars.
