FIELD INVESTIGATION PHOTOGRAPH ALBUM

**OPERABLE UNIT NO. 6
(SITES 36, 43, 44, 54 AND 86)**

**MARINE CORPS AIR STATION, NEW RIVER
JACKSONVILLE, NORTH CAROLINA**

AUGUST 17, 1995

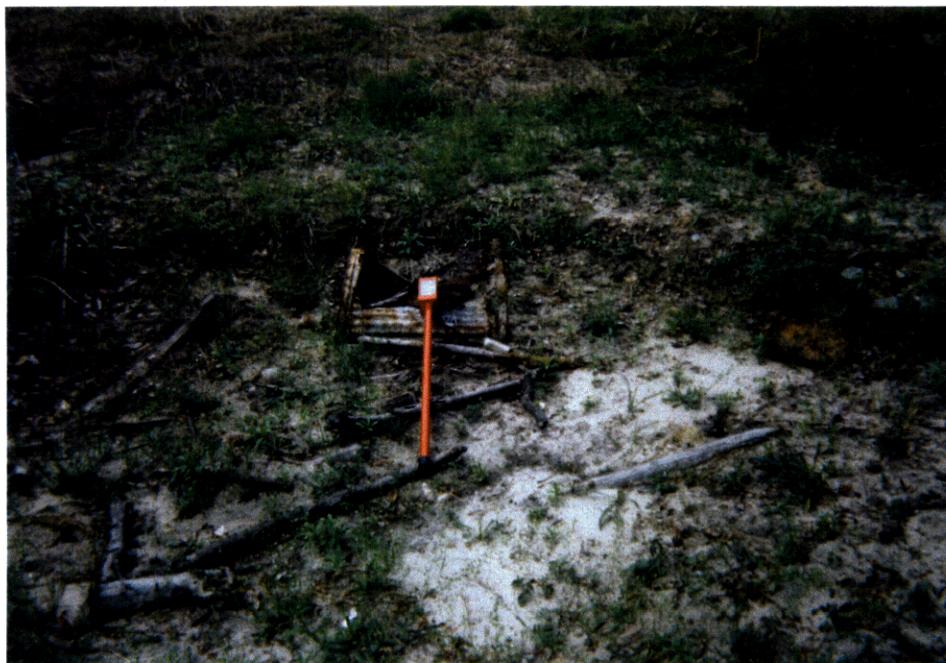
OU6.TP.1995.37

The magnetometer, pictured here, was used to locate buried metallic objects and debris. Test pit locations were based upon both visual observations of partially buried debris and magnetometer readings.

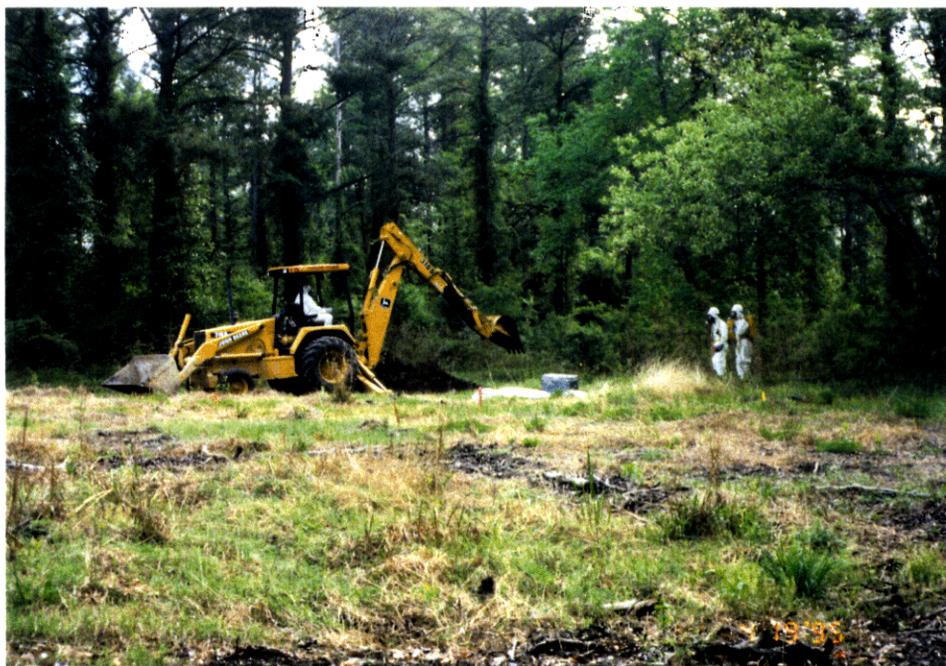
OU6.TP.1995.38

This photograph depicts test pit operations at Site 36.

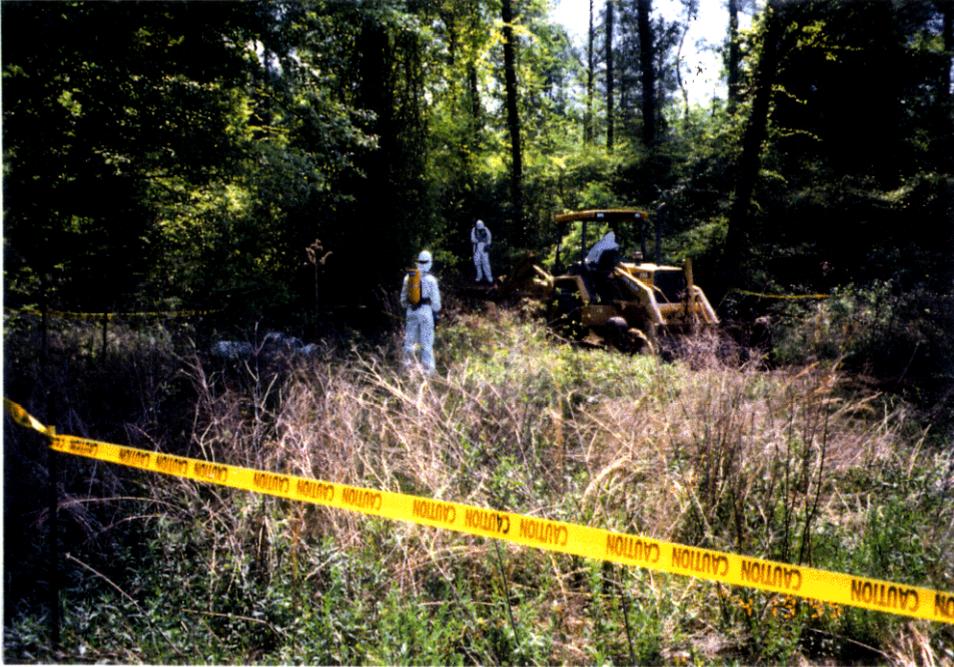
OU6.TP.1995.39

A John Deere model 310D backhoe was used during test pit investigations at Sites 36, 43, and 44.

Exploratory test pit investigations were conducted at Sites 36, 43, and 44 to determine the presence and nature of buried material. Potential test pit locations were identified through visual site inspection and use of a hand-held magnetometer. The visual site inspection sought to identify signs of contamination or waste disposal such as soil staining, debris, fill areas, or depressions. In conjunction with the visual site inspection, a magnetometer was employed during the test pit investigation to identify buried metallic objects. Due to the presence and wide distribution of metallic debris throughout each of the three sites, only locations with magnetic detections indicating objects with an apparent length greater than three feet were selected for excavation activities.

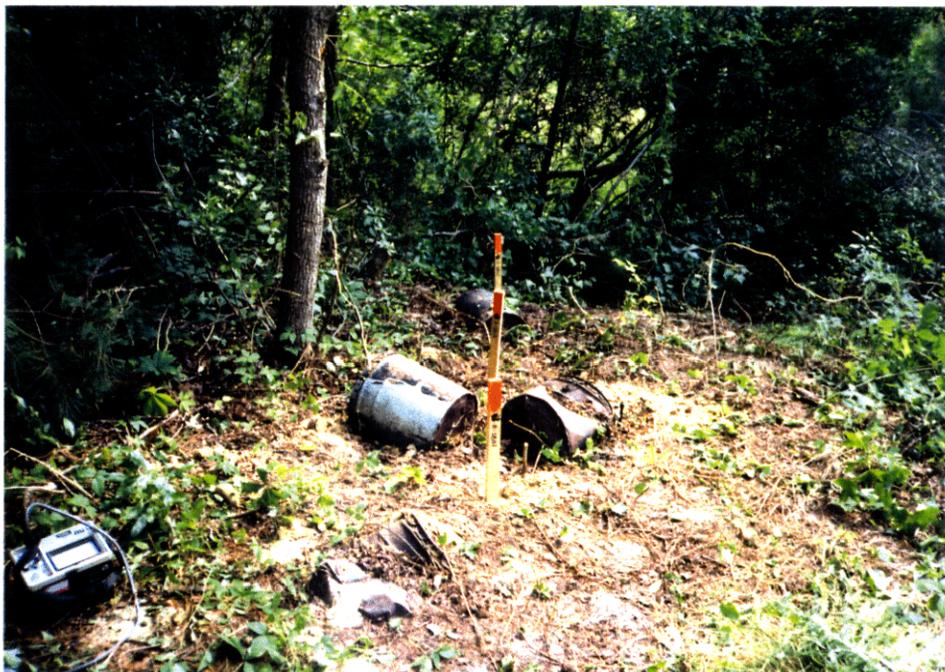
OU6.DM.1995.41

This photograph depicts 5-gallon containers that were sampled as part of the drum investigation at Site 36. One of the containers was partially buried at this location.

A drum investigation was conducted at Site 36 as part of the RI at OU No.6. Drum investigation operations were performed using Level B health and safety protection. Pertinent information regarding the location and condition of each container were recorded on a drum log. Each container was given a unique identification number. Content samples were obtained using disposable sampling equipment. Samples were then shipped to a Naval Energy and Environmental Support Activity (NEESA) certified laboratory for characterization.
