**FIELD INVESTIGATION PHOTOGRAPH ALBUM**

**OPERABLE UNIT NO. 13  
(SITE 63 - VERONA LOOP DUMP)**

**MARINE CORPS BASE, CAMP LEJEUNE  
NORTH CAROLINA**

**MAY 9, 1996**

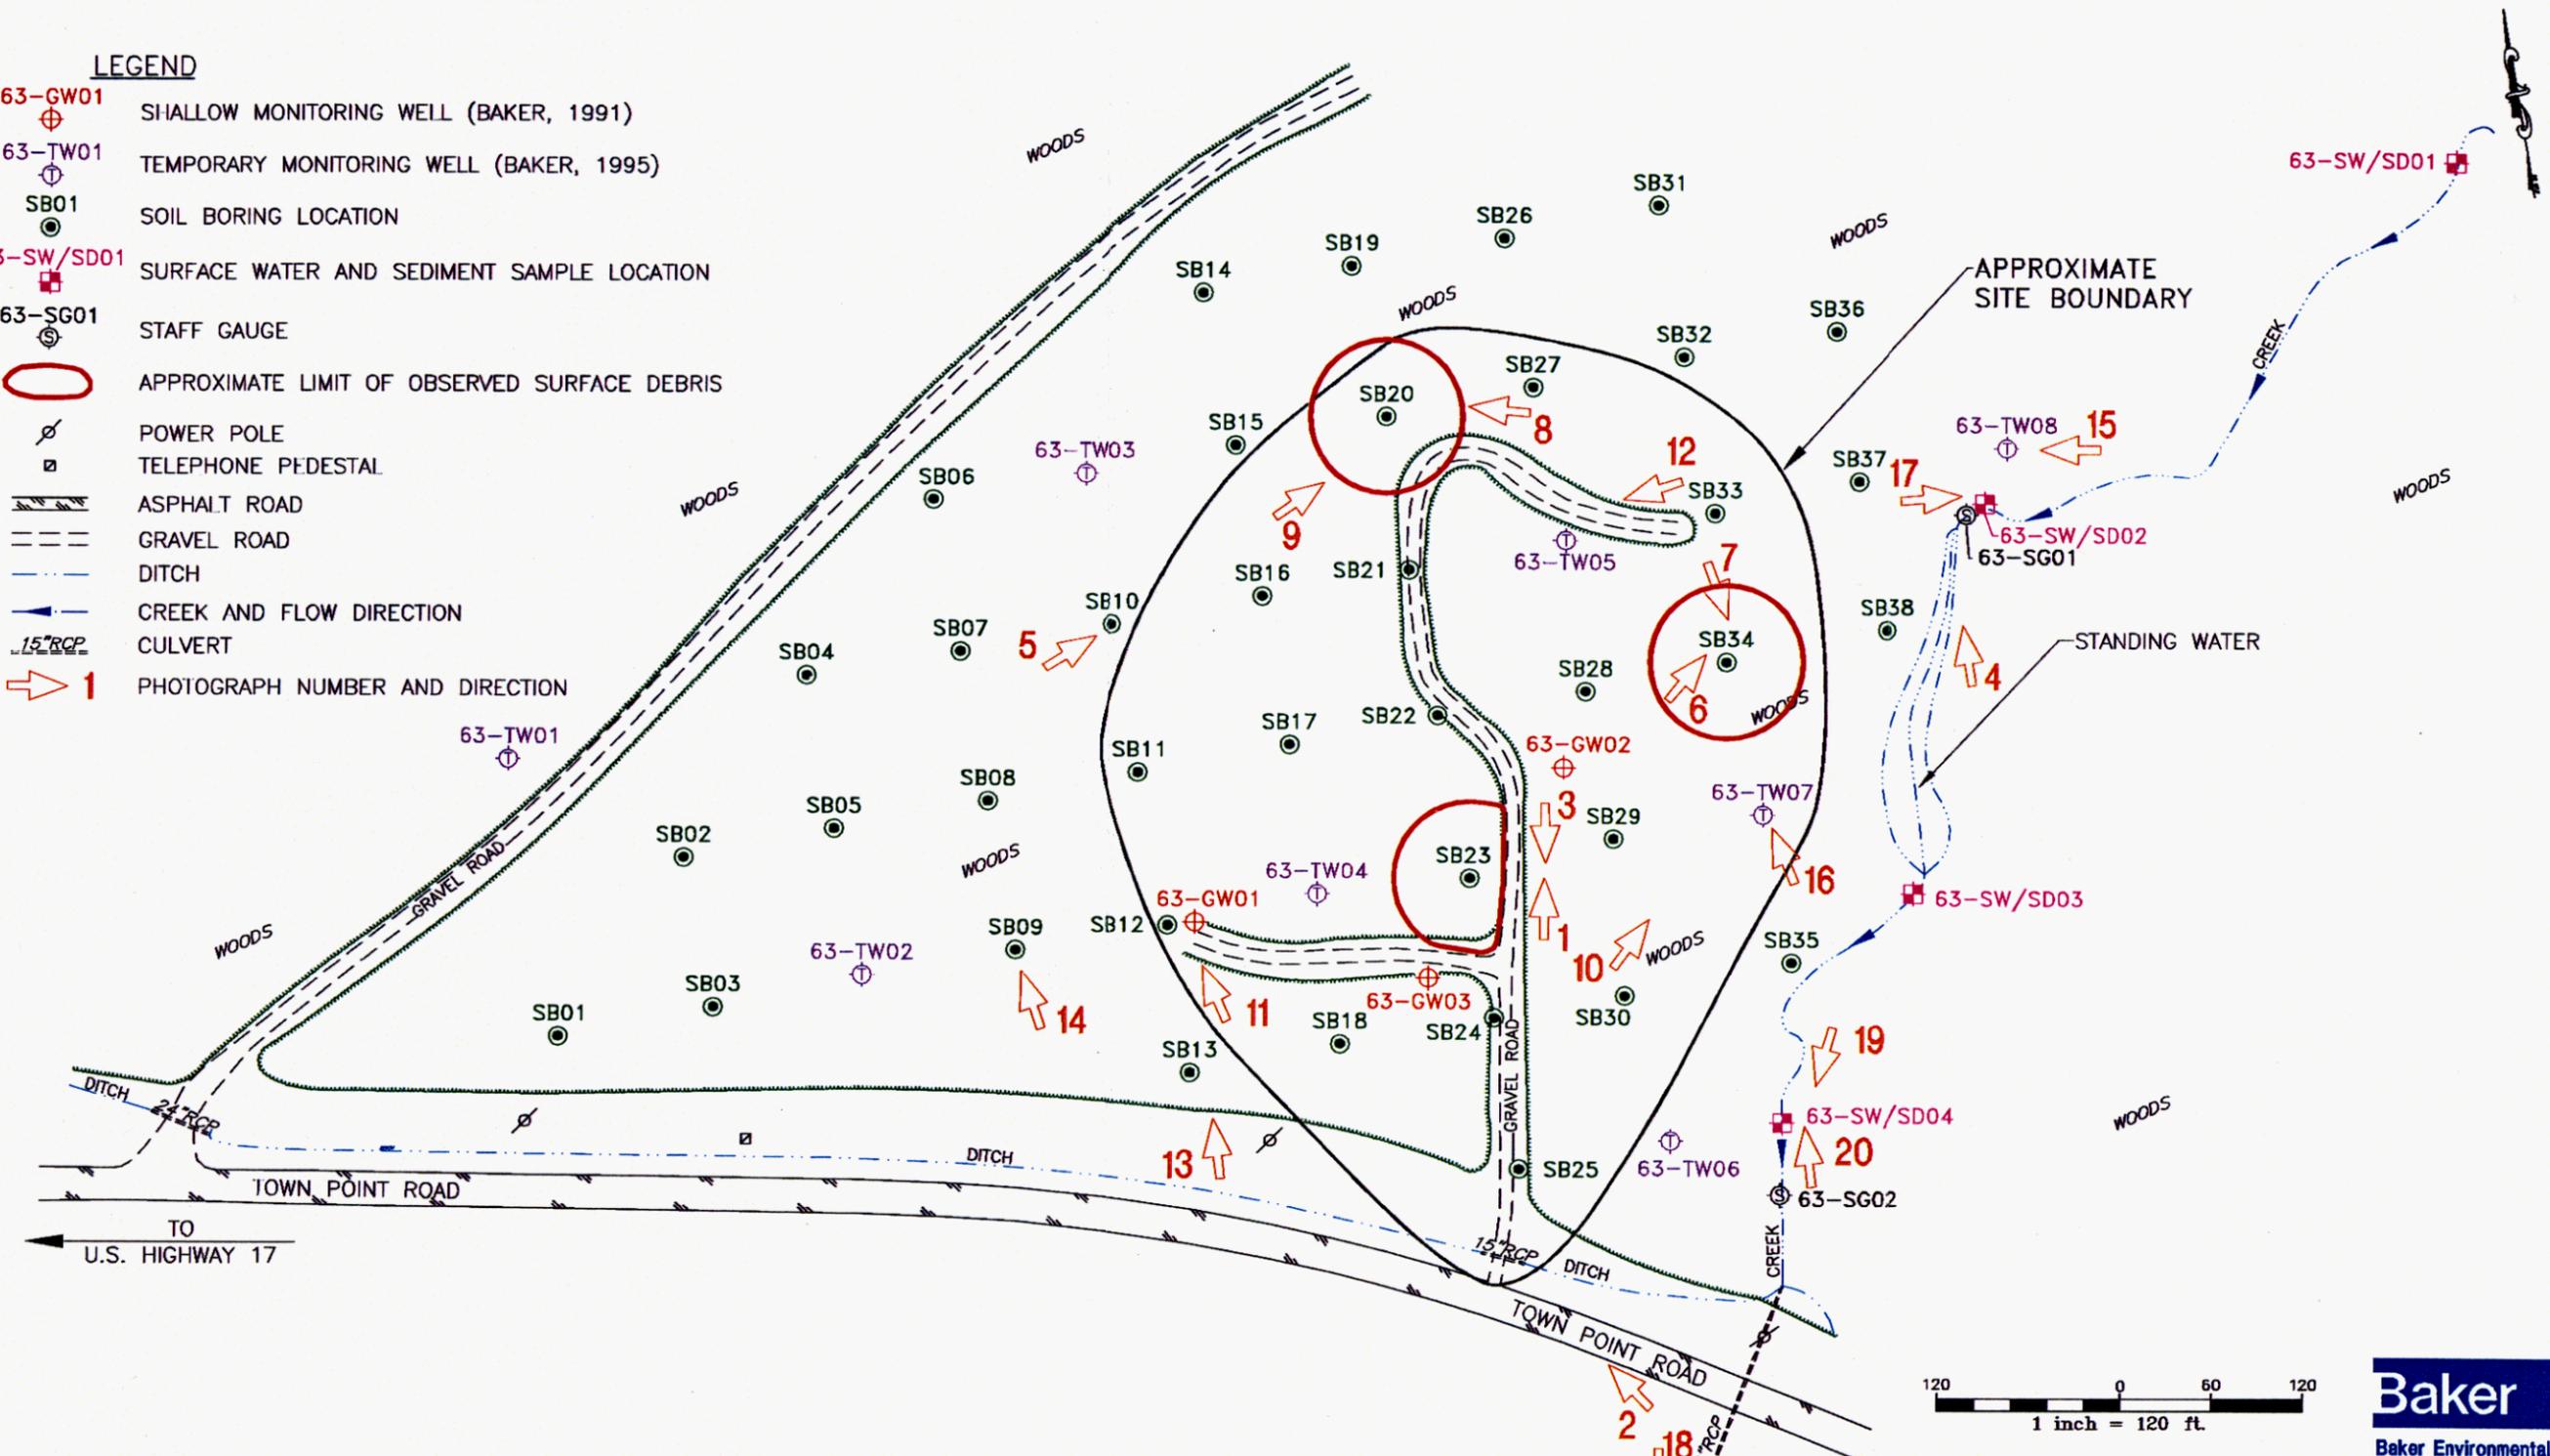
**FIGURE 1-2**  
**SITE MAP AND**  
**FIELD INVESTIGATION PHOTOGRAPHS**  
**SITE 63, VERONA LOOP DUMP**  
**REMEDIAL INVESTIGATION, CTO-0340**  
**MARINE CORPS BASE, CAMP LEJEUNE**  
**NORTH CAROLINA**

The Field Investigation Photograph Album is formatted to allow ease of review. Section 1.0 provides the introduction, purpose, and format of the photograph album. Section 2.0 provides a brief description of Site 63 and a summary of the known or suspected waste management activities. Photographs have been included within Section 2.0 that illustrate present site conditions. Section 3.0 describes the various field investigations conducted at OU No. 13. Representative photographs of all field investigation activities (e.g., Soil Investigation, Groundwater Investigation) are included in this section. Corresponding 35 millimeter color slides of all photographs contained in this album are provided in Appendix A. Figure 1-2 presents a field investigation site map of the Verona Loop Dump and the approximate location and direction of photographs contained herein.

A soil investigation was conducted at Site 63 to characterize potential soil contamination that may have resulted from previous waste management practices or site activities. Analytical data were compiled during the investigation to assess both the human health and ecological risks associated with exposure to site soil. Soil collection was performed using a direct-push (GeoProbe™) sampling system. Borings were advanced by either a truck-mounted rig or by a hand sampler unit. The direct-push sampling system employed a stainless steel cutting shoe and collection tube. A dedicated acetate liner, inserted into the stainless steel collection tube, was used to collect and then extrude soil samples for field and laboratory analyses. All soil sampling activities conducted at Site 63 were performed in Level D personnel protection. A total of 46 test borings were sampled during the soil investigation at Site 63. Soil samples were collected throughout Site 63 as provided on Figure 1-2.

A total of five surface water and five sediment samples were collected at Site 63 with each sampling station yielding one surface water and one sediment sample. Each of the sampling stations were located in an unnamed tributary to Mill Run, which borders the eastern portion of the study area. Figure 1-2 depicts the locations of the surface water and sediment sampling locations. Surface water samples were assigned the designation "SW" and "SD" was specified for identification of sediment samples.

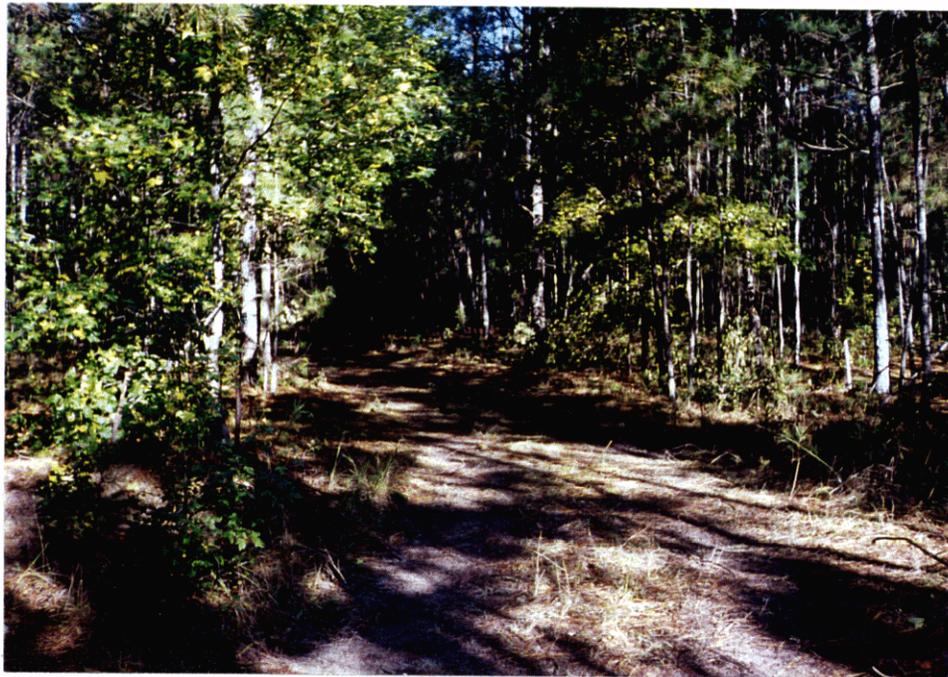
**OU13.Site 63.1995.01:** This photograph depicts conditions at Site 63. The gravel road pictured here provides access to the central portion of the study area; unimproved paths extend outward from this road.

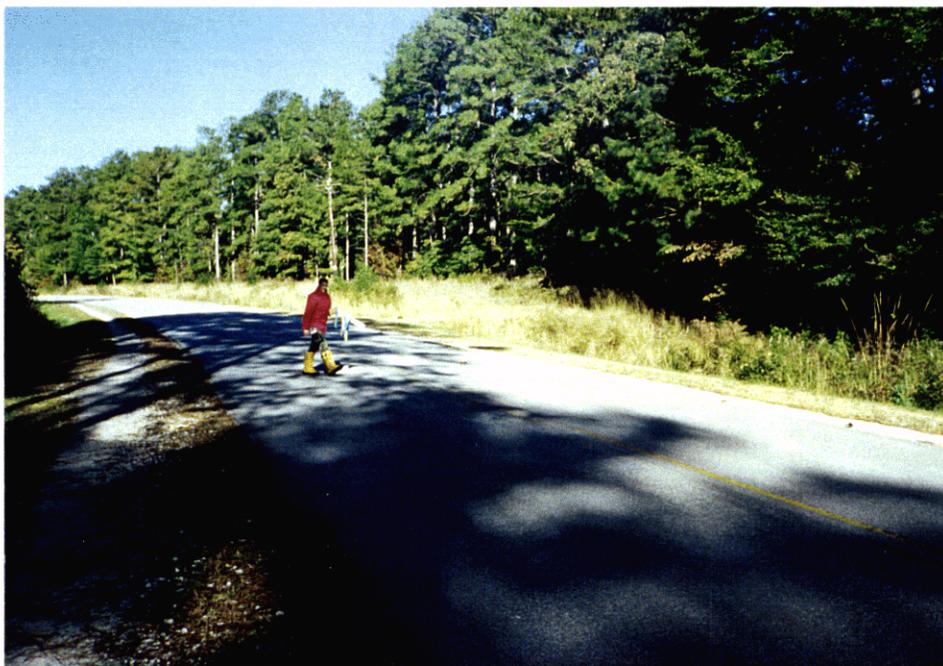
**OU 13.Site 63.1995.02:** This photograph was taken from Town Point Road facing Site 63. The study area is located along Town Point Road, approximately 1.3 miles east of U.S. Route 17.

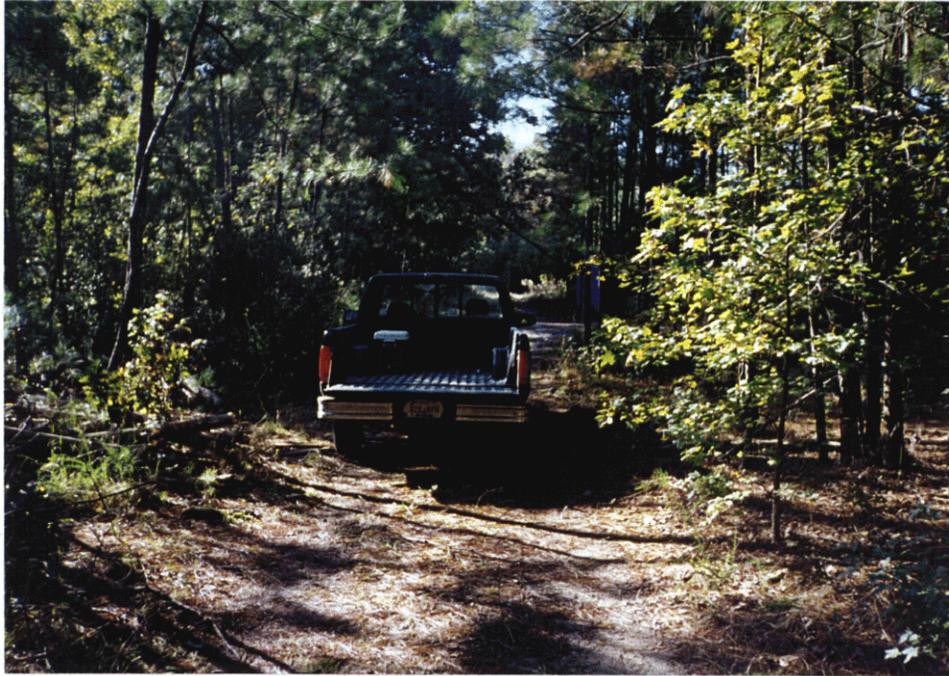
**OU 13.Site 63.1995.03:** This photograph was taken facing south from the Site 63 gravel access road toward Town Point Road. As pictured, much of the site is heavily vegetated with dense understory and trees greater than three inches in diameter.

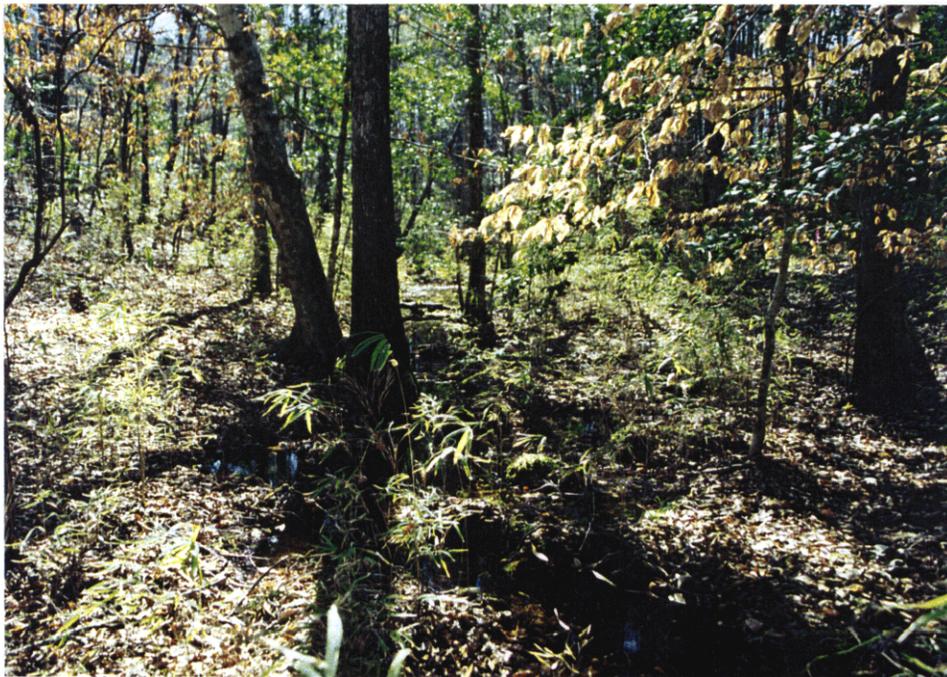
**OU 13.Site 63.1995.04:** This photograph depicts the unnamed tributary that borders Site 63 to the east. The tributary is less than two feet wide at this location.

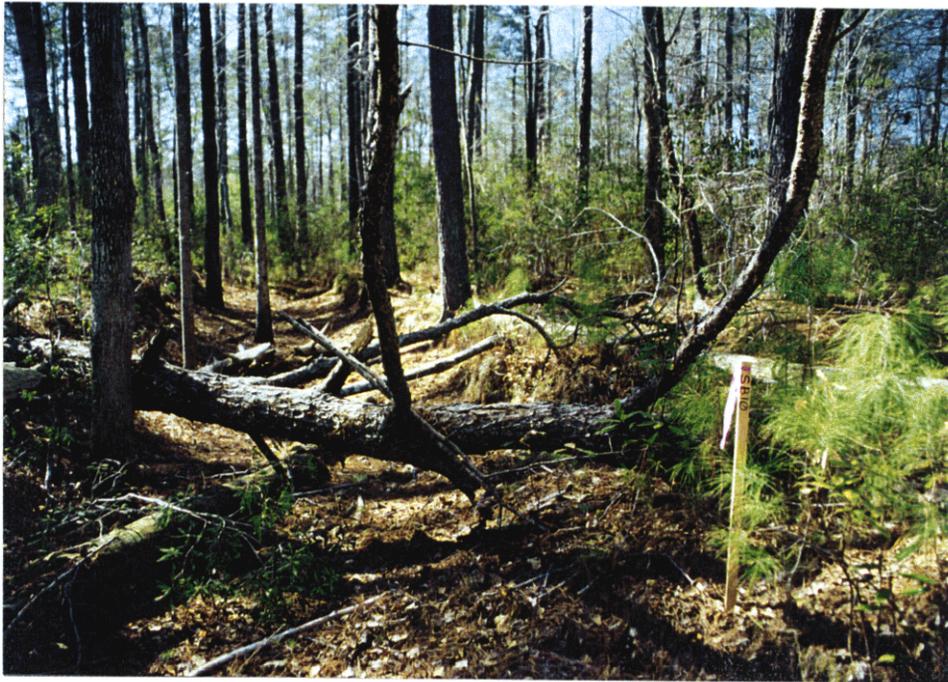
**OU 13.Site 63.1995.05:** This photograph depicts the western portion of the study area, adjacent to soil test boring 63-SB10.

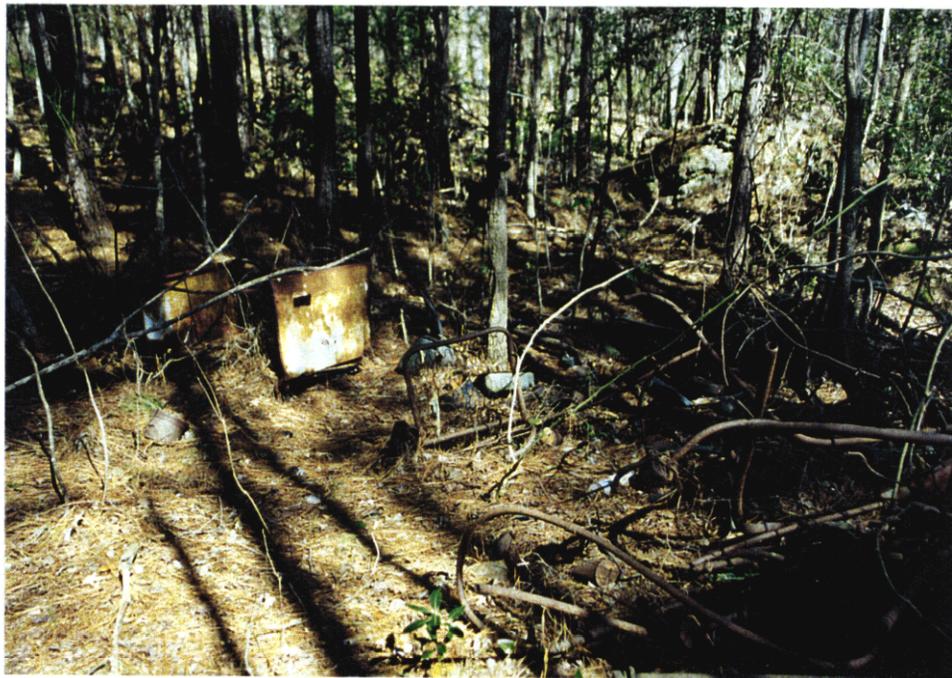
**OU 13.Site 63.1995.06:** This photograph depicts some of the debris and scrap metal identified during the field investigation.

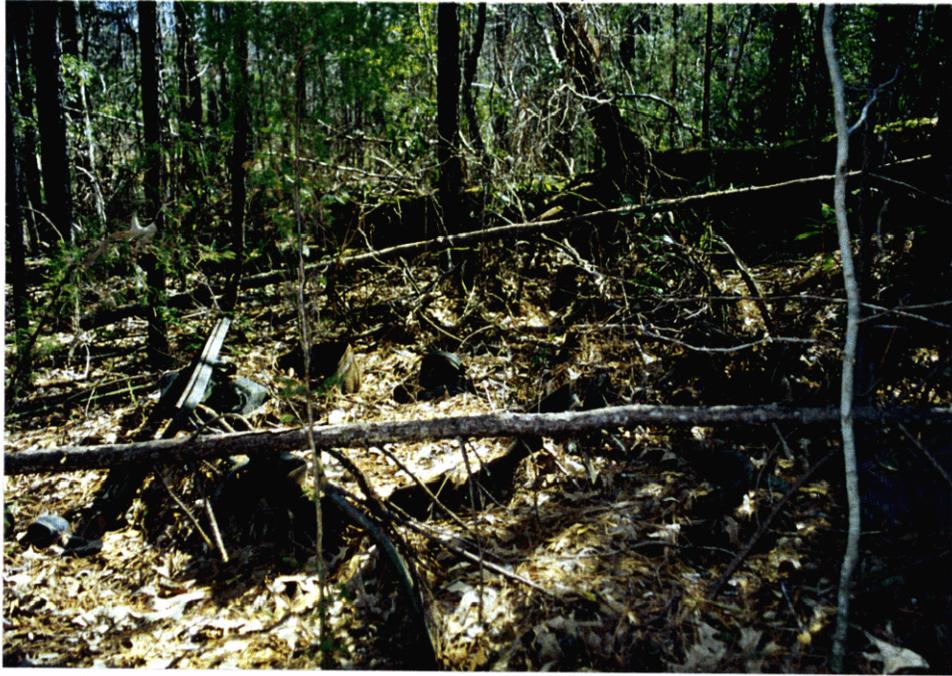
**OU 13.Site 63.1995.07:** Rubber tires and vehicle parts, as pictured, were identified on the ground surface at Site 63. Glass shards, wood, and rusted metal debris were found in a limited number of subsurface samples obtained from the central portion of the study area.

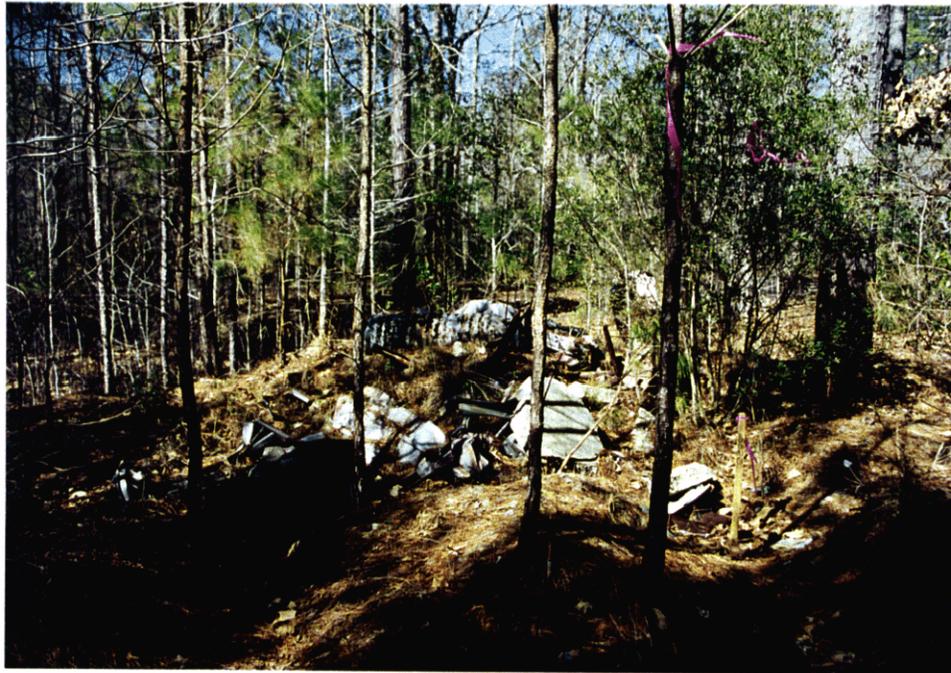
**OU 13.Site 63.1995.08:** Reinforced concrete rubble, construction material, and various other inert debris, as pictured, were also identified at Site 63.

Upon visual inspection of the site, conclusive indications (e.g., distressed vegetation, denuded areas, etc.) of hazardous waste disposal were not apparent; however, reinforced concrete rubble, construction material, and various other inert debris were identified during several site visits. The observed waste material was limited to a number of distinct piles or areas, rather than being strewn throughout the study area.

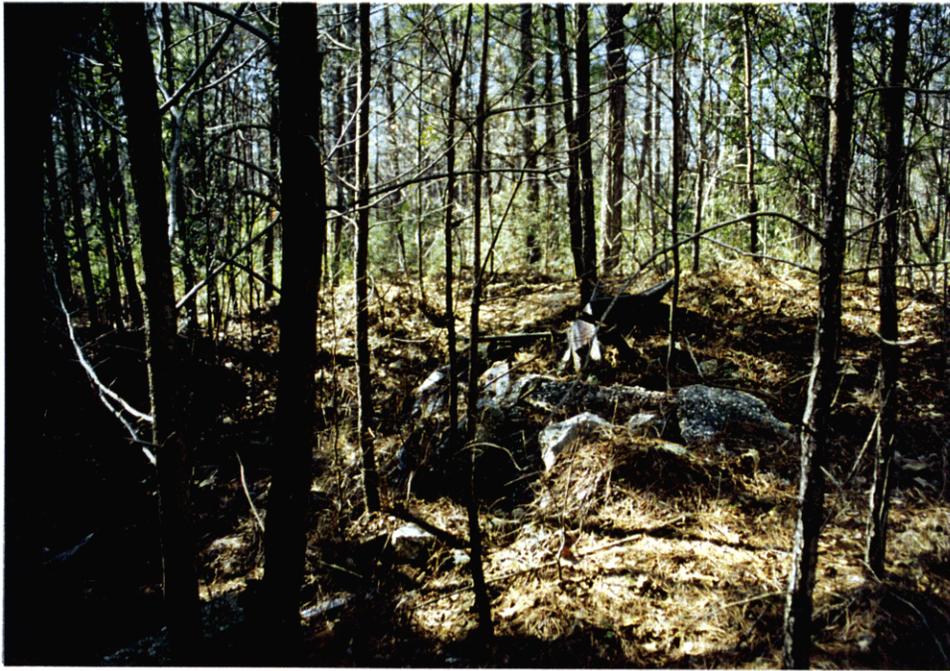
**OU13.Site 63.1995.09:** The observed surface debris, as pictured, was limited to a number of distinct piles or areas rather than being strewn throughout the study area (refer to Figure 1-2).

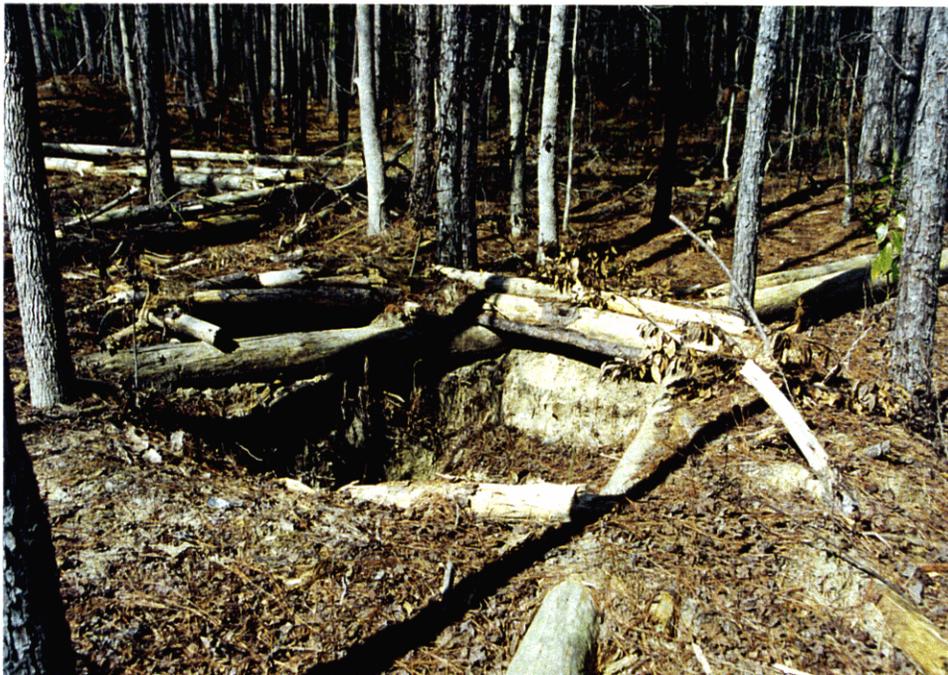
**OU13.Site 63.1995.10:** This photograph depicts one of the many personnel entrenchments, presumably constructed during training exercises, that have been hand-excavated throughout the study area. As pictured, an earthen berm and felled trees have been used to form protective works.

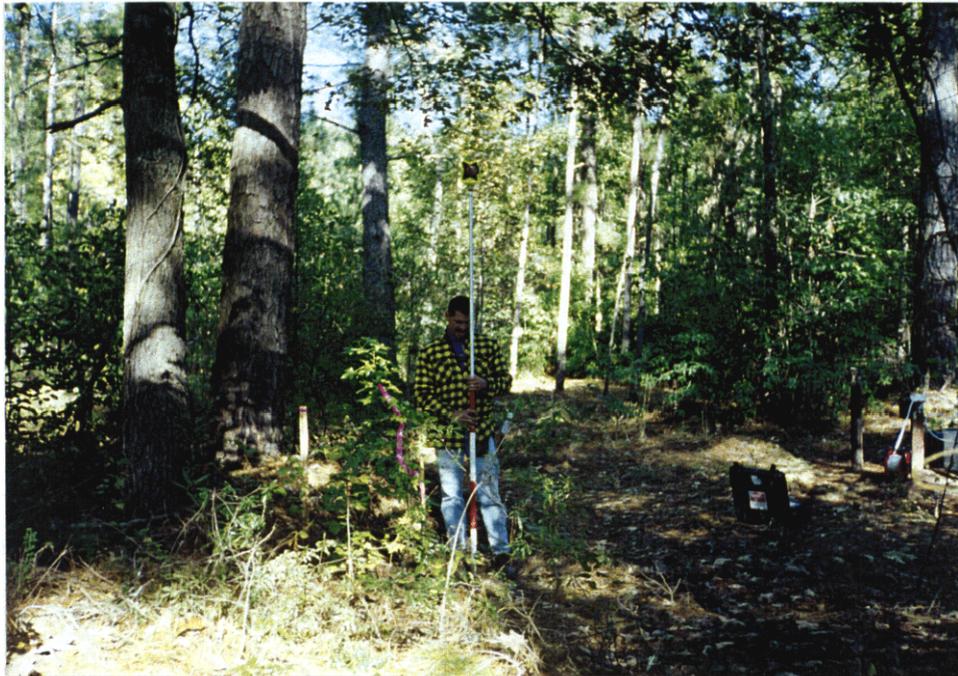
**OU13.SL.1995.11:** During the Site 63 field investigation each test boring, monitoring well, and surface water/sediment sampling location was surveyed to the nearest tenth of a foot. Horizontal data points were referenced to the North Carolina State Plane Coordinate System.

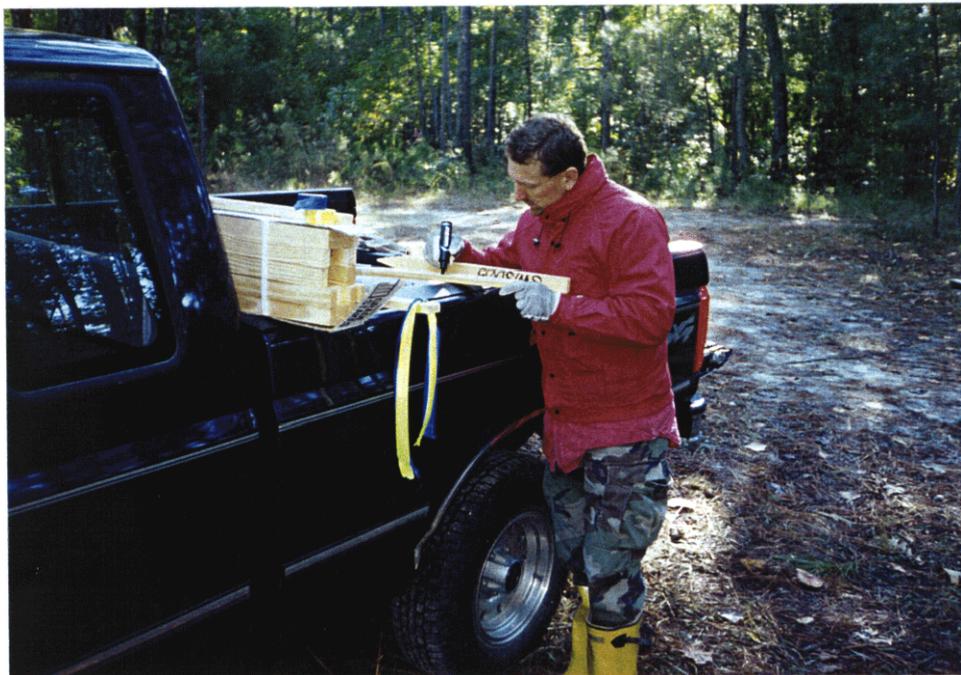
**OU13.SL.1995.12:** Wooden stakes and flagging, as pictured, were used to identify the various sampling locations at Site 63.

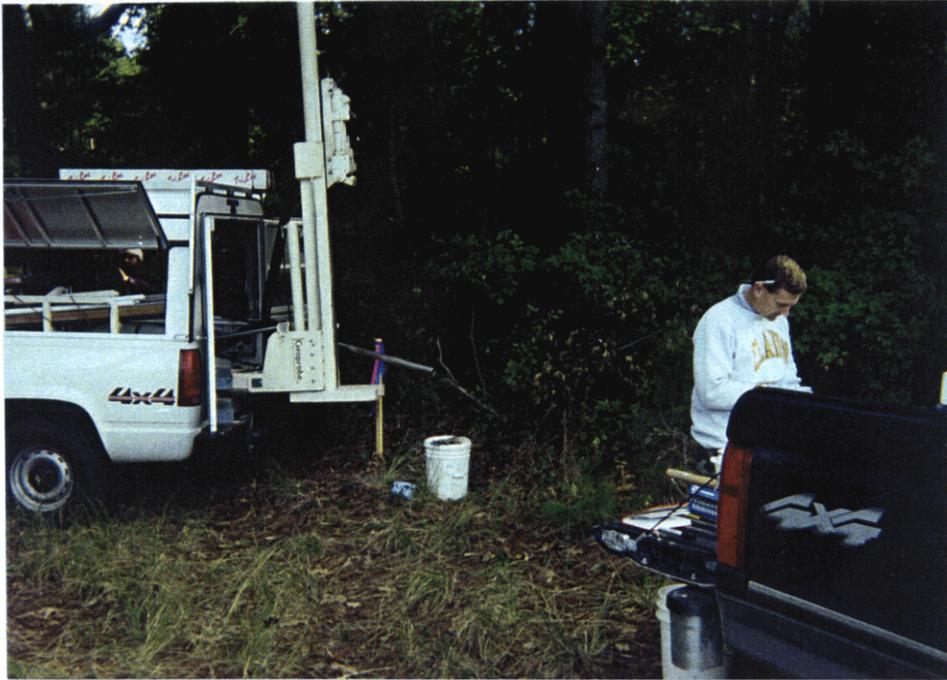
**OU13.SL.1995.13:** As this photograph depicts, all operations relating to the soil investigation (i.e., soil acquisition, field analysis, and decontamination) were mobilized between test boring locations.

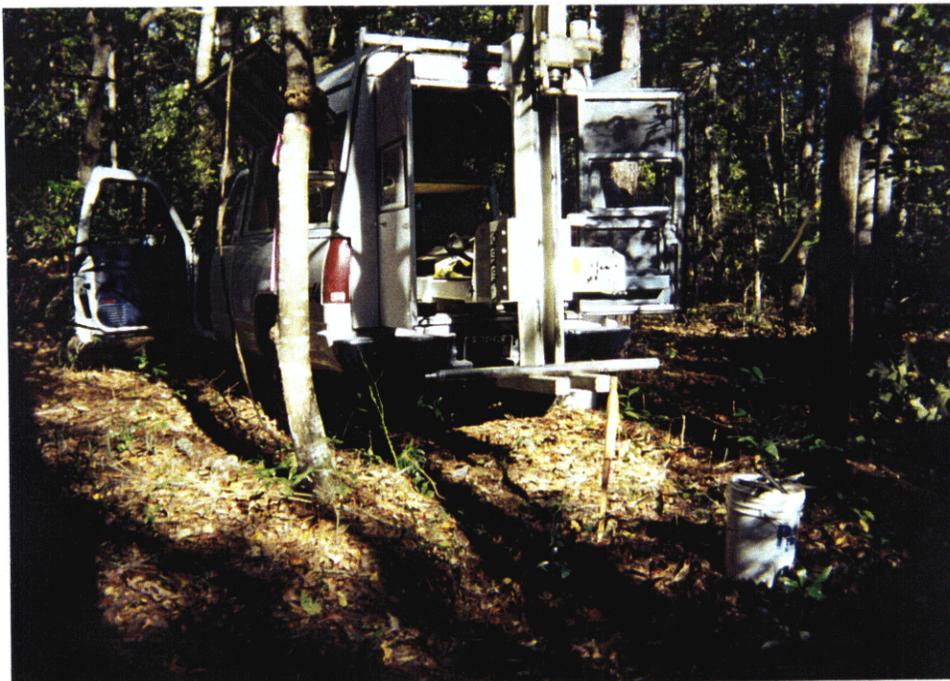
**OU13.SL.1995.14:** This photograph depicts GeoProbe™ soil sampling operations. The direct push sampling system, as pictured, generated only a very small amount of waste soils during the investigation.

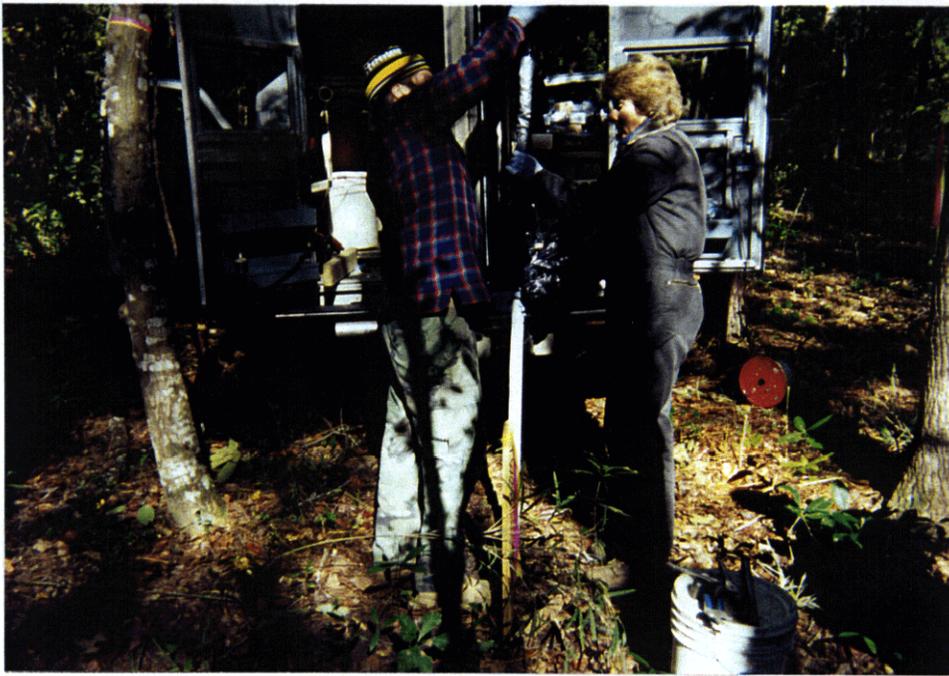
**OU13.GW.1995.15:** Temporary monitoring wells were installed using the same direct push sampling system employed during the soil investigation. The personnel pictured here are in the process of installing the one-inch polyvinyl chloride well.

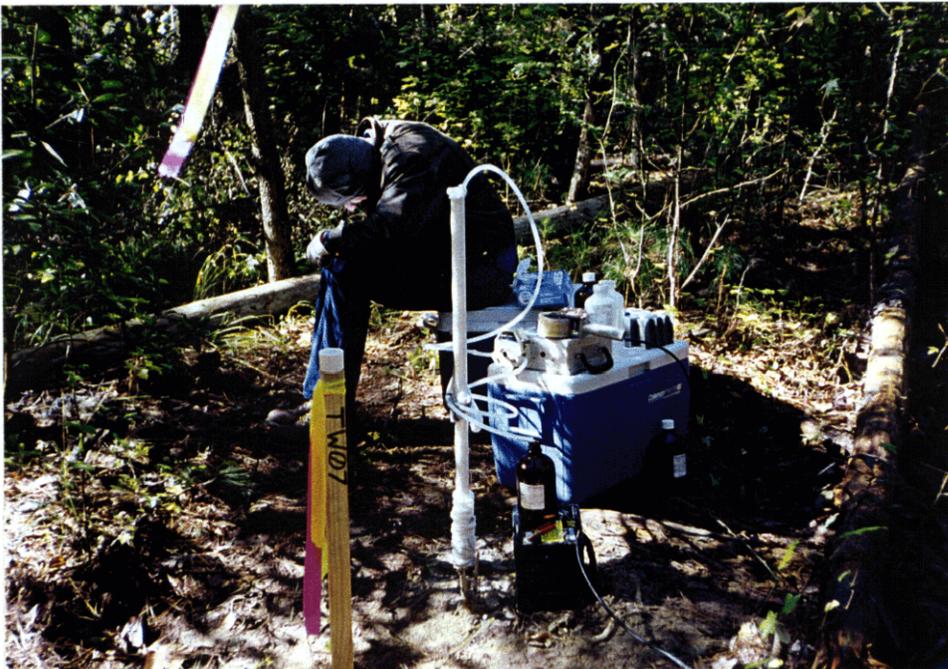
**OU13.GW.1995.16:** Groundwater sampling operations were mobilized between temporary wells. A peristaltic pump (GeoPump™), with the intake set two to three feet into the static water column, was used to purge and sample each of the permanent and temporary monitoring wells.

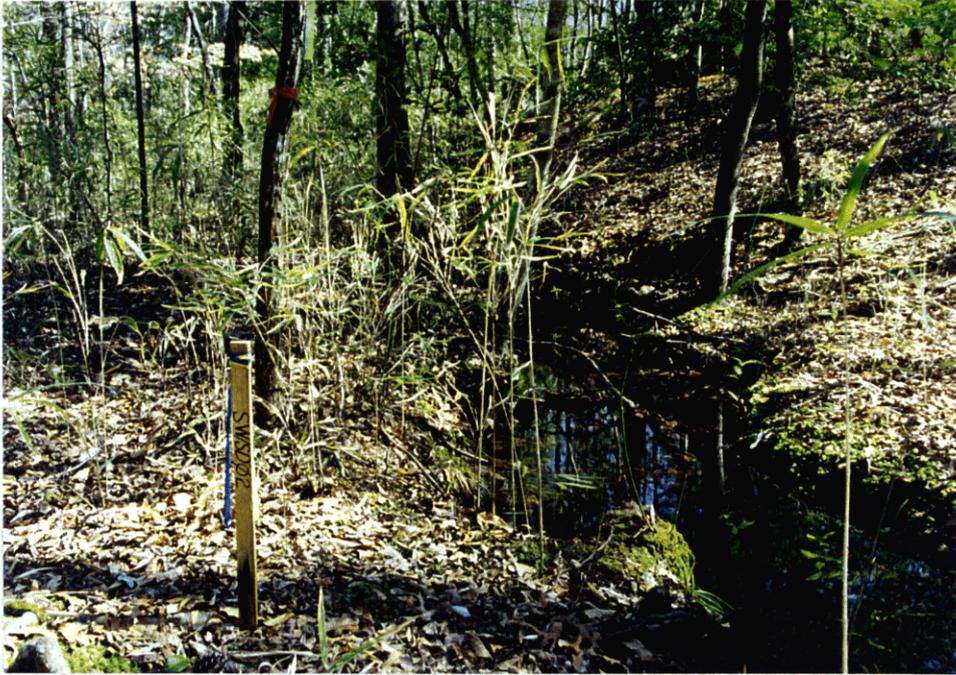
**OU13.SW.1995.17:** This photograph depicts surface water and sediment sampling station 63-SW/SD02. The unnamed tributary that borders the eastern portion of the study area is approximately eight inches deep at this location.

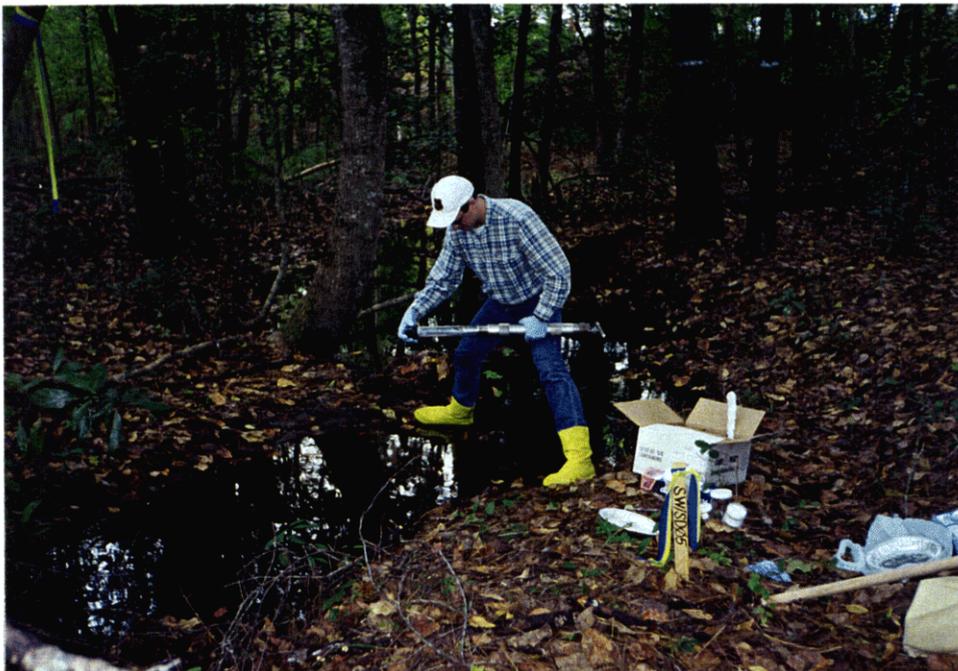
**OU13.SW.1995.18:** Sediment samples were collected using a manually-driven core barrel, as pictured, and dedicated acetate sleeves. The sediment samples were then extruded from the acetate sleeves into appropriate sample jars.

Sediment samples were collected below the aqueous layer by driving a sediment corer, equipped with a disposable tube, into the sediment. The first six inches of sediment at each station were submitted for analyses. The sediment was extruded from the disposable sampling tube and placed into the appropriate sample containers. Sampling containers were provided by the laboratory and certified to be contaminant free. The volatile fraction was collected first, followed by the remaining analytical parameters. Samples to be analyzed for TCL semivolatiles, pesticides, PCBs, total organic carbon (TOC), and TAL metals were thoroughly homogenized before the sample jars were filled. Surface water and sediment samples were collected at downstream sampling locations first. All sample locations were marked by placing a wooden stake at the nearest point along the bank.

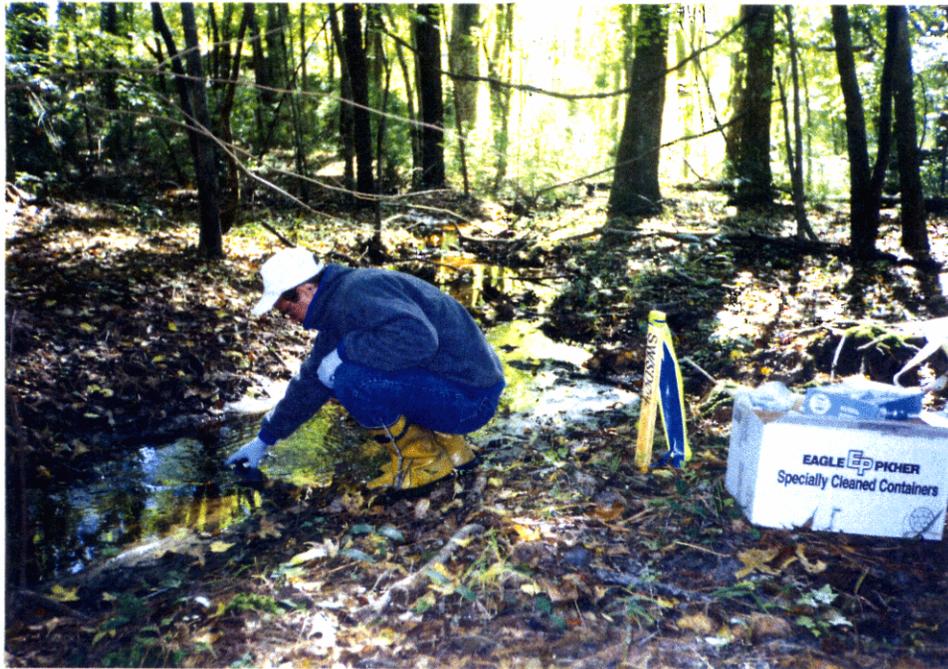
**OU13.SD.1995.19:** This photograph depicts surface water collection procedures. At each of the five surface water sampling stations, samples were collected by dipping containers directly into the water.

At each of the five surface water sampling stations, samples were collected by dipping containers directly into the water. Samples to be analyzed for volatiles were obtained first, samples for additional analytical fractions were collected immediately following. Care was taken to avoid excessive agitation that could result in loss of VOCs. Water quality readings were taken at each sampling station (i.e., pH, dissolved oxygen, salinity, specific conductance, and temperature).

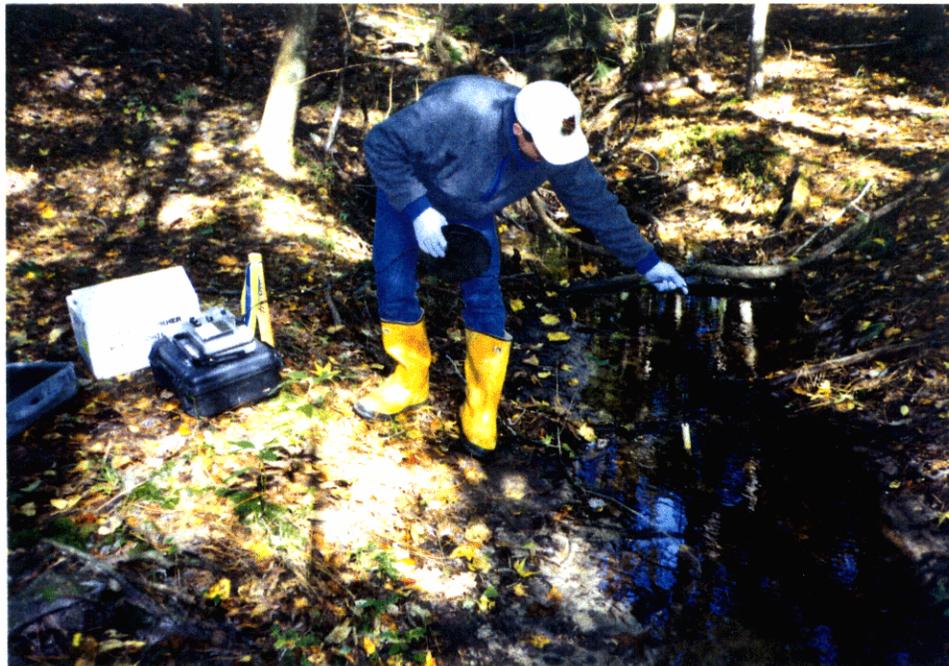
**OU13.SD.1995.20:** In addition to laboratory tests, measurements of specific conductance, pH, and dissolved oxygen were recorded during the surface water investigation.
