Interim Measures Report
SWMU - 25/07D
Highway 58 Dump Site A

NSWC Crane
Crane, Indiana

November, 1999

**Southern Division
Naval Facilities Engineering Command
North Charleston, South Carolina
29419-9010**

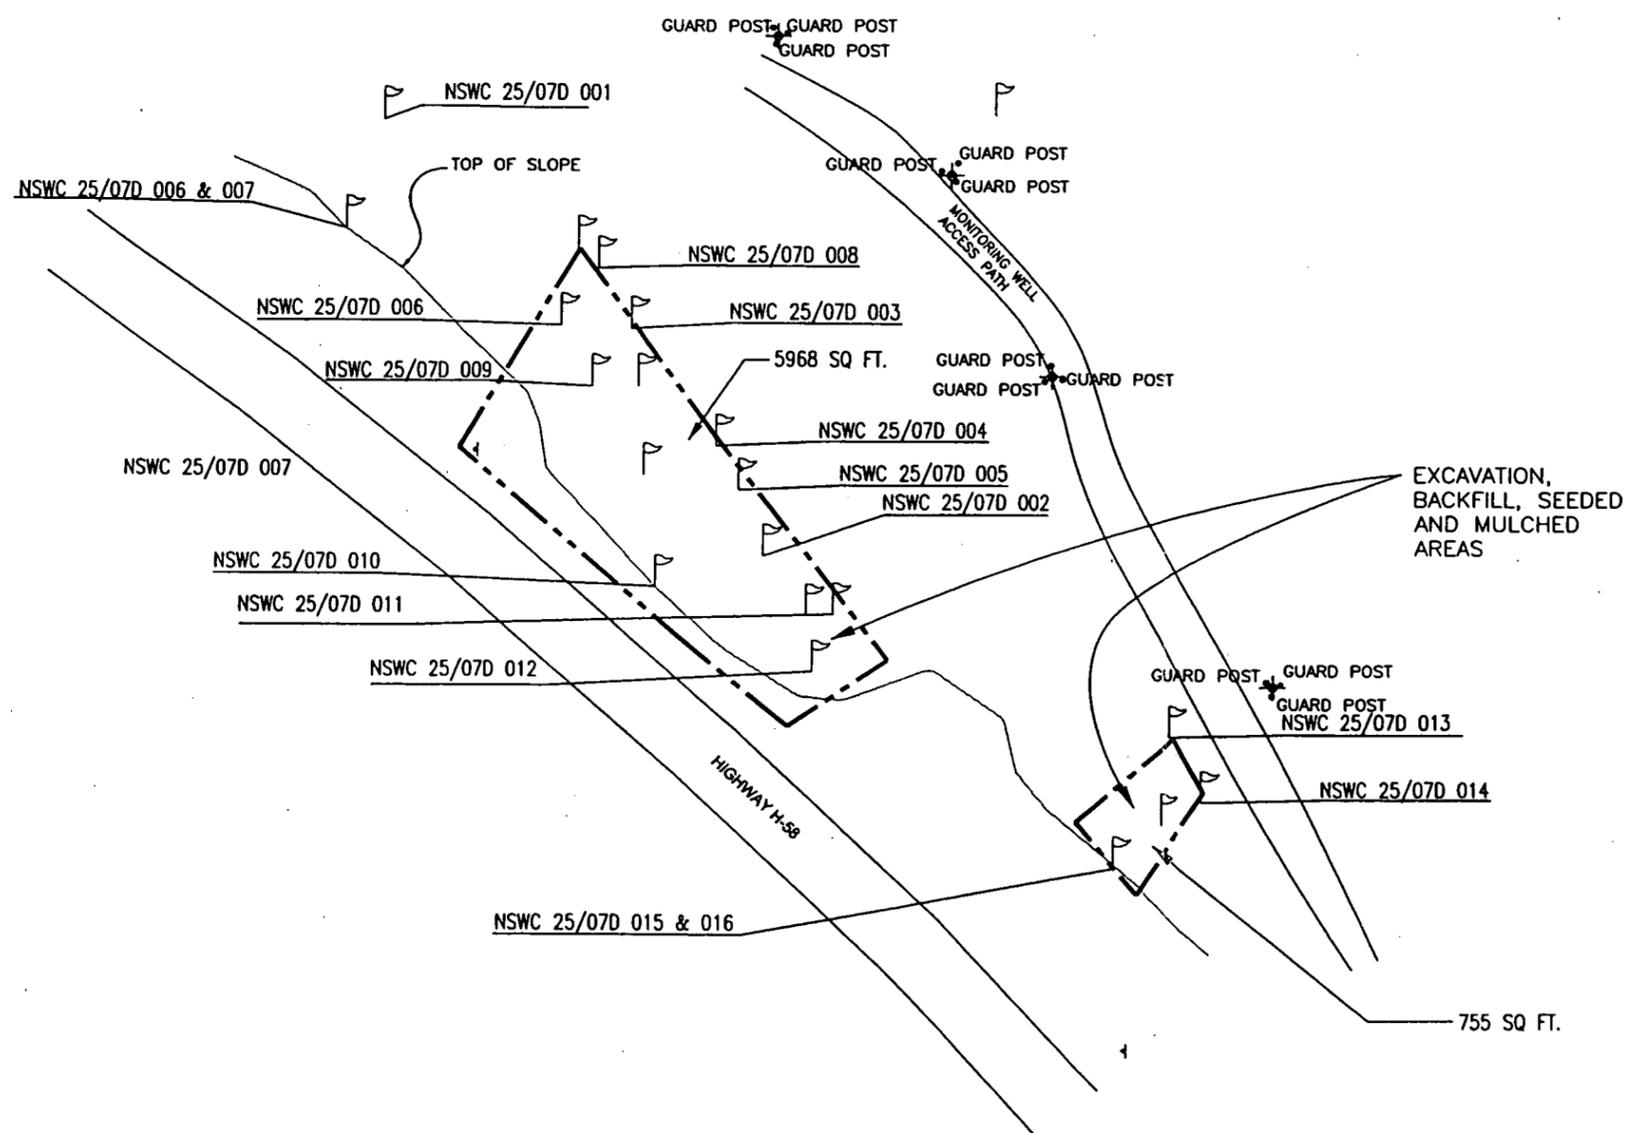
| <u>FIGURE</u> | <u>PAGE</u> |
|--|---|
| 4-1 SAMPLE LOCATIONS | 4-5 |

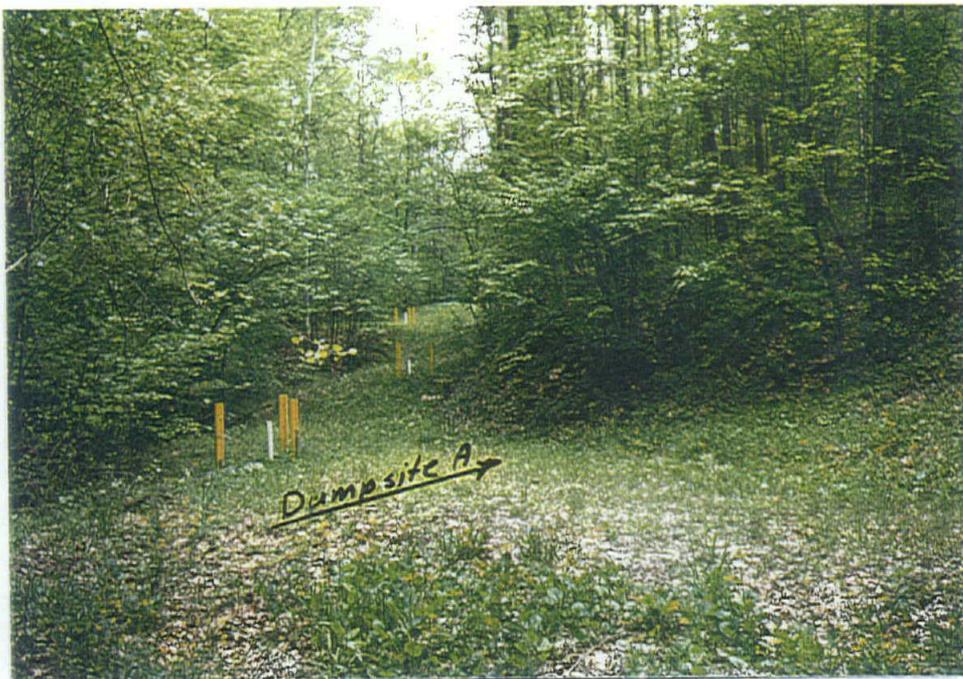
PHOTO 1a & 1b

ROLL: 1
FRAME: 3
DATE: 11 MAY 95
PHOTOGRAPHER: J. SMITH
DESCRIPTION: Possible access
along the sampling wells north
and bottom of the dump site
hill.

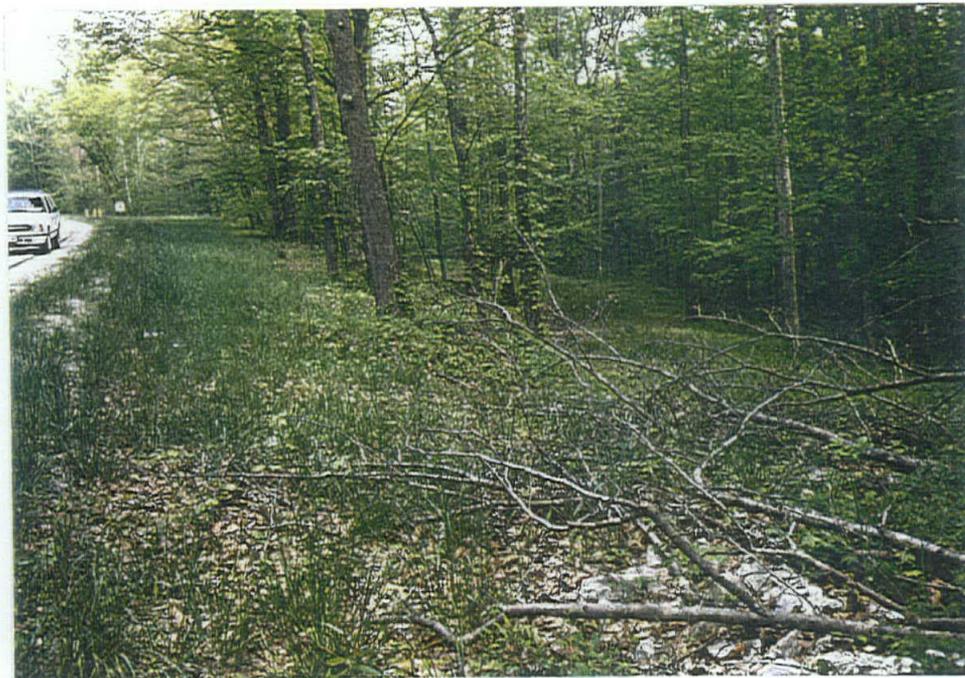
ROLL: 3
FRAME: 7A
DATE: 12 MAY 95
PHOTOGRAPHER: J. SMITH
DESCRIPTION: Access from
highway H58 that passes by the
above sampling wells.

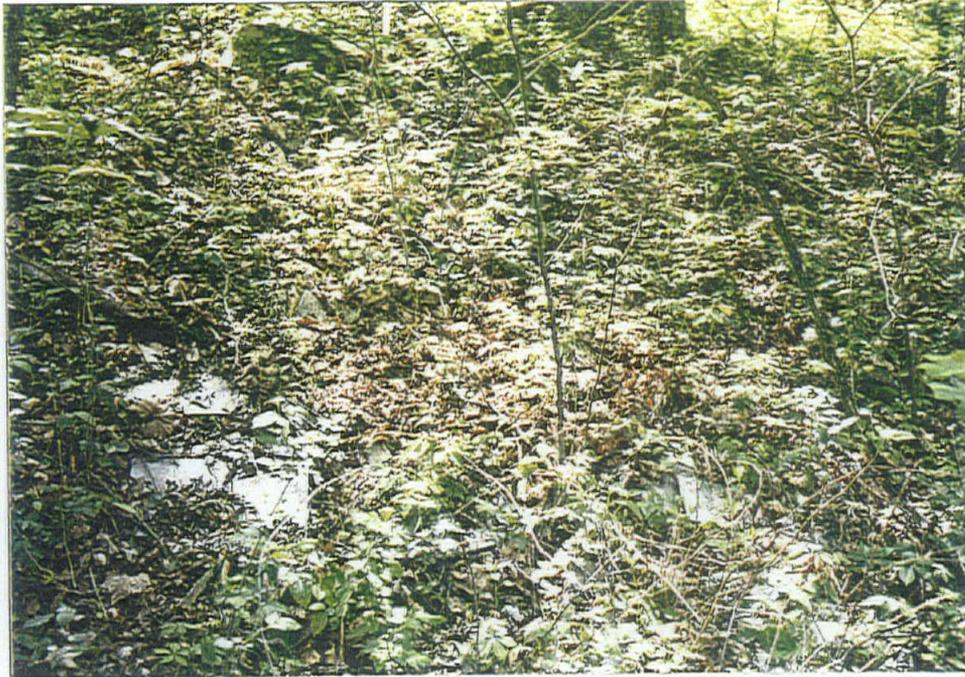
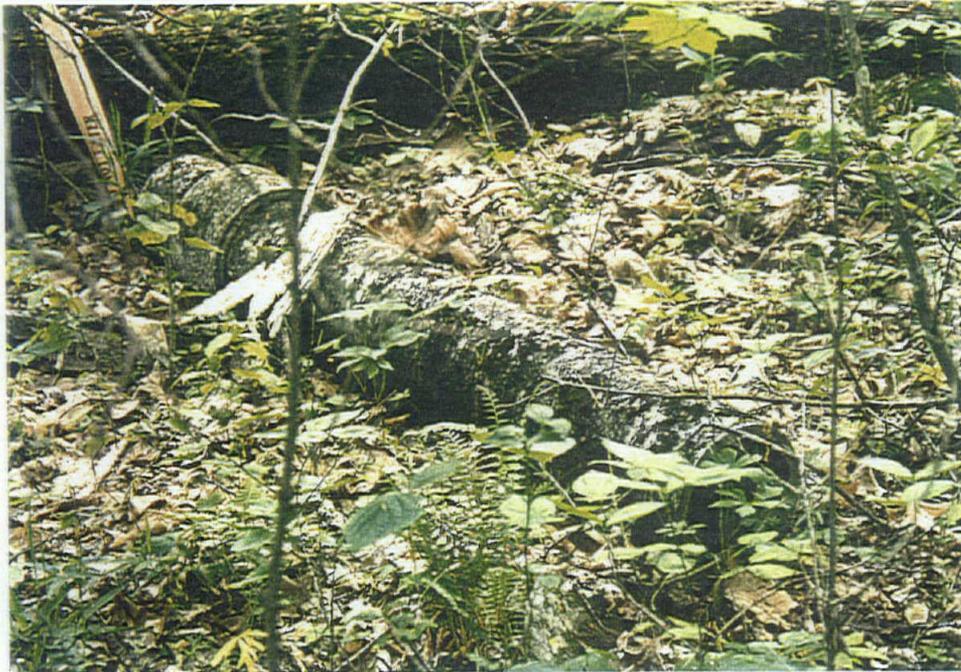
PHOTO 2a & 2b

Visual inspection of Highway 58 Dump Site A indicated scattered debris consisting of transite siding and pipe, various sizes of concrete pipe and block, metal cans, caps, drums, blocks of roofing tar, chunks of cast concrete, metal pipe, cast metal drains, and electrical porcelain insulators. There were no detectable smells or organic vapor indications noted in the area during the initial walk downs. Inert (concrete-filled) hardware, such as 12.75 inch warheads (Hedgehog), had been used as filler to prevent land erosion. A memo dated June 5, 1995, in Appendix B, shows a sketch of the configuration of disposed ordnance buried at the site. Photographs 2a through 5b in Appendix A show the debris and heavy foliage at the dump site.

ROLL: 1
FRAME: 1
DATE: 11 MAY 95
PHOTOGRAPHER: J. SMITH
DESCRIPTION: **Example of trash; transite siding.**

ROLL: 1
FRAME: 4
DATE: 11 MAY 95
PHOTOGRAPHER: J. SMITH
DESCRIPTION: **Example of trash; transite pipe.**

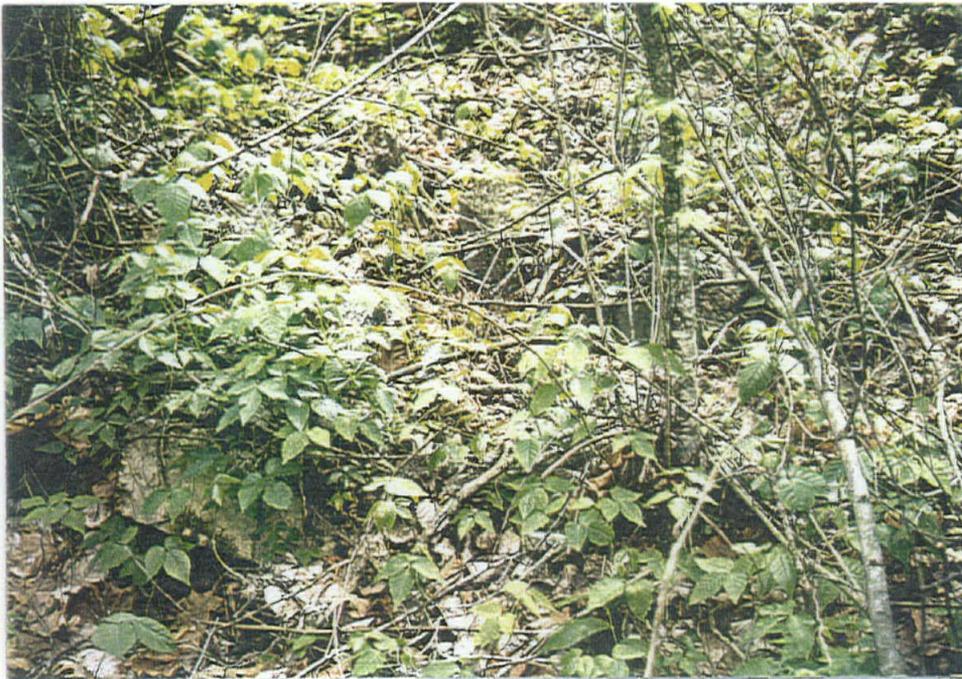
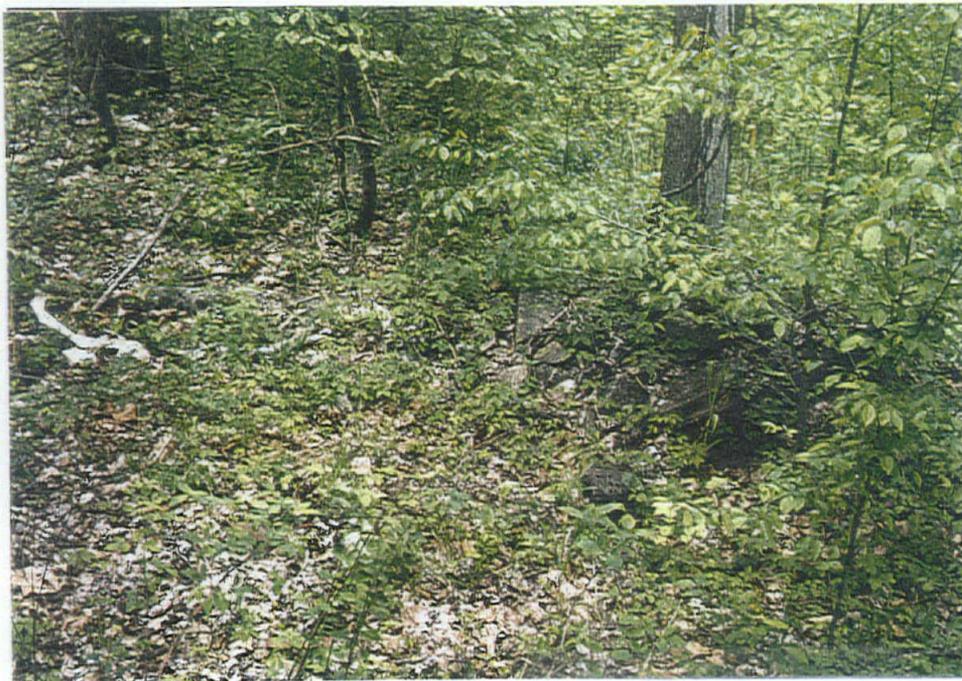
PHOTO 3a & 3b

ROLL: 1
FRAME: 8A
DATE: 11 MAY 95
PHOTOGRAPHER: J. SMITH
DESCRIPTION: **Concrete blocks
various thickness 8' to 10".**

ROLL: 1
FRAME: 9A
DATE: 11 MAY 95
PHOTOGRAPHER: J. SMITH
DESCRIPTION: **Concrete pipe,
cinder blocks, electrical
porcelain insulators, metal pipe
metal sheeting.**

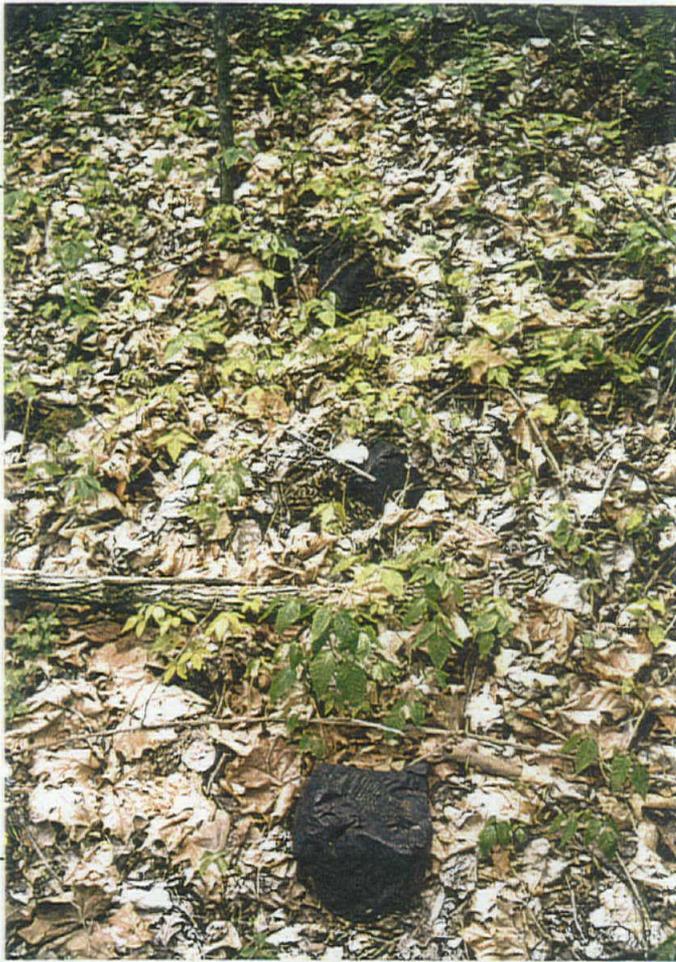
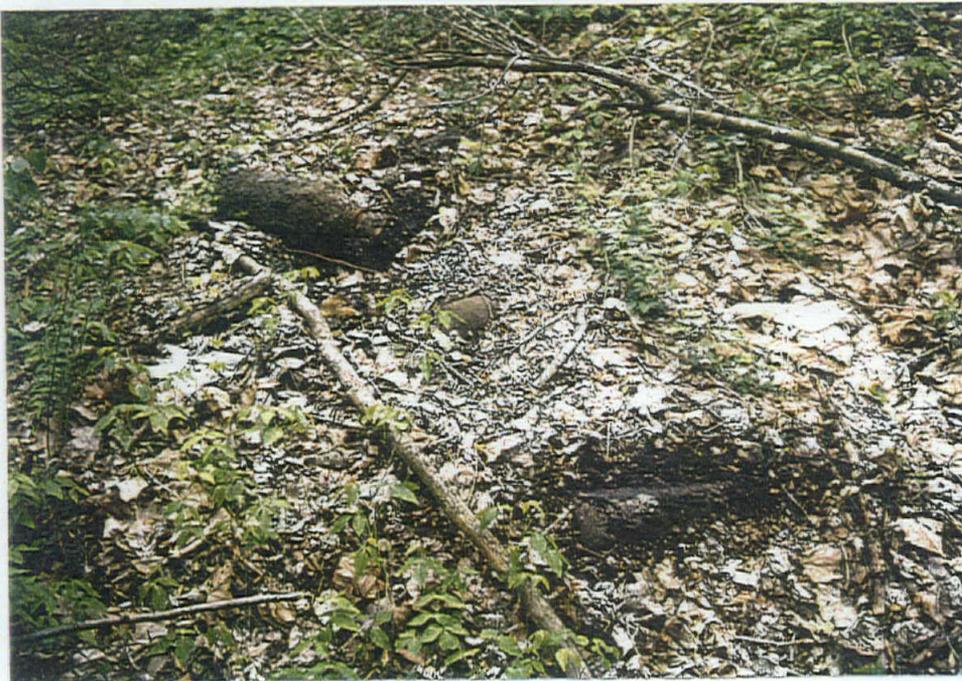
PHOTO 4a & 4b

ROLL: 1
FRAME: 6A
DATE: 11 MAY 95
PHOTOGRAPHER: J. SMITH
DESCRIPTION: **Roofing tar
blocks with smaller pieces
below leaves.**

ROLL: 1
FRAME: 7A
DATE: 11 MAY 95
PHOTOGRAPHER: J. SMITH
DESCRIPTION: **Buried metal
cylinders.**

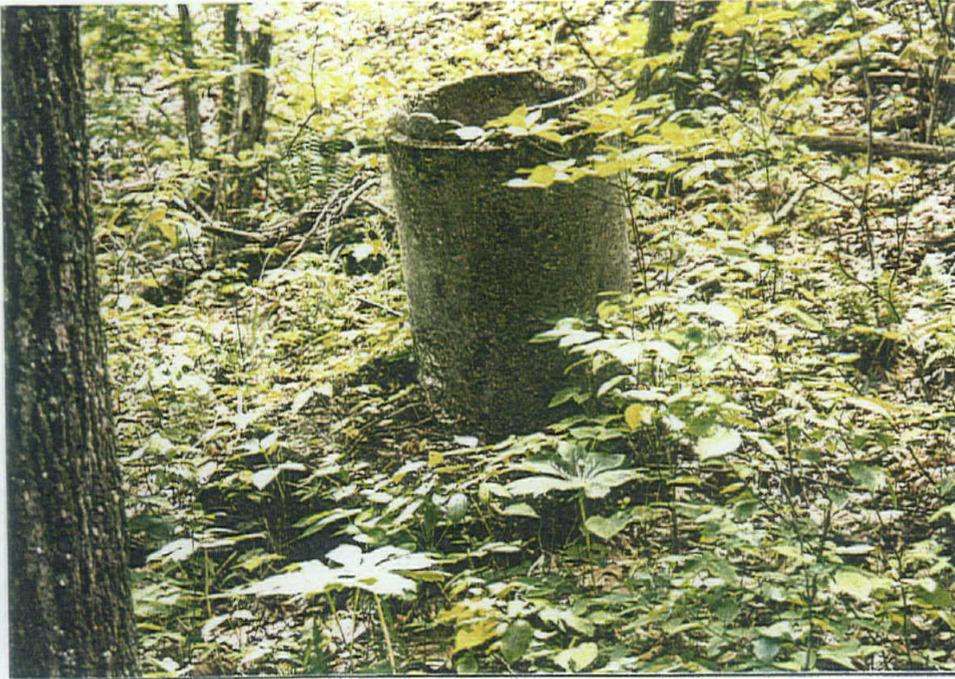
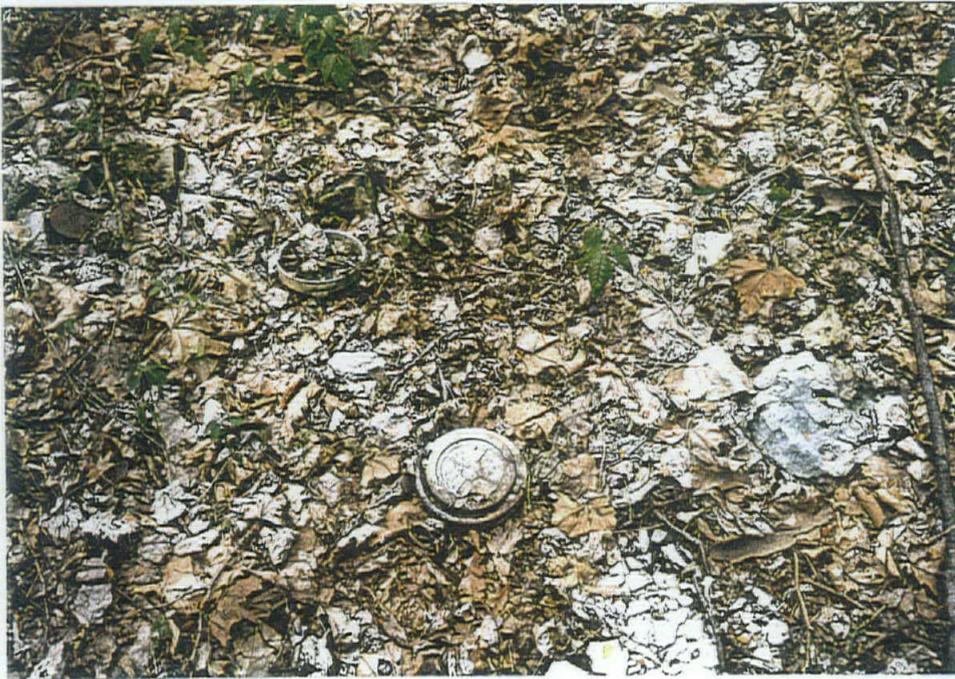
PHOTO 5a & 5b

ROLL: 1
FRAME: 4A
DATE: 11 MAY 95
PHOTOGRAPHER: J. SMITH
DESCRIPTION: Concrete pipe
attached to 10' of concrete
header.

ROLL: 1
FRAME: 5A
DATE: 11 MAY 95
PHOTOGRAPHER: J. SMITH
DESCRIPTION: Metal caps with
more covered by dead leaves.

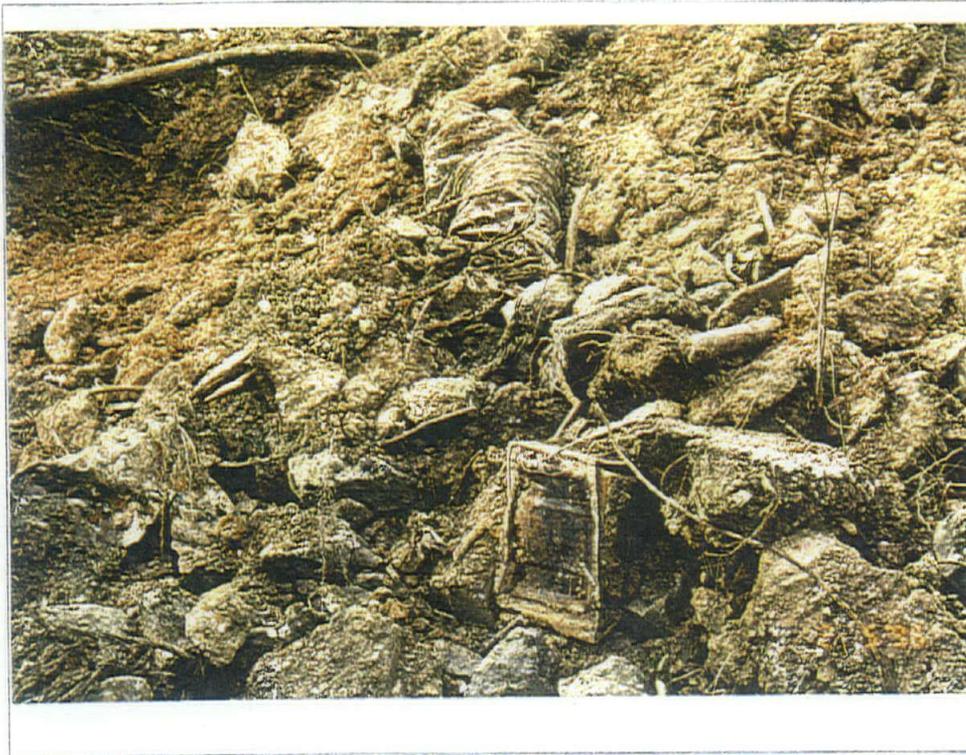
PHOTO 6a & 6b

ROLL: 23
FRAME: 06
DATE: 2/ 5/96
SWMU: 25/07D
BY: B. Kemp
TIME: 10:05
DESCRIPTION:
Looking south, road above into
bank.

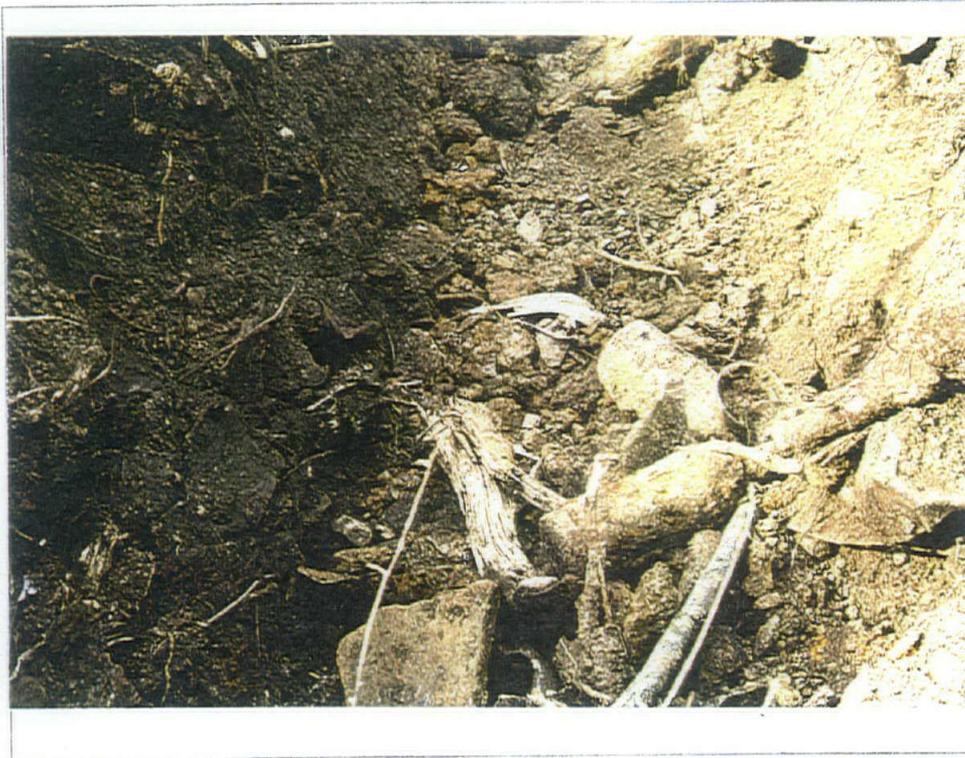
ROLL: 23
FRAME: 17
DATE: 2/ 5/96
SWMU: 25/07D
BY: B. Kemp
TIME: 10:10
DESCRIPTION:
Looking down and north from the
road.

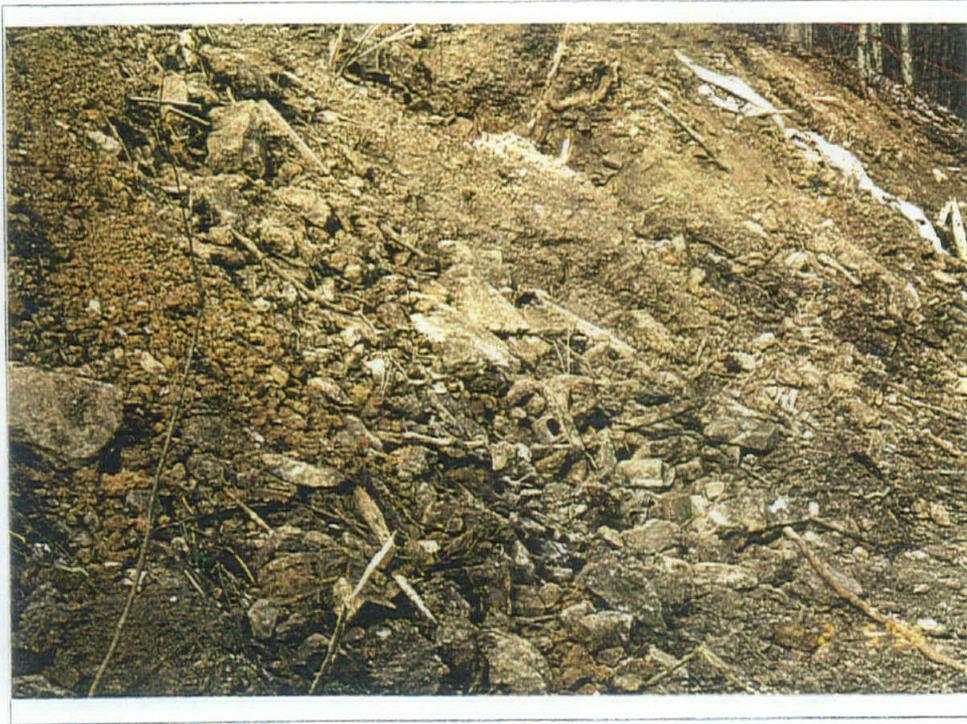
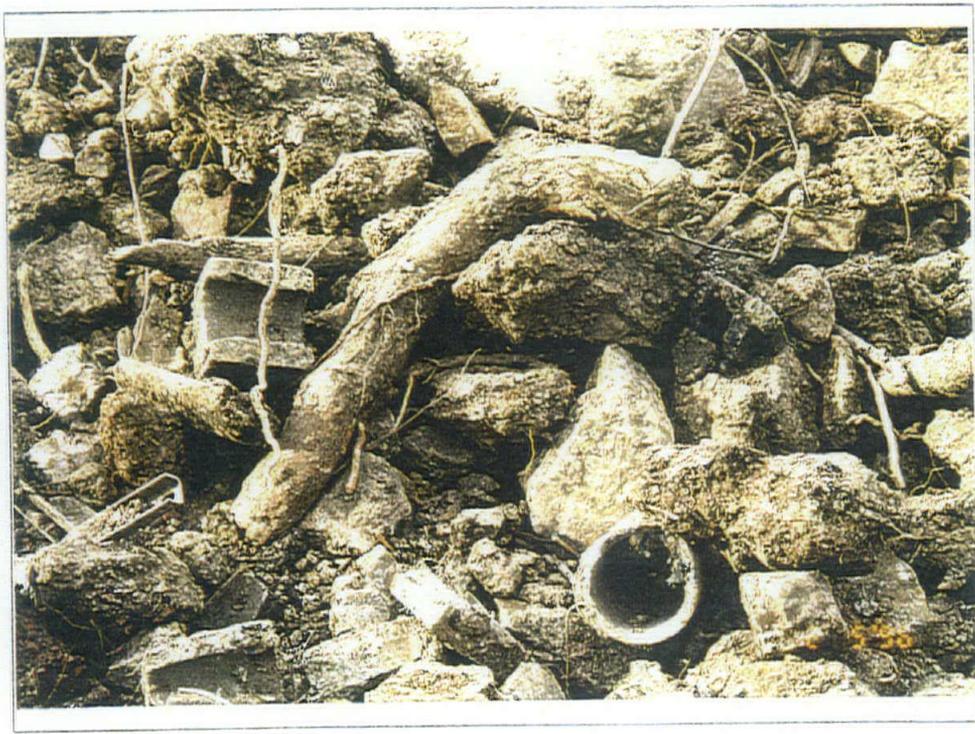
PHOTO 7a & 7b

ROLL: 23
FRAME: 09
DATE: 2/ 5/96
SWMU: 25/07D
BY: B. Kemp
TIME: 10:06
DESCRIPTION:
Looking north down at excavation

ROLL: 23
FRAME: 10
DATE: 2/ 5/96
SWMU: 25/07D
BY: B. Kemp
TIME: 10:07
DESCRIPTION:
Looking north down at excavation

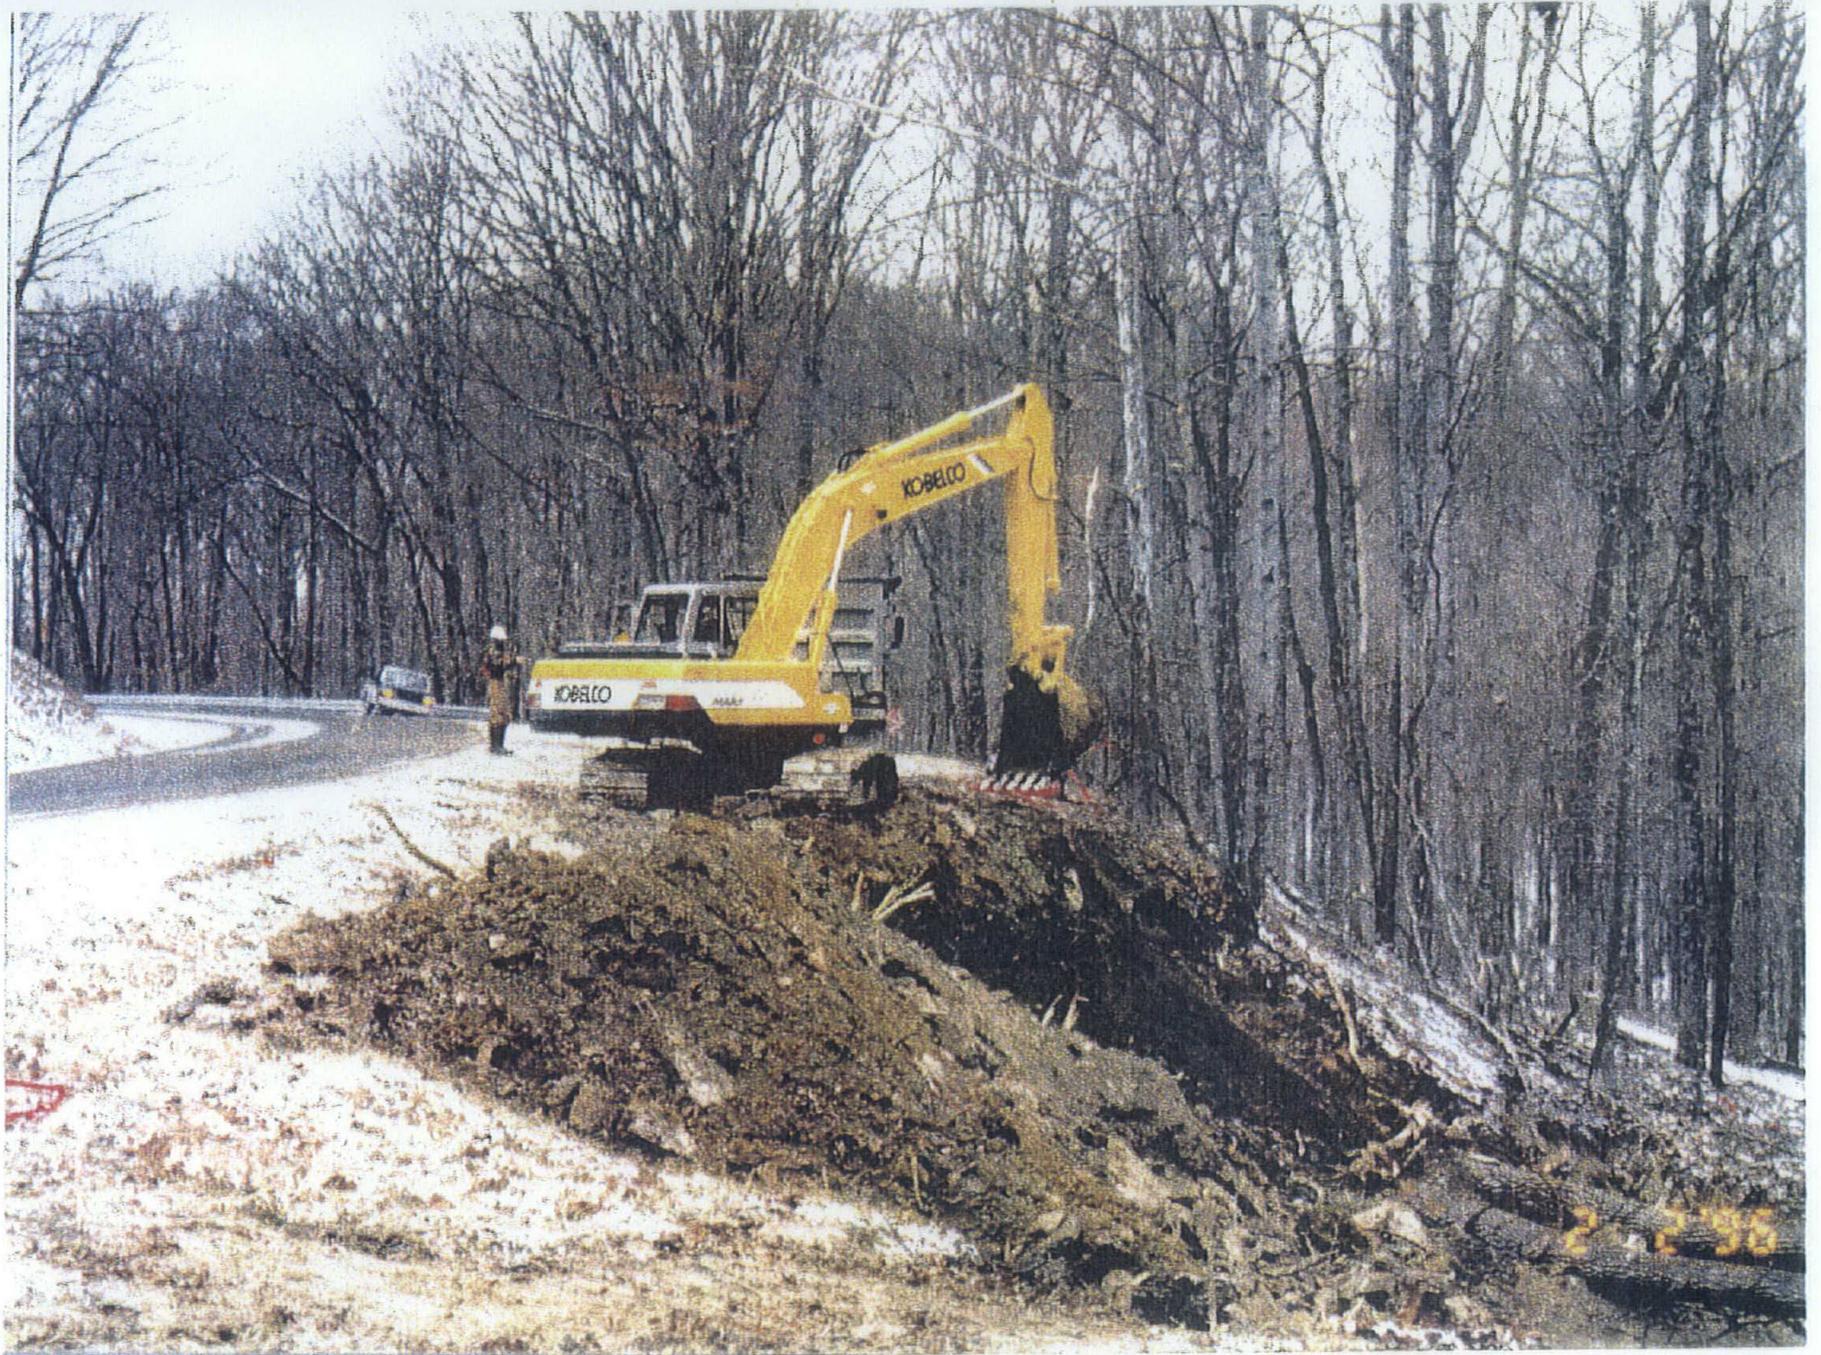
PHOTO 10

A small excavator and skid steer loader was used to remove the large debris and ammunition shells. Photograph 10 in Appendix A shows the excavator and triaxle dump truck. Random smaller debris was hand-picked wherever possible, with minimal disturbance to the hillside. During debris clean-up, workers scanned the completed areas with metal detectors to confirm the removal of metallic cans, drums, and debris. Metal debris as deep as two feet below ground surface was detected and removed. All the excavated debris mixed with transite material and incidental soil was removed and disposed as special waste at an approved landfill.
