**INITIAL ASSESSMENT STUDY
OF NAVAL WEAPONS STATION EARLE
COLTS NECK, NEW JERSEY**

NEESA 13-020

INITIAL ASSESSMENT STUDY
NAVAL WEAPONS STATION EARLE, COLTS NECK, NEW JERSEY
UIC: N60478

Fred C. Hart Associates, Inc.
530 Fifth Avenue
New York, New York 10036

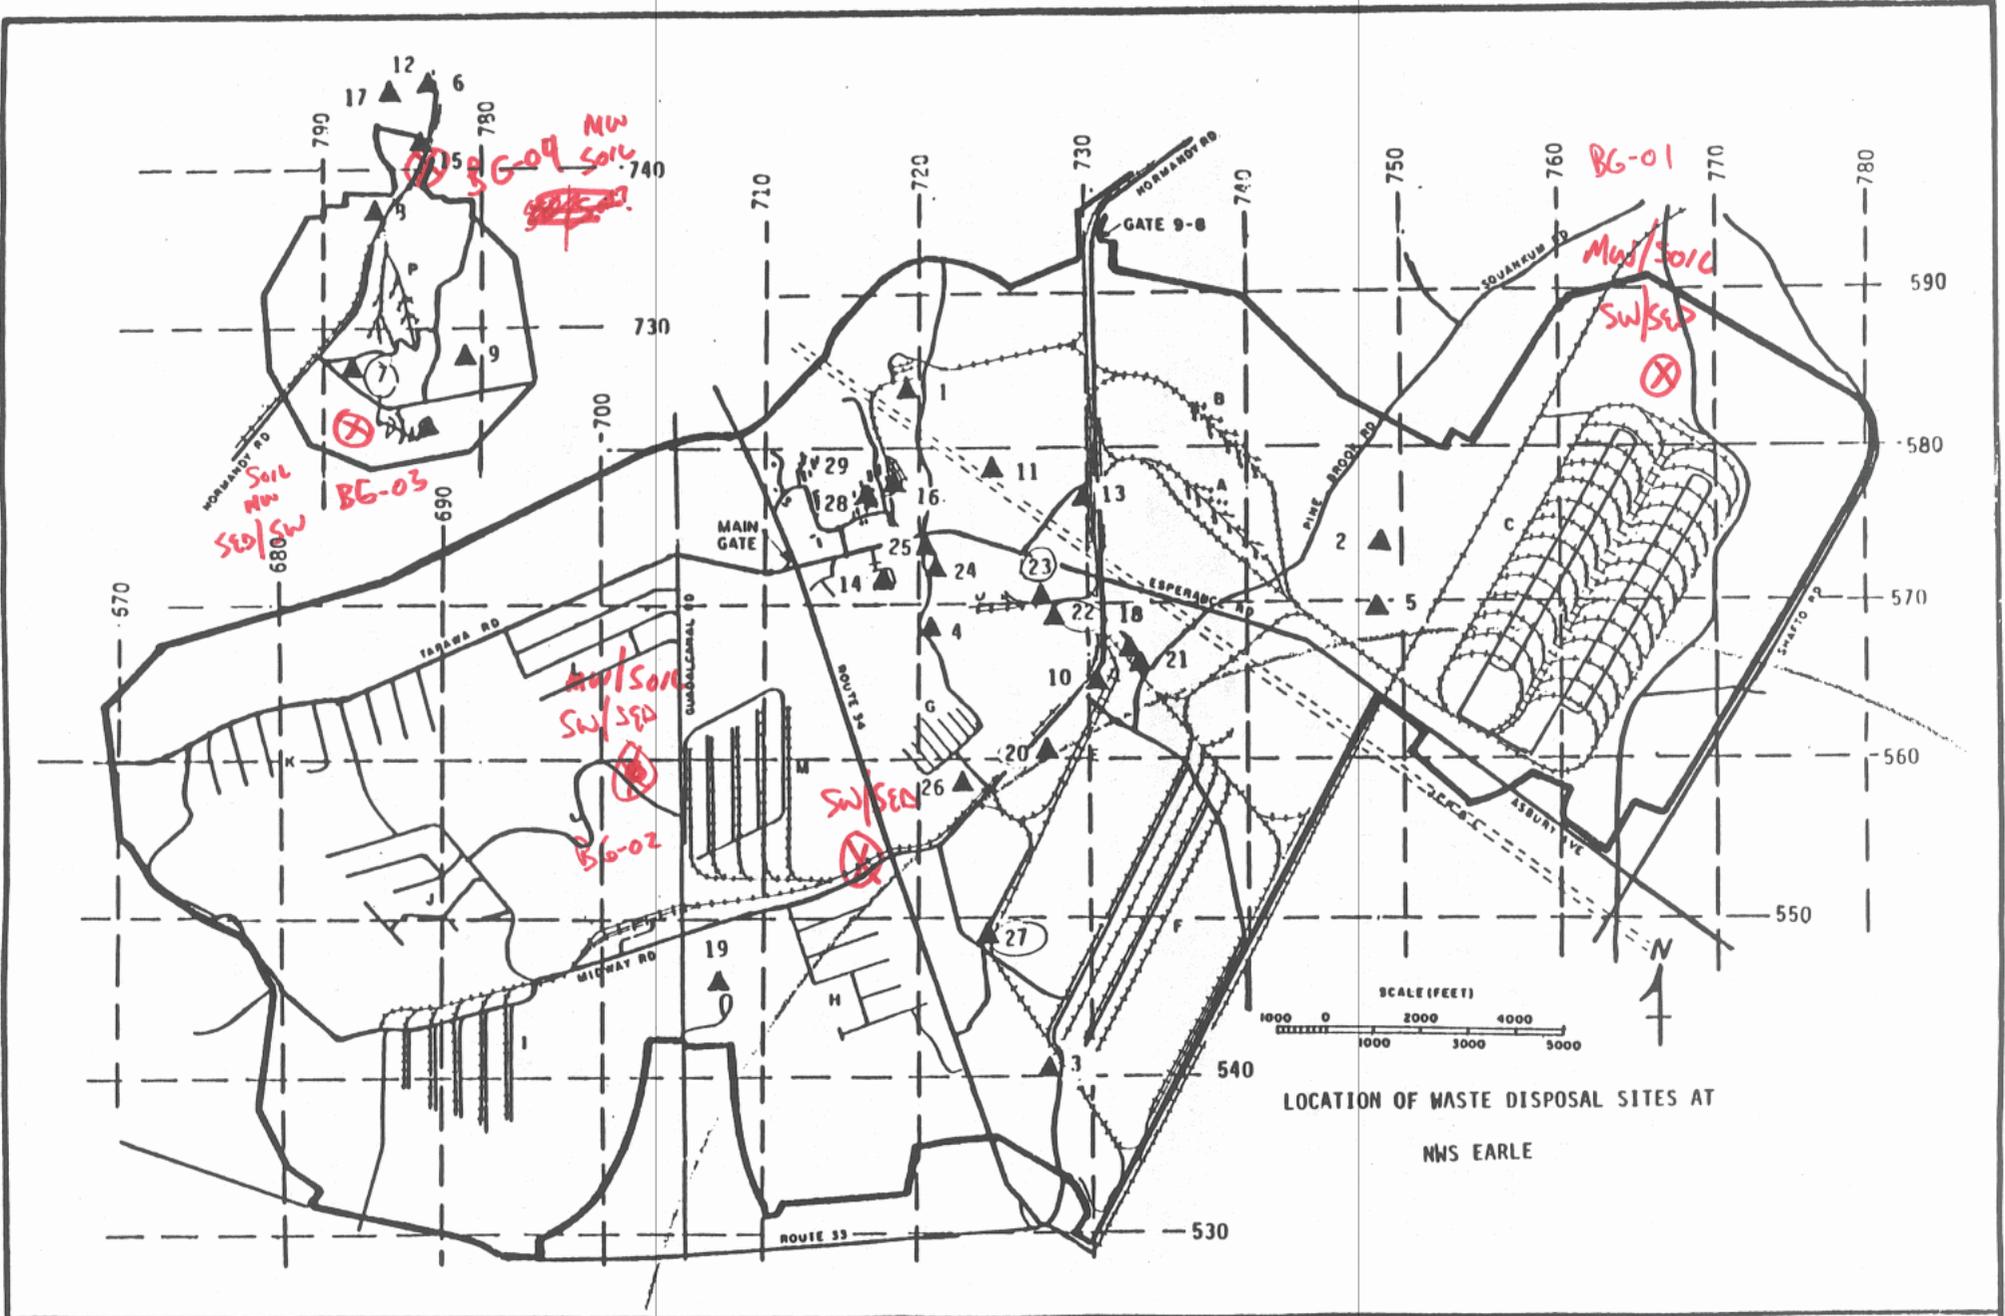
Figure 3-1. Location of Waste Disposal Sites at NWS Earle.

The locations of the 29 waste disposal sites identified during the IAS activities are shown in Figure 3-1. Of these 29 sites, 4 are recommended for further study and the remaining 25 are not. All 29 sites are discussed in Sections 3.3 and 3.4.

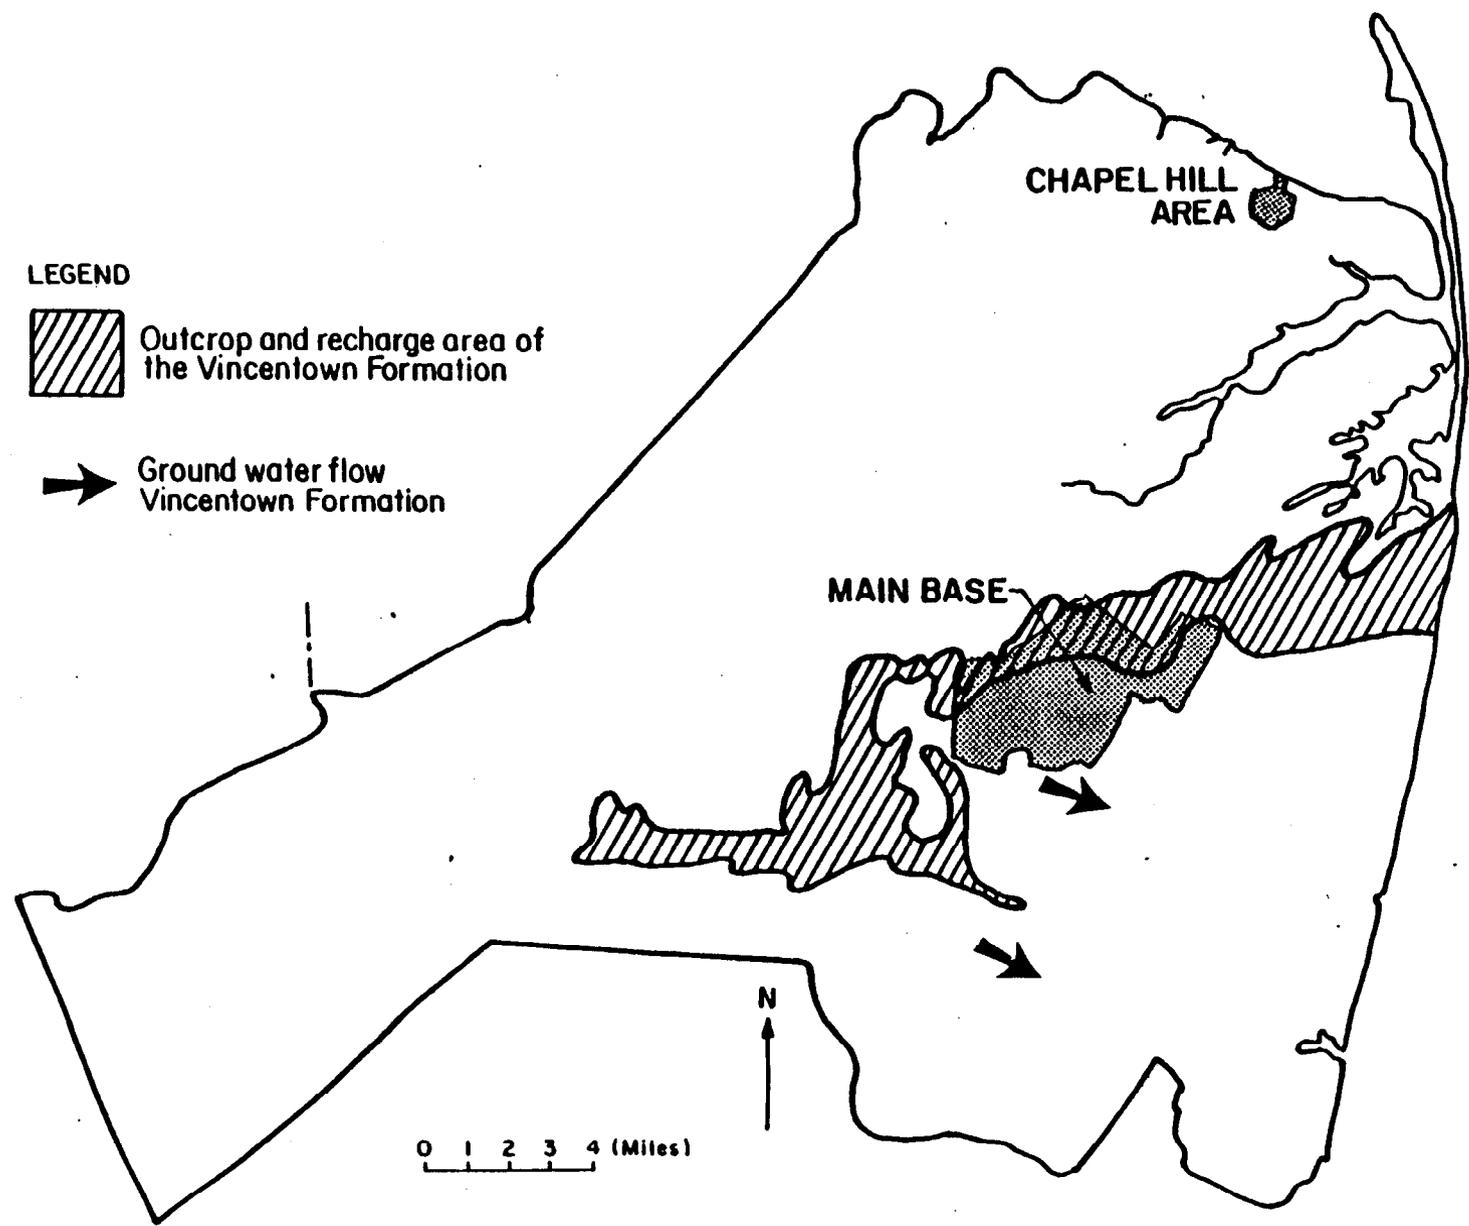
FIGURE 5-9. Groundwater Flow Direction in Vincentown Formation.

Ground water flow Vincentown Formation

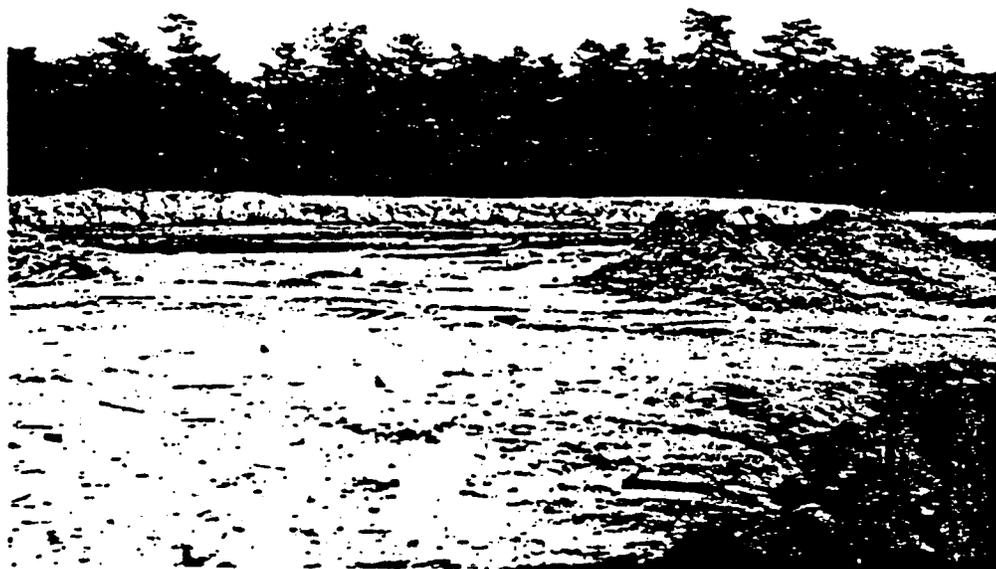
Figure 6-7 SITE NO. 2, ORDNANCE
DEMILITARIZATION SITE SHOWING LACK OF SITE
DRAINAGE TO THE NORTH AND LACK OF VEGETATION

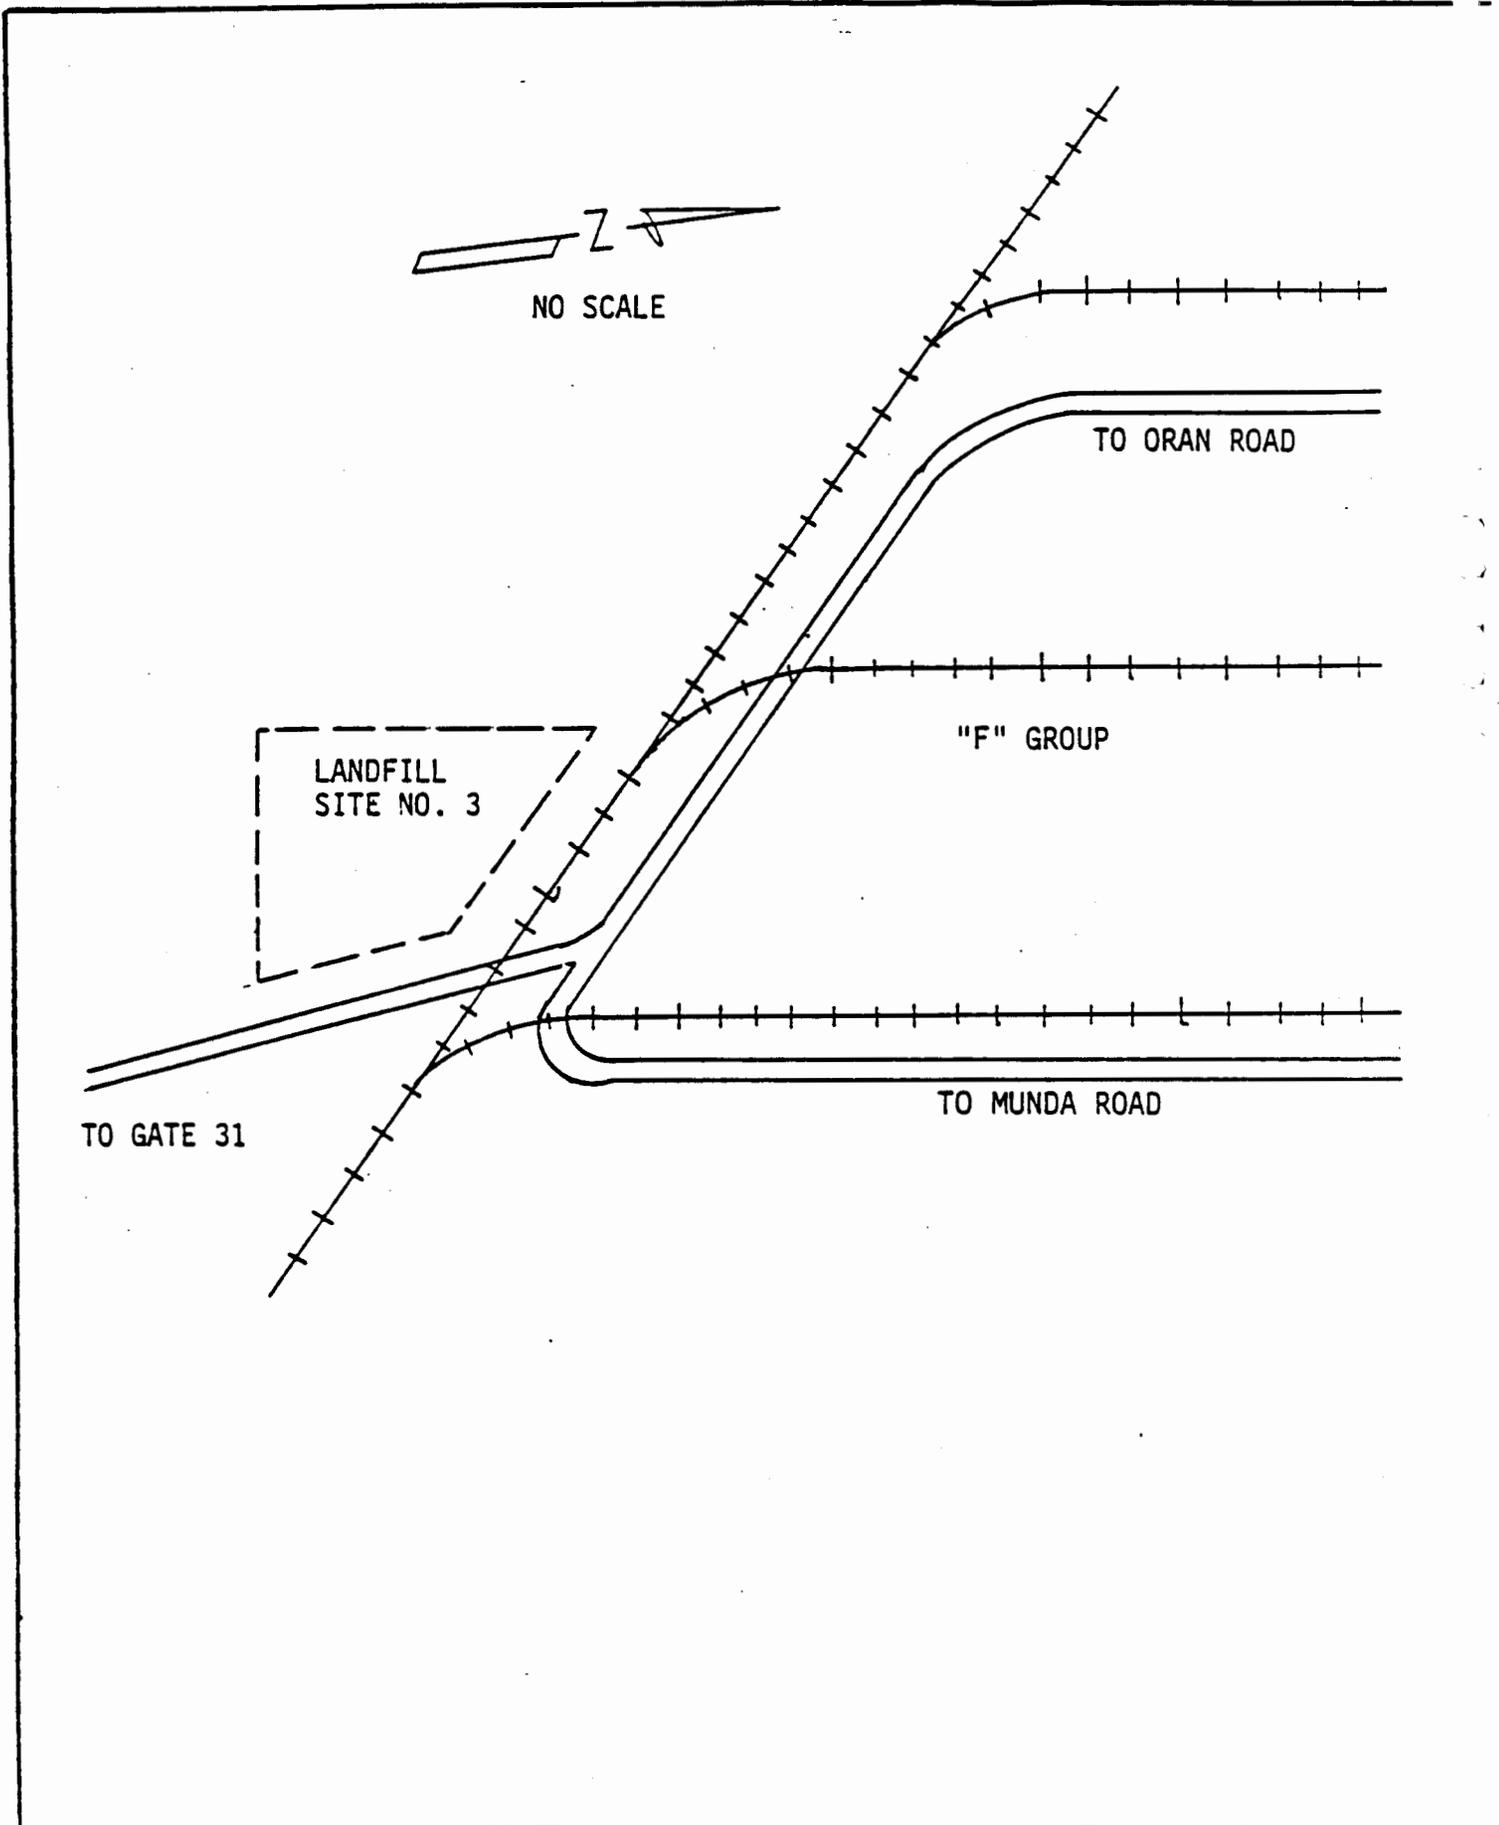
Based upon the estimates of Station solid waste production presented in Section 6.3.5 (1.7 tons of waste per day), the total wastes disposed of at this site would have been approximately 4,800 tons. This would have consisted primarily of municipal wastes such as paper, glass, plastics, trash, etc. However, the material disposed of at this site would have included other items such as the following:

Figure 6-8 APPROXIMATE LOCATION OF SITE NO. 3, THE LANDFILL SOUTHWEST OF "F" GROUP

- Paints and paint thinners.
- Solvents (e.g., toluene and acetone), varnishes and shellacs.
- Acids, alcohols and caustics.
- Pesticide containers and rinsewaters.
- Waste wood (construction debris and dunnage).
- Small amounts of asbestos from pipe and boiler insulation and automotive brake linings.
- Other industrial wastes.

The major concern at this site is the risk posed by the highly permeable soils, which are conducive to off-base migration, and the potential for effects on groundwater users outside the Station. A study of the soils in the "F" Group area for foundation purposes indicates that the soils are sandy from the surface to the water table, which averages 15 feet below the ground in this area. In addition, the area is located in the recharge zone of the Kirkwood Aquifer. While this aquifer is not a source of supply for any formal public water systems in the vicinity of the Main Station, it is used for domestic purposes by private home dwellers in the area via shallow private wells. The groundwater flow is to the southeast and east; the nearest potential receptors are in a local community located less than one mile to the south of the Station.

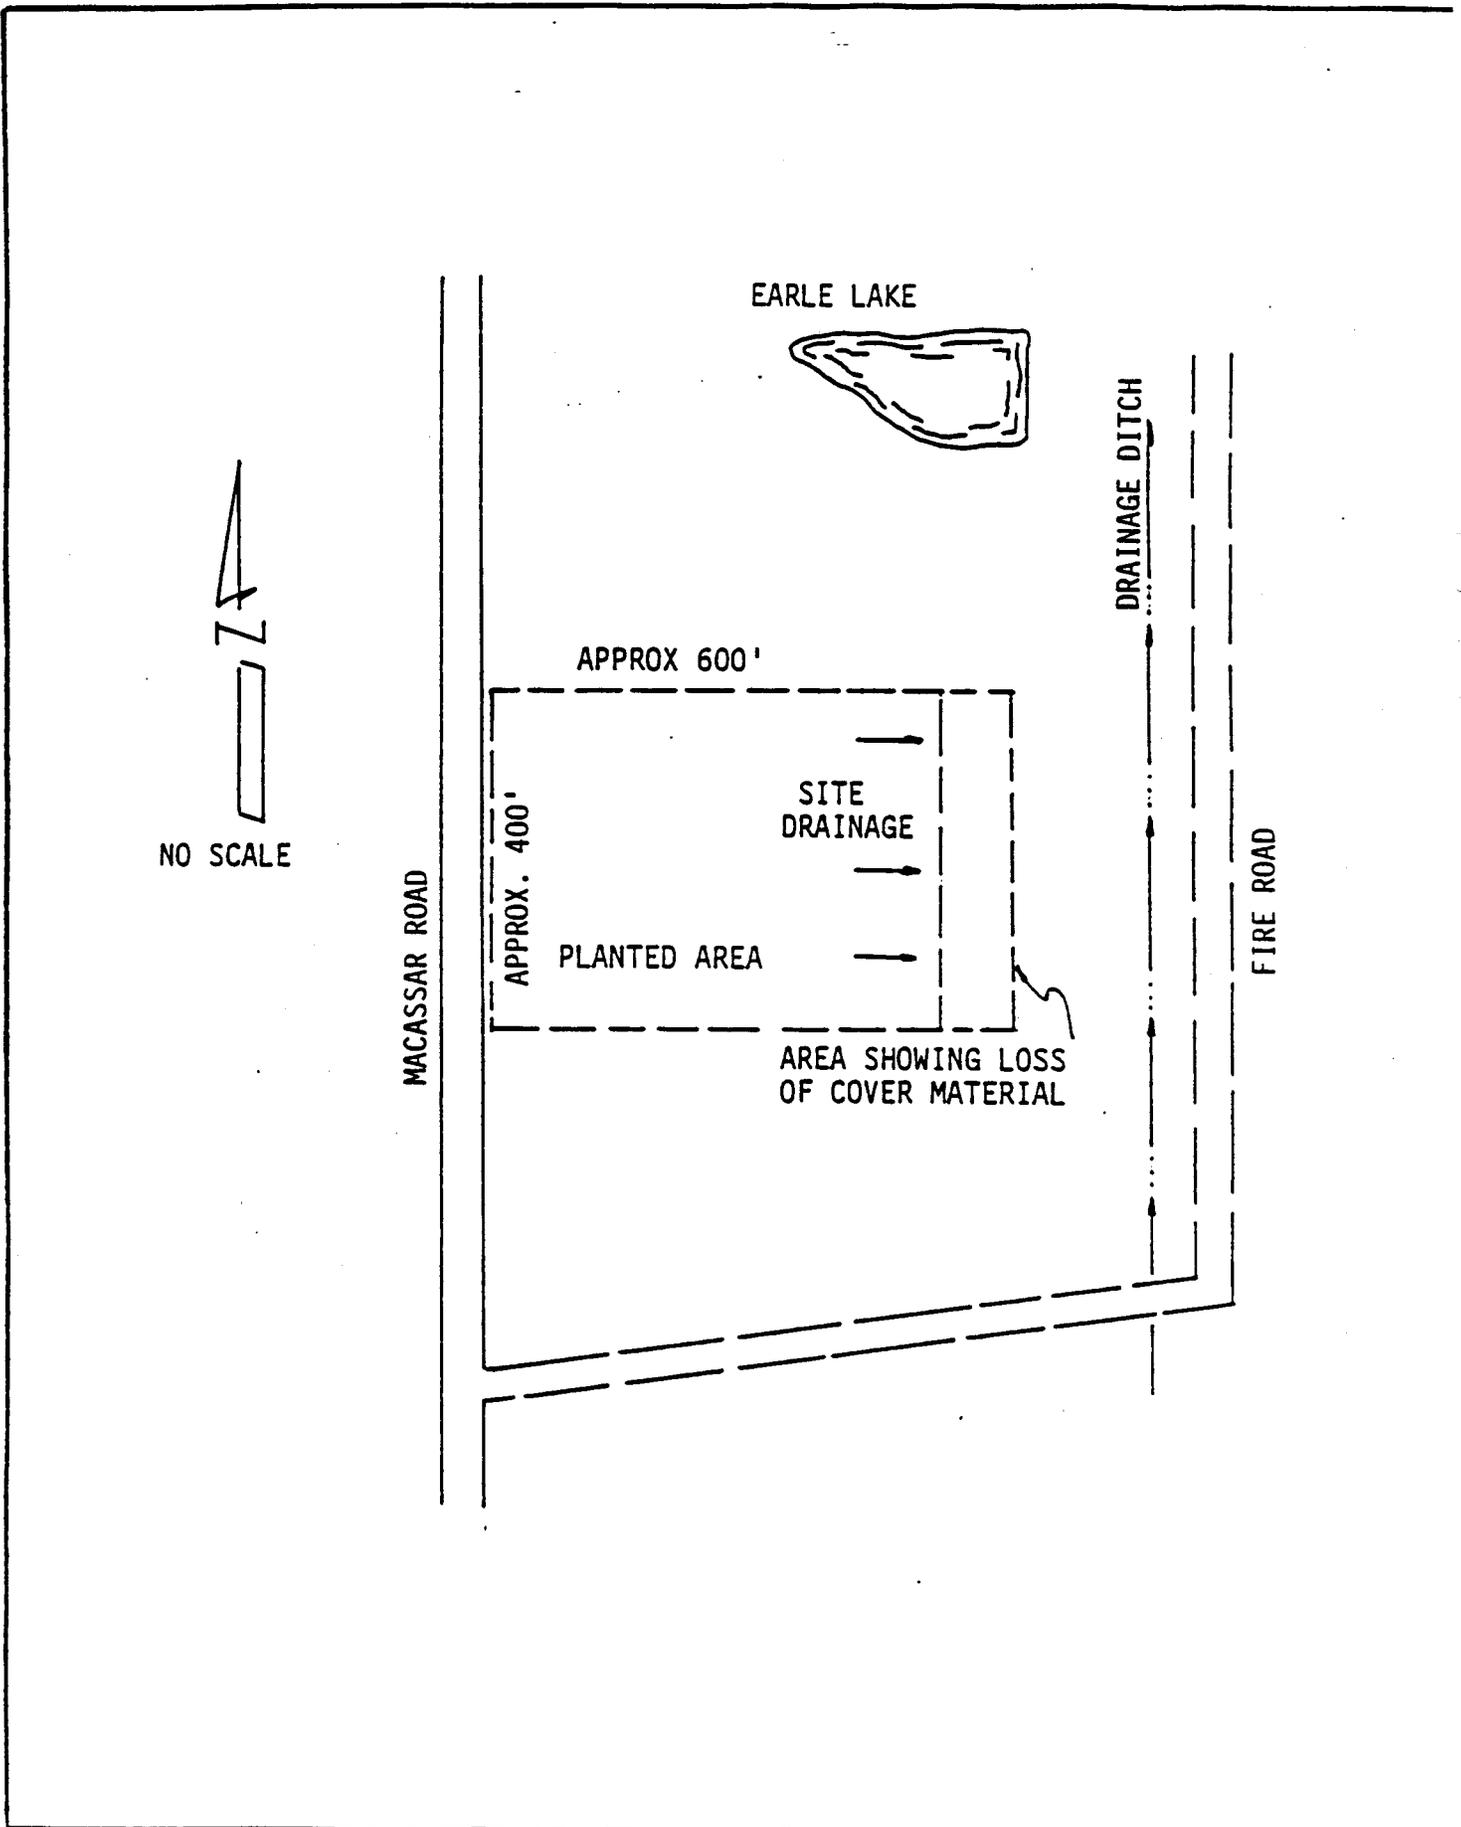
This landfill is within the area of Cranberry Hill, part of a series of low hills that traverse the Main Base. The hills consist of the

Figure 6-9 APPROXIMATE LOCATION OF SITE NO. 4, THE LANDFILL WEST OF "D" GROUP

Cohansey Sand, a formation of interbedded sands and clays. The soil underlying the site is a rapidly permeable sand which will allow easy infiltration. However, the Cohansey Sand in this area contains white, dark, red and gray kaolinite clays interbedded with the sand; these clays would retard verticle migration and favor lateral migration. Several springs have been reported at the base of the hill, indicating that some groundwater in the Cohansey Sand may be perched.

This site is recommended for a Confirmation Study because of the potential disposal of potentially hazardous materials in an area where the hydrogeology is conducive to contaminant migration. This landfill is situated in the Cohansey Sand, a permeable sand formation which lies above the Kirkwood Aquifer. This aquifer is used for domestic purposes by private home dwellers in the vicinity via shallow private wells. The groundwater flow of the aquifer is southeasterly, and the nearest private users of this water are located 1.5 miles southeast of the site.

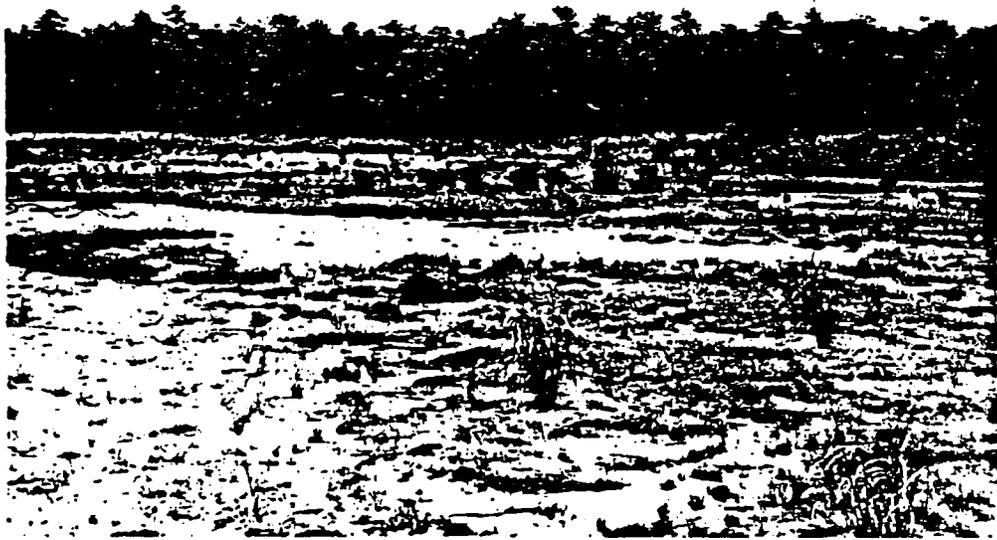
Figure 6-10 Site No. 5, Landfill West of Army Barricades showing typical vegetation

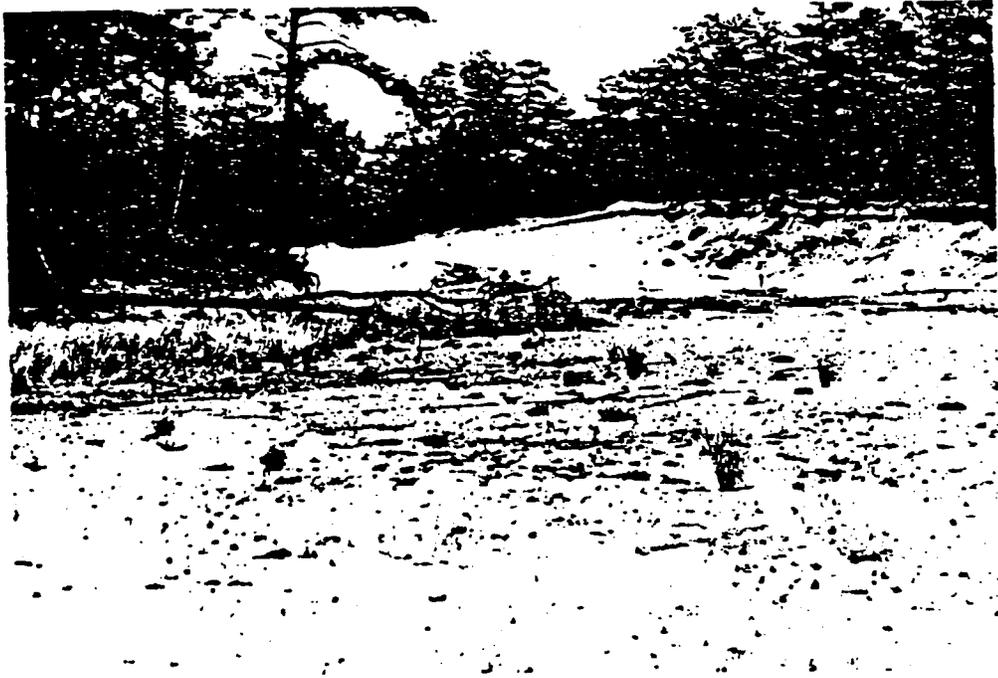
Figure 6-11 Site No. 5, Landfill West of Army Barricades showing typical erosion patterns adjacent to site

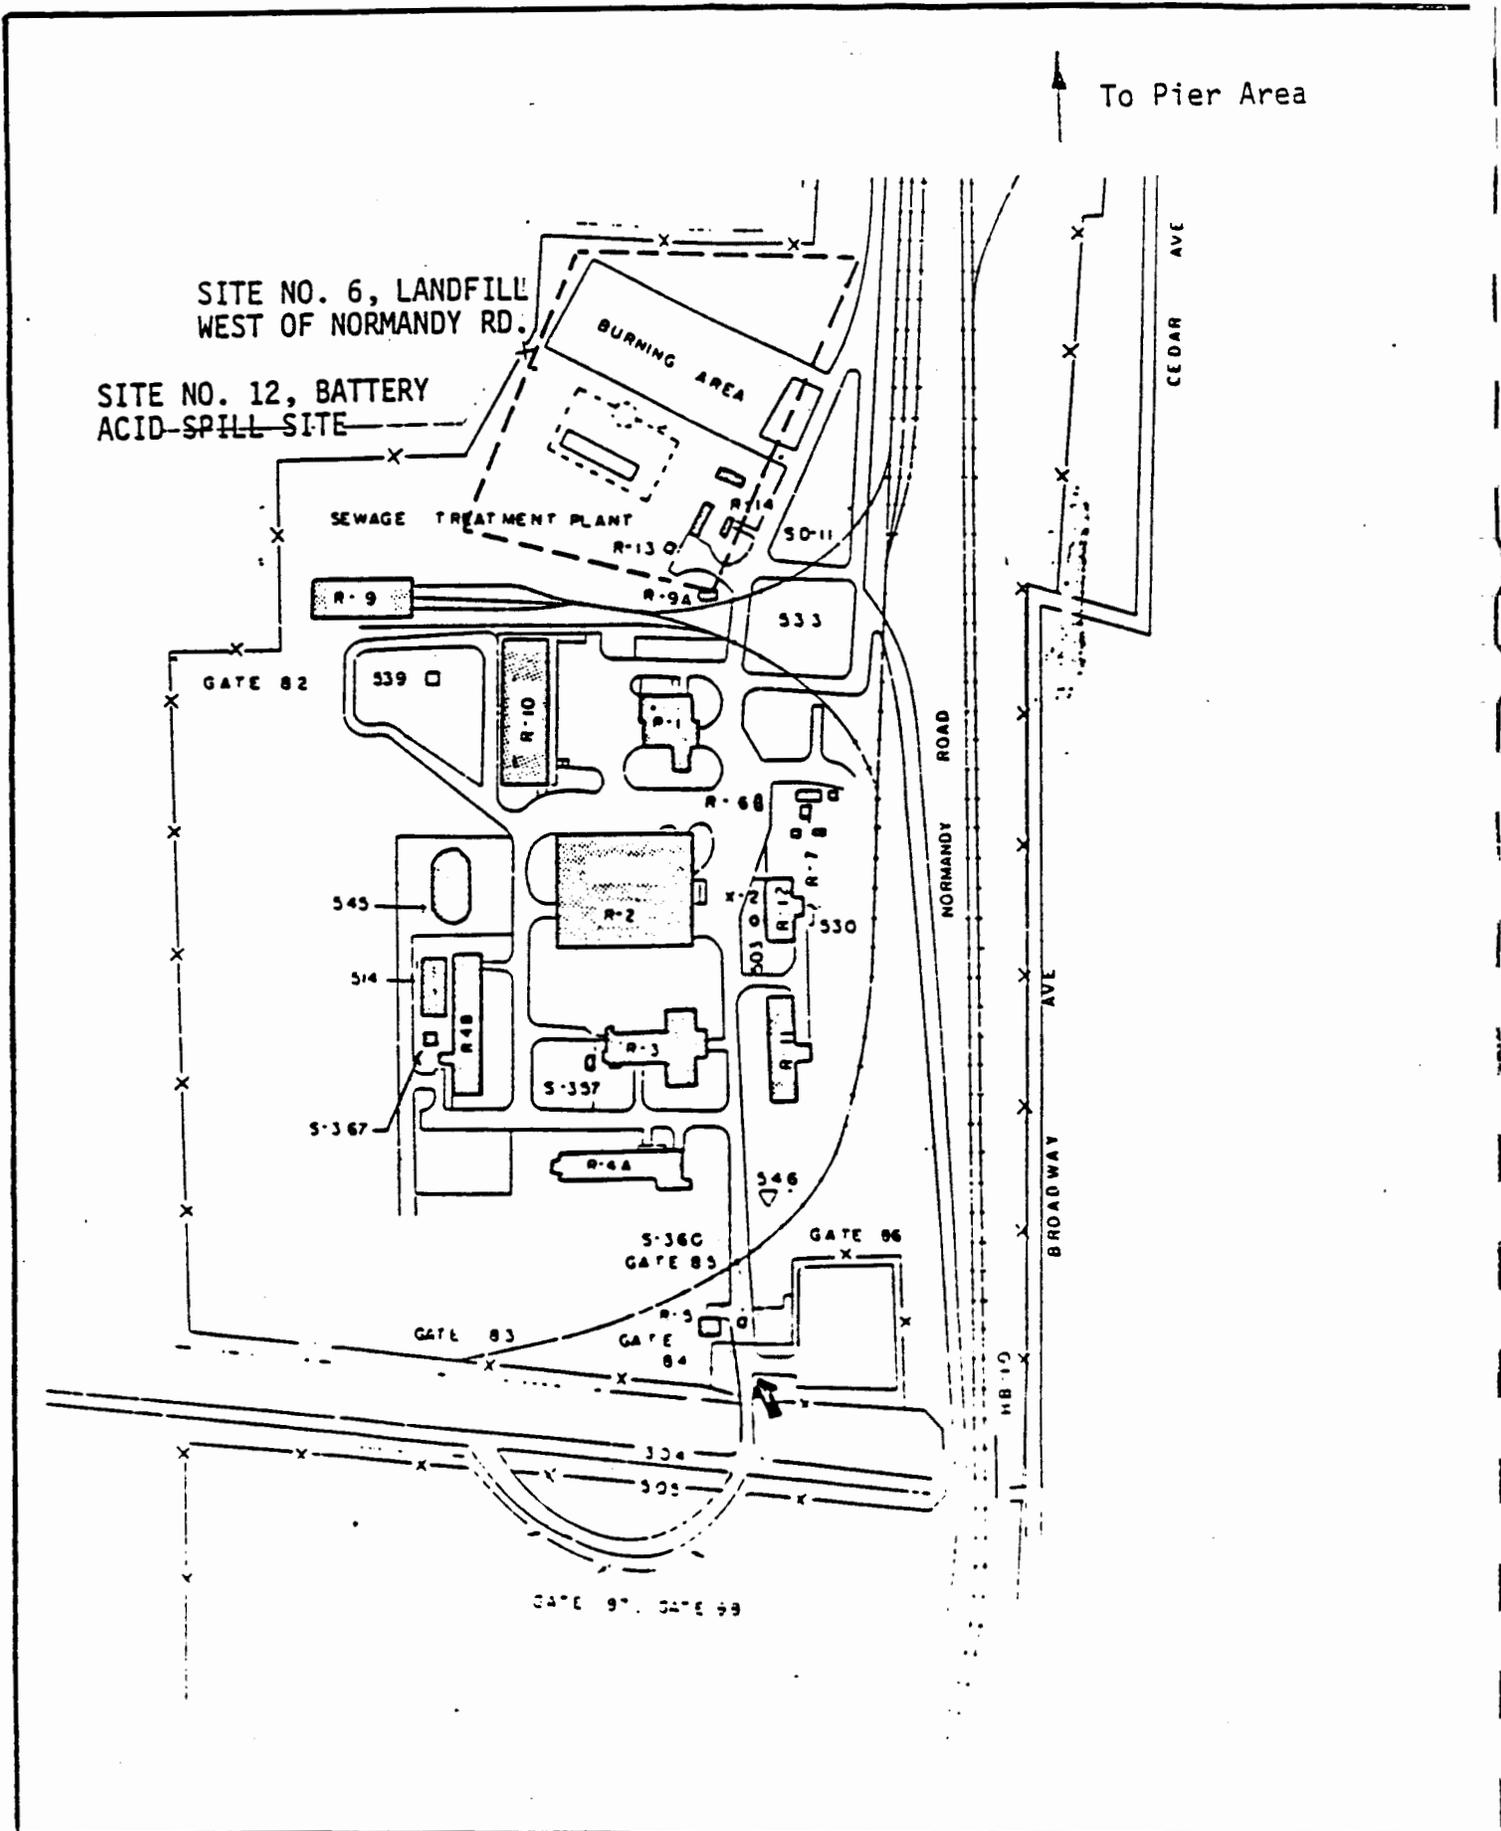
This five-acre site, located at coordinates 783-728, was used from 1965 to 1977 for general station waste from the Waterfront Area. The average quantity disposed of was reported to be 25,000 tons per year [2]. However, a discussion with personnel of the Public Works Department indicated that the annual loading should have been less than 2500 tons of refuse. This included munitions shipping wastes (dunnage, packing materials, etc.), shop wastes from the Waterfront Public Works Shop and the

Figure 6-12 APPROXIMATE LOCATION OF SITE NO. 6, LANDFILL WEST OF NORMANDY ROAD, AND SITE NO. 12, BATTERY ACID SPILL SITE

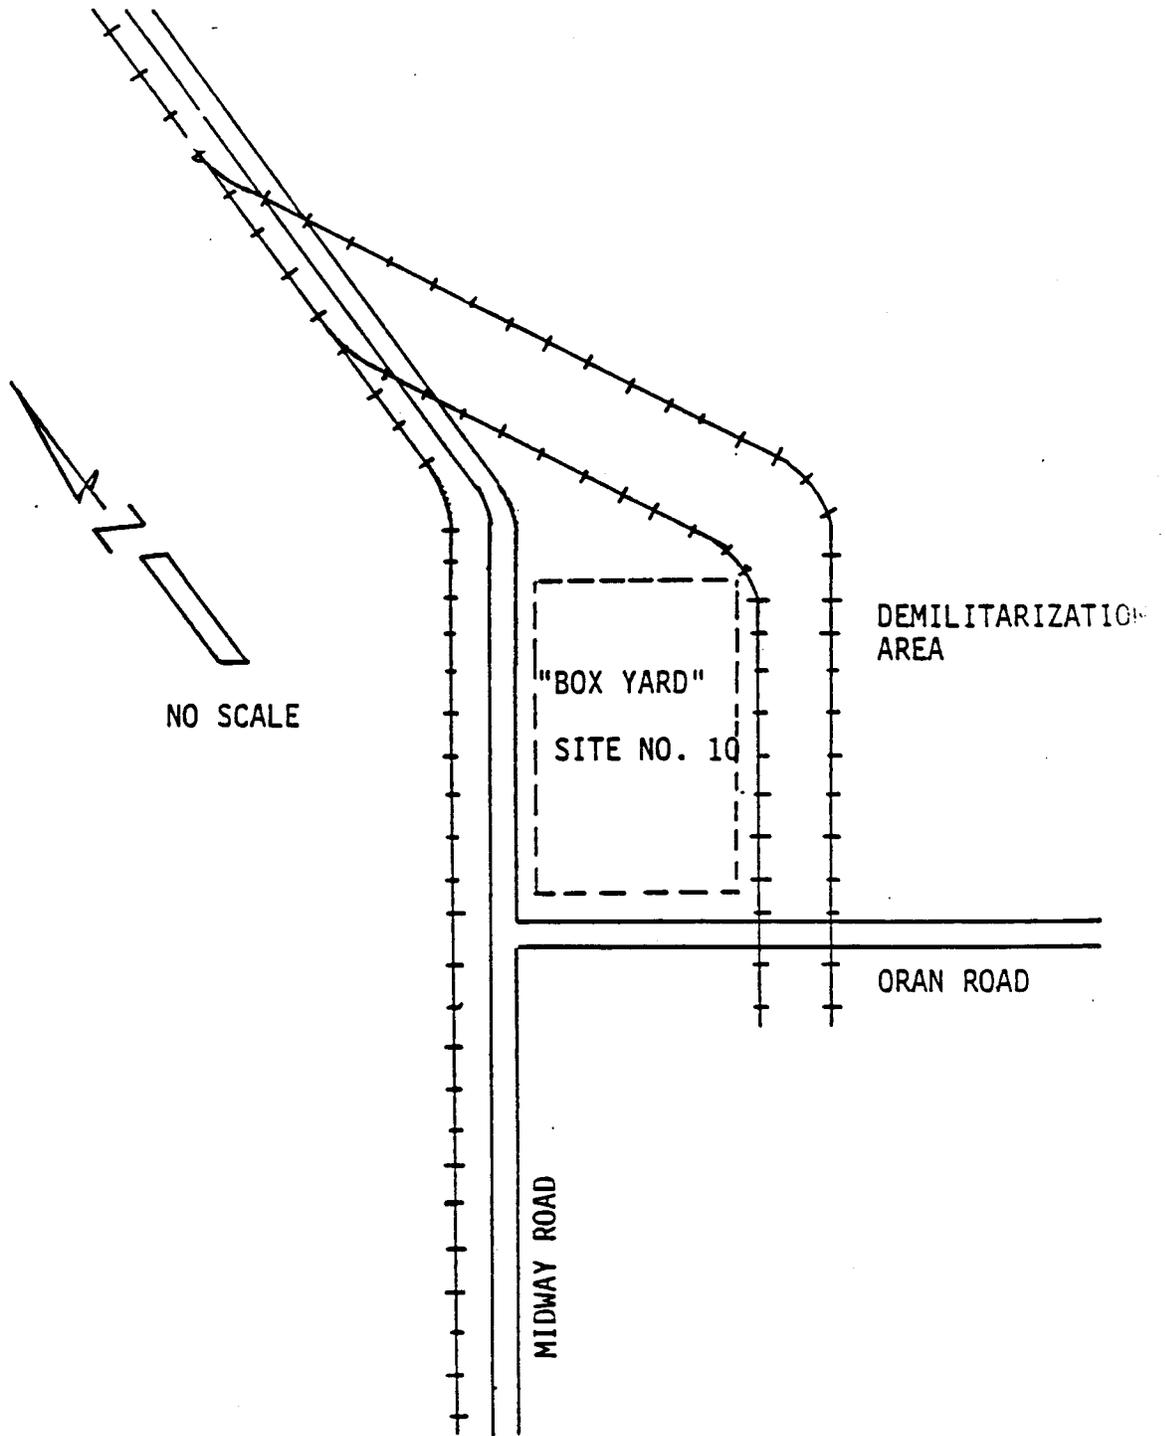
This site was also used from 1974 to 1977 for occasional fire-fighting training exercises. These exercises were conducted in and around two unlined pits which were dug at this site, each measuring roughly 30 ft. x 30 ft. x 2 ft. (depth). The typical practice involved placing a reject airplane or vehicle in the pit, soaking it and the pit with fuel oil (or possibly a mixture of fuel oil and waste oil), and setting the area ablaze.

Figure 6-14 APPROXIMATE LOCATION OF SITE NO. 10
SCRAP METAL LANDFILL NEAR BUILDING S-589

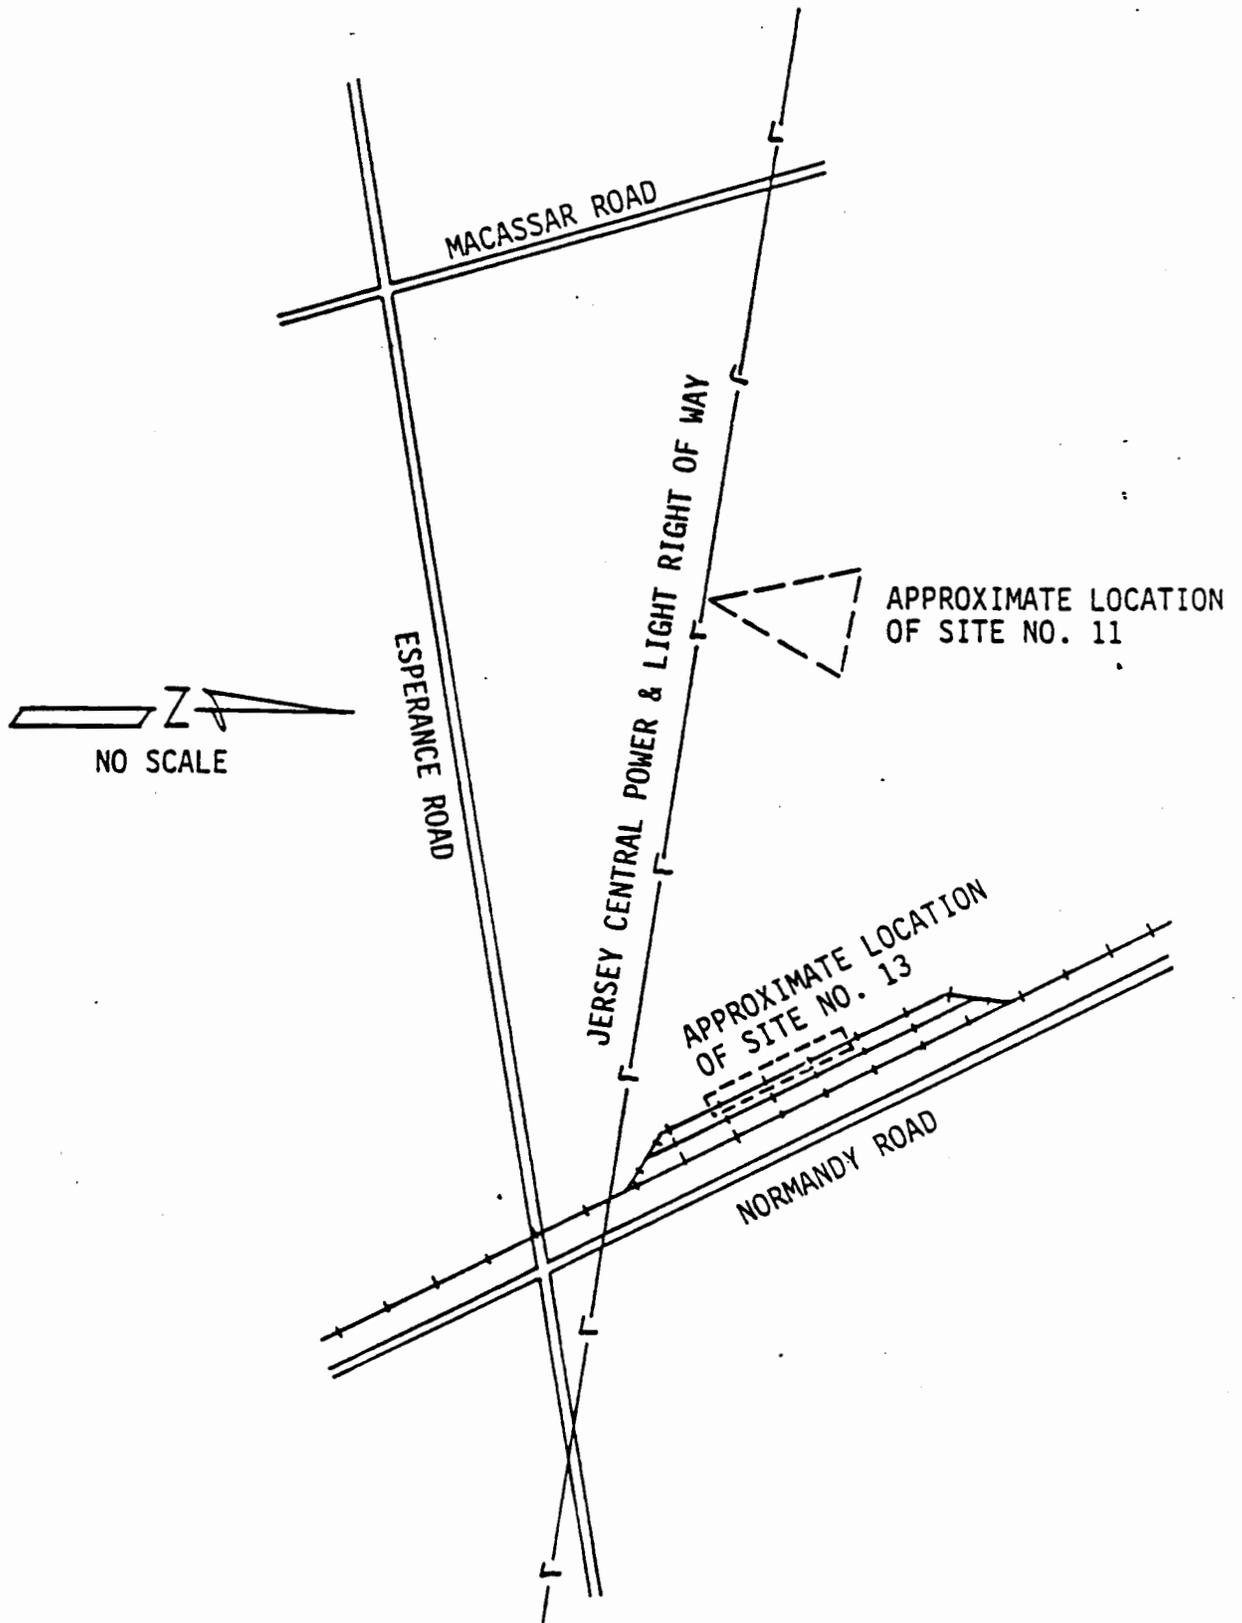
The Defense Property Disposal Office (DPDO) Storage Yard is located near the Rail Classification Yards at coordinates 730-577. The approximate site location is shown in Figure 6-15. Activities conducted at this site included the storage of scrap metals and the storage of forklift

Figure 6-15 APPROXIMATE LOCATIONS OF SITE NO. 11, CONTRACT ORDNANCE DISPOSAL AREA, AND SITE NO. 13, DEFENSE PROPERTY DISPOSAL OFFICE YARD

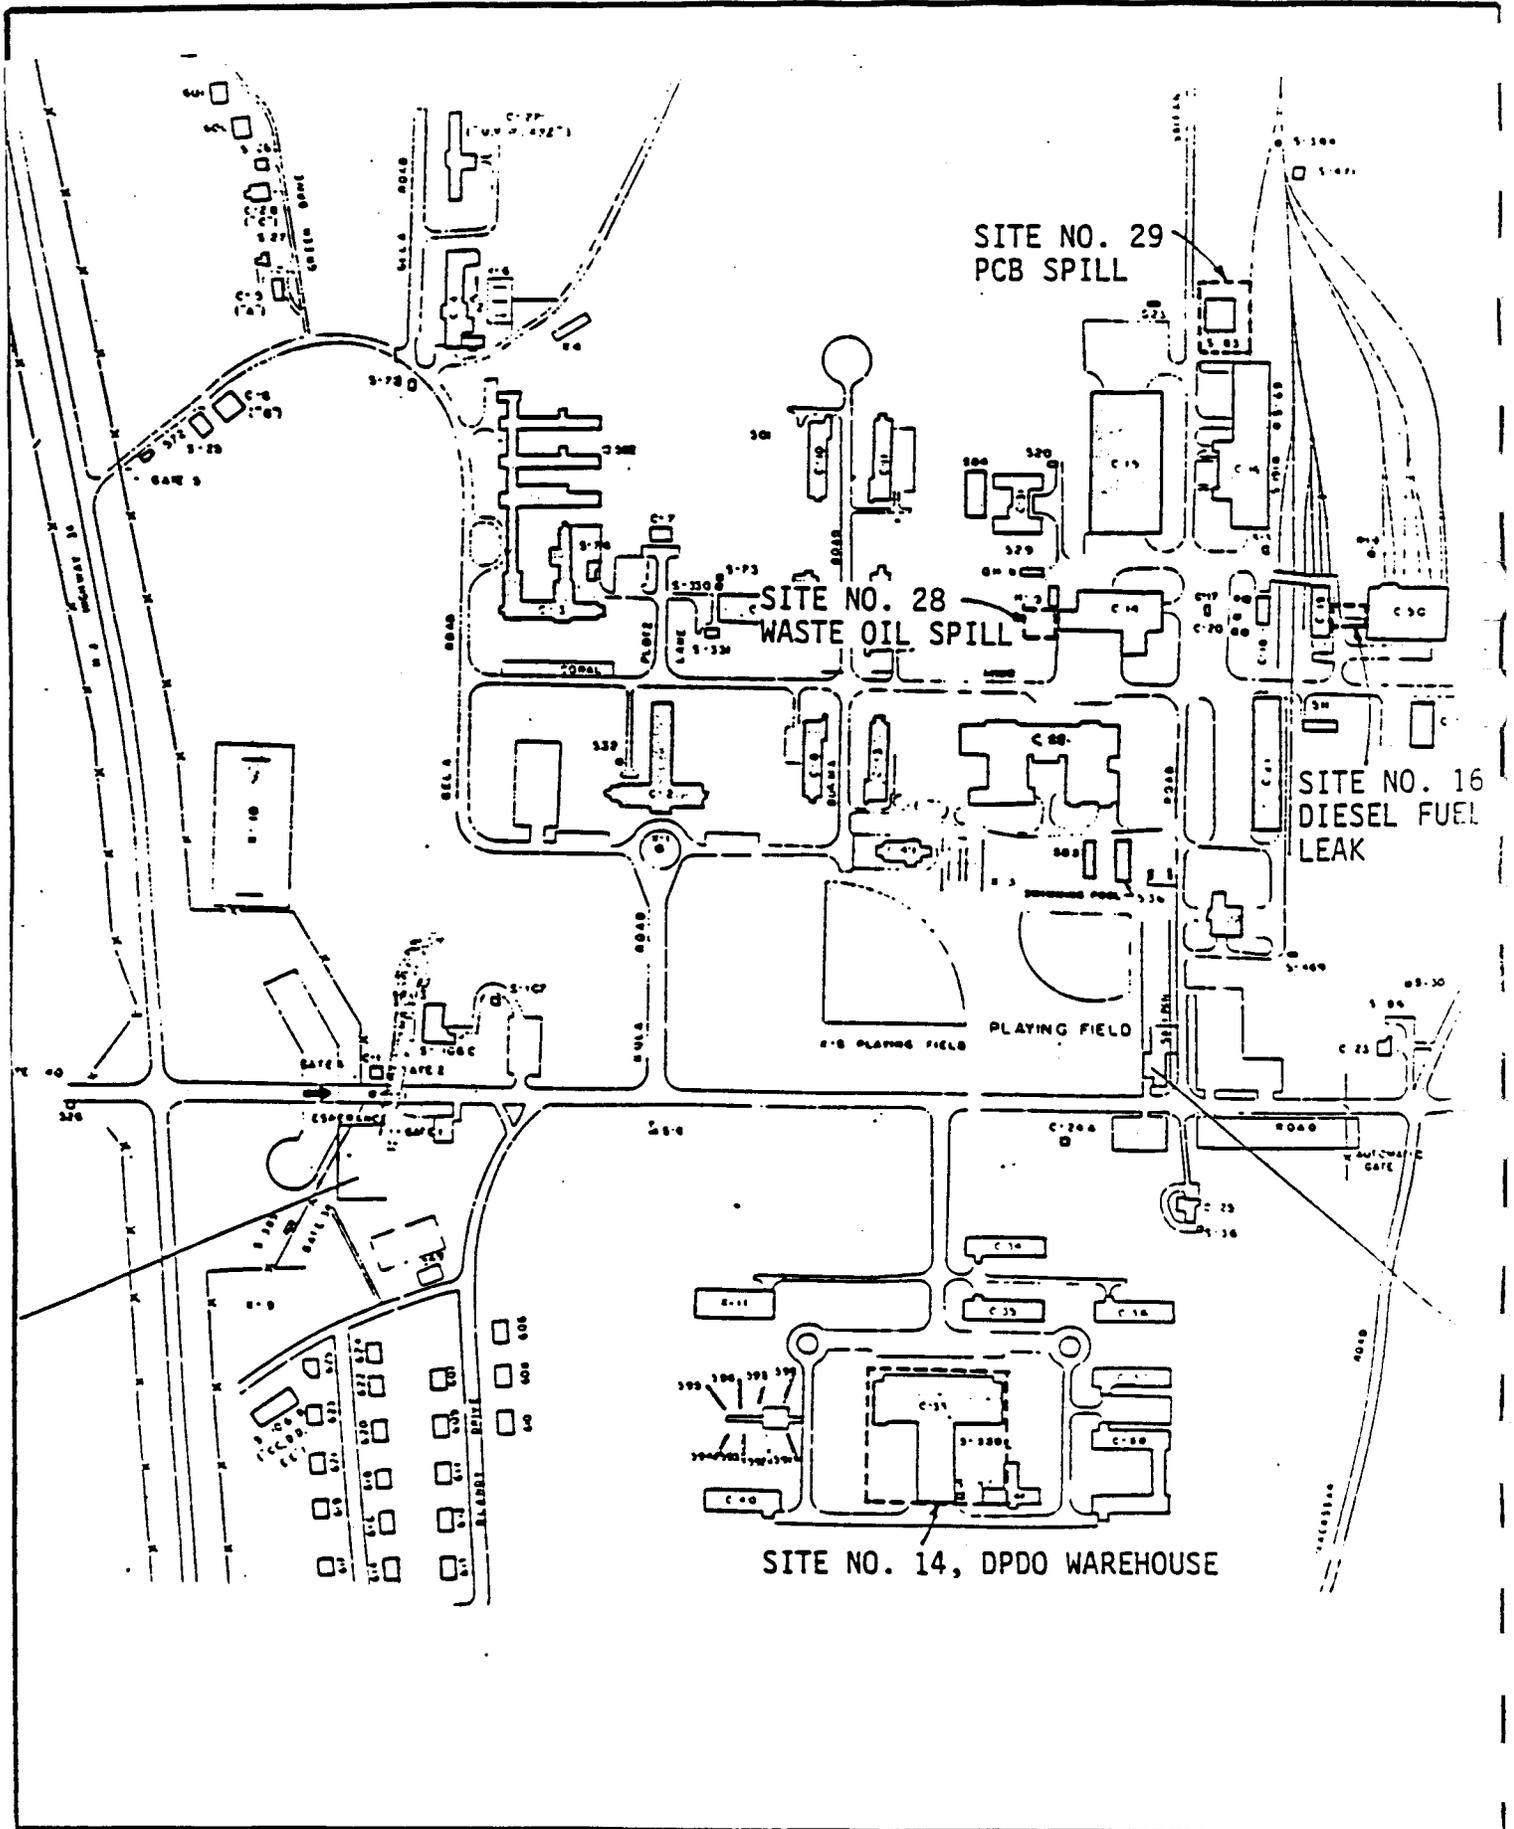
Figure 6-16 APPROXIMATE LOCATION OF WASTE DISPOSAL SITES IN THE MAIN BASE ADMINISTRATION AREAS: SITE NOS. 14, 16, 28 AND 29

The underground waste oil storage tank located behind Building C-14 has overflowed within the last year, with one to several gallons of oil being spilled on the ground surface. (See Figure 6-16 for site location).

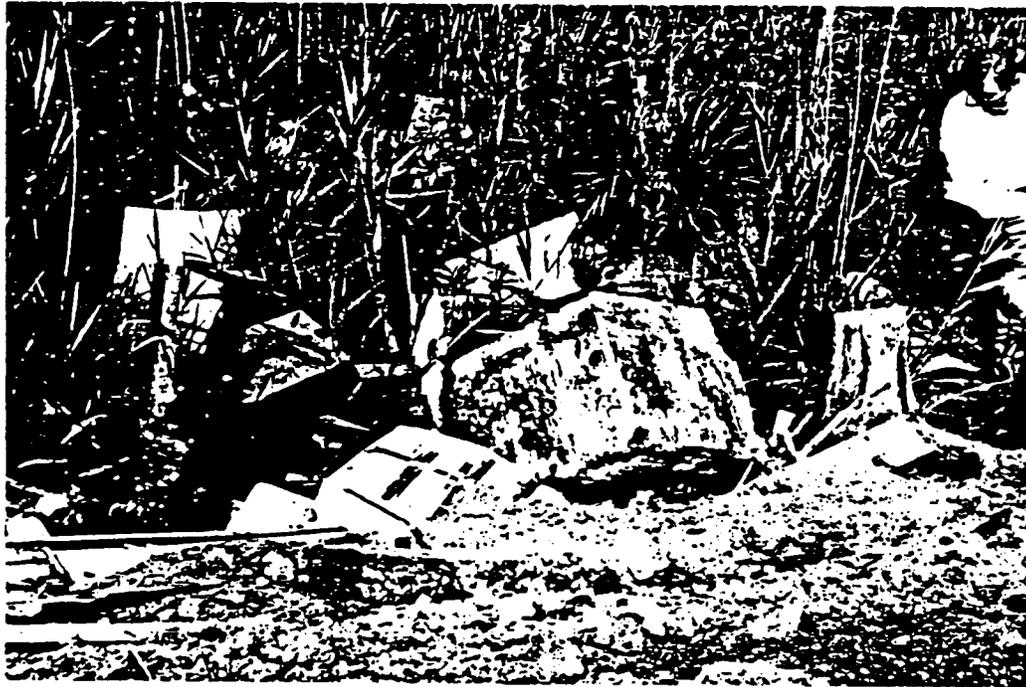
Figure 6-17 Site No. 17, Disposal Area Behind Training Barge, showing nature of material disposed and lack of vegetation stress
