**INITIAL ASSESSMENT STUDY
OF NAVAL WEAPONS STATION EARLE
COLTS NECK, NEW JERSEY**

NEESA 13-020

INITIAL ASSESSMENT STUDY
NAVAL WEAPONS STATION EARLE, COLTS NECK, NEW JERSEY
UIC: N60478

Fred C. Hart Associates, Inc.
530 Fifth Avenue
New York, New York 10036

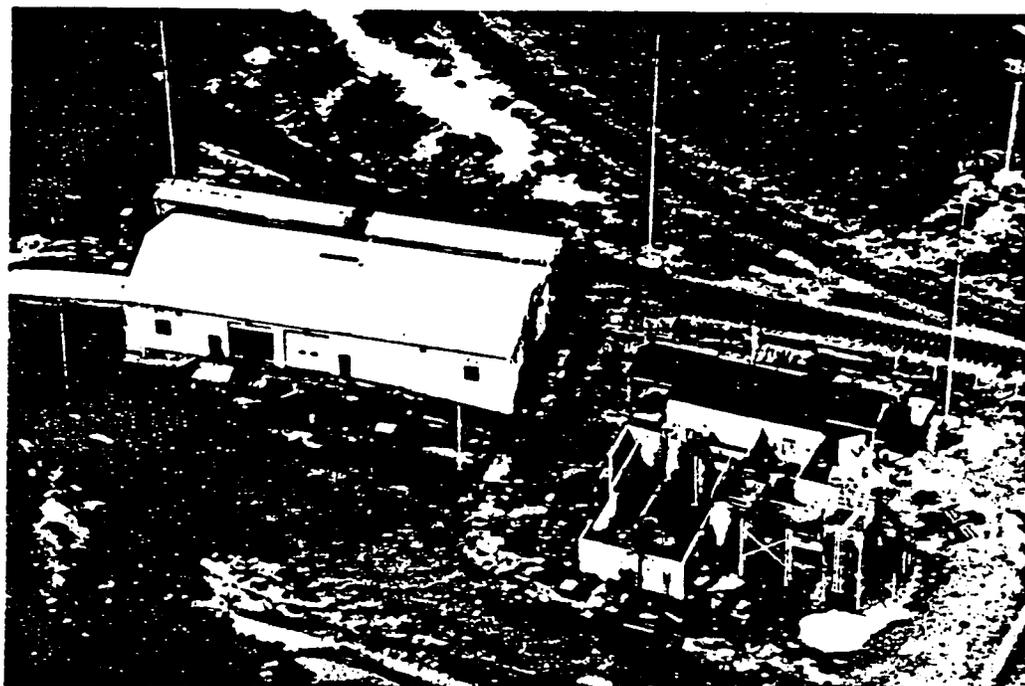
This furnace, located at coordinates 734-567, and shown in Figure 6-18, was placed in operation in 1978, and is used to demilitarize small caliber (up to 40 mm) ammunition by burning. Waste areas at the site include about 50 sq. ft. of soil contaminated by metal fragments dropping off the furnace discharge conveyor. In this fragment form, (e.g. metal chips) the metals in question (typically iron and copper) are inert and as such do not pose a threat to human health or the environment. Therefore, this site is not recommended for a Confirmation Study.

Figure 6-18 Site No. 18, Demilitarization Furnace, aerial view showing air pollution control devices

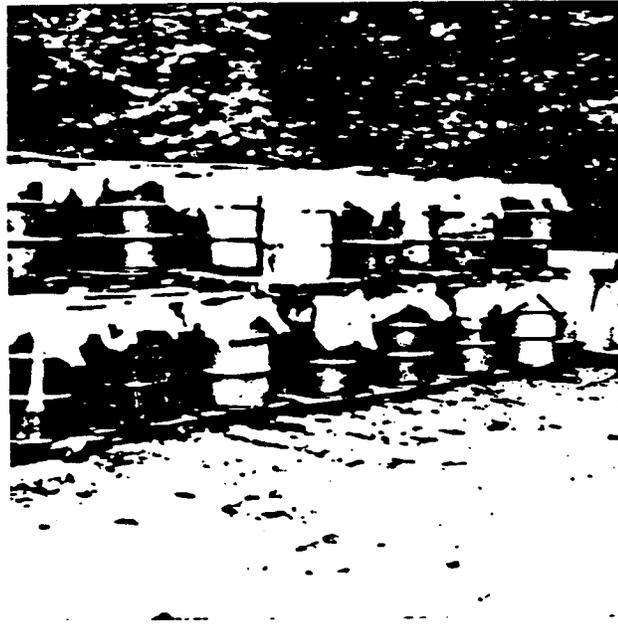
Figure 6-20 Site No. 21, Baghouse and Cyclone Dust Storage Area, showing area affected by material spilling from drums, which were not covered until July 1982
