Encl:  
(1) Draft Work Plan for Site 8

**WORK PLAN**  
**SITE 8 LANDFILL EAST OF S-186**

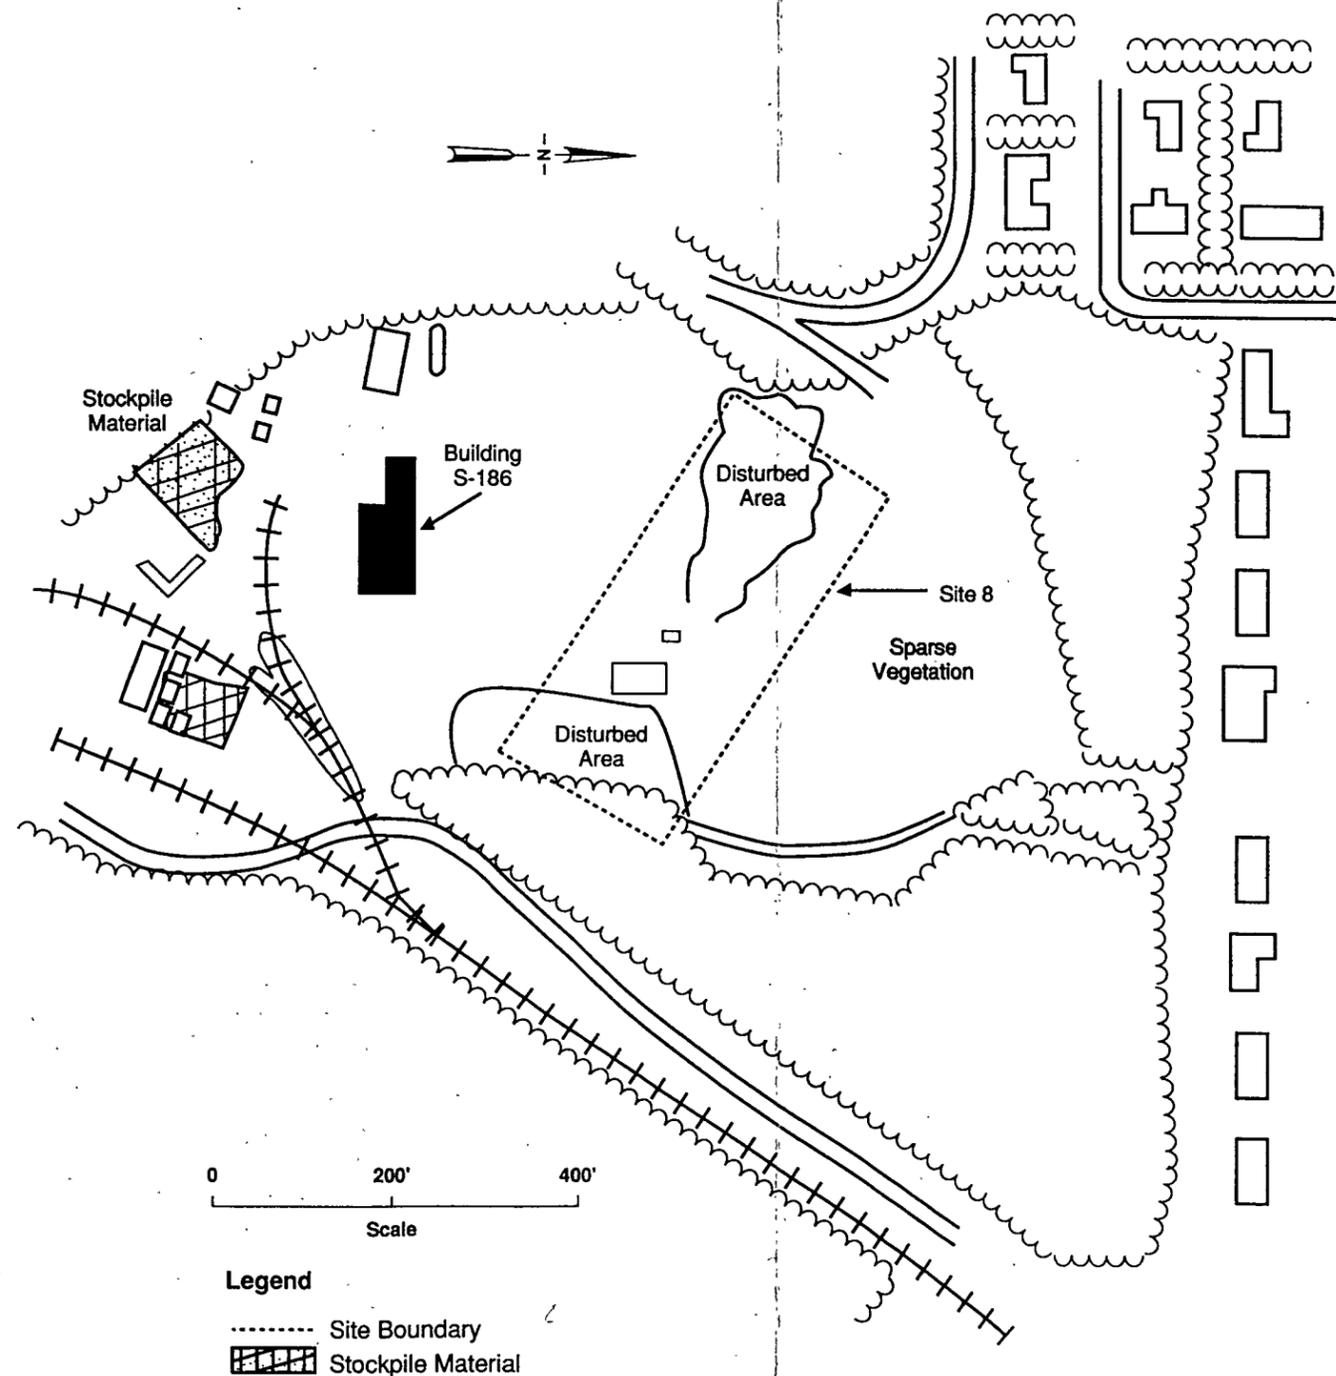
**FIGURE 1 AERIAL PHOTOGRAPH ANALYSIS SHOWING SURFICIAL CHARACTERISTICS OF SITE 8**

1971 aerial photograph showing Site 8 - Dunnage Disposal Landfill northeast of building S-186. Surficial evidence of disturbed soils.

During the 12 June 1989 field visit by Technical Review Committee (TRC) members, the site could not be identified due to lush vegetation growth. Through an aerial photograph search conducted by Weston and Northern Division on March 13, 1991, photos were found showing lumber stacked behind and to the east of Building S-186. The 1971 photo shows three aluminum lifeboats that were reported buried at the site sometime between 1972 and 1974.

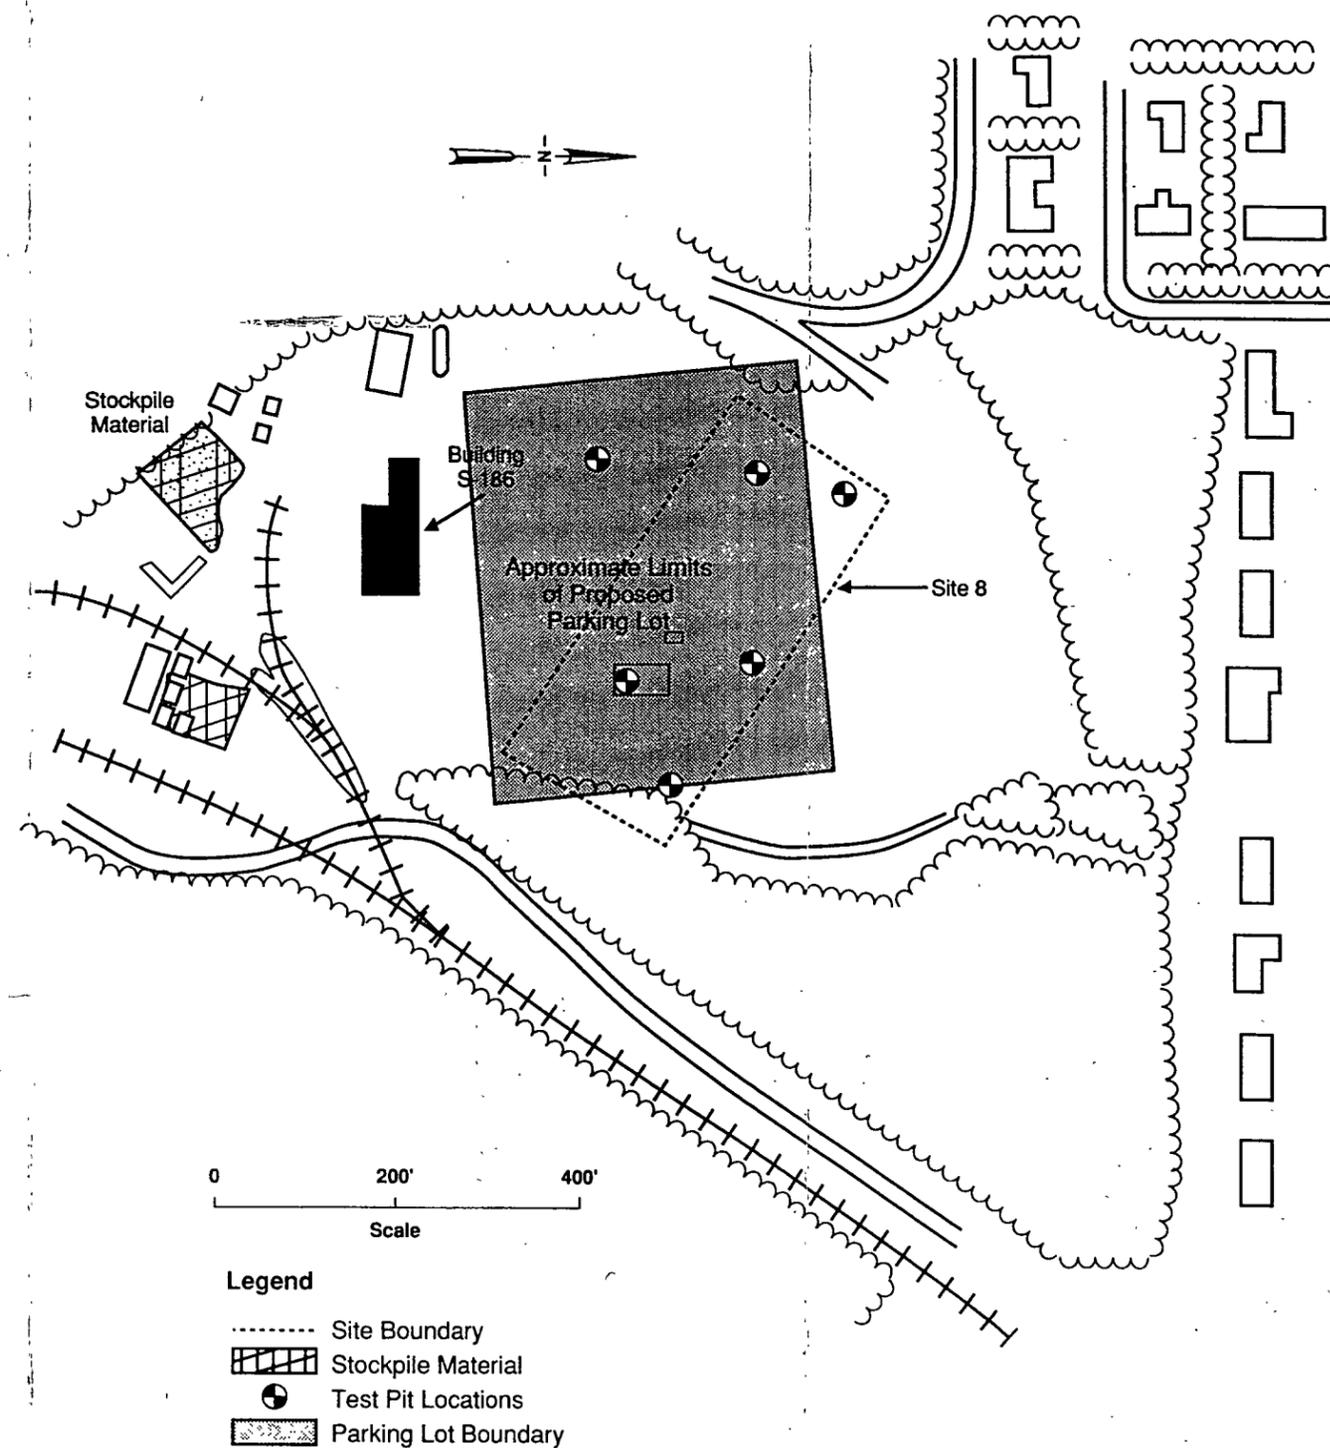
**FIGURE 2 AERIAL PHOTOGRAPH ANALYSIS SHOWING SURFICIAL CHARACTERISTICS OF SITE 8**

1977 aerial photograph showing Site 8 - Dunnage Disposal Landfill northeast of building S-186. Weathering effects and re-establishing vegetation evident in previously disturbed areas.

In order to define the limits of the landfill and obtain samples for chemical analyses, a backhoe will be used to excavate six test pits at the site. Three or four test pits will be excavated along the northern and northeastern boundary of the site. These boundaries are downslope and have the potential for possible contamination migrating offsite is the greatest in this area. At least one test pit will be upslope. For characterization purposes, one pit will be in the approximate center of the site. See Figure 2.
