# **Site-Screening Process Closeout Report**

## **Depth Charge Testing Area**

Joint Expeditionary Base Little Creek-Fort Story  
Naval Amphibious Base Little Creek  
Virginia Beach, Virginia

**September 2010**

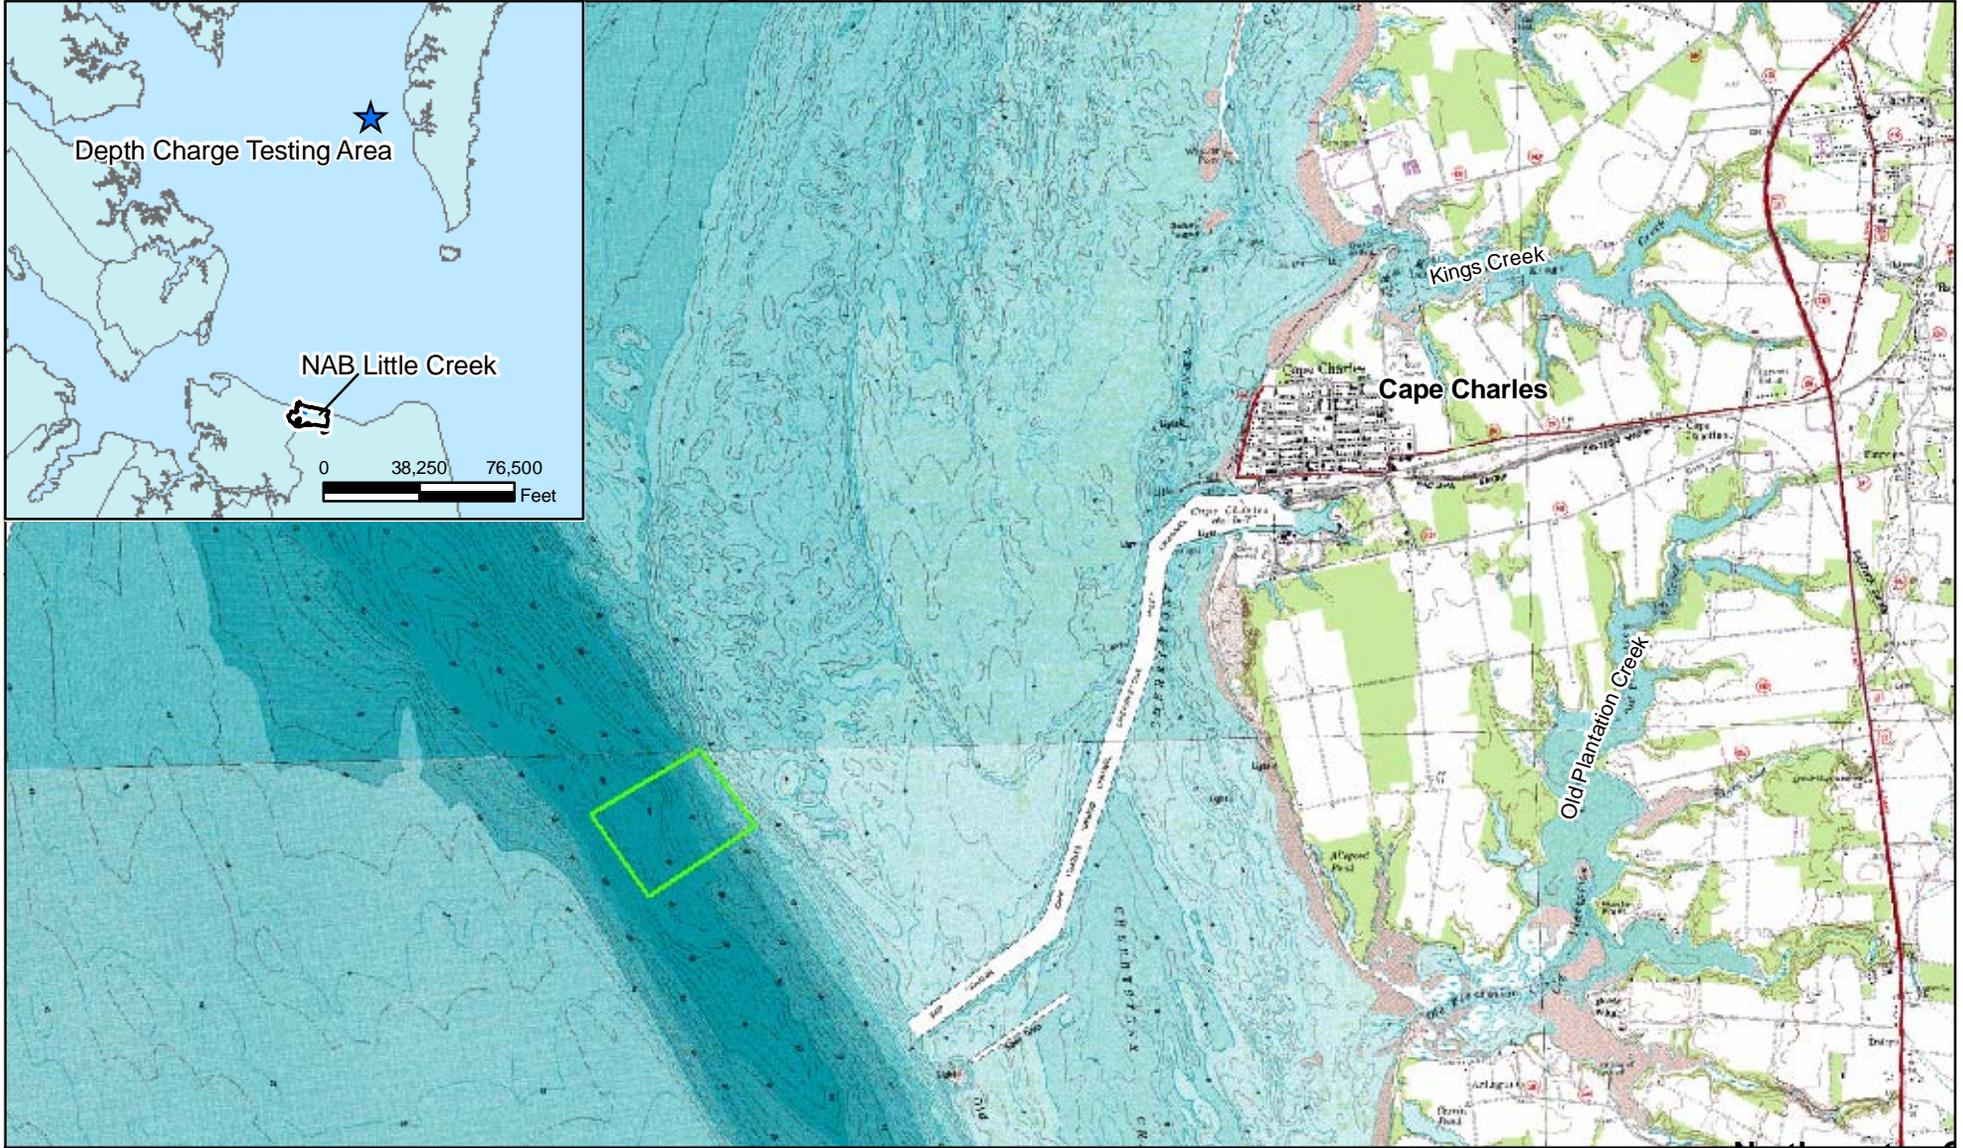
Figure 1-1  
Depth Charge Testing Area  
Depth Charge Testing Area Site-Screening Process Closeout Report  
Naval Amphibious Base Little Creek  
Joint Expeditionary Base Little Creek - Fort Story  
Virginia Beach, Virginia

**Legend**  
■ Depth Charge Testing Area  
□ Installation Boundary

NAB Little Creek encompasses 2,215 acres in the northwest corner of Virginia Beach, Virginia, adjacent to the Chesapeake Bay (**Figure 1-1**). The facility is primarily industrial, with personnel providing logistics and support services for local commands, organizations, home-ported ships, and other United States and allied units to meet amphibious warfare-training requirements of the Armed Forces of the United States. The base is also used for recreational, commercial, and residential purposes. Ancillary activities that have occurred at NAB Little Creek with potential for contaminant release include: vehicle and boat maintenance, boat painting and sandblasting, construction and repair of buildings and piers, mixing and application of pesticides, electroplating of musical instruments, laundry and dry cleaning operations, historical land filling of waste and construction debris, medical and dental treatment, generation of steam for heat, fuel storage and use, and munitions storage and use. Activities conducted outside of NAB Little Creek with the potential for contaminant release include maritime testing and training exercises conducted in the Chesapeake Bay.

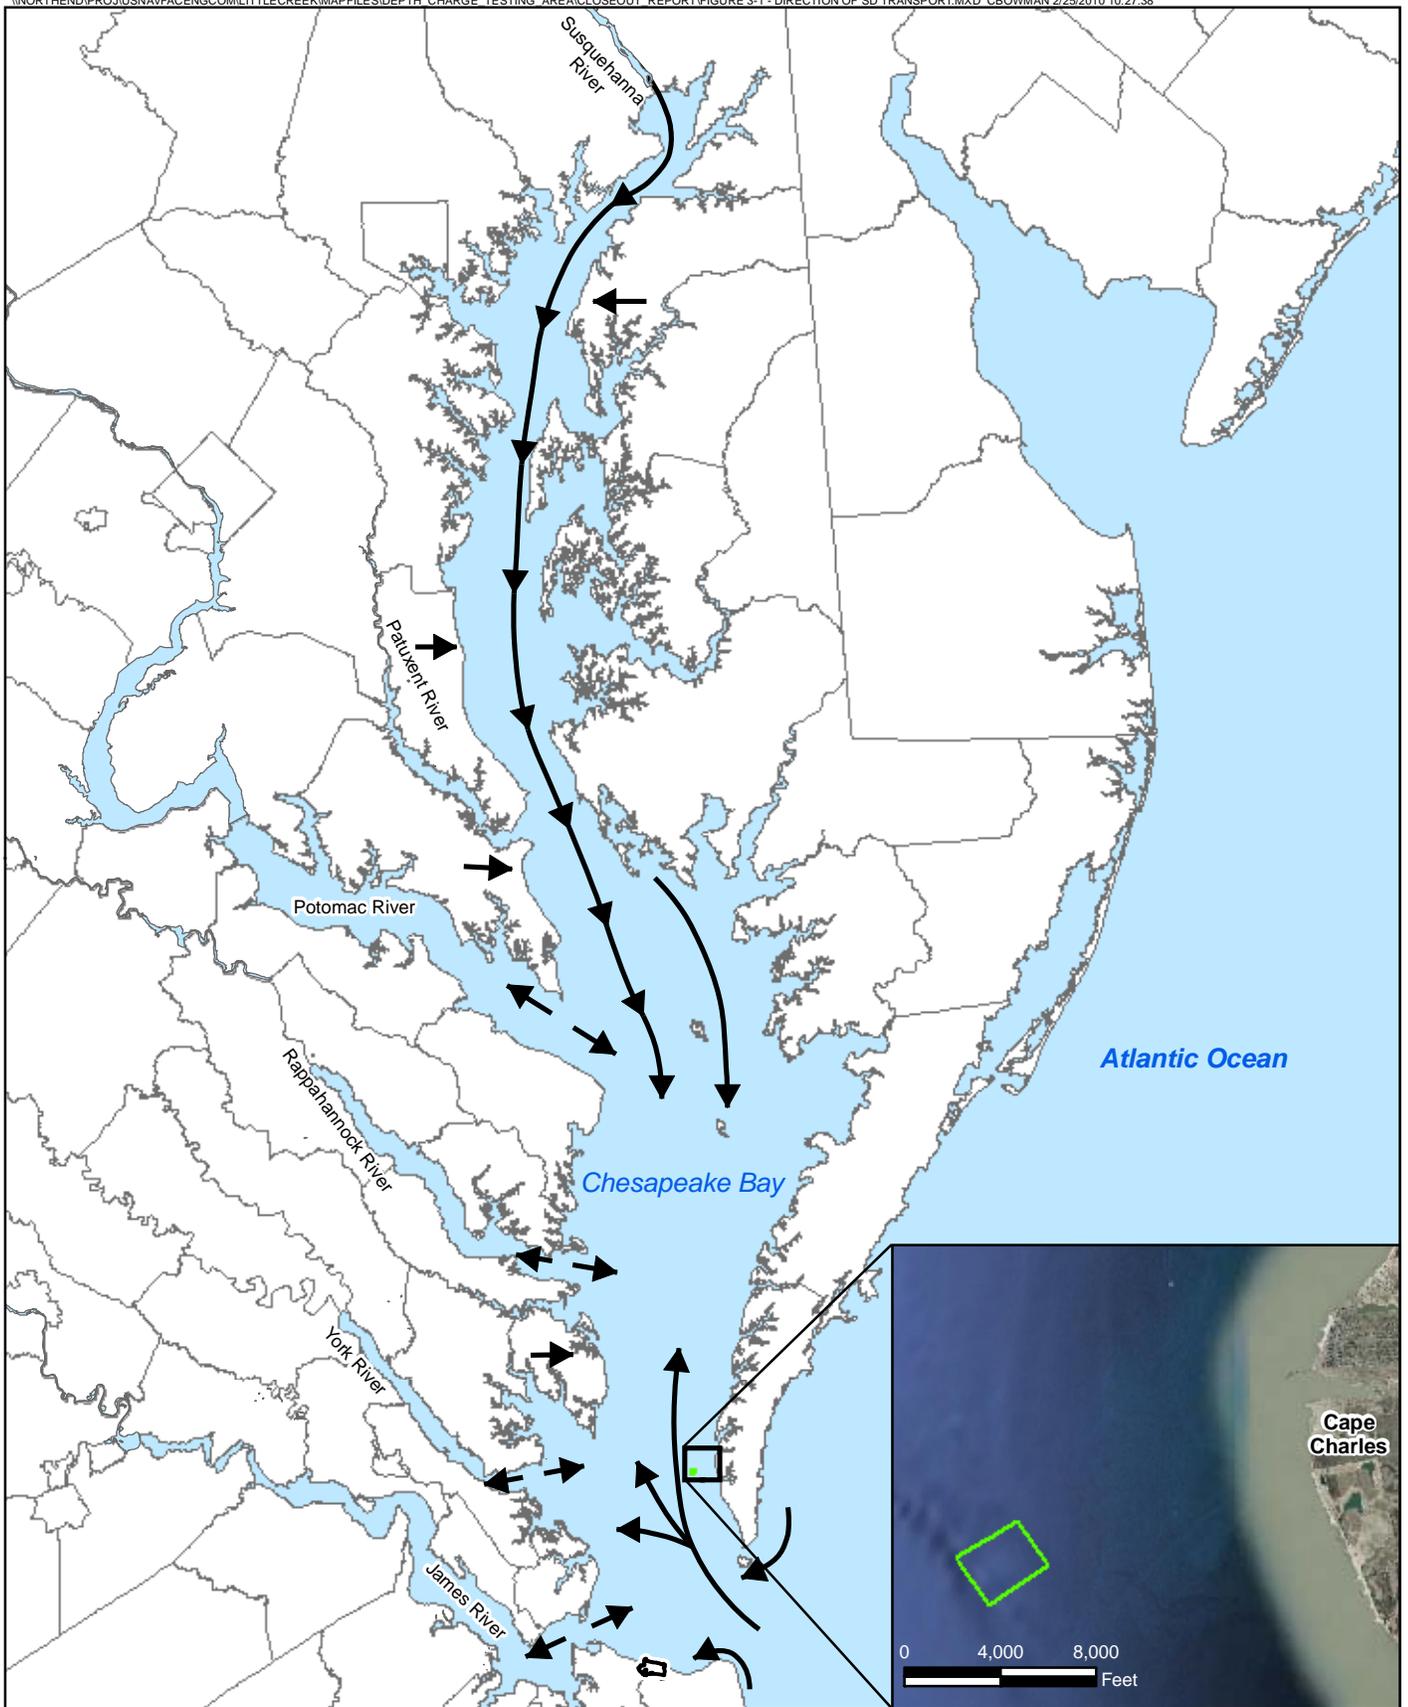
Figure 3-1  
Direction of Sediment Transport - Chesapeake Bay  
Depth Charge Testing Area Site-Screening Process Closeout Report  
Naval Amphibious Base Little Creek  
Joint Expeditionary Base Little Creek - Fort Story  
Virginia Beach, Virginia

Adapted from: Virginia Institute of Marine Science. 1990. A 100-year sediment budget for Chesapeake Bay: Special Report in Applied Marine Science and Ocean Engineering, no. 307, Gloucester Point, Virginia.

Chesapeake Bay sediments in the approximate location of the Depth Charge Testing Area consist of mud, sand, and shells (National Oceanic and Atmospheric Administration [NOAA], 2009a,b). Site specific geology and the thickness of the sediments are unknown. However, the source of the sediment in the mouth of the Chesapeake Bay is derived from erosion of the shoreline and marshes, ocean input, transport from rivers and streams, and biogenic production of skeletal and organic material (USGS, 2003). The major pathways of sediment transport within the bay are shown in **Figure 3-1** (Virginia Institute of Marine Science, 1990).

Torpex and HBX have low to moderate solubilities. These compounds would most likely intermix with sediment and migrate in the south-southeastern sediment transport direction (**Figure 3-1**). With the potential for 66 years of migration, the MC constituents are expected to be dispersed at concentrations below screening levels.
