SITE OF KNOWN BURIED ASBESTOS CONTAINING MATERIAL (ACM) BUILDING RUBBLE
REPORT NS NEWPORT RI
7/1/2011
NAVFAC MIDLANT

Sites of Known
Buried ACM
Building Rubble

July 2011

**NAVAL STATION NEWPORT RHODE ISLAND
BURIED ACM BUILDING RUBBLE SITES**

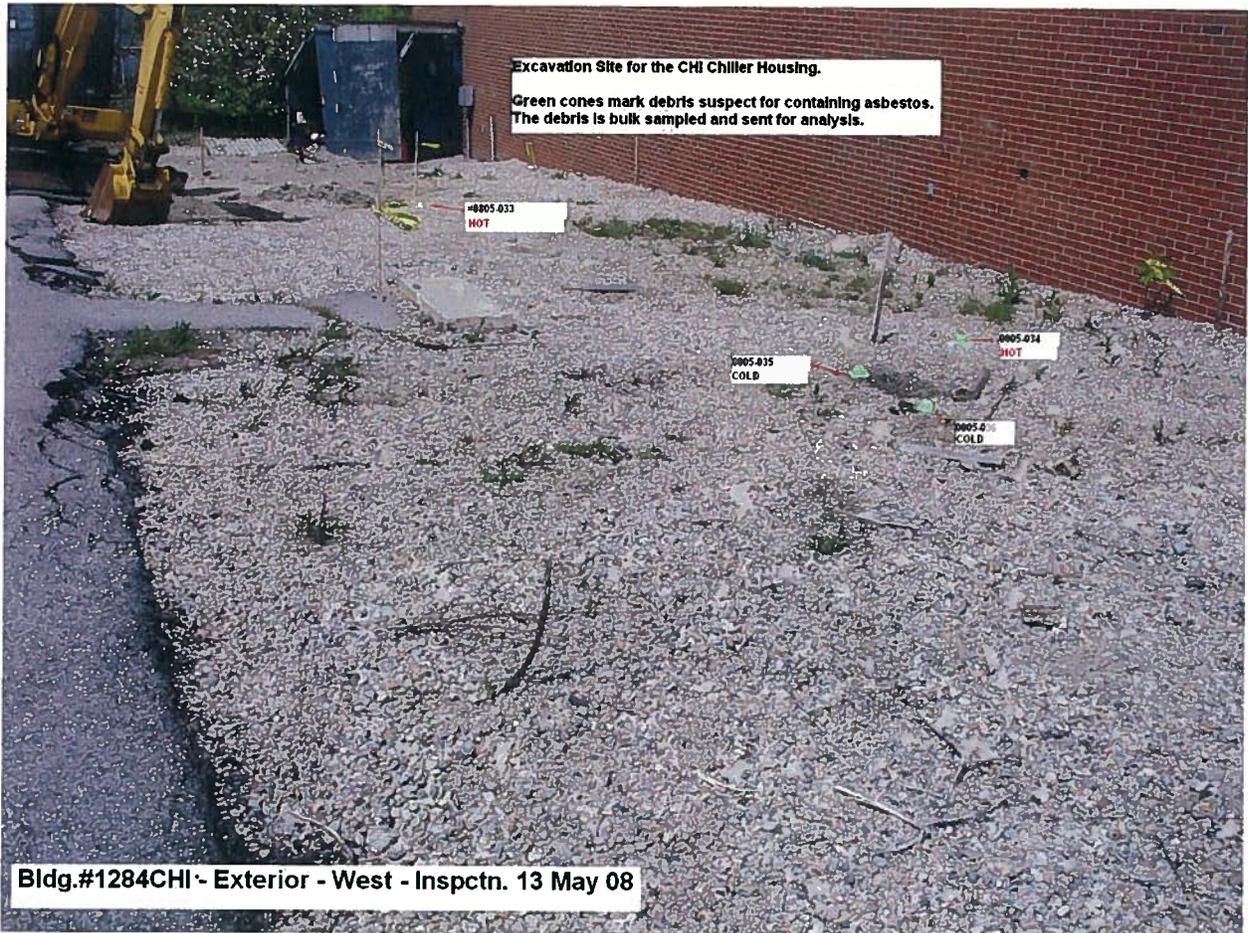
The small excavator in the upper left indicates what little soil was disturbed before noting the suspect material.

NAVFAC Npt Environmental conducted an inspection which included bulk sampling. Laboratory analysis finds 40% Chrysotile in sample pieces of A/C panel

ACM contaminated soil was addressed thru soil management and
used as back fill on site

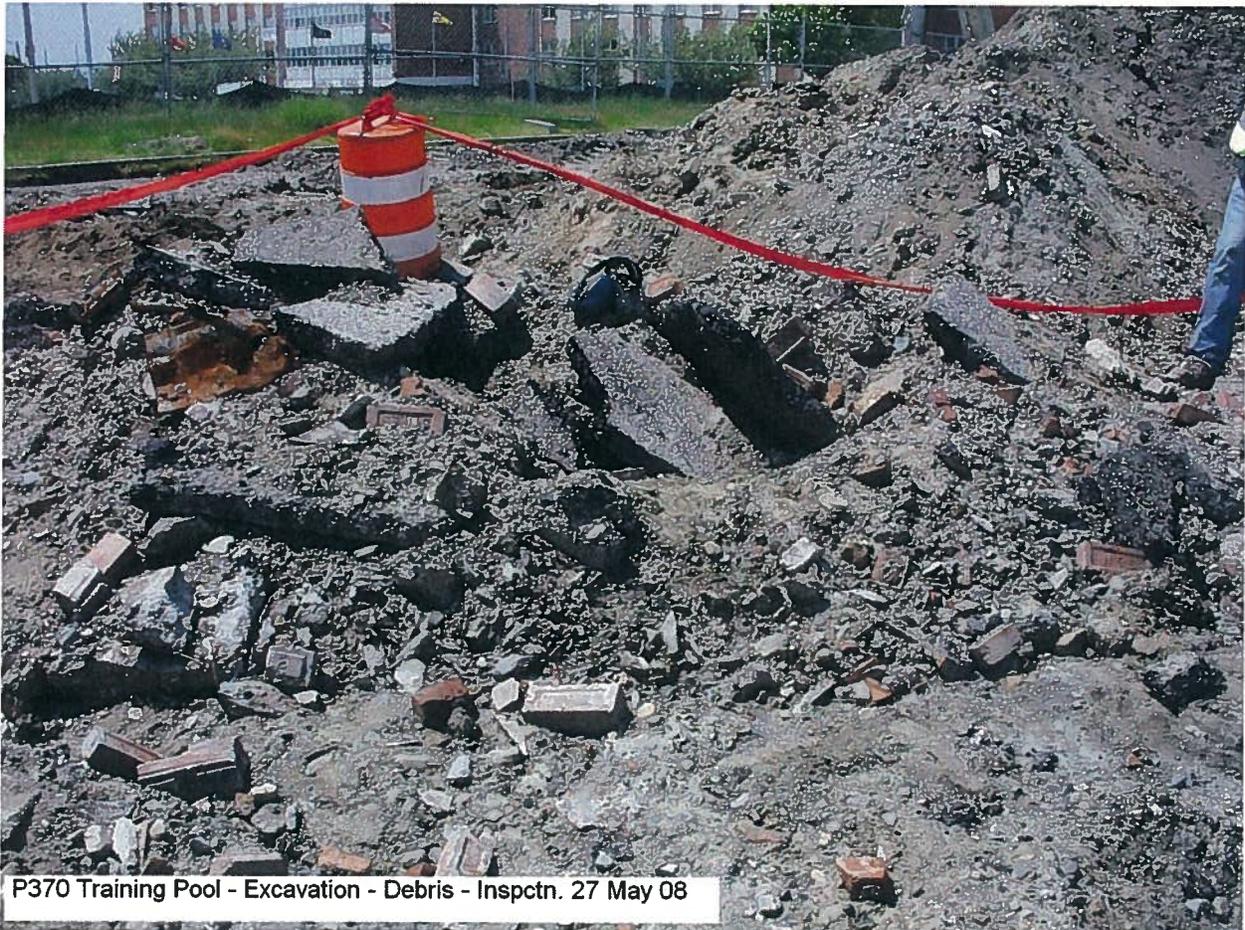
(Site 2 cont.)

We learn as we go. Building rubble is the "flag" to stop and investigate.

Intermixed within soil spoil piles, A/C panels in pieces and VAT sometimes still adhered to un-earthed concrete slabs.

Each find causes project delays, extra costs and site specific asbestos hazard abatement plans and implementation

NAVFAC NEWPORT conducted an extensive removal of those soils
found to be contaminated with ACM materials.

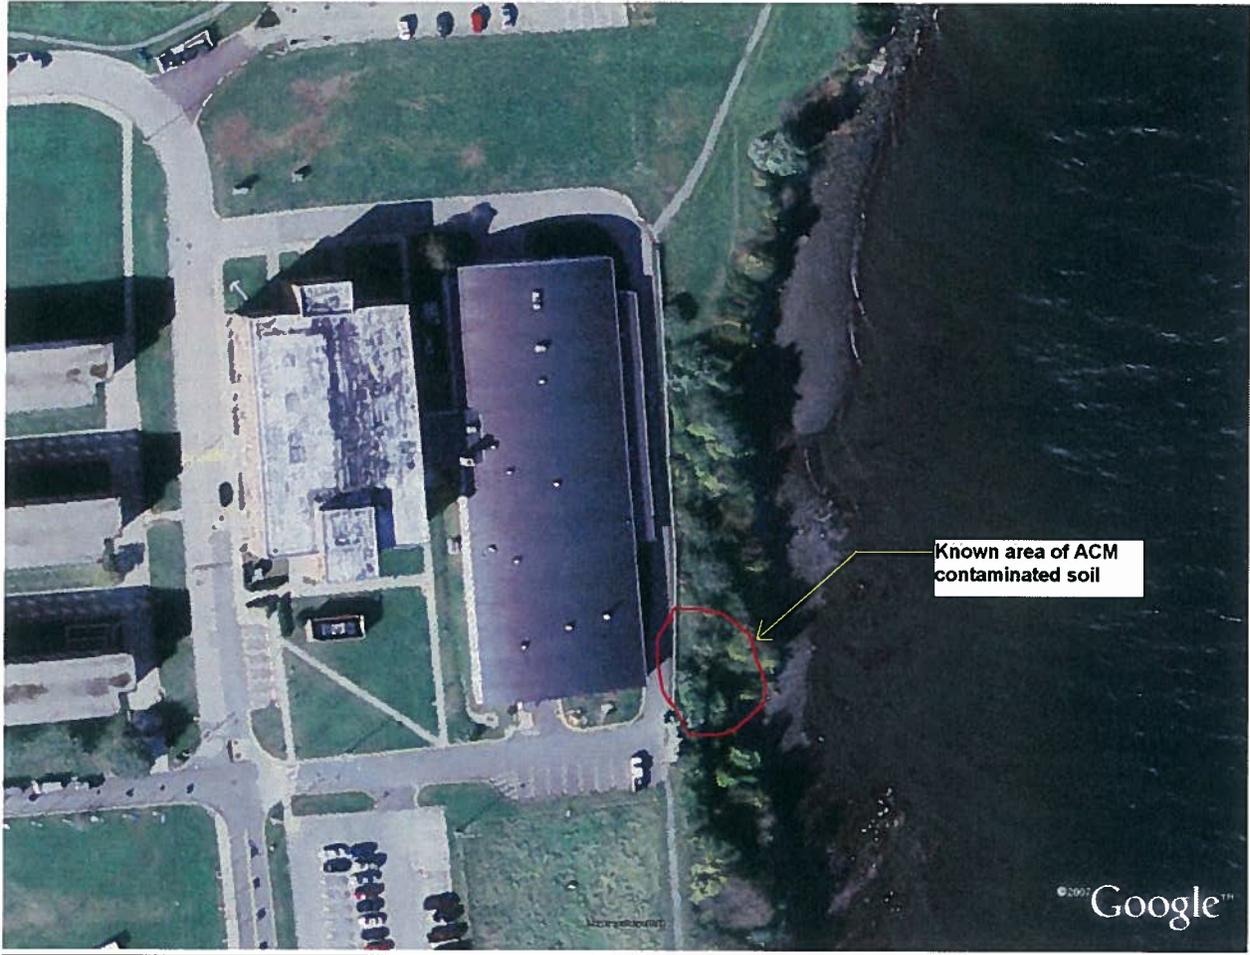
Site #3
MarDet Bldg. #1112CP

Contained in the awarded contract for the construction of the NAVY SUPPLY CORPS SCHOOL is interior and exterior renovation to Bldg. #1112CP.

During construction of the retaining wall, a dump site for A/C (Asbestos Cement) panels is un-earthed.
(See photo below)

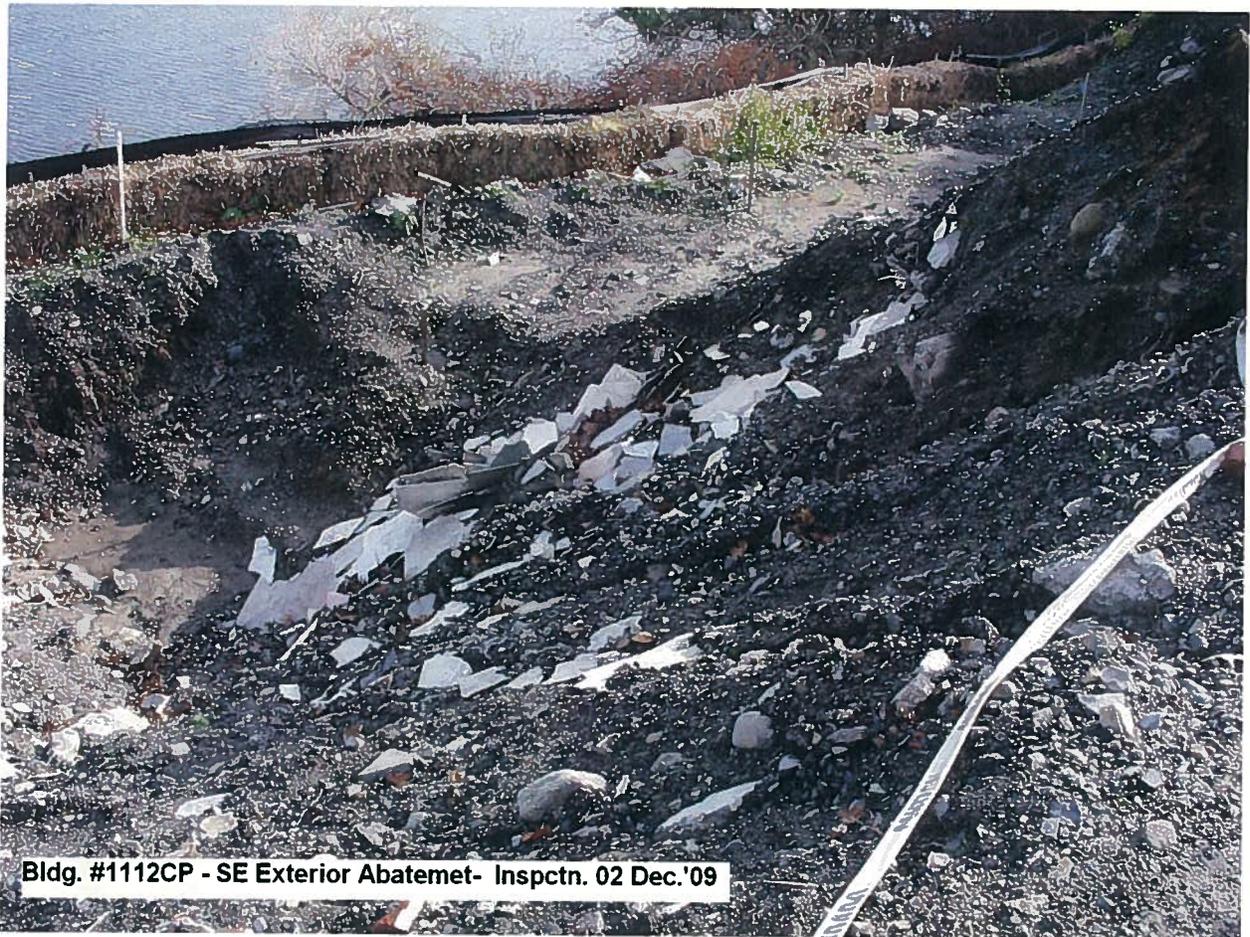
(Site #3 cont.)

The A/C paneling pictured here tested positive for asbestos with a 45% Chrysotile content

NAVFAC Npt Environmental is alarmed by the close proximity of this site to a body of navigable water

Only that ACM rubble, in the path of retaining-wall construction, is removed and disposed.

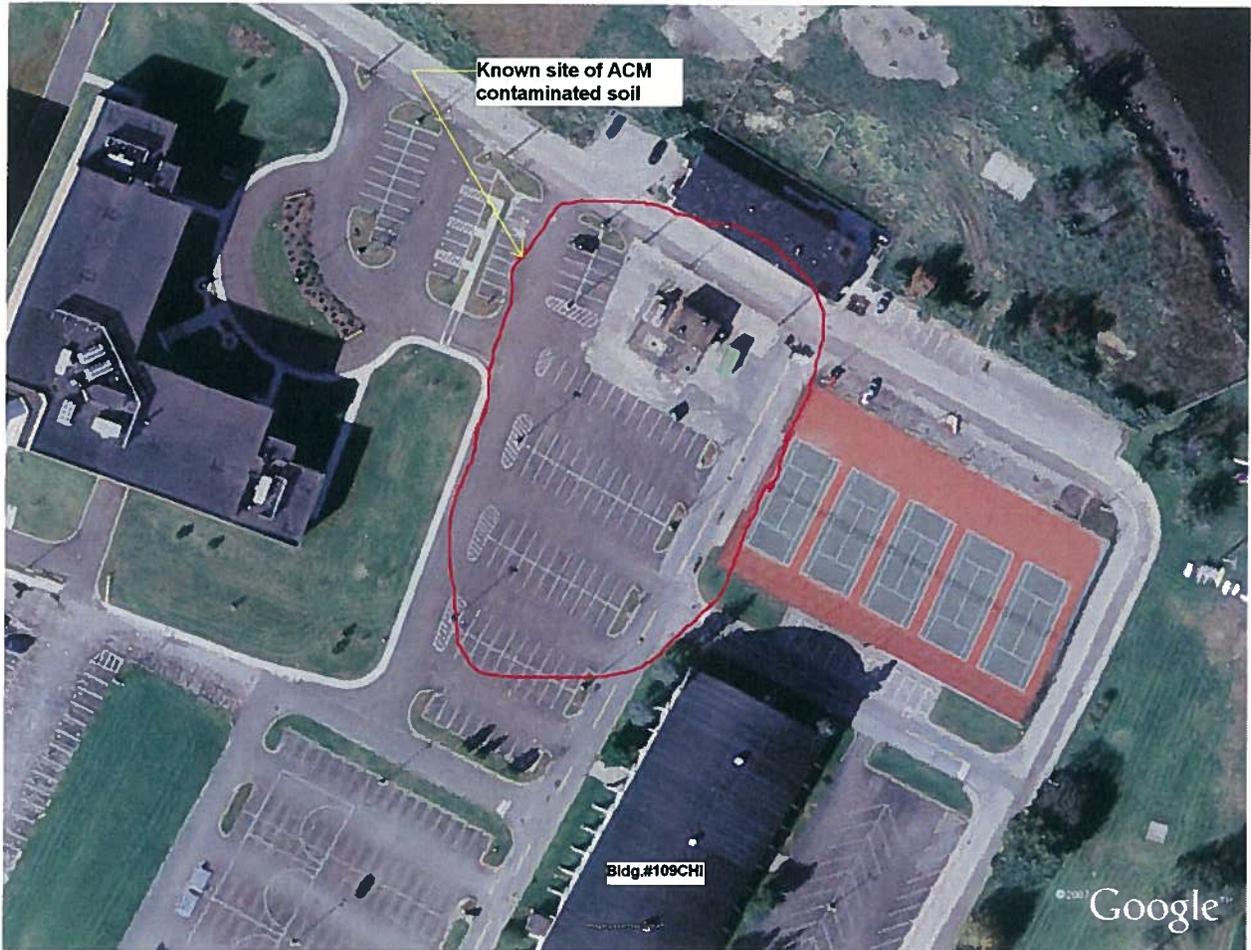
SITE #4
P-347 Fitness Center

P-347 is the construction of the Fitness Center.

Contaminated soil encountered during excavation was removed and disposed. No "chasing" of ACM was performed.

Contractor has a RI licensed asbestos crew and a Private Qualified Person (PQP) on site during all excavation and soil drilling activities

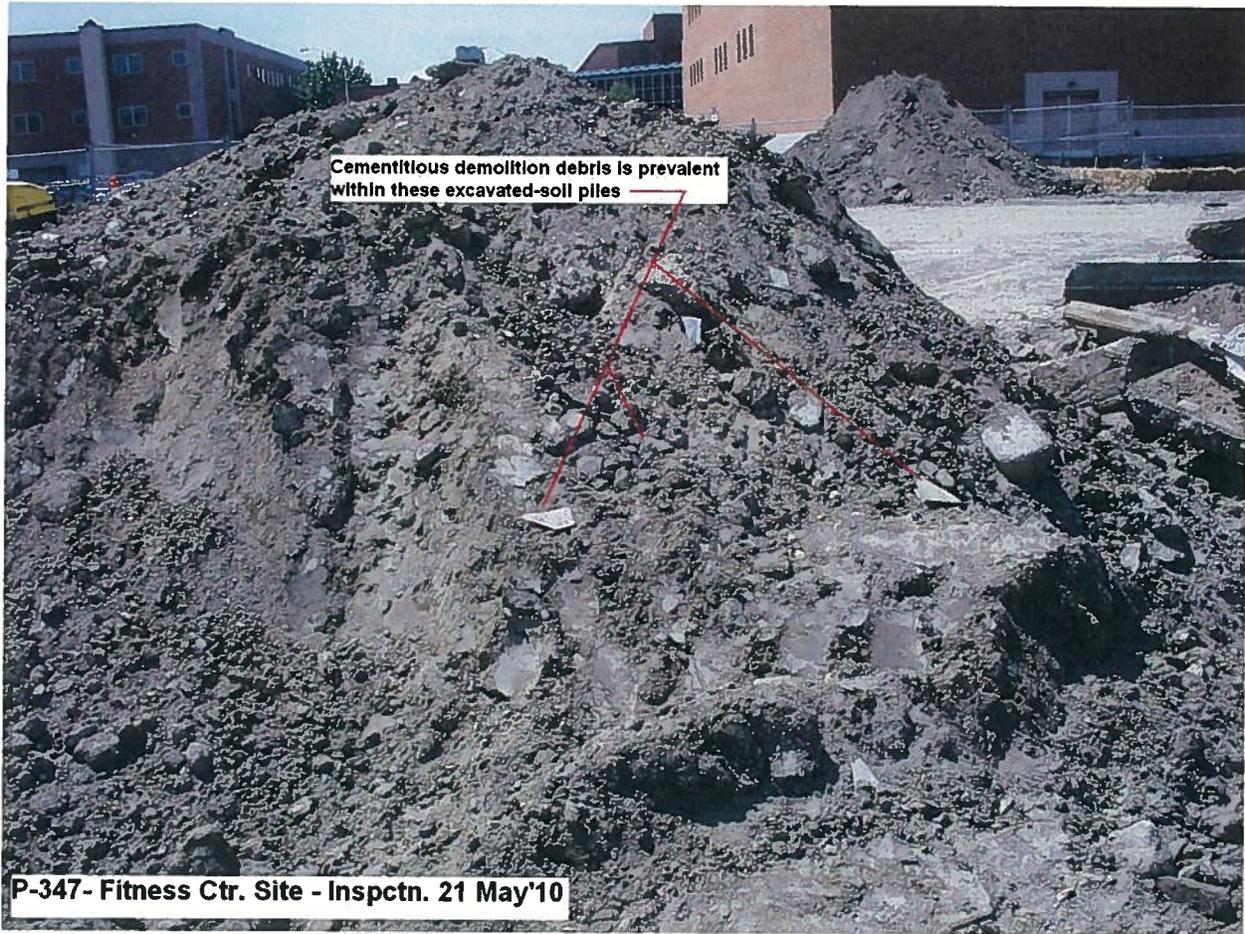
(Site #4 cont.)

The site preparation for construction of the Fitness Center uncovered ACM building rubble.

In addition to the pieces of A/C panel, discarded pipe with ACM TSI still attached is un-earthed

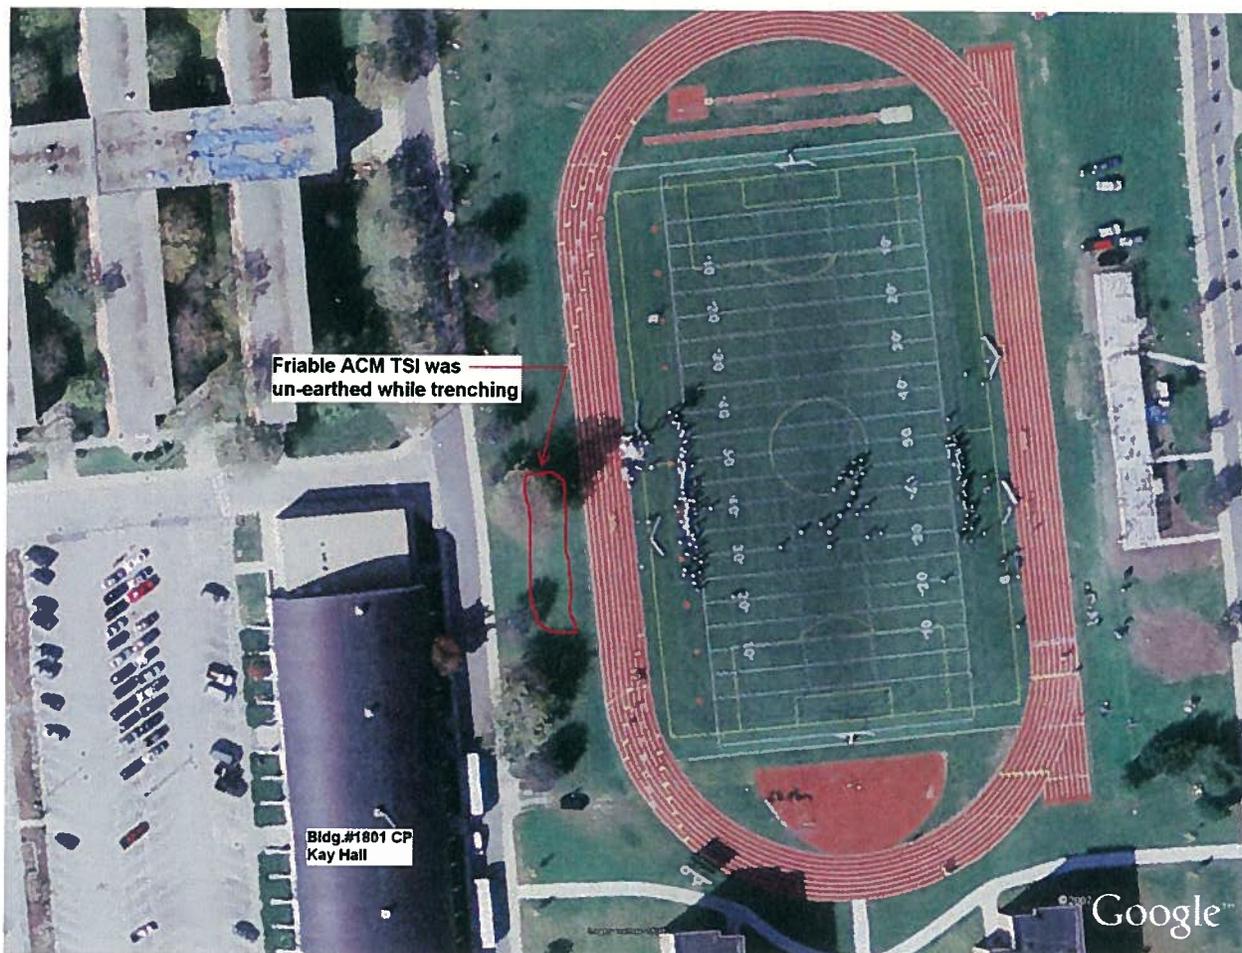
SITE #5
Nimitz Field Lighting

During excavation for the electric power conduits, the contractor alerted NAVY of suspect material noted in the spoil piles.

Here, as in other instances, the ACM is discovered after a nighttime rainfall, which washes the soil/mud from the debris allowing it to "stand out" on the soil pile

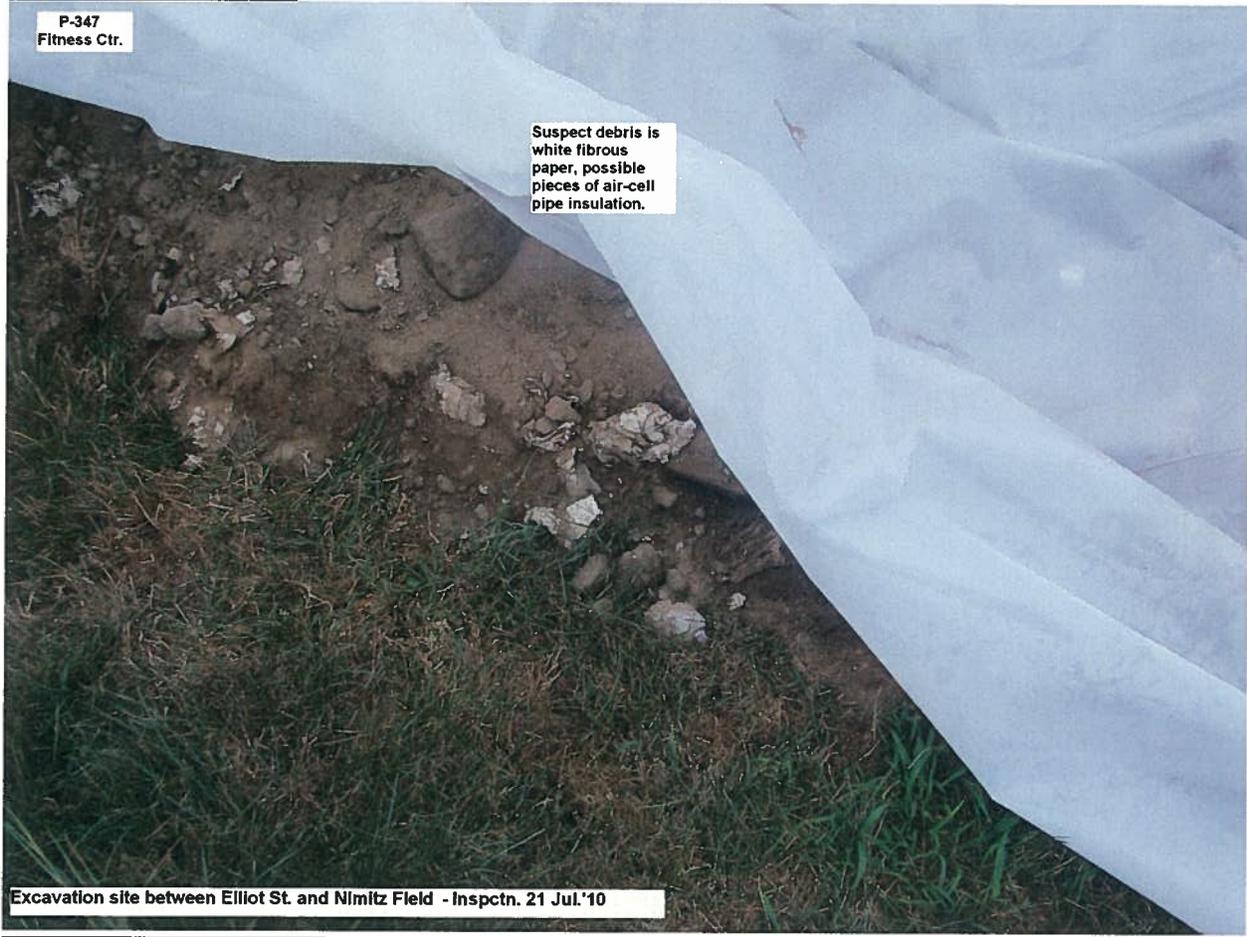
(Site #5 cont.)

Material suspect to be ACM TSI is sampled and sent for laboratory analysis.

Lab findings confirm ACM with an 80% Chrysotile composition.

Contractor is ordered to abate the asbestos hazard which now includes contaminated soil

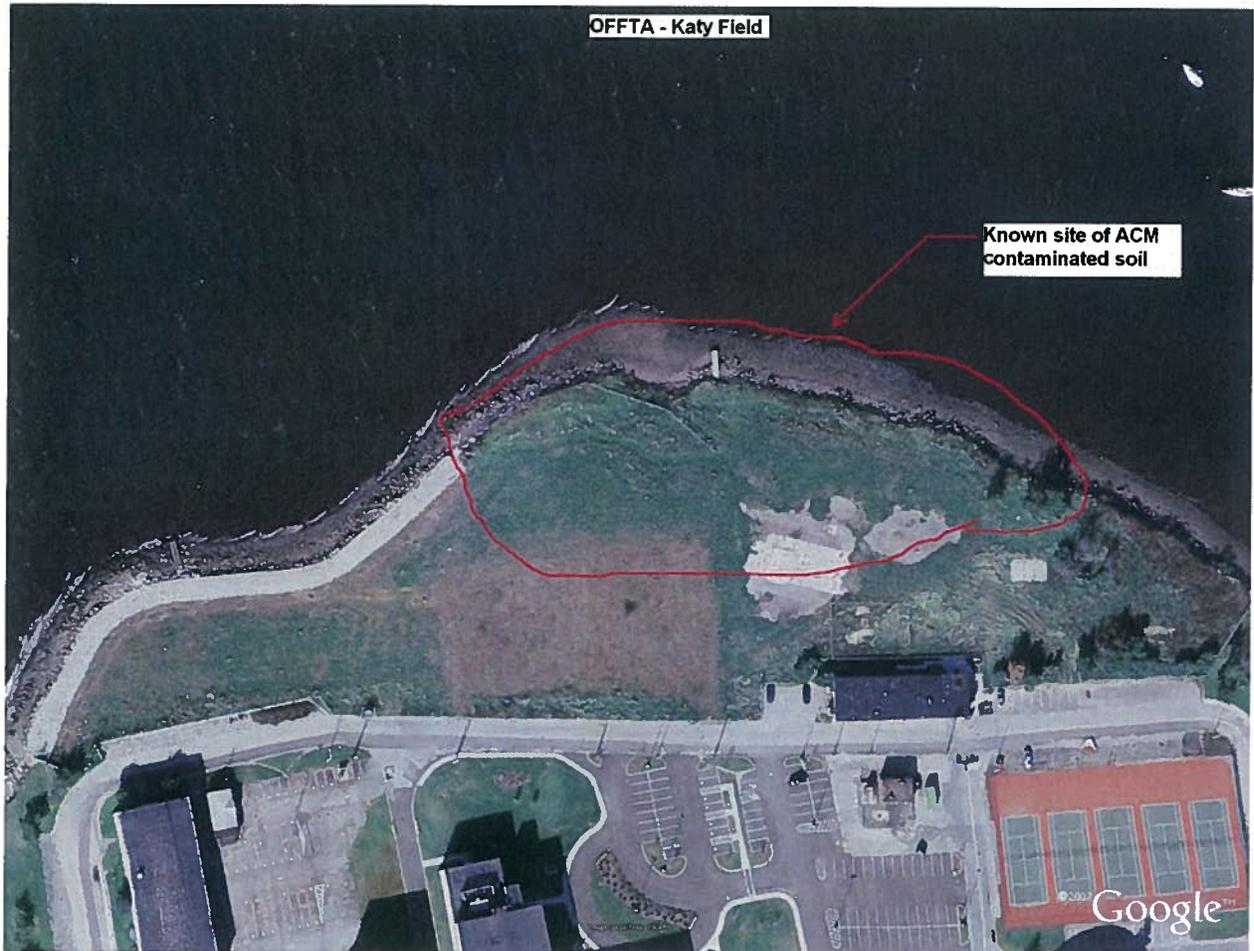
The IR Site #9 Re-construction of the shore line revetment is to be accomplished in two (2) phases; first the western portion then the eastern portion.

As the western portion nears completion, dime-sized pieces of VAT are discovered.

Work is halted while NAVFAC MIDLANT wrestles with an economically feasible solution
See next photo

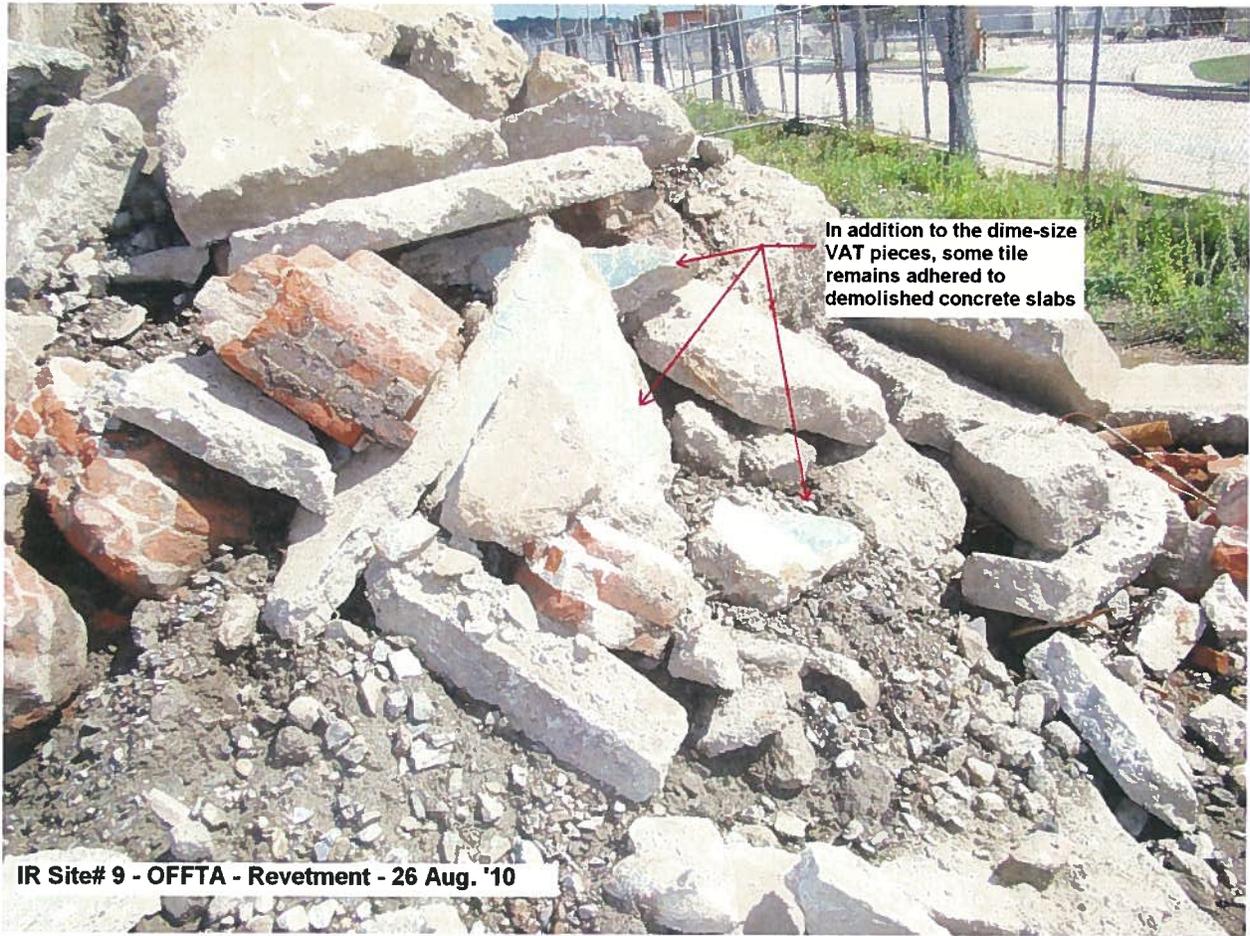
(Site #6 cont.)

It is the small, broken pieces of VAT strewn about the site, including the High/Low tide marks, increasing the difficulty in developing an asbestos hazard abatement plan.

The revetment reconstruction is on "Hold" until which time a plan to address the asbestos contamination is devised.

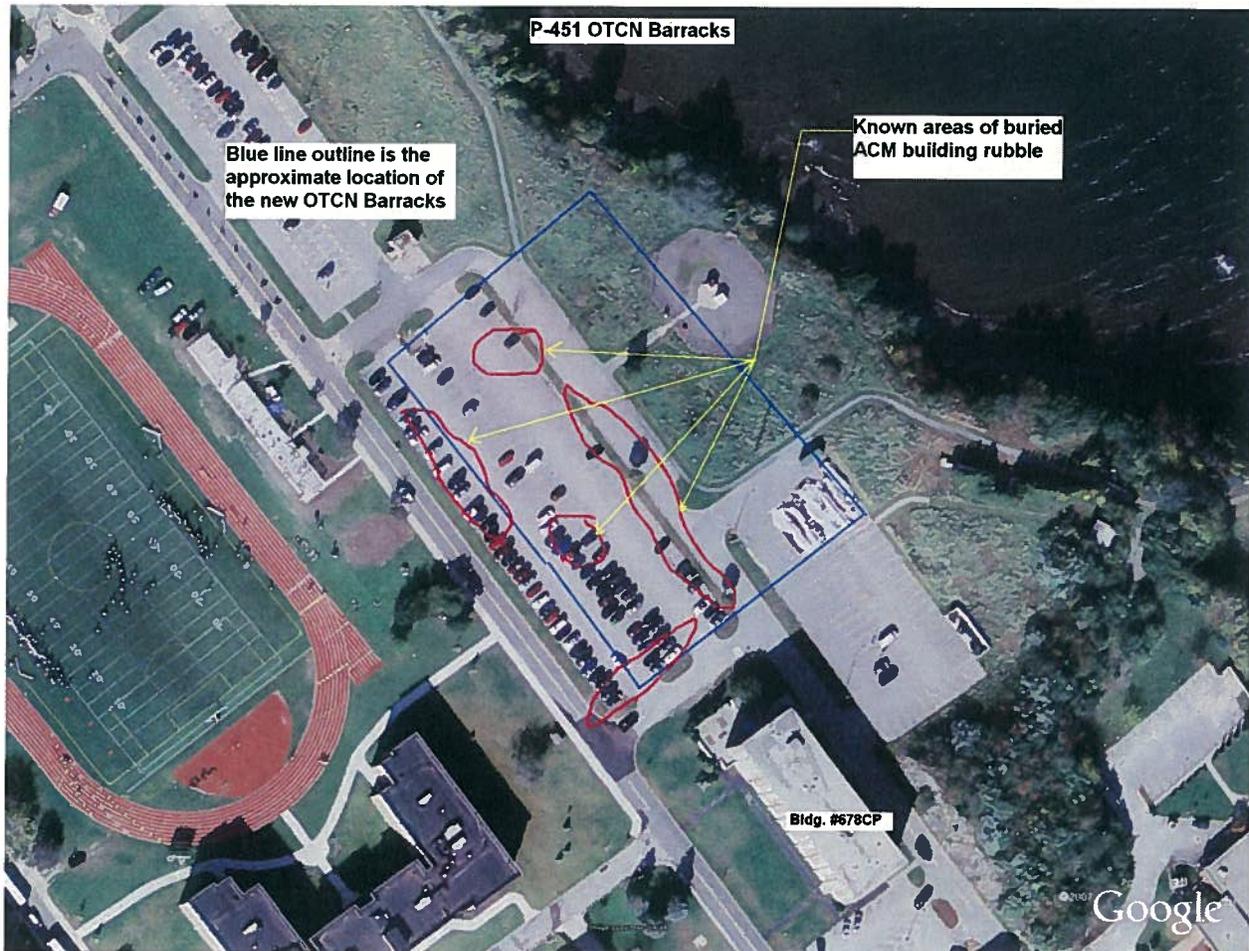
SITE #7
OTCN Barracks

During design, random test pits were dug at the site. A few "hits" indicated the potential for buried ACM building rubble.

No provisions were made in the award to address such issues if
or when they may arise
See next photo

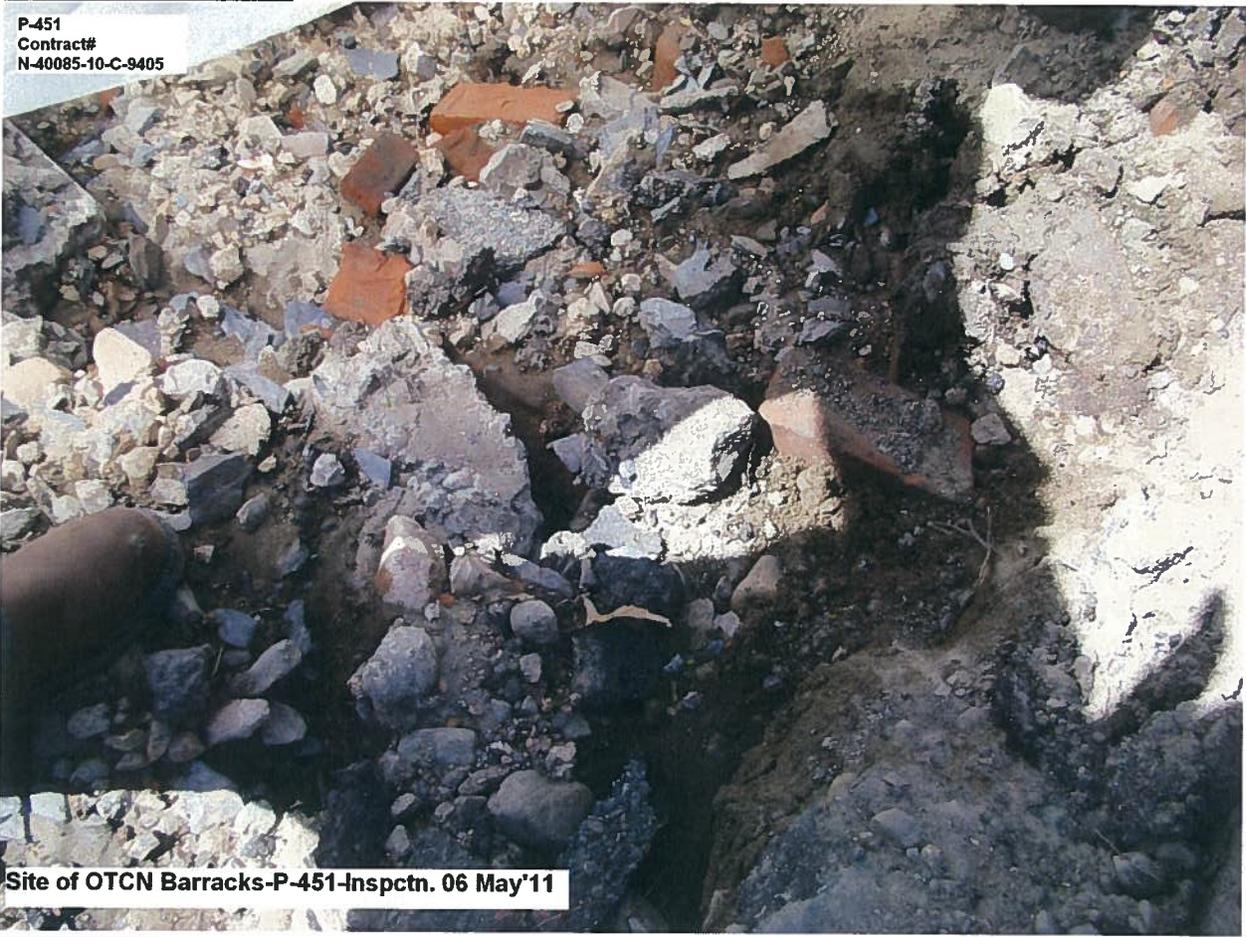
(Site #7 cont.)

This site has rendered an array of ACM materials some of which are A/C panels and friable ACM TSI

Until the accepted asbestos hazard abatement plan is operational, each encounter with buried ACM debris turns the site preparation away and to another on-site area.

An Environmental Specialist is retained by the contractor and is on-site during ALL excavations to watch and document as is needed

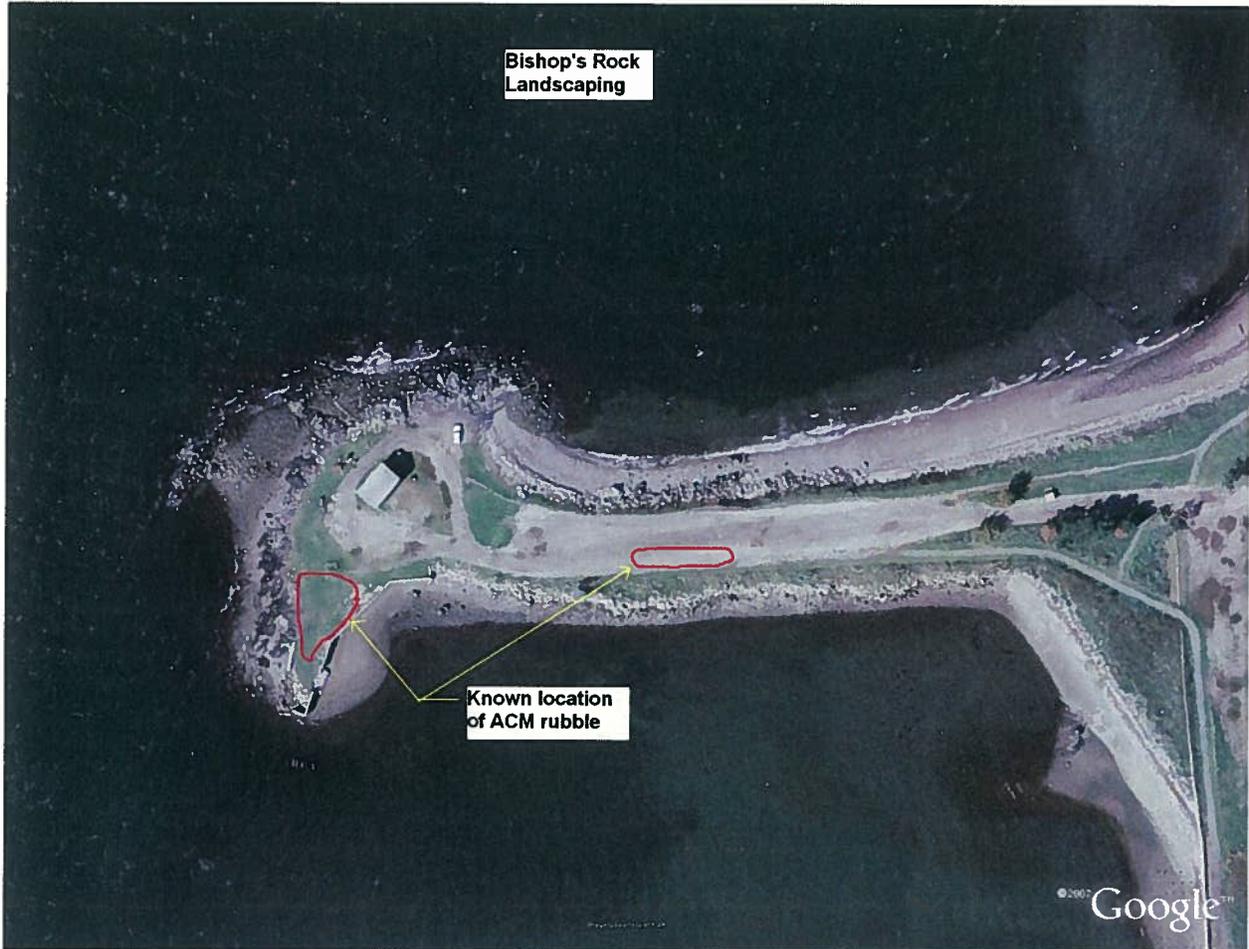
SITE #8
Bishop's Rock

Excavated soil spoil piles are inspected on 15 April 2011.

Discovered within the soil piles and surrounding area are palm size pieces of A/C (Asbestos Cement) panels and green floor tiles.

The green floor strongly resembles those discovered on the nearby sites.

Green floor tile on neighboring sites was sampled and found to be ACM

Laboratory analysis finds 20% - 30% Chrysotile in the A/C pieces

It is supposed that building demolition debris was deposited on this site as fill for both the causeway and the island.

NAVFAC Newport as of 23 June '11 has issued the contractor an RFP.

NAVFAC Newport awaits the contractor's estimated quantity of contaminated soil to be removed and disposed and the means and methods to do so.

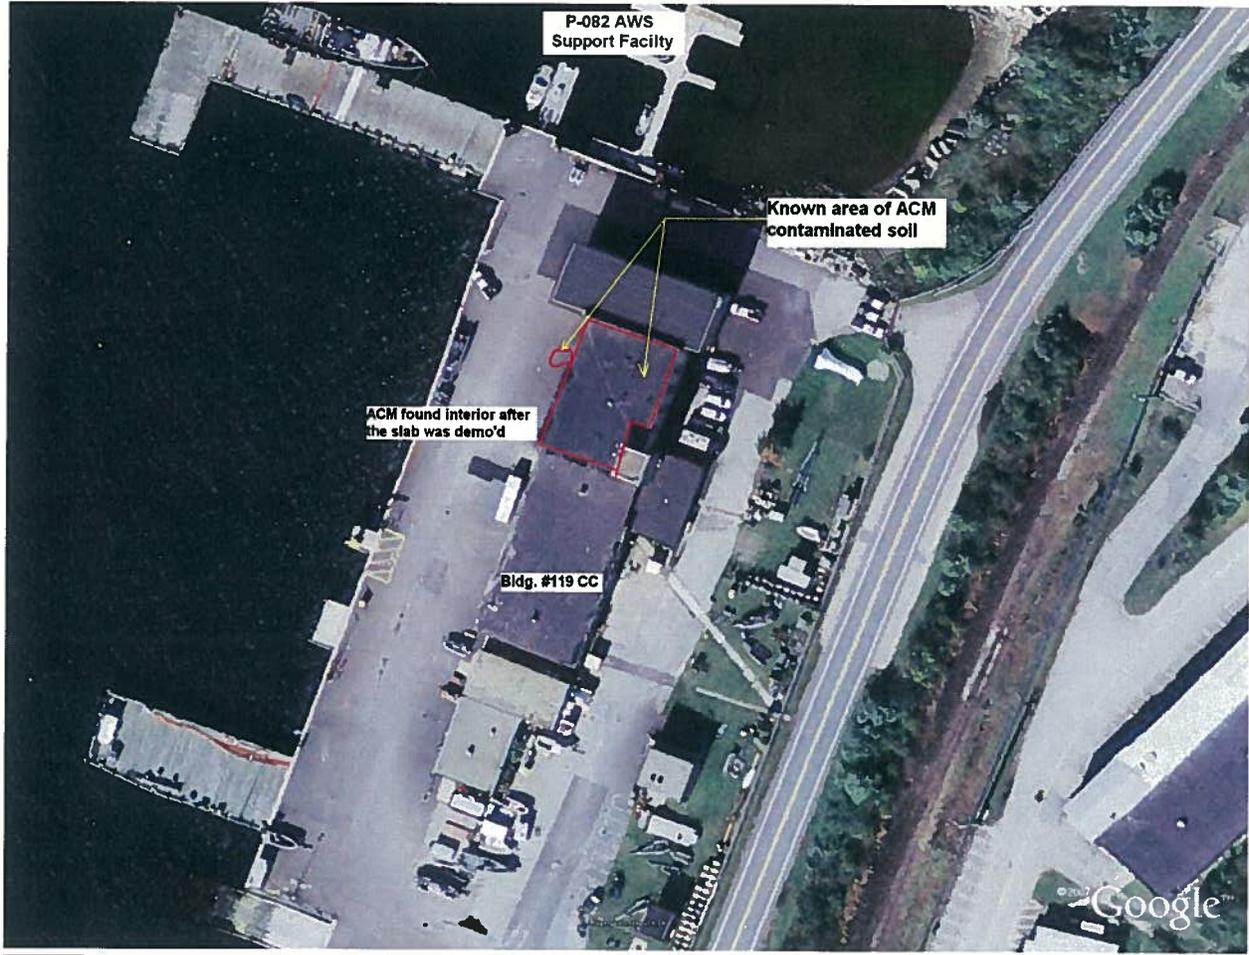
Contractor demolition of the grade level interior slab reveals
ACM contaminates; Friable Thermal System Insulation (TSI)
considered Regulated Asbestos Containing Material (RACM) by the
US EPA

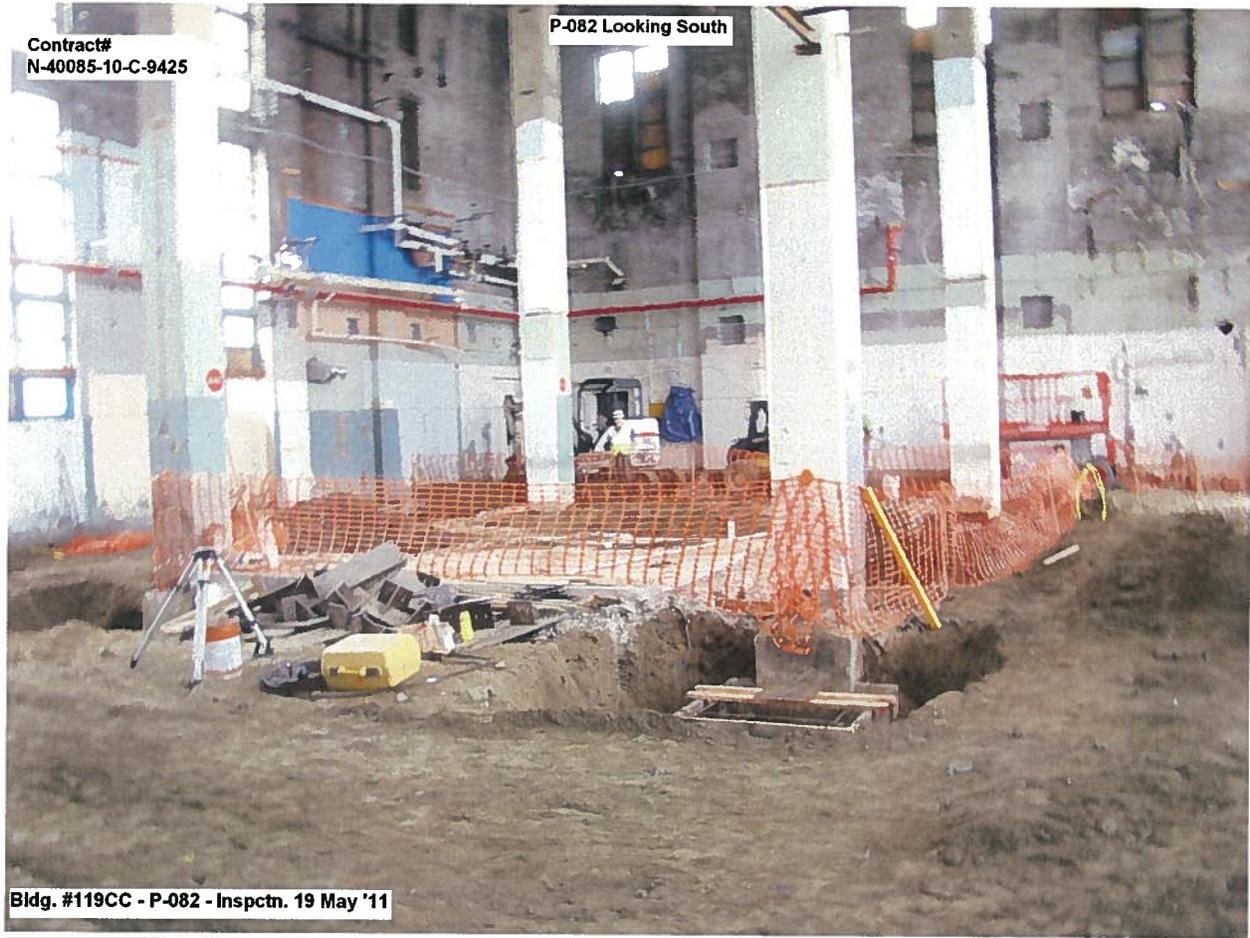
(Site #9 cont.)

The facility's interior is gutted and its concrete slab is demolished.

During a routine inspection by NAVFAC Npt Environmental, ACM TSI is discovered. Sampling and laboratory analysis documents a 60% to 80% Chrysotile content.

NAVFAC Npt FEAD issues an RFP for removal and disposal of ACM contaminated soils
