TS-PIC-91129
March 1992

EPA **Site Analysis**
New London Submarine Base
Groton, Connecticut

Site Analysis
New London Submarine Base
Groton, Connecticut

by
Dean Anderson, Imagery Analyst
The Bionetics Corporation
Warrenton, Virginia 22186

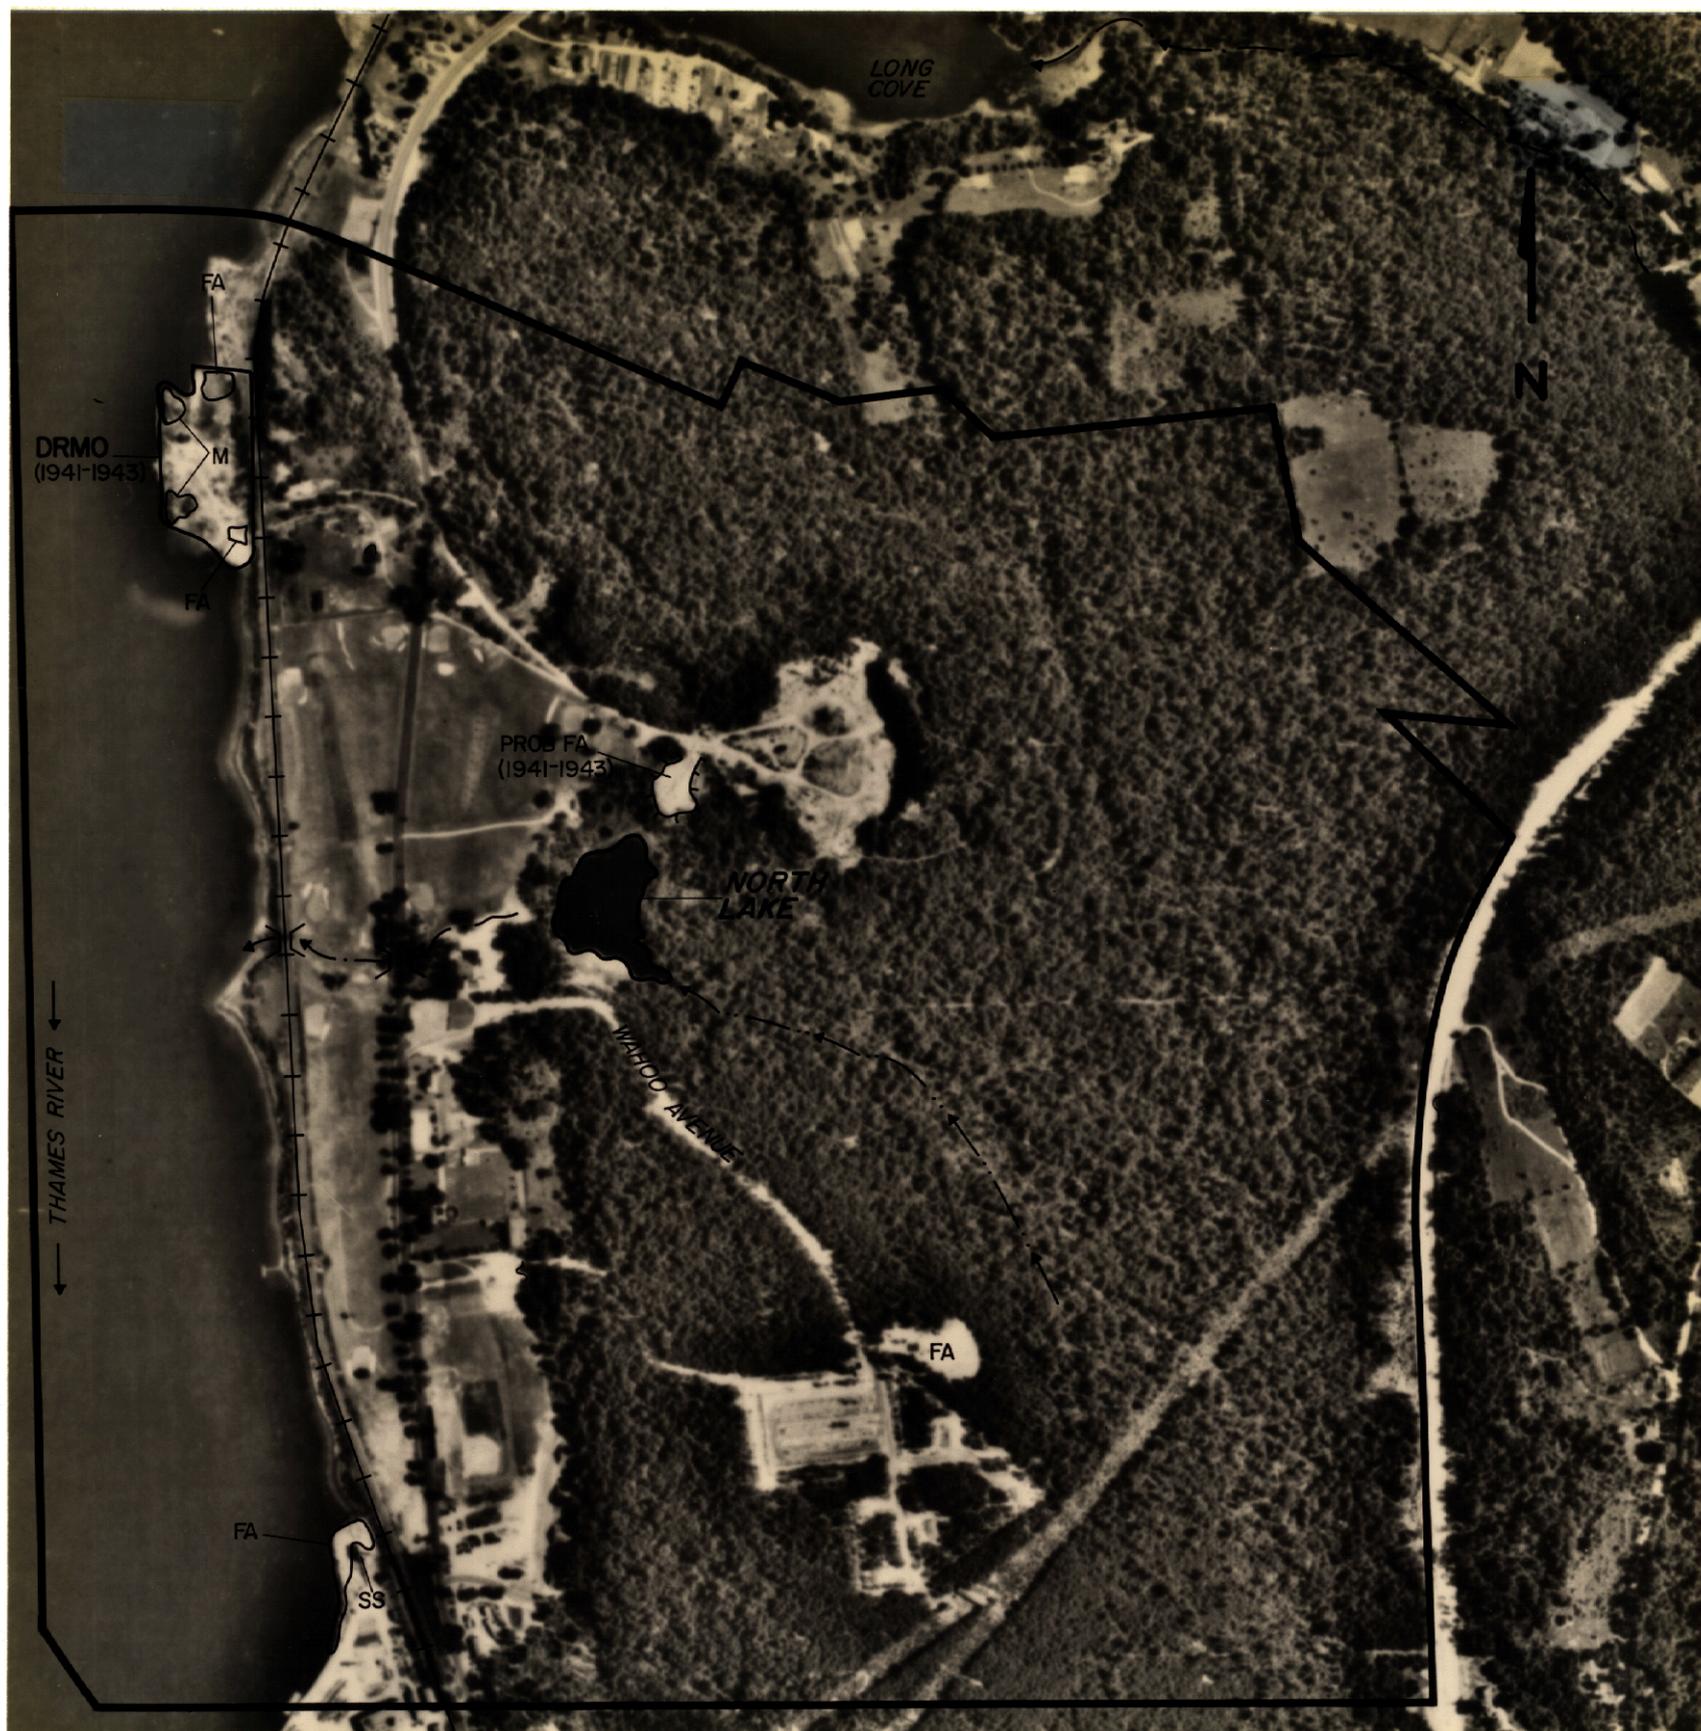
In 1941, only a small pool of liquid was visible in the southwest corner of North Lake. Currently, the lake appears to be filled to near capacity. No significant activity is noted at North Lake throughout the remainder of this analysis. It will be annotated but is not discussed further.

A probable fill area, first evident in 1941, is located northeast of North Lake. This area is possibly being used to stockpile material excavated from the area directly to the east. Additional fill areas are found in the southwestern and south central portions of the study area. Filling has occurred along the Thames River in the southwest corner of the study area since 1941, and filling is evident in an area which appears to be a probable weapons storage facility under construction in the south central portion of the study area.

A drainage analysis was performed for this year, with any significant changes noted on subsequent years of photography. Drainage originating within the site flows west towards the Thames River.

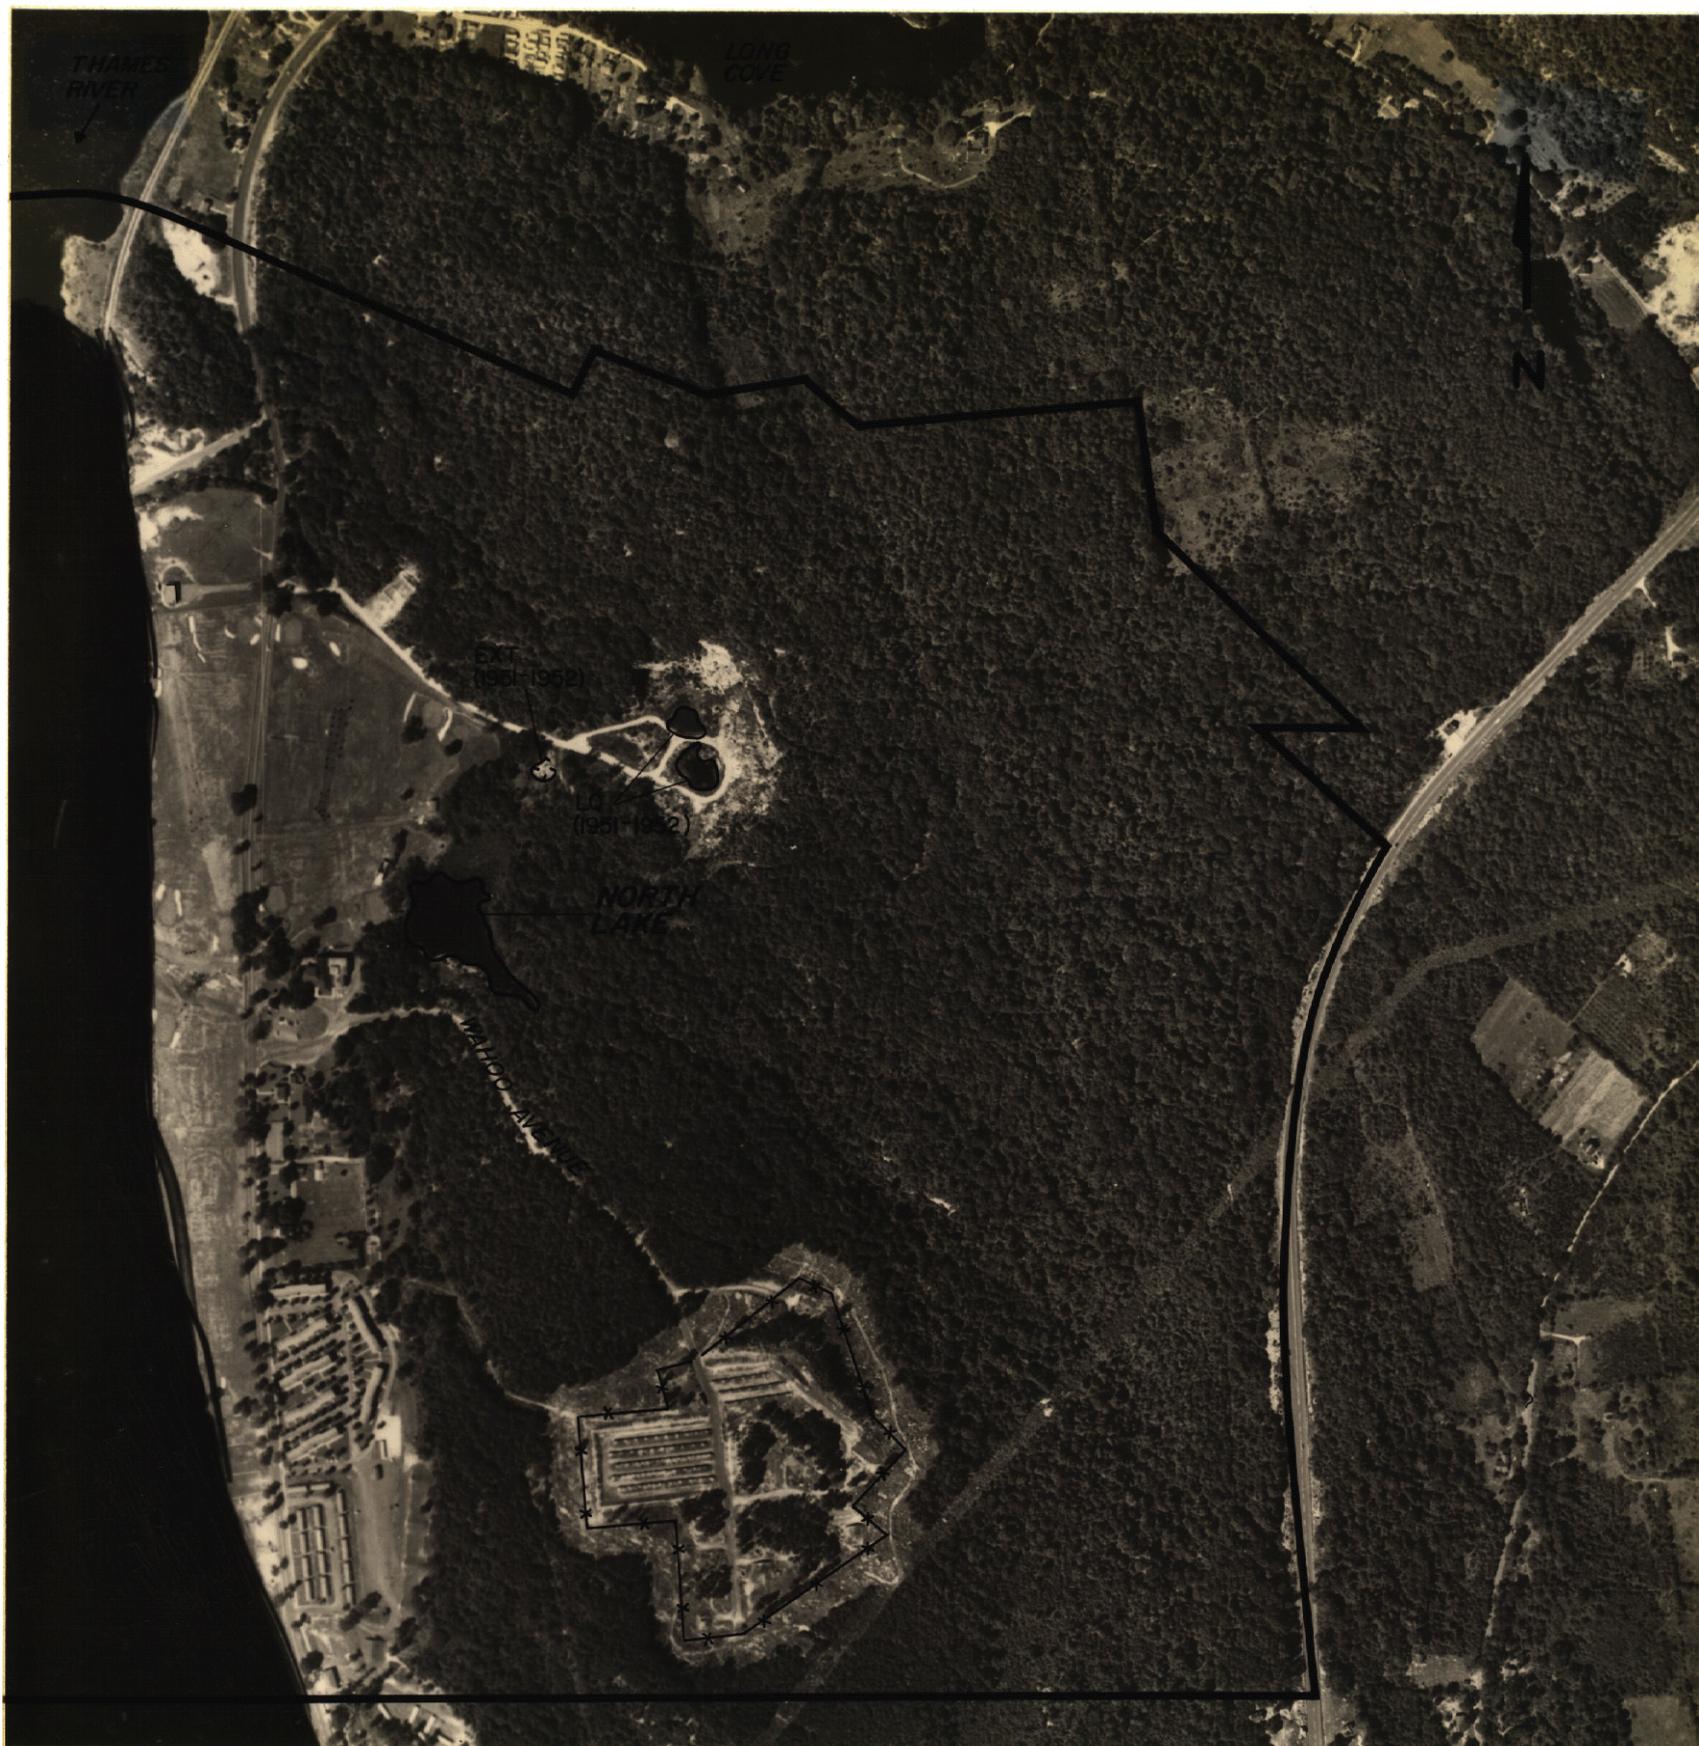
In 1951 and 1952, material is being extracted (EXT) from the probable fill area noted in 1943. Additionally, two pools of liquid (LQ) are evident in the area directly east of the extraction.

The probable weapons storage facility is now fenced. It will no longer be annotated or discussed unless significant environmental activity is associated with it.

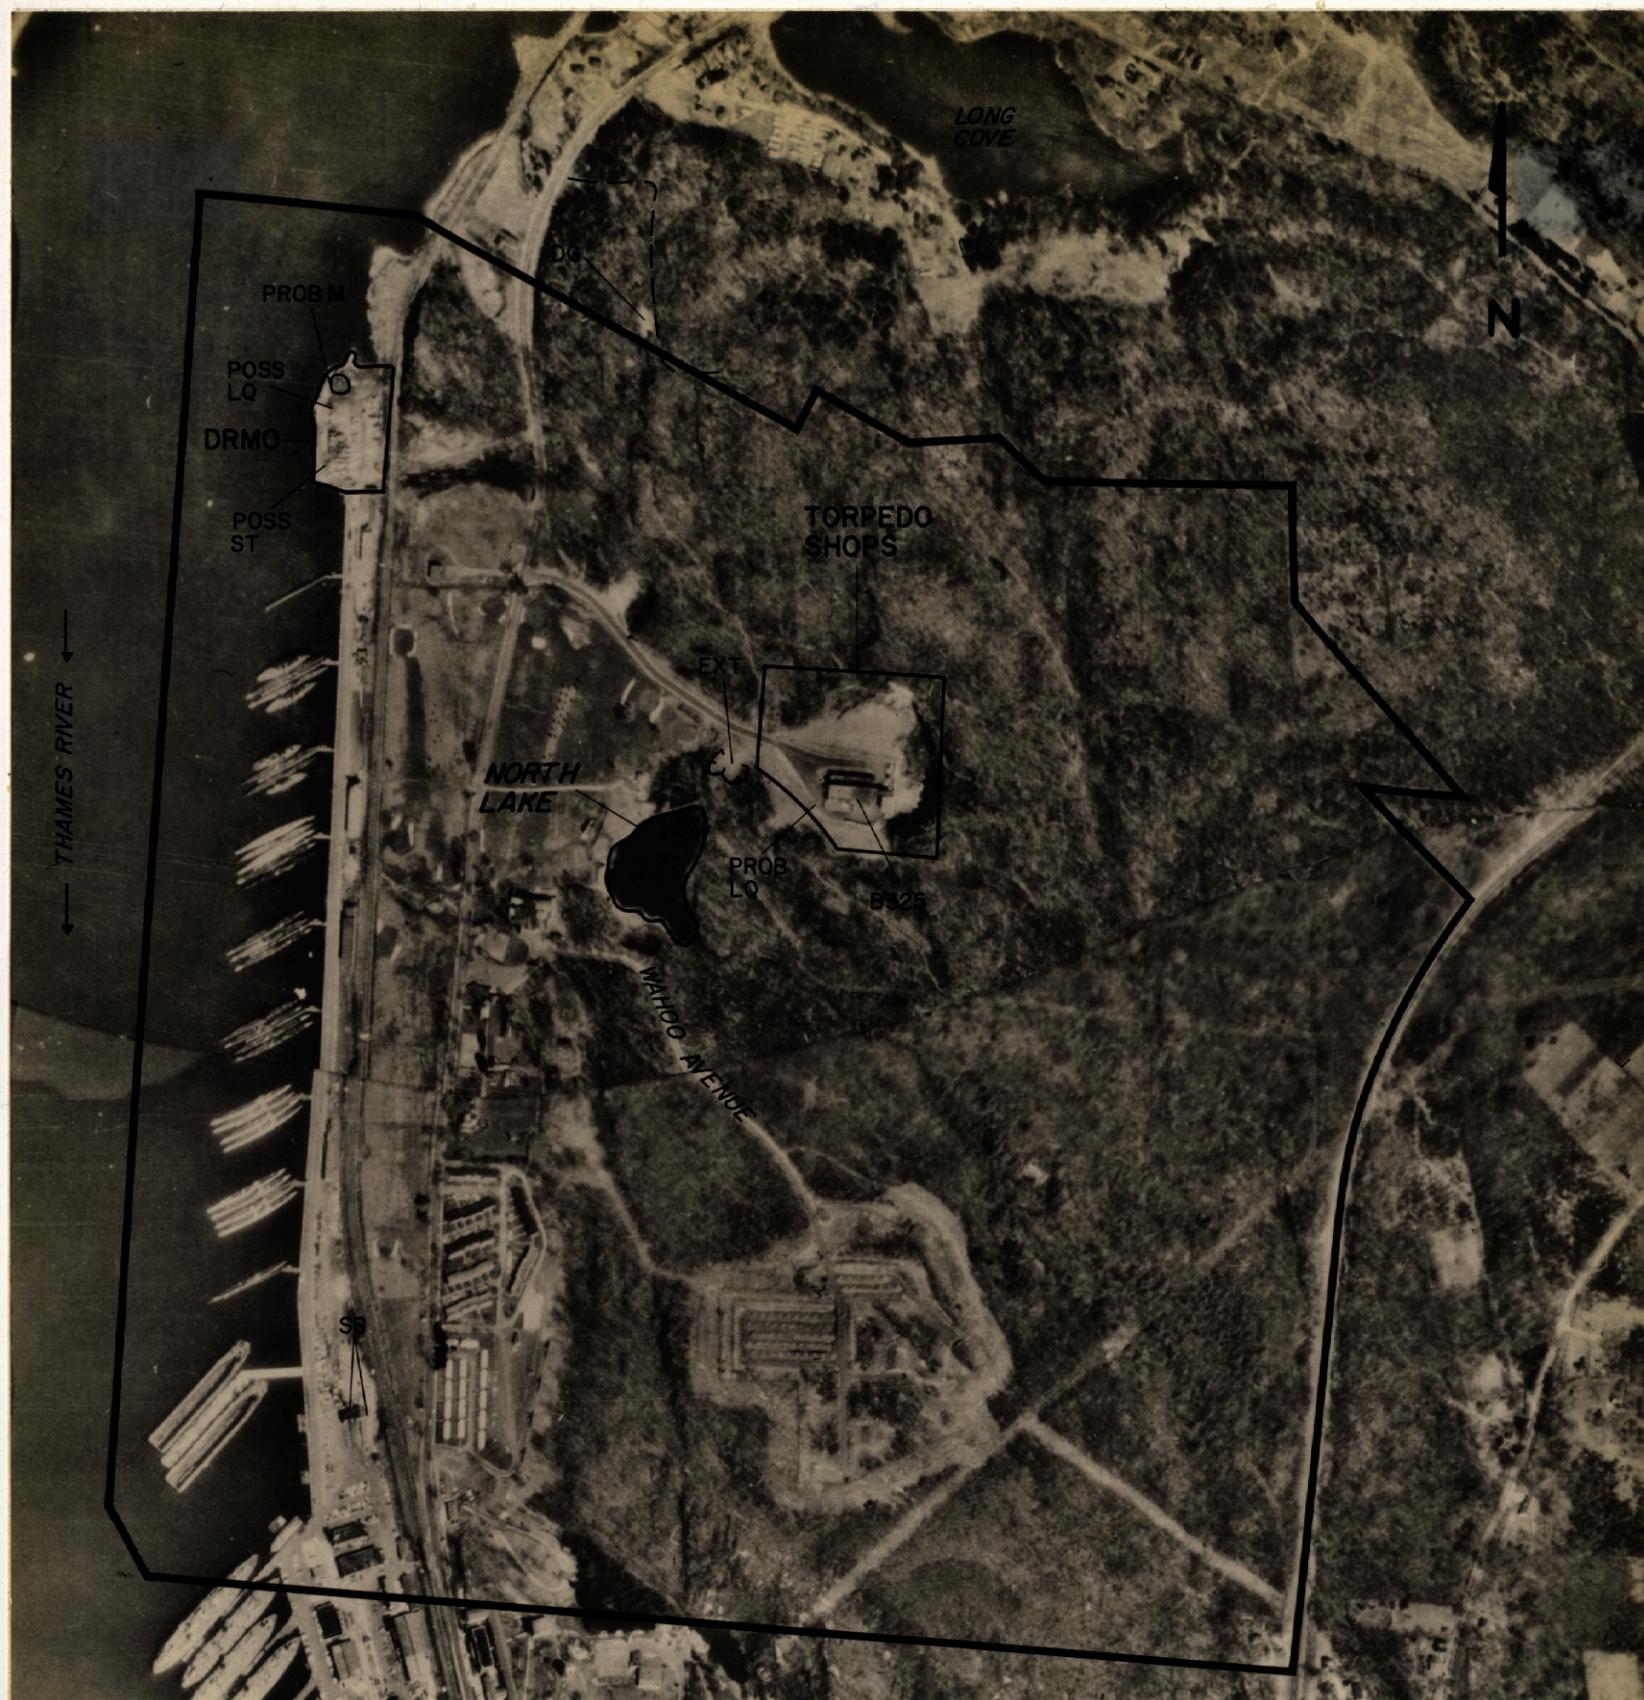
Some additional filling (not annotated) has occurred in the DRMO. A pile of probable material and a possible pool of liquid are visible in the northwestern portion of the DRMO. Smoke (not annotated) emanates from the possible pool of liquid, suggesting that it may be on fire. A stained access road which appears to support vehicular traffic leads through the DRMO. A trail which leads to the probable material appears stained. An additional possible stain (ST) is noted in the southwest corner, and open storage is evident in the southwestern and eastern portions.

The extraction remains northeast of North Lake, but appears inactive. Directly north of the study area, an access road leads past an area of disturbed ground (DG).

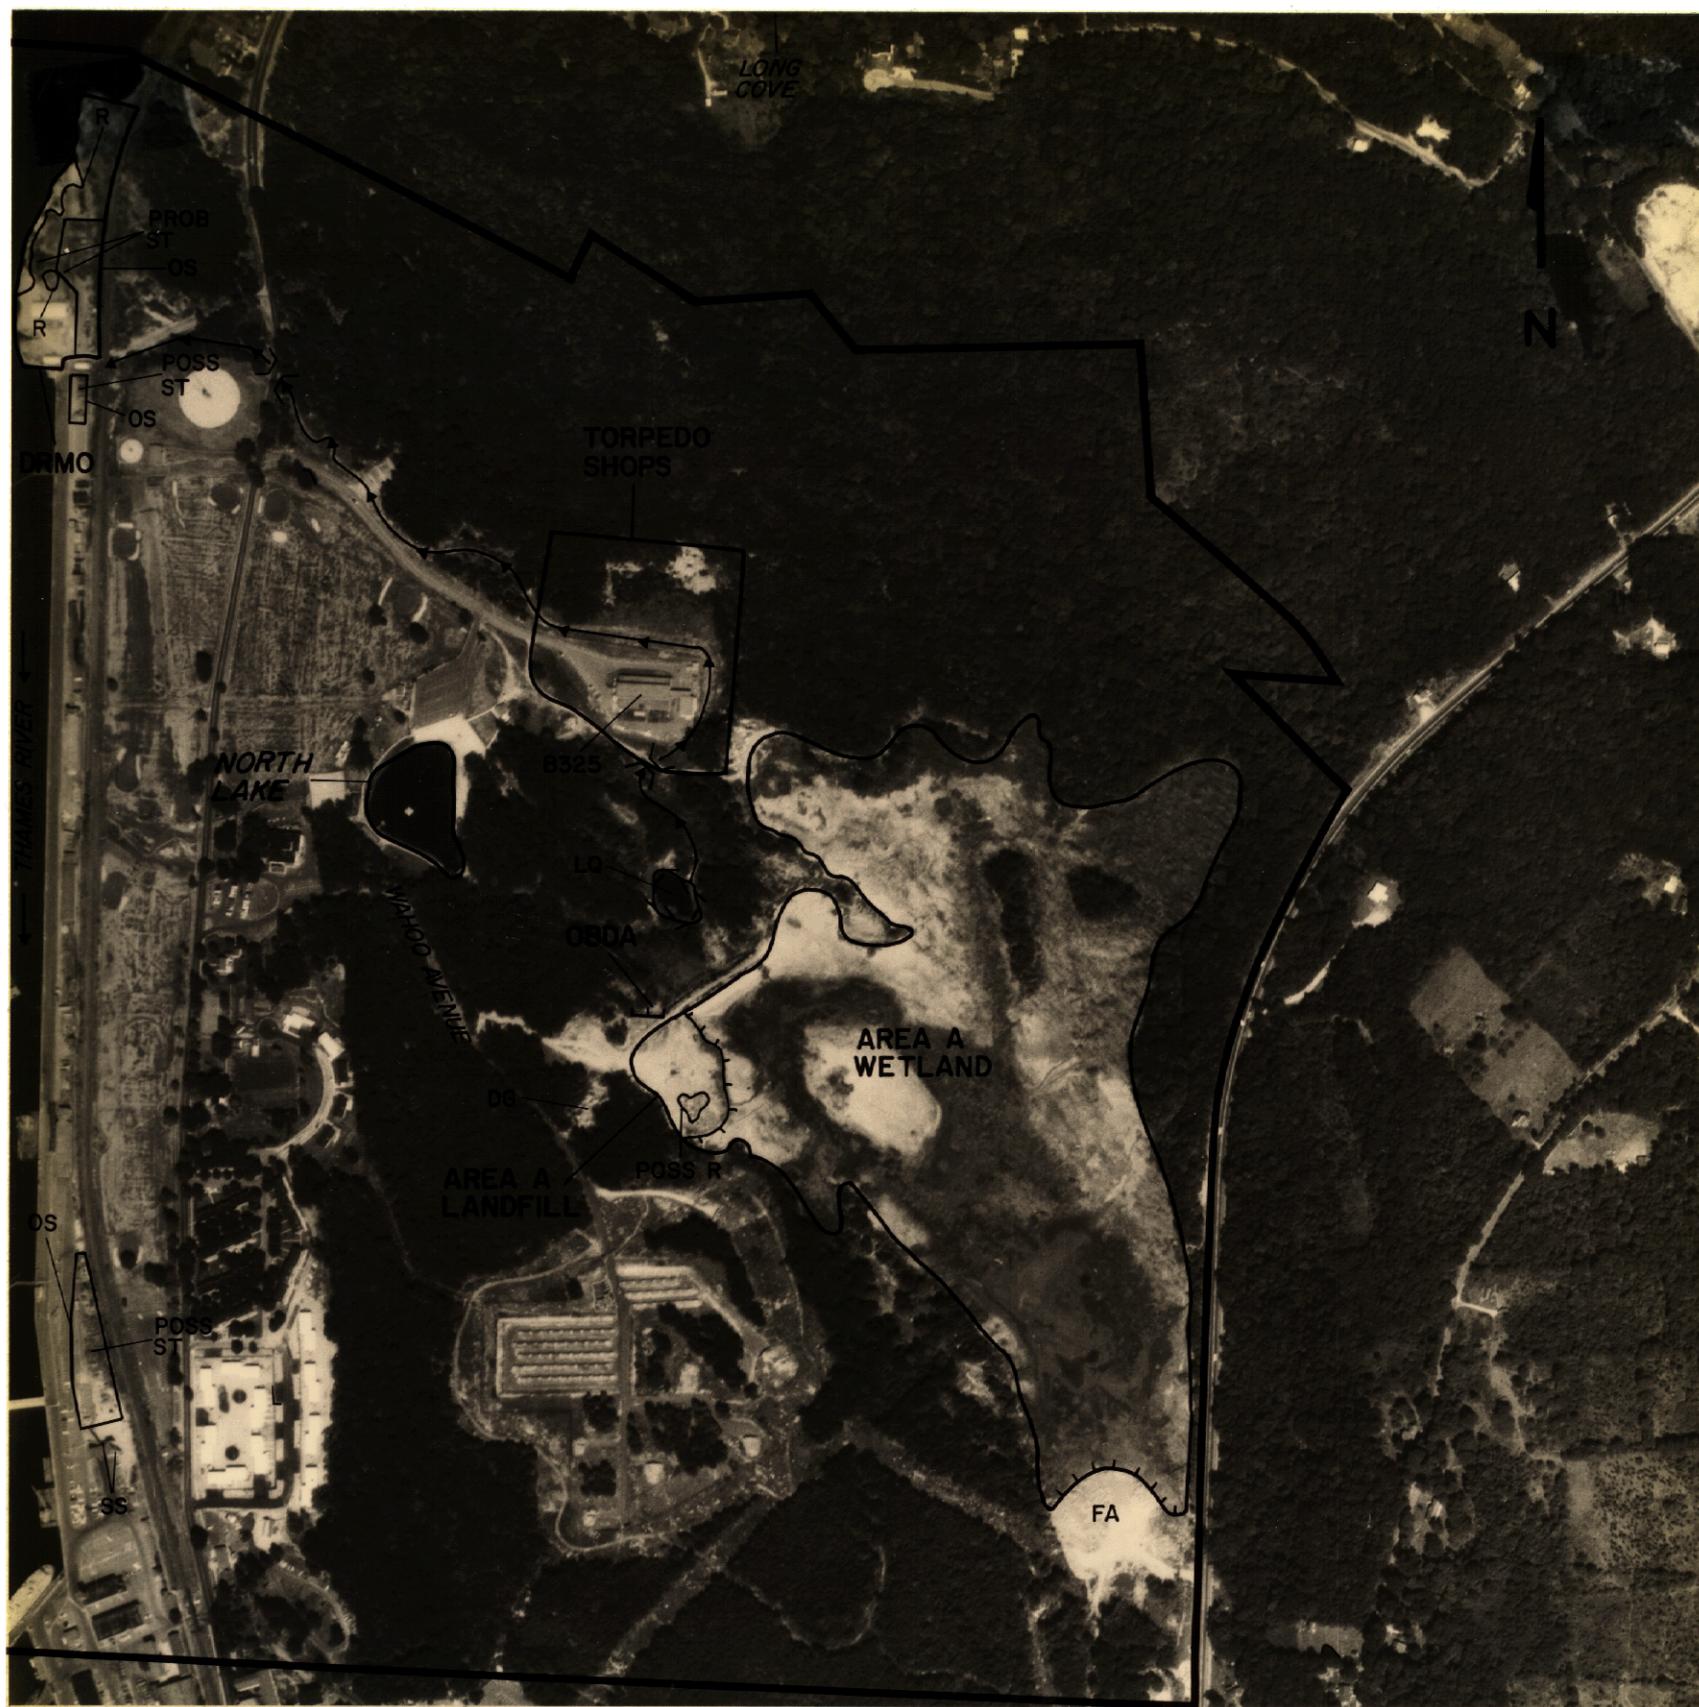
Additional filling has occurred along the Thames River within the DRMO since 1957. Piles of multi-toned refuse (R) are visible along the west edge of the DRMO, suggesting that it has been pushed out into the Thames River. Probable staining is apparent near the refuse and within the open storage (OS) area along the east side of the DRMO.

Two open storage areas are located south of the DRMO along the Thames River. Possible stains are evident in both areas. Numerous containers and/or crates are also visible in the southern open storage area.

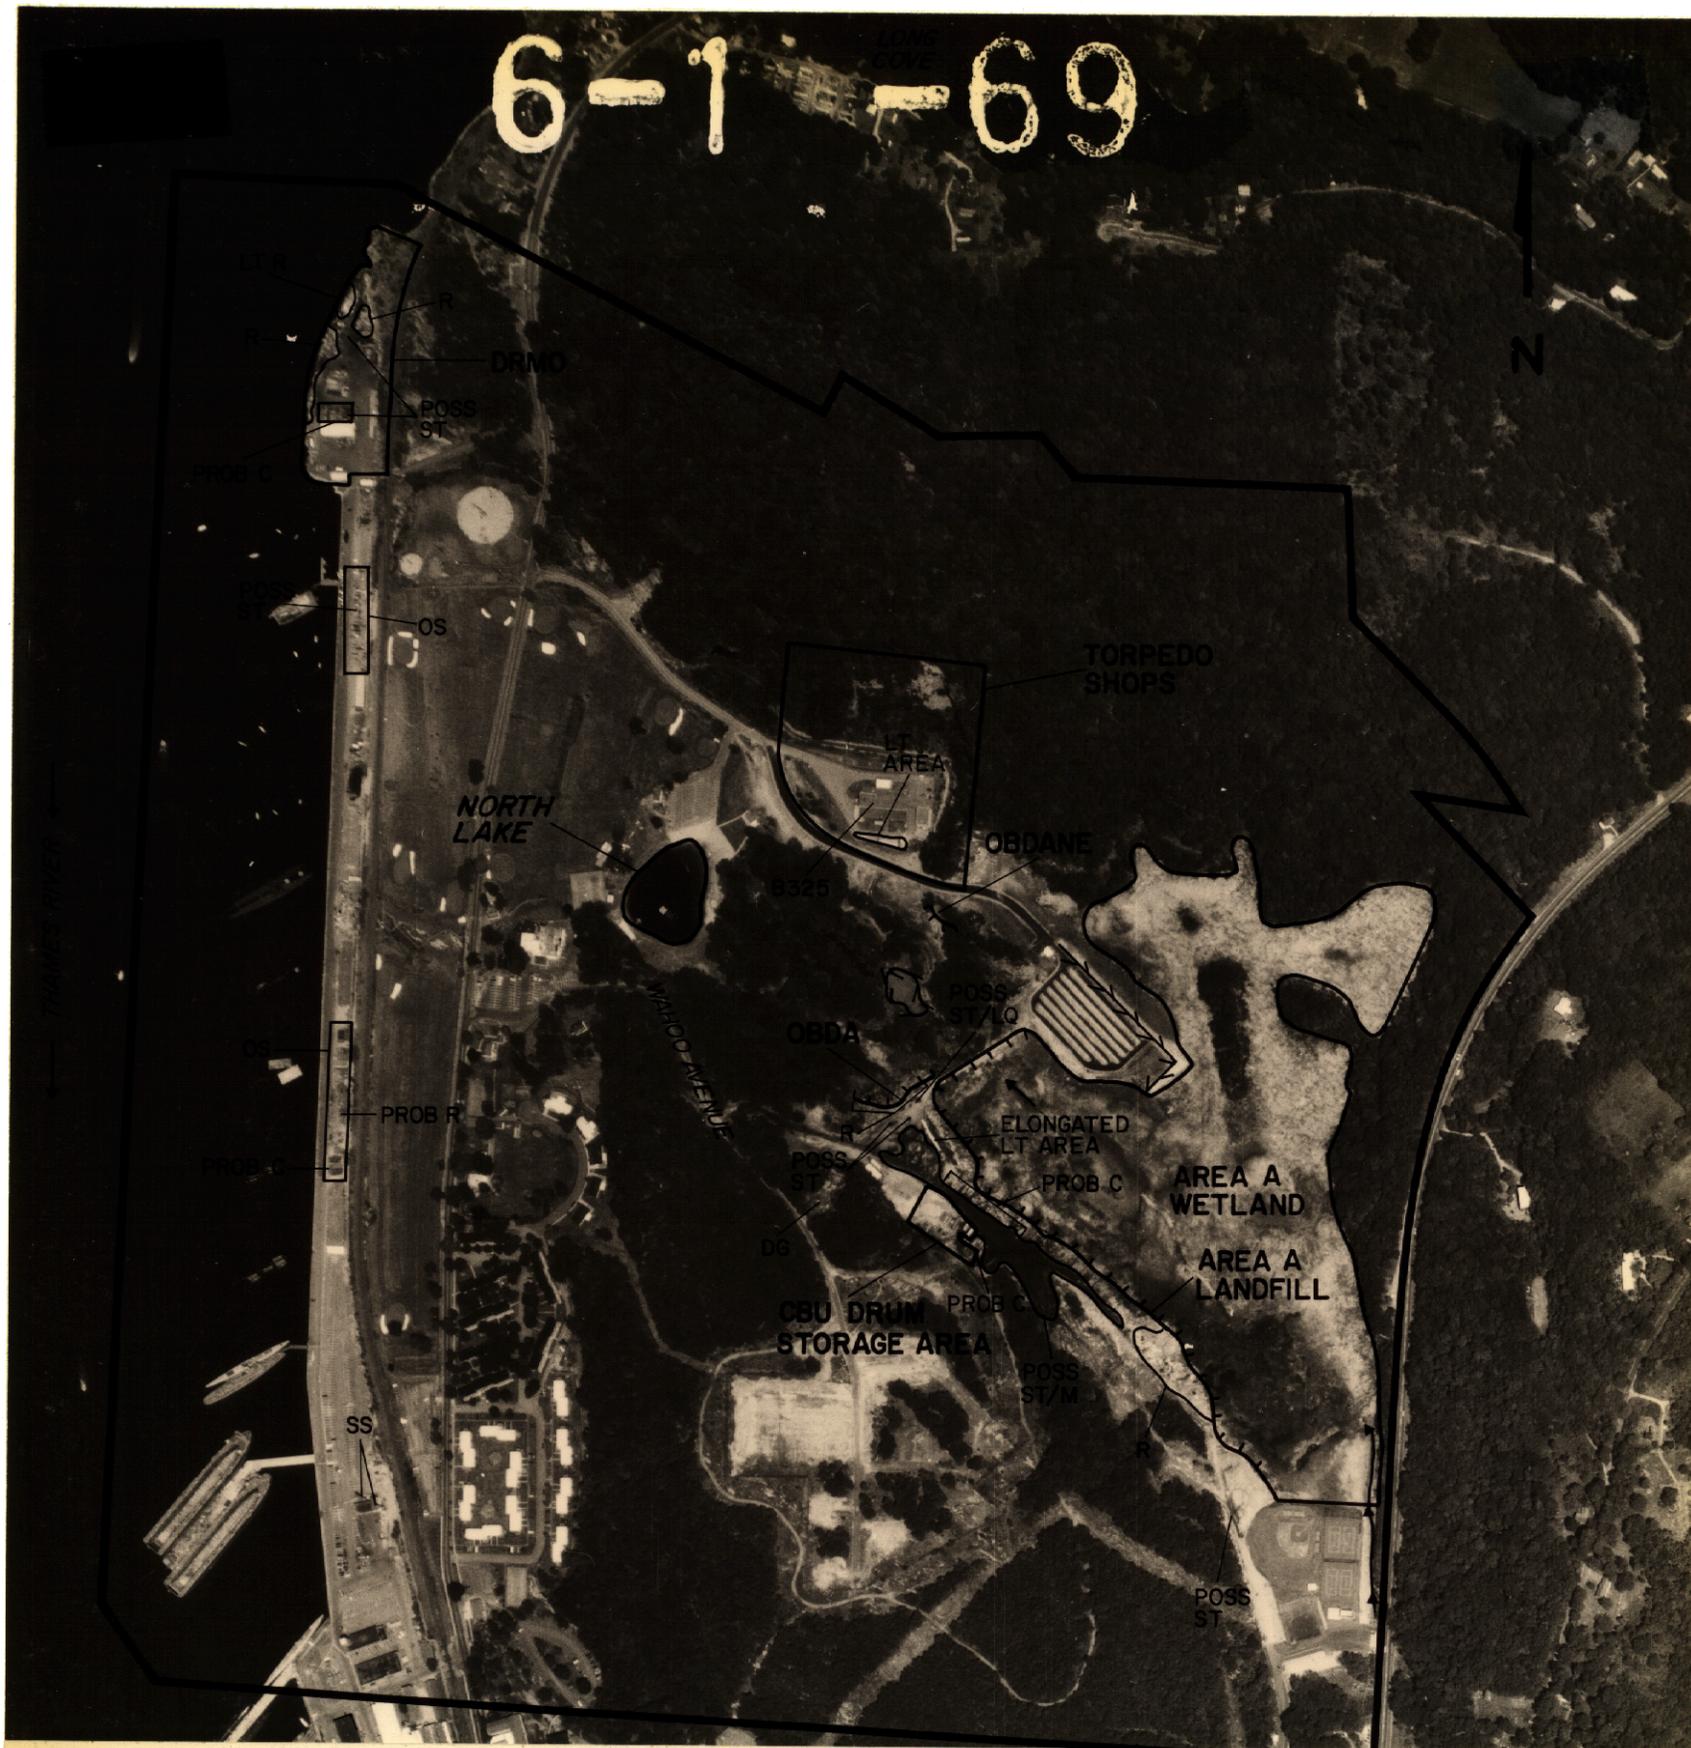
FIGURE 6
NEW LONDON SUBMARINE BASE

Piles of refuse are still visible along the Thames River within the DRMO. The northern pile of refuse is lighter-toned (LT) than the others. The eastern pile of refuse may be intermixed with stacked boxes and/or crates. A possible stain is visible between the piles of refuse. Another possible stain is seen near numerous probable containers (C), directly north of a building in the southern portion of the DRMO.

The OBDA has expanded, and an increased volume of multi-toned refuse is evident along the top of the bank and on the fill face. Two possible stains and a possible stain and/or liquid are also visible on the bank of the disposal area. A weapons storage

The Area A Landfill has expanded along the southwest edge of the Area A Wetland. An elongated light-toned area and numerous stacked probable containers are visible near the fill face in the northwestern portion of the landfill. A large possible stain and/or material is evident along the southwest edge of the Area A Landfill, between the probable containers and the CBU Drum Storage Area. This area is darker-toned than the surrounding soils, and vehicular activity is evident throughout the area. Piled coarse-textured multi-toned refuse and a possible stain are evident in the southeastern portion of the landfill. Numerous pools of liquid (not annotated) are scattered throughout the landfill. Surface water runoff from directly south and within the landfill drains north as overland flow into the Area A Wetland. Liquid (not annotated) is visible along the south edge and in the southeast corner of the Area A Wetland.

Four rows of probable containers are evident in the eastern portion of the CBU Drum Storage Area. These probable containers are similar to those found in the Area A Landfill. Possible staining (not annotated) is apparent along the northwest edge of the probable containers.

A possible stain is visible in an open storage area immediately south of the DRMO. Another open storage area farther south contains a pile of probable refuse and numerous neatly arranged probable containers.

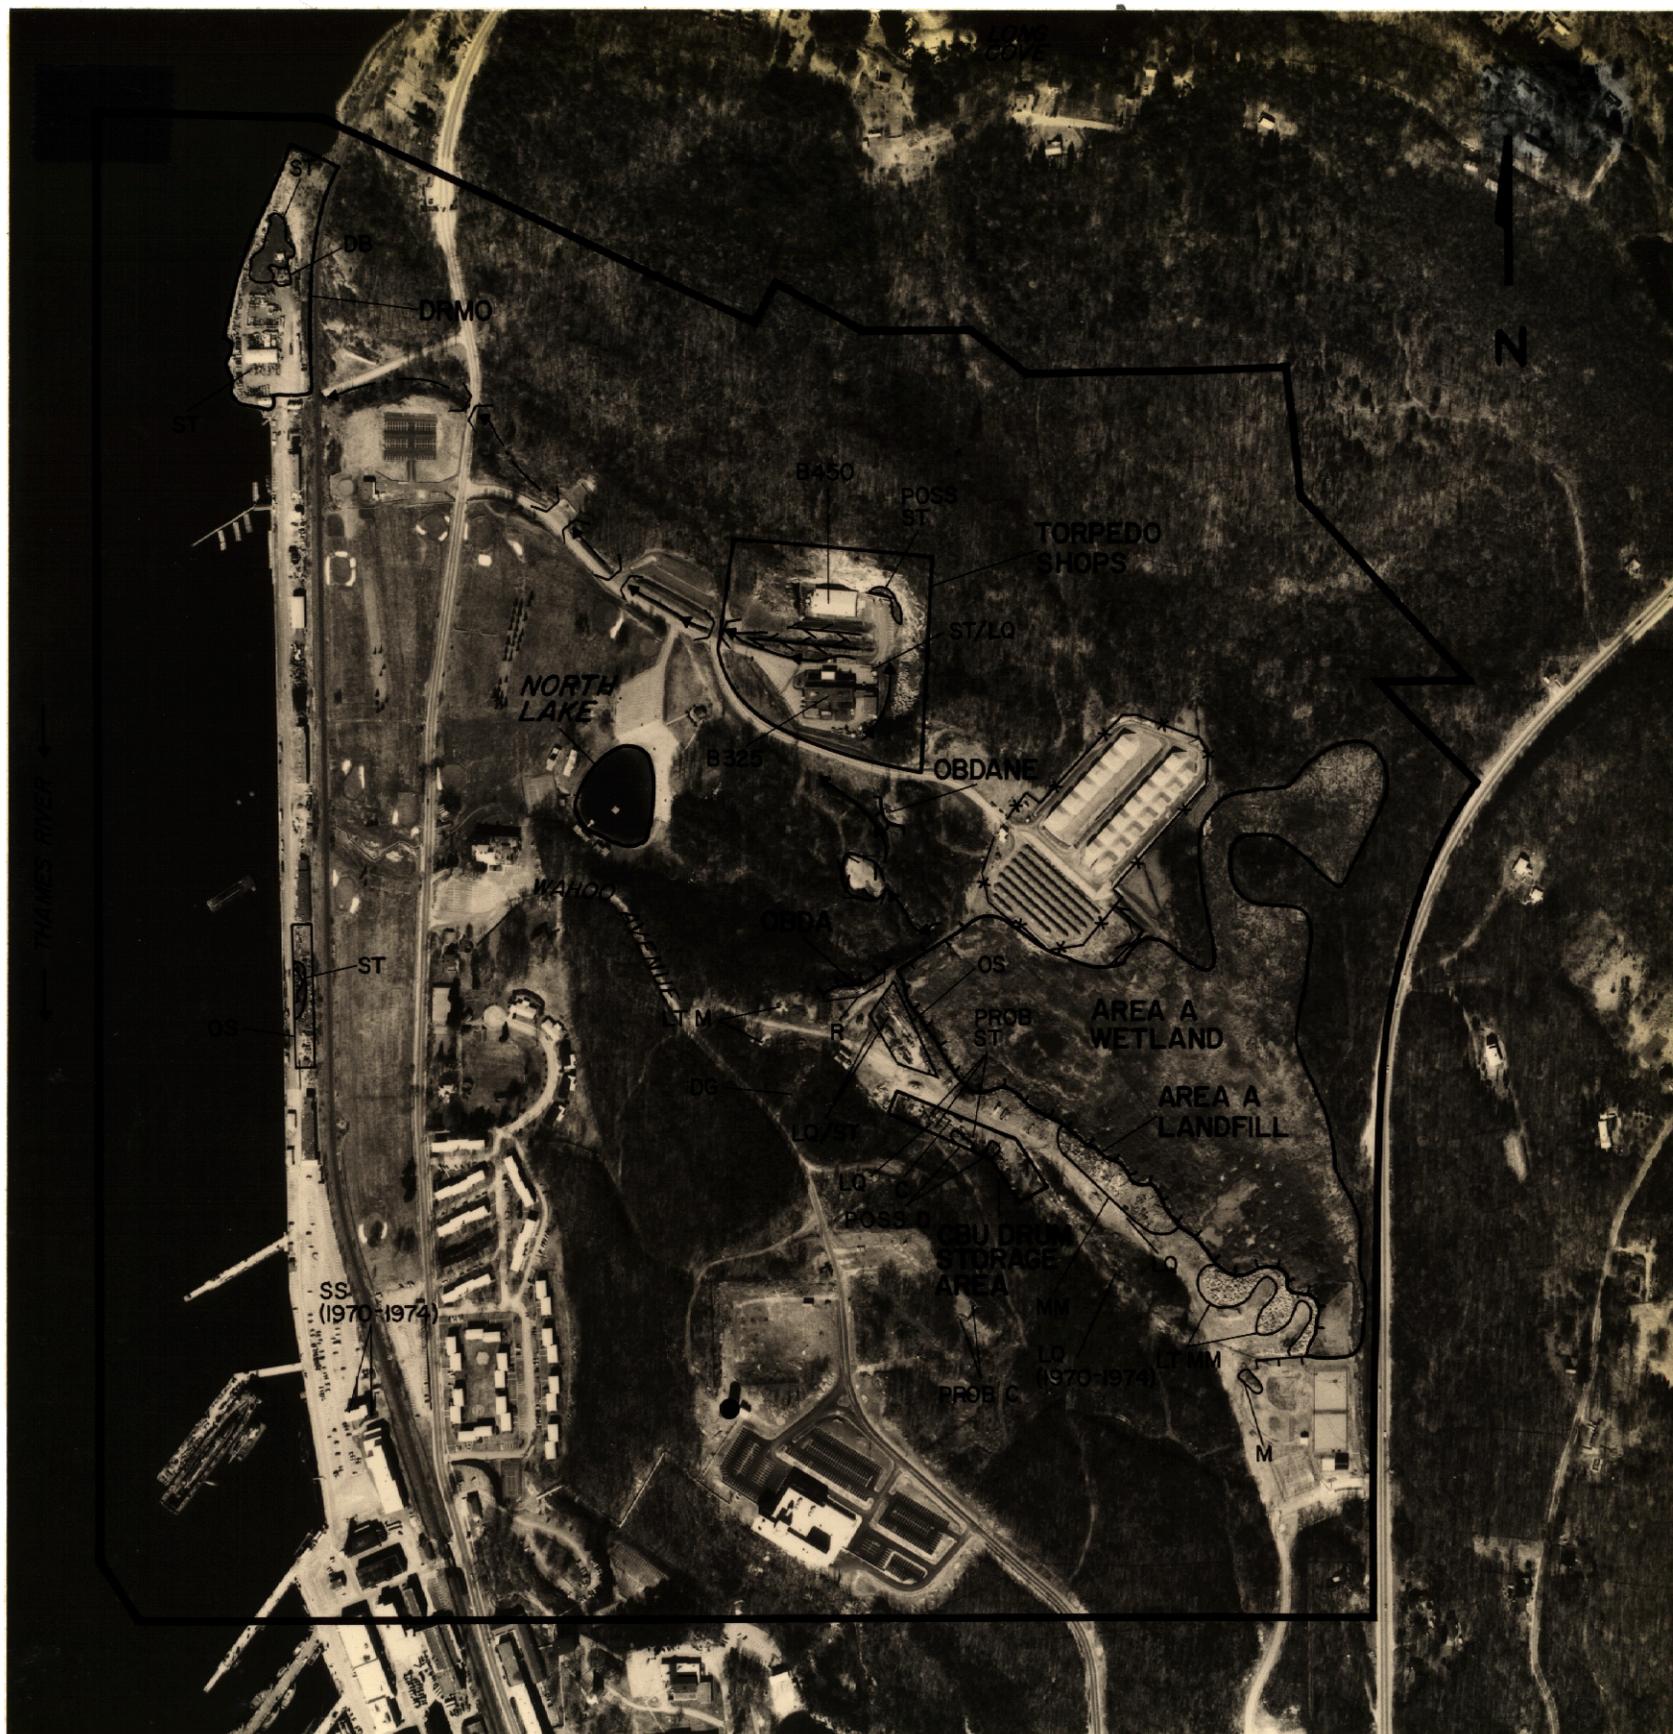
The open storage of equipment and materials is evident throughout the DRMO. A pile of debris (DB) and an adjacent large stained area are visible in the central portion of the DRMO. Probable containers and/or crates and vehicles (neither annotated) are seen along the northwest and southwest edges of the DRMO, respectively. A stain is visible near the south edge of a building in the southern portion of the DRMO.

B450 is now seen north of B325. A possible stain is noted northeast of B450. Staining and/or liquid is seen on the road near the northeast corner of B325. Open storage of materials and/or equipment is apparent southeast of B325.

Liquid and/or the stain remaining from a liquid is visible in and adjacent to the open storage area southeast of the OBDA. This liquid and/or resulting stain originates near two light-toned quonset structures (not annotated) directly south of the OBDA. The liquid and/or stain extends to the Area A Wetland.

This drum storage area has expanded since 1969. Two stacks of numerous possible drums (D) are evident in the south central portion of the storage area. Probable staining is visible north of one stack of possible drums. Additional probable stains and a pool of liquid are visible west of numerous containers.

Additional refuse and/or material has been deposited at the OBDANE. The deposited refuse and/or material appears to have been mixed with earthen material. No additional activity is noted at the OBDANE in future years, and it will not be annotated or discussed further.

Staining is apparent in an open storage area near the Thames River, south of the DRMO. Probable refuse and numerous containers were seen in this open storage area in 1969.

Two piles of light-toned material and two areas of neatly arranged probable containers are visible northwest and south of the CBU Drum Storage Area, respectively. The probable containers are located near a storage bunker (not annotated). A new building has been constructed in the southern portion of the study area, where a portion of the probable weapons storage area was dismantled.

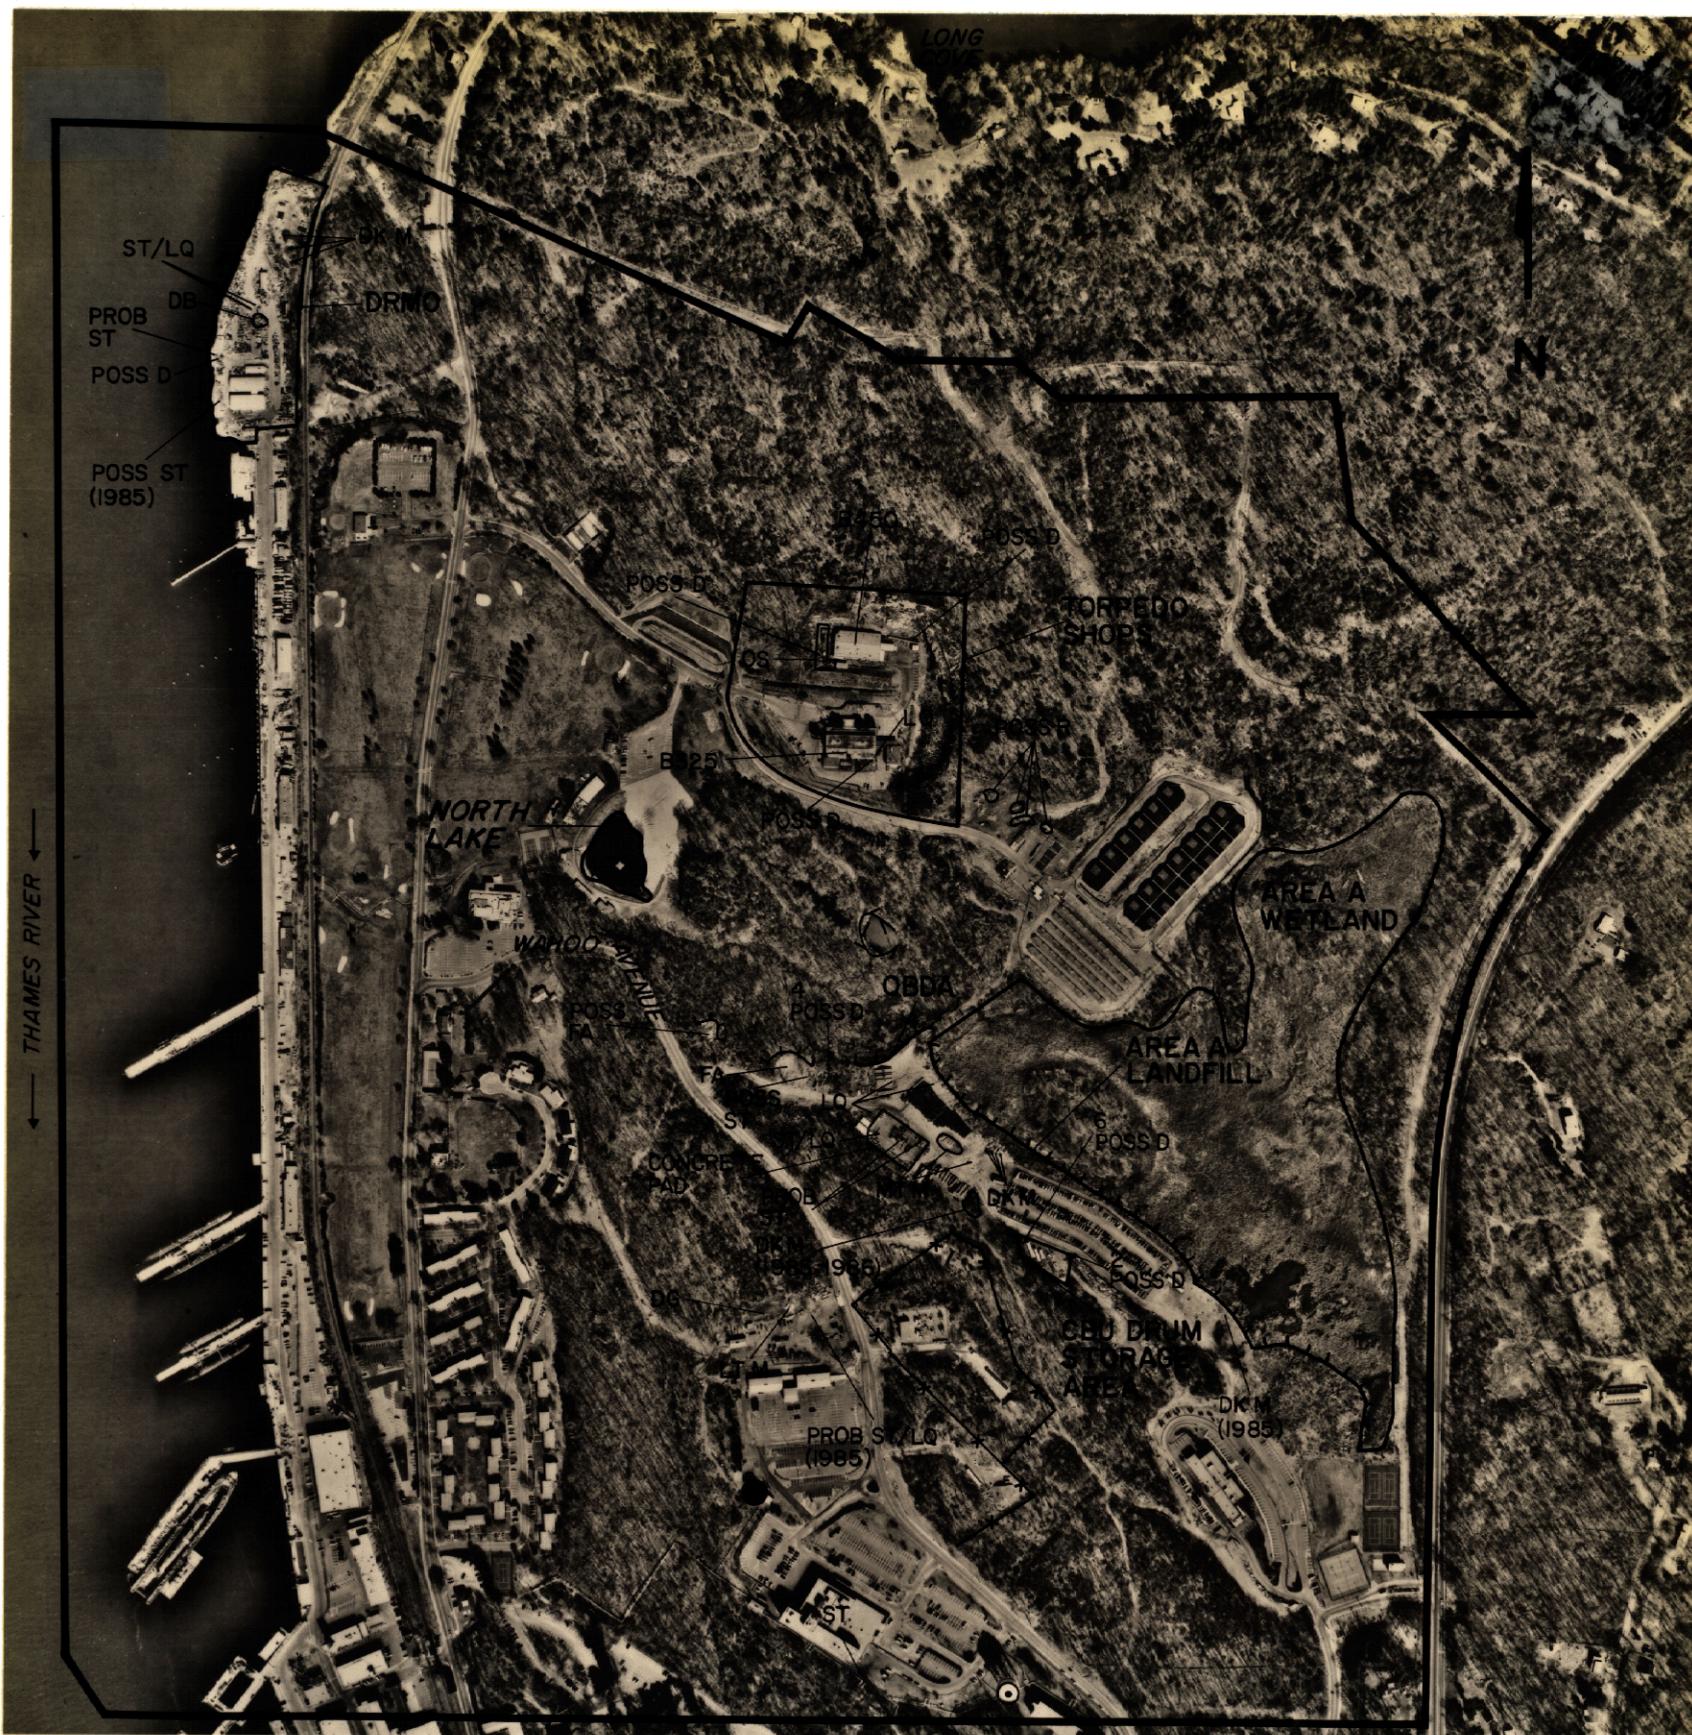
In 1985, numerous piles of dark-toned material and increased activity were noted in the northern portion of the DRMO. Possible staining was apparent west of the building in the southern portion, and open storage was mainly found along the Thames River in the western portion.

In 1986, increased quantities of material in open storage areas are evident throughout the DRMO. Three piles of dark-toned (DK) material, as well as two areas containing dark-toned objects (not annotated) which are uniform in size and shape, are found in the northern portion. Direct access to the nearby railroad tracks is apparent, indicating that material is probably loaded or unloaded in this area. In the central portion of the DRMO, two stains and/or pools of liquid are directly north of a pile of multi-toned debris. Staining was first noted in this location in 1985. A retaining wall is visible on the west side of containers and/or crates (not annotated) in an open storage area west of the pile of debris. Farther south, probable staining is evident near numerous possible drums seen along the Thames River.

Possible drums are noted in an open storage area west of B450 and also directly east of B450. Most of the possible drums are seen east of B450, just north of a small building (not annotated). Elsewhere, possible drums and a pool of liquid are visible on the southeast side of B325.

Although no active disposal appears to be occurring at the OBDA, scattered refuse (not annotated) is evident in the northeastern portion of the fill face. No additional activity is noted at the OBDA throughout the remainder of this analysis, and it will not be annotated or discussed further.

Although no additional landfilling is evident after 1974, activity is visible on the landfill through 1991. The deployed personnel parking lot (not annotated), located in the central
