TS-PIC-91129
March 1992

EPA **Site Analysis**
New London Submarine Base
Groton, Connecticut

Site Analysis
New London Submarine Base
Groton, Connecticut

by
Dean Anderson, Imagery Analyst
The Bionetics Corporation
Warrenton, Virginia 22186

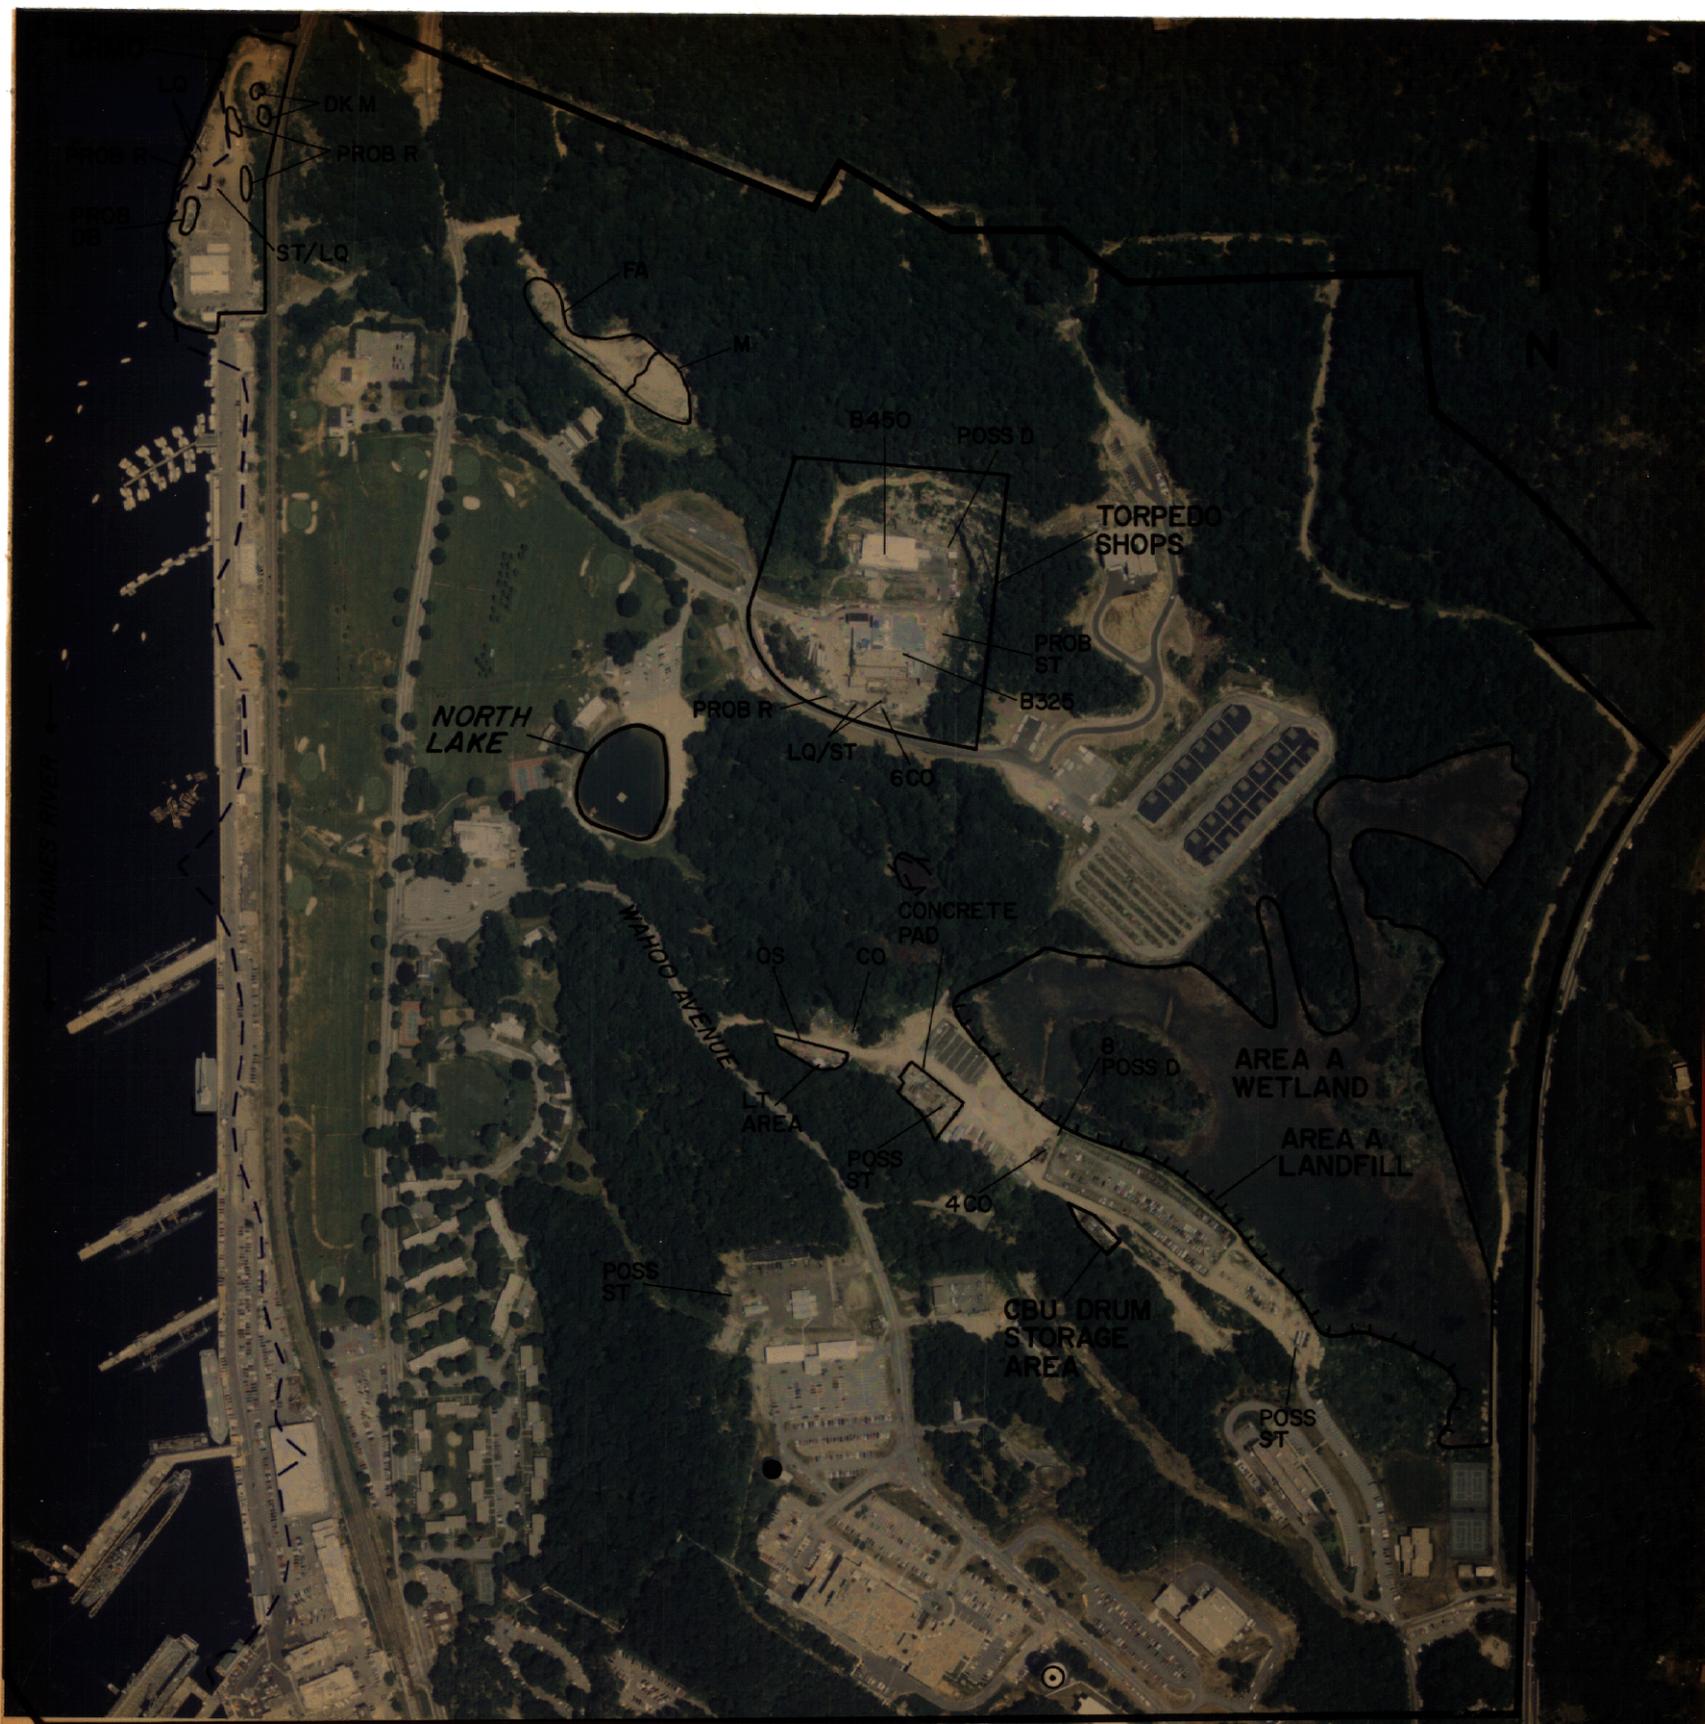
Dark-toned material or the residue remaining from the piles of dark-toned material seen in 1986 is evident in the northern portion of the DRMO. Three piles of probable refuse, stacked probable debris, and three stains and/or pools of liquid are visible in the central portion of the DRMO. The soil surrounding the southwestern pile of probable refuse is stained.

Numerous vehicles, equipment and materials, probably related to construction and/or maintenance activities, are seen in the parking areas surrounding B325. Liquid and/or the remaining stain from a liquid emanates from the south side of B325. A pile of probable refuse and six cylindrical objects (CO) are also found south of B325. A probable stain is visible near construction and/or maintenance activity east of B325. The possible drums remain east of B450.

A possible stain is visible amongst material and equipment on the concrete pad in the northwestern portion of the Area A Landfill. Eight possible drums and four cylindrical objects are noted west of the deployed personnel parking lot (not annotated) in the central portion of the landfill. A possible stain is evident near three possible tractor trailers (not annotated) in the southeastern portion of the landfill. No additional filling is noted within the landfill area, and the general appearance of the area is neat and orderly.

The fill area and possible fill area (neither annotated) seen northwest of the Area A Landfill in 1986 have begun to revegetate. A cylindrical object is evident in the east corner of the revegetating fill area. A light-toned area is apparent in an open storage area southwest of the cylindrical object.

A possible stain is visible in an area west of Wahoo Avenue where disturbed ground, light-toned material, and probable staining were noted in 1985 and 1986.

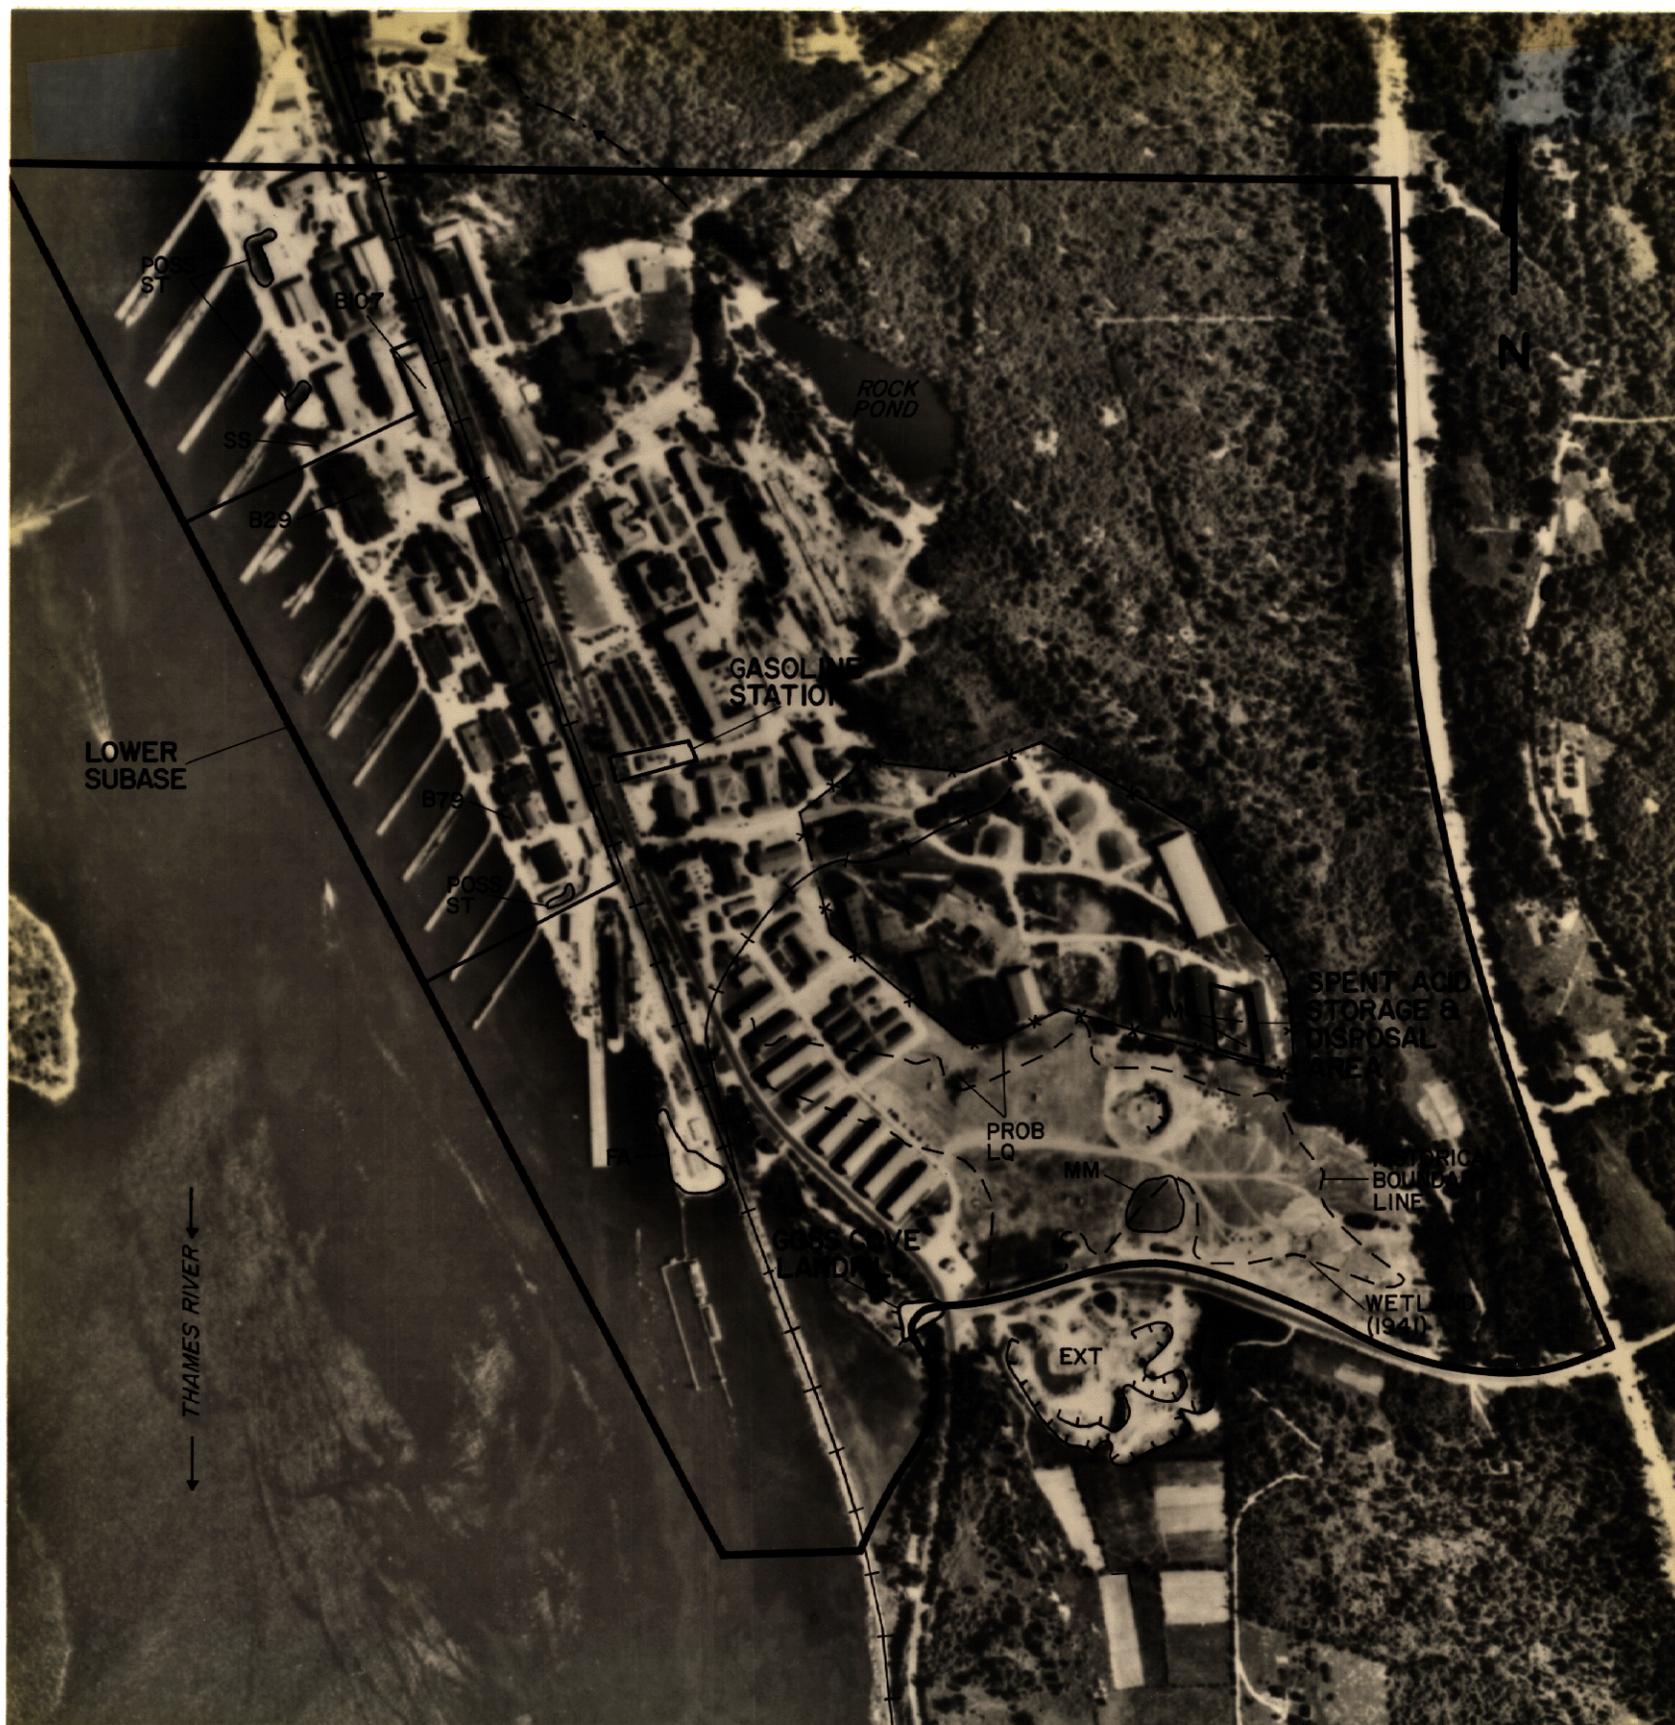
A possible stain is currently seen near a small building (not annotated) near the southern boundary of the Lower Subase.

An area along the Thames River, south of the Lower Subase, has been filled since 1941. Structures are seen on and adjacent to the fill area.

The historical boundary of a wetlands area, visible in 1941, is annotated on Figure 10. In 1941, approximately three-quarters of the area within this boundary was open water. By 1943, the

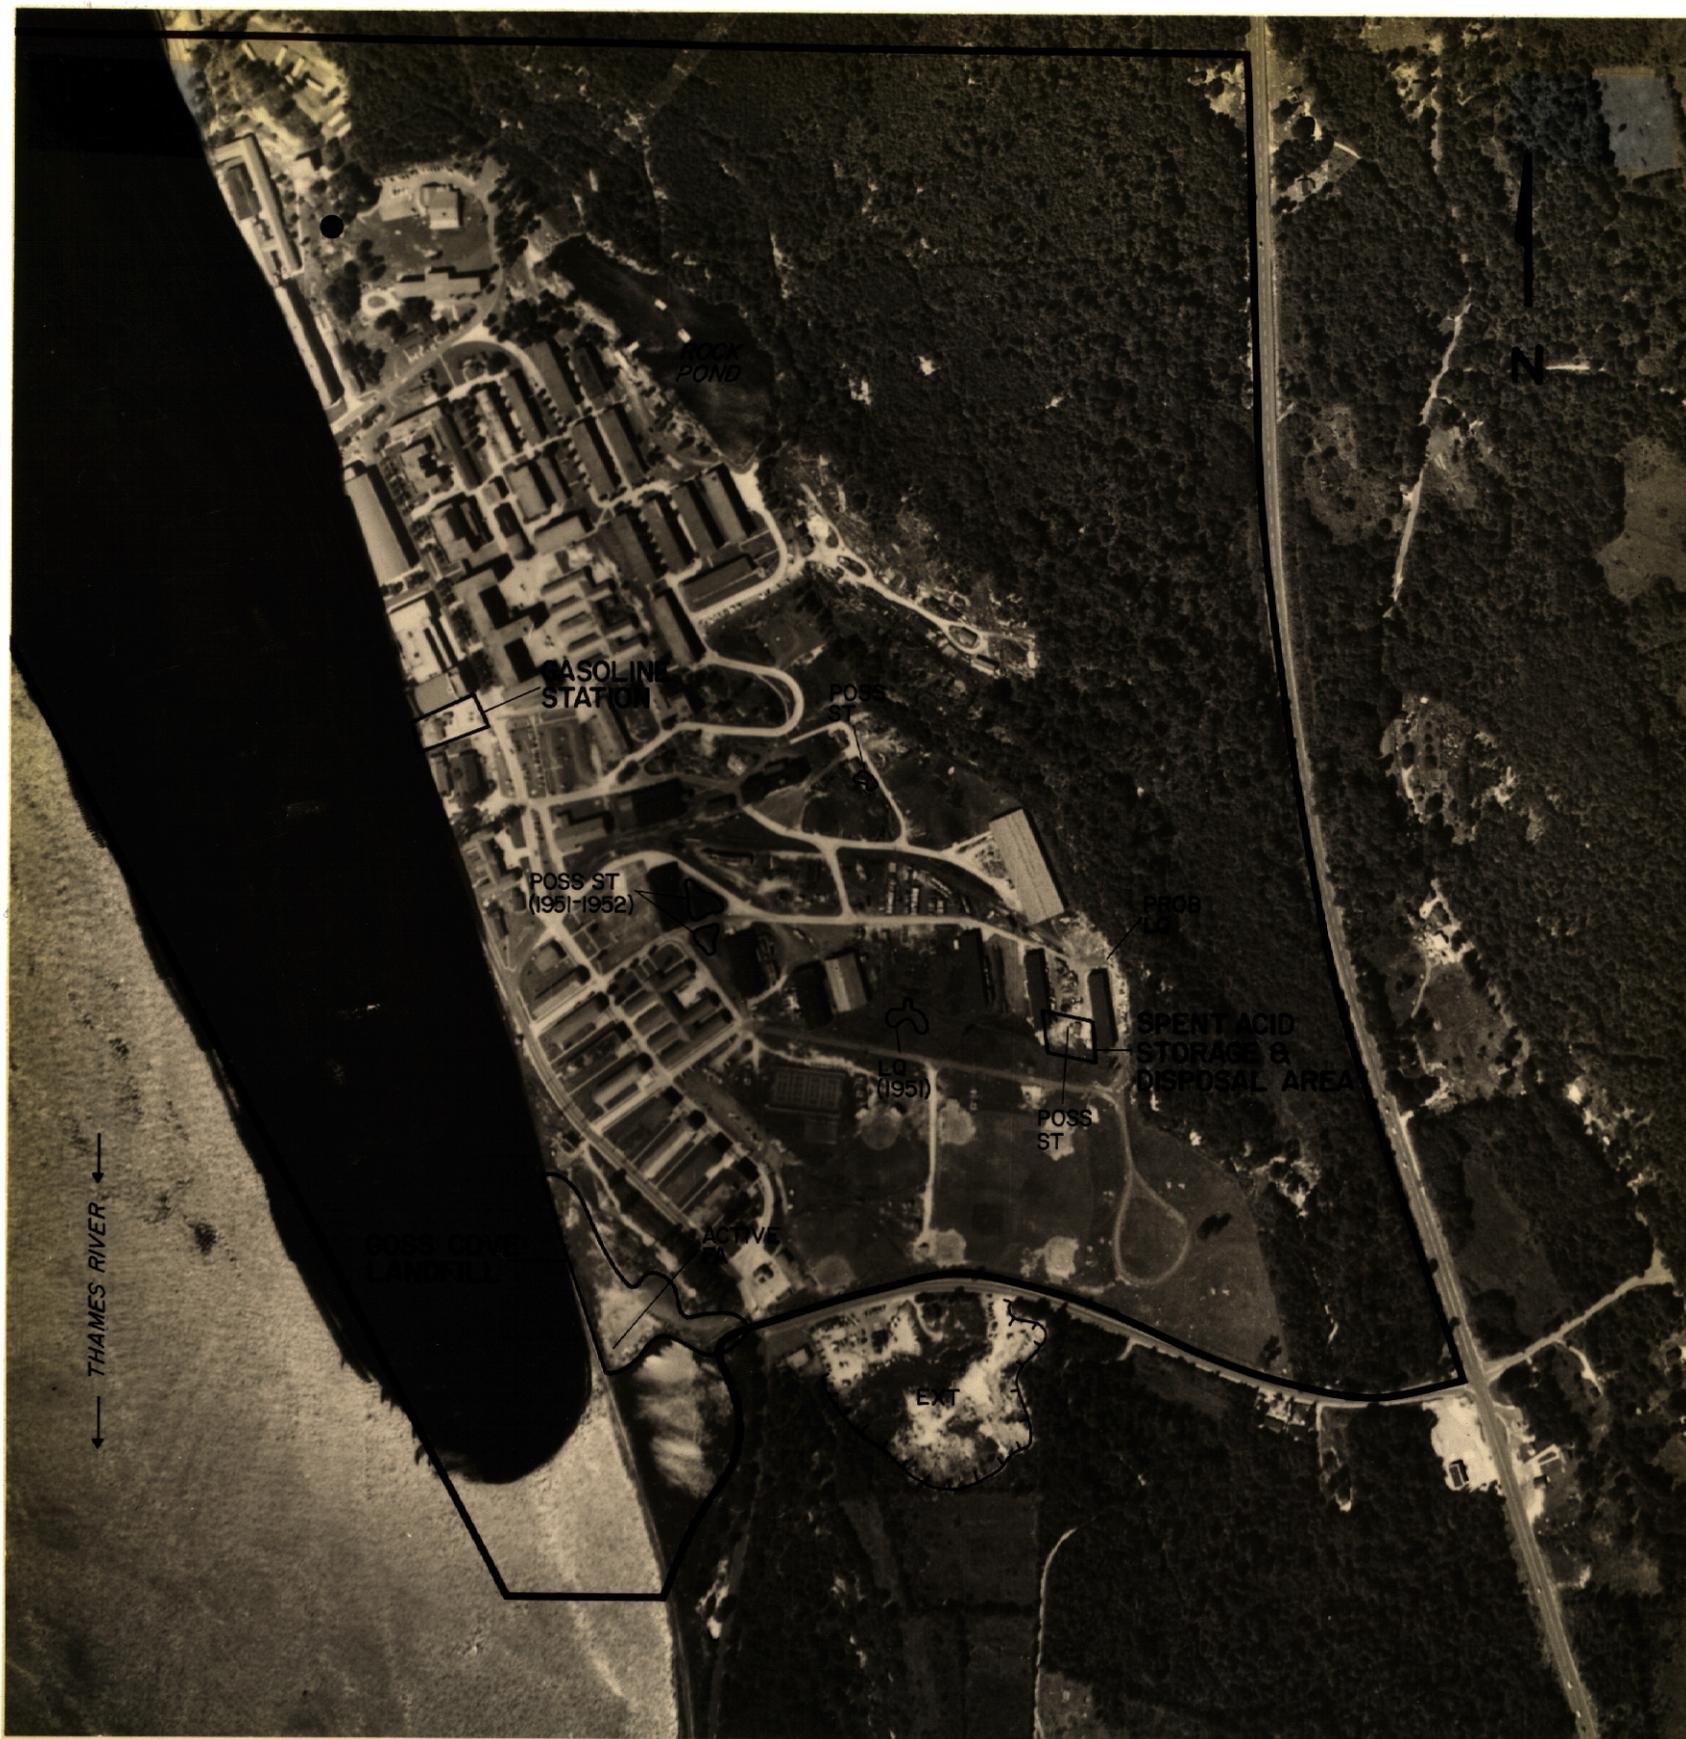
Three possible stains, two of which were evident in 1951, are visible in the central portion of the study area. Additionally, an elongated pool of probable liquid is seen north of the Spent Acid Storage and Disposal Area. A pool of liquid was also apparent west of the Spent Acid Storage and Disposal Area in 1951.

An area directly southeast of Rock Pond, first apparent in 1951, has been cleared (not annotated) and appears to be a construction materials storage area. Two small structures (neither annotated) are noted in the east and west ends of the aforementioned area.

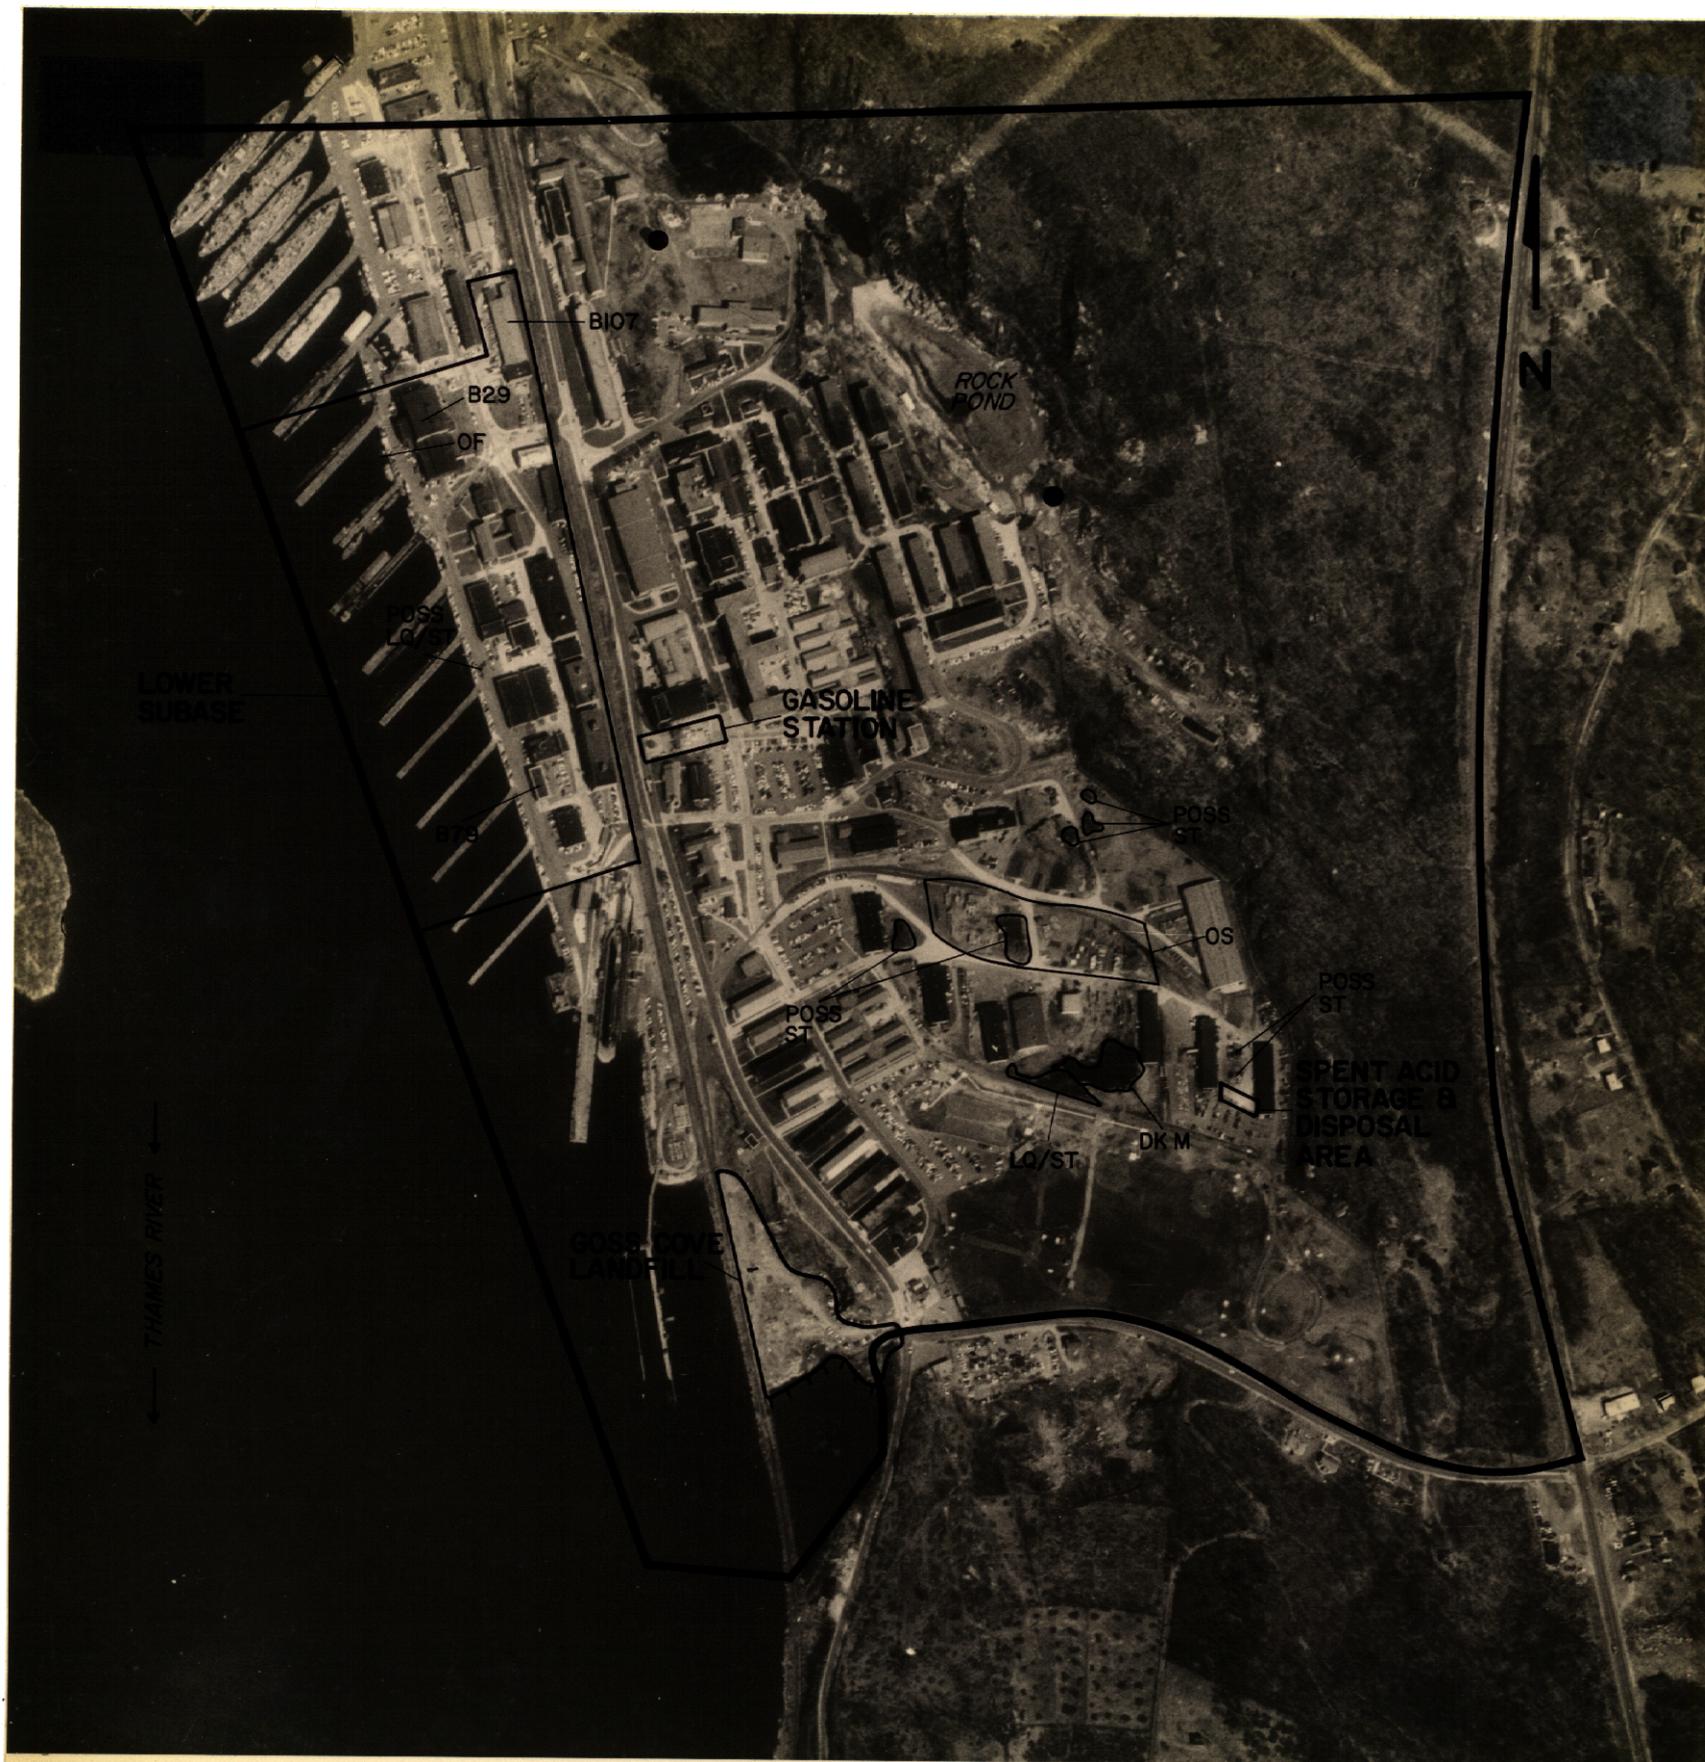
A large pile of dark-toned material and a pool of liquid and/or the stain remaining from a liquid are visible west of the Spent Acid Storage and Disposal Area. Two possible stains are evident northwest of the dark-toned material. One of these possible stains is located in an open storage area, while the other is noted where possible stains were seen in 1951 and 1952. Three possible stains are apparent near earthen bunkers (not annotated) north of the open storage area, and two possible stains are seen north of the Spent Acid Storage and Disposal Area.

Rock Pond appears to be almost dry.

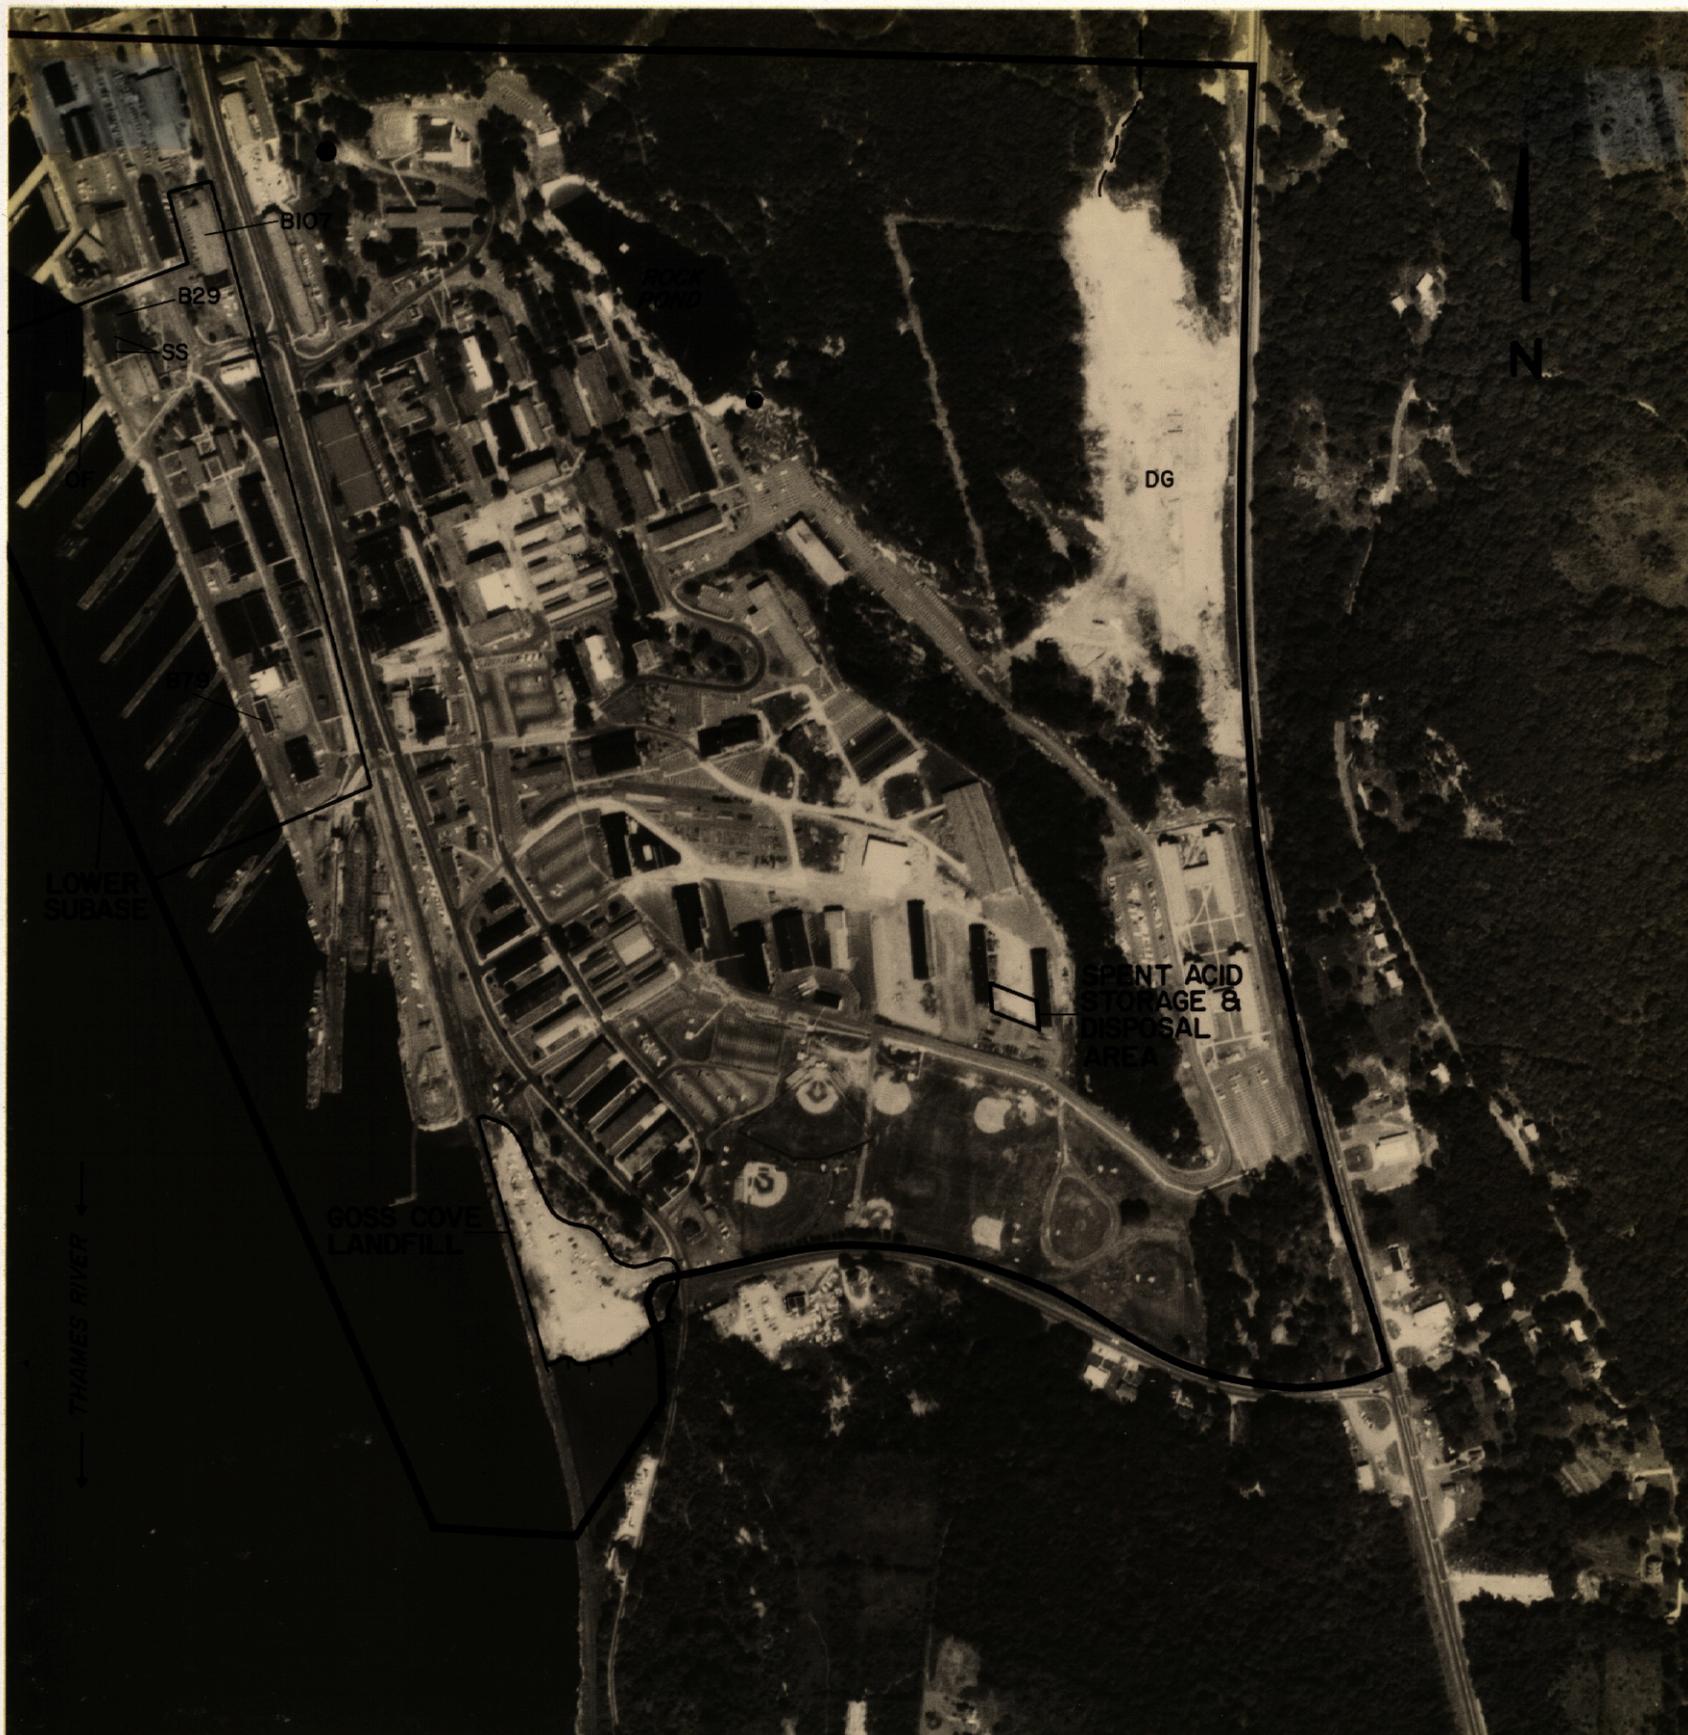
The construction materials storage area (not annotated) southeast of Rock Pond has been paved for parking. The small pond visible in previous years northwest of Rock Pond has been filled and also paved for parking.

The disturbed ground in the northeastern portion of the study area is where building construction site preparations are underway. A road extends from this location to the fill area shown in Study Area A on Figure 5.

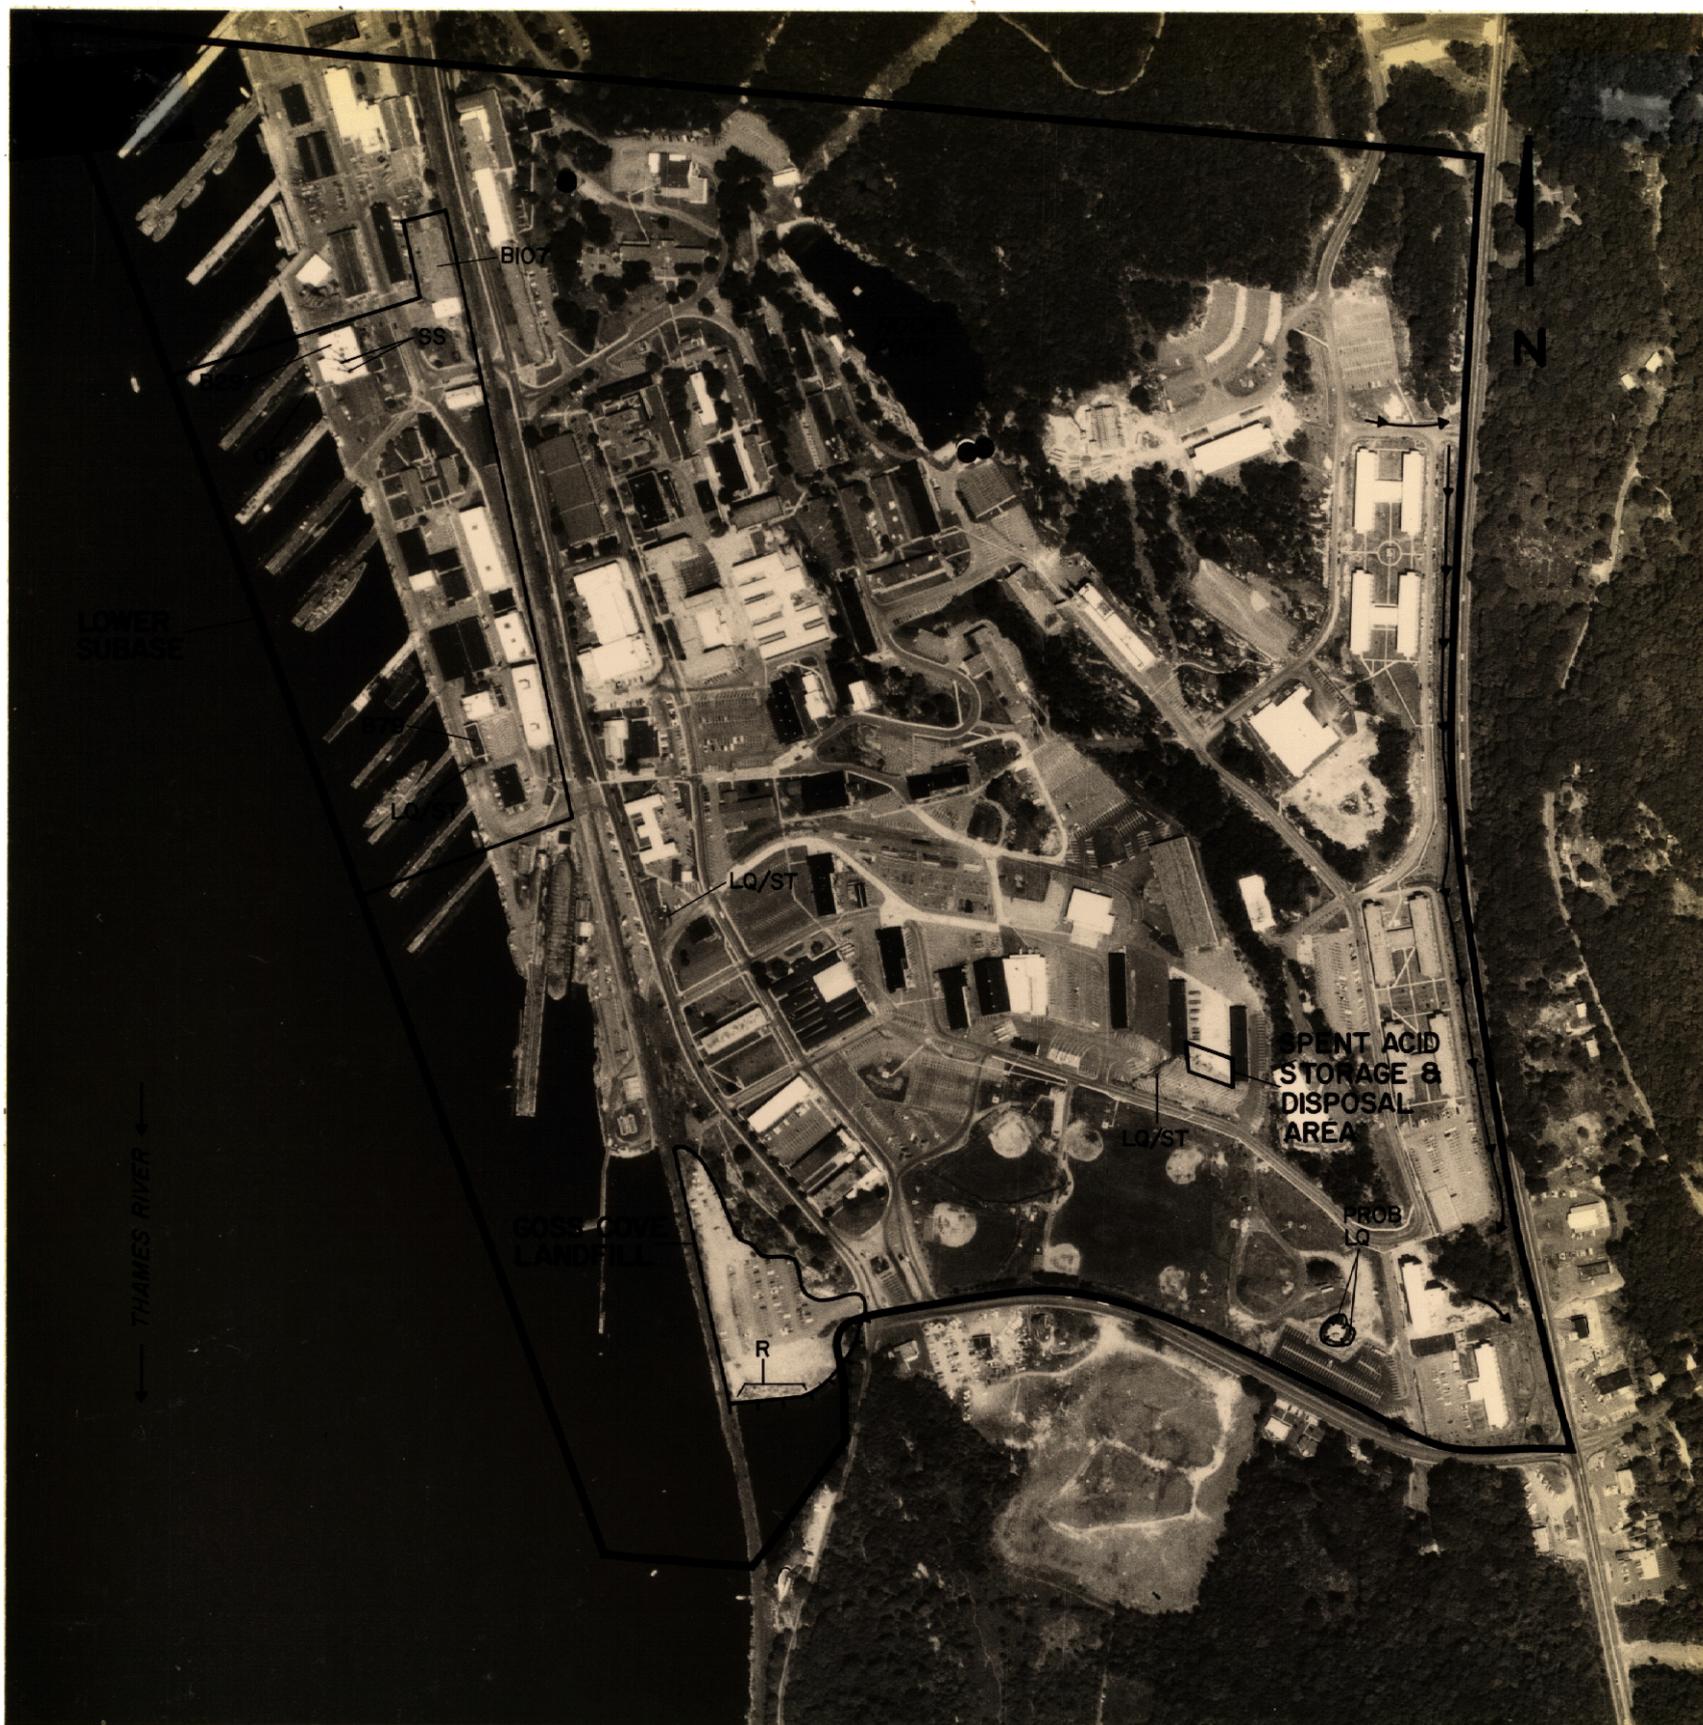
Another liquid flow and/or the stain remaining from a liquid is apparent southeast of the Lower Subase. Liquid and/or staining originates near the southeast corner of a building (not annotated).

Three new buildings (not annotated) have been constructed in the northeastern portion of the study area where the site preparations were noted in 1963.

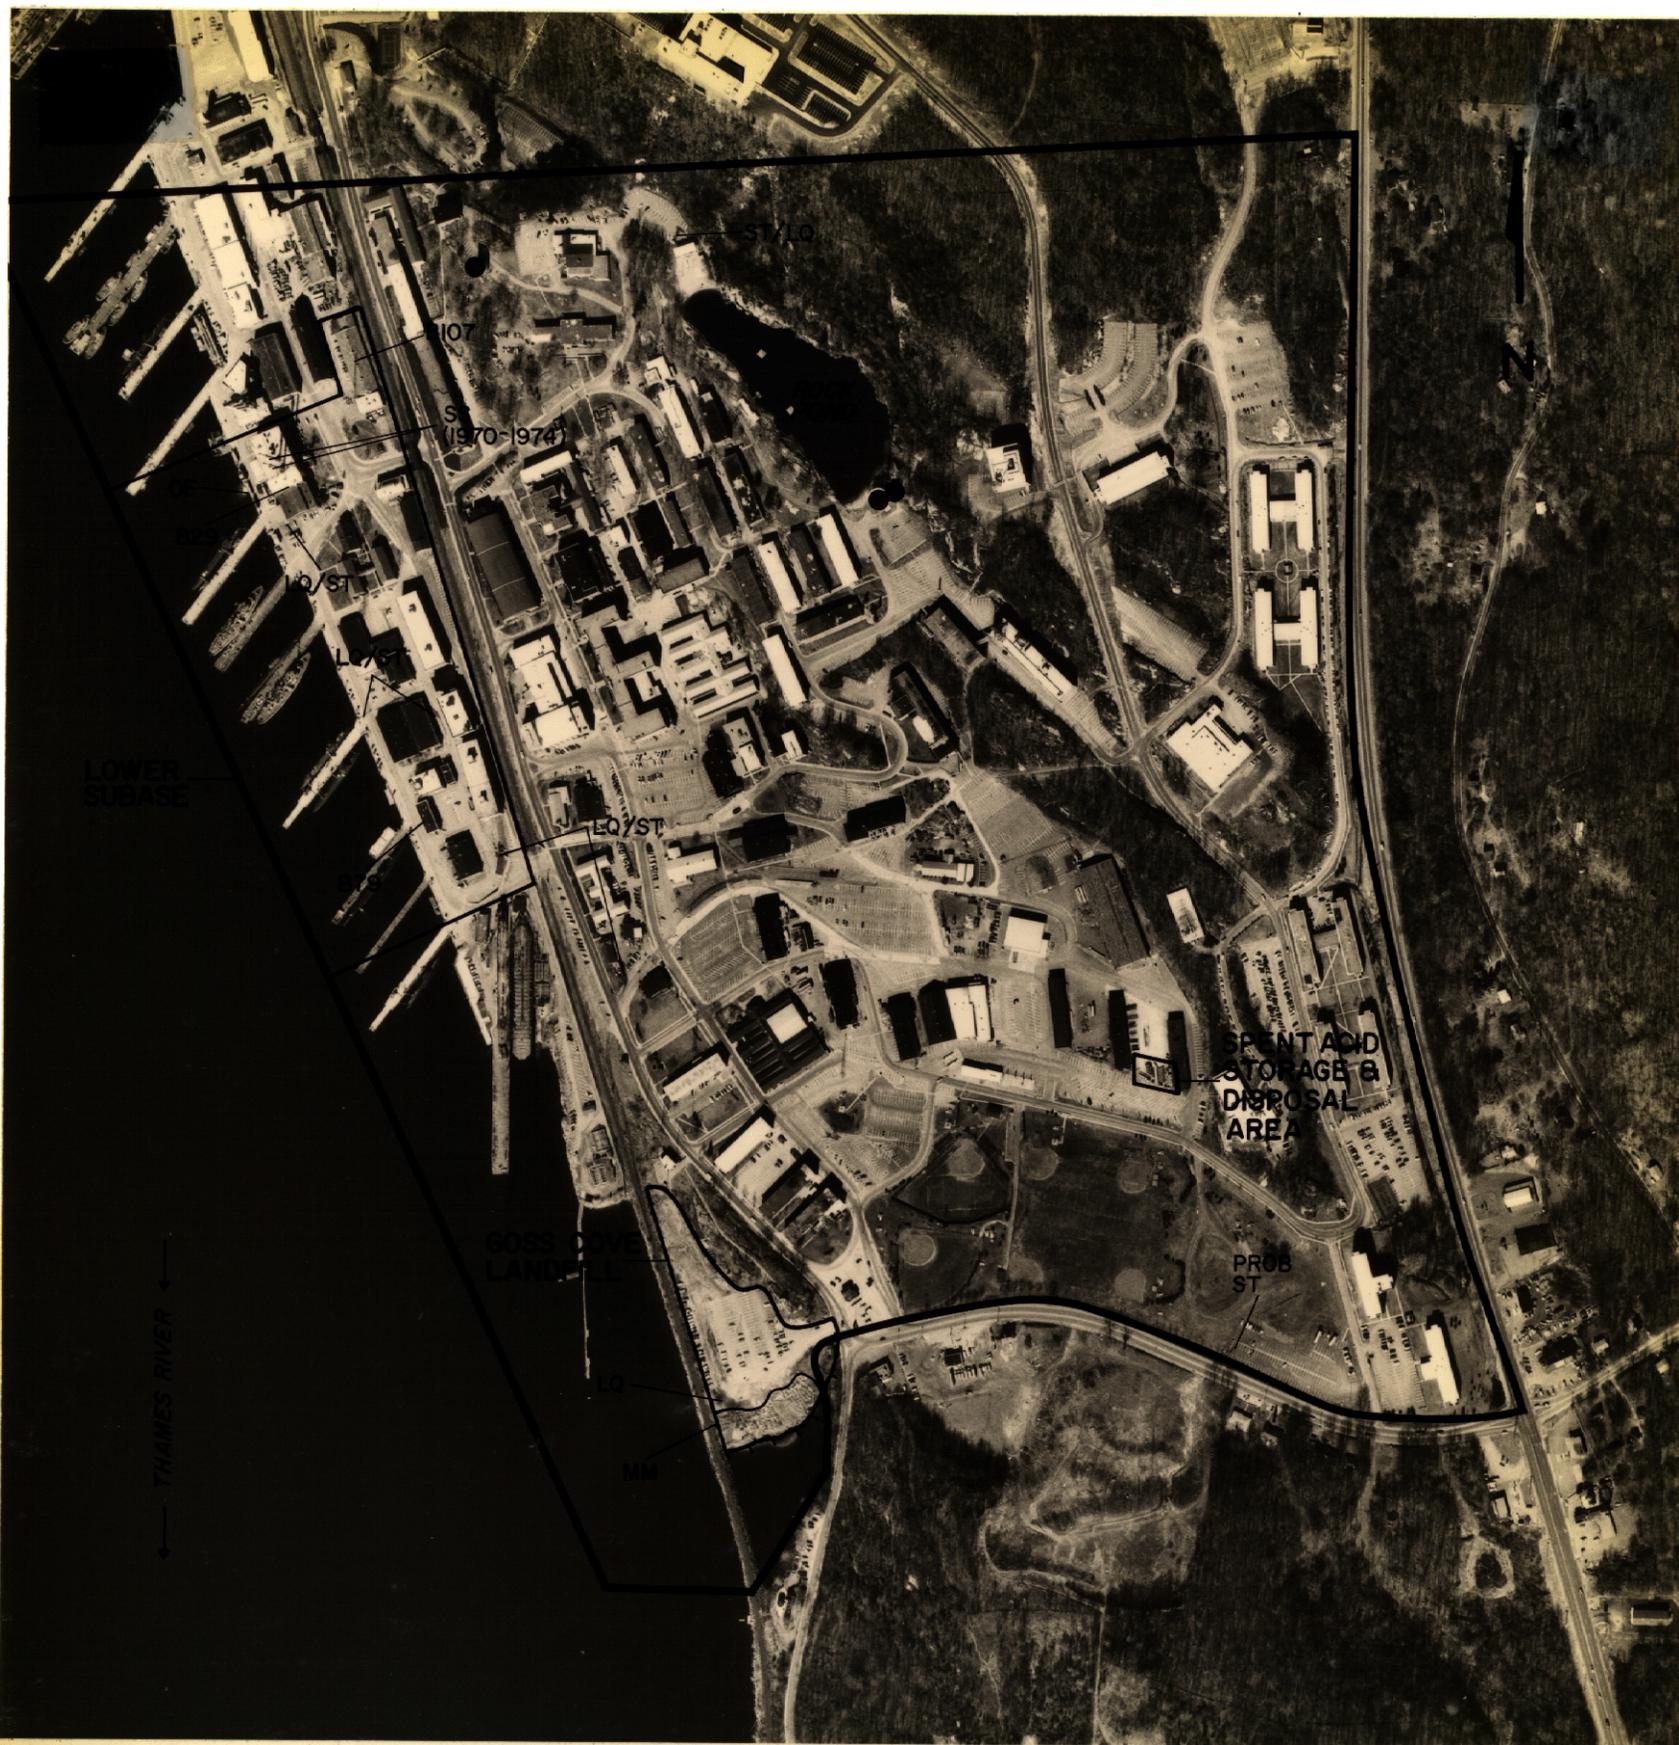
The liquid flow and/or stain remaining from a liquid is still apparent southeast of the Lower Subase. Another liquid flow and/or stain is visible on the paved parking area northwest of Rock Pond. Elsewhere, a probable stain is evident near a row of probable containers (not annotated) on a parking lot (not annotated) in the southeastern portion of the study area.
