TS-PIC-91129
March 1992

EPA **Site Analysis**
New London Submarine Base
Groton, Connecticut

Site Analysis
New London Submarine Base
Groton, Connecticut

by
Dean Anderson, Imagery Analyst
The Bionetics Corporation
Warrenton, Virginia 22186

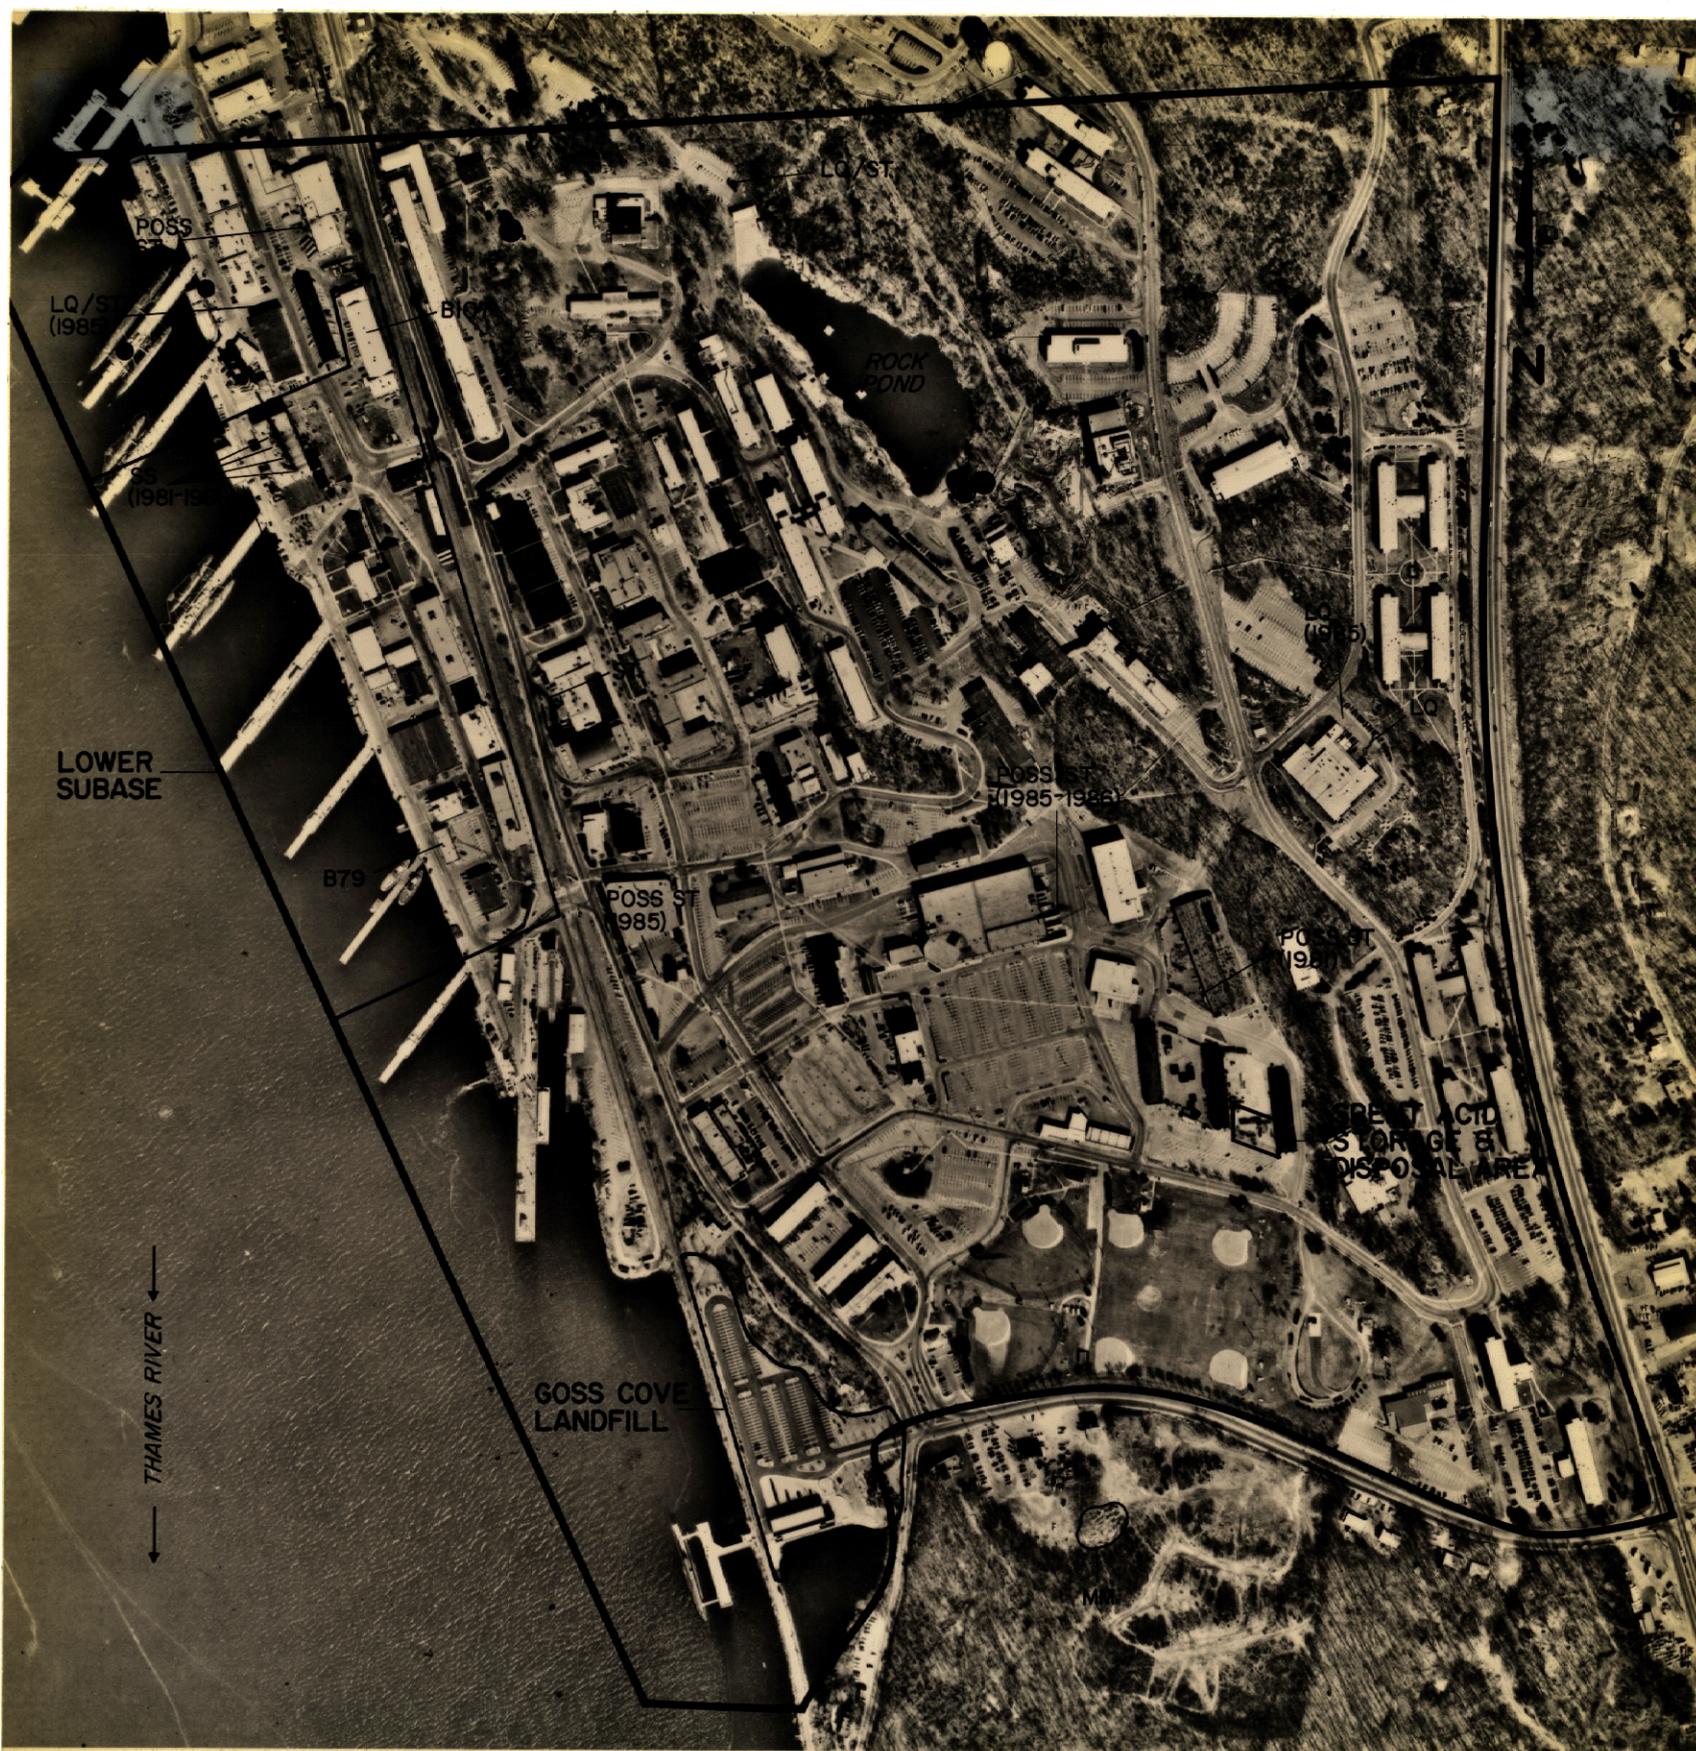
In 1986, staining is visible on the road surface east of the Lower Subase, and possible stains are noted in the northwestern and central portions of the study area. Liquid and/or the stain remaining from a liquid is seen on the paved parking lot north of Rock Pond, and liquid flows north from the same building in the eastern portion of the study area where liquid was seen in 1985.

Mounded material, consisting of many mounds, such as that created by emptying numerous dump truck loads, is visible in the excavated area south of the study area which was annotated on Figure 11. Staining (not annotated) is also seen in the areas directly northwest of this mounded material.

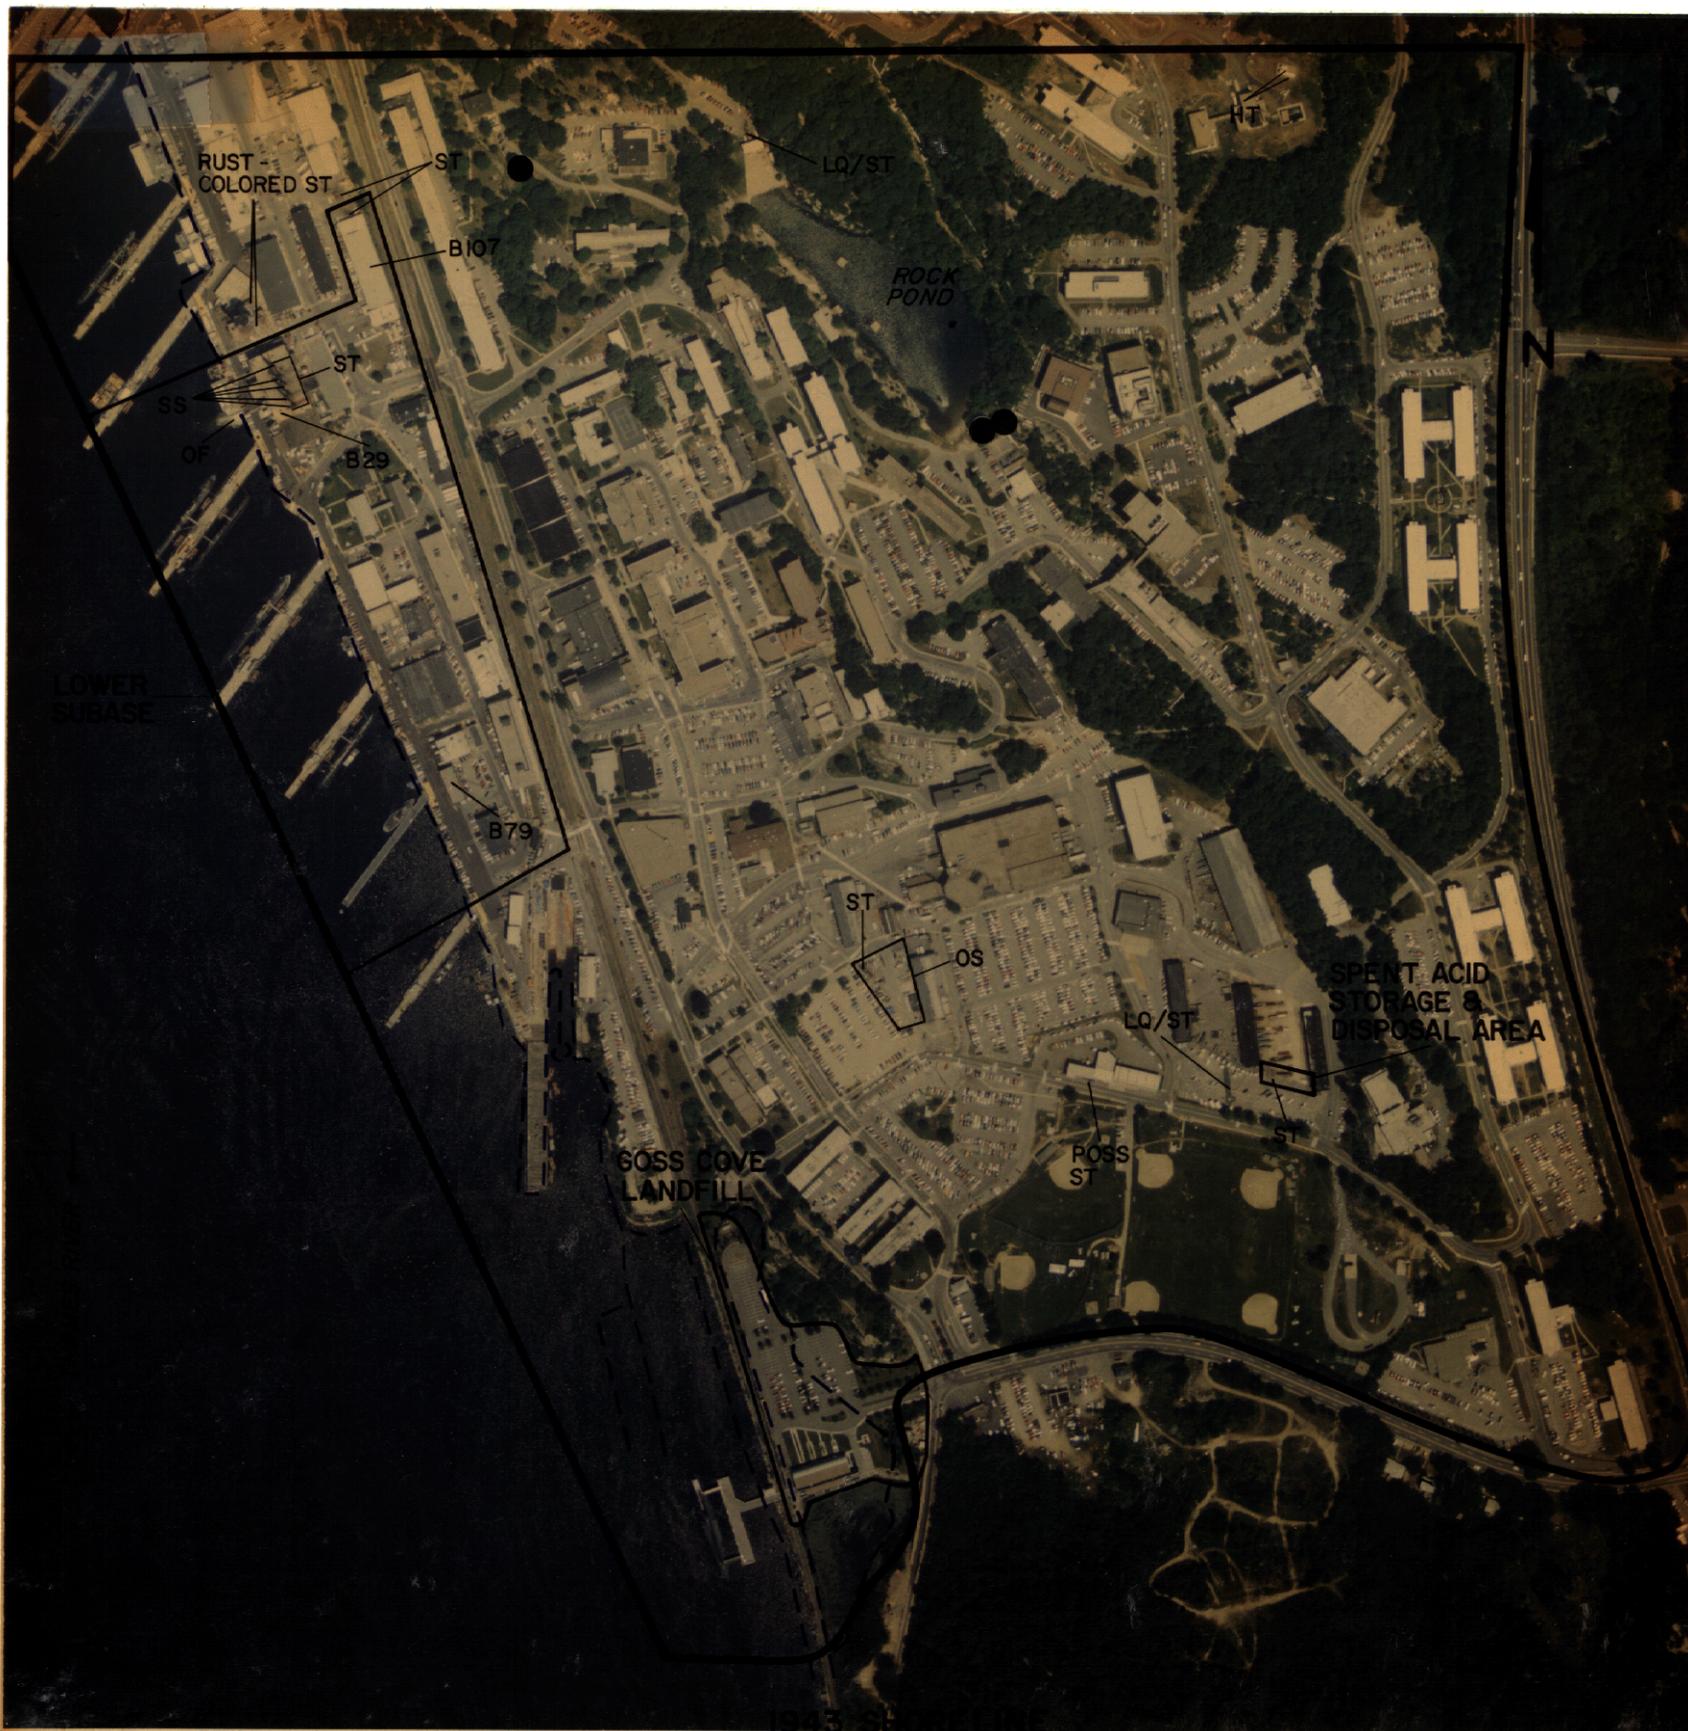
Staining is noted on the roof of B29 and directly north of B107.

Flowing liquid and/or the stain remaining from a liquid and a possible stain are visible west of the Spent Acid Storage and Disposal Area. Farther west, additional staining is evident in an open storage area. Liquid and/or the stain remaining from a liquid is still seen on the paved parking lot north of Rock Pond.

Rust-colored stains are evident north of B29.
