FINAL SITE INSPECTION REPORT MUNITIONS RESPONSE SITES AT DAM NECK ANNEX
AND NAVAL AUXILIARY LANDING FIELD FENTRESS NAS OCEANA VA

02/01/2011
CH2M HILL

Final
Site Inspection Report
Munitions Response Program
Munitions Response Sites at Dam Neck Annex and
Naval Auxiliary Landing Field Fentress
Naval Air Station Oceana
Virginia Beach, Virginia

February 2011

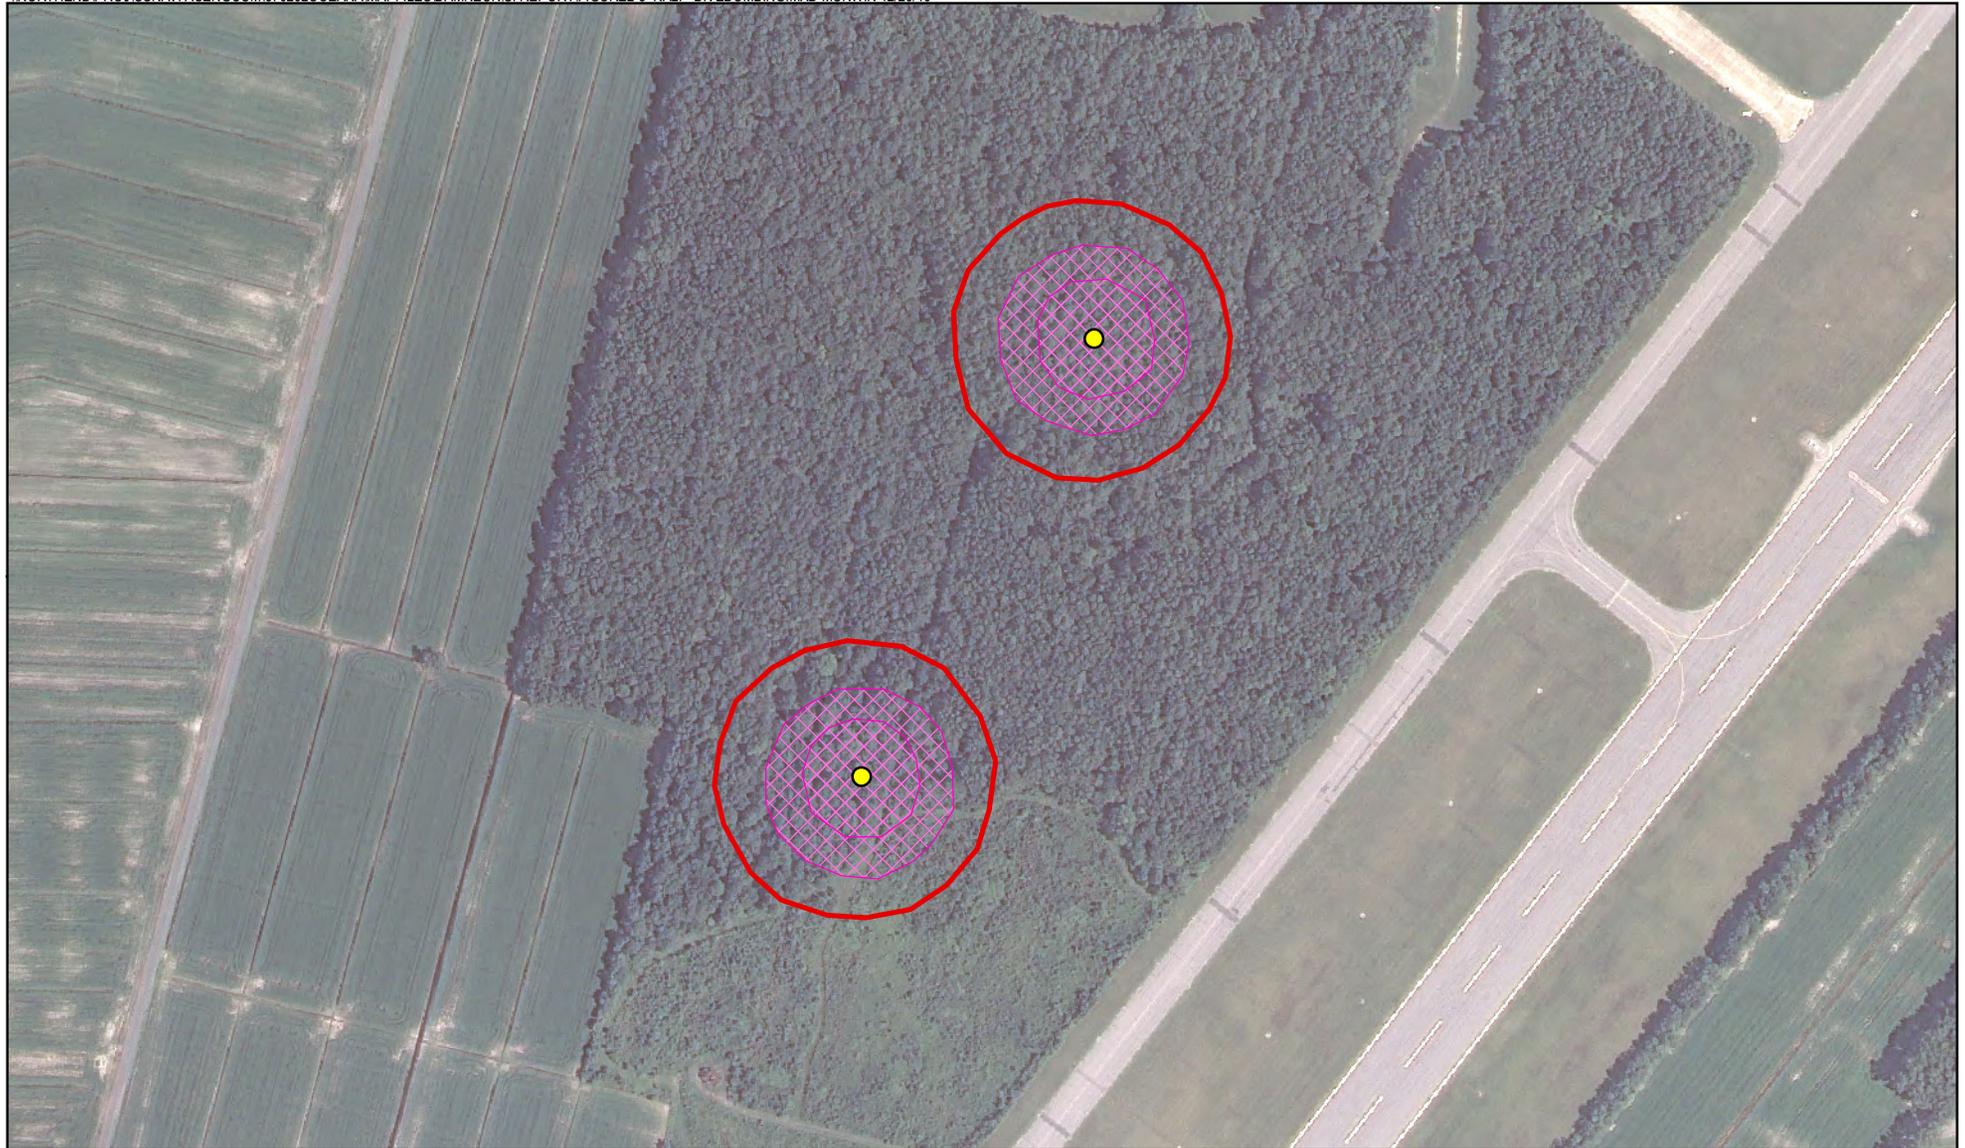
Figure 2-2
Site Inspection Report
Mortar Ranges
Dam Neck Annex - Naval Air Station Oceana
Virginia Beach, Virginia

MTMR-North is located in the southeastern portion of Dam Neck Annex, east of the Regulus Avenue and Loon Court intersection (**Figure 2-2**). The range was used in the 1940s and 1950s. Portions of the historic range boundary for the MTMR-North are overlapped by the active Drone Launching Area and another MR site, the former Rifle Range.

The MTMR-South is located in the southeastern portion of Dam Neck Annex east of the Regulus Ave and Bullpup Street intersection (**Figure 2-2**). The range was used in the 1940s and 1950s. Approximately 10 percent of the eastern portion of the site is developed and covered by parking lots and buildings. The remainder of the site is undeveloped and heavily wooded. Additionally, a portion of the site is within a Dune Management Area and is protected pursuant to the Coastal Primary Sand Dune Protection Act. This program is administered by the VMRC. The historic range boundary overlaps a small portion another MRP eligible site, the MIA. The acreage that is shared by the overlapping MRP sites is assigned to the MTMR-South. As such, the resulting MRP eligible portion of the historic MTMR-South is approximately 17 acres. Based on the range boundaries and period of use, probable munitions used at the MTMR-South include .30 and .50 caliber small arms projectiles and practice 60 mm and 81 mm mortars and only practice mortars are believed to have been used based on the distance between the probable firing point and impact area.

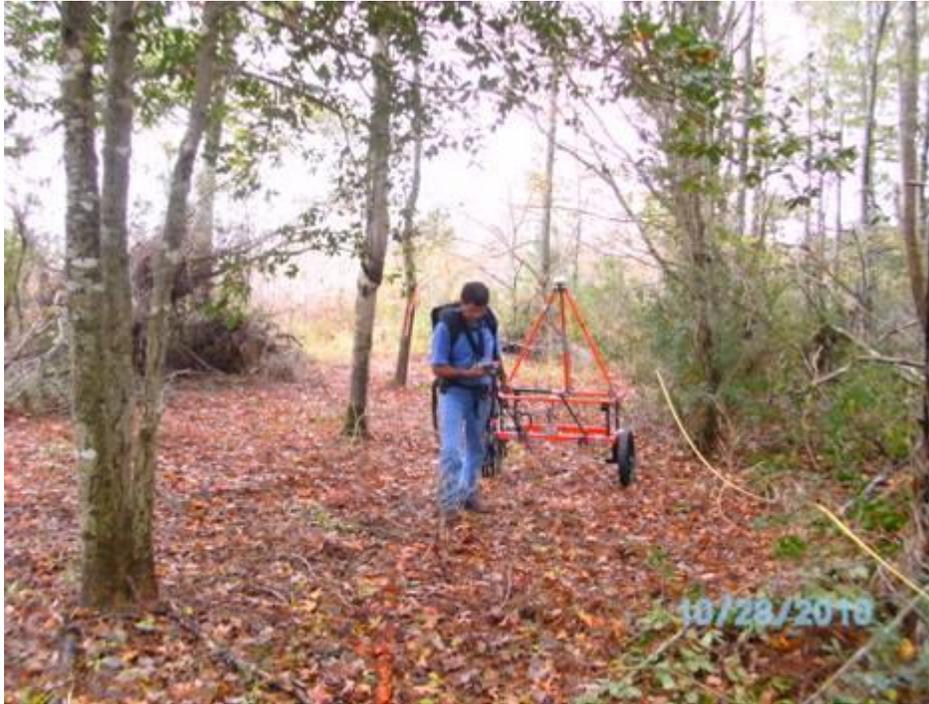
PHOTOGRAPH 3-1
CH2M HILL DGM Survey Activities NALF Fentress

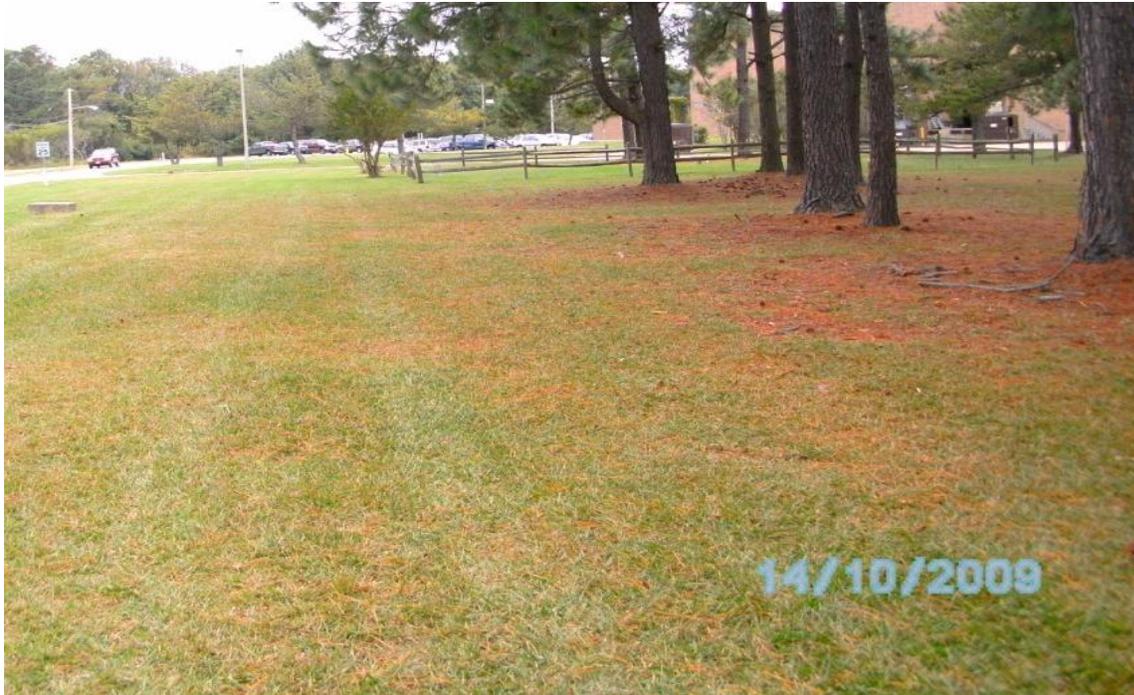
No evidence of surface MEC or subsurface anomalies was found during the site reconnaissance activities and no evidence was reported to have been found during construction or infrastructure installation activities in the developed portion of the range (i.e., firing points). The undeveloped portion of the former range lies outside of the suspected target/impact area and is a heavily forested/vegetated area. The suspected target/impact area of the former range lies within the operational range area and is not eligible for investigation under the MRP.

PHOTOGRAPH 4-1
Current Conditions of the Firing Line/Platform at the MTMR-North

Based on the above observations, no further action is recommended at the MTMR-North.

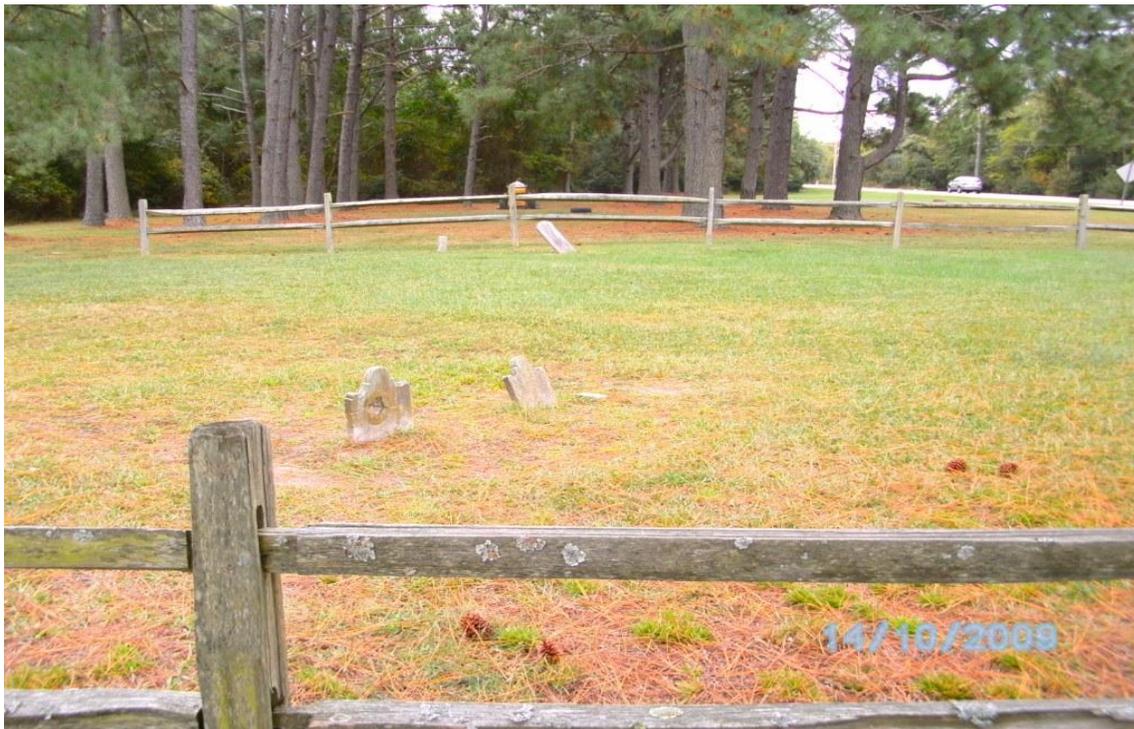
PHOTOGRAPH 4-2
Historic Gravesite at the Firing Line/Platform at the MTMR-North

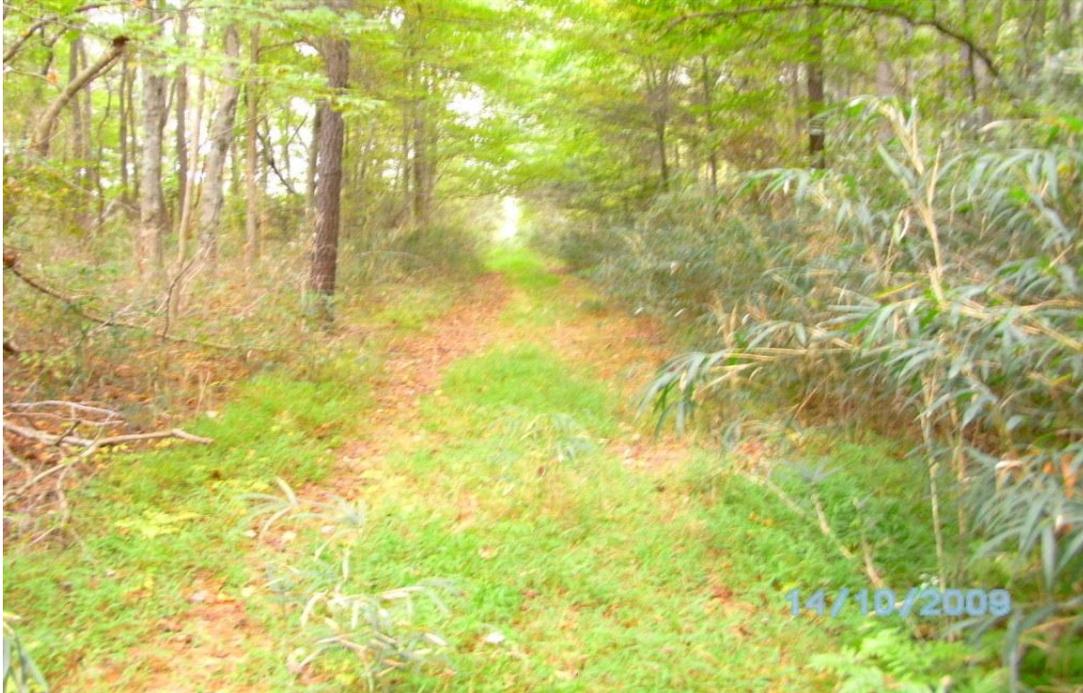
- Bunkers at the DBTs were located and found to be overgrown with dense vegetation.
- Entrance roads to the north and south DBTs were inspected and found to be in poor condition due to erosion and dense vegetation (**Photographs 4-3 and 4-4**).
- At the south DBT center, three AN-MK23 practice bombs and an unfuzed M18 Signal Smoke Grenade were found on the ground surface (**Photographs 4-5, 4-6, and 4-7**).
- Several subsurface anomalies were also identified during the limited hand-held magnetometer survey performed at the south DBT; one subsurface anomaly was identified at the north DBT.

PHOTOGRAPH 4-4
Condition of Entrance Roads to the North and South DBTs

Further investigation, including additional vegetation removal and DGM survey activities with positioning at a high enough accuracy for reacquisition of anomalies, as well as an intrusive investigation to inspect and identify a selected subset of the anomalies, is recommended. If the sources of the anomalies are identified as MEC, sampling for MC will be required.

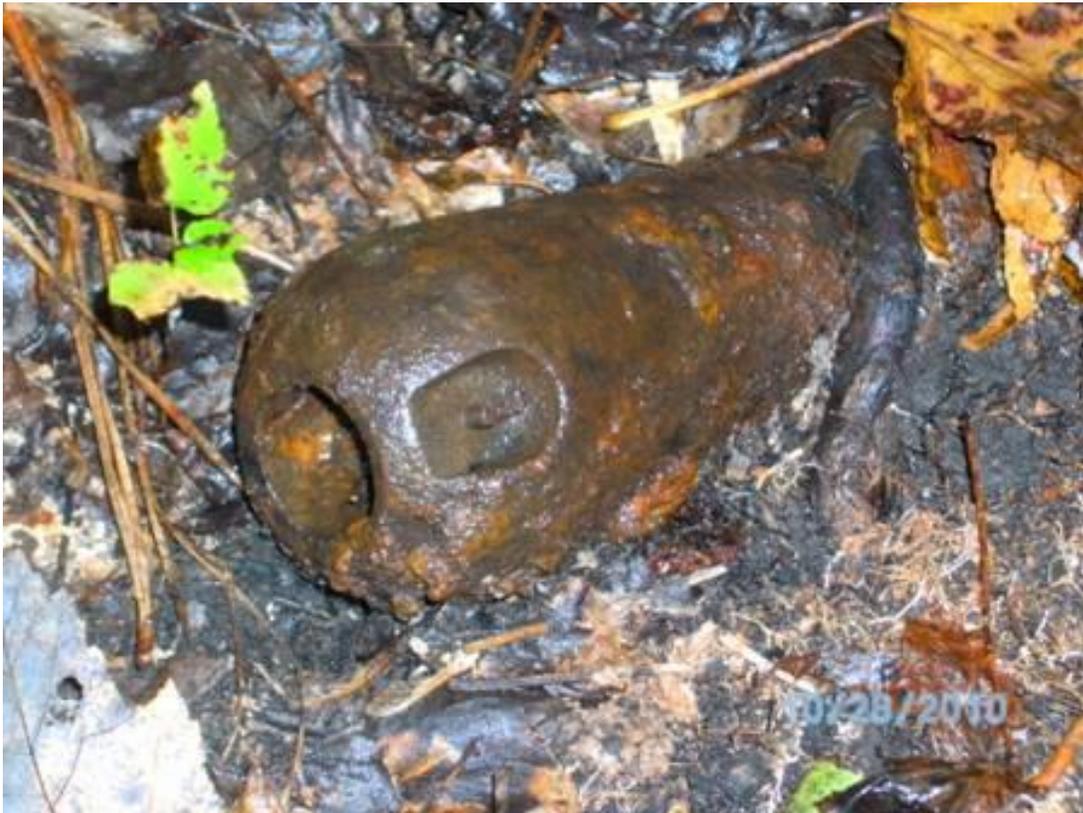
PHOTOGRAPH 4-5
AN-MK23 Charged Practice Bomb at Southern DBT

During the MEC clearance activities completed immediately prior to the start of the DGM survey, the AN-MK23 practice bombs and unfuzed M18 Smoke Signal Grenade found during the PA site reconnaissance activities were reacquired. It was determined that the signal charges in two of the practice bombs were intact. Local Navy Explosives Ordnance Disposal personnel were notified and ultimately responded and removed these items.

During the site reconnaissance activities performed at the DBTs, three AN-MK23 practice bombs and an unfuzed M18 Signal Smoke Grenade were found on the ground surface of the southern target. Several subsurface anomalies were also identified at the north and south DBTs. It was determined that the signal charges in two of the AN-MK23 practice bombs found in the southern target were intact during UXO clearance activities performed prior to the DGM survey. Local Navy Explosive Ordnance Disposal personnel responded and removed these items. A number of subsurface anomalies were identified at each target during the DGM survey activities at the DBTs and because the DBTs are located in an undeveloped area of NALF Fentress, it is not likely that these anomalies are associated with cultural sources.

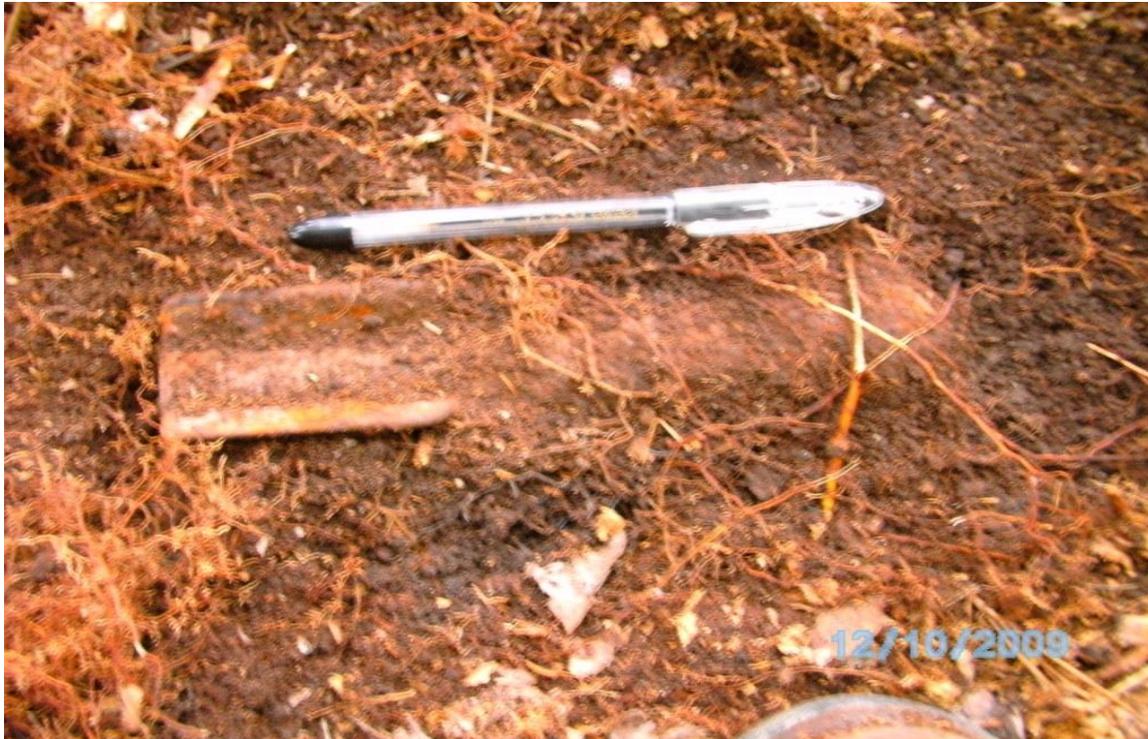
PHOTOGRAPH 4-6
MD at Southern DBT

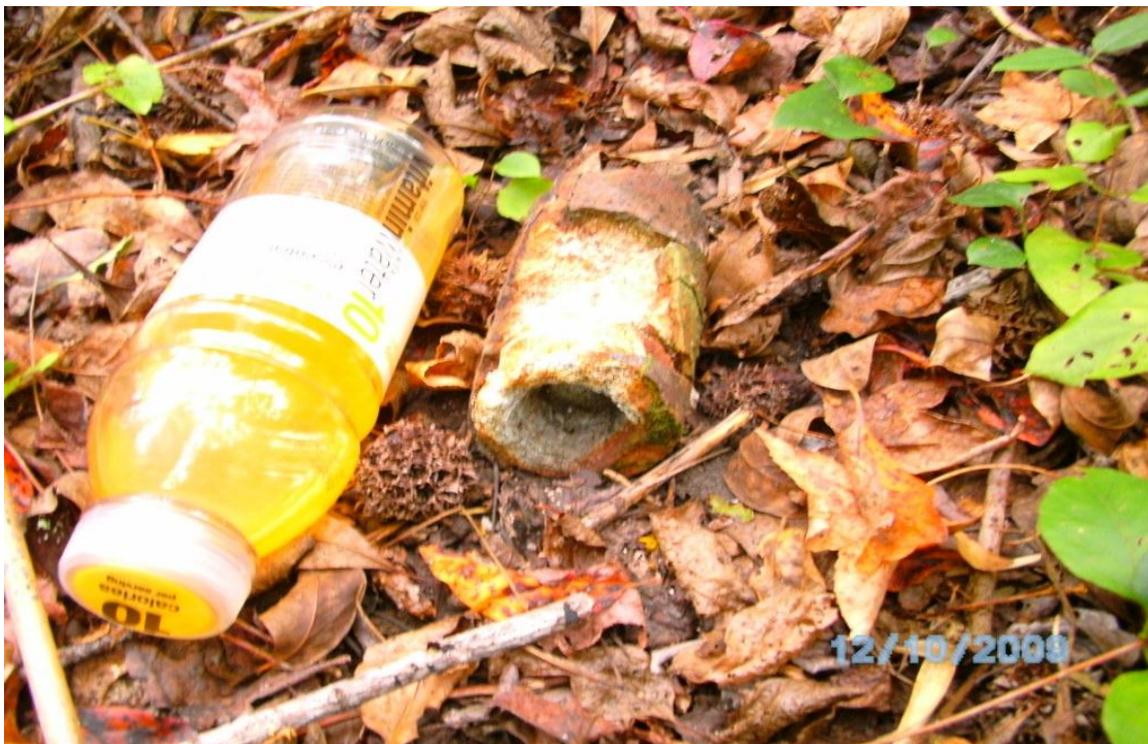
PHOTOGRAPH 4-7
Unfuzed M18 Signal Smoke Grenade at Southern DBT

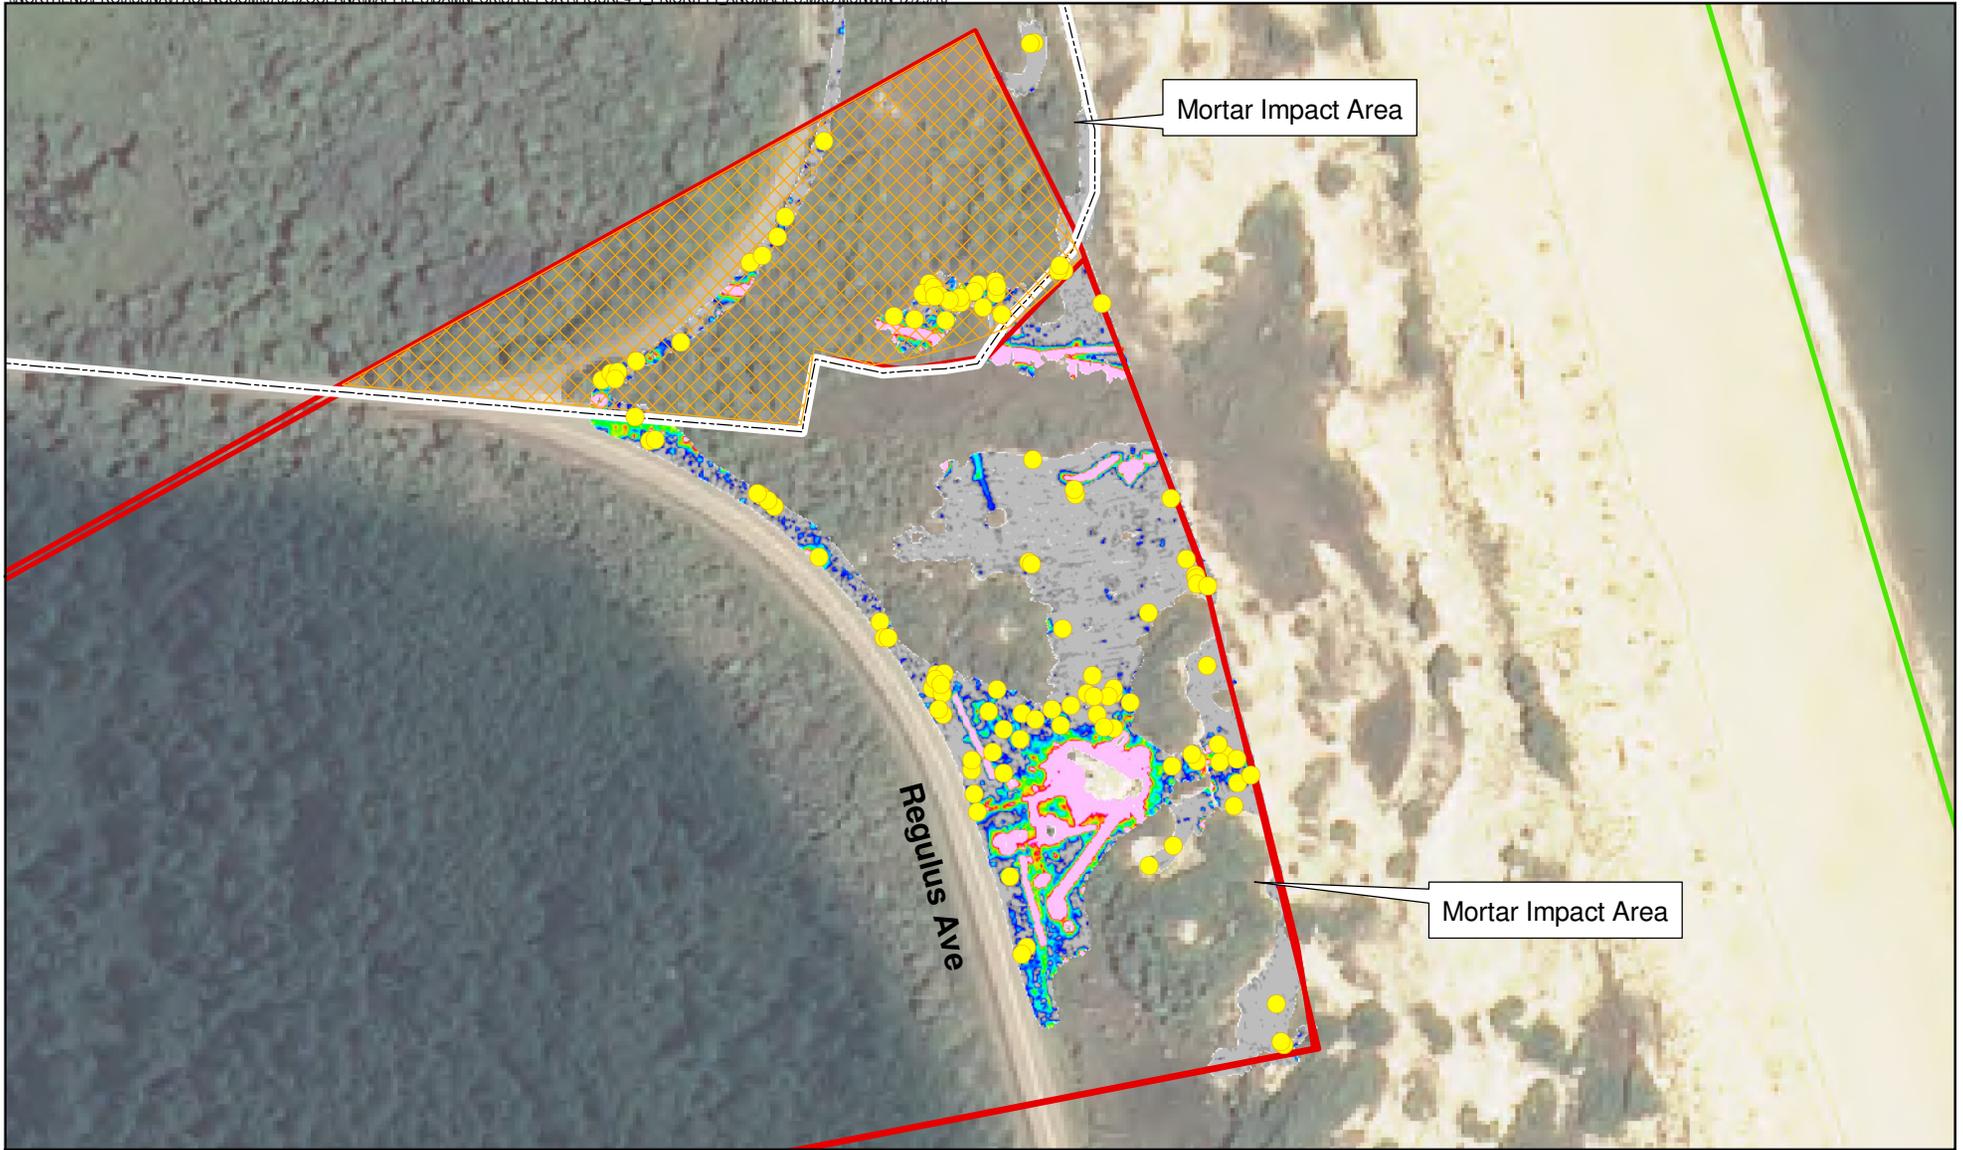
Although discrimination of MEC from other metallic items using EM61-MK2 data is not feasible to any significant degree, the detected anomalies were subdivided into prioritized groups based on the experience of the CH2M HILL Project Geophysicist (primarily using anomaly size, amplitude and decay parameters). Priority 1 anomalies are those determined to be the most likely to represent subsurface MEC (60mm or 81mm mortars in the top two feet) if present at the site; however, non-munitions related metallic items can create similar responses in the geophysical data. These anomalies are recommended to be first should intrusive investigations be performed. A total of 127 Priority 1 anomalies were identified from the MTMR-South and MIA data (**Figure 4-1**).

The portion of each former range located west of Regulus Avenue is located outside of the target/impact area and is a heavily vegetated wetland. No surface MEC was found in the portion of each former range located east of Regulus Avenue (suspected target/impact area) and the distribution of the anomalies identified during the DGM survey of this area do not appear to be in a pattern that indicates an impact area, although an intrusive investigation would be required to confirm whether the sources of the anomalies are MEC. There is a very low concentration of high density/high millivolt discreet anomalies potentially representing MEC (60mm or 81mm mortars in the top 2 feet) area within the sand dunes; however, again these anomalies could be caused by non-munitions related metallic items.

Figure 4-1
Site Inspection Report
Priority 1 Anomalies - Moving Target Mortar Range South
and Mortar Impact Area
Dam Neck Annex - Naval Air Station Oceana
Virginia Beach, Virginia

Based on the above observations, further investigation, including an intrusive investigation to inspect and identify a selected subset of the anomalies located during the SI is recommended at the MTMR-South and MIA to determine if the sources of the anomalies are MEC, but only in the portions of the sites that are east of Regulus Avenue. If determined to be MEC, then the MEC should be removed and properly disposed of, and additional actions potentially including MC sampling, DGM and intrusive investigation activities will be required. Note that there are land use controls in place to restrict or prevent unauthorized

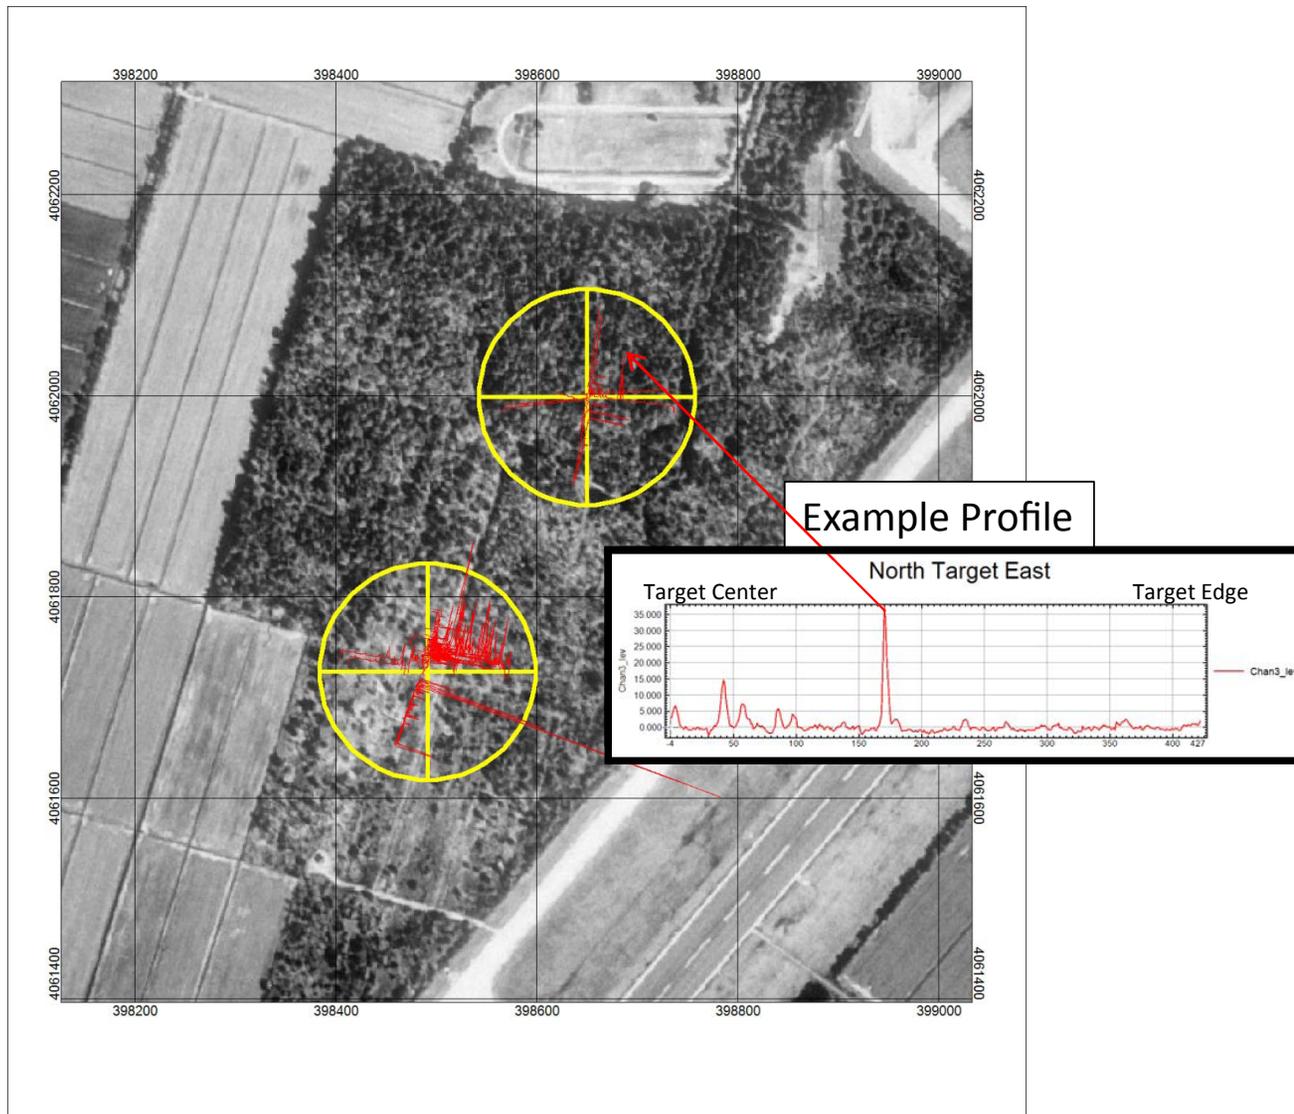
Figure 4-2
Site Inspection Report
DGM Transects - Dive Bombing Targets
NALF Fentress - Naval Air Station Oceana
Virginia Beach Virginia

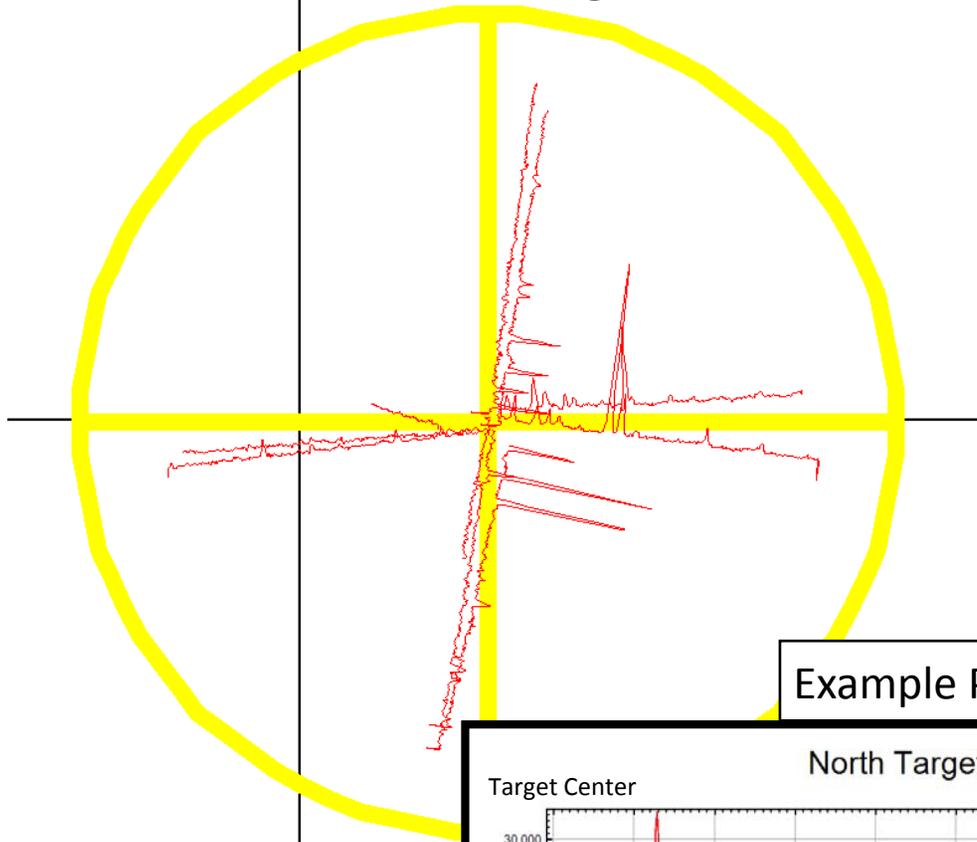
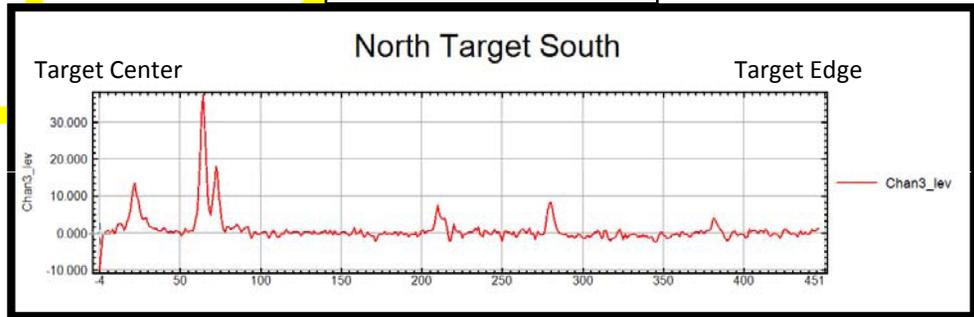
Figure 4-3
Site Inspection Report
DGM Results - North Dive Bombing Target
NALF Fentress - Naval Air Station Oceana
Virginia Beach Virginia

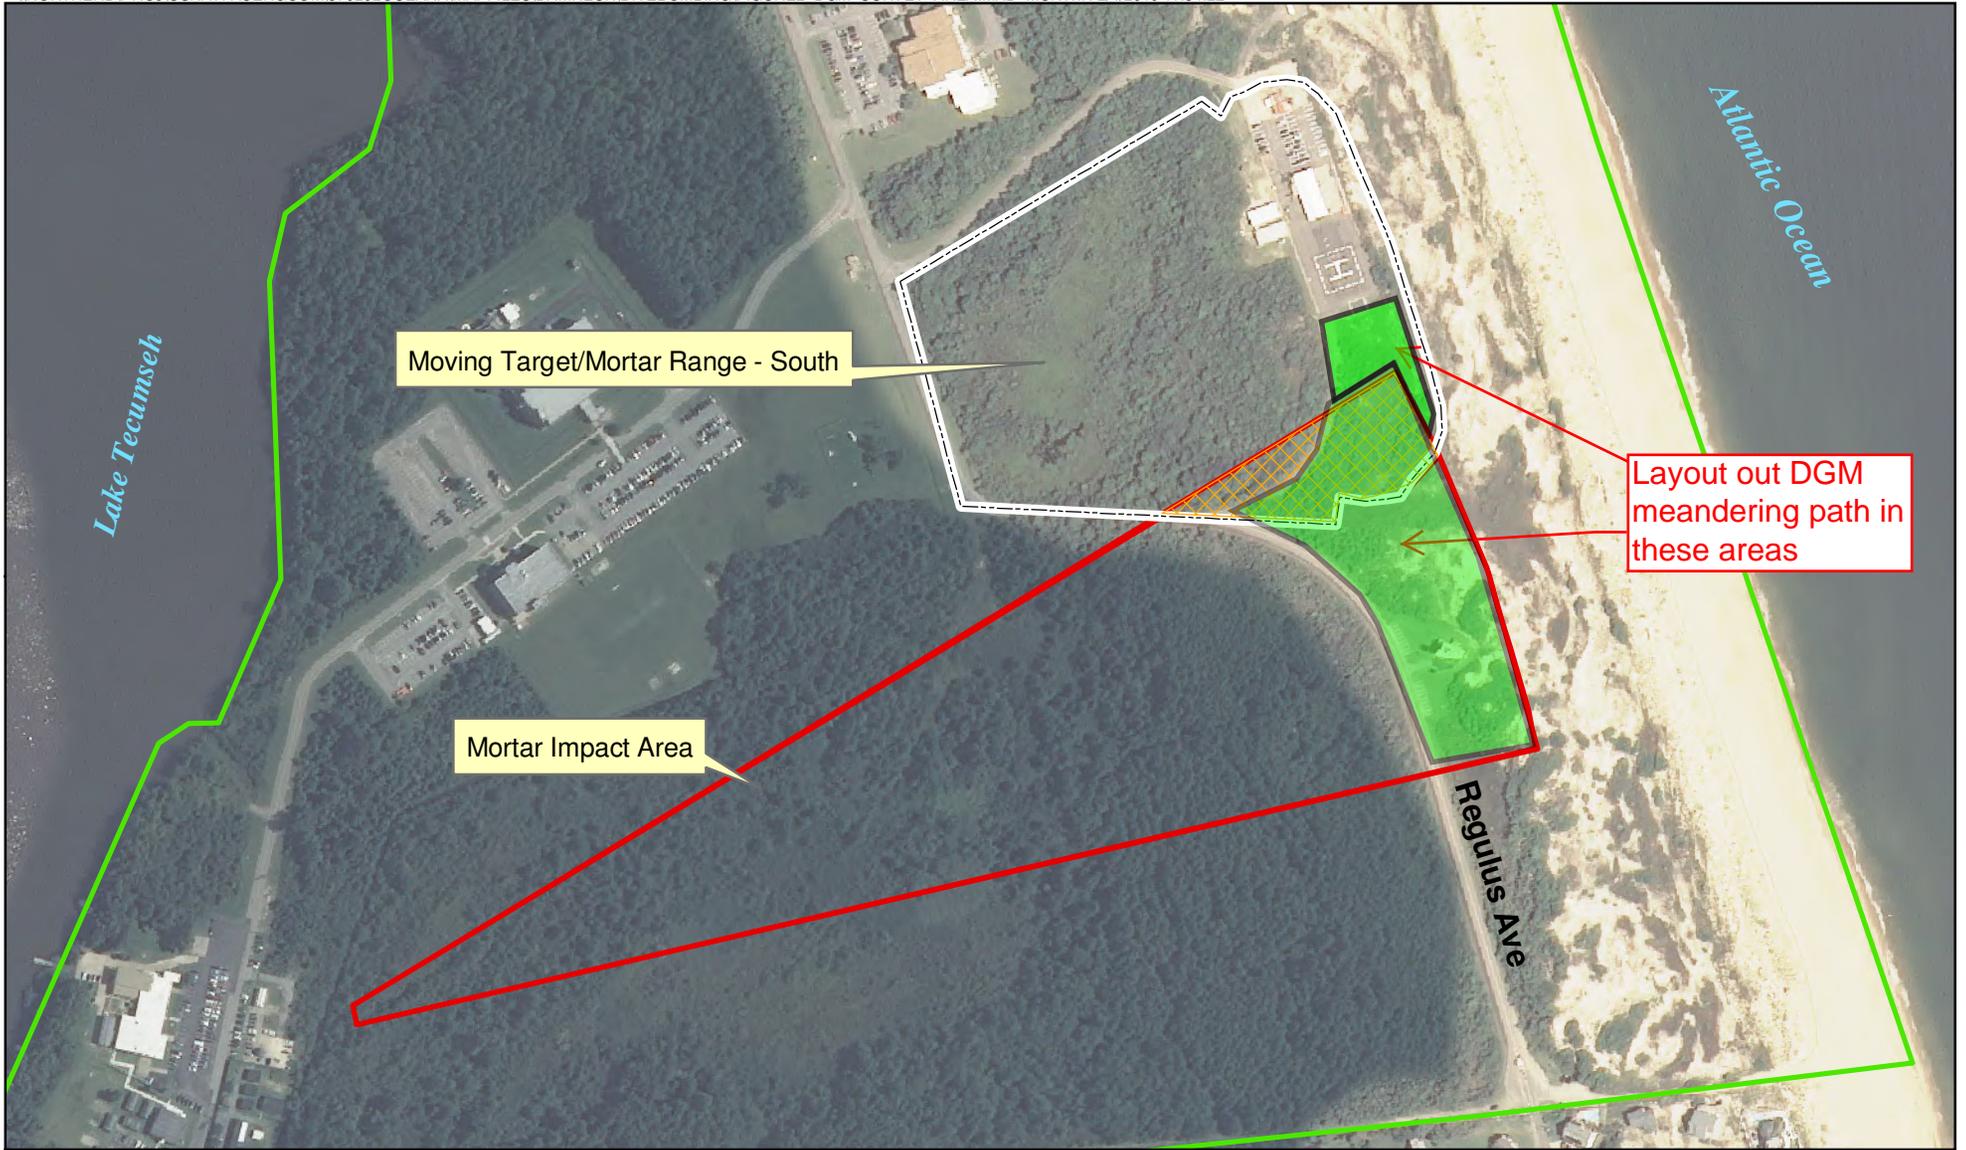
Figure 2
DGM Survey Area for the Mortar Ranges
Dam Neck Annex
Virginia Beach, Virginia

at the Mortar Impact Area and a small portion of undeveloped land in the southern end of the suspected impact area of the Moving Target Mortar Range (South) were included in the DGM survey. The areal extent of the DGM survey is shown shaded in green on **Figure 2** and encompasses approximately 6 acres. A parking area, several large buildings, and a helipad occupy the majority of the eastern portion of the site. The western portion of the site is a heavily wooded undeveloped wetland area not used by the installation.
