INTERIM RESOURCE CONSERVATION AND RECOVERY ACT FACILITY ASSESSMENT
WITH TRANSMITTAL LETTER MCRD PARRIS ISLAND SC
4/4/1990
A T KEARNEY INC

Reference: EPA Contract No. 68-W9-0040; Work Assignment No. R04-05-08; United States Marine Corps Recruit Depot, Parris Island, South Carolina; EPA I.D. No. SC6170022762; Interim RCRA Facility Assessment Report; Final Deliverable

APPENDIX C
PHOTOGRAPH LOG

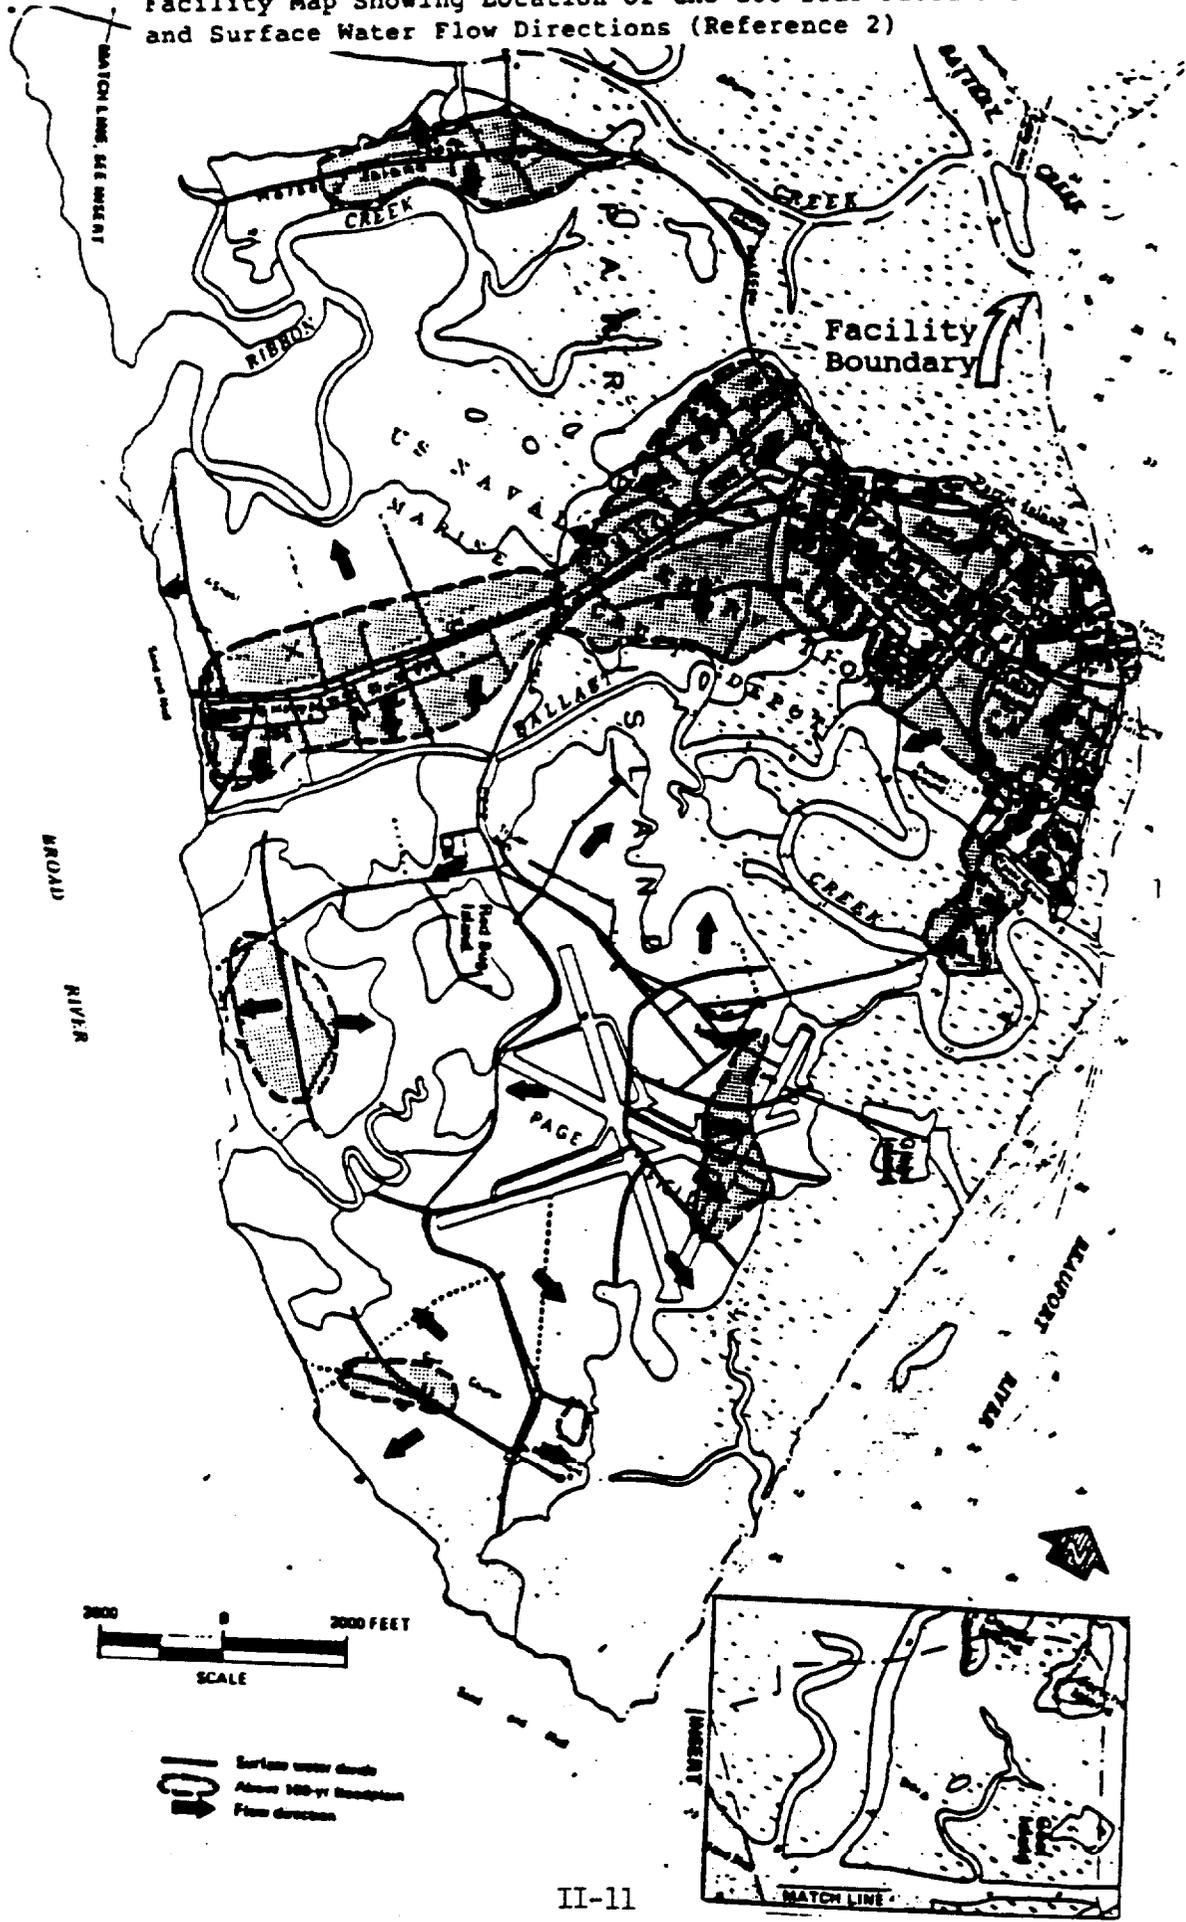
Facility Map Showing Location of the 100-Year Flood Plain and Surface Water Flow Directions (Reference 2)

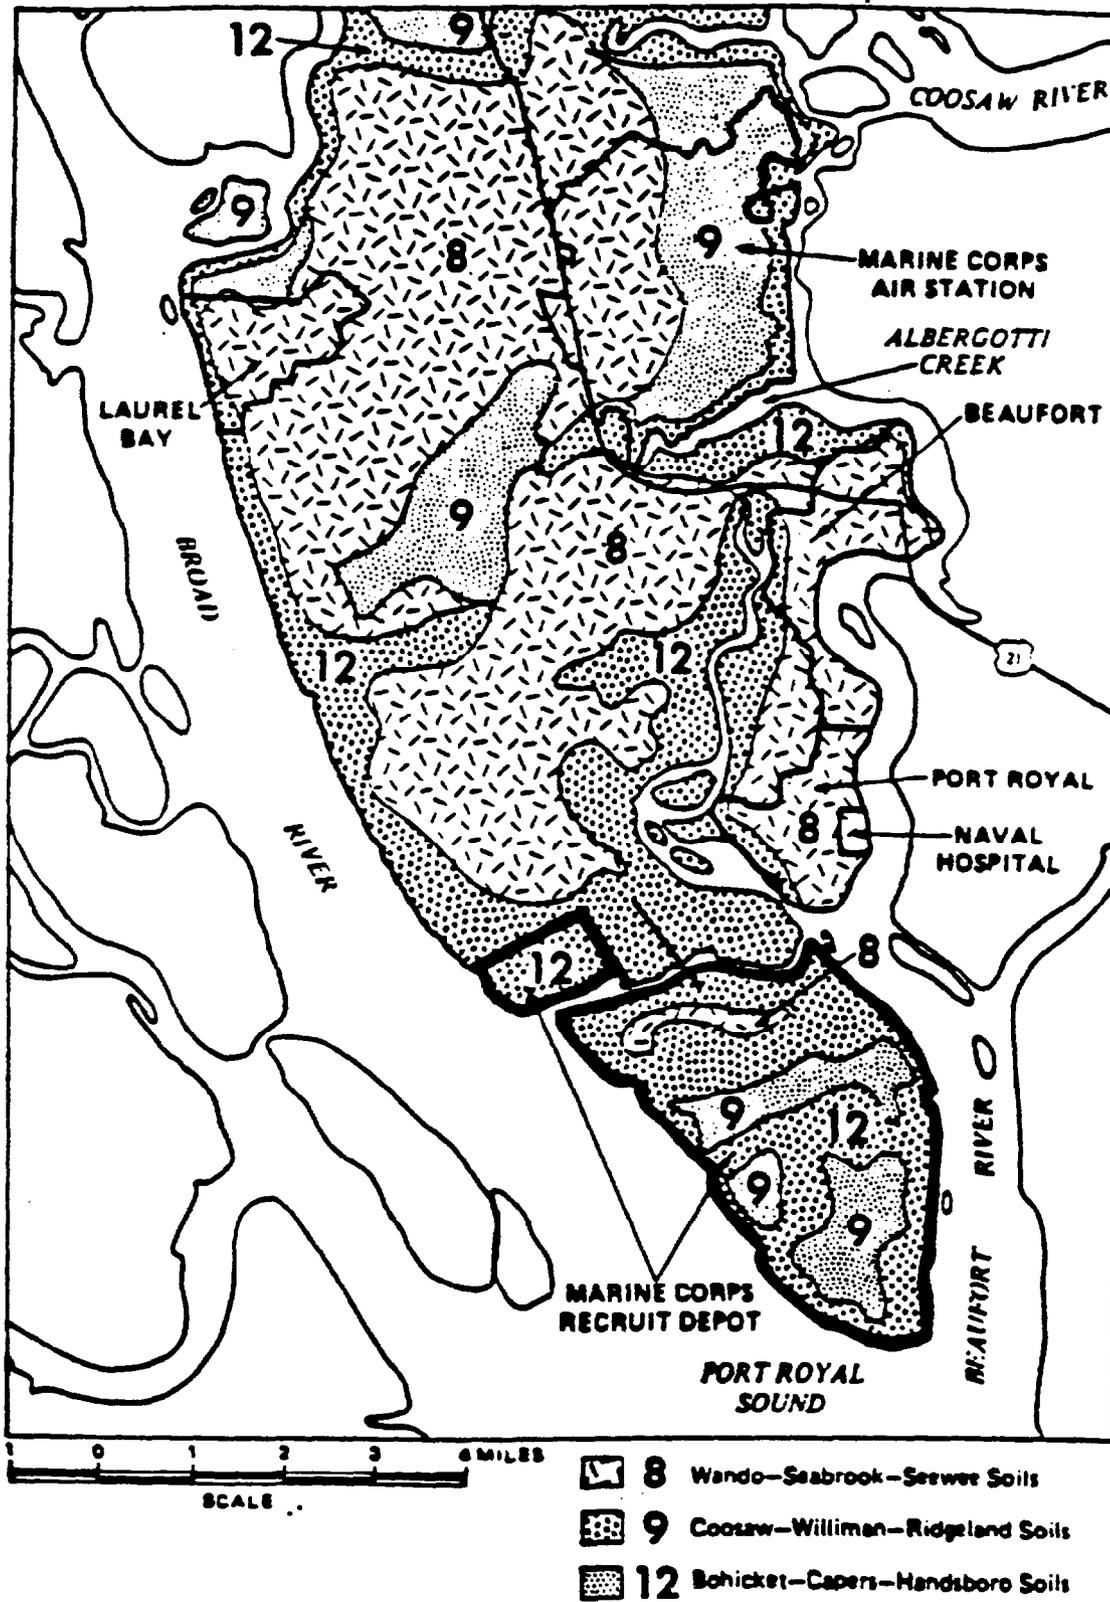
Figure 3

Facility Map Showing principle Soil Units (Reference 2)

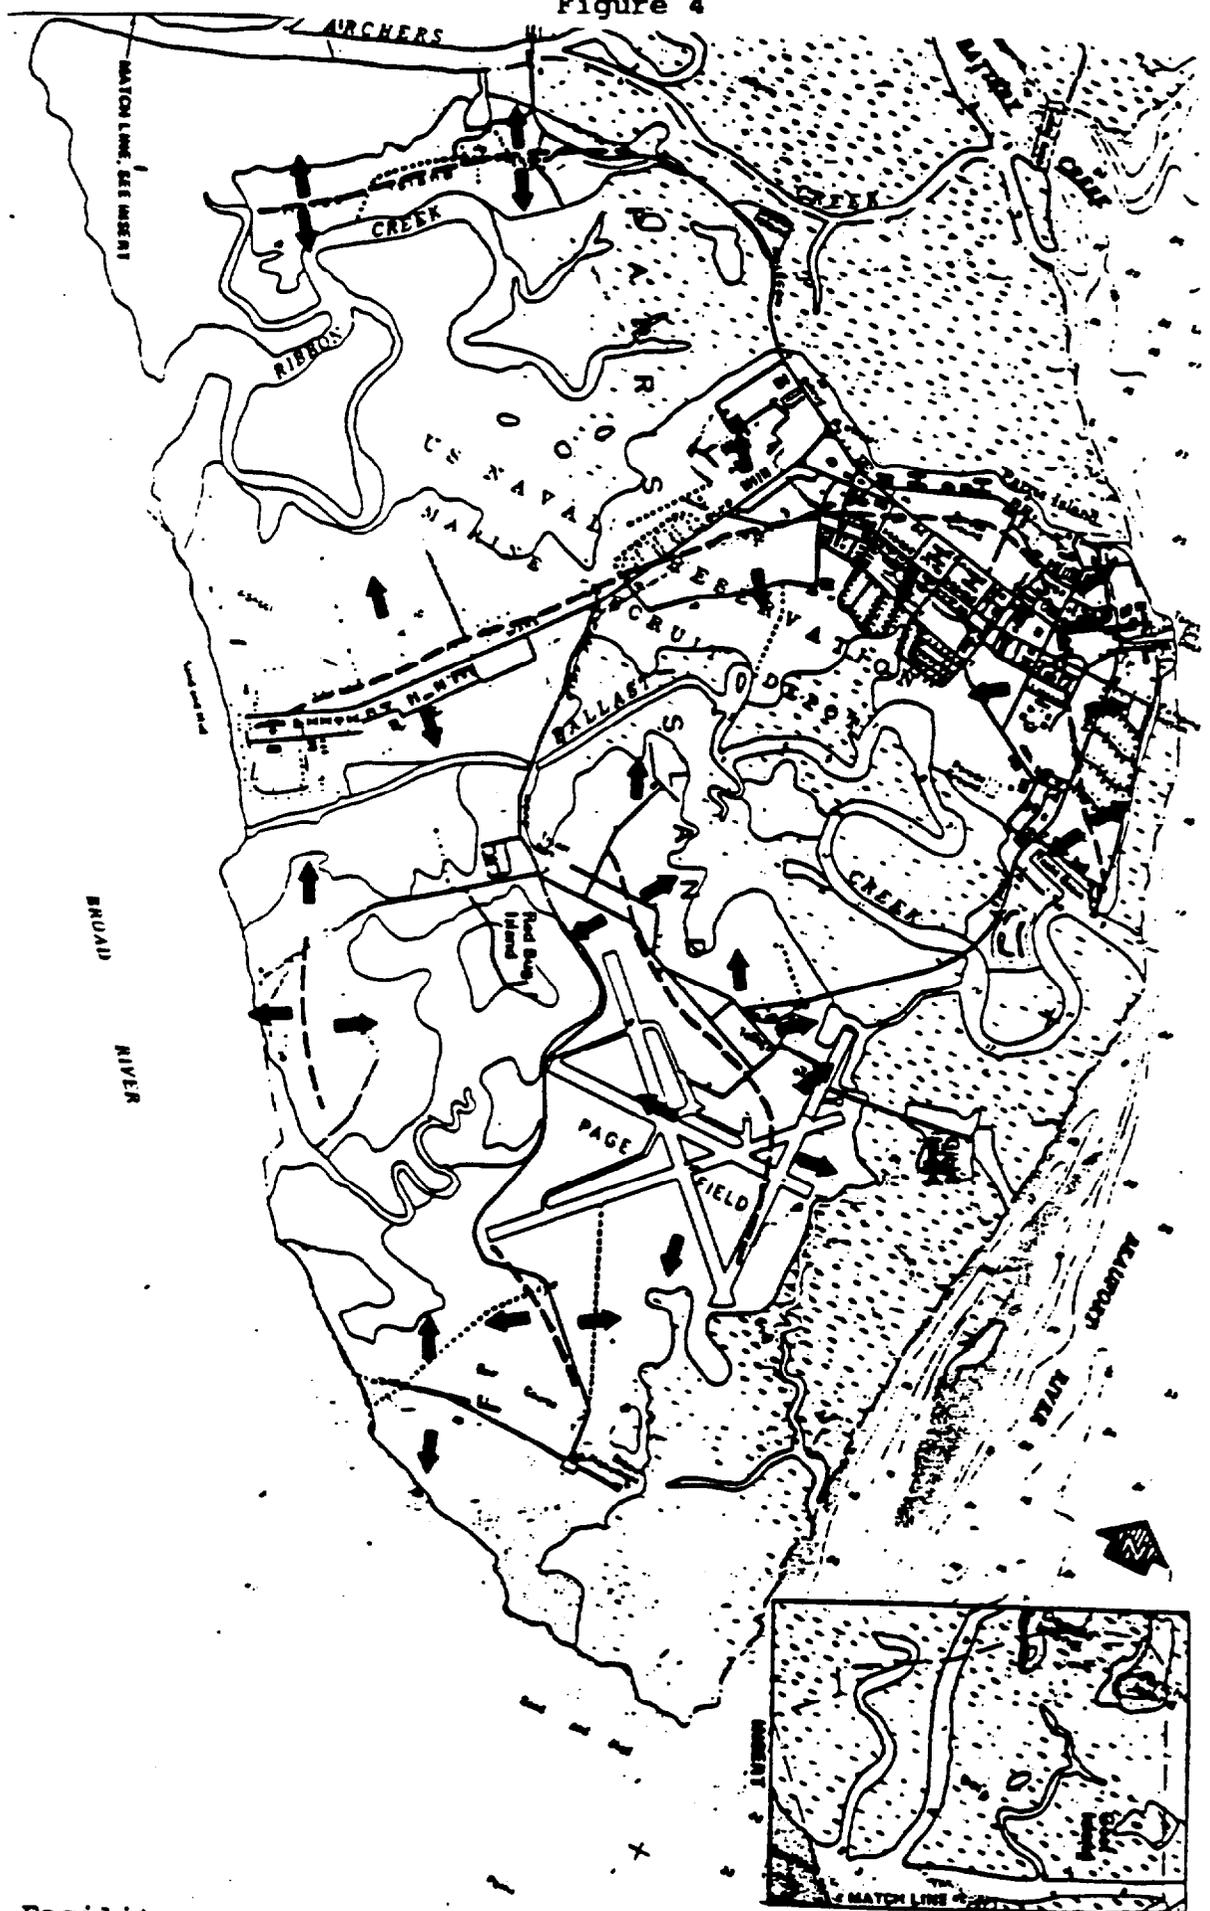
Figure 4

Facility Map Showing Surficial Groundwater Flow Directions (Reference 2)

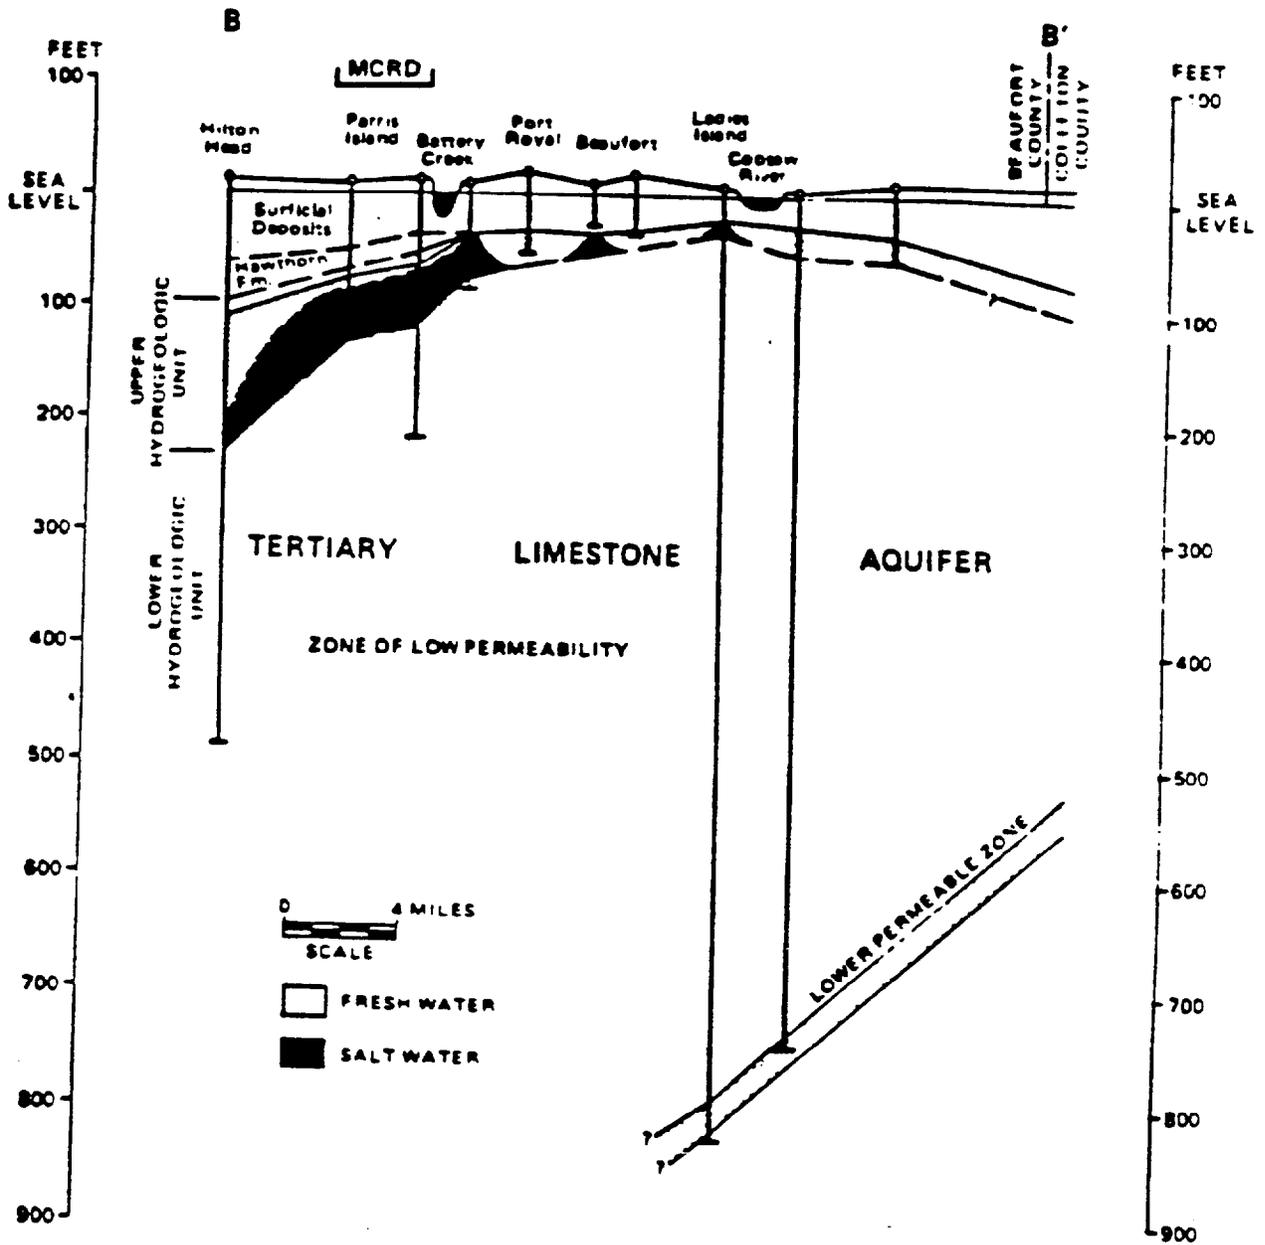
Figure 5

Hydrogeological Cross-Section of the Tertiary Limestone Aquifer (Reference 2)

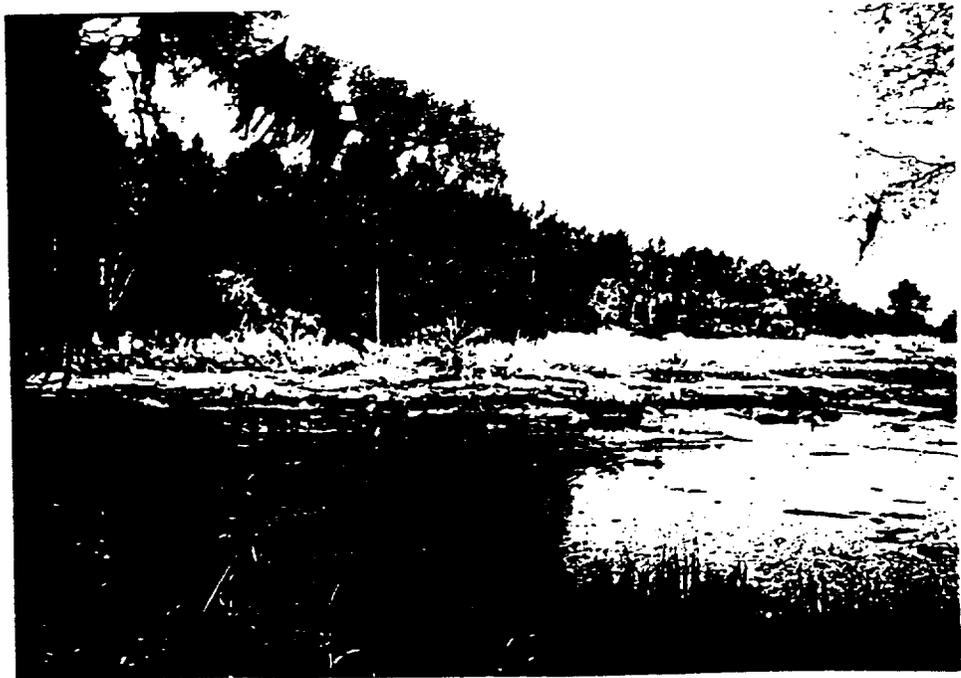
1.1

Overview of the Incinerator Landfill (Site 1) (SWMU 1) on Horse Island in the north section of the facility facing northwest. The creek in the foreground is Archers Creek.

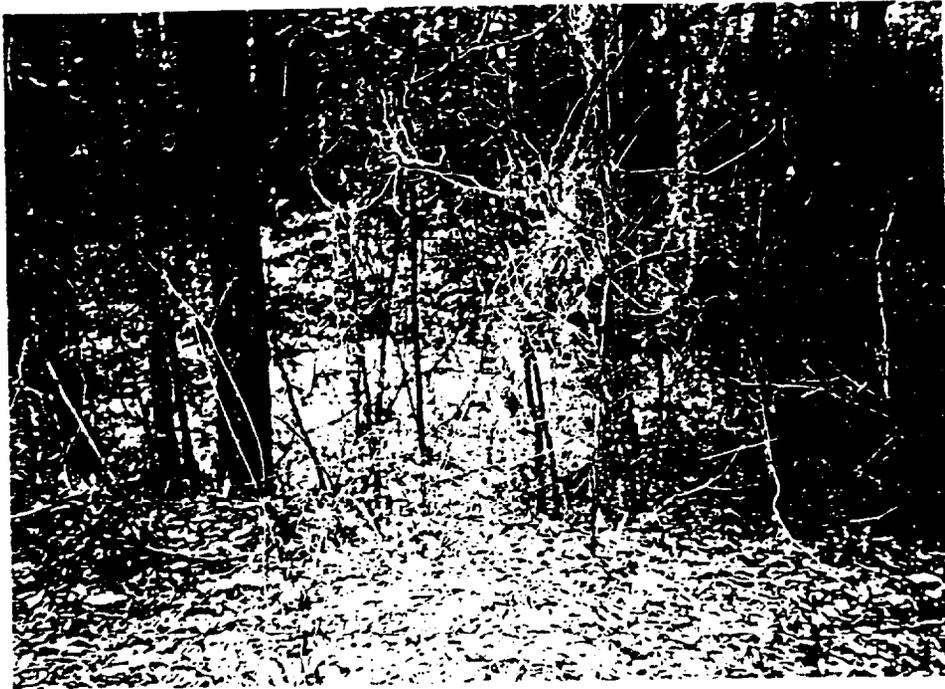
2.1 South-facing view of the Borrow Pit Landfill (Site 2) (SWMU 2) in the north-central section of Horse Island in the north section of the facility. The landfill is in the depression featured in the center of the photograph.

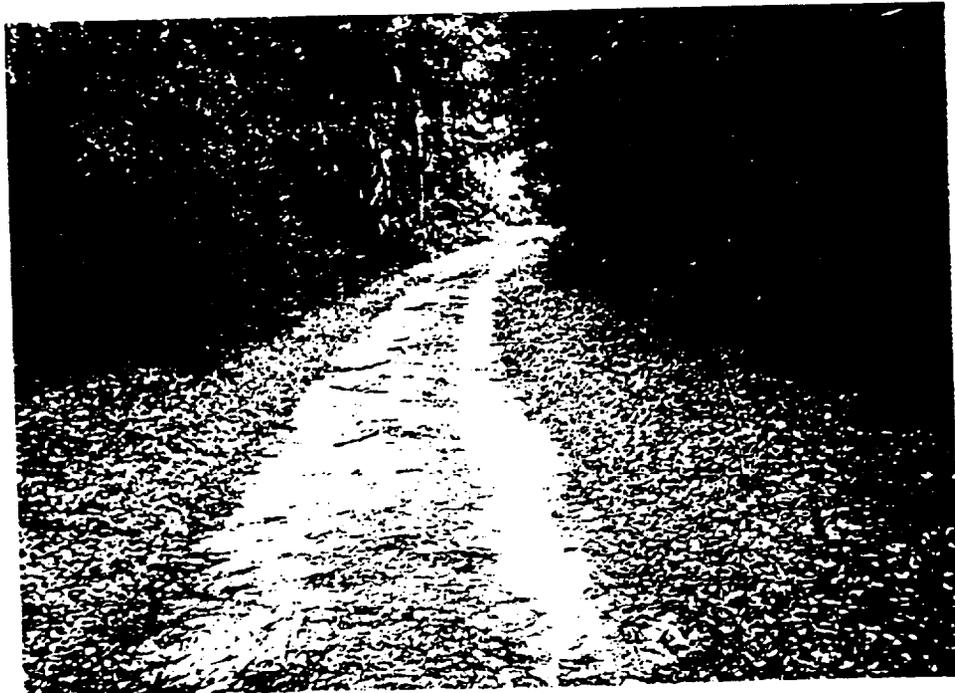
2.2 Northeast view facing the road providing access to the Borrow Pit Landfill (Site 2) (SWMU 2). The landfill is located to the right of the road.

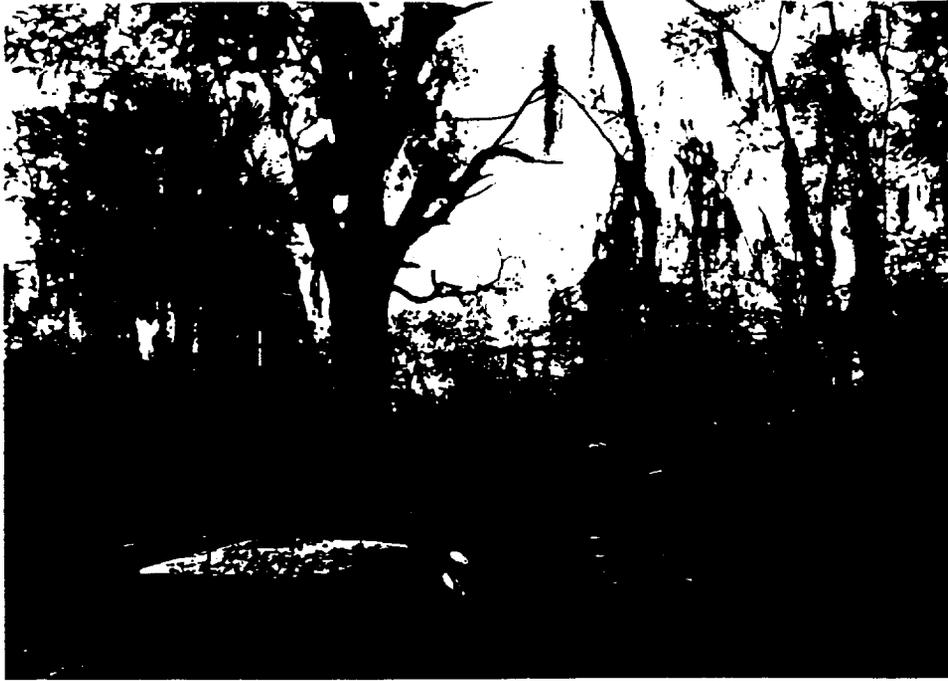
2.3 Close-up of a groundwater monitoring well for the Borrow Pit Landfill (Site 2) (SWMU 2) facing northwest. A marsh is situated beyond the trees featured in the center of the photograph.

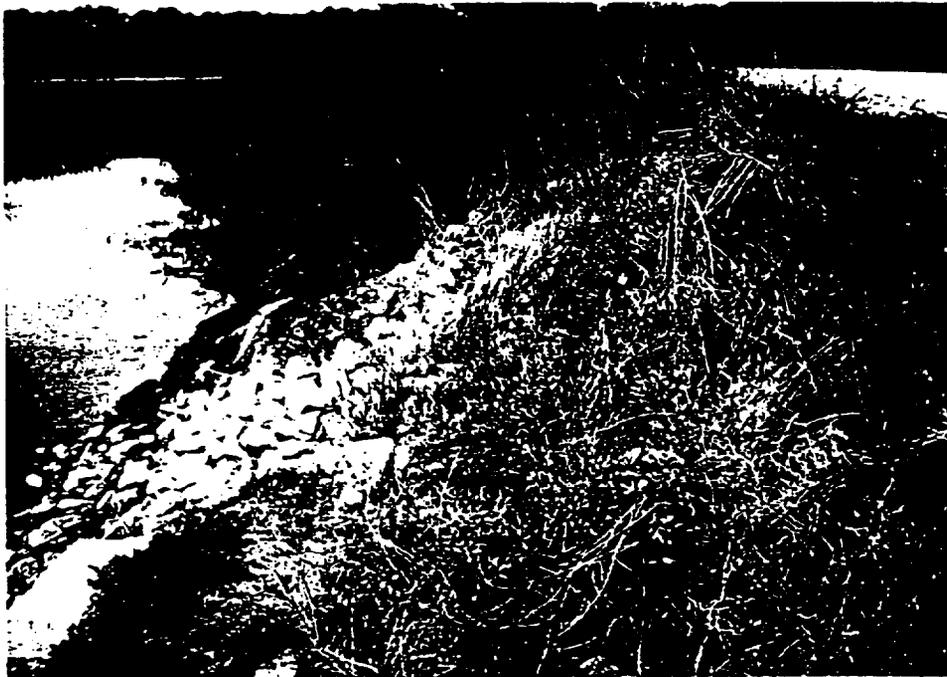
3.1 North-facing view of the Causeway Landfill (Site 3) (SWMU 3) showing a portion of the rip-rap sides. The landfill connects Horse Island to Parris Island. The water featured in the left-hand side of the photograph is connected to Ribbon Creek.

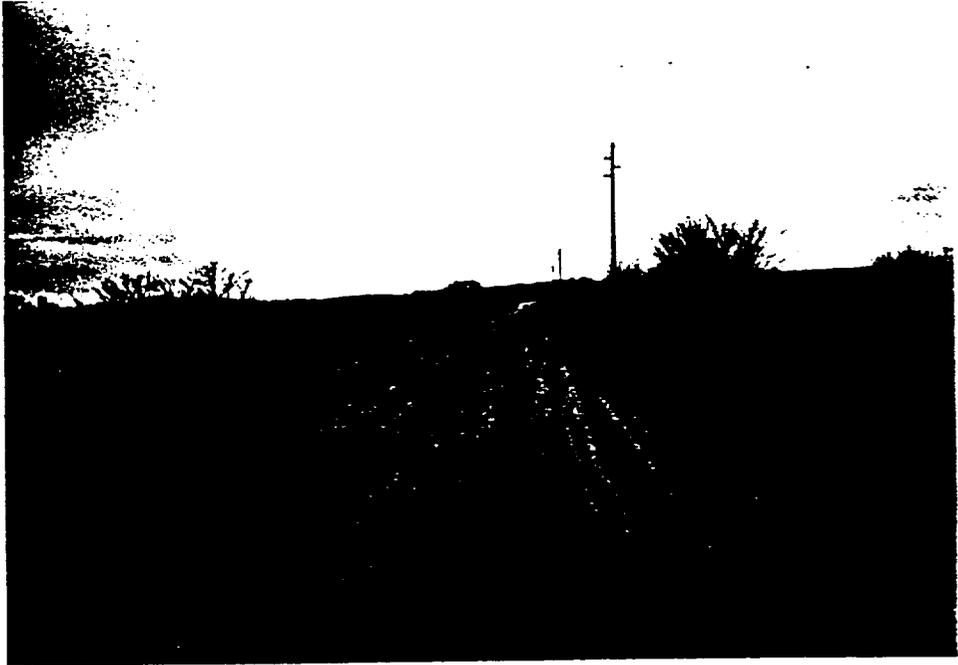
3.2 Overview of the Causeway Landfill (Site 3) (SWMU 3) facing southeast.

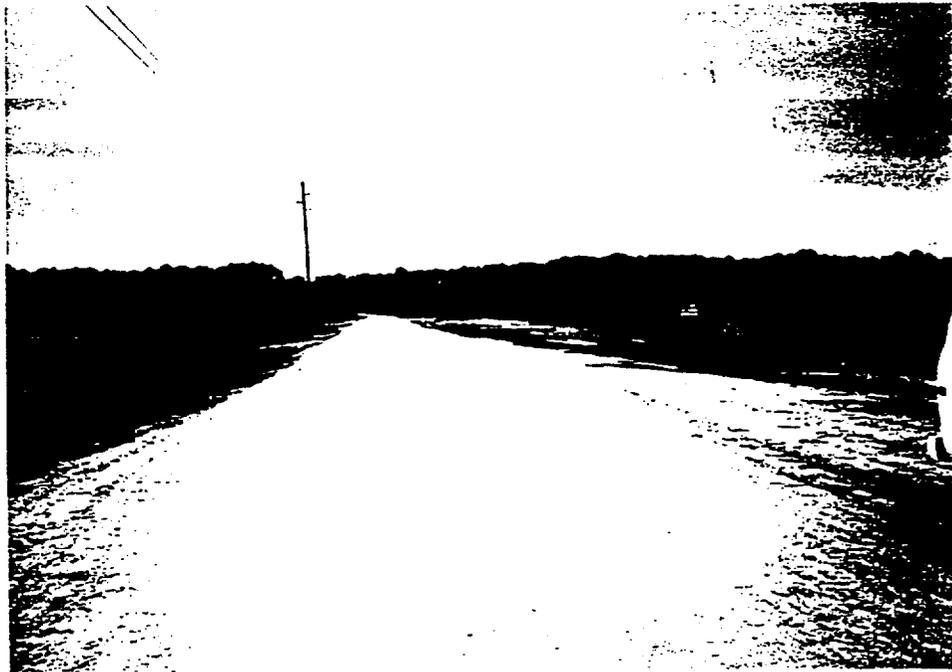
3.3 Overview of the Causeway Landfill (Site 3) (SWMU 3) facing northwest. Note the Dumpster (SWMU 44) in the right-center of the photograph.

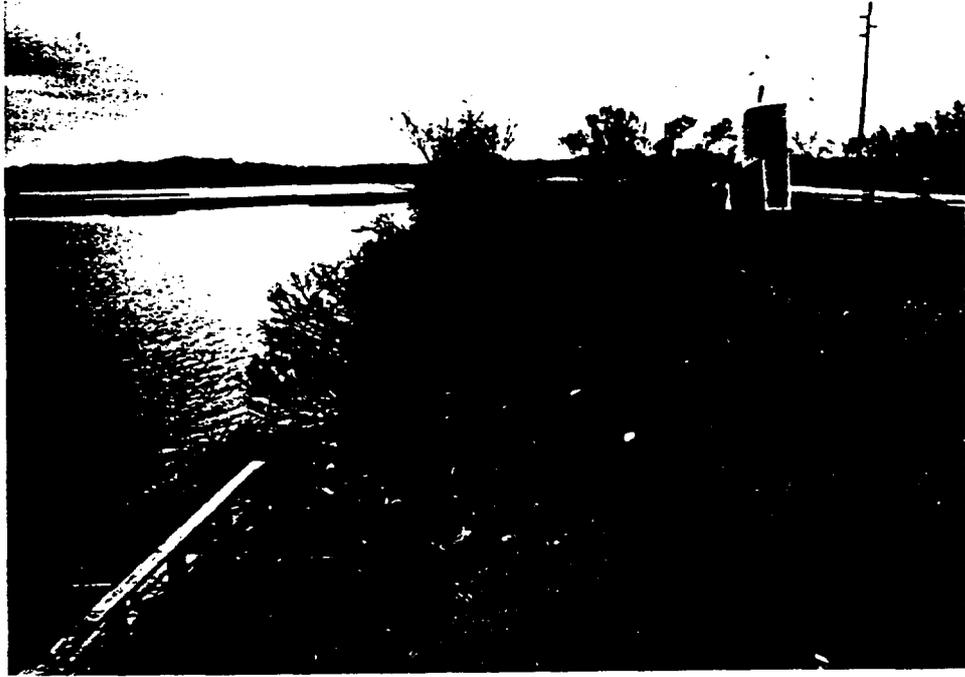
3.4 Southeast-facing view of the Causeway Landfill (Site 3) (SWMU 3) showing the tidal pond on the left side of the photograph. The pond is connected to Ribbon Creek.

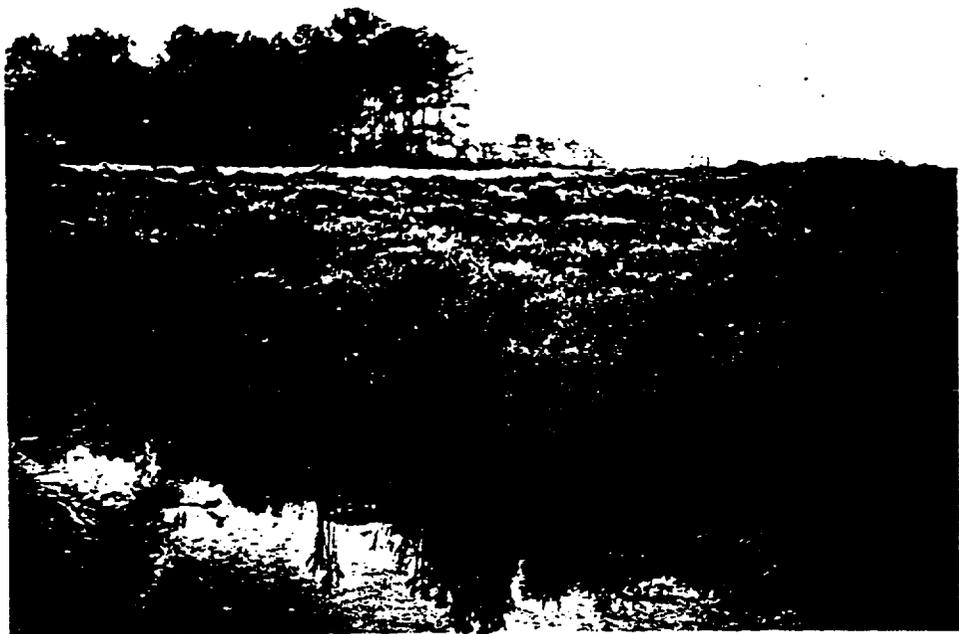
4.3

Continuation of photographs 4.1 and 4.2.

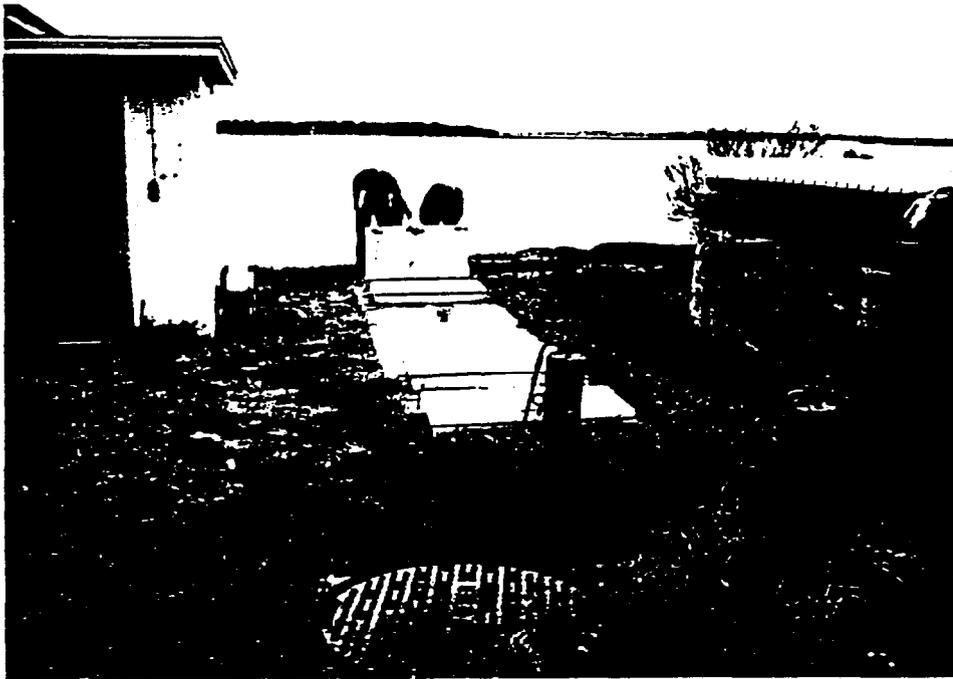
5.1 View of the Power Station Oil/Water Separator (SWMU 20) along the Beaufort River in the northeast section of the facility. The view also shows the approximate location of the river bank used as the Former Paint Shop Disposal Area (Site 5) (SWMU 5). The view is facing east.

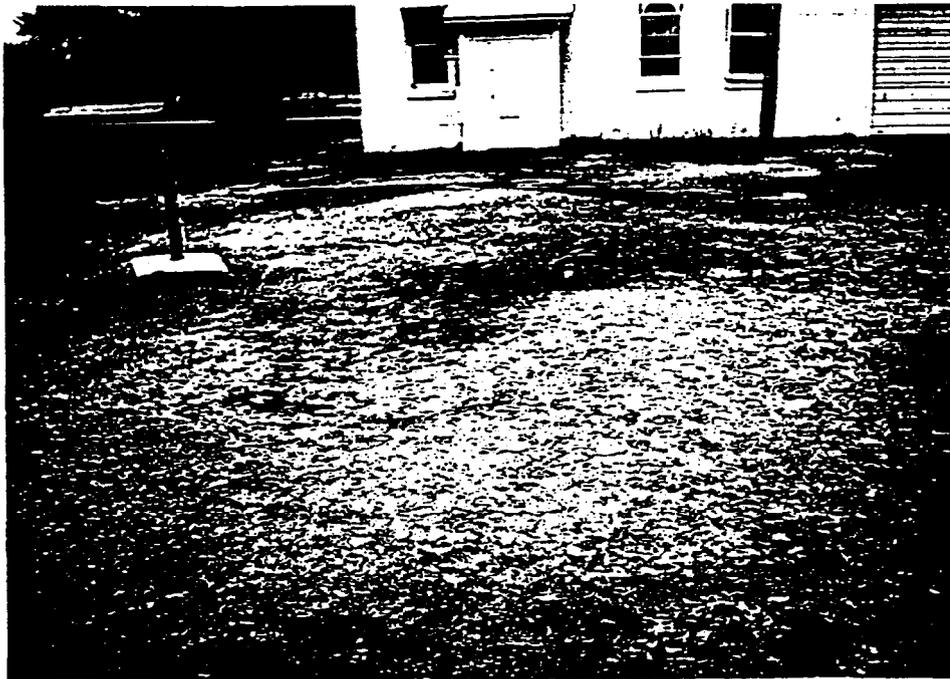
6.1 View of the Former Hobby Shop Spill Area (Site 6) (SWMU 6) located in the vicinity of Page Field in the southeast section of the facility. The view is facing south. Note the pipe inlet in the center of the photograph and the groundwater monitoring in the left hand corner of the photograph. The darkened area around the inlet was caused by the previous evening's rainfall.

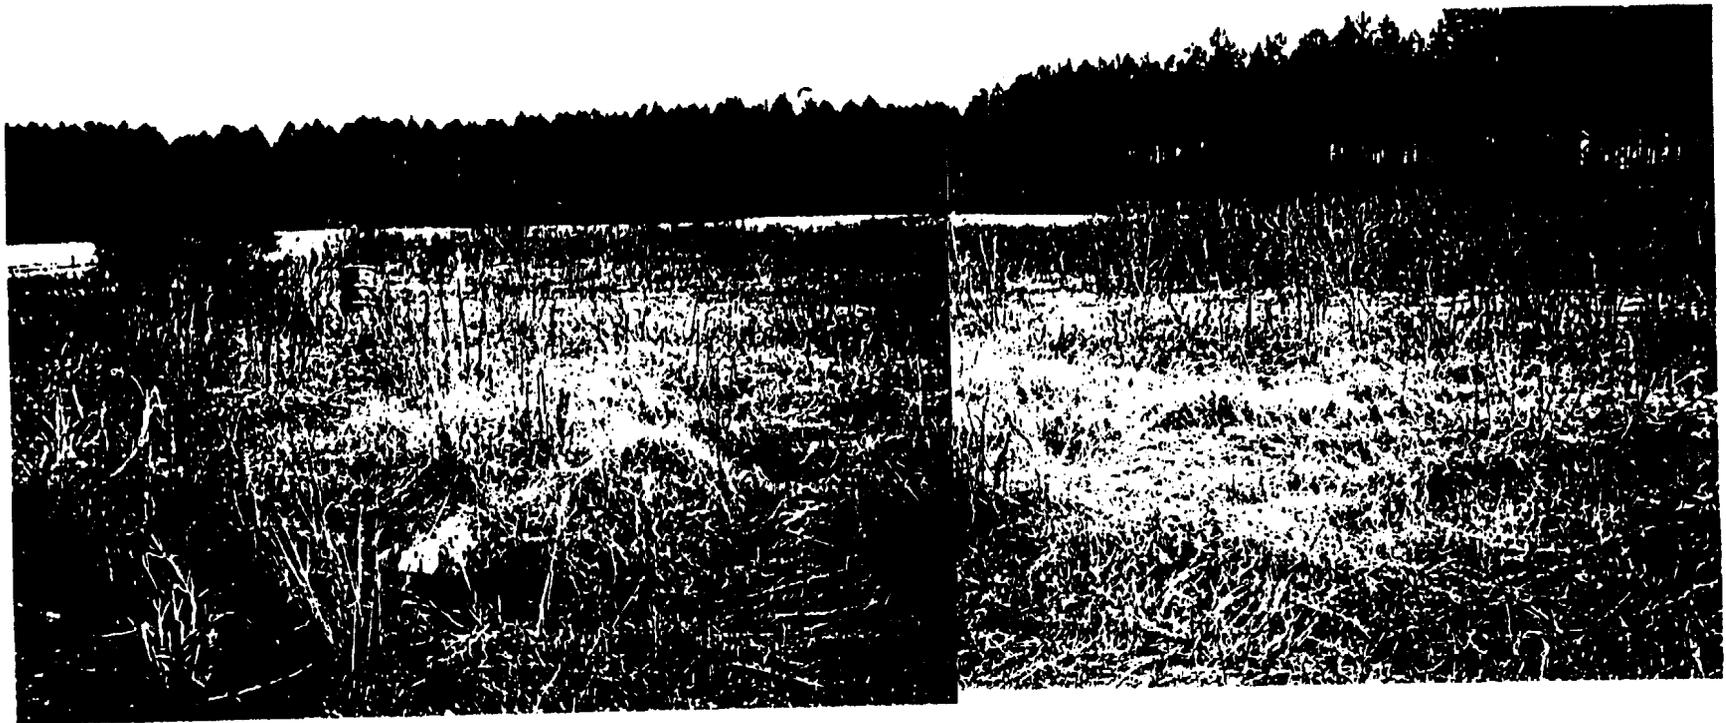
7.1, 7.2

Panorama of a portion of Page Field showing the location of the Page Field Fire Training Pit (Site 7) (SWMU 7). This unit is located in the southeast section of the facility. The view is facing southeast. The drum featured in the upper left-hand corner of the panorama contains groundwater monitoring well cuttings.

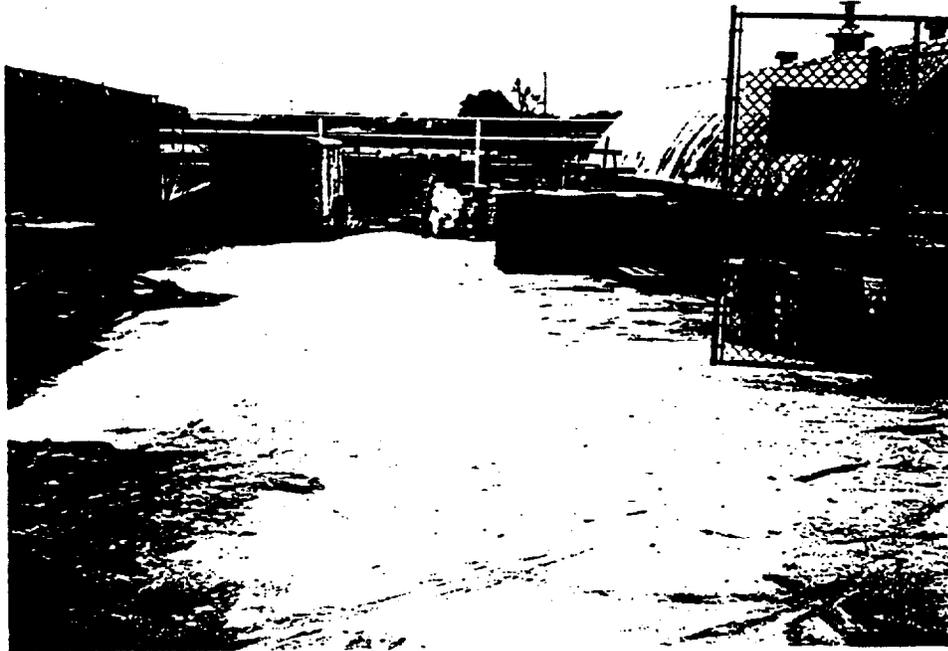
8.1 East-facing view of the northeast section of the facility in the vicinity of Building 277N showing the location of the Paint Waste Storage Area (Site 9) (SWMU 8)

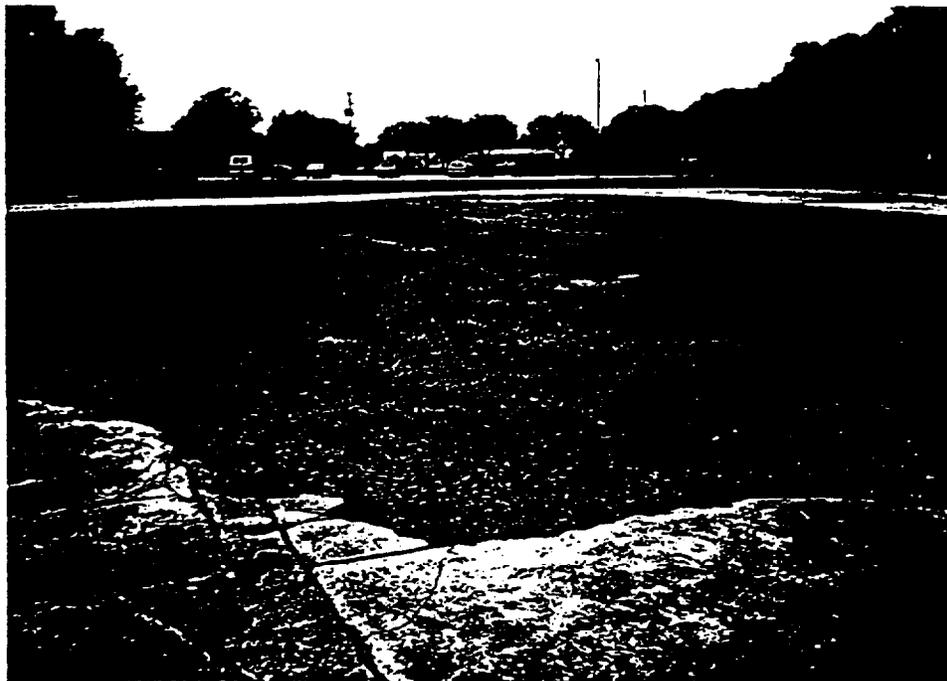
9.1 View of the former location of Building 850 showing the approximate location of the MCX Service Station Spill Area (Site 11) (SWMU 9). The unit is in the northeast section of the facility. The view is facing north.

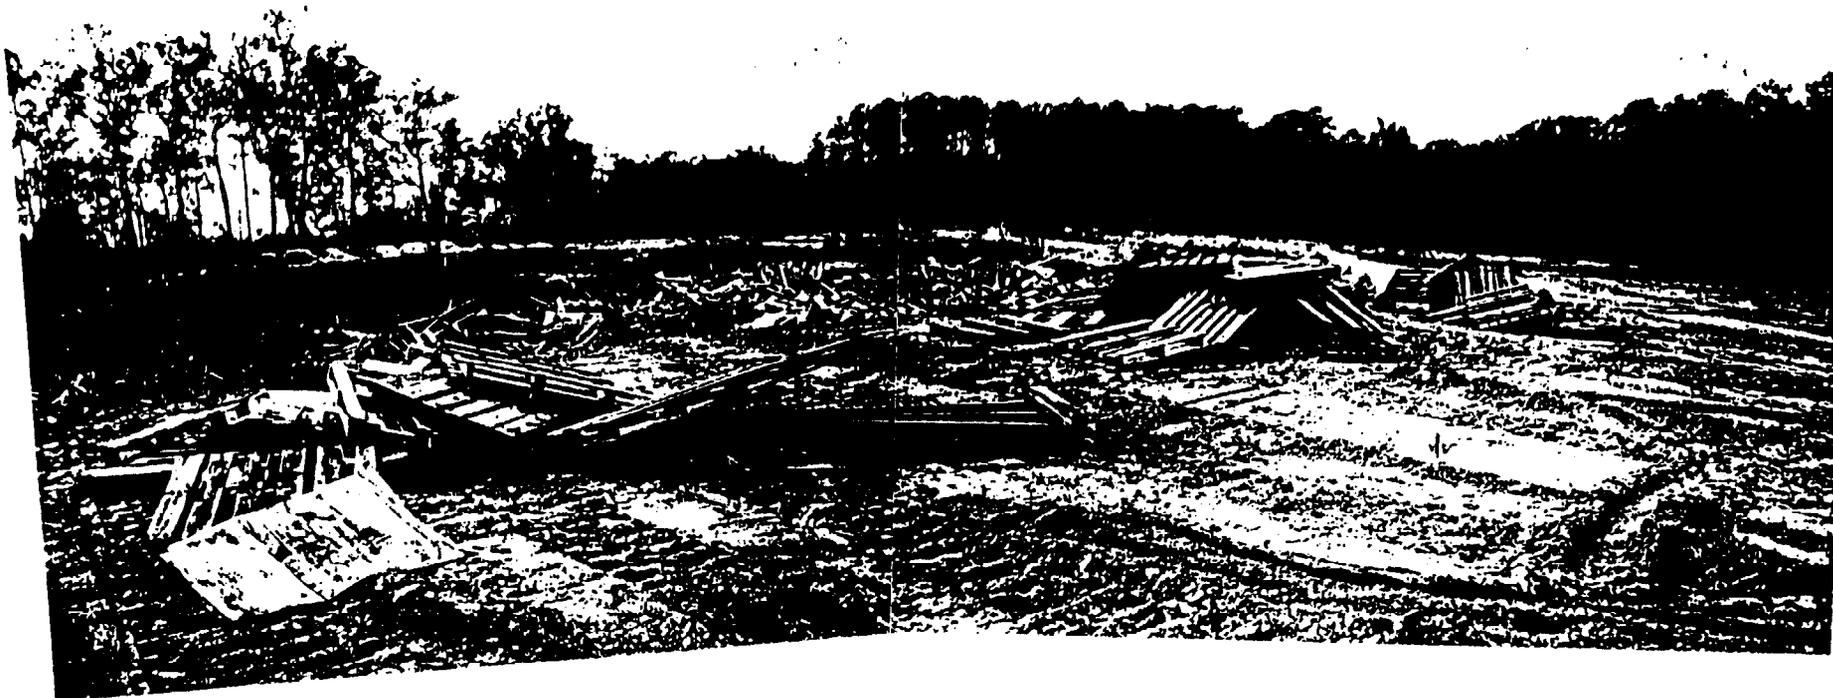
11.1 11.2 Panorama of the Inert Disposal Area A (Site 13) (SWMU 11) located in the central section of Horse Island in the north section of the facility. The view is facing northwest.

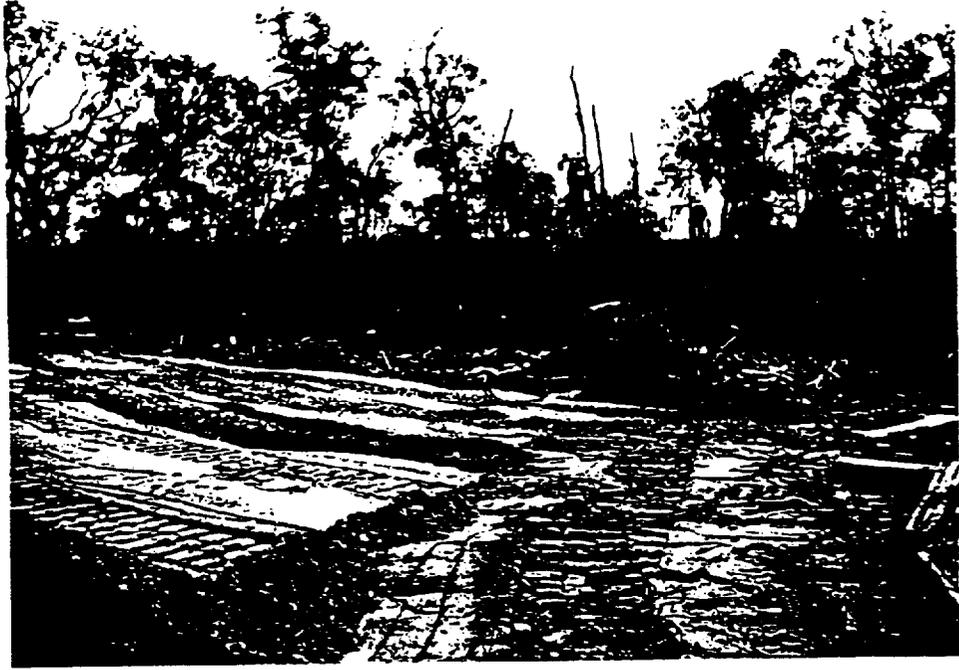
11.3 Continuation of the Inert Disposal Area A (Site 13) (SWMU 11) panorama shown in photographs 11.1 and 11.2. This photograph continues from the left of that panorama.

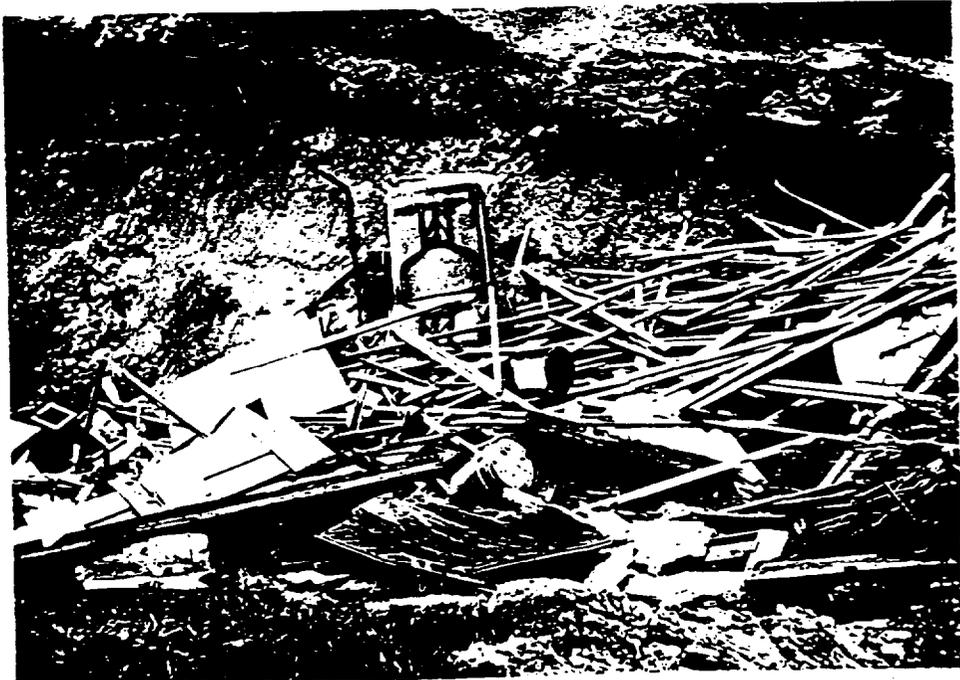
11.4 Close-up of a trench showing the type of wastes disposed at the Inert Disposal Area A (Site 13) (SWMU 11). Note some of the waste is metal.

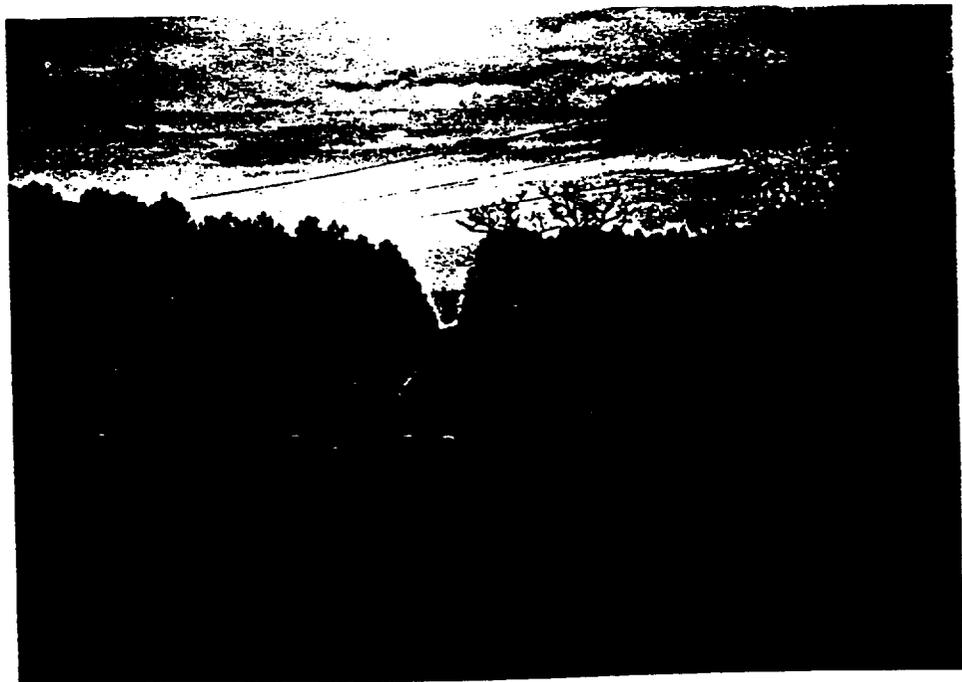
15.1 Northeast view of the road to Elliot's Beach in the west section of the facility. This road is one of the Dirt Roads (Site 15) (SWMU 15) that received oil sprays for dust control.

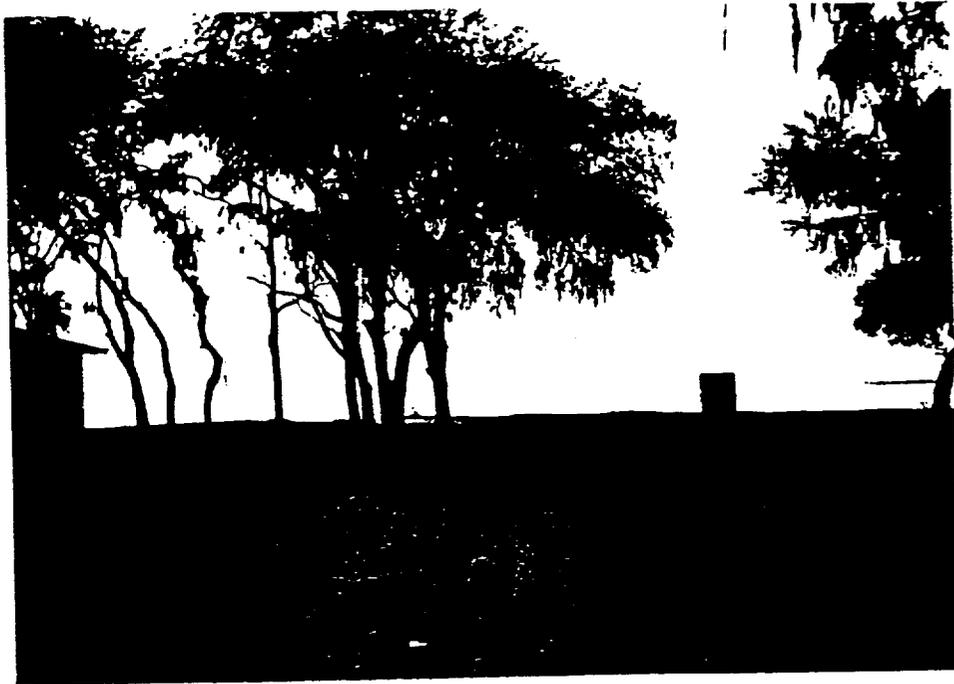
15.2 Southwest view of the Broad River taken from the road to Elliot's Beach. This road is one of the Dirt Roads (Site 15) (SWMU 15) that received oil sprays for dust control.

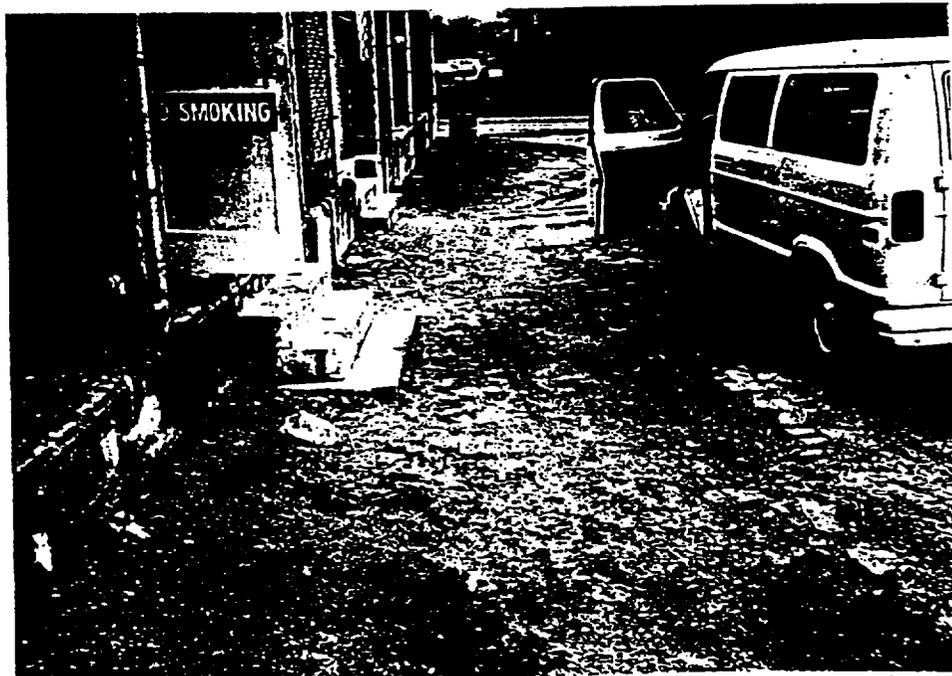
16.1 View of the Pesticide Rinsate Disposal Area (Site 16) (SWMU 16) in the northeast section of the facility. The view is facing northeast.
