INTERIM RESOURCE CONSERVATION AND RECOVERY ACT FACILITY ASSESSMENT
WITH TRANSMITTAL LETTER MCRD PARRIS ISLAND SC
4/4/1990
A T KEARNEY INC

Reference: EPA Contract No. 68-W9-0040; Work Assignment No. R04-05-08; United States Marine Corps Recruit Depot, Parris Island, South Carolina; EPA I.D. No. SC6170022762; Interim RCRA Facility Assessment Report; Final Deliverable

APPENDIX C
PHOTOGRAPH LOG

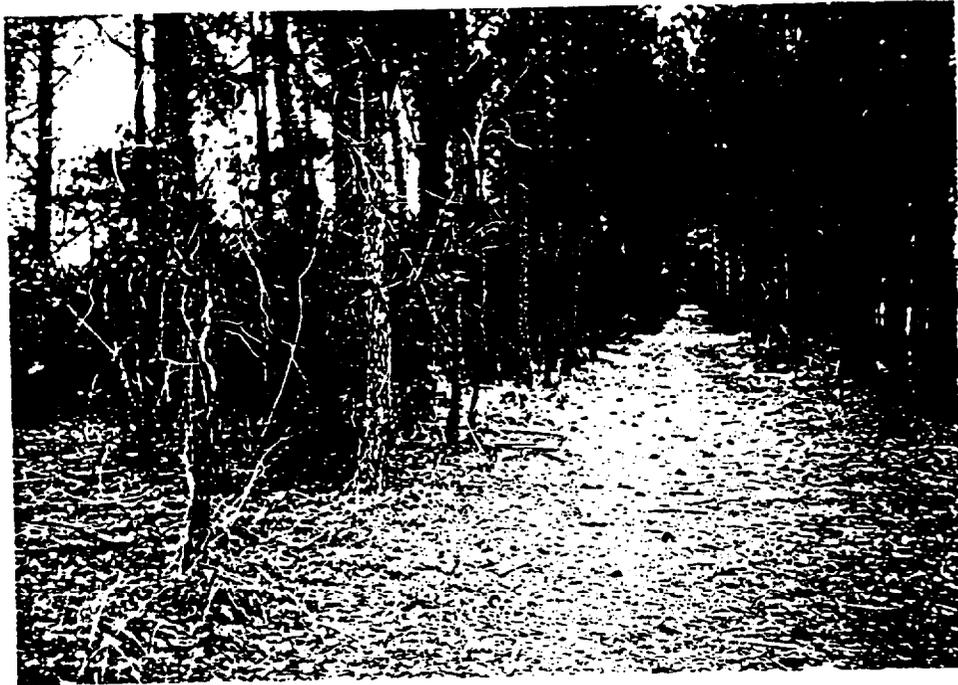
17.1 View of the road leading to the Page Field Tanks (AS-16) (Site 17) (SWMU 17) in the south section of the facility. The view is facing northeast.

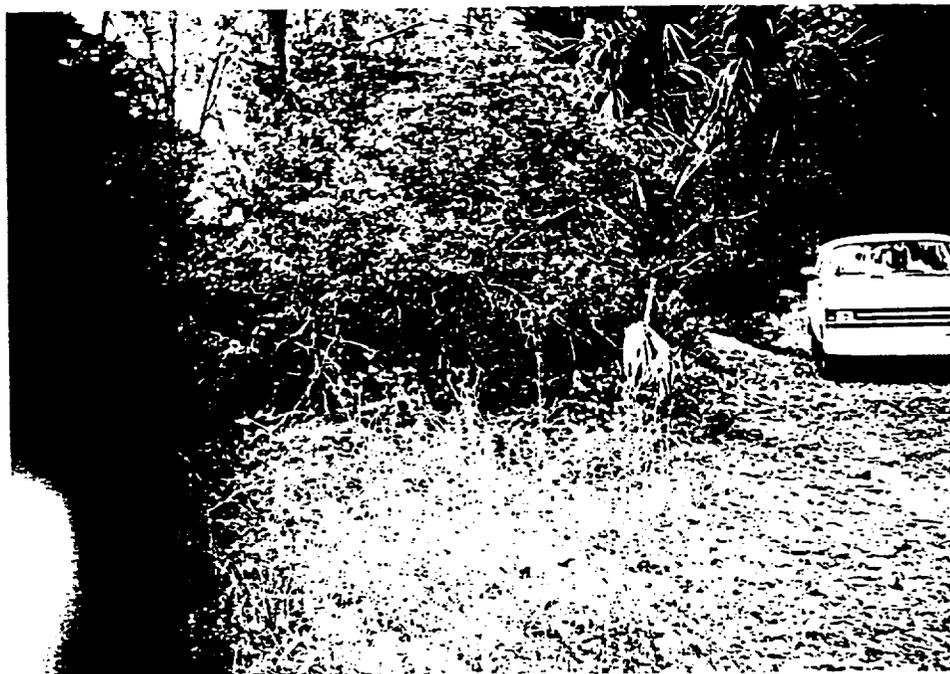
17.2 Close-up of the earthen mound covering the Page Field Tanks (AS-16) (Site 17) (SWMU 17). The view is facing north.

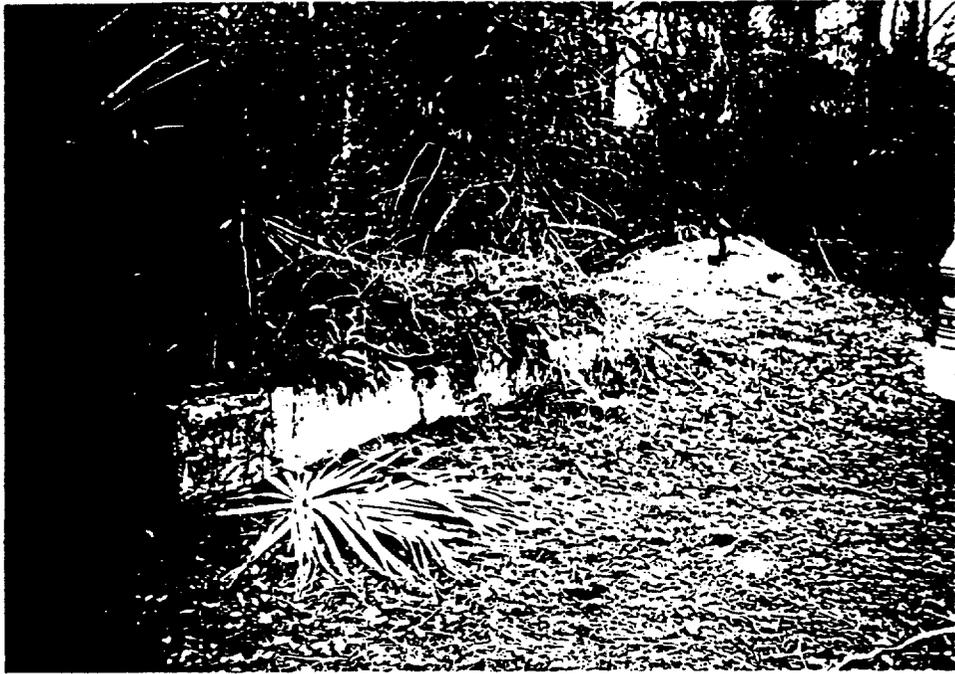
17.3 Close-up of the manway leading to the Page Field Tanks (AS- 16) (Site 17) (SWMU 17). The view is facing northwest.

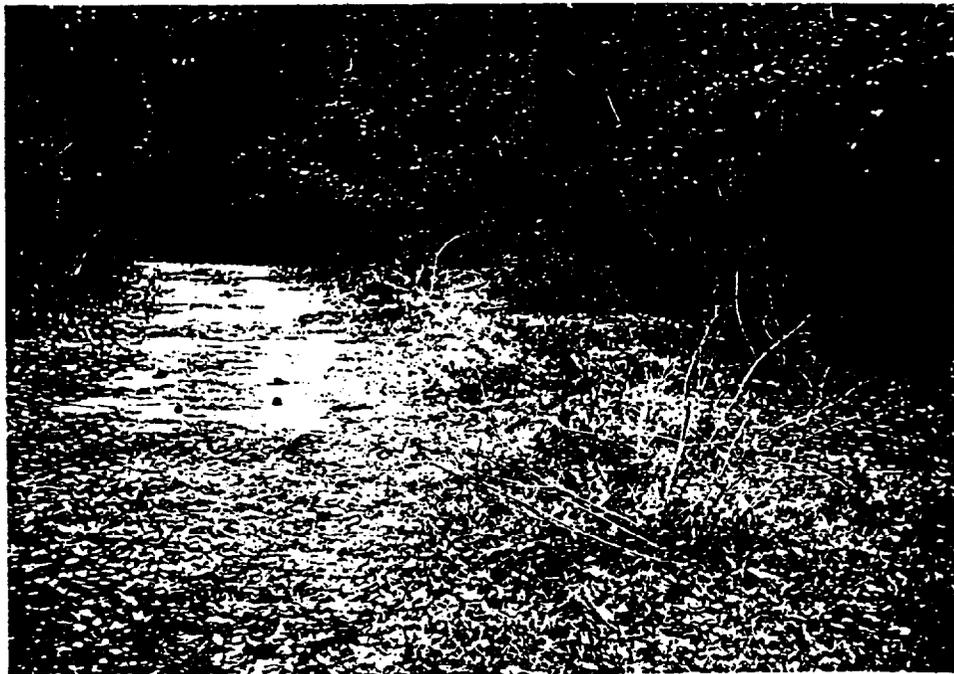
18.1 View of the road leading to the Page Field Tanks (AS-17) (Site 18) (SWMU 18) located in the central section of the facility. The view is facing southwest.

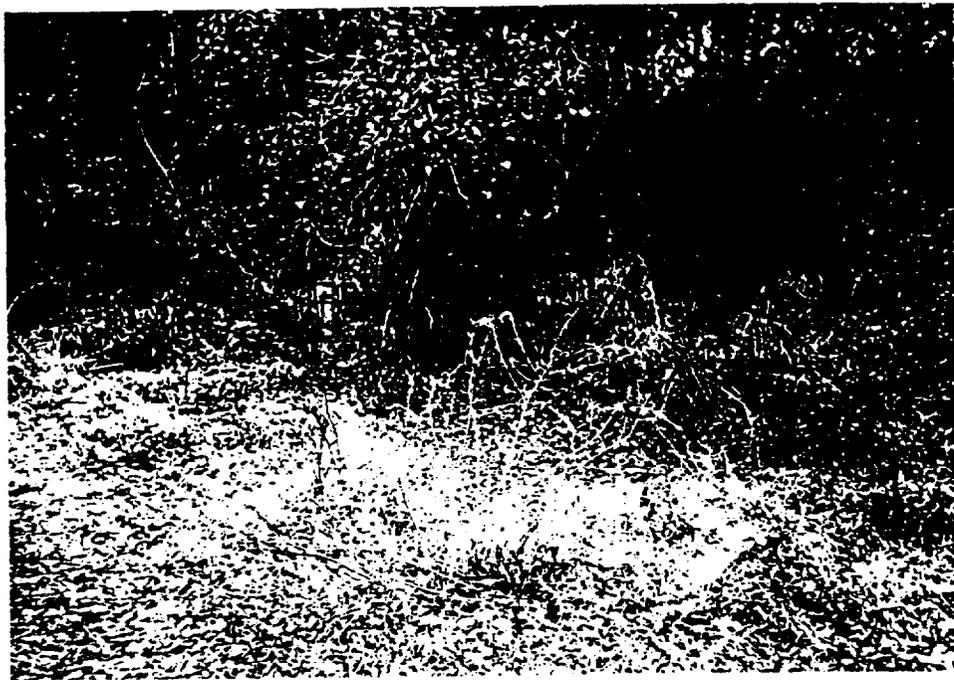
18.2 View of the mound covering the Page Field Tanks (AS 17) (Site 18) (SWMU 18). Note the drum in the left center of the photograph which contains the well cuttings for the groundwater monitoring well in front of the drum.

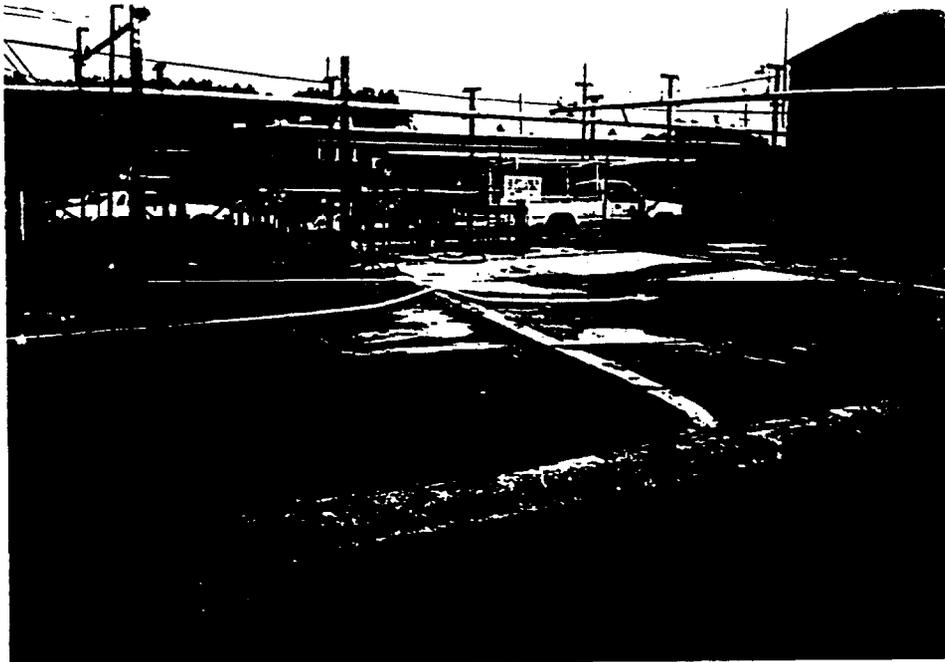
19.1 Overview of the Diesel Shop Vehicle Washing Pad (SWMU 19) located in the northeast section of the facility. The view is facing northwest. Note the drums in the background. The drums in the background are for refuse collected when cleaning garbage trucks.

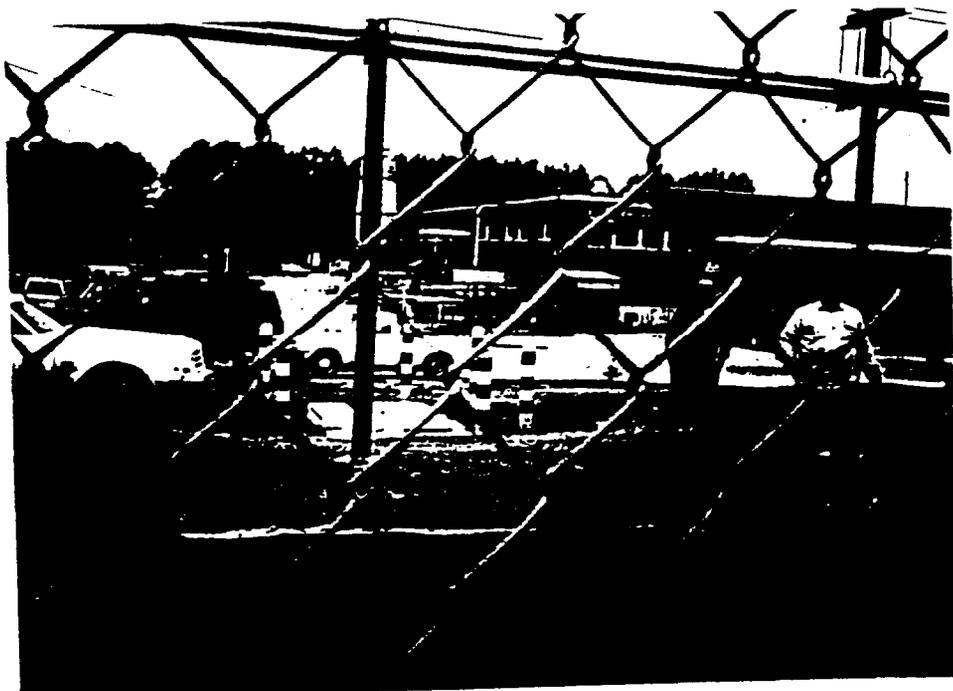
19.2 View of the oil/water separator utilized by the Diesel Shop Vehicle Washing Pad (SWMU 19). The oil/water separator is beneath the white cover surrounded by the black and yellow posts.

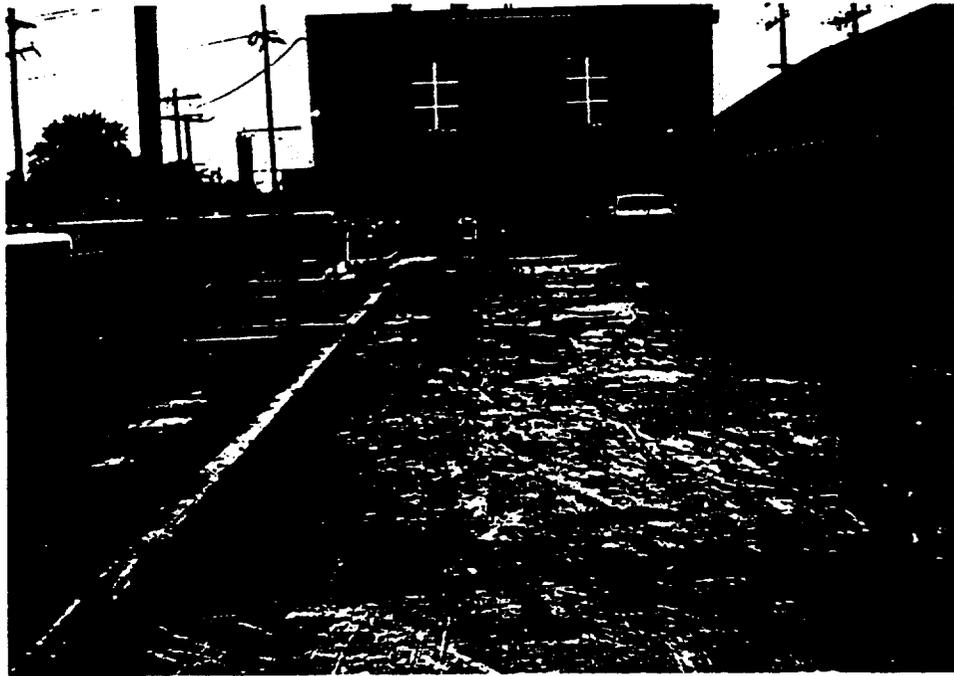
20.1 View of the fuel unloading pad at the Power Station located along the Beaufort River in the northeast section of the facility. Runoff from this pad is received by the Power Station Oil/Water Separator (SWMU 20). Note the No.6 fuel oil stain along the secondary containment walls

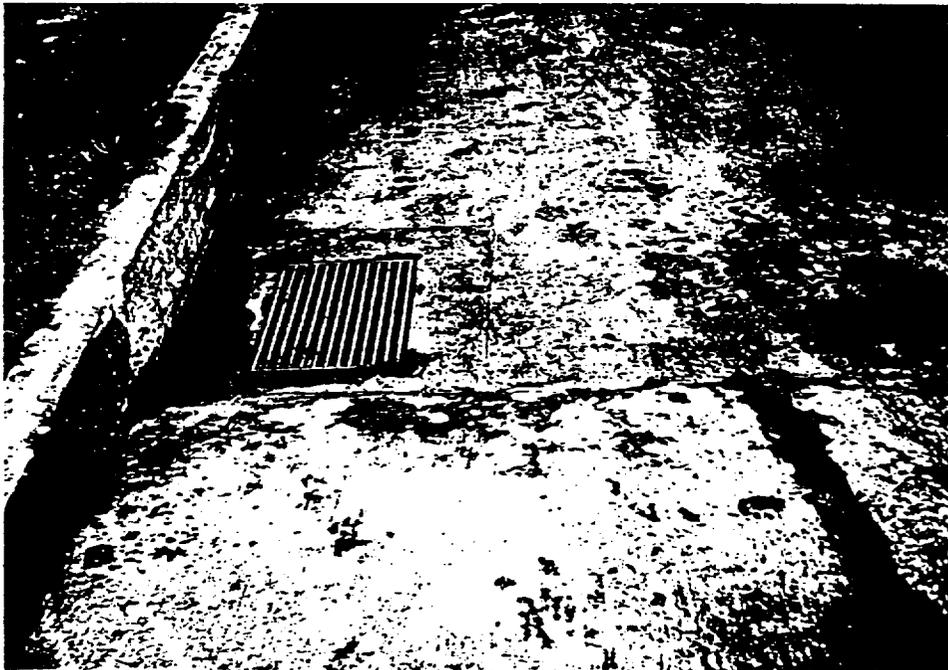
20.2 Close-up of the drain for the unloading pad featured in photograph 20.1. The drain discharges into the Power Station Oil/Water Separator (SWMU 20).

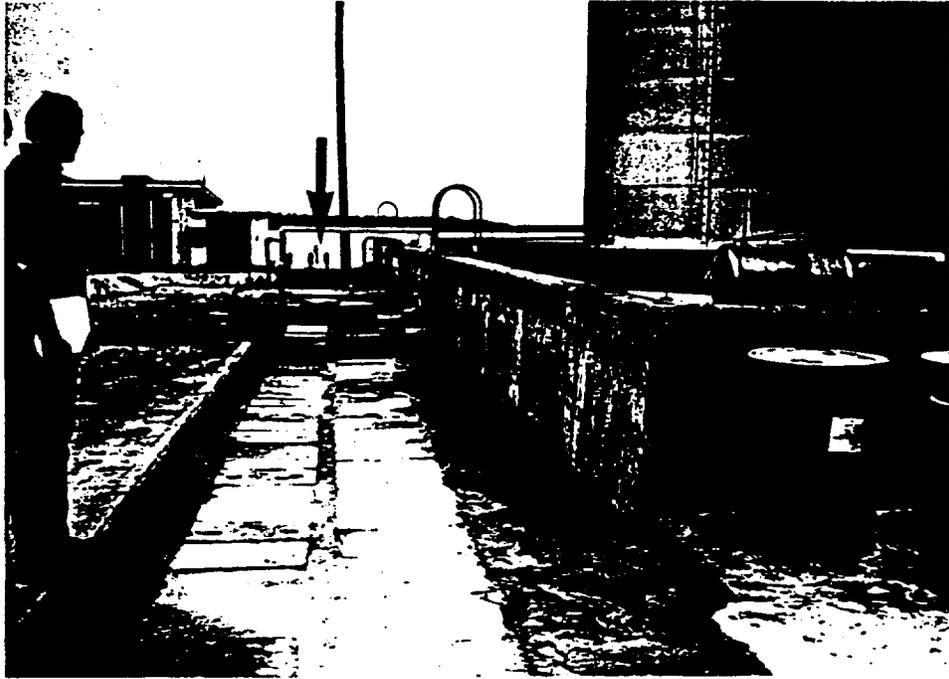
20.3 View of the Power Station fuel containment system showing the fuel unloading pad on the left, the Beaufort River in the center, the Power Station Oil/Water Separator (SWMU 20) (indicated by an arrow), and the secondary containment for the No. 6 fuel tanks. The large silver tanks contain No. 6 fuel oil. The green drum in the lower right hand corner of the photograph is staged at the Power Station SAA (SWMU 28). The view is facing east.

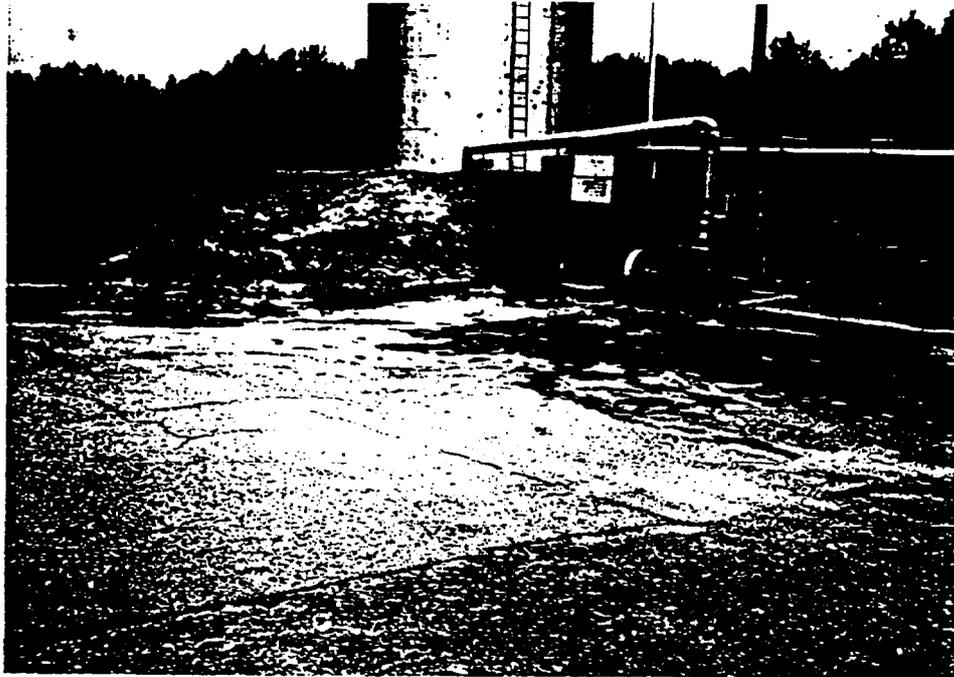
21.1 Overview of the Weapons Power Plant containment area showing the fuel unloading pumps and the No. 6 fuel oil tank. Runoff from this area is received by the Weapons Power Plant Oil/Water Separator (SWMU 21). This unit is in the west section of the facility. The view is facing south.

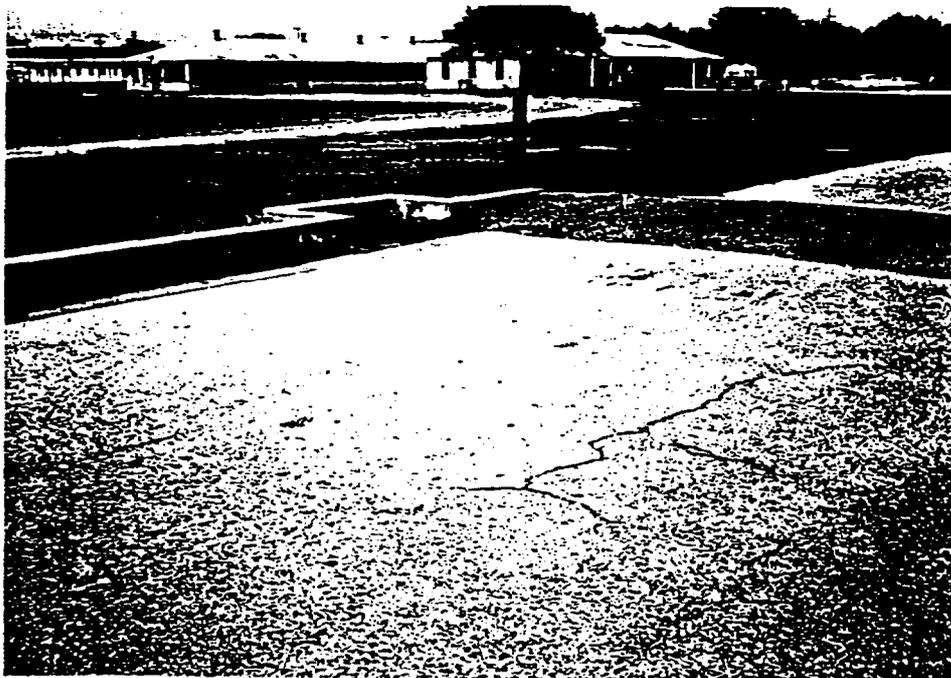
21.2 View of the fuel unloading pad and drain for the Weapons Power Plant facing east. The orange pipe is the valve for the Weapons Power Plant Oil/Water Separator (SWMU 21).

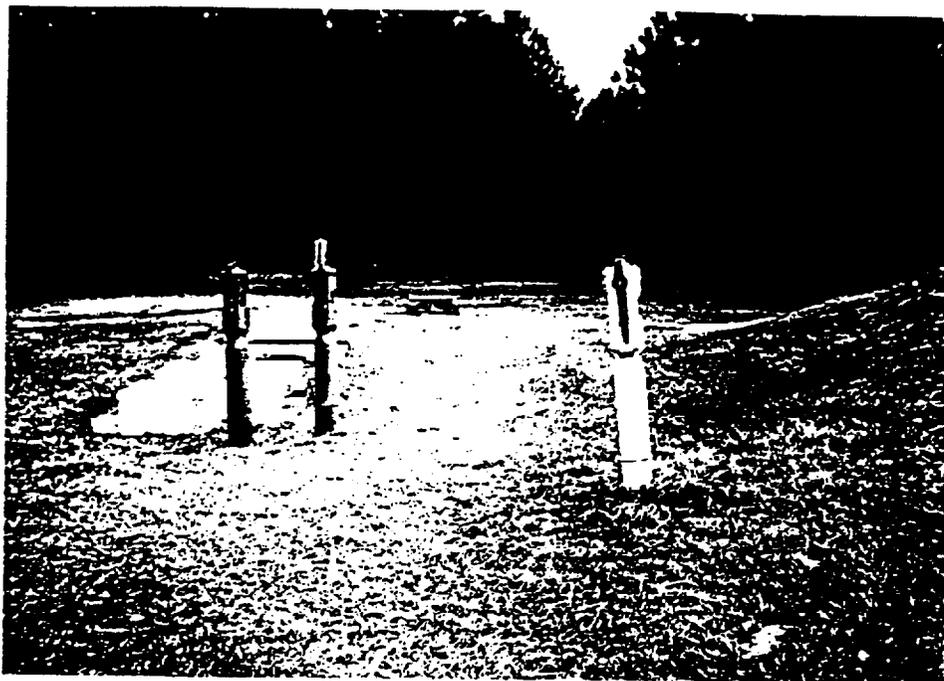
21.3 Overview of the Weapons Power Plant Oil/Water Separator (SWMU 21) showing the control valves. The valve on the right is from the secondary containment for the No. 6 fuel oil tank. The view is facing west. The marsh and Broad River are beyond the trees in the background.

<u>Unit No.</u>	<u>Unit Name</u>	<u>Operational Dates</u>	<u>Suggested Sampling</u>	<u>Evidence of Release (Yes/No)</u>
21	Weapons Power Plant Oil/Water Separator	1980s to Present	Sample the effluent prior to discharge to nearby marsh. Analyze for Appendix IX metals and semi-volatiles. Based on these results, further sampling may be warranted at nearby marsh.	No
27	Equipment Parade Deck	Unknown	Sample the soil beneath the cracks in the asphalt, particularly in stained areas, to determine if hazardous constituents have been released. Analyze the samples for Appendix IX metals, volatiles, semi-volatiles and PCBs.	Yes
28	Power Station SAA	1988 to Present	Conduct soil sampling beneath the cracks of the concrete pad and along the edge of the pad to determine if hazardous constituents have been released. Analyze the samples for Appendix IX metals, volatiles and semi-volatiles.	Yes
35	DRMO Salvage Yard	1964 to Present	Sample the soil beneath the cracks featured in photograph 35-1. Analyze the samples for Appendix IX metals and semi-volatiles.	Yes

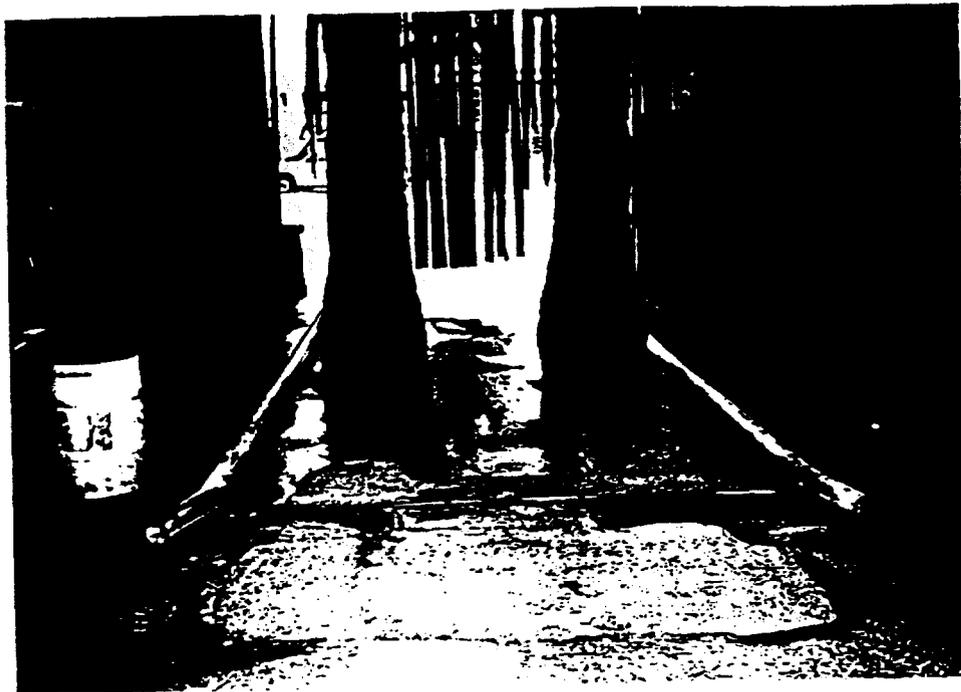
22.1 Overview of the Motor Pool Car wash (SWMU 22) located in the northeast section of the facility. The view is facing east.

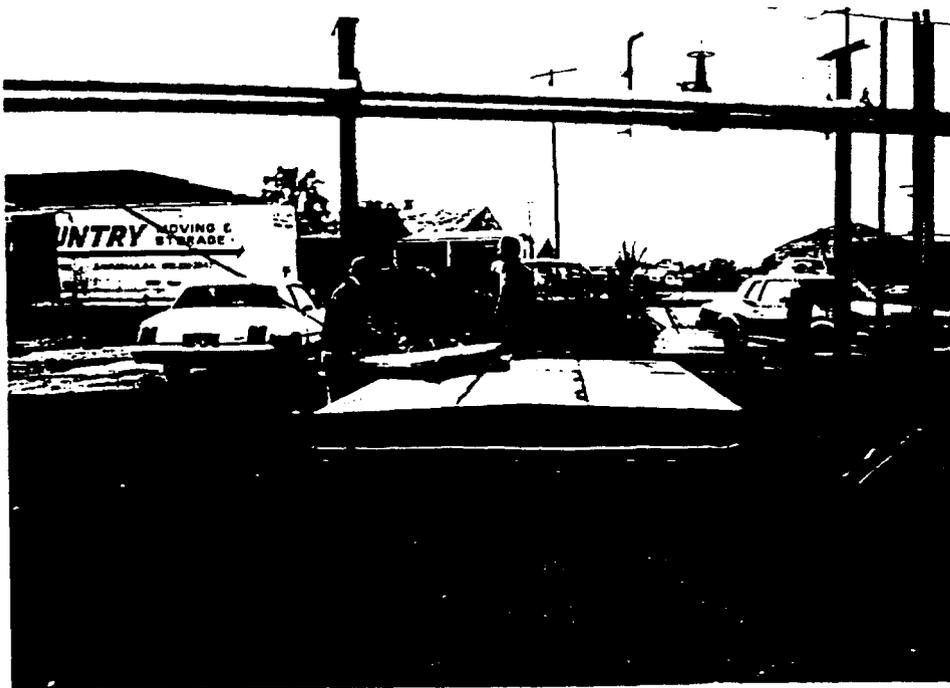
22.2 View of the oil/water separator utilized by the Motor Pool Car Wash (SWMU 22) facing west.

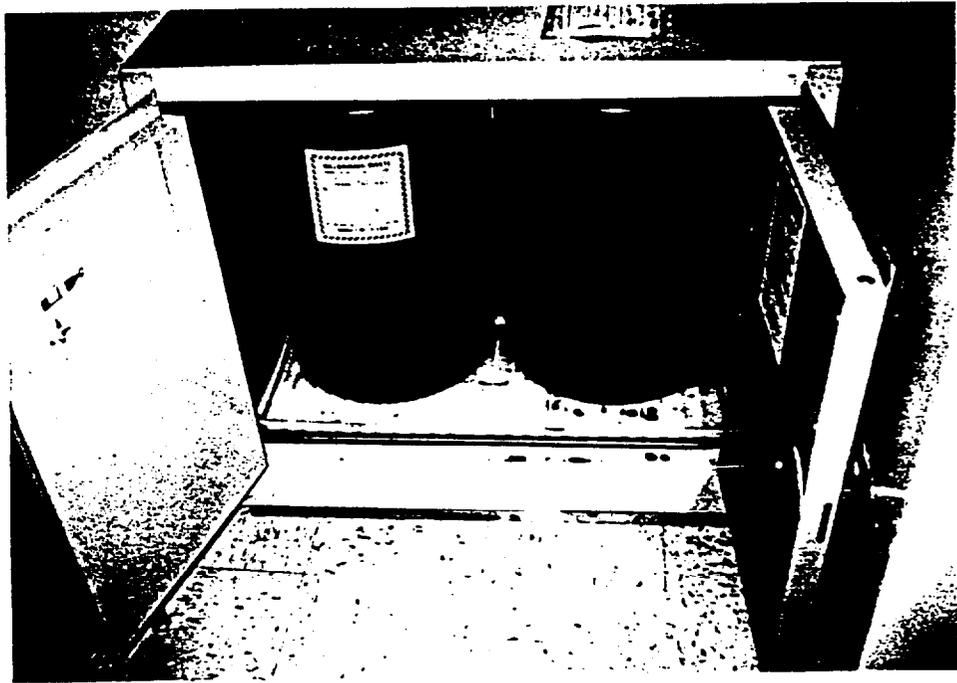
23.1 Interior view of the Indoor Dental Lab SAA (SWMU 23) showing the cabinet used to store the spent developer and fixer. This unit is located in the northeast section of the facility.

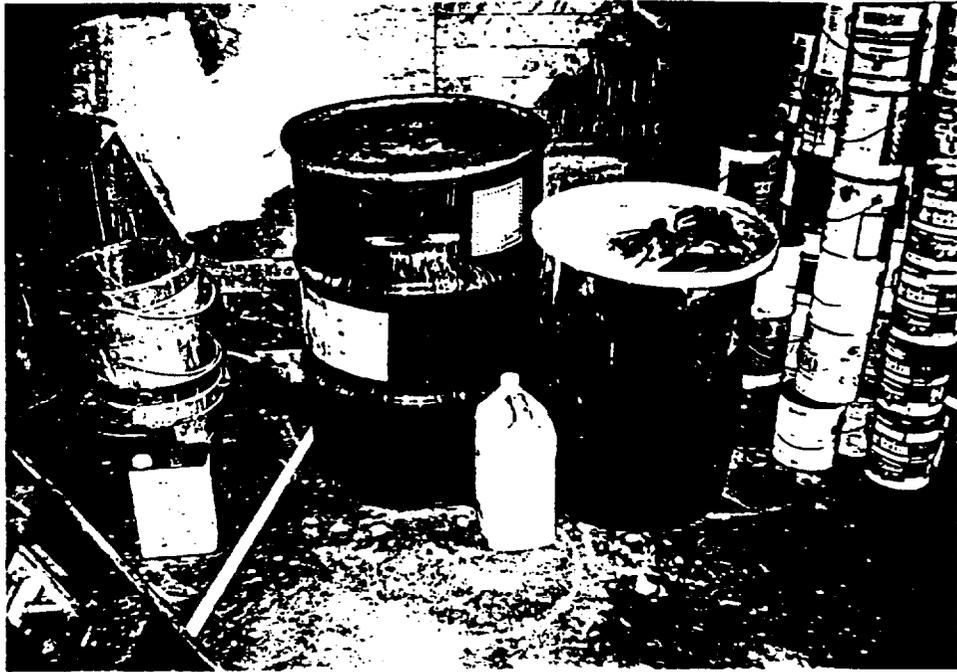
25.1 Interior view of Building 177N showing the the types of container and general condition of the Paint Shop SAA (SWMU 25). This unit is located in the northeast section of the facility.

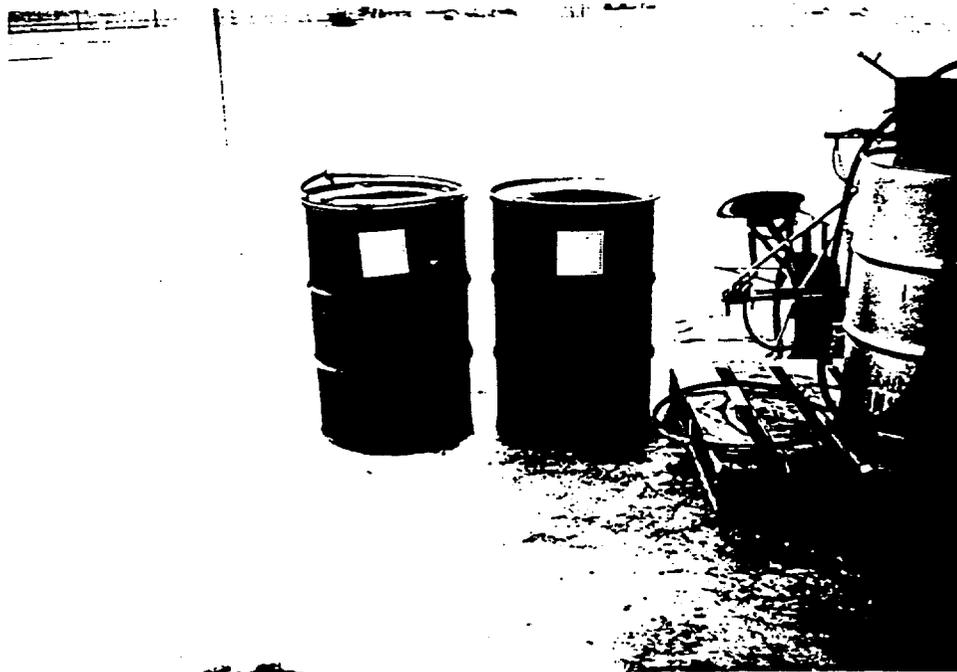
26.1 View of the Pesticide SAA (SWMU 26) located in the northeast section of the facility. The black drums are for empty pesticide containers.

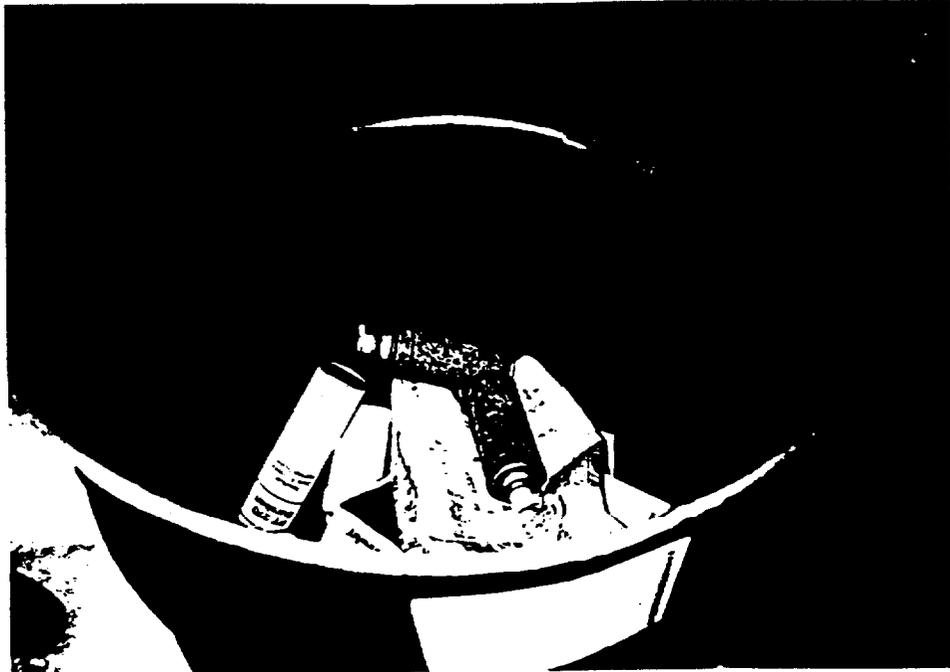
26.2 Close-up of a drum containing empty pesticide containers at the Pesticide SAA (SWMU 26).

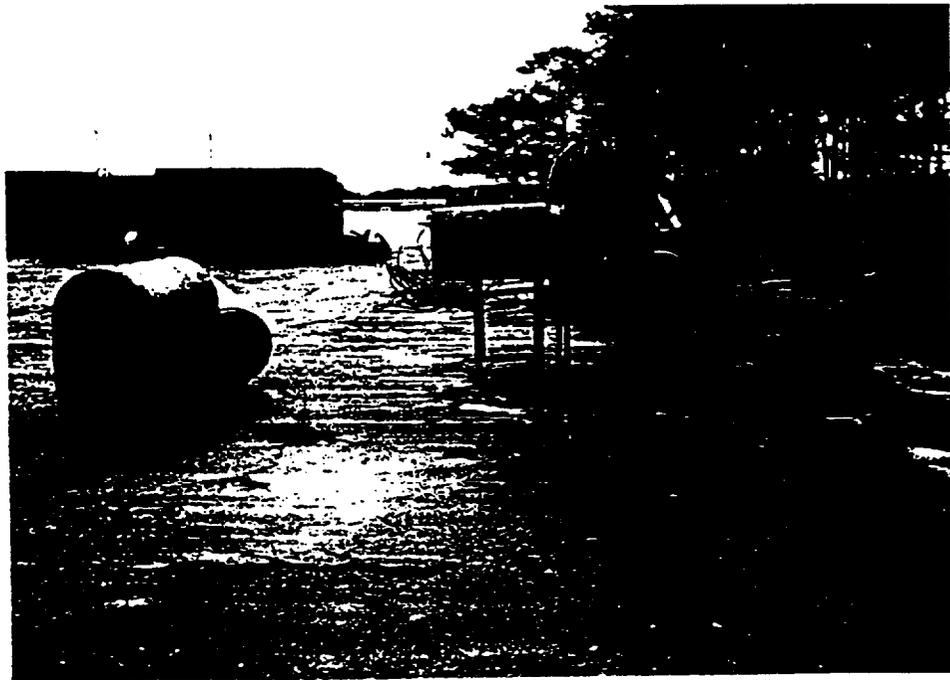
27.1 View of the Equipment Parade Deck SAA (SWMU 27) located in the northeast section of the facility facing east. Note the stains and the poor condition of the asphalt. The tanks reportedly contained fuel oil.

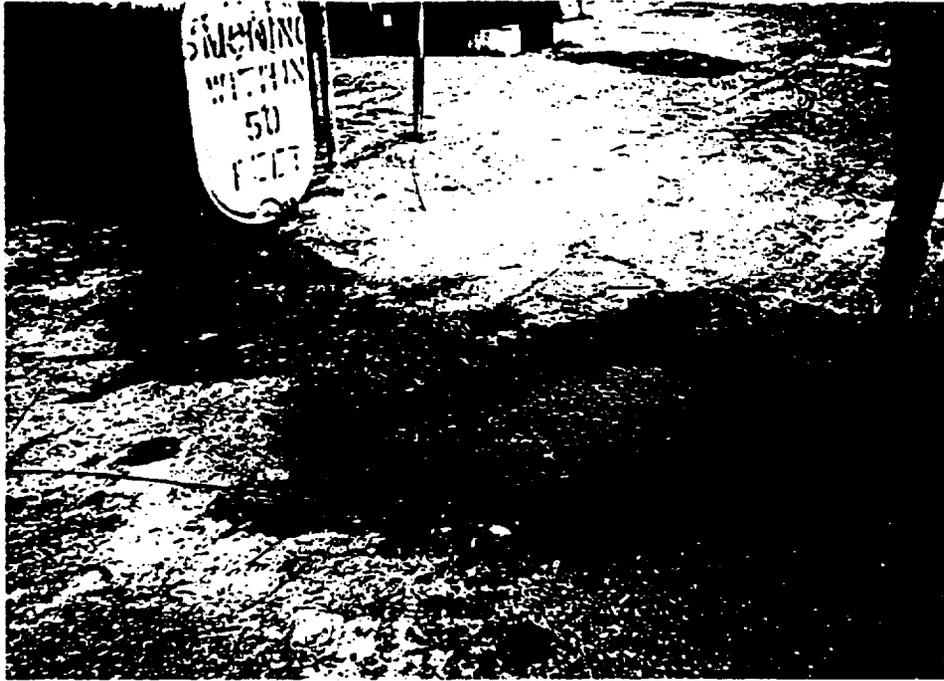
27.2 Close-up of the asphalt at the Equipment Parade Deck SAA (SWMU 27) showing staining.

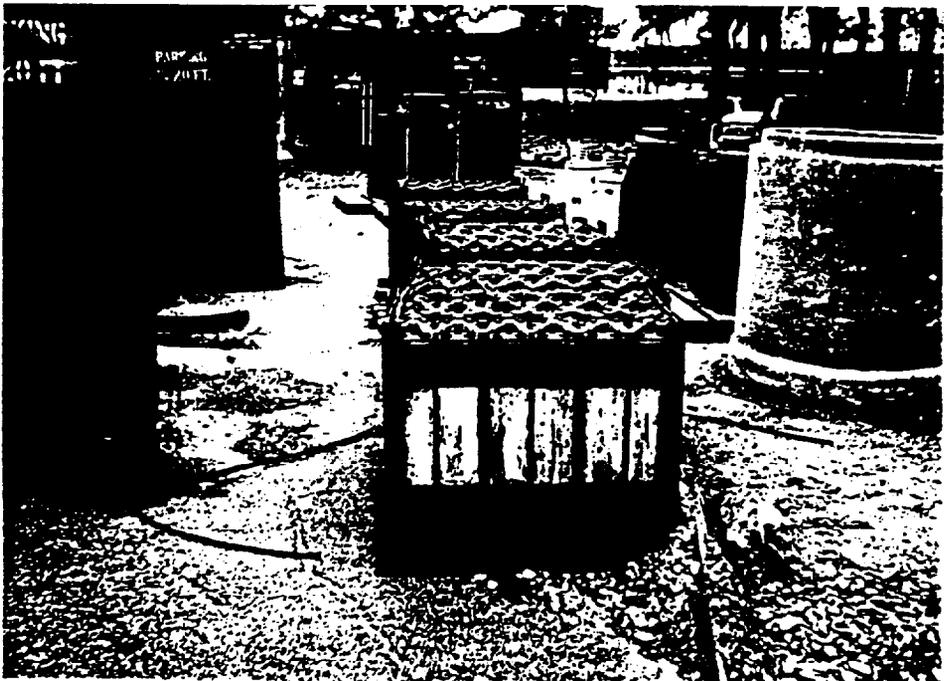
27.3 View of the Equipment Parade Deck SAA (SWMU 27) showing the reportedly PCB free transformers, dumpsters and large batteries. Note the crack in the asphalt.

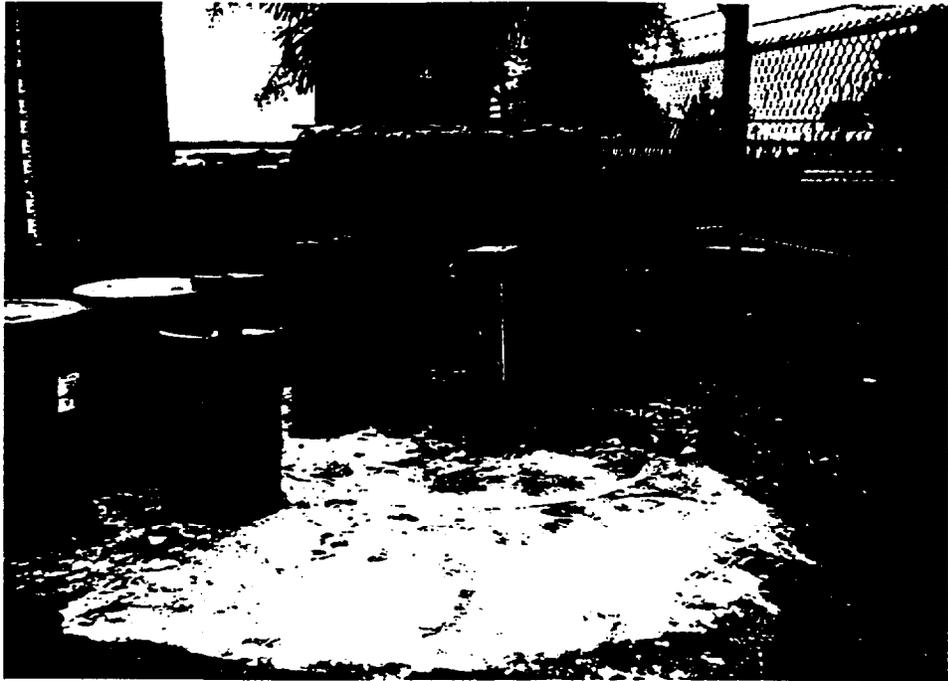
28.1 View of the Power Station SAA (SWMU 28) located in the northeast section of the facility. The view is facing southeast. The black drum contains waste oil and the green drums contain soil contaminated with No. 6 fuel oil. The white powder is lime. The horizontal tank is kerosene storage. Note the stained area beneath the tank. The unit is adjacent to the No. 6 fuel oil storage area.

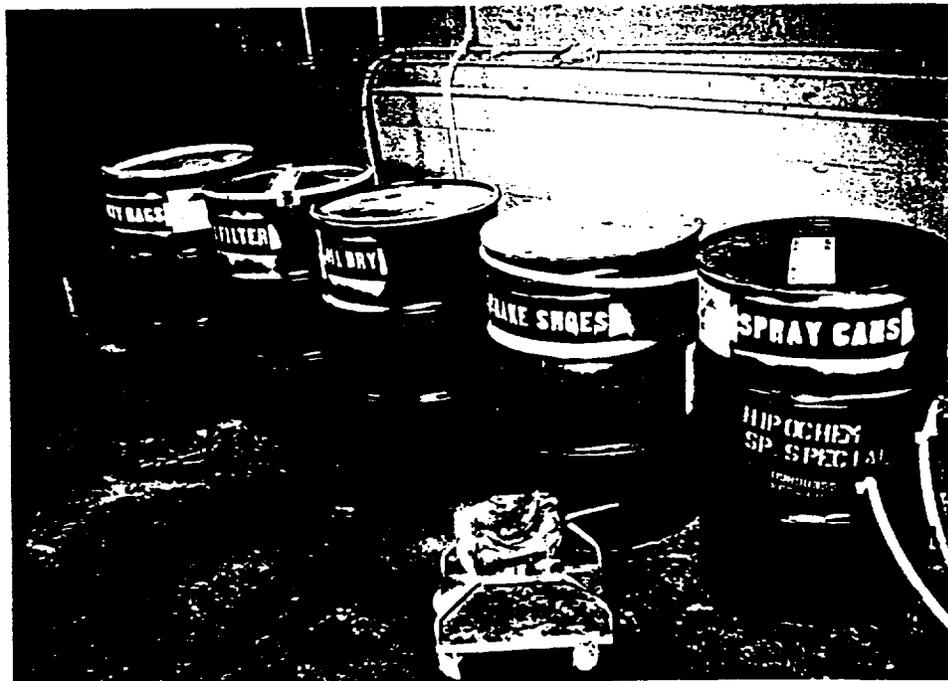
29.1 View of the Indoor Motor Pool SAA (SWMU 29) located in the northeast section of the facility.

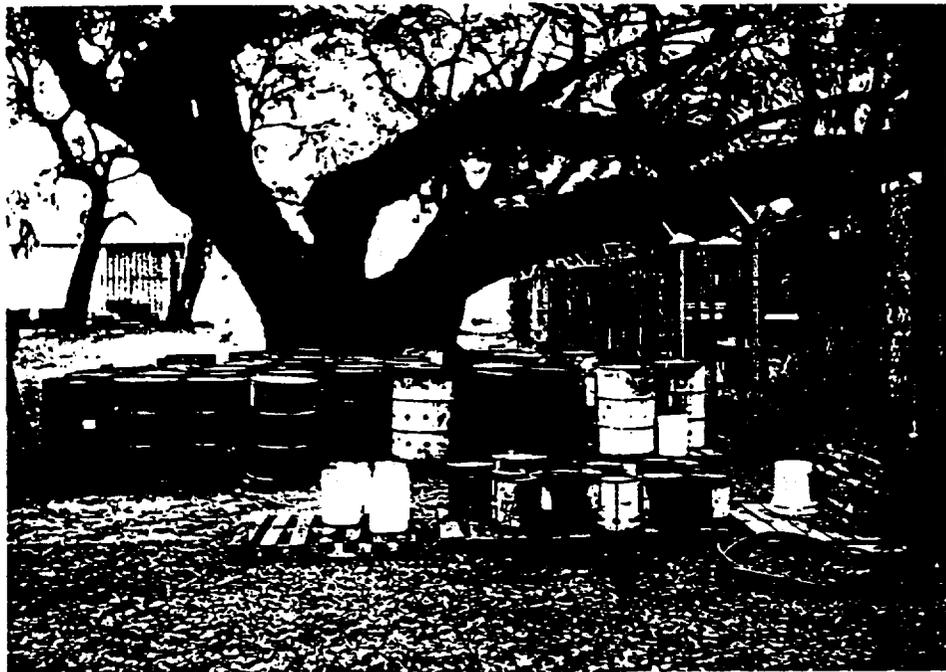
30.1 Southeast view of the Empty Drum Storage Area SAA (SWMU 30) located in the northeast section of the facility.

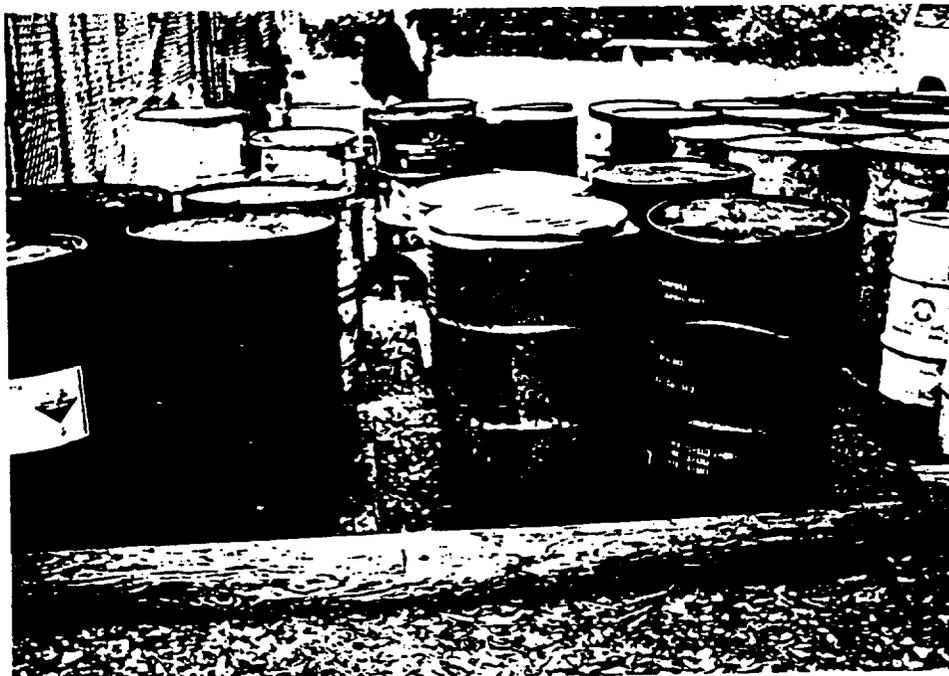
30.2 Close-up of the Empty Drum Storage Area SAA (SWMU 30) facing northwest.

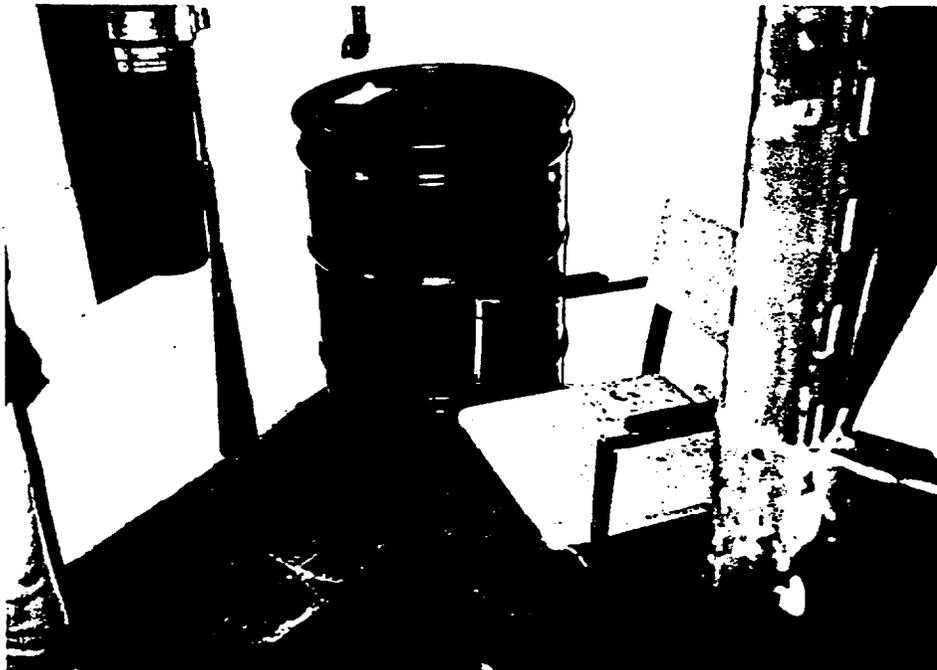
32.1 View inside the Laundry Building located in the northeast section of the facility showing the Laundry SAA (SWMU 32). Note the stained floor.

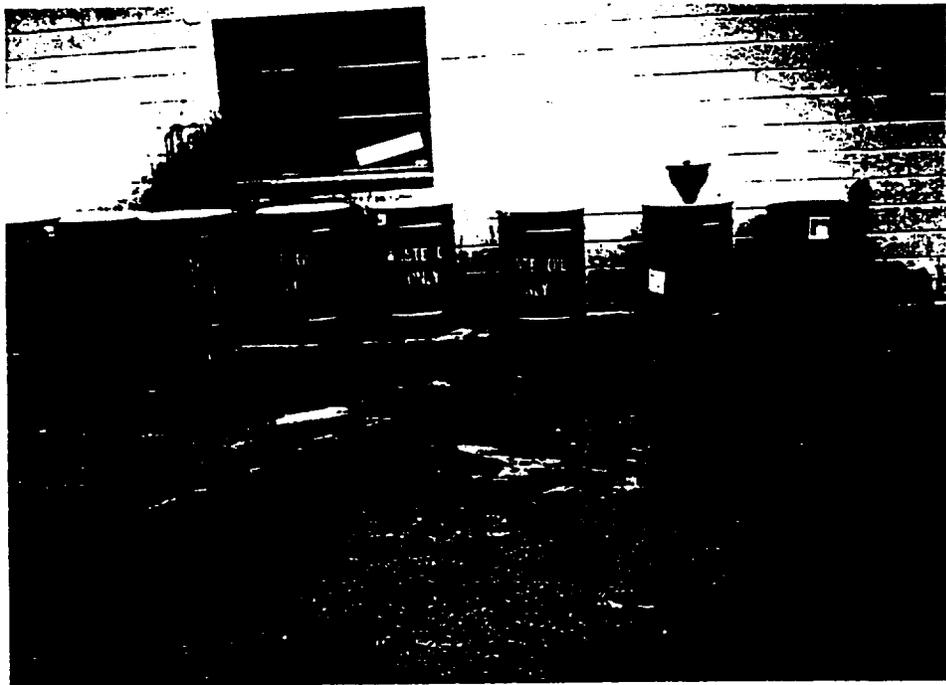
33.1 View of the Motor Pool SAA (SWMU 33) located in the northeast section of the facility facing east. The inlet in the right-hand side of the photograph leads to the Motor Pool Underground Waste Oil Tank (SWMU 43).

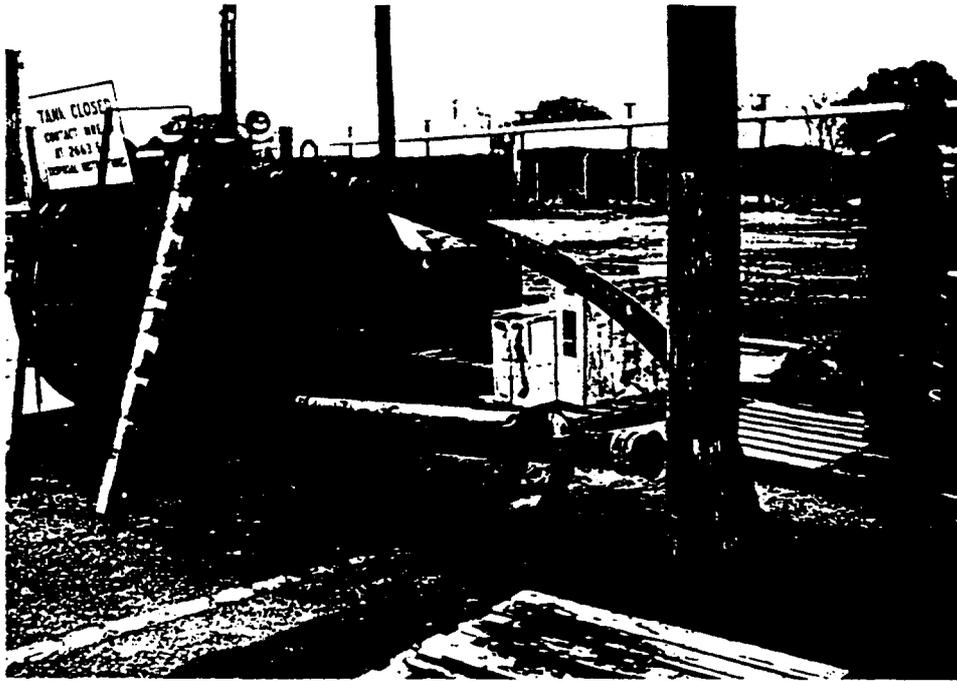
34.1 View of the Motor Pool Waste Oil Tank (SWMU 34) facing northeast. This unit was recently taken out of service. According to facility representatives, the spill around the telephone pole is the result of the moving activities. This tank was previously located at the Motor Pool SAA (SWMU 33) which is approximately 150 feet south of the area featured in this photograph.

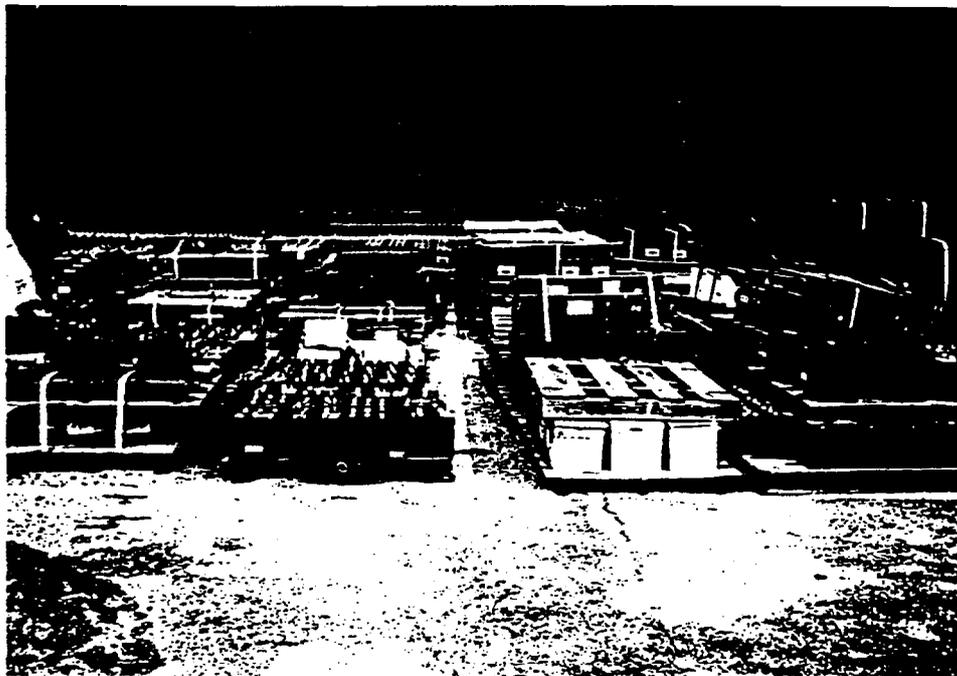
35.1 View of the battery storage area at the DRMO Salvage Yard (SWMU 35) located in the north section of the facility. The view is facing north. Note the crack in the asphalt and the battery storage conditions.

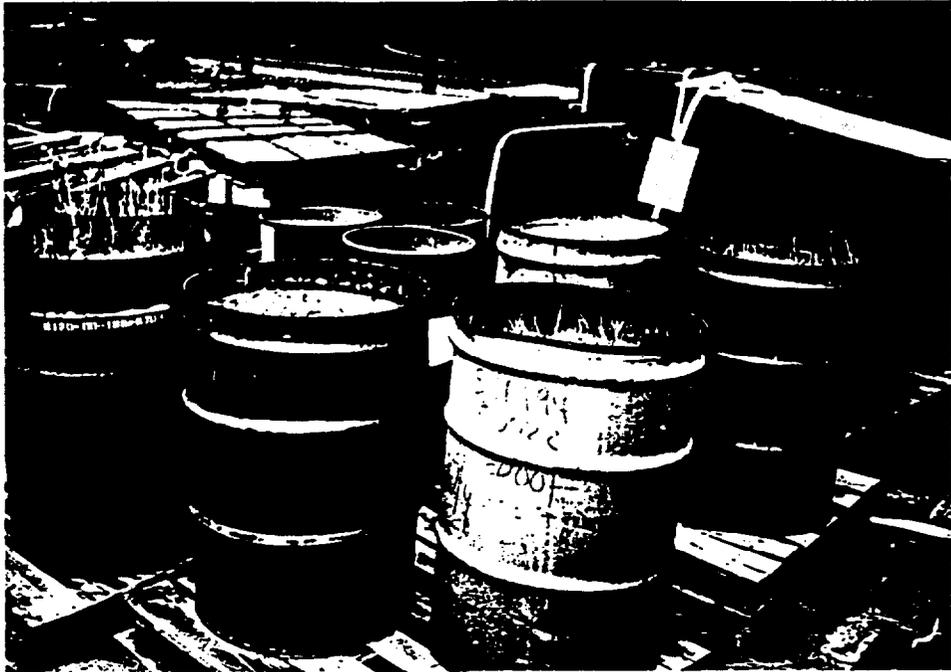
35.2 Close-up of drums containing scrap lead at the DRMO Salvage Yard (SWMU 35).

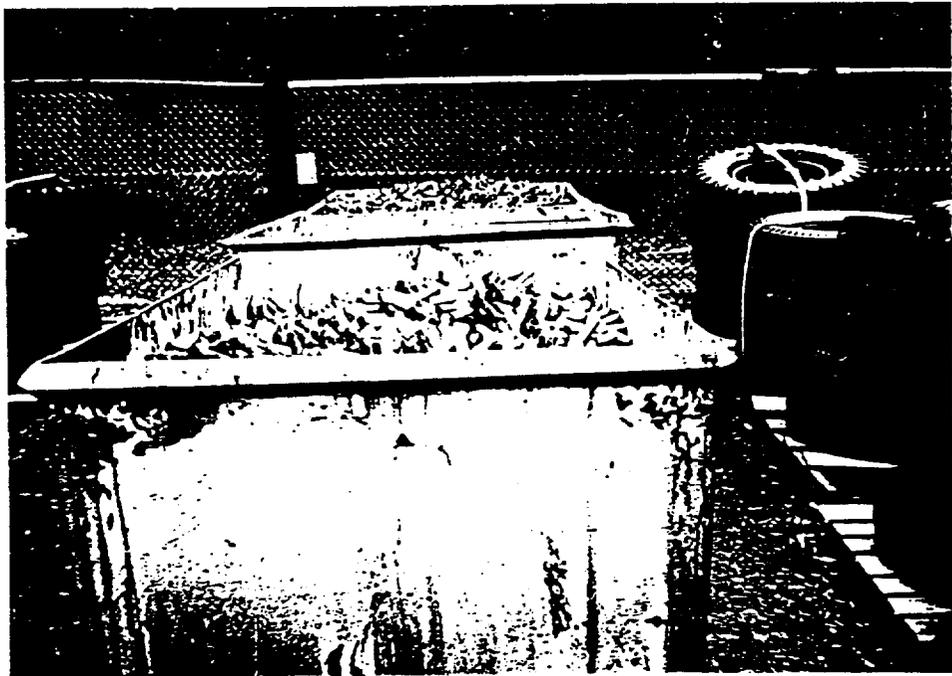
35.3 View of metal hoppers containing scrap brass at the DRMO Salvage Yard (SWMU 35).
