INTERIM RESOURCE CONSERVATION AND RECOVERY ACT FACILITY ASSESSMENT
WITH TRANSMITTAL LETTER MCRD PARRIS ISLAND SC
4/4/1990
A T KEARNEY INC

Reference: EPA Contract No. 68-W9-0040; Work Assignment No. R04-05-08; United States Marine Corps Recruit Depot, Parris Island, South Carolina; EPA I.D. No. SC6170022762; Interim RCRA Facility Assessment Report; Final Deliverable

APPENDIX C
PHOTOGRAPH LOG

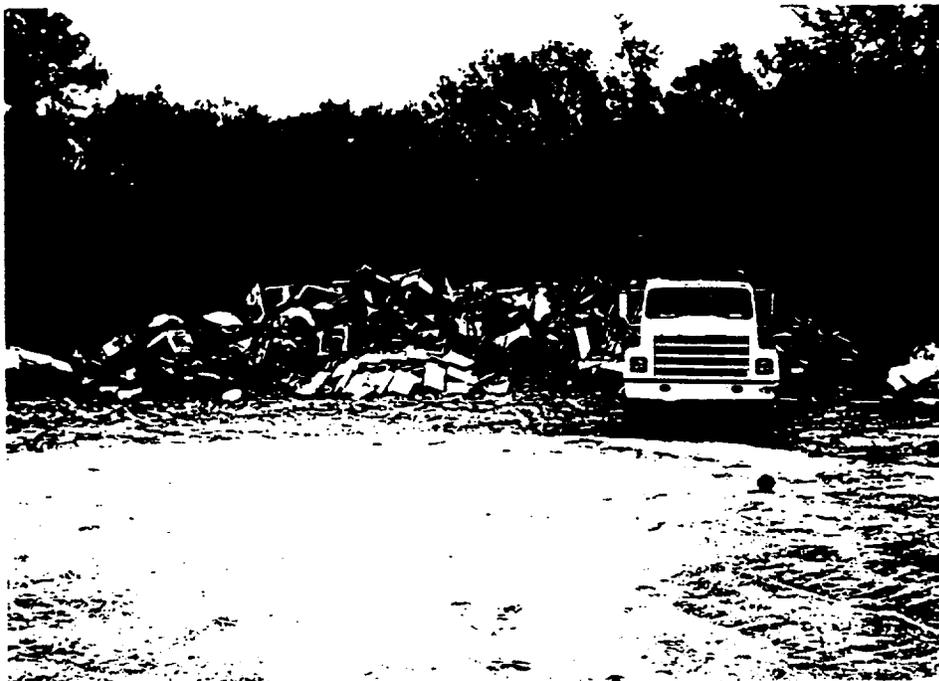
35.4 Southeast-facing view of the scrap metal pile at the DRMO Salvage Yard (SWMU 35). This section of the yard is the only section that is not paved.

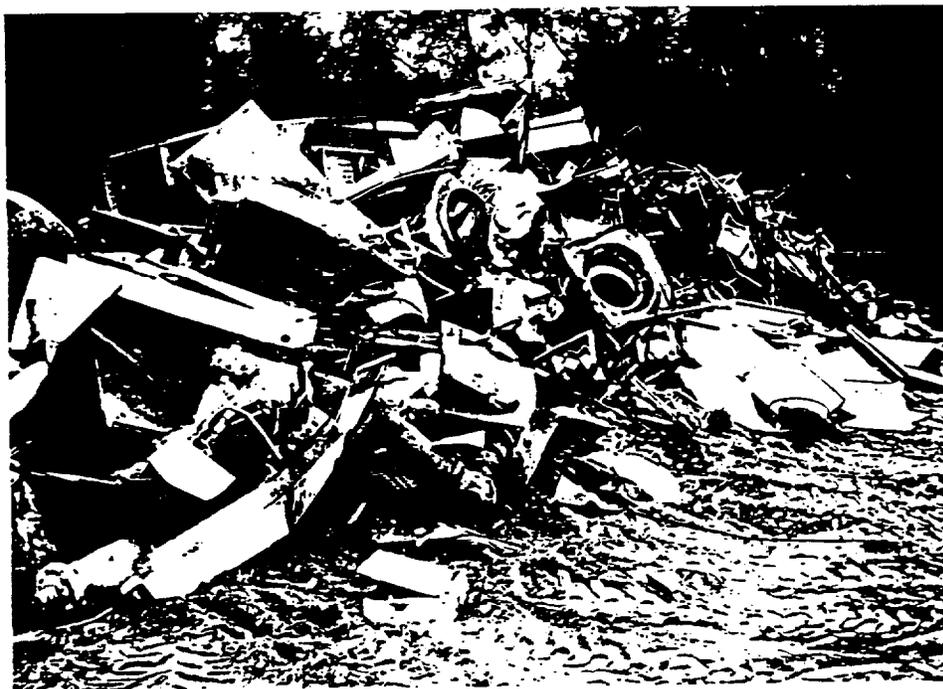
35.5 Close-up of the scrap metal pile at the DRMO Salvage Yard (SWMU 35) facing south.

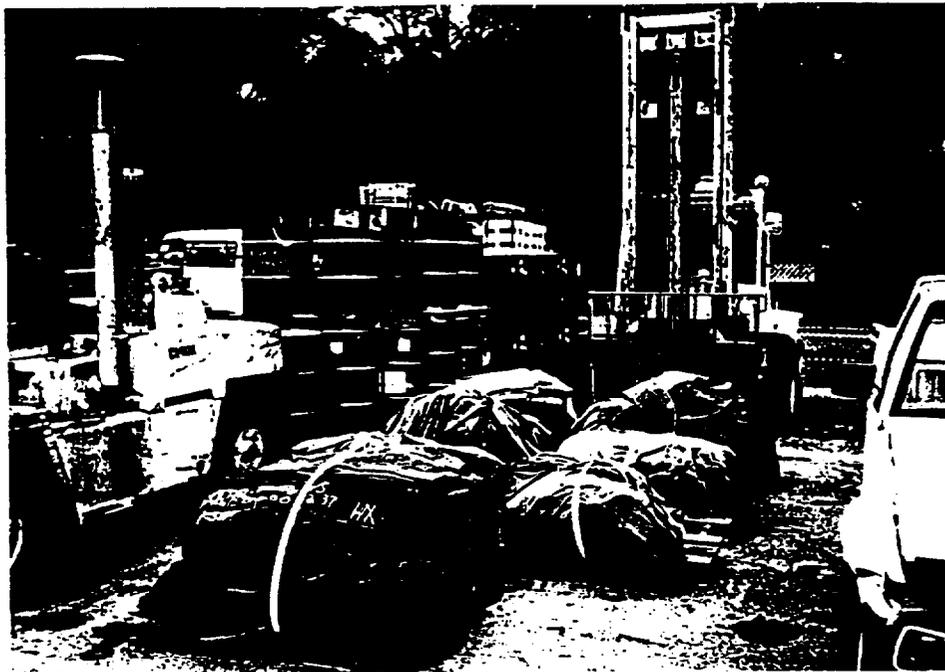
35.6 North-facing view of the DRMO Salvage Yard (SWMU 35) showing empty drums for salvage. These drums did not contain hazardous constituents. However, this unit has received empty drums that contained hazardous constituents.

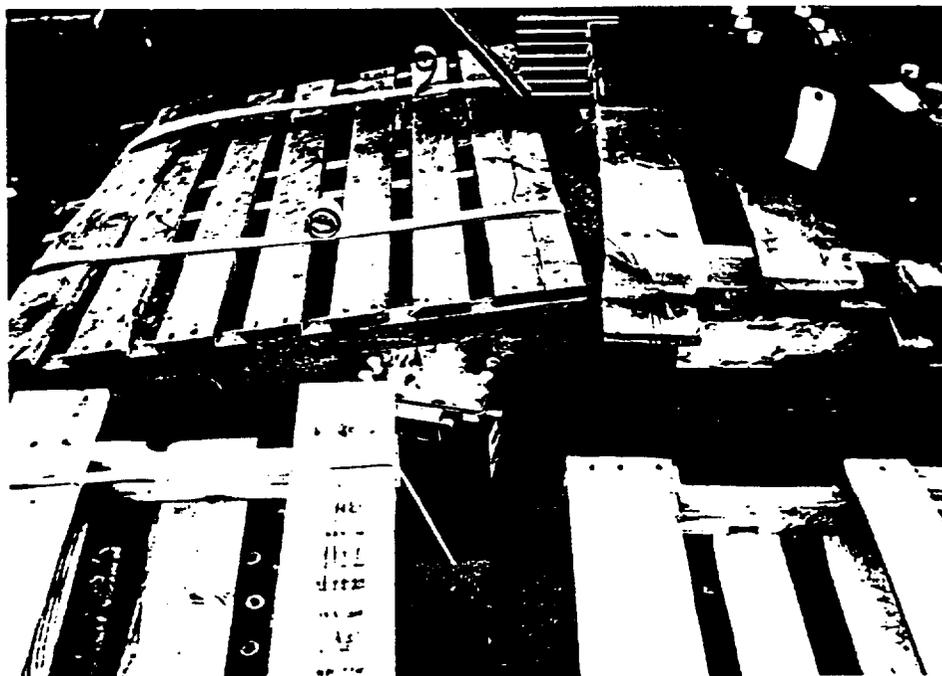
35.7 Close-up of the battery storage area at the DRMO Salvage Yard (SWMU 35) shown in photograph 35.1. Note the condition of the battery featured in the center of the photograph.

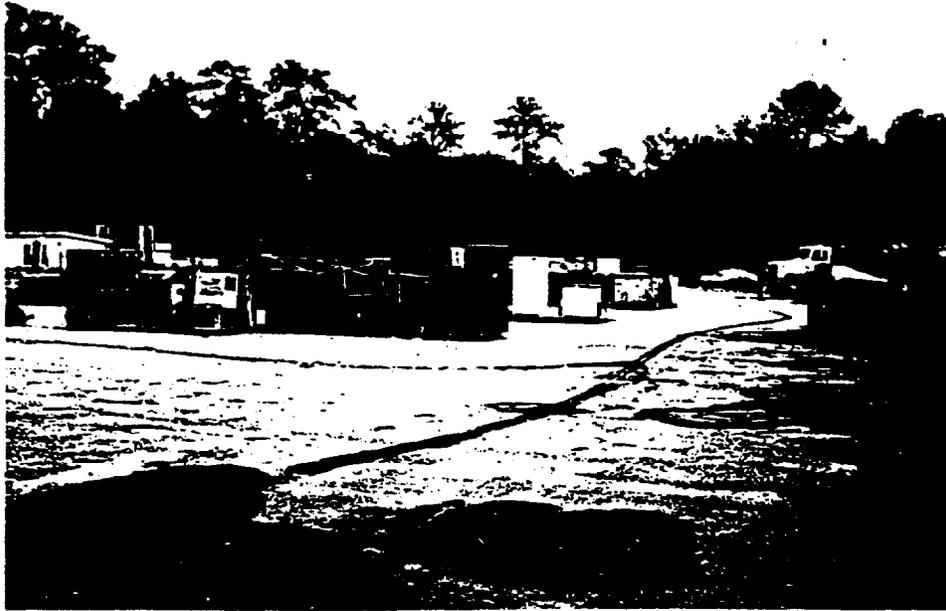
35.8 Overview of the DRMO Salvage Yard (SWMU 35) facing east.

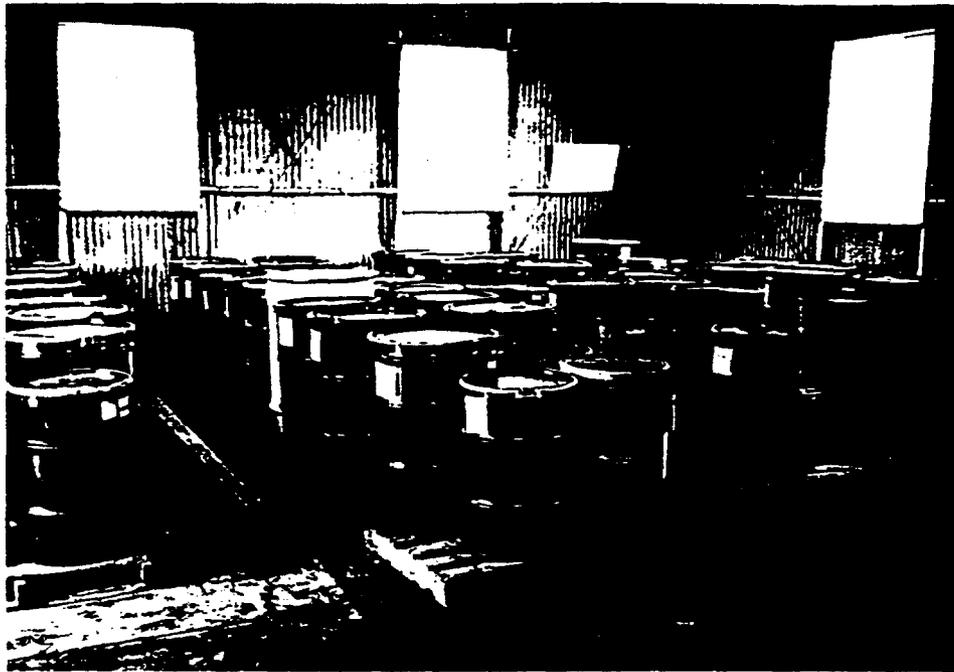
36.1 Interior view of the Hazardous Waste Storage Shed (SWMU 36) located in the northeast section of the facility. The facility intends to limit the status of this unit to less-than-90 day storage.

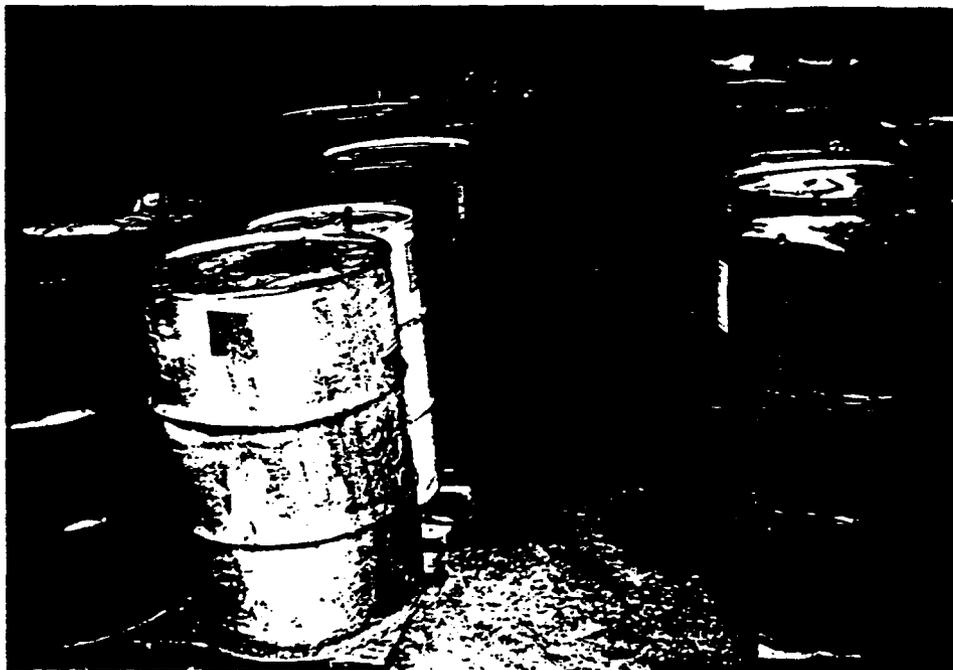
36.2 View of the Hazardous Waste Storage Shed (SWMU 36). Although the floor had some staining, it appeared in good condition.

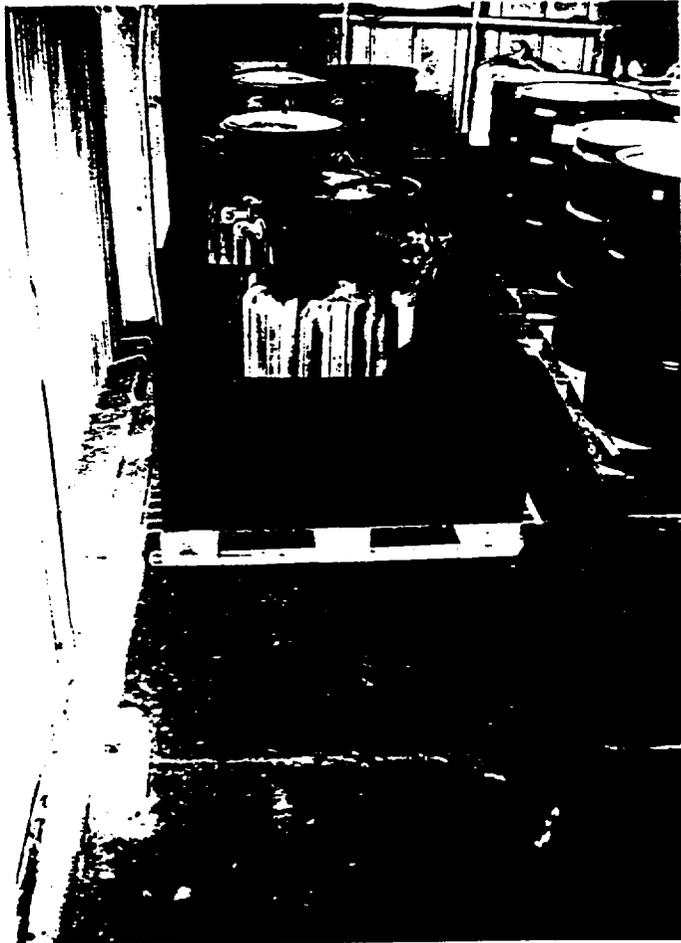
36.4 View of the PCB transformer storage techniques at the Hazardous Waste Storage Shed (SWMU 36).

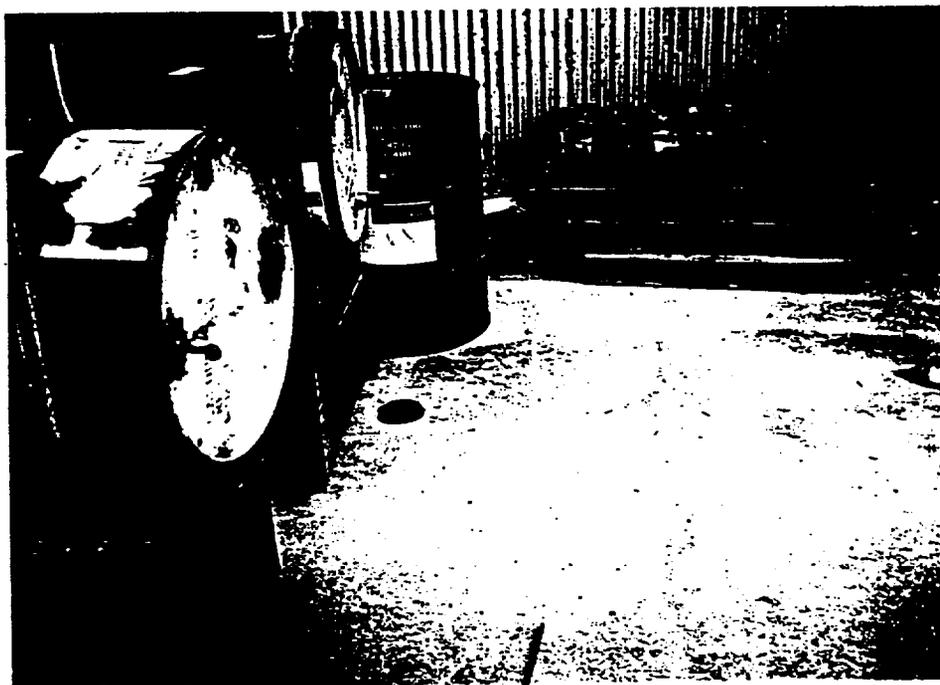
37.1 Close-up of the lacquer storage area at the Overflow Storage Pad (SWMU 37) located in the northeast section of the facility. According to facility representatives, a small drip pan is normally situated beneath the product drums. Note leakage. The concrete did not appear stained in this area and the drippage appeared to be limited to the pad. This pad was constructed over the Paint Waste Storage Area (Site 9) (SWMU 8).

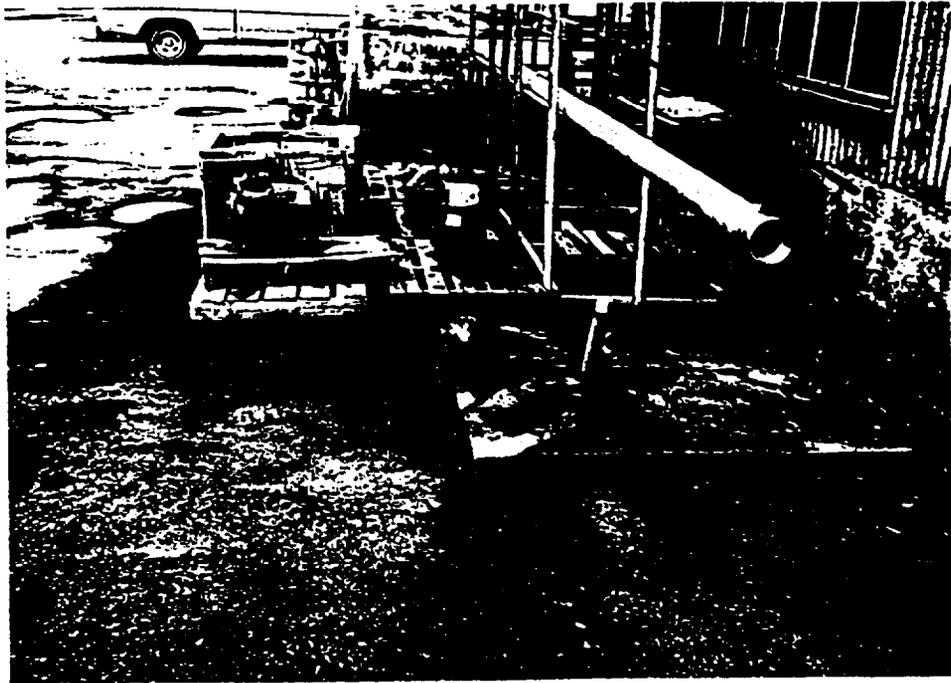
38.1 View of the inlet to the Underground Waste Oil Tank (SWMU 38) located in the northeast section of the facility. The unit is presently inactive and is scheduled for removal under the state UST program. The flammable tank in the background is an inactive fuel oil tank.

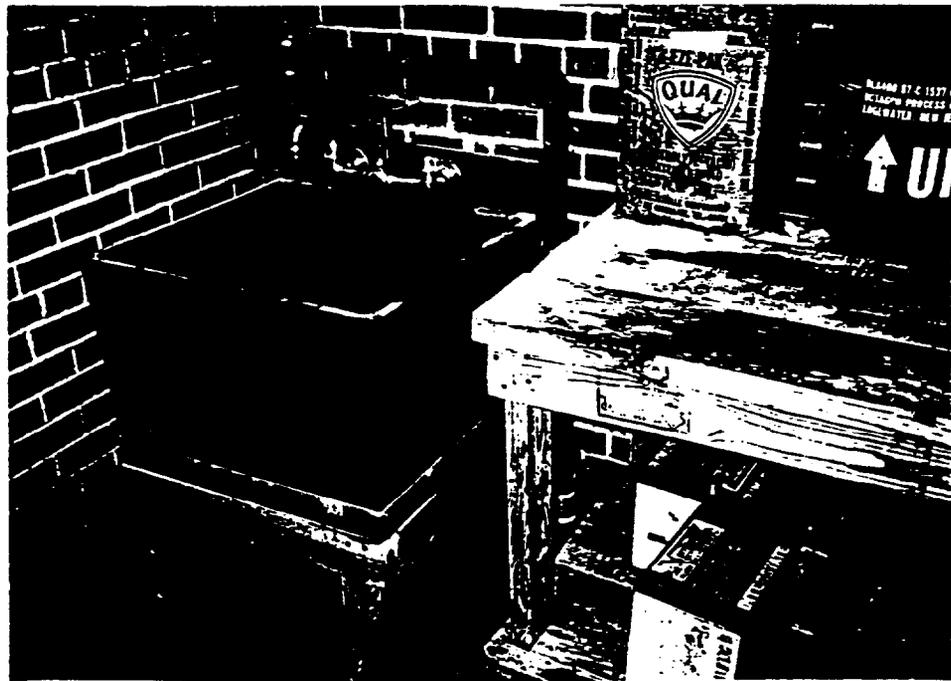
39.1 View of the Electrolyte Basin (SWMU 39) inside the Motor Pool Building located in the northeast section of the facility.

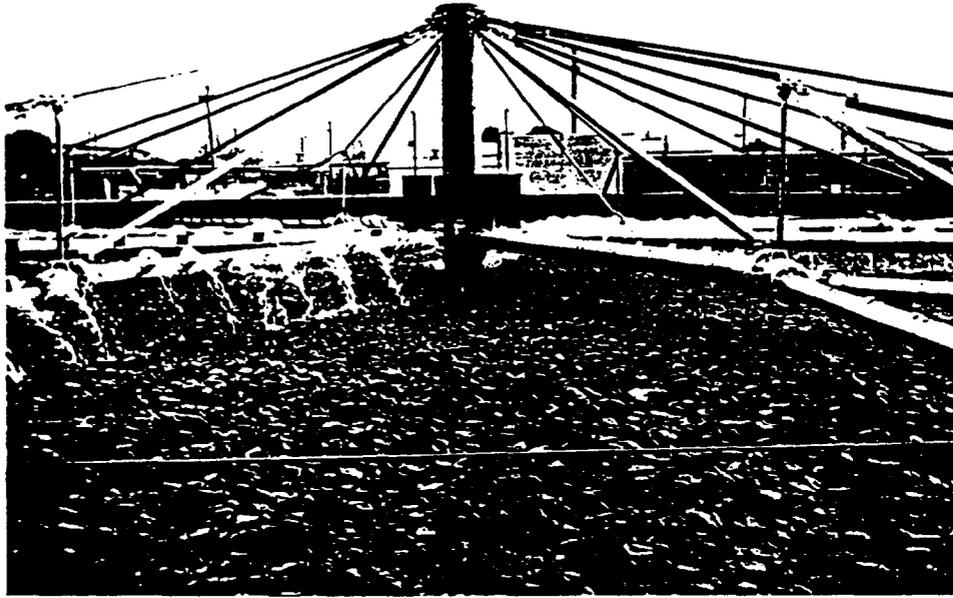
40.1 View of the trickle filter at the Sanitary Waste Water Treatment Plant (SWMU 40) facing southeast. The arrow indicates the approximate location of the mercury spill caused by a faulty seal.

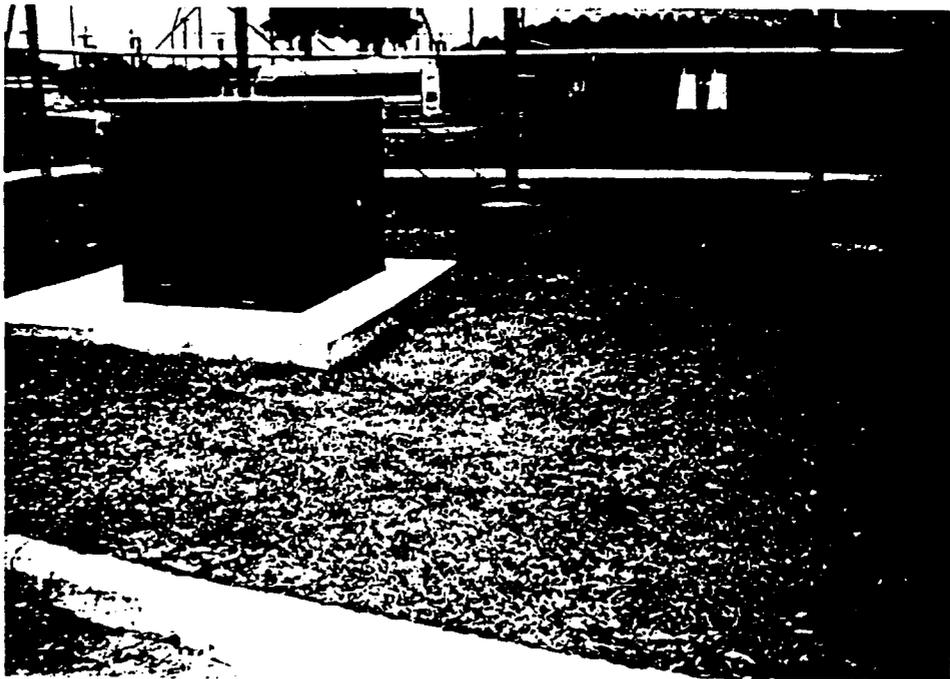
A.1 View of the west side of Building 111 showing the approximate location of the PCB Spill Area A (Site 8) (AOC A). This area is located in the northeast section of the facility.
