MASTER WORK PLAN VOLUME 1 OF 3 FOR INSTALLATION RESTORATION PROGRAM
MCRD PARRIS ISLAND SC
3/27/1998
BROWN AND ROOT ENVIRONMENTAL

Master Work Plan

Marine Corps Recruit Depot

Parris Island, South Carolina

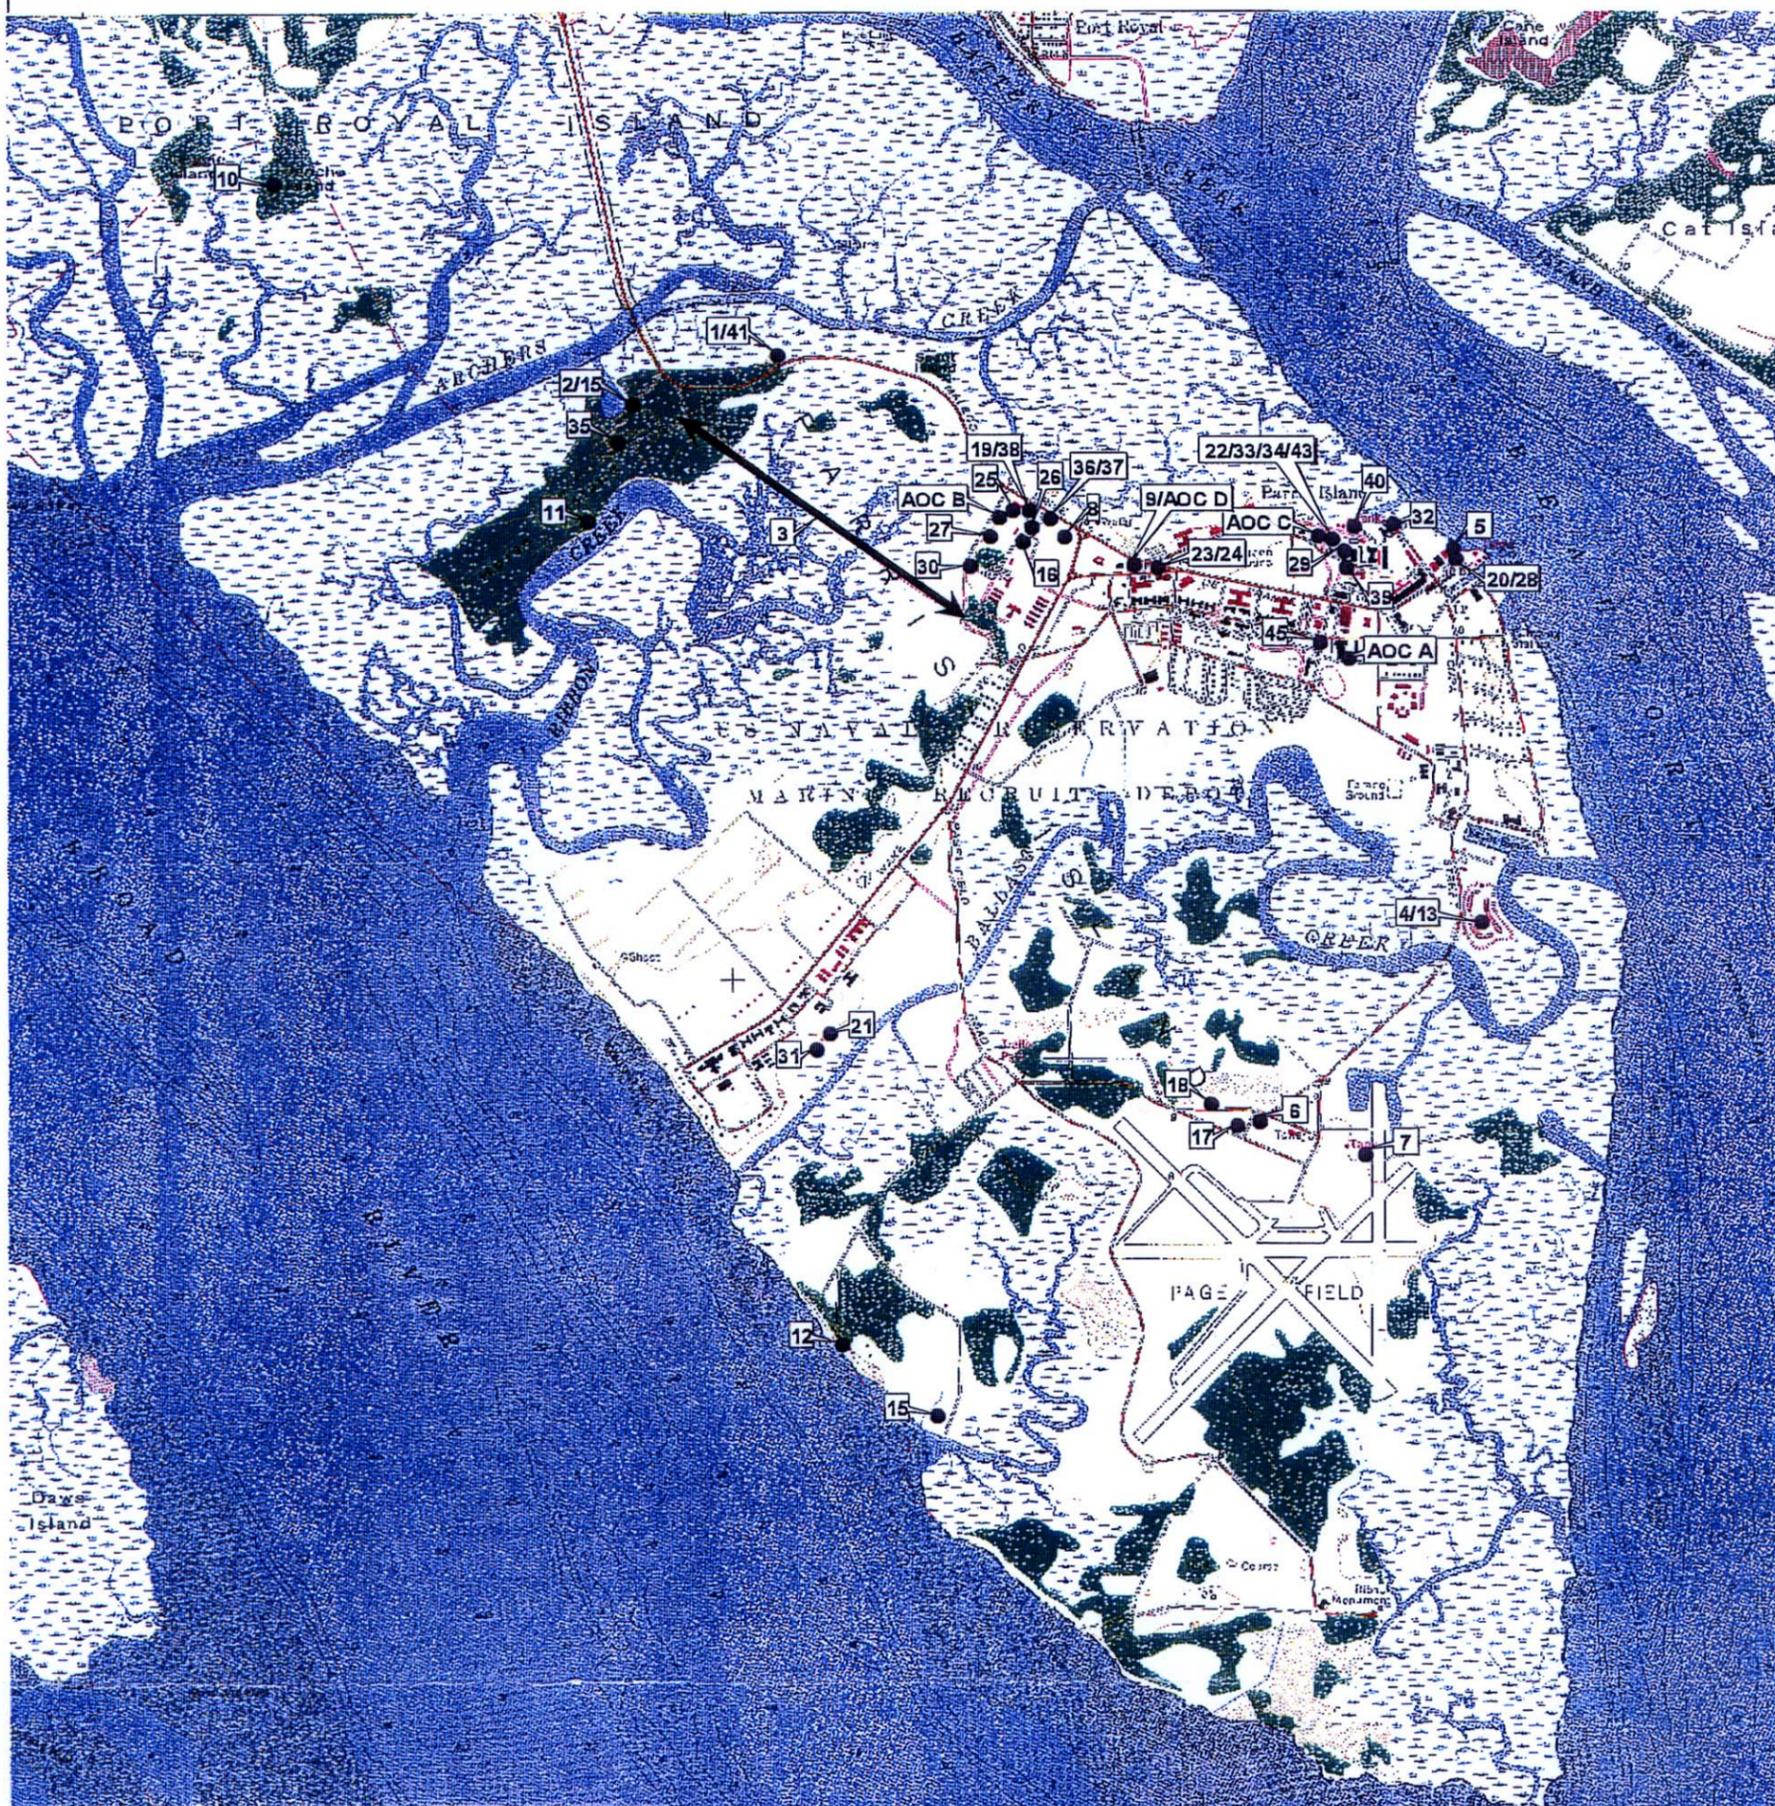
● 11 Solid Waste Management Unit Number

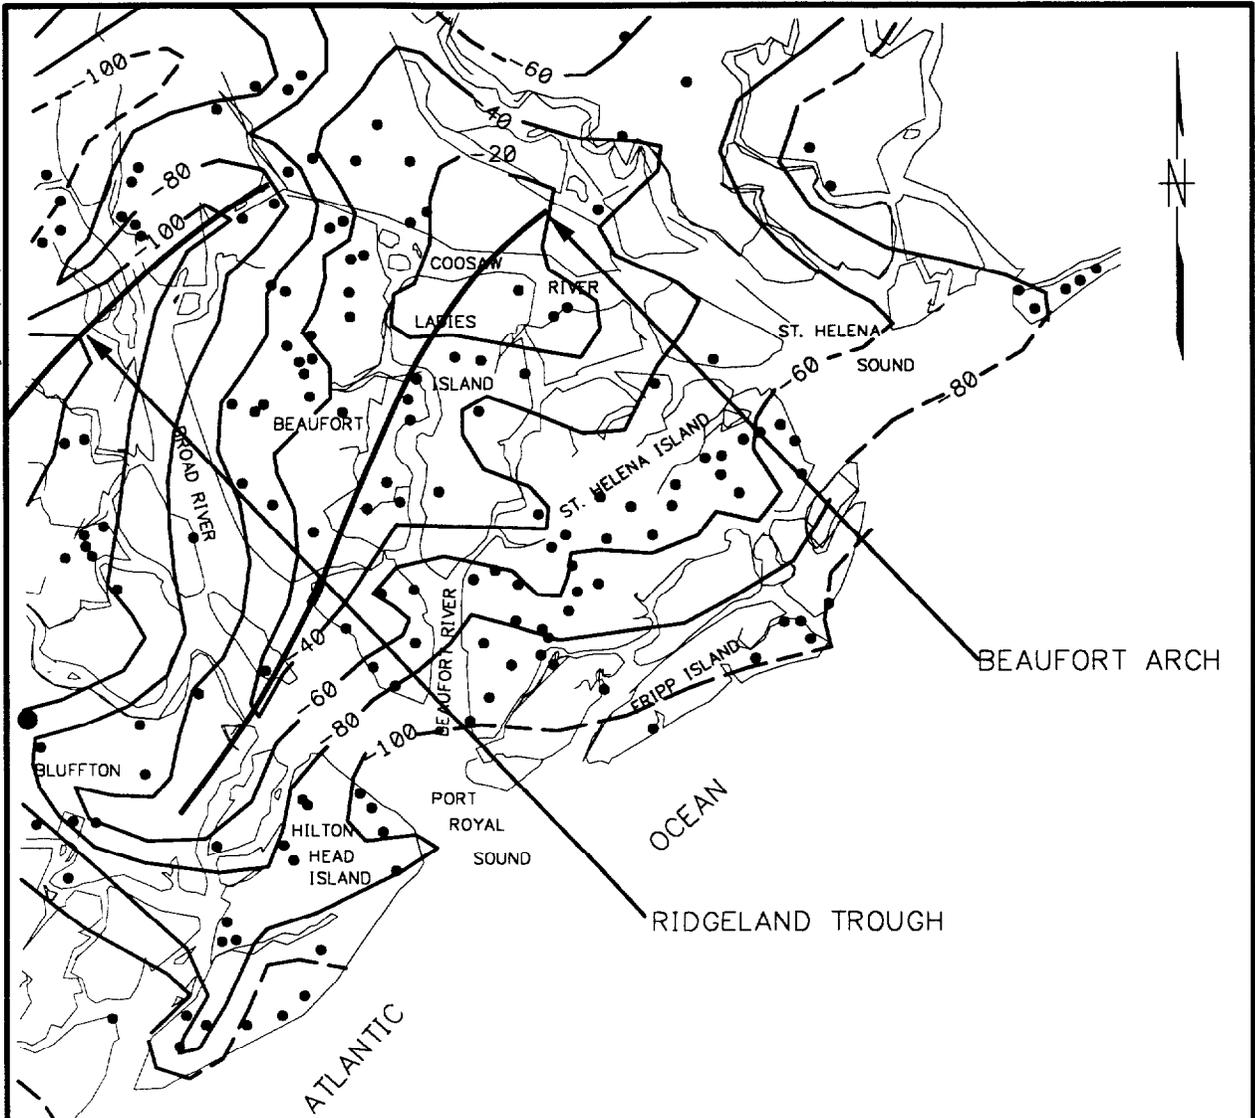
CONTOURS SHOW ALTITUDE OF TOP OF PRINCIPAL ARTESIAN AQUIFER. DASHED WHERE APPROXIMATE. CONTOUR INTERVAL 20 FEET. DATUM IS MEAN SEA LEVEL.

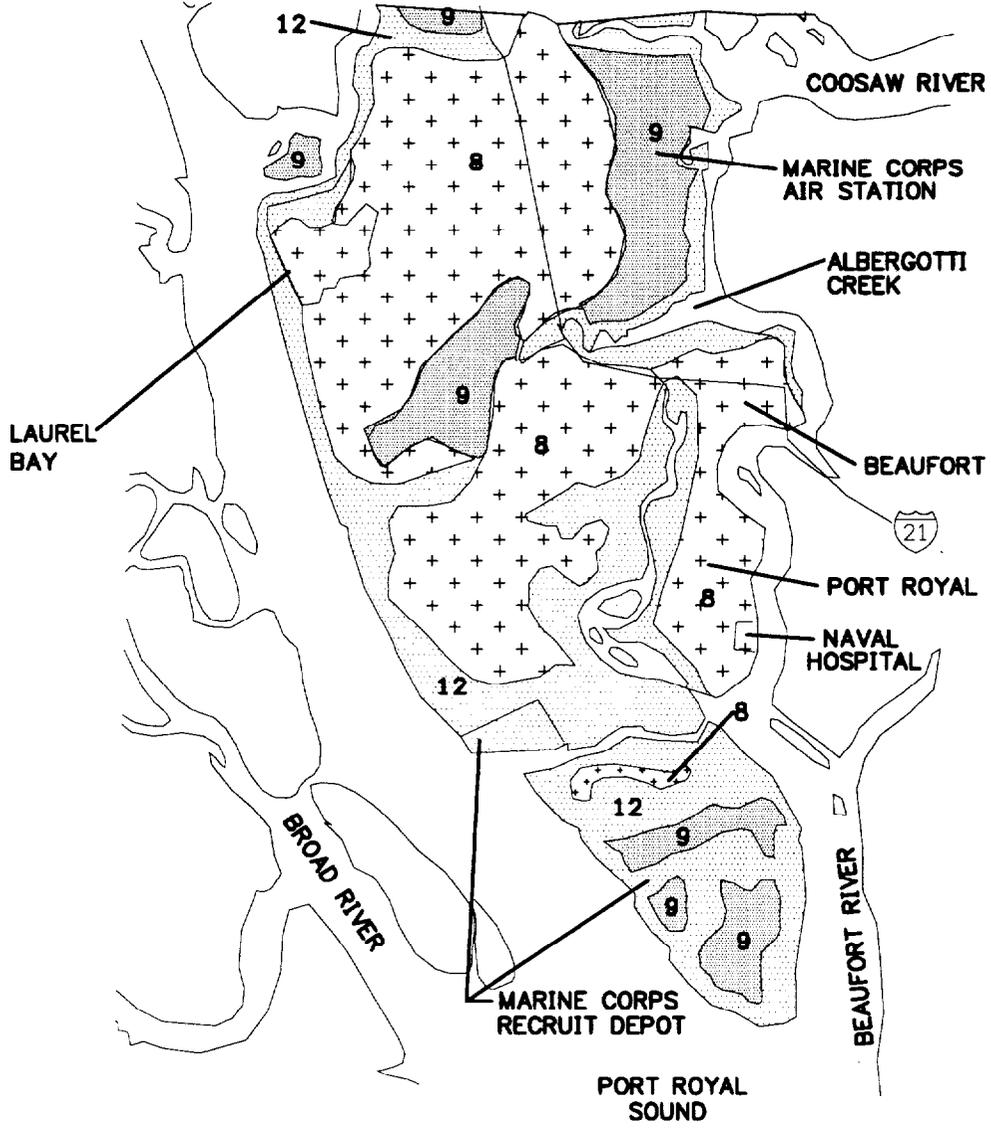
- LEGEND**
- 8 [Cross-hatch pattern] WANDO-SEABROOK-SEEWEE SOIL UNIT
 - 9 [Stippled pattern] COOSAW-WILLIMAN-RIDGELAND SOIL UNIT
 - 12 [White background] BOHICKET-CAPERS-HANDBORO SOIL UNIT

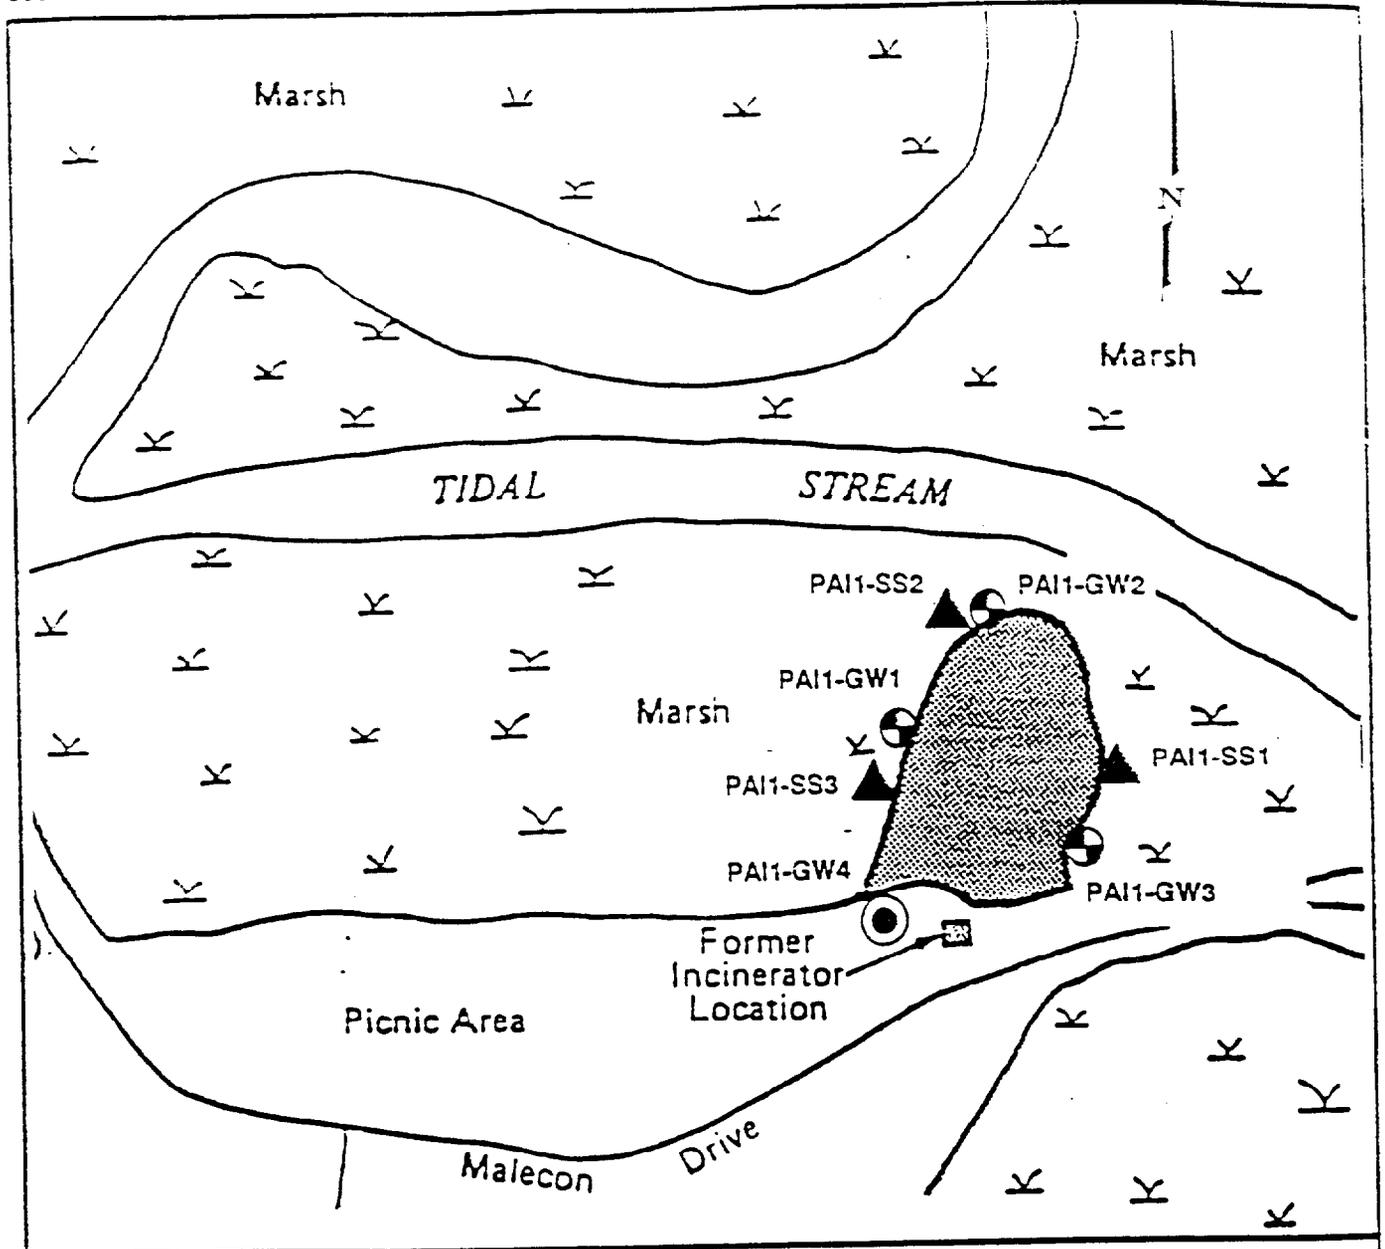
FIGURE 2
SAMPLING LOCATIONS AT SITE 1

- PAI1-GW4 ● Monitoring well/groundwater sample
- PAI1-GW3 ⊙ Temporary piezometer/groundwater sample
- PAI1-SS3 ▲ Surface sediment samples
- Site
- ▣ Structure

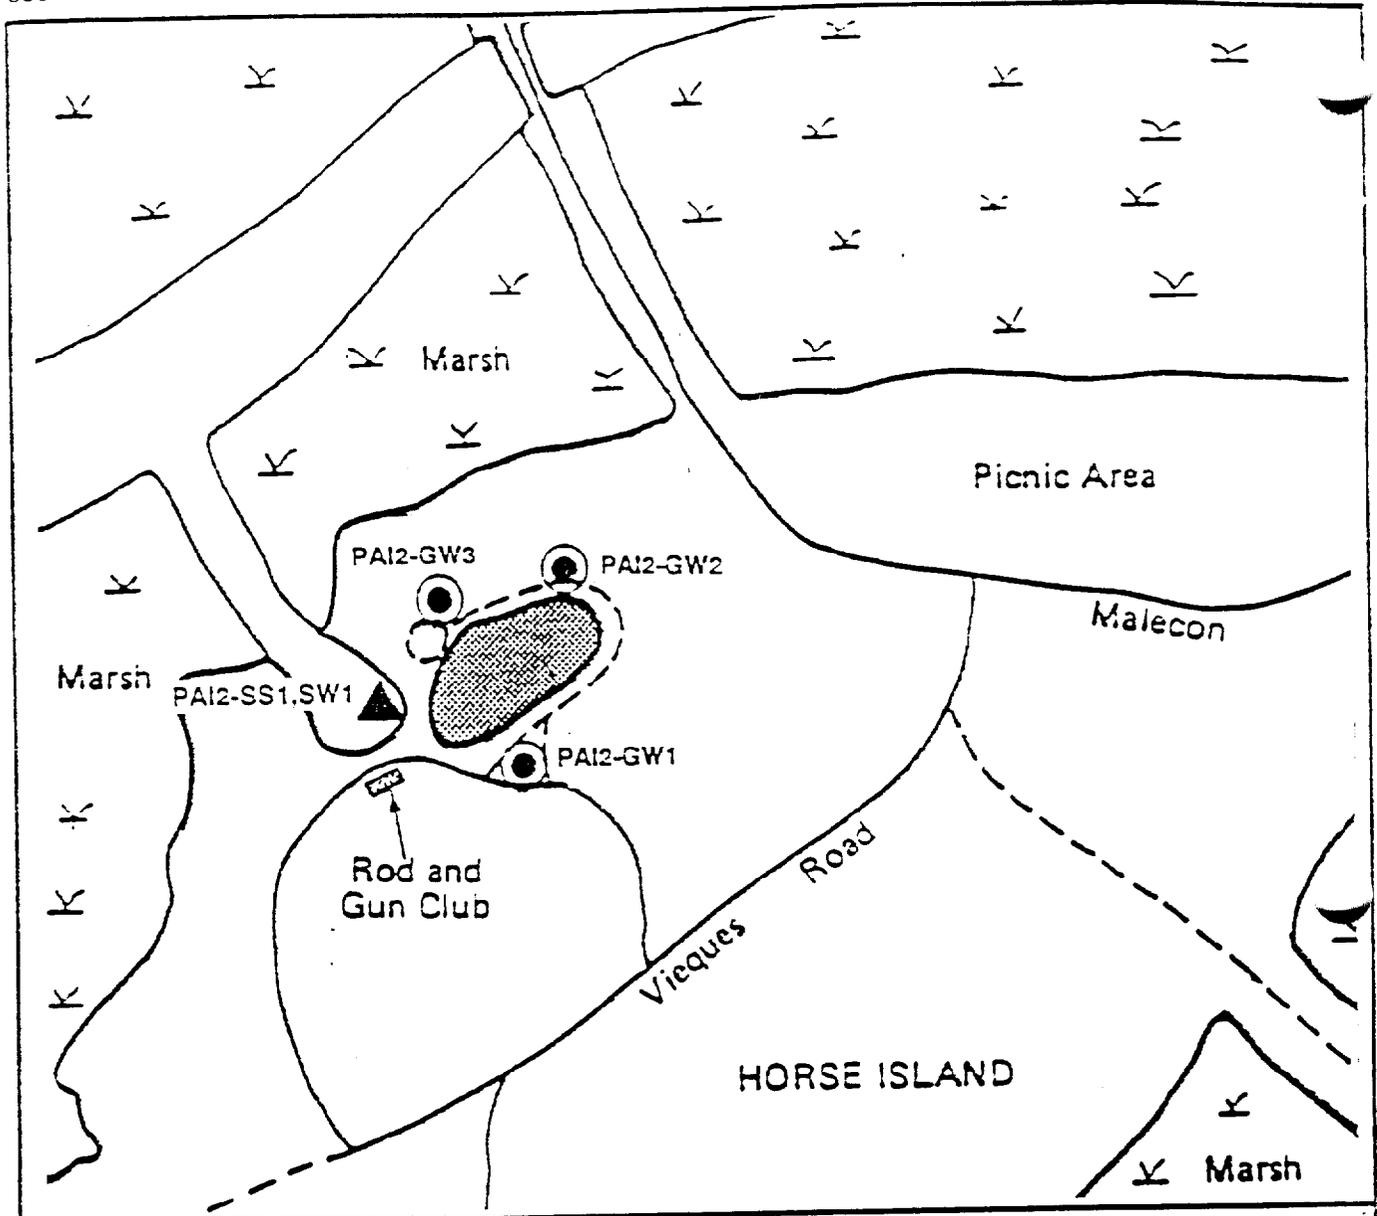
FIGURE 3
SAMPLING LOCATIONS AT SITE 2

- Monitoring well/groundwater sample
- ▲ Surface water and sediment samples
- ▨ Site
- ▩ Structure
- Dirt Road

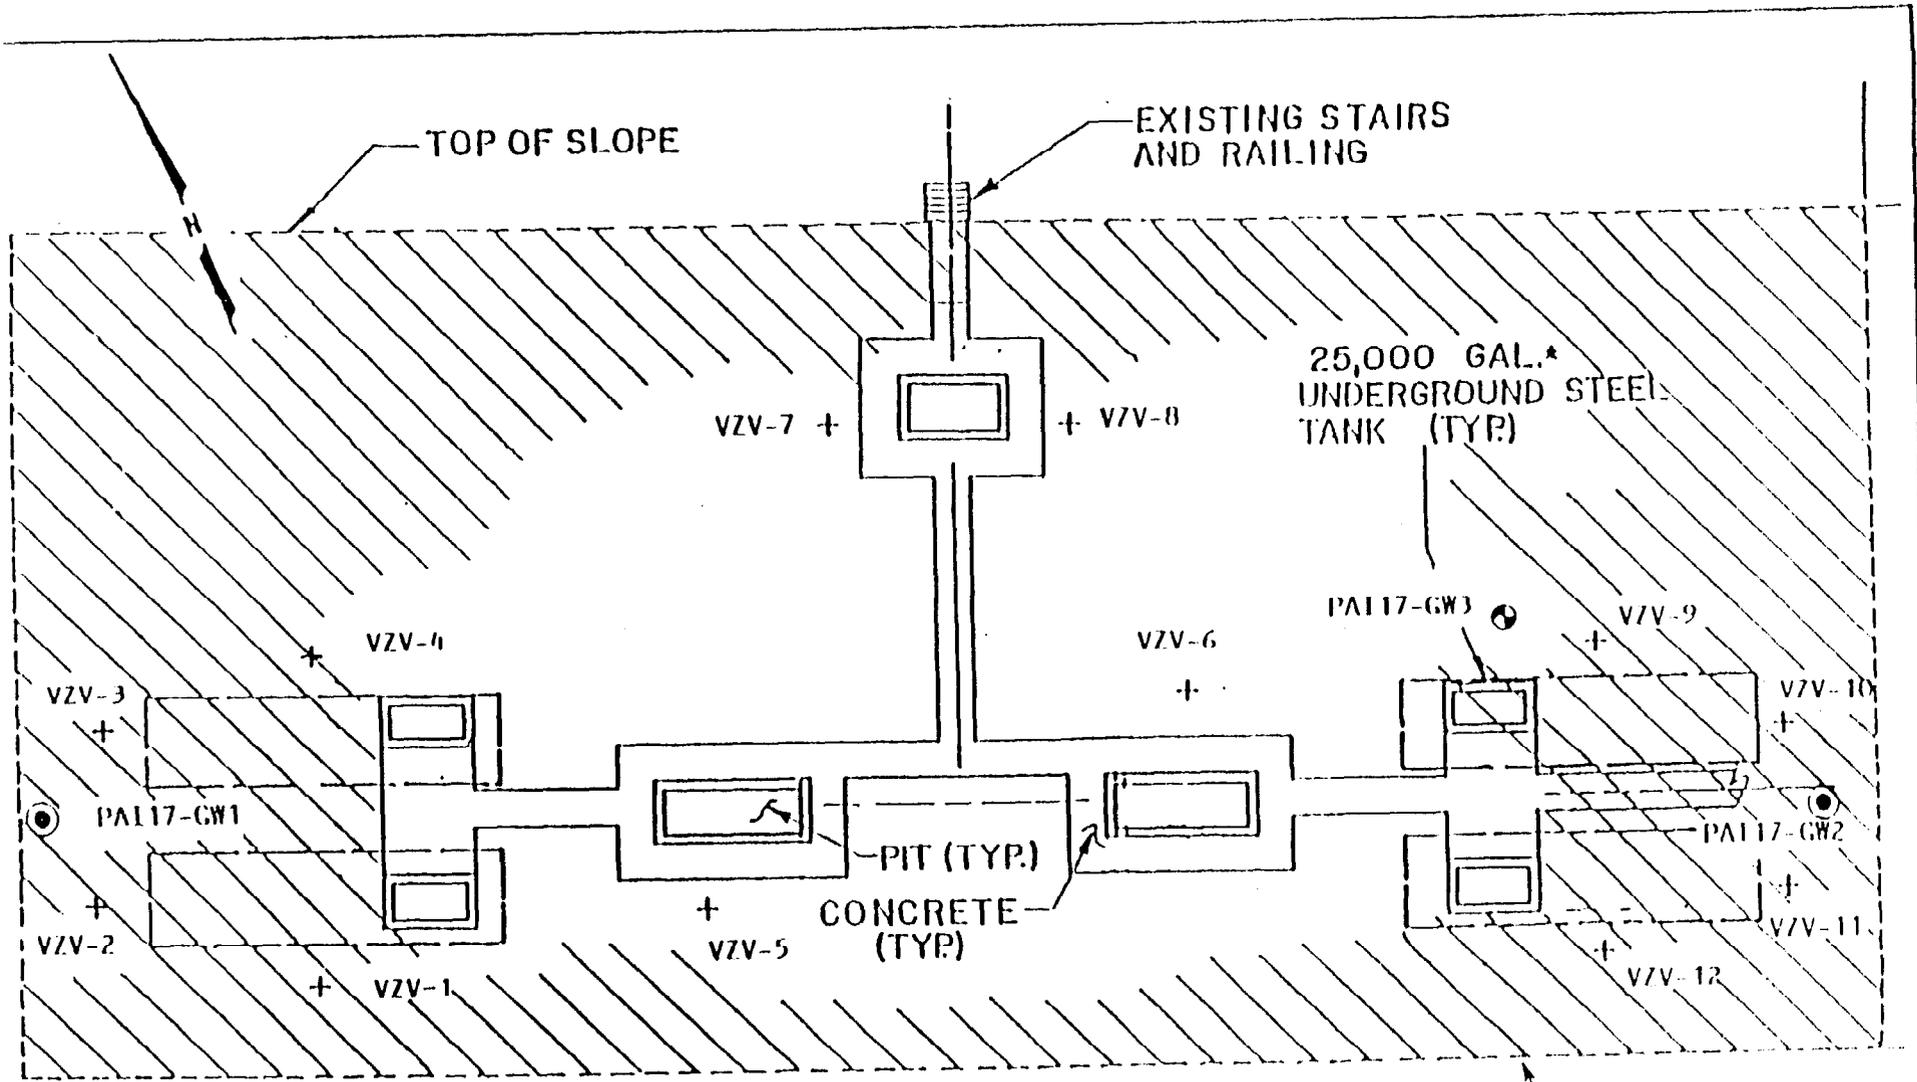
FIGURE 8
SAMPLING LOCATIONS AT SITE 17

- Existing monitoring well, Installed by previous contractor
- ⊙ Monitoring well
- + VZV probe location
