LETTER REPORT REGARDING WETLAND INSPECTION SPRING 2011 AREA OF  
CONCERN 55C (AOC55C) NAS SOUTH WEYMOUTH MA  
6/22/2011  
TETRA TECH

June 22, 2011

Subject: Area of Concern 55C – Spring 2011 Wetland Inspection  
Naval Air Station South Weymouth, Weymouth, Massachusetts

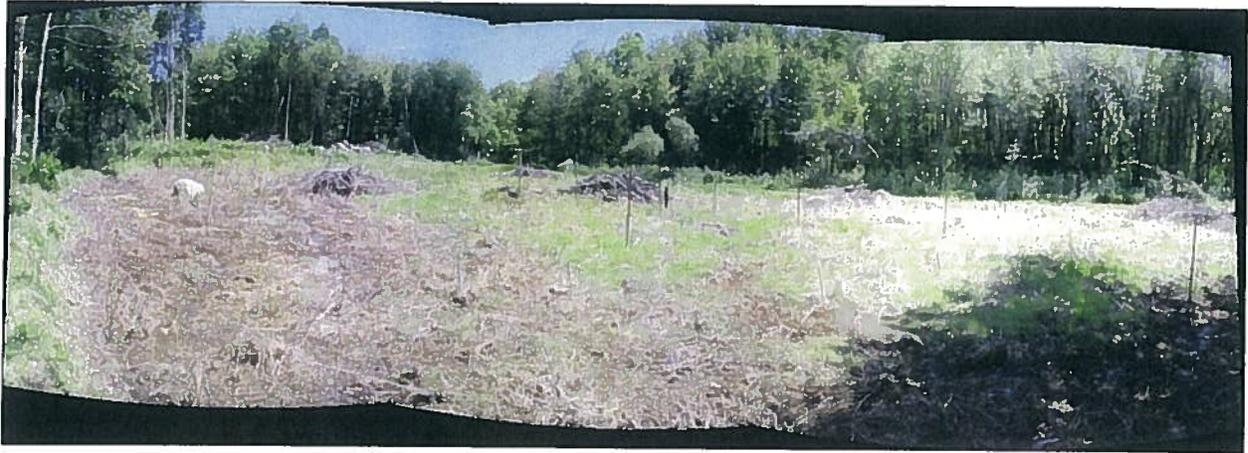
**PHOTO 1  
VIEW OF AOC 55C  
PANORAMIC FROM TOP OF BERM**

- **Herbaceous Vegetation:** The overall cover of herbaceous vegetation was low (Photo 1). Young shoots of wetland and upland species were present but sparse throughout much of the restoration area. There were several sections, including immediately south of the vernal pool, where no new growth was observed.
- **Invasive Species:** Three invasive species were observed within the restoration area; Japanese knotweed, purple loosestrife, and glossy buckthorn. Approximately 15 stems of Japanese knotweed were scattered throughout the restored area and several relatively small yet dense patches were observed in the vicinity of the former stockpile area and at points along the haul road. All of the Japanese knotweed stems that were observed within the restoration area were manually removed at the time of the spring assessment.

- Reseed the entire restoration area with a mix of containing native wetland species.
- Planted trees that did not survive should be replanted. Although it did not appear that mortality was due to heavy deer browse, the replacement material should be monitored closely for evidence of herbivory. If it appears that this is significant factor, deer browse deterrents such as bud caps or tree shelters should be employed.
- The stands of Japanese knotweed that occur along the haul road and surrounding the restoration area should be eradicated.
- Manual removal of glossy buckthorn from the fringes of the restoration should be conducted annually each fall for the duration of the monitoring period.

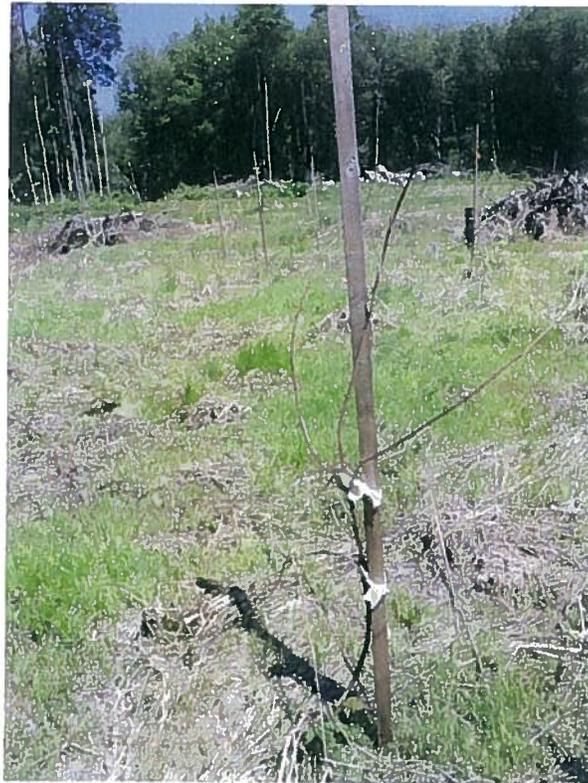
**PHOTO 2  
VIEW OF AOC 55  
ONE OF PLANTED RED MAPLES**

- **Plantings:** Although many of the smaller (<3 feet tall) planted shrubs and trees appeared to be of good vigor, nearly all of the taller trees (>3 feet tall) were dead or nearly so (Photo 2). Several of the low vigor plants had leaves only near the base within approximately 6 inches of the ground surface. Signs of deer, including tracks and scat, were observed throughout the wetland.
