**Naval Air Station South Weymouth
South Weymouth, MA**

**Environmental Baseline Survey for Transfer (EBST)
Nomans Land Island**

12 March 1998

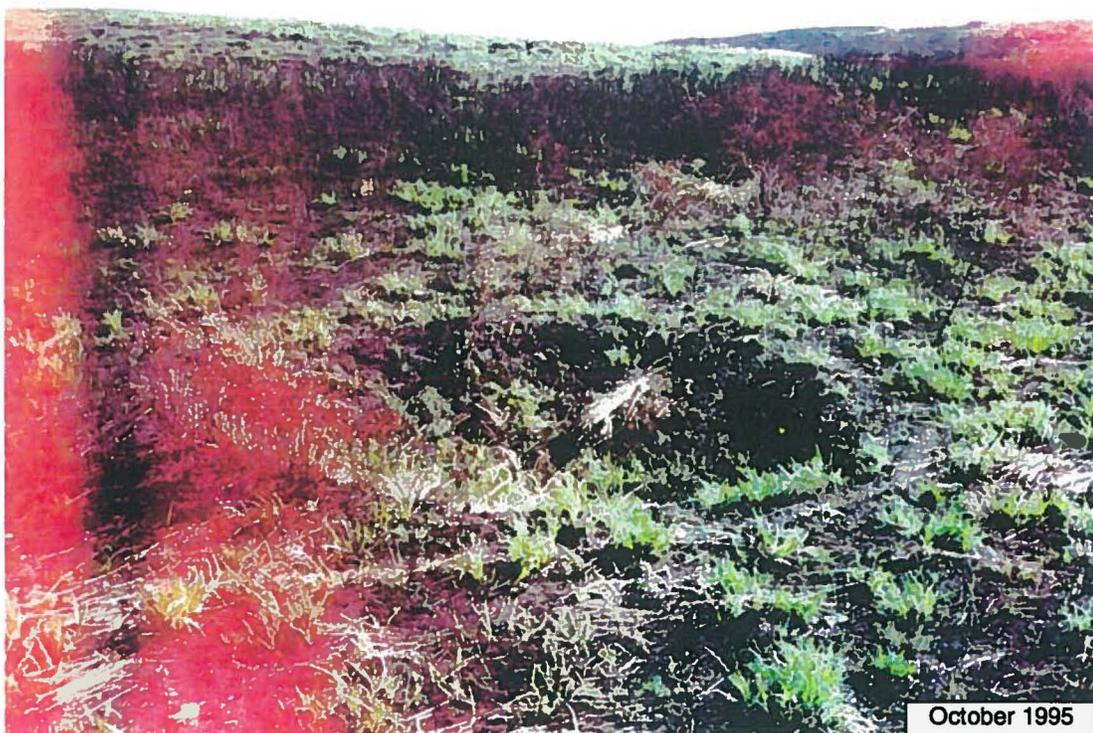
Crater sizes ranged from approximately three feet in diameter and three feet deep, to ten or more feet in diameter and five feet deep. (Photograph 2)

Photograph 2 – Typical crater

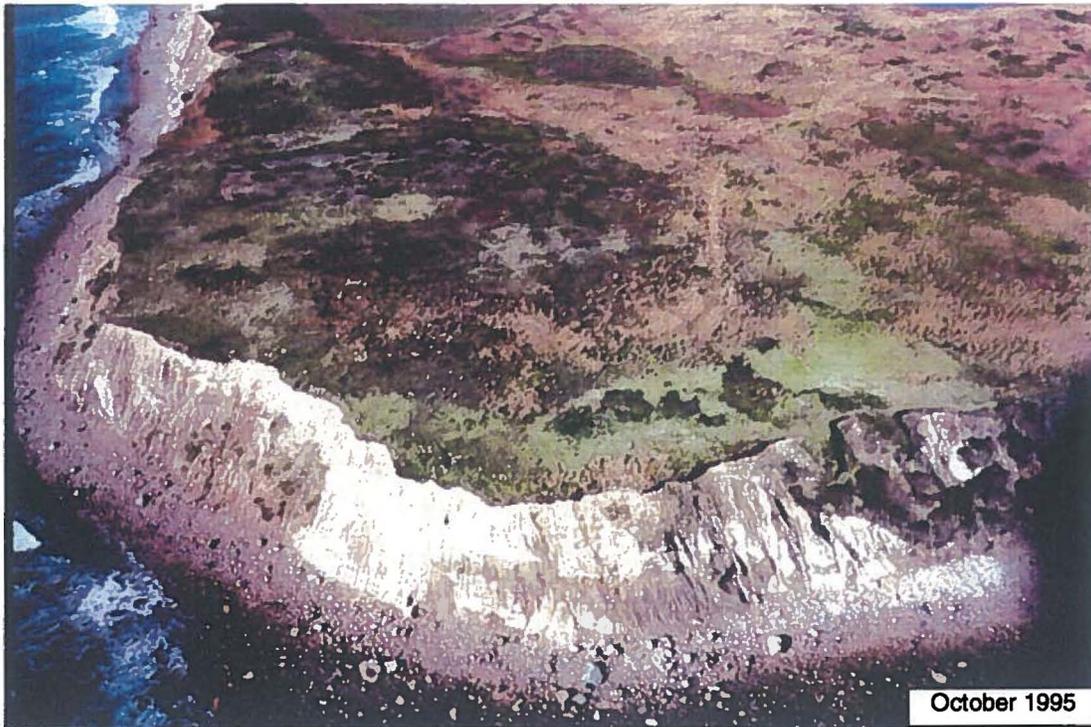
Photograph 3 – Aerial view showing vegetation coverage on western side of island

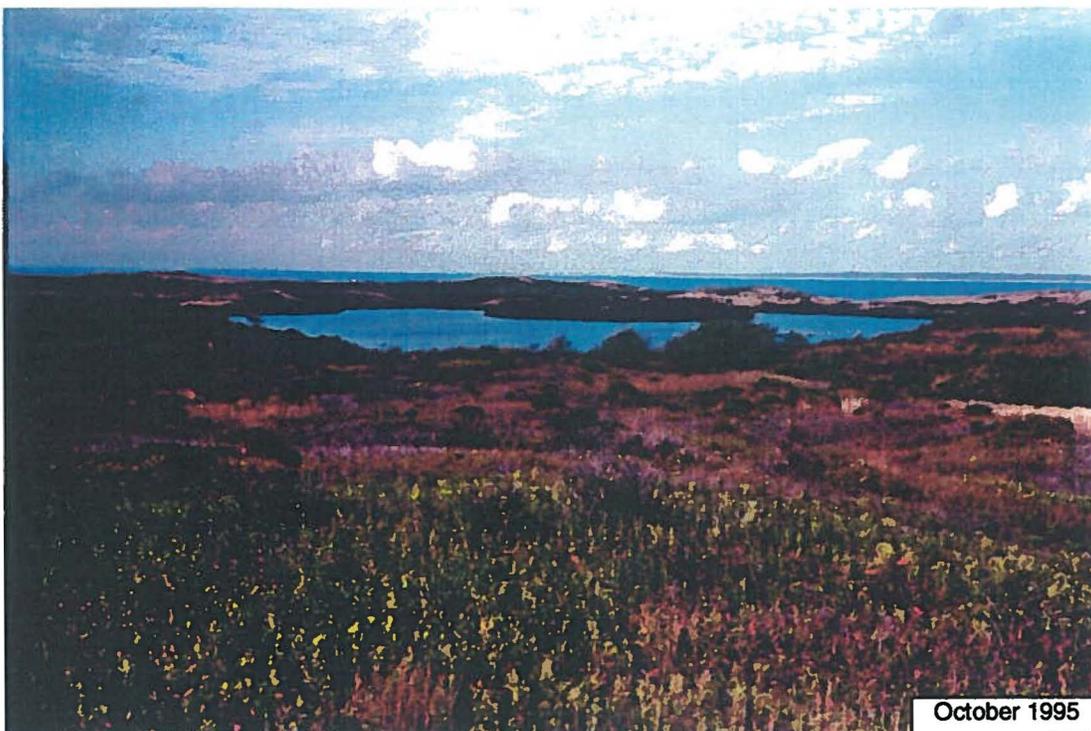
Photograph 4 – View of vegetation around Ben's pond

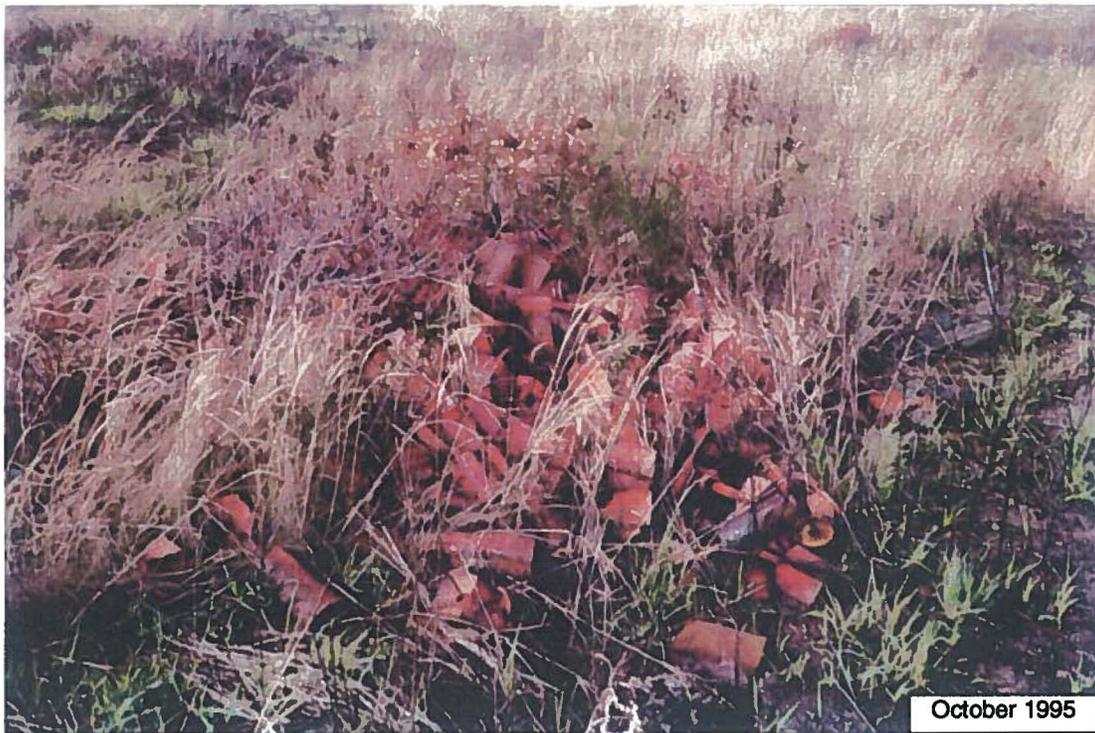
Photograph 5 – Inert ordnance in netting

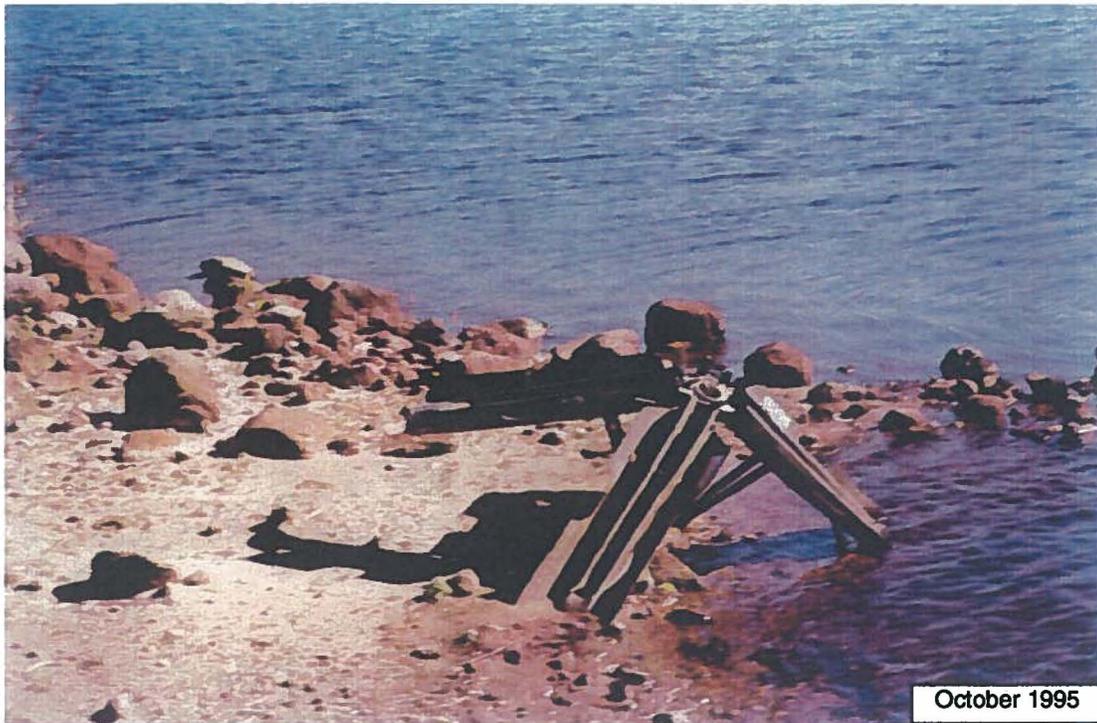
Photograph 7 – Typical practice ordnance around ponds

The UXO sweep in April 1997 did not address the issue of ordnance in the ponds. Ordnance located on the dry pond beds was inerted or removed by the UXO sweep. Conditions noted during site visits in 1996 and 1997 were not significantly different from those noted during the October 1995 site visit.

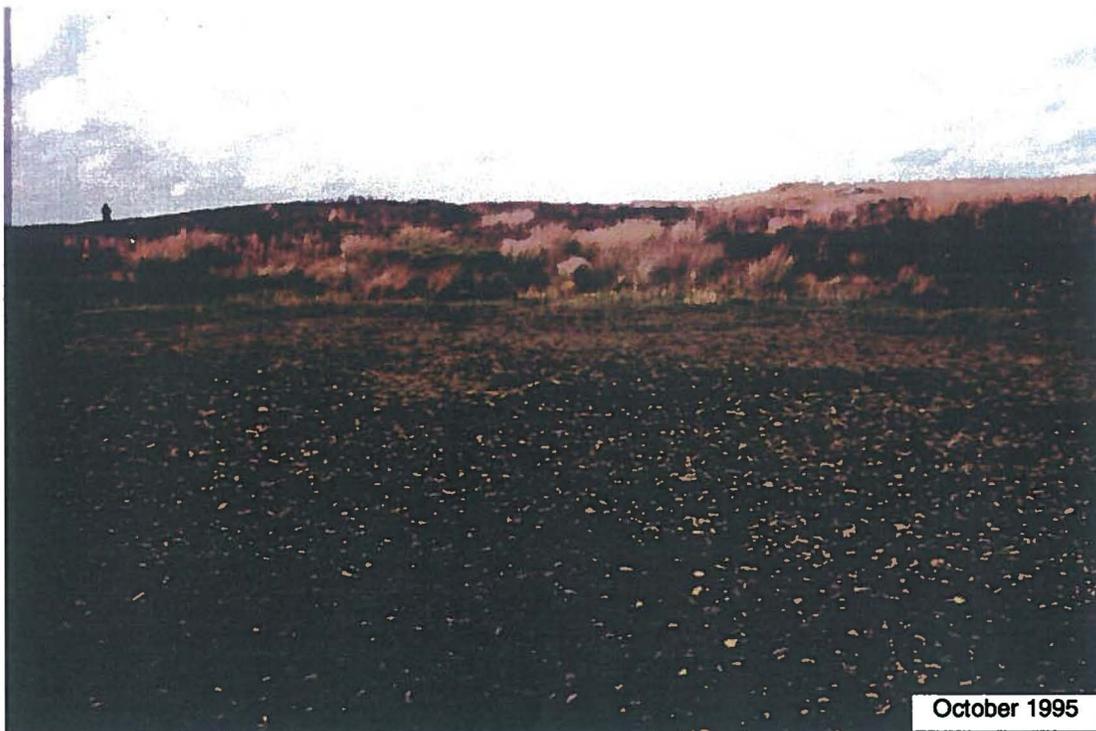
Several of the smaller ponds on the island also were observed to contain evidence of ordnance. None of the smaller ponds appeared to contain cloudy water. The pond south of the old airstrip was dry during the October 1995 site visit. The survey team was able to walk across a dark caked mud pond floor. Several inert small ordnance rounds were found on the dry pond bed (Photograph 8).

Photograph 8 – Dry pond bed

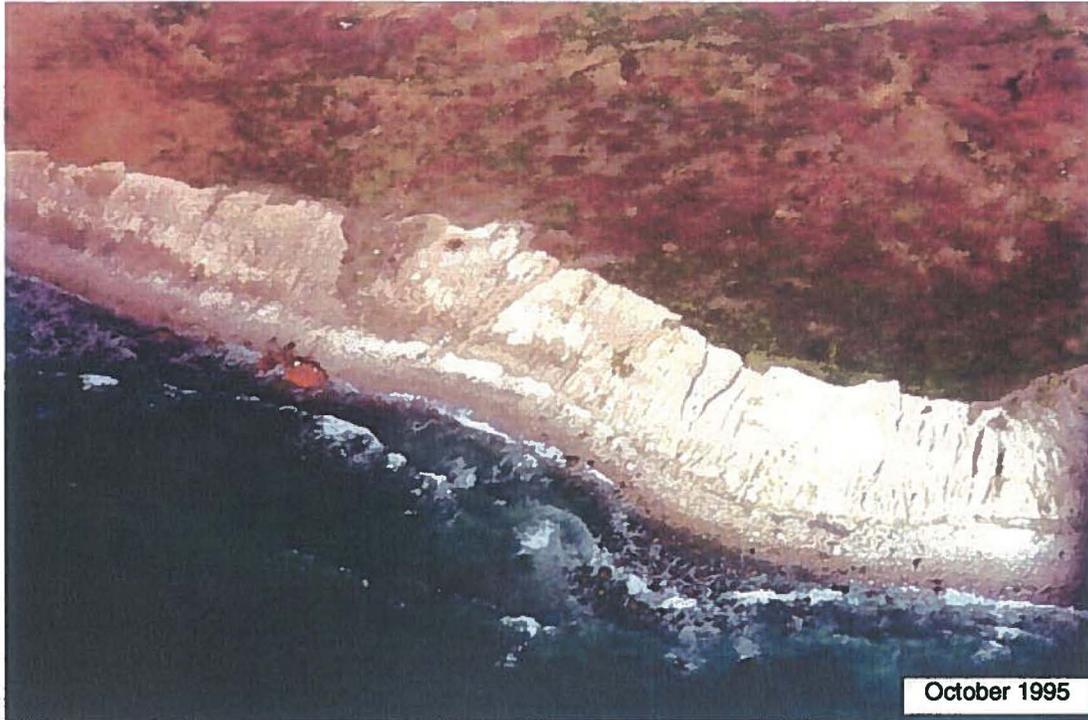
As noted in October 1995 the beaches were strewn with typical shore debris, and some ordnance. It is reported that the UXO sweep conducted in April 1997 removed some live ammunition cartridges from the beach area. Site visits in 1996 and 1997 documented debris (assumed to be litter from boaters and other islands) typically washing on and off the shore of the island (Photograph 9).

Photograph 9 – Aerial view of debris on shoreline (shipwreck)

Debris from offshore sources has been found on the shoreline. The debris (except the removed ammunition cartridges) has not been identified to consist of hazardous materials. The Navy will take no further actions regarding debris on the shoreline of the island, unless newly discovered debris is determined to be a potential UXO item.

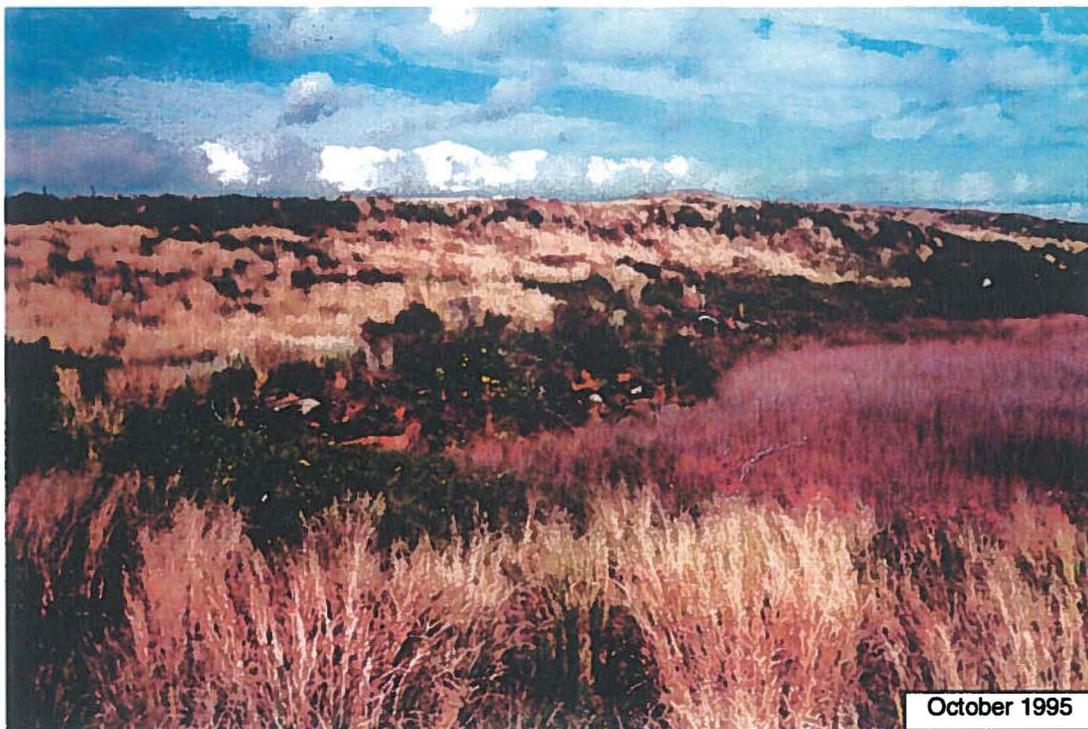
As reported from the October 1995 site visit, several deteriorating buildings are located on the island. The remains of two concrete block buildings and a concrete foundation are located on the north side of the island. (Photograph 10, Photograph 11) The concrete foundation appears to have been the floor of a third building. Heavy vegetation surrounds the building remnants, which made it difficult to get near one of the buildings. The building remnants include several long rusting pipes, and what looks like an oil heater and a pump assembly. (Photograph 12) The October 1995 survey team found no other signs of fuel or petroleum product usage.

Photograph 10 – Building remnants

Based upon the record searches and site investigations, the Navy believes that there are no hazardous materials at the remnants of the former Seabee buildings. The Navy intends to conduct a site visit in 1998 in conjunction with the Fish and Wildlife Service to note the condition of the building remnants. No further actions regarding the remnants of the Seabee buildings is intended based upon available information.

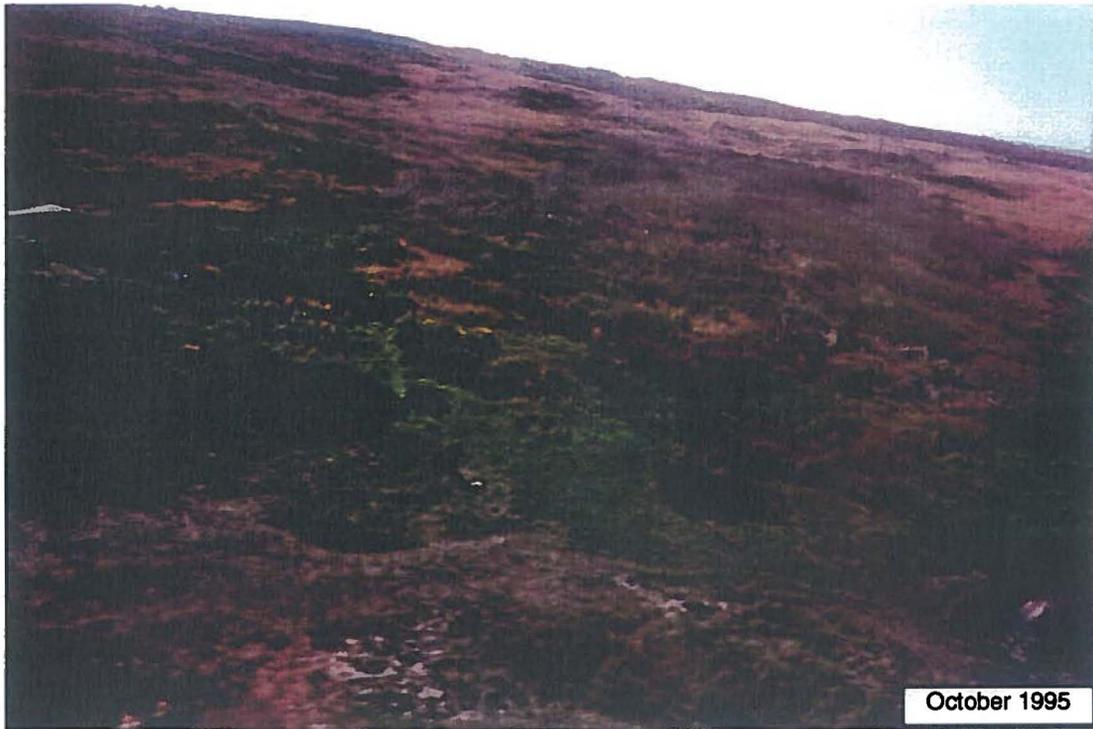
Photograph 11 – Building remnants

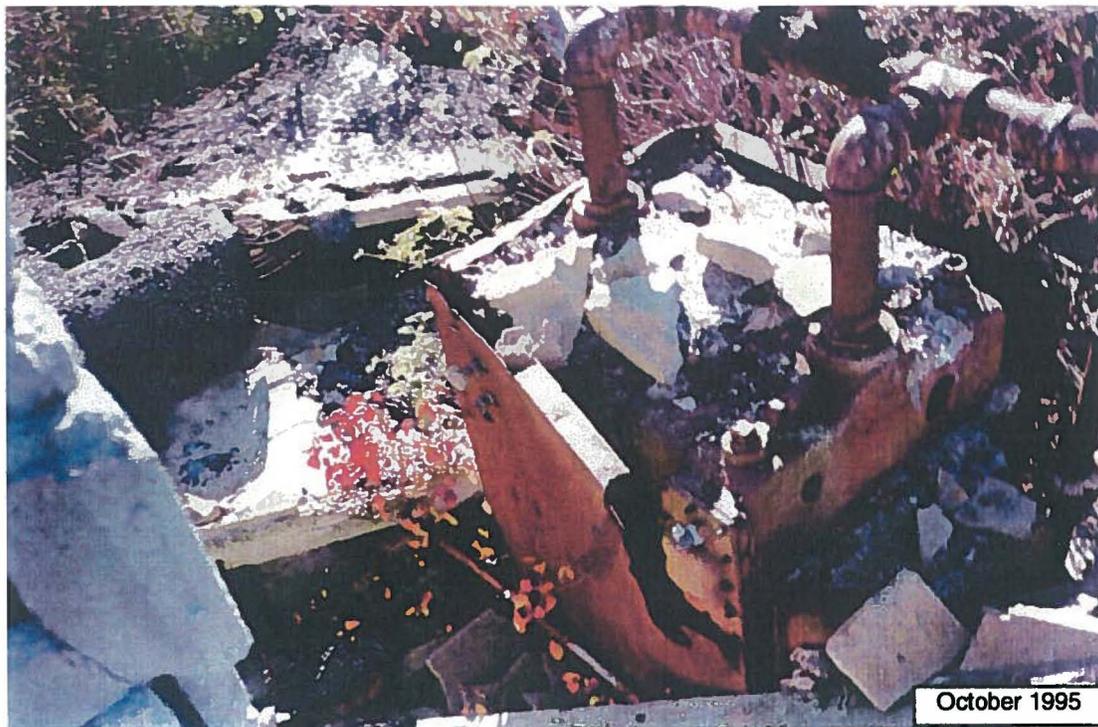
Photograph 12 – Equipment in building remnants

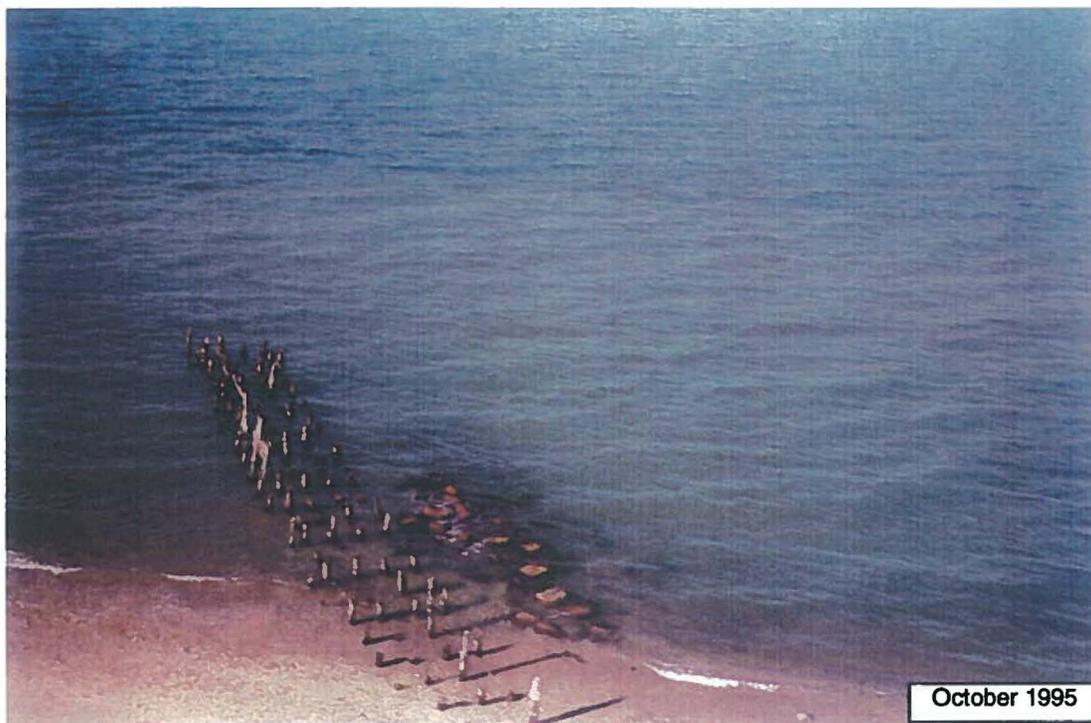
The remains of a pier lie in a small cove north of the buildings. (Photograph 13) The pier's piles were just visible above the water. A rusting 4-inch metal pipe exits the shore bank near the pier. (Photograph 14) The former use of the pipeline is unknown. It appears to have run between the pier and the block buildings.

Photograph 13 – Pier remnants

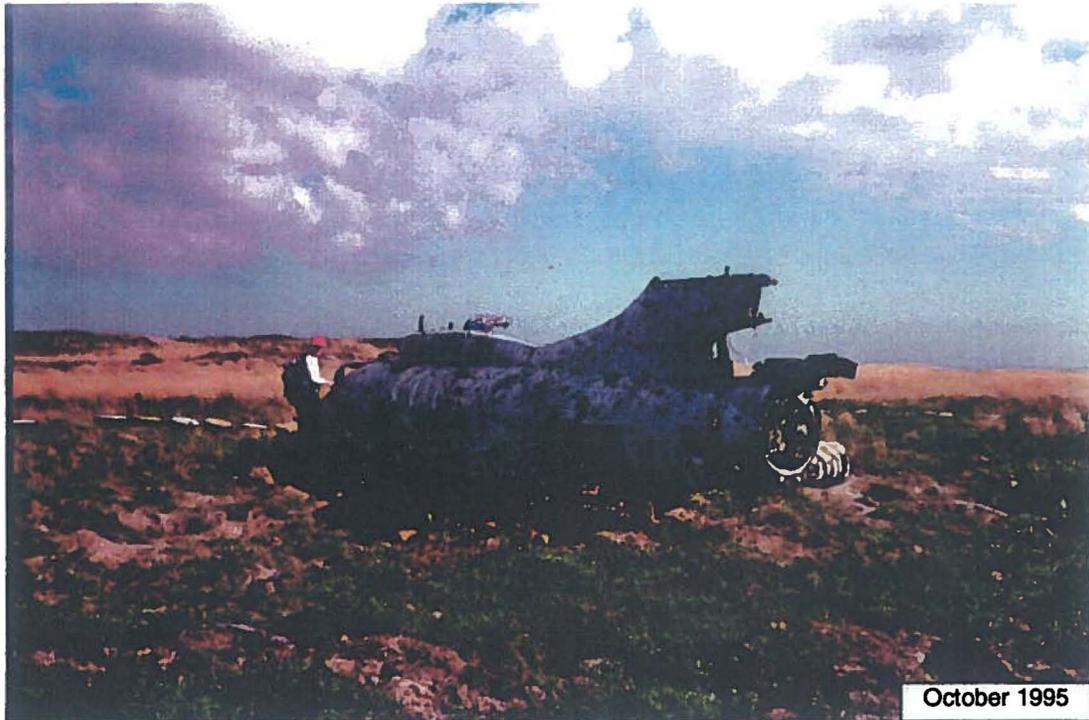
The October 1995 site visit identified that four large, rusting navigation buoys were present on the western half of the island. On the south side of the island, at the end of the old landing strip, a wingless fuselage shell of a former A-4 fighter jet was present. (Photograph 15, Photograph 16) There was no evidence of release from the fuselage. The four buoys were spaced approximately 300 yards apart along the jeep trail. Pilots had once used these items as targets. Site visits in 1997 have noted that the navigation buoys and A-4 jet have been since removed from the island.

Photograph 15 – A-4 target (removed 1996)

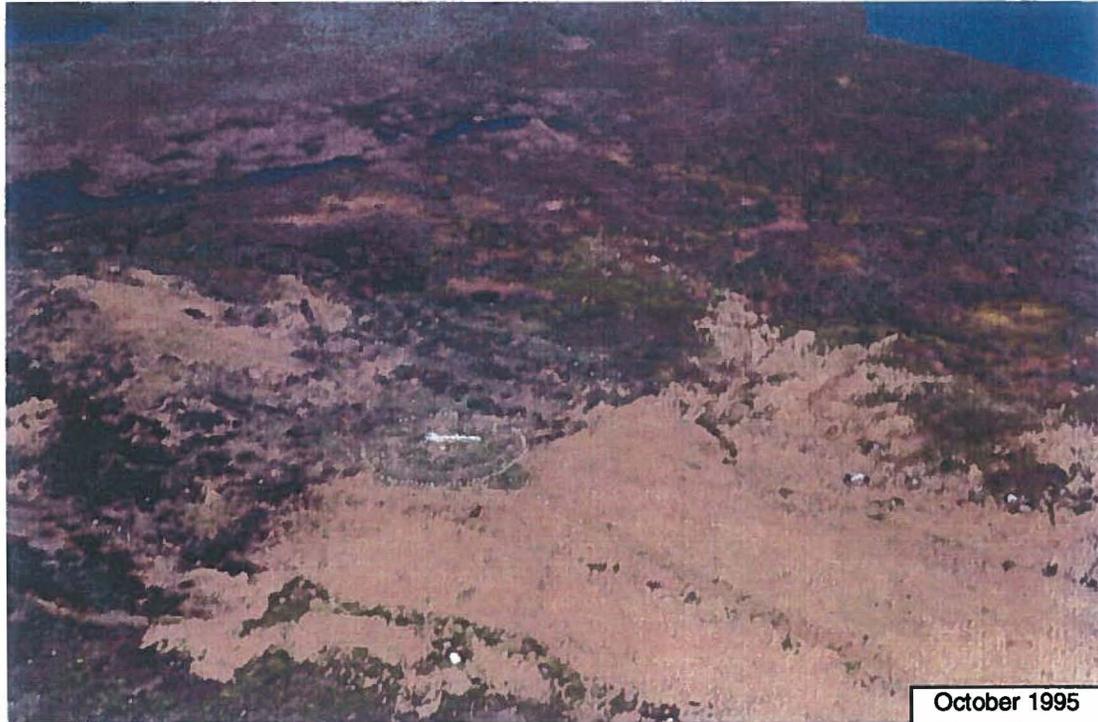
Photograph 16 – Aerial view of A-4 target near dummy airstrip

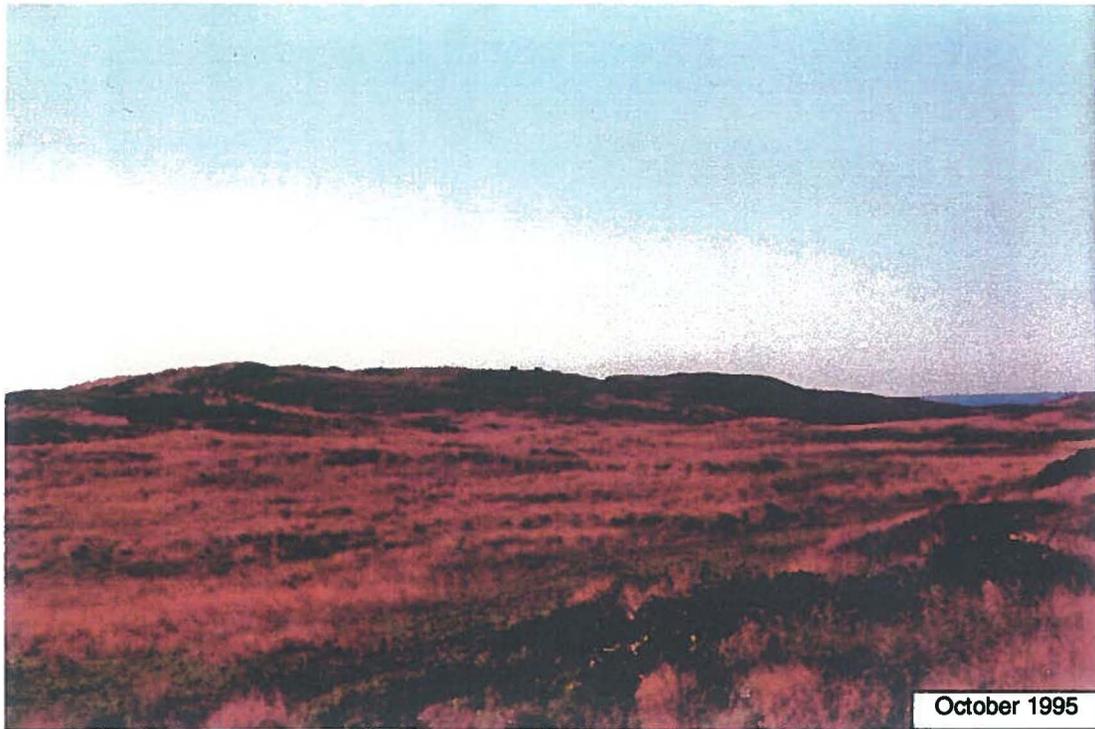
As noted during the site visit in October 1995, tufts of green grass had sprouted in the areas observed to have been burned. Photograph 17, Photograph 18, and Photograph 19 all show examples of the nature and extent of the vegetation on the island.

Photograph 17 – View of vegetation (October 1995)

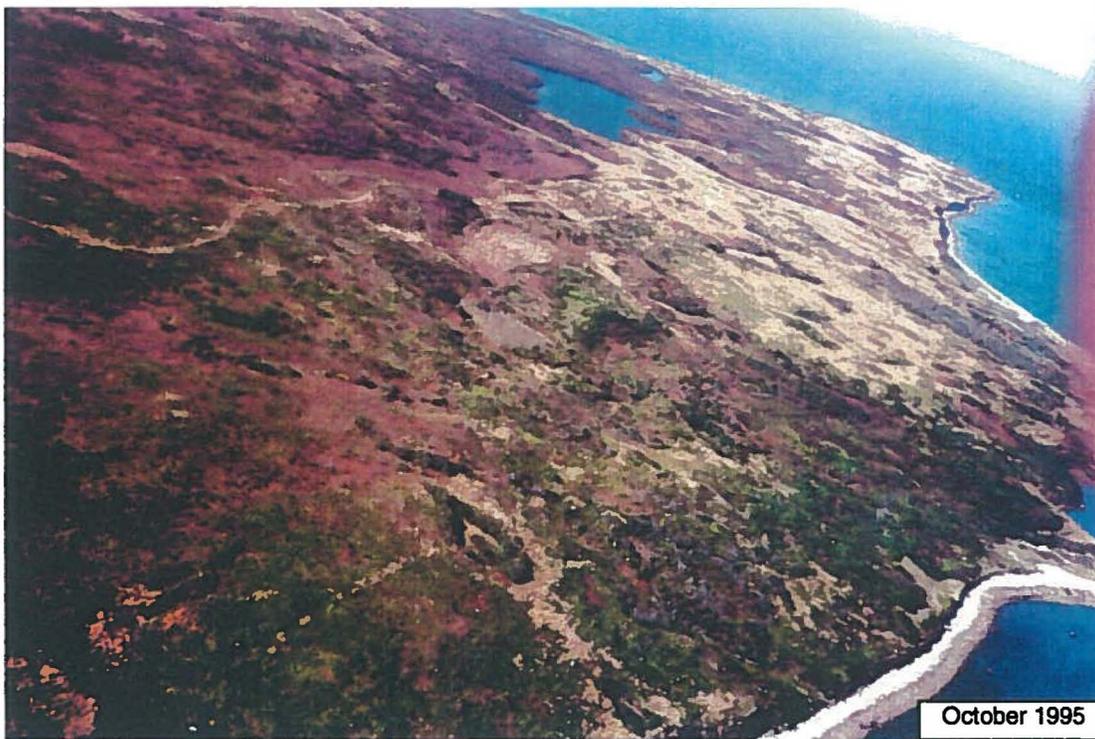
Photograph 18 – Aerial view of pre-1940 settlement and surrounding vegetation

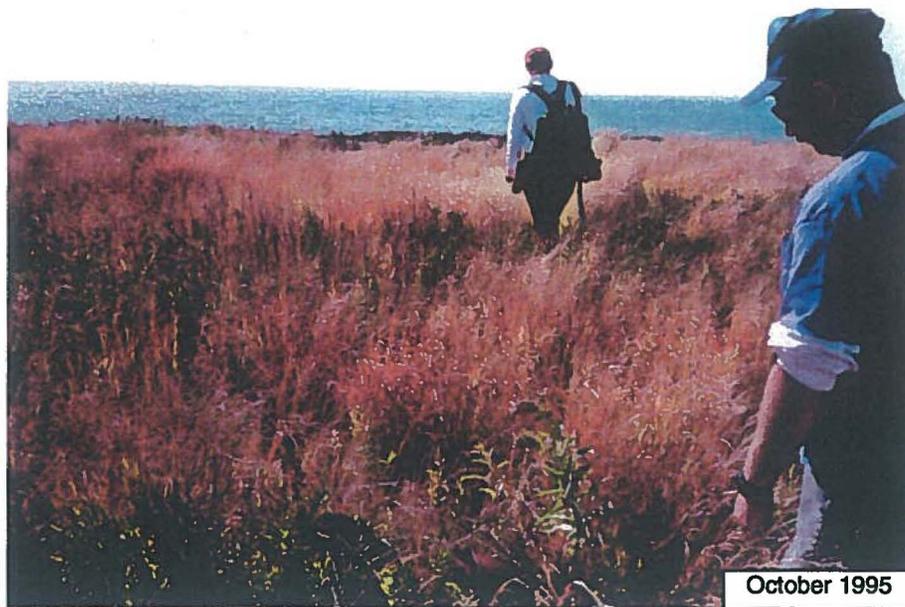
Photograph 19 – Typical vegetation

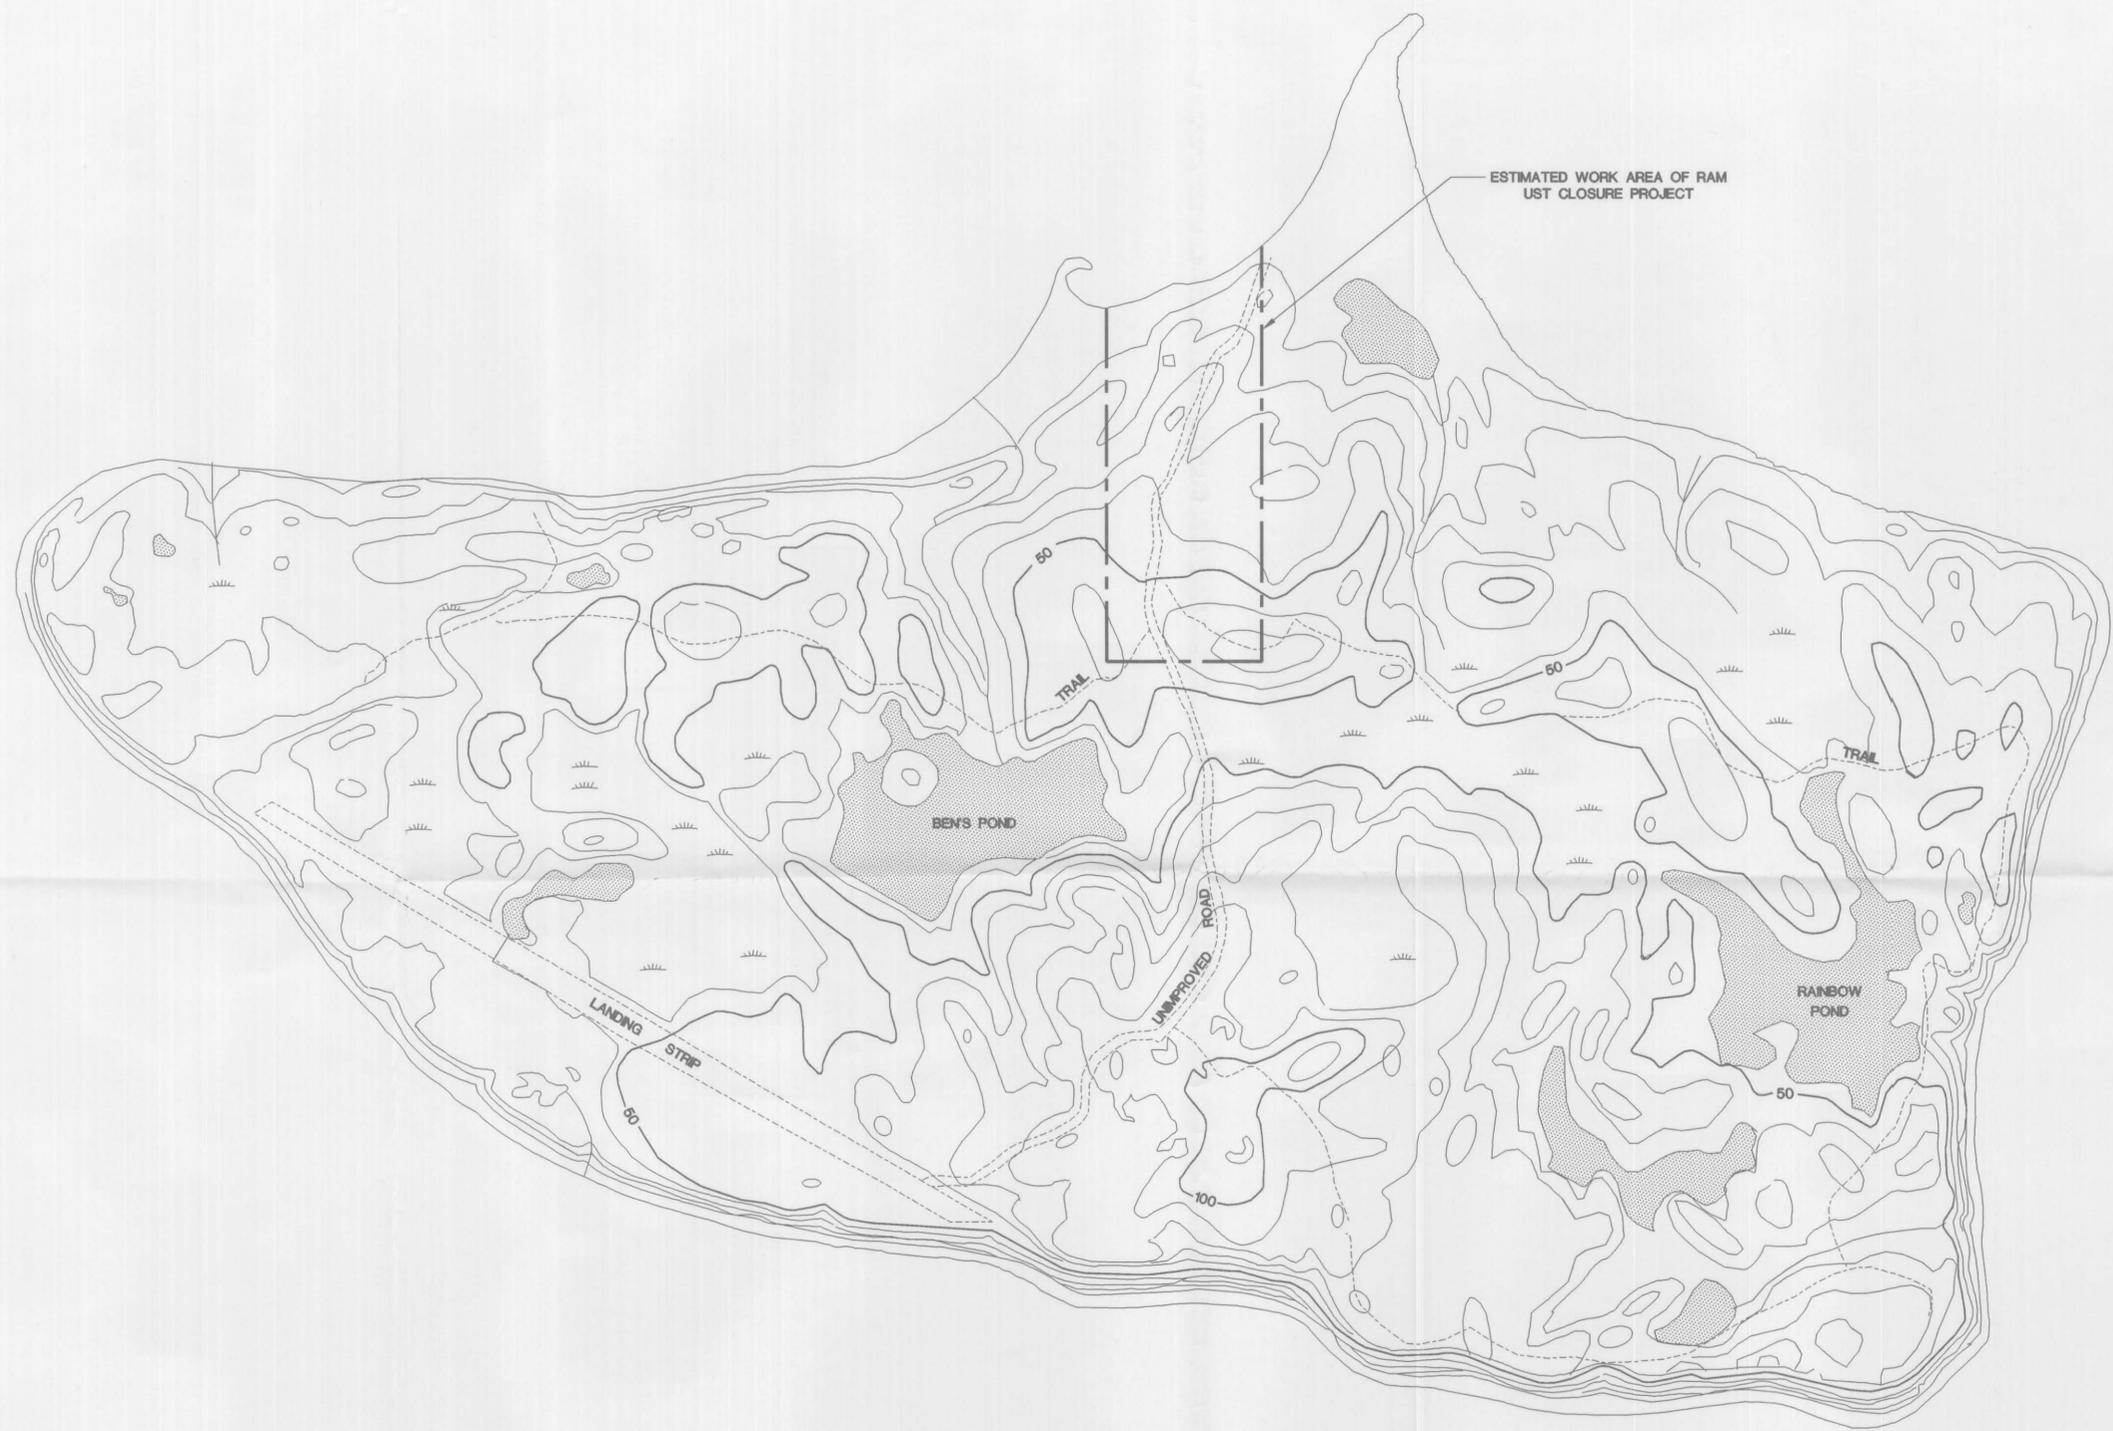
ESTIMATED WORK AREA OF RAM
UST CLOSURE PROJECT
