# DEPARTMENT OF THE NAVY

Re: St. Juliens Creek Annex November 30, 1999  
Site Visit and Work in Progress Meeting Minutes

## November 30th, 1999 Meeting Minutes

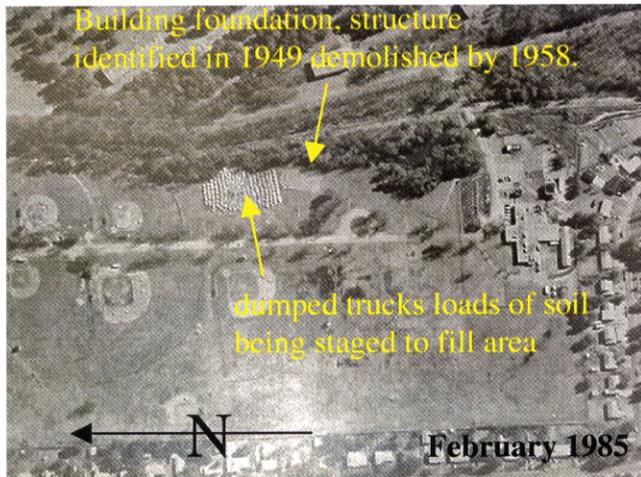
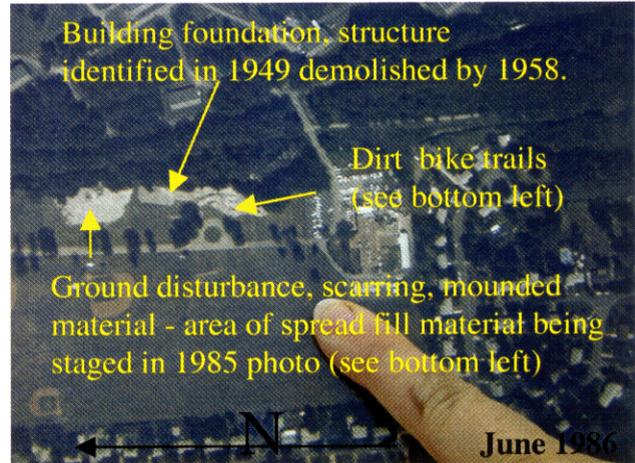
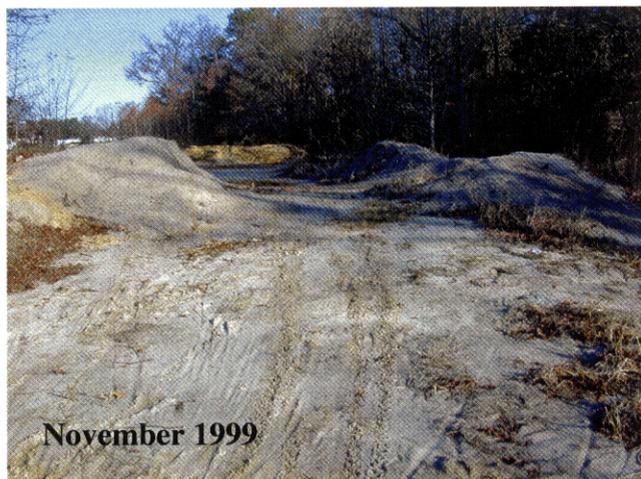
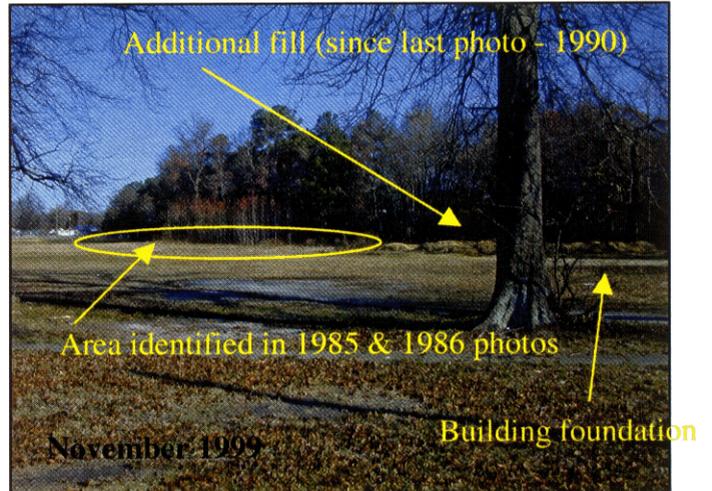
## EPIC - AOC #7

In City of Portsmouth outgrant area, south of ballfields and west of upper reaches of St. Juliens Creek

October 1974 - storage on building foundation area

February 1985 - rows of mounded material (dumped trucks loads of soil being staged to fill area)

June 1986 - ground disturbance, scarring, mounded material (spread fill material).

- Review of EPIC study in June 1999 recommended site recon/visit to determine if any additional action is required.
- Evaluated during November 1999 site visit. Based on additional review of aerial photography and evaluating site conditions (past and present), the “ground-scarring” appears to be soil brought to fill the area. The AOC area has rough grading, a distinct drop in elevation along the east (creek) side, and is vegetated with grass and saplings of various varieties. Several background study sediment and surface water sampling points located in the upper reaches of St. Juliens Creek are near this AOC.
- **NFA is proposed - Navy will provide details of site identification and rationale for NFA determination in the SSA report.**

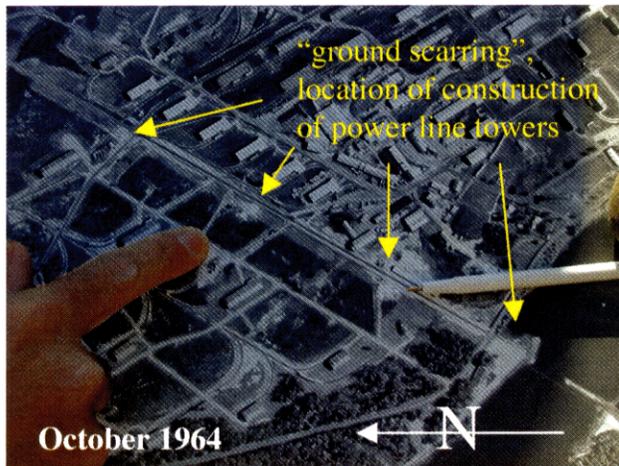
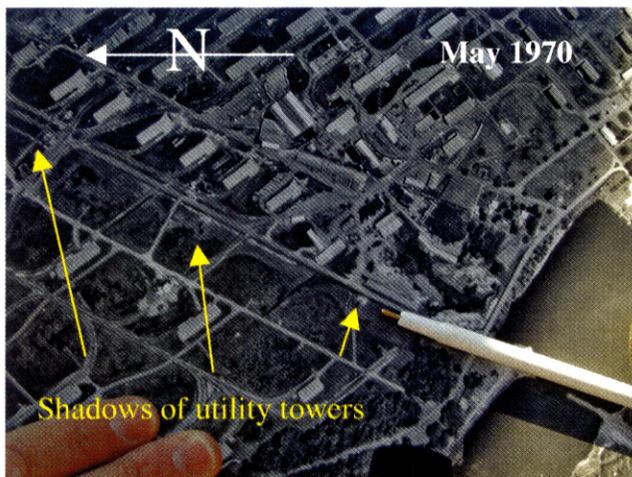
## EPIC - AOC #6

Located across and to the east of Landfill B (Site 2).

March 1963 - no activity at this location

October 1964 - identified ground scarring and possible waste disposal

May 1970 and later - high voltage transmission towers located at areas of disturbance in 1964 photo.

- Review of EPIC study in June 1999 recommended site recon/visit to determine if any additional action is required.
- Evaluated during November 1999 site visit. Based on additional review of aerial photography and evaluating site conditions (past and present), the "ground-scarring" was caused by the construction of high voltage transmission towers across the facility. The shadows of these towers appear in photos after the 1964 construction period.
- **NFA is proposed - Navy will provide details of site identification and rational for NFA determination in the SSA report.**

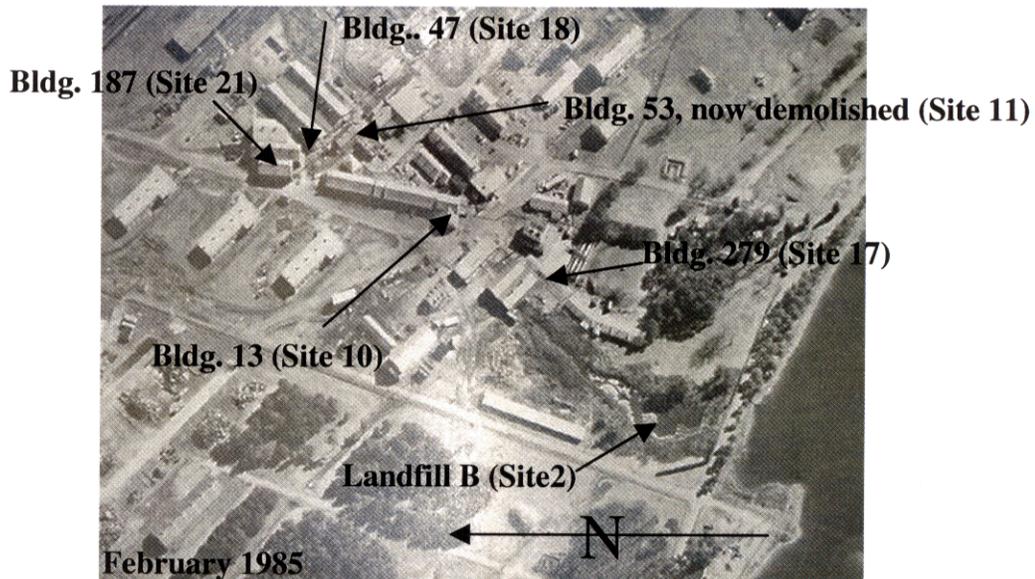
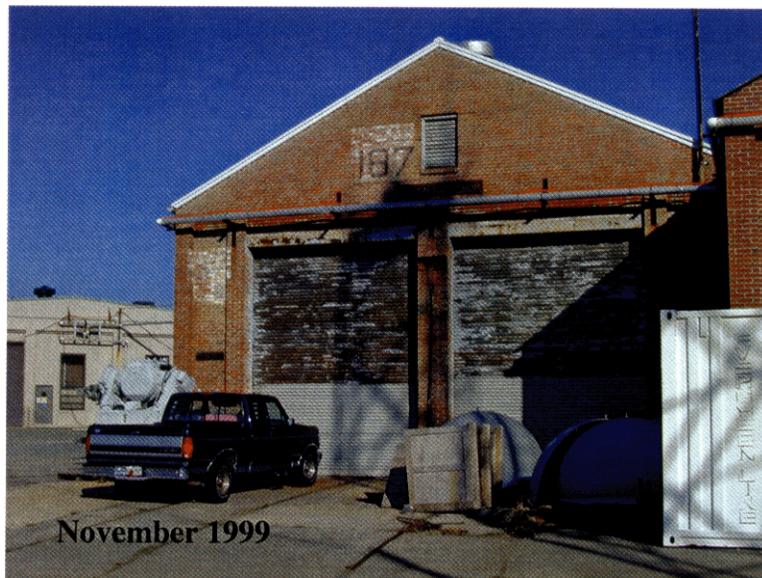
## SITE 21

Building 187 was a locomotive shed, used for locomotive maintenance. The IAS report stated that the area around the locomotive shed is saturated with oil.

- Included for evaluation in SSA investigation which will group sites into categories based on additional action: additional investigation (RI) required, removal action warranted, or no further action determination.
- SSA report will provide documentation that no ecological receptors are located at this site (Step 1), and recommend NFA for ecological concerns. BTAG concurred with this proposal during the November 1999 site visit.

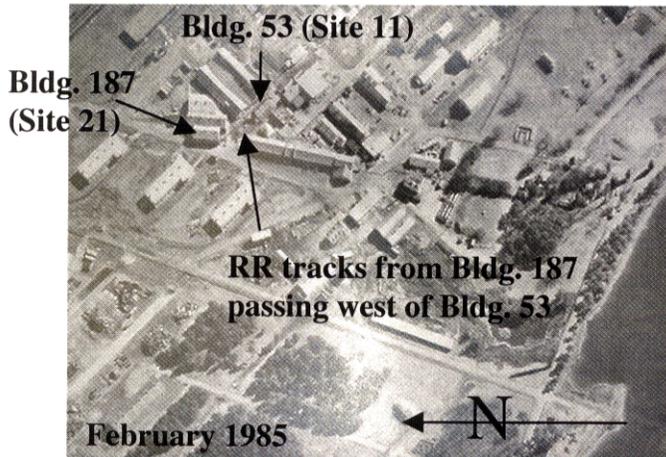
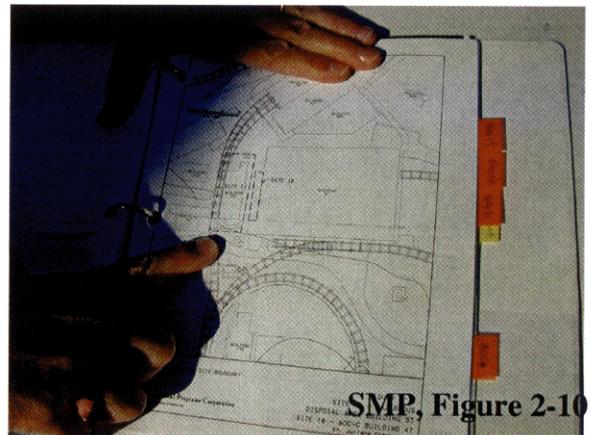
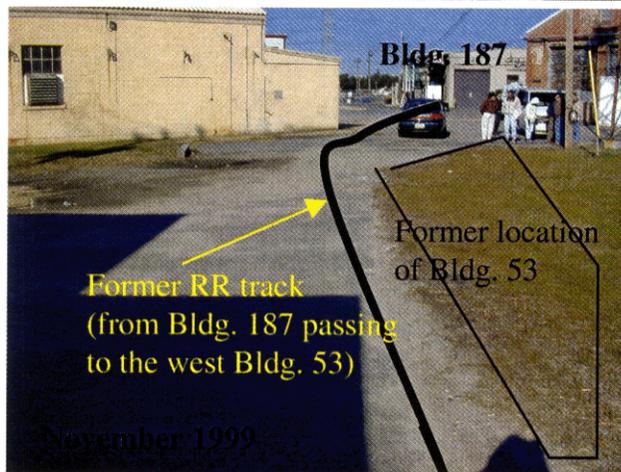
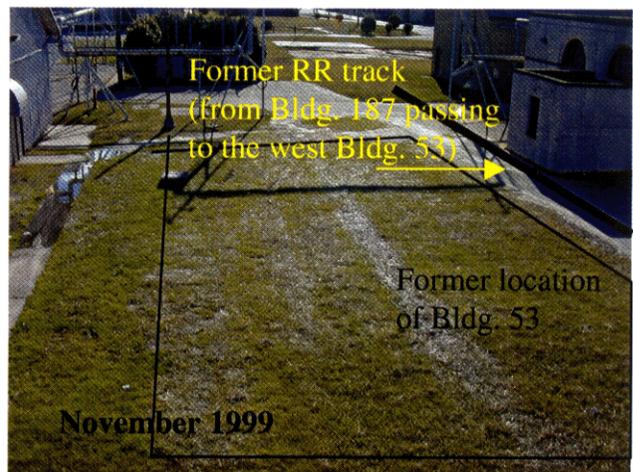
## SITE 11 (RFA - SWMU 15)

Disposal area in former RR track bed located southeast and adjacent to Building 53 (now demolished).

Building 53 was the facility electrical shop located in the industrial area east of Craddock Street. In the IAS it was stated that station electricians used 5 gallons per month of trichloroethylene. Most of the solvent evaporated, but the remainder was disposed on the railroad track bed adjacent to Building 53.

- Included for evaluation in SSA investigation which will group sites into categories based on additional action: additional investigation (RI) required, removal action warranted, or no further action determination.
- SSA report will provide documentation that minimal/no ecological receptors are located at this site (Step 1), and recommend NFA for ecological concerns. BTAG concurred with this proposal during the November 1999 site visit.

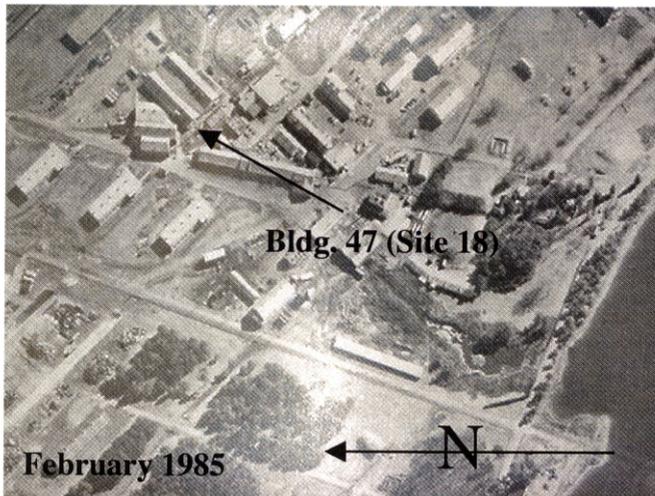
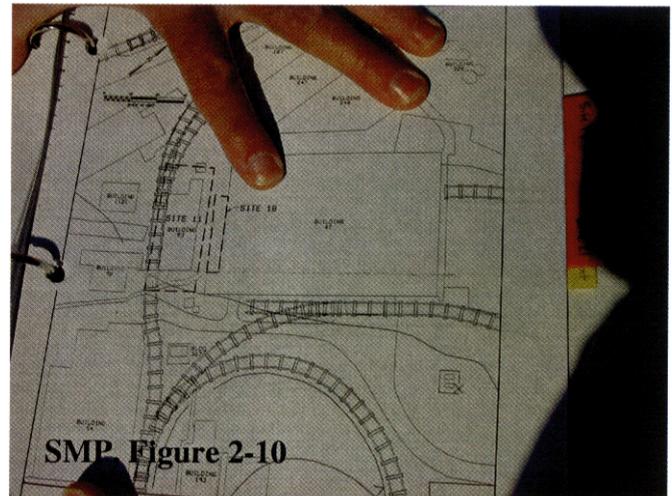
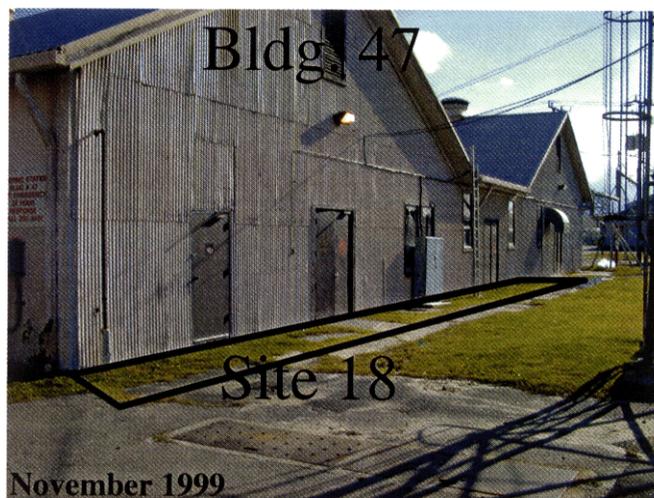
## SITE 18 (RFA - AOC B, AOC C)

Located on the south side of Building 47, next to former Building 53.

Site 18 is located adjacent to the south wall of Building 47. This site was first identified as an area of concern in the RFA at which time sand blasting grit was observed at this location. Although Building 47 housed two sand blasting booths, personnel working in that building reported that they did not use black blasting grit in their machines; therefore, the source of the grit is unknown.

- Included for evaluation in SSA investigation which will group sites into categories based on additional action: additional investigation (RI) required, removal action warranted, or no further action determination.
- SSA report will provide documentation that minimal/no ecological receptors are located at this site (Step 1), and recommend NFA for ecological concerns. BTAG concurred with this proposal during the November 1999 site visit.

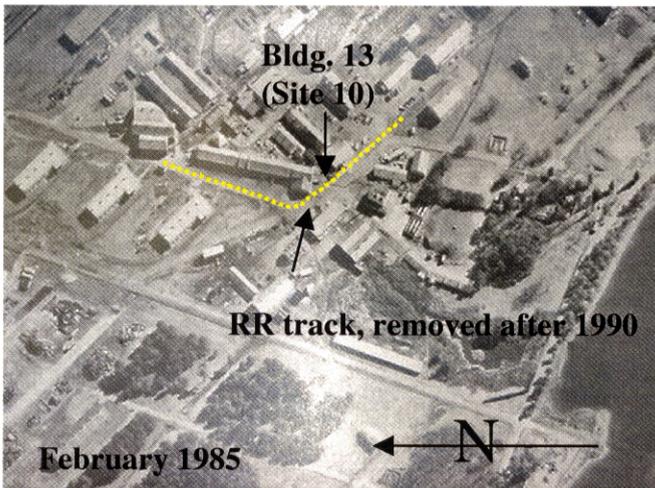
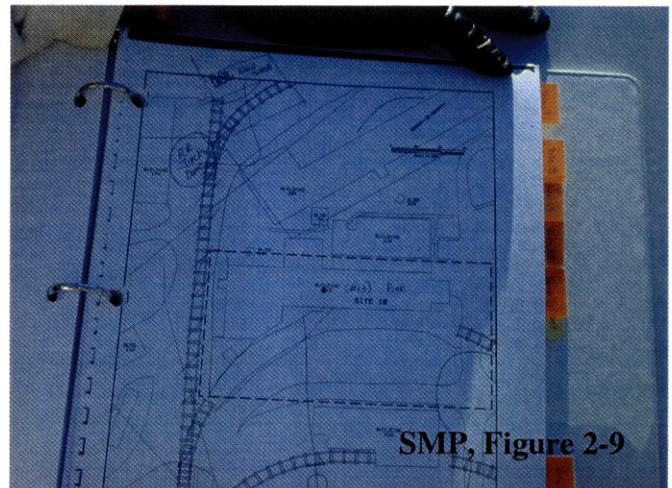
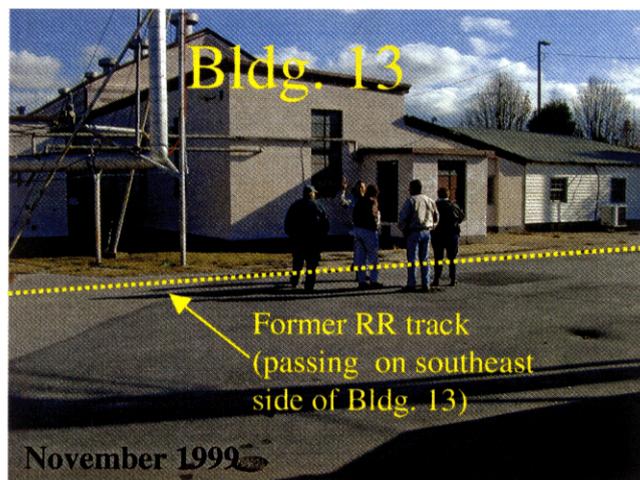
## SITE 10 (RFA - SWMU 14)

Adjacent to Building 13 (south side) along former RR track bed.

This site is located in the vicinity of Building 213. The site is the reported disposal location for wastes generated during hardware cleaning operations from prior to 1940 to the mid-1970s. It is reported that liquid wastes were poured on the railroad tracks, although during the RFA, no evidence of a release was observed.

- Included for evaluation in SSA investigation which will group sites into categories based on additional action: additional investigation (RI) required, removal action warranted, or no further action determination.
- SSA report will provide documentation that minimal/no ecological receptors are located at this site (Step 1), and recommend NFA for ecological concerns. BTAG concurred with this proposal during the November 1999 site visit.

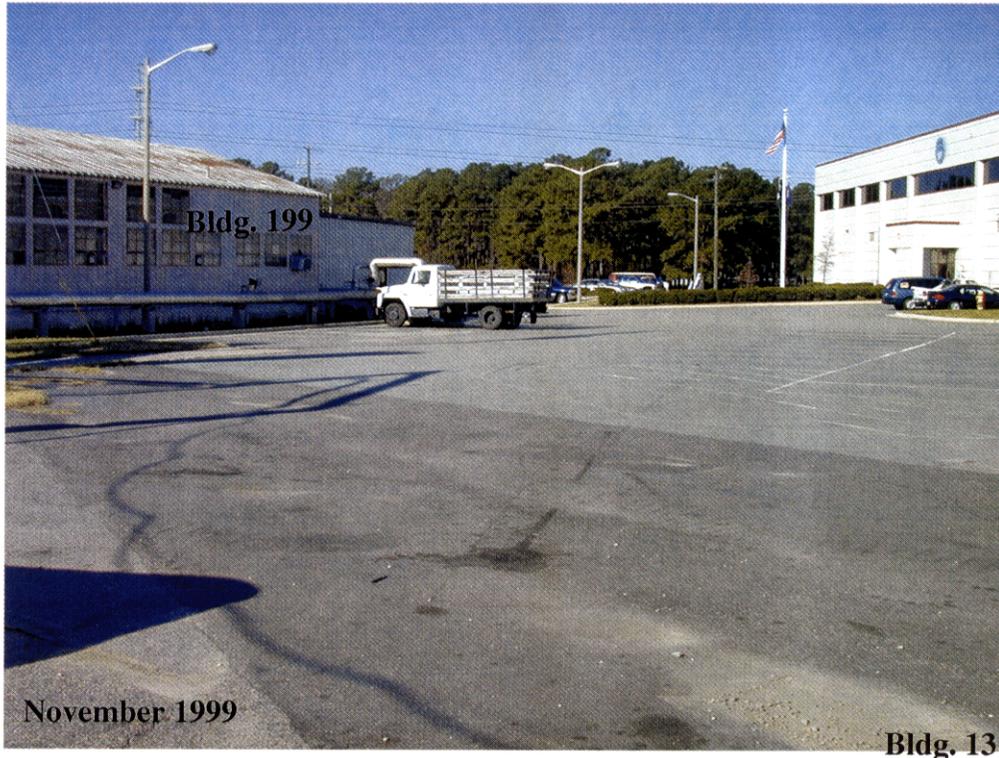
## **(RFA - SWMU 31) Swale beneath Building 13**

Former swale located between Buildings 13 and 199/278 (also see Sites 10 and 17). Area between these buildings has been paved since 1949 photos (road in 1937).

- Evaluated during November 1999 site visit. Based on review of aerial photography and evaluating site conditions (past and present) swale from Building 13 to Building 199 discharged into the tidal marsh behind Buildings 199 & 279. This marsh is under investigation as part of the Landfill B (Site 2) RI.
- **NFA is proposed, discussion of Building 13 (Site 10) in SSA investigation report will briefly address RFA SWMU 31.**

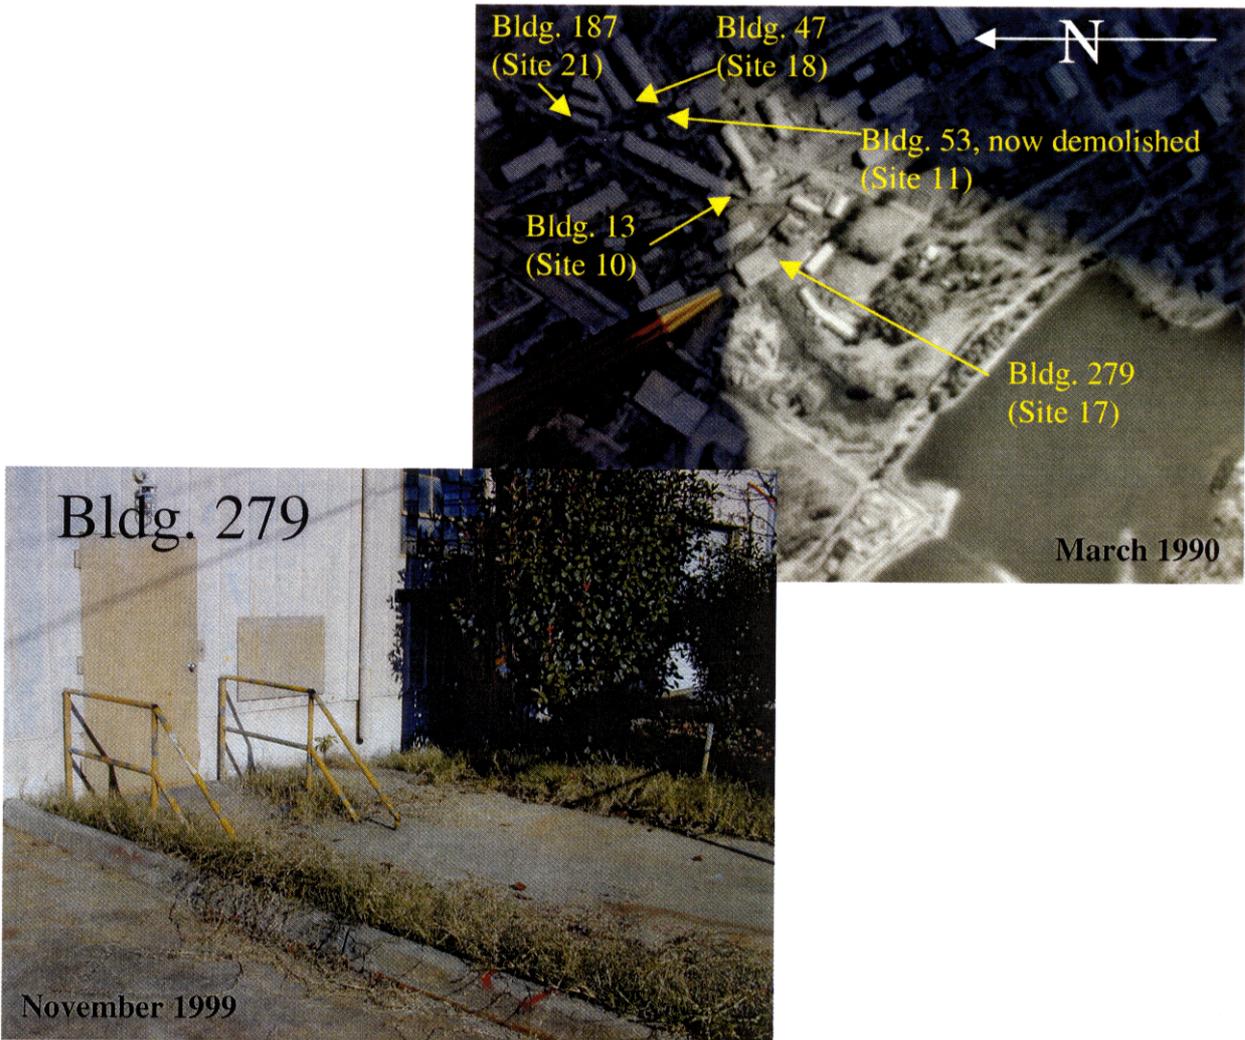
## SITE 17 (RFA - AOC A)

This small structure is located within the industrial area, east of Craddock Street and consists of a concrete storage pad located just outside Building 279. The storage pad is used to store drums of degreaser. Stains on the ground near the pad, as well as indications of poor management were noted during the RFA.

- Planned SI for Sites 15 & 17 to determine additional action: additional investigation (RI) required, removal action warranted, or no further action determination.
- Sites 15 & 17 SI report will include a Screening ERA. BTAG concurred with this proposal during the November 1999 site visit. BTAG recommended combining this site ecologically with Site 2, Landfill B, which is adjacent to the site.

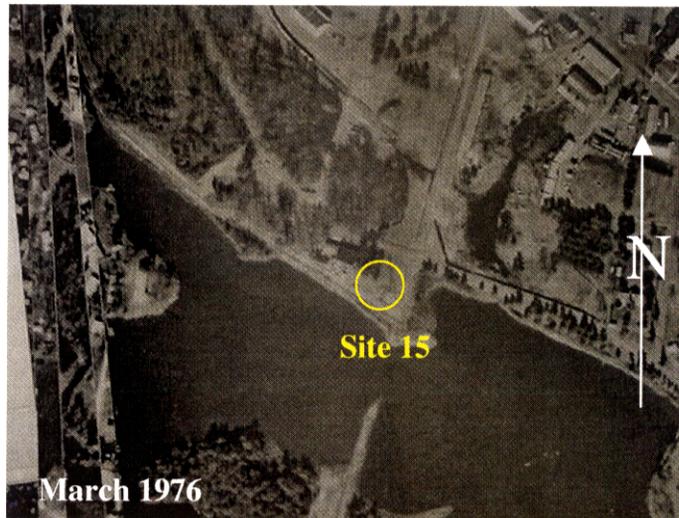
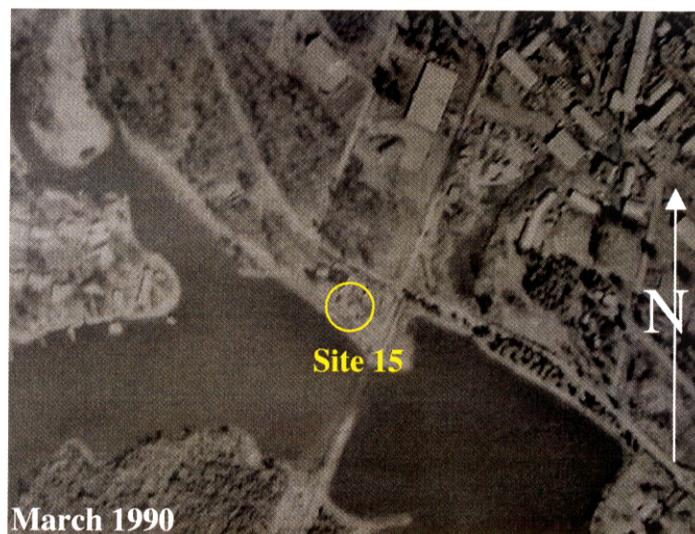
## SITE 15 (RFA - SWMU 27)

The fire training site consists of two celled areas behind (east) of Building 271 which are used to train fire fighting personnel. One of the celled areas consists of a burn area where wooden pallets, soaked in diesel fuel, were burned and extinguished with water. The other area is a steel-lined burn pit (4 ft by 4 ft by 3 ft deep) which was filled with diesel fuel, ignited, and extinguished with carbon dioxide.

- Planned SI for Sites 15 & 17 to determine additional action: additional investigation (RI) required, removal action warranted, or no further action determination.
- Sites 15 & 17 SI report will include a Screening ERA. BTAG concurred with this proposal during the November 1999 site visit. BTAG recommended combining this site ecologically with Site 2, Landfill B, which is adjacent to the site.

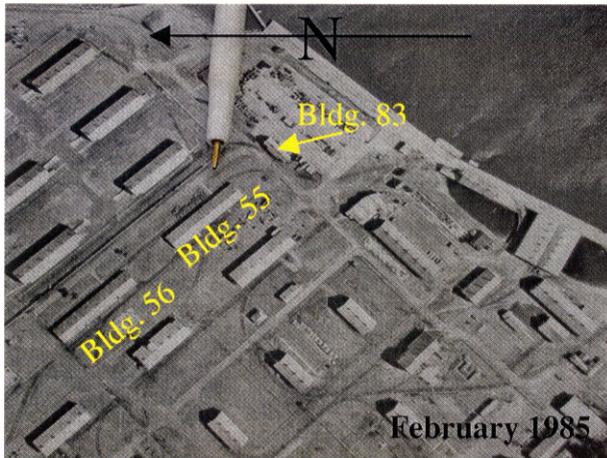
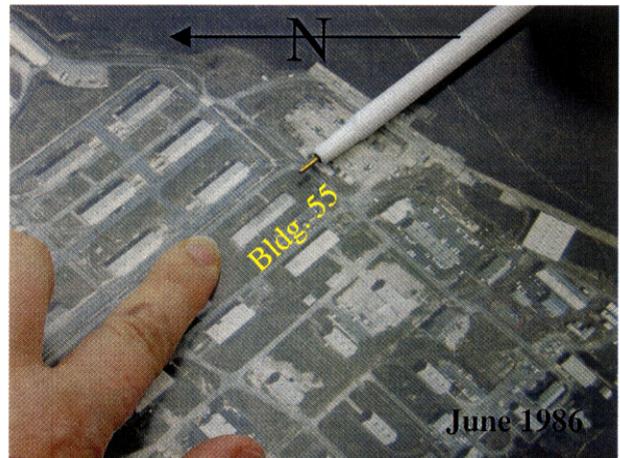
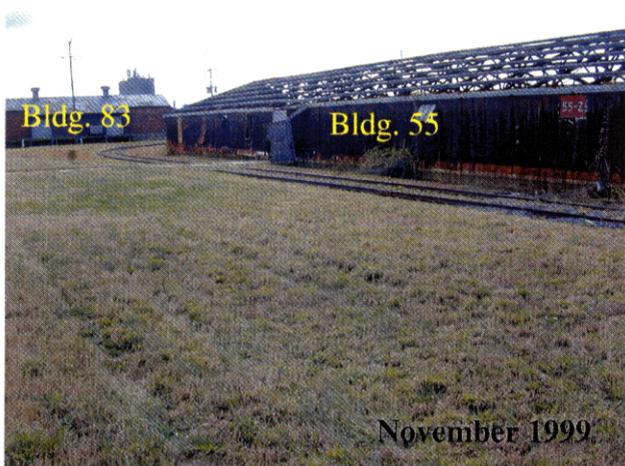
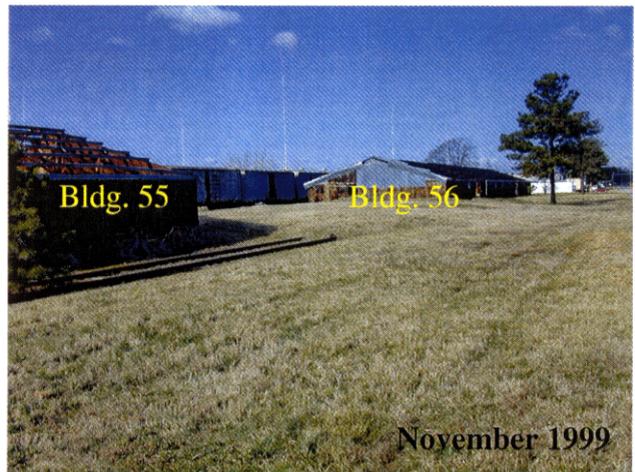
## EPIC - AOC 11

Located northeast of Building 55.

February 1985 & June 1986 - Open storage of drums/material at Bldg. 55, between RR and road. No evidence of storage in previous or later photos.

- Review of EPIC study in June 1999 recommended site recon/visit to determine if any additional action is required.
- Evaluated during November 1999 site visit. Based on additional review of aerial photography and evaluating site conditions (past and present), **NFA is proposed - Navy will provide details of site identification and rationale for NFA determination in the SSA report.**

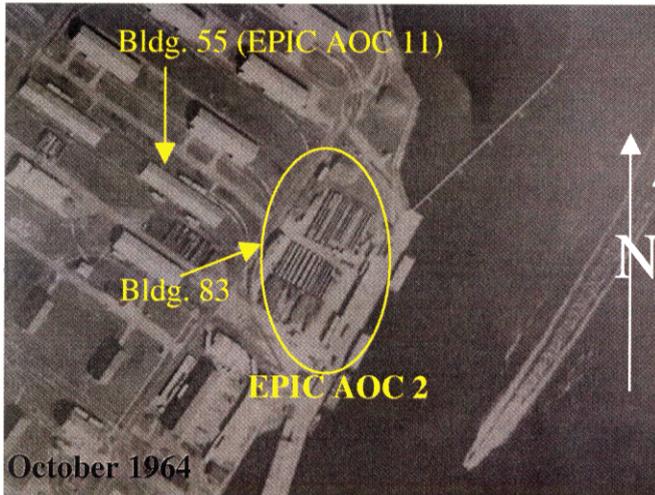
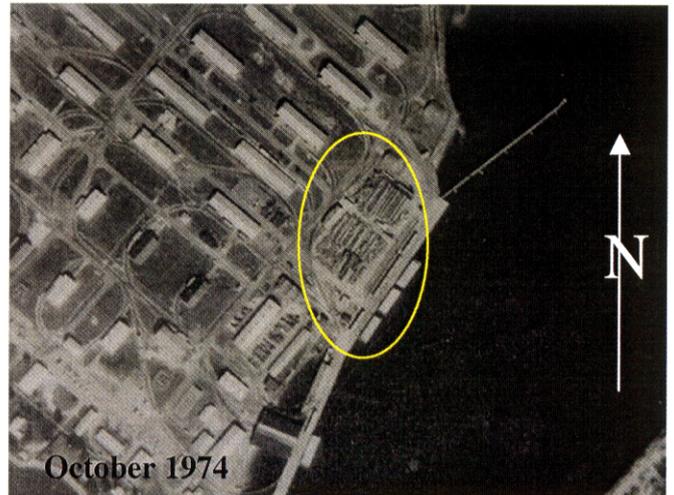
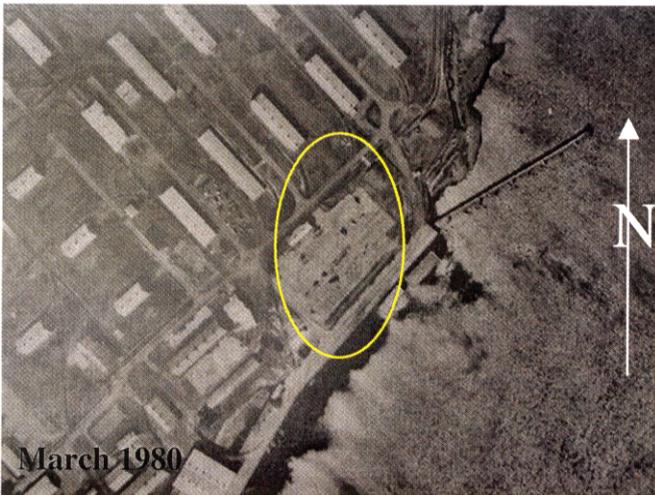
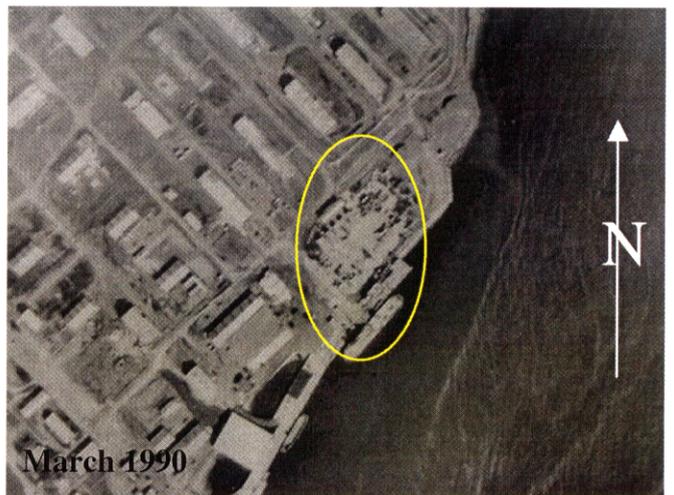
## EPIC - AOC 2

Piers, in front of Building 83.

Storage of materials, possible ordnance materials, in extended rows pattern. Storage of items in this manner, is not evident after the 1976 photos; all SJCA ordnance operations/processes moved to NWS Yorktown in 1977. No releases have been reported in this storage area.

- Review of EPIC study in June 1999 recommended site recon/visit to determine if any additional action is required.
- Evaluated during November 1999 site visit. The Navy will research and provide additional information regarding the storage of materials in this area. This information will be provided in the SSA report. No sampling is proposed in this area. Potential NFA site - Navy will provide details of site and make further action determination in the SSA report.

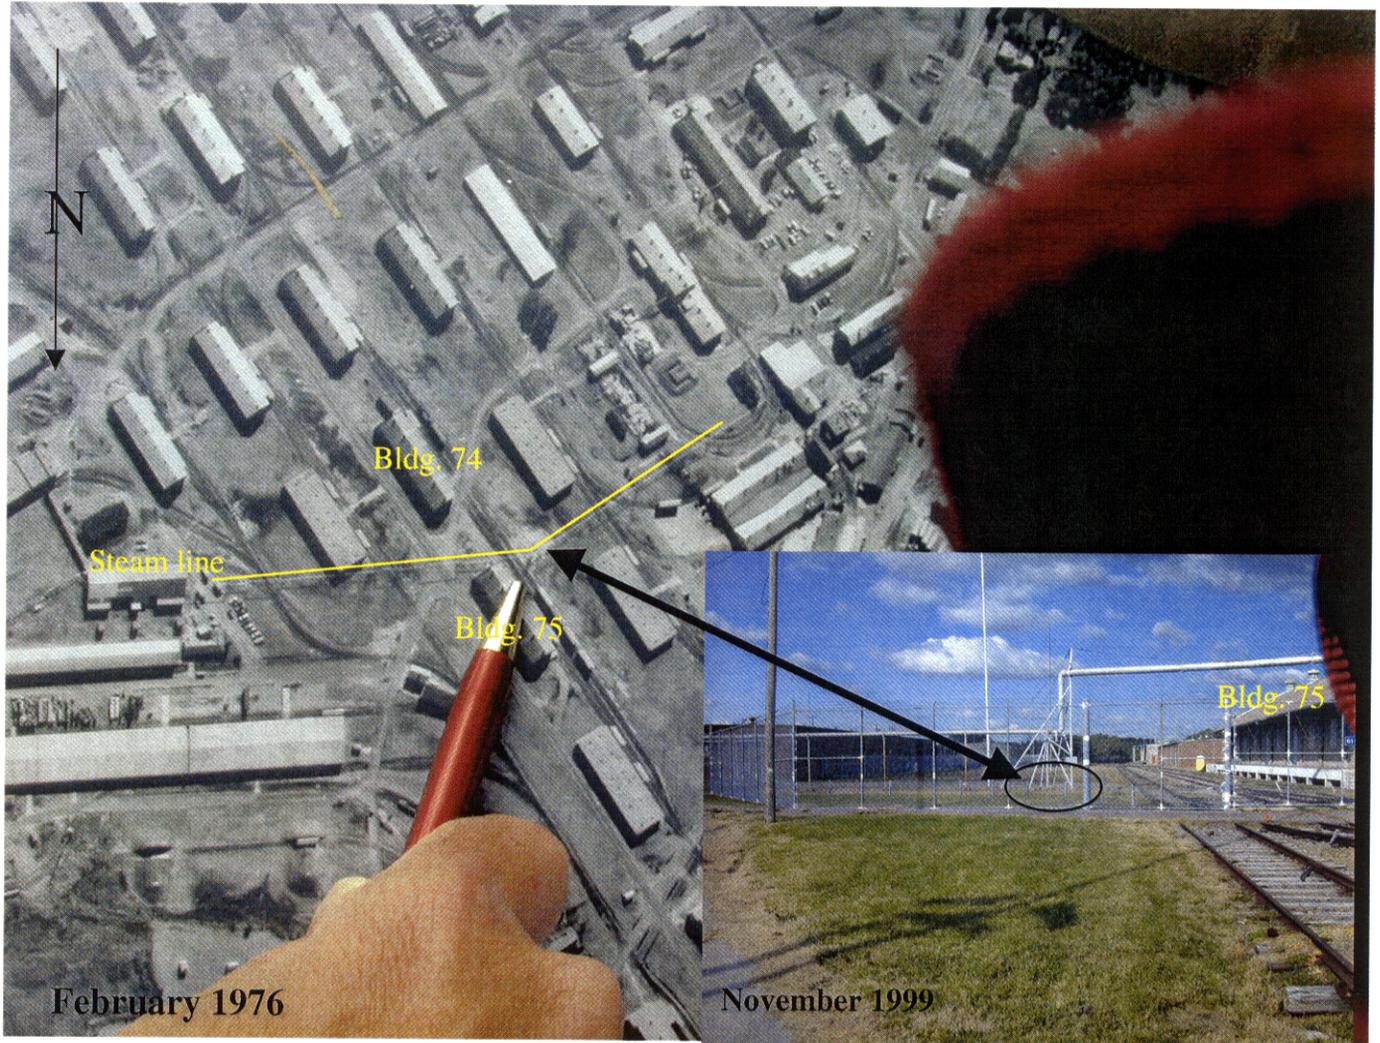
## EPIC - AOC 9

Located southwest of Building 74.

February 1976 - Ground scarring under steam line, next to RR tracks. AOC identified in previous 1970s and early 1980s photos.

- Review of EPIC study in June 1999 recommended site recon/visit to determine if any additional action is required.
- Evaluated during November 1999 site visit. Based on additional review of aerial photography and evaluating site conditions (past and present), **NFA is proposed - Navy will provide details of site identification and rationale for NFA determination in the SSA report.**

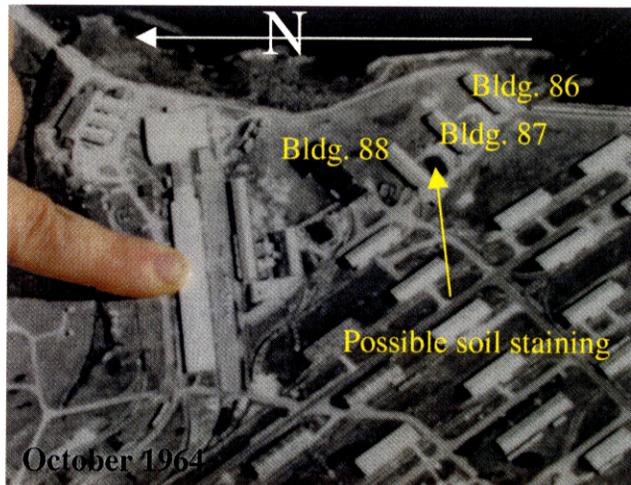
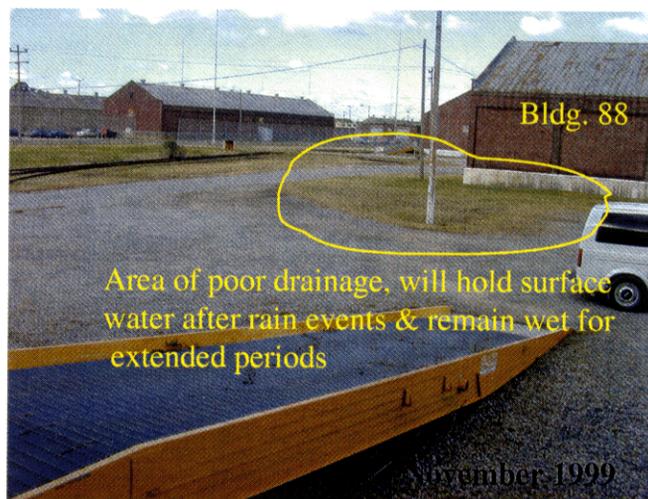
## EPIC - AOC 5

Located between Buildings 87 and 88.

October 1964 - Possible soil staining

- Review of EPIC study in June 1999 recommended site recon/visit to determine if any additional action is required.
- Evaluated during November 1999 site visit. Based on additional review of aerial photography and evaluating site conditions (past and present), the “soil staining” appears to be ponded water or wet soils due to poor drainage in the area (grading is not towards any catch basin).
- **NFA is proposed - Navy will provide details of site identification and rationale for NFA determination in the SSA report.**

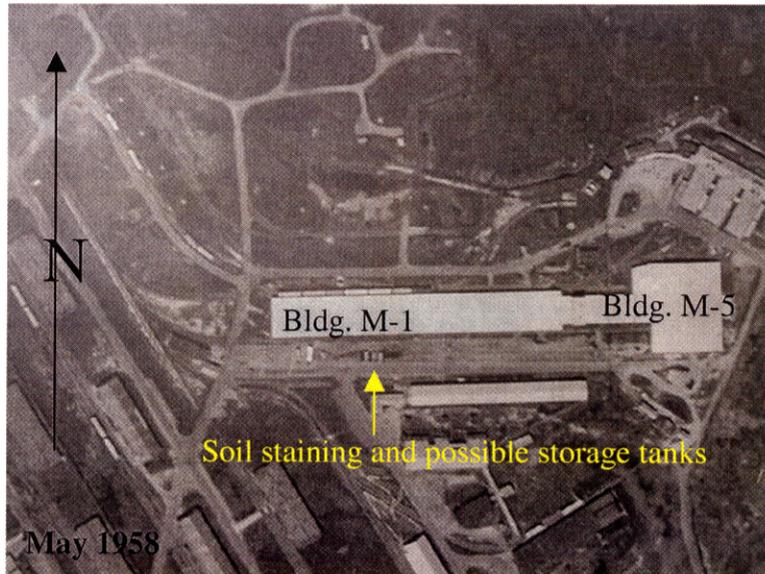
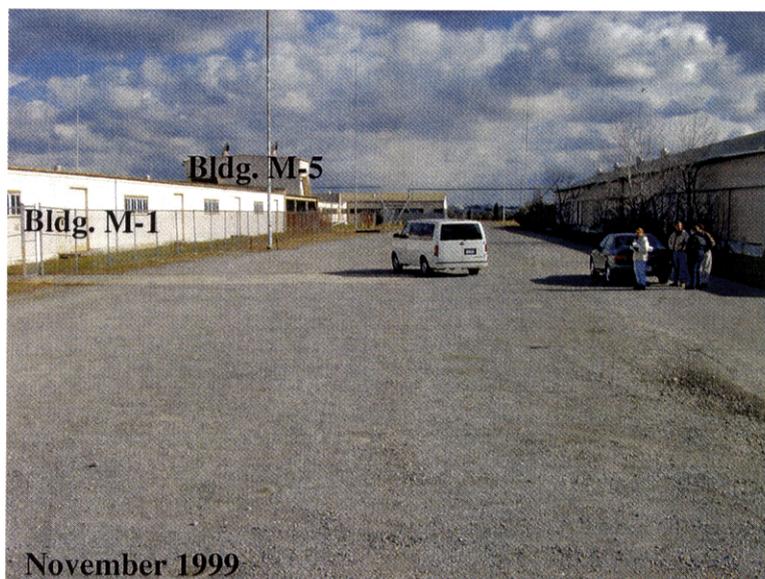
## EPIC - AOC 4

Parking lot, located south of Building M-1.

May 1958 - Soil staining identified south of Building M-1, possible storage tanks.

- Review of EPIC study in June 1999 recommended site recon/visit to determine if any additional action required.
- Evaluated during November 1999 site visit. Based on additional review of aerial photography and evaluating site conditions (past and present), the “soil staining” appears to be from automobiles/trucks in the a parking lot. The “storage tanks” are believed to be trailers.
- **NFA is proposed - Navy will provide details of site identification and rational for NFA determination in the SSA report.**

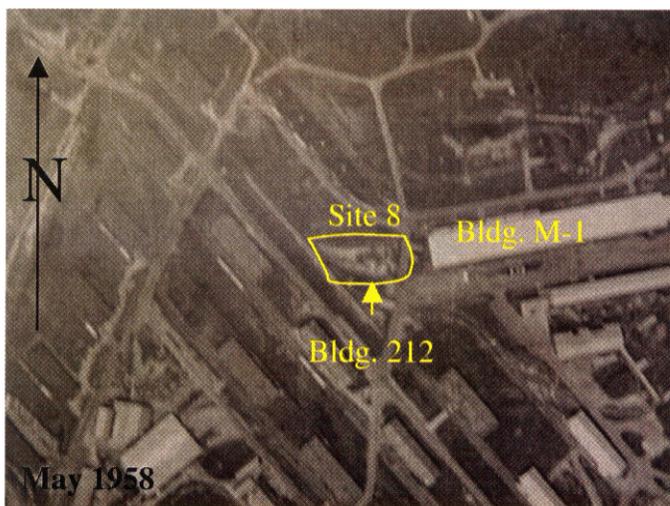
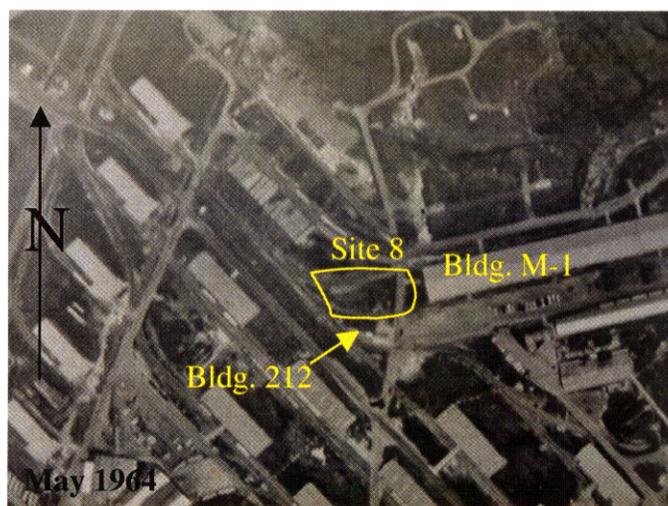
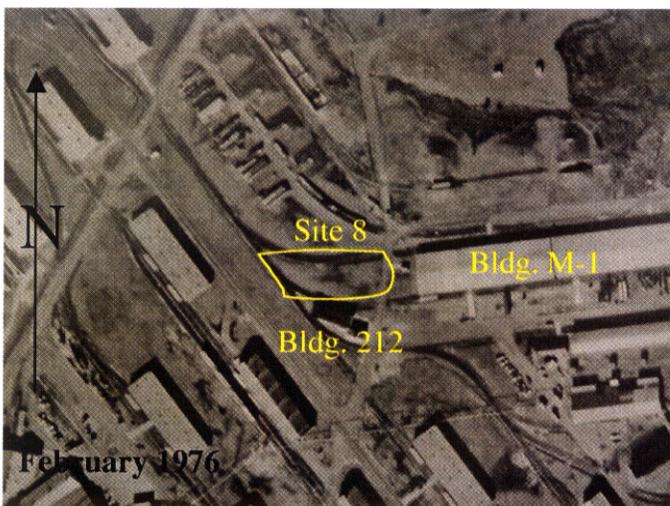
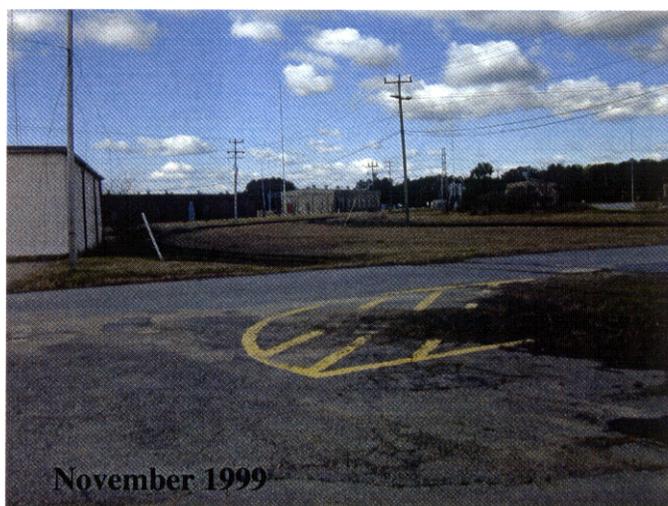
## SITE 8 (RFA - SWMU 9) - Cross and Mine

Located at the intersection of Cross Street and Mine Road, adjacent to and north of Building 212 and across the street from Building M-1.

This site was used for disposal of rinse water from mobile insecticide and herbicide spray trucks from the 1950s to mid 1960s. An estimated 675,000 gallons of rinse water was discharged directly to soil and allowed to infiltrate.

- Included for evaluation in SSA investigation which will group sites into categories based on additional action: additional investigation (RI) required, removal action warranted, or no further action determination.
- SSA report will provide documentation that minimal/no ecological receptors are located at this site (Step 1), and recommend NFA for ecological concerns. BTAG concurred with this proposal during the November 1999 site visit.

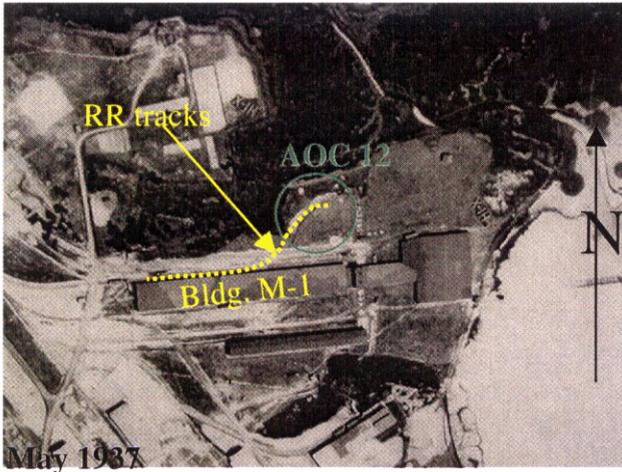
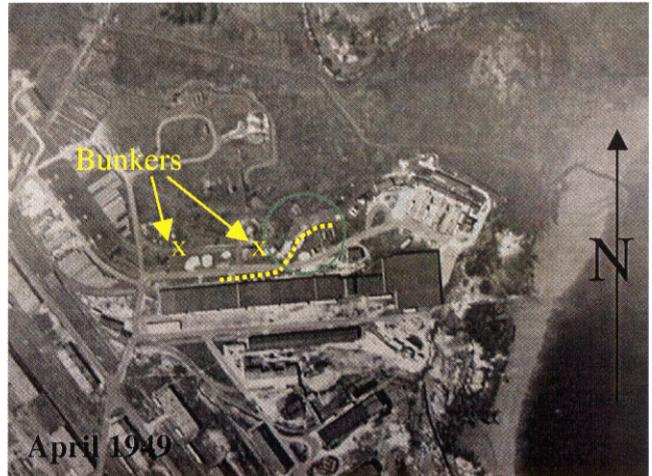
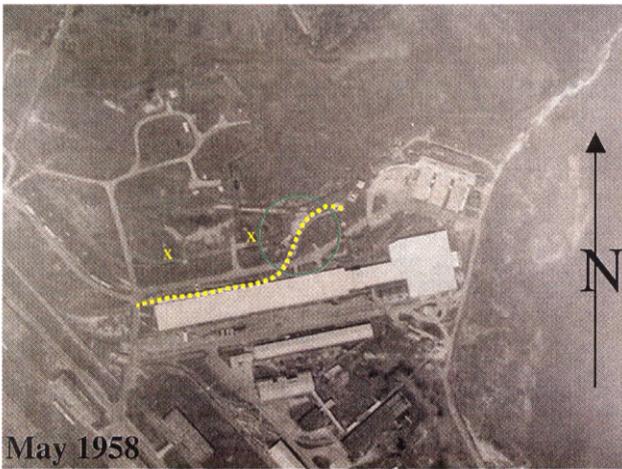
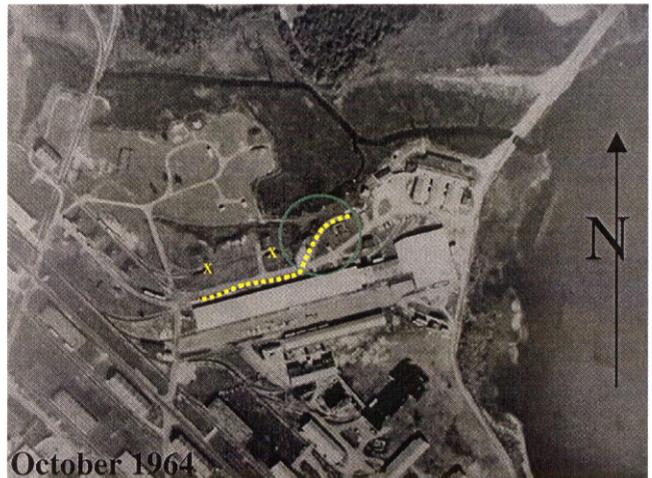
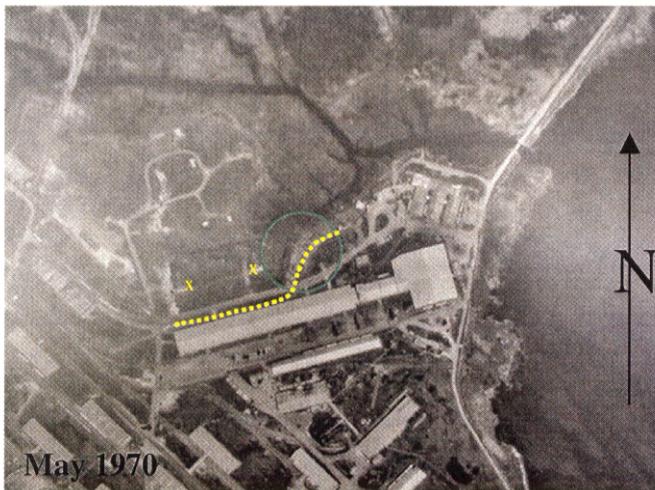
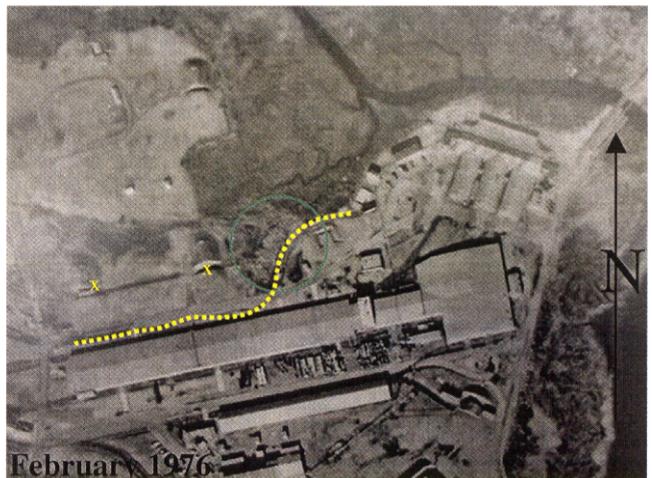
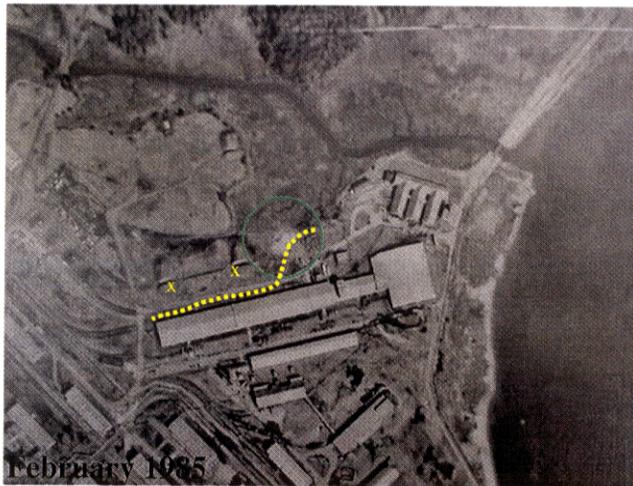
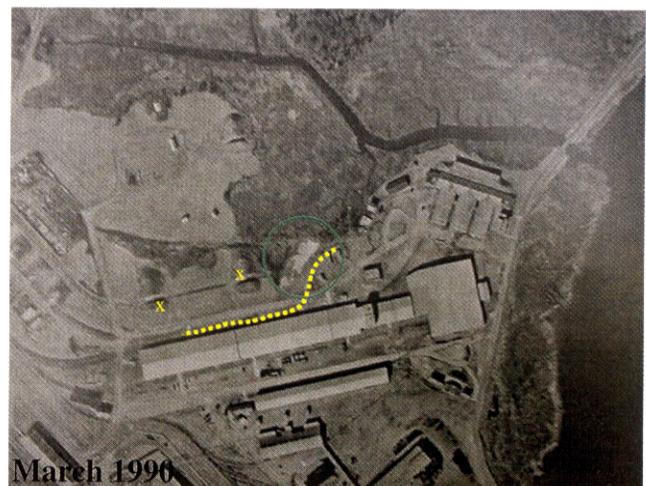
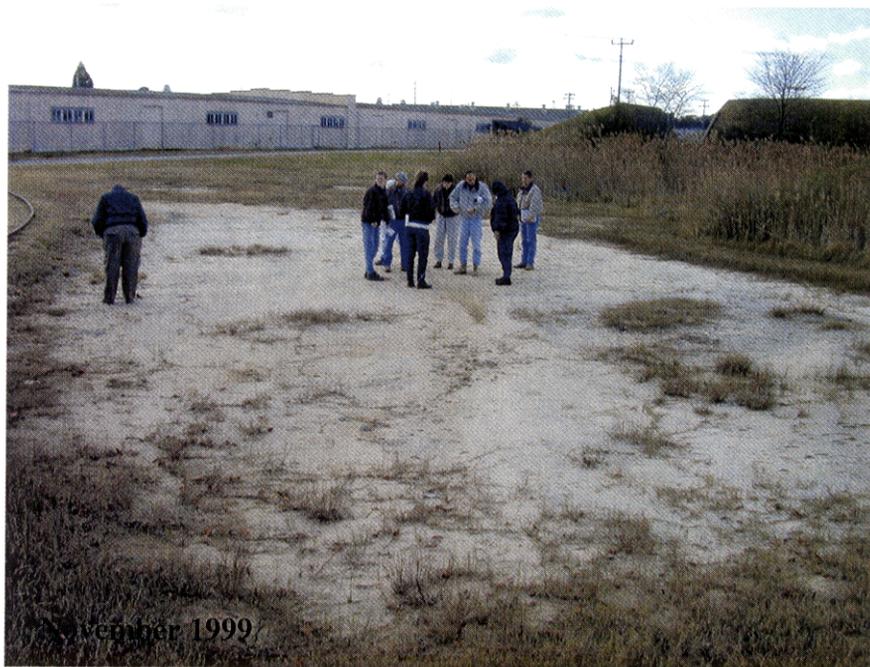
# EPIC - AOC 12

Located north of Buildings M-1 and M-5, directly adjacent to Blows Creek.

Sandy flat area next to RR tracks is void of vegetation for extended period of time. No storage of waste disposal is shown in this area.

- Review of EPIC study in June 1999 recommended site recon/visit to determine if any additional action is required.
- Evaluated during November 1999 site visit. Based on additional review of aerial photography and evaluating site conditions (past and present), the area of former marsh (1937) has been filled as evidenced by shell fragments found in the sandy soils; however, due to the lack of vegetation in the area for extended periods of time this AOC is proposed for additional investigation.
- Soil (surface and sub-surface) and geo-physics are proposed for the SSA field investigation to determine additional action: additional investigation (RI) required, removal action warranted, or no further action determination.
