# DEPARTMENT OF THE NAVY

Re: St. Juliens Creek Annex November 30, 1999  
Site Visit and Work in Progress Meeting Minutes

## November 30th, 1999 Meeting Minutes

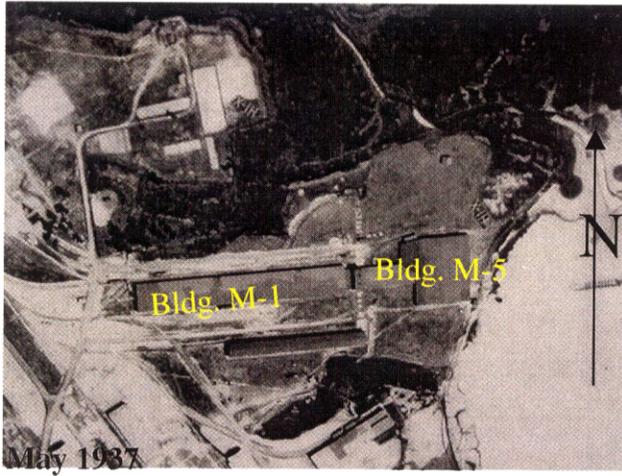
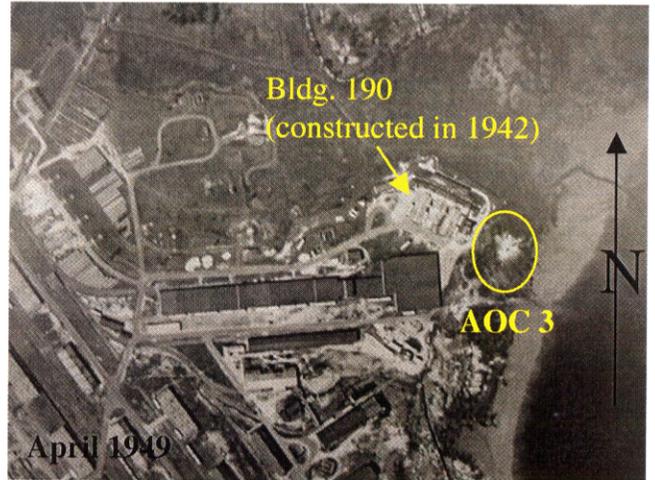
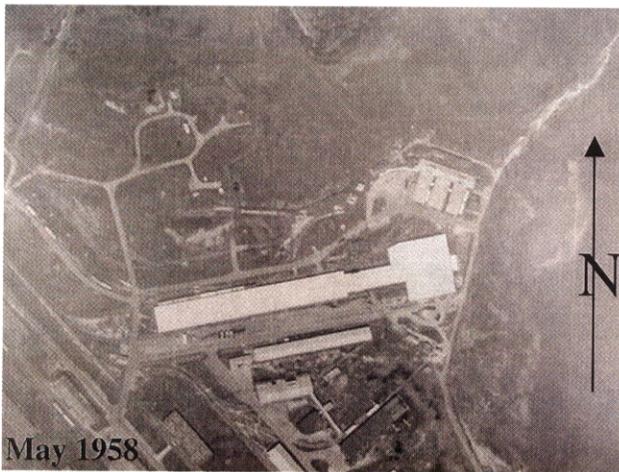
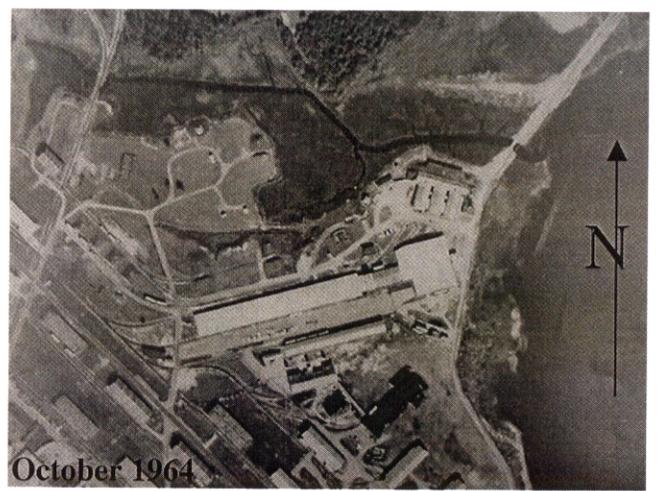
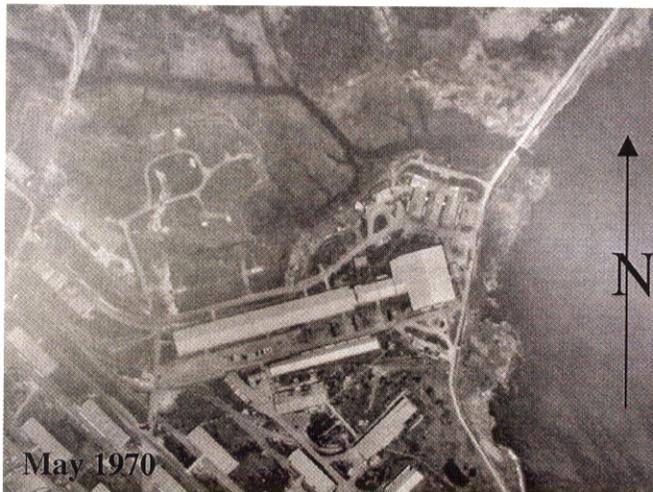
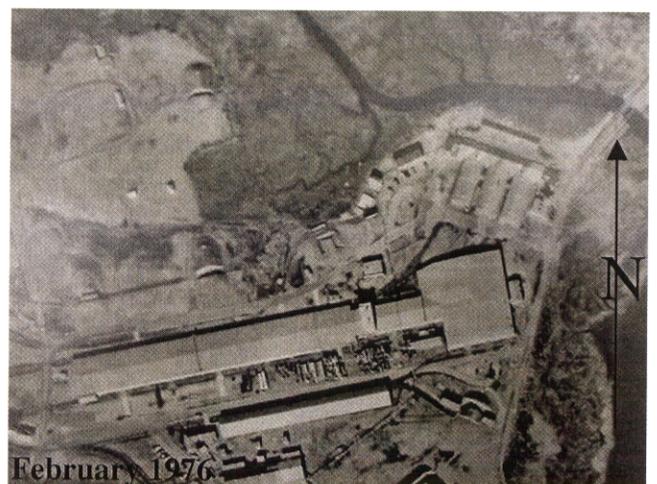
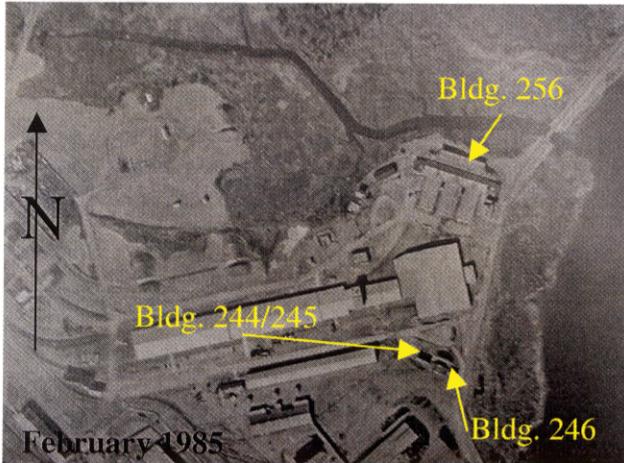
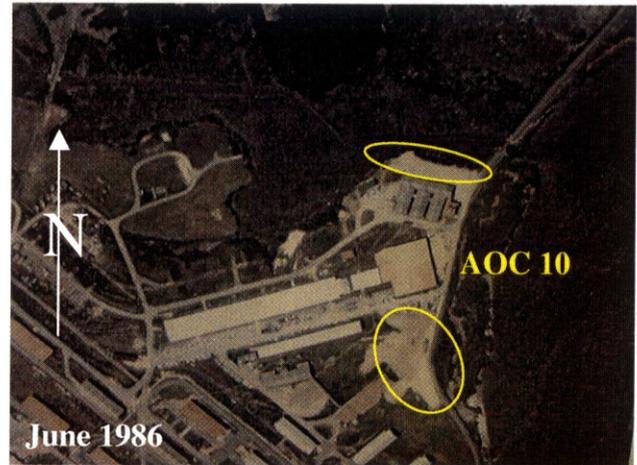
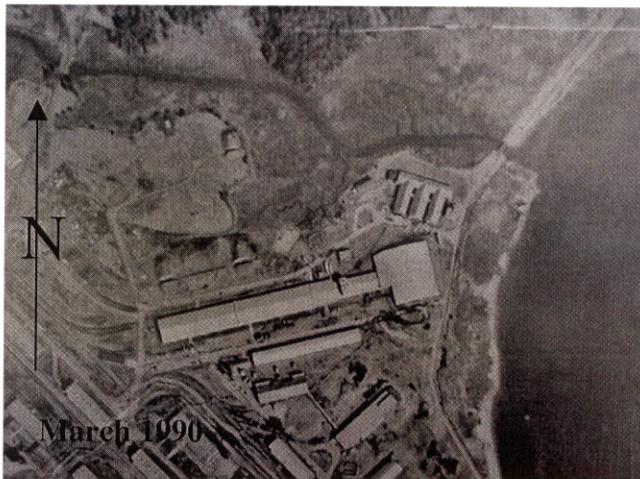
# EPIC - AOCs 3 & 10

Ground scarring located in the vicinity of Building M-5 and Wharf Area, identified as:

AOC 3 - (April 1949)

AOC 10 - (June 1986)

- Review of EPIC study in June 1999 recommended site recon/visit to determine if any additional action is required.
- Evaluated during November 1999 site visit. Based on additional review of aerial photography and evaluating site conditions (past and present), the “ground-scarring” at AOC 3 is fill material ( note the extension of the facility to the east of Building M-5 from the previous photo in 1937) and the “ground-scarring” at AOC 10 is activity associated with the demolition of Buildings 244, 245, 256 & 256.
- **NFA is proposed - Navy will provide details of site identification and rational for NFA determination in the SSA report.**

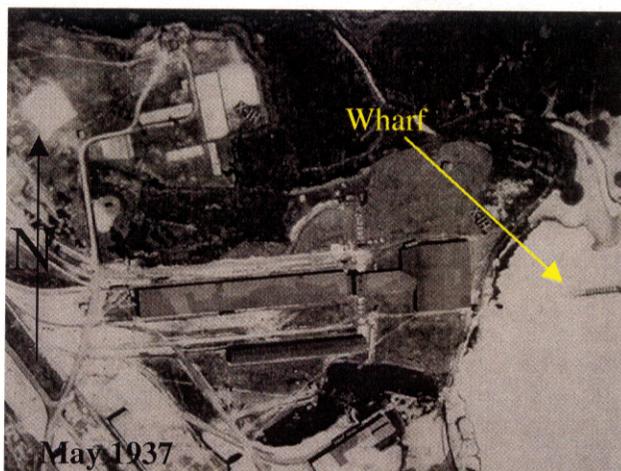
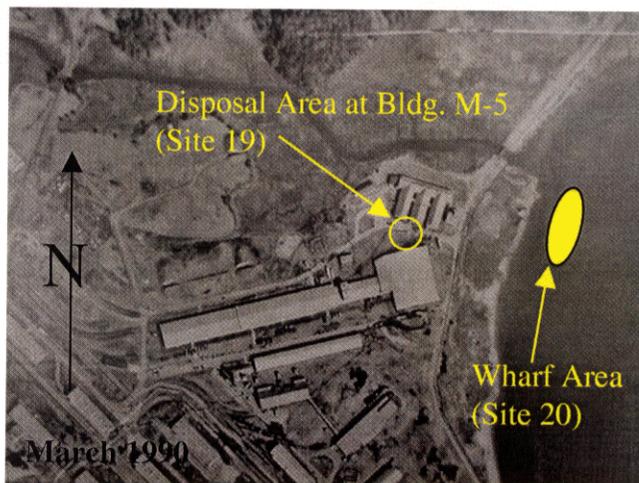
## SITES 19 & 20

**Site 19** - Located along the NE side of Building M-5 in the area where the RR diverge into Building 190 loading bays. It was reported that various ordnance items may have been disposed of in this area during past ordnance management activities.

**Site 20** - Former wharf off building M-5. The IAS concluded that it was likely that ordnance had been dropped into the sediments adjacent to the former wharf during loading and unloading operations. During the RRR, an underwater reconnaissance and a magnetometer survey were performed in that area. The magnetometer survey identified approximately 68 buried "contacts" surrounding the former wharf pilings. Many individual contacts were identified in random locations between the pilings. The most significant concentration of contacts are along the center west side of the pilings, between the pilings and the river bank. It is important to note that contacts might indicate any type of buried metal object, and do not necessarily indicate the presence of buried ordnance. No visual confirmation of contacts were made during the RRR data collection study.

- Included for evaluation in SSA investigation to determine additional investigation requirements, or removal action warranted, or no further action required.

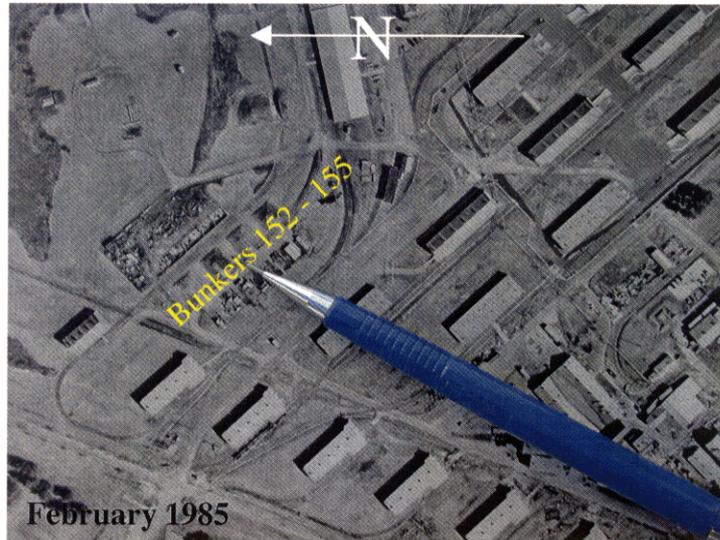
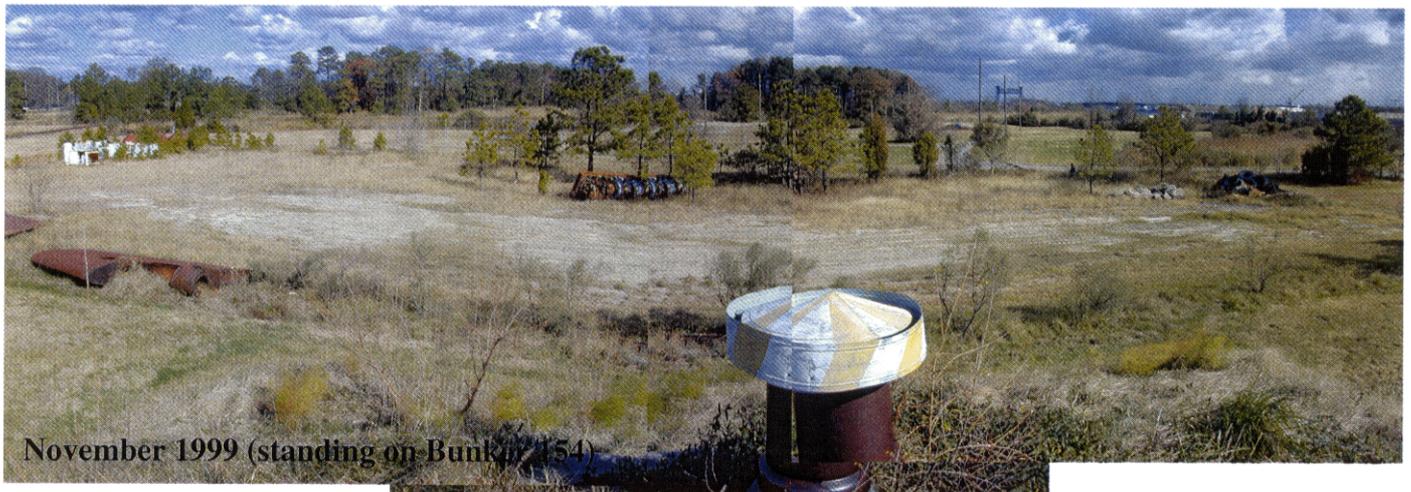
## SITE 7 (RFA - SWMU 17) - Old Storage Yard #1

Open storage area behind Buildings (bunkers) 152 to 155

This site consists of a fenced, outdoor grassy area used to store a variety of material including anchors, chain and equipment. During previous site investigations, 5-gallon containers of hydraulic oil, lubricating oil, lead paint, and open drums of sandblast grit were observed. Also during the investigations, evidence that oils had leaked or was drained onto soil from some of the equipment being stored at the site.

- Included for evaluation in SSA investigation which will group sites into categories based on additional action: additional investigation (RI) required, removal action warranted, or no further action determination.
- SSA report will provide documentation that minimal/no ecological receptors are located at this site (Step 1), and recommend NFA for ecological concerns. BTAG concurred with this proposal during the November 1999 site visit.
- Small area of soil staining noted under the remaining piece of equipment - will be addressed in the SSA report.

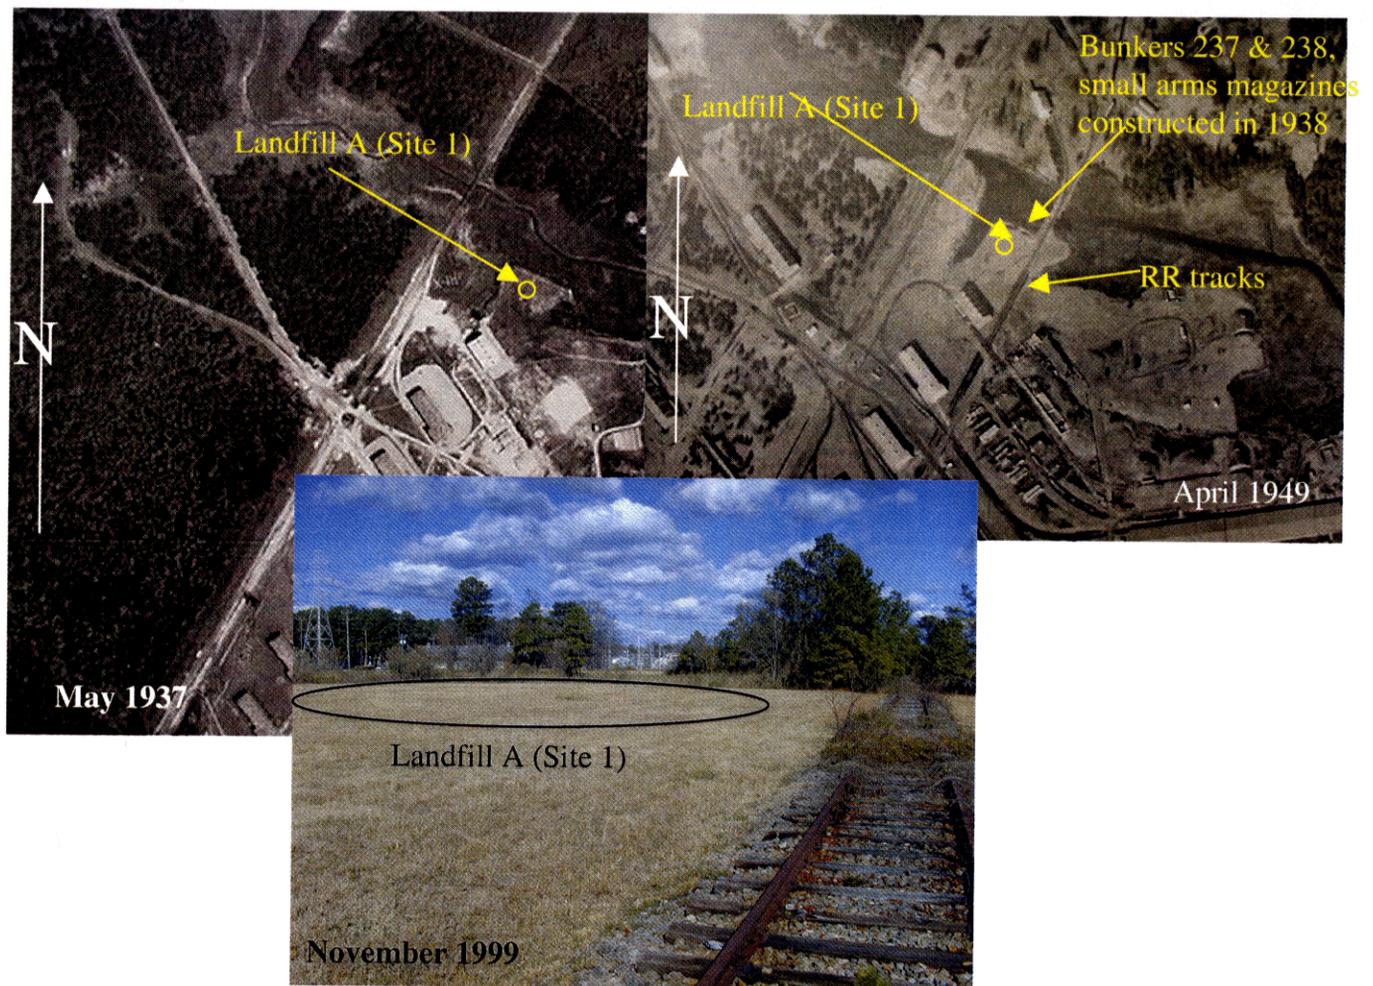
## SITE 1 (RFA - SWMU 1)- LANDFILL A

Adjacent to Buildings (bunkers) 237 and 238 (now demolished)

The landfill was used from 1921 to 1924 primarily for the disposal of trash and garbage. Additionally, some pesticides, acids and bases were dumped at the site. Reportedly, the trash was burned at the site and the ashes used to fill the marsh area at the site (adjacent to Blows Creek). The estimated volume of disposed material (prior to being burned) is estimated at 30,000 cubic yards.

- Included for evaluation in SSA investigation which will group sites into categories based on additional action: additional investigation (RI) required, removal action warranted, or no further action determination.
- SSA report will provide the preliminary conceptual site model for the ERA process. BTAG recommended evaluating EPA's HRS data to determine if any contamination is migrating from this site. If a contamination gradient is not evident, which is expected due to site's age, additional sediment samples in Blow's Creek at the perimeter of the site may be collected to support a possible NFA determination.

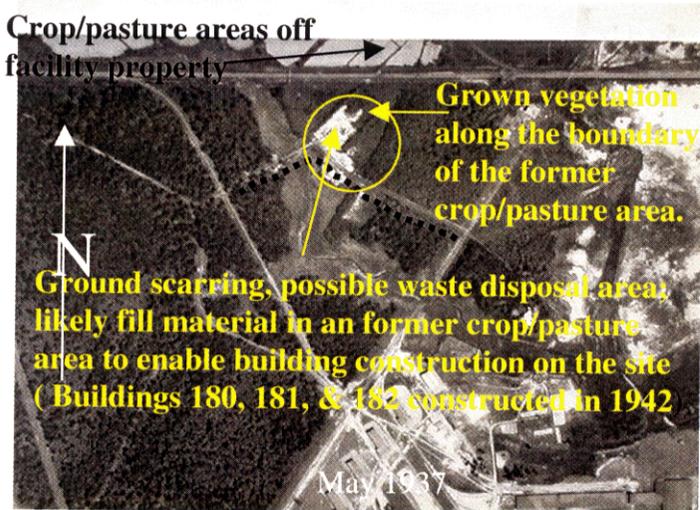
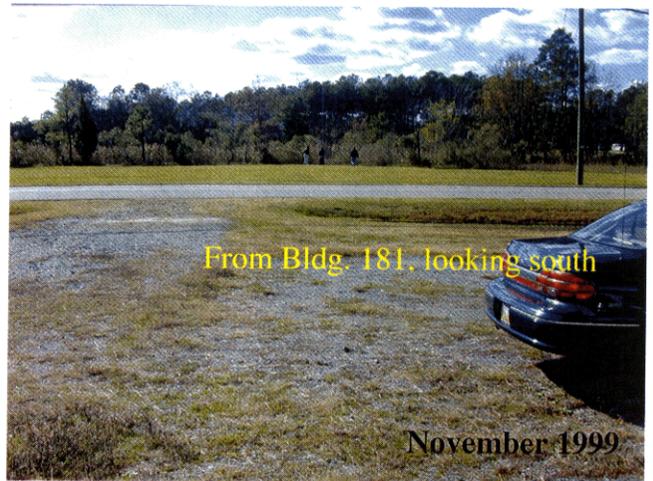
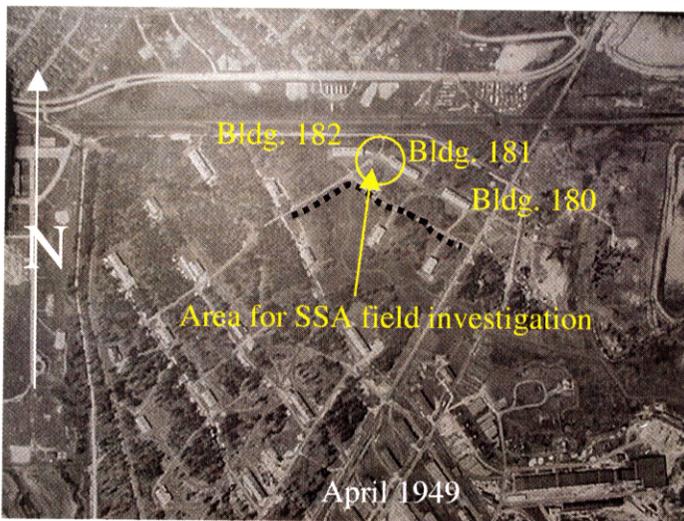
# EPIC - AOC 1

Corner of E Street & Marsh Road, west of Building 182 & 181.

May 1937 - Ground scarring, possible waste disposal area.

- Review of EPIC study in June 1999 recommended site recon/visit to determine if any additional action is required.
- Evaluated during November 1999 site visit. Based on additional review of aerial photography and evaluating site conditions (past and present), the “ground-scarring” is probably fill material in an former crop/pasture area to enable building construction on the site. The linear features around the AOC is grown vegetation along the boundaries of the former crop/pasture area.
- Soil (surface and sub-surface) and geo-physics are proposed for the SSA field investigation to determine additional action: additional investigation (RI) required, removal action warranted, or no further action determination.
