Final Data Acquisition/ Summary Report

Penniman Shell Loading Plant Site Williamsburg, York County, VA

29 October 1999

Prepared for
U.S. Environmental Protection Agency Region III
Federal Facilities Section
Philadelphia, PA

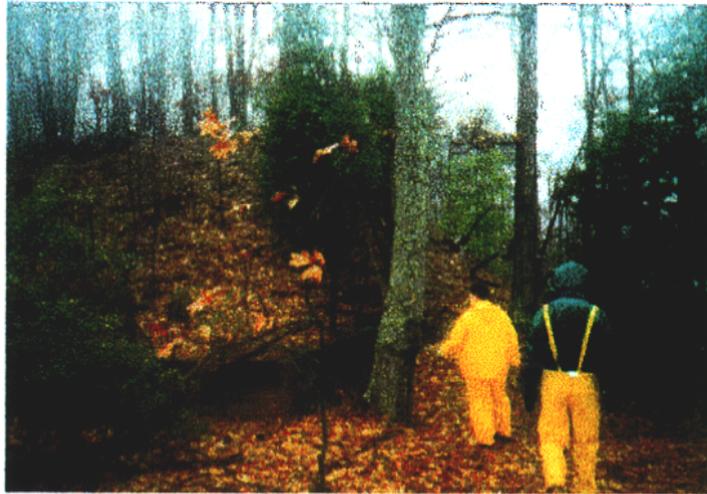
Date: February 1998 by Region III SATA
Remark: View of TNT Graining House bunker remains. Penniman Lake is located approximately 30 feet to the right of the photographer.

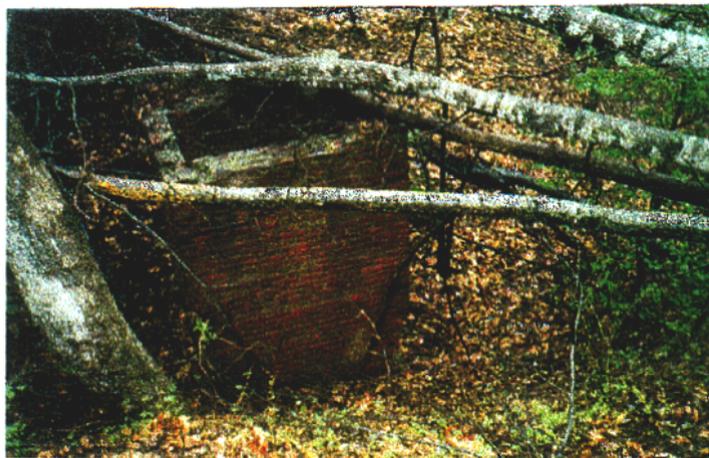
Date: February 1998 by Region III SATA
Remark: View of the remains of the Ammonia Evaporating Building. Penniman Lake is located approximately 50 feet to the right of the photographer.

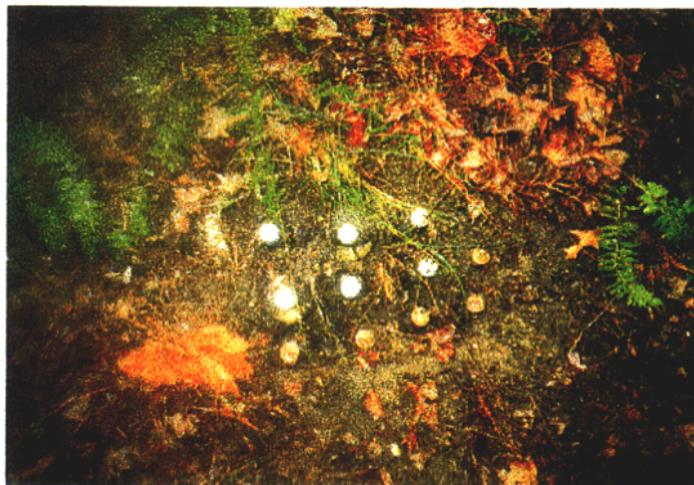
Date: February 1998 by Region III SATA
Remark: Intra-venous bottles of 5% dextrose solution located at U.S. Navy Area of Concern 2.

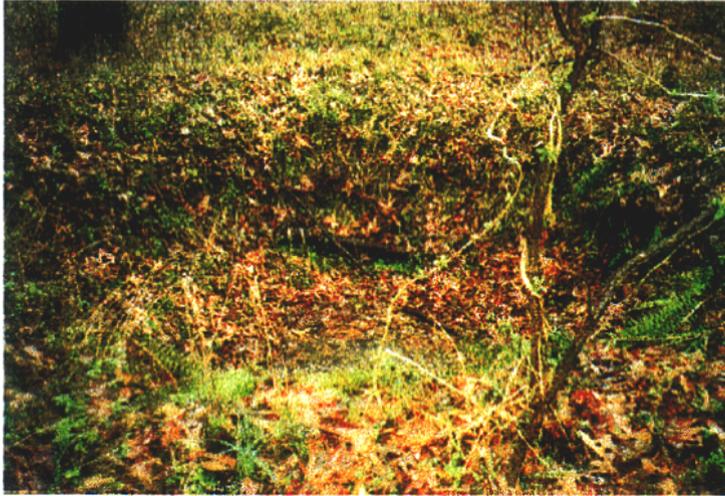
Date: February 1998 by Region III SATA
Remark: View of a typical "blast hole" in the magazine portion of the U.S. EPA "Shipping Area". Large examples of these holes are over 15 feet in diameter and 6 feet deep.

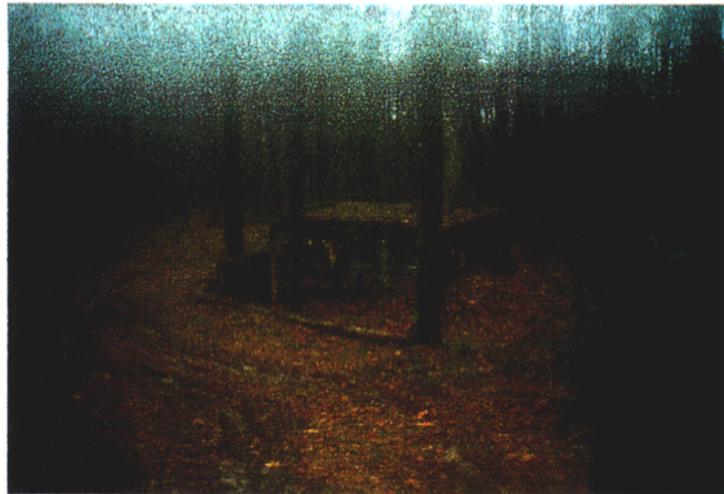
Date: February 1998 by Reion III SATA
Remark: View, facing north, of the remains of the Booster Test Pit located in the U.S. EPA "Shell Loading" Area.

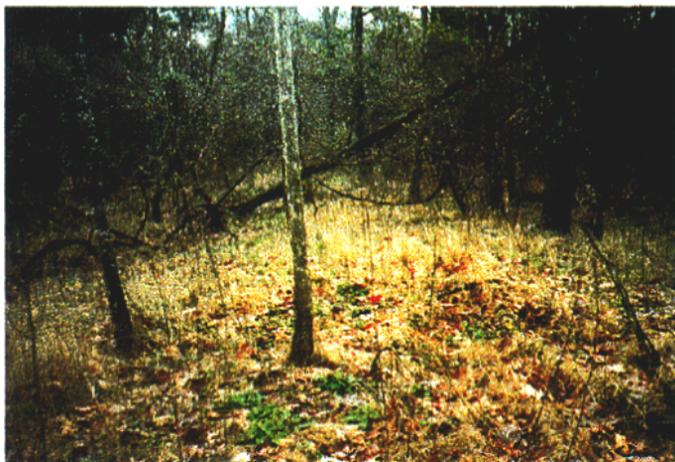
Date: February 1998 by Region III SATA
Remark: View of the remains of a railroad bed in the magazine portion of the U.S. EPA "Shipping Area."

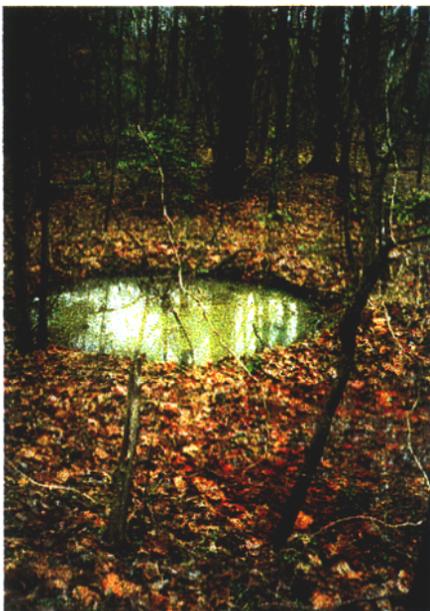
Date: February 1998 by Region III SATA
Remark: View of a typical "blast hole" found in magazine portion of the U.S. EPA "Shipping Area." Many of these holes fill with water during rainstorms.

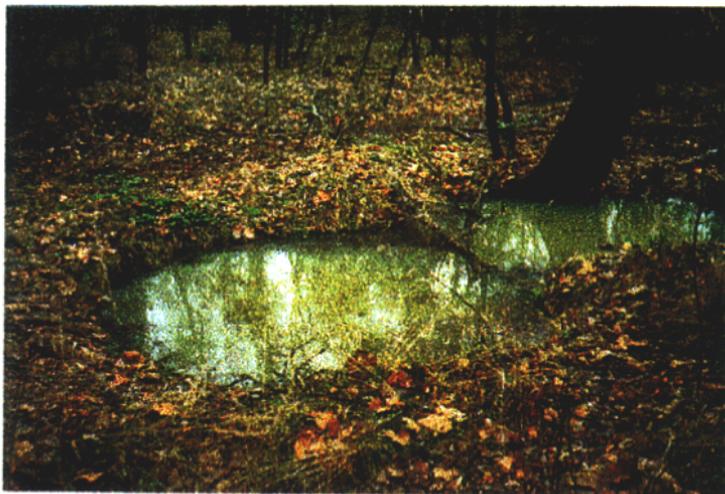
Date: February 1998 by Region III SATA
Remark: A view of the typical "blast holes" found in the magazine portion of the U.S. EPA "Shipping Area." In many instances, these holes are so close together, they overlap as shown here.

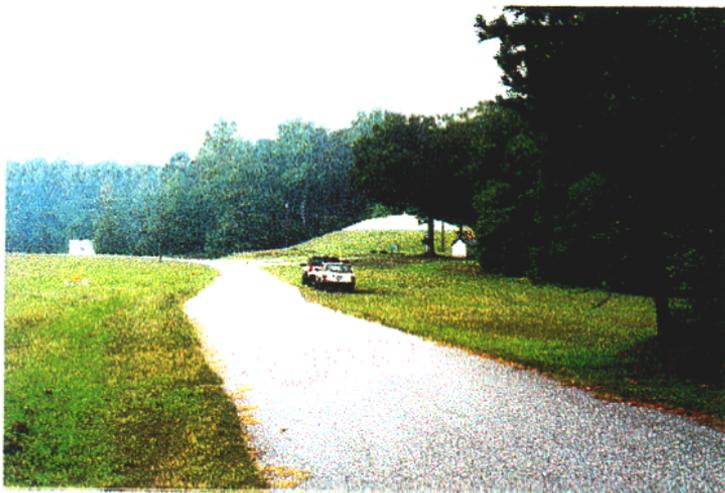
Date: 15 September 1998 by Region III SATA
Remark: View facing south along Chapman Road of the USN CAX Water Treatment Plant. U.S. Navy Area of Concern 1 "Scrap Metal Dump" (U.S. EPA "Jones Pond Landfill") is located to the right in wooded area. Jones Pond is also located to the right.

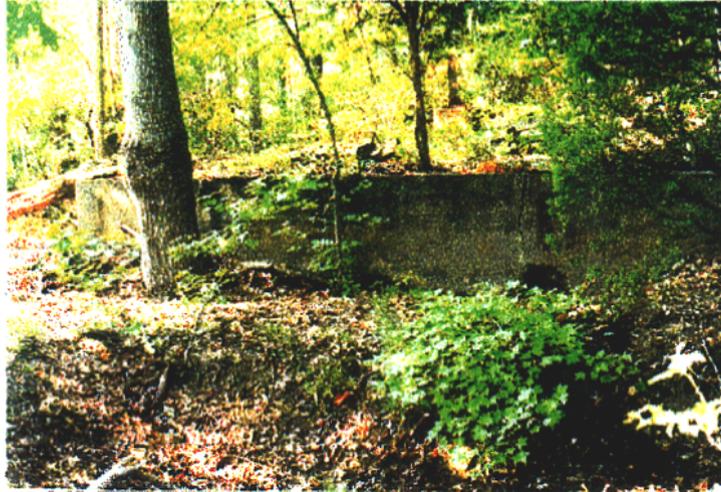
Date: 15 September 1998 by Region III SATA
Remark: View of the TNT graining house ruins with TNT catch basin in the foreground. Penniman Lake is located approximately 25 feet behind the photographer.

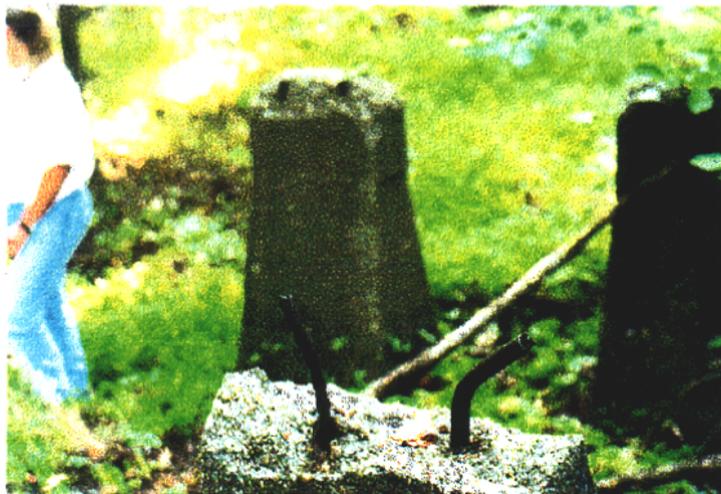
Date: 15 September 1998 by Region III SATA
Remark: View of the "Soldering House" area showing differing types of re-bar in poured concrete.

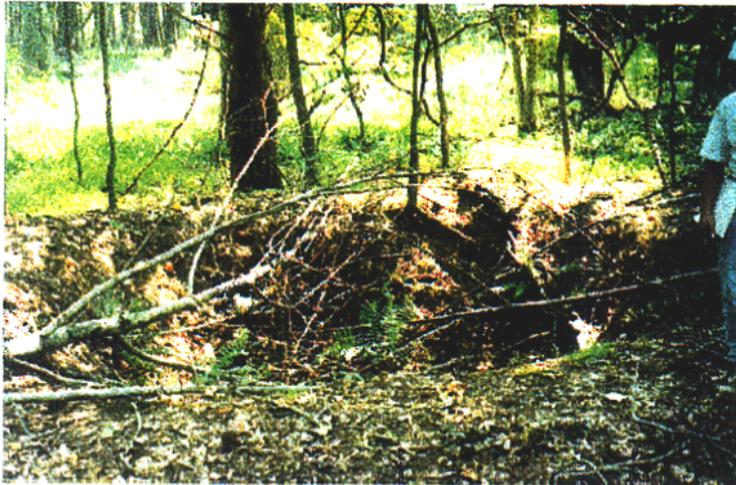
Date: 15 September 1998 by Region III SATA
Remark: View of a large "blast hole" in the magazine portion of the U.S. EPA "Shipping Area."

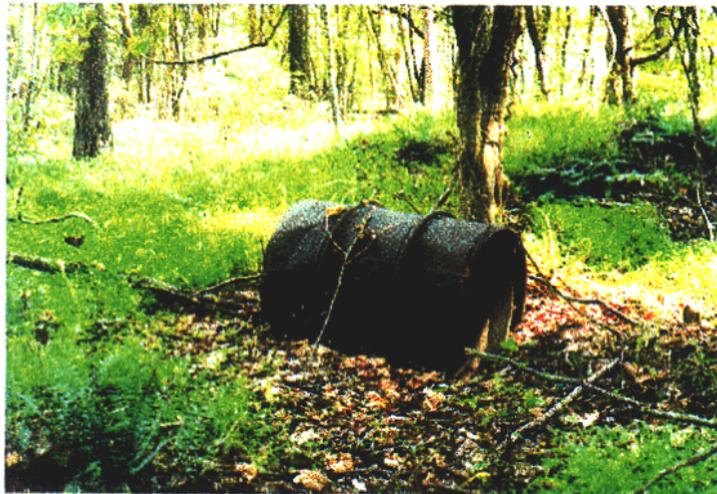
Date: 15 September 1998 by Region III SATA
Remark: View of the abandoned drum in the magazine portion of the U.S. EPA "Shipping Area." This drum is suspected to be a WW I or WW II era, FM/FS smoke drum.

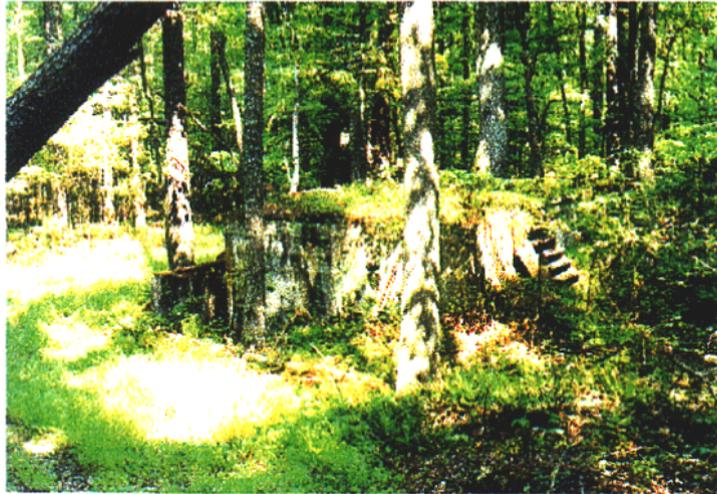
Date: 15 September 1998 by Region III SATA
Remark: View of the Booster Test Pit remains in the U.S. EPA "Shell Loading" Area. According to CAX personnel, these ruins are frequently used by deer hunters during deer hunts on USN CAX Property.

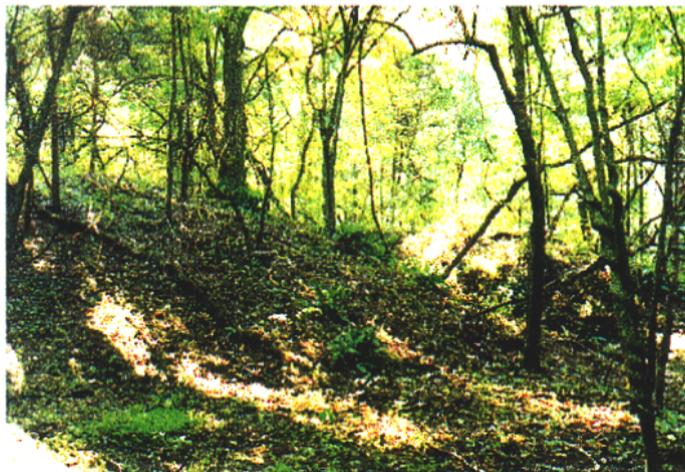
Date: 15 September 1998 by Region III SATA
Remark: View of a typical example of the nitro-starch dry houses and dry storage bunkers located in the U.S. EPA "TNT Production" Area.

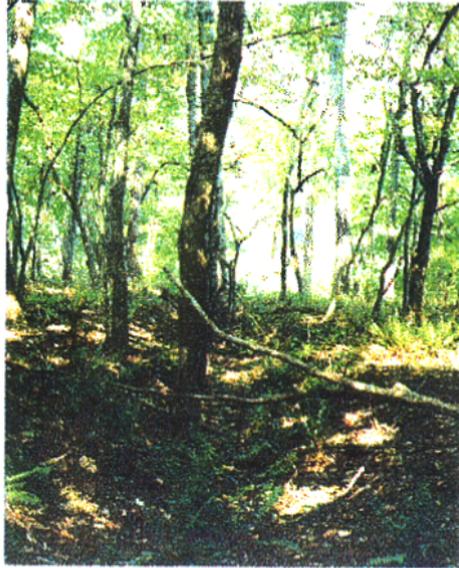
Date: 15 September 1998 by Region III SATA
Remark: View of a shallow ditch located in the U.S. EPA "Shell Loading" Area. This ditch contained 3-inch diameter steel pipes of undetermined origin.

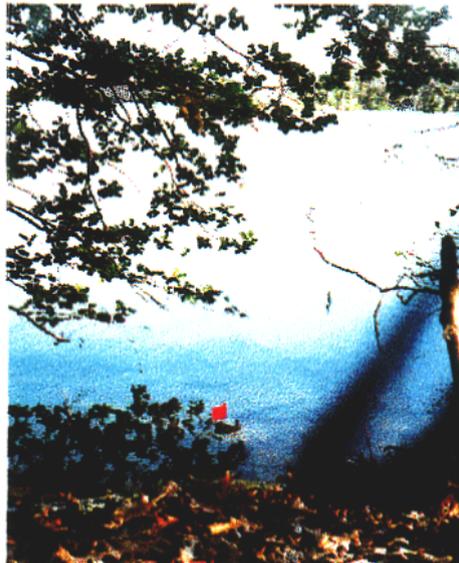
Date: 12 January 1999 by Region III SATA
Remark: View of sample locations PEN1-SW-02 and PEN1-SED-02 (Penniman Lake).

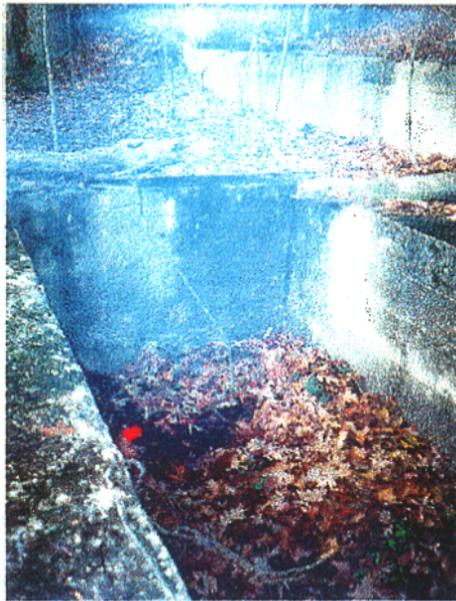
Date: 12 January 1999 by Region III SATA
Remark: View of sample location PEN1-SO-03 (TNT graining house ruins sump). This area was found to be high in 2,4,6-TNT.

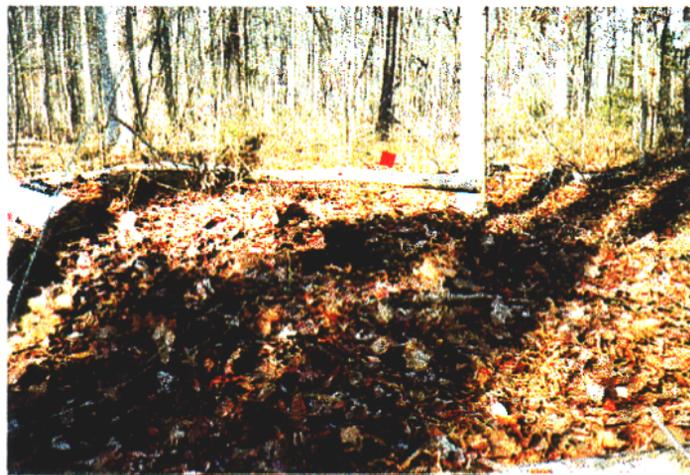
Date: 12 January 1999 by Region III SATA
Remark: View of sample location PEN1-SO-07 (slag pile near plant "G" 75-mm lines). This slag material is found throughout the site.

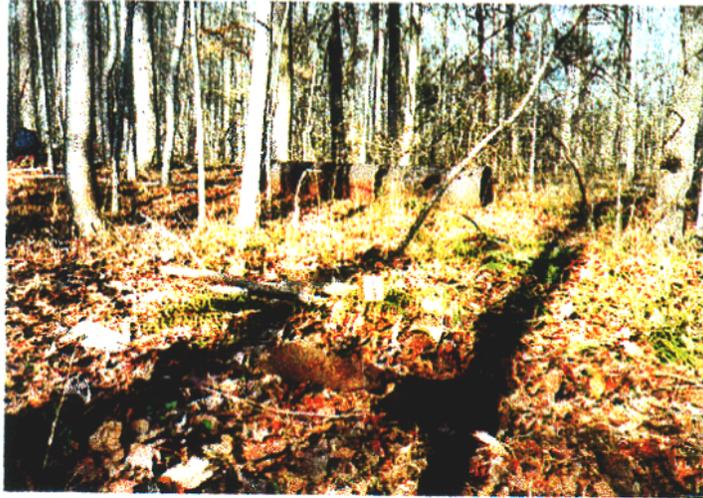
Date: 12 January 1999 by Region III SATA
Remark: View of sample location PEN1-SO-06 ("mixing" tank near plant "G" 75-mm lines). The purpose of this tank is unknown.

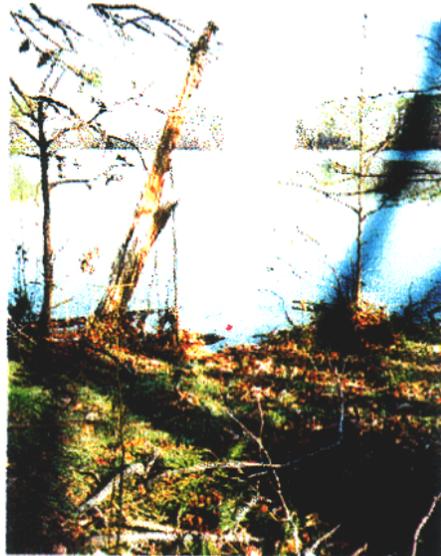
Date: 12 January 1999 by Region III SATA
Remark: View of sample location PEN1-SED-01 (Penniman Lake).

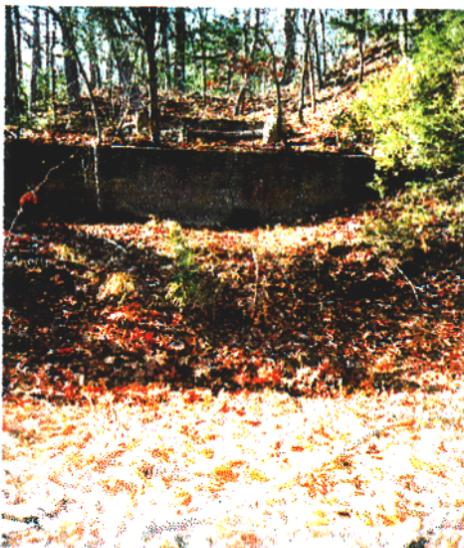
Date: 12 January 1999 by Region III SATA
Remark: View of sample location PEN1-SO-04 (TNT catch box ruins) in U.S. EPA "Shell Loading" Area. Penniman Lake is located directly behind the photographer.

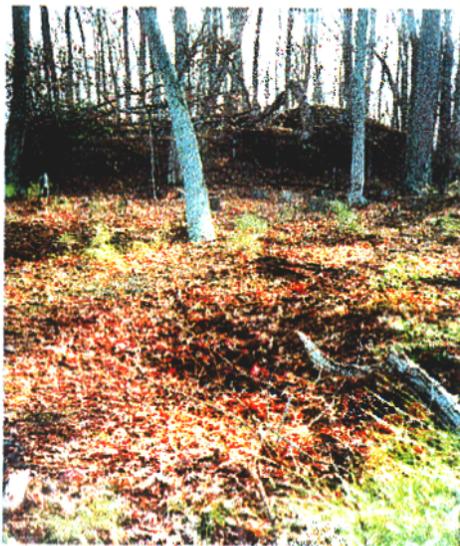
Date: 12 January 1999 by Region III SATA
Remark: View of sample location PEN1-SO-01 (ammonia settling pits) in U.S. EPA "Shell Loading" Area.

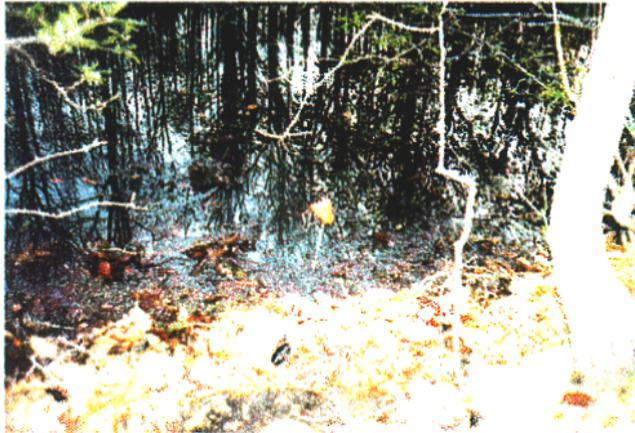
Date: 12 January 1999 by Region III SATA
Remark: View of sample location PEN1-DW-01, SW-01, SW-01A, and SED-05 (Jones Pond).

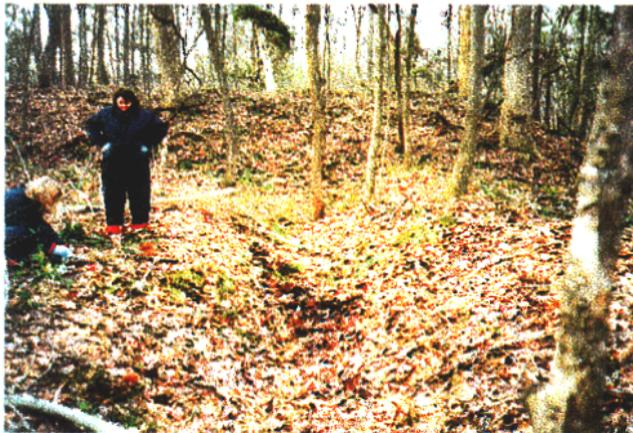
Date: 13 January 1999 by Region III SATA
Remark: View of sample location PEN1-SED-07 (drainage ditch leading to Cheatham Pond from box pack houses) in U.S. EPA "TNT Production" Area.

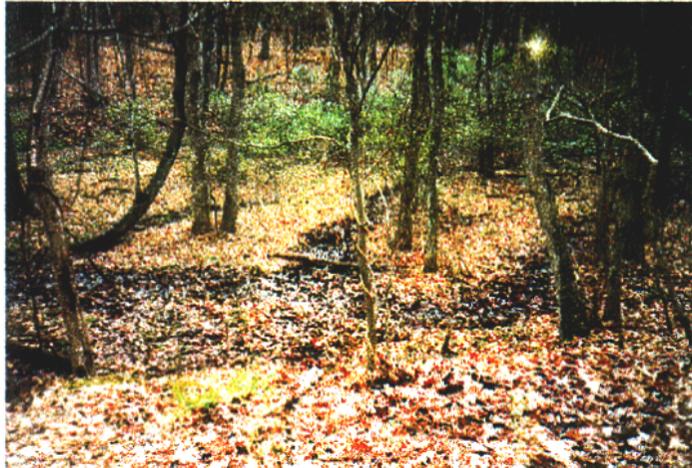
Date: 13 January 1999 by Region III SATA
Remark: View of sample location PEN1-SED-08 (wetlands near pack houses) in U.S. EPA "TNT Production" Area. This wetlands leads directly into Cheatham Pond.

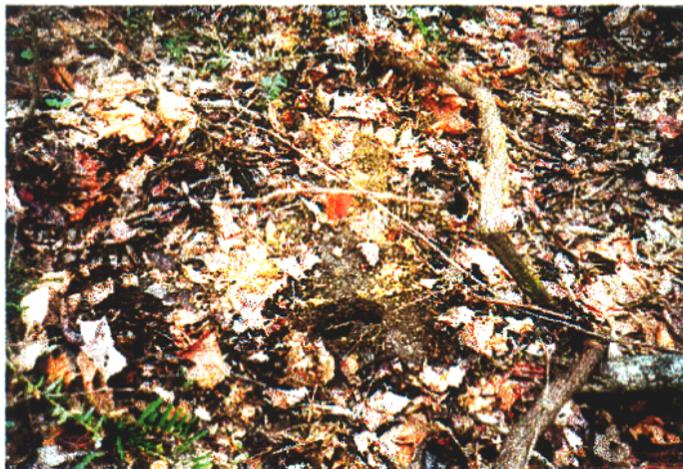
Date: 13 January 1999 by Region III SATA
Remark: View of sample location PEN1-SED-06 (nitro-starch dry house floor) in U.S. EPA "TNT Production" Area.

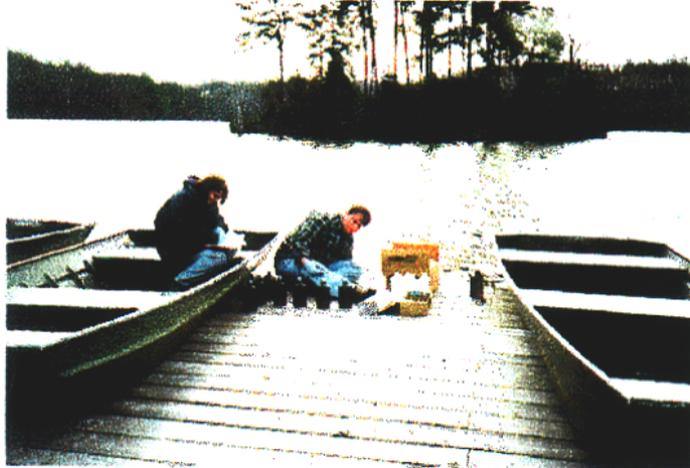
Date: 13 January 1999 by Region III SATA
Remark: View of background sample location PEN1-SW-03 (collected at fishing dock in Cheatham Pond).

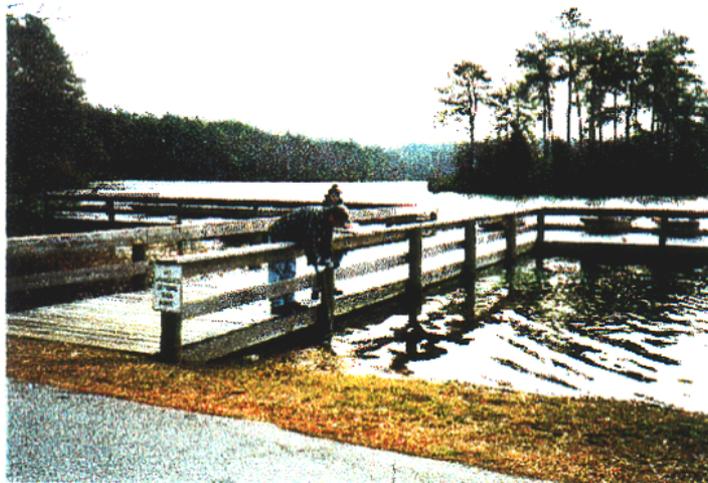
Date: 13 January 1999 by SATA Region III
Remark: View of background sample location PEN1-SED-09 (collected from fishing dock in Cheatham Pond).

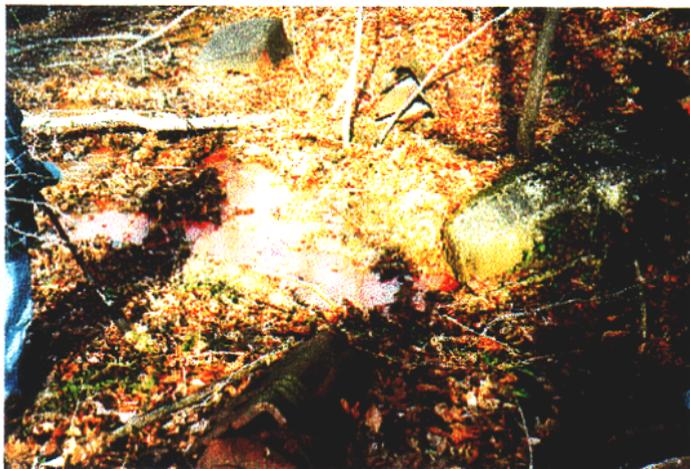
Date: 13 January 1999 by Region III SATA
Remark: View of sample location PEN1-SED-04 (northern portion of channel leading from the U.S. EPA "Jones Pond Landfill" Area and U.S. Navy AOC 1 to Jones Pond).

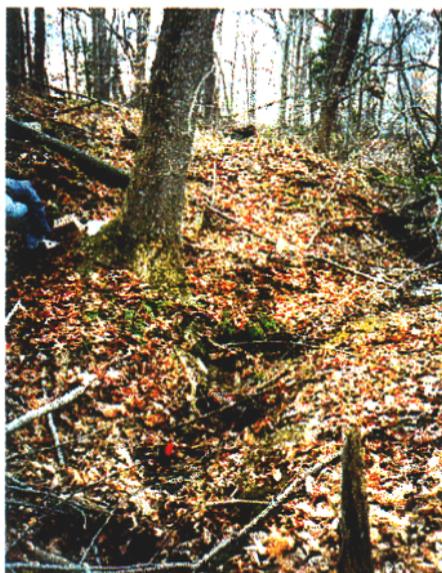
Date: 13 January 1999 by Region III SATA
Remark: View of sample location PEN1-SED-03 (southern portion of channel leading from U.S. EPA "Jones Pond Landfill" Area and U.S. Navy AOC 1 to Jones Pond).

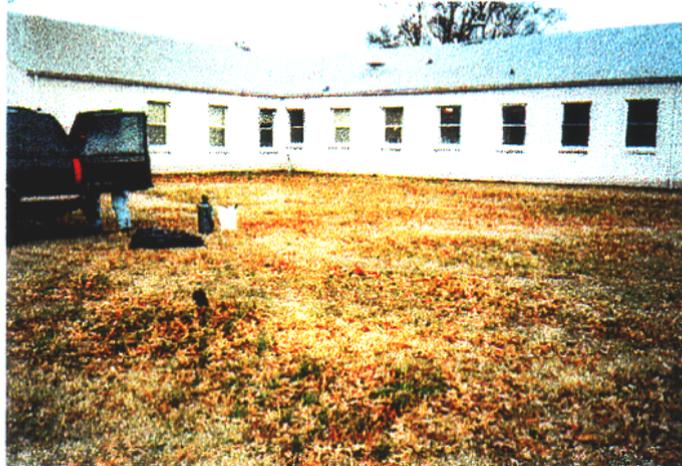
Date: 13 January 1999 by Region III SATA
Remark: View of sample locations PEN1-SO-13 and SO-14 (U.S. EPA "1918 Drum Storage" Area). Note the proximity to CAX Building #113 in background.

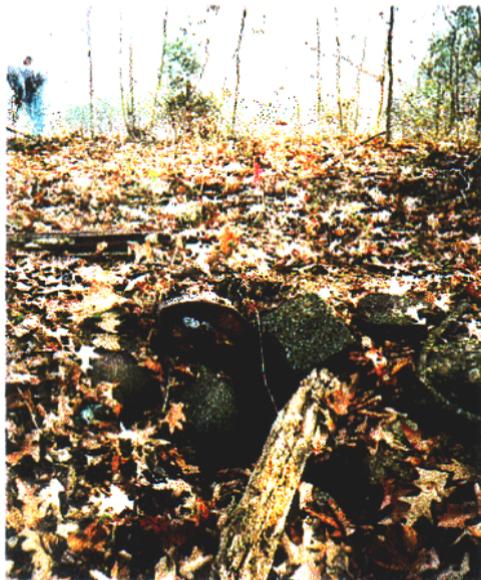
Date: 13 January 1999 by Region III SATA
Remark: View of leaking drum in U.S. EPA "Jones Pond Landfill" Area (U.S. Navy AOC 1). Sample PEN1-SO-08 was not collected as no soil was present.

- Soil samples should be collected from the Jones Pond Landfill area (AOC 1) to determine the presence of hazardous substances.

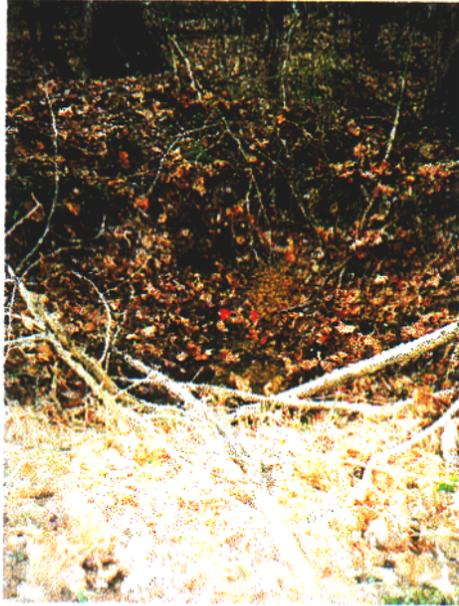
Date: 13 January 1999 by Region III SATA
Remark: View of sample locations PEN1-SO-11 and SO-12 (blast hole) in U.S. EPA "Shipping Area."

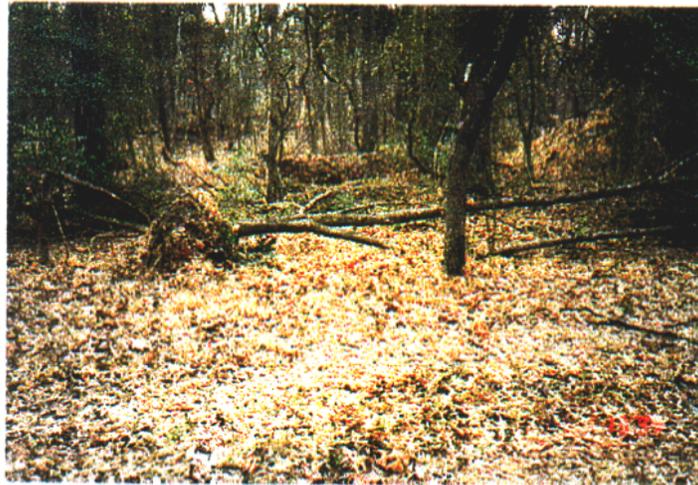
Date: 13 January 1999 by Region III SATA
Remark: View of sample blast hole containing sample locations PEN1-SO-11 and SO-12 (blast hole) from dirt access road (U.S. EPA "Shipping Area").

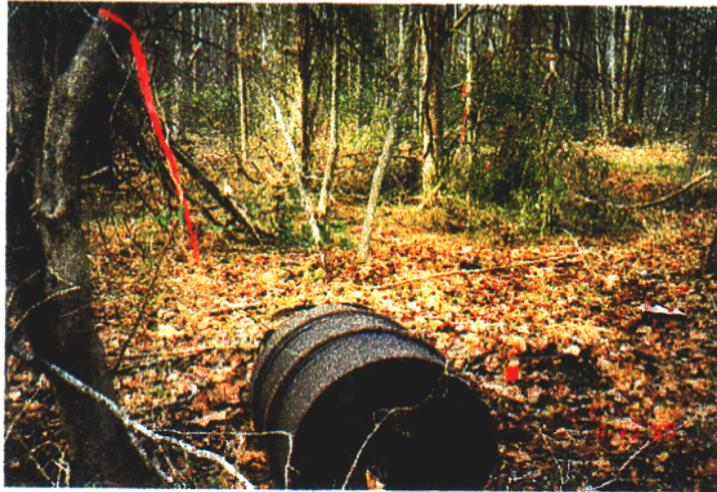
Date: 13 January 1999 by Region III SATA
Remark: View of sample locations PEN1-SO-09 and SO-10 (FM smoke drum and downgradient samples) in U.S. EPA "Shipping Area."

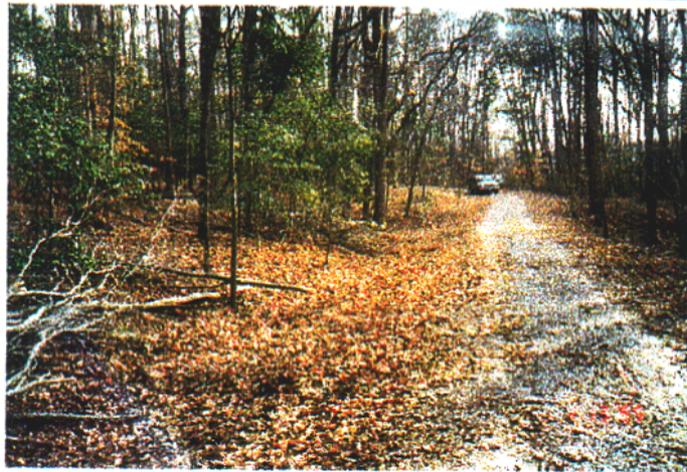
Date: 13 January 1999 by Region III SATA
Remark: View towards 90 degree turn in gravel road from area of sample location PEN1-SO-15 (background DOI property).

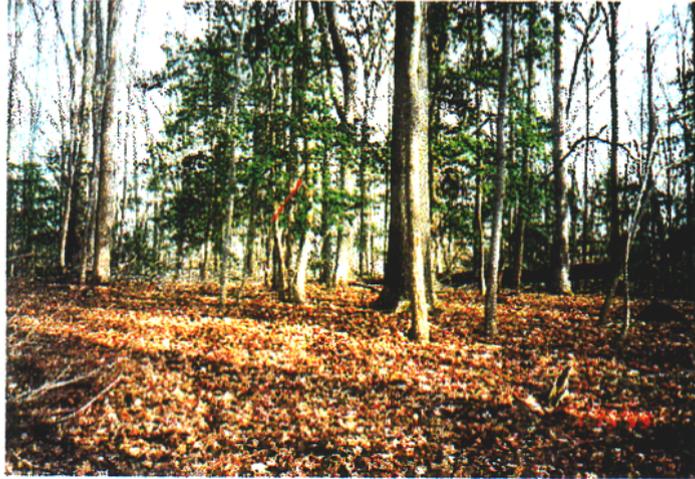
Date: 13 January 1999 by Region III SATA
Remark: View of sample location PEN1-SO-15 (background DOI property).

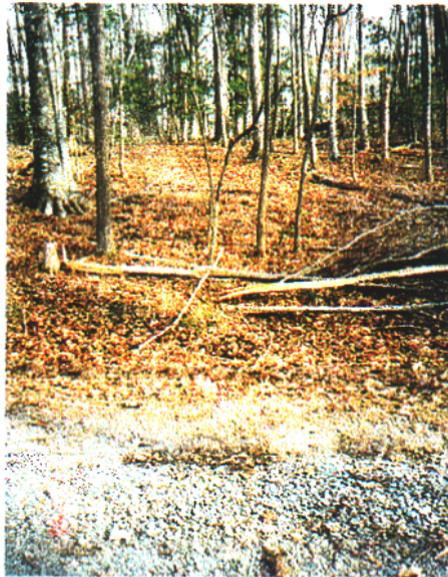
Date: 13 January 1999 by Region III SATA
Remark: View of sample location PEN1-SO-15 (taken from same location as previous picture).
