Subject: Cheatham Annex Site Trip Report #1

Trip Report #1

USN Supply Center Cheatham Annex
Williamsburg, Virginia

USNC Cheatham Annex Site
Williamsburg, York County, VA

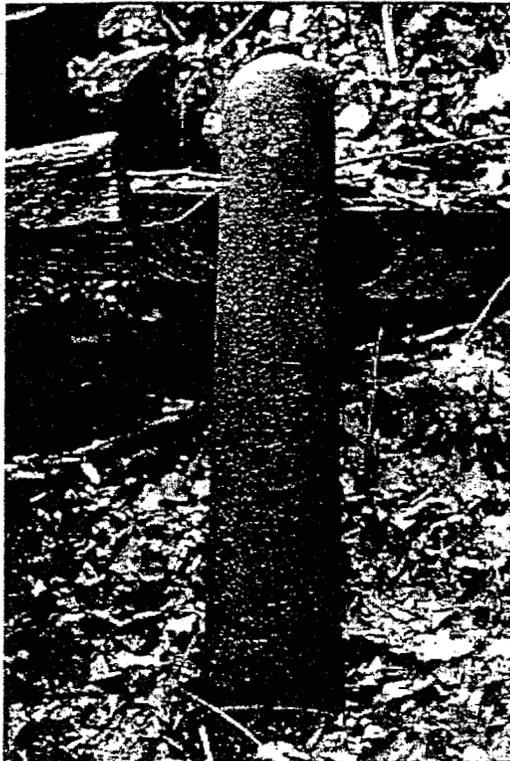
inches in diameter and 54 inches long and were severely corroded. Markings were distinguishable on both of these cylinders, and included raised lettering around the neck which stated "THE PROPERTY OF THE LIQUID CARBONIC CO". Additional markings on one of these cylinders included stamped lettering as follows:

THE L.C. Co.
TESTED TO 3200 LBS PER INCH
2114 1910 0 NET WEIGHT 10° 49 LBS
CAPACITY 54.97 LBS

These cylinders had intact valves and welded base supports.

Photograph 2. An overview of one of the cylinders found at Jones Pond landfill area.

The two cylinders found in the landfill area near Jones Pond are currently unidentified. WESTON is awaiting additional information from the Liquid Carbonic Company and other sources on these cylinders. This information will be provided to the RPM in letter format when it is received.

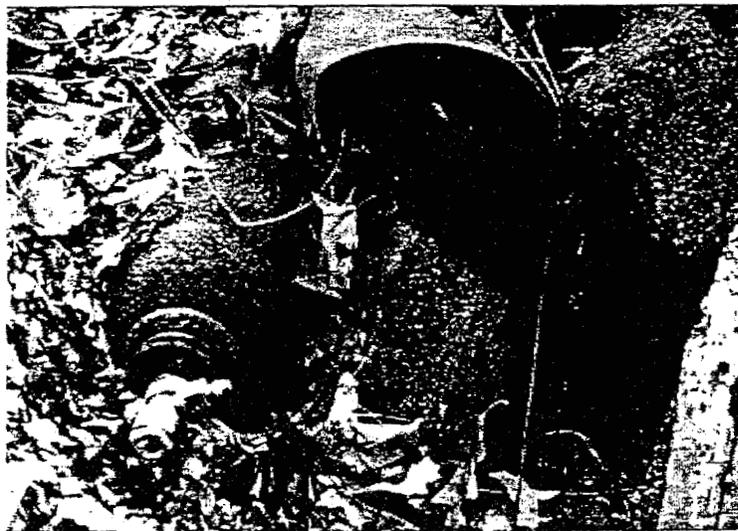
Photograph 4. The oozing drum found at the Jones Pond landfill area.

- IR SITE 12
AOC-2 • The landfill area near Jones Pond, especially under the black powder drum found leaking a black, grease-like material and around the type B drum found riddled with pick holes.

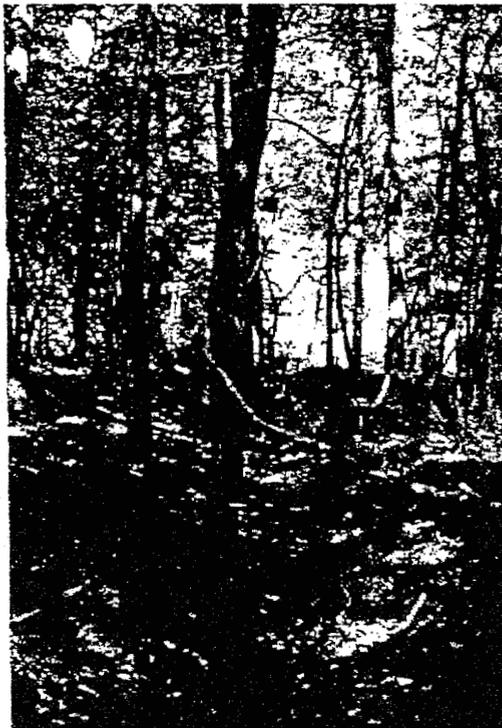
Photograph 6. The shallow ditch containing 3" steel pipes near the shipping house area.

An amendment to the work plan for the site will be prepared which will detail the scope of work for locating, mapping, and identifying the buried steel pipes found on site. In addition, a Labor Hour Pool level of effort (LOE) estimate and request for additional hours will be prepared in order to detail the LOE requirement for shell fragment identification and additional research.

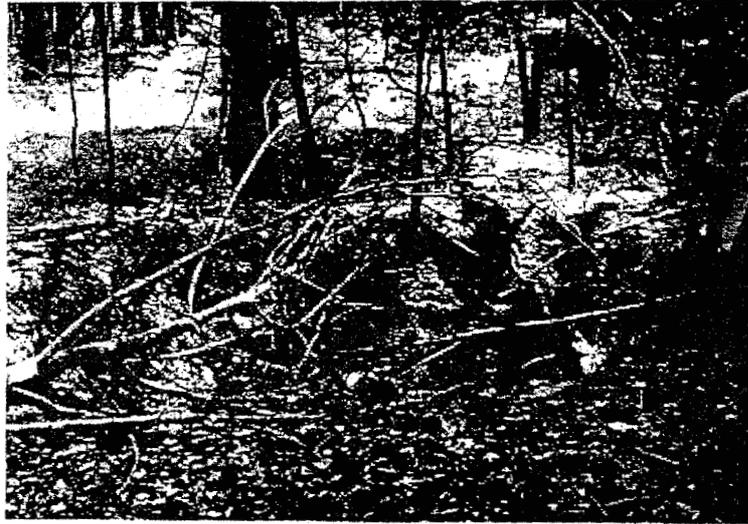
1410 hours - The reconnaissance group arrived at the blast hole area, which extends over several acres in the magazine area to the north of Sanda Avenue. This area consisted of a large number of blast craters, ranging in size from approximately 6 feet in diameter by 3 feet deep to approximately 20 feet in diameter by approximately 8 feet deep. WESTON's military ordnance expert indicated that these blast holes were most likely utilized in quality assurance tests of explosive batches or shell batches prior to shipment. According to the ordnance expert, blast testing would be conducted in one area until the resulting crater became too large to enter, at which time a new location would be selected for testing. From observations at the site, it did not seem to be common practice to refill these test craters. WESTON's ordnance expert indicated that the potential for finding live blasting agents or UXO in these pits was unlikely; however, shell fragments would likely be found which could be identified to more accurately characterize the activities at the site. RPM Thomson directed SATA to collect a subsurface soil sample from one of the larger blast pits in this area. The RPM also directed SATA to make attempts to locate and collect shell fragments in these pits for identification by the WESTON ordnance expert.

Photograph 7. A typical example of the blast holes found in the magazine area.

DoI In addition, the ordnance expert recommends that a magnetic survey be conducted in and around several of the blast holes located near the magazine area to locate shell fragments. These fragments, if found, will be identified by the ordnance expert in order to determine the exact types of shells loaded at this facility. This identification will aid in determining whether chemical munitions were loaded at the Penniman plant.

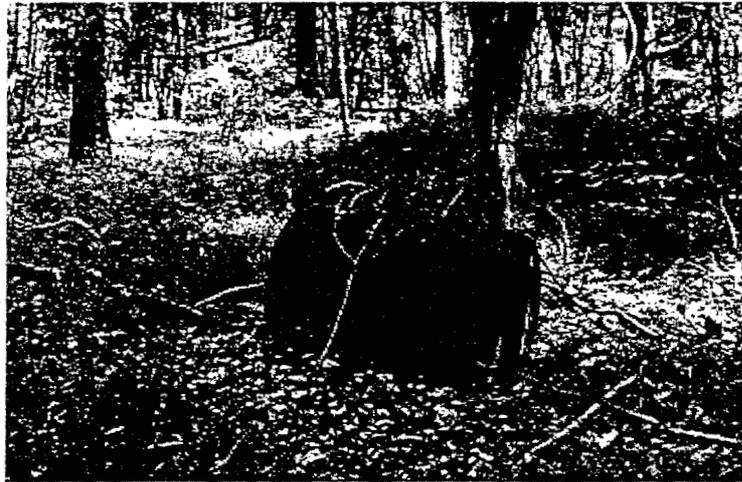
1415 hours - The reconnaissance group arrived at the abandoned empty drum in the magazine area. This drum was larger than a normal shipping drum, having a capacity of approximately 70 to 110 gallons, and had two steel reinforcing bands which were located at approximately 1/3 and 2/3 of the drums height. The drum was in extremely poor condition and was empty. According to RPM Thomson, previous inspections of this drum identified a steel manufacturers plate with the words "American Steel Barrel, Brooklyn, New York." This plate was not observed during the time of the 15 September reconnaissance. The WESTON ordnance expert tentatively identified the drum as an intermediate container used for either the chemical warfare agent mustard gas, or the chemical concealment agent FM smoke. This drum could potentially date to the World War I era. It was noted that a relatively large area around this drum was free of vegetative growth, which appeared unusual for the time of year and the location of the drum. The RPM directed SATA to collect several soil samples from around this drum area for standard EPA contract laboratory program (CLP) analytical parameters as well as mustard gas and FM smoke breakdown compounds. The RPM also directed SATA to complete a comprehensive reconnaissance of this area during the winter months to locate any additional drums.

Based upon U.S. military documentation, the ordnance expert confirmed that the chemical drum located in the magazine area may have contained FS smoke, FM smoke, H mustard agent, or HD mustard agent if it was a U.S. military drum. The U.S. military designation for this drum is believed to be type A model A, which is normally a 55-gallon drum with a 2¼-inch bung located on the side and a ¼-inch bung located on the top (US Army 1946a and 1946b). The drum located at the site is larger than a 55-gallon drum, and therefore it is suspected that this drum contained FS or FM smoke rather than mustard agent and likely dates from the 1930's or 1940's (US Army 1946b). It is recommended that the diameter and length of this drum be recorded to determine the exact capacity of the container. The most common FS or FM smoke containers are 110-gallon, and are 32 inches in diameter and 44 inches in length (US Army 1946b). Fifty-five gallon drums are 26 inches in diameter and 35 inches in length.

Photograph 8. The FM/FS smoke drum found in the magazine area

- DOI • Around the type A chemical drum found in the magazine area.
- 200' EAST OF WAREHOUSE
CAX? • In and around the ruins of the building designated as the "dope house" in the 1916 engineering drawings.

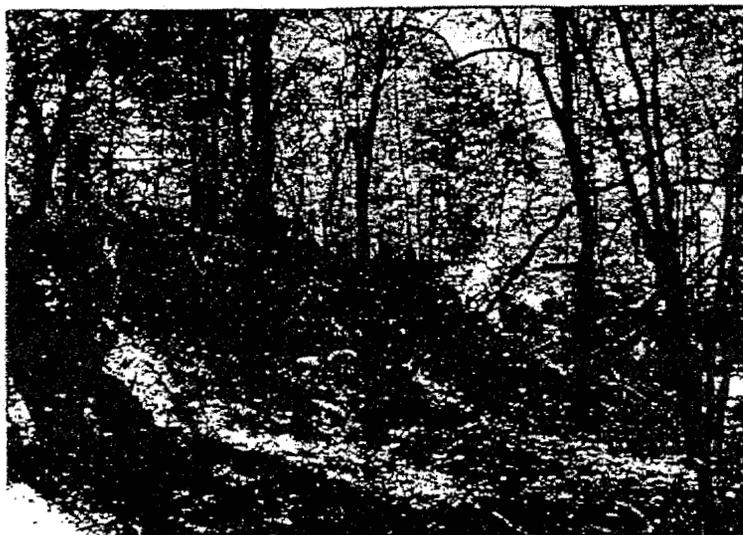
1445 hours - The reconnaissance group arrived at the nitro-starch drying house and nitro-starch dry storage house area. These consisted of numerous bunkers, abandoned fire hydrants, and building foundation remains. Based upon field observations and 1916 engineering drawings, there were two types of bunkers in this area, a larger type appearing to be the drying houses, and a smaller type appearing to be dry store houses. The larger bunkers were identified as having brick-lined "sumps," and piping which extended through the bunker and into a shallow ditch which led to the swamp area. The RPM directed SATA to collect a sample from one of these sumps, and to collect several samples from one of the drainage ditches leading to the swamp area.

Photograph 9. A typical example of the remains of the nitro-starch house bunkers.

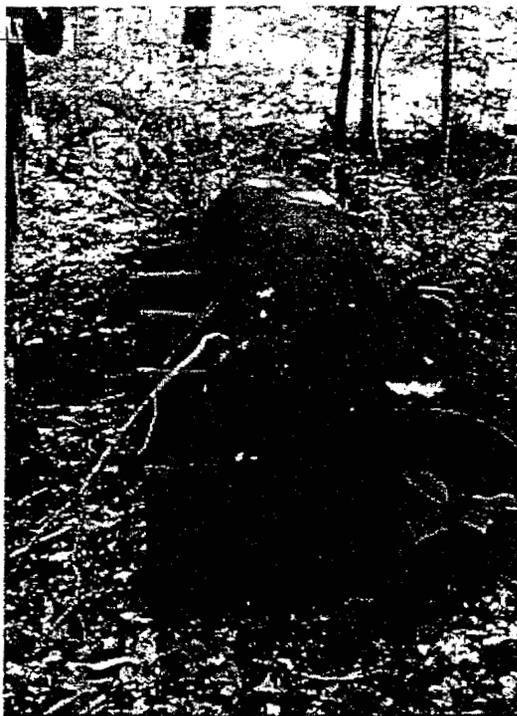
Photograph 10. A "mixing tank" found above ground in the shipping house area.

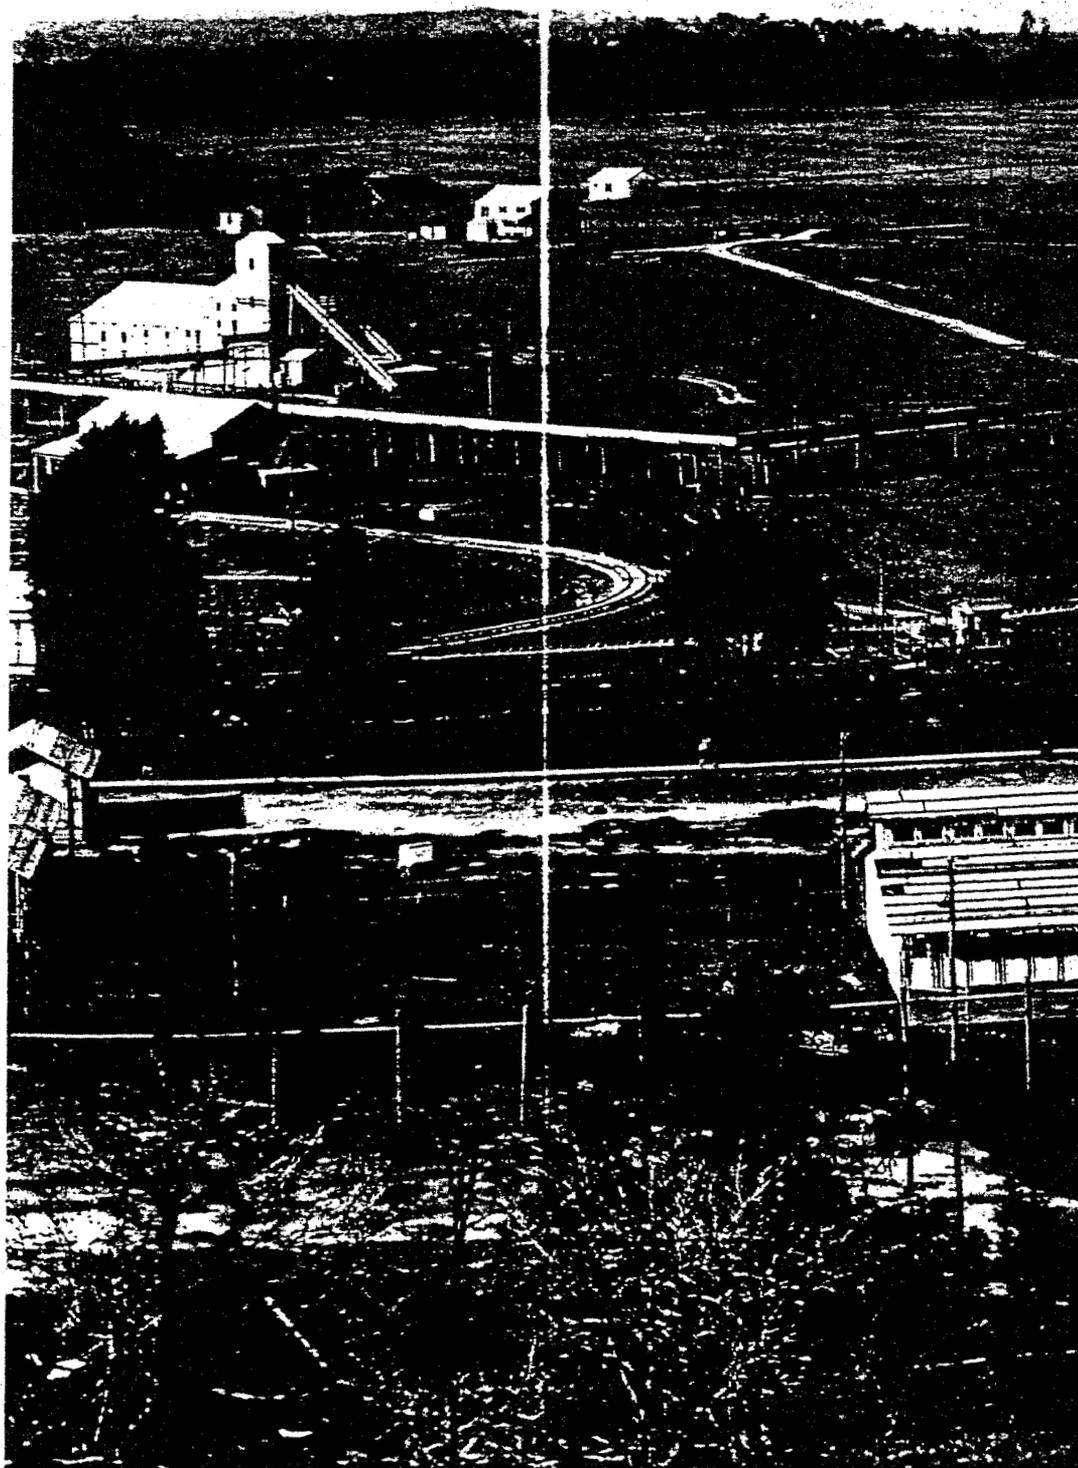
Photograph 11.

It appears that the Penniman Shell Loading facility utilized a brine solution for cooling the explosive compounds in the buildings identified as "nitrating houses" on the 1916 engineering drawings. Documentation provided by the ordnance expert details the design of this system, which includes an above-ground 4-inch brine water line placed inside a wooden box duct which is filled with granulated cork pieces as insulation. This line would carry very cold brine water to the nitrating houses where explosive nitro-compounds would be synthesized. This cold brine

water kept the reaction cool to prevent detonation (Van Nostrand, Report, Hackh's, Report, and Compton). The 1918 panoramic photograph which faces northward (Attachment 1, photograph #11) appears to depict a wooden, insulating water line duct extending into the nitrating houses.

1918 photograph showing a wooden pipe box which is suspected to be an insulating line for brine cooling water.
(1918 panoramic photograph # 6 of 12, Hagley Museum, Wilmington, DE.)
