FINAL SITE MANAGEMENT PLAN FOR FISCAL YEAR 2013 NAS WILLOW GROVE PA
11/1/2013
TETRA TECH

Site Management Plan Fiscal Year 2013

Former Naval Air Station Joint Reserve Base (NAS JRB) Willow Grove, Pennsylvania

**SITE MANAGEMENT PLAN
FISCAL YEAR 2013**

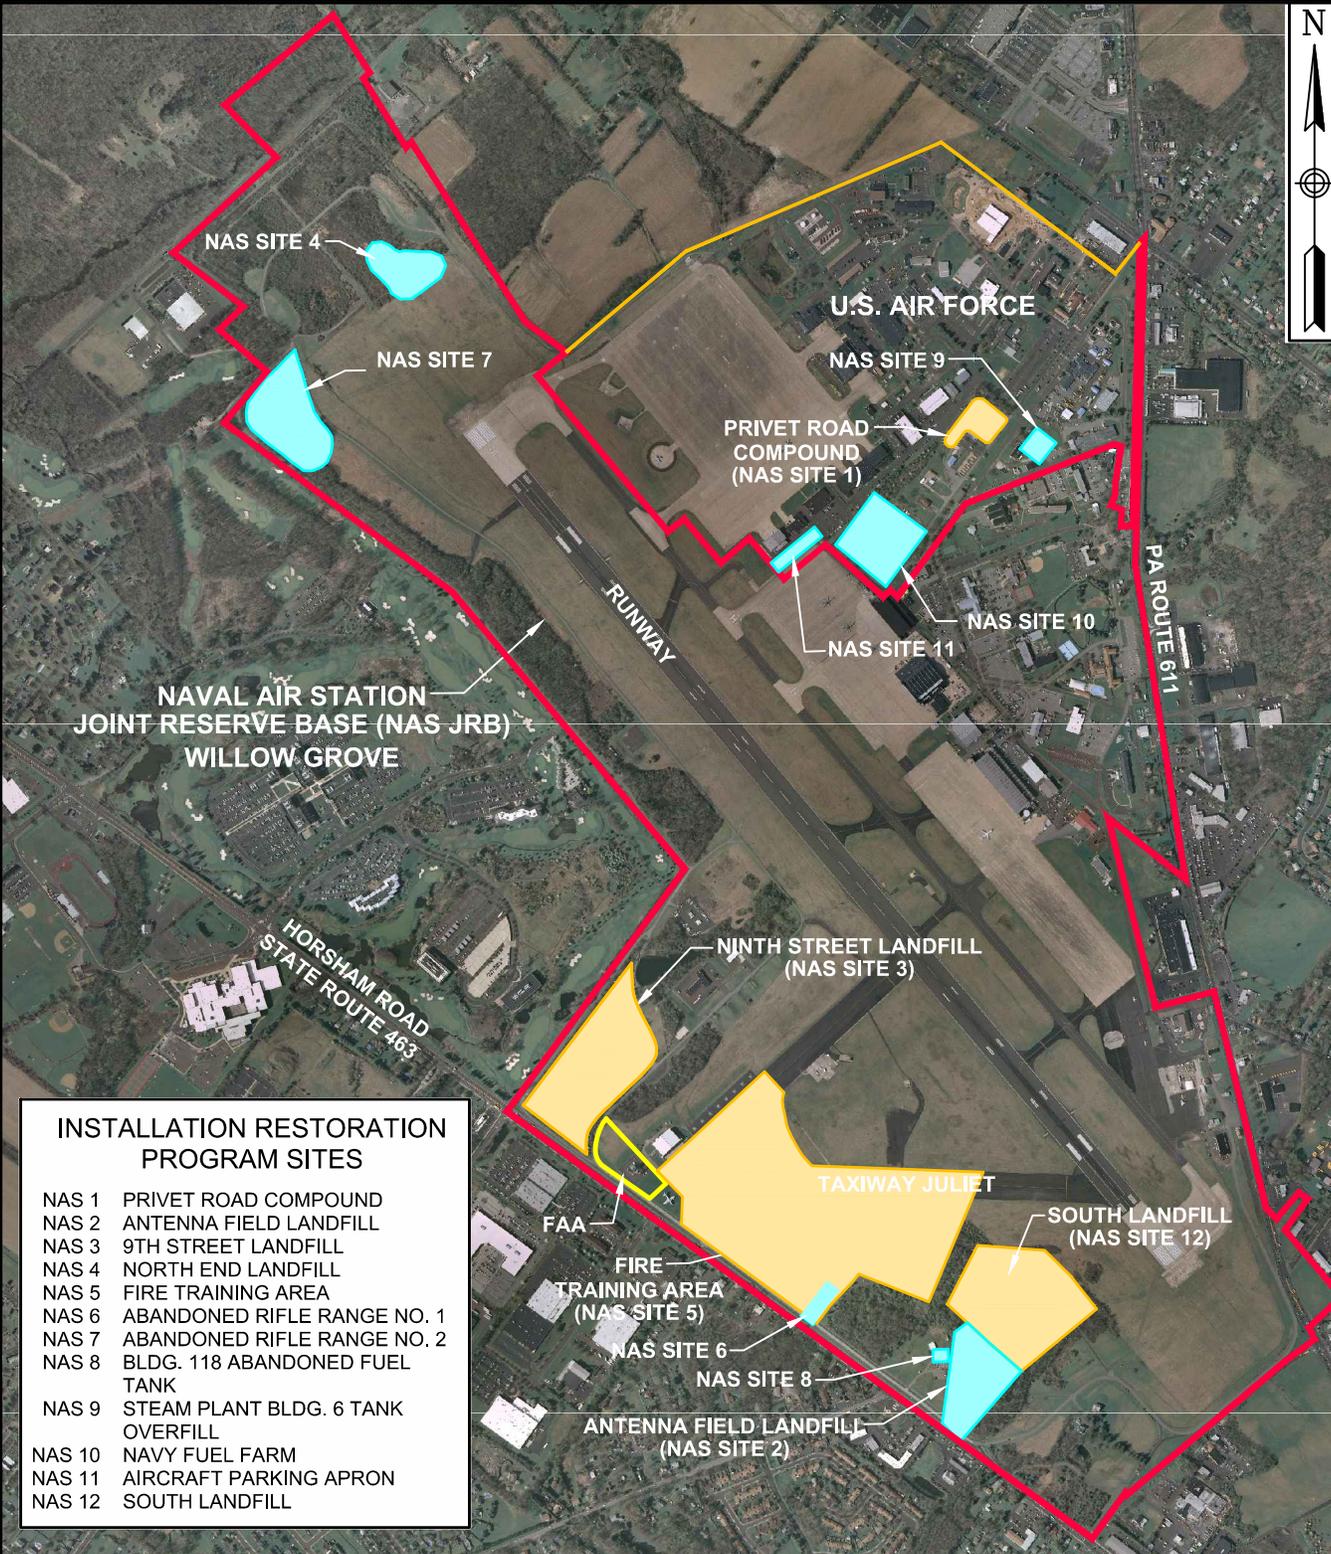
SCALE AS NOTED	
FILE 112G02014BM01-1	
REV 0	DATE 06/14/13
FIGURE NUMBER FIGURE 3-1

NAS 1	PRIVET ROAD COMPOUND
NAS 2	ANTENNA FIELD LANDFILL
NAS 3	9TH STREET LANDFILL
NAS 4	NORTH END LANDFILL
NAS 5	FIRE TRAINING AREA
NAS 6	ABANDONED RIFLE RANGE NO. 1
NAS 7	ABANDONED RIFLE RANGE NO. 2
NAS 8	BLDG. 118 ABANDONED FUEL TANK
NAS 9	STEAM PLANT BLDG. 6 TANK OVERFILL
NAS 10	NAVY FUEL FARM
NAS 11	AIRCRAFT PARKING APRON
NAS 12	SOUTH LANDFILL

**LOCATION OF IR SITES
NAS JRB WILLOW GROVE
WILLOW GROVE, PENNSYLVANIA**

The Ninth Street Landfill site is located at the western boundary of the facility, immediately north of Ninth Street (Figure 3-1). Disposal operations at the 9-acre site were initiated as a replacement for the Antenna Field Landfill in 1960. Wastes were burned and then buried in excavated trenches. Wastes were similar to those at Site 2, and included general wastes, bulk items, paint waste, asbestos, and sewage sludge (NEESA, 1986). Transformers containing PCBs were also stored and serviced in a salvage yard established on the landfill after the landfill's closure in 1967 (EA Engineering, 1990). Figure 3-4 shows the site layout.

The Fire Training Area is located in the south-central portion of NAS JRB, approximately midway between Runway 10/28 and State Route 463 (Figure 3-1). The site is located immediately south of Taxiway Juliet and covers an irregularly shaped area of approximately 1.25 acres, as shown on Figure 3-6. The training area was used from 1942 to 1975 for large-scale firefighting exercises, which included the disposal and burning of flammable liquid wastes generated by the Naval Air Station. Wastes, including solvents, paint chemicals, xylenes, toluene, and various petroleum compounds, were consumed at the rate of up to 4,000 or more gallons per year in these firefighting exercises. The area was also reportedly used for the drum storage of these flammable materials during the periods between burning exercises.

The site is located in the northwestern corner of the facility, west of the north end of Runway 15/33 (Figure 3-1). Construction and operation of the range were similar to Site 6, and consisted of a 1-acre earthen rampart to collect fired rounds of ammunition. The range operated from 1965 until 1977, when the current range located in Building 176 at the Army Reserve Compound was constructed. The rampart, along with the spent ammunition, was regraded in 1977. This area was subsequently used as a landfill for inert materials including clean fill, broken concrete, asphalt, and cinderblocks. In addition, dry wastewater treatment sludge and emulsified oil and grease from on-site oil/water separators were reported to have been buried at the site (NEESA, 1986). Figure 3-8 presents an aerial view of the site.

The site consists of a former underground 500-gallon heating fuel tank located approximately 50 feet north of Building 118 (Figure 3-1). The tank was placed in service in 1959, and was abandoned in place in 1980 when it was replaced with a 290-gallon above ground tank. The tank contained only No. 2 heating fuel and serviced Building 118. In 1980, oil was observed seeping into the basement of Building 118. This occurred on an intermittent basis, and the oil was removed after each occurrence. The tank was investigated as a result of the seepage. The tank was empty and soils in the excavation around the tank did not indicate the presence of released materials; however, the fill and riser pipes were removed and the tank was buried in place (NEESA, 1986). Figure 3-9 presents an aerial view of the site.

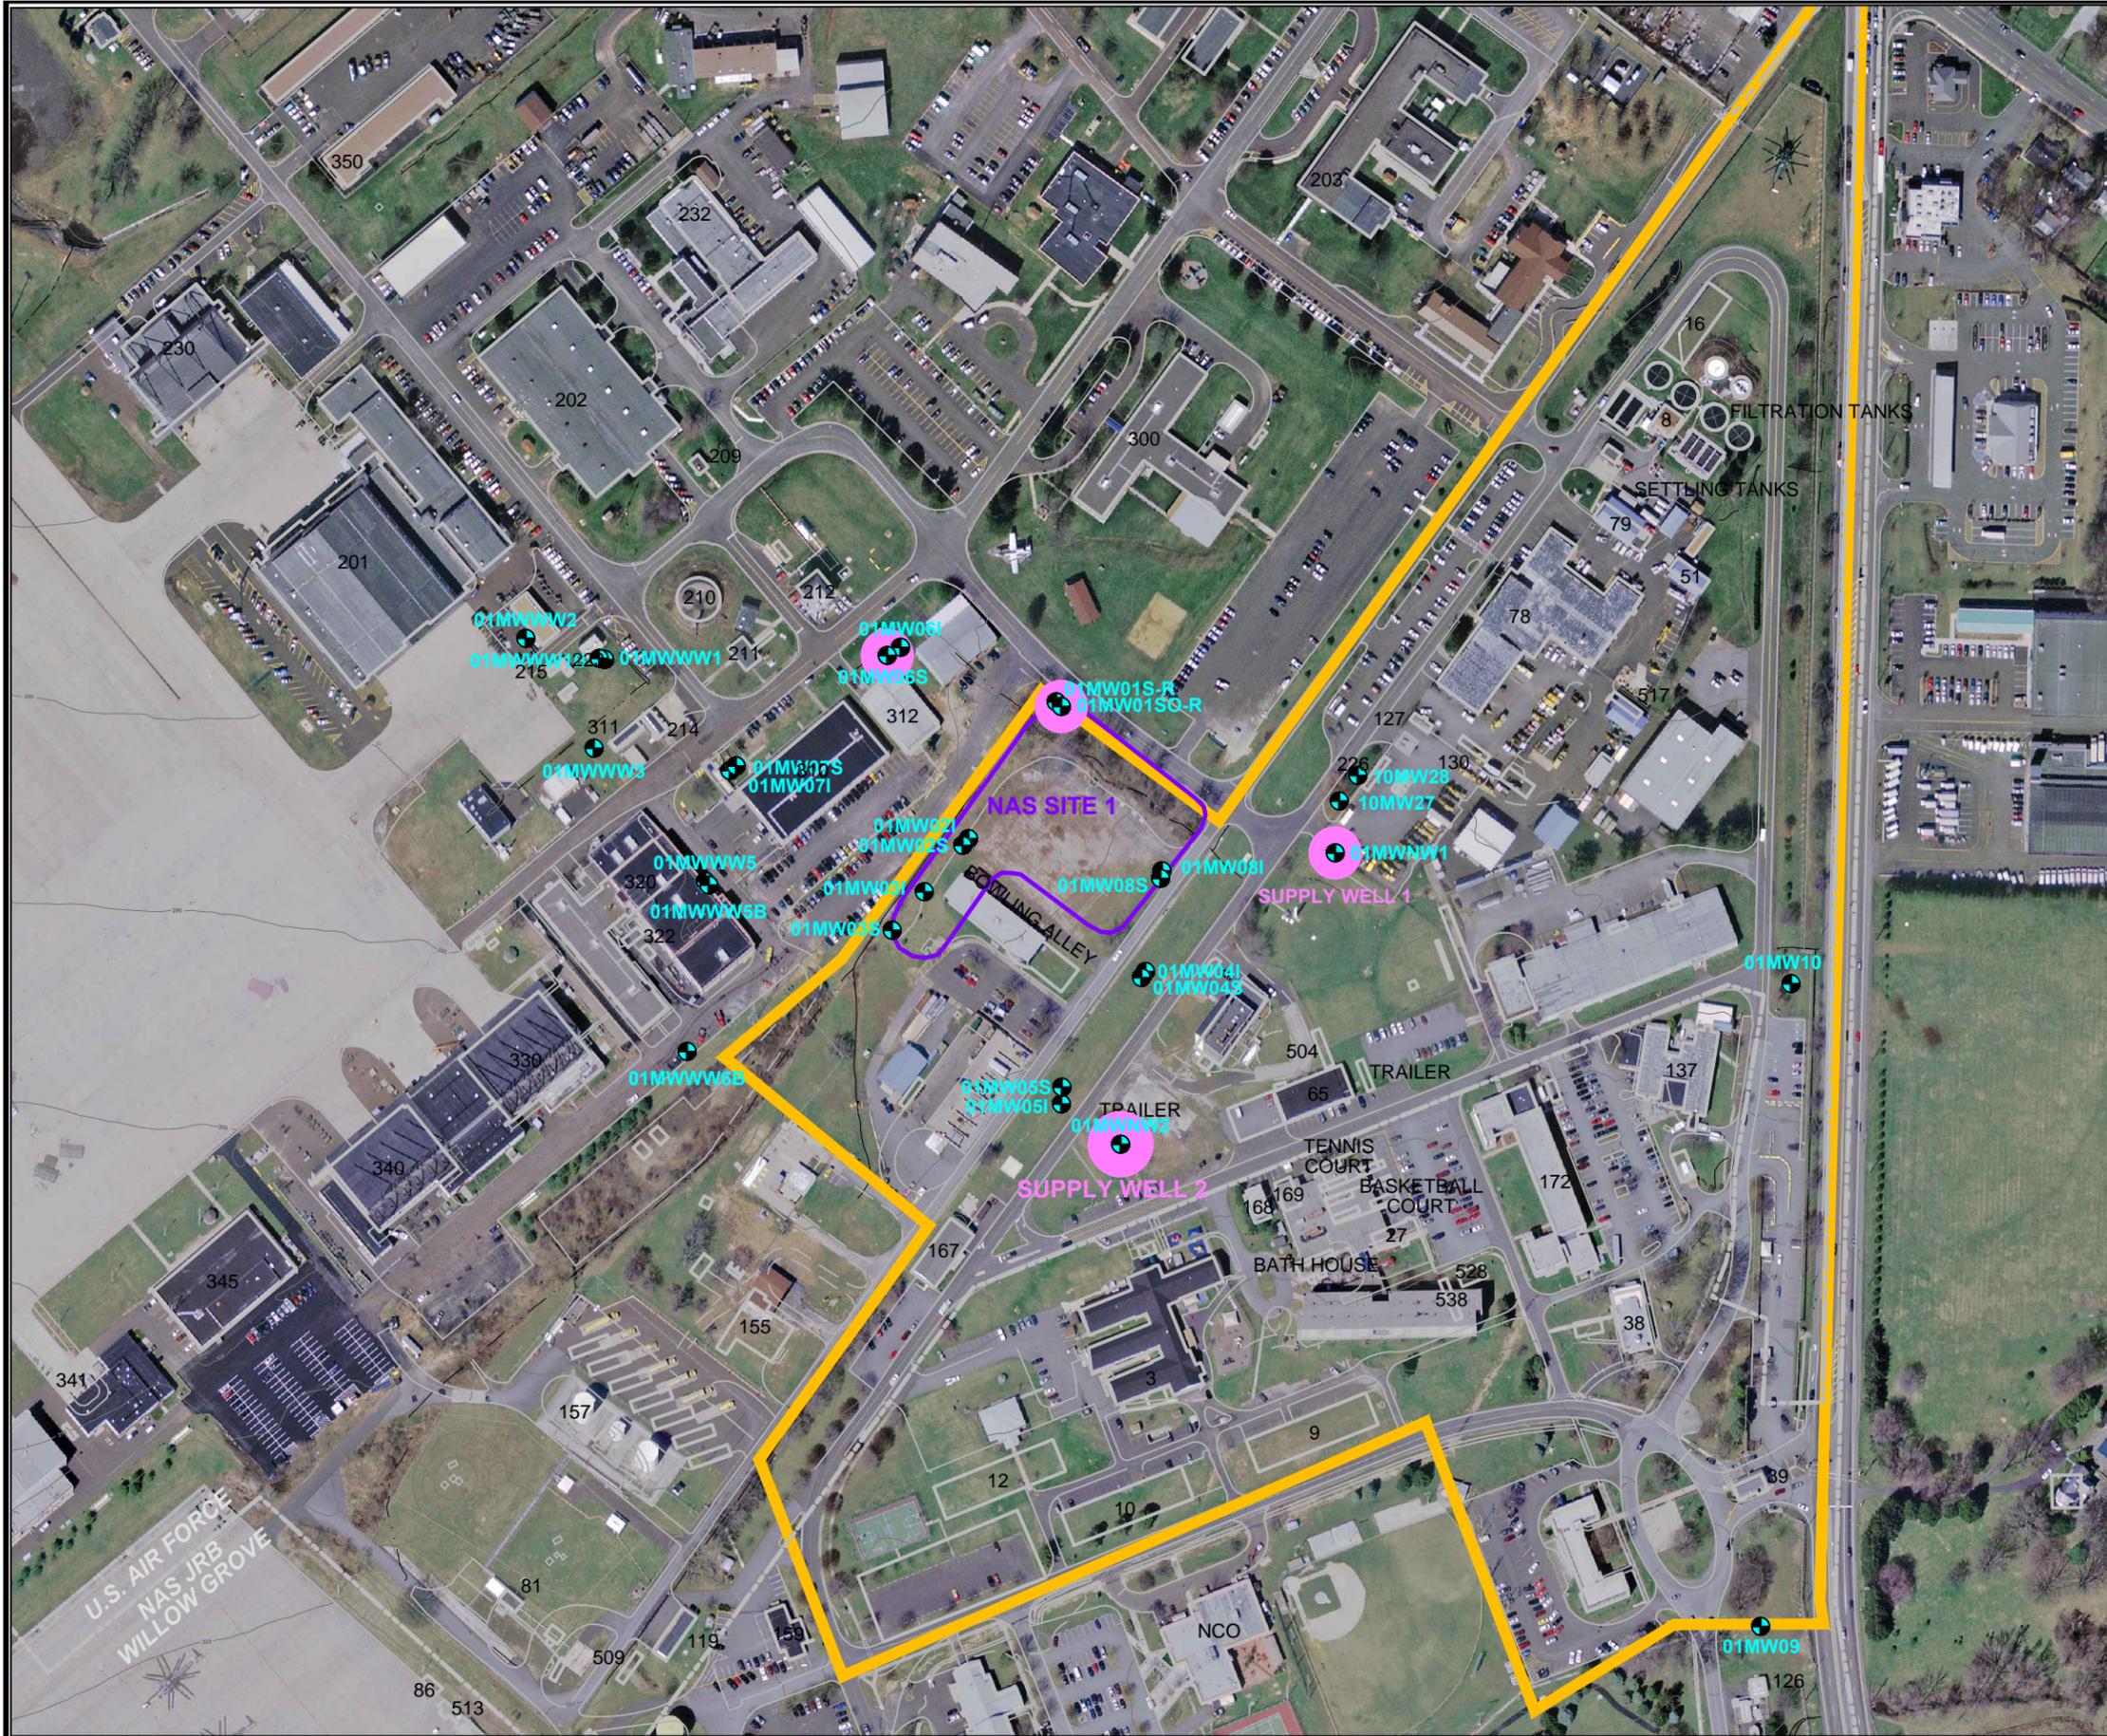
FILE 112G02014GM01-1	SCALE AS NOTED
FIGURE NUMBER FIGURE 3-2	REV DATE 0 06/13/13

**SITE LAYOUT
SITE 1 – PRIVET ROAD
NAS JRB WILLOW GROVE
WILLOW GROVE, PENNSYLVANIA**

The former Privet Road Compound is located west of Privet Road, across from the steam plant (Building No. 6). Figure 3-2 shows the current Site 1 layout. The entire site area was approximately 2 acres and consisted of a bowling alley, parking lot, and a 0.5-acre fenced area. Trash handling operations at the Privet Road Compound began in 1967 when the Ninth Street Landfill (Site 3) was closed. To replace the landfill, regular trash pickup and off-site disposal were initiated. The Privet Road Compound site was used to process wastes from 1967 to 1975. A fence was erected around the compound area in 1972 to control waste disposal and handling within the compound. The suspected waste handling area, however, is believed to have extended throughout Site 1, including the area where the Bowling Alley and parking lot were located.

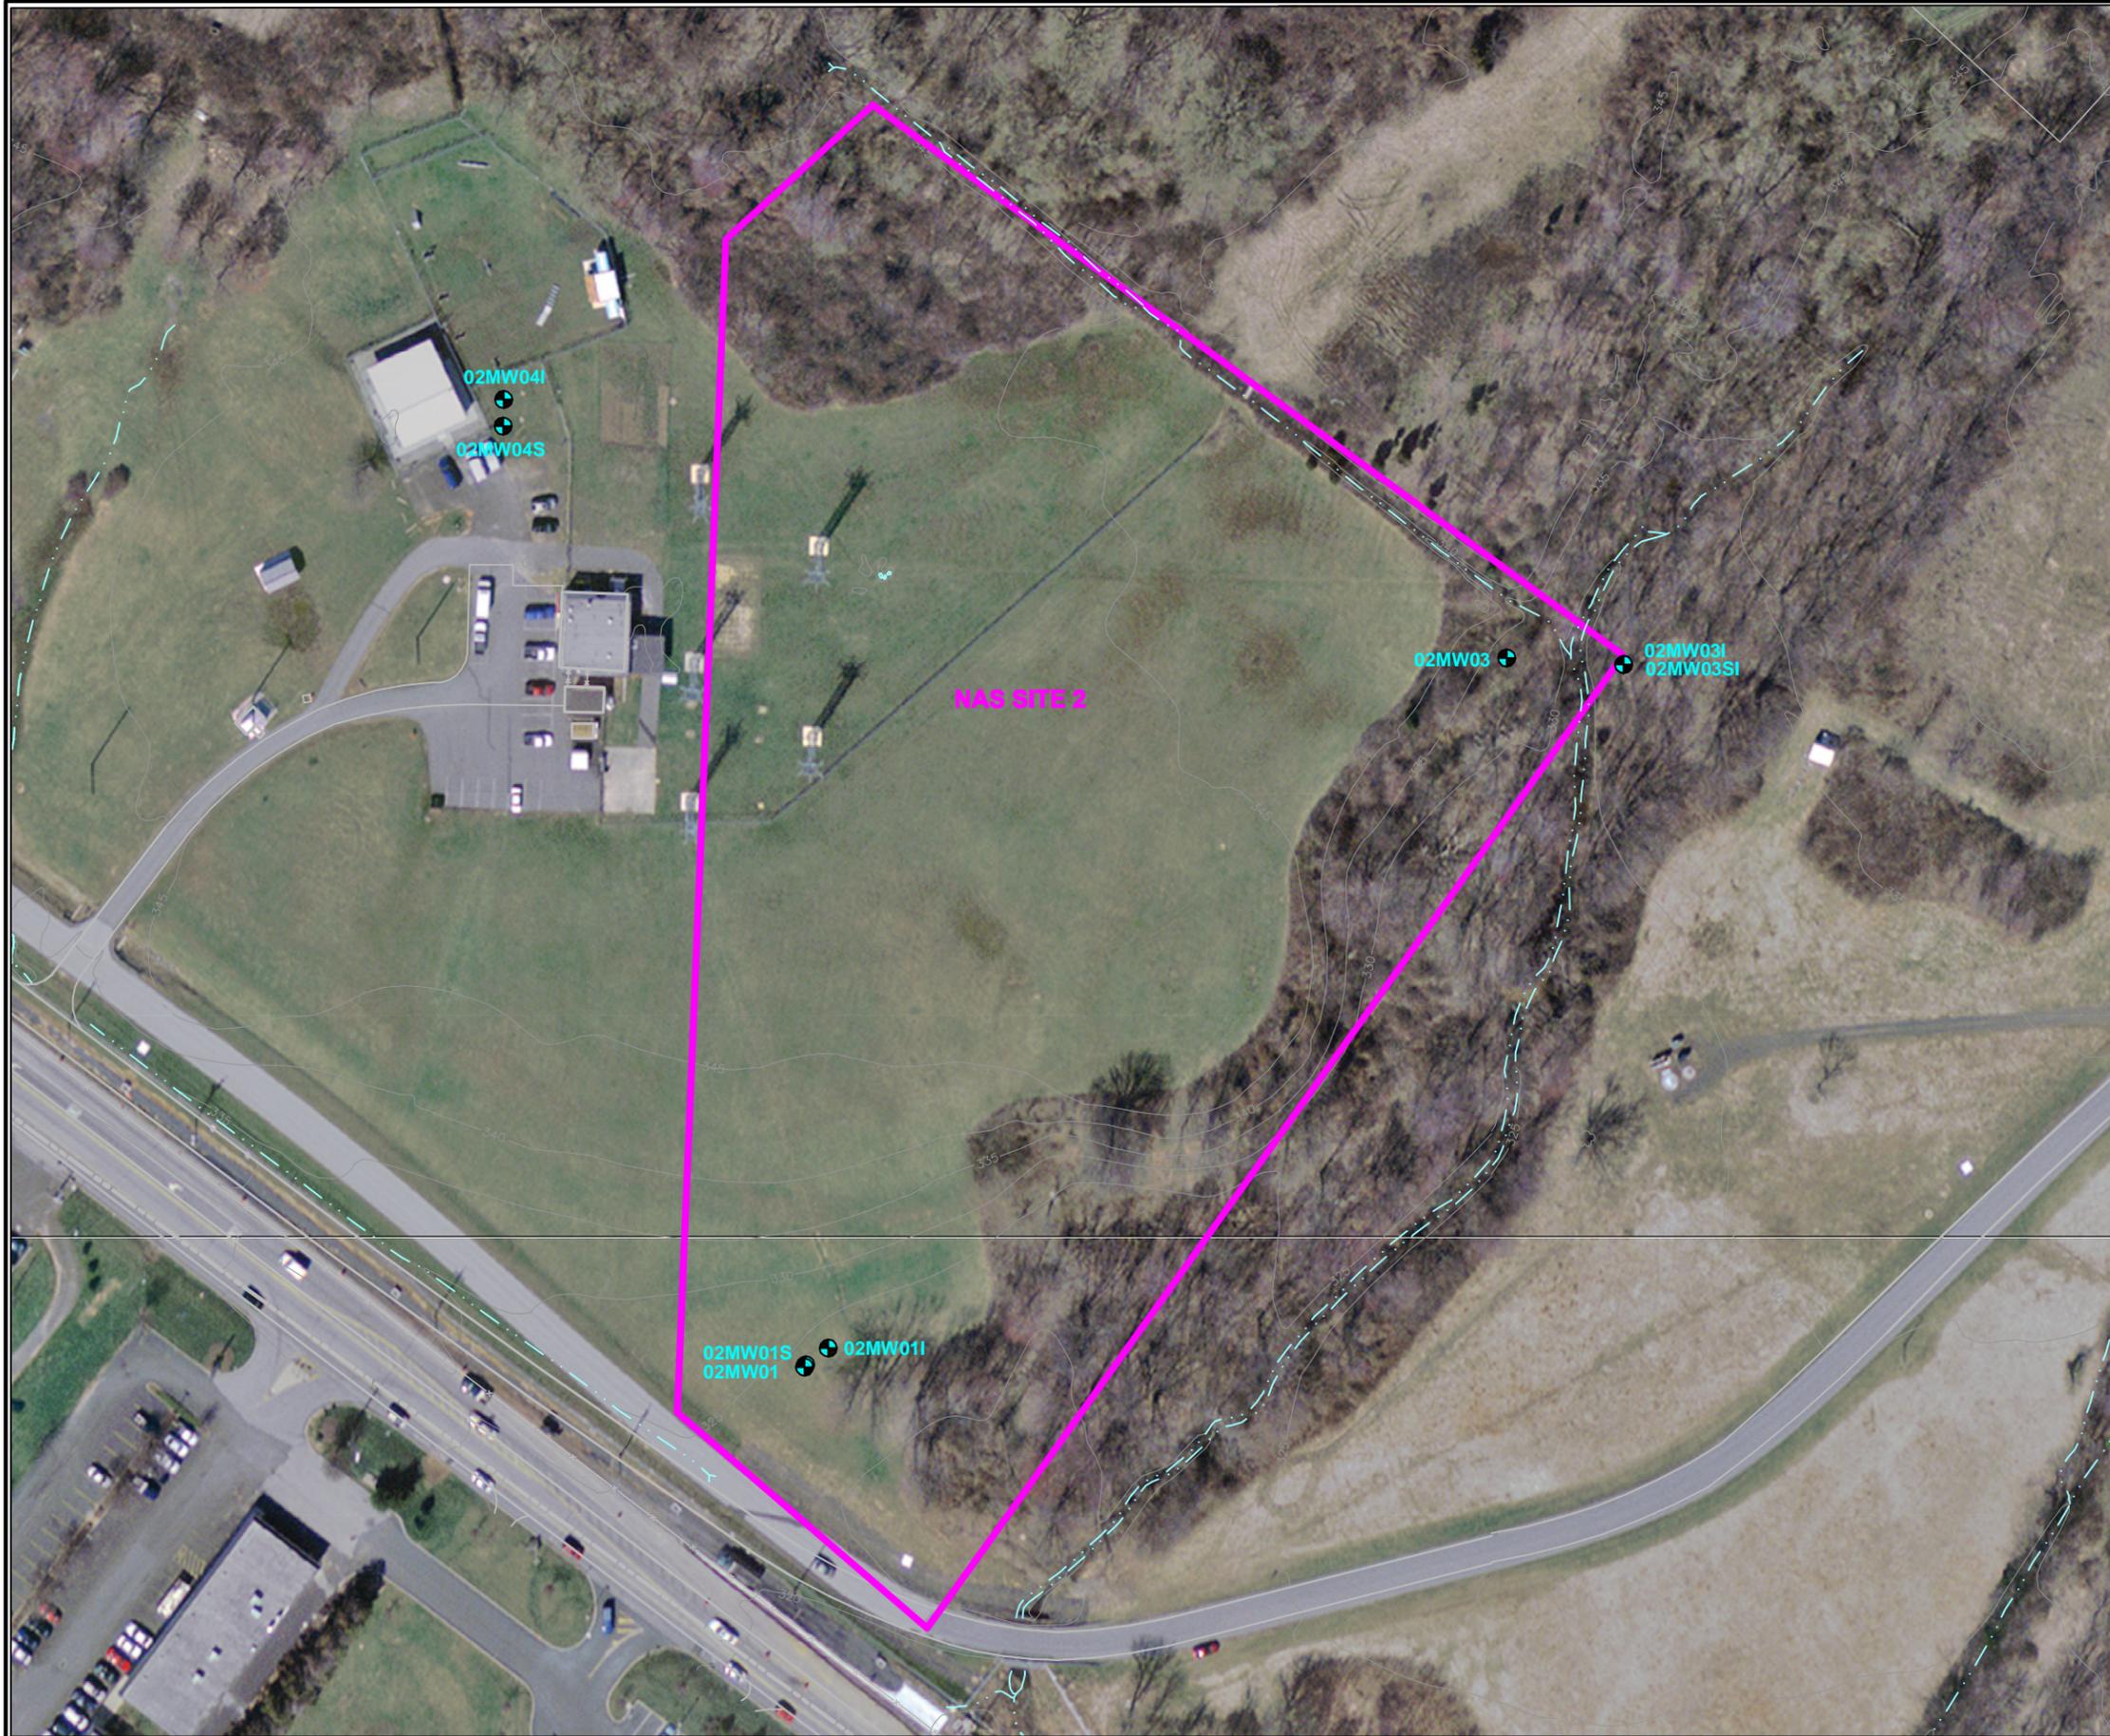
FILE 112G02014GM01-2	SCALE AS NOTED
FIGURE NUMBER FIGURE 3-3	REV DATE 0 06/26/12

SITE LAYOUT
 SITE 2 – ANTENNA FIELD LANDFILL
 NAS JRB WILLOW GROVE
 WILLOW GROVE, PENNSYLVANIA

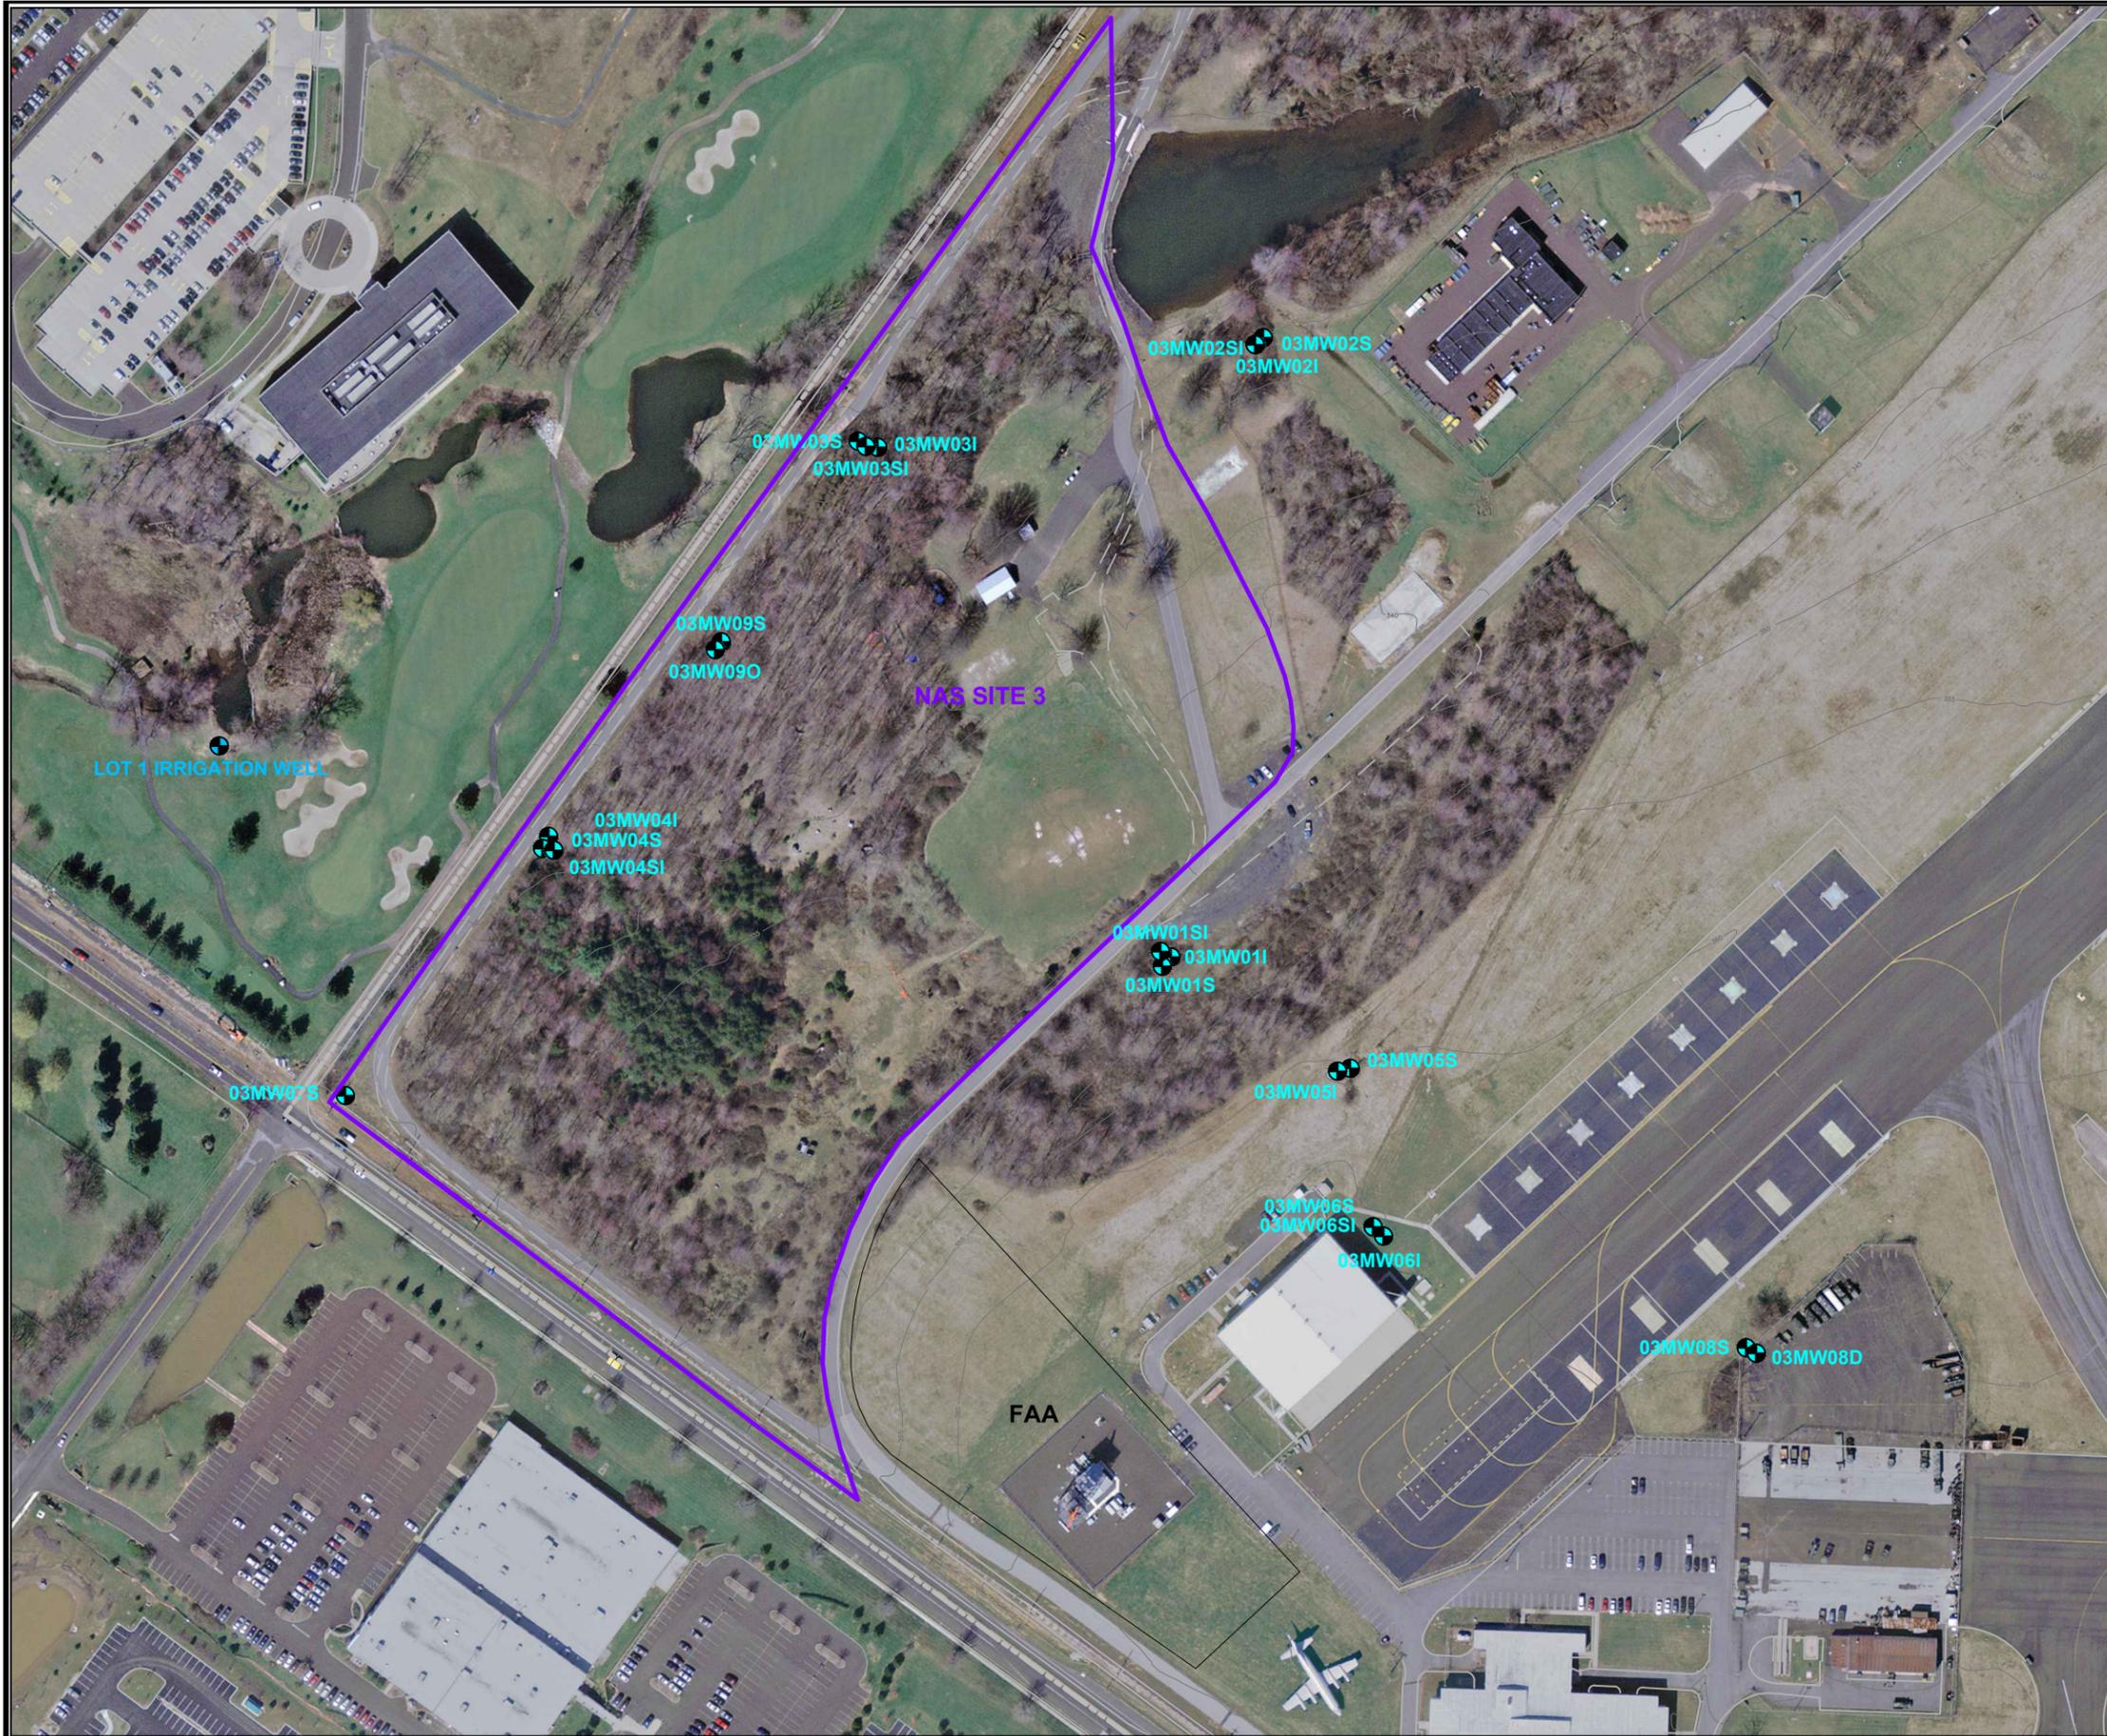
FILE 112G02014GM01-3	SCALE AS NOTED
FIGURE NUMBER FIGURE 3-4	REV DATE 0 06/13/13

- ON-SITE MONITORING WELL LOCATION
- OFF BASE WELL LOCATION
- SITE BOUNDARY
- INSTALLATION BOUNDARY

SITE LAYOUT
SITE 3 – NINTH STREET LANDFILL
NAS JRB WILLOW GROVE
WILLOW GROVE, PENNSYLVANIA

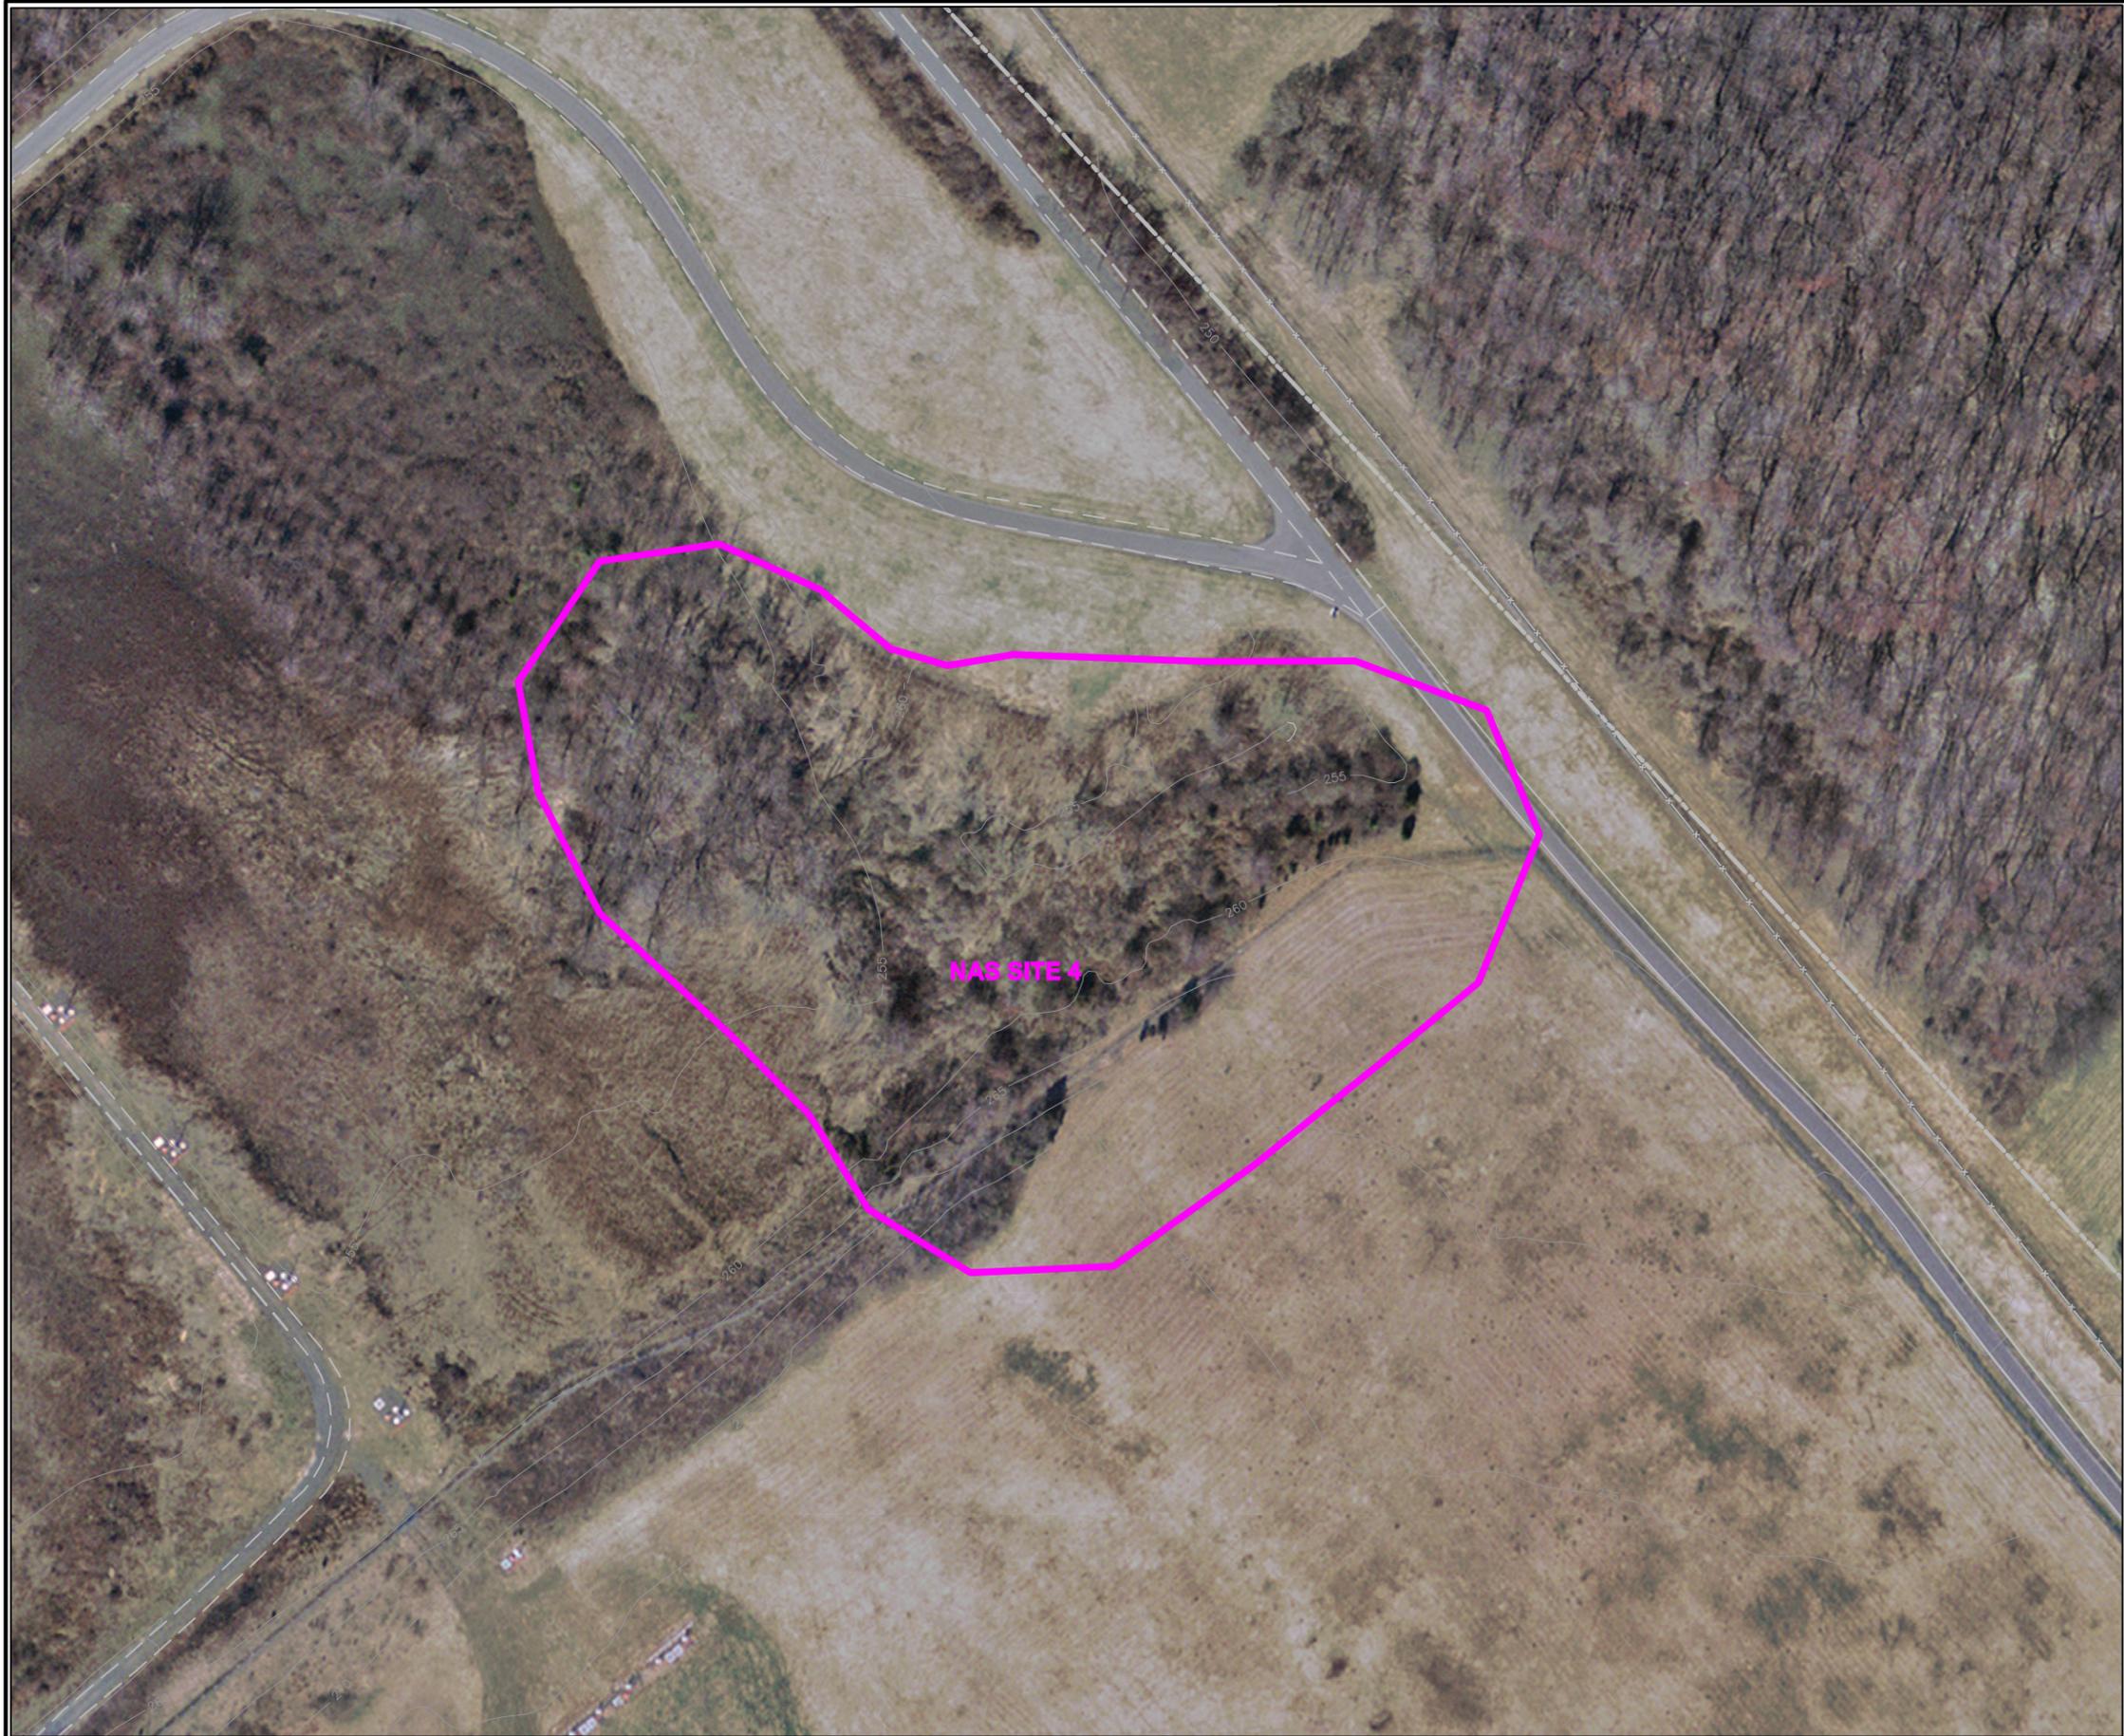
FILE 112G02014GM01-4	SCALE AS NOTED
FIGURE NUMBER FIGURE 3-5	REV DATE 0 06/26/12

SITE LAYOUT
 SITE 4 – NORTH END LANDFILL
 NAS JRB WILLOW GROVE
 WILLOW GROVE, PENNSYLVANIA

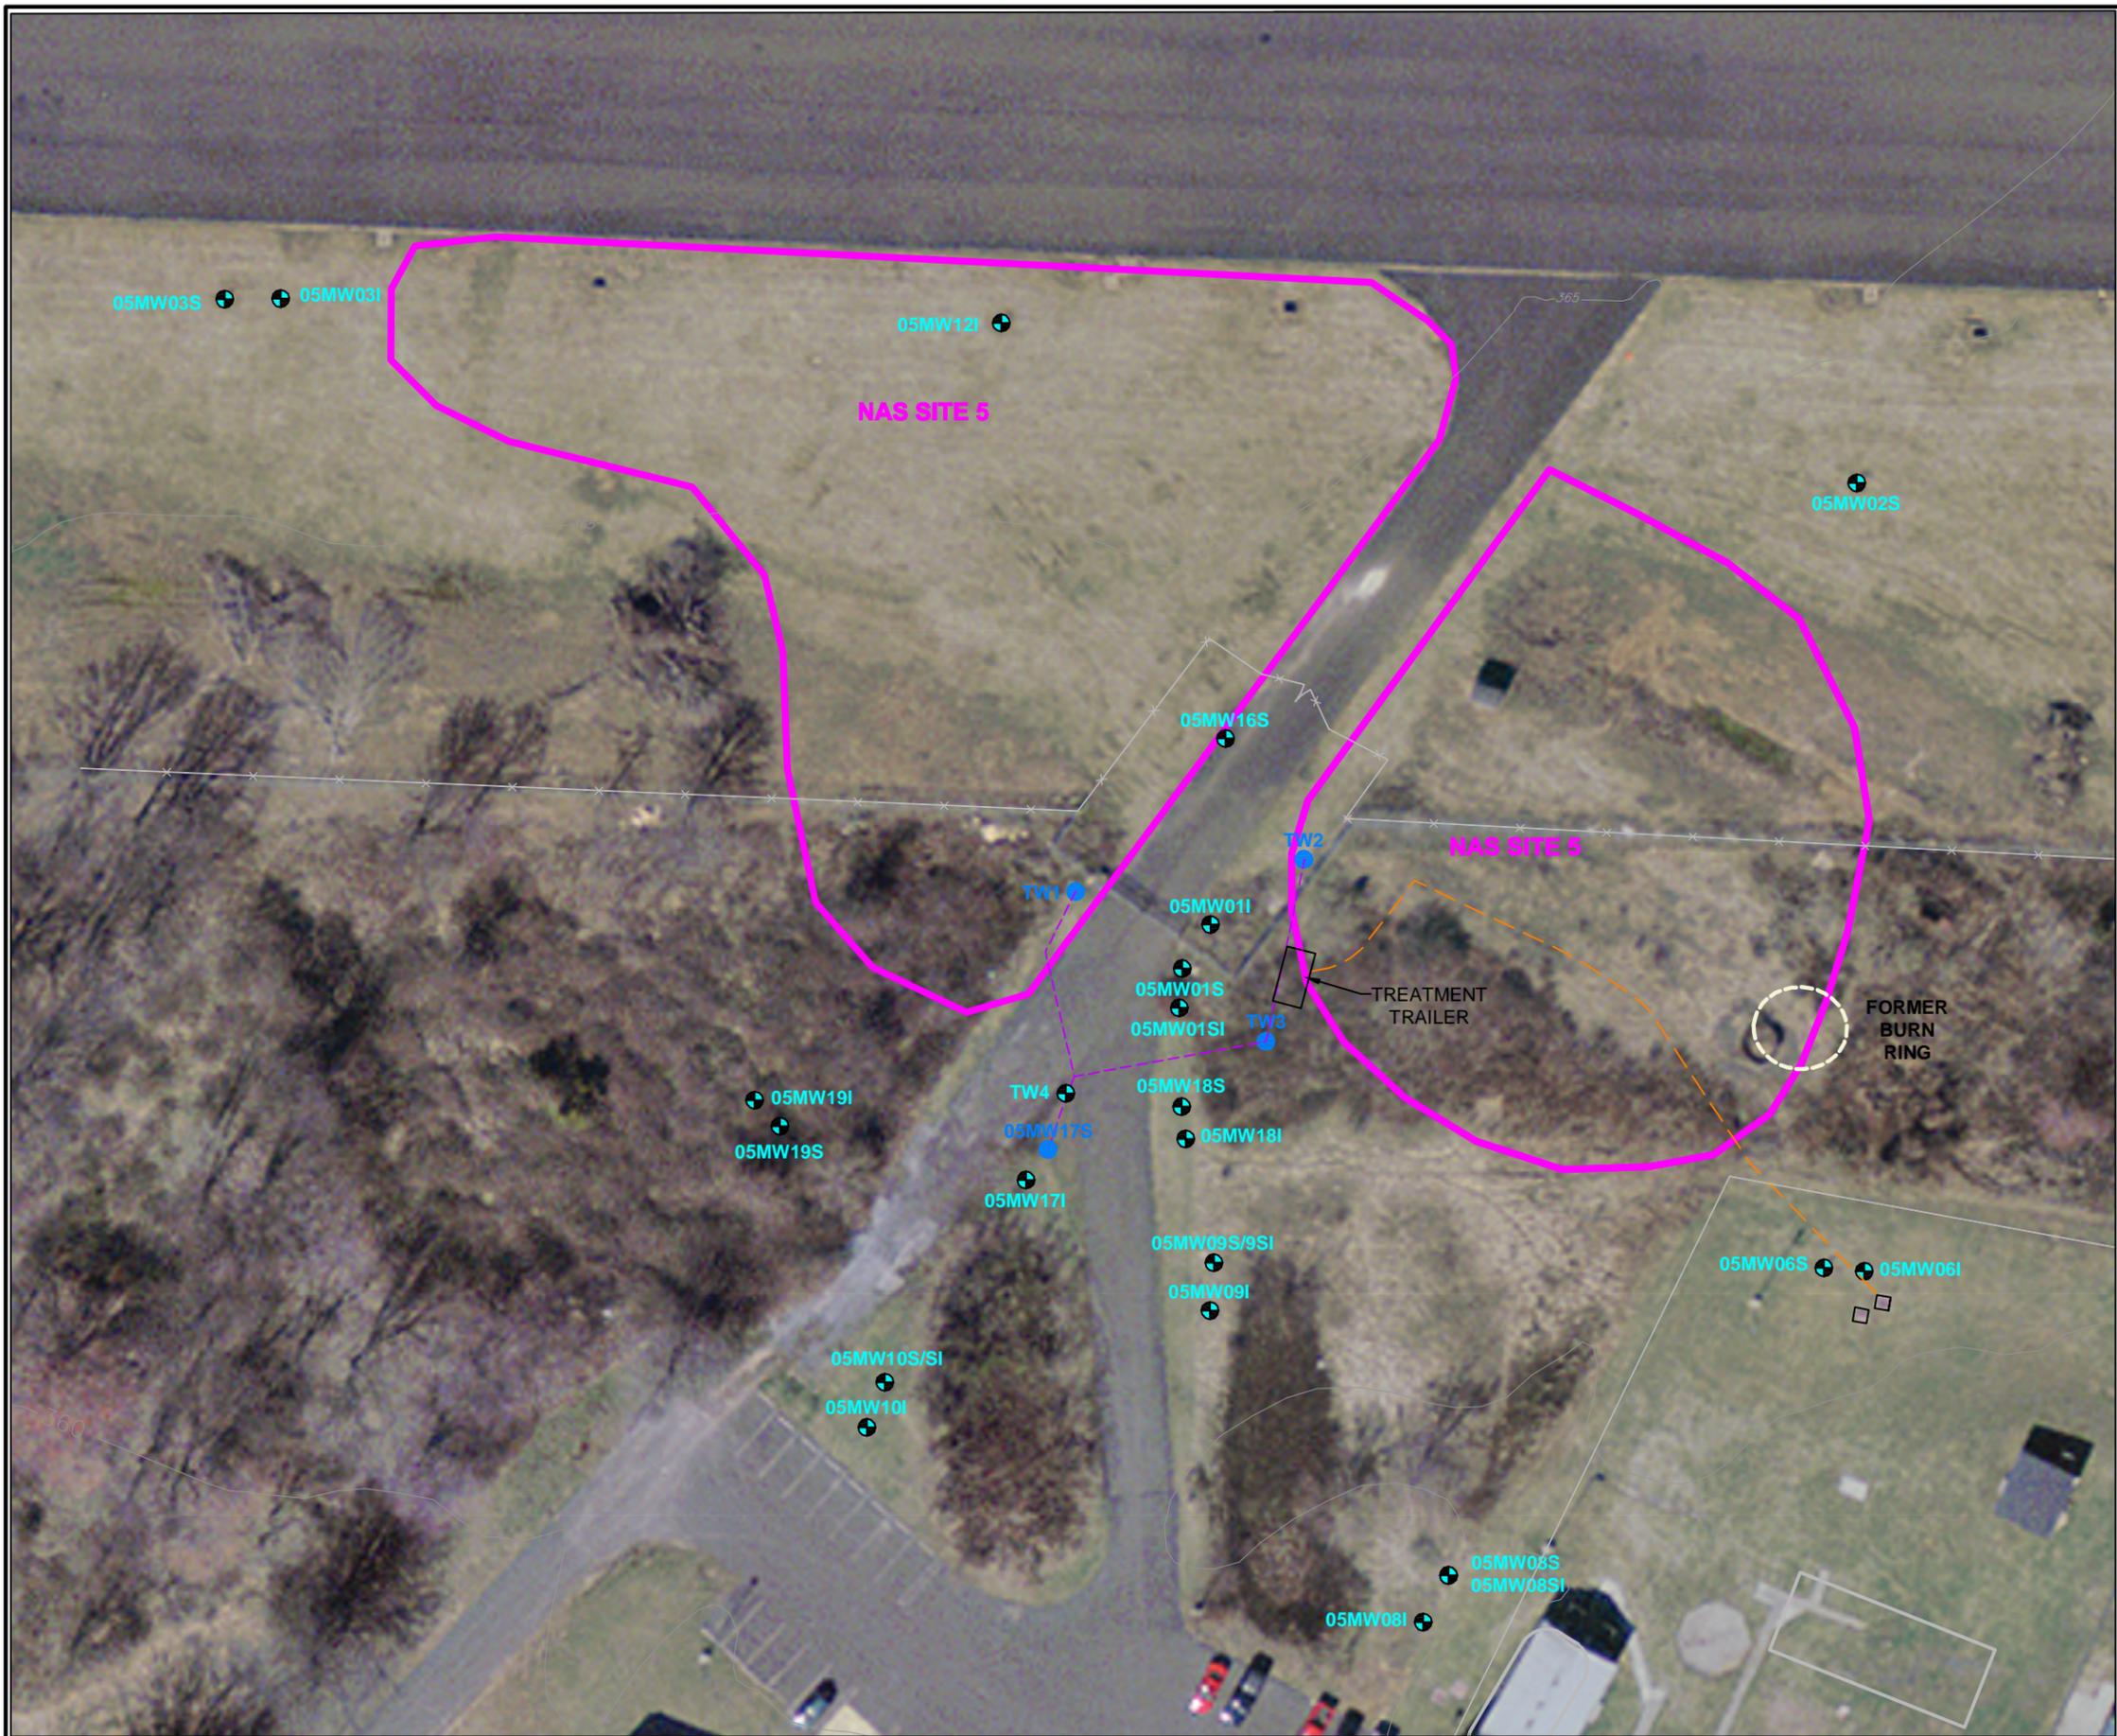
FILE 112G02014GM01-5	SCALE AS NOTED
FIGURE NUMBER FIGURE 3-6	REV DATE 0 06/26/12

- MONITORING WELL LOCATION
- INJECTION/EXTRACTION WELL LOCATION
- - - UNDERGROUND ELECTRIC AND WATER LINE
- - - UNDERGROUND ELECTRIC LINE
- SITE BOUNDARY
- INSTALLATION BOUNDARY

SITE LAYOUT
 SITE 5 – FIRE TRAINING AREA
 NAS JRB WILLOW GROVE
 WILLOW GROVE, PENNSYLVANIA

The Fire Training Area is primarily covered by grasses, with some woody and brushy vegetation present within the southern portion of the area. The burn area consisted of a "burning ring" that was actually a section of a partially buried steel tank, wide open at the top with an intact bottom below the surrounding grade, which was located in the south-central portion of the site (Tetra Tech, 2002c).
