FINAL SITE MANAGEMENT PLAN FOR FISCAL YEAR 2013 NAS WILLOW GROVE PA
11/1/2013
TETRA TECH

Site Management Plan Fiscal Year 2013

Former Naval Air Station Joint Reserve Base (NAS JRB) Willow Grove, Pennsylvania

**SITE MANAGEMENT PLAN
FISCAL YEAR 2013**

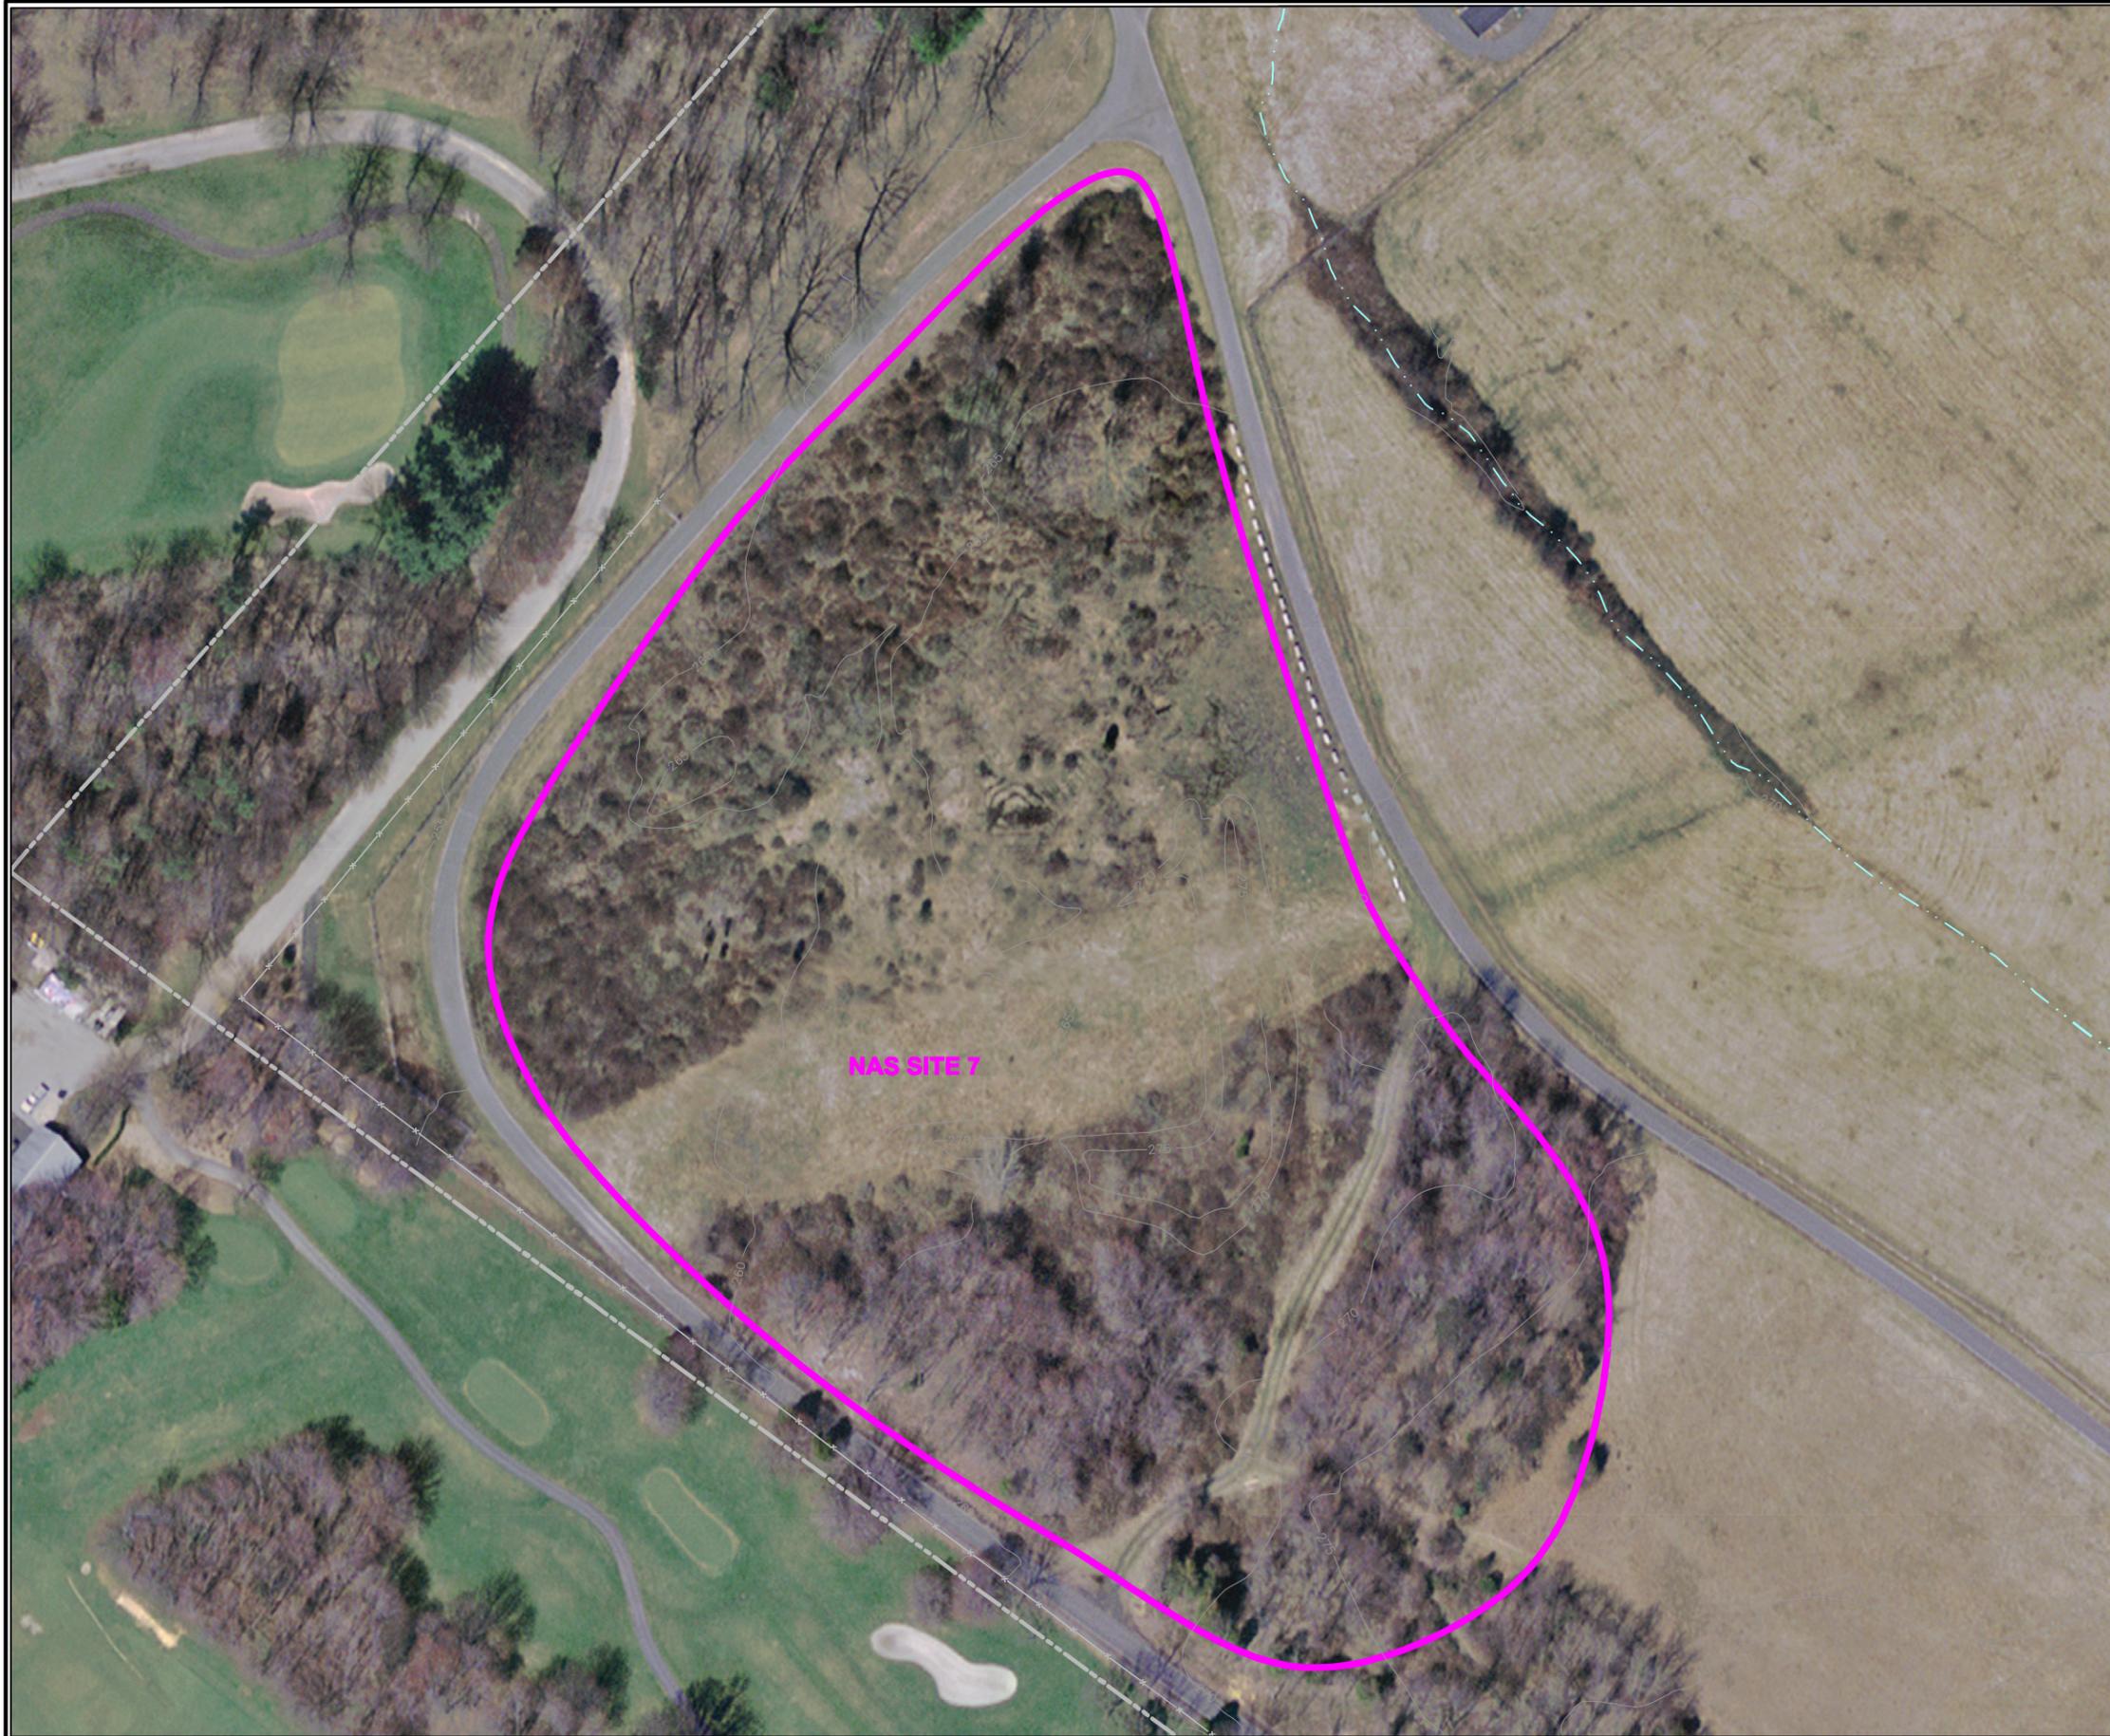
FILE 112G02014GM01-7	SCALE AS NOTED
FIGURE NUMBER FIGURE 3-8	REV DATE 0 06/26/12

SITE LAYOUT
SITE 7 – ABANDONED RIFLE RANGE 2
NAS JRB WILLOW GROVE
WILLOW GROVE, PENNSYLVANIA

The site is located in the northwestern corner of the facility, west of the north end of Runway 15/33 (Figure 3-1). Construction and operation of the range were similar to Site 6, and consisted of a 1-acre earthen rampart to collect fired rounds of ammunition. The range operated from 1965 until 1977, when the current range located in Building 176 at the Army Reserve Compound was constructed. The rampart, along with the spent ammunition, was regraded in 1977. This area was subsequently used as a landfill for inert materials including clean fill, broken concrete, asphalt, and cinderblocks. In addition, dry wastewater treatment sludge and emulsified oil and grease from on-site oil/water separators were reported to have been buried at the site (NEESA, 1986). Figure 3-8 presents an aerial view of the site.

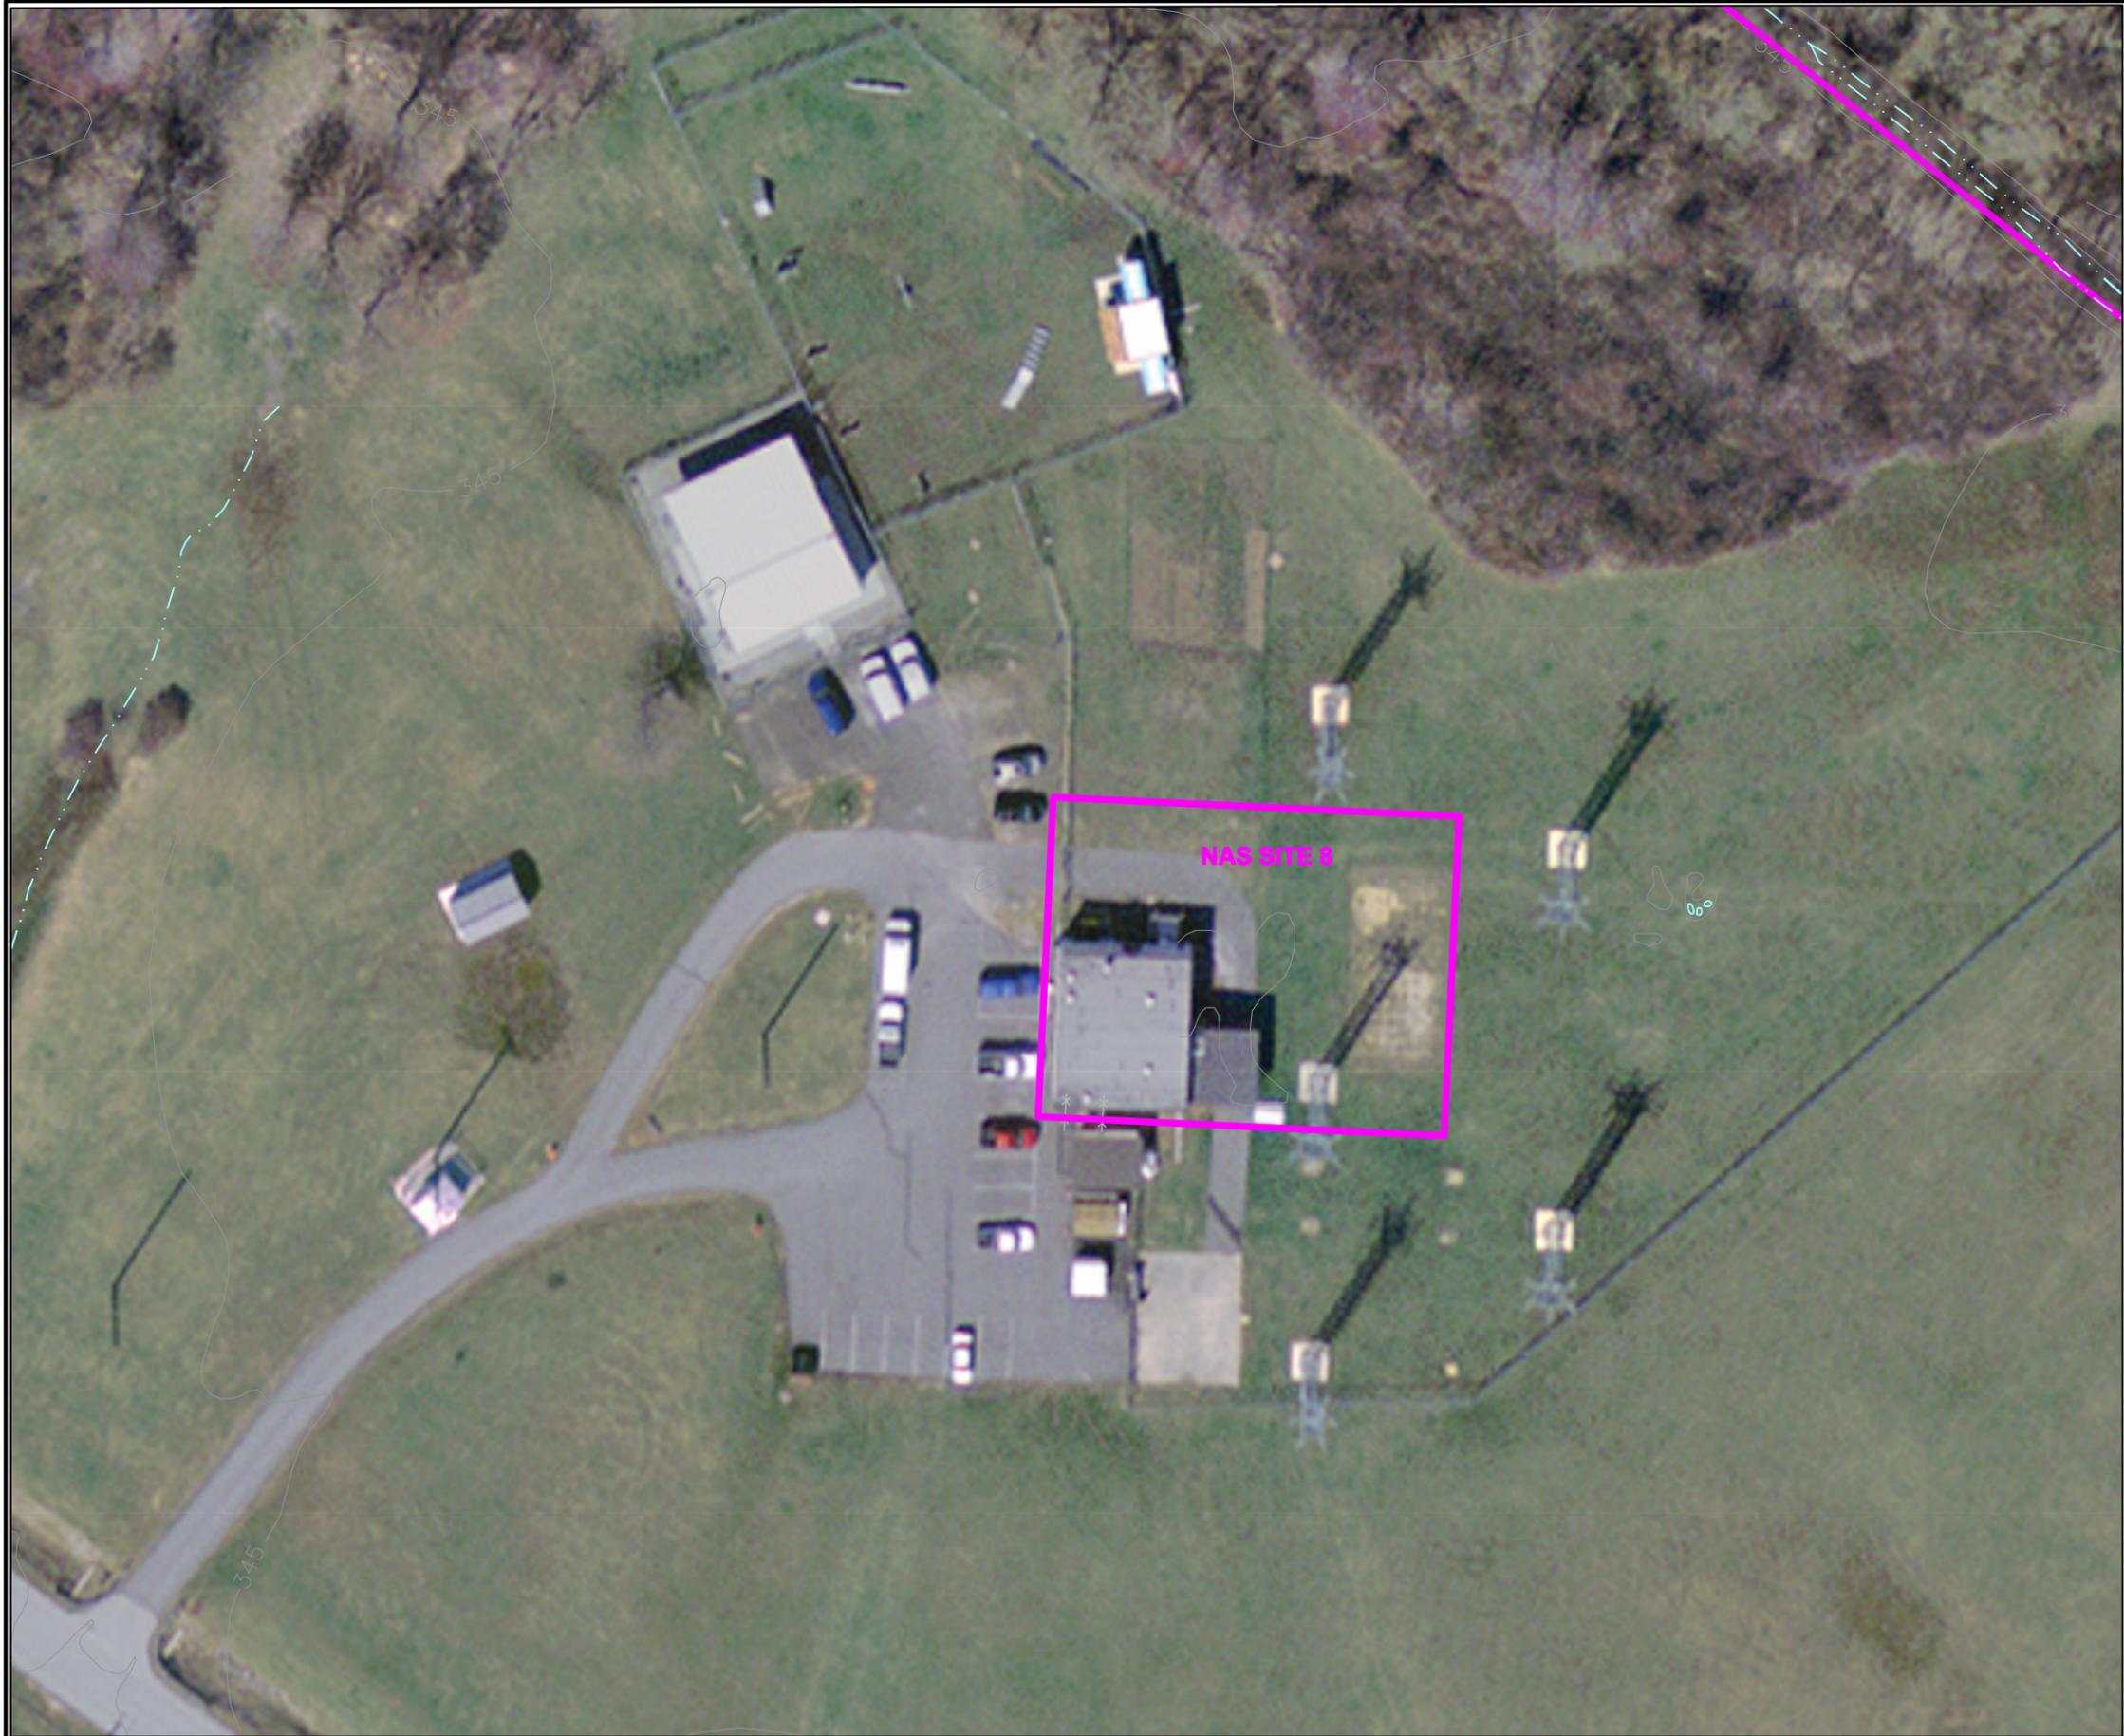
FILE 112G02014GM01-8	SCALE AS NOTED
FIGURE NUMBER FIGURE 3-9	REV DATE 0 06/26/12

SITE LAYOUT
 SITE 8 – BUILDING 118
 ABANDONED FUEL TANK
 NAS JRB WILLOW GROVE
 WILLOW GROVE, PENNSYLVANIA

The site consists of a former underground 500-gallon heating fuel tank located approximately 50 feet north of Building 118 (Figure 3-1). The tank was placed in service in 1959, and was abandoned in place in 1980 when it was replaced with a 290-gallon above ground tank. The tank contained only No. 2 heating fuel and serviced Building 118. In 1980, oil was observed seeping into the basement of Building 118. This occurred on an intermittent basis, and the oil was removed after each occurrence. The tank was investigated as a result of the seepage. The tank was empty and soils in the excavation around the tank did not indicate the presence of released materials; however, the fill and riser pipes were removed and the tank was buried in place (NEESA, 1986). Figure 3-9 presents an aerial view of the site.

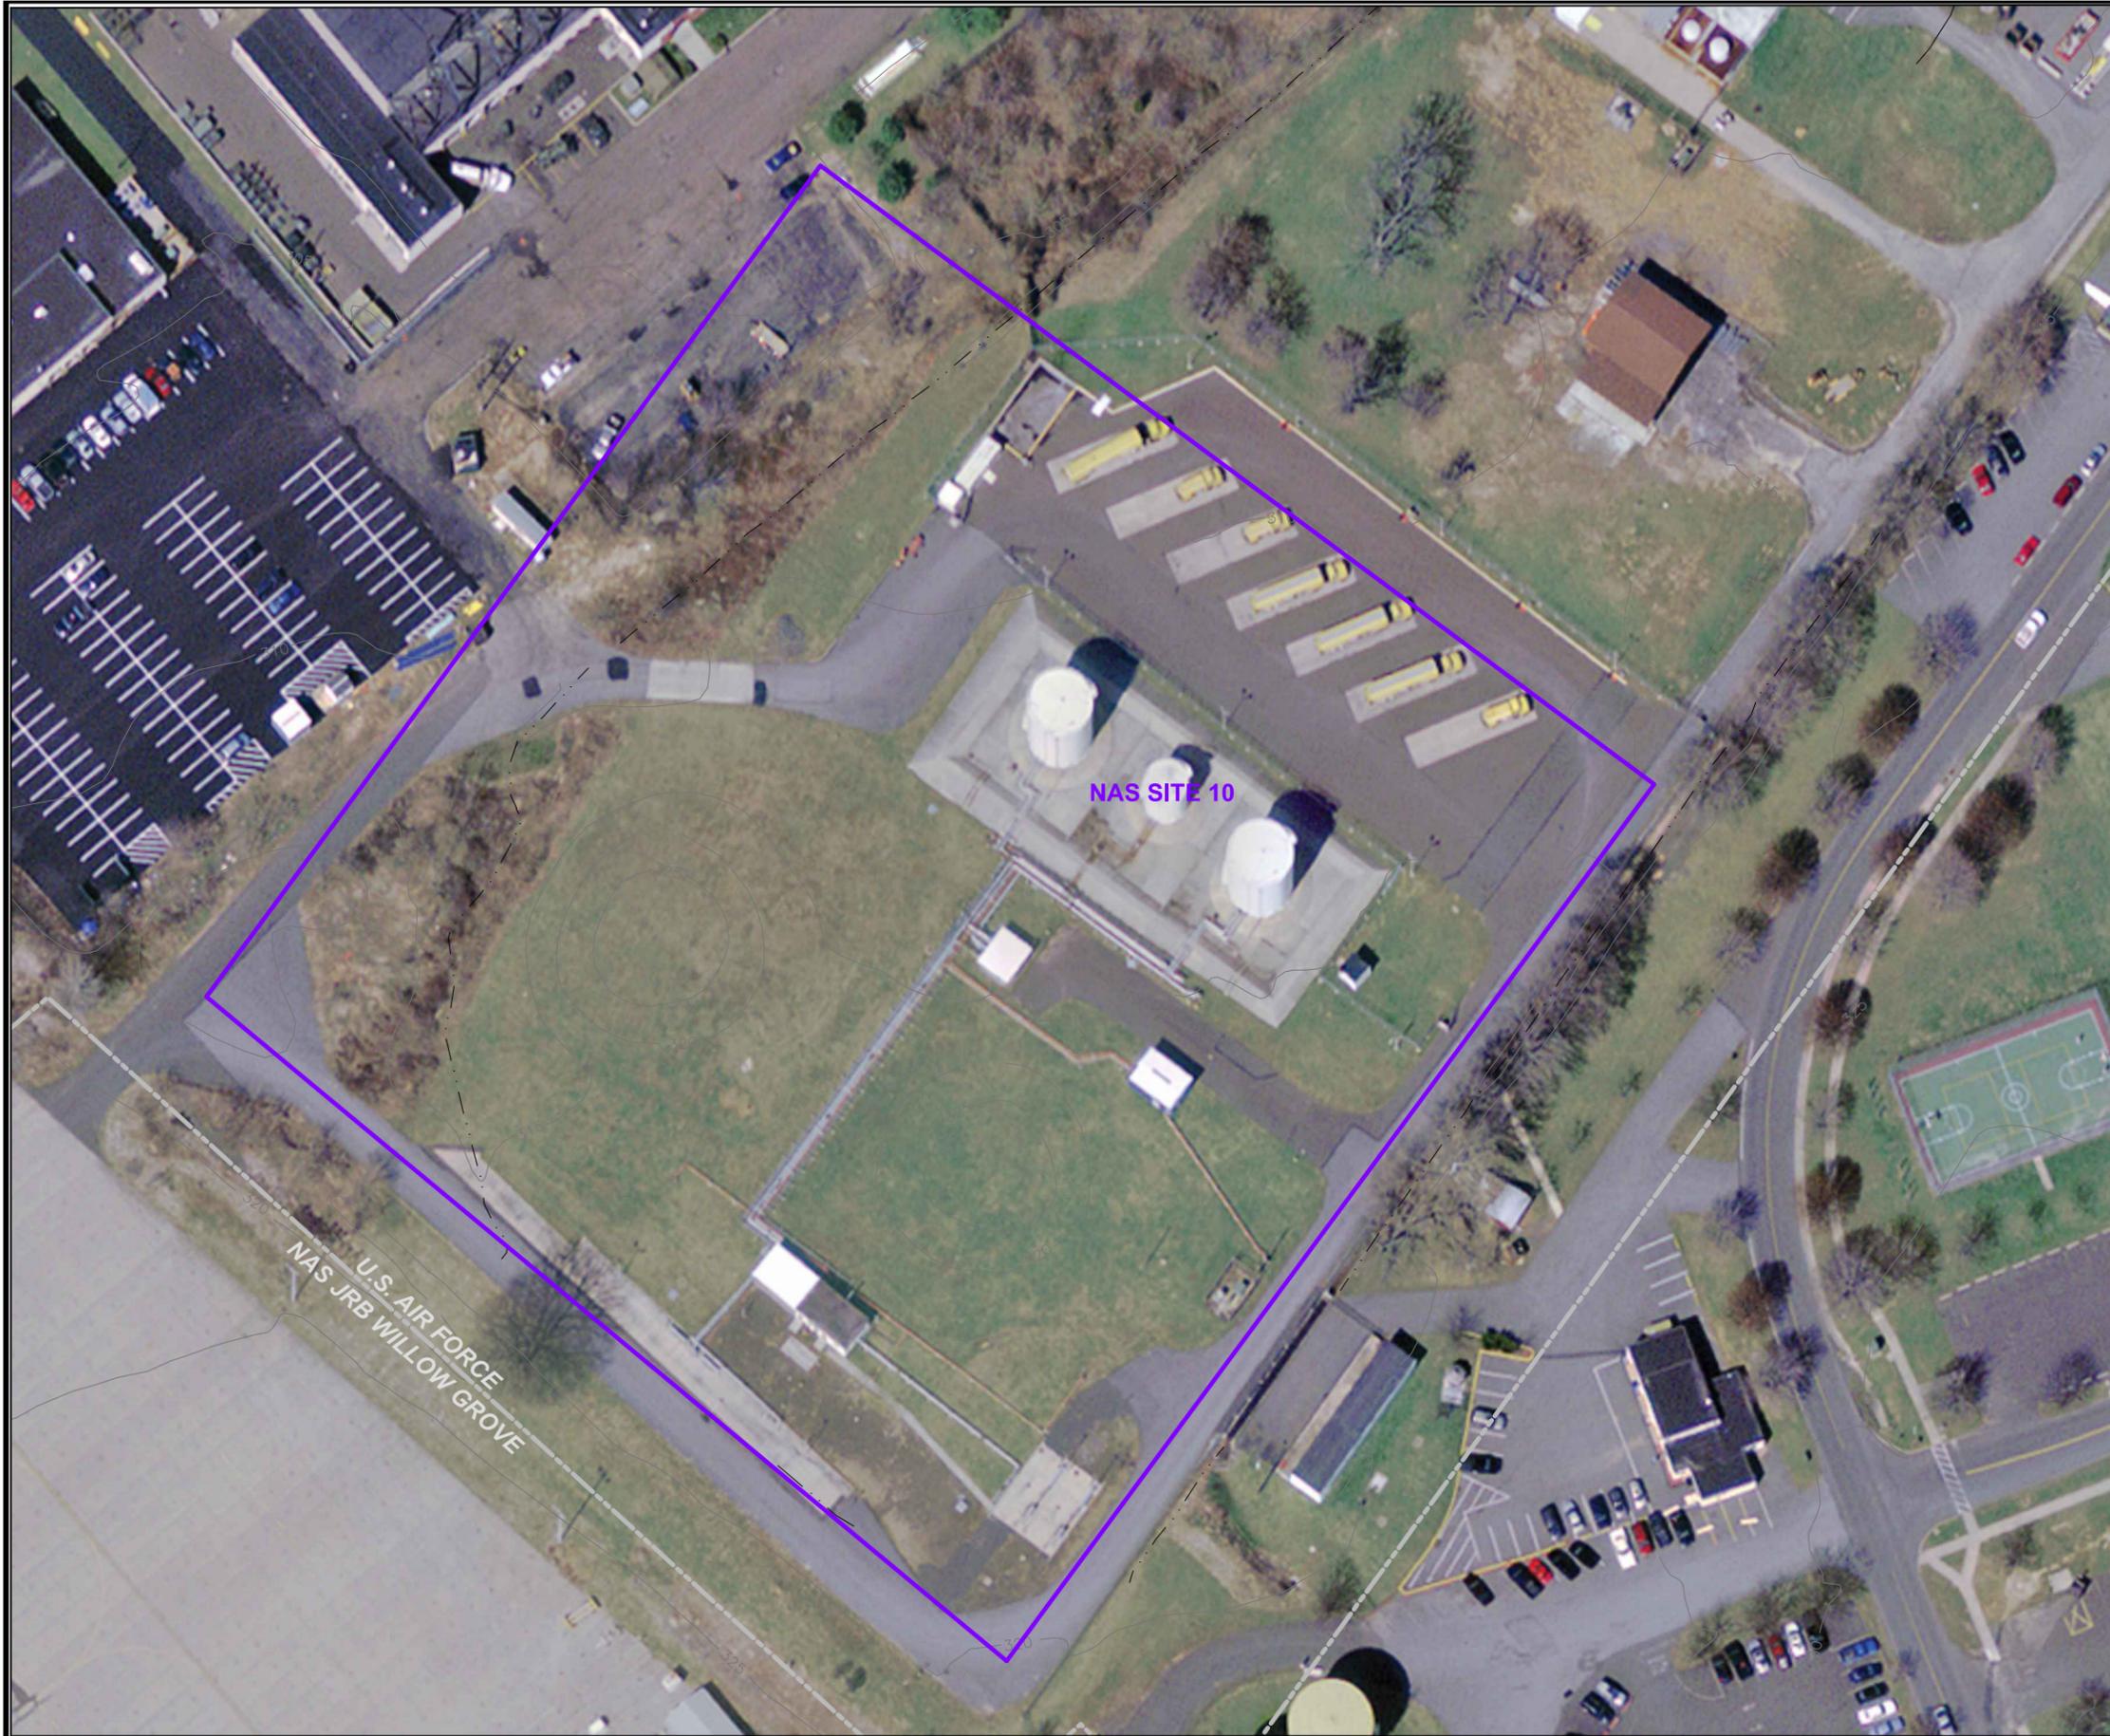
FILE 112G02014GM01-10	SCALE AS NOTED
FIGURE NUMBER FIGURE 3-11	REV DATE 0 06/13/13

SITE LAYOUT
 SITE 10 – NAVY FUEL FARM
 NAS JRB WILLOW GROVE
 WILLOW GROVE, PENNSYLVANIA

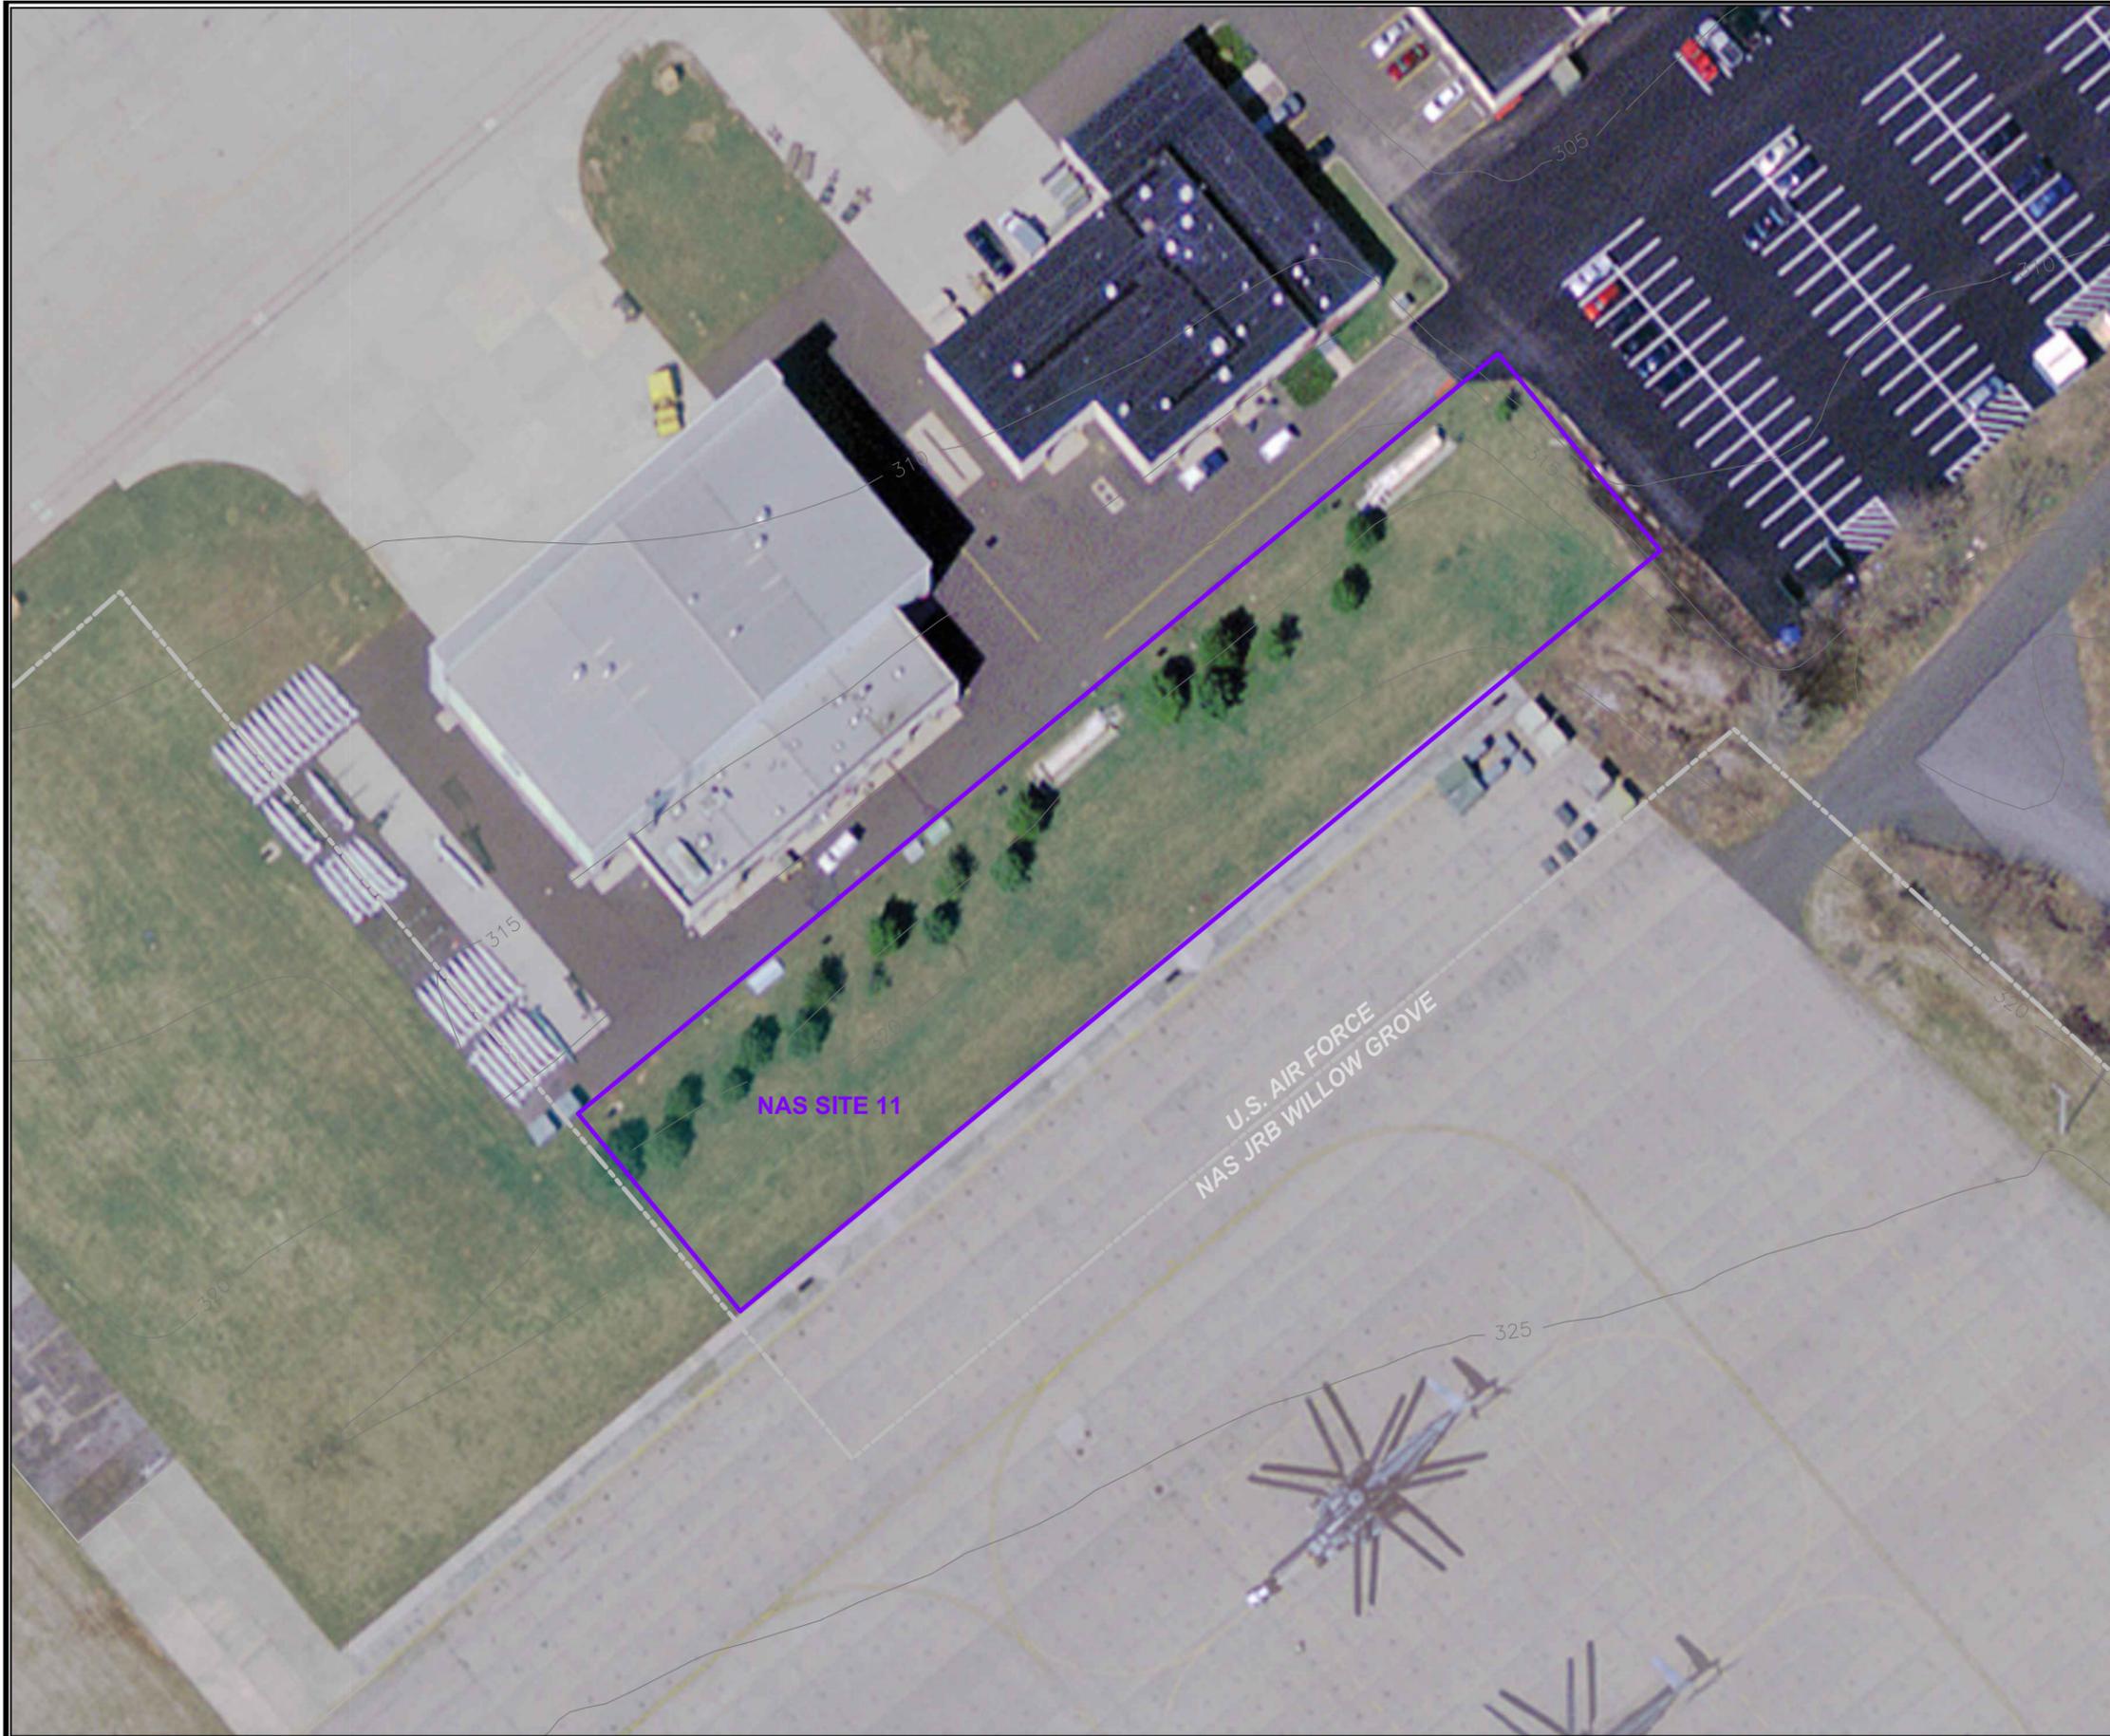
FILE 112G02014GM01-11	SCALE AS NOTED
FIGURE NUMBER FIGURE 3-12	REV DATE 0 06/13/13

**SITE LAYOUT
SITE 11 – AIRCRAFT DE-FUELING AREA
NAS JRB WILLOW GROVE
WILLOW GROVE, PENNSYLVANIA**
