TECHNICAL MEMORANDUM ABOVEGROUND STORAGE TANK INSPECTION BUILDING
181, 183, AND 184 NAS WILLOW GROVE PA
08/12/2013
RESOLUTION CONSULTANTS

Technical Memorandum
Aboveground Storage Tank Inspection – Building 181, 183, and 184
NAS JRB Willow Grove, PA
August 12, 2013

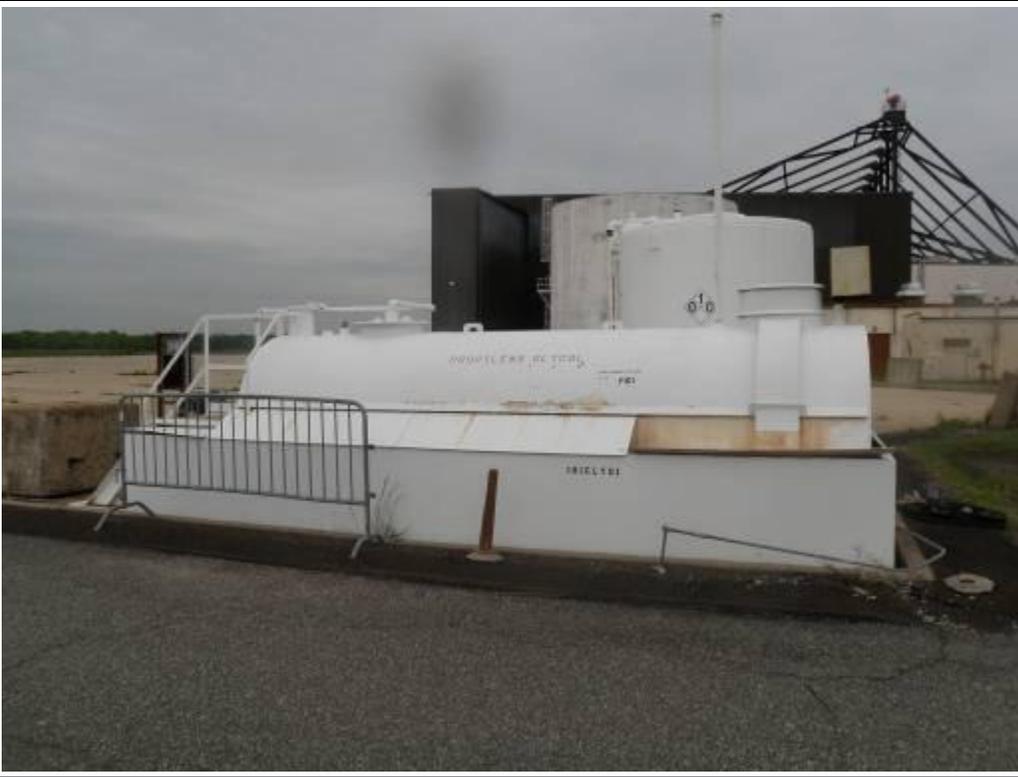
Photo No. 1	Date: 5/15/13
------------------------------	-------------------------

View of the closed in-place propylene glycol AST (181GLY01) located observed approximately 100 feet southwest of Building 184.

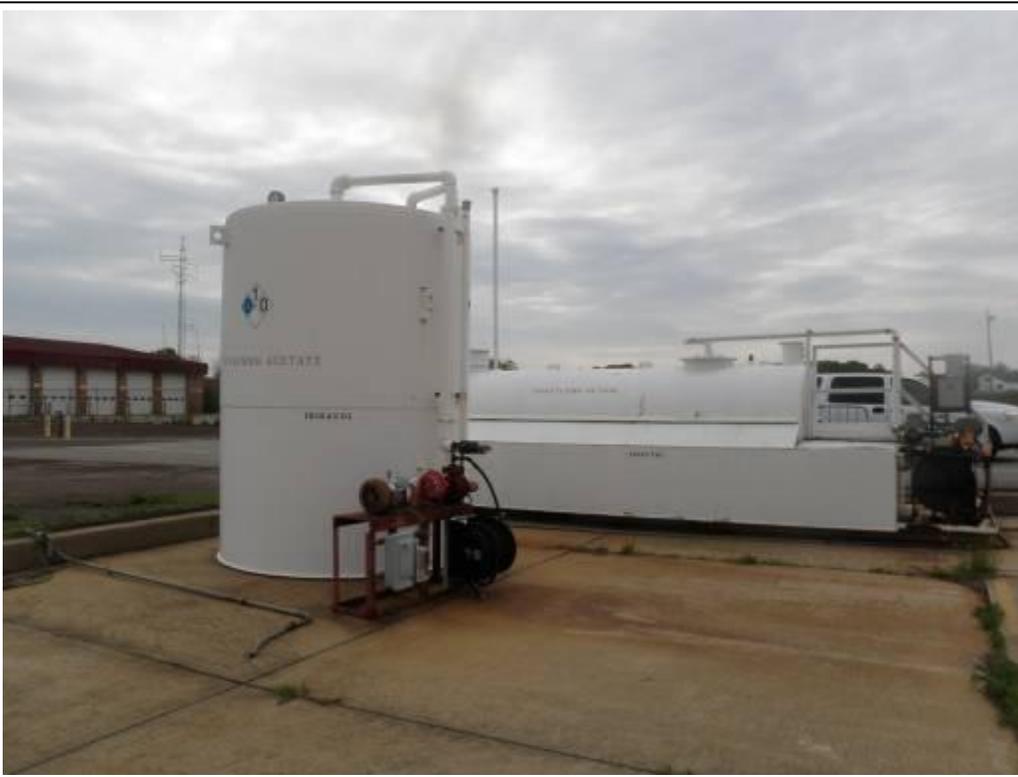
Photo No. 2	Date: 5/15/13
------------------------------	-------------------------

View of the closed in-place potassium acetate AST (181KAC01) located observed approximately 100 feet southwest of Building 184.

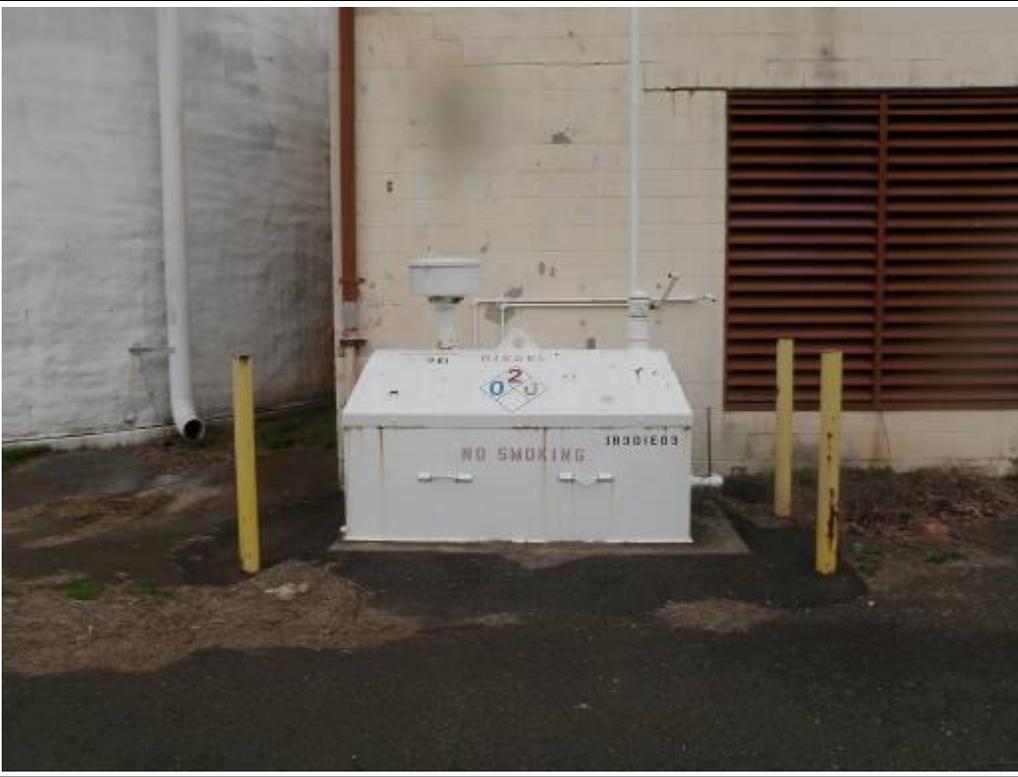
Photo No.: 3	Date: 5/15/13
-------------------------------	-------------------------

Front view of a diesel AST (183DIE03) observed on the southern side of Building 183.

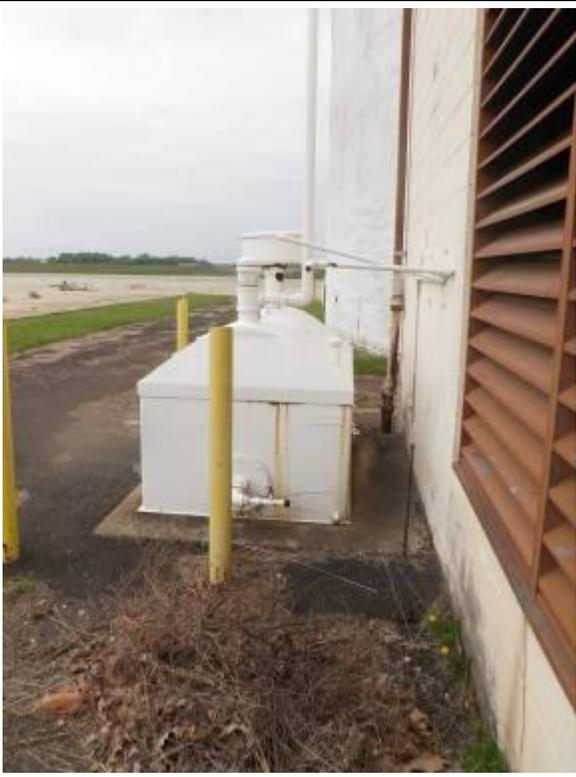
Photo No.: 4	Date: 5/15/13
-------------------------------	-------------------------

Side view of a diesel AST (183DIE03) observed on the southern side of Building 183.

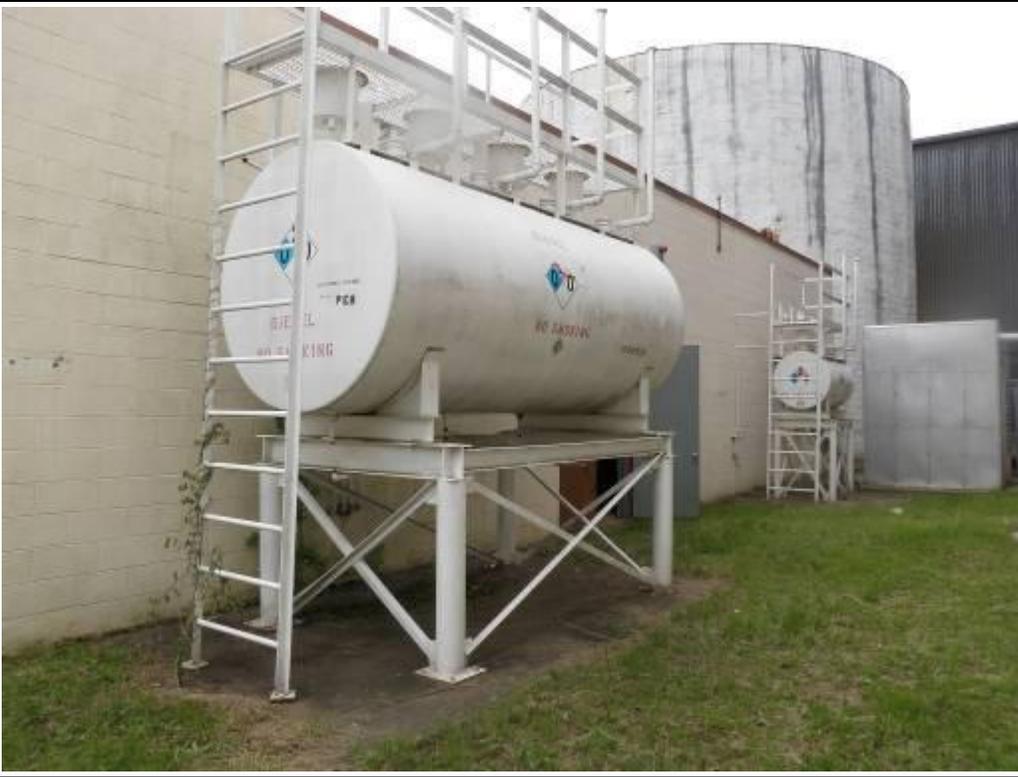
Photo No.: 5	Date: 5/15/13
-------------------------------	-------------------------

View of diesel ASTs (183 DIE01 and 183 DIE02) observed on the northern side of Building 183.

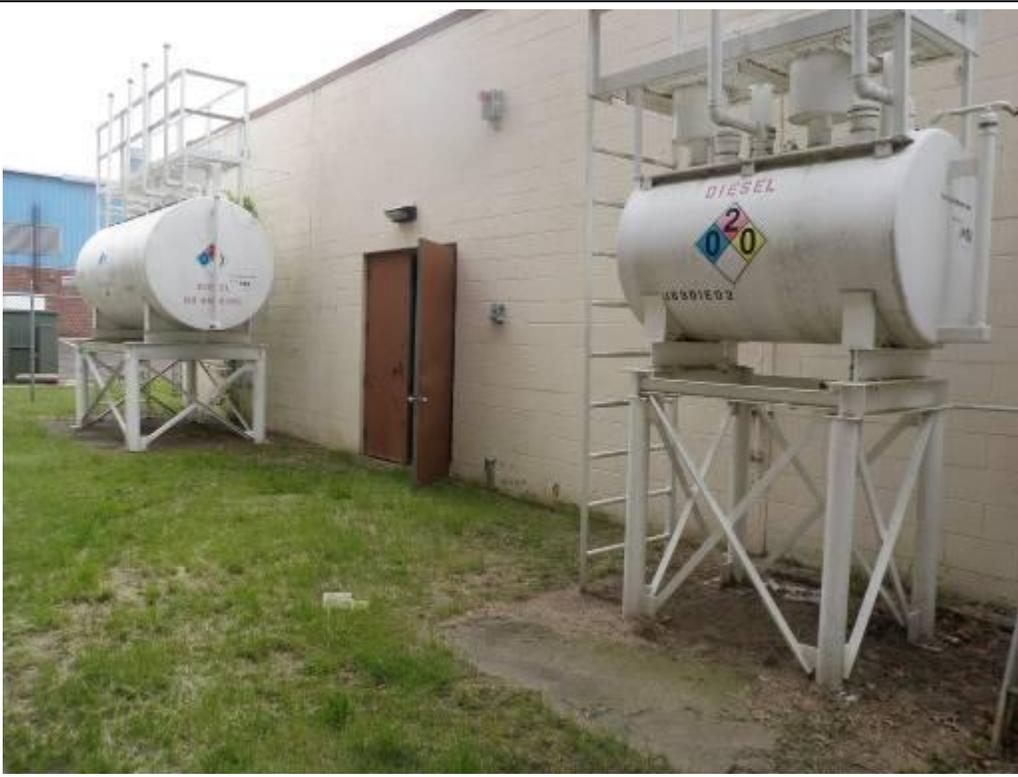
Photo No.: 6	Date: 5/15/13
-------------------------------	-------------------------

Alternative view of diesel ASTs (183 DIE01 and 183 DIE02) observed on the northern side of Building 183.
