Final Technical Memorandum

**Summary Report for Non-Intrusive
Geophysical Investigation
Turkey Road Landfill (Formerly Site 2)**

Naval Weapons Station Yorktown
Yorktown, Virginia

GEOPHYSICAL INVESTIGATION REPORT

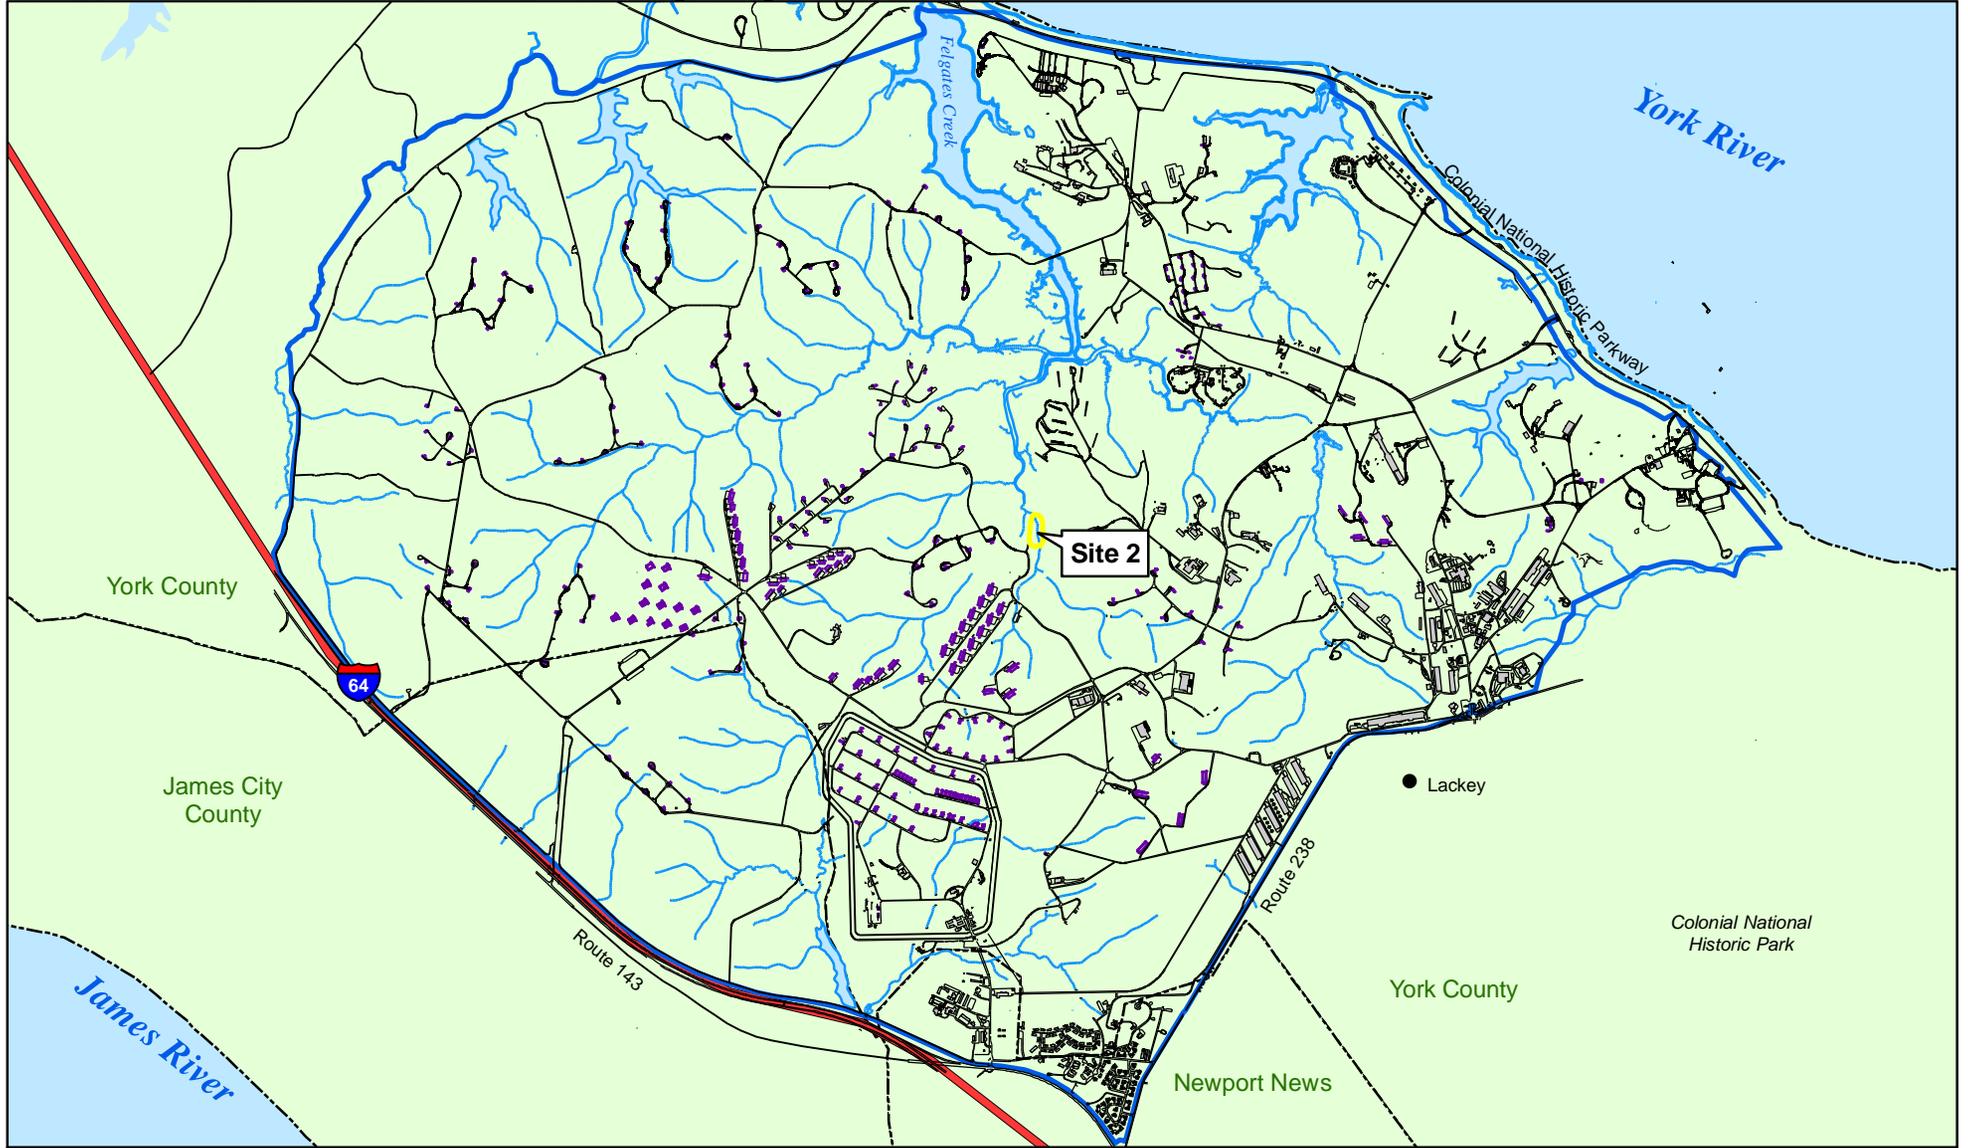
Turkey Road Landfill is a 5-acre landfill located east of Turkey Road and adjacent to a wetland area of the Southern Branch of Felgates Creek and two unnamed tributaries that border the landfill (**Figure 1**). Operations at the landfill reportedly began in the 1940s and ceased in 1981. Wastes disposed in this landfill reportedly included mercury and carbon-zinc batteries, tree stumps and limbs, construction rubble, missile hardware (e.g., wings, fins, power packs), electrical devices, and unidentified drums and tanks. An estimated 240 tons of waste were disposed during the period of use. Waste material was primarily located along the tributaries to the Southern Branch of Felgates Creek. Key documents and milestones in the site's history are summarized in **Table 1**.

Naval Weapons Station (WPNSTA) Yorktown is a 10,624-acre installation located on the Virginia Peninsula in York and James City Counties and the City of Newport News (**Figure 1**). WPNSTA Yorktown is bounded on the northwest by WPNSTA Yorktown Cheatham Annex and the King's Creek Commerce Center, on the northeast by the York River and the Colonial National Historic Parkway, on the southwest by Route 143 and Interstate 64, and on the southeast by Route 238 and the town of Lackey. MRS 2 is a 5-acre disposal area located east of Turkey Road in a wetland area adjacent to the southern branch of Felgates Creek (**Figure 2**).

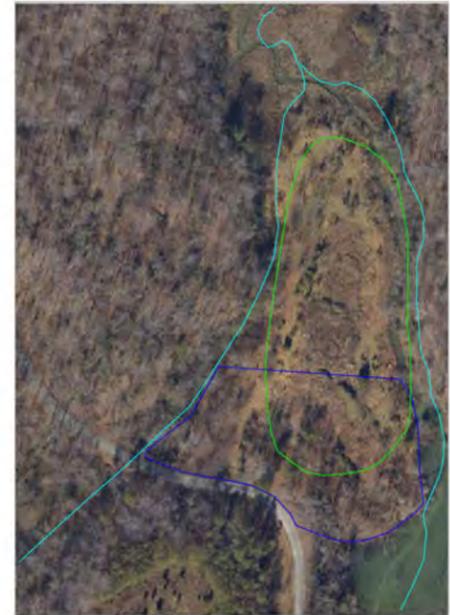
Figure 2
Site 2 - Turkey Road Landfill
WPNSTA Yorktown
Yorktown, Virginia

As part of the Preliminary Site Investigation (SI) for the MRS a magnetometer investigation was conducted to ascertain the extent of buried ferrous metal in an area consisting of approximately three vegetated acres in the southern part of the Turkey Road Landfill (**Figure 2**). The primary objective of the investigation was to determine the southern boundary of the landfill. Details concerning the equipment, approach, methods, operational procedures, and quality control methods to be implemented during the geophysical investigation were outlined in the geophysical investigation plan (GIP) which was part of the Technical Memorandum Work Plan (CH2M HILL, 2010). The information and general tasks needed to support the investigation were identified as:

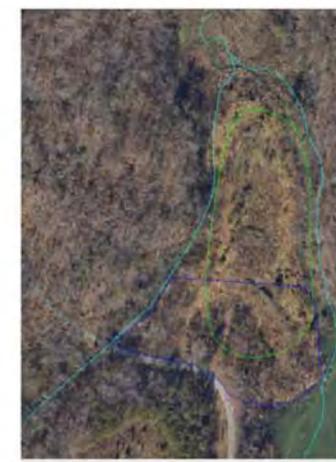
FIGURE 3
 Site 2 -Turkey Road Landfill DGM Transects
 WPNSTA Yorktown
 Yorktown, Virginia

Prior to geophysical mapping, 5-foot wide transects were cleared of vegetation and marked with wooden stakes as visual aids for walking the transects and positioning the data. Data was then collected using a Geometrics G-858 magnetometer along each of the transects. Use of a global positioning system (GPS) or robotic total system (RTS) was not feasible due to the forested canopy. Therefore, the data were collected by the magnetometer at a constant rate, which meant local positions could be calculated when the magnetometer operator walked at a constant pace between the stakes. The data positions were subsequently converted to North American Datum of 1983 (NAD83) Universal Transverse Mercator (UTM) Zone 18N coordinates; the data collected were reviewed by the field team and then sent to NAEVA's office for preprocessing and processing using Geosoft Oasis Montaj software. A map overlain with the processed transect data is provided as **Figure 3**, and a

The G-858 was operated in vertical gradient mode (two vertically-separated sensors operating simultaneously), eliminating the necessity for a magnetics base station. Ferrous material typically manifests a remnant magnetic field that varies in orientation from that of the Earth's magnetic field. The summation of the remnant field to the Earth's field results in distortions in the overall field. These local, high frequency (short wavelength) anomalies in the Earth's magnetic field can therefore be interpreted as caused by ferrous material. G-858 data were collected at a rate of 10 readings per second.

- Evaluation and refinement of normalization corrections
- Evaluation and refinement of lag
- Additional digital filtering and enhancement, as necessary
- Generation of formatted ASCII files containing processed data
- Generation of final maps showing contoured gridded data and culture (**Figure 3**)

All data were processed as described in Section 3.2. All recorded culture information is noted and identified on the transect block map (**Figure 3**). Final data delivery reports list down-line data density statistics, lag, and gridding parameters used in processing each transect block.

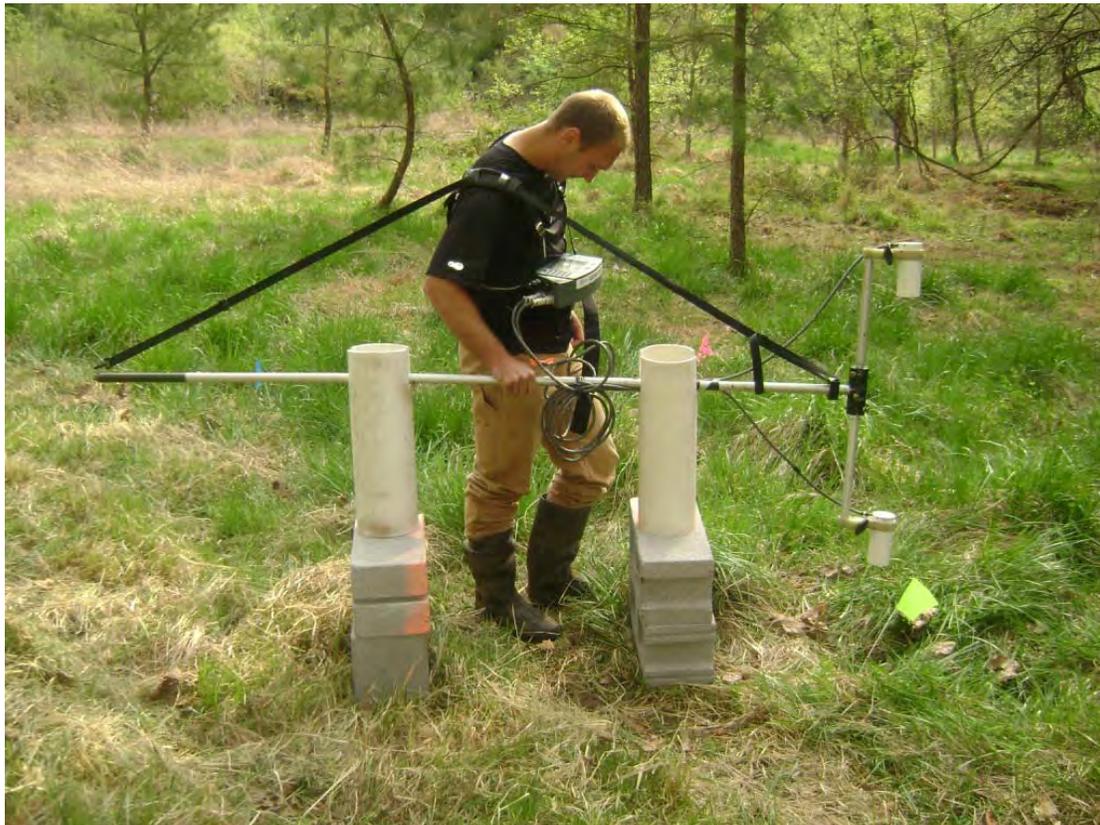
Figure 5: Collection of Static Test

To establish confidence in the data reliability, quality control (QC) tests were conducted throughout the project. Tests were conducted prior to, during, and after all data collection sessions, and were reviewed by a qualified geophysicist. All QC tests for the G-858 magnetometer were conducted after a minimum 20 minute warm-up period for the electronics. QC tests performed included Static Background and Static Spike Tests, Cable Shake Tests, Personnel Tests, Azimuthal Tests, Octant Tests, and Repeat Data Tests. These tests all provided results within acceptable limits (**Appendix A**), though some positioning error was introduced because a GPS or RTS could not be utilized and position calculations relied upon the assumption of a constant walking speed maintained by the magnetometer operator.

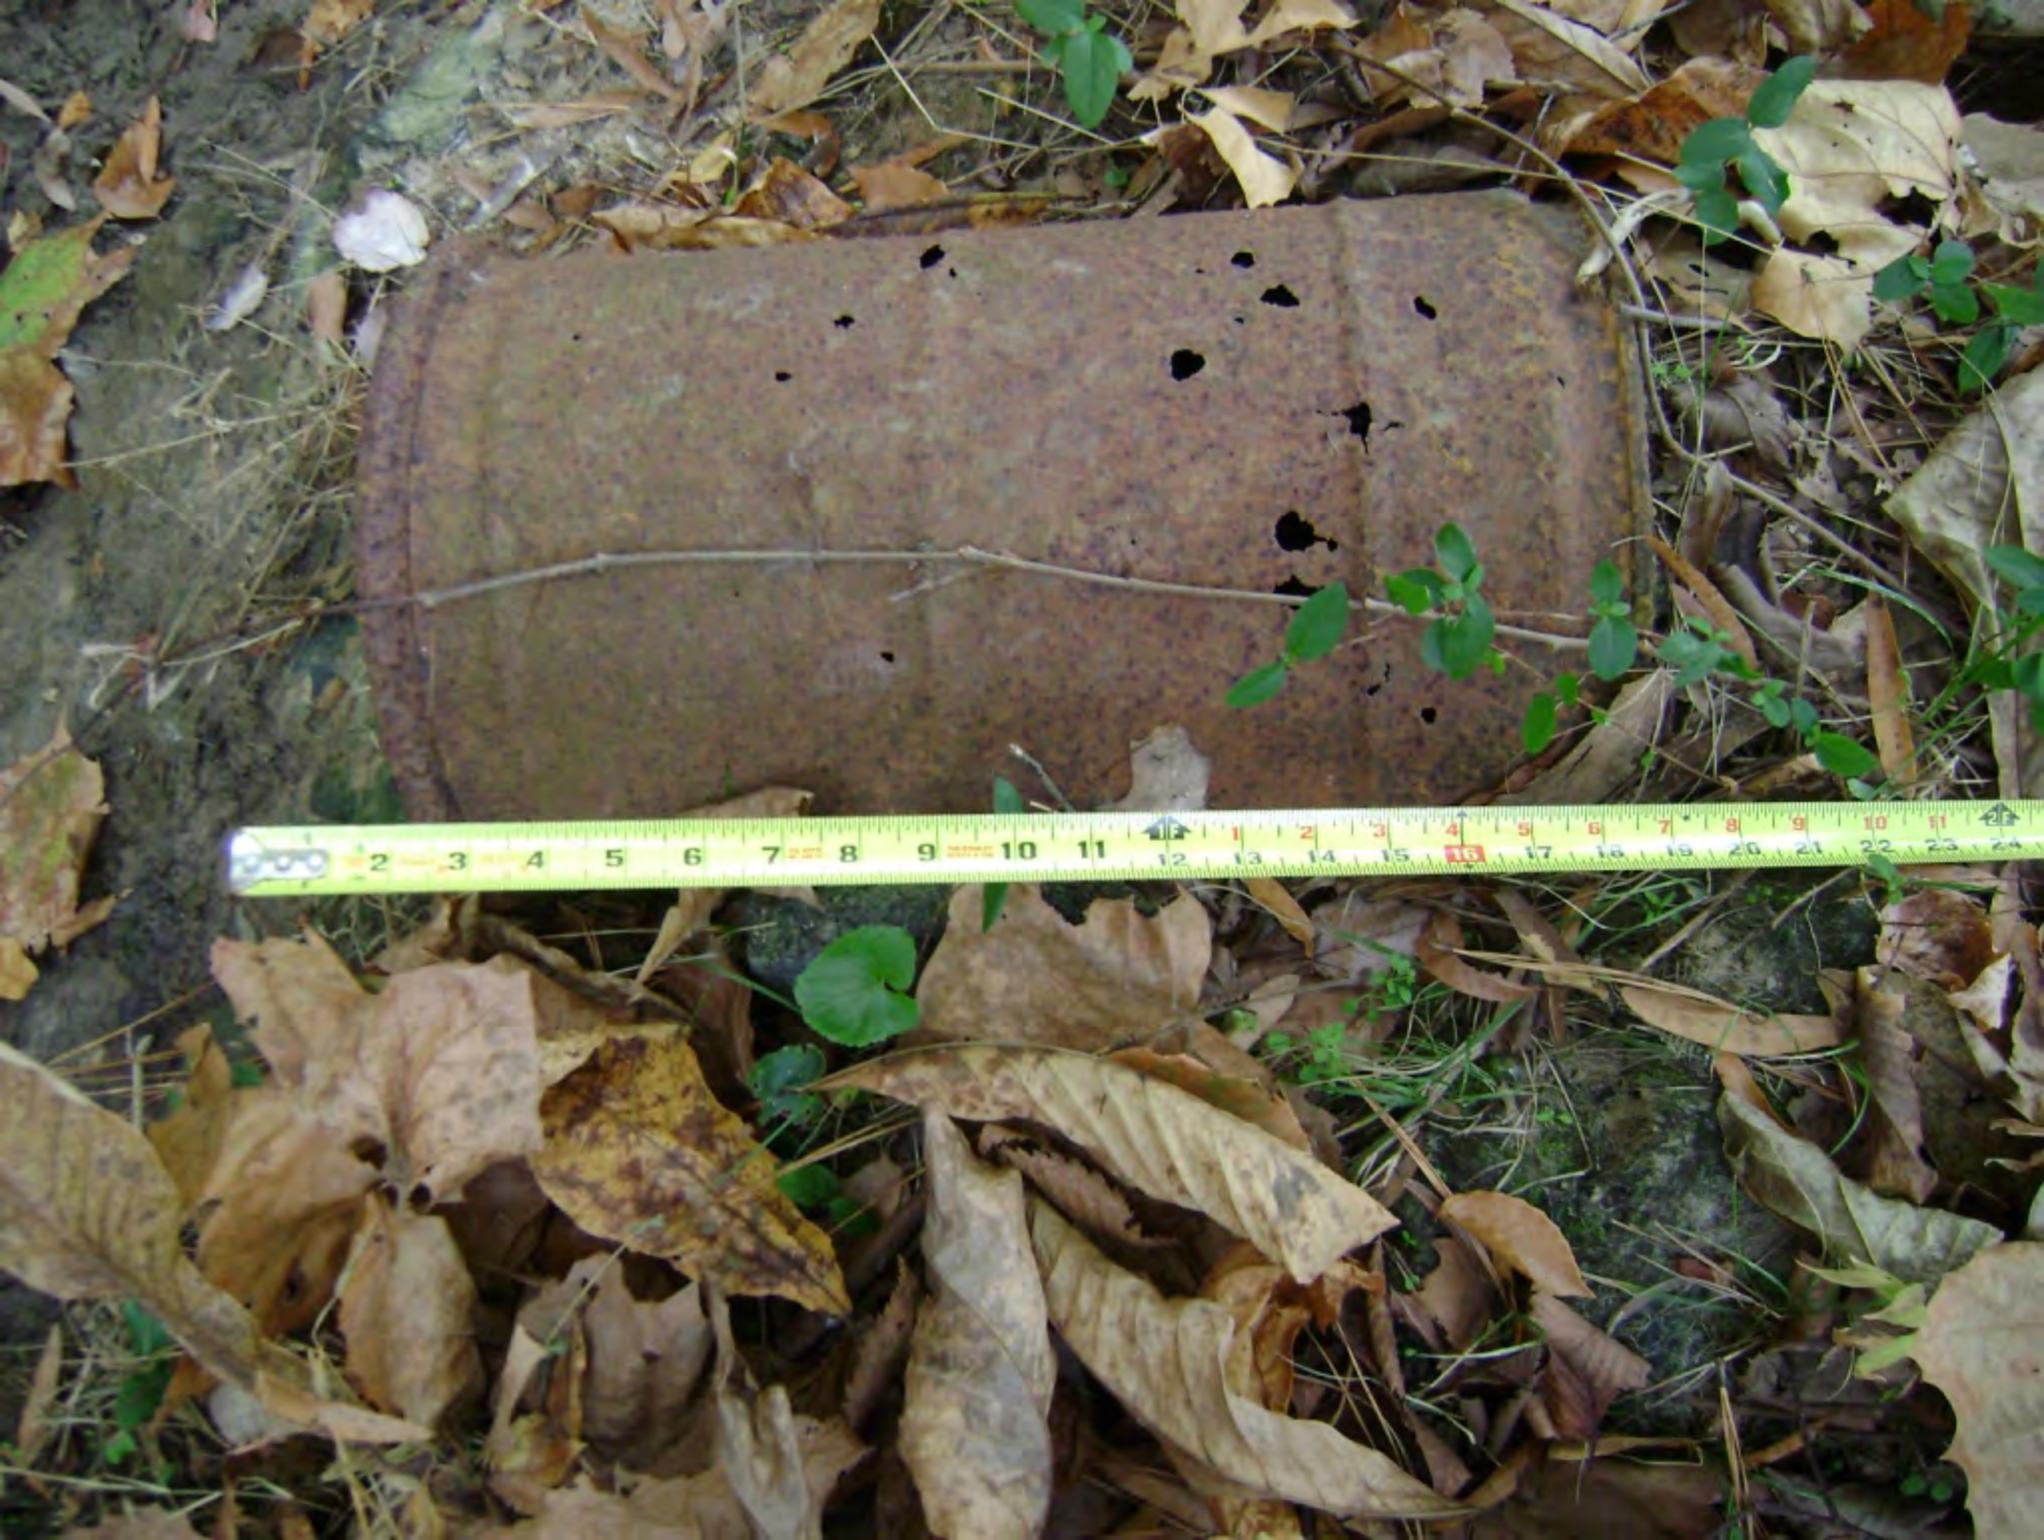
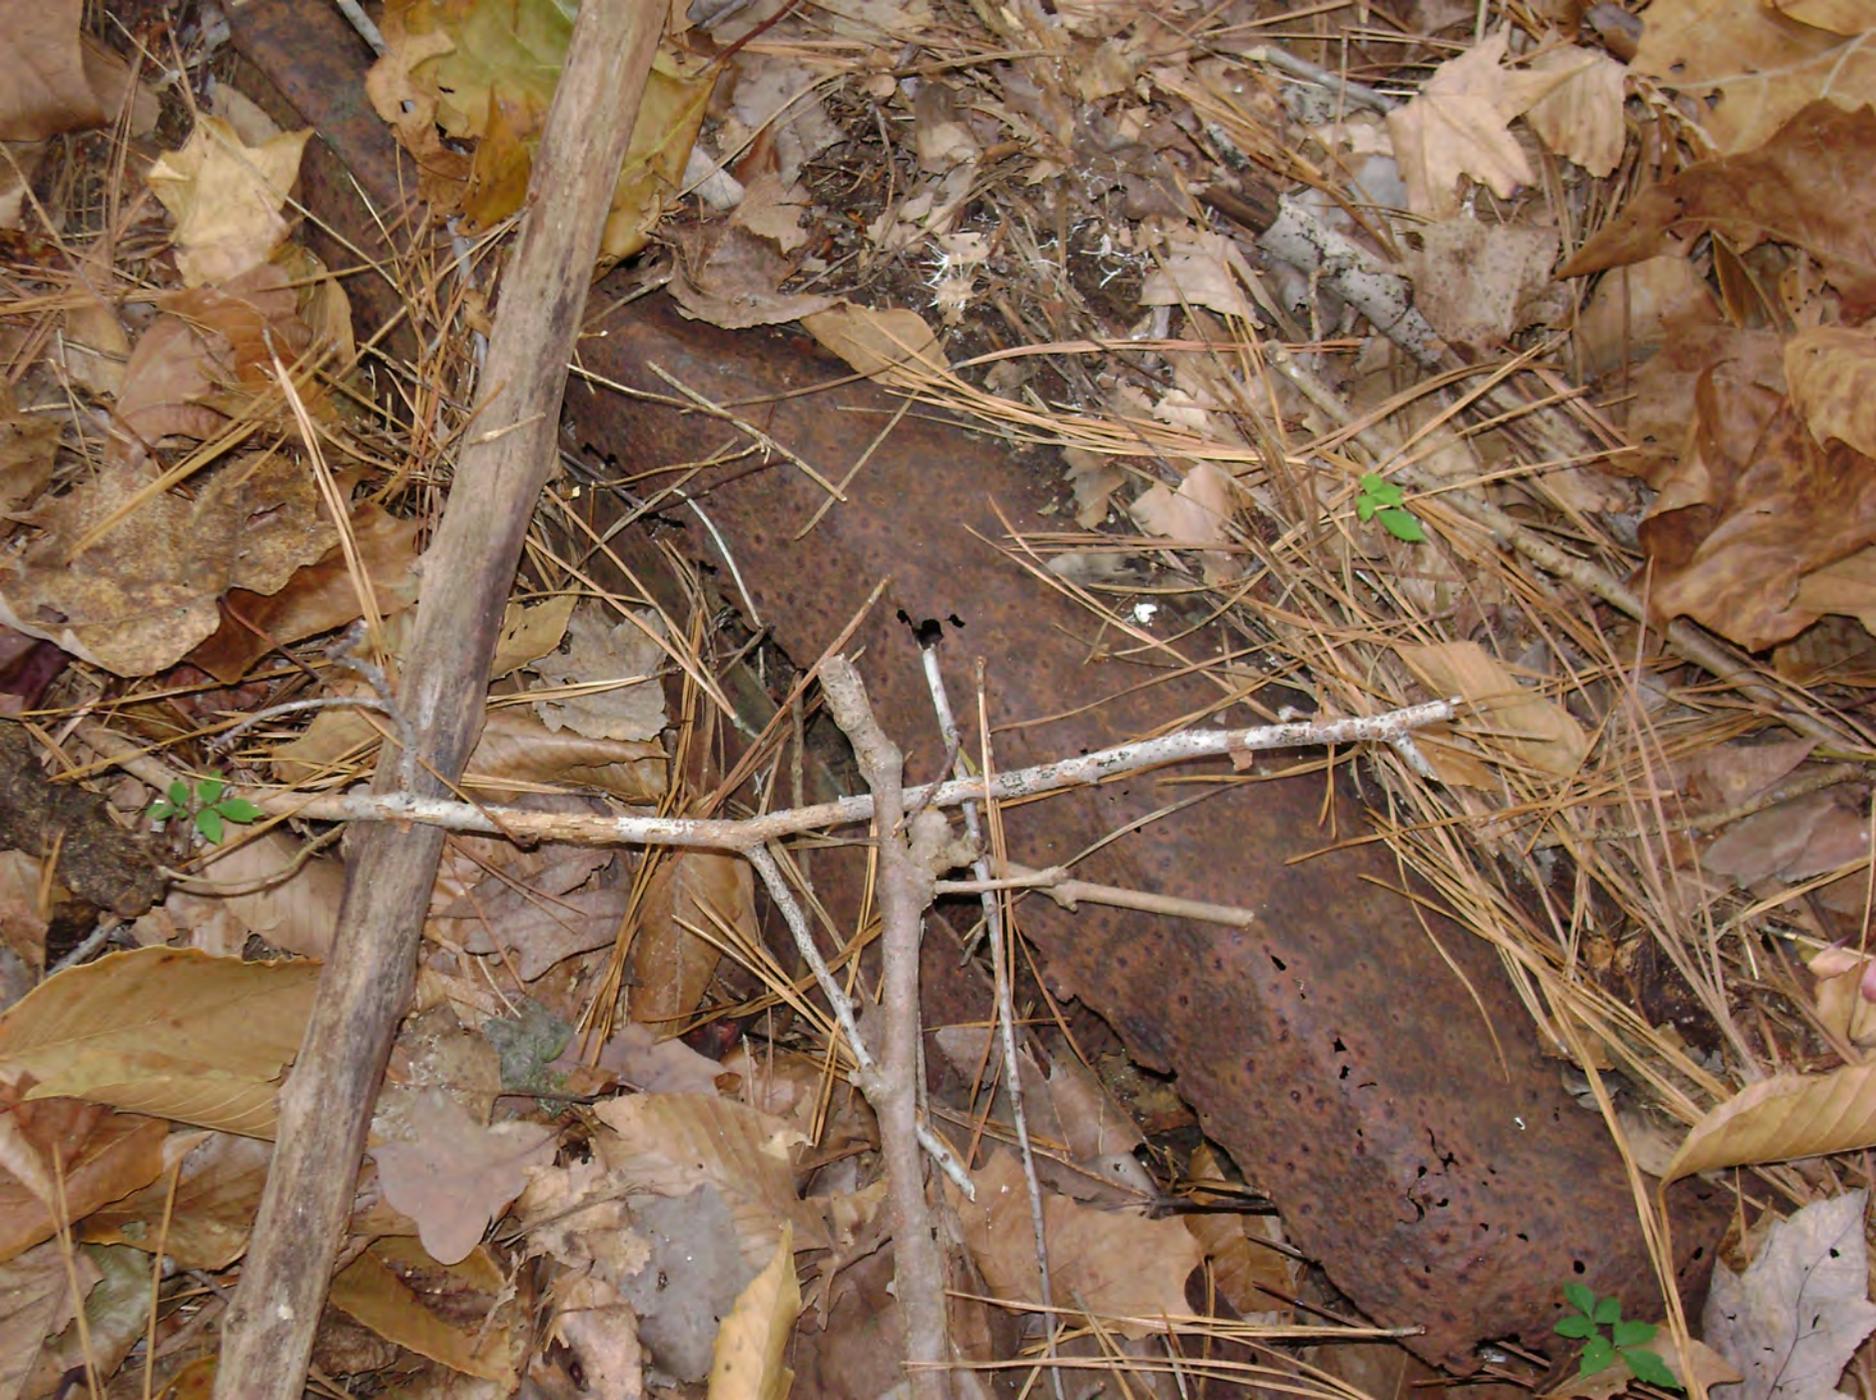
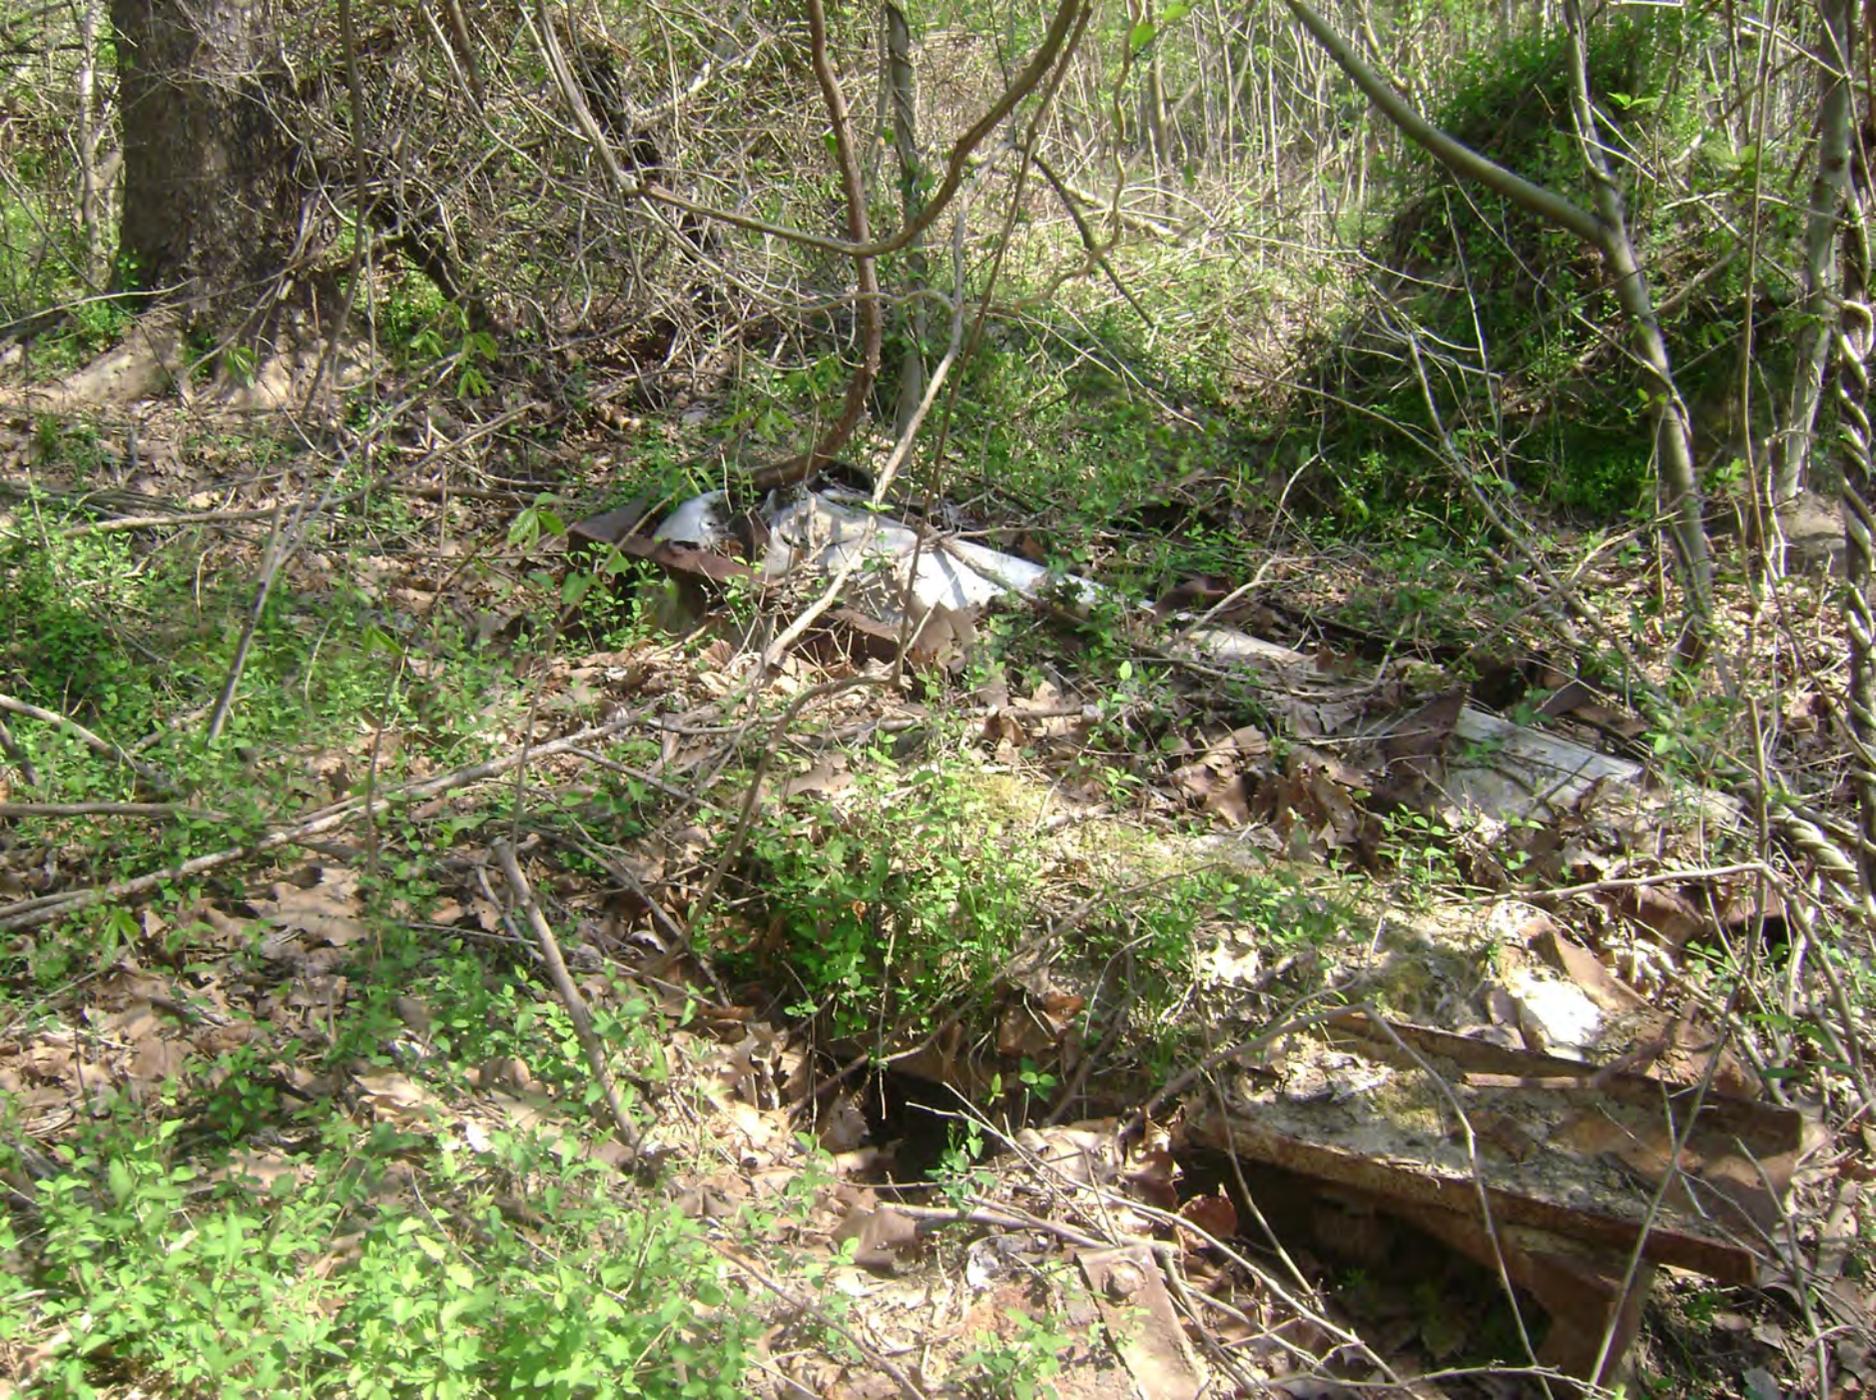
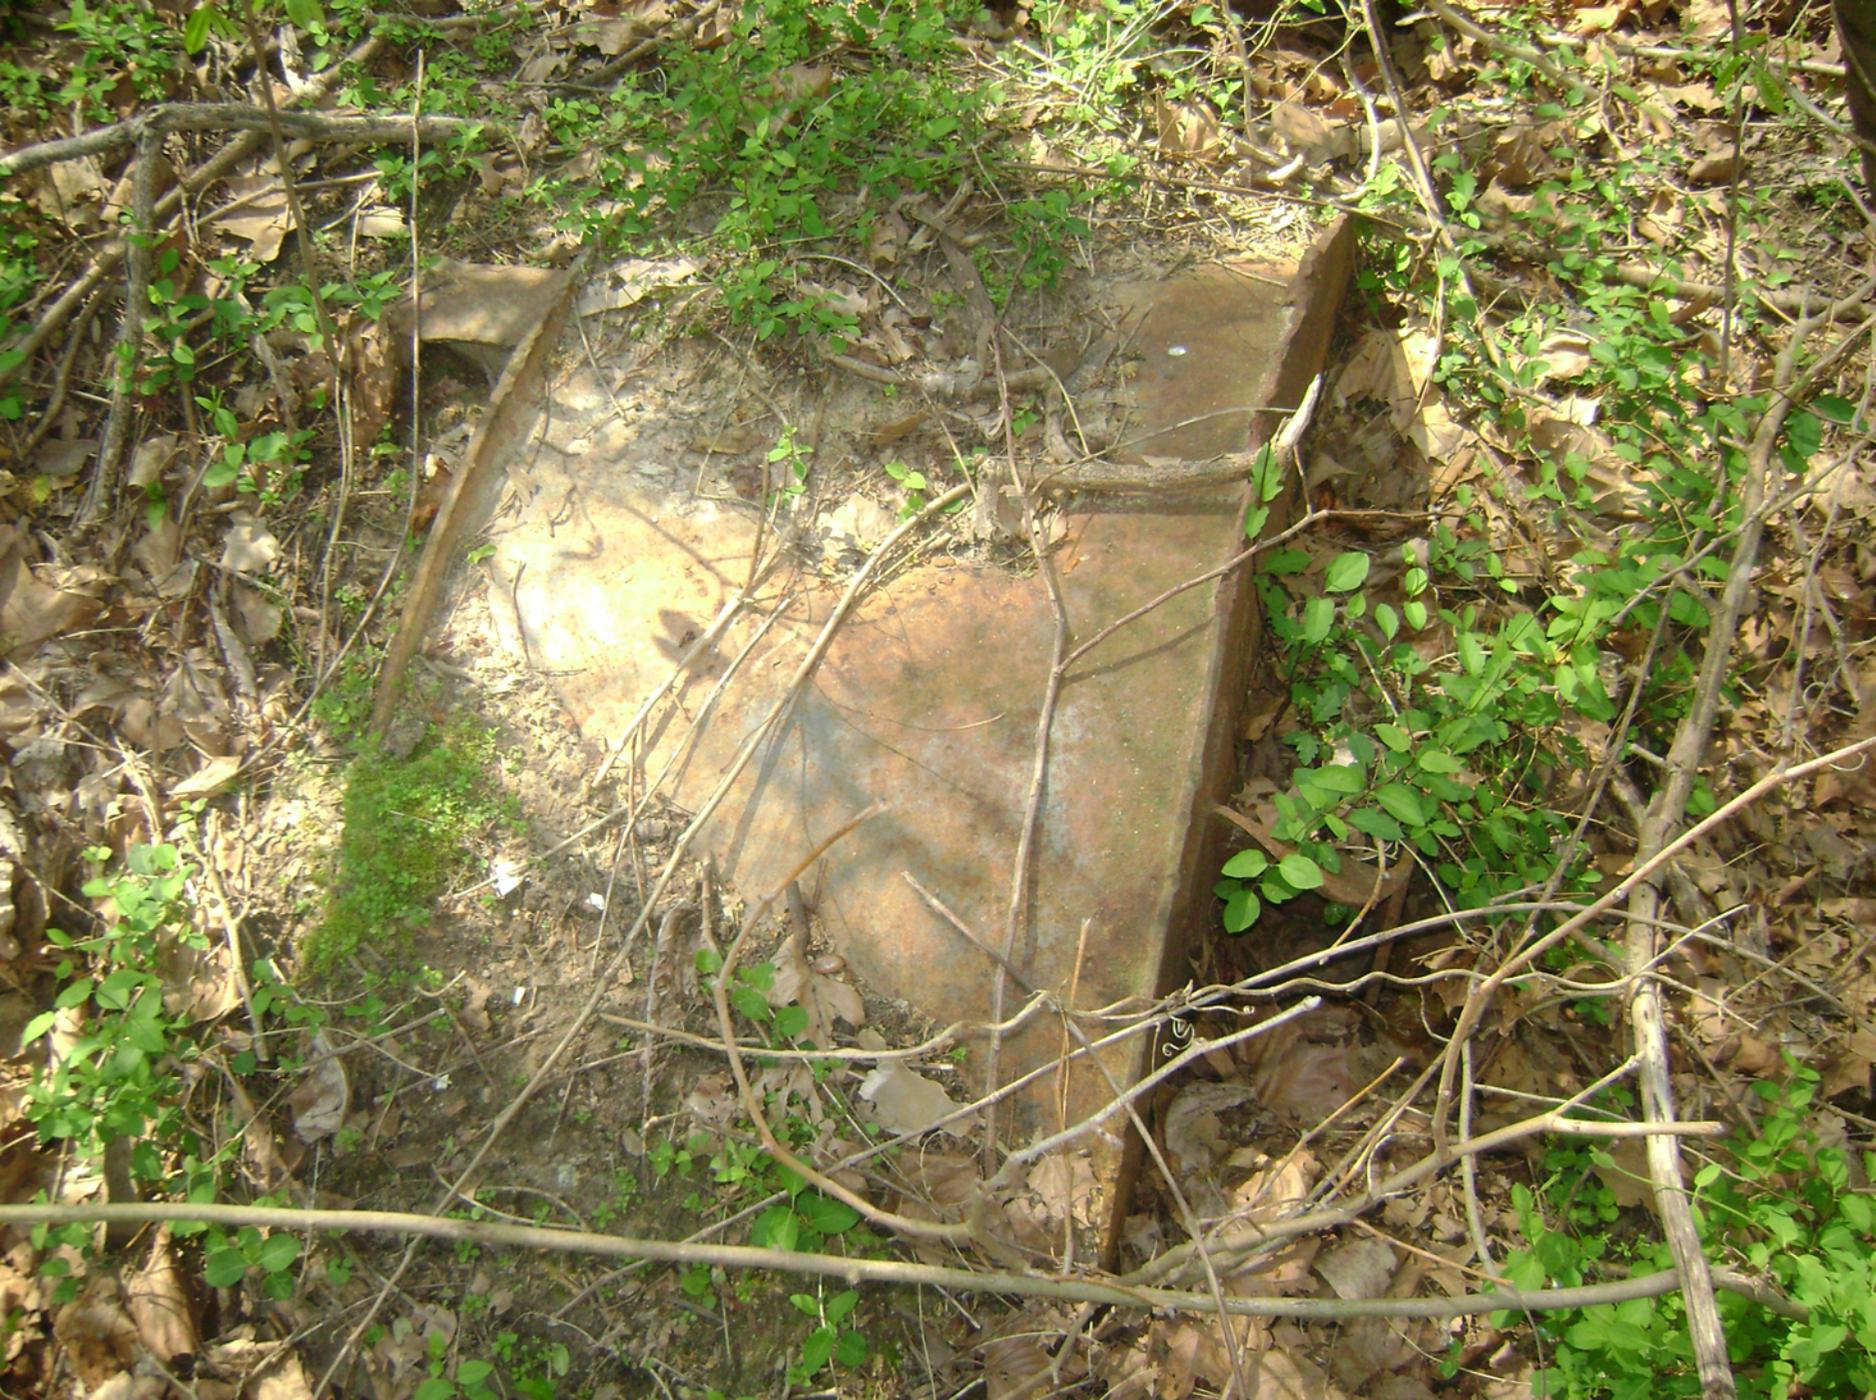
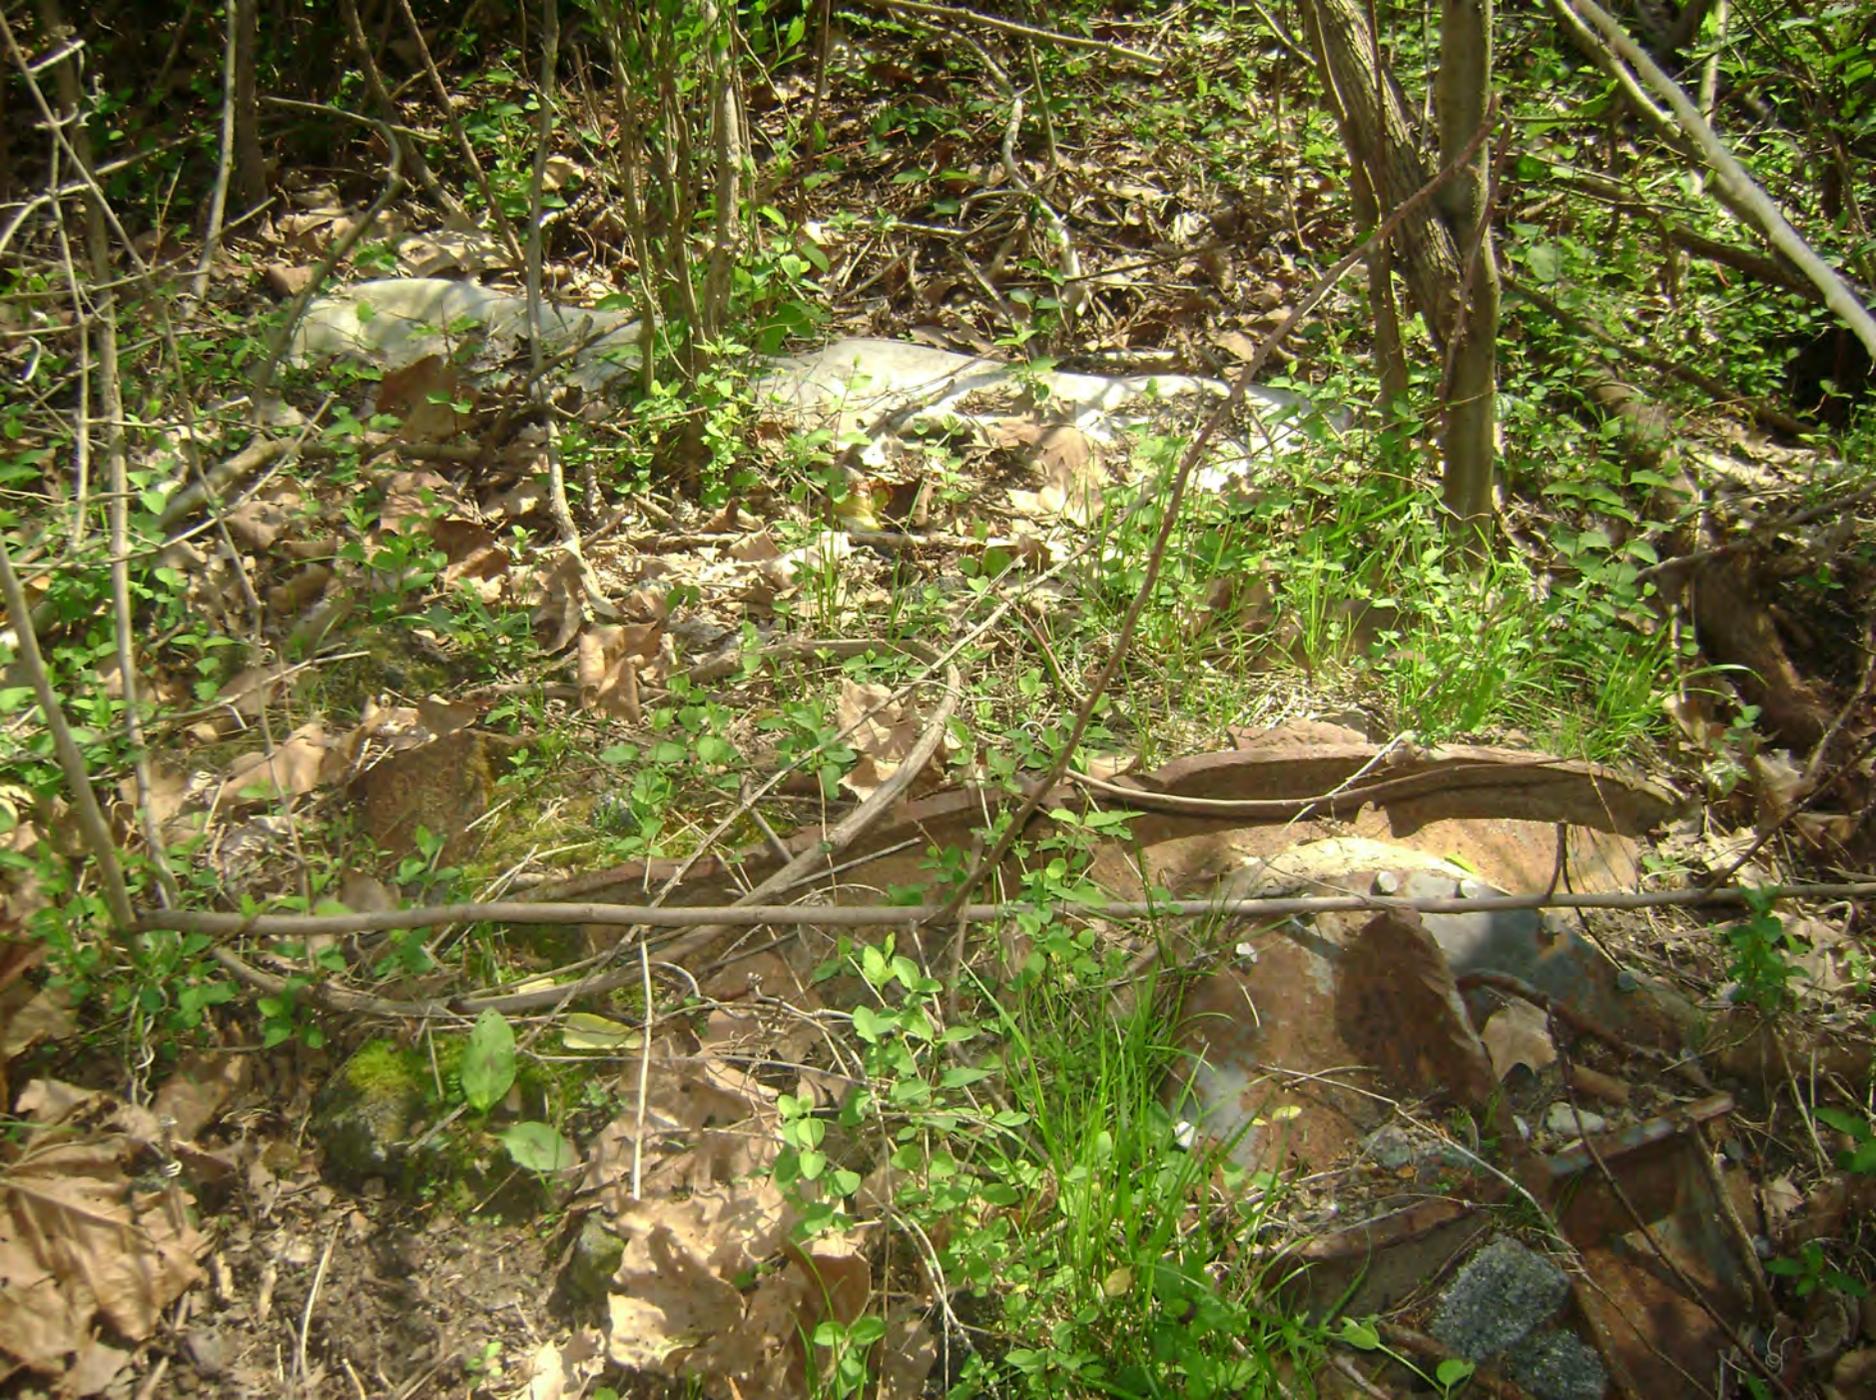
Appendix B
Debris Photo Summary

- A removal action was completed in 1994 at Site 2 to remove surface and near surface debris and waste. However, this removal action only removed the surface and near surface waste from designated areas at the site. Based upon the results of the DGM data collected and visual observations while in the field, metallic debris is still located at the site. Site photographs taken during the DGM survey further support this conclusion (**Appendix B**).
